Your Ref: Porsche 911 Carrera S Convertible
(chassis number WP0ZZZ99ZNS239105)
Our Ref : CI/TP23005685/D

06 June 2023

**INSPECTION REPORT OF AN UNREGISTERED PORSCHE 911 CARRERA S
CONVERTIBLE MOTOR CAR WITH CHASSIS NUMBER
WP0ZZZ99ZNS239105**

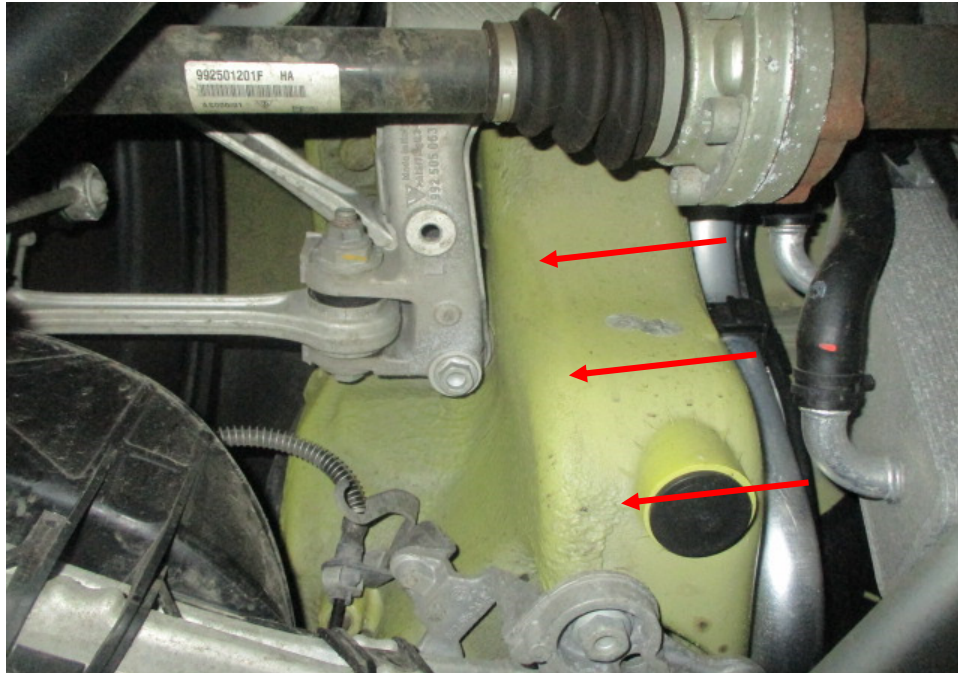
Photo 31 shows the chassis/structural body at the underside rear left of the Motor Car. The original factory sealant (arrowed) at the joints along the chassis/structural body was observed to be untouched. In general, I had found no work was carried out on the chassis/structural body of the Motor Car. The chassis/structural body of the Motor Car was originally fitted.

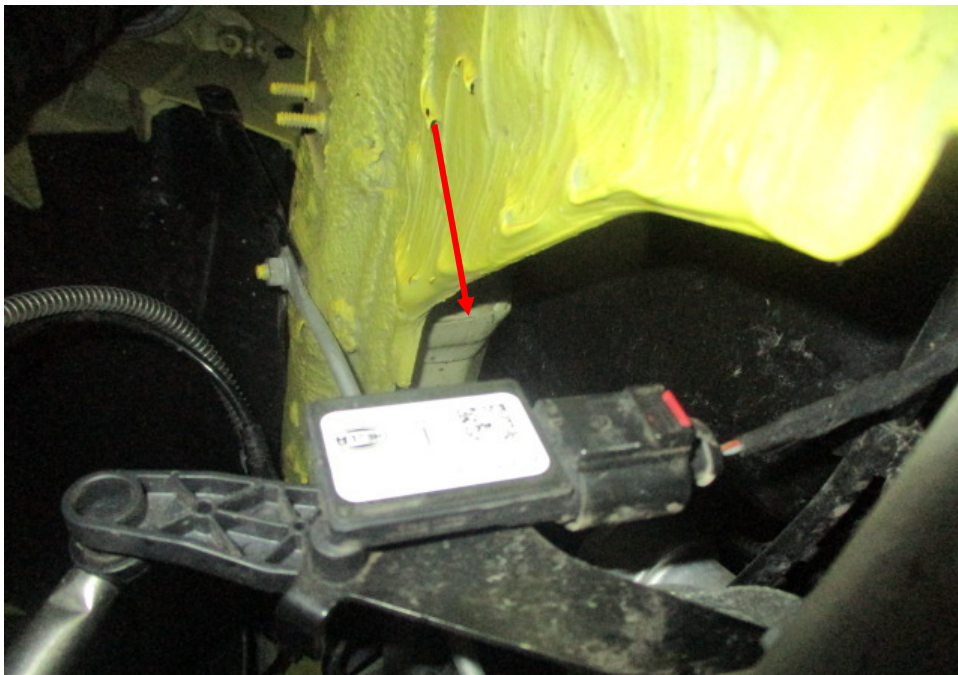
Photo 32 shows the chassis/structural body at the underside front left of the Motor Car. I did not find any weld marks other than original spot weld marks on the chassis/structural body of the Motor Car. The original factory sealant (arrowed) at the joints along the chassis/structural body was untouched, indicating no work was done on the chassis/structural body of the Motor Car and that the chassis/structural body was originally fitted.

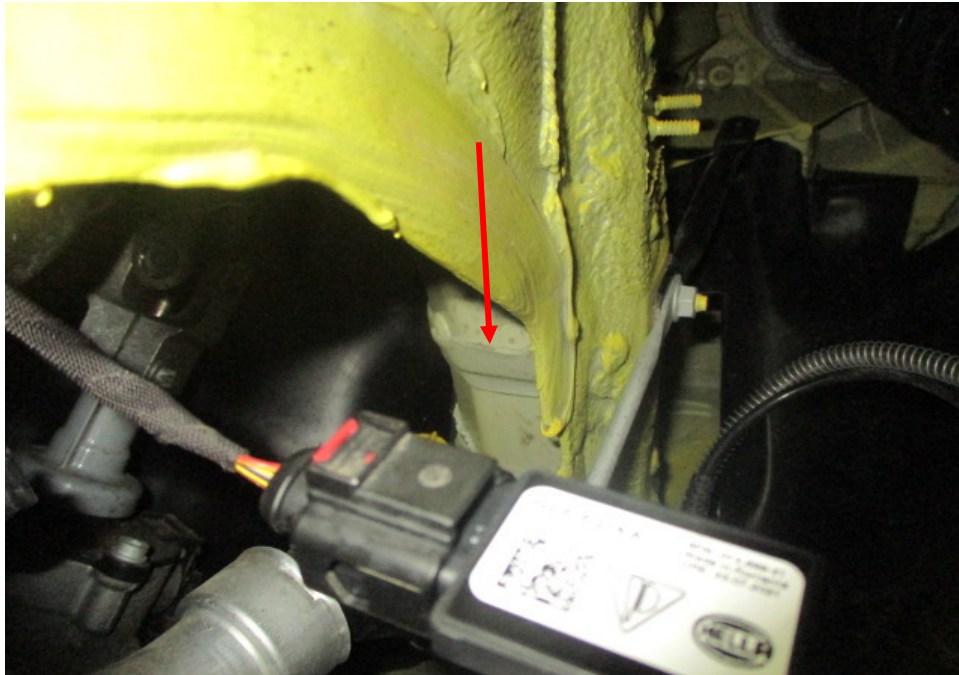
Photo 33 shows the chassis/structural body at the underside front right of the Motor Car. The original factory sealant (arrowed) at the joints along the chassis/structural body was observed to be untouched. In general, I had found no work was carried out on the chassis/structural body of the Motor Car. The chassis/structural body of the Motor Car was originally fitted.
