Our Ref : CI/SBS23005722/N

30 May 2023

SBS Transit Ltd.

MECHANICAL INSPECTION REPORT OF MOTOR BUS SG 1226Y

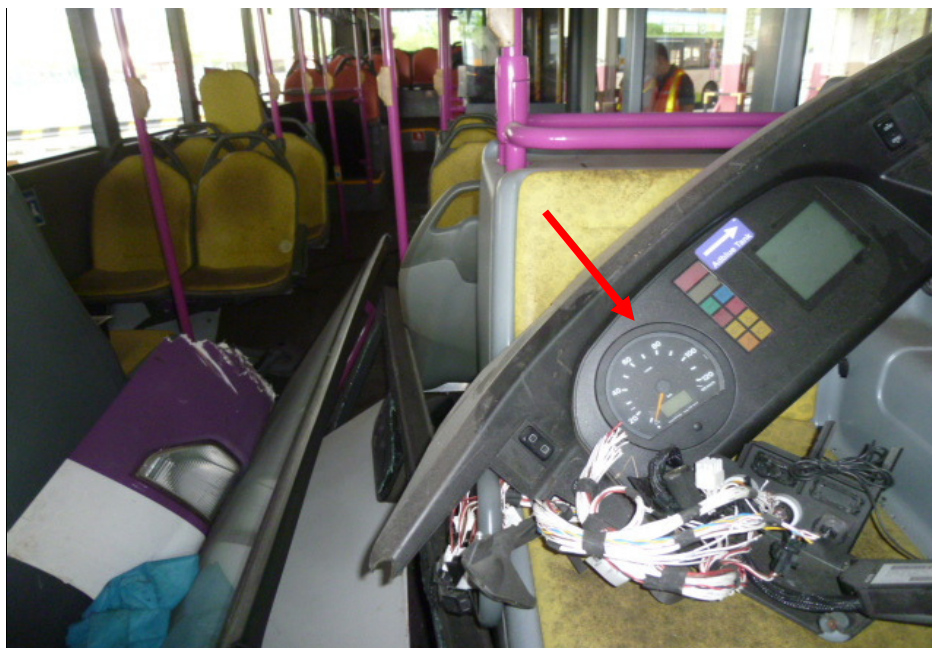
4. The mileage of the Motor Bus at the time of our inspection was not able to be recorded as the whole dashboard including the odometer had been dislodged as a result of the accident.
5. The Motor Bus was observed to sustained damage at its front portion. Its front cabin structure, front windscreen, front bumper, front body panel and front door were damaged as a result of the accident.

Photo 1 shows the dislodged instrument cluster (arrowed) as a result of the accident. Therefore no mileage could be recorded at the time of our inspection.

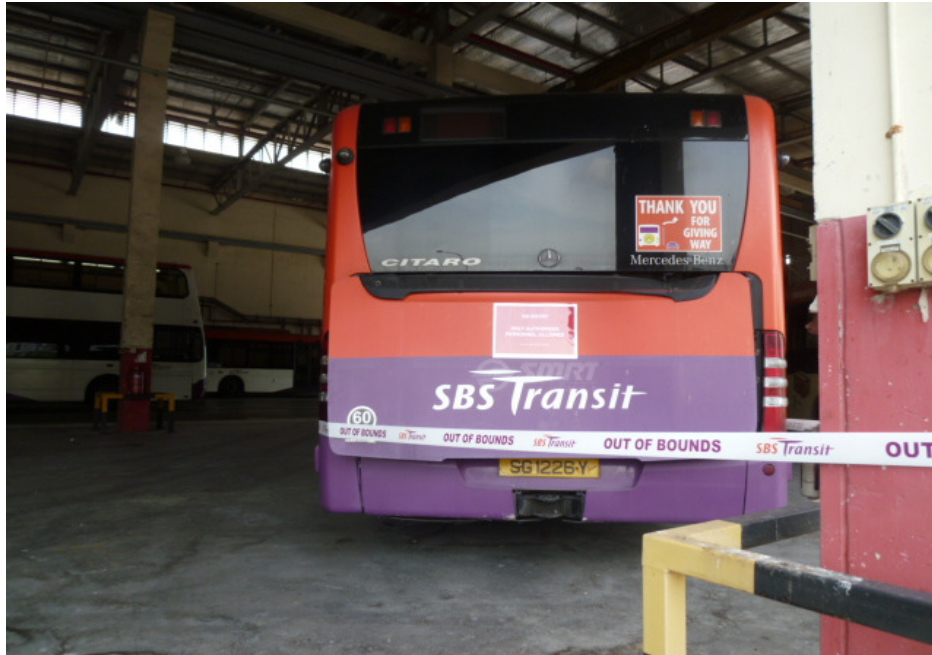
Photo 2 shows a close up view of the rear portion of the Motor Bus at the time of our inspection. The rear portion of the Motor Bus was observed to have been unaffected by the accident.

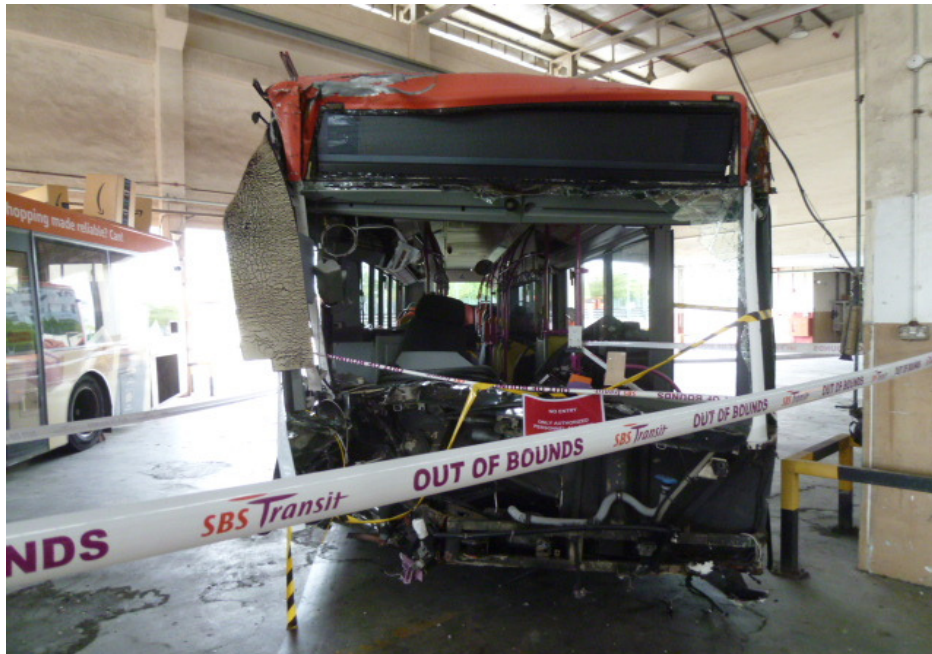
Photo 3 shows a general view of the frontal portion of the Motor Bus at the time of our inspection. The Motor Bus was observed to sustained damages at its frontal portion. Its front cabin structure, front windscreen, front bumper, front body panel and front door were damaged as a result of the accident.

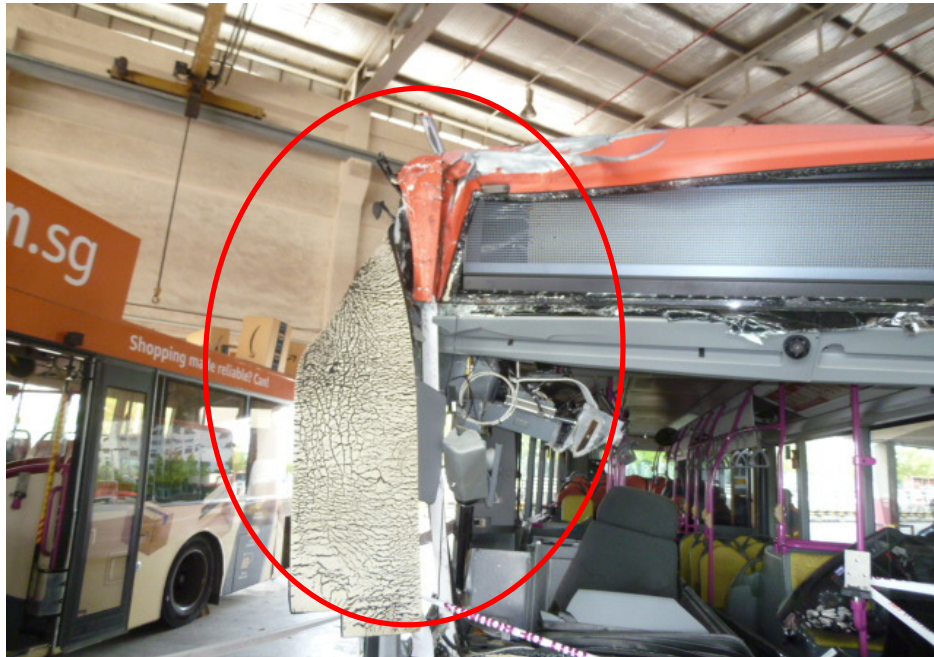
Photo 4 shows a close up view of the front body of the Motor Bus at the time of our inspection. The Motor Bus was observed to sustained damages at its frontal portion. Its front cabin structure (circled) was damaged as a result of the accident.

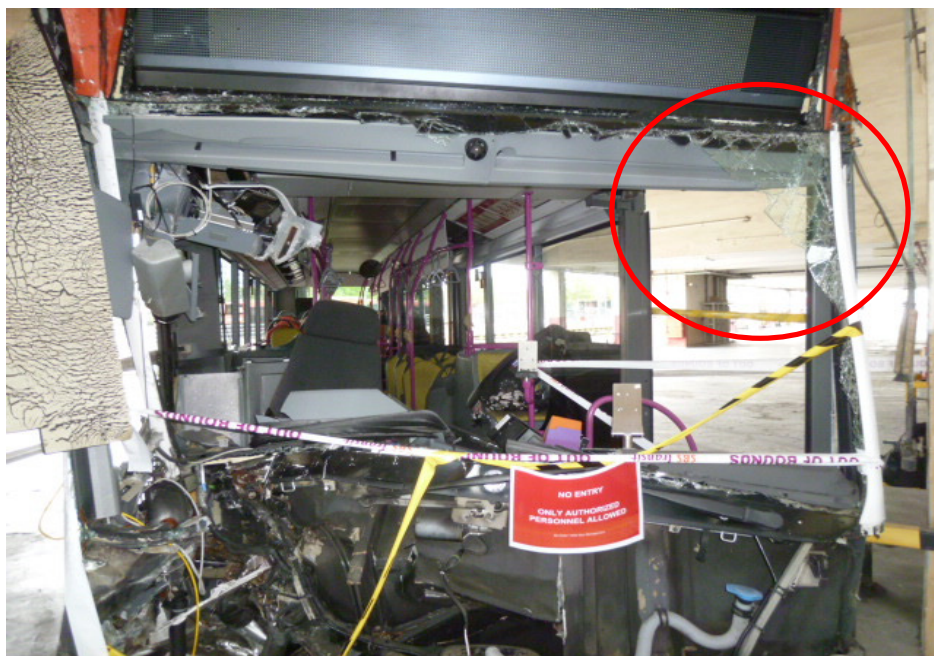
Photo 5 shows a close up view of the frontal portion of the Motor Bus at the time of our inspection. The Motor Bus was observed to sustained damages at its frontal portion. Its front windscreen was shattered as a result of the accident (circled).

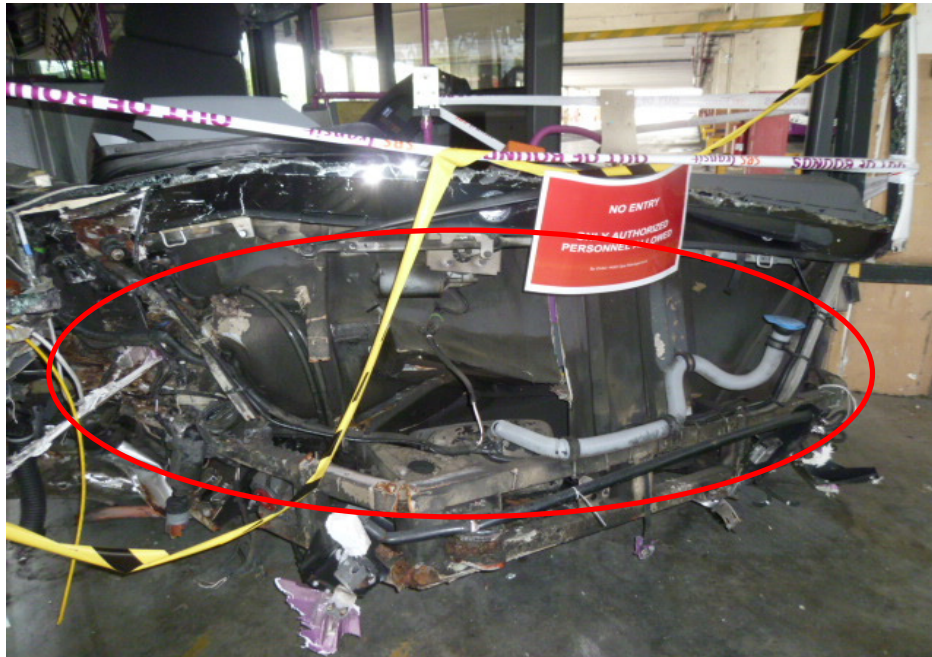
Photo 6 shows a close up view of the frontal portion of the Motor Bus at the time of our inspection. The Motor Bus was observed to sustained damage at its front portion. Its front bumper and front body panel (circled) were damaged as a result of the accident.

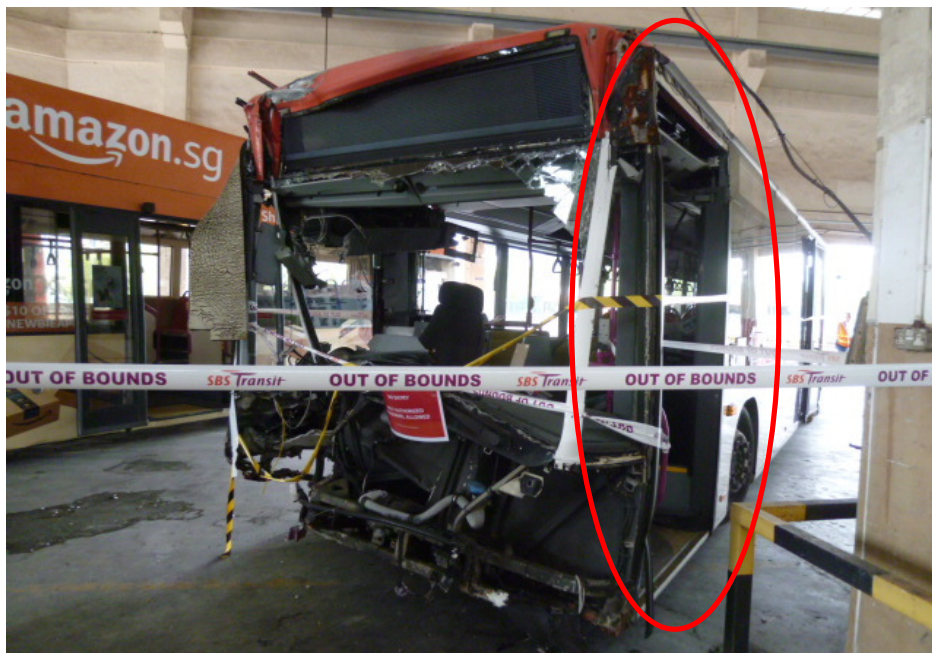
Photo 7 shows a close up of the left frontal portion of the Motor Bus at the time of our inspection. The Motor Bus was observed to sustained damage at its frontal portion. Its front door (circled) was damaged as a result of the accident.

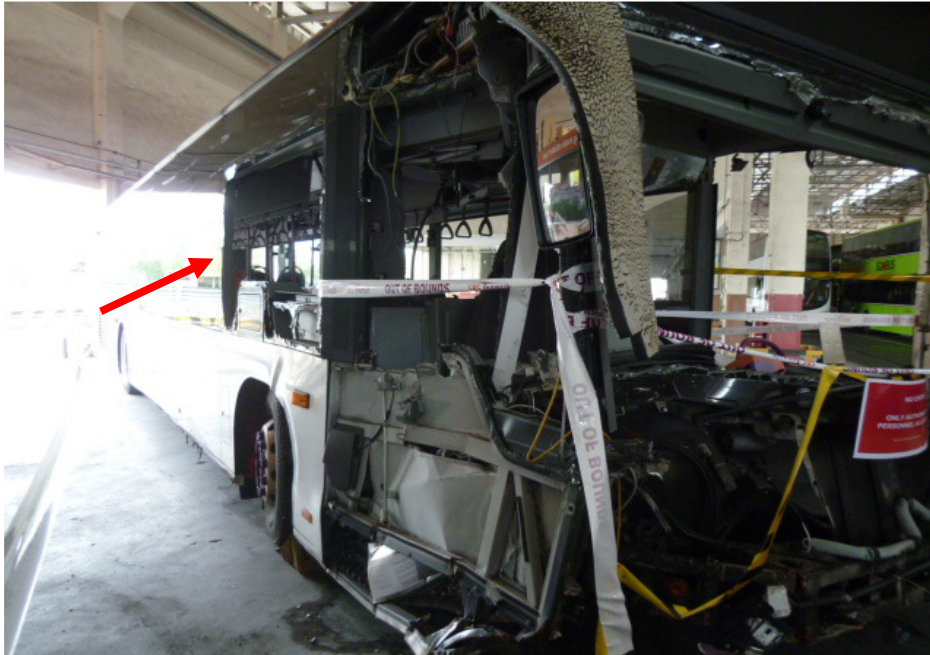
Photo 8 shows a close up view of the right body of the Motor Bus at the time of our inspection. The right portion of the Motor Bus was observed to have been unaffected by the accident. However, the windscreen was removed by the SCDF officers for rescue procedures (arrowed).

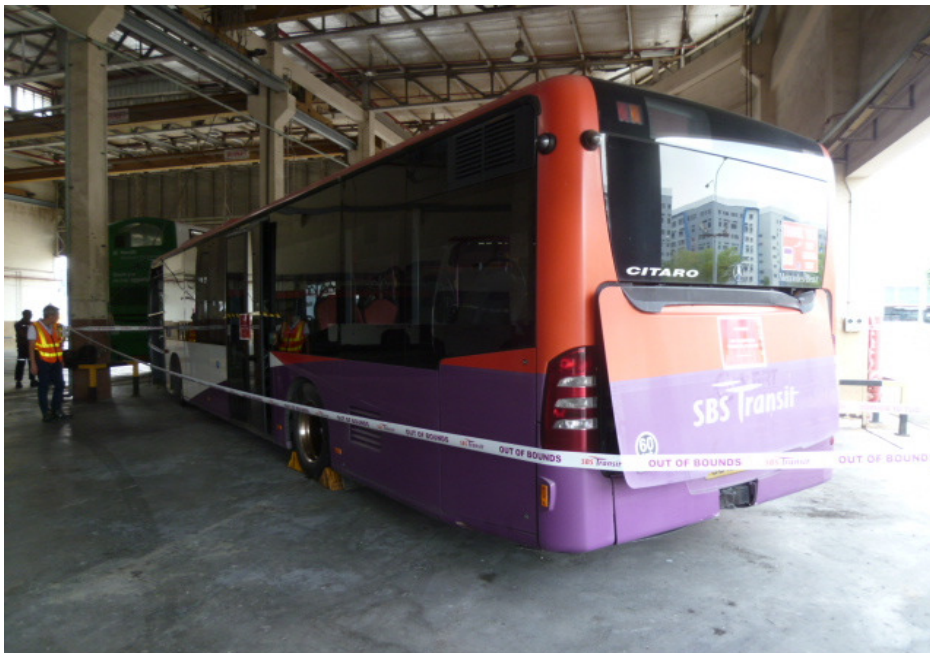
Photo 9 shows the left rear portion of the Motor Bus at the time of our inspection. The left portion of the Motor Bus was observed to have been unaffected by the accident.

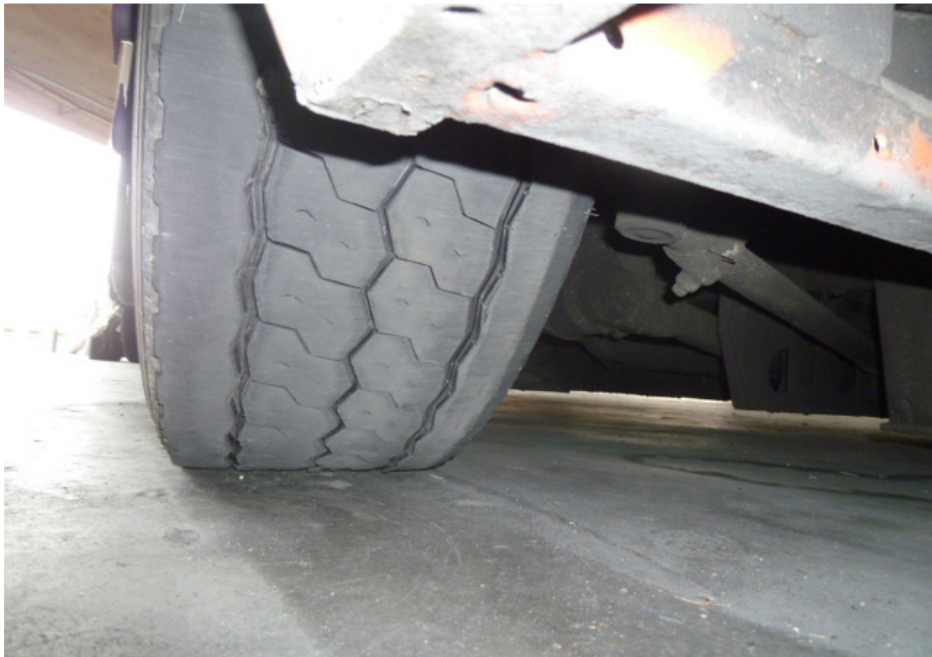
Photo 10 shows the condition of the front right tyre of the Motor Bus, which was observed to be in serviceable condition with remaining tread depth of approximately 17mm. The tyre, which was wrapped around standard steel wheel rim, was also observed to be sufficiently inflated for vehicular operation. There was no tear, cut or burst mark(s) on the outer and the inner sidewalls as well as across the tread of the 6 tyres that were fitted on the Motor Bus.

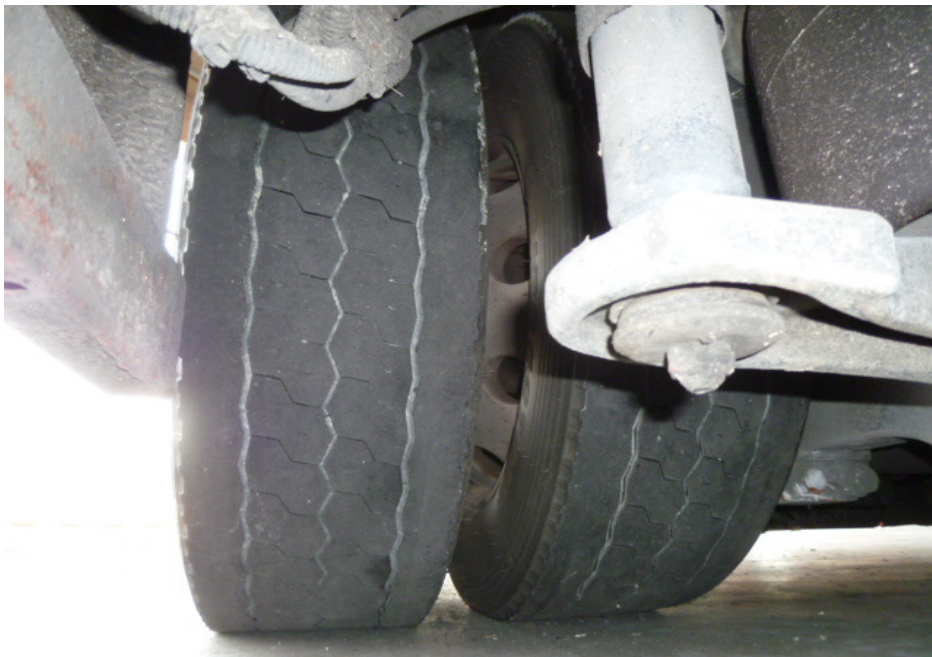
Photo 11 shows the condition of the rear right tyres of the Motor Bus, which were observed to be in serviceable condition with remaining tread depth of approximately 9mm. The tyres, which were wrapped around standard steel wheel rims, were also observed to be sufficiently inflated for vehicular operation.

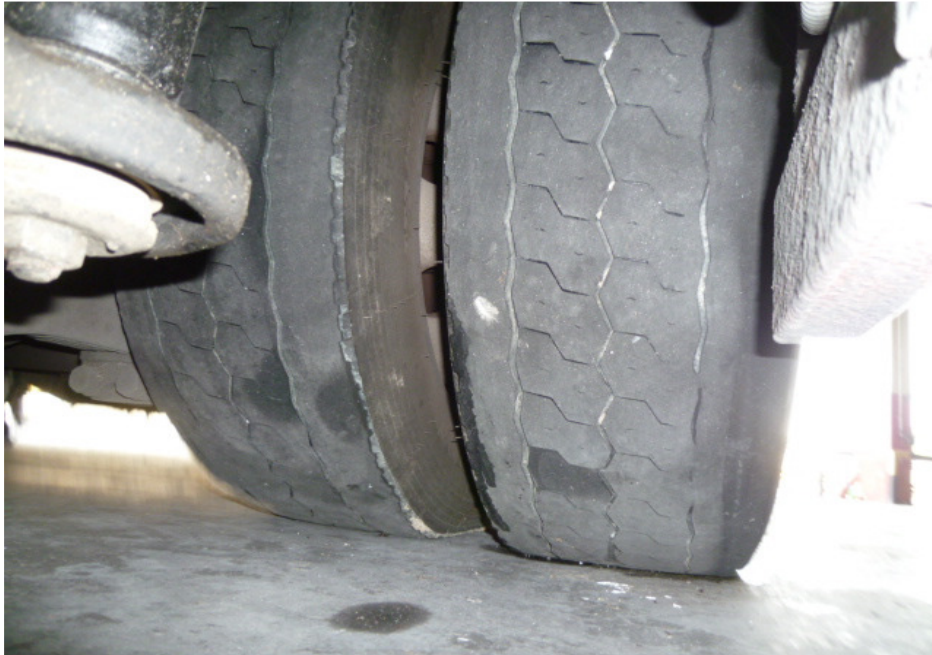
Photo 12 shows the condition of the rear left tyres of the Motor Bus, which were observed to be in serviceable condition with remaining tread depth of approximately 4mm. The tyres, which were wrapped around standard steel wheel rims, were also observed to be sufficiently inflated for vehicular operation. There was also no damage found on all 6 steel wheel rims of the Motor Bus.

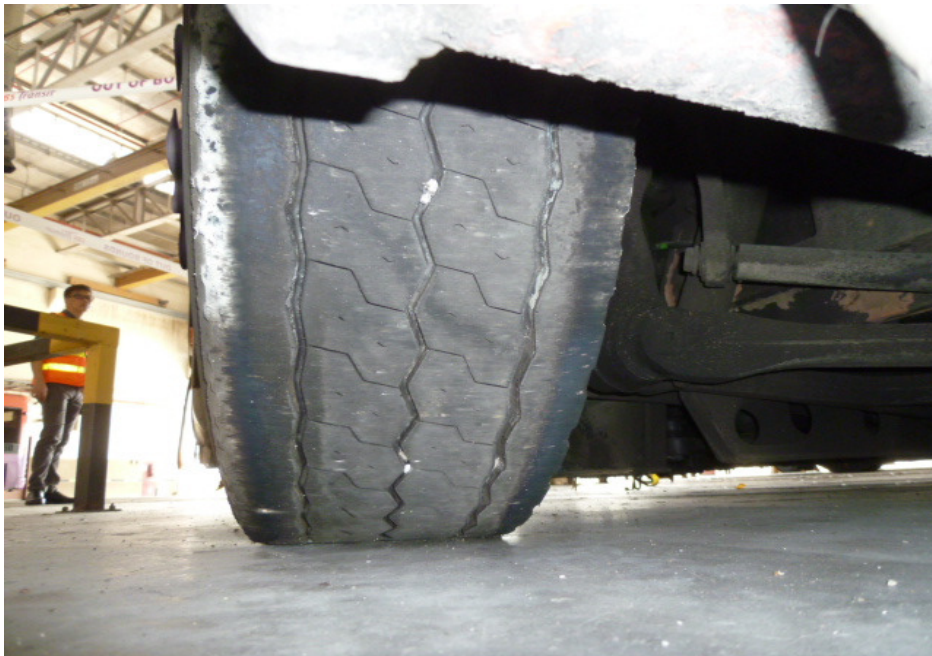
Photo 13 shows the condition of the front left tyre of the Motor Bus, which was observed to be in serviceable condition with remaining tread depth of approximately 10mm. There was also no tear, cut or burst mark(s) on the outer and the inner sidewalls as well as across the tread of the 6 tyres that were fitted on the Motor Bus.

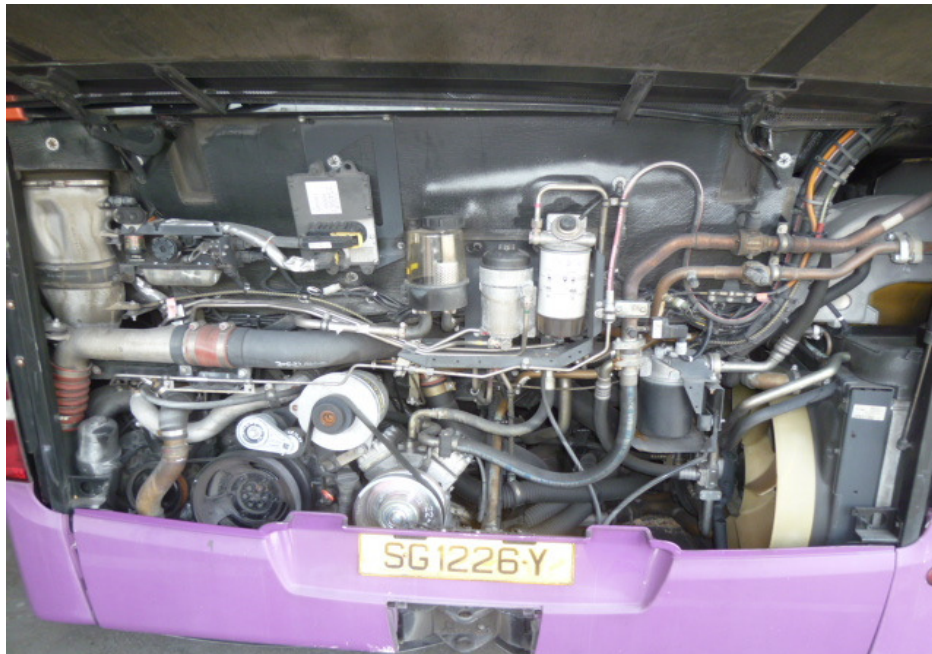
Photo 14 shows a general view of the Motor Bus's engine compartment, which was accessed by lifting the rear of the Motor Bus. The various parts and components inside the engine compartment were unaffected by the accident. There was also no sign(s) or indication(s) of fresh fluid leakage and/or fluid stain within the engine compartment

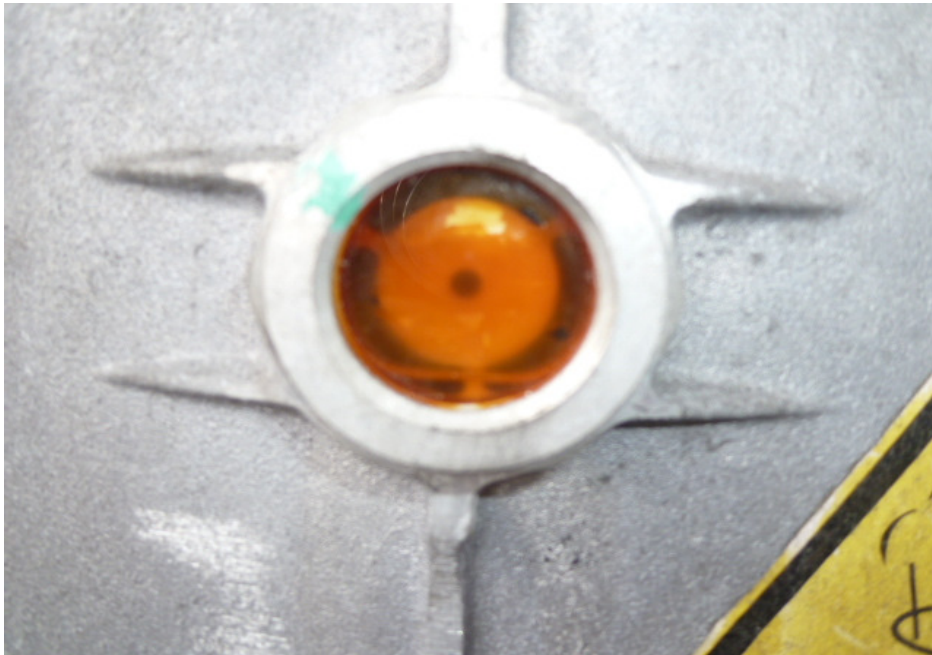
Photo 15 shows the engine coolant reservoir of the Motor Bus at the time of our inspection. The engine coolant was observed to be of sufficient level for operating purposes and without any visible contamination.

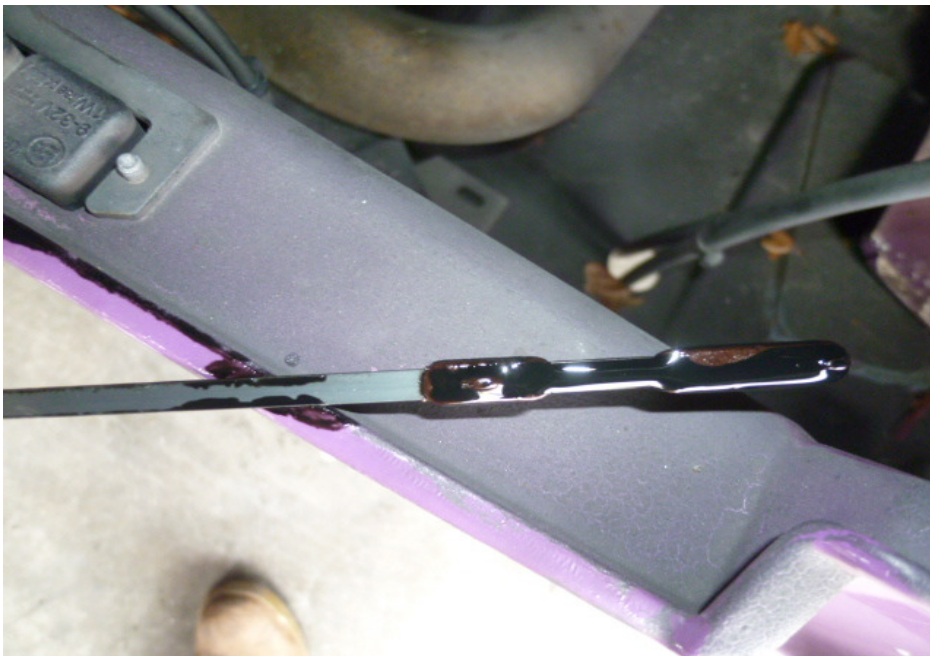
Photo 16 shows the engine oil dip stick system of the Motor Bus at the time of our inspection. The engine oil was observed to be of sufficient level for operating purposes and without any visible contamination.

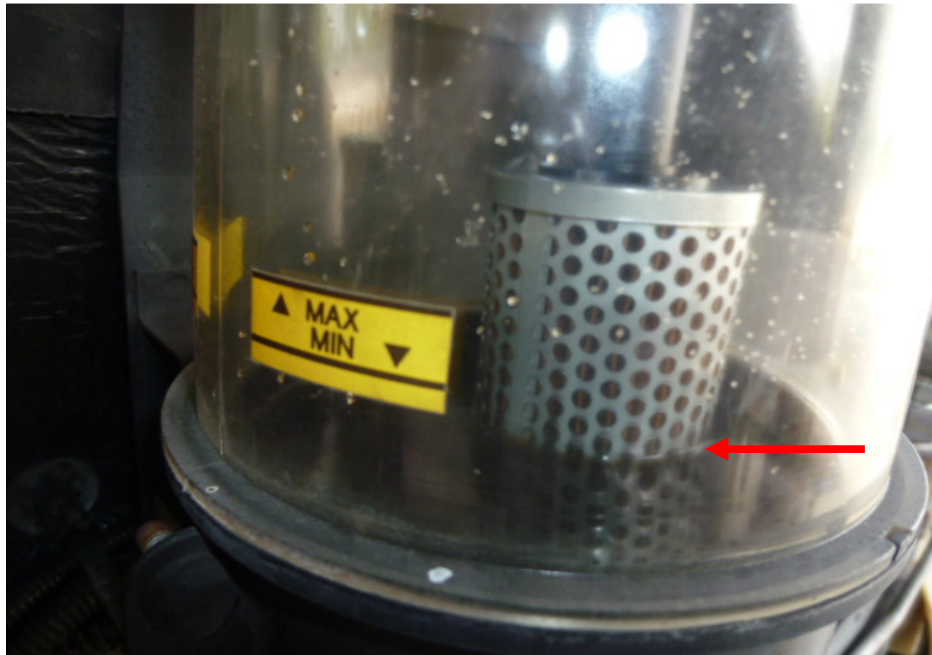
8. Upon examination of the Motor Bus's engine compartment, we had observed all the parts and components inside the engine compartment to be intact and unaffected by the accident. The engine oil and engine coolant were found to be of sufficient level for operating purposes and visually, there was also no contamination found to these fluids. However, the power steering fluid was observed to be of insufficient level as there was leakage of fresh fluid at the power steering box as a result of the accident.

Photo 17 shows the power steering fluid of the Motor Bus at the time of our inspection. The power steering fluid (arrowed) was observed to be of insufficient level due to a leakage at the power steering box as a result of the accident.

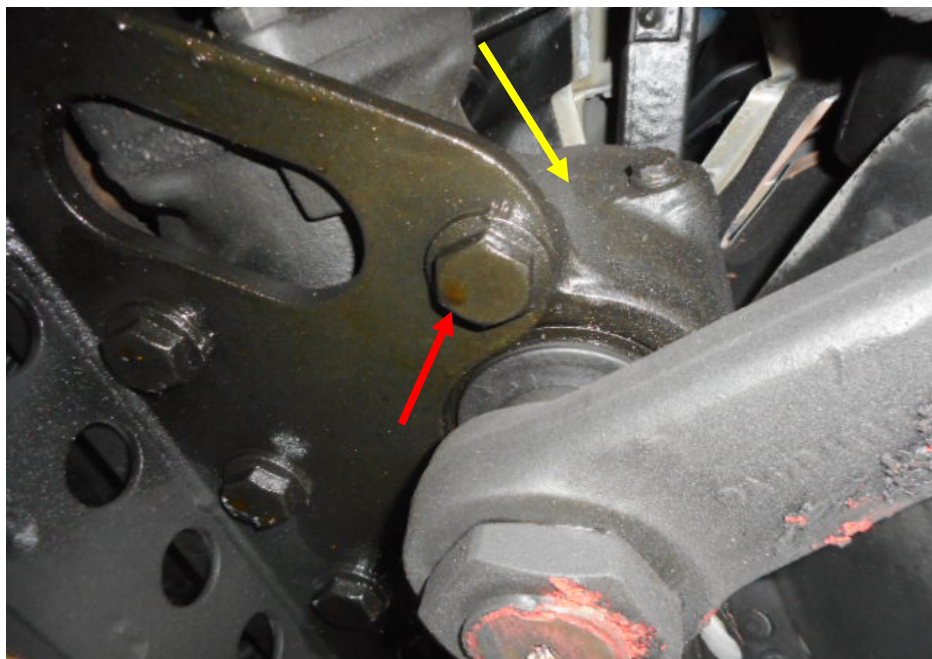
Photo 18 shows the power steering fluid of the Motor Bus at the time of our inspection. The power steering fluid (red arrow) was observed to be of insufficient level due to a leakage at the power steering box (yellow arrow) as a result of the accident.

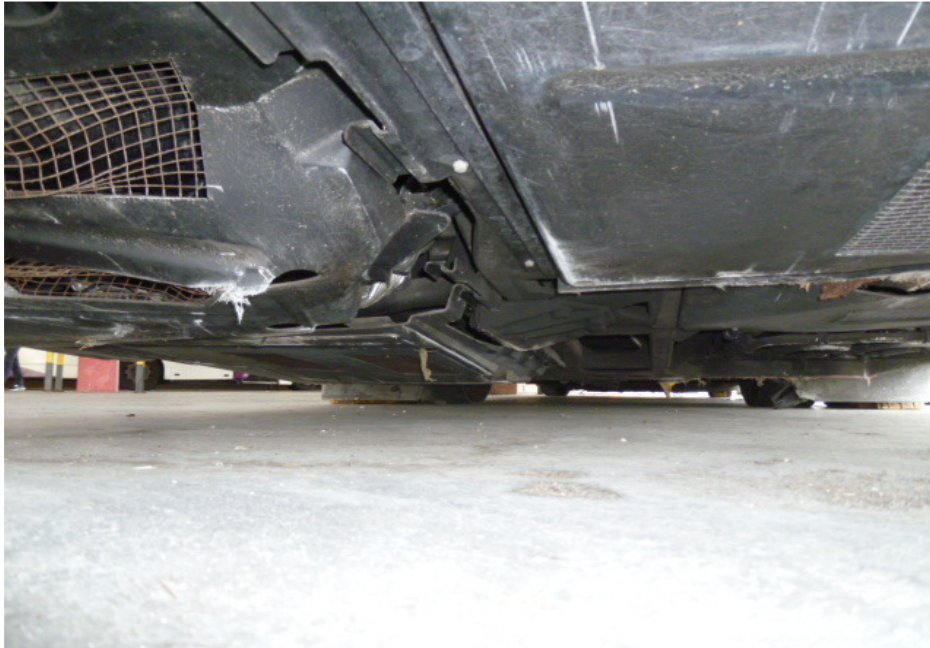
Photo 19 shows the undercarriage of the Motor Bus, at the area where the engine housing and transmission housing are located. We did not find any sign(s) or indication(s) of fluid leak and/or fluid stain(s) on the underside of the Motor Bus.

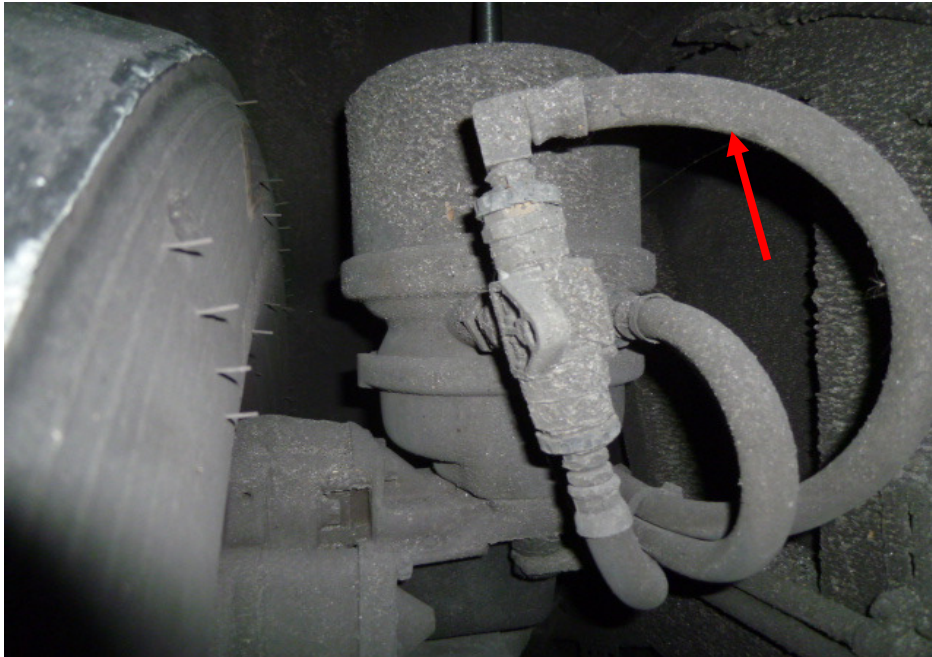
Photo 20 shows the brake pipe (arrowed) at the rear right wheel of the Motor Bus. We did not observe any leakage of brake fluid at the time of our inspection of the Motor Bus. Our visual examination of the various mechanical components of the braking system were generally intact and unaffected by the accident.

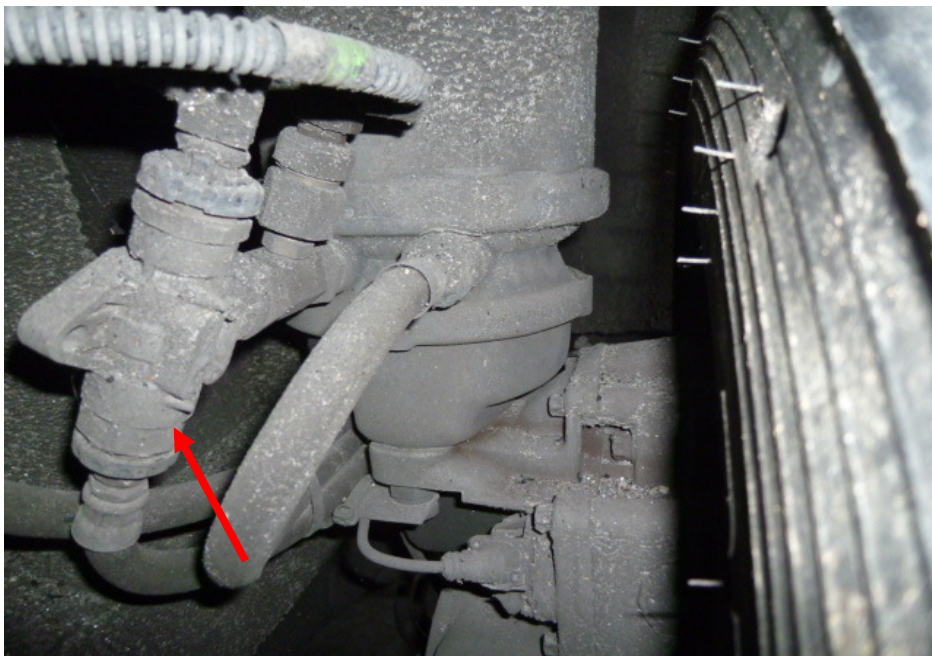
Photo 21 shows the brake pipe (arrowed) at the rear left wheel of the Motor Bus. We did not observe any leakage of brake fluid at the time of our inspection of the Motor Bus. Our visual examination of the various mechanical components of the braking system were generally intact and unaffected by the accident.

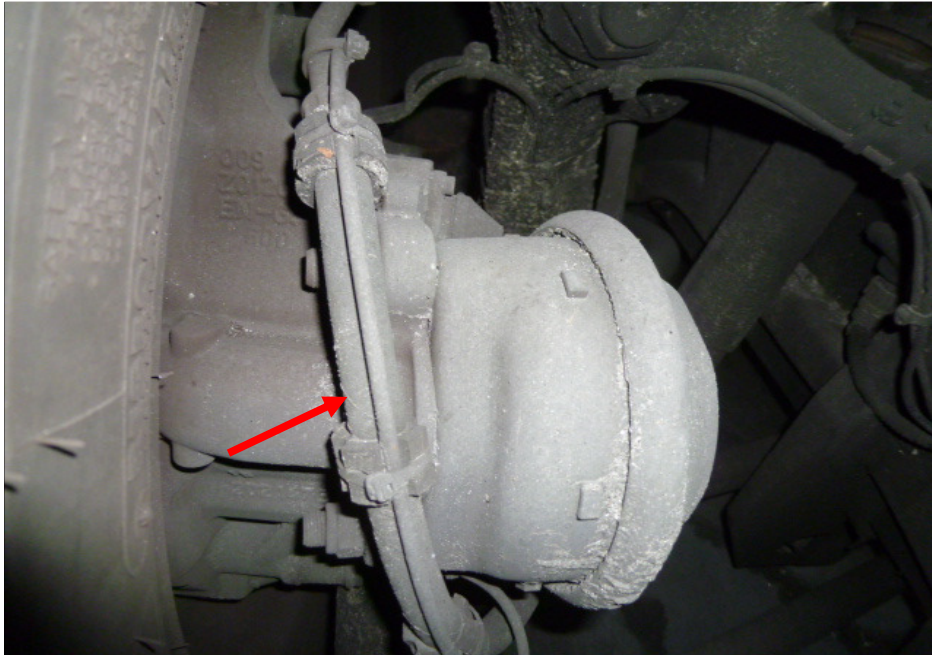
Photo 22 shows the brake pipe (arrowed) at the front right wheel of the Motor Bus. We did not observe any leakage of brake fluid at the time of our inspection of the Motor Bus. Our visual examination of the various mechanical components of the braking system were generally intact and unaffected by the accident.

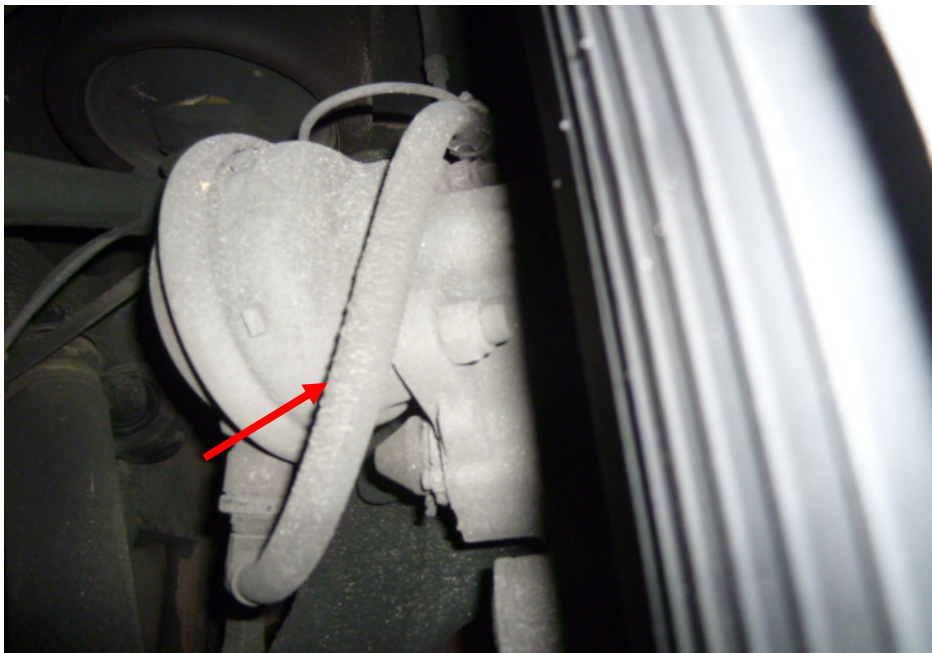
Photo 23 shows the brake pipe (arrowed) at the front left wheel of the Motor Bus. We did not observe any leakage of brake fluid at the time of my inspection of the Motor Bus. Our visual examination of the various mechanical components of the braking system were generally intact and unaffected by the accident.

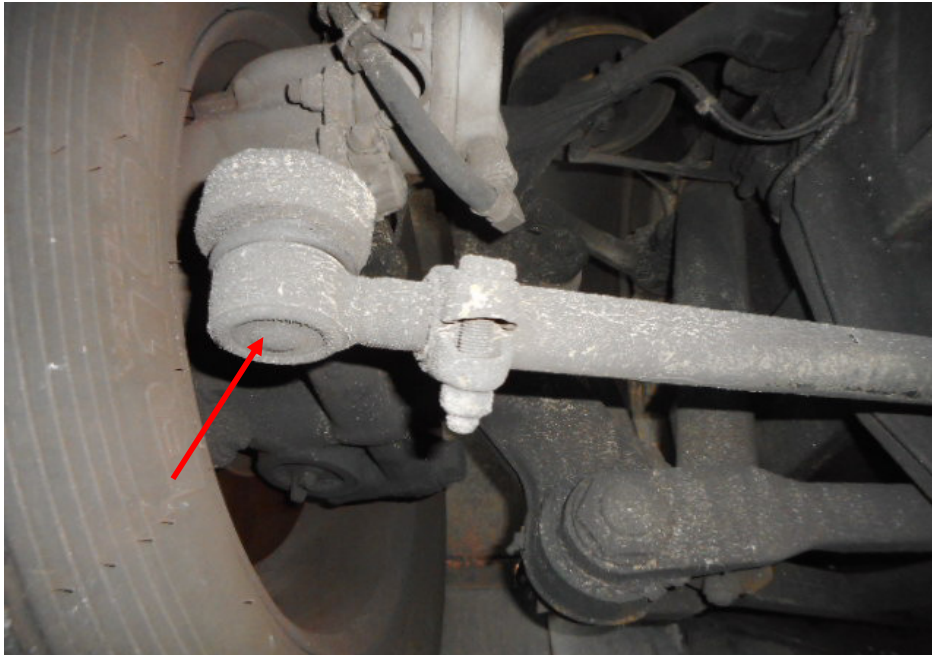
Photo 24 shows the various undercarriage components at the front right wheel of the Motor Bus, in particular the steering tie rod end (arrowed). The various steering components were all found to be intact. There was also no sign of fluid stain(s) observed on the various undercarriage components.

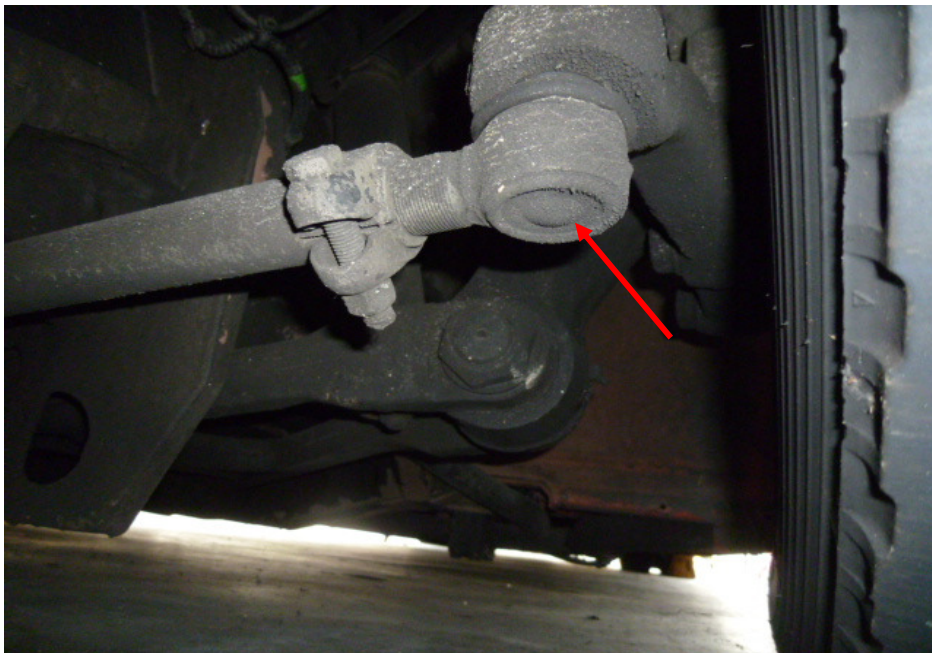
Photo 25 shows the various undercarriage components at the front left wheel of the Motor Bus, in particular the steering tie rod end (arrowed). The various steering components were all found to be intact. There was also no sign of fluid stain(s) observed on the various undercarriage components.

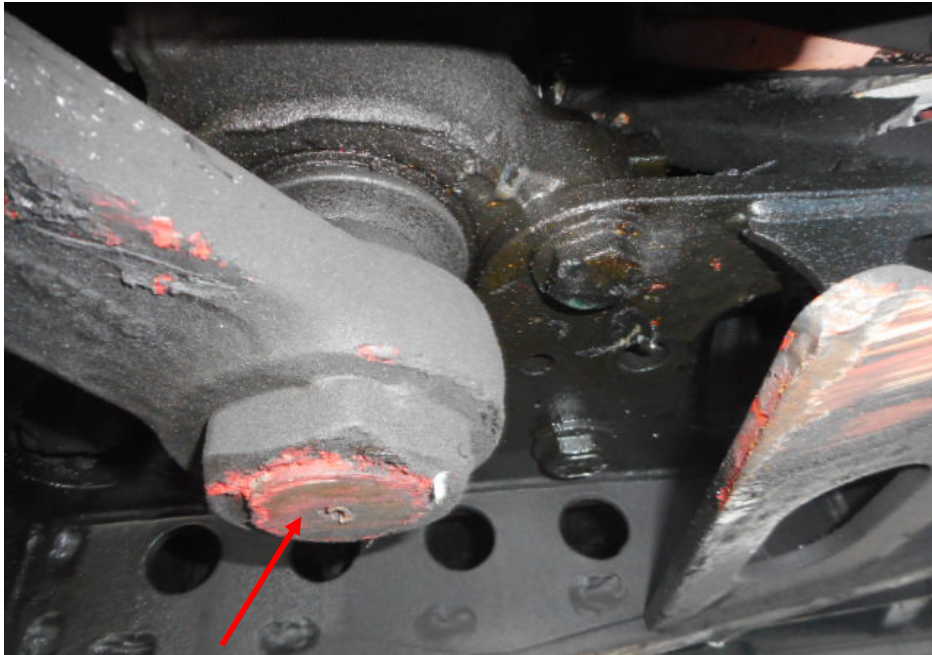
10. Our subsequent checks on the underside of the Motor Bus also revealed only power steering fluid stain from the power steering box. Visually, all the other various undercarriage components of the Motor Bus were all observed to be intact and without any visible damage. See photos 14 – 19 below.

Photo 26 shows the steering box component (arrowed) at the undercarriage of the Motor Bus was found to have sustained damages as a result of the accident and there was sign of fresh fluid stain observed on the component.
