Your Ref: TP IP/04948/2023
Our Ref : CI/TPD23005726/N

20 June 2023

Fatal Accident Investigation Team

INSPECTION REPORT OF MOTORCYCLE FY 1785J

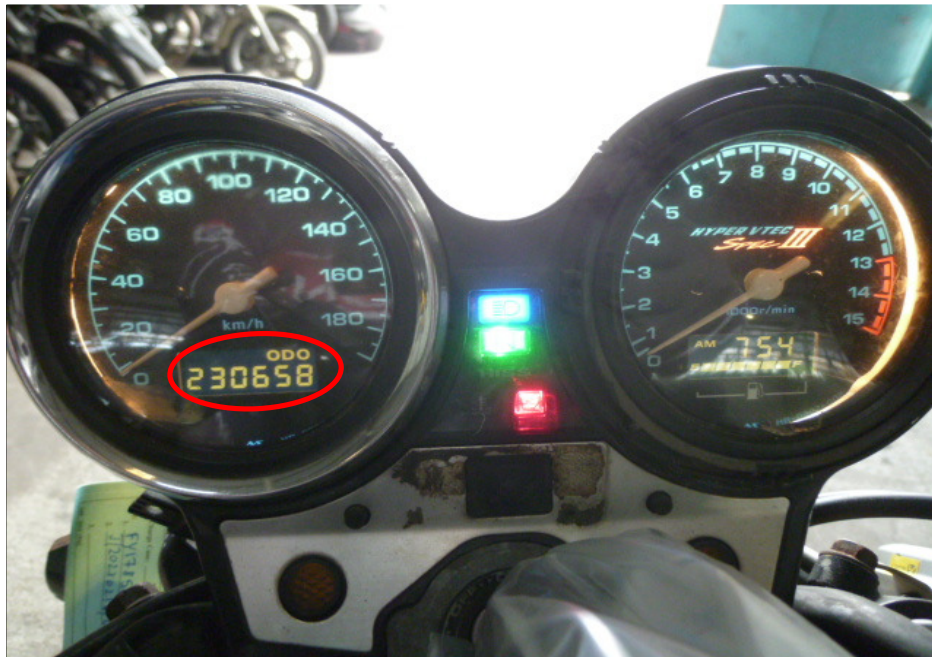
Photo 1 shows the speedometer gauge of the Motorcycle where the mileage recorded at the time of our inspection was 230, 658km (circled).

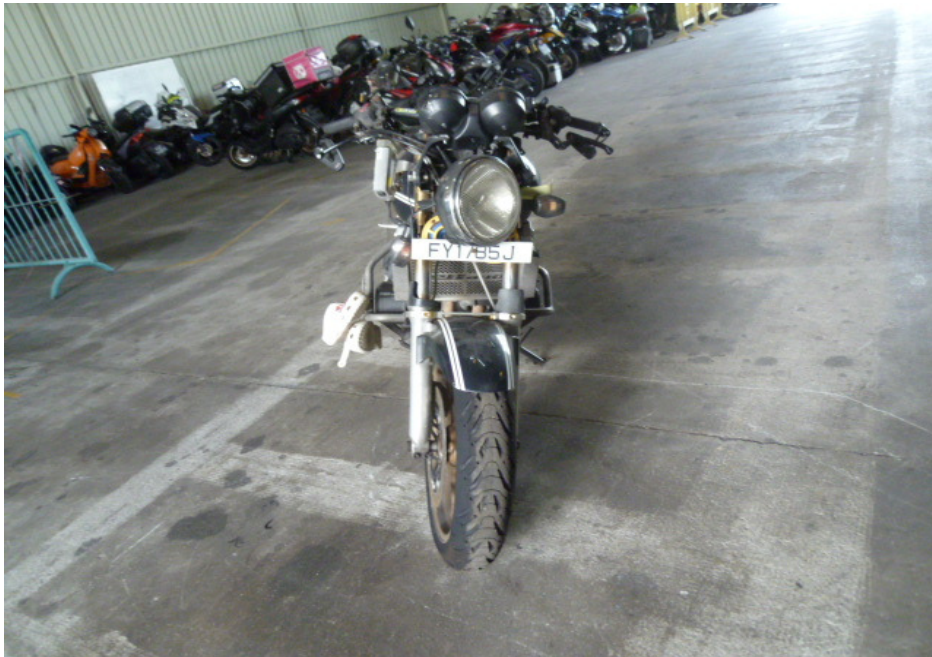
Photo 2 shows a general view of the frontal portion of the Motorcycle at the time of our inspection. The Motorcycle was observed to have sustained damages at its frontal portion and right body.

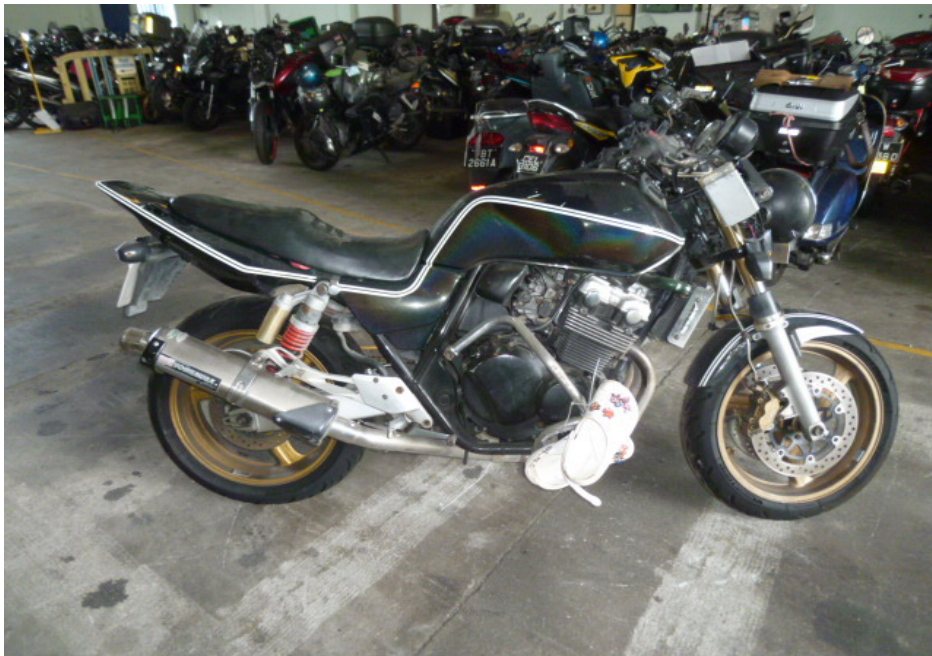
4. The mileage of the Motorcycle at the time of our inspection was 230, 658km.
5. The Motorcycle was observed to have sustained damages at its frontal portion and right body. The body parts that were found to have been damaged include its headlight, front mudguard, right handlebar end, front brake lever, petrol tank and right engine crashbar, amongst others.

Photo 3 shows a general view of the right body of the Motorcycle at the time of our inspection. The Motorcycle was observed to have sustained damages at its frontal portion and right body. The body parts that were found to have been damaged include its headlight, front mudguard, right handlebar end, front brake lever, petrol tank, and right engine crashbar, amongst others.

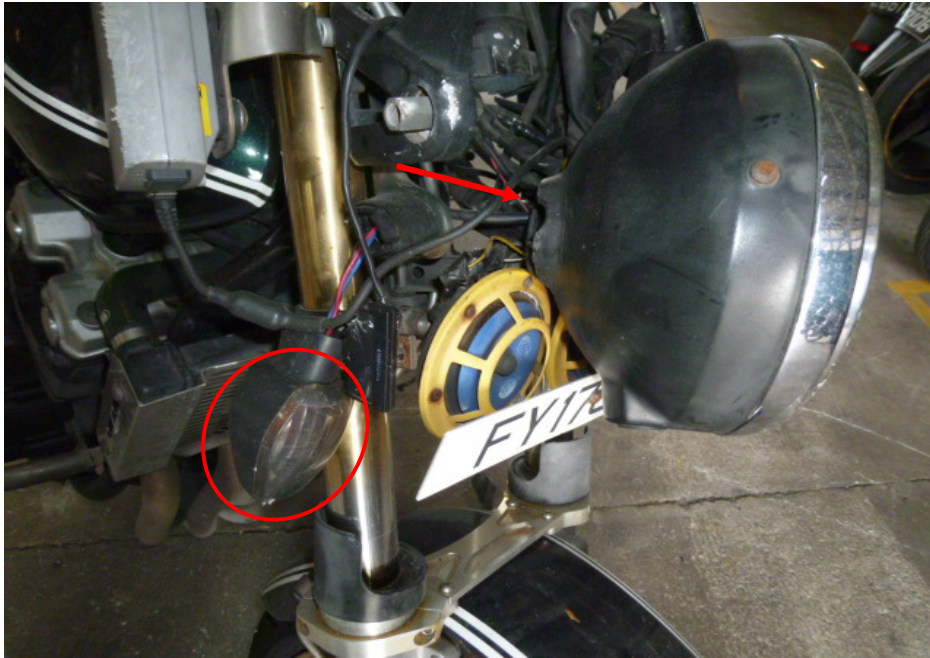
Photo 4 shows a closer view of the broken headlight (arrowed) and broken right front signal lamp (circled) of the Motorcycle as a result of the accident.

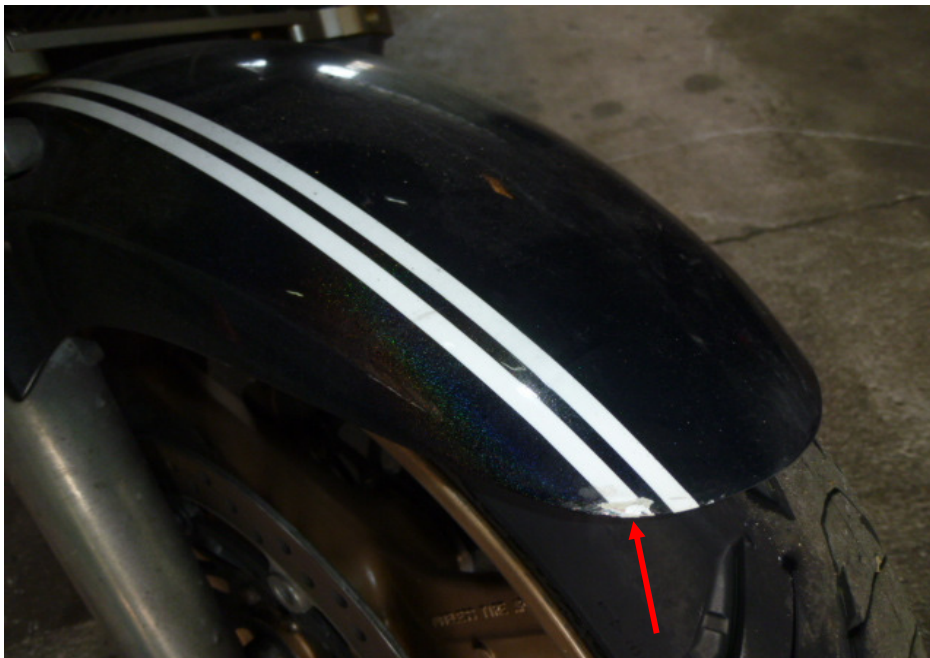
Photo 5 shows a closer view of the front mudguard which was amongst the body parts at the front body of the Motorcycle that had sustained damage as a result of the accident (arrowed).

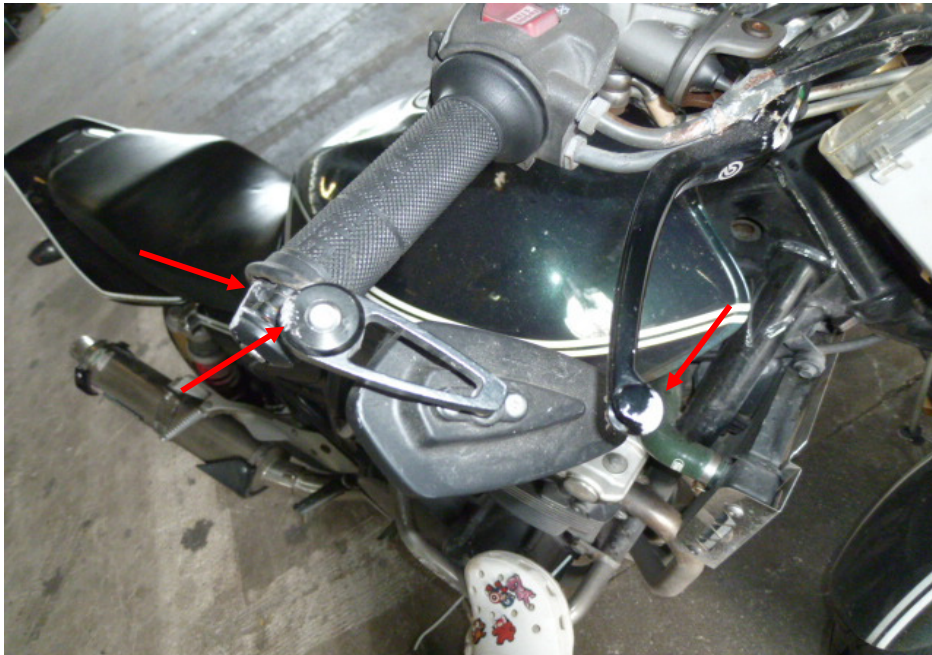
Photo 6 shows a closer view of the front brake lever, right side mirror and right handlebar end (arrowed) which were amongst the body parts at the front body of the Motorcycle that had sustained damage as a result of the accident.

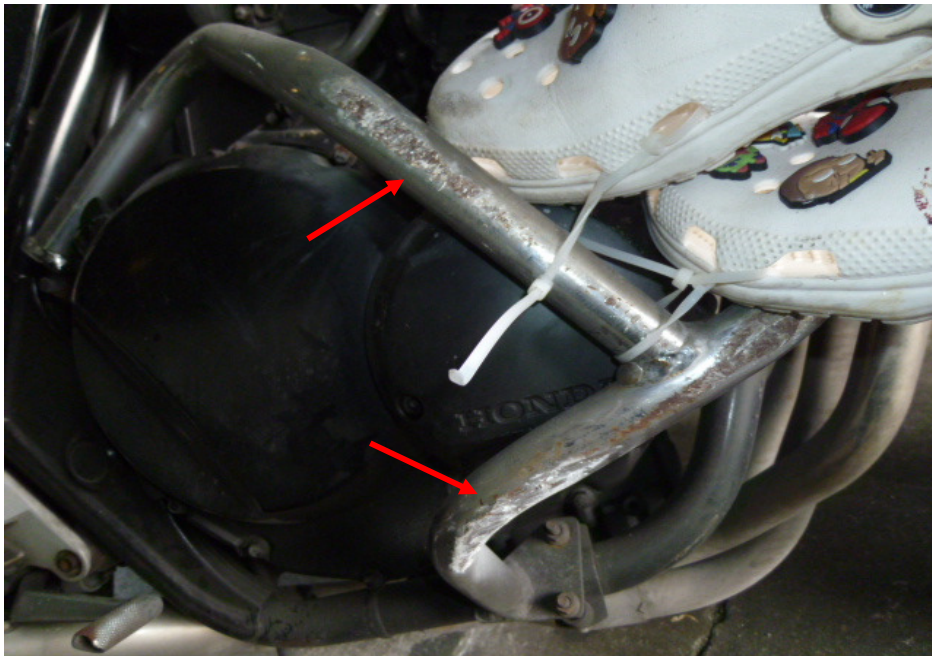
Photo 7 shows the grazed right engine crashbar of the Motorcycle as a result of the accident (arrowed).

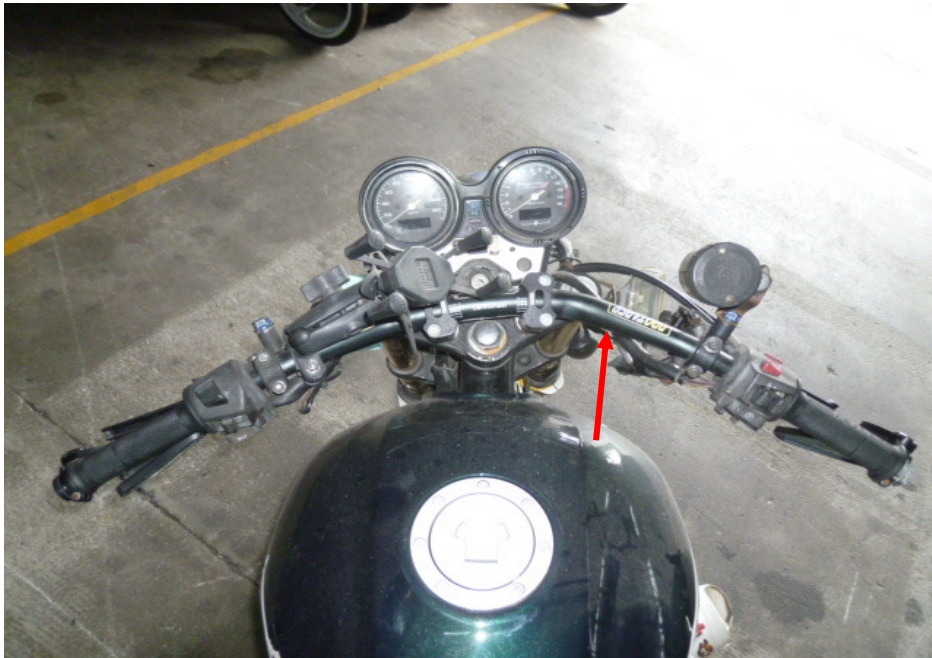
Photo 8 shows the bent handlebar of the Motorcycle (arrowed) at the time of our inspection.

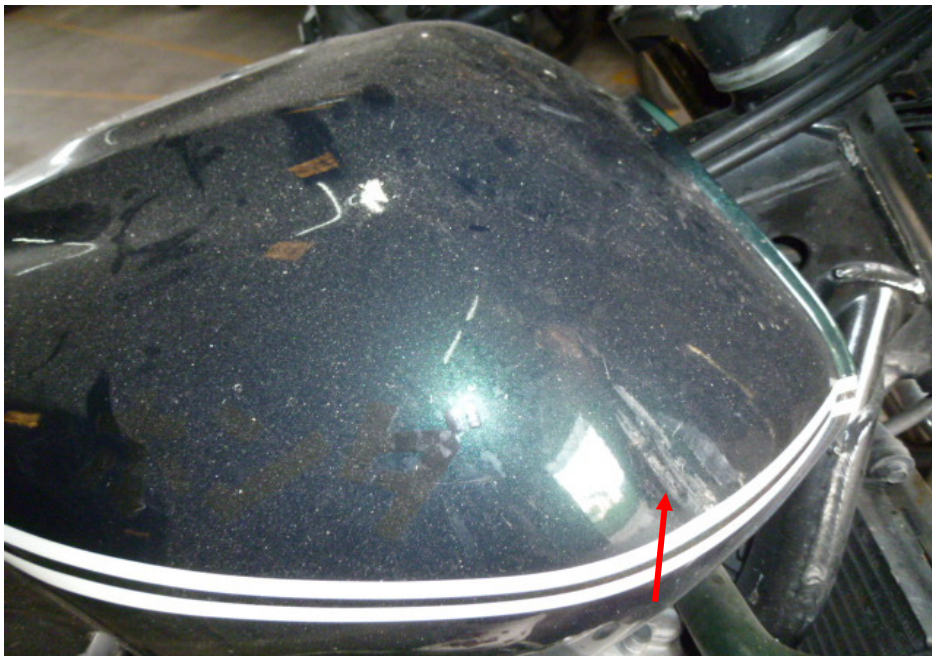
Photo 9 shows the dented petrol tank (arrowed) of the Motorcycle as a result of the accident.

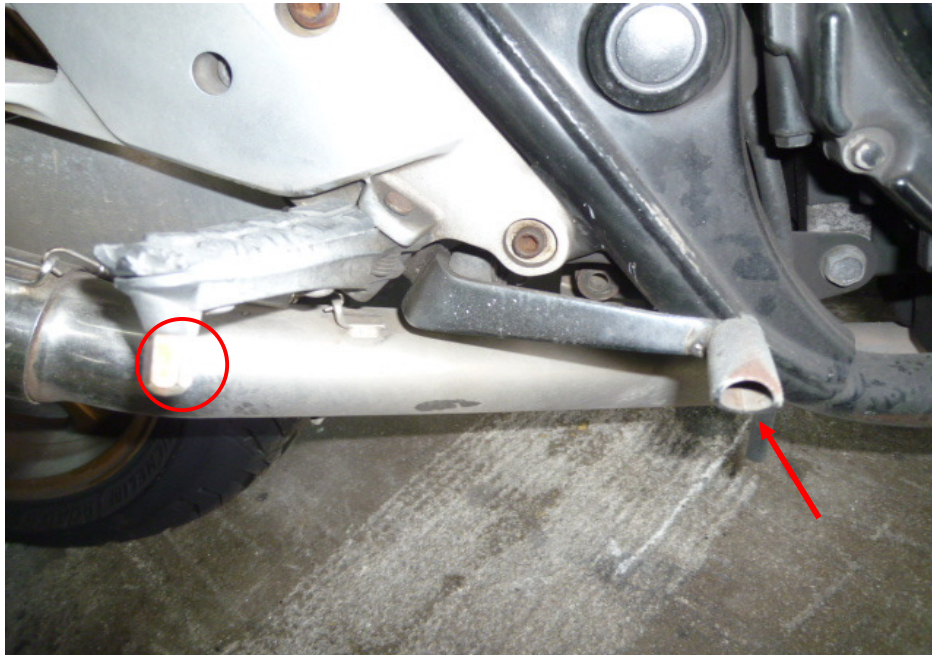
Photo 10 shows a closer view of the right front footrest (circled) and rear brake pedal (arrowed) which were amongst the body parts of the Motorcycle that had sustained damage as a result of the accident.

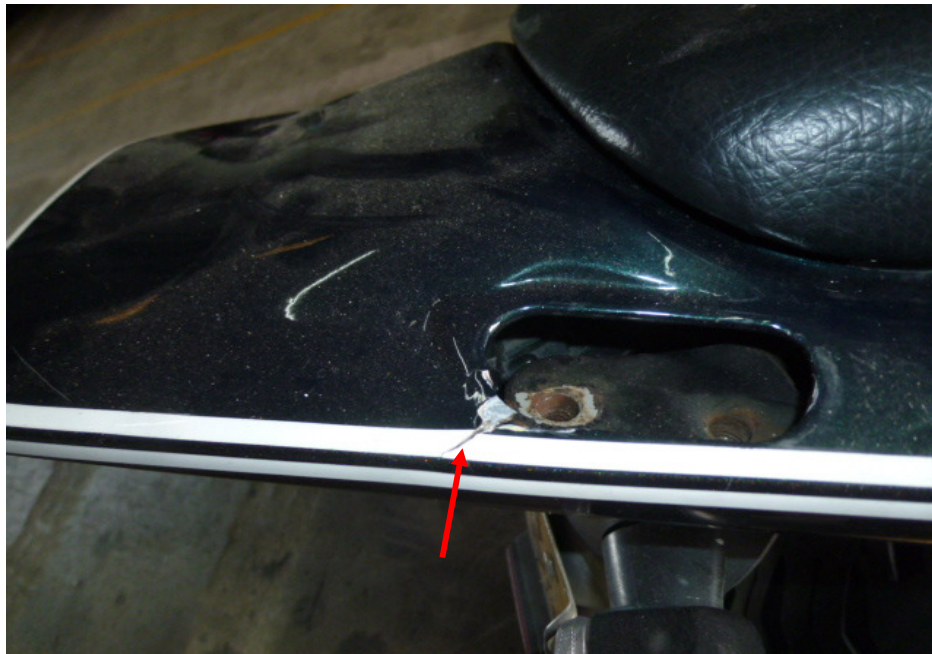
Photo 11 shows the cracked right rear side cover (arrowed) of the Motorcycle as a result of the accident.

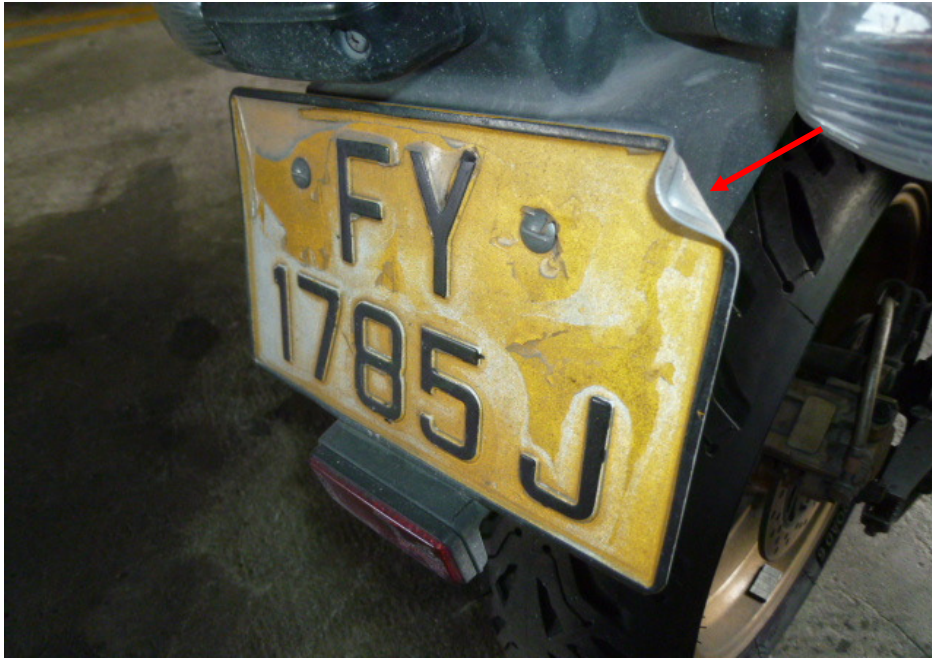
Photo 12 shows a closer view of the dented rear number plate (arrowed) of the Motorcycle as a result of the accident.

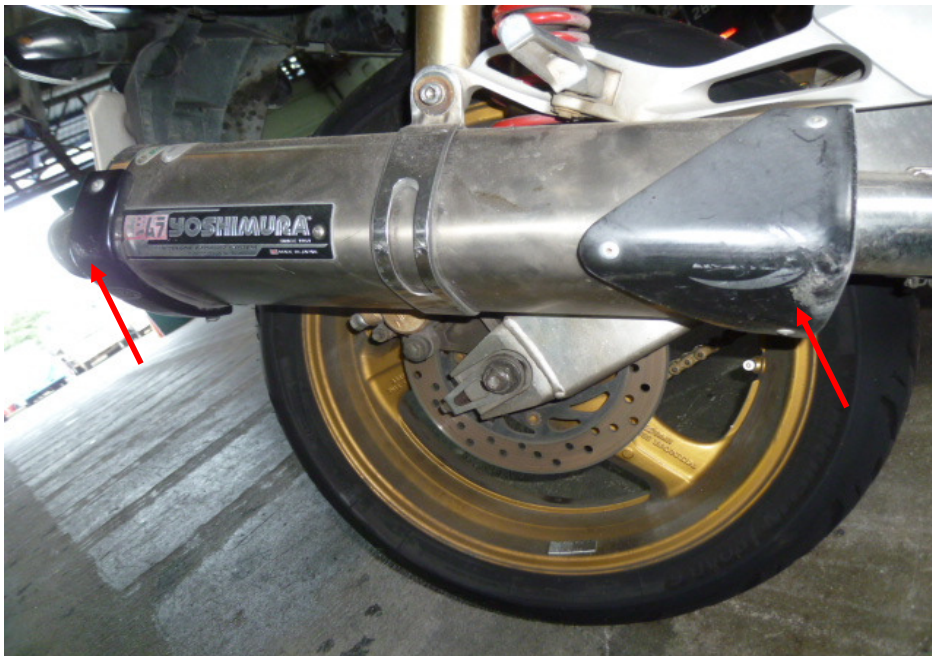
Photo 13 shows a closer view of the grazed exhaust muffler guard (arrowed) which was amongst the body parts at the rear body of the Motorcycle that had sustained damage as a result of the accident.

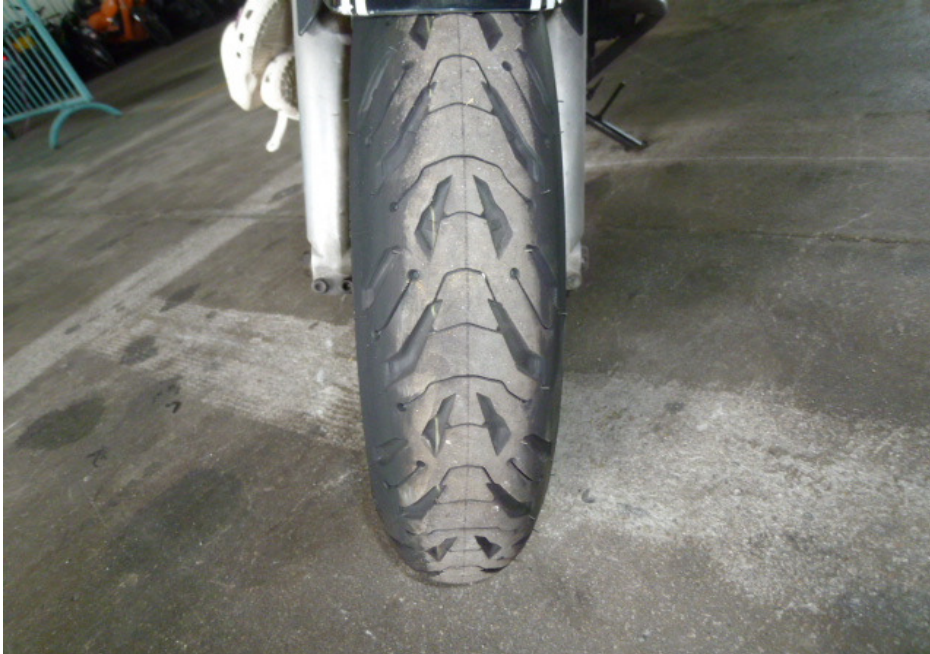
Photo 14 shows the front tyre of the Motorcycle at the time of our inspection. The front tyre was observed to be in serviceable condition with remaining tread depth of approximately 6mm. The pattern of the tread was also clearly visible. There was no tear, burst mark(s) and/or punctured hole(s) on the sidewalls as well as across the tread of the front tyre.

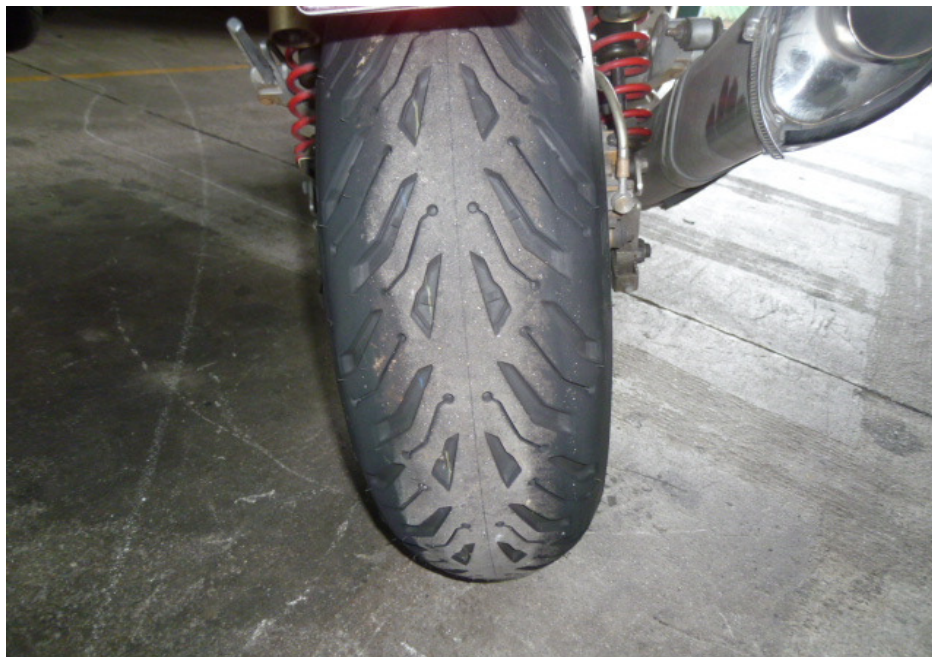
Photo 15 shows the condition of the Motorcycle's rear tyre. The rear tyre was observed to be in serviceable condition with remaining tread depth of approximately 8mm. The tyre was also observed to be sufficiently inflated for vehicular operation. We did not observe any tear, burst mark(s) and/or punctured hole(s) on the sidewalls as well as across the tread of the rear tyre.

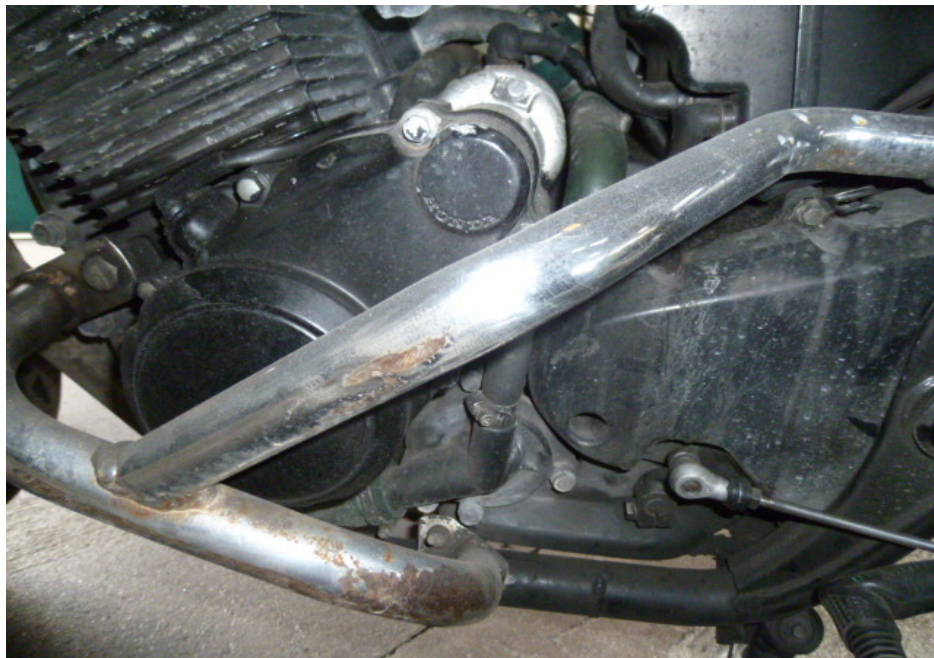
Photo 16 shows the left side of the engine of the Motorcycle at the time of our inspection. The various engine related parts and components were found to be intact with no visible damage. There was also no sign(s) or indication(s) of fluid leak observed around the left engine area of the Motorcycle.

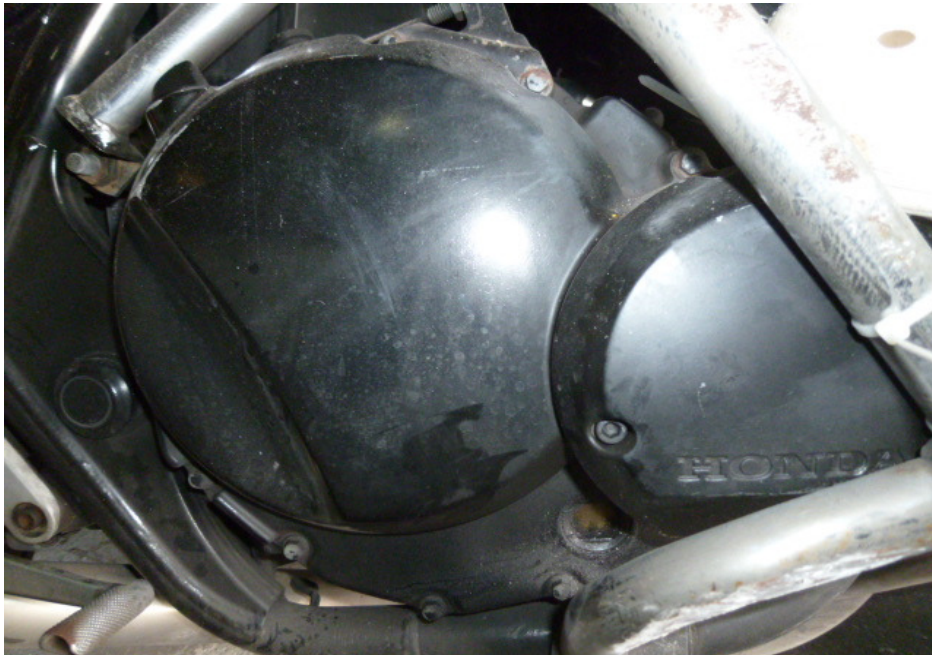
Photo 17 shows the right side of the engine of the Motorcycle at the time of our inspection. The various engine related parts and components were found to be intact with no visible damage. There was also no sign(s) or indication(s) of fluid leak observed around the right engine area of the Motorcycle.

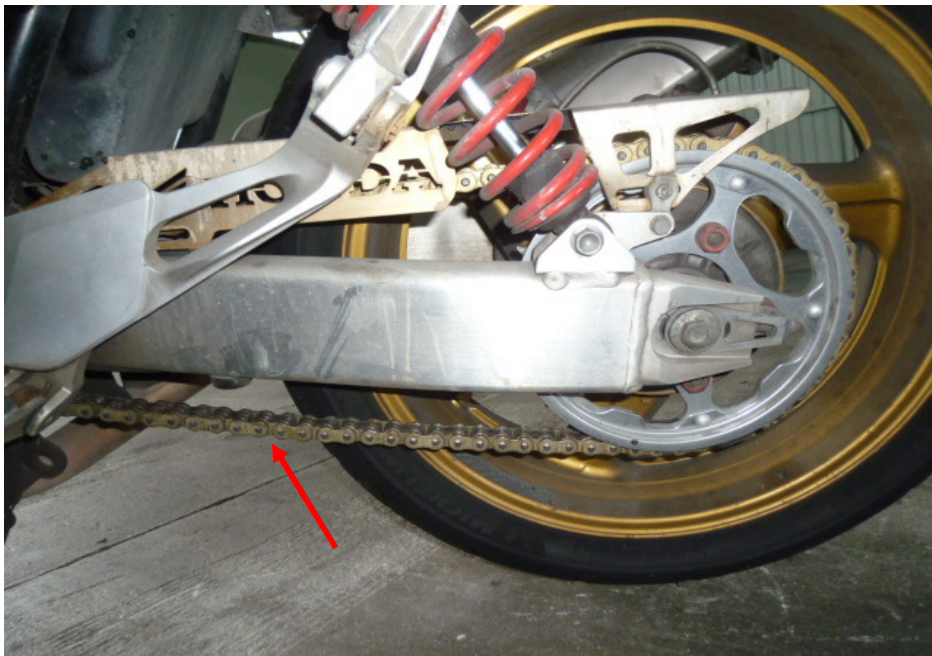
Photo 18 shows the general view of the gear train (arrowed) of the Motorcycle, which was observed to be intact with no misalignment. It was also adequately lubricated for operating purposes.

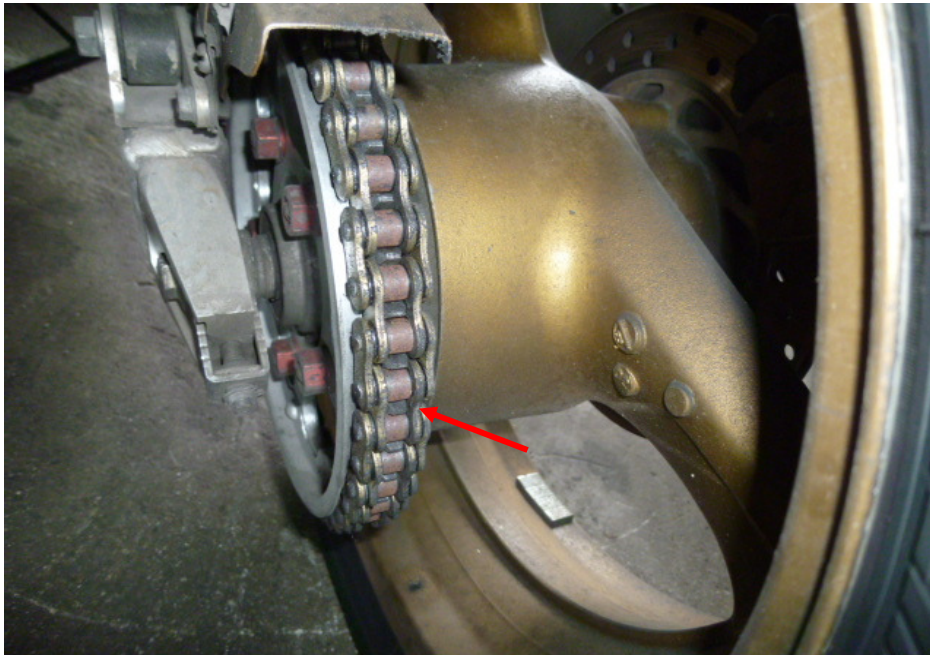
Photo 19 shows a closer view of the gear train (arrowed) of the Motorcycle, which was observed to be intact with no misalignment. It was also adequately lubricated for operating purposes.

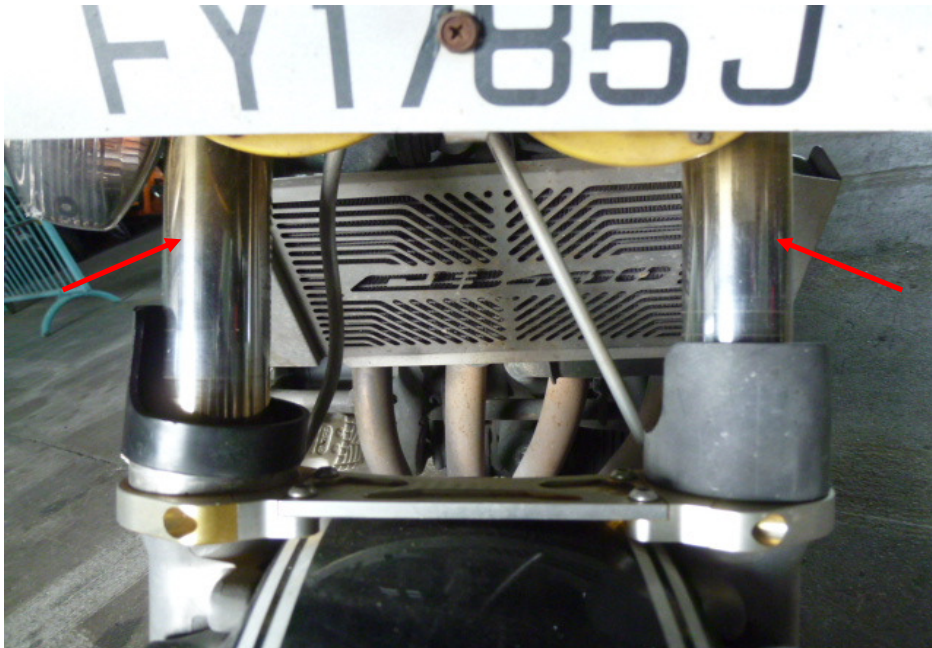
11. Our checks on the various steering components of the Motorcycle revealed that its steering system was in serviceable condition. Its front forks were found to be intact and undamaged. Turning the handle bar towards the left and right also did not produce any abnormal free play and/or resistance.

Photo 20 shows the front fork (arrowed) of the Motorcycle. The front fork and fork bracket of the Motorcycle were both found to be intact and undamaged. Turning the Motorcycle's handle bar towards the left and right did not produce any abnormal free play and/or resistance. The steering system of the Motorcycle was in serviceable condition at the time of our inspection.

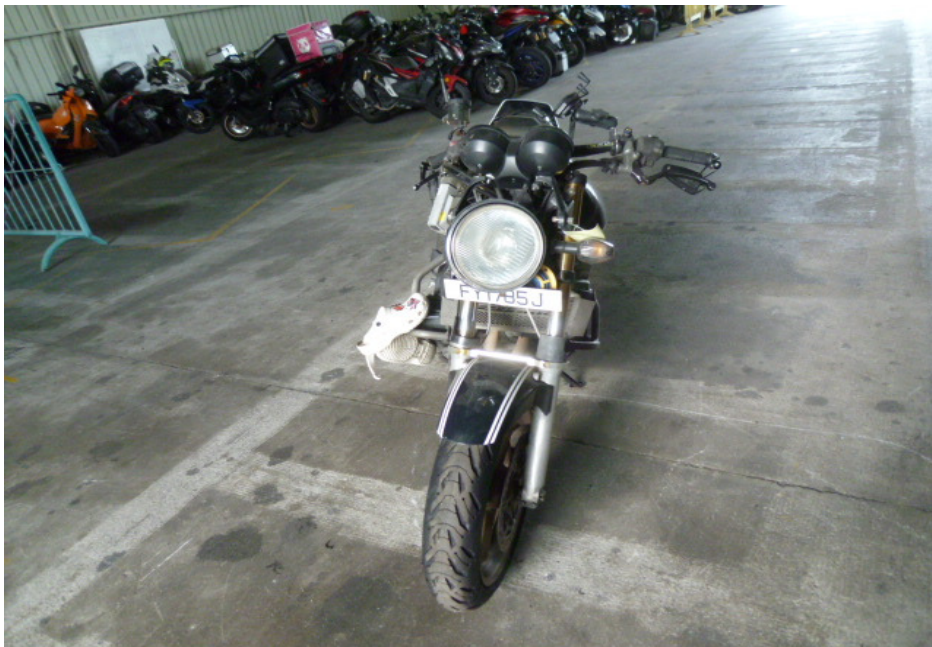
Photo 21 shows the front wheel of the Motorcycle turned towards its full right. Turning the Motorcycle's handle bar towards the left and right did not produce any abnormal free play and/or resistance. This would indicate that the steering system of the Motorcycle was in serviceable condition at the time of our inspection.

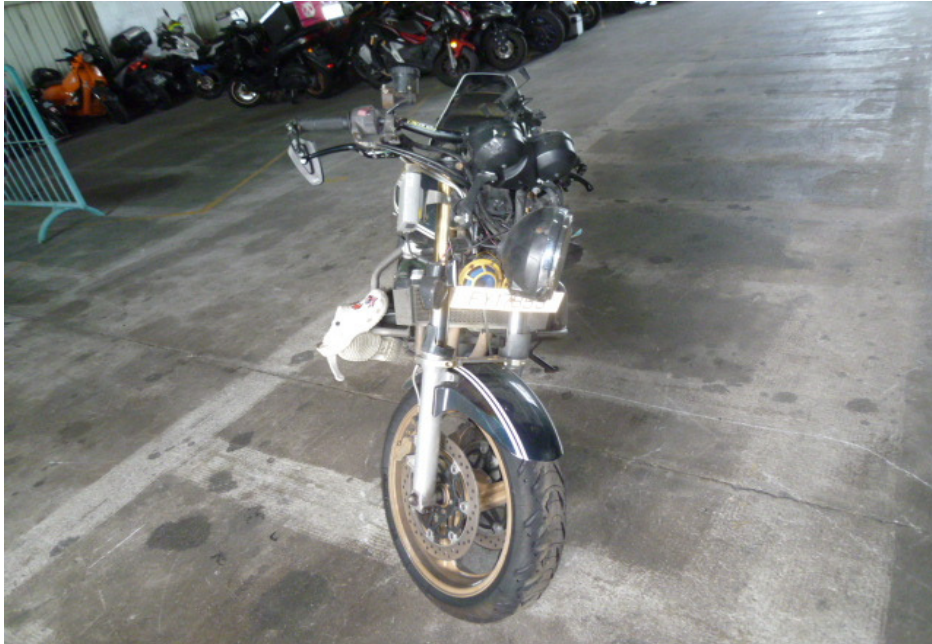
Photo 22 shows the front wheel of the Motorcycle turned towards its full left. Turning the Motorcycle's handle bar towards the left and right did not produce any abnormal free play and/or resistance. This would indicate that the steering system of the Motorcycle was in serviceable condition at the time of our inspection.

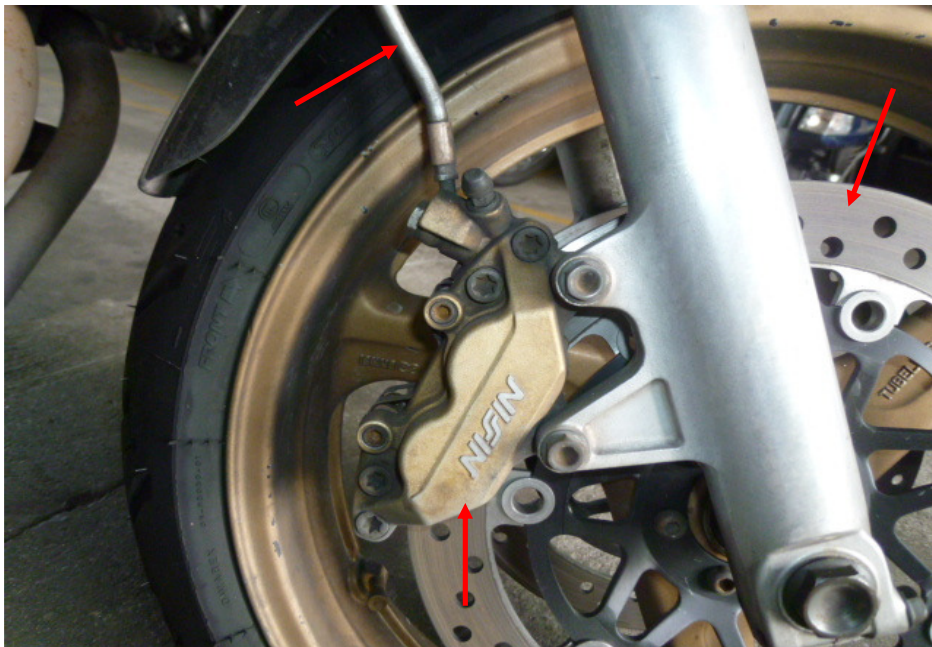
Photo 23 shows a close up view of the front brake caliper, front brake disc and front brake hose (arrowed) at the right side of the Motorcycle's front wheel, which are all part of the components in the hydraulic front brake system of the Motorcycle. Our visual checks of these various components had revealed all to be intact with no visible damage. No leakage of brake fluid was also observed.

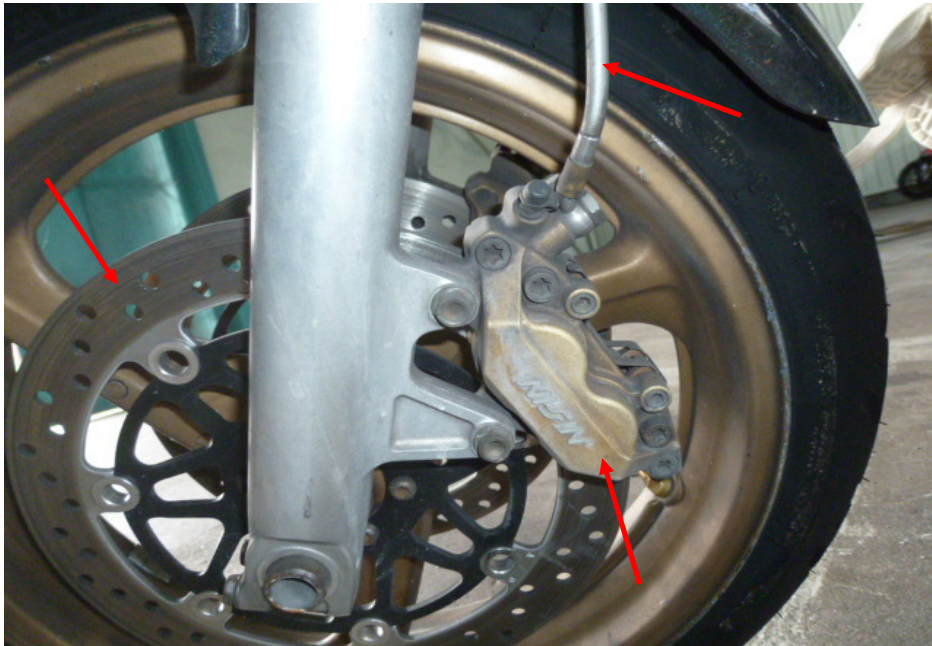
Photo 24 shows a close up view of the front brake caliper, front brake disc and front brake hose (arrowed) at the left side of the Motorcycle's front wheel, which are all part of the components in the hydraulic front brake system of the Motorcycle. Our visual checks of these various components had revealed all to be intact with no visible damage. No leakage of brake fluid was also observed.

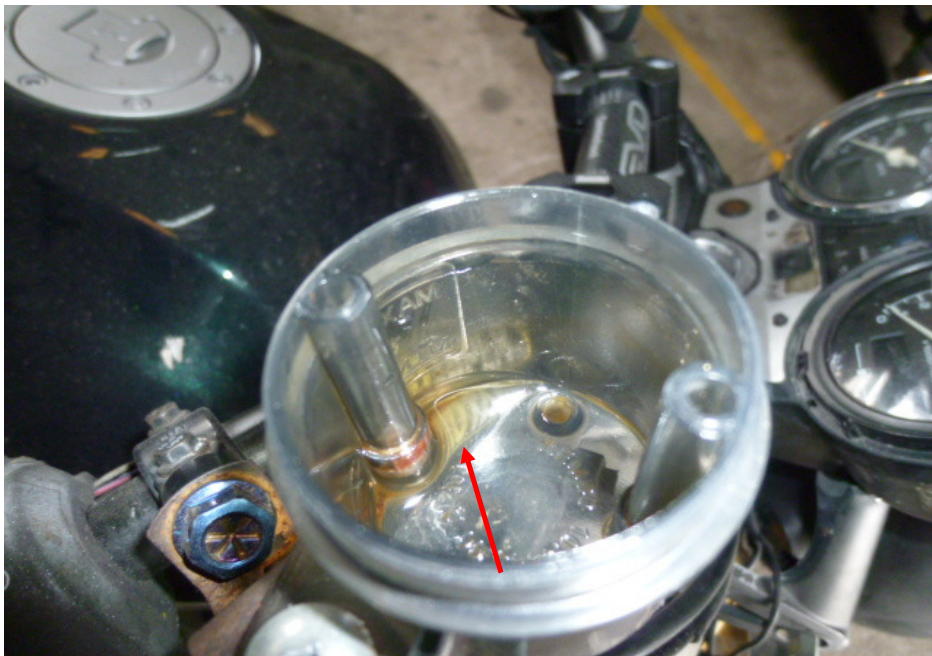
14. The front brake fluid reservoir was found to be empty. Upon closer examination, we observed the reservoir hose was detached from the front brake master cylinder as a result of the accident. The brake fluid for the rear brake was found to be of sufficient level for operational purposes and without any contamination.

Photo 25 shows the brake fluid reservoir for the front brake of the Motorcycle. The brake fluid was observed to be of insufficient level for operational purposes (arrowed).

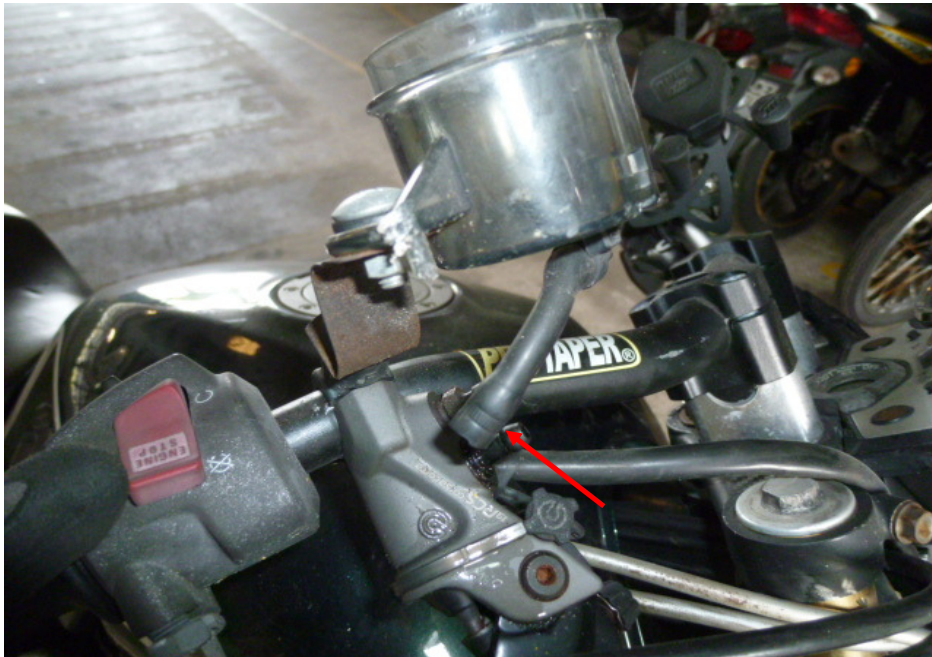
Photo 26 shows upon closer examination, we observed the reservoir hose was detached from the front brake master cylinder (arrowed) as a result of the accident.

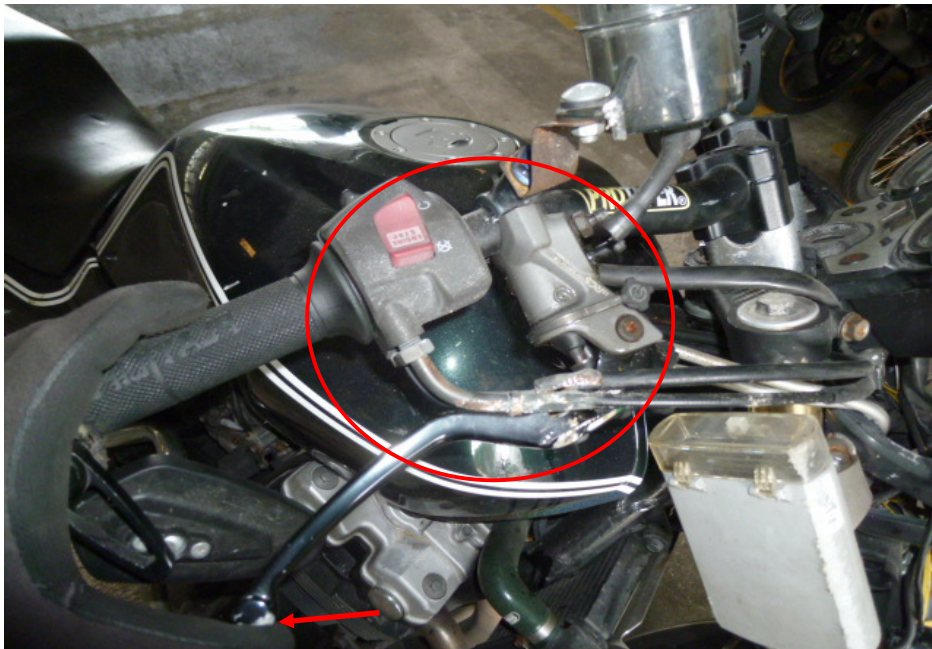
15. For this case, we were not able to determine whether the front braking system of the Motorcycle was in serviceable condition. The accident had caused the throttle cable housing of the Motorcycle to rotate. Hence we were unable to fully depress the front brake lever to determine if there was any resistance felt (spongy like feel) and if there is any leakage of pressure/vacuum in the front brake system.

Photo 27 shows the front brake lever being depressed (arrowed). We were not able to determine whether the front braking system of the Motorcycle was in serviceable condition. The accident had caused the throttle cable housing of the Motorcycle to rotate (circled). Hence we were unable to fully depress the front brake lever to determine if there was any resistance felt (spongy like feel) and if there is any leakage of pressure/vacuum in the front brake system.

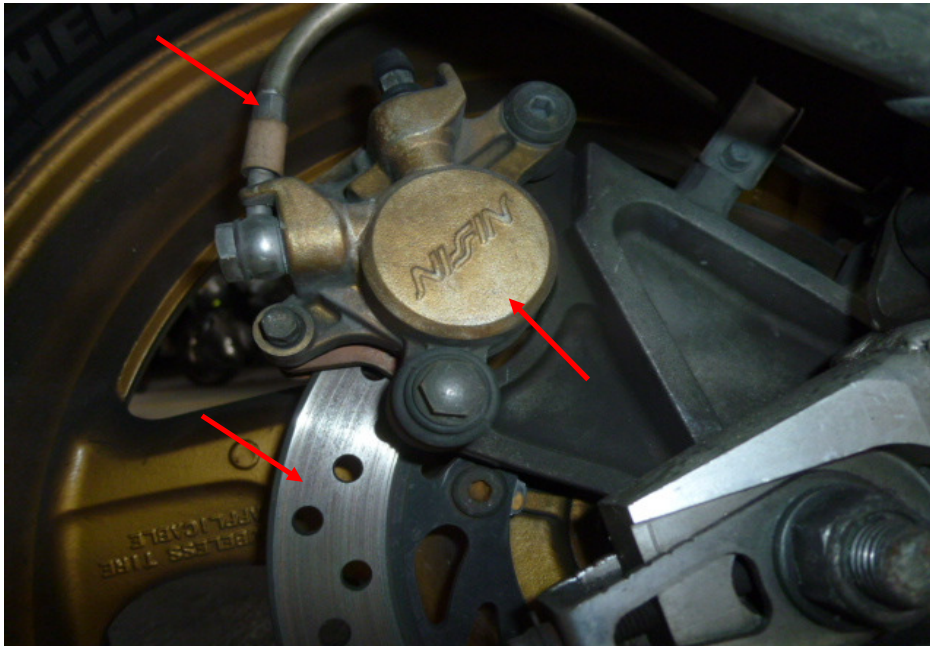
Photo 28 shows a close up view of the rear brake caliper, rear brake disc and rear brake hose (arrowed) of the Motorcycle, which are all part of the components in the hydraulic rear brake system of the Motorcycle. Our visual checks of these various components had revealed all to be intact with no visible damage. No leakage of brake fluid was also observed.

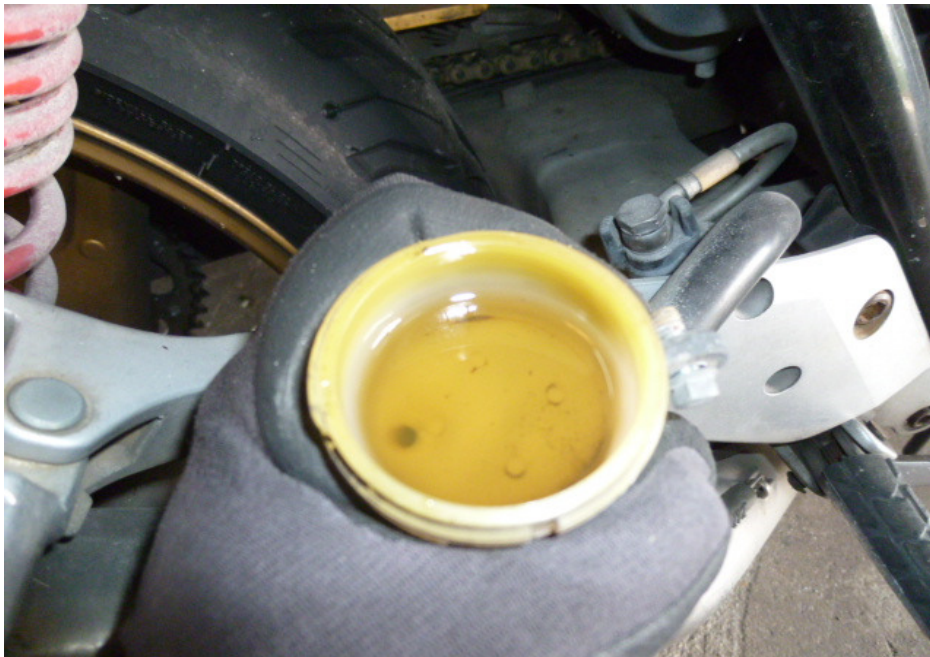
Photo 29 shows the brake fluid reservoir for the rear brake of the Motorcycle. The brake fluid was observed to be of sufficient level for operational purposes and without any contamination.
