Your Ref: TPIP/06750/2023
Our Ref : CI/TPD23005729/N

Fatal Accident Investigation Team

INSPECTION REPORT OF MOTORCYCLE FBM 5984K

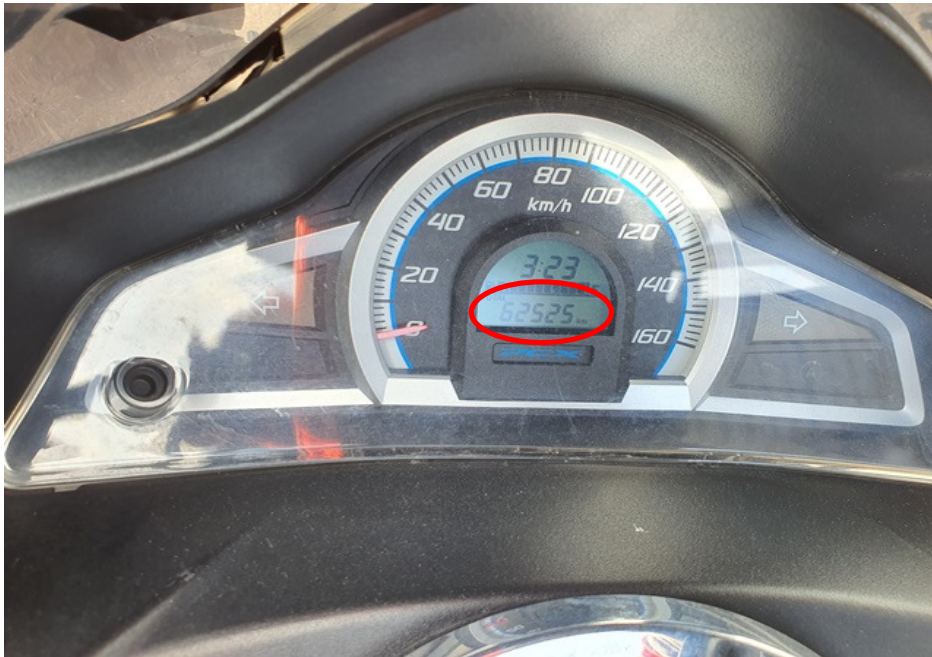
Photo 1 shows the speedometer gauge of the Motorcycle where the mileage recorded at the time of our inspection was 62, 525km (circled).

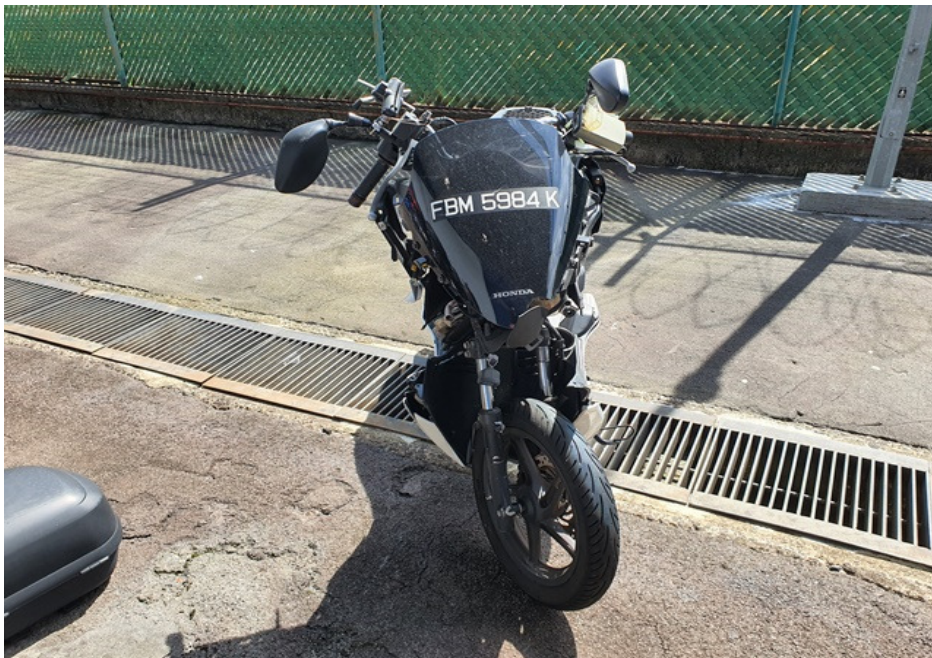
Photo 2 shows a general view of the frontal portion of the Motorcycle at the time of our inspection. The Motorcycle was observed to have sustained damages all around.

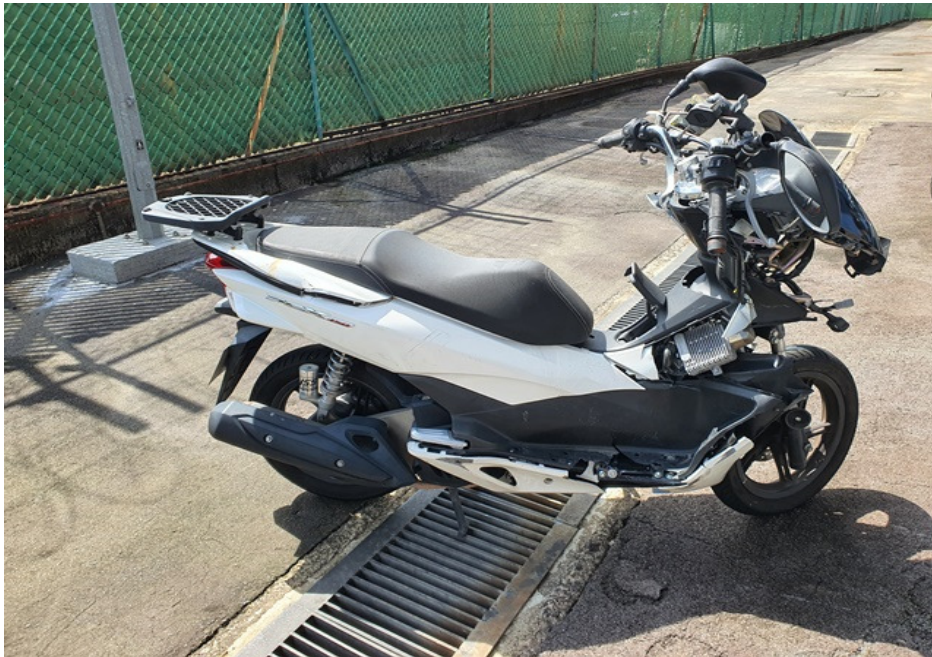
Photo 3 shows a general view of the right body of the Motorcycle at the time of our inspection. The Motorcycle was observed to have sustained damages all around.

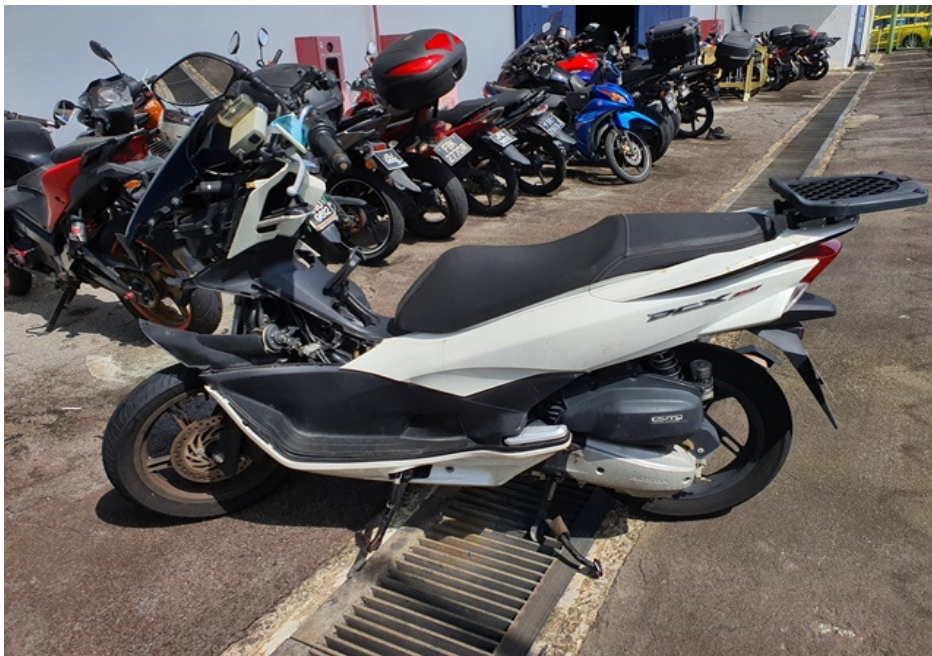
Photo 4 shows a general view of the left body of the Motorcycle at the time of our inspection. The Motorcycle was observed to have sustained damages all around.

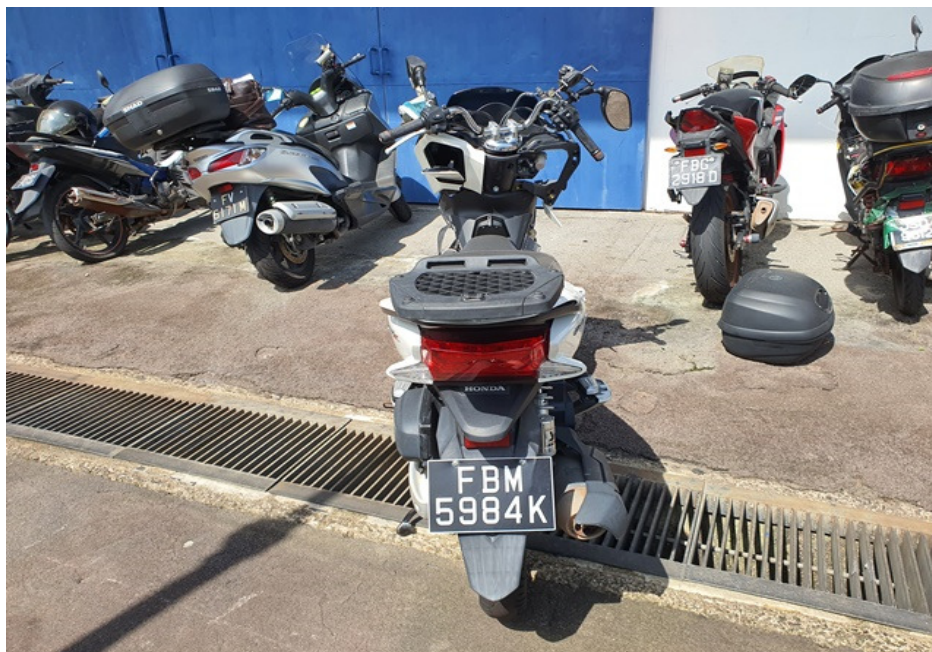
Photo 5 shows a general view of the rear portion of the Motorcycle at the time of our inspection. The Motorcycle was observed to have sustained damages all around. The body parts that were found to have been damaged include its windshield, front cowling, headlight assembly, brake levers, side mirrors, handlebar ends, handlebar, side cowlings, right bottom cowling, right rear side cover and exhaust muffler shield, amongst others as a result of the accident

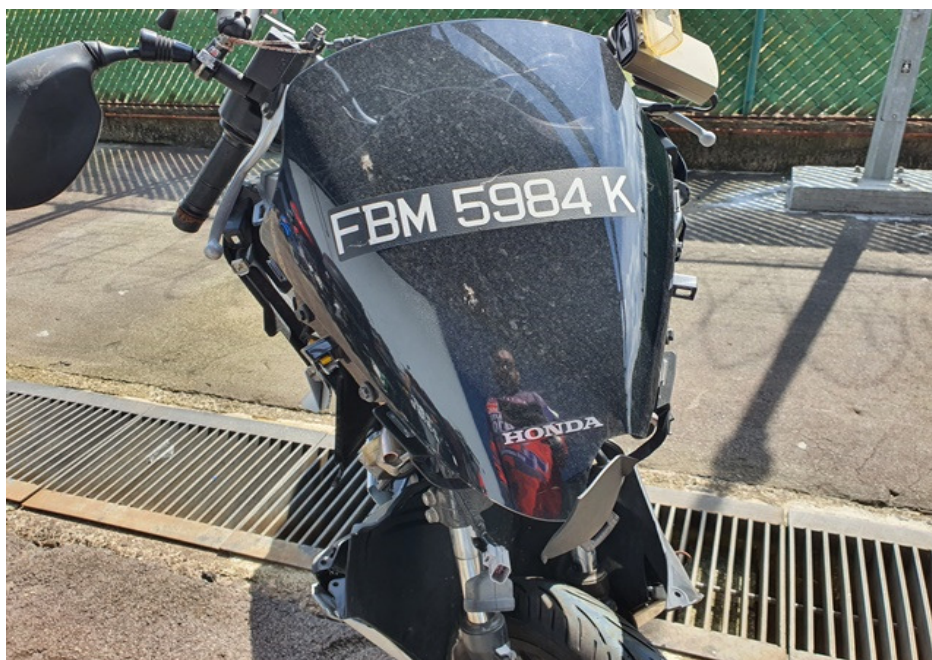
Photo 6 shows a closer view of the cracked windshield and front cowling of the Motorcycle at the time of our inspection

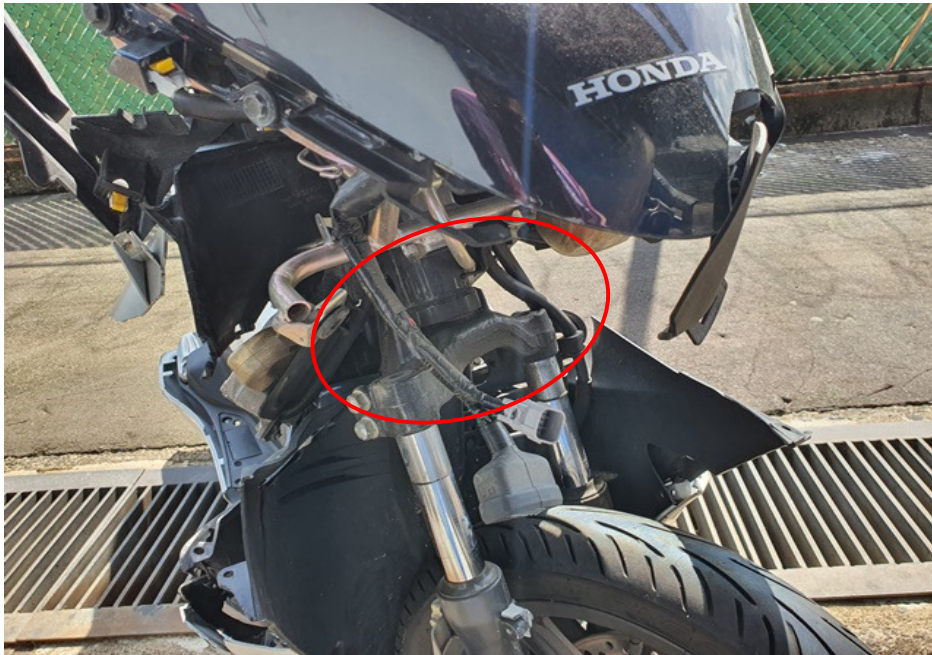
Photo 7 shows a closer view of the missing headlight assembly (arrowed) which was amongst the body parts at the front body of the Motorcycle that had sustained damage at the time of our inspection.

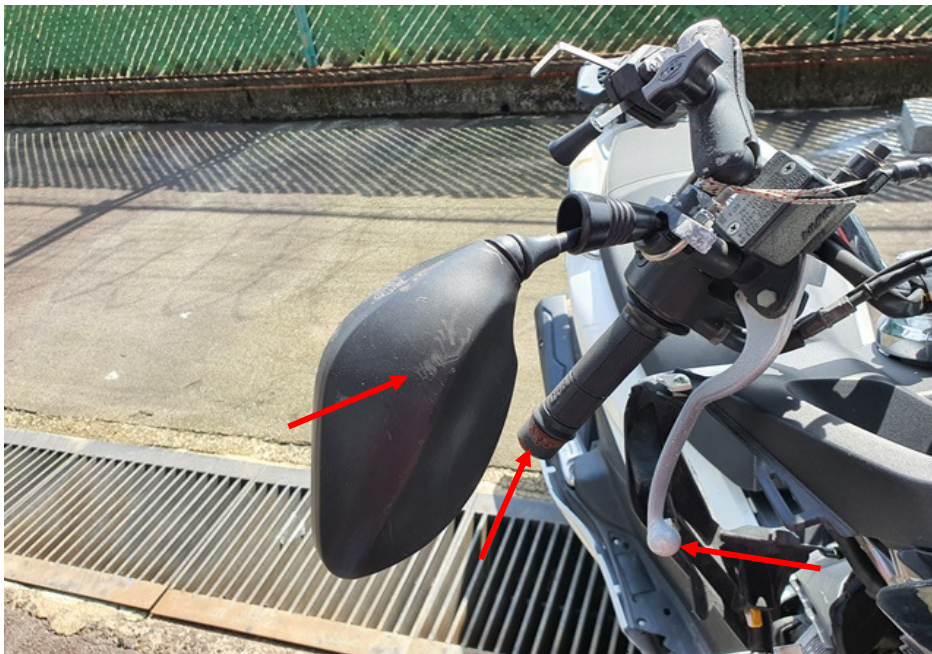
Photo 8 shows a closer view of the right side mirror, right handlebar end and front brake lever of the Motorcycle which were observed to be damaged at the time of our inspection (arrowed).

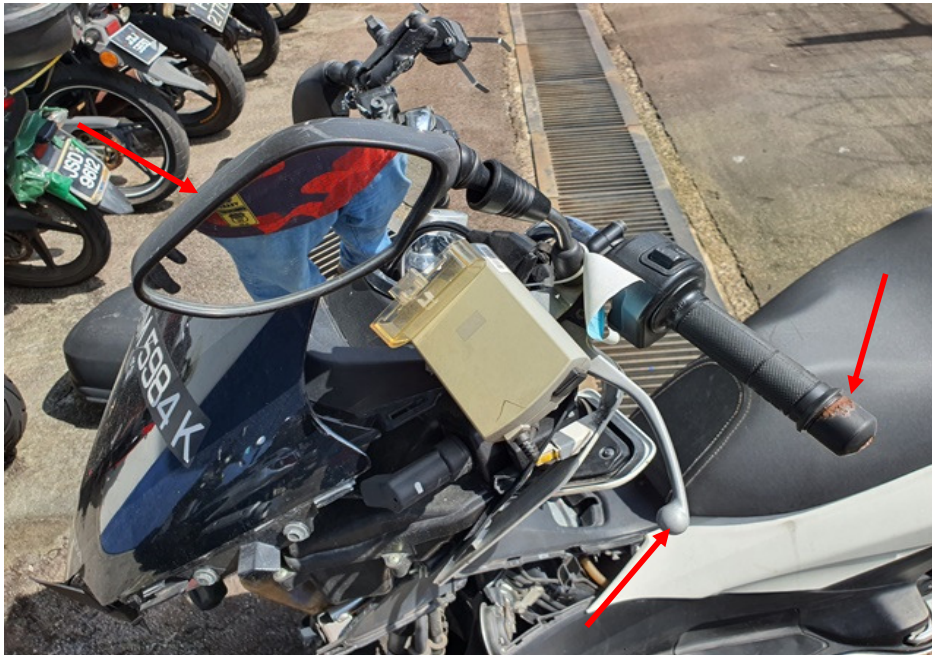
Photo 9 shows a closer view of the left side mirror, left handlebar end and rear brake lever of the Motorcycle which were observed to be damaged at the time of our inspection (arrowed).

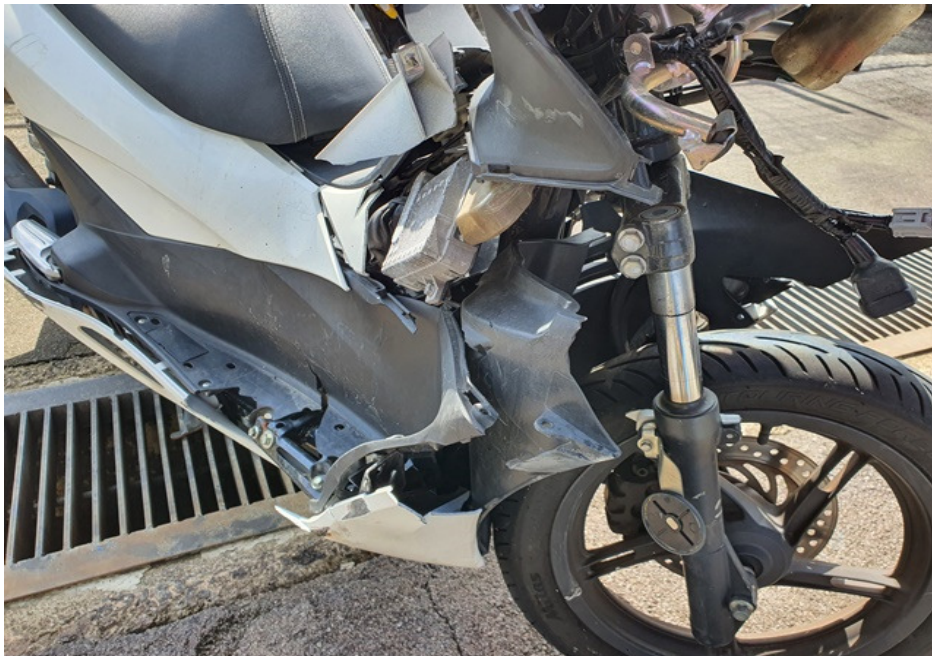
Photo 10 shows the cracked right side cowling of the Motorcycle at the time of our inspection.

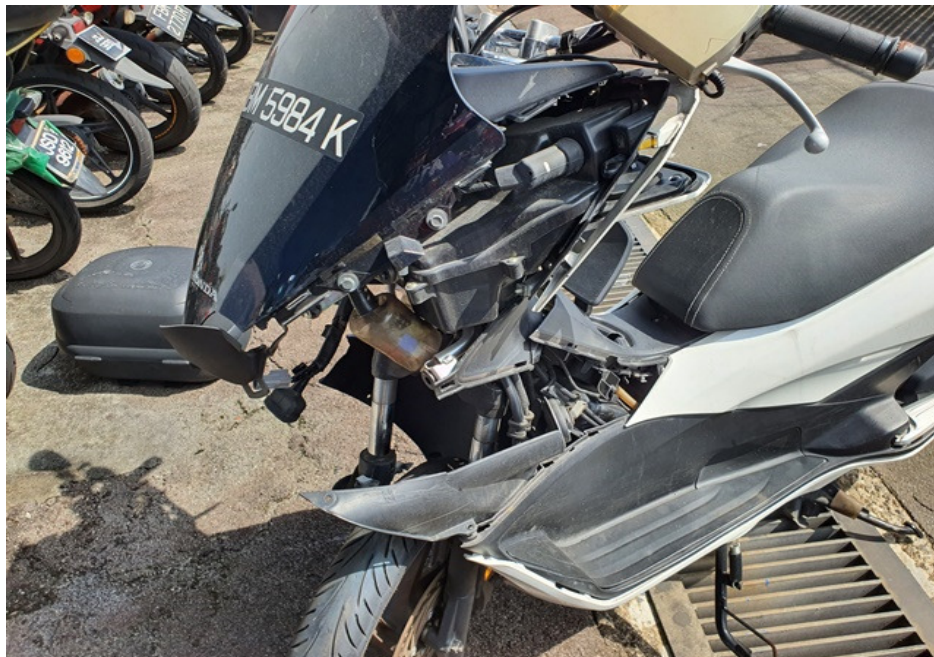
Photo 11 shows the cracked left side cowling of the Motorcycle at the time of our inspection.

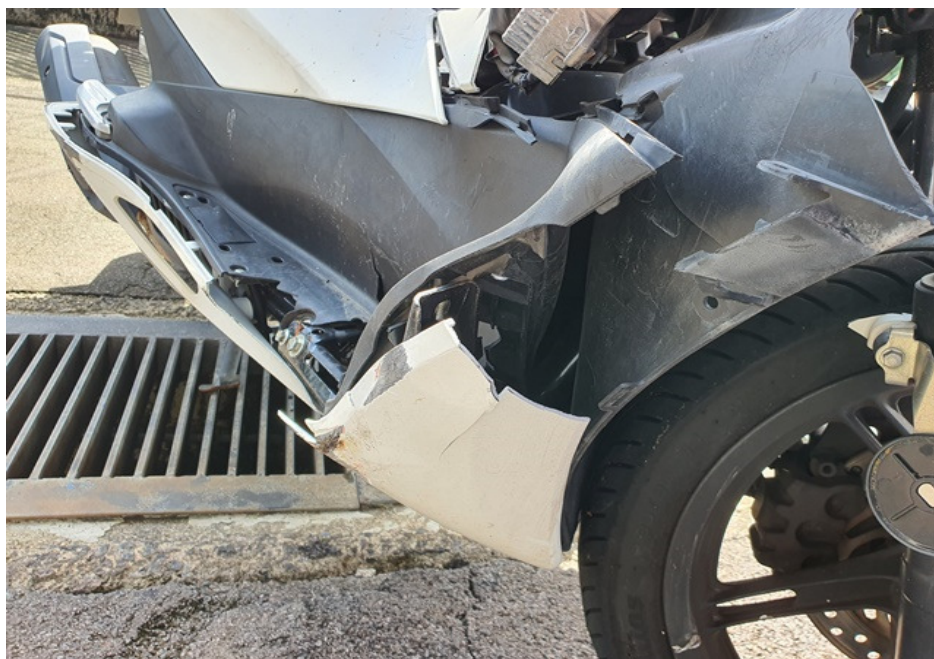
Photo 12 shows a close-up view of the cracked right bottom cowling of the Motorcycle at the time of our inspection.

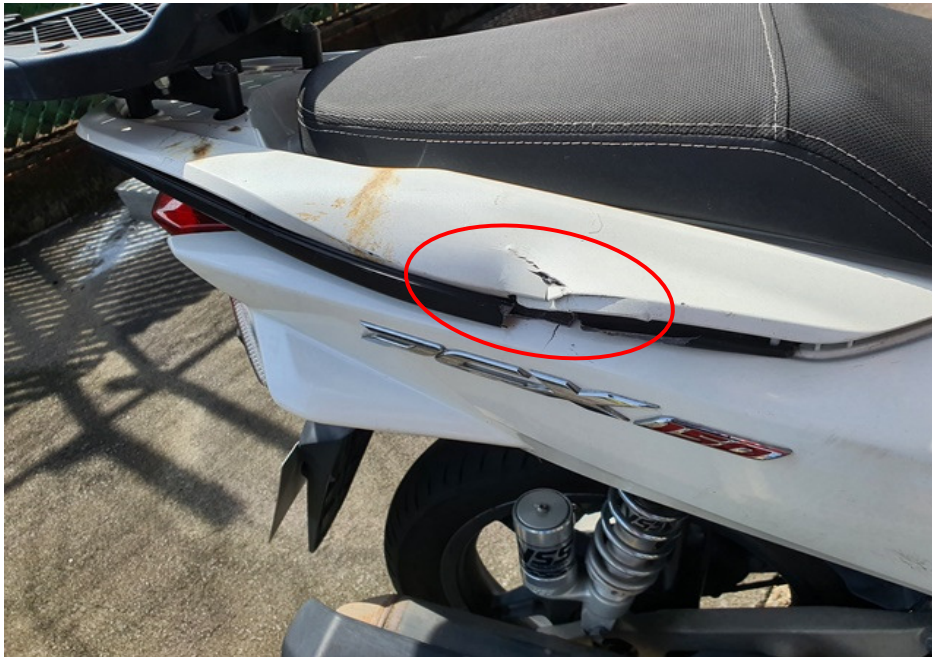
Photo 13 shows a closer view of the cracked right rear side cover of the Motorcycle at the time of our inspection (circled).

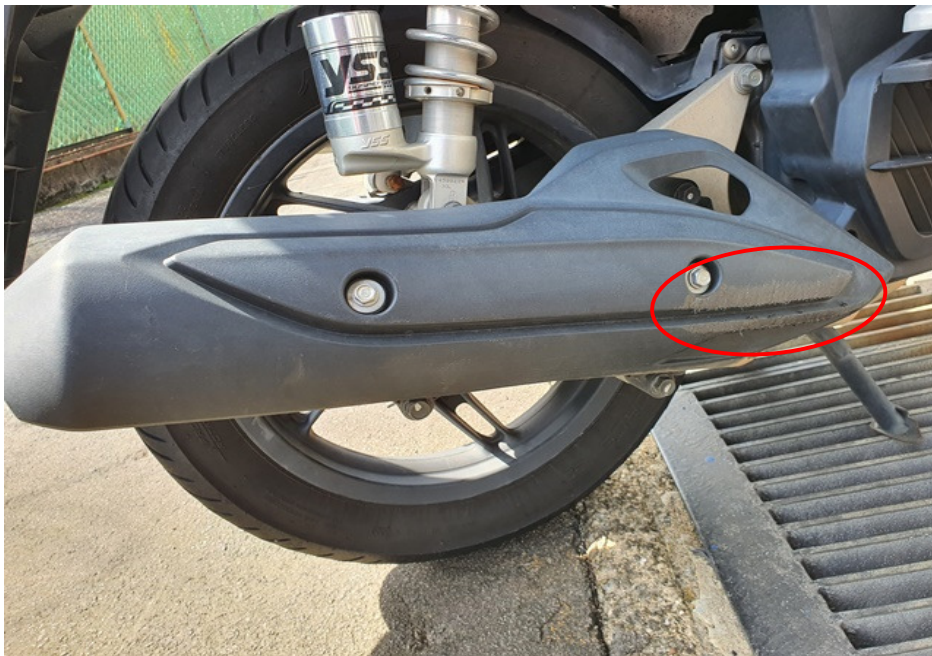
Photo 14 shows a closer view of the grazed exhaust muffler heat shield of the Motorcycle at the time of our inspection (circled).

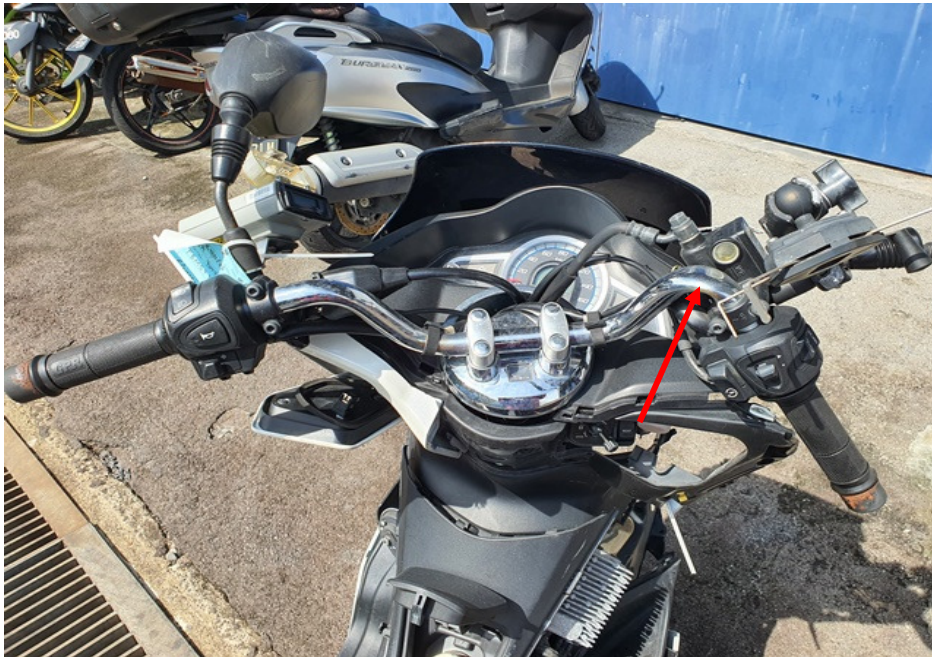
Photo 15 shows a closer view of the bent handlebar of the Motorcycle at the time of our inspection (arrowed).

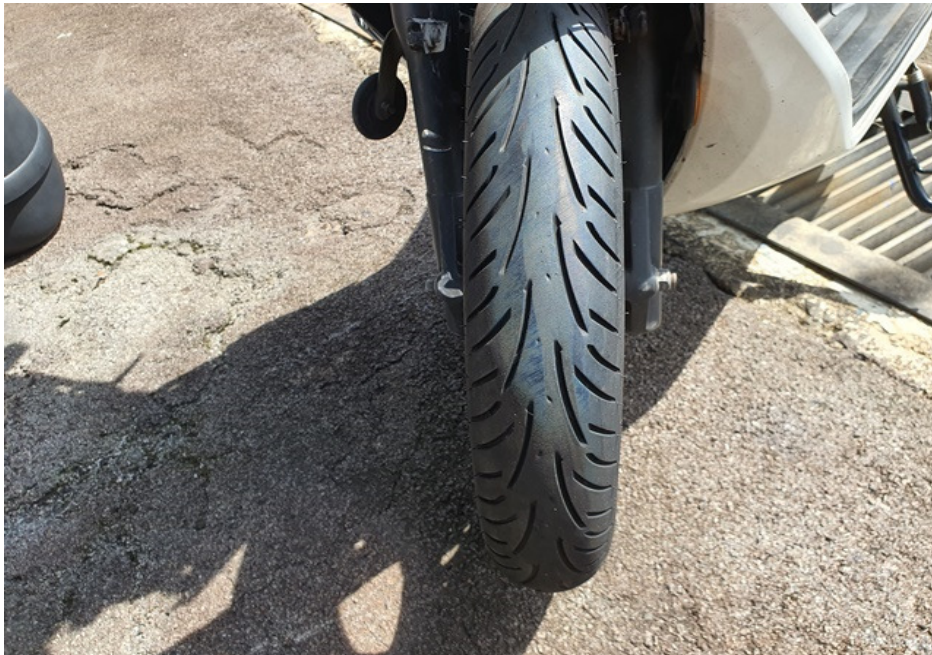
6. At the time of our inspection, the Motorcycle's front tyre was observed to be in serviceable condition. The tread pattern of the front tyre was clearly visible. We did not observe any tear, burst mark(s) and/or punctured hole(s) on the sidewalls as well as across the tread of the 2 tyres. The 2 tyres were both observed to be sufficiently inflated for vehicular operation. However the rear tyre was observed to be bald. The tyre brand, tyre size and remaining tread depth of the 2 tyres were recorded as follows:-

Photo 16 shows the condition of the Motorcycle's front tyre. The front tyre was observed to be in serviceable condition with remaining tread depth of approximately 3mm. There was no tear, burst mark(s) and/or punctured hole(s) on the sidewalls as well as across the tread of the front tyre.

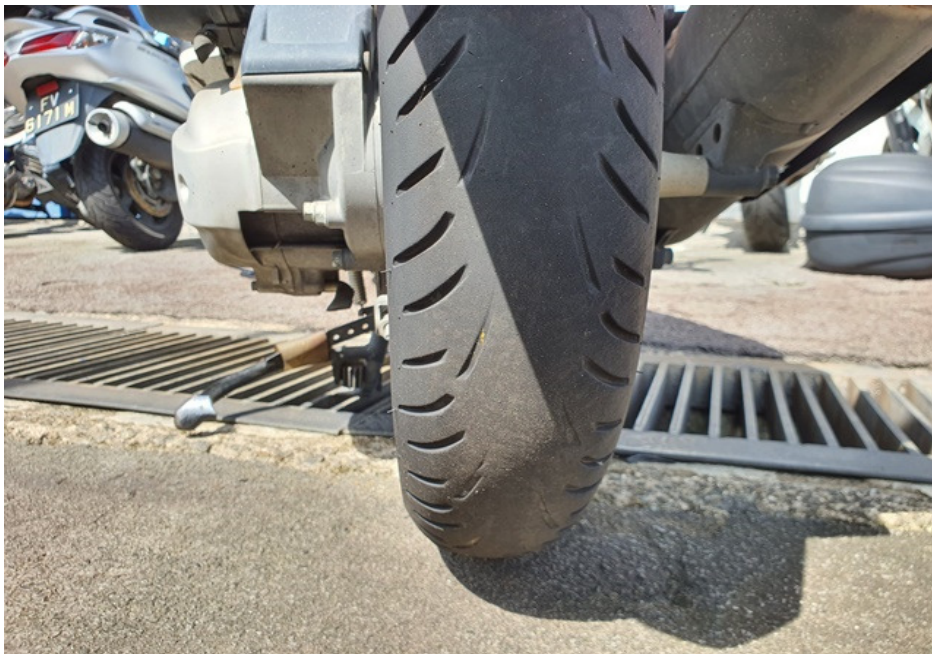
Photo 17 shows the condition of the Motorcycle's rear tyre. The rear tyre was observed to be bald. The tyre was also observed to be sufficiently inflated for vehicular operation. We did not observe any tear, burst mark(s) and/or punctured hole(s) on the sidewalls as well as across the tread of the rear tyre.

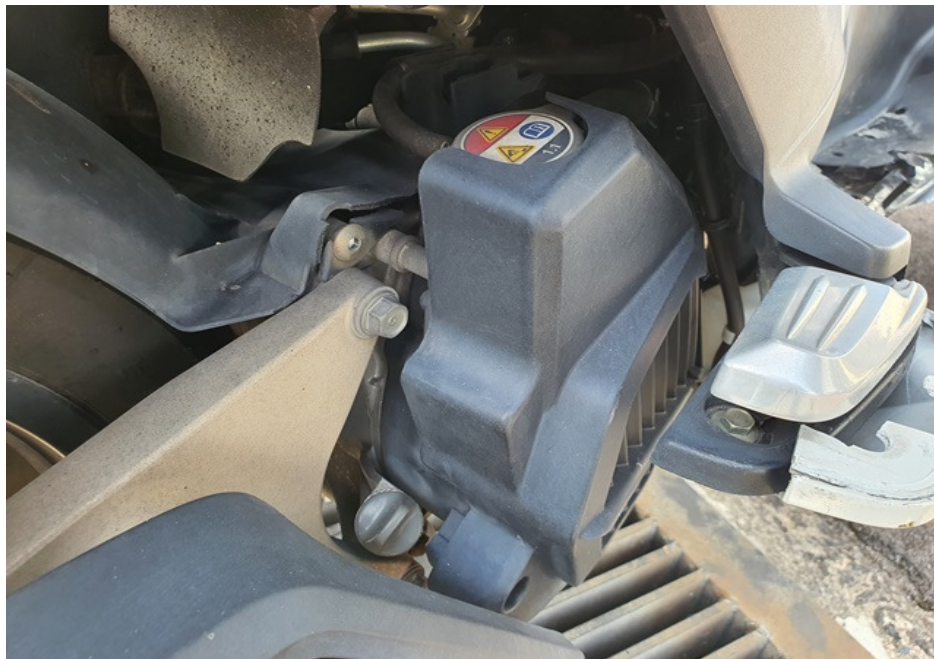
Photo 18 shows the radiator of the Motorcycle at the time of our inspection. The radiator was found to be intact with no visible damage. There was also no sign(s) or indication(s) of fluid leak observed around the radiator of the Motorcycle.

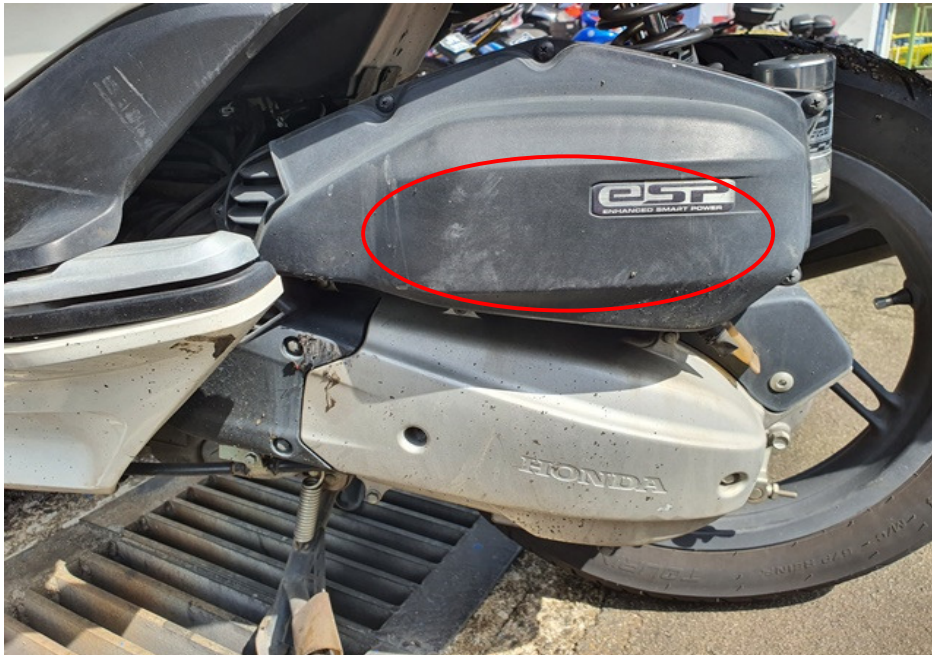
Photo 19 shows the drive train cover of the Motorcycle which had sustained damages of grazing nature at the time of our inspection (circled) however the engine components were still intact.

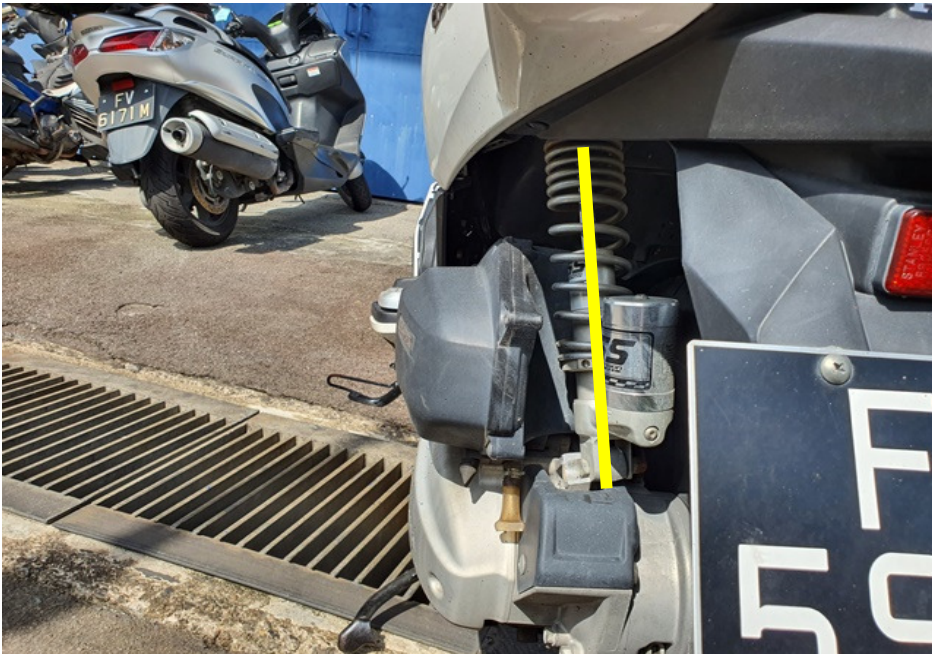
Photo 20 shows the left shock absorber of the Motorcycle which was found to be intact without any misalignment.

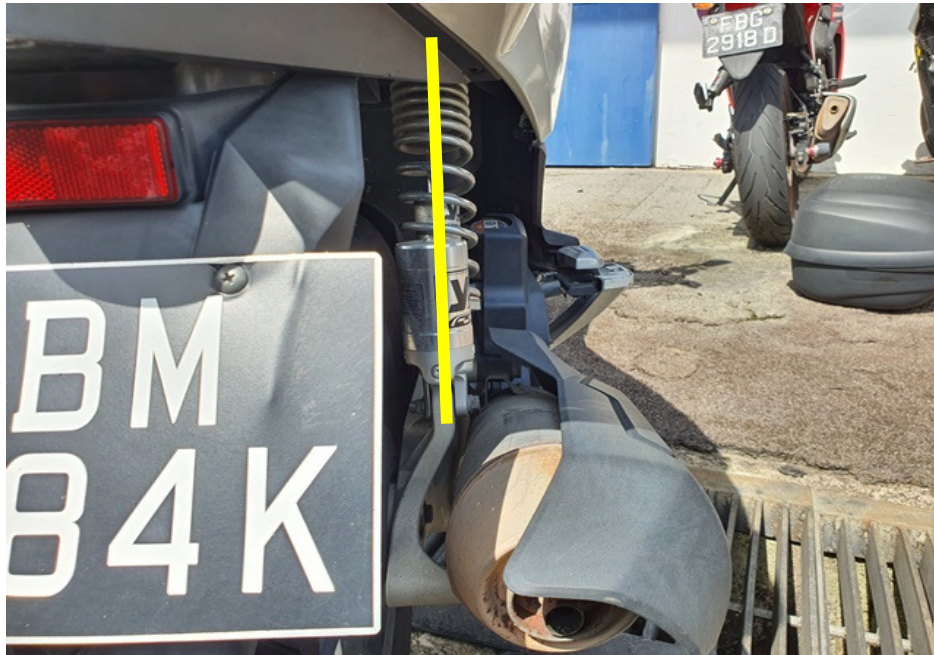
Photo 21 shows the right shock absorber of the Motorcycle which was found to be intact without any misalignment.

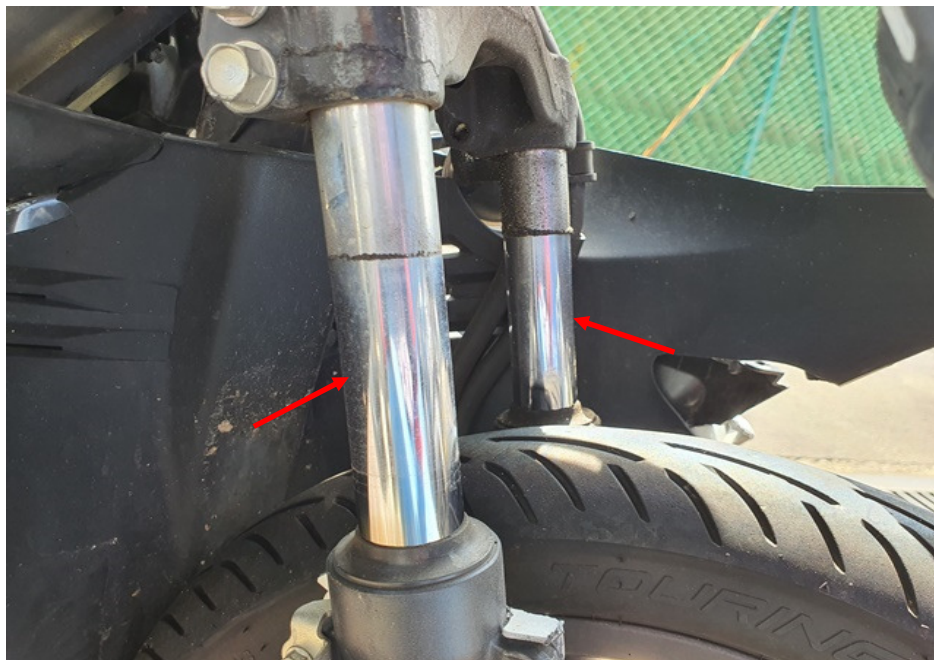
10. For this case, we were not able to conduct any test(s) on the steering system of the Motorcycle due to the damage of its front forks. The front forks were found to be bent as a result of the accident.

Photo 22 shows the front forks of the Motorcycle. The front forks were observed to be bent (arrowed) as a result of the accident. We were hence not able to conduct any tests on the steering system of the Motorcycle.

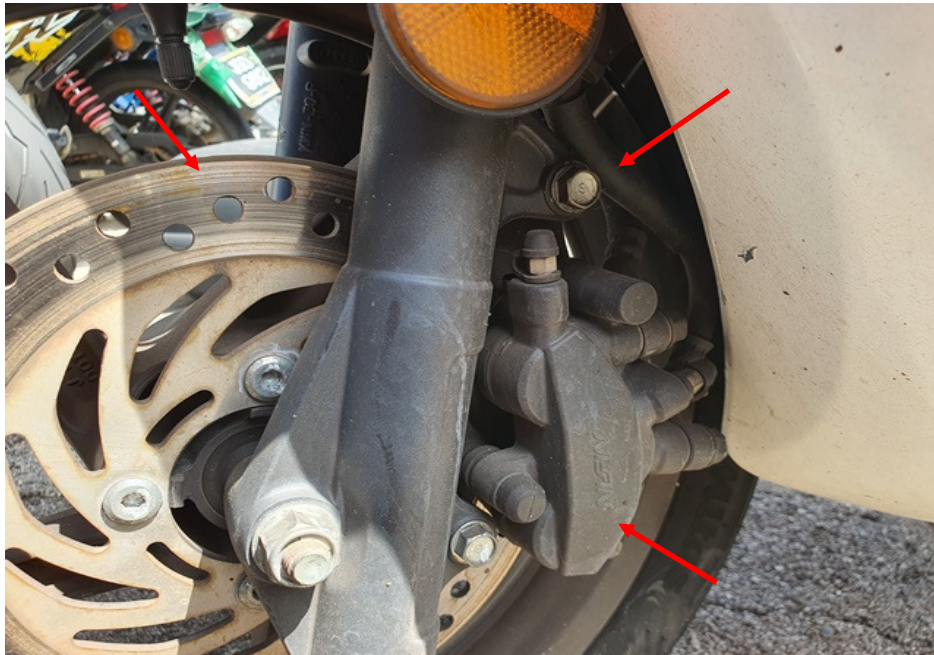
Photo 23 shows a close up view of the front brake caliper, front brake disc and front brake hose (arrowed) of the Motorcycle, which are all part of the components in the hydraulic front brake system of the Motorcycle. Our visual checks of these various components had revealed all to be intact with no visible damage. No leakage of brake fluid was also observed.

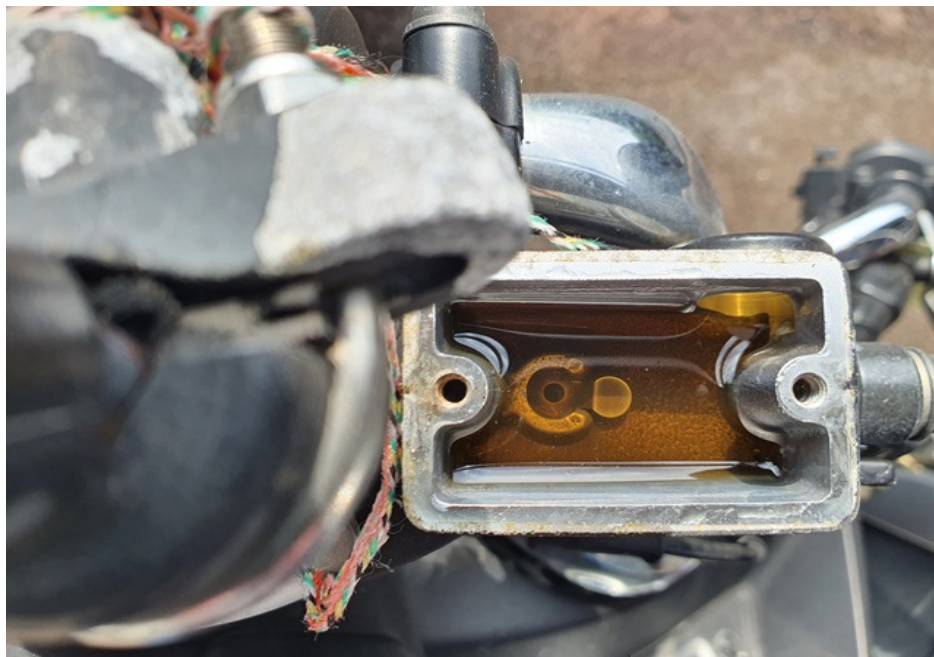
Photo 24 shows the brake fluid reservoir for the front brake of the Motorcycle. The brake fluid was observed to be of sufficient level for operational purposes and without contamination.

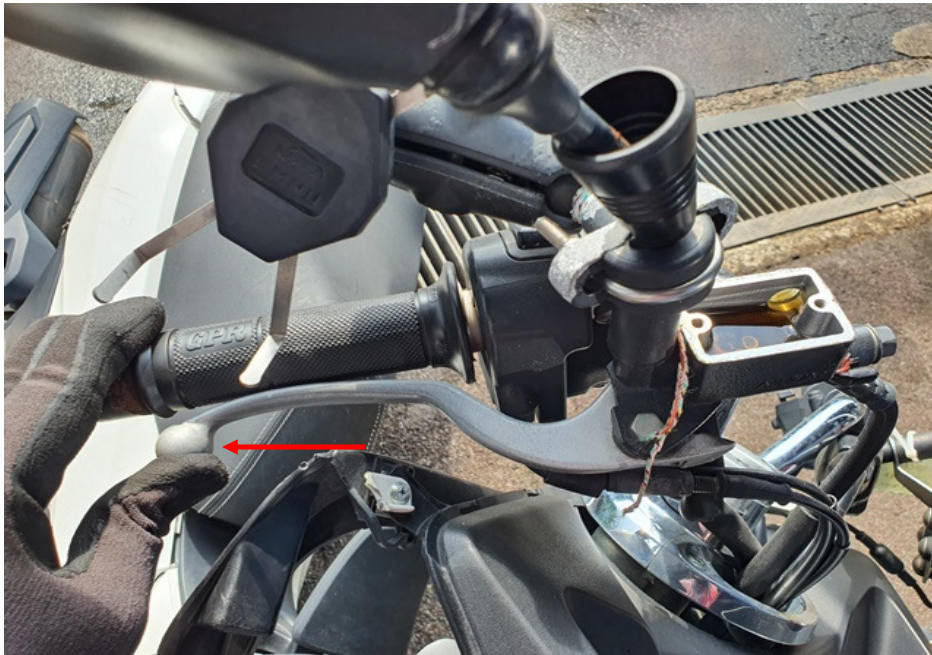
12. Static brake tests conducted on the Motorcycle had appeared to indicate that the brake system of the Motorcycle was not in serviceable condition. There was no resistance felt (spongy like feel) upon pressing the front brake lever. This would indicate that there may be a leakage of pressure/vacuum in the front braking system.
13. For this case, we were not able to carry out any operational tests to the steering system and braking system of the Motorcycle due to the damage of the front forks, which had rendered the Motorcycle immobile for the operational tests. We were not able to push the Motorcycle manually forward and backward, simulating movement of the Motorcycle, for the operational tests. See photos 22 – 29 below.

Photo 25 shows the front brake lever being depressed. There was no resistance felt (spongy like feel) upon pressing the front brake lever (arrowed). This would indicate that there may be a leakage of pressure/vacuum in the front brake system.

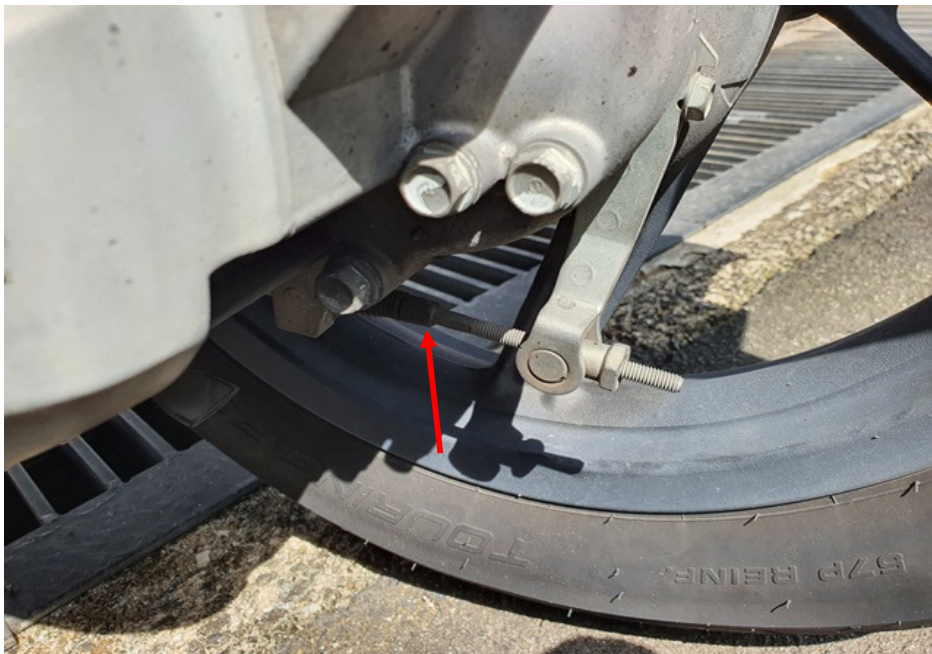
Photo 26 shows the rear wheel of the Motorcycle. The type of brake system for the rear wheel was of a mechanical type, controlled by the brake foot pedal of the Motorcycle. Our checks of the cable (arrowed), spring and drum which are all part of the components in the rear brake system of the Motorcycle reveal all to be intact and without damage.
