Your Ref: TPIP/04512/2023  
Our Ref : CI/TPD23005734/N

**Fatal Accident Investigation Team**

**MECHANICAL INSPECTION REPORT OF MOTORCYCLE JTR 3354**

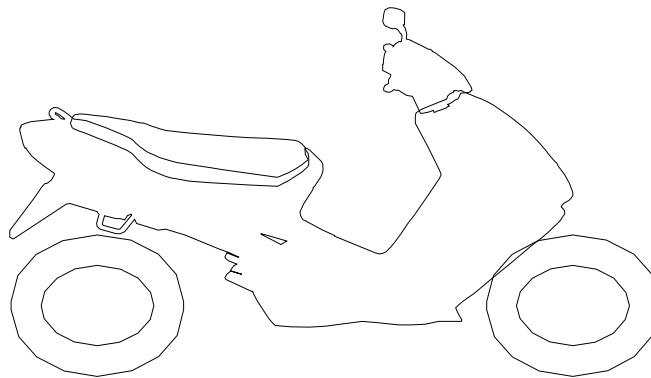
Maxxis 70/90 - 17 (2mm)  
(Deflated)

Maxxis 70/80 - 17 (4mm)

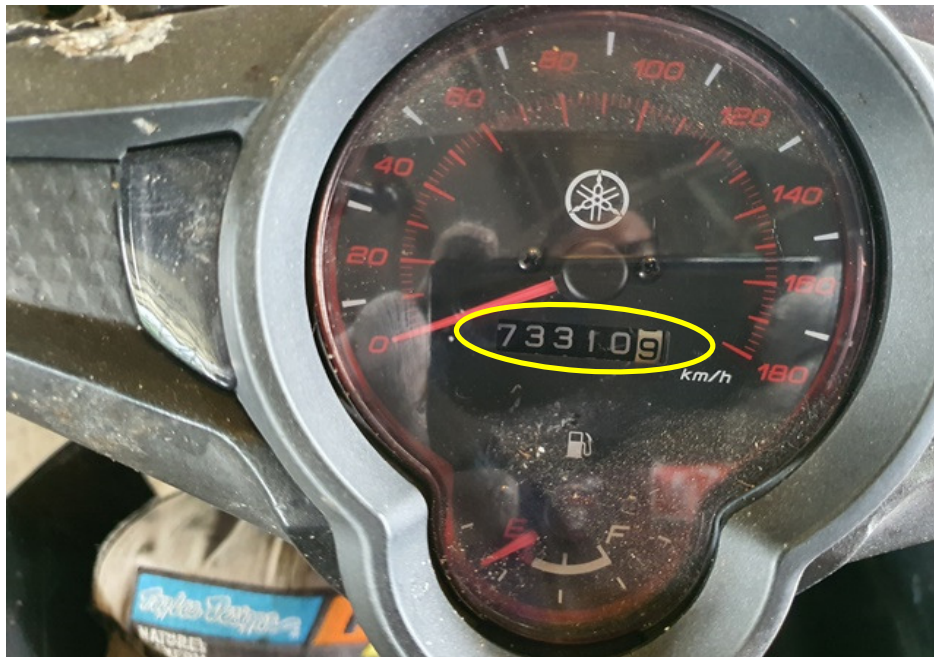
**Photo 1** shows the speedometer gauge of the Motorcycle. The mileage of the Motorcycle at the time of our inspection was 73, 310km (circled).

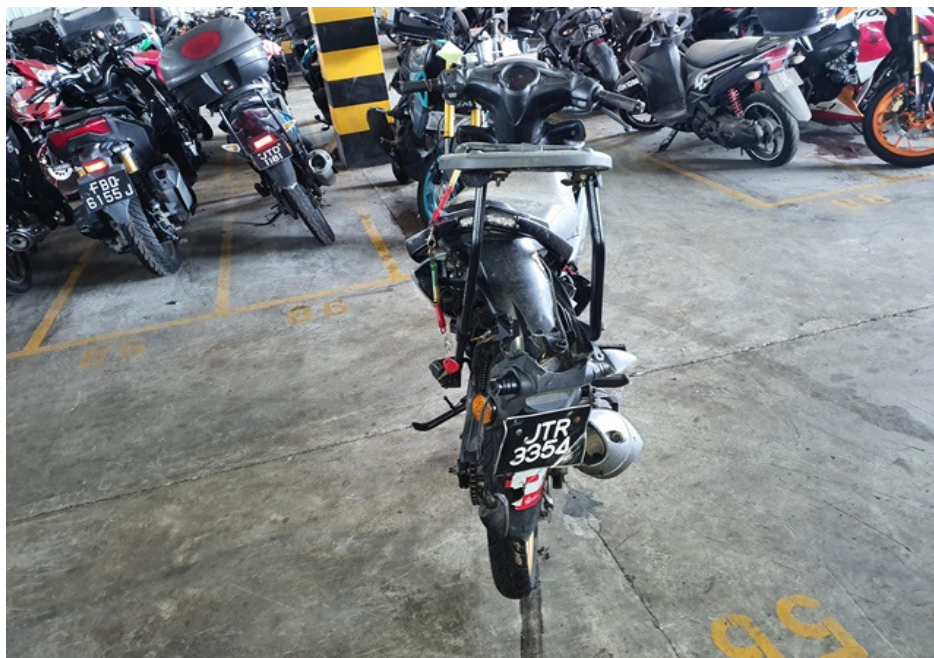
**Photo 2** shows a general view of the rear portion of the Motorcycle at the time of our inspection. The Motorcycle had sustained damages all around.

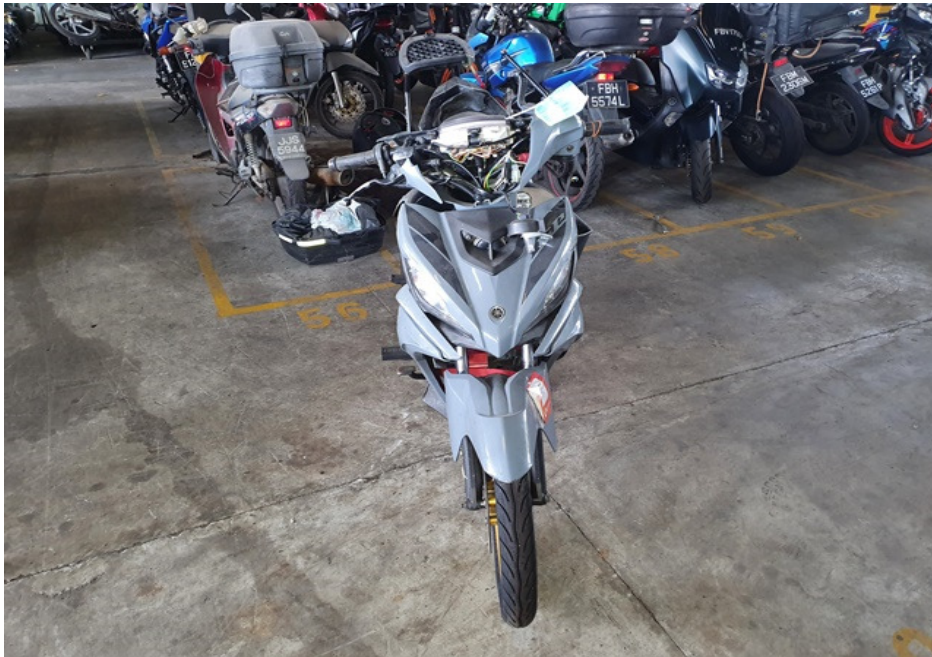
**Photo 3** shows a general view of the frontal portion of the Motorcycle at the time of our inspection. The Motorcycle had sustained damages all around.

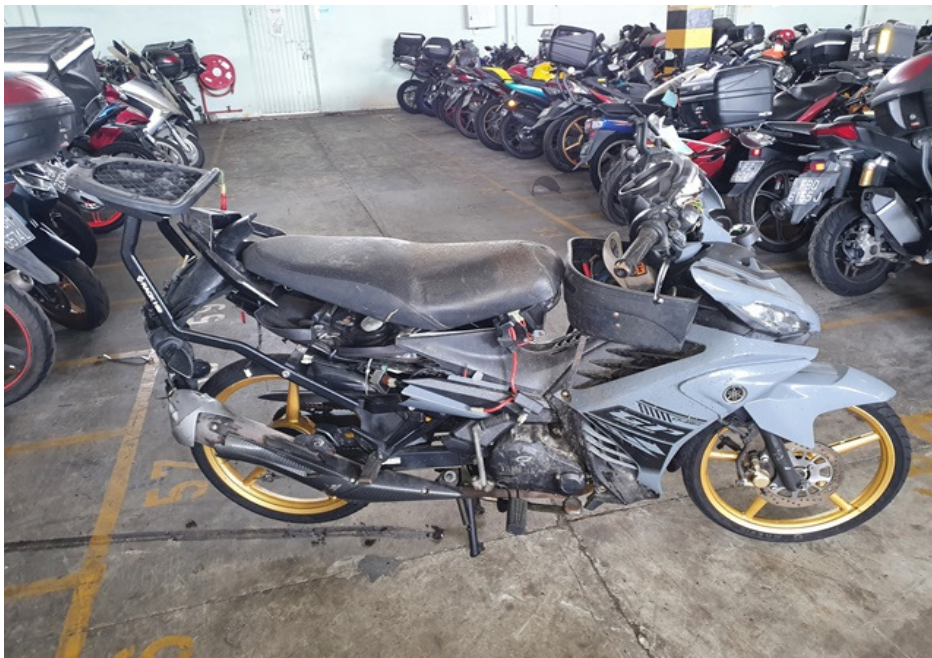
**Photo 4** shows a general view of the right body of the Motorcycle at the time of our inspection. The Motorcycle had sustained damages all around.

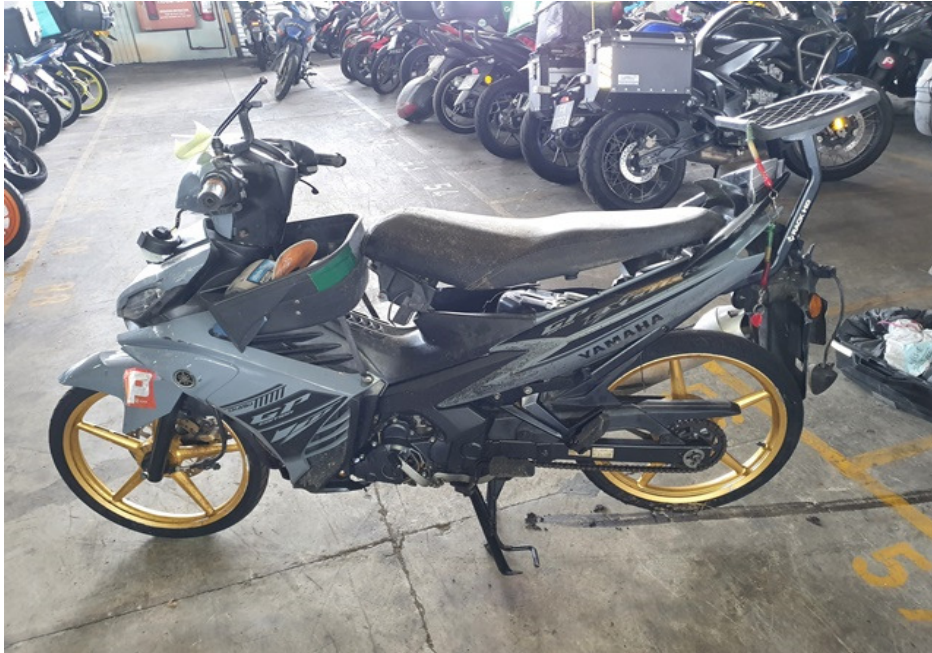
**Photo 5** shows a general view of the rear portion of the Motorcycle at the time of our inspection. The Motorcycle had sustained damages all around. Body parts that were found to have been damaged include its headlight assembly, front fork assembly, front cowlings, front mudguard, handlebar ends, side mirrors, clutch lever, front brake lever, front basket, side cowlings, gear shift pedal, left front footrest, right rear side cover, top box rack, tail light assembly, rear mudguard and exhaust muffler heat shield, amongst others.

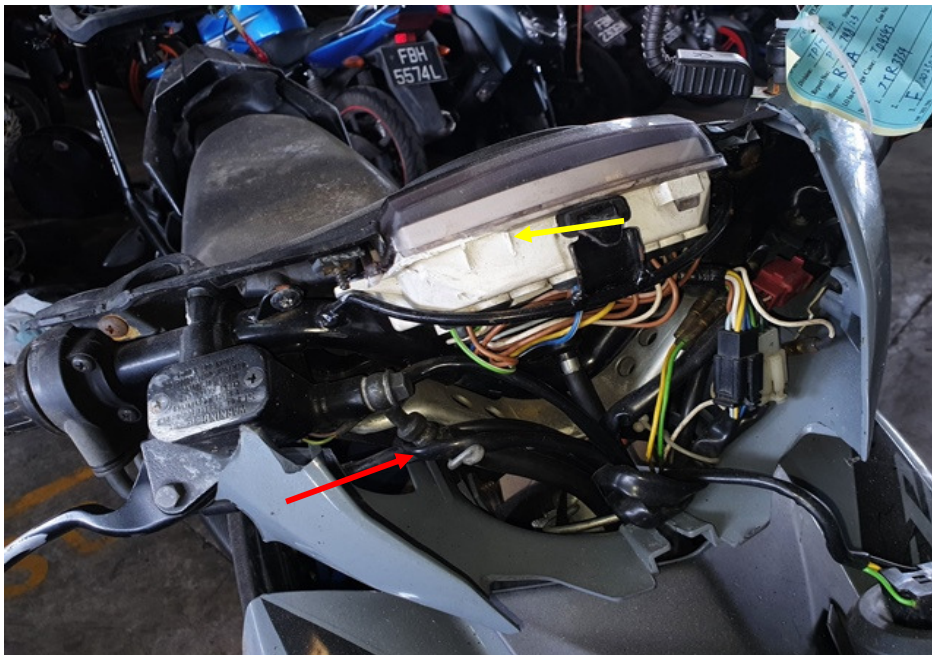
**Photo 6** shows a closer view of the missing headlight assembly (arrowed) of the Motorcycle at the time of our inspection.

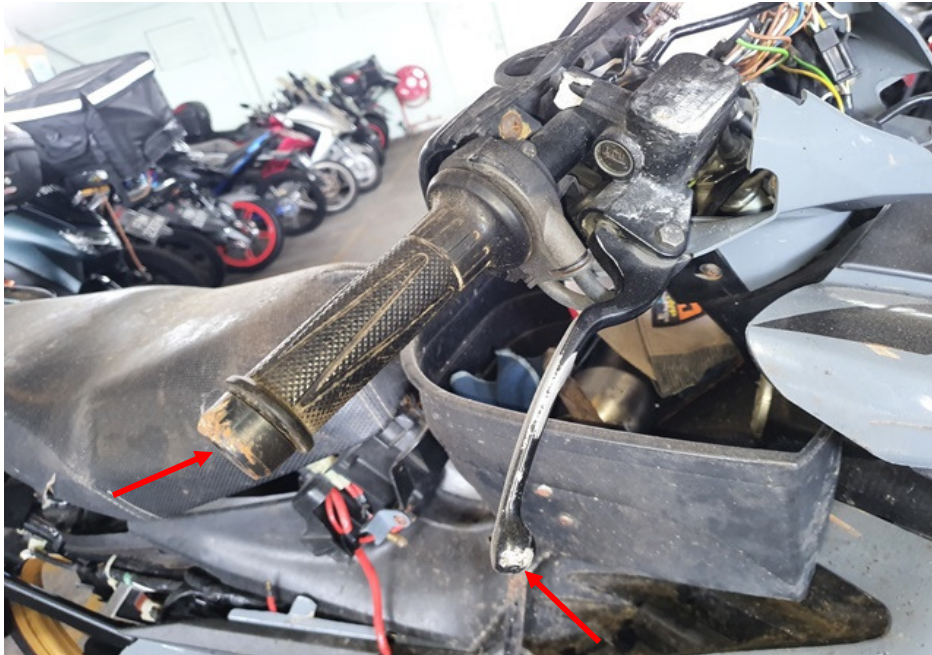
**Photo 7** shows a closer view of the grazed front brake lever and right handlebar end of the Motorcycle (arrowed) at the time of our inspection.

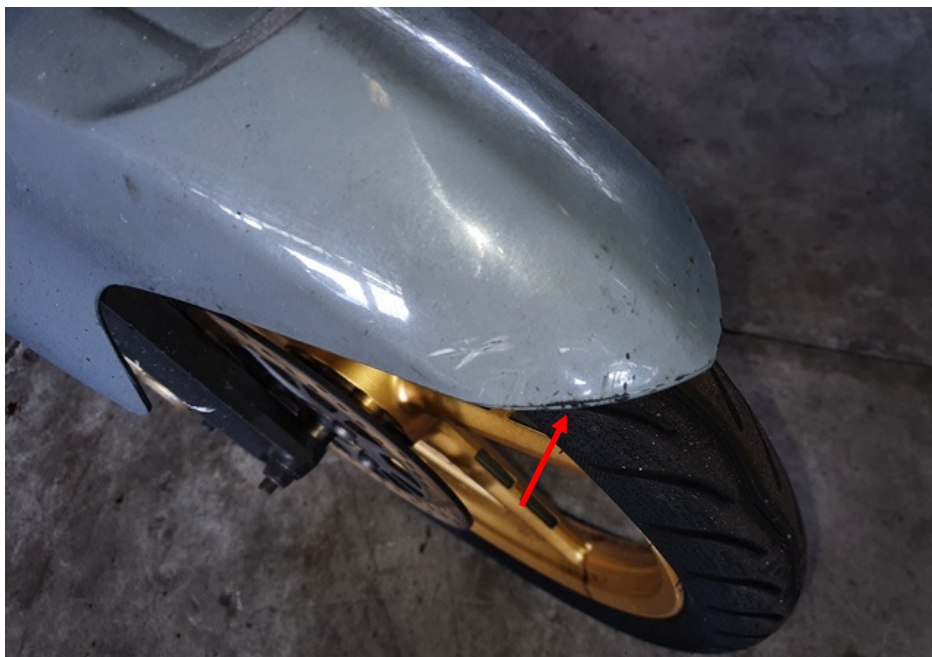
**Photo 8** shows a closer view of the grazed front mudguard of the Motorcycle (arrowed) at the time of our inspection.

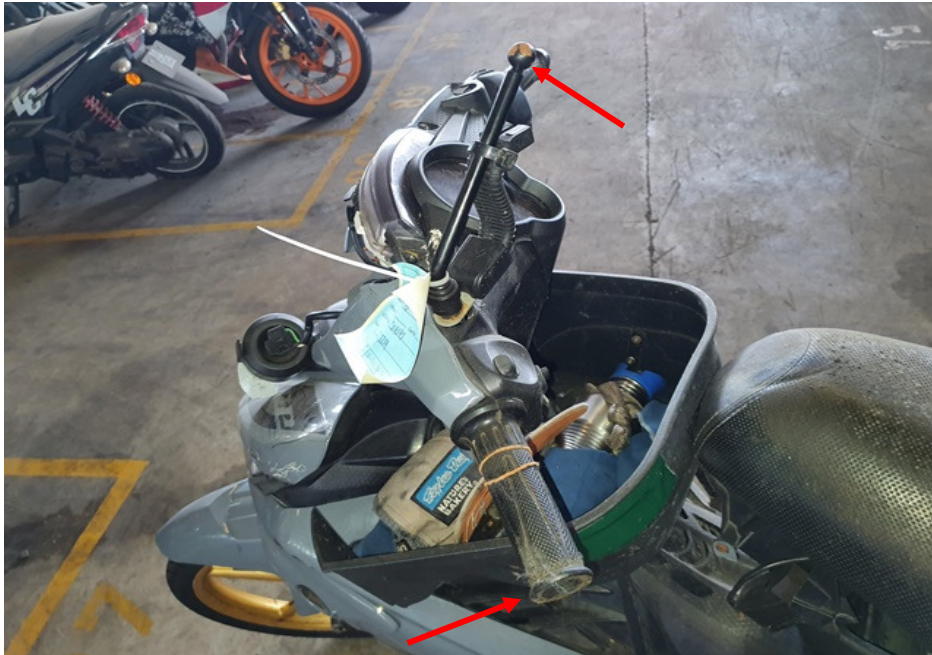
**Photo 9** shows a closer view of the damaged left side mirror and left handlebar end of the Motorcycle (arrowed) at the time of our inspection.

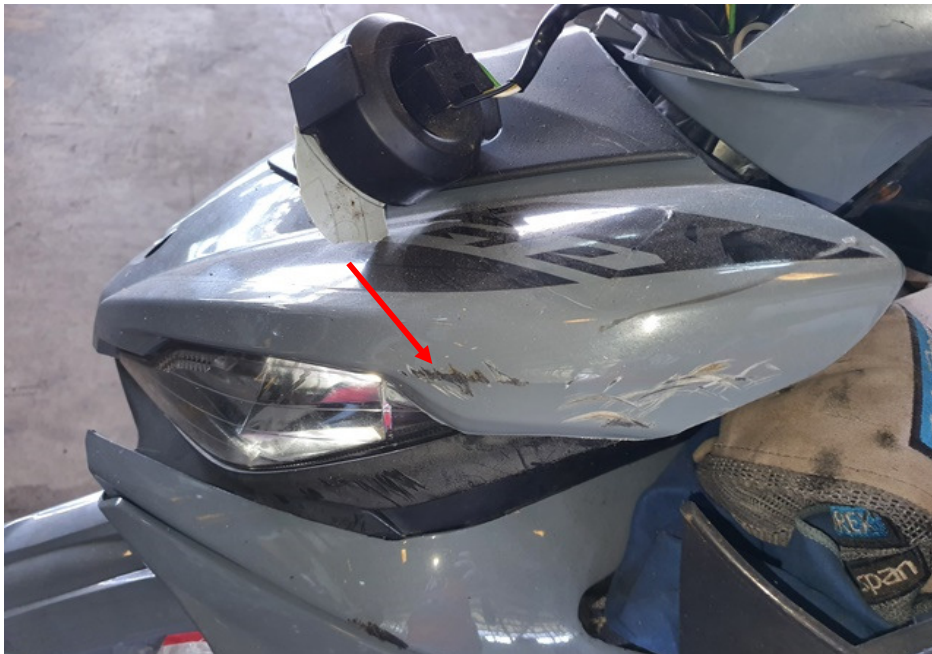
**Photo 10** shows a closer view of the grazed front cowling of the Motorcycle at the time of our inspection (arrowed).

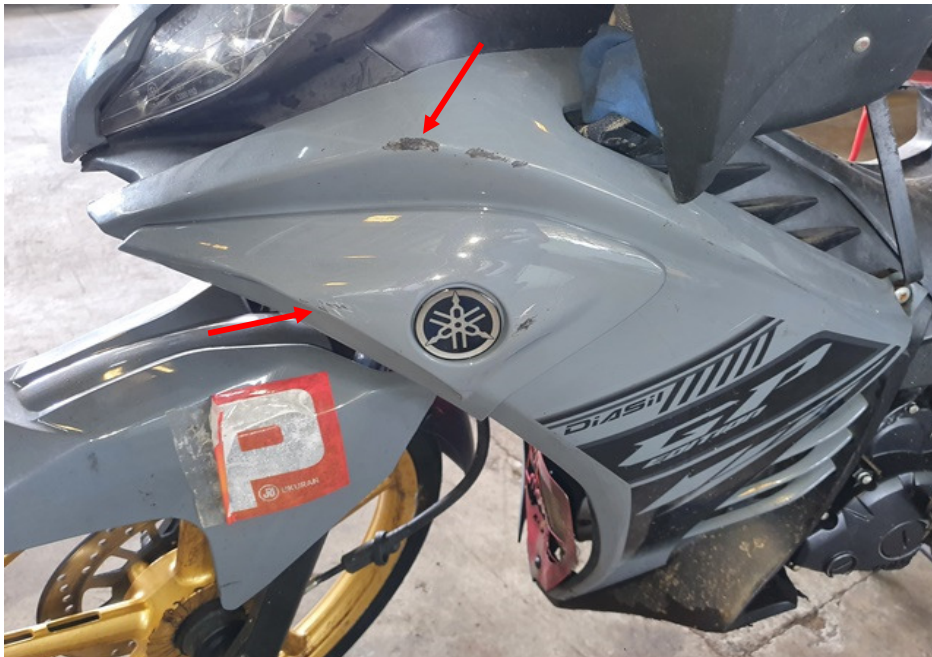
**Photo 11** shows a closer view of the grazed left cowling of the Motorcycle at the time of our inspection (arrowed).

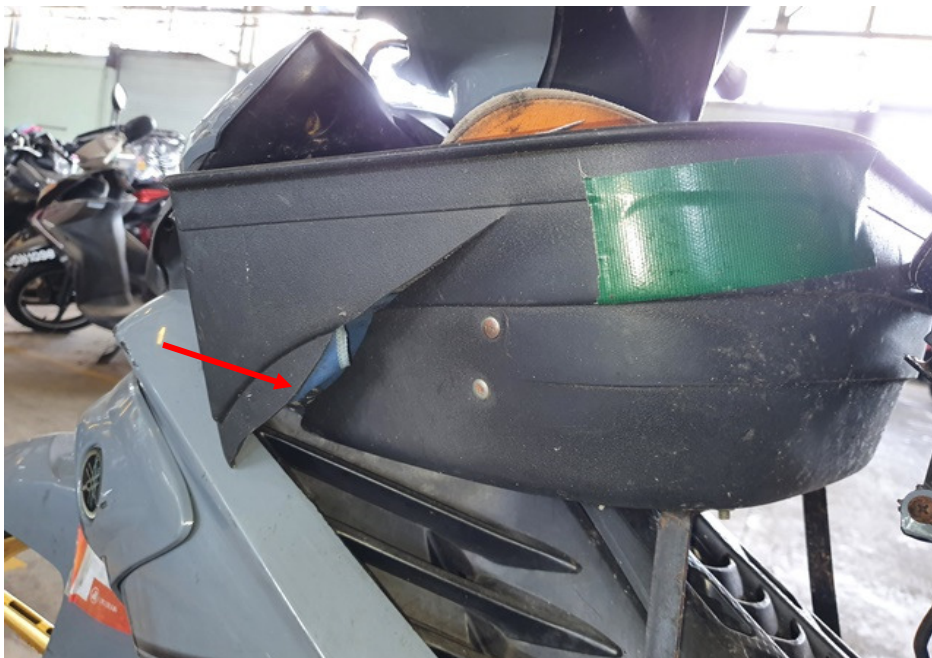
**Photo 12** shows a closer view of the cracked front basket of the Motorcycle at the time of our inspection (arrowed).

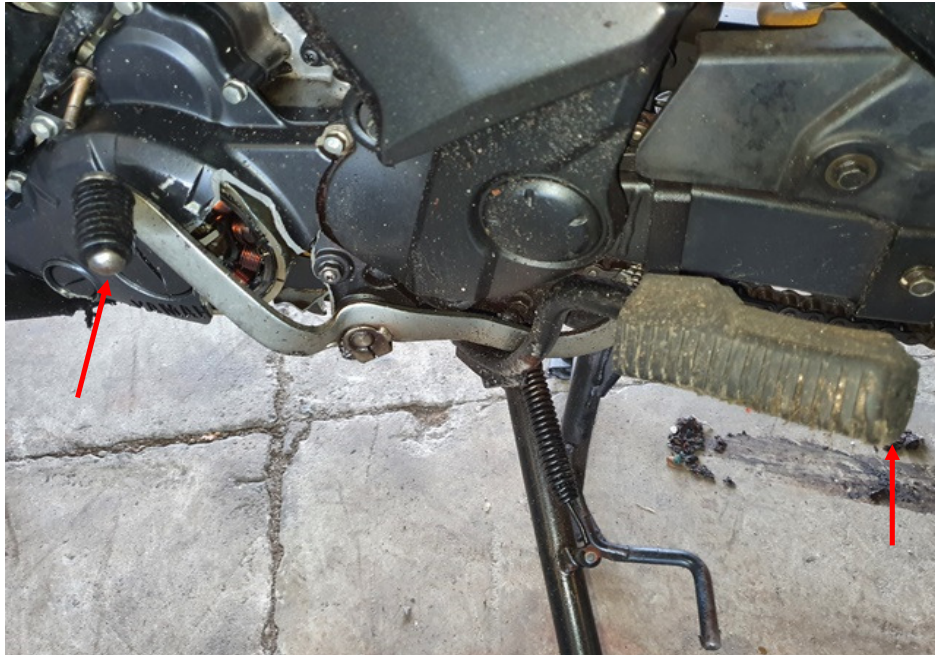
**Photo 13** shows the gear shift pedal and left front footrest of the Motorcycle which had sustained damage at the time of our inspection (arrowed).

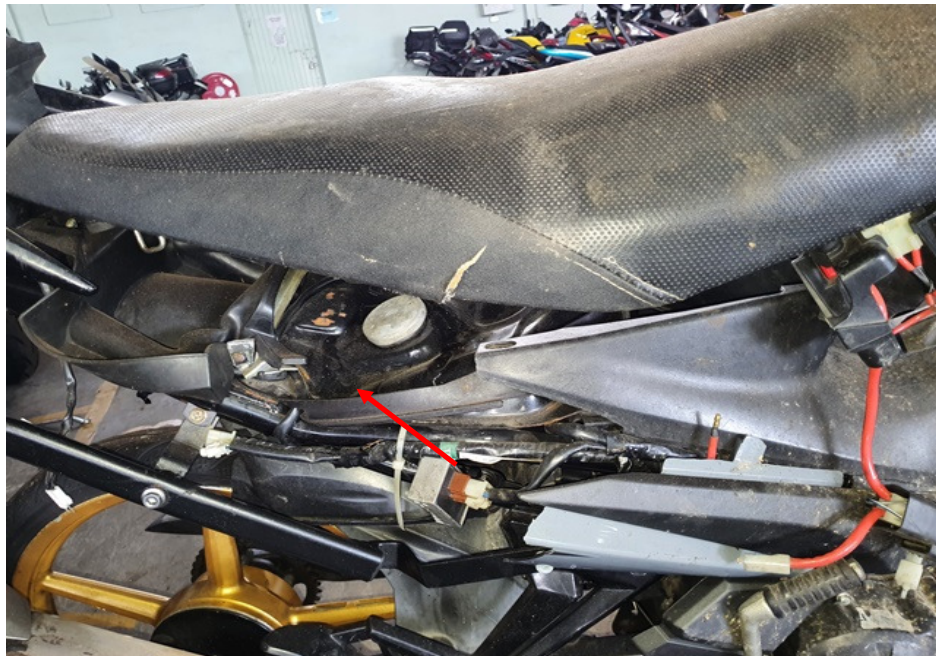
**Photo 14** shows a closer view of the missing right rear side cover of the Motorcycle at the time of our inspection (arrowed).

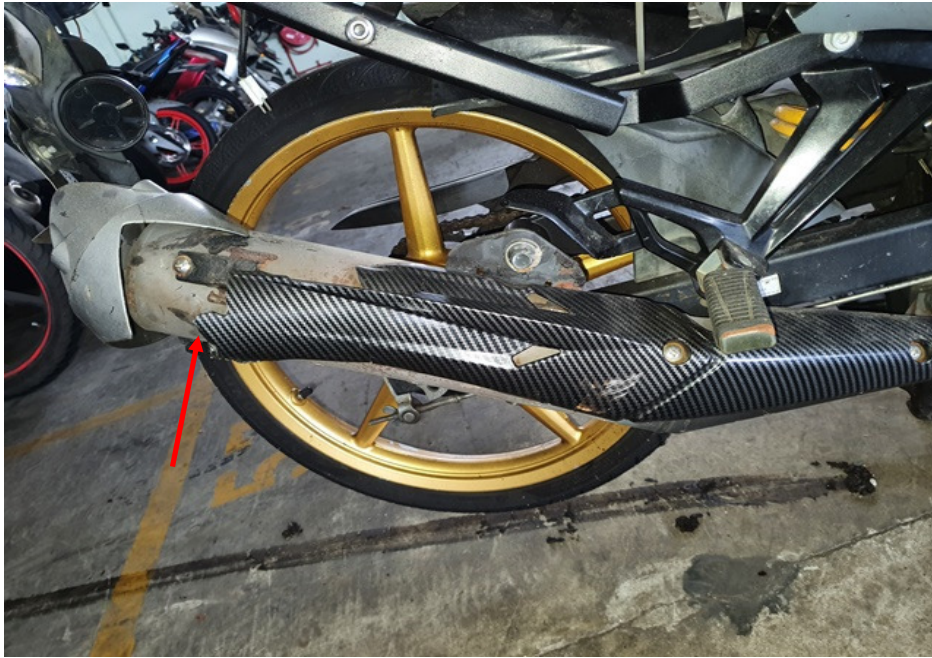
**Photo 15** shows a closer view of the cracked exhaust muffler hear shield of the Motorcycle (arrowed) at the time of our inspection.

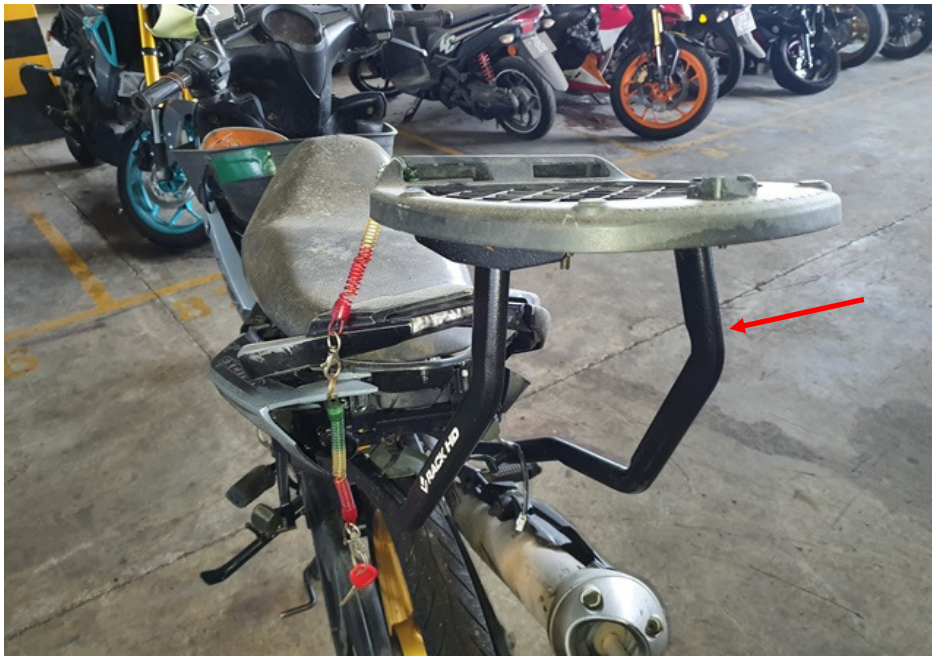
**Photo 16** shows the bent top box rack (arrowed) of the Motorcycle at the time of our inspection.

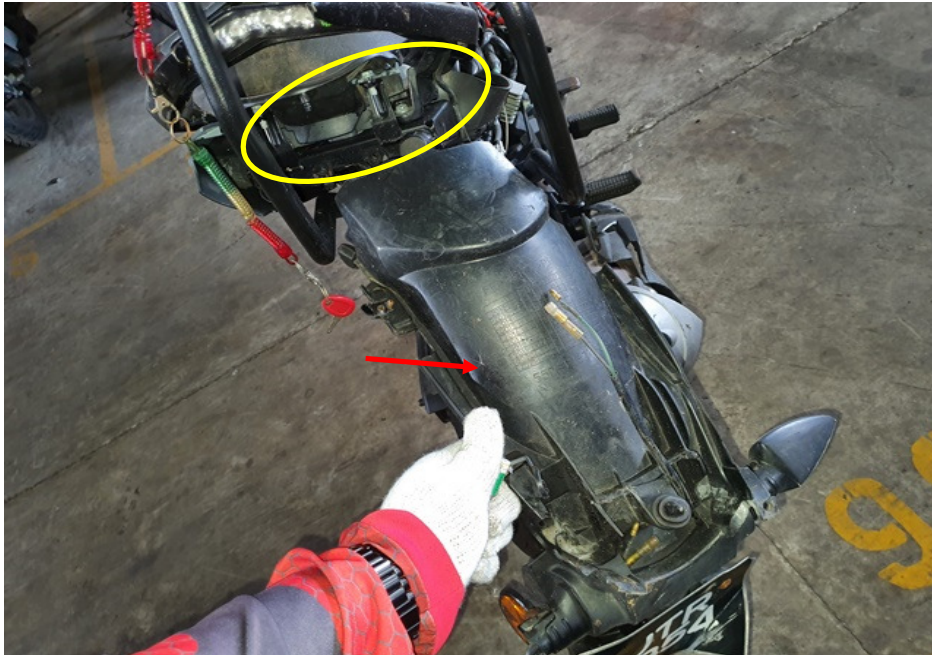
**Photo 17** shows the dislodged rear mudguard (arrowed) and missing tail light (circled) of the Motorcycle at the time of our inspection.

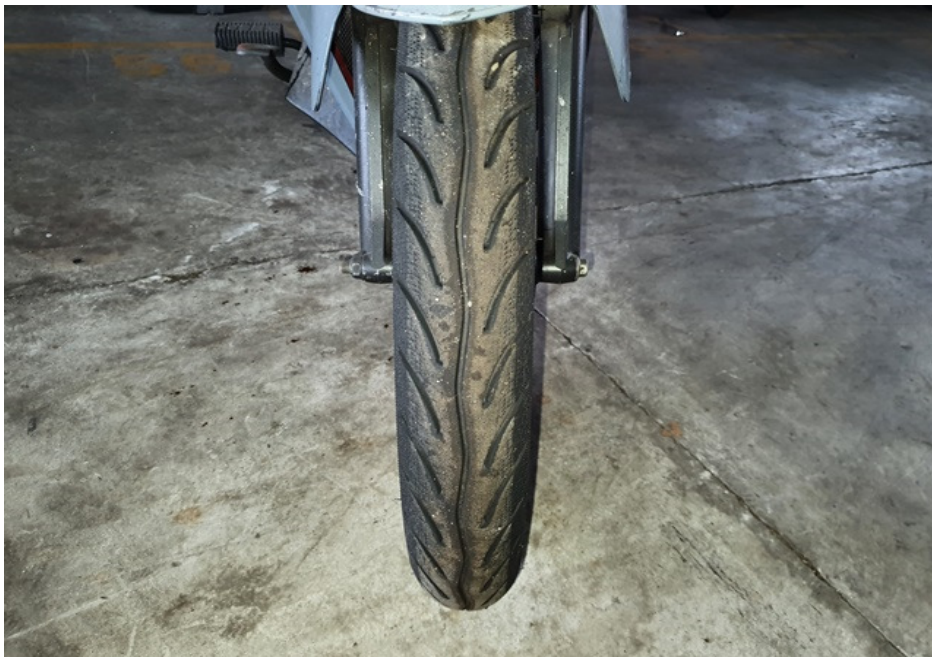
**Photo 18** shows the condition of the Motorcycle's front tyre. The front tyre was observed to be in serviceable condition with remaining tread depth of approximately 4mm. There was no tear, burst mark(s) and/or punctured hole(s) on the sidewalls as well as across the tread of the front tyre.

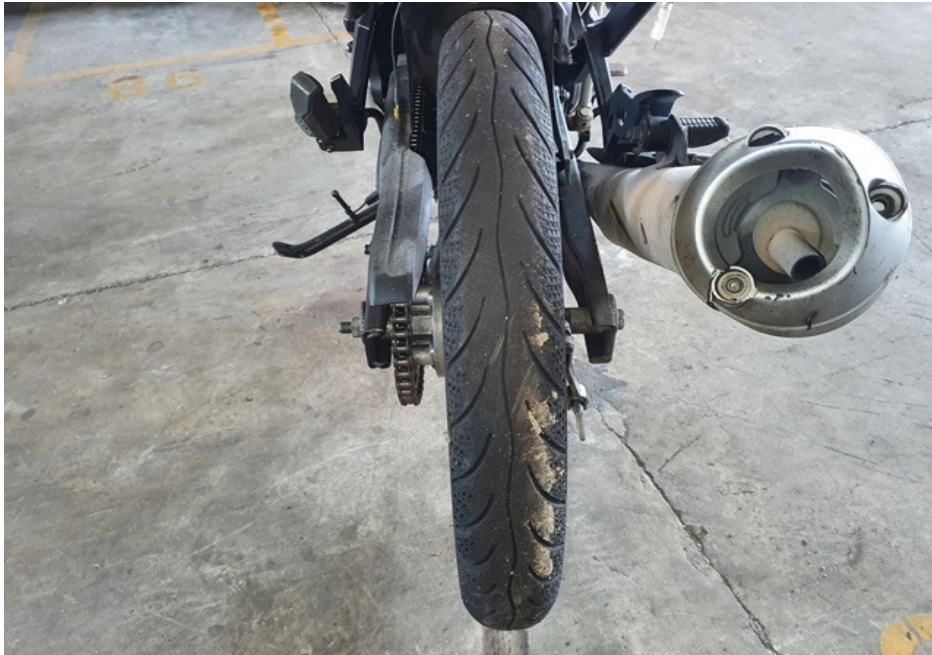
**Photo 19** shows the condition of the Motorcycle's rear tyre. The rear tyre was observed to be in serviceable condition with remaining tread depth of approximately 2mm. We did not observe any tear, burst mark(s) and/or punctured hole(s) on the sidewalls as well as across the tread of the rear tyre. However the rear tyre was also observed to be deflated.

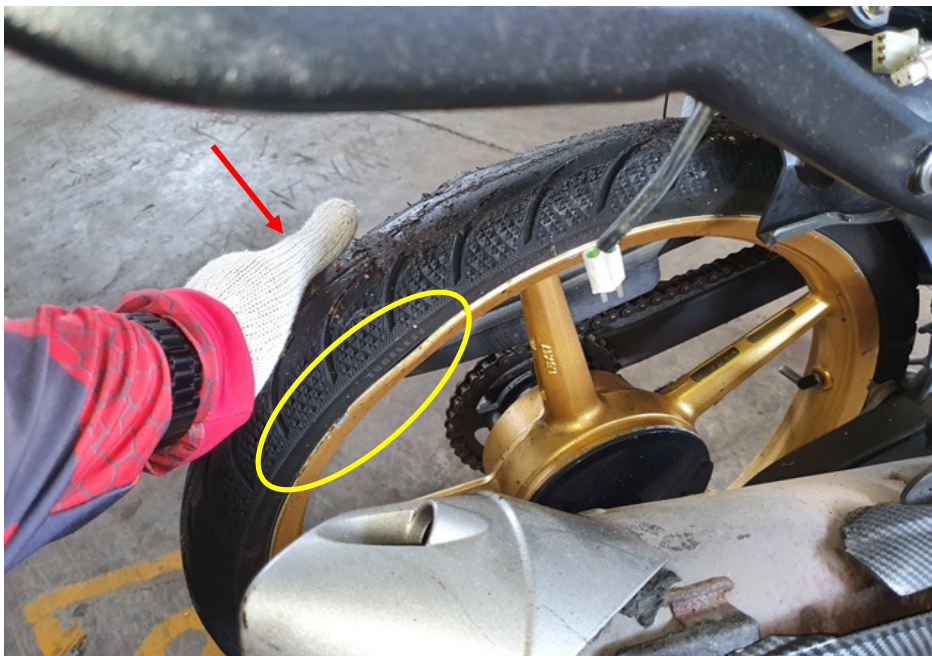
9. The 2 tyres were wrapped around alloy wheel rims. At the time of our inspection, we did not observe any visible damage on the front wheel rim of the Motorcycle. However we did observe that the rear wheel rim was bent. See photos 1 – 20 below.

**Photo 20** shows the deflated rear tyre (arrowed) and bent rear wheel rim (circled) of the Motorcycle at the time of our inspection.

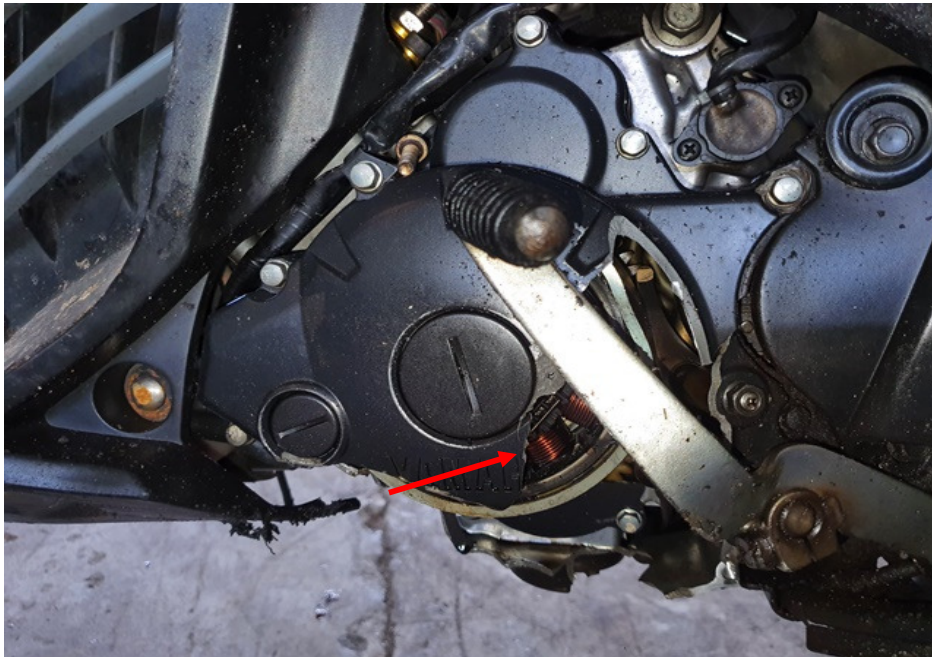
**Photo 21** shows the left side of the engine of the Motorcycle at the time of our inspection. The left engine cover was found to be cracked (arrowed). However there was no fluid leak and/or fluid stain found around the left engine area of the Motorcycle.

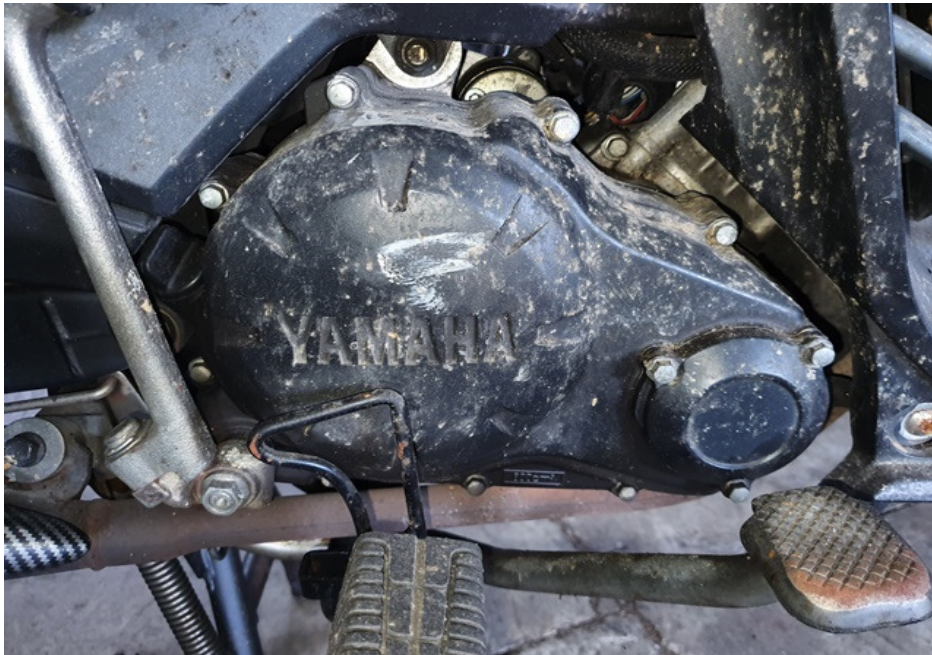
**Photo 22** shows the right side of the engine of the Motorcycle at the time of our inspection. The various engine related parts and components were found to be intact with no visible damage. There was also no sign(s) or indication(s) of fluid leak observed around the right engine area of the Motorcycle.

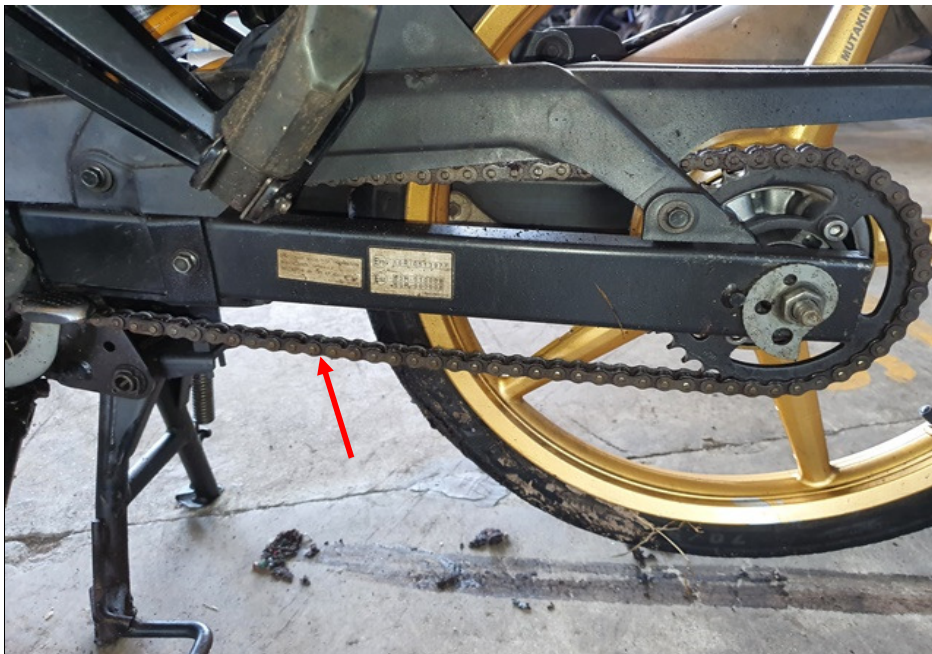
**Photo 23** shows the gear train (arrowed) of the Motorcycle, which was observed to be intact with no misalignment. It was also adequately lubricated for operating purposes. The gear train rotates the rear wheel of the Motorcycle.

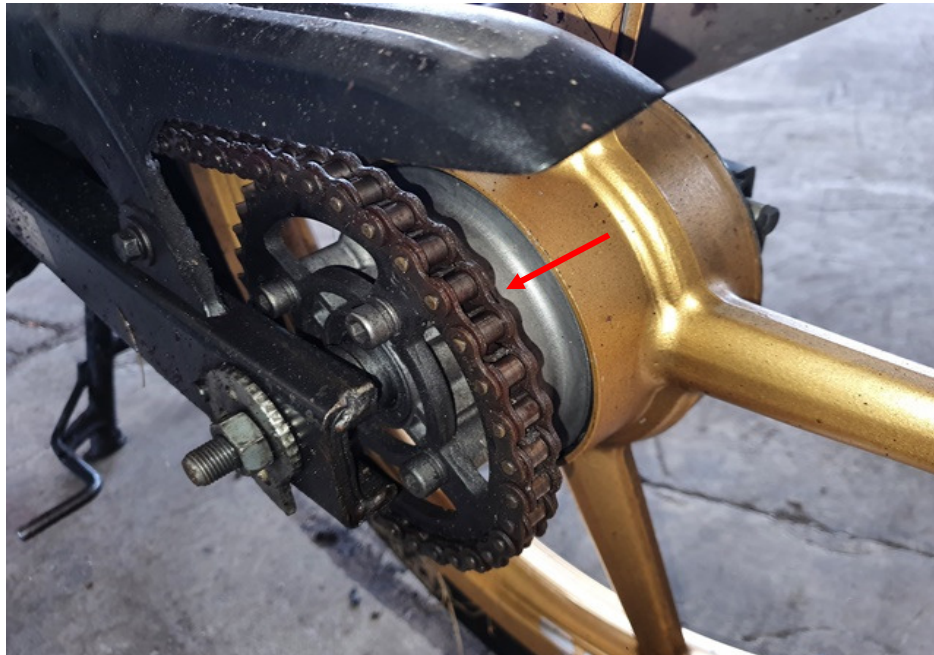
**Photo 24** shows the closer view of the gear train (arrowed) of the Motorcycle, which was observed to be intact with no misalignment. It was also adequately lubricated for operating purposes.

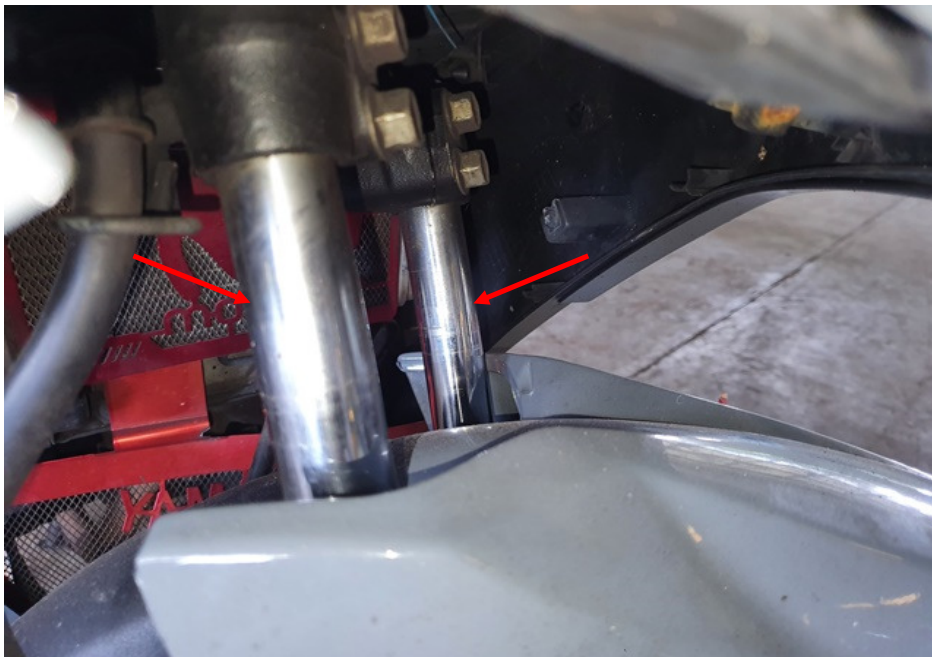
12. For this case, we were not able to conduct any test(s) on the steering system of the Motorcycle due to the damage of its fork assembly. The front forks were found to be bent as a result of the accident.

**Photo 25** shows the front forks of the Motorcycle. The front forks were observed to be bent as a result of the accident (arrowed). We were hence not able to conduct any tests on the steering system of the Motorcycle.

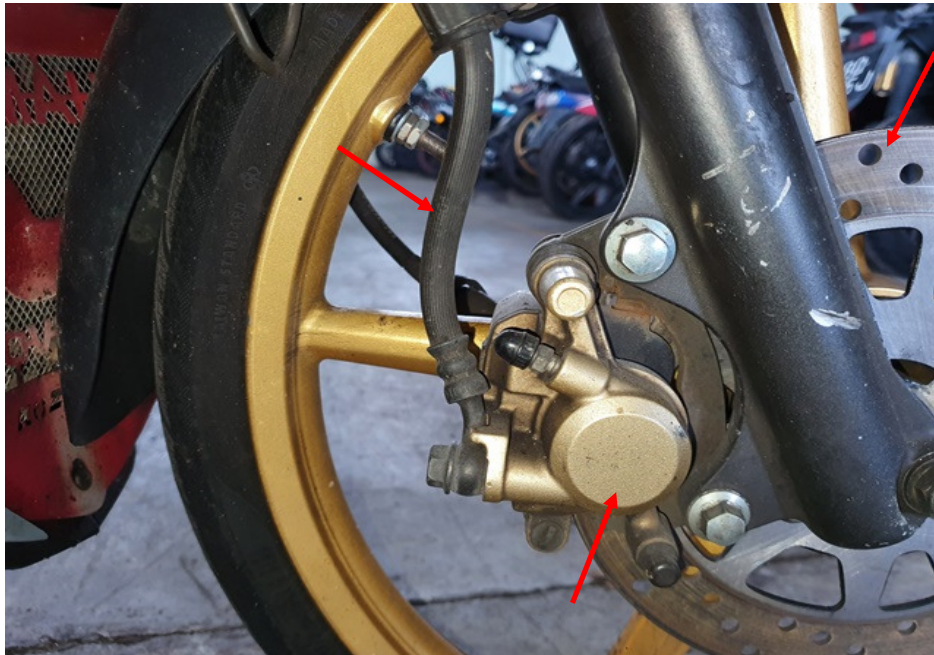
**Photo 26** shows a close up view of the front brake caliper, front brake disc and front brake hose (arrowed) of the Motorcycle, which are all part of the components in the hydraulic front brake system of the Motorcycle. Our visual checks of these various components had revealed all to be intact with no visible damage. No leakage of brake fluid was also observed.

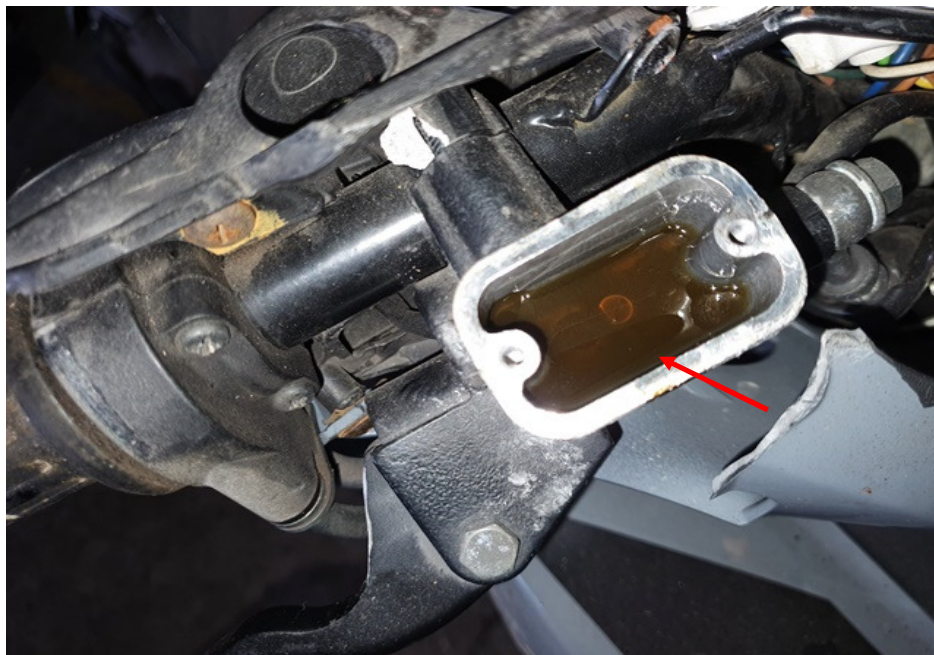
**Photo 27** shows the brake fluid reservoir for the front brake of the Motorcycle. The brake fluid was found to be of sufficient level for operating purposes. However the brake fluid was found to be contaminated (arrowed).

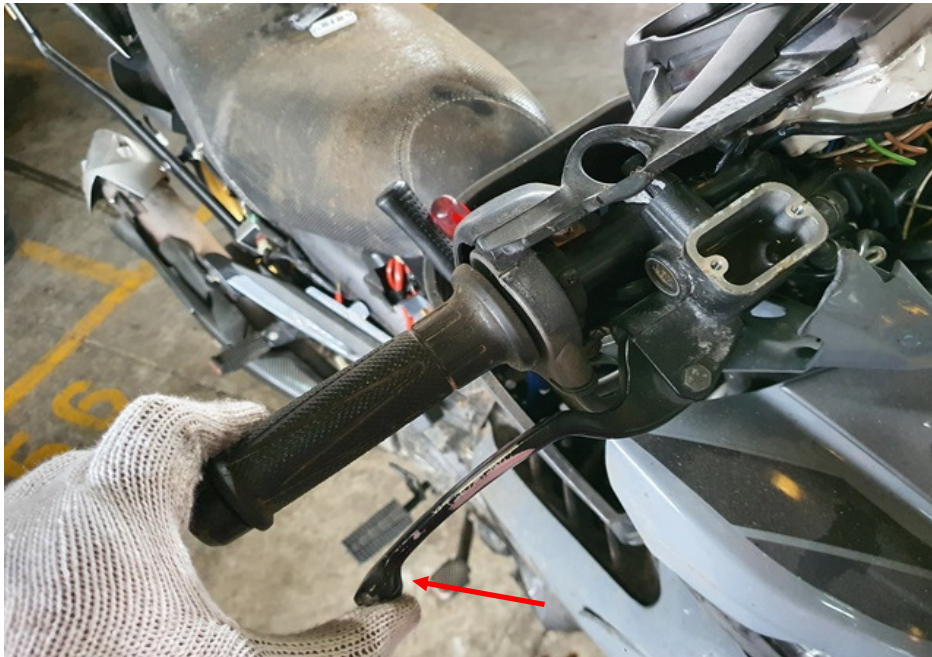
**Photo 28** shows the front brake lever being depressed. There was some resistance felt (spongy like feel) upon pressing the front brake lever (arrowed). This would indicate that there is no leakage of pressure/vacuum in the front brake system.

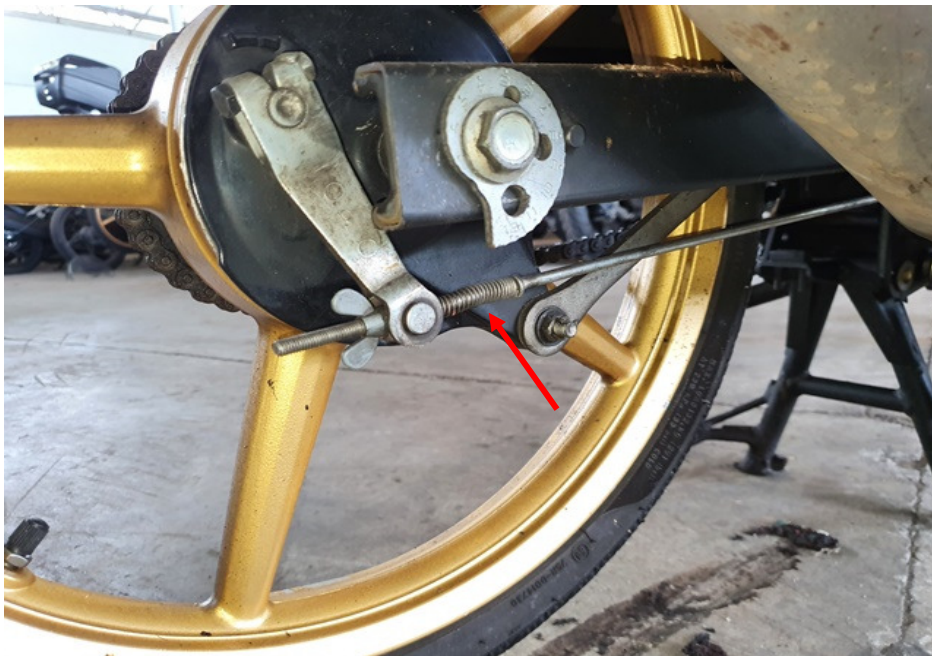
**Photo 29** shows the rear wheel of the Motorcycle. The type of brake system for the rear wheel was of a mechanical type, controlled by the brake foot pedal of the Motorcycle. Our checks of the cable (arrowed), spring and drum which are all part of the components in the rear brake system of the Motorcycle reveal all to be intact and without damage.
