Your Ref: TPIP/05256/2023  
Our Ref: CI/TPD23005737/N

9 June 2023

### **Fatal Accident Investigation Team**

### **INSPECTION REPORT OF MOTORCYCLE FBM 2855U**

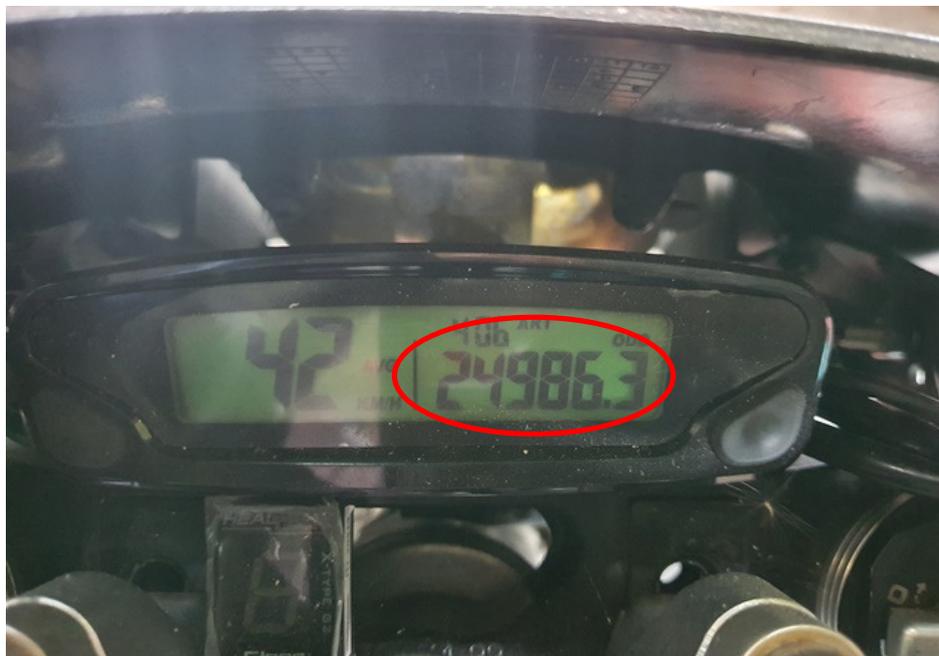
**Photo 1** shows the speedometer gauge of the Motorcycle where the mileage recorded at the time of our inspection was 24, 986km (circled).

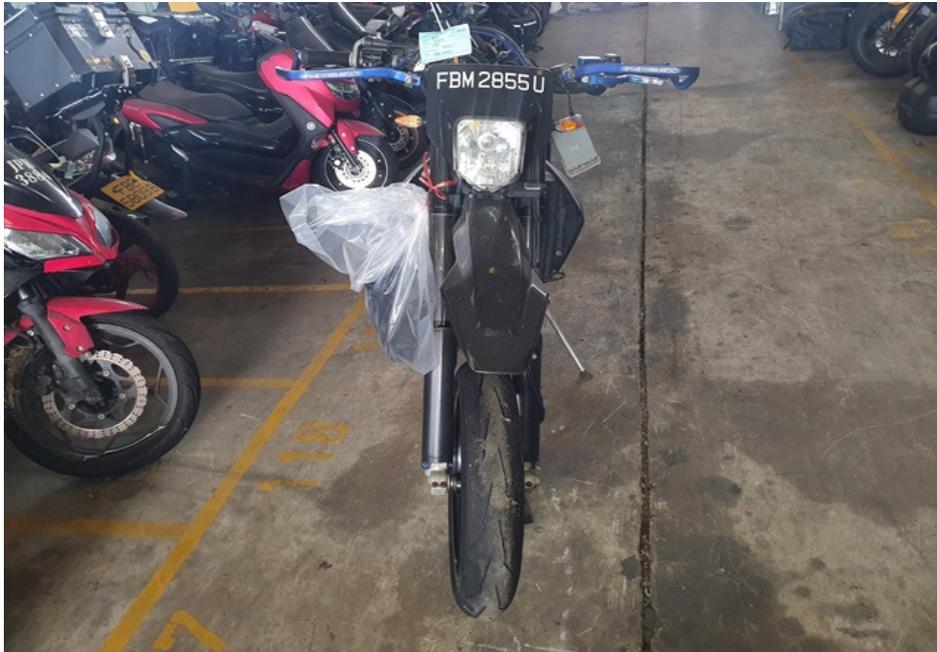
**Photo 2** shows a general view of the frontal portion of the Motorcycle at the time of our inspection. The Motorcycle was observed to have sustained damages along its frontal portion and right body.

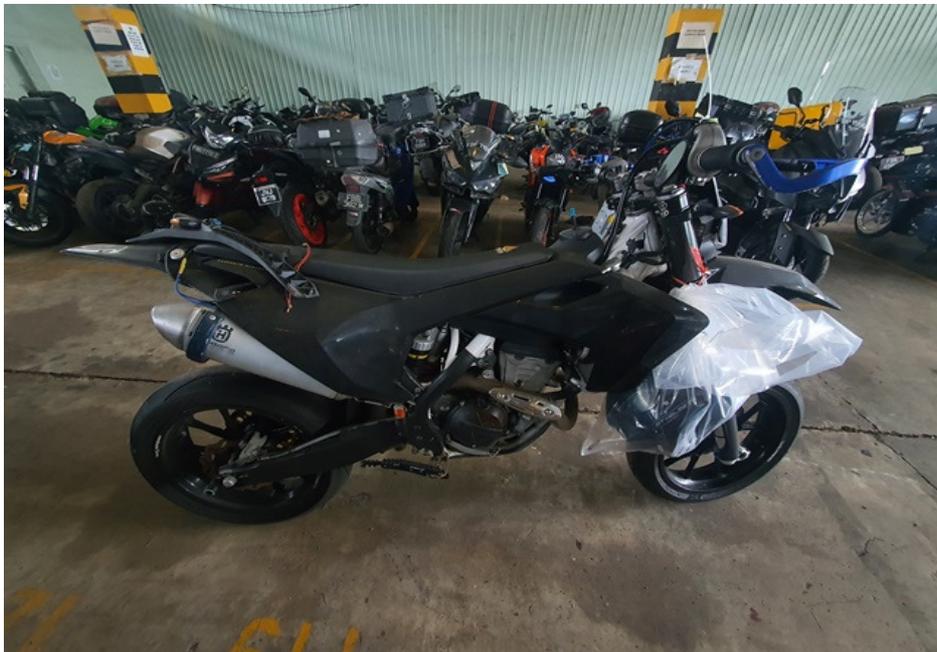
**Photo 3** shows a general view of the right body of the Motorcycle at the time of our inspection. The Motorcycle was observed to have sustained damages along its frontal portion and right body.

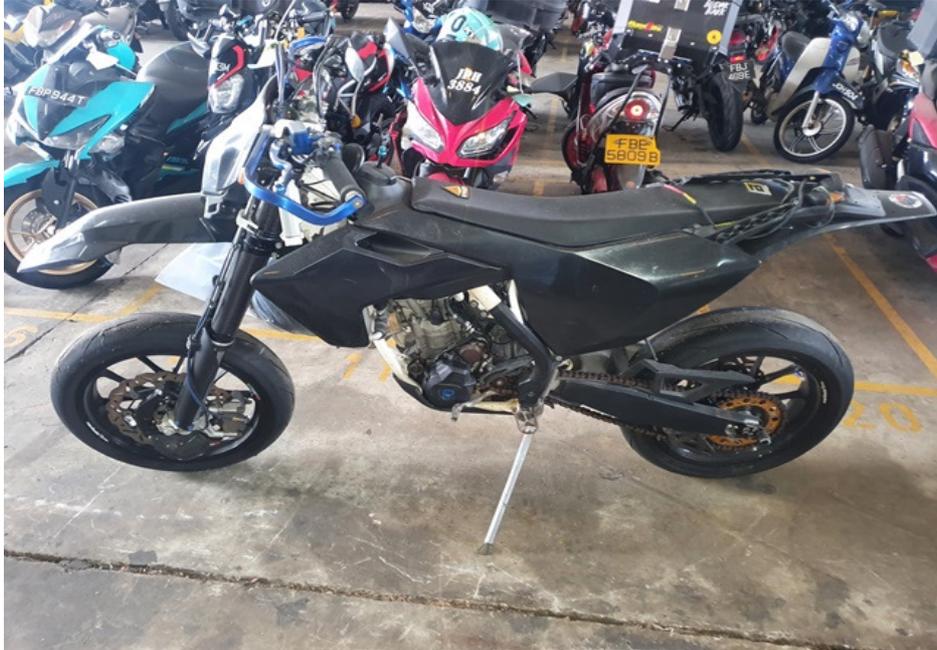
**Photo 4** shows a general view of the left front body of the Motorcycle at the time of our inspection. The Motorcycle was observed to have sustained damages at its frontal portion and right body. The body parts that were found to have been damaged include its front mudguard, ERP unit, front brake lever guard, front brake lever, rear mudguard and exhaust muffler guard, amongst others.

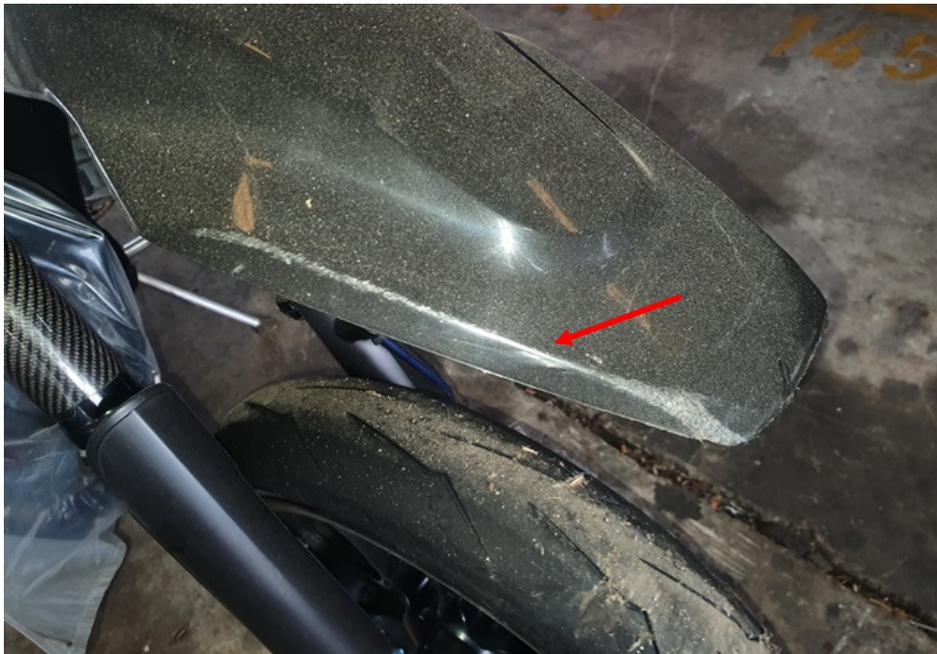
**Photo 5** shows a closer view of the grazed front mudguard (arrowed) of the Motorcycle at the time of our inspection.

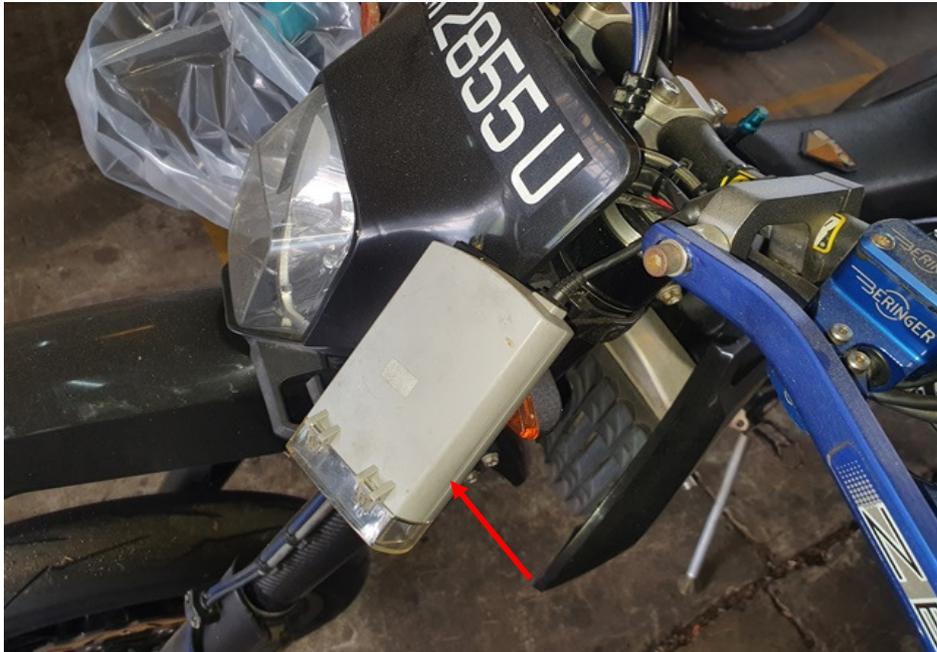
**Photo 6** shows a closer view of the dislodged ERP unit (arrowed) of the Motorcycle at the time of our inspection.

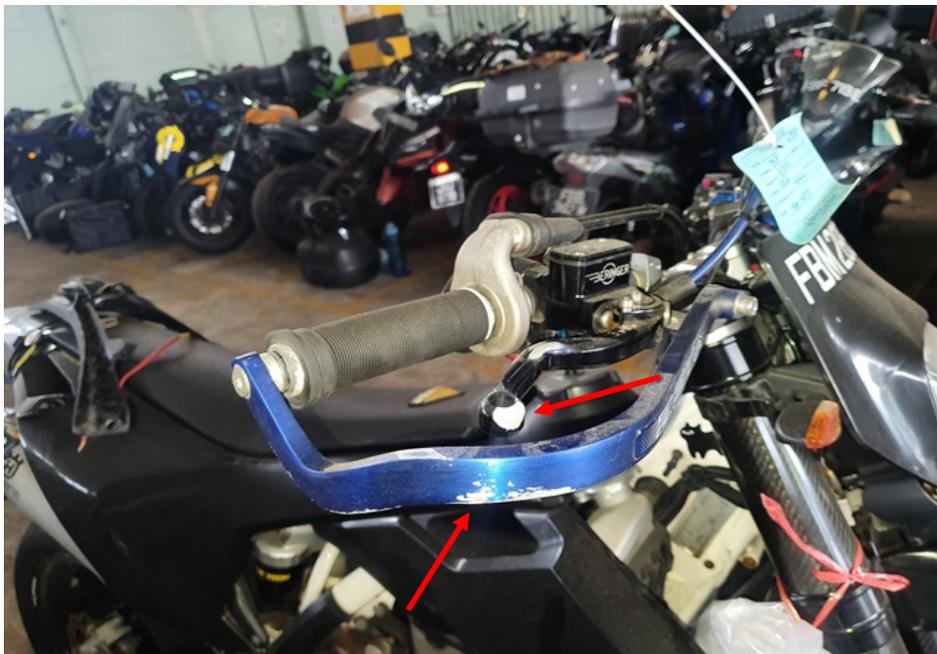
**Photo 7** shows a closer view of the front brake lever guard and front brake lever (arrowed) of the Motorcycle at the time of our inspection.

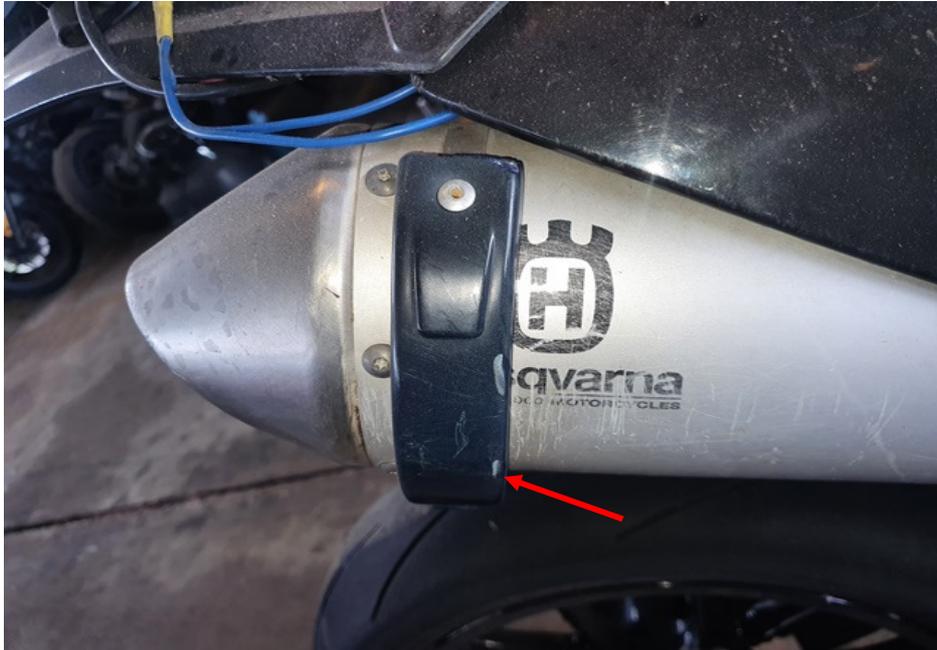
**Photo 8** shows a closer view of the grazed exhaust muffler guard (arrowed) of the Motorcycle at the time of our inspection.

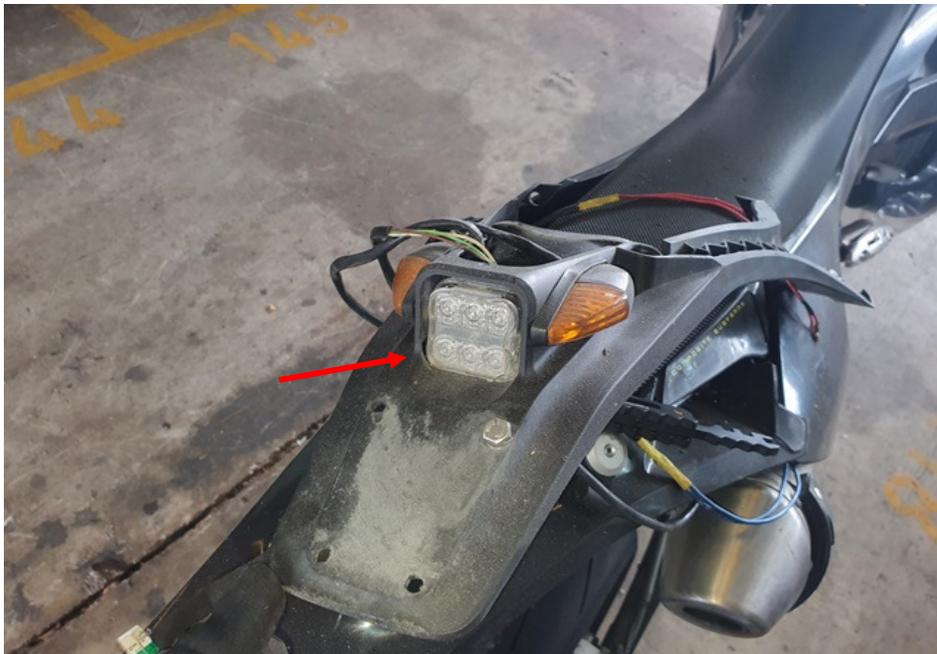
**Photo 9** shows the dislodged rear mudguard (arrowed) of the Motorcycle at the time of our inspection.

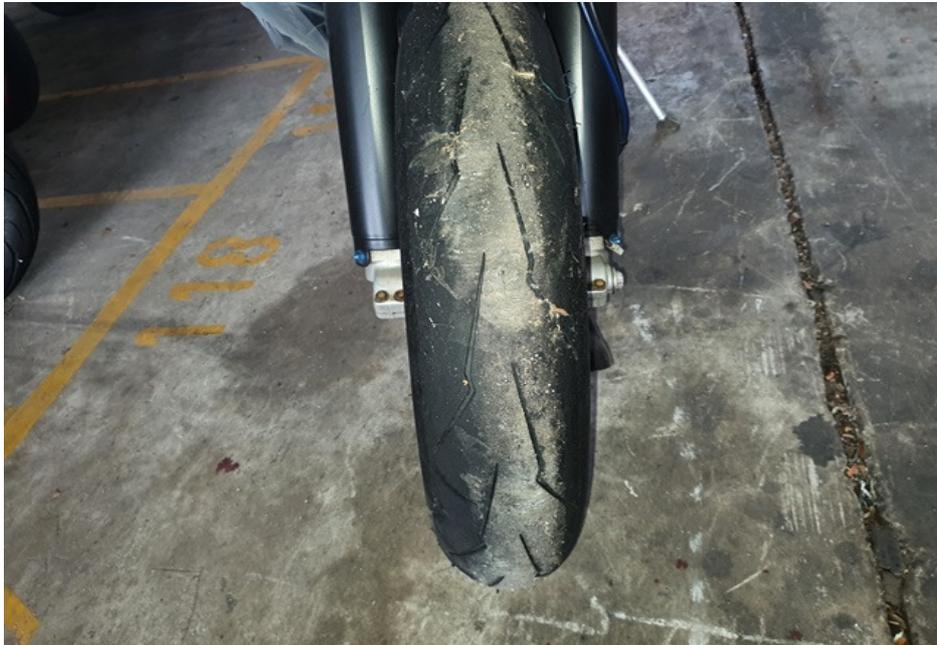
**Photo 10** shows the front tyre of the Motorcycle at the time of our inspection. The front tyre was observed to be in serviceable condition with remaining tread depth of approximately 3mm. The pattern of the tread was also clearly visible. There was no tear, burst mark(s) and/or punctured hole(s) on the sidewalls as well as across the tread of the front tyre.

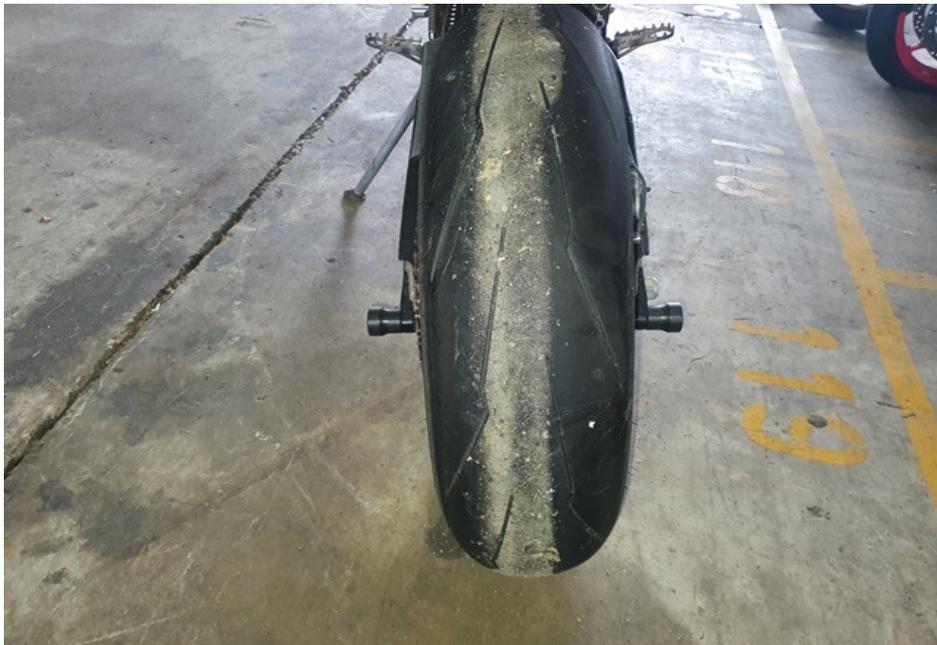
**Photo 11** shows the condition of the Motorcycle's rear tyre. The rear tyre was observed to be in serviceable condition with remaining tread depth of approximately 3mm. The tyre was also observed to be sufficiently inflated for vehicular operation. We did not observe any tear, burst mark(s) and/or punctured hole(s) on the sidewalls as well as across the tread of the rear tyre.

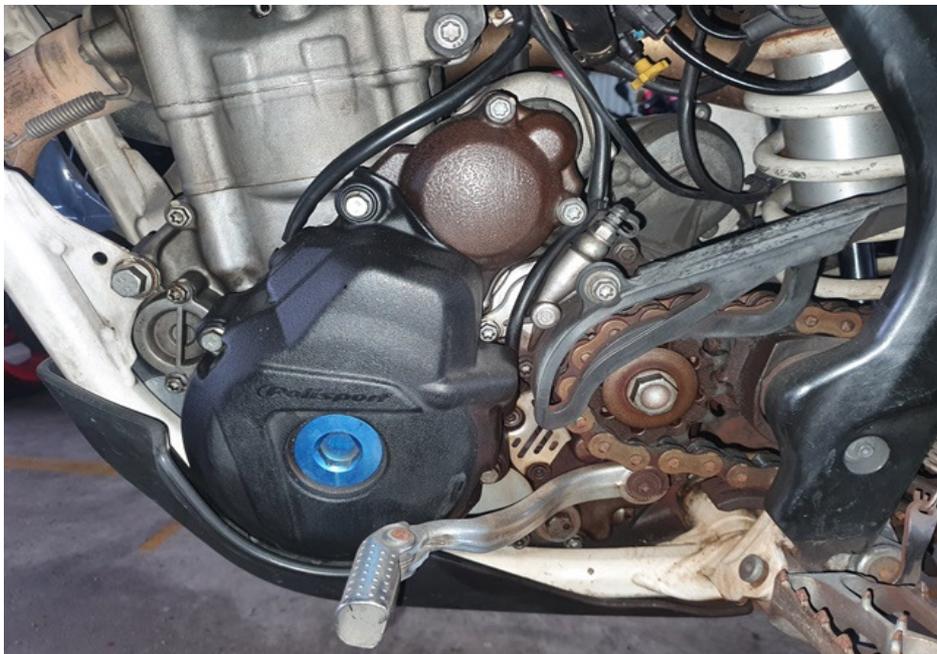
**Photo 12** shows the left side of the engine of the Motorcycle at the time of our inspection. The various engine related parts and components were found to be intact with no visible damage. There was also no sign(s) or indication(s) of fluid leak observed around the left engine area of the Motorcycle.

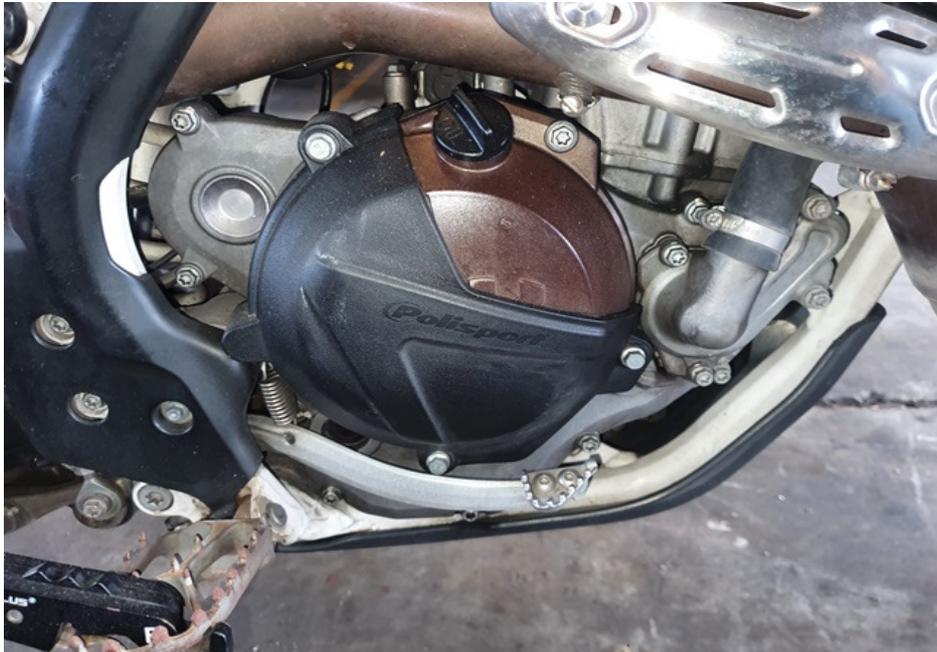
**Photo 13** shows the right side of the engine of the Motorcycle at the time of our inspection. The various engine related parts and components were found to be intact with no visible damage. There was also no sign(s) or indication(s) of fluid leak observed around the right engine area of the Motorcycle.

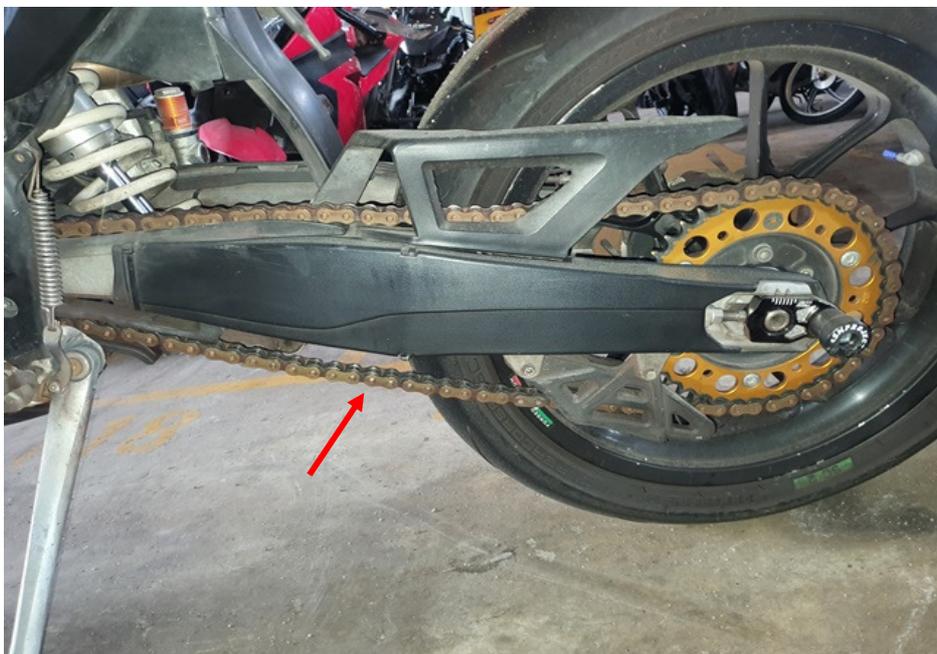
**Photo 14** shows the general view of the gear train (arrowed) of the Motorcycle, which was observed to be intact with no misalignment. It was also adequately lubricated for operating purposes.

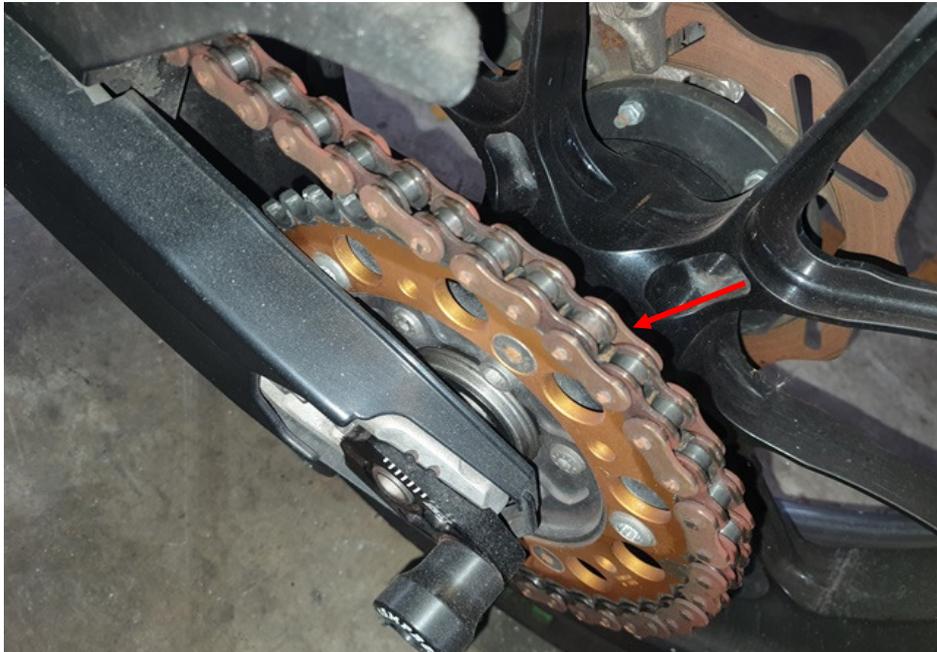
**Photo 15** shows a closer view of the gear train (arrowed) of the Motorcycle, which was observed to be intact with no misalignment. It was also adequately lubricated for operating purposes.

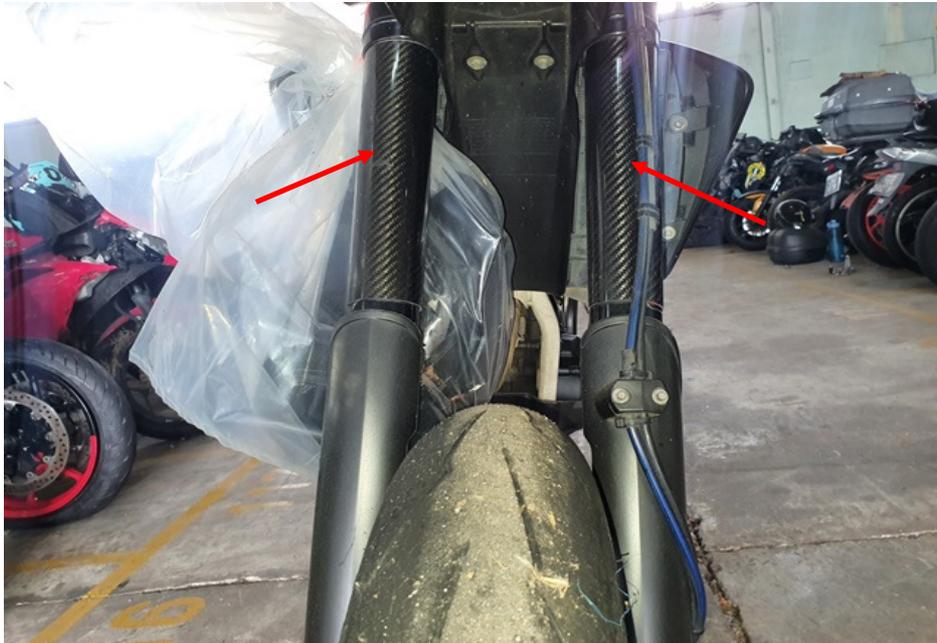
**Photo 16** shows the front fork assembly (arrowed) of the Motorcycle. The front forks and fork bracket of the Motorcycle were both found to be intact and undamaged. Turning the Motorcycle's handle bar towards the left and right did not produce any abnormal free play and/or resistance. The steering system of the Motorcycle was in serviceable condition at the time of our inspection.

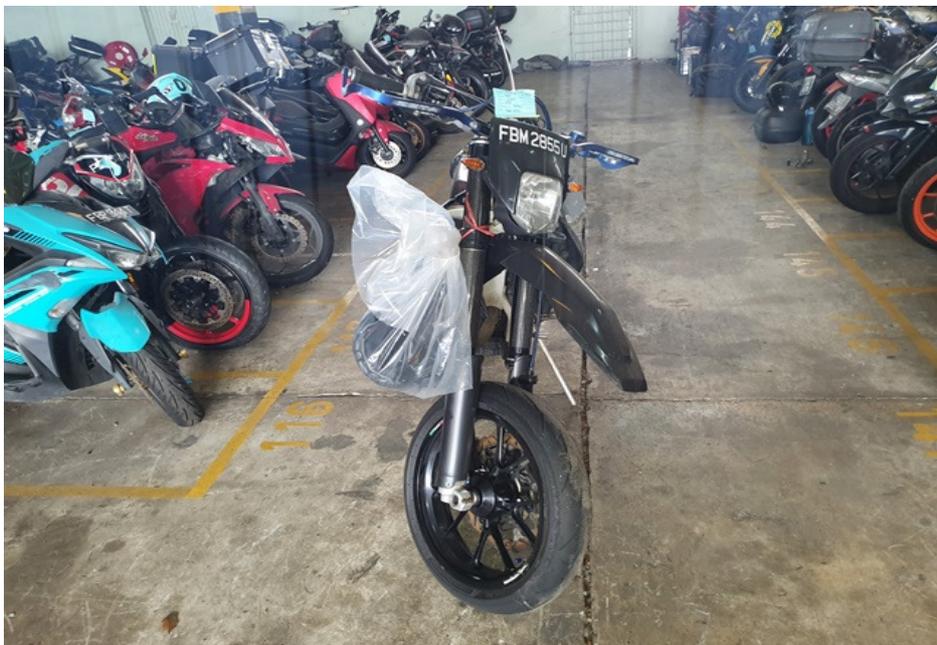
**Photo 17** shows the front wheel of the Motorcycle turned towards its full left. Turning the Motorcycle's handle bar towards the left and right did not produce any abnormal free play and/or resistance. This would indicate that the steering system of the Motorcycle was in serviceable condition at the time of our inspection.

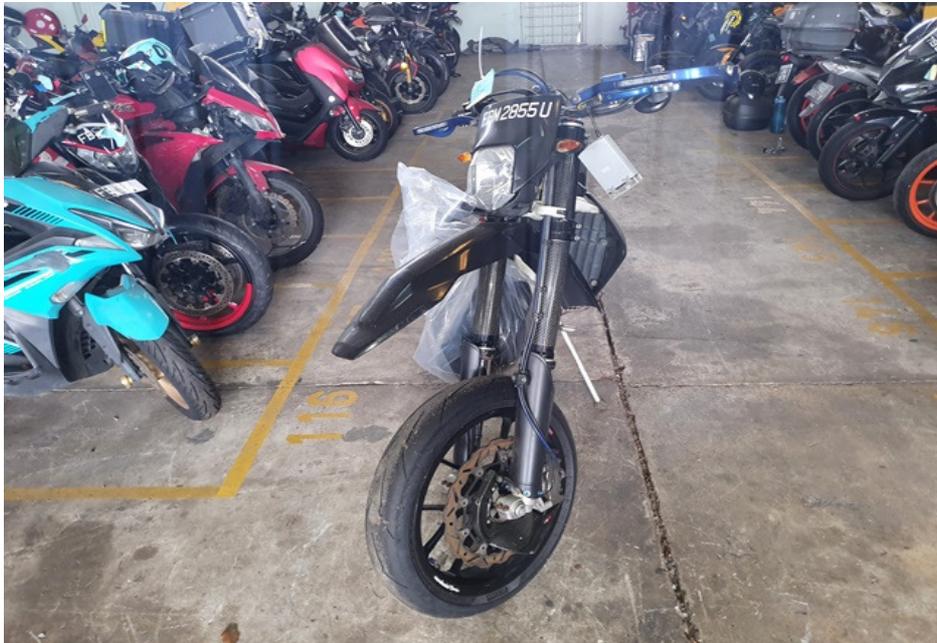
**Photo 18** shows the front wheel of the Motorcycle turned towards its full right. Turning the Motorcycle's handle bar towards the left and right did not produce any abnormal free play and/or resistance. This would indicate that the steering system of the Motorcycle was in serviceable condition at the time of our inspection.

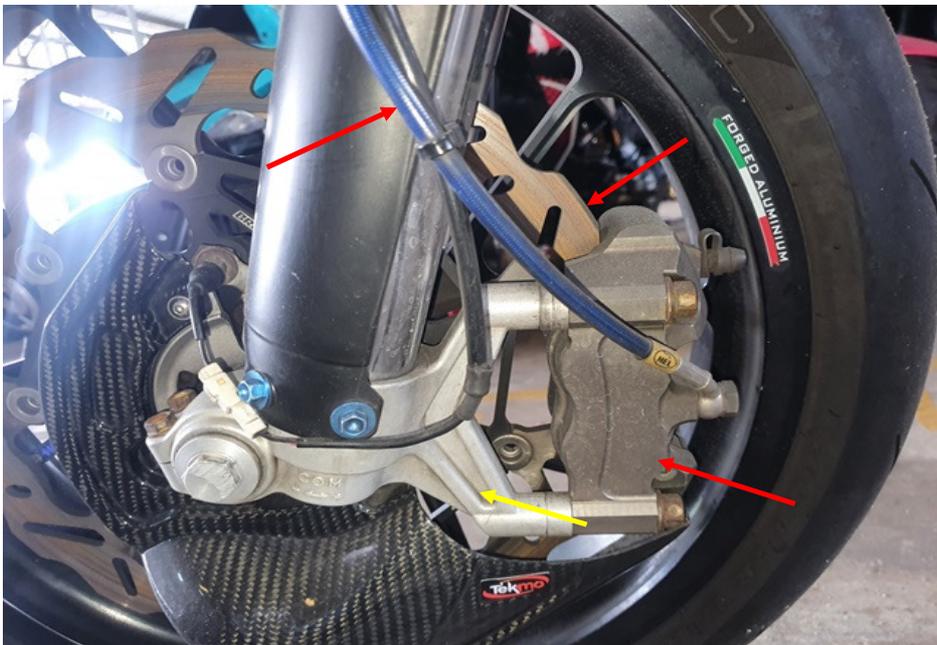
**Photo 19** shows a close up view of the front brake caliper, front brake disc and front brake hose (arrowed) of the Motorcycle, which are all part of the hydraulic front brake system of the Motorcycle. Our visual checks of these various components had revealed all to be intact with no visible damage. No leakage of brake fluid was also observed.

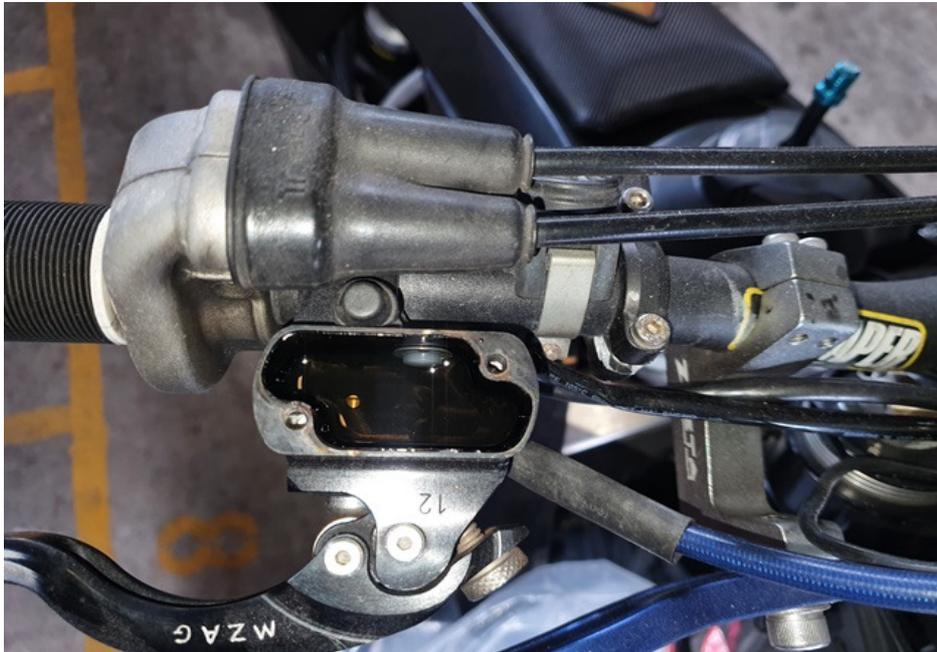
**Photo 20** shows the brake fluid reservoir for the front brake of the Motorcycle. The brake fluid was observed to be of sufficient level for operational purposes and without any contamination.

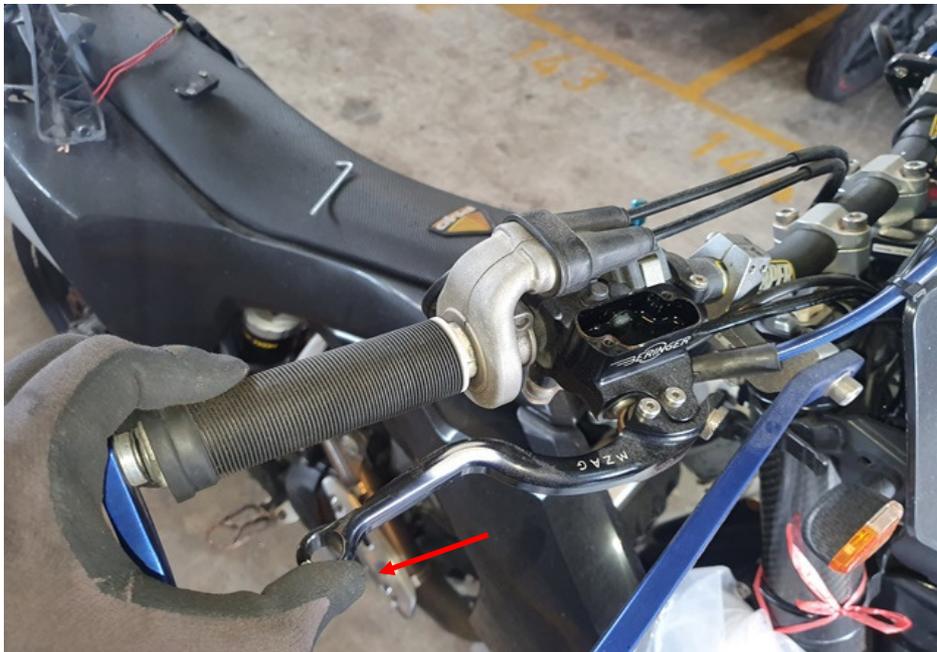
**Photo 21** shows the front brake lever being depressed. There was some resistance felt (spongy like feel) upon pressing the front brake lever (arrowed). This would indicate that there is no leakage of pressure/vacuum in the brake system.

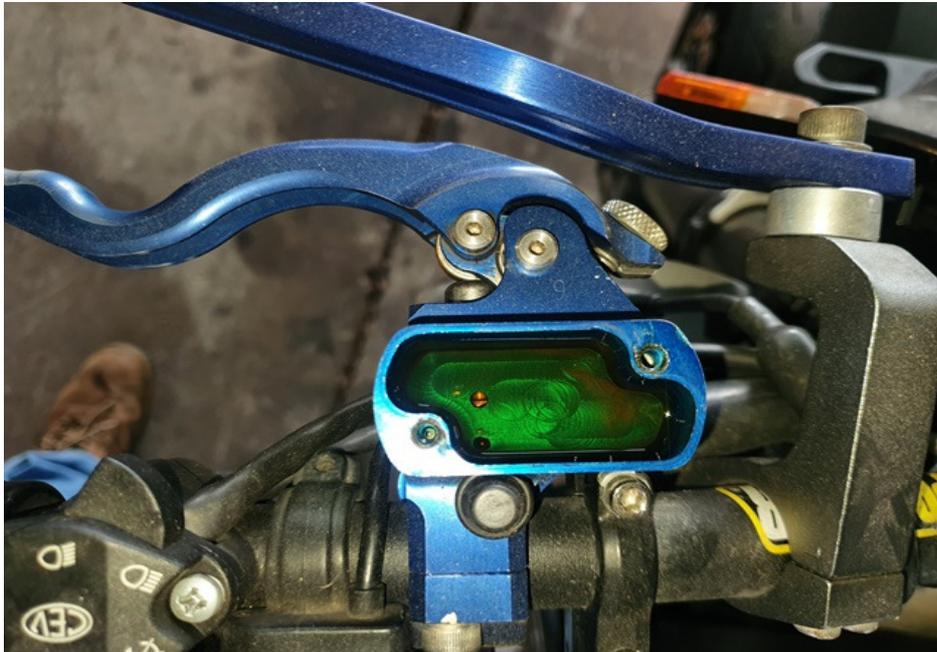
**Photo 22** shows the hydraulic clutch fluid reservoir for the hydraulic clutch system of the Motorcycle. The hydraulic clutch fluid was observed to be of sufficient level for operational purposes and without any contamination.

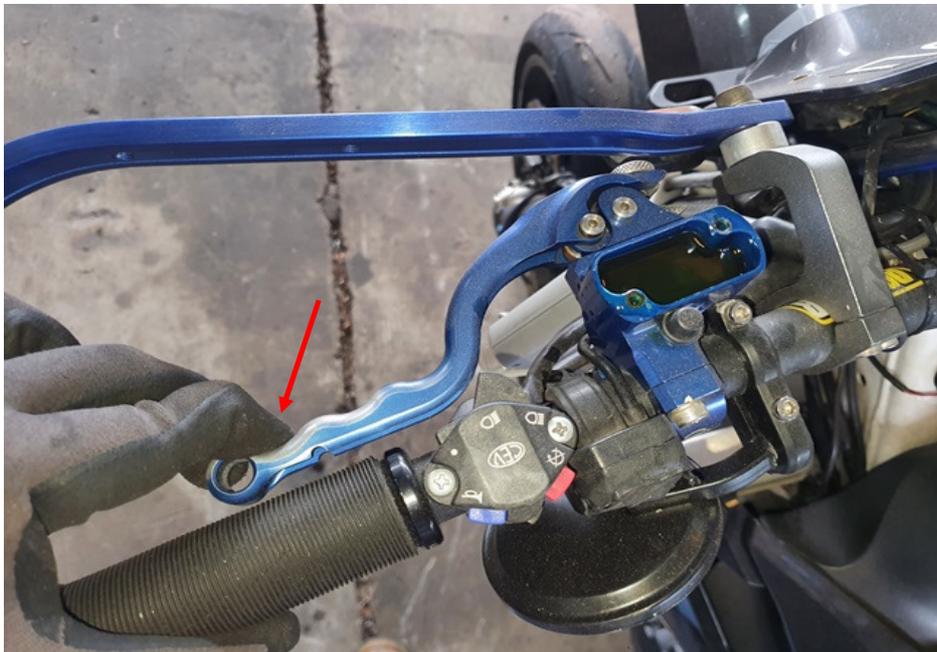
**Photo 23** shows the clutch lever being depressed. There was some resistance felt (spongy like feel) upon pressing the clutch lever (arrowed). This would indicate that there is no leakage of pressure/vacuum in the hydraulic clutch system.

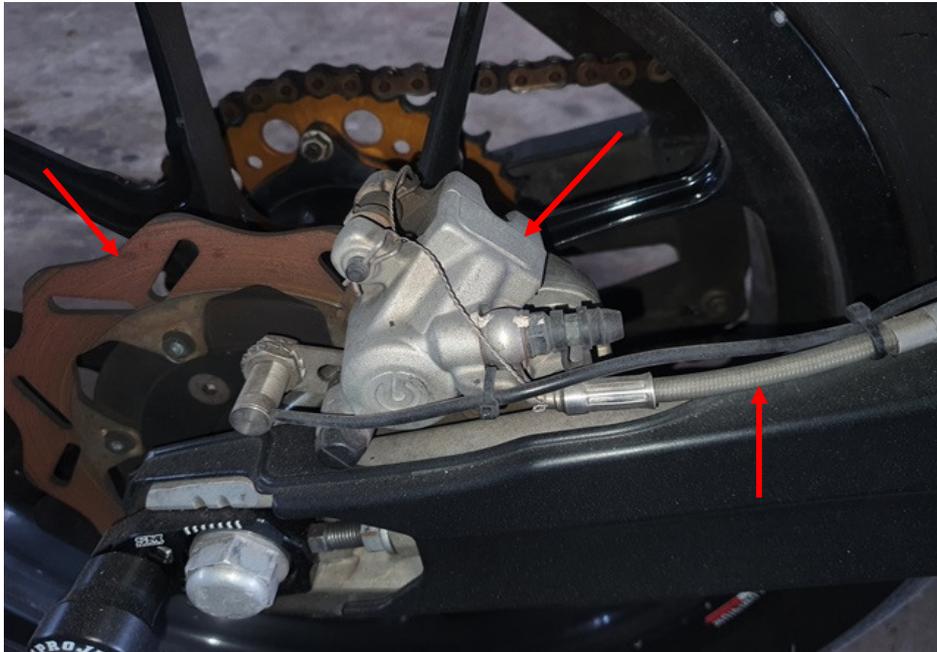
**Photo 24** shows a close up view of the rear brake caliper, rear brake disc and rear brake hose (arrowed) of the Motorcycle, which are all part of the components in the hydraulic rear brake system of the Motorcycle. Our visual checks of these various components had revealed all to be intact with no visible damage. No leakage of brake fluid was also observed.

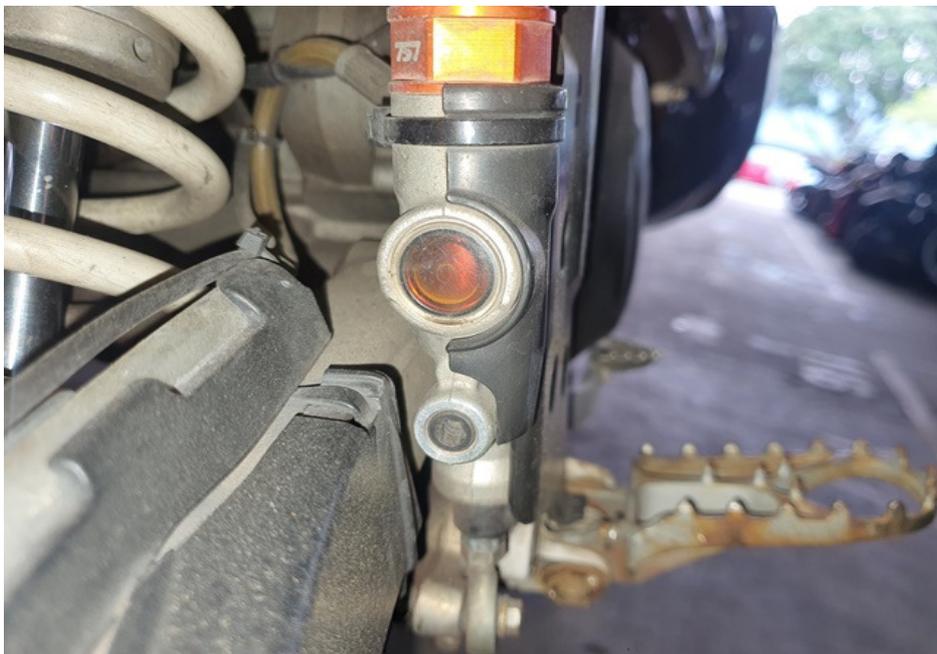
**Photo 25** shows the brake fluid reservoir for the rear brake of the Motorcycle. The brake fluid was observed to be of sufficient level for operational purposes and without any contamination.
