Fatal Accident Investigation Team

INSPECTION REPORT OF MOTORCYCLE FBK 5164X

1. We refer to your request dated 7 March 2023 to conduct a physical inspection of a motorcycle bearing registration number FBK 5164X herein referred to as “**Motorcycle**”), which was involved in a fatal road traffic accident on 26 February 2023.
2. The purpose of this inspection is to primarily determine if there was any possible mechanical failure to the Motorcycle that may have contributed to the accident.
3. Following the request, we had carried out a physical inspection of the Motorcycle on 14 July 2023 at the premises of Traffic Police vehicle pound, 517 Airport Road Singapore 539942. We now set out below our observations and comments with respect to this inspection.

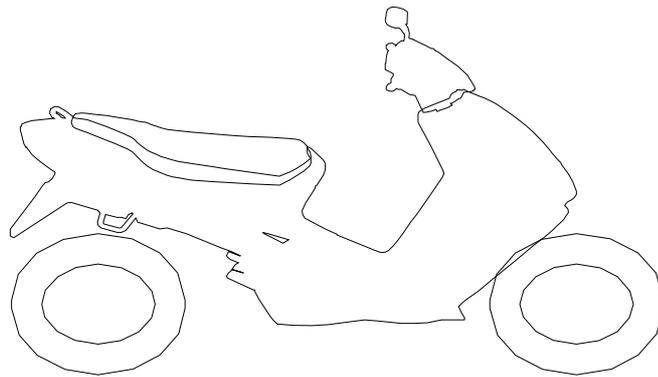
7. The tyre brand, tyre size and remaining tread depth of the 2 tyres were recorded as follows:-

Pirelli 140/70 - 17 (3mm)

Pirelli 90/80 - 17 (1mm)

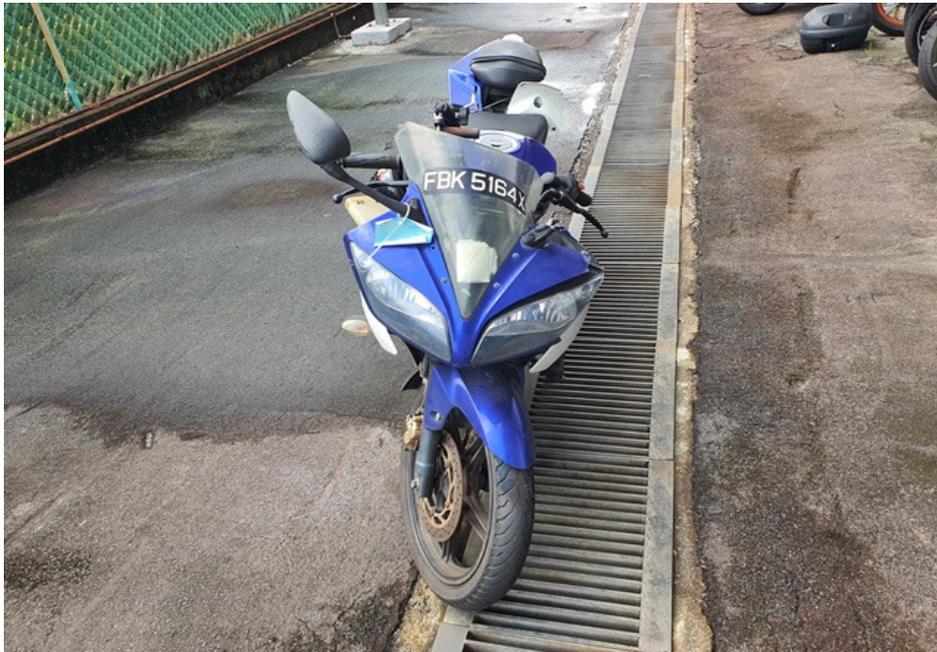
Photo 1 shows a general view of the frontal portion of the Motorcycle at the time of our inspection. The Motorcycle was observed to have sustained damages at its frontal portion and left body.

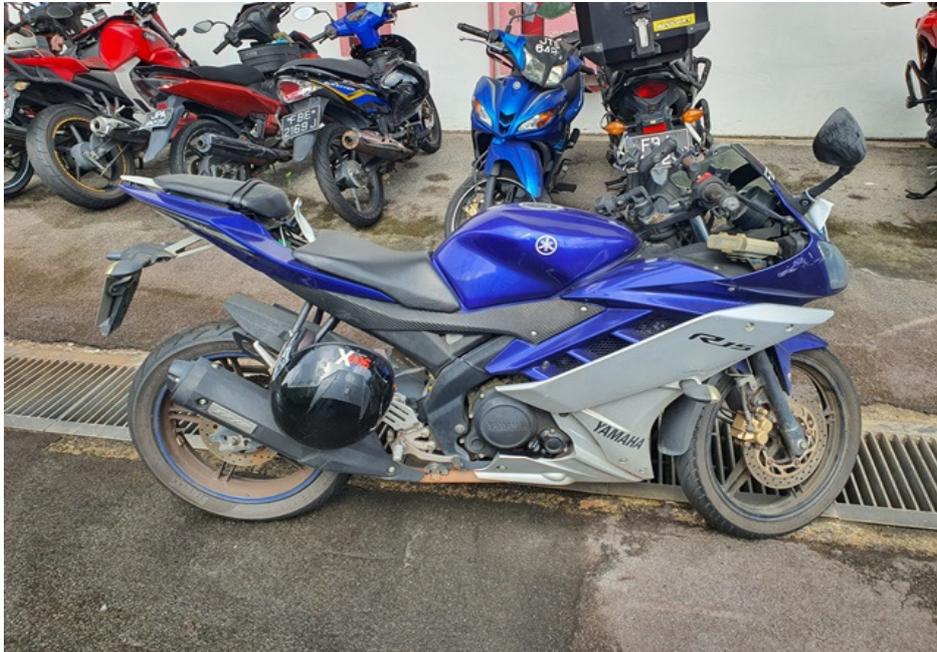
Photo 2 shows a general view of the right body of the Motorcycle at the time of our inspection. The Motorcycle was observed to have sustained damages at its frontal portion and left body.

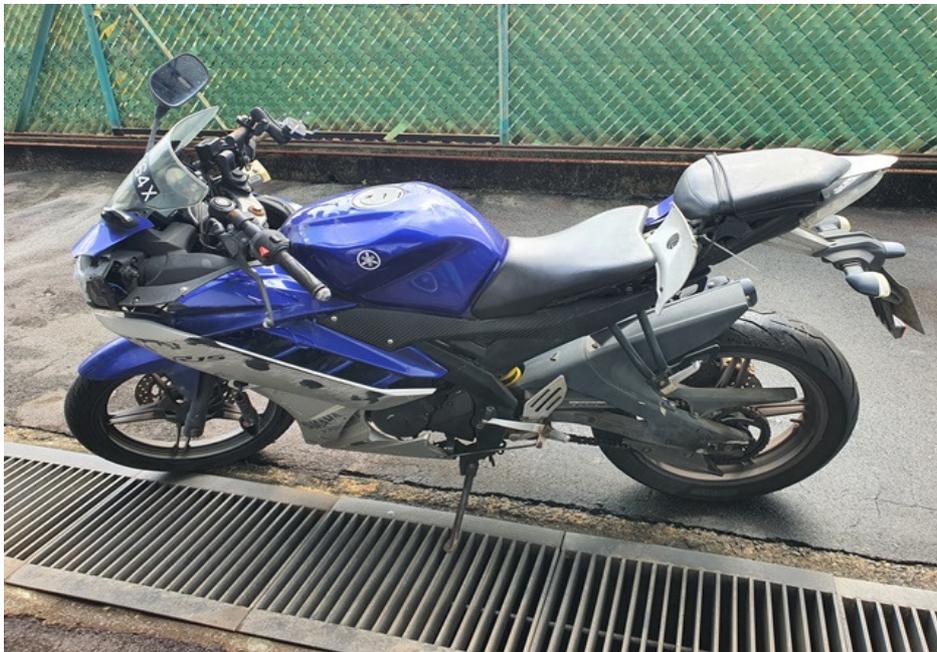
Photo 3 shows a general view of the left body of the Motorcycle at the time of our inspection. The Motorcycle was observed to have sustained damages at its frontal portion and left body. The body parts that were found to have been damaged include its front cowling, front mudguard, clutch lever, left side mirror, gear shift pedal, left front footrest and left rear side cover, amongst others.

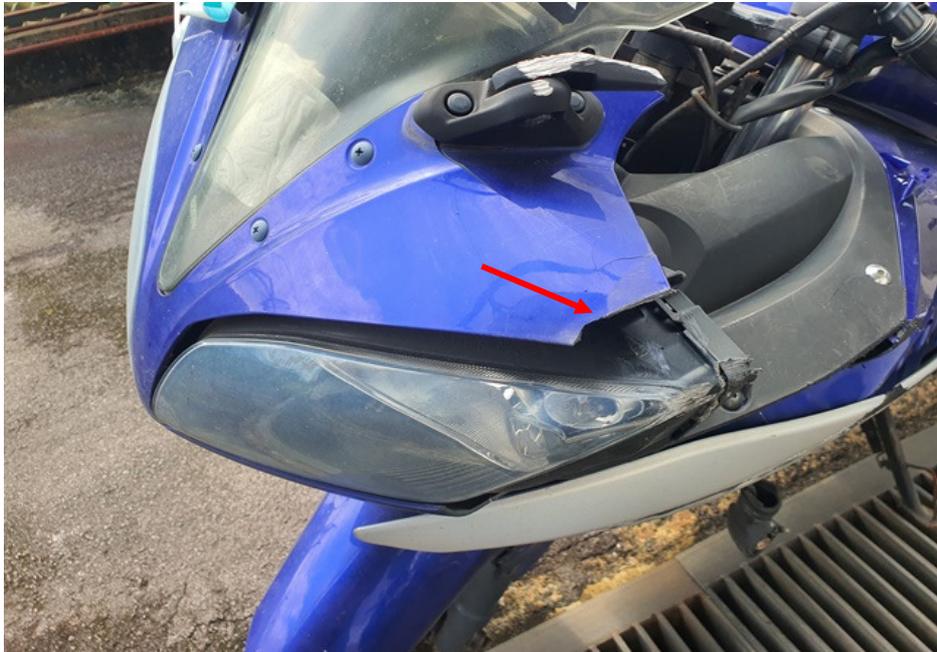
Photo 4 shows a closer view of the cracked front cowling (arrowed) of the Motorcycle at the time of our inspection.

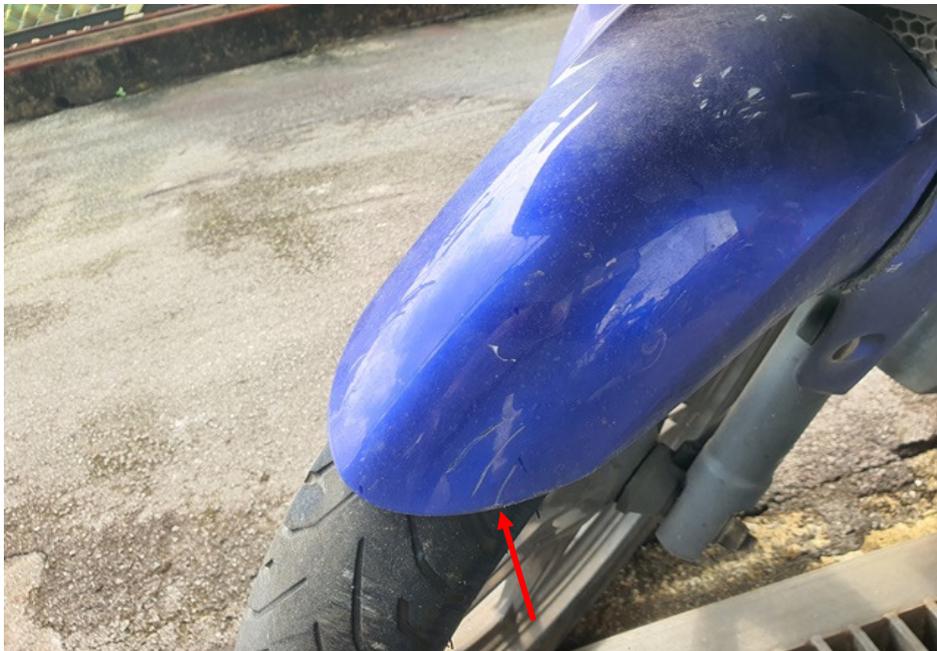
Photo 5 shows a closer view of the grazed front mudguard of the Motorcycle at the time of our inspection (arrowed).

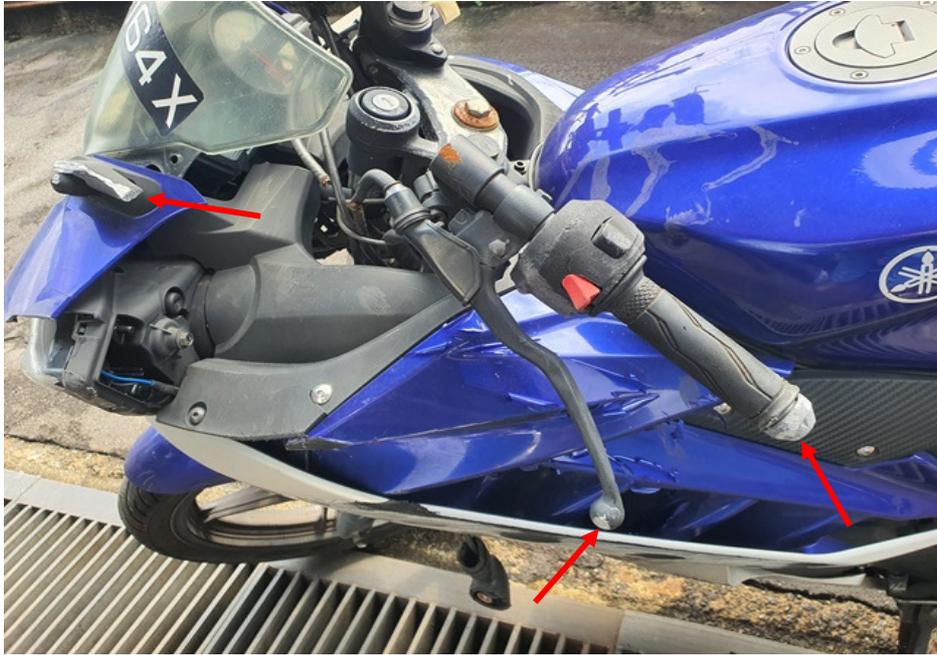
Photo 6 shows the clutch lever, left handlebar end and left side mirror (arrowed), which were amongst the body parts of the Motorcycle that had sustained damage at the time of our inspection.

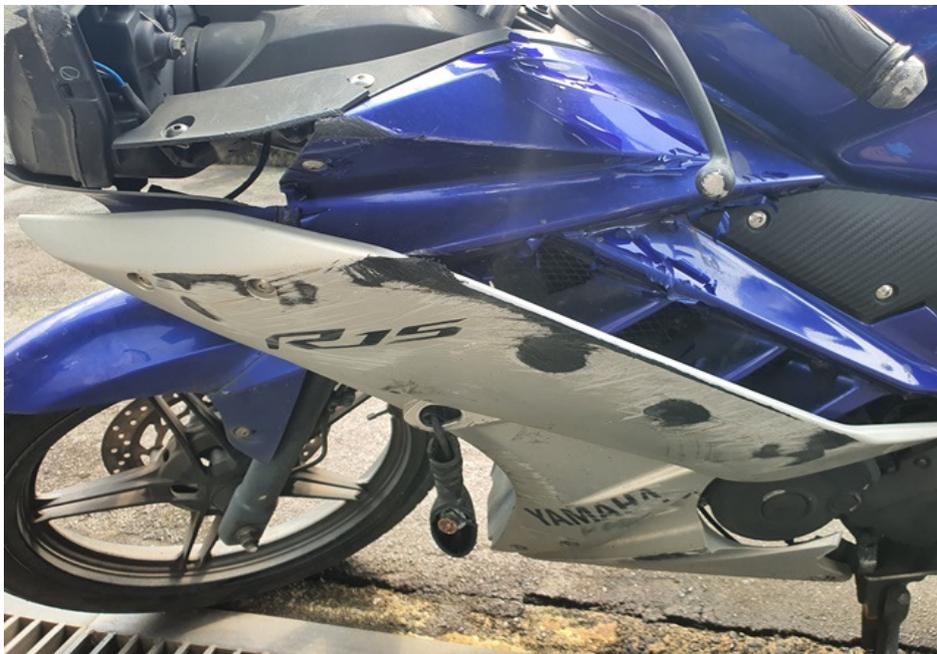
Photo 7 shows a closer view of the grazed left cowling of the Motorcycle at the time of our inspection.

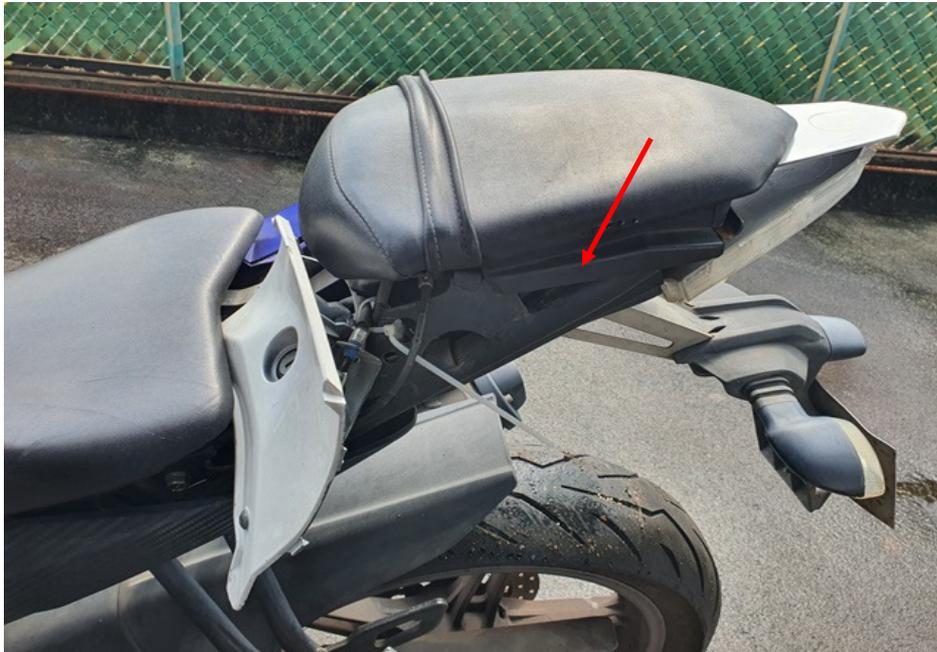
Photo 8 shows a closer view of the missing left rear side cover (arrowed) of the Motorcycle at the time of our inspection.

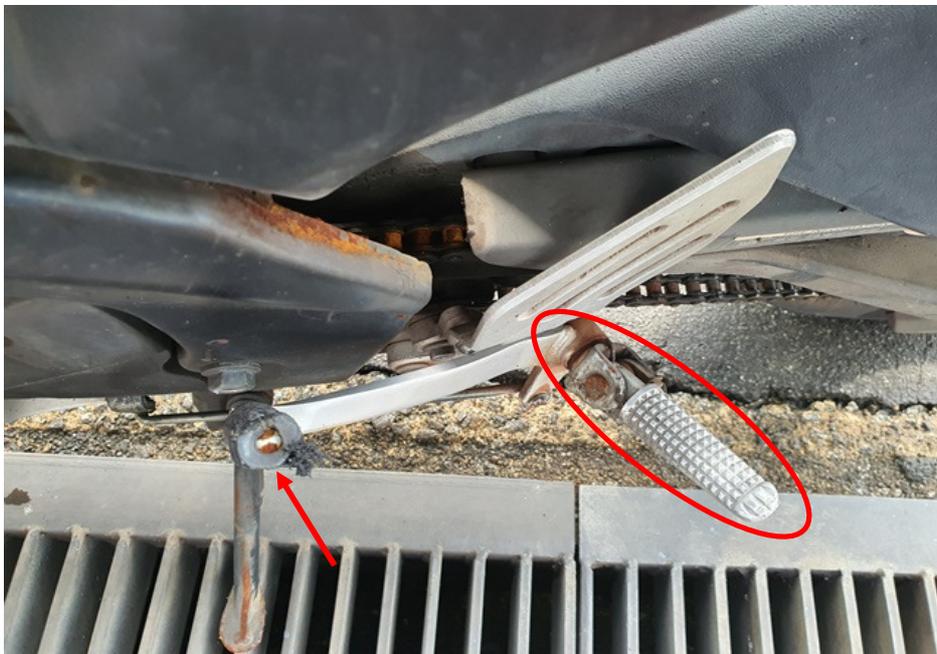
Photo 9 shows a closer view of the grazed gear shift pedal (arrowed) and left front footrest (circled) of the Motorcycle at the time of our inspection.

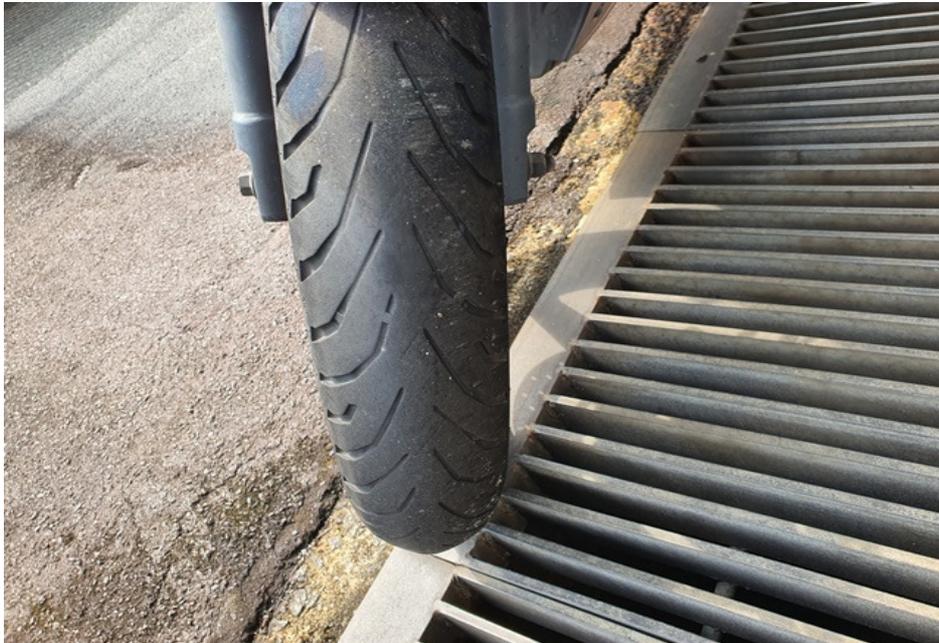
Photo 10 shows the front tyre of the Motorcycle at the time of our inspection. The front tyre was observed to be in serviceable condition with remaining tread depth of approximately 1mm. The pattern of the tread was also clearly visible. There was no tear, burst mark(s) and/or punctured hole(s) on the sidewalls as well as across the tread of the front tyre.

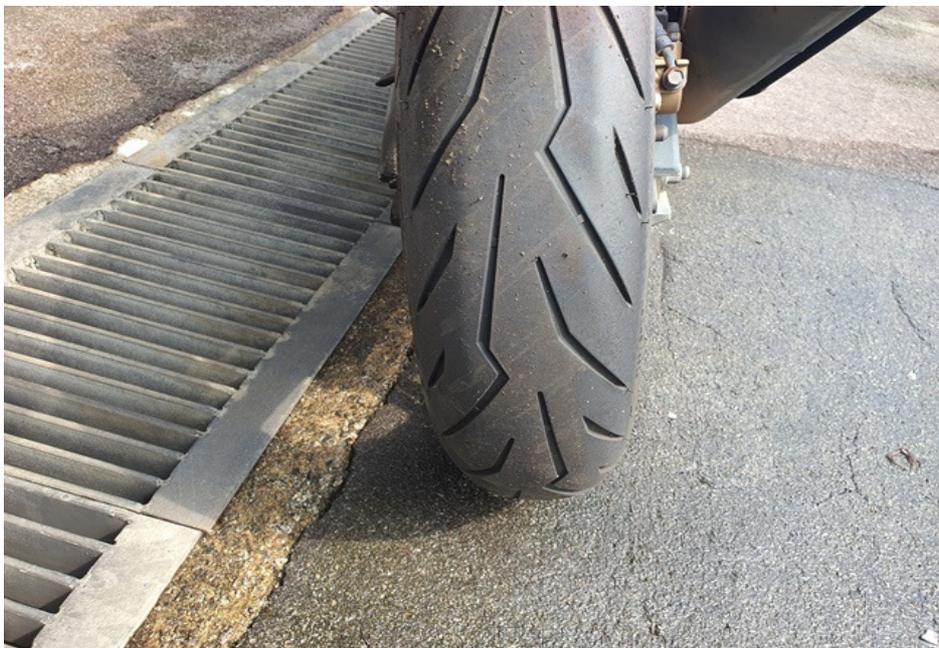
Photo 11 shows the condition of the Motorcycle's rear tyre. The rear tyre was observed to be in serviceable condition with remaining tread depth of approximately 3mm. The tyre was also observed to be sufficiently inflated for vehicular operation. We did not observe any tear, burst mark(s) and/or punctured hole(s) on the sidewalls as well as across the tread of the rear tyre.

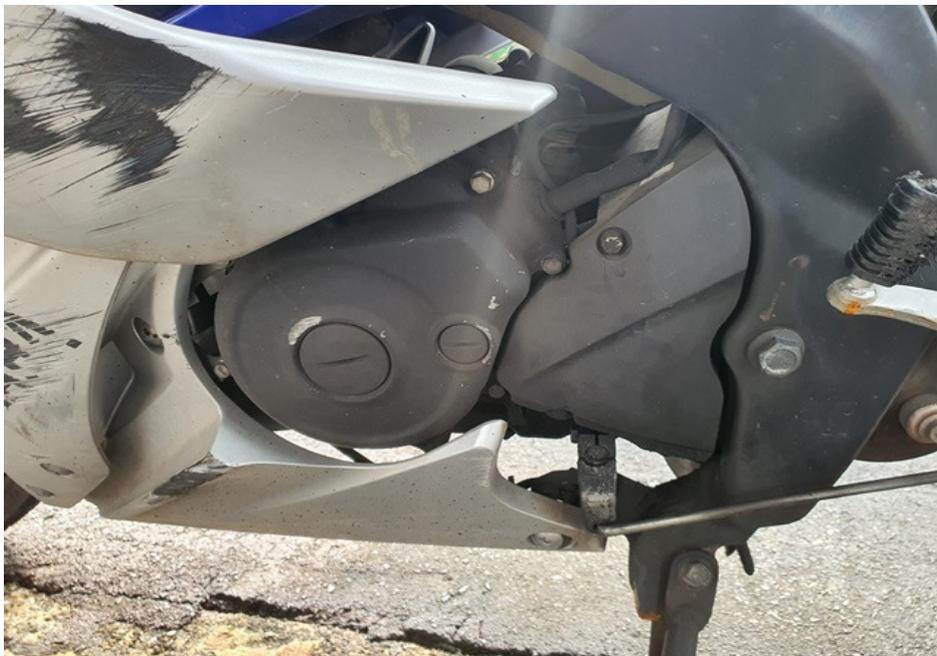
Photo 12 shows the left side of the engine of the Motorcycle at the time of our inspection. The various engine related parts and components were found to be intact with no visible damage. There was also no sign(s) or indication(s) of fluid leak observed around the left engine area of the Motorcycle.

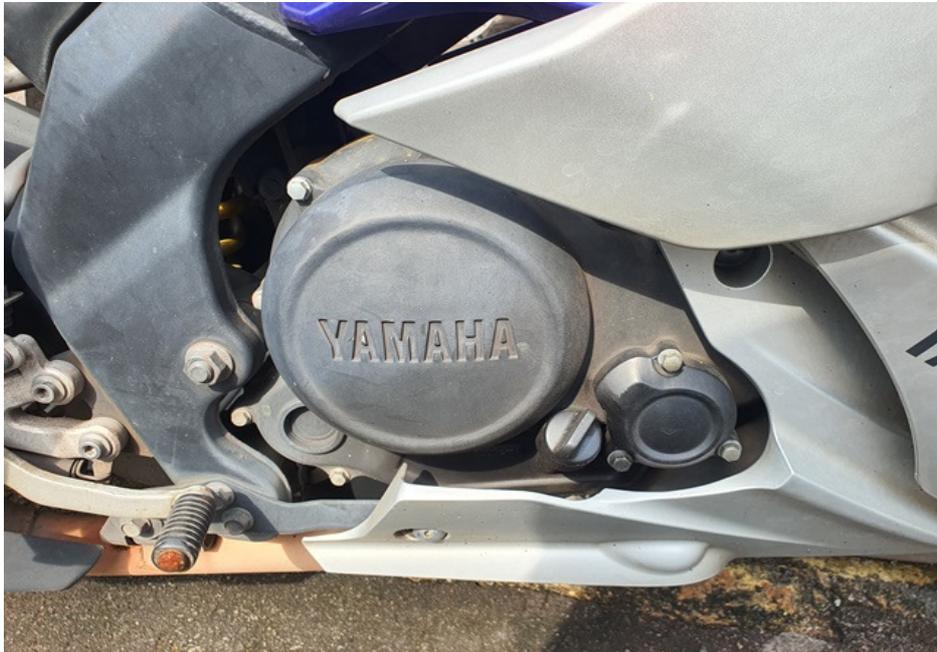
Photo 13 shows the right side of the engine of the Motorcycle at the time of our inspection. The various engine related parts and components were found to be intact with no visible damage. There was also no sign(s) or indication(s) of fluid leak observed around the right engine area of the Motorcycle.

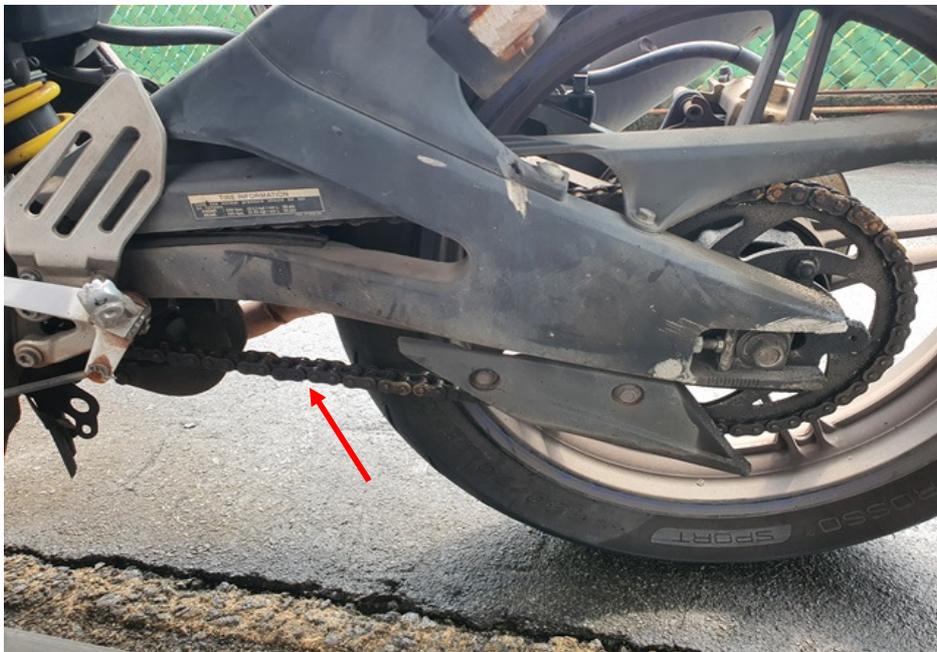
Photo 14 shows the general view of the gear train (arrowed) of the Motorcycle, which was observed to be intact with no misalignment. It was also adequately lubricated for operating purposes.

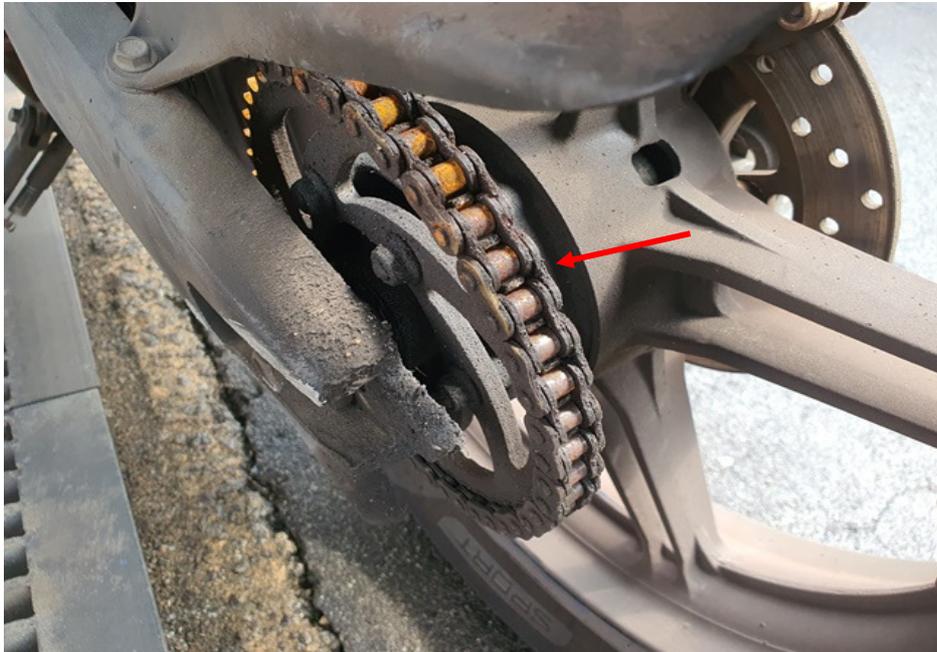
Photo 15 shows a closer view of the gear train (arrowed) of the Motorcycle, which was observed to be intact with no misalignment. It was also adequately lubricated for operating purposes.

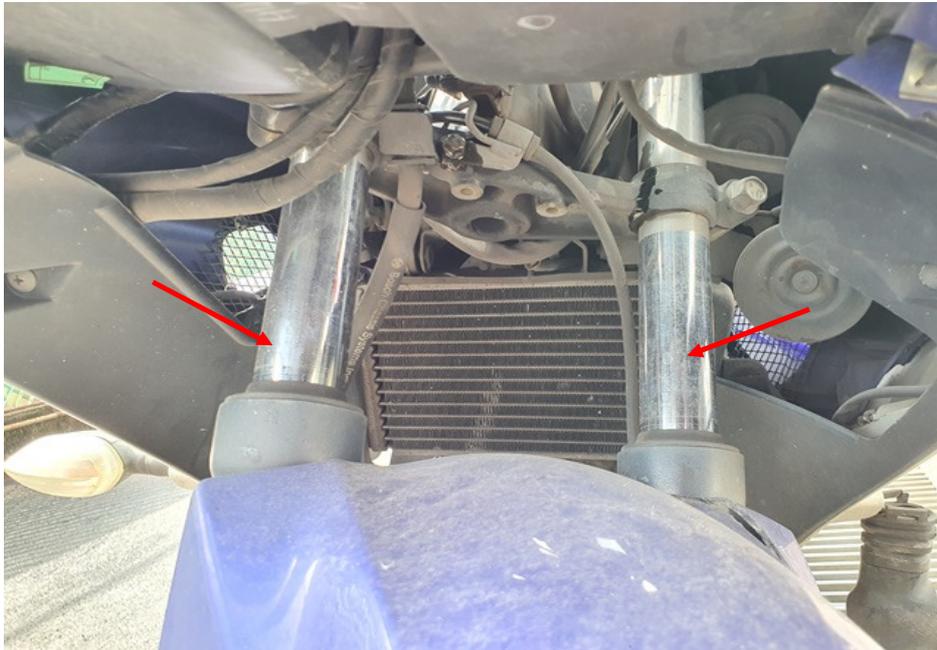
Photo 16 shows the front fork assembly (arrowed) of the Motorcycle. The front fork and fork bracket of the Motorcycle were both found to be intact and undamaged. However we were unable to turn the handle bar towards the left and right as the handlebar was locked at the time of our inspection.

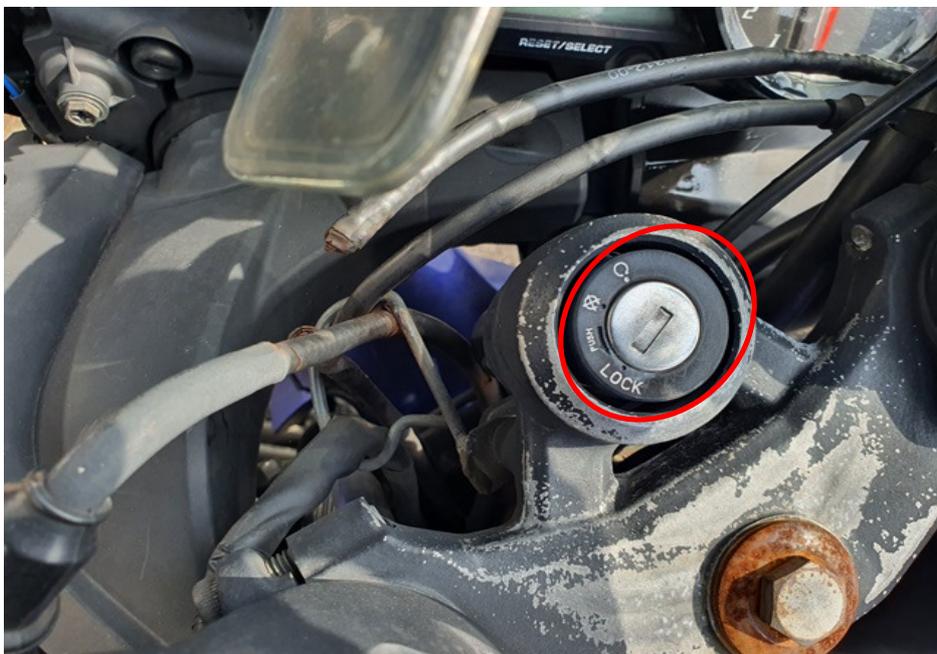
Photo 17 shows the ignition of the Motorcycle. It was at the 'LOCK' position at the time of our inspection (circled). Due to the unavailability of the ignition key, we were unable to unlock and turn the handle bar towards the left and right to test the steering system of the Motorcycle

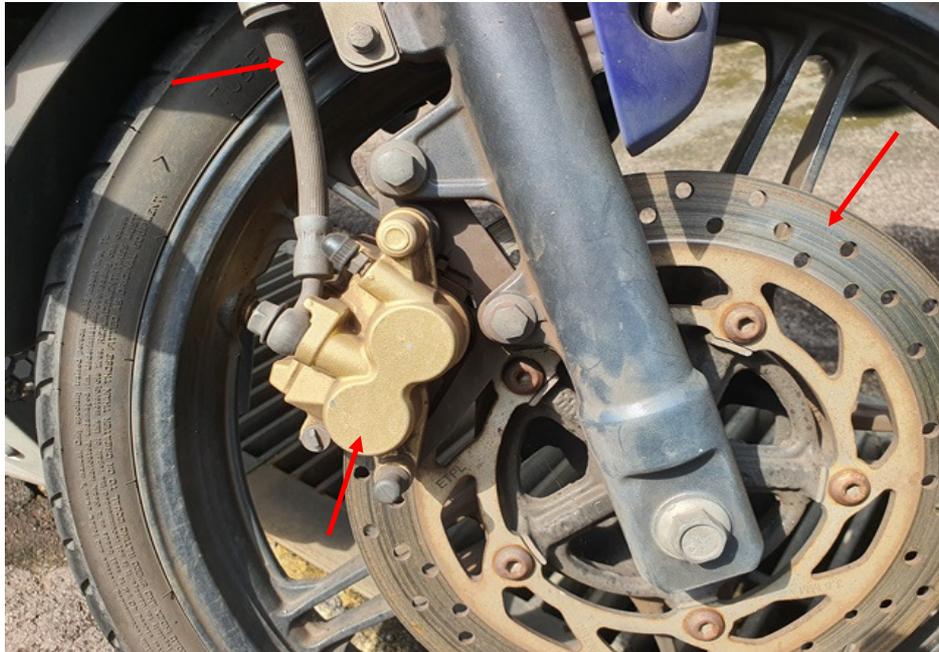
Photo 18 shows a close up view of the front brake caliper, front brake disc and front brake hose (arrowed) of the Motorcycle, which are all part of the components in the hydraulic front brake system of the Motorcycle. Our visual checks of these various components had revealed all to be intact with no visible damage. No leakage of brake fluid was also observed.

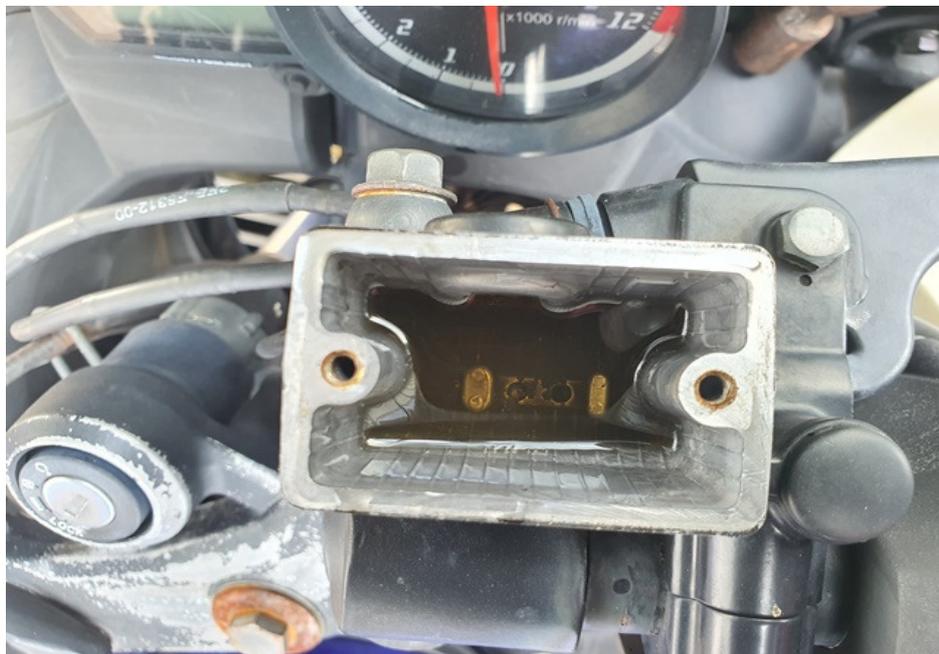
Photo 19 shows the brake fluid reservoir for the front brake of the Motorcycle. The brake fluid was found to be of sufficient level for operating purposes and without any contamination.

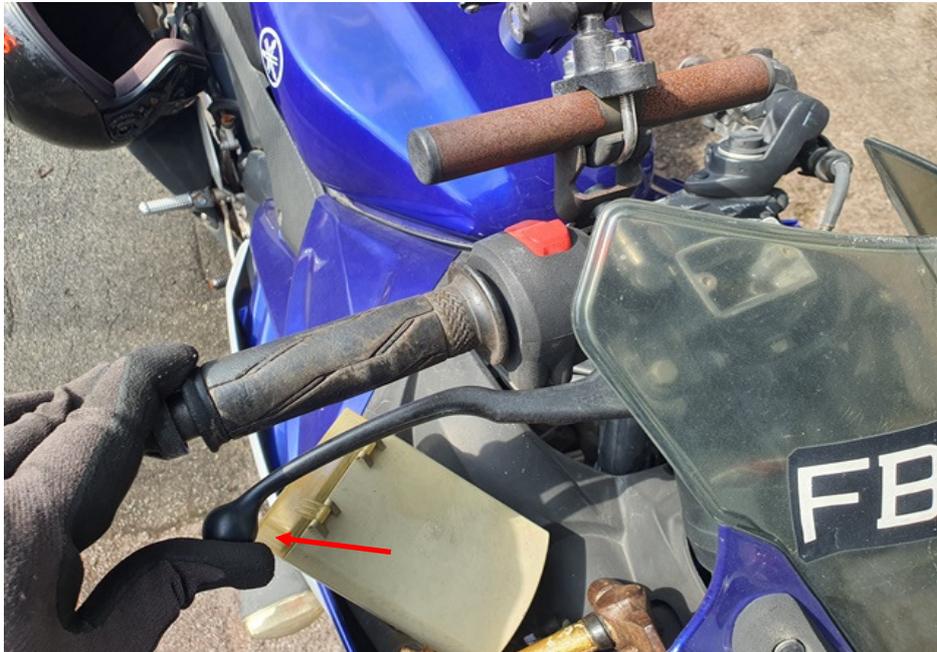
Photo 20 shows the front brake lever being depressed. There was some resistance felt (spongy like feel) upon pressing the front brake lever (arrowed). This would indicate that there is no leakage of pressure/vacuum in the front brake system.

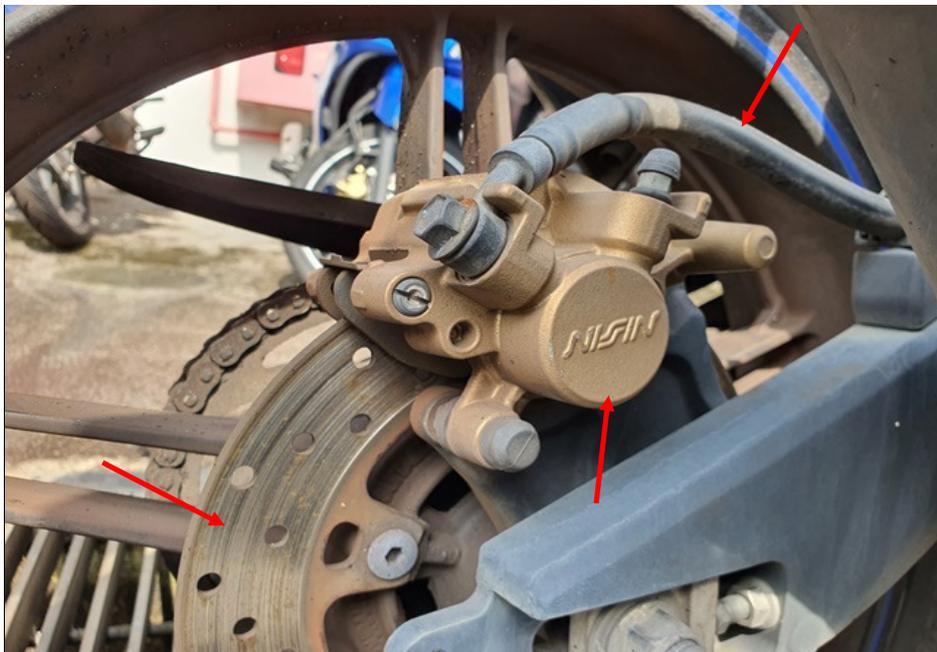
Photo 21 shows a close up view of the rear brake caliper, rear brake disc and rear brake hose (arrowed) of the Motorcycle, which are all part of the components in the hydraulic rear brake system of the Motorcycle. Our visual checks of these various components had revealed all to be intact with no visible damage. No leakage of brake fluid was also observed.
