Your Ref: TPIP/05401/2023
Our Ref : CI/TPD23005739/N

14 June 2023

Fatal Accident Investigation Team

INSPECTION REPORT OF MOTORCYCLE JSH 6448

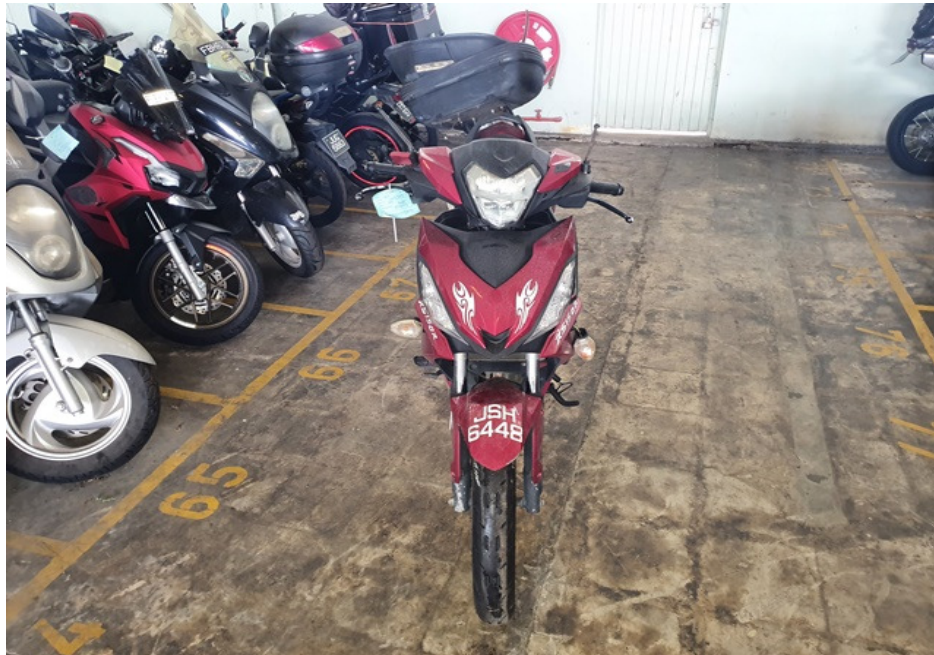
Photo 1 shows a general view of the frontal portion of the Motorcycle at the time of our inspection. The Motorcycle was observed to have sustained damages all around. The mileage of the Motorcycle could not be recorded at the time of our inspection due to unavailability of the ignition key.

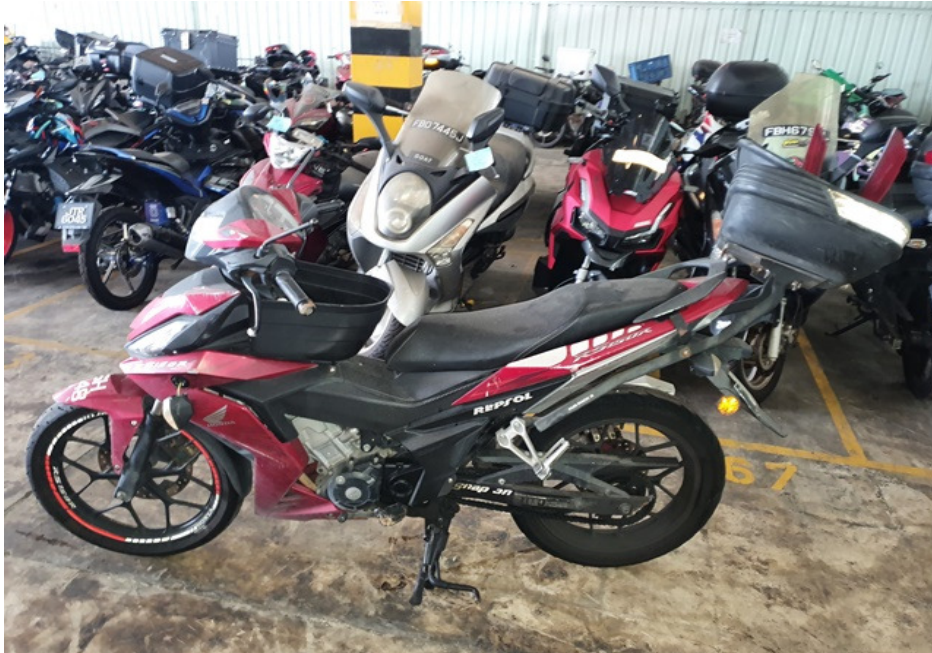
Photo 2 shows a general view of the left body of the Motorcycle at the time of our inspection. The Motorcycle was observed to have sustained damages all around.

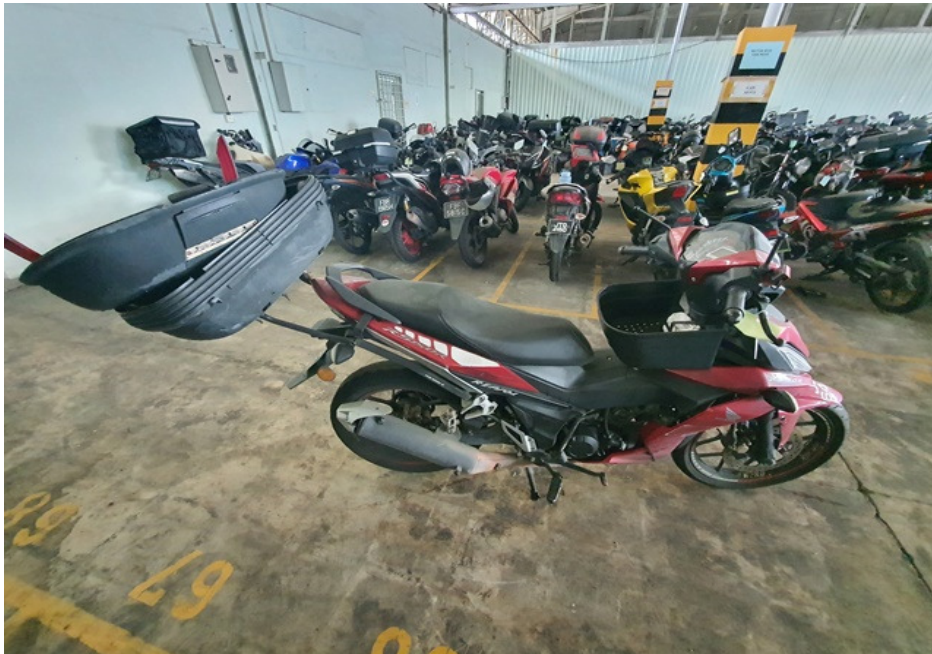
Photo 3 shows a general view of the right body of the Motorcycle at the time of our inspection. The Motorcycle was observed to have sustained damages all around.

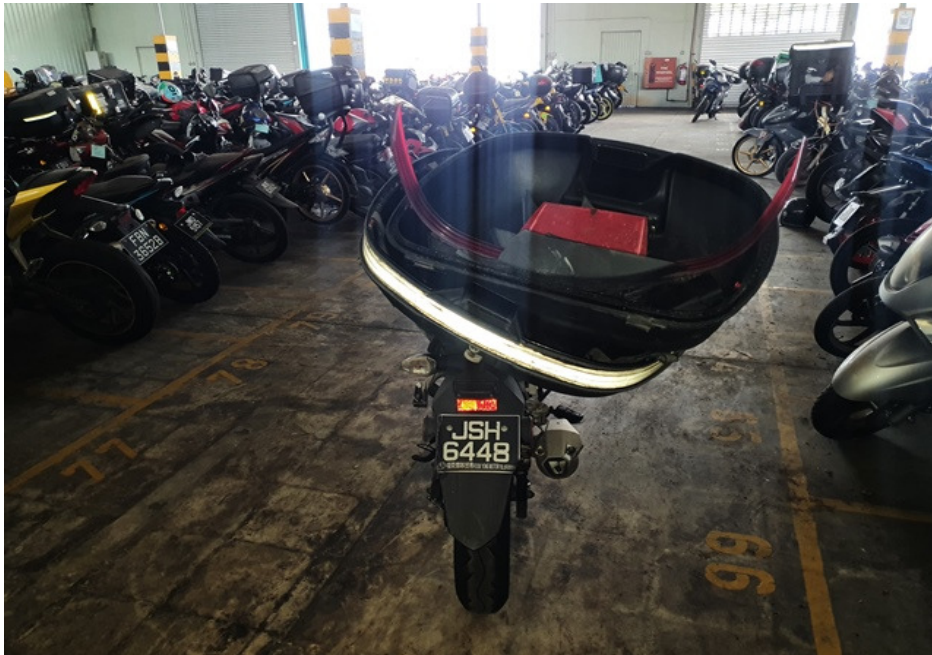
Photo 4 shows a general view of the rear portion of the Motorcycle at the time of our inspection. The Motorcycle was observed to have sustained damages all around. The body parts that were found to have been damaged include its head cowlings, headlight, side cowlings, left side mirror, clutch lever, left handlebar end, rear brake pedal, right front footrest and rear side covers, amongst others.

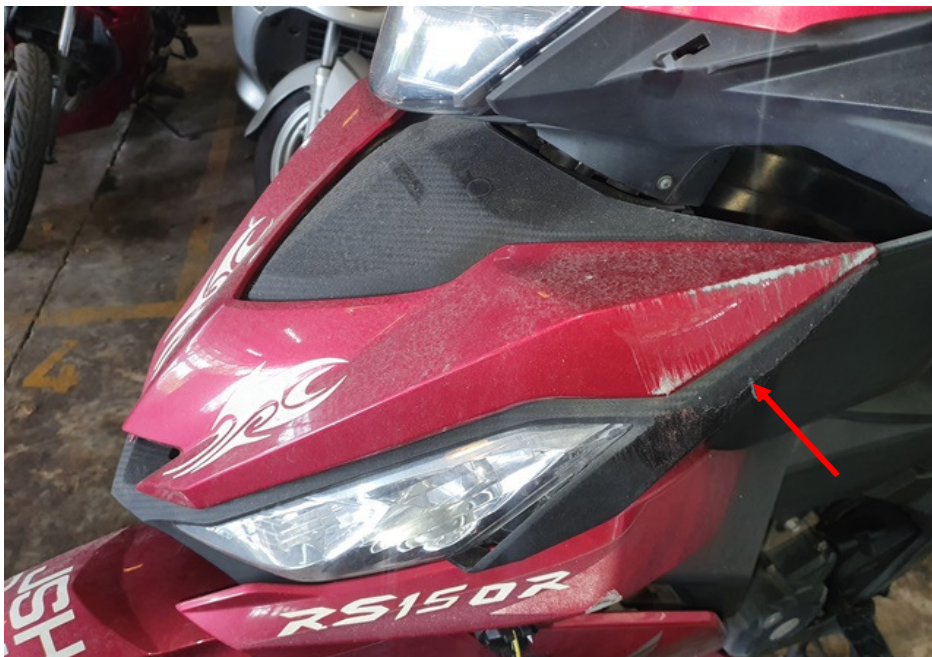
Photo 5 shows a closer view of grazed front cowlings (arrowed) of the Motorcycle at the time of our inspection.

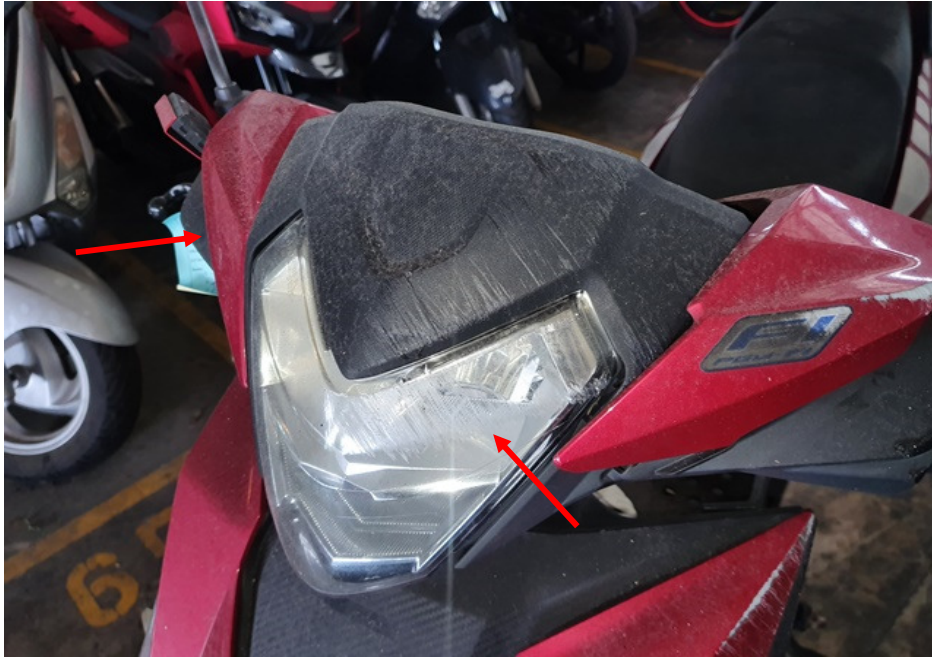
Photo 6 shows the head cowling and headlight (arrowed), which was amongst the body parts of the Motorcycle that had sustained damage at the time of our inspection.

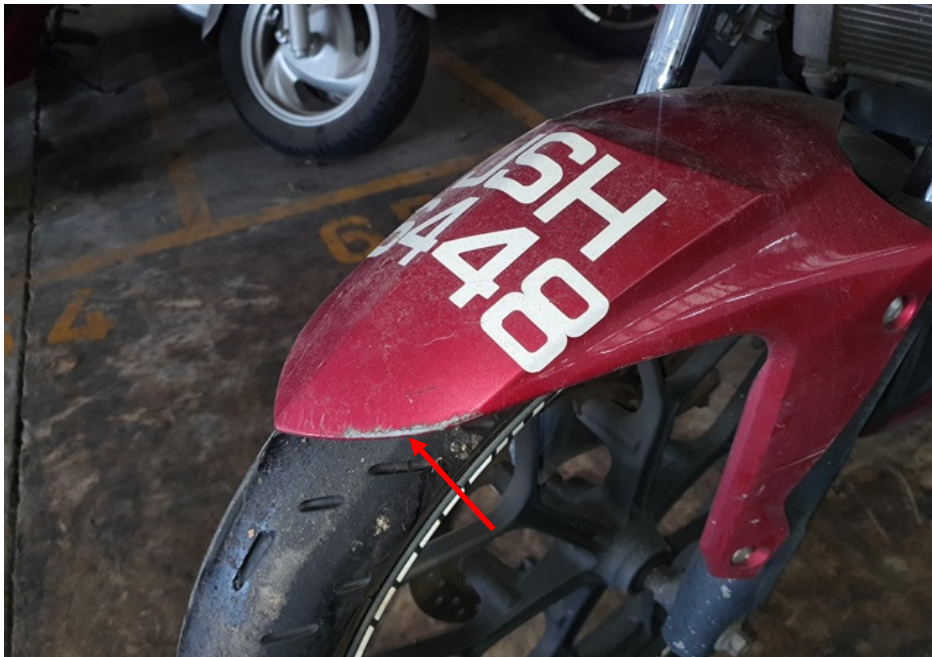
Photo 7 shows a closer view of grazed front mudguard (arrowed) of the Motorcycle at the time of our inspection.

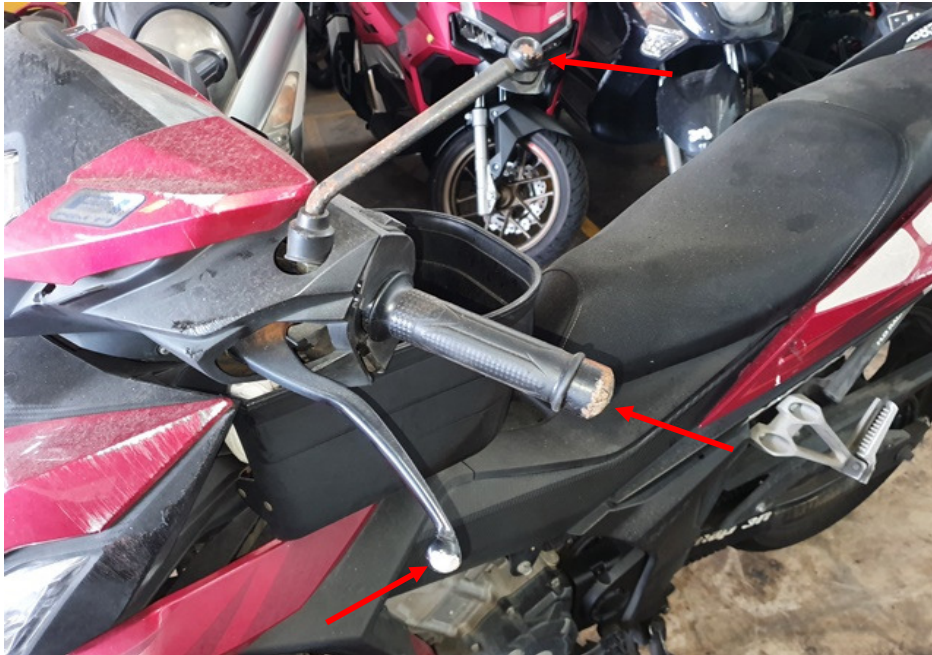
Photo 8 shows the left handlebar end, clutch lever and left side mirror (arrowed), which were amongst the body parts of the Motorcycle that had sustained damage at the time of our inspection.

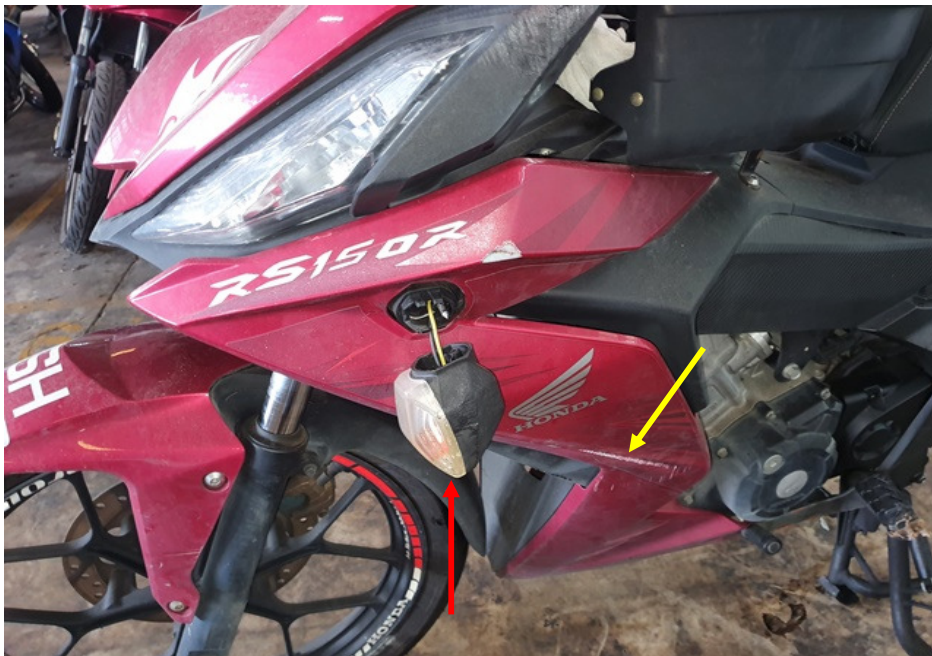
Photo 9 shows a closer view of grazed left cowling and dislodged left front signal lamp (arrowed) of the Motorcycle at the time of our inspection.

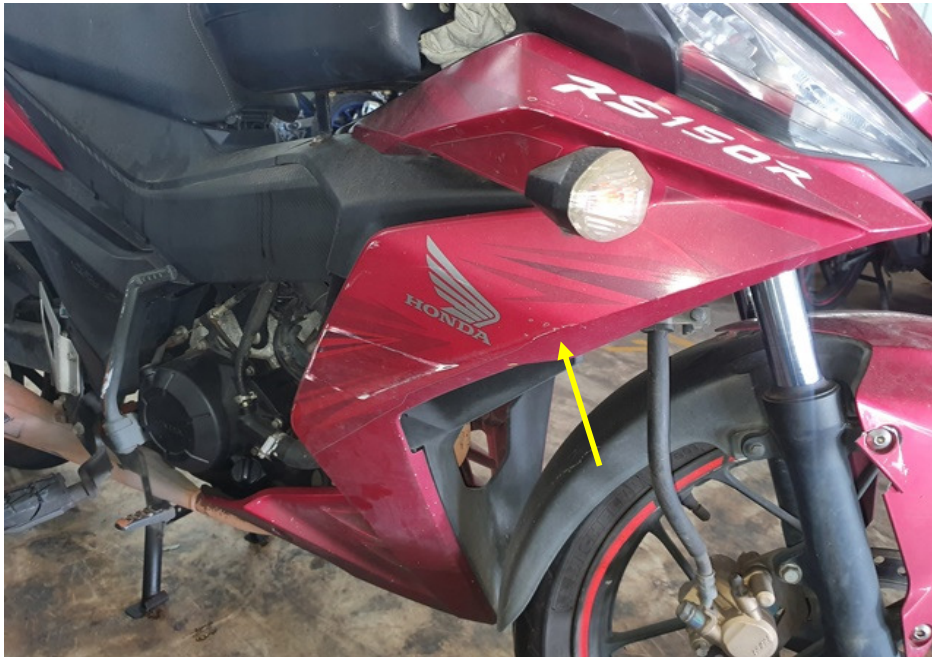
Photo 10 shows a closer view of grazed right cowling (arrowed) of the Motorcycle at the time of our inspection.

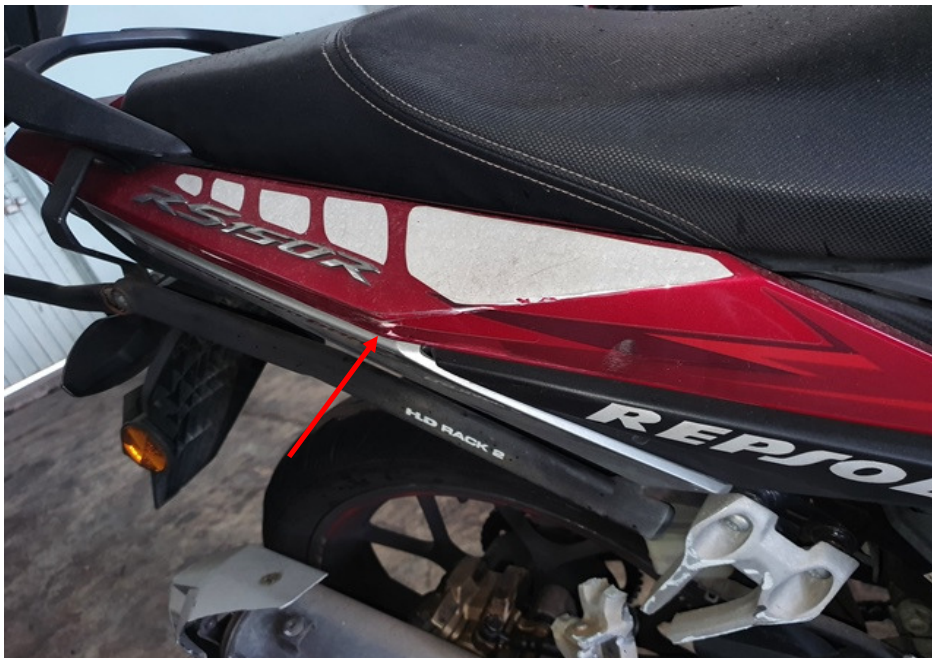
Photo 11 shows a closer view of the grazed right rear side cover of the Motorcycle at the time of our inspection (arrowed).

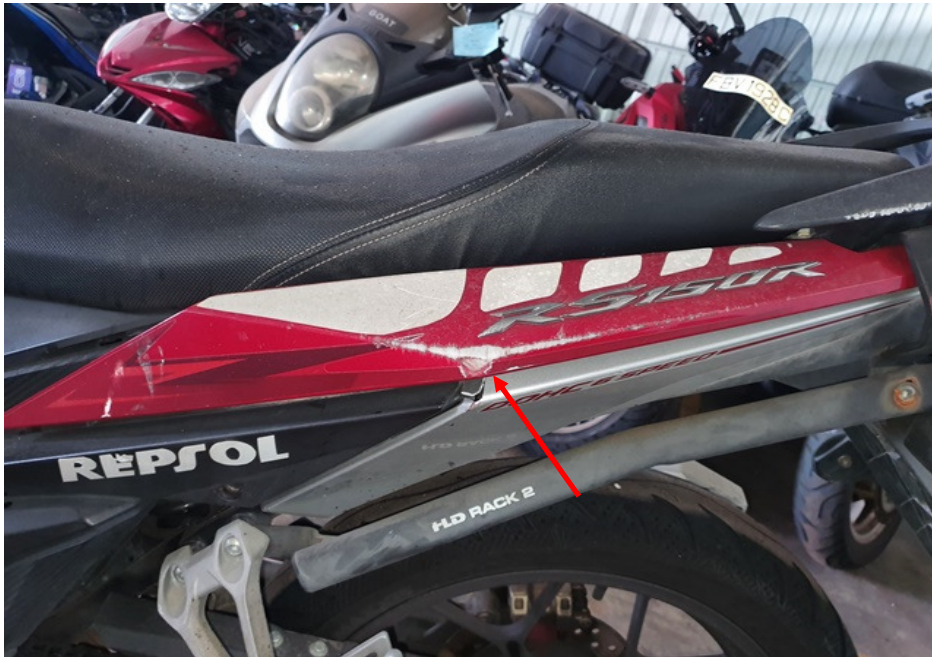
Photo 12 shows a closer view of the grazed left rear side cover of the Motorcycle at the time of our inspection (arrowed).

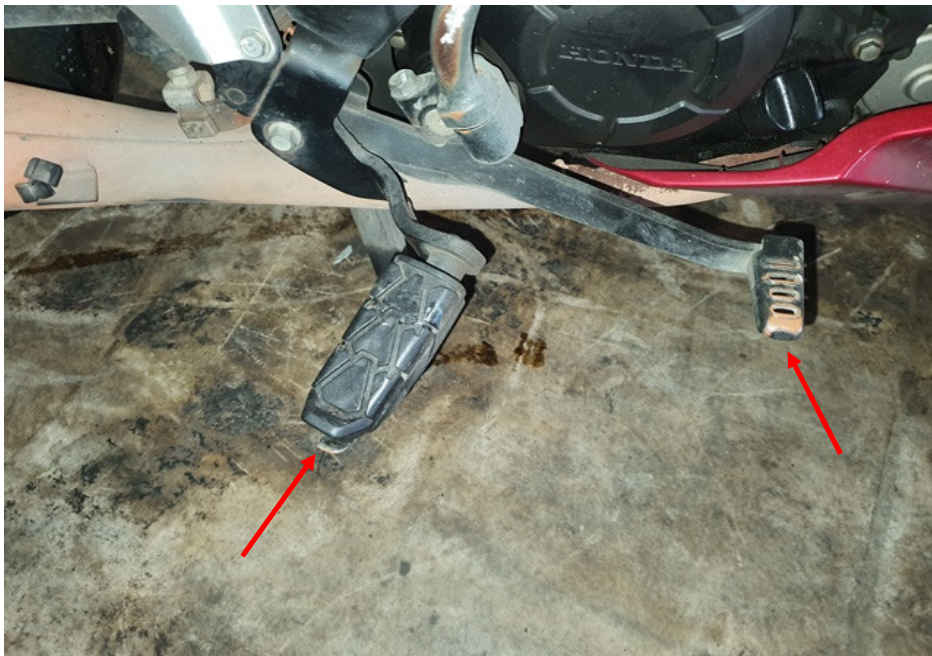
Photo 13 shows the rear brake pedal and right front footrest of the Motorcycle that had sustained damage at the time of our inspection (arrowed).

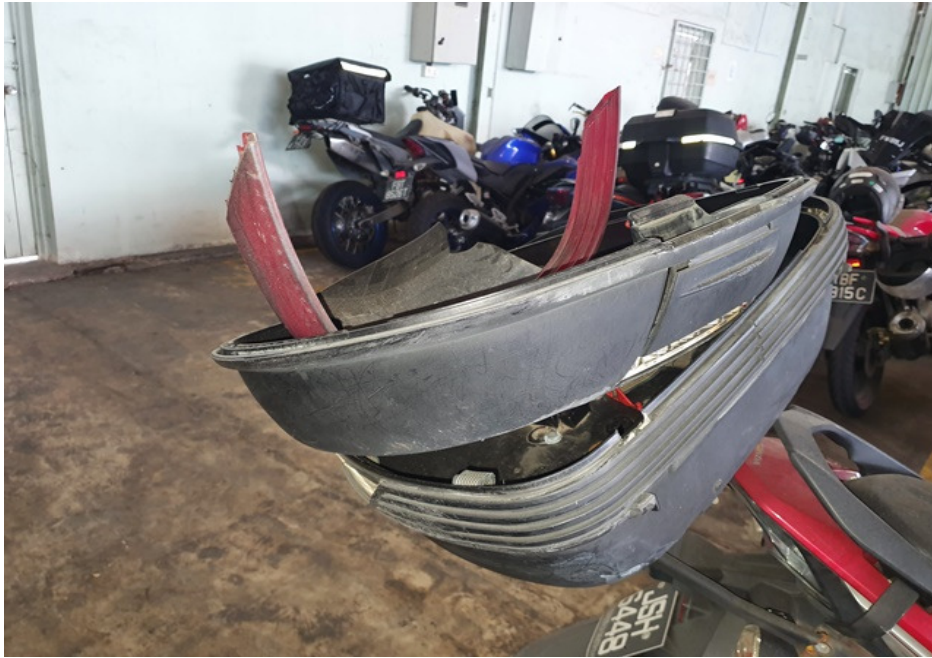
Photo 14 shows a closer view of the broken top box of the Motorcycle at the time of our inspection.

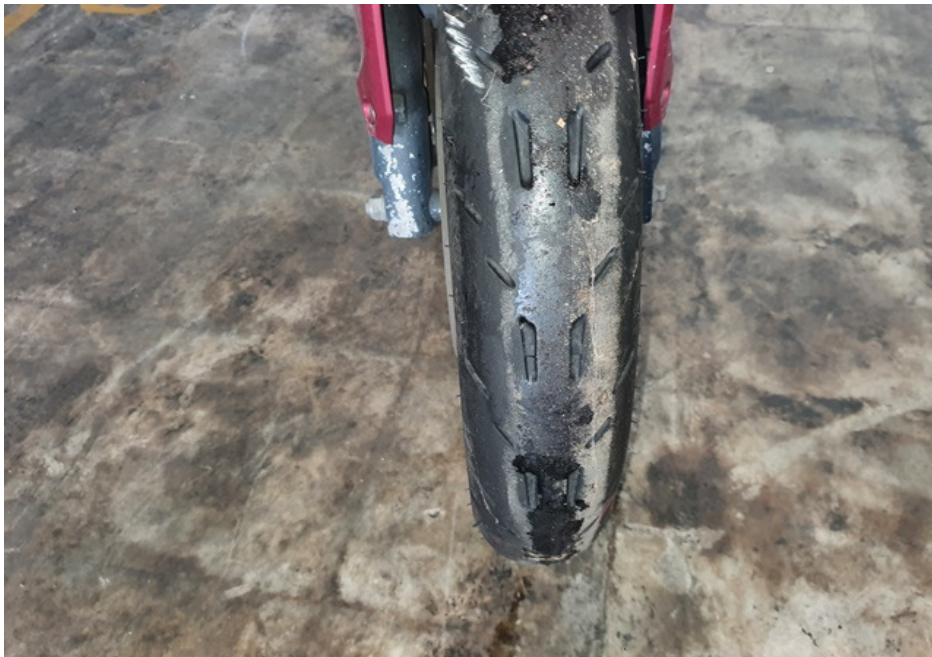
Photo 15 shows the front tyre of the Motorcycle at the time of our inspection. The front tyre was observed to be in serviceable condition with remaining tread depth of approximately 3mm. The pattern of the tread was also clearly visible. There was no tear, burst mark(s) and/or punctured hole(s) on the sidewalls as well as across the tread of the front tyre.

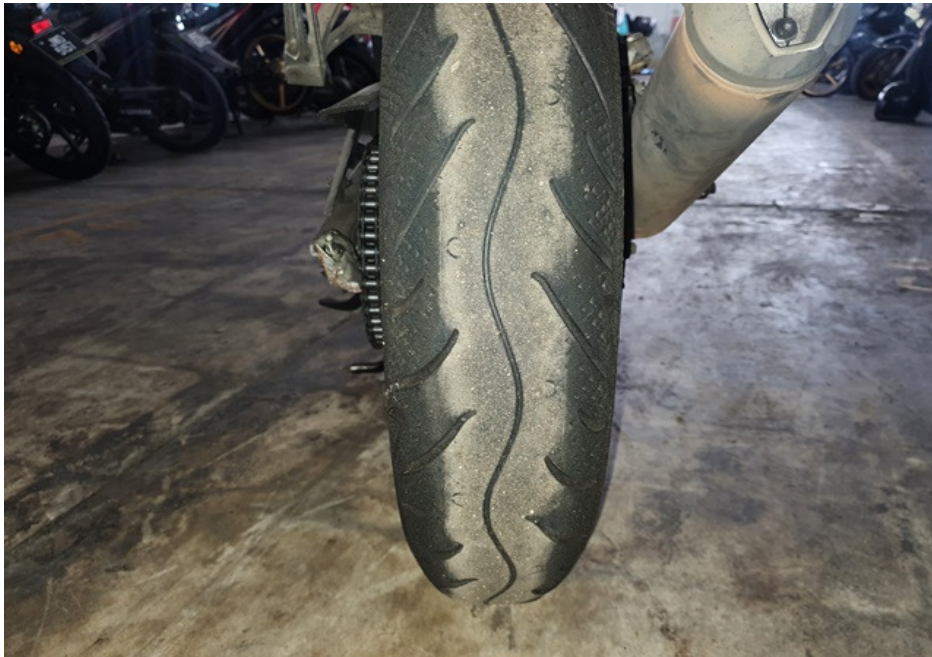
Photo 16 shows the condition of the Motorcycle's rear tyre. The rear tyre was observed to be in serviceable condition with remaining tread depth of approximately 1mm. The tyre was also observed to be sufficiently inflated for vehicular operation. We did not observe any tear, burst mark(s) and/or punctured hole(s) on the sidewalls as well as across the tread of the rear tyre.

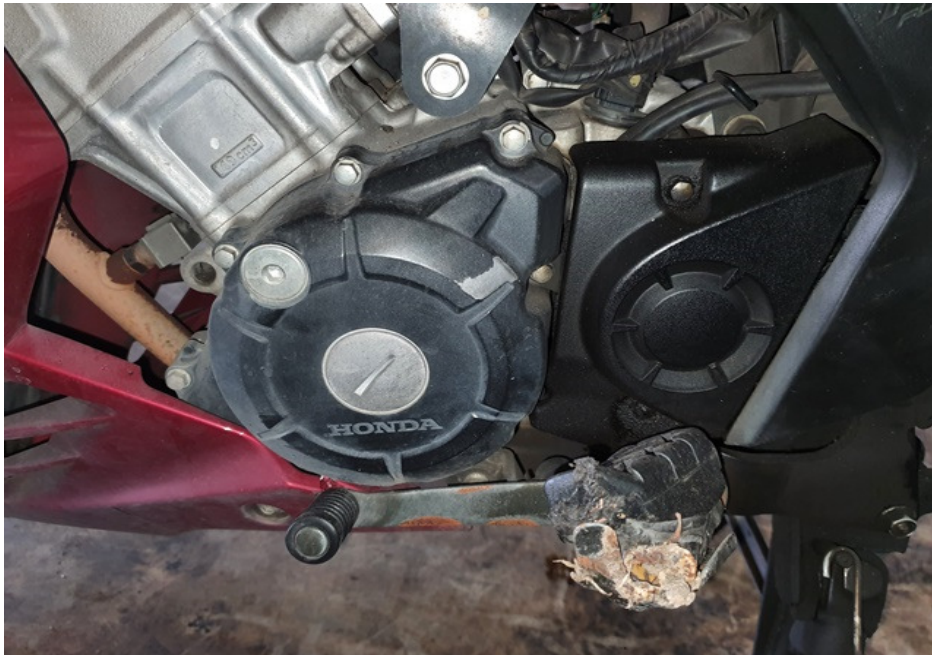
Photo 17 shows the left side of the engine of the Motorcycle at the time of our inspection. The various engine related parts and components were found to be intact with no visible damage. There was also no sign(s) or indication(s) of fluid leak observed around the left engine area of the Motorcycle.

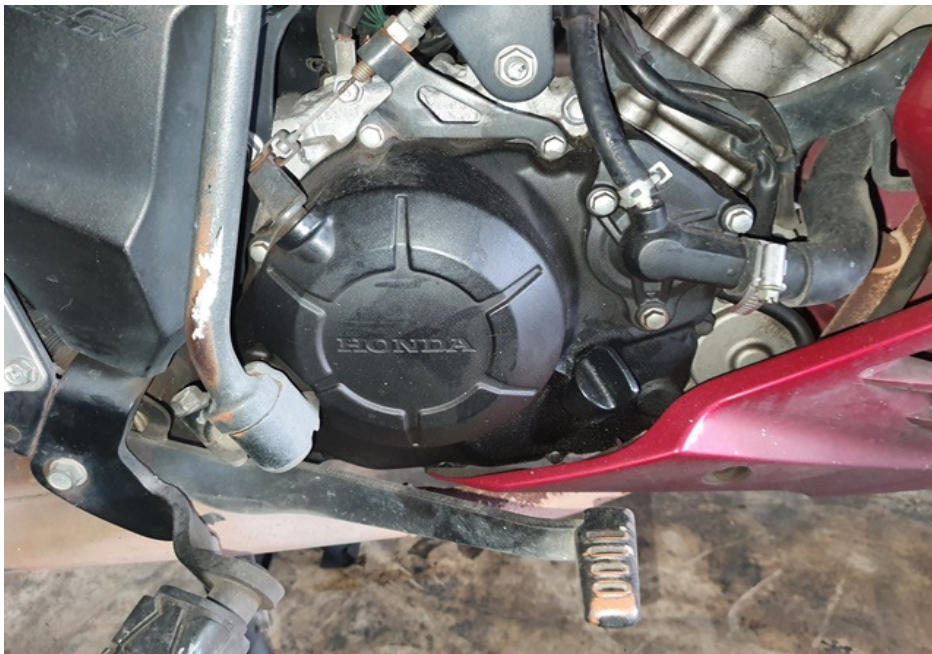
Photo 18 shows the right side of the engine of the Motorcycle at the time of our inspection. The various engine related parts and components were found to be intact with no visible damage. There was also no sign(s) or indication(s) of fluid leak observed around the right engine area of the Motorcycle.

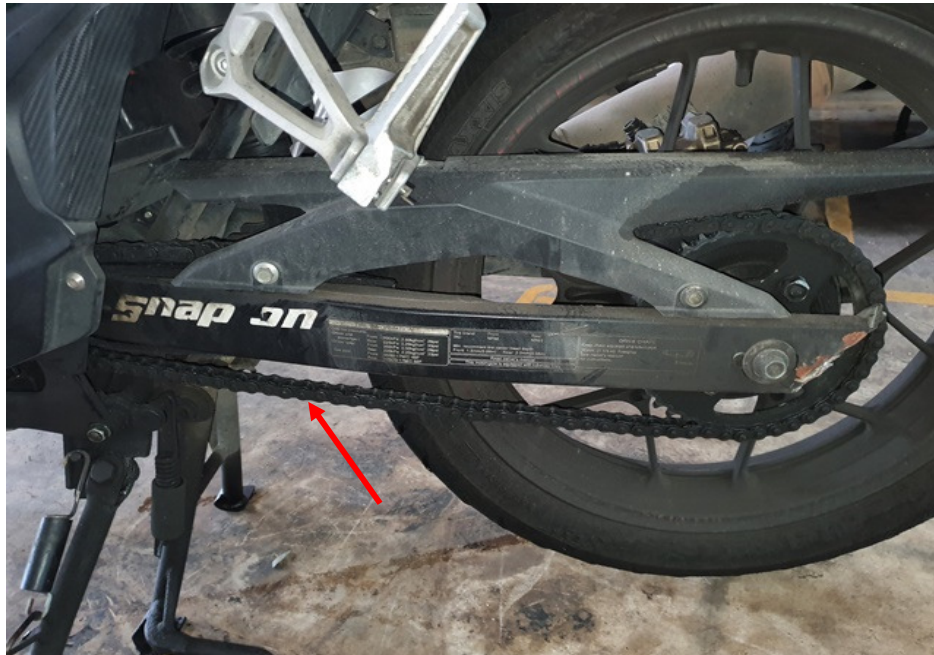
Photo 19 shows the general view of the gear train (arrowed) of the Motorcycle, which was observed to be intact with no misalignment. It was also adequately lubricated for operating purposes.

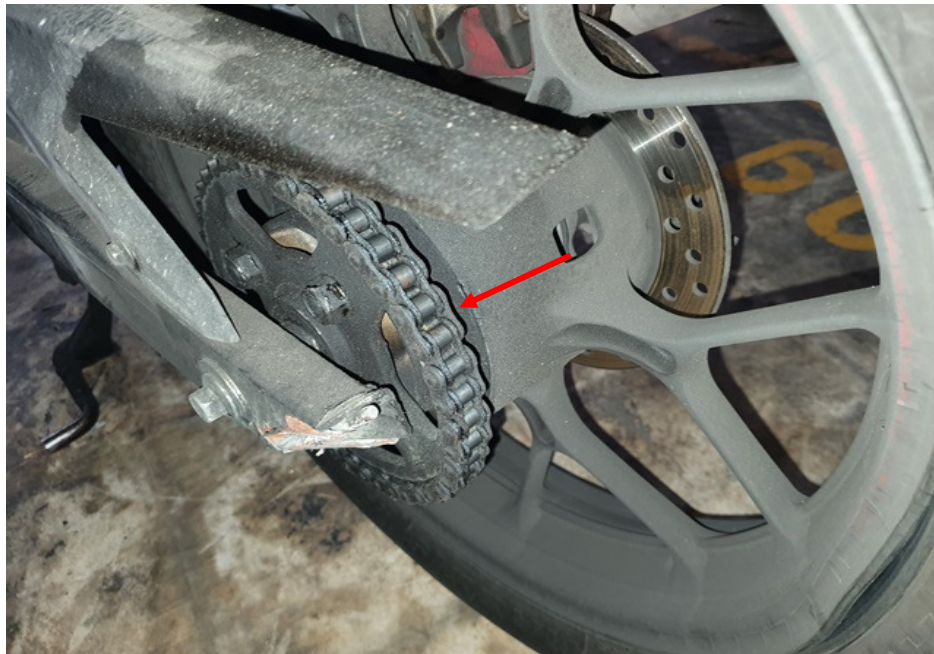
Photo 20 shows a closer view of the gear train (arrowed) of the Motorcycle, which was observed to be intact with no misalignment. It was also adequately lubricated for operating purposes.

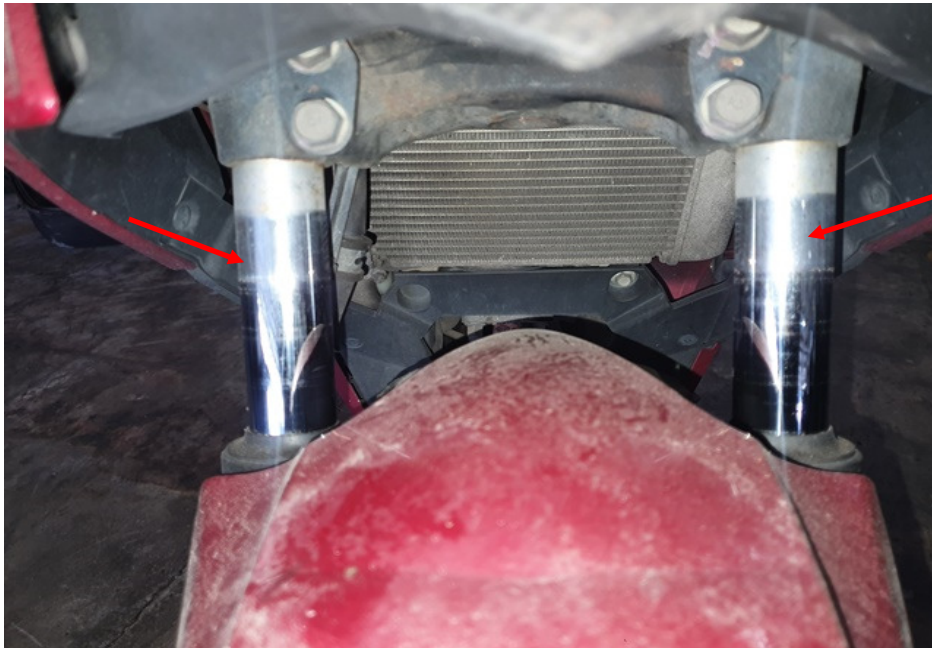
Photo 21 shows the front forks (arrowed) of the Motorcycle. The front forks and fork bracket of the Motorcycle were both found to be intact and undamaged. Turning the Motorcycle's handle bar towards the left and right did not produce any abnormal free play. The steering system of the Motorcycle was in serviceable condition at the time of our inspection.

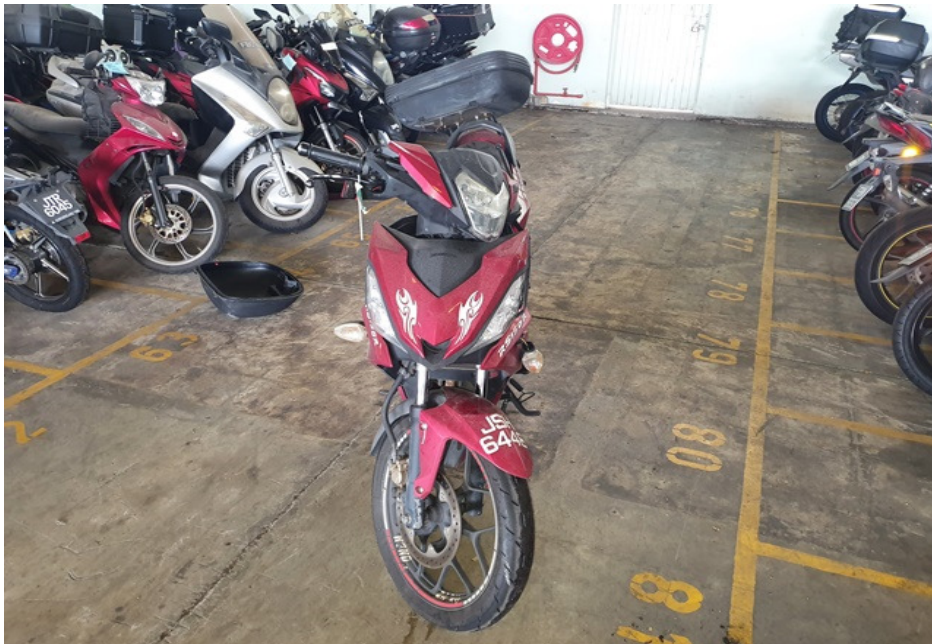
Photo 22 shows the front wheel of the Motorcycle turned towards its full left. Turning the Motorcycle's handle bar towards the left did not produce any abnormal free play and/or resistance. This would indicate that the steering system of the Motorcycle was in serviceable condition at the time of our inspection.

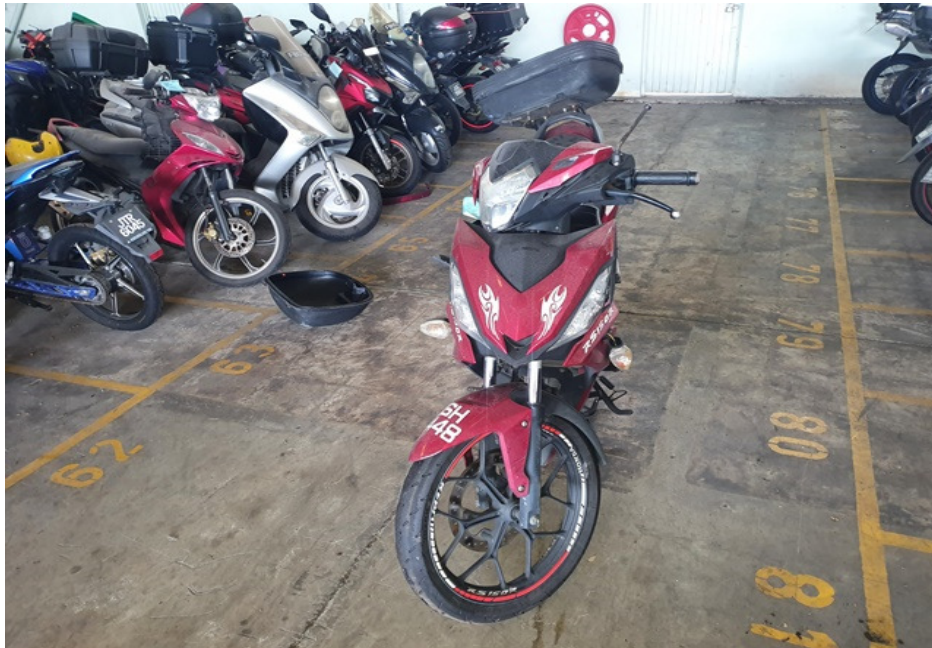
Photo 23 shows the front wheel of the Motorcycle turned towards its full right. Turning the Motorcycle's handle bar towards the right did not produce any abnormal free play and/or resistance. This would indicate that the steering system of the Motorcycle was in serviceable condition at the time of our inspection.

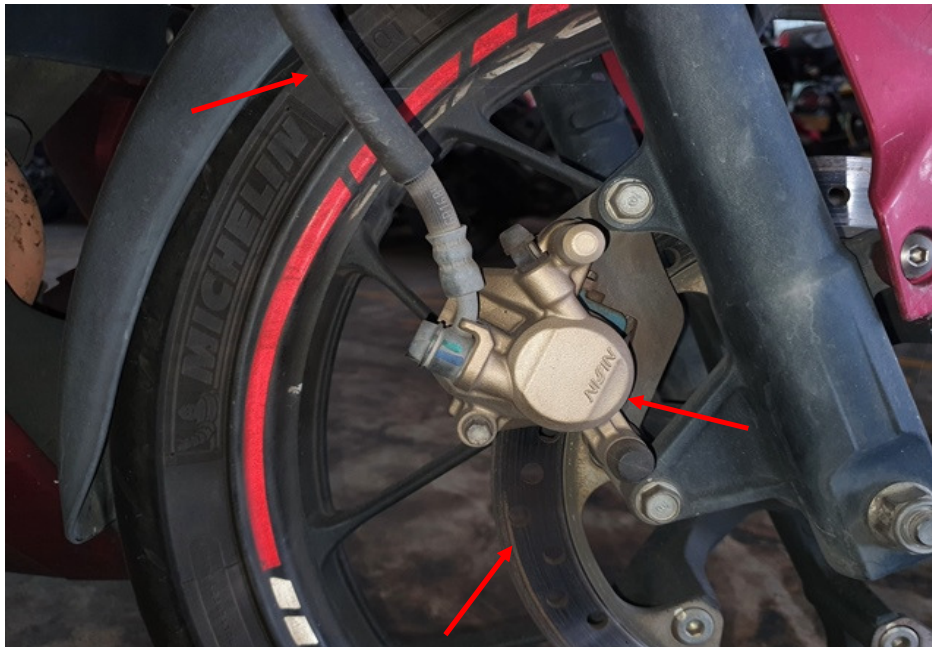
Photo 24 shows a close up view of the front brake caliper, front brake disc and front brake hose (arrowed) of the Motorcycle, which are all part of the components in the hydraulic front brake system of the Motorcycle. Our visual checks of these various components had revealed all to be intact with no visible damage. No leakage of brake fluid was also observed.

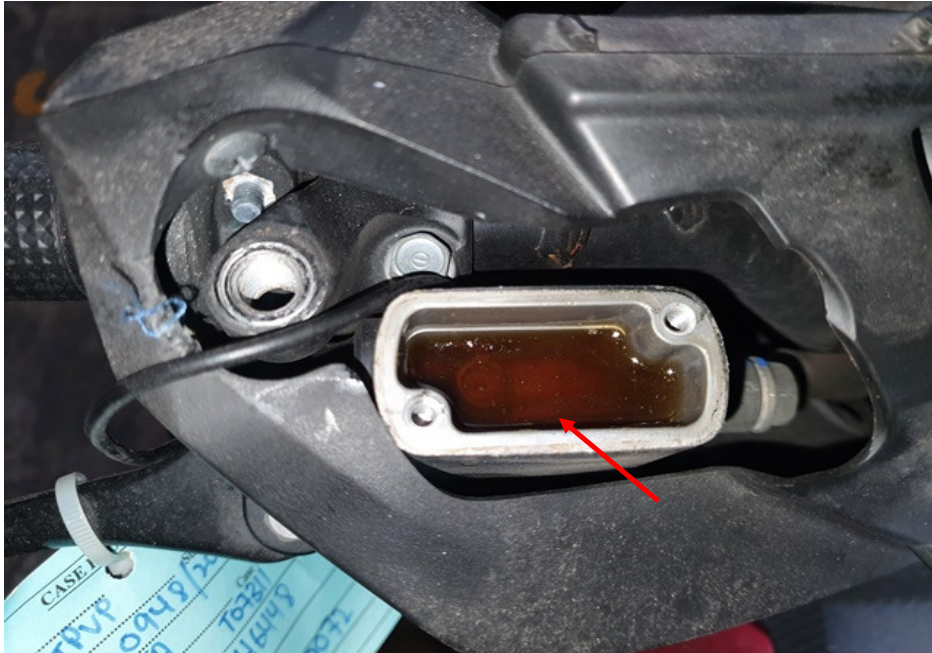
Photo 25 shows the brake fluid reservoir for the front brake of the Motorcycle. The brake fluid was observed to be of sufficient level for operational purposes. However it was found to be slightly contaminated (arrowed).

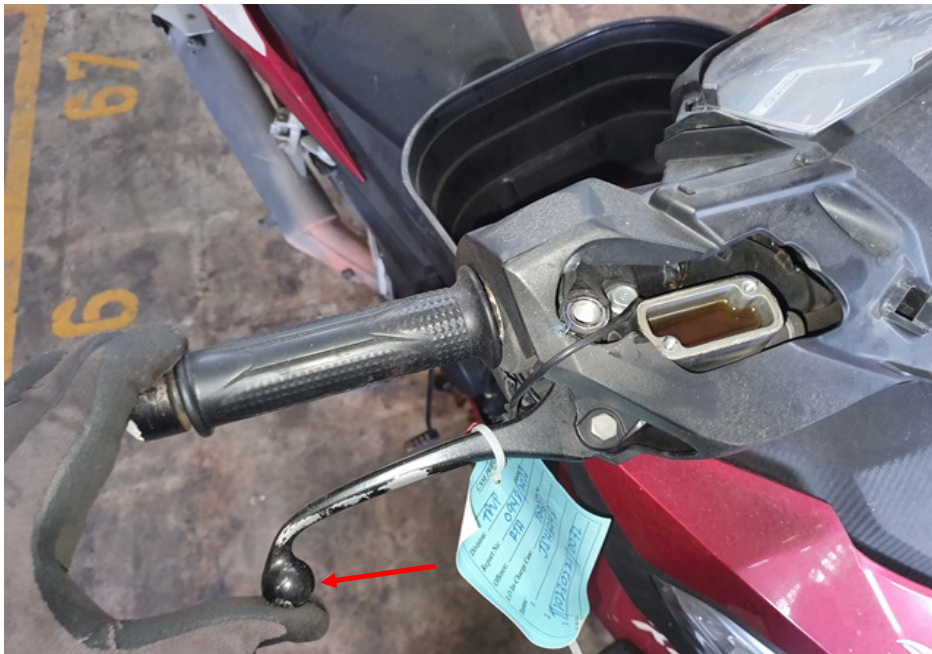
Photo 26 shows the front brake lever being depressed. There was some resistance felt (spongy like feel) upon pressing the front brake lever (arrowed). This would indicate that there is no leakage of pressure/vacuum in the front brake system.

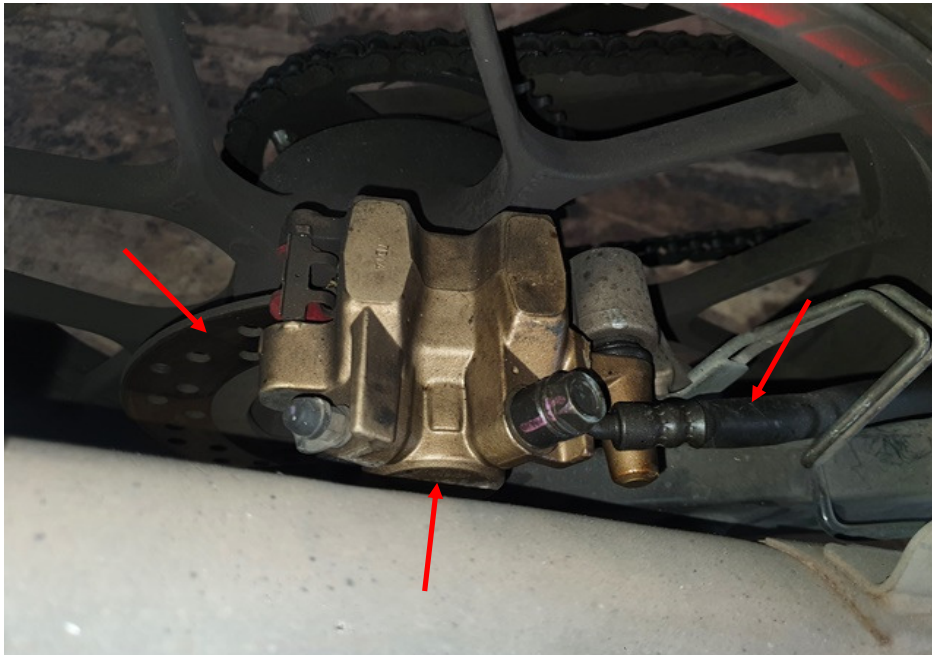
Photo 27 shows a close up view of the rear brake caliper, rear brake disc and rear brake hose (arrowed) of the Motorcycle, which are all part of the components in the hydraulic rear brake system of the Motorcycle. Our visual checks of these various components had revealed all to be intact with no visible damage. No leakage of brake fluid was also observed.

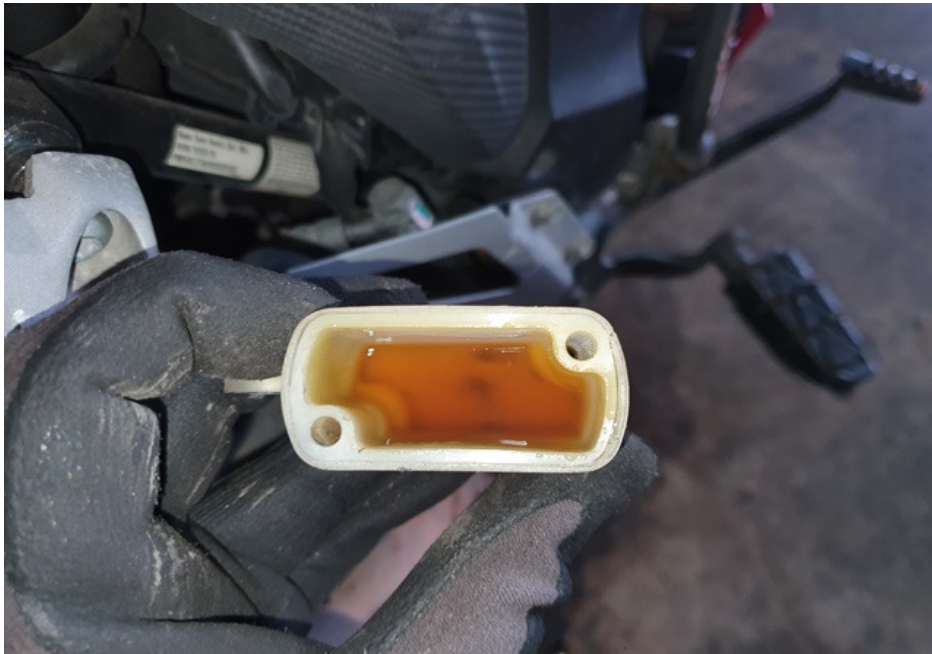
Photo 28 shows the brake fluid reservoir for the rear brake of the Motorcycle. The brake fluid was observed to be of sufficient level for operational purposes and without any contamination.

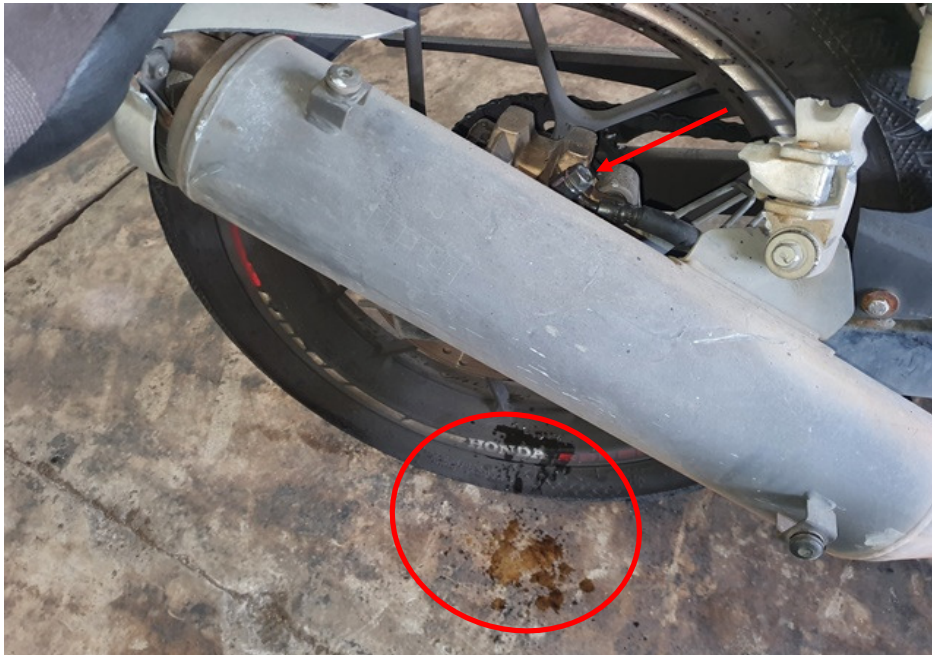
15. We subsequently carried out an operational test of the Motorcycle's braking system. This was done by manually pushing the Motorcycle forward and backward, simulating the Motorcycle in motion, and thereafter engaging the front brake and rear brake of the Motorcycle. At the end of the short operational test, we did not observe any abnormal behaviour of the Motorcycle's front braking system. The front wheel of the Motorcycle was able to stop rotating immediately upon depressing the brake lever. However the rear wheel of the Motorcycle was unable to stop rotating upon stepping on the brake pedal. Upon closer examination, we observed leakage of brake fluid from the rear brake caliper of the Motorcycle every time the rear brake pedal was stepped on. See photos 21 – 30 below.

Photo 29 shows the rear wheel of the Motorcycle which was unable to stop rotating upon stepping on the brake pedal during the operational test of the rear braking system. Upon closer examination, we observed leakage of brake fluid (circled) from the rear brake caliper (arrowed) of the Motorcycle.

16. Basing on our physical inspection of the Motorcycle, it appears that the steering system and front braking system of the Motorcycle were all in serviceable condition. The rear braking system of the Motorcycle was observed not to be in serviceable condition.
17. The 2 tyres of the Motorcycle were found to be in serviceable condition. There was no tear, cut or burst mark(s) on the outer and the inner sidewalls as well as across the tread of the 2 tyres. The 2 tyres were sufficiently inflated for vehicular operation with remaining tread depth of approximately 3mm and 1mm.

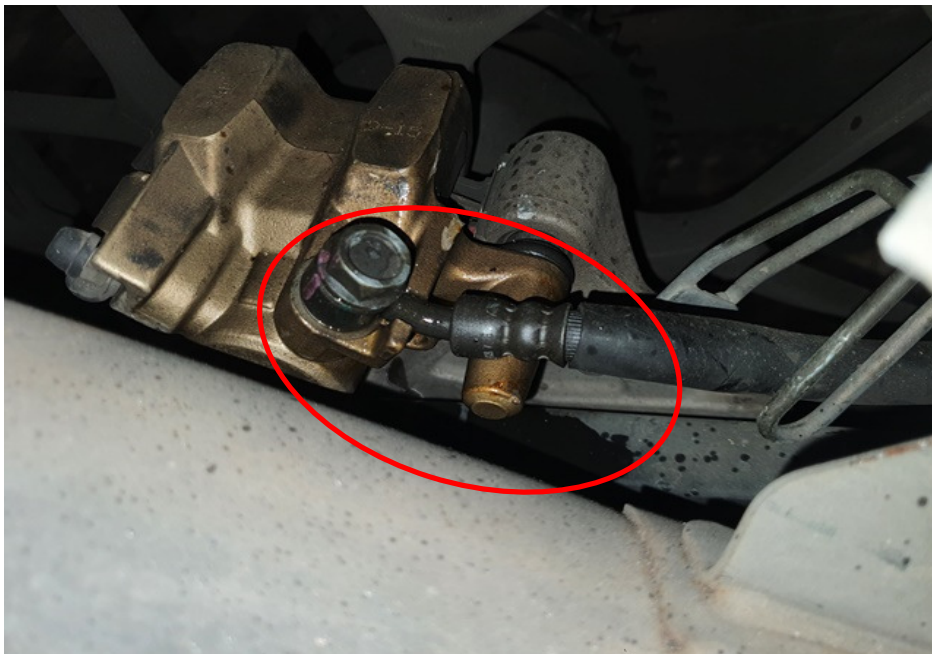
Photo 30 shows a close up view of the rear brake caliper of the Motorcycle. Upon closer examination, we observed leakage of brake fluid (circled) from the rear brake caliper of the Motorcycle every time the rear brake pedal was stepped on.
