Your Ref: TP IP/04213/2023  
Our Ref : CI/TPD23005741/N

**Fatal Accident Investigation Team**

**INSPECTION REPORT OF MOTORCYCLE FBP 4280Z**

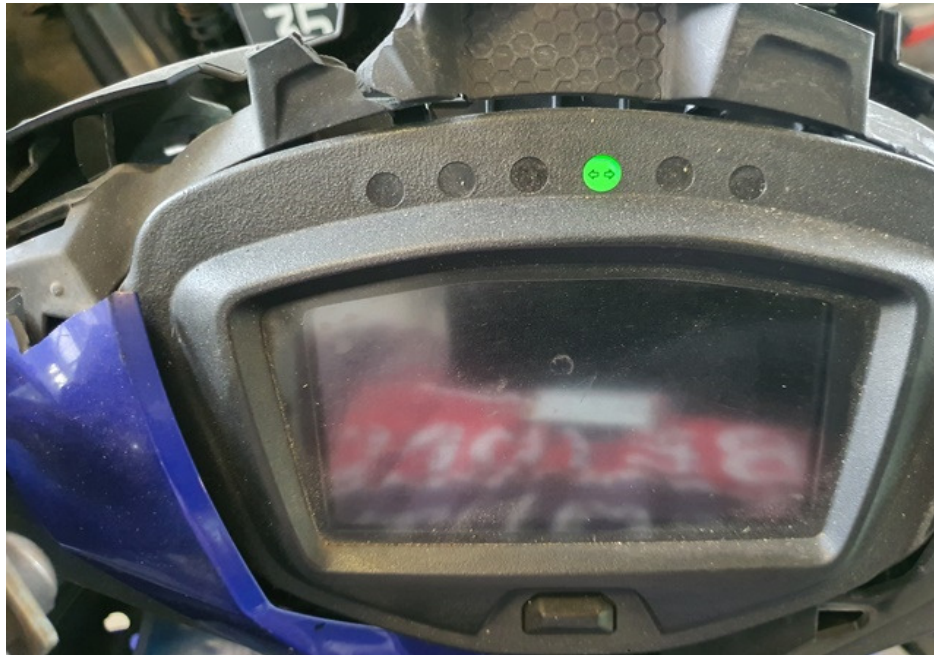
4. The mileage of the Motorcycle could not be recorded at the time of our inspection due to damage sustained to the speedometer display screen.
5. The Motorcycle was observed to have sustained damages all around. The body parts that were found to have been damaged include its head cowling, headlight, side cowlings, right side mirror, front brake lever, right handlebar end, gear shift pedal, left front footrest and rear side covers, amongst others.

**Photo 1** shows the speedometer gauge of the Motorcycle. The mileage of the Motorcycle could not be recorded at the time of our inspection due to damage sustained to the speedometer display screen.

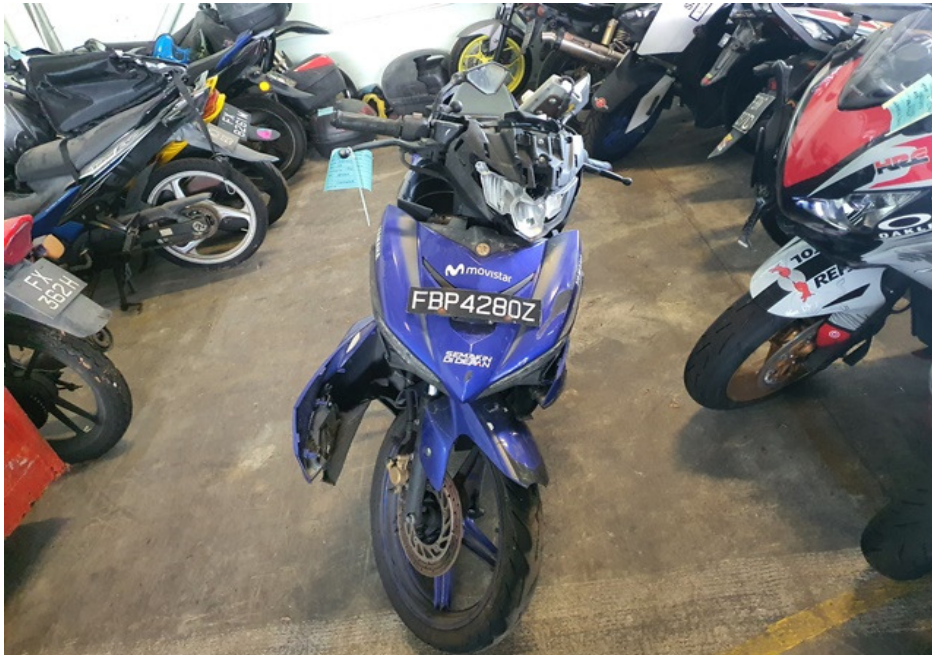
**Photo 2** shows a general view of the frontal portion of the Motorcycle at the time of our inspection. The Motorcycle was observed to have sustained damages all around.

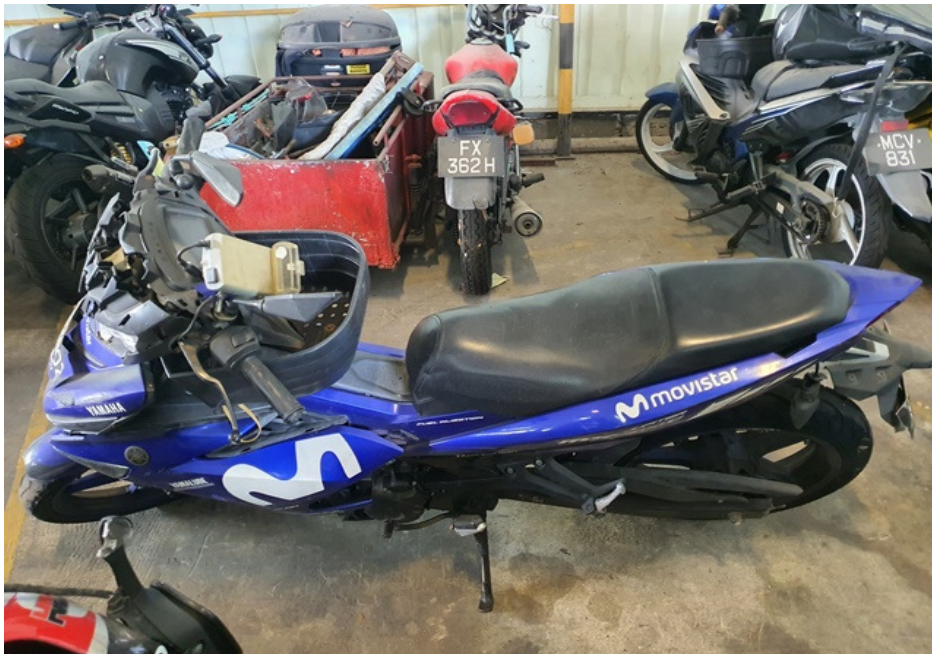
**Photo 3** shows a general view of the left body of the Motorcycle at the time of our inspection. The Motorcycle was observed to have sustained damages all around.

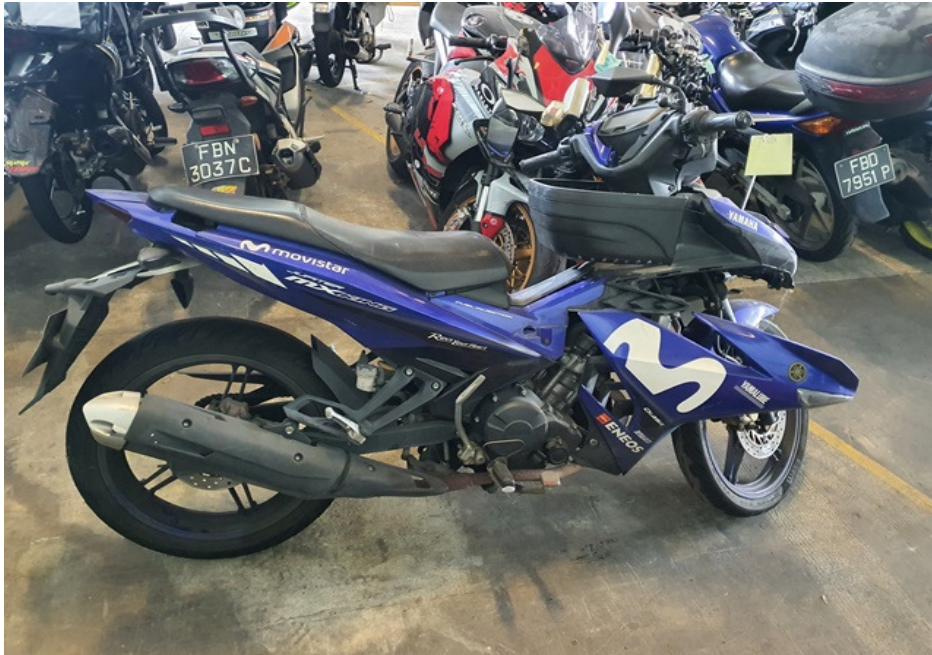
**Photo 4** shows a general view of the right body of the Motorcycle at the time of our inspection. The Motorcycle was observed to have sustained damages all around. The body parts that were found to have been damaged include its head cowl, headlight, side cowlings, right side mirror, front brake lever, right handlebar end, gear shift pedal, left front footrest and rear side covers, amongst others.

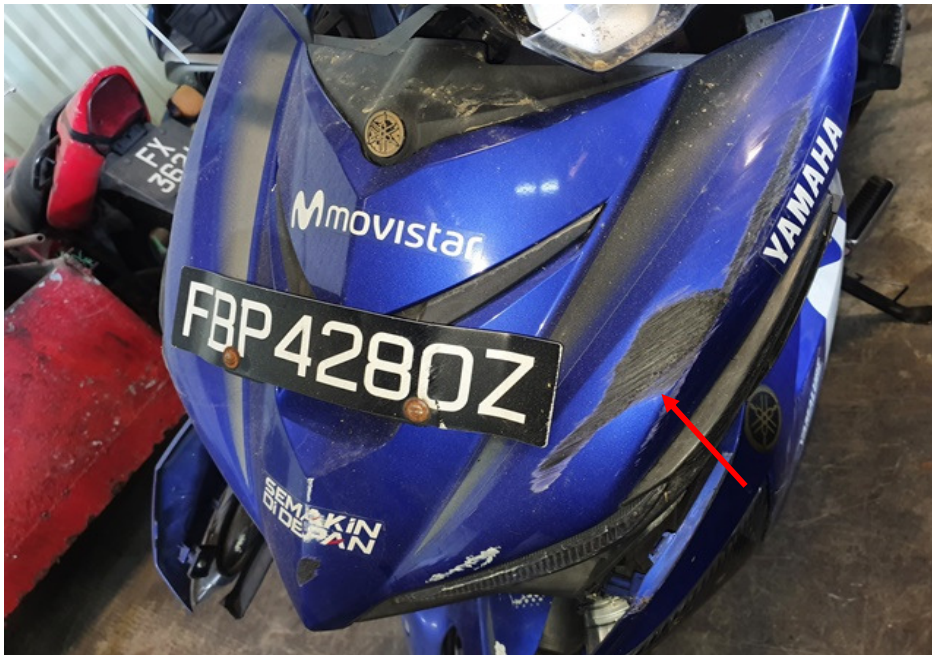
**Photo 5** shows a closer view of grazed front cowl (arrowed) of the Motorcycle at the time of our inspection.

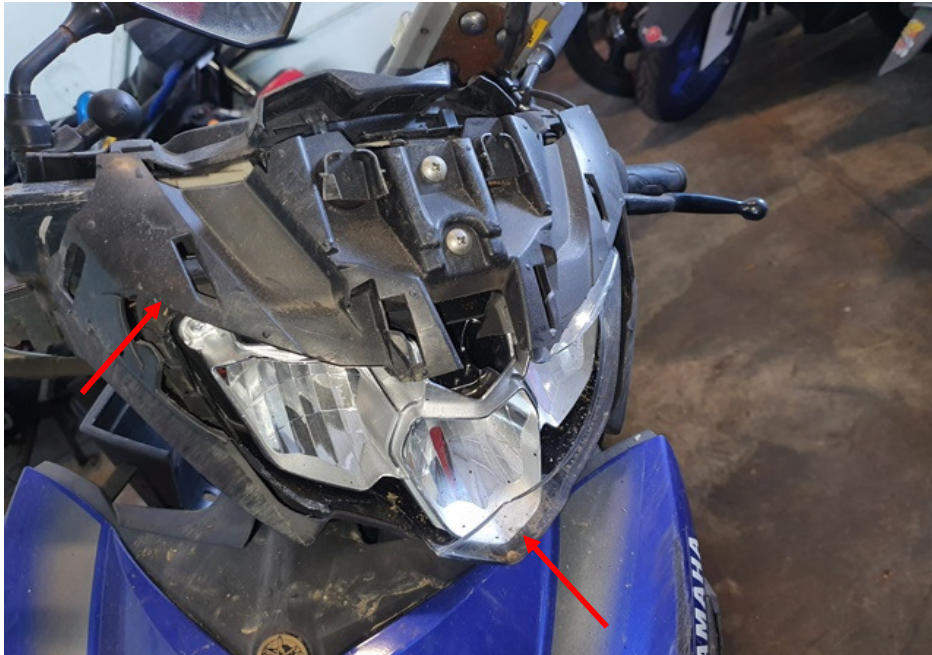
**Photo 6** shows the head cowl and headlight (arrowed), which was amongst the body parts of the Motorcycle that had sustained damage at the time of our inspection.

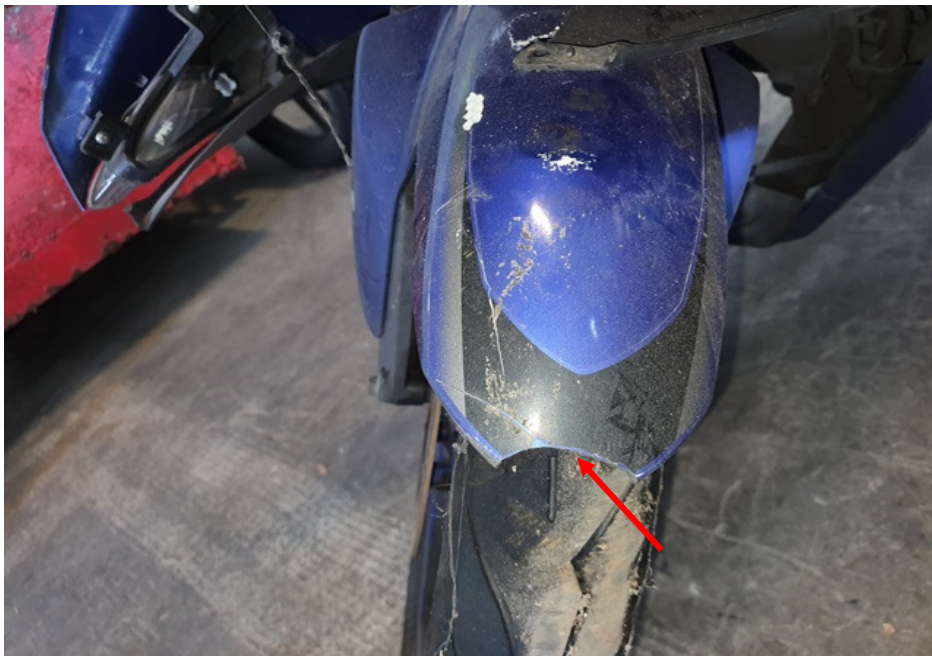
**Photo 7** shows a closer view of cracked front mudguard (arrowed) of the Motorcycle at the time of our inspection.

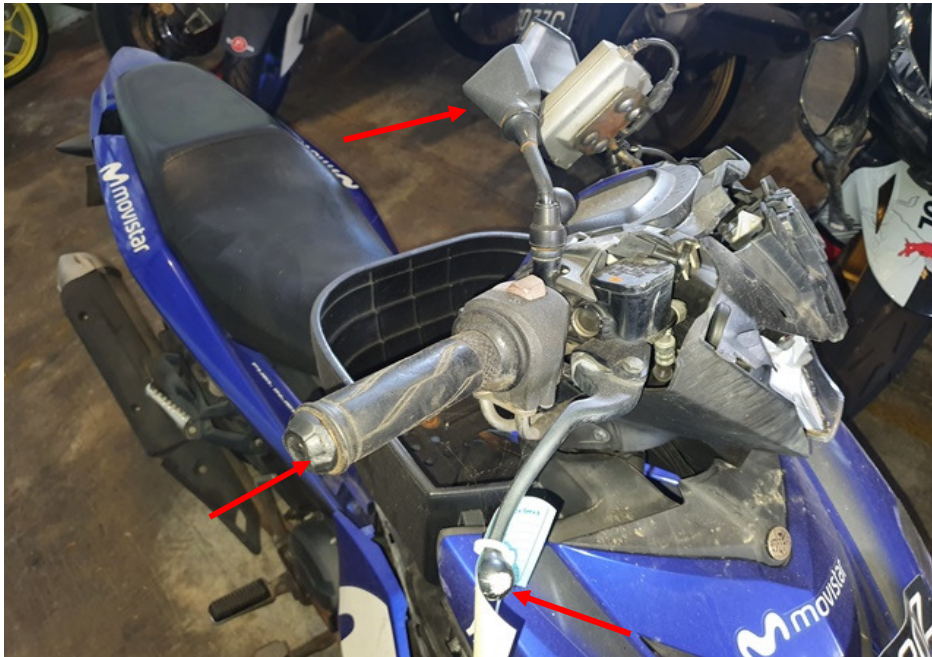
**Photo 8** shows the right handlebar end, front brake lever and right side mirror (arrowed), which were amongst the body parts of the Motorcycle that had sustained damage at the time of our inspection.

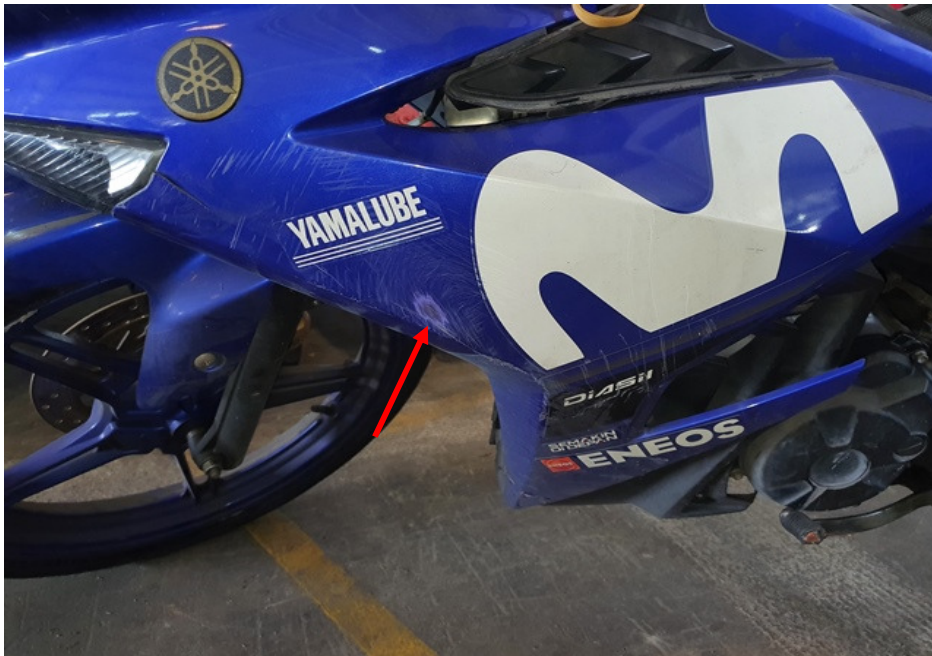
**Photo 9** shows a closer view of grazed left cowling (arrowed) of the Motorcycle at the time of our inspection.

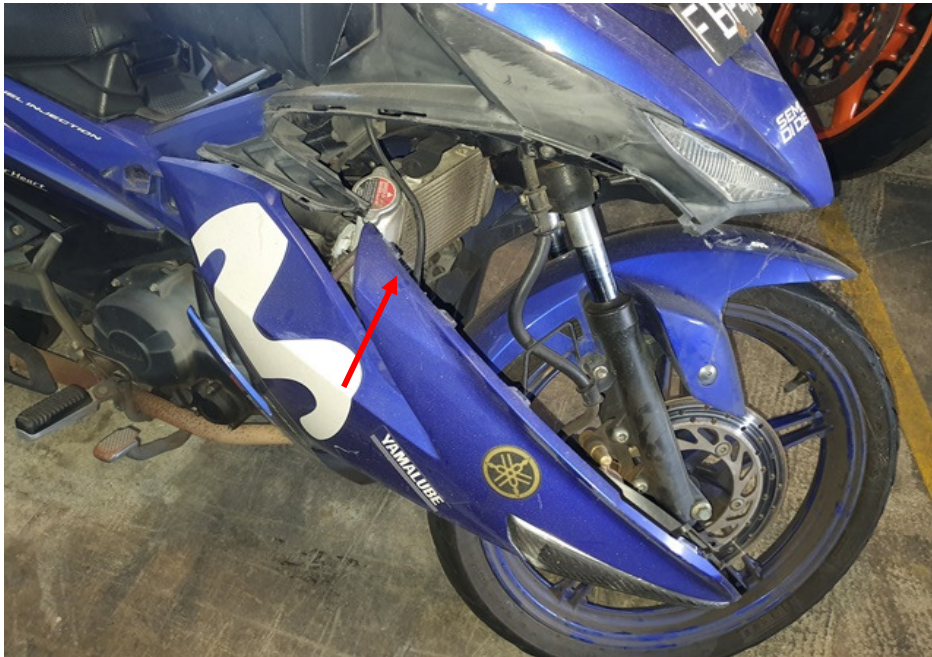
**Photo 10** shows a closer view of cracked right cowling (arrowed) of the Motorcycle at the time of our inspection.

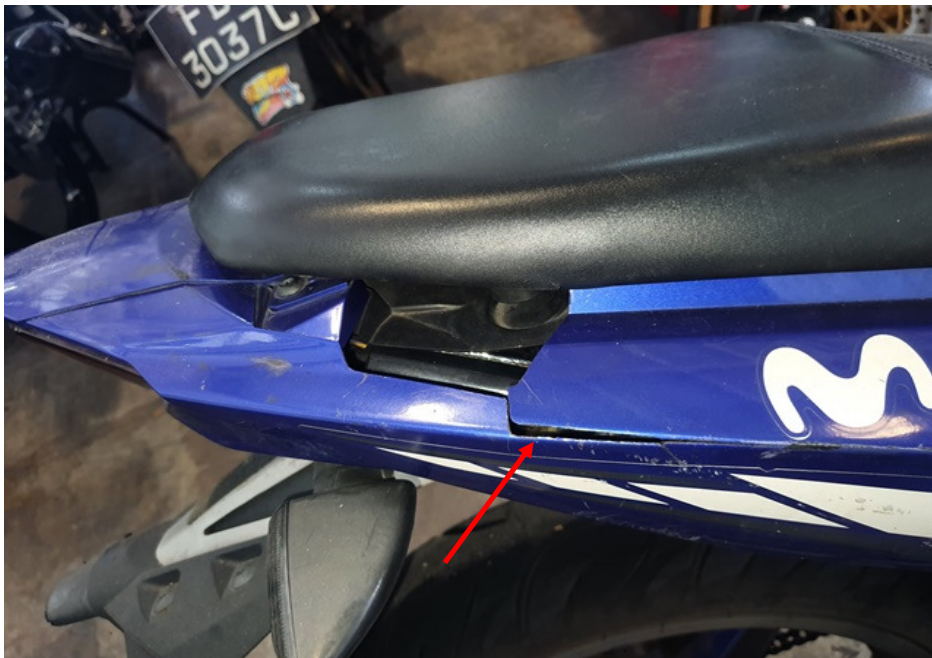
**Photo 11** shows a closer view of the cracked right rear side cover of the Motorcycle at the time of our inspection (arrowed).

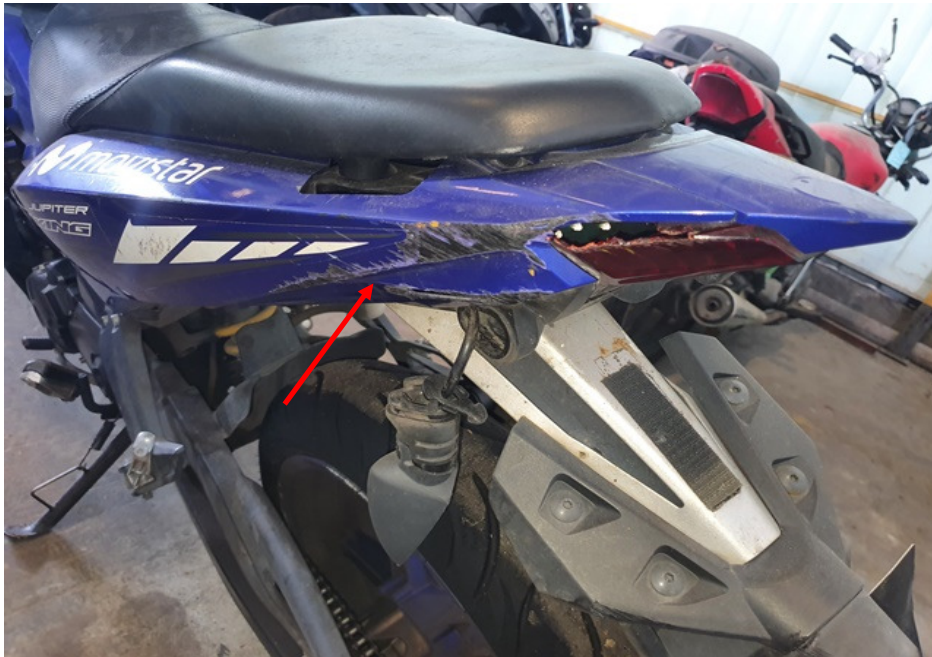
**Photo 12** shows a closer view of the grazed left rear side cover of the Motorcycle at the time of our inspection (arrowed).

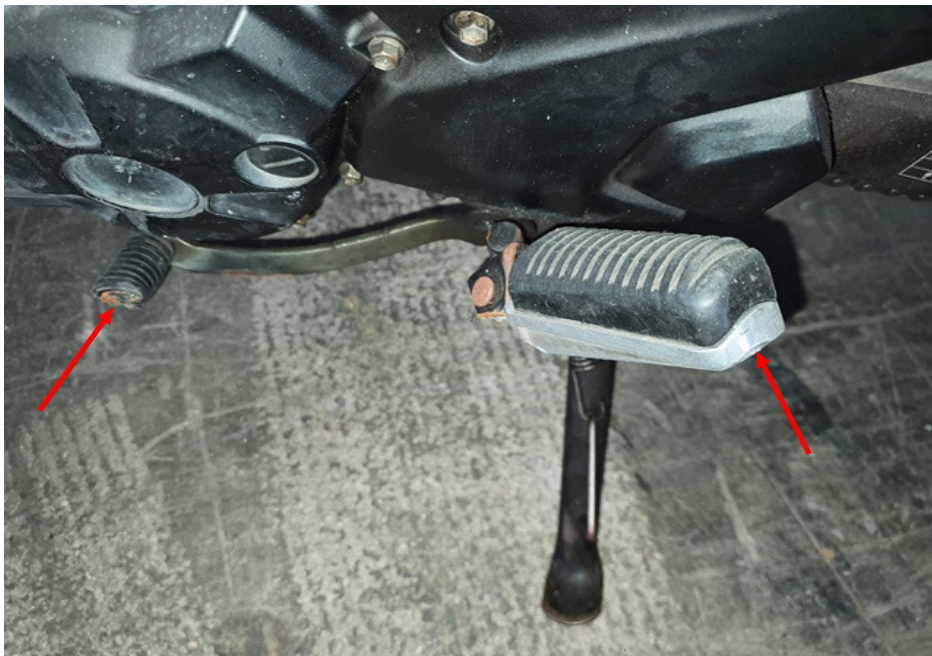
**Photo 13** shows the gear shift pedal and left front footrest of the Motorcycle that had sustained damage at the time of our inspection (arrowed).

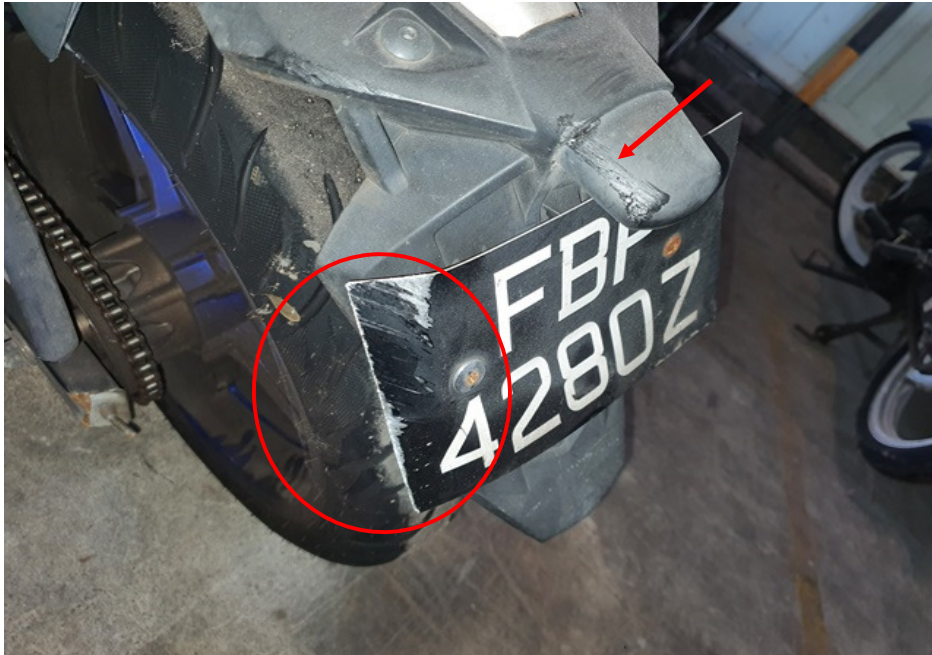
**Photo 14** shows a closer view of the grazed rear mudguard (arrowed) and dented number plate (circled) of the Motorcycle at the time of our inspection.

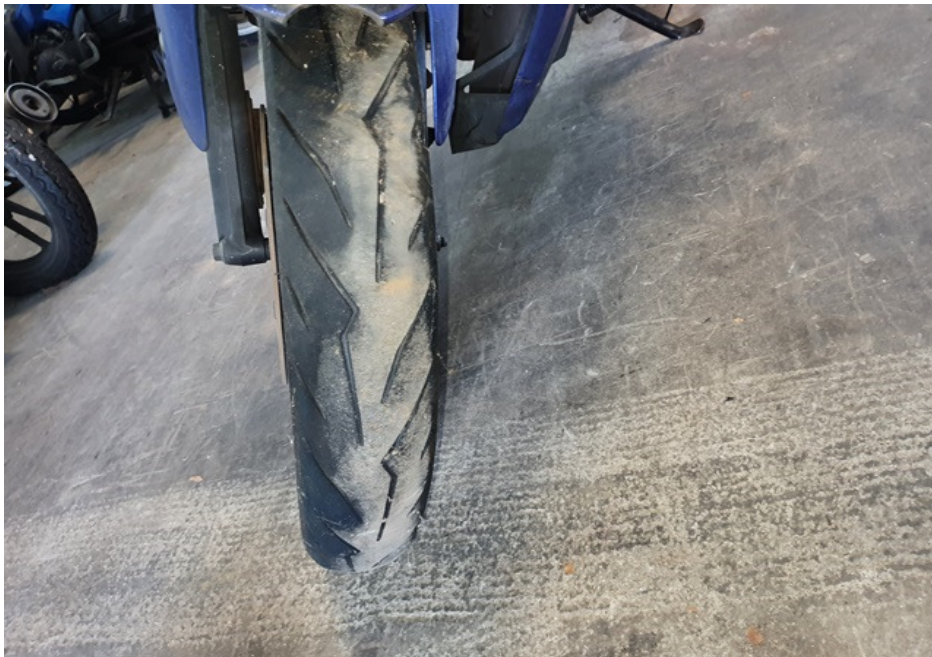
**Photo 15** shows the front tyre of the Motorcycle at the time of our inspection. The front tyre was observed to be in serviceable condition with remaining tread depth of approximately 1mm. The pattern of the tread was also clearly visible. There was no tear, burst mark(s) and/or punctured hole(s) on the sidewalls as well as across the tread of the front tyre.

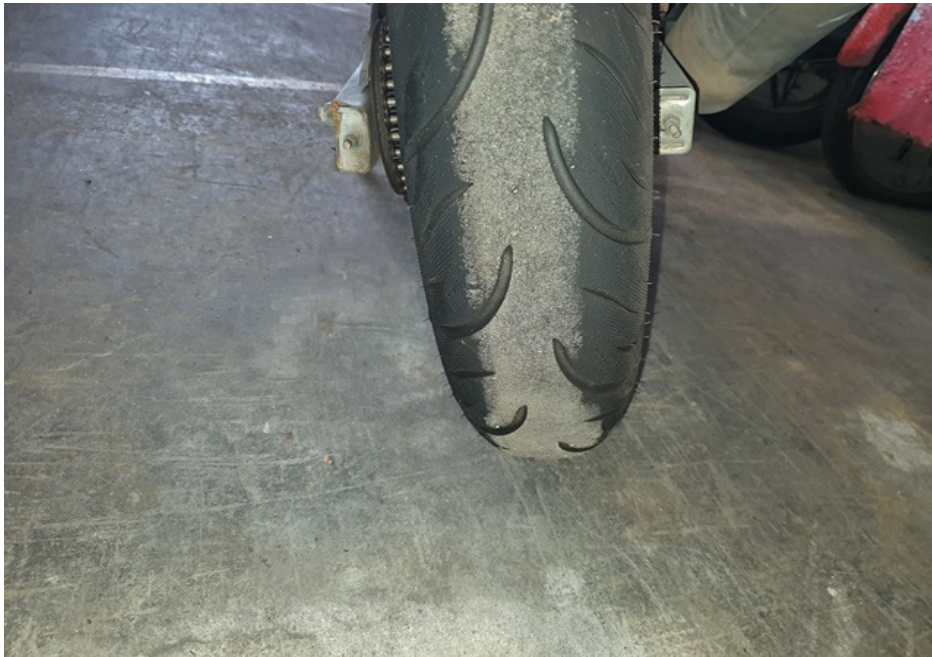
**Photo 16** shows the condition of the Motorcycle's rear tyre. The rear tyre was observed to be in serviceable condition with remaining tread depth of approximately 3mm. The tyre was also observed to be sufficiently inflated for vehicular operation. We did not observe any tear, burst mark(s) and/or punctured hole(s) on the sidewalls as well as across the tread of the rear tyre.

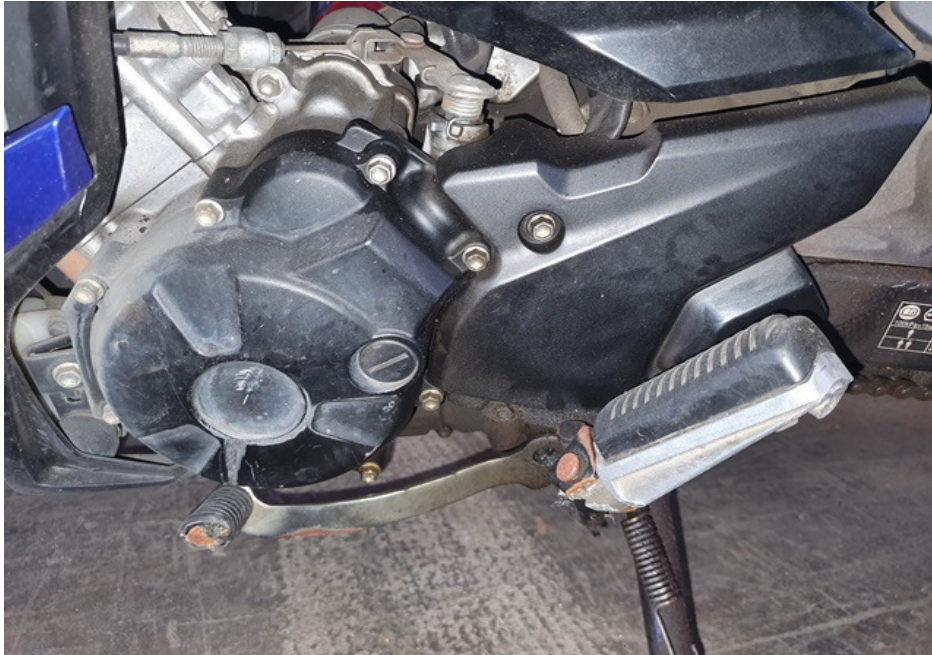
**Photo 17** shows the left side of the engine of the Motorcycle at the time of our inspection. The various engine related parts and components were found to be intact with no visible damage. There was also no sign(s) or indication(s) of fluid leak observed around the left engine area of the Motorcycle.

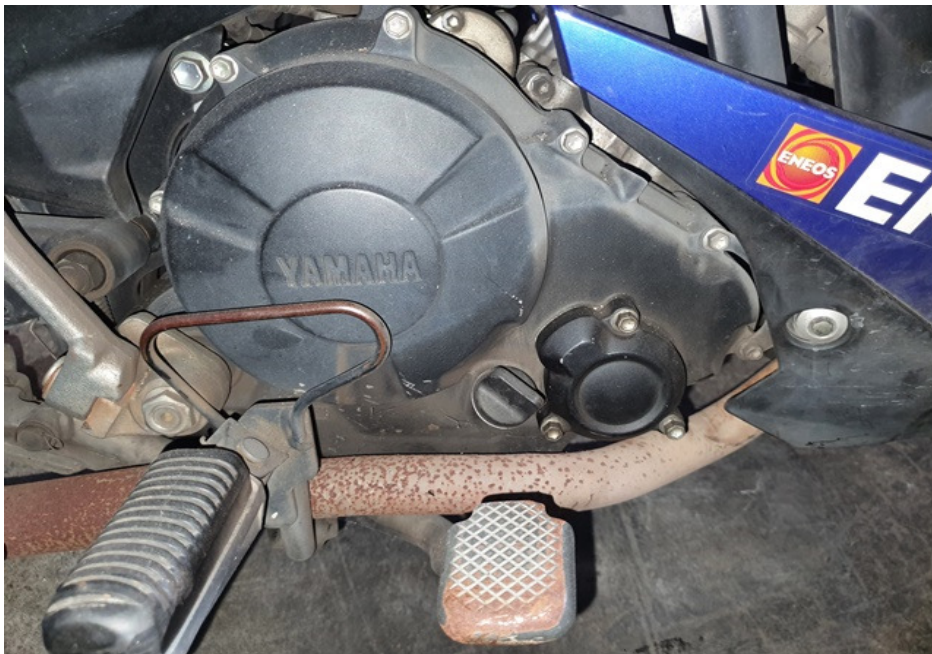
**Photo 18** shows the right side of the engine of the Motorcycle at the time of our inspection. The various engine related parts and components were found to be intact with no visible damage. There was also no sign(s) or indication(s) of fluid leak observed around the right engine area of the Motorcycle.

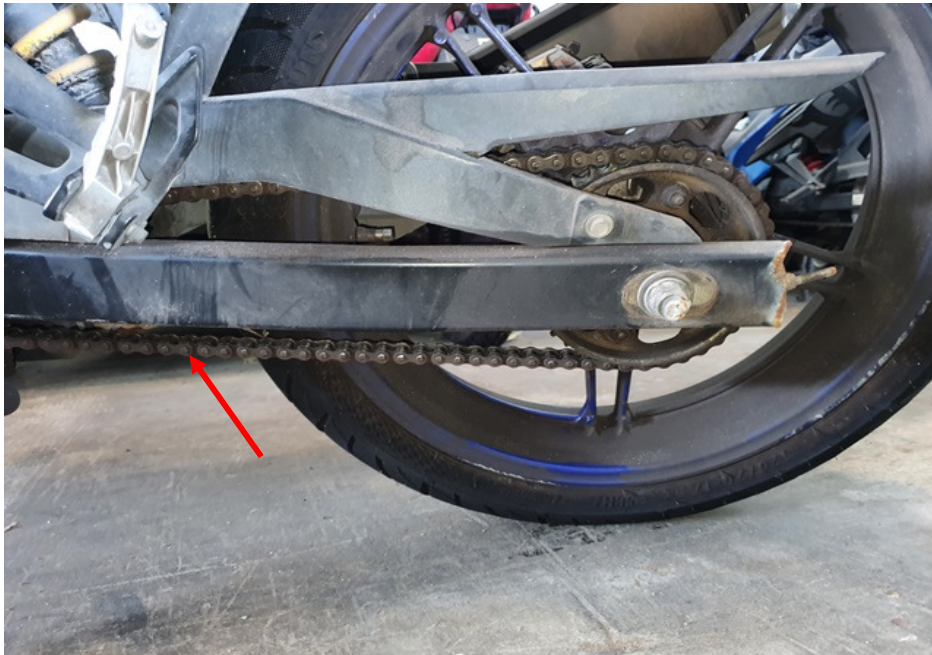
**Photo 19** shows the general view of the gear train (arrowed) of the Motorcycle, which was observed to be intact with no misalignment. It was also adequately lubricated for operating purposes.

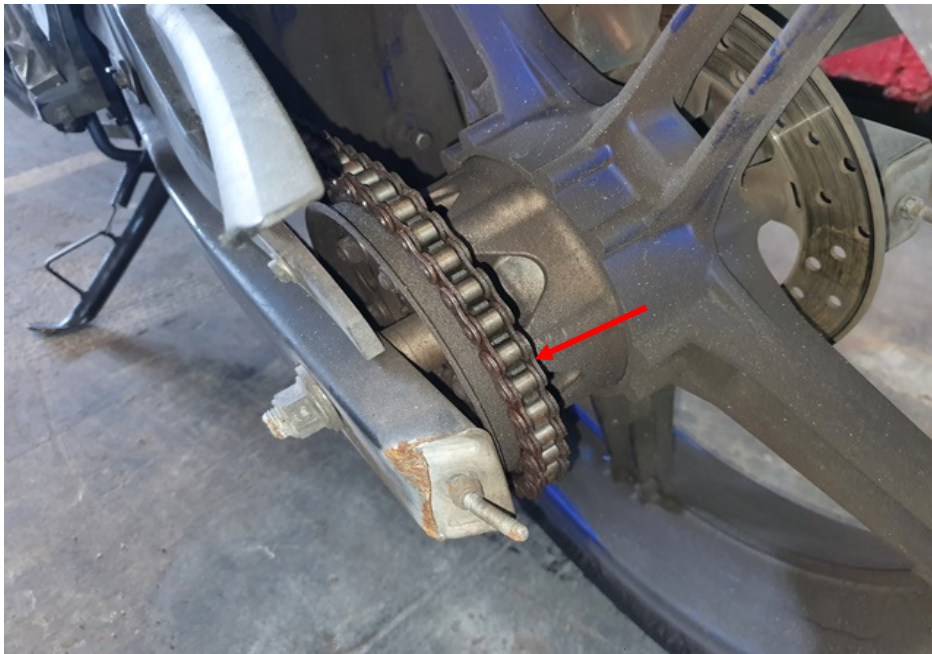
**Photo 20** shows a closer view of the gear train (arrowed) of the Motorcycle, which was observed to be intact with no misalignment. It was also adequately lubricated for operating purposes.

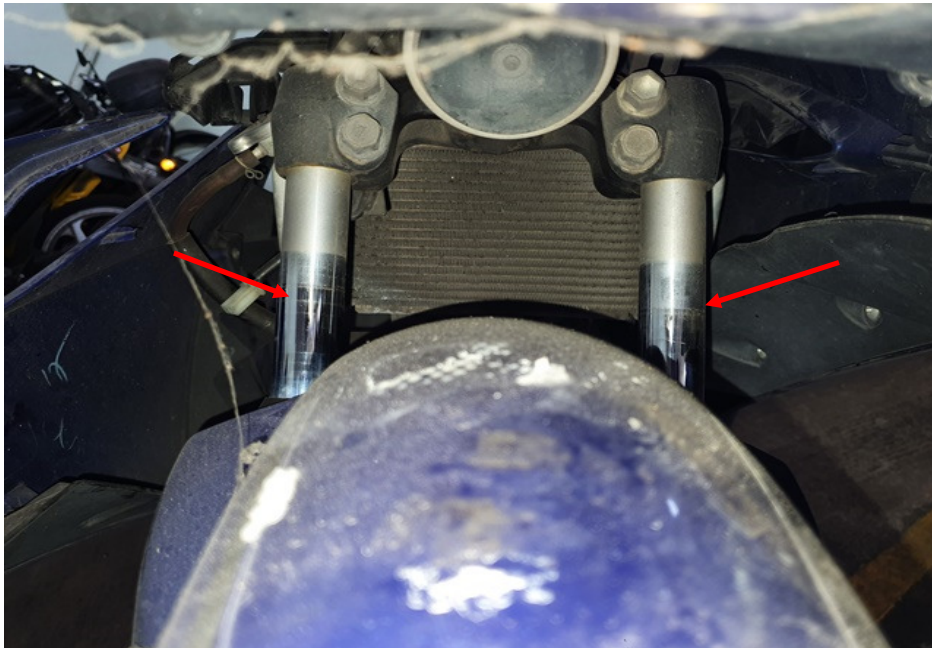
**Photo 21** shows the front forks (arrowed) of the Motorcycle. The front forks and fork bracket of the Motorcycle were both found to be intact and undamaged. Turning the Motorcycle's handle bar towards the left and right did not produce any abnormal free play. The steering system of the Motorcycle was in serviceable condition at the time of our inspection.

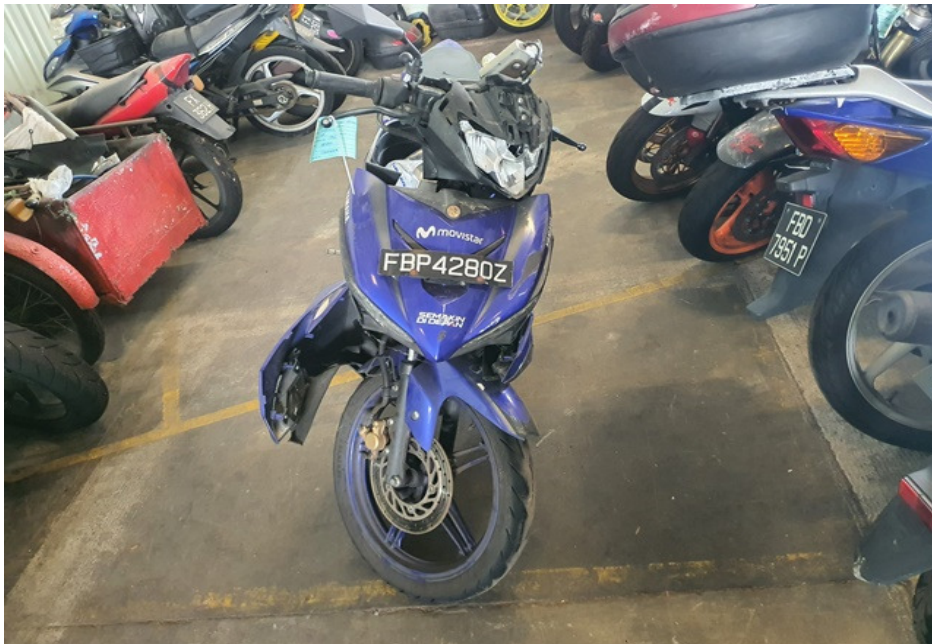
**Photo 22** shows the front wheel of the Motorcycle turned towards its full left. Turning the Motorcycle's handle bar towards the left did not produce any abnormal free play and/or resistance. This would indicate that the steering system of the Motorcycle was in serviceable condition at the time of our inspection.

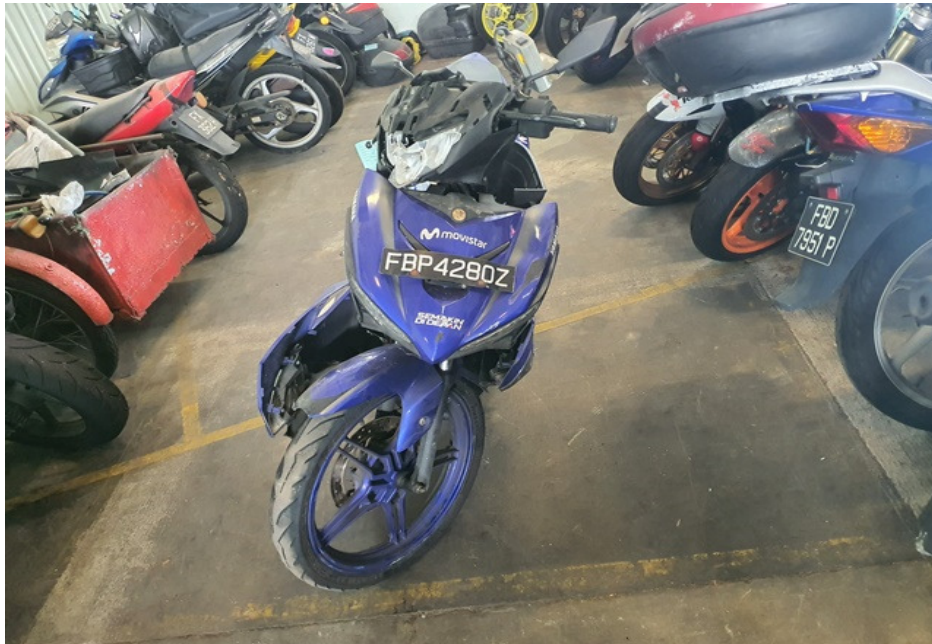
**Photo 23** shows the front wheel of the Motorcycle turned towards its full right. Turning the Motorcycle's handle bar towards the right did not produce any abnormal free play and/or resistance. This would indicate that the steering system of the Motorcycle was in serviceable condition at the time of our inspection.

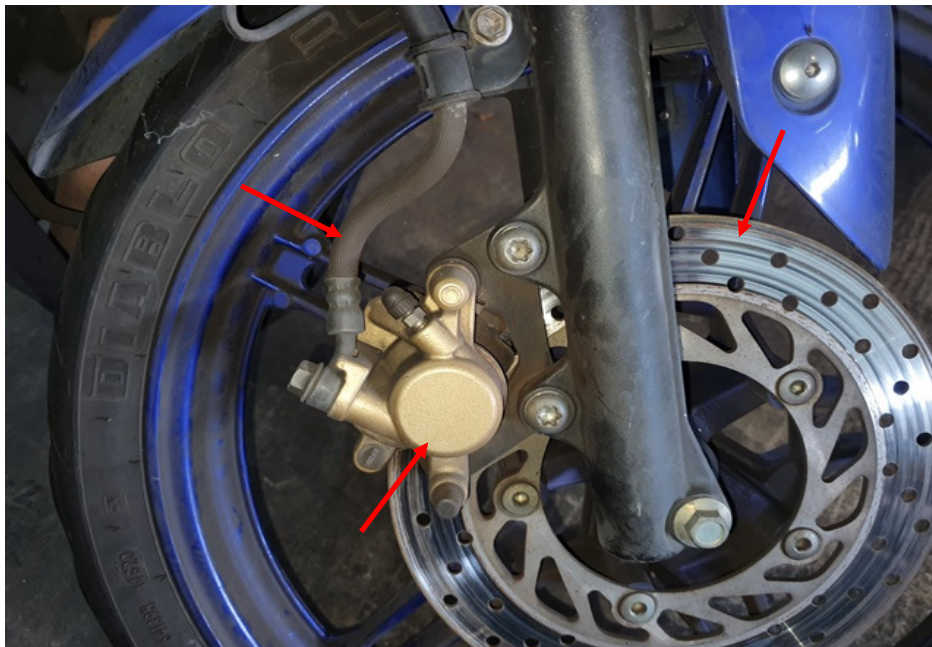
**Photo 24** shows a close up view of the front brake caliper, front brake disc and front brake hose (arrowed) of the Motorcycle, which are all part of the components in the hydraulic front brake system of the Motorcycle. Our visual checks of these various components had revealed all to be intact with no visible damage. No leakage of brake fluid was also observed.

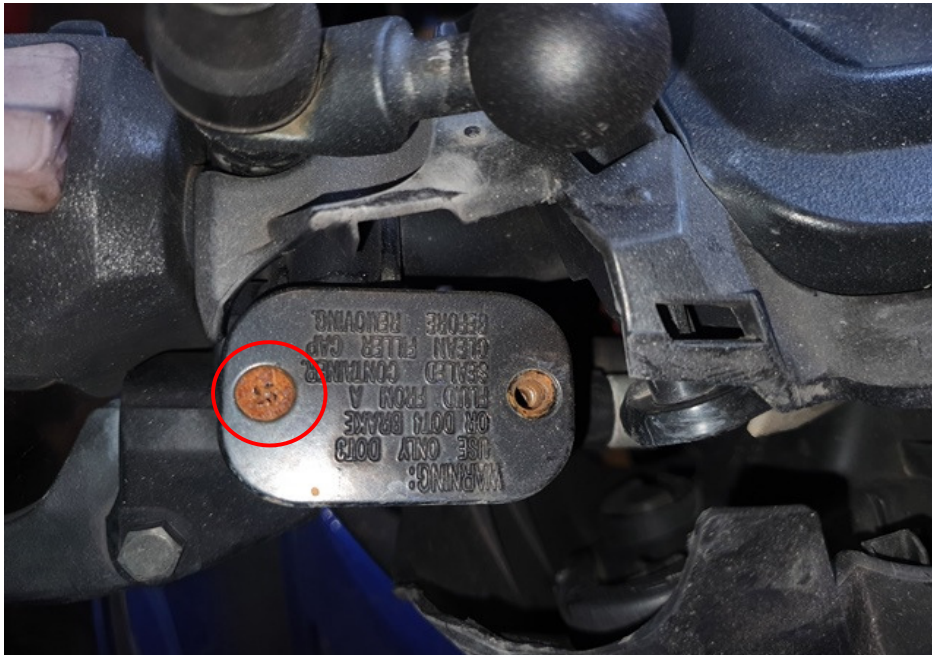
14. We were unable remove the front brake reservoir cover to examine whether the front brake fluid was without contamination due to a worn out screw. However the front brake fluid was observed to be of sufficient level for operational purposes. The brake fluid for the rear brake was found to be of sufficient level for operational purposes and without any contamination.

**Photo 25** shows the brake fluid reservoir cover for the front brake of the Motorcycle. We were unable to examine whether the front brake fluid was without contamination due to a worn out screw (circled).

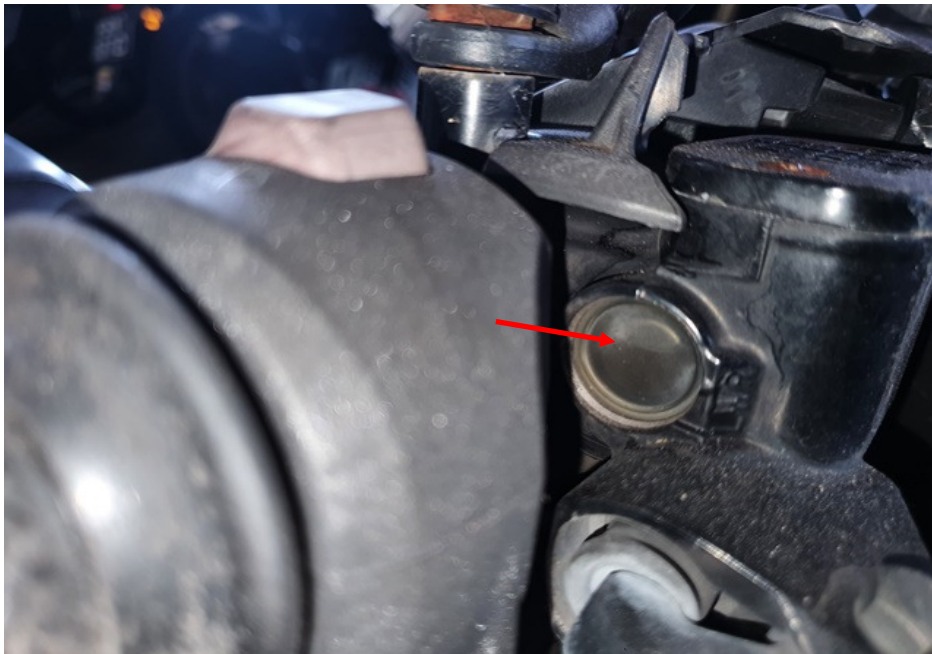
**Photo 26** shows a close up view of the brake fluid reservoir for the front brake of the Motorcycle. The brake fluid was observed to be of sufficient level for operational purposes (arrowed).

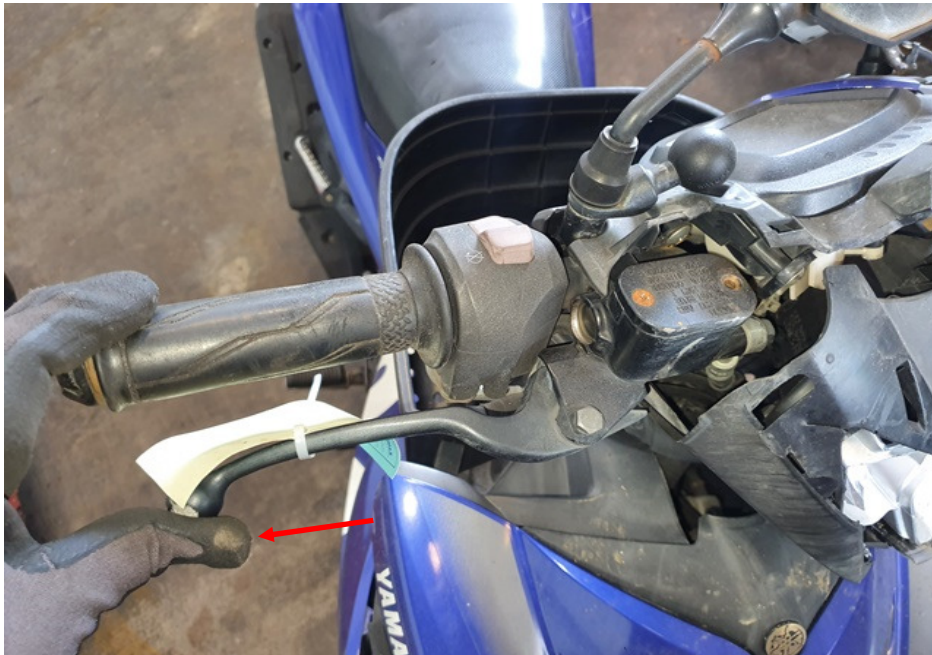
15. Static brake tests conducted on the Motorcycle had appear to indicate that the braking system of the Motorcycle was in serviceable condition. There was some resistance felt (spongy like feel) upon pressing the brake lever and upon stepping on the brake pedal. This would indicate that there was no leakage of pressure/vacuum in the brake system.

**Photo 27** shows the front brake lever being depressed. There was some resistance felt (spongy like feel) upon pressing the front brake lever (arrowed). This would indicate that there is no leakage of pressure/vacuum in the front brake system.

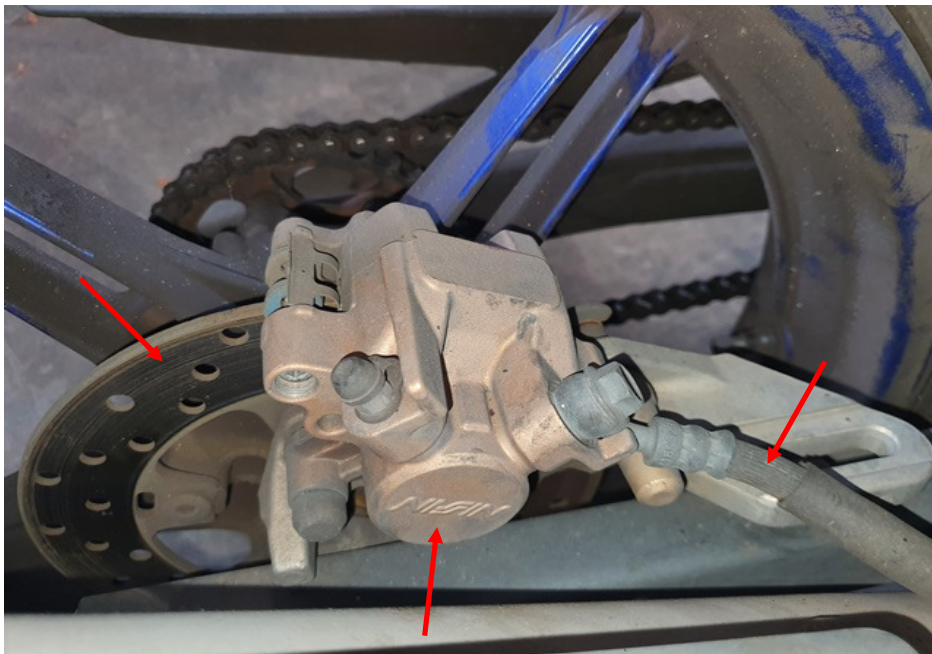
**Photo 28** shows a close up view of the rear brake caliper, rear brake disc and rear brake hose (arrowed) of the Motorcycle, which are all part of the components in the hydraulic rear brake system of the Motorcycle. Our visual checks of these various components had revealed all to be intact with no visible damage. No leakage of brake fluid was also observed.

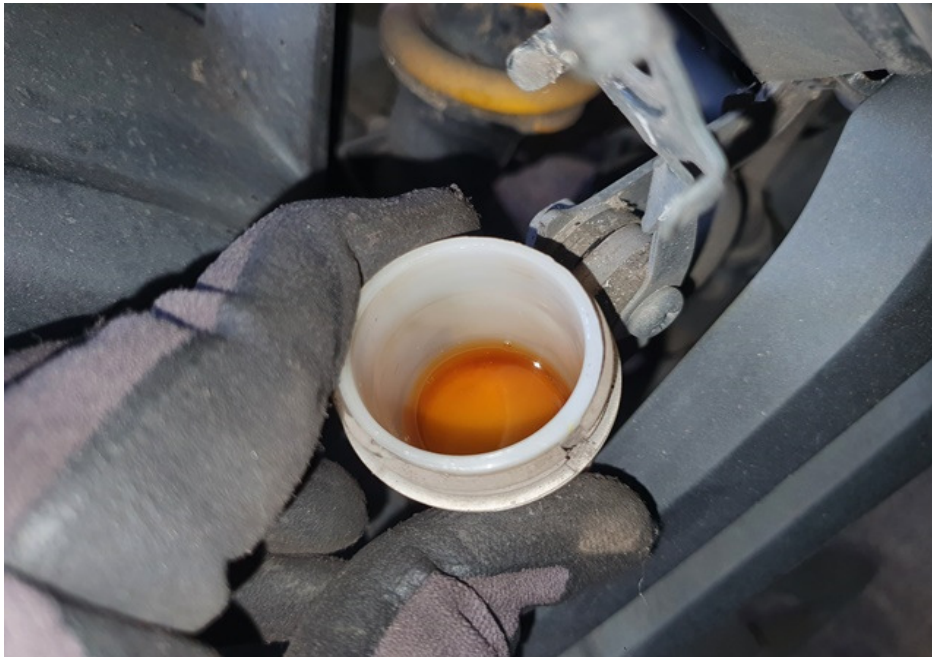
**Photo 29** shows the brake fluid reservoir for the rear brake of the Motorcycle. The brake fluid was observed to be of sufficient level for operational purposes and without any contamination.
