Your Ref: M2303020  
Our Ref : CS4/TMI23005766/N

5 June 2023

### **TECHNICAL INVESTIGATION REPORT OF FIRE INCIDENT INVOLVING THE INSURED VEHICLE TRC 8055K ON 15 MAY 2023**

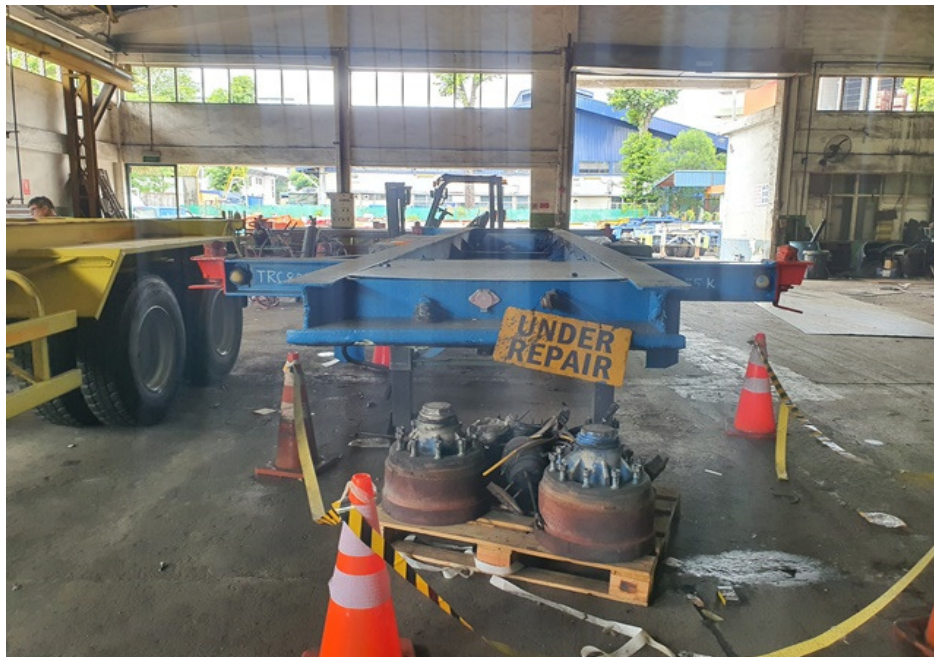
**Photo 1** shows the general view of the frontal portion of the Insured Vehicle at the time of our inspection. The frontal portion of the Insured Vehicle was unaffected by the fire.

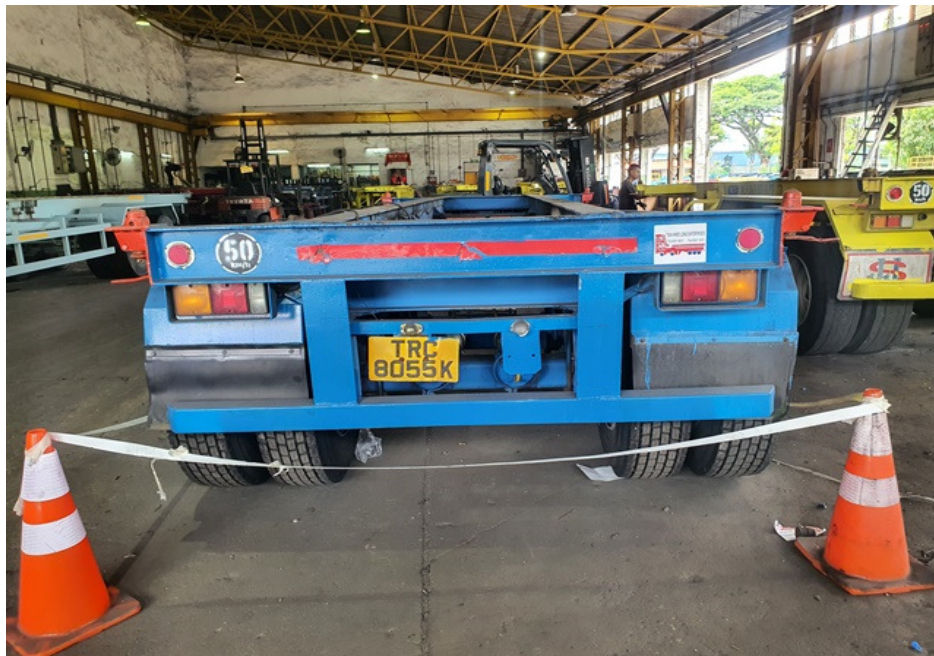
**Photo 2** shows the general view of the rear portion of the Insured Vehicle at the time of our inspection. The rear portion of the Insured Vehicle was unaffected by the fire.

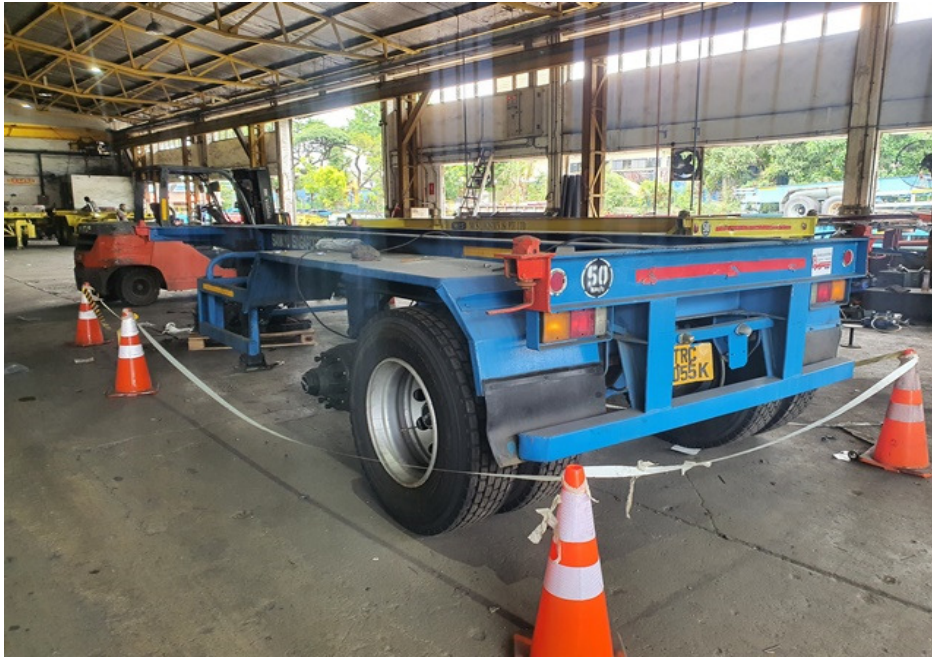
**Photo 3** shows the general view of the left portion of the Insured Vehicle at the time of our inspection. The exterior body of the Insured Vehicle had sustained fire damage at the centre portion. Affected parts had included the centre wheel panels.

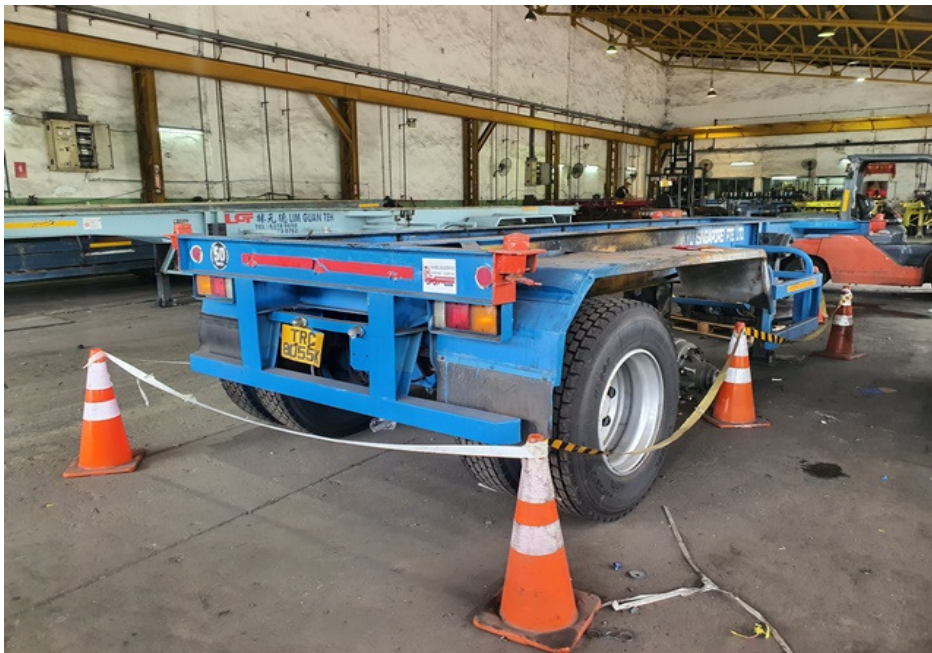
**Photo 4** shows the general view of the right portion of the Insured Vehicle at the time of our inspection. The exterior body of the Insured Vehicle had sustained fire damages at the right centre wheel and rim area as well as its right centre wheel panel portion. Affected parts had included the right wheel panel and the right centre wheel and rims.

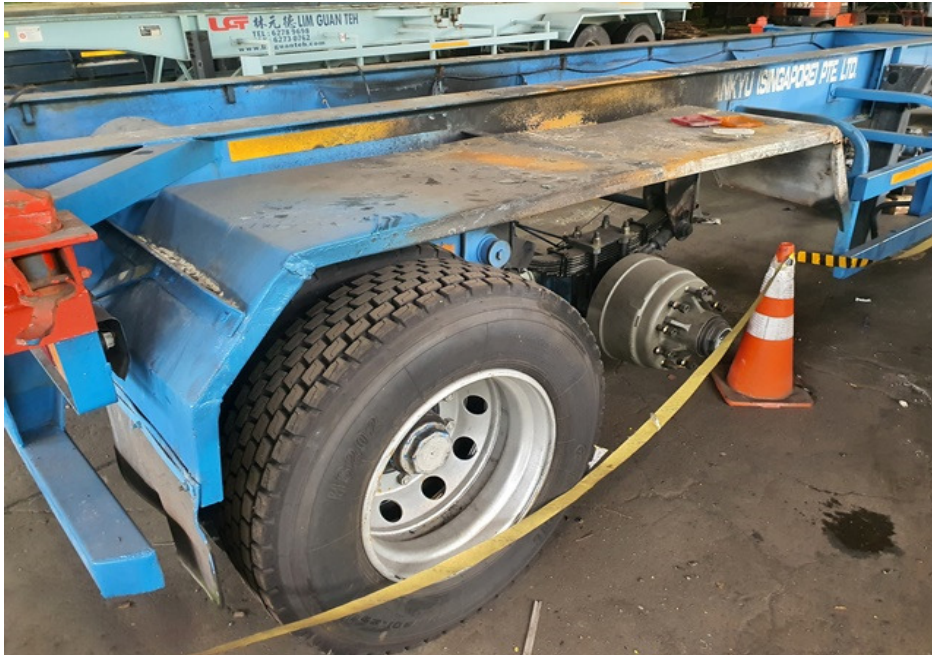
**Photo 5** shows the close up view of the right centre portion of the Insured Vehicle at the time of our inspection. The right wheel panel and right centre wheel rims and the tyres of the Insured Vehicle had sustained severe fire damage.

8. Upon closer examination of the right centre portion of the wheel rims and its tyres of the Insured Vehicle as well as around the immediate vicinity to where the fire had likely started, we had observed that the outer wheel rim had sustained the highest heat intensity burn marks (whitish burn marks) that were found on the surface of it and it was also dented and cracked.

9. In our opinion, the dent and cracked damages observed on the right centre outer wheel rim was likely not the result of the fire. In support to this claim we have investigated further; we focus on our findings to the wheel rim and tyres area and identify that the moving components in the area are the drum brakes system and the wheel drum itself.

11. Secondly, we have examined the outer right centre wheel rim and notice that the dent and cracked wheel rim was caused by an impact that had caused the deformed damage to it. See photos 7 - 10 below.

27. The possibility of the fire being due to external factors (foreign material(s) stuck on hot surfaces, arson and sabotage amongst others) would seem likely as in our opinion, the fire was cause due to the right centre outer wheel rim contacting the road surfaces where it was travelling on, where metal material of the wheel rim rubbing on the road surfaces causing sparks that had ignited the combustible materials in the vicinity like the rubber tyres, wirings and spreading onto the wheel panel of the Insured Vehicle. We are in view that the right centre outer tyre had suffered a puncture causing the right outer wheel rim to contact the road surfaces resulting in the fire. As we observed that the dent and cracked damages on the rear right outer wheel rim was due to an impact resulting in the damages. The puncture to the right centre outer tyre had caused the Insured Vehicle to tilt down slightly to the right result in the right centre outer wheel rim to contact the road surfaces and causing the damages as well.

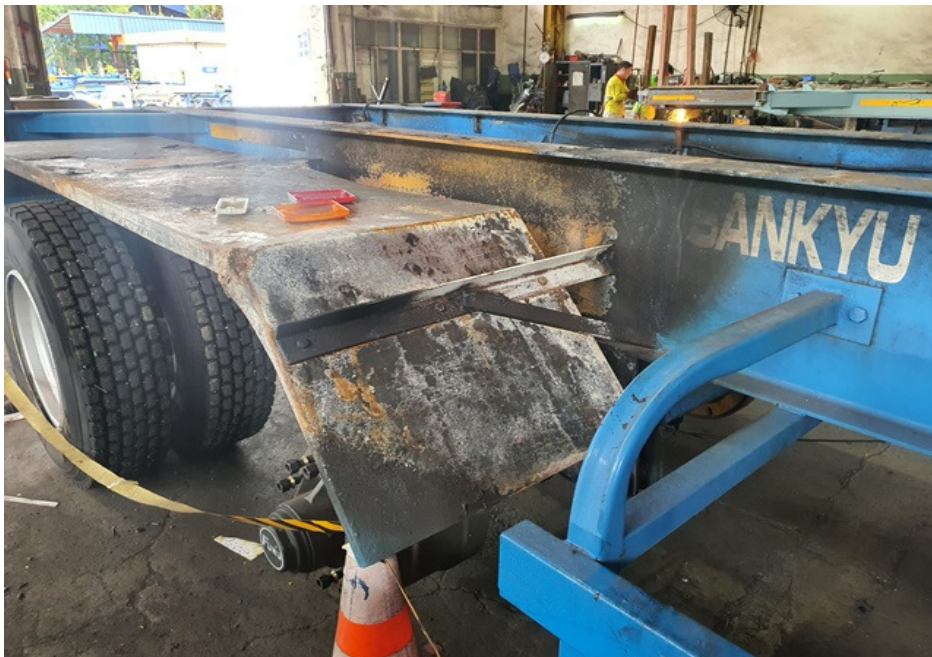
**Photo 6** shows a closer view of the right centre portion of the Insured Vehicle at the time of our inspection. The fire damage was observed to be at its right centre portion. The right centre wheel panel was observed to be affected by the fire.

7. For this particular case, the fire appears to have originated from the right centre portion of the Insured Vehicle, around the right centre wheel rims and tyres portion of the Insured Vehicle. This can be determined from the nature of the fire damage which was more extensive at the right centre portion. Basing on the circumstances of the fires' origin at the material time of incident as well as examining the area where the extent of fire damage was most severe, we can determine that the fire had likely started from the right centre wheel rims and tyres portion of the Insured Vehicle.

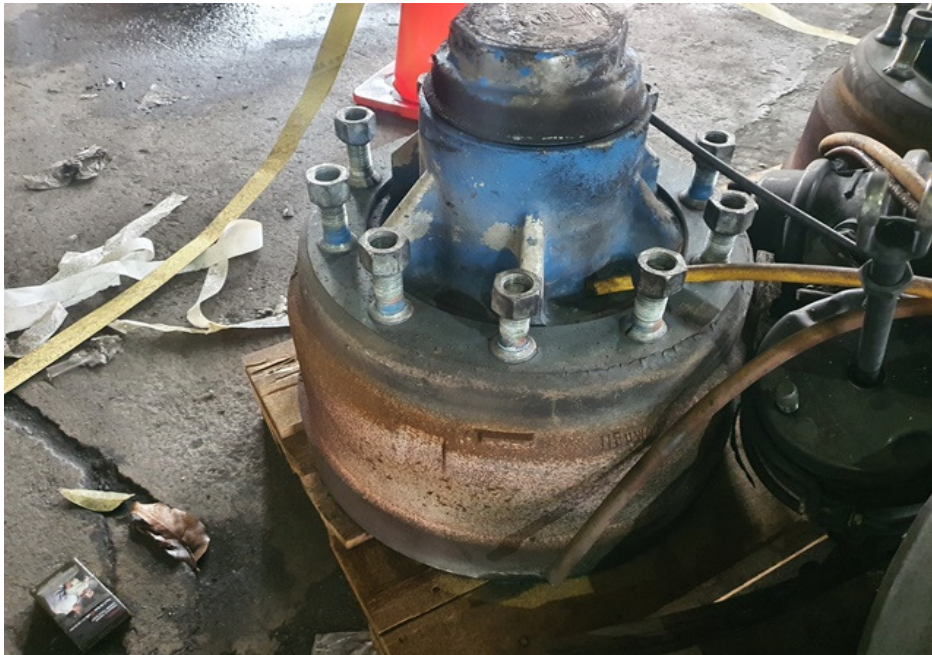
10. Firstly, we have removed the right wheel rims of the Insured Vehicle to inspect their drum brakes and brake pads and we did not notice any signs of brakes lock up or burn to either the exterior or interior surface of the rear right brake drums and top or bottom of the brake pads on the Insured Vehicle.

**Photo 7** shows a general view of the right centre brake drum and brake pad of the Insured Vehicle after the wheel rim was removed. Upon closer examination, we did not observe any damages to the brake drum.

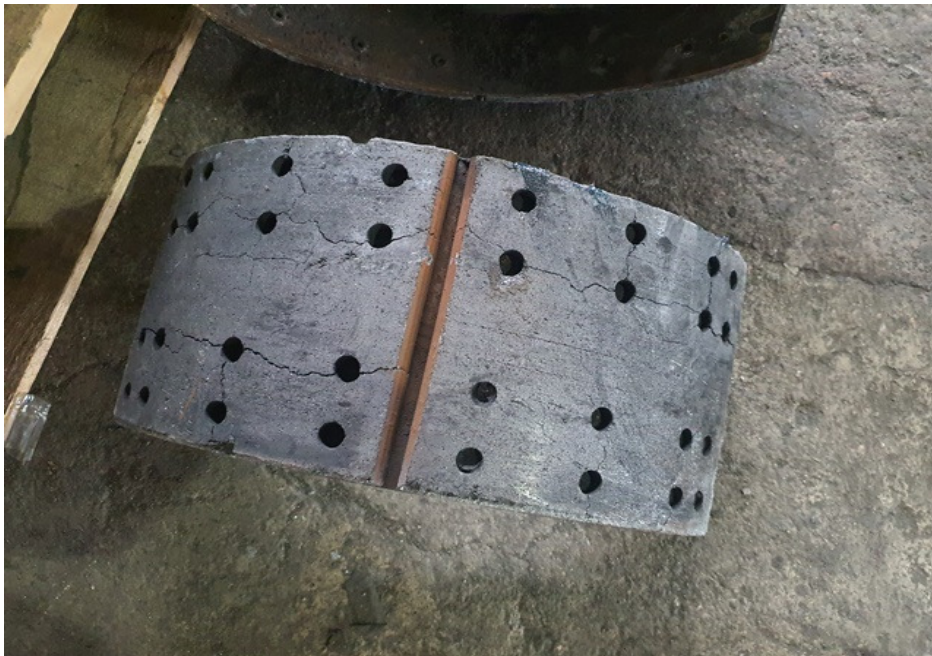
**Photo 8** shows a close up view of the rear left top brake drum pad of the Insured Vehicle. Upon closer examination, we did not observed any damages to the brake drum pad.

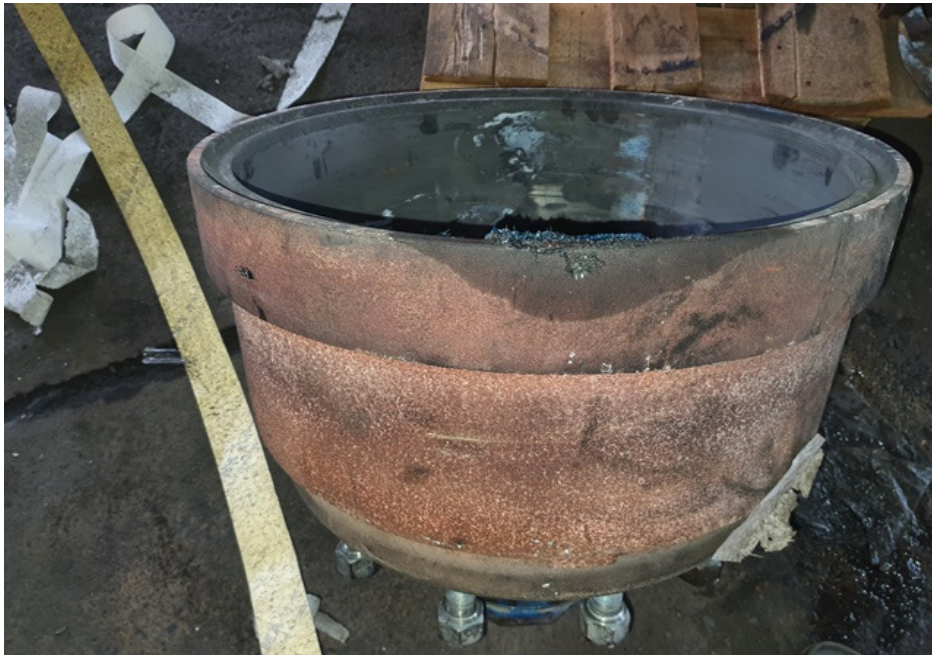
**Photo 9** shows a general view of the rear left brake drum of the Insured Vehicle. Upon closer examination, we did not observe any damages to the exterior surface of the brake drum.

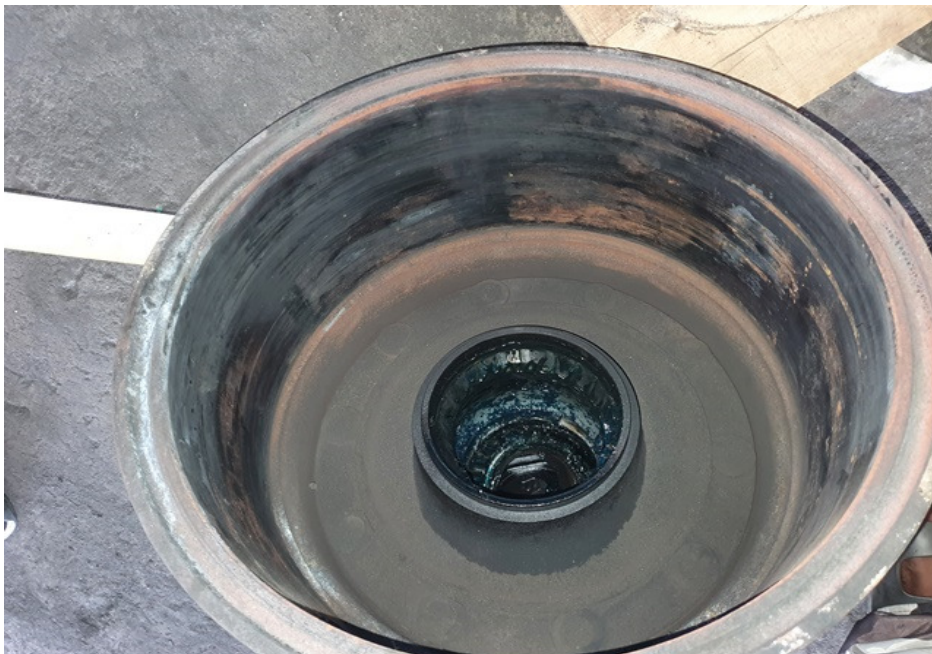
**Photo 10** shows a general view of the rear left brake drum of the Insured Vehicle. Upon closer examination, we did not observe any damages to the interior surface of the brake drum.

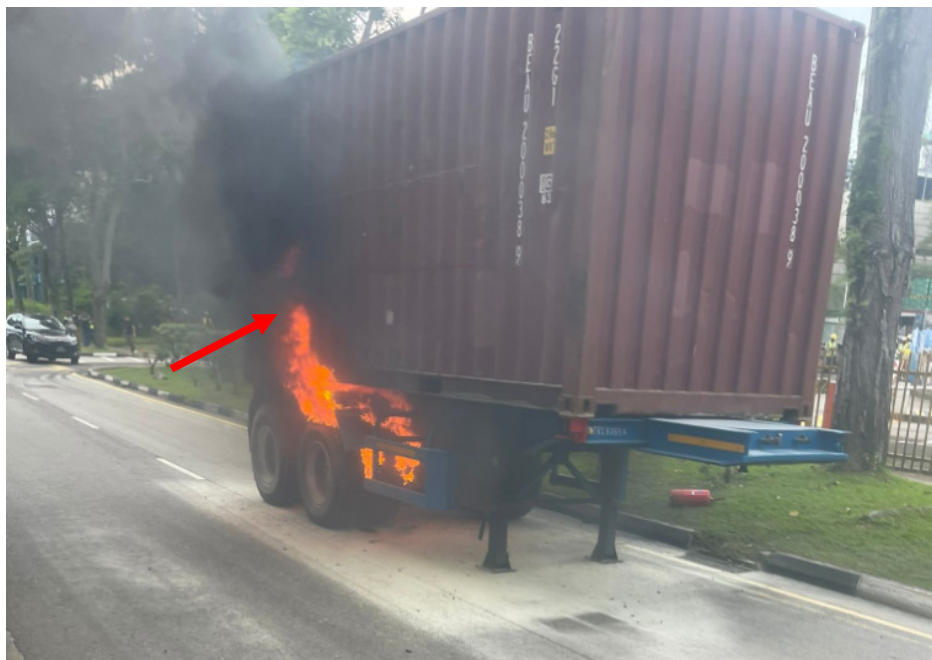
24. Our examination of the photograph revealed that the Insured Vehicle was observed to be tilted down to right side and the fire at the material time of incident. The photographs had also showed the Insured Vehicle on fire and similar extent of damage and burn pattern to the Insured Vehicle as per what we had observed during our physical inspection of the Insured Vehicle. Apart from the aforesaid, there was no further notable information that could be gathered from these photographs. See photos 11 - 13 below.

**Photo 11** shows flames emitting from the right centre portion Insured Vehicle (arrowed) of the Insured Vehicle at the material time of incident. The photograph had showed similar extent of damage and burn pattern to the Insured Vehicle as per what we had observed during our physical inspection of the Insured Vehicle.

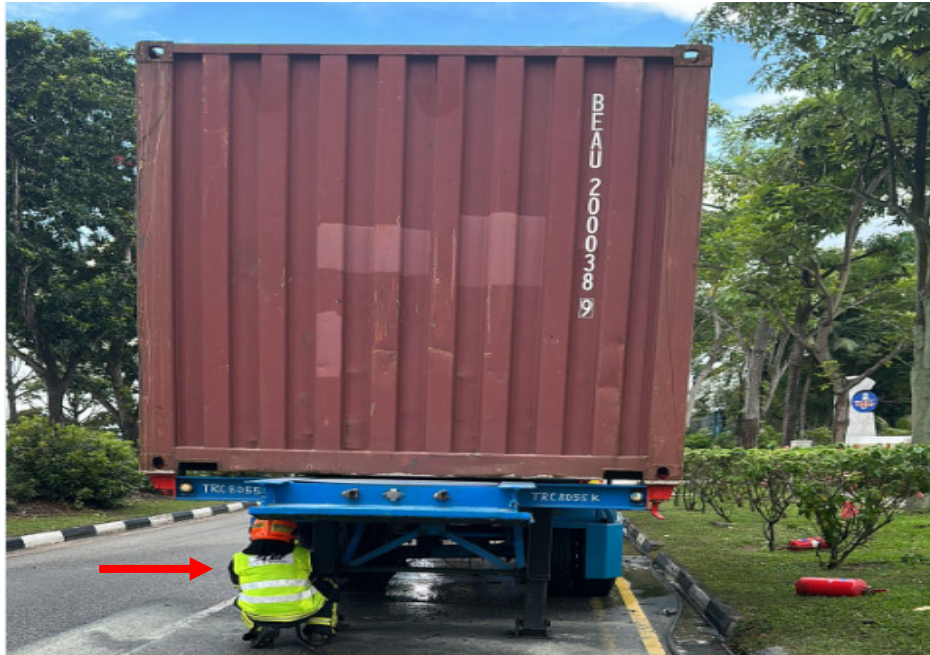
**Photo 12** shows a firefighter dousing the right centre wheels of the Insured Vehicle with water post- incident (arrowed). Generally, the information that could be gathered from the incident scene photographs provided by Mr Tan had corresponded to the events that he had related to us, which is SCDF had responded to the incident.

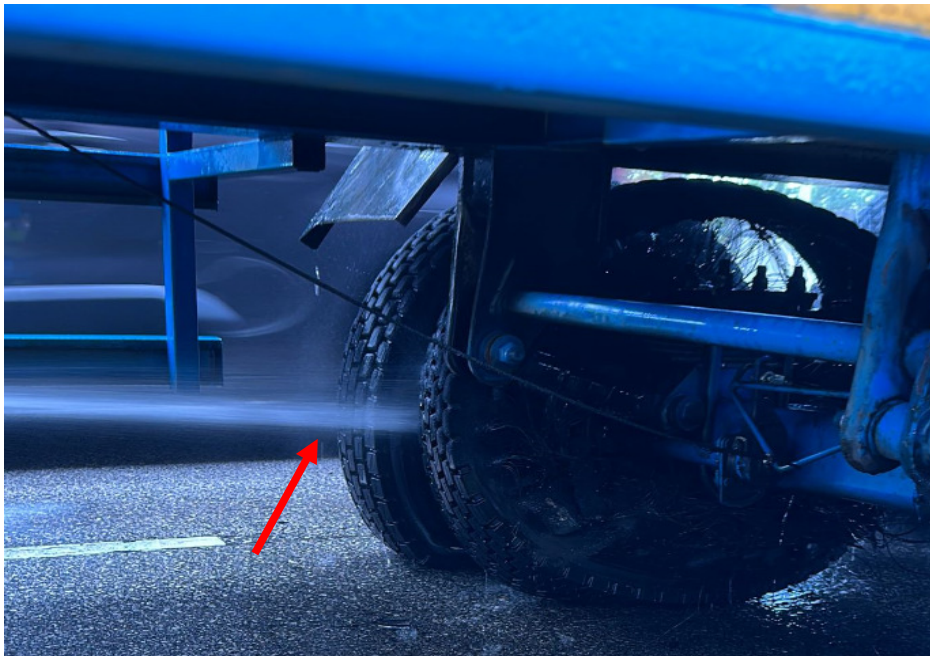
**Photo 13** shows a close up view of the water being doused onto the right centre tyres of the Insured Vehicle with water post- incident (arrowed). Generally, the information that could be gathered from the incident scene photographs provided by Mr Tan had corresponded to the events that he had related to us, which is the fire had started from the right centre wheel.
