Your Ref: TP IP/02813/2023
Our Ref : CI/TPD23005774/P

Fatal Accident Investigation Team

MECHANICAL INSPECTION REPORT OF TIPPER TRUCK WD 3581B

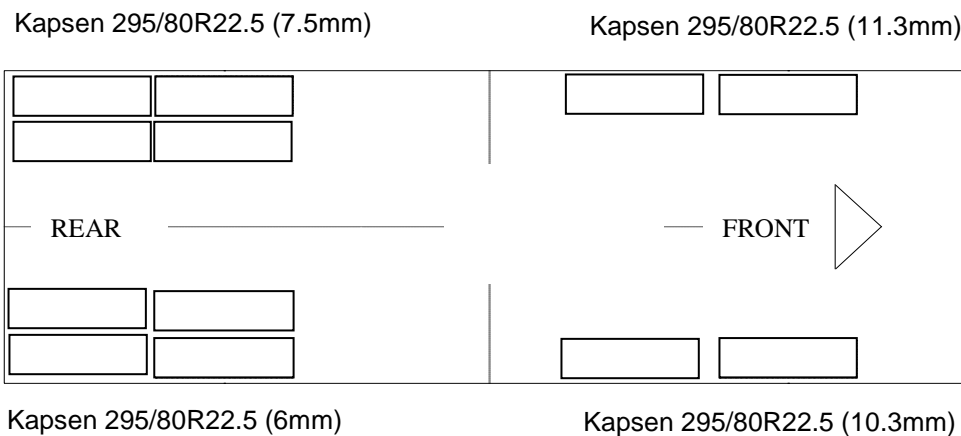
6. The 4 front tyres and 8 rear tyres of the Tipper Truck were observed to be in serviceable condition and sufficiently inflated for vehicular operation. I did not find any tear, cut or burst mark(s) on the outer and the inner sidewalls as well as across the tread of the 12 tyres of the Tipper Truck. The tyre brand, tyre size and remaining tread depth of the 12 tyres of the Tipper Truck were recorded as follows:-

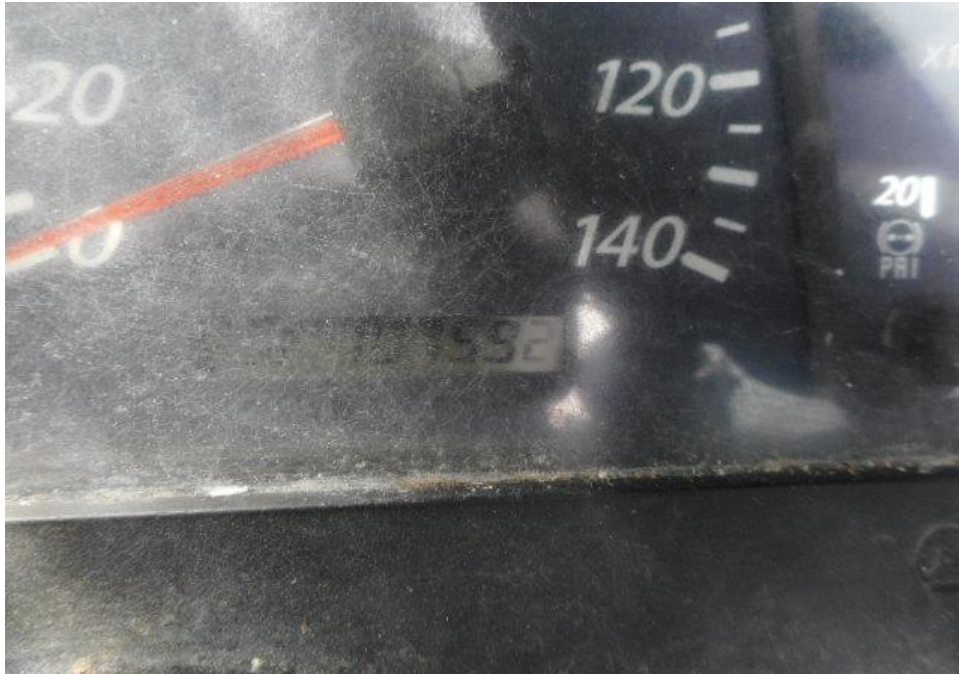
Photo 1 shows a general view of the instrument cluster of the Tipper Truck at the time of my inspection. The mileage of the Tipper Truck was 959,845km

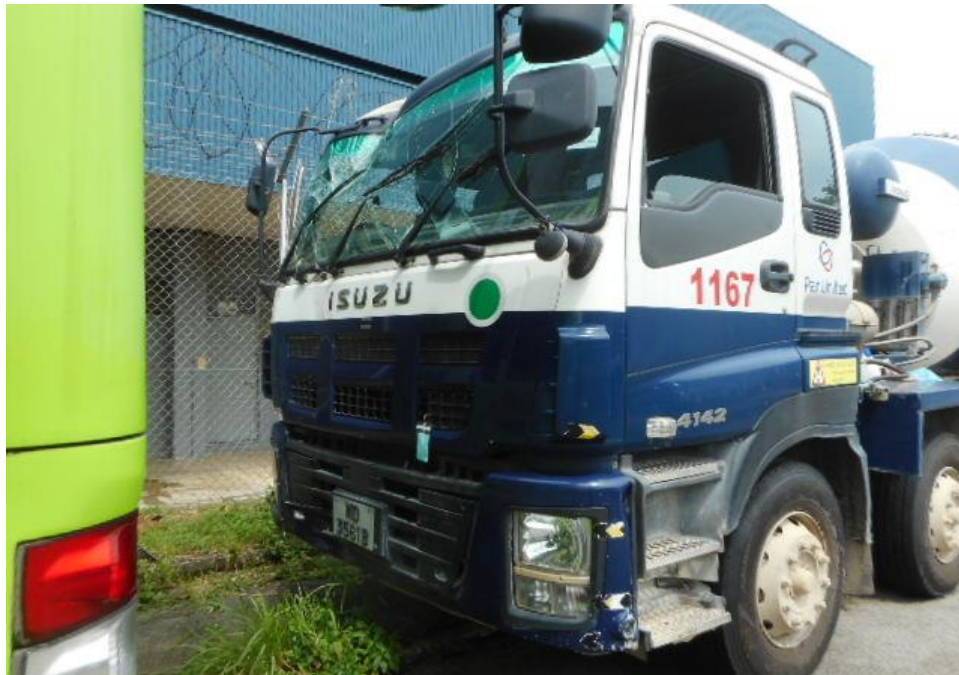
Photo 2 shows a general view of the front body of the Tipper Truck at the time of my inspection. The Tipper Truck was observed to sustain damaged at its front portion. Its front windscreen and front bumper portion was damaged at the time of my inspection.

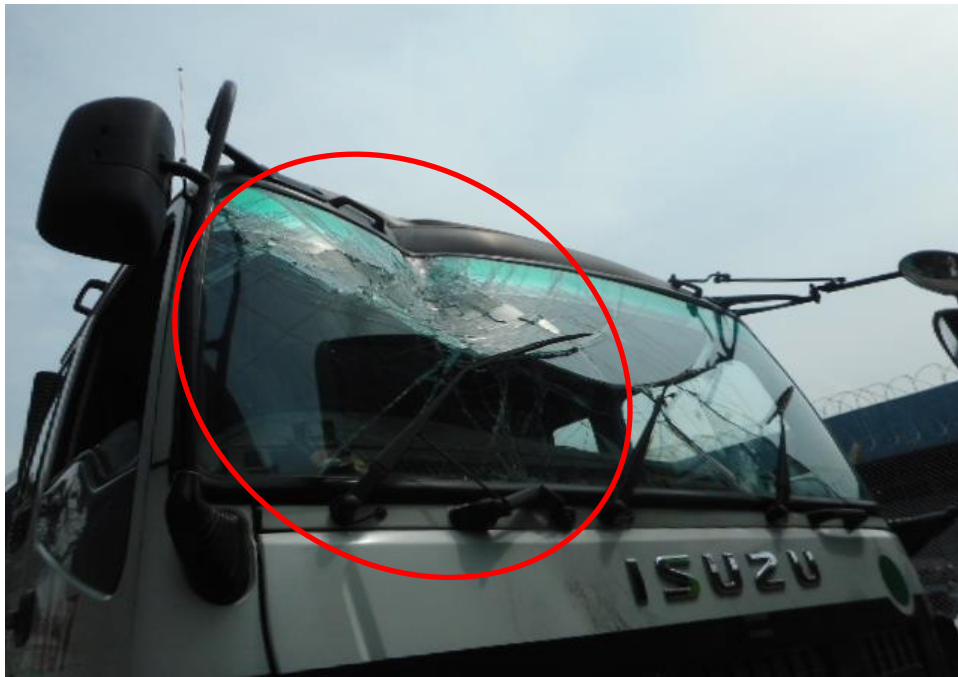
Photo 3 shows a general view of the front body of the Tipper Truck at the time of my inspection. The Tipper Truck was observed to sustain damaged on its front portion. Its front windscreen (circled) was damaged at the time of my inspection.

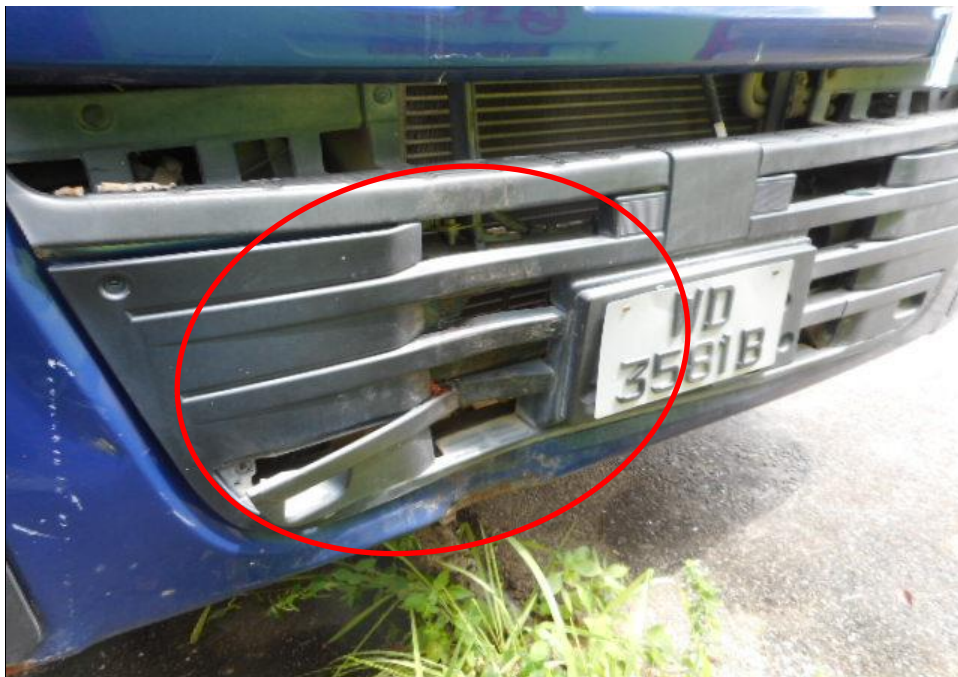
Photo 4 shows a general view of the front body of the Tipper Truck at the time of my inspection. The Tipper Truck was observed to sustain damaged on its front portion. Its front bumper (circled) was damaged at the time of my inspection.

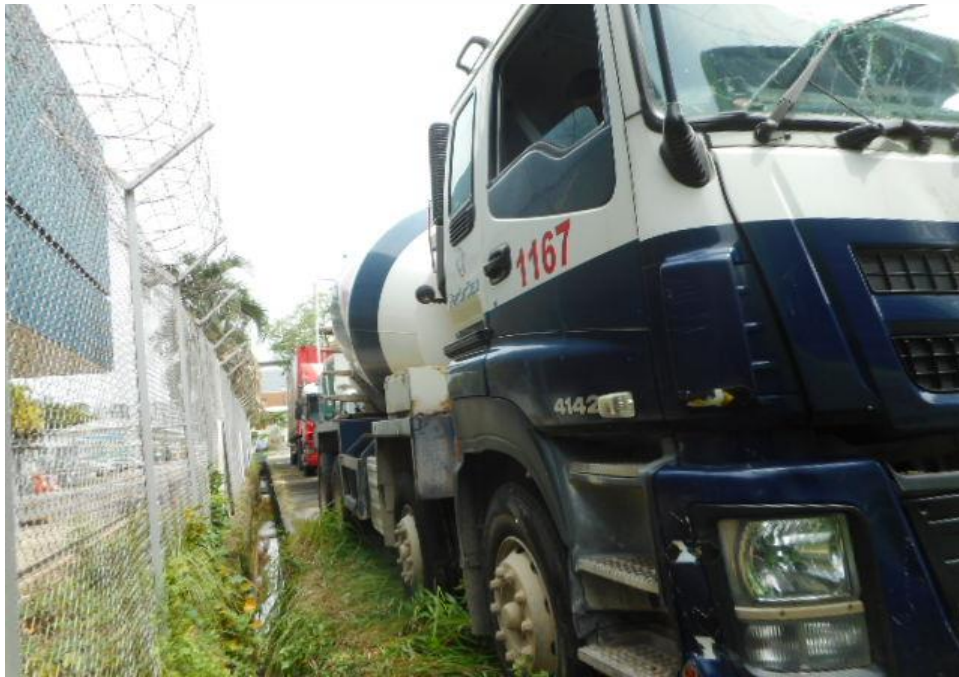
Photo 5 shows a general view of the front right body of the Tipper Truck at the time of my inspection. The Tipper Truck was observed to be intact and unaffected by the accident.

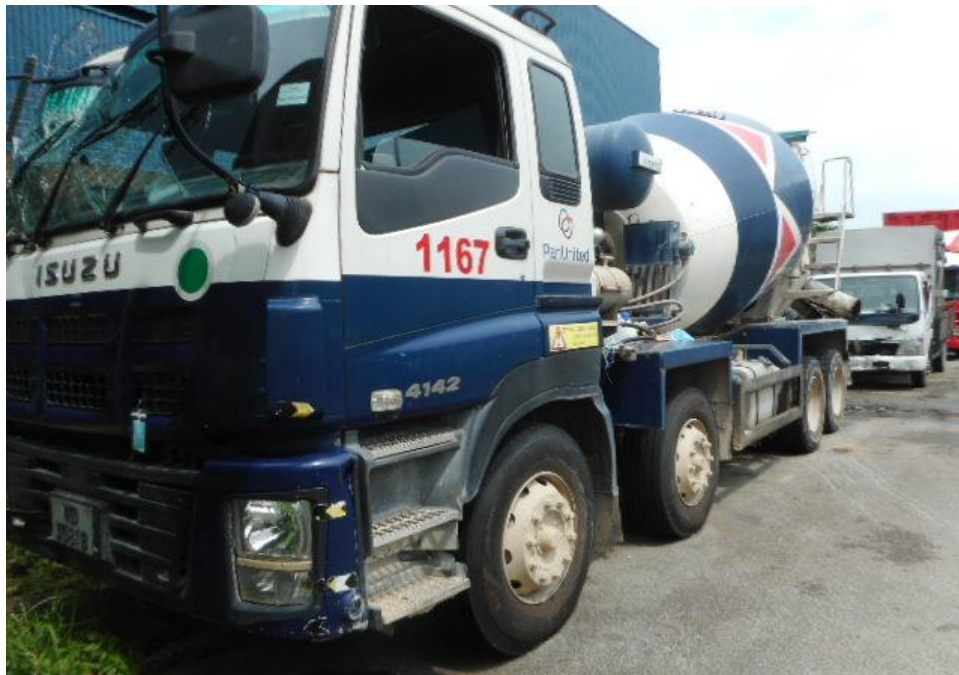
Photo 6 shows a general view of the front left body of the Tipper Truck at the time of my inspection. The Tipper Truck was observed to be intact and unaffected by the accident.

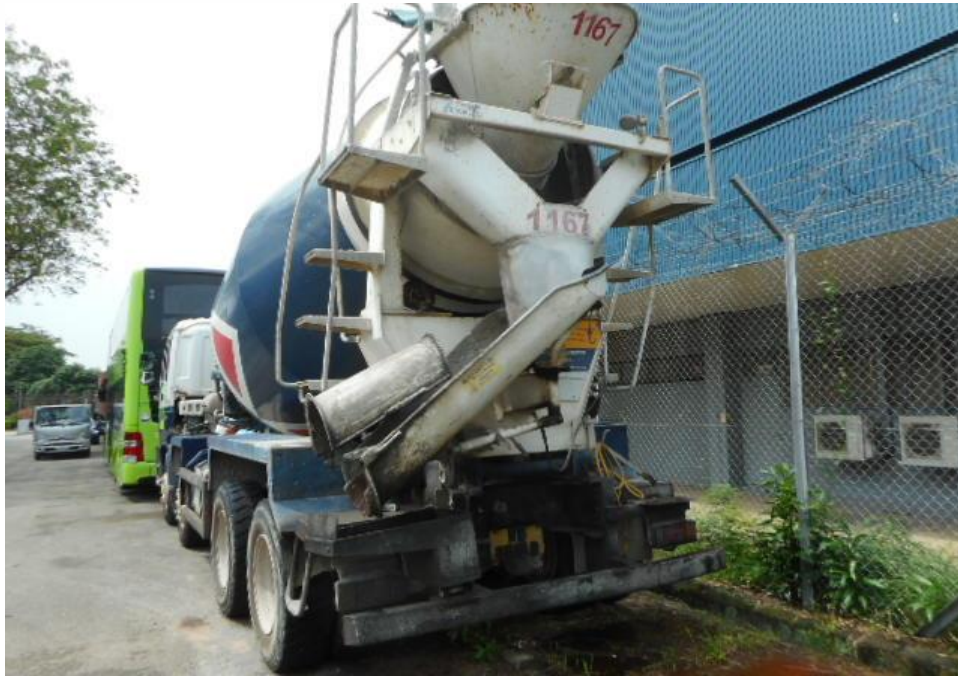
Photo 7 shows a general view of the Tipper Truck's rear body at the time of my inspection. The Tipper Truck was observed to be intact and unaffected by the accident.

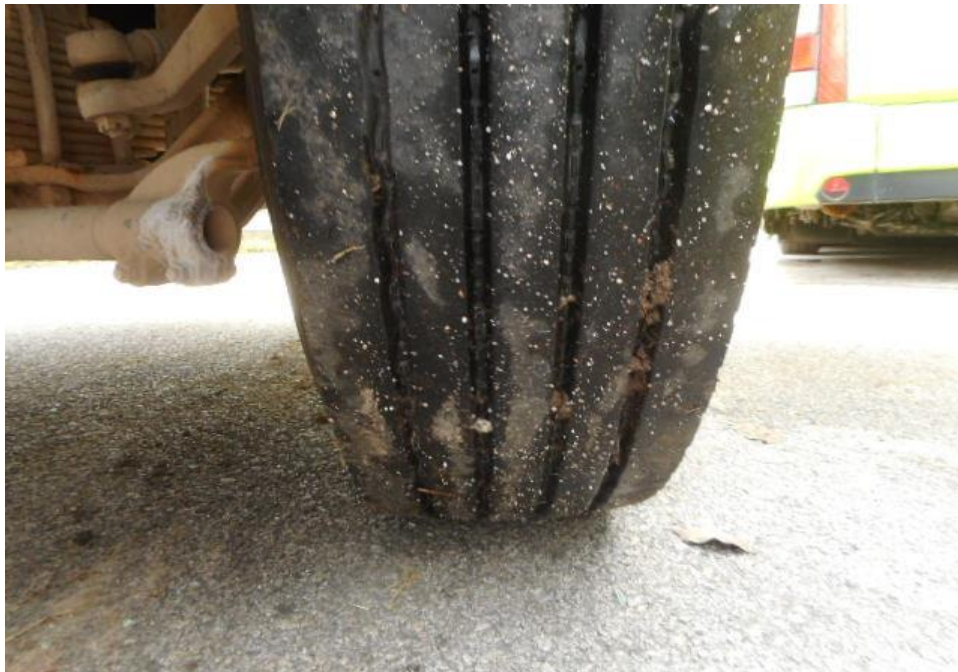
Photo 8 shows the condition of the front right tyre of the Tipper Truck, which was observed to be in serviceable condition with remaining tread depth of approximately 10.3mm. The tyre, which was wrapped around standard steel wheel rim, was also observed to be sufficiently inflated for vehicular operation. There was no tear, cut or burst mark(s) on the outer and the inner sidewalls as well as across the tread of the 12 tyres that were fitted on the Tipper Truck.

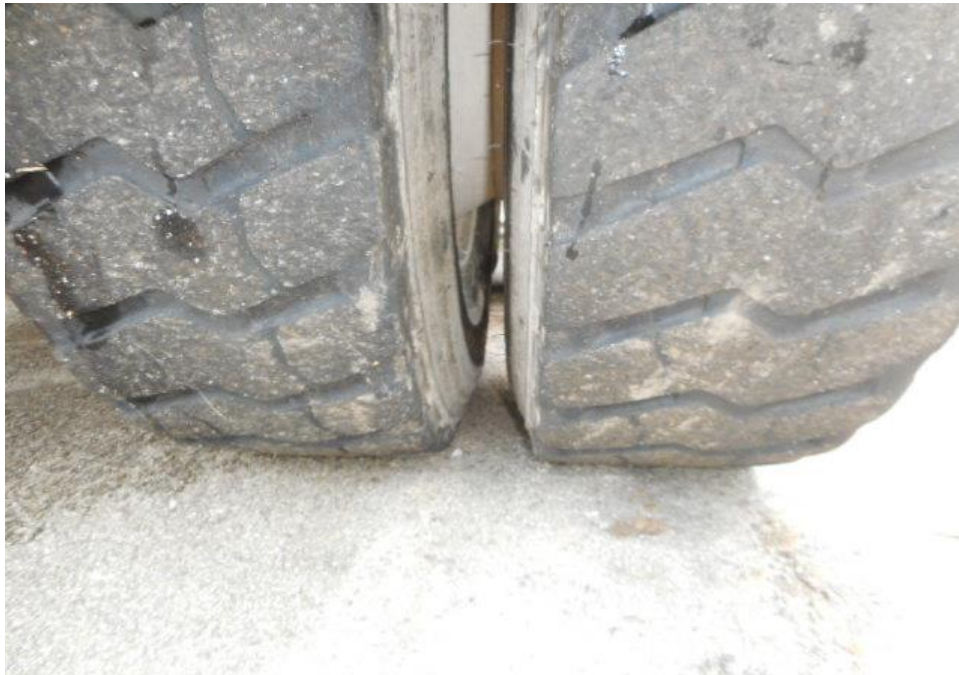
Photo 9 shows the condition of the rear right tyres of the Tipper Truck, which was observed to be in serviceable condition with remaining tread depth of approximately 6mm. The tyre, which was wrapped around standard steel wheel rim, was also observed to be sufficiently inflated for vehicular operation.

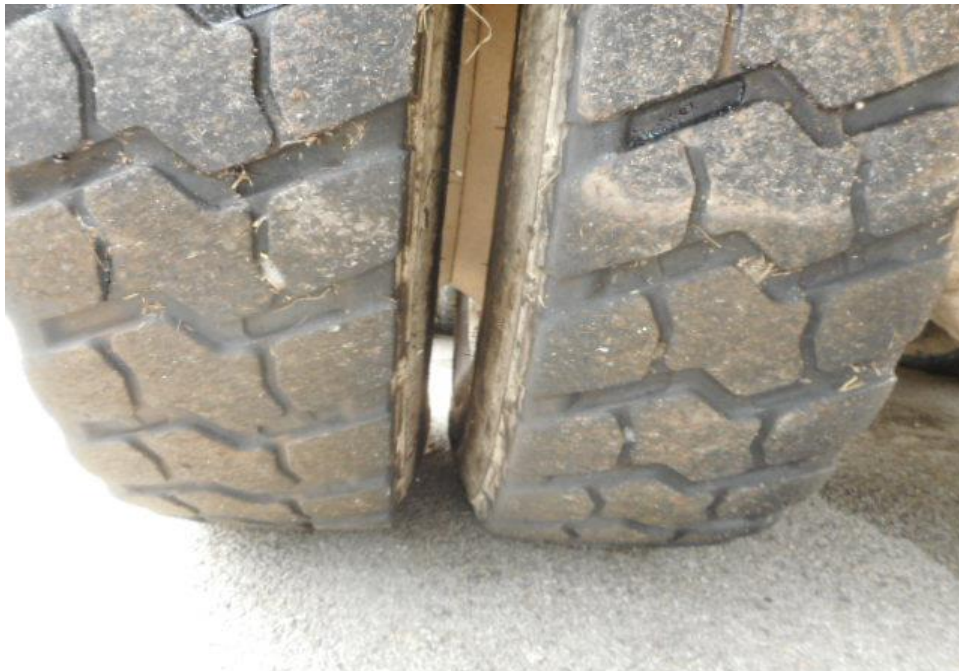
Photo 10 shows the condition of the rear left tyres of the Tipper Truck, which was observed to be in serviceable condition with remaining tread depth of approximately 7.5mm. The tyres, which were wrapped around standard steel wheel rim, were also observed to be sufficiently inflated for vehicular operation. There was also no damage found on all 12 steel wheel rims of the Tipper Truck.

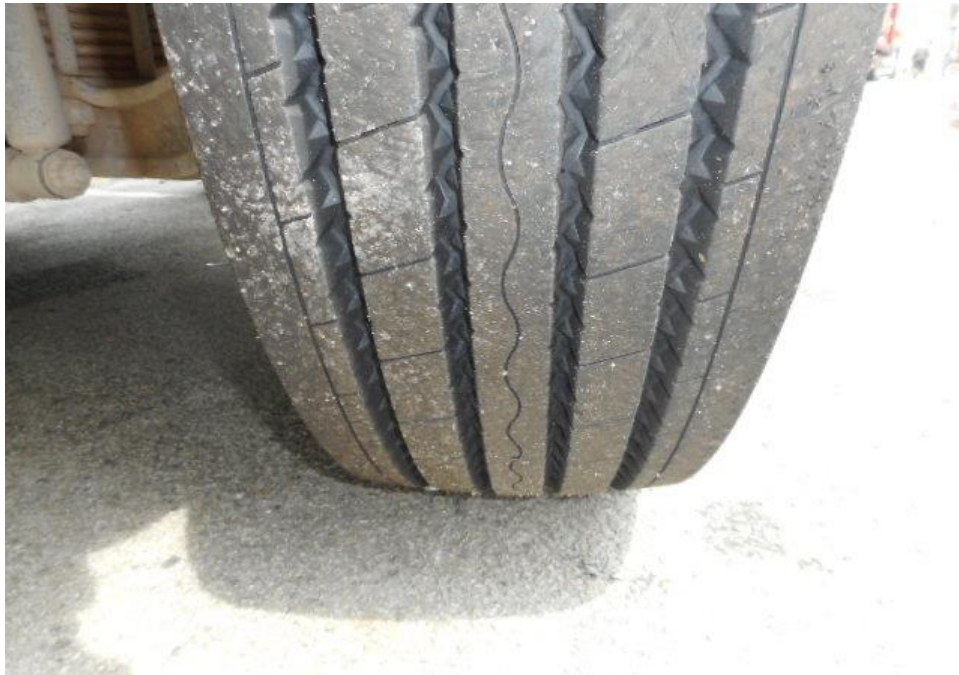
Photo 11 shows the condition of the front left tyres of the Tipper Truck, which were observed to be in serviceable condition with remaining tread depth of approximately 11.3mm. There was also no tear, cut or burst mark(s) on the outer and the inner sidewalls as well as across the tread of the 12 tyres that were fitted on the Tipper Truck.

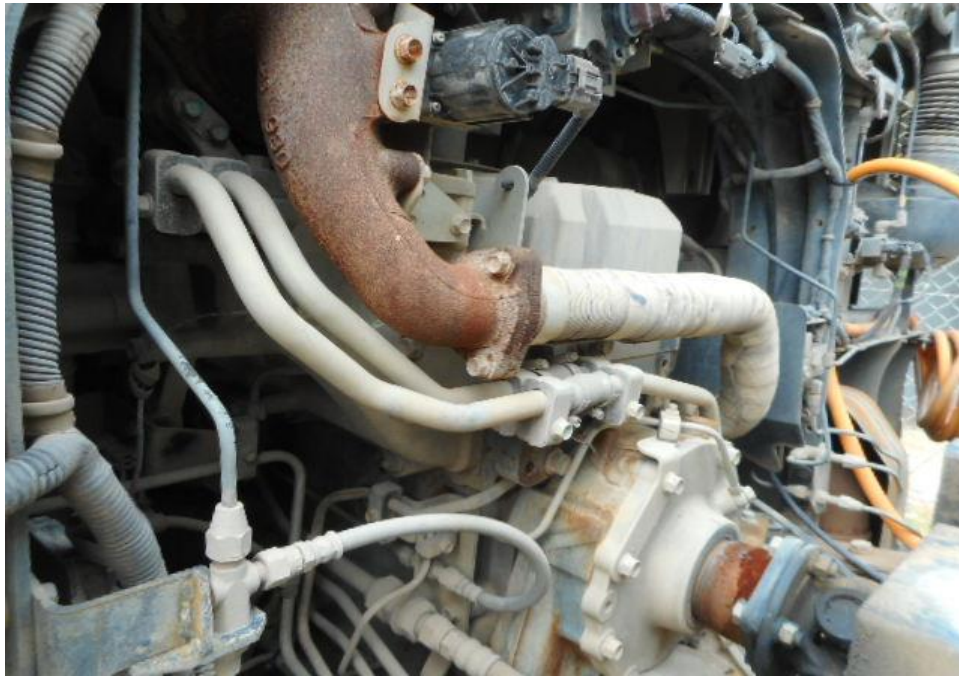
Photo 12 shows a general view of the Tipper Truck's engine compartment, which was accessed by lifting the front cabin of the Tipper Truck. The various parts and components inside the engine compartment were unaffected by the accident. There was also no sign(s) or indication(s) of fresh fluid leakage and/or fluid stain within the engine compartment

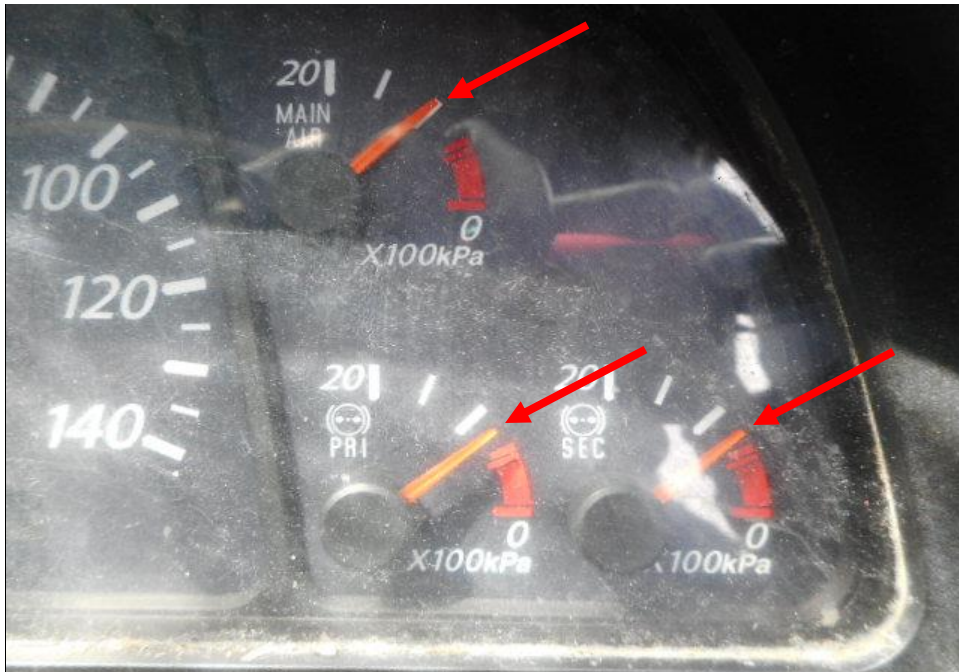
Photo 13 shows the air in the air brake cylinders of the Tipper Truck at the time of my inspection. The air in the cylinder was observed to be of sufficient level & serviceable at the time of the accident.

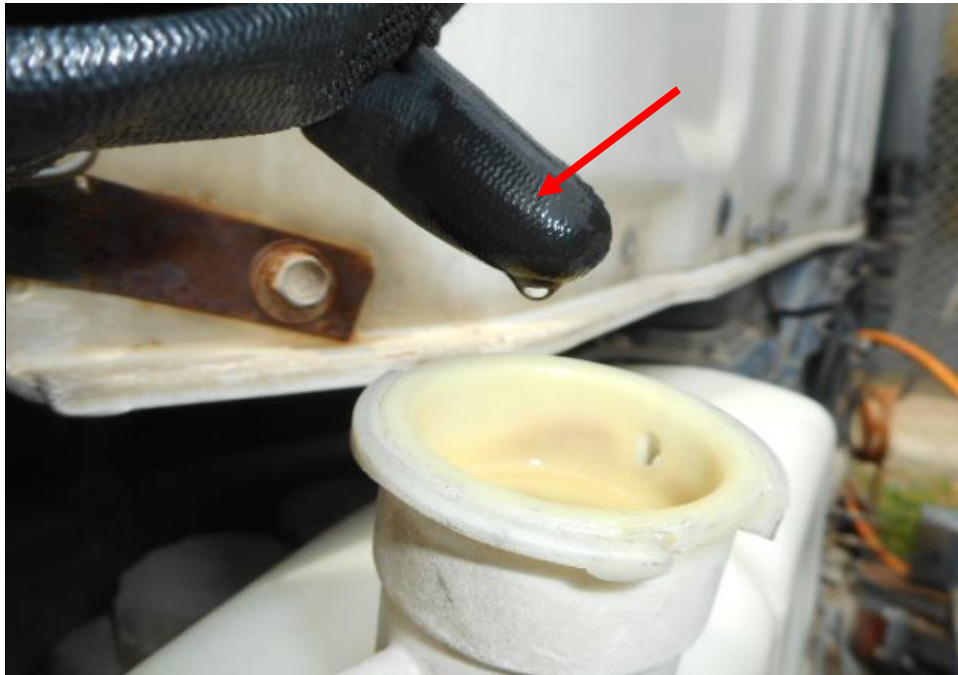
Photo 14 shows the engine coolant reservoir of the Tipper Truck at the time of my inspection. The engine coolant was observed to be of sufficient level (arrowed) and without any visible contamination.

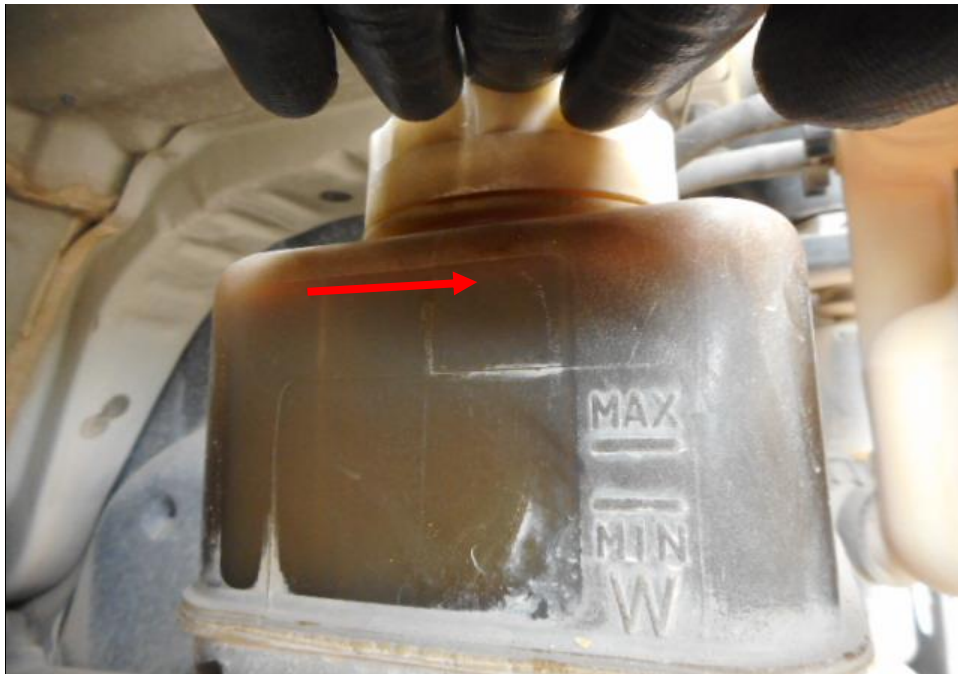
Photo 15 shows the power steering fluid reservoir of the Tipper Truck at the time of my inspection. The power steering fluid was observed to be of sufficient level (arrowed) and without any visible contamination.

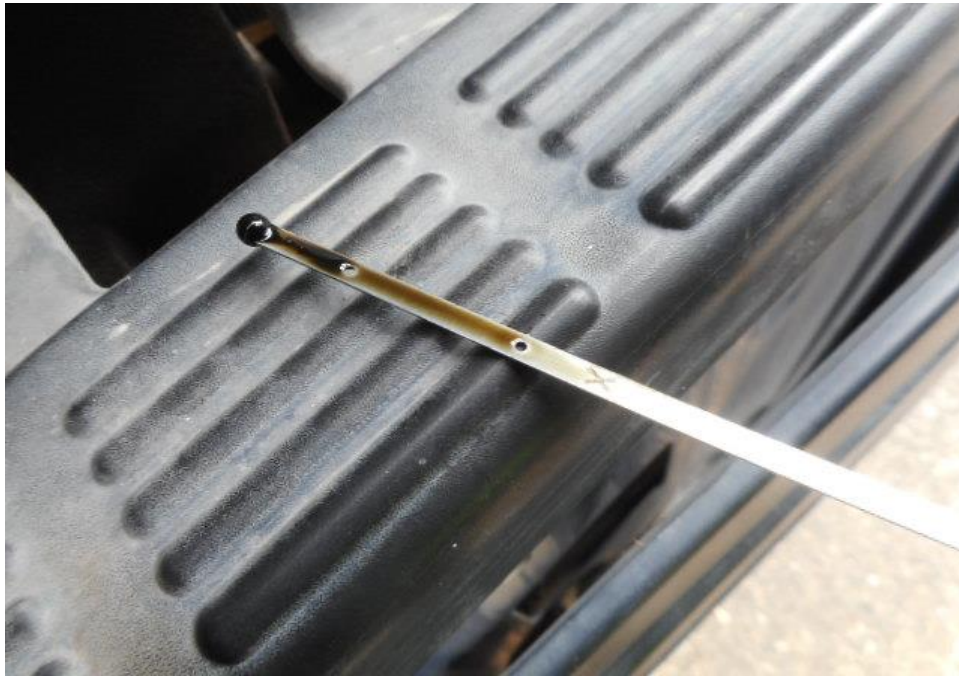
Photo 16 shows the engine oil dip stick of the Tipper Truck at the time of my inspection. The engine oil was observed to be of insufficient level at the time of our inspection.

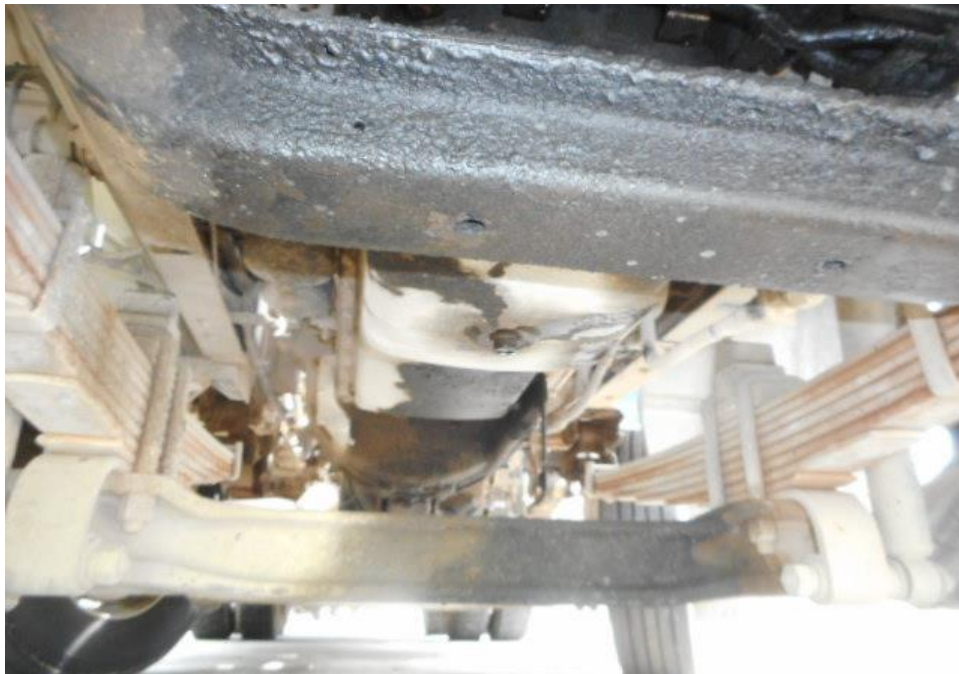
Photo 17 shows the undercarriage of the Tipper Truck, at the area where the engine housing located. I observed old fluid stains on the underside of the Tipper Truck.

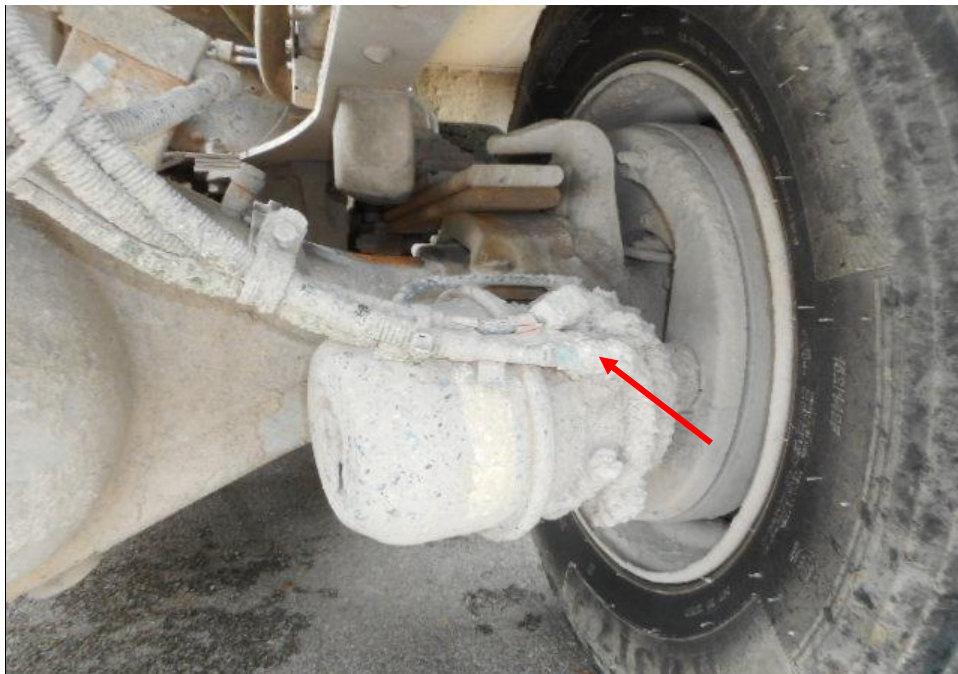
Photo 18 shows the brake pipe (arrowed) at the rear right wheel of the Tipper Truck. I did not observe any leakage of brake fluid at the time of my inspection of the Tipper Truck. My static tests of the Tipper Truck's braking system, along with my visual examination of the various mechanical components in the braking system, had indicated that there was no internal leakage of pressure/vacuum. Hence the braking system of the Tipper Truck was likely to be in serviceable condition at the material time of accident.

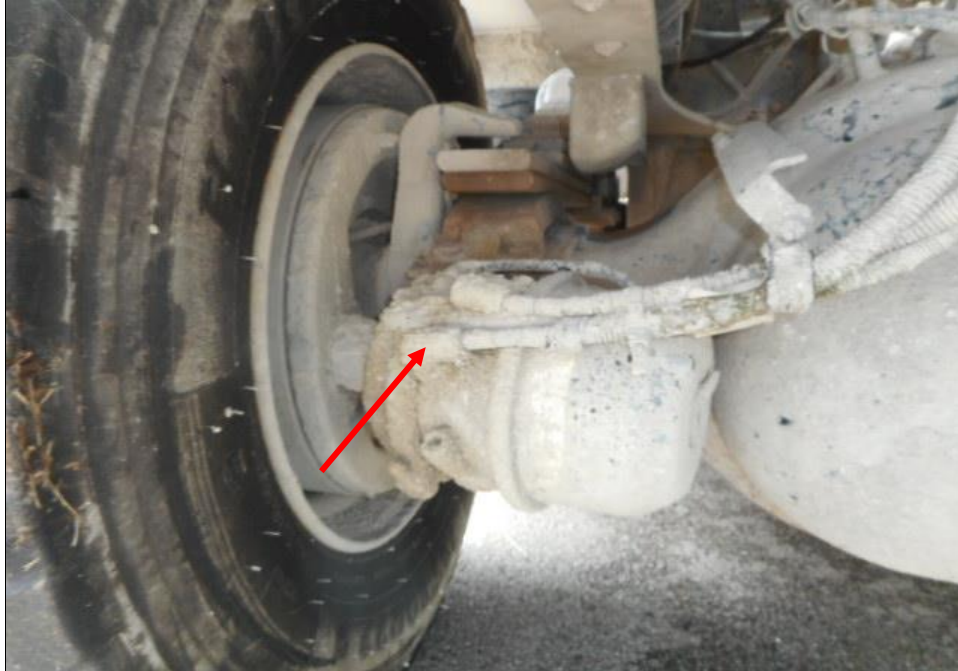
Photo 19 shows the brake pipe (arrowed) at the rear left wheel of the Tipper Truck. I did not observe any leakage of brake fluid at the time of my inspection of the Tipper Truck. My static tests of the Tipper Truck's braking system, along with my visual examination of the various mechanical components in the braking system, had indicated that there was no internal leakage of pressure/vacuum. Hence the braking system of the Tipper Truck was likely to be in serviceable condition at the material time of accident.

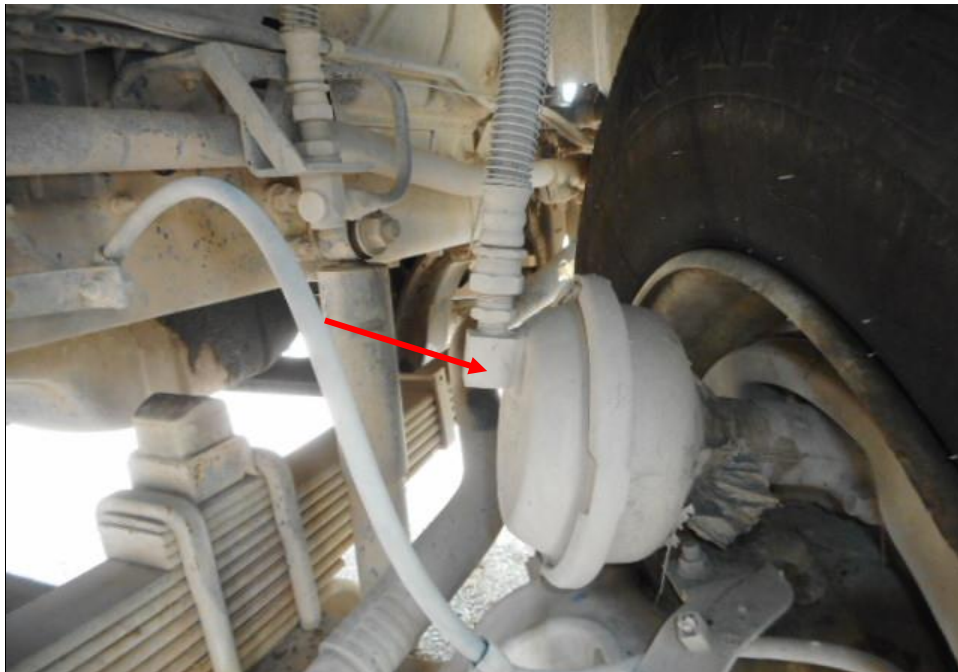
Photo 20 shows the brake pipe (arrowed) at the front right wheel of the Tipper Truck. I did not observe any leakage of brake fluid at the time of my inspection of the Tipper Truck. My static tests of the Tipper Truck's braking system, along with my visual examination of the various mechanical components in the braking system, had indicated that there was no internal leakage of pressure/vacuum. Hence the braking system of the Tipper Truck was likely to be in serviceable condition at the material time of accident.

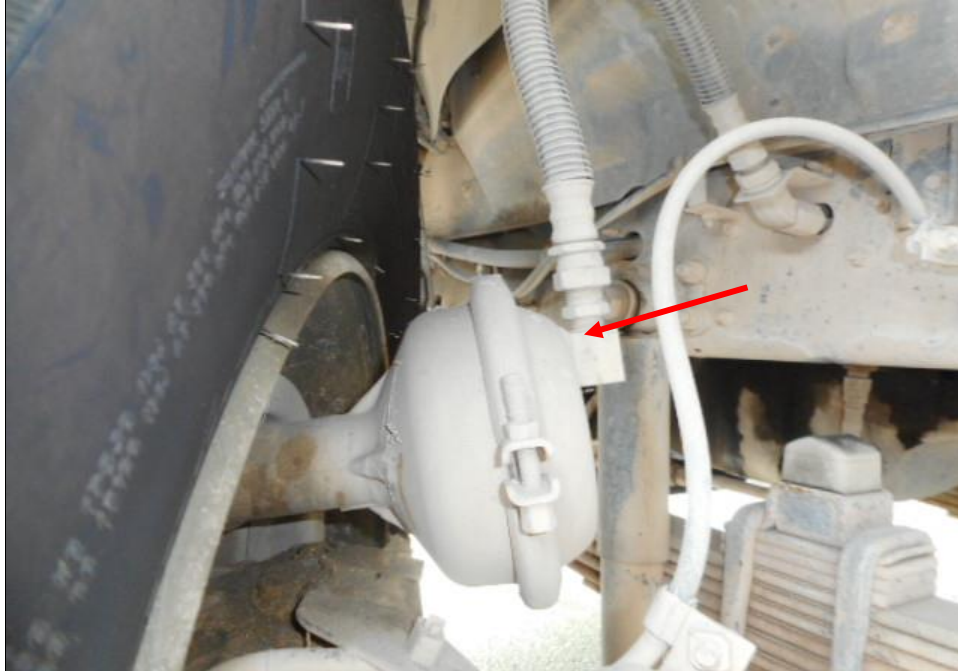
Photo 21 shows the brake pipe (arrowed) at the front left wheel of the Tipper Truck. I did not observe any leakage of brake fluid at the time of my inspection of the Tipper Truck. My static tests of the Tipper Truck's braking system, along with my visual examination of the various mechanical components in the braking system had indicated that there was no internal leakage of pressure/vacuum. Hence the braking system of the Tipper Truck was likely to be in serviceable condition at the material time of accident.

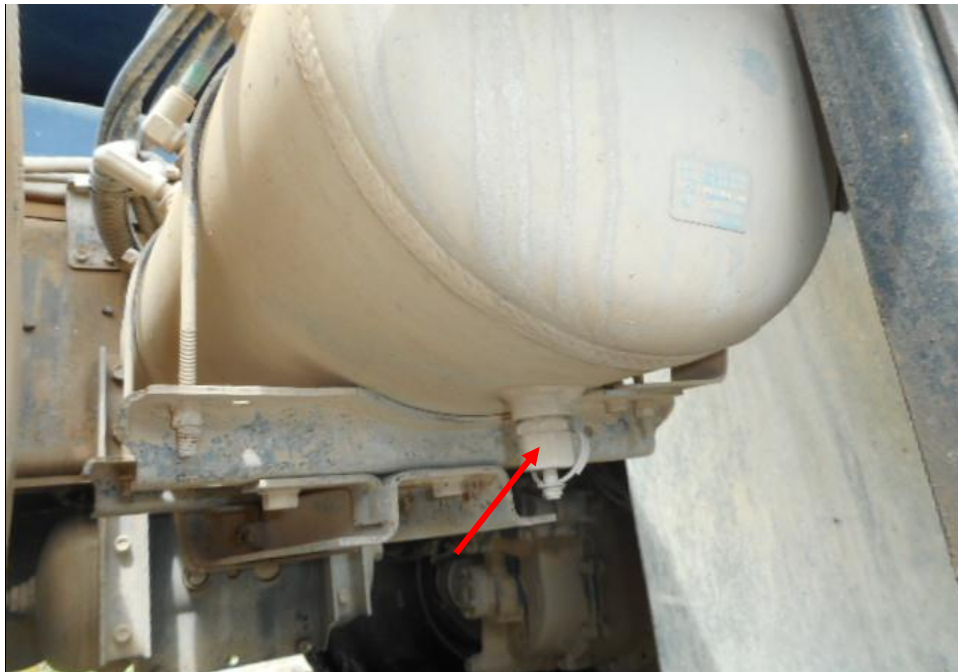
Photo 22 shows the air brake cylinders (arrowed) at the undercarriage of the Tipper Truck. I did not observe any leakage of air brake fluid at the time of my inspection of the Tipper Truck. My static tests of the Tipper Truck's braking system, along with my visual examination of the various mechanical components in the braking system had indicated that there was no internal leakage of pressure/vacuum. Hence the braking system of the Tipper Truck was likely to be in serviceable condition at the material time of accident.

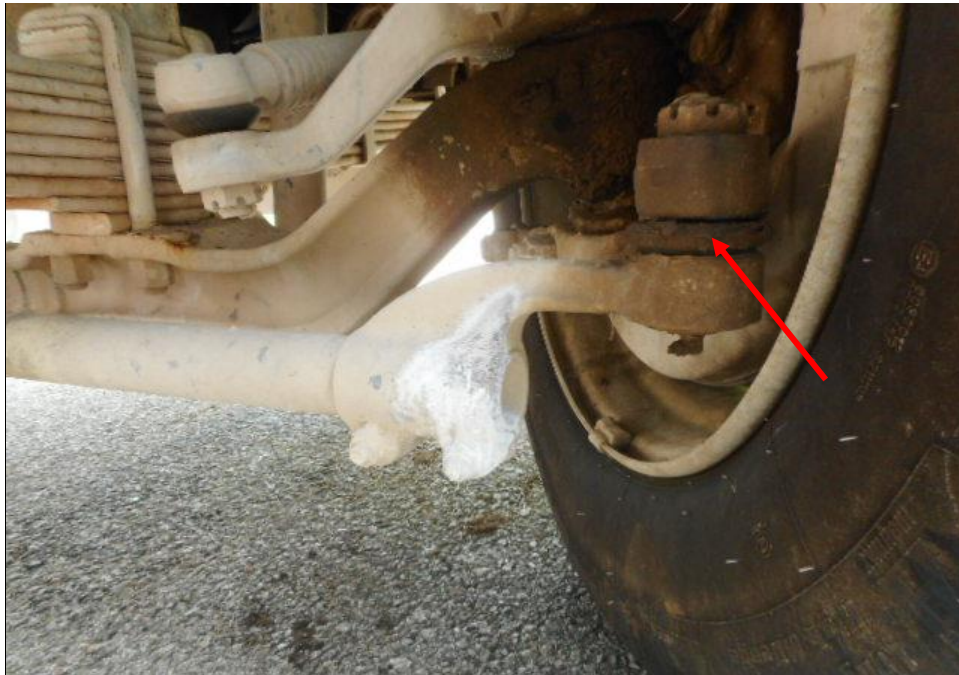
Photo 23 shows the various undercarriage components at the front right wheel of the Tipper Truck, in particular the steering tie rod end (arrowed). The various steering components were all found to be intact, suggesting that the steering system of the Tipper Truck was likely to be in serviceable condition at the material time of accident. There was also no sign of fluid stain(s) observed on the various undercarriage components.

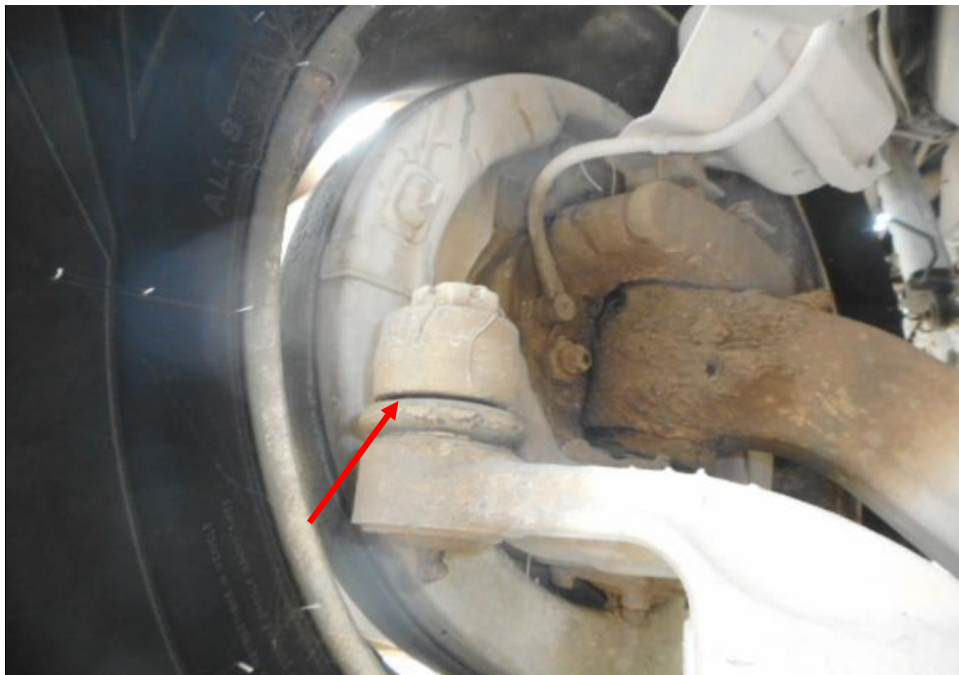
Photo 24 shows the various undercarriage components at the front left wheel of the Tipper Truck, in particular the steering tie rod end (arrowed). The various undercarriage components of the Tipper Truck were all found to be intact without any visible damage. There was also no sign of fluid stain(s) observed on the various undercarriage components.

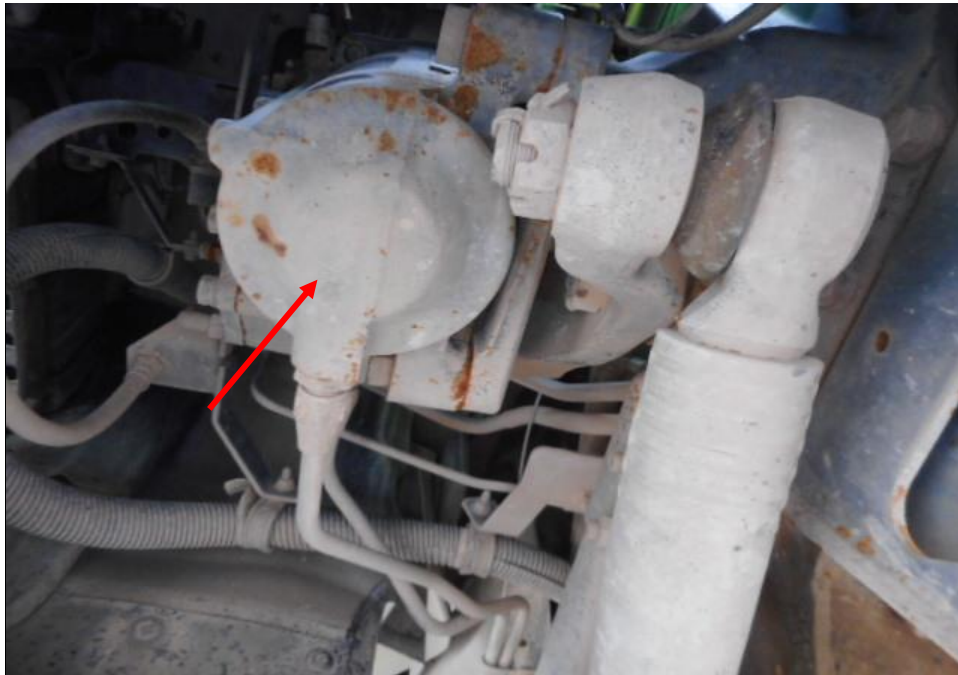
Photo 25 shows the steering box component (arrowed) at the undercarriage of the Tipper Truck was found to be intact without any visible damage. There was also no sign of fluid stain(s) observed on the various undercarriage components.

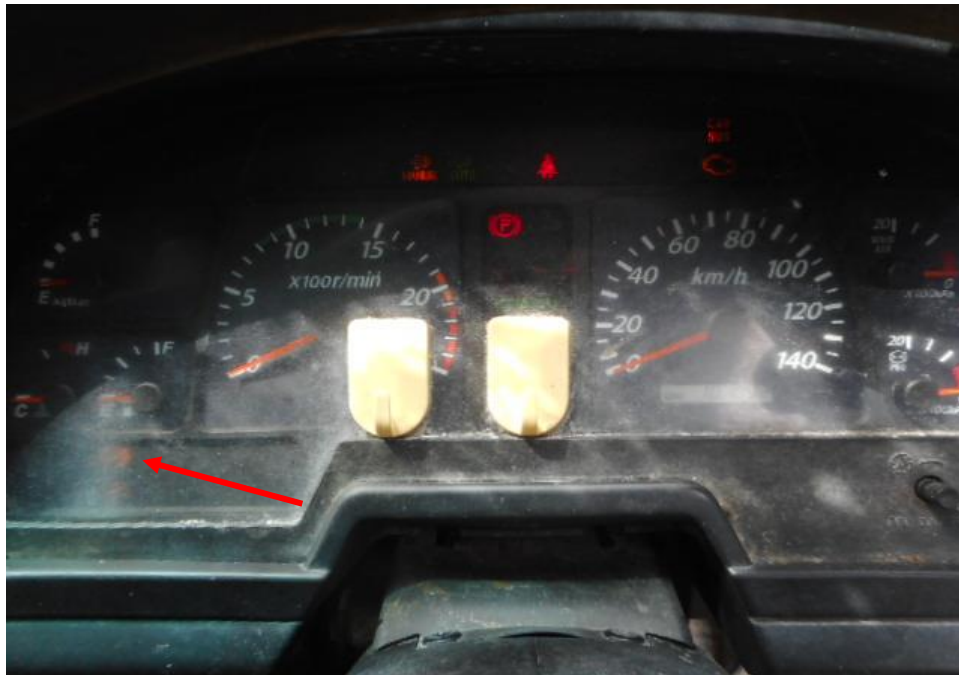
Photo 27 shows the warning light for Anti-lock brake system (ABS) (arrowed) appearing on the instrument panel of the Tipper Truck during the self-test of its various electronic operating systems when its engine was cranked.

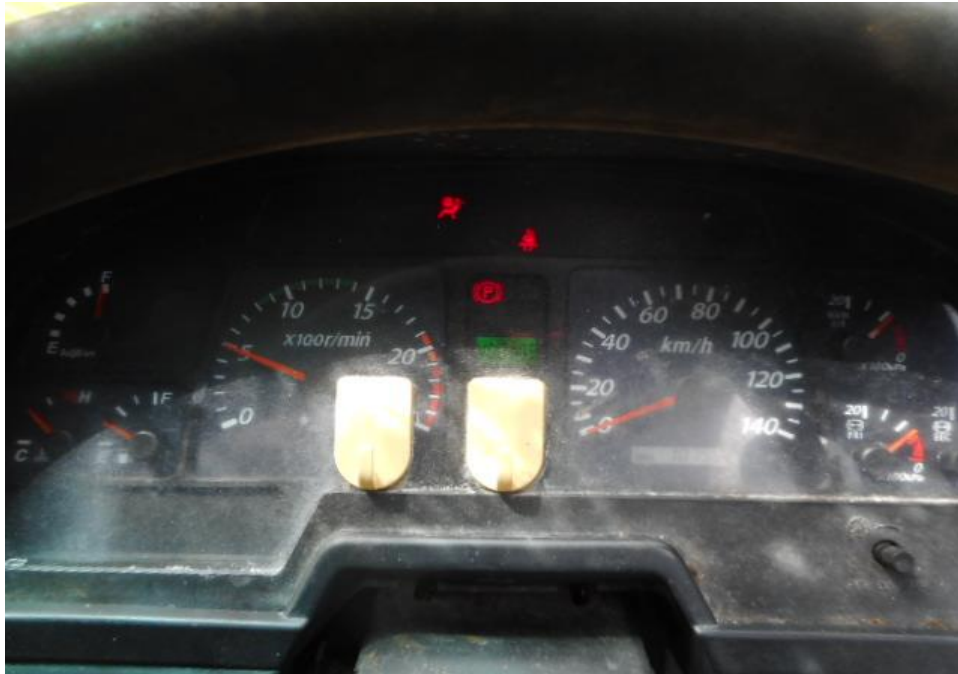
Photo 28 shows no warning lights illuminated on the instrument panel of the Motor Lorry after the engine was cranked. This would suggest that there was no abnormality to the electronic operating system of the Motor Lorry, like the ABS and etc.
