Your Ref: TP IP/34185/2022  
Our Ref : CI/TPD23005775/P

**MECHANICAL INSPECTION REPORT OF MOTOR CAR SJF 856Y**

1. I refer to your request on 28<sup>th</sup> April 2023 to conduct a physical inspection of a Motor car bearing registration number SJF 856Y (herein referred to as “**Motor Car**”), which was involved in a road traffic accident on 16<sup>th</sup> December 2022.
2. The objective of the inspection is to determine if there was any possible mechanical failure to the Motor car that may have contributed to the accident.
3. Following the request, I had carried out a physical inspection of the Motor Car on 15<sup>th</sup> July 2023 at the premises of Traffic Police vehicle pound, 517 Airport Road Singapore 539942. I now set out below my observations and comments with respect to this inspection.

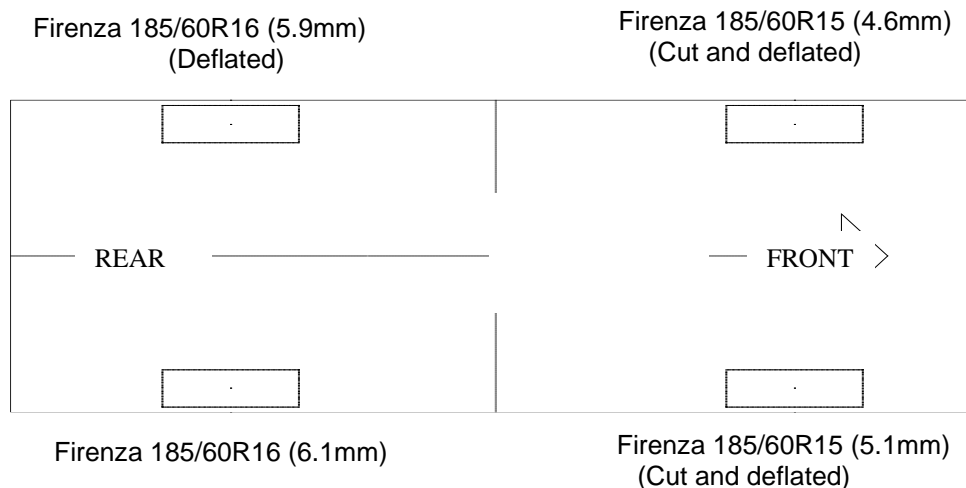
6. The Motor Car's front right and left tyre was observed to be cut and deflated and their wheel rims also damaged as well as the rear left tyre was observed to be deflated as a result of the accident. However, the rear right tyre and wheel rim was observed to be in serviceable condition. I did not find any tear, cut or burst mark(s) on the outer and the inner sidewalls as well as across the tread of the tyre. The rear right tyre were observed to be sufficiently inflated for vehicular operation. The tyre brand, tyre size and remaining tread depth of the 4 tyres were recorded as follows:-

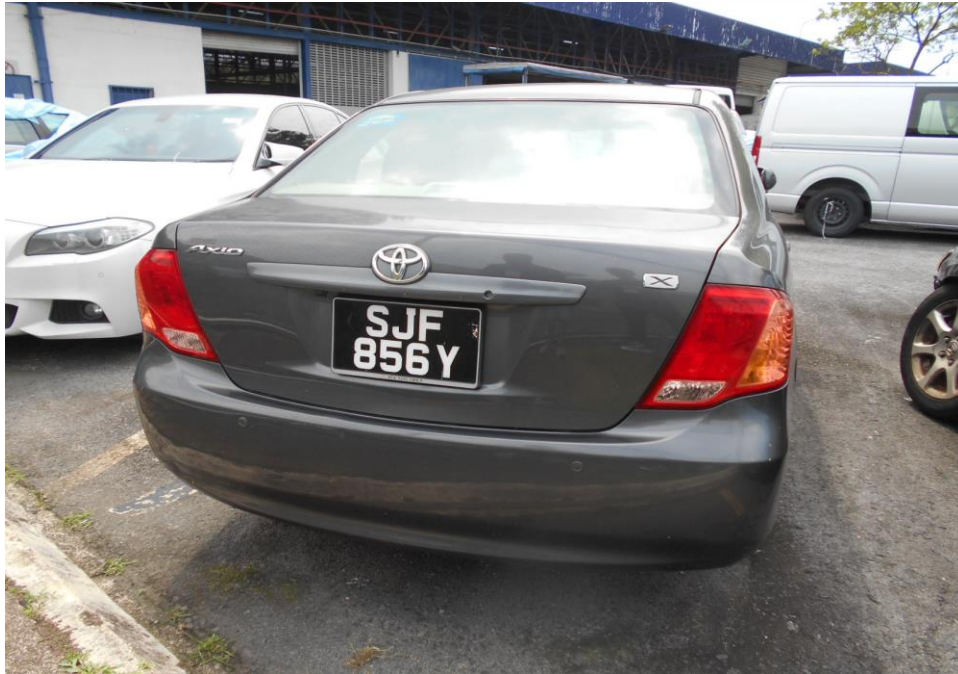
**Photo 1** shows a general view of the Motor Car's rear body at the time of my inspection. The rear portion of the Motor Car was observed to have been undamaged by the accident.

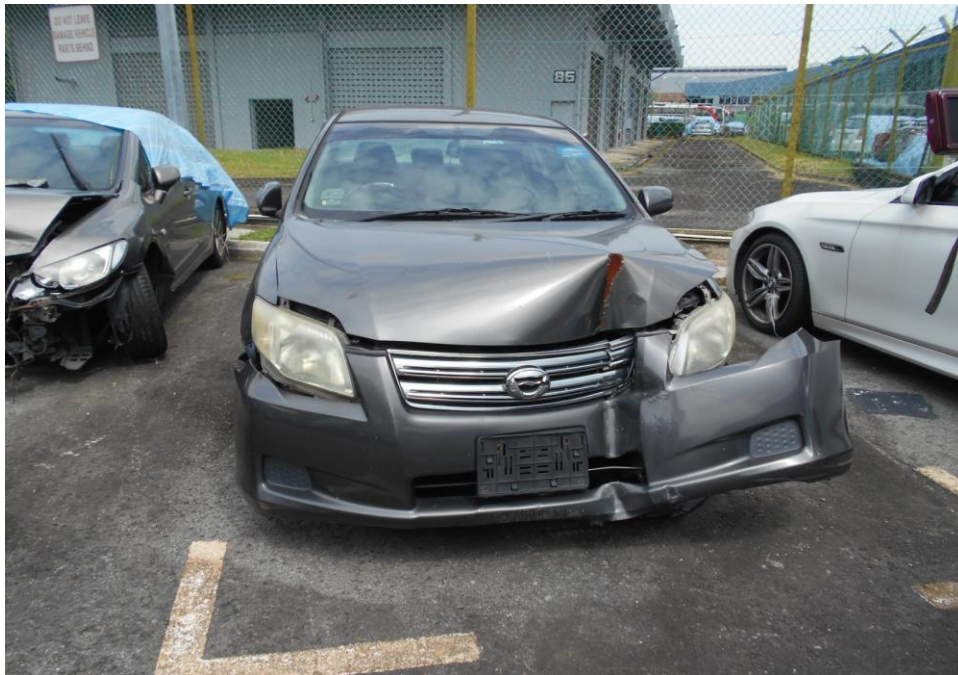
4. The mileage of the Motor Car at the time of my inspection was not recorded as the engine of the Motor Car was unable to be jumpstarted up despite multiple attempts in jumpstarting it.
5. The Motor car was observed to have sustained damage at its front portion and right portion. Its front bonnet, front bumper, grille and rear right door was the body parts that were damaged as a result of the accident.

**Photo 2** shows a general view of the Motor Car's front body at the time of my inspection. The Motor Car was observed to have sustained damage at its front portion. Its front bonnet, front bumper as well as its front grille were amongst the body parts that were damaged as a result of the accident.

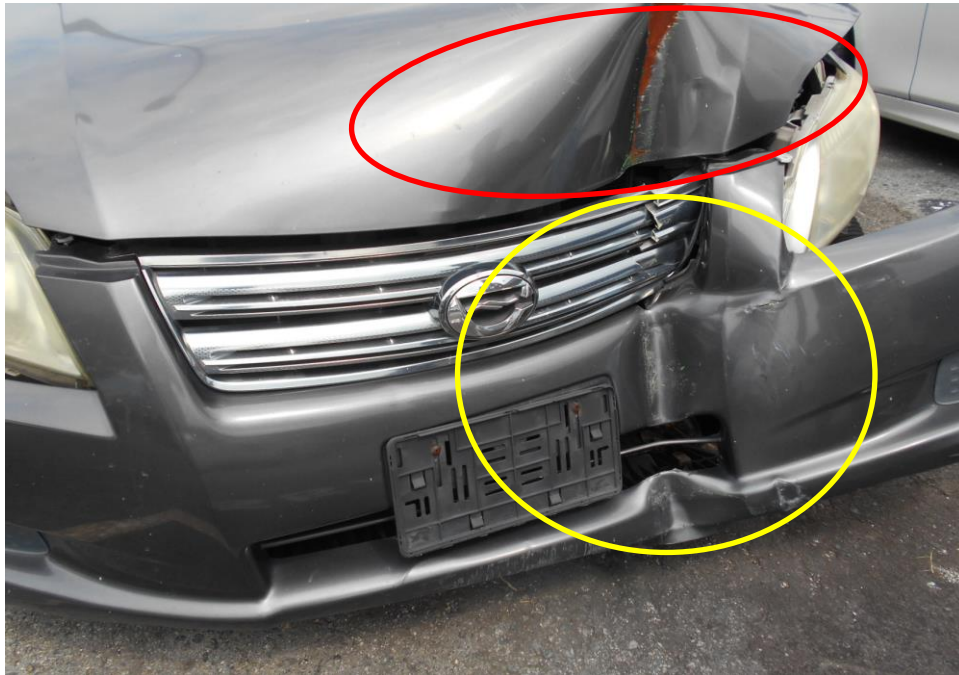
**Photo 3** shows the close up view of the Motor Car's front body at the time of my inspection. The Motor car was observed to have sustained damage at its front portion. Its front bonnet (red circle), its front grille and bumper (yellow circle) was damaged as a result of the accident.

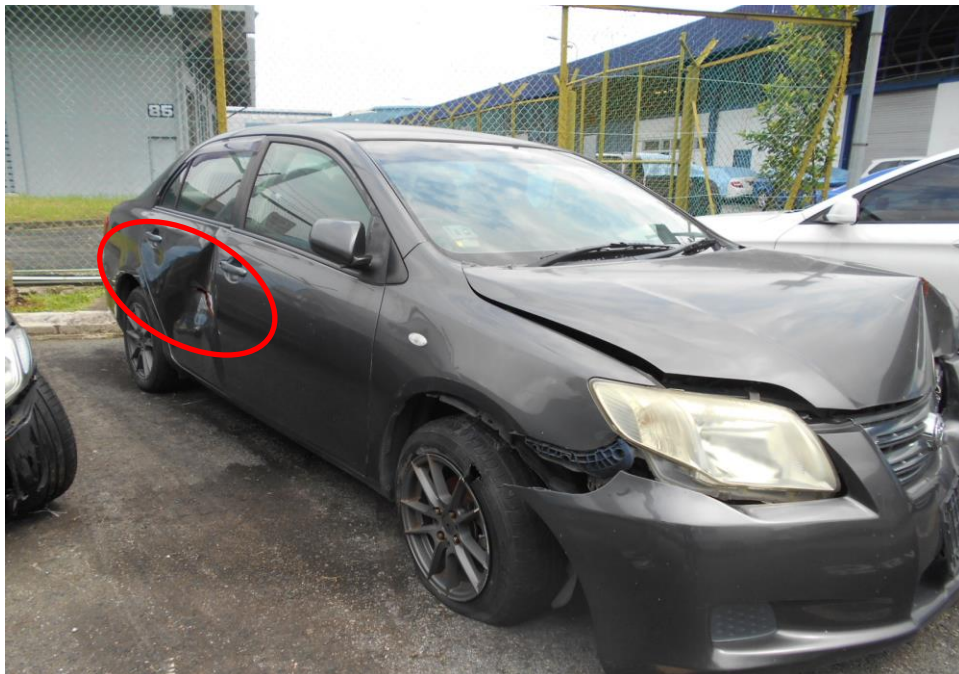
**Photo 4** shows a general view of the Motor Car's right portion at the time of my inspection. The right rear door (circled) of the Motor Car was observed to have been damaged as a result of the accident.

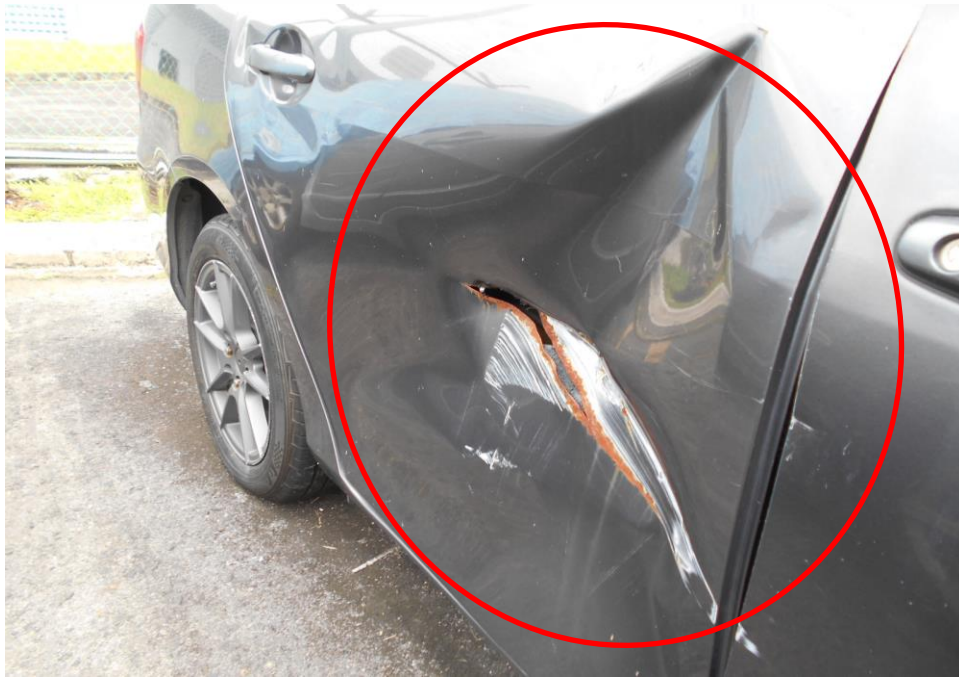
**Photo 5** shows the close up view of the Motor Car's right portion at the time of my inspection. The right rear door (circled) of the Motor Car was observed to have been damaged as a result of the accident.

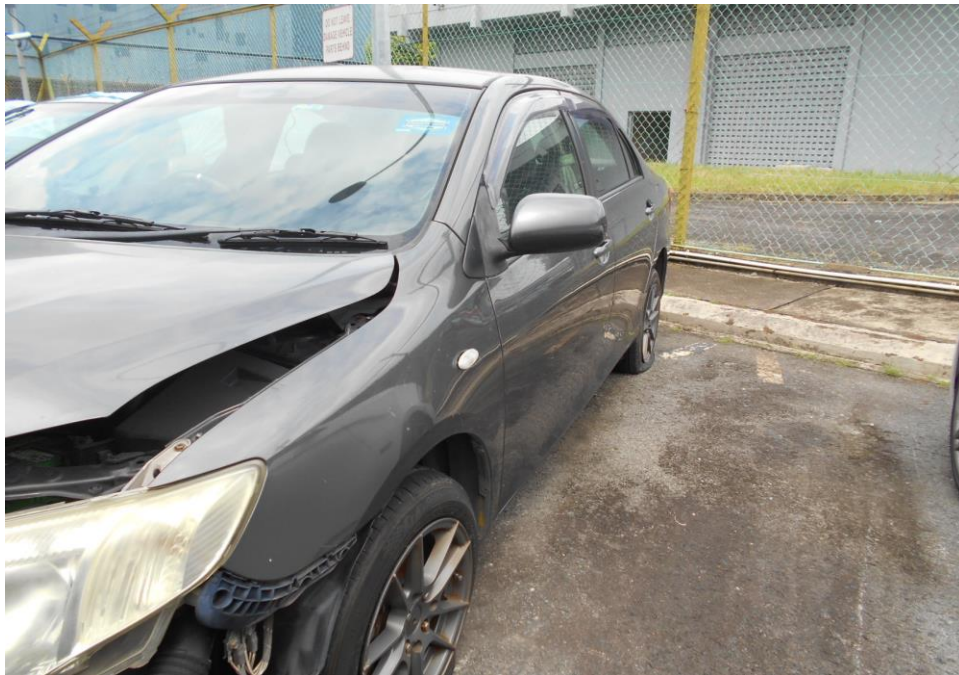
**Photo 6** shows a general view of the Motor Car's left body at the time of my inspection. The left portion of the Motor Car was observed to have been undamaged by the accident.

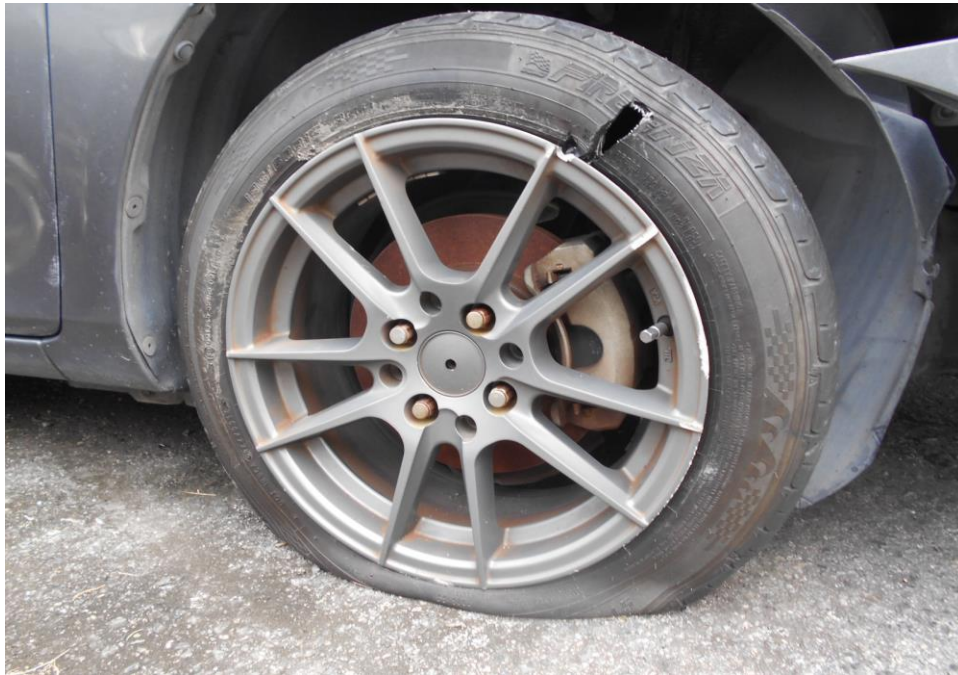
**Photo 7** shows the general condition of the front right tyre and wheel rim of the Motor Car, which was observed to be cut and deflated and the wheel rim was damaged as a result of the accident with remaining tread depth of approximately 5.1mm.

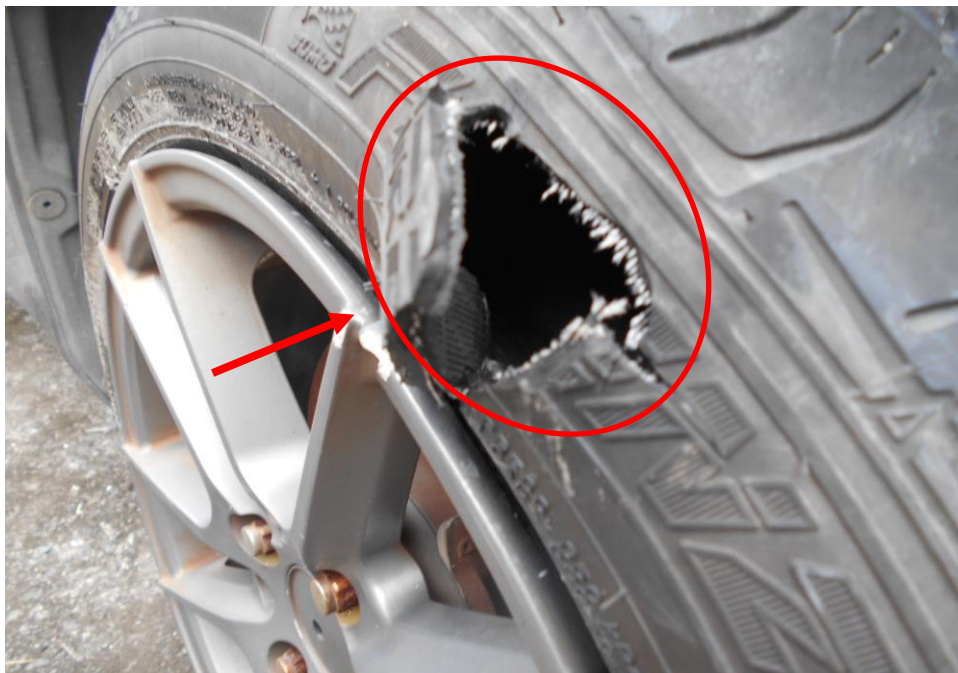
**Photo 8** shows the close up condition of the front right tyre and wheel rim of the Motor Car, which was observed to be cut and deflated (circled) and the wheel rim (arrowed) was damaged as a result of the accident with remaining tread depth of approximately 5.1mm

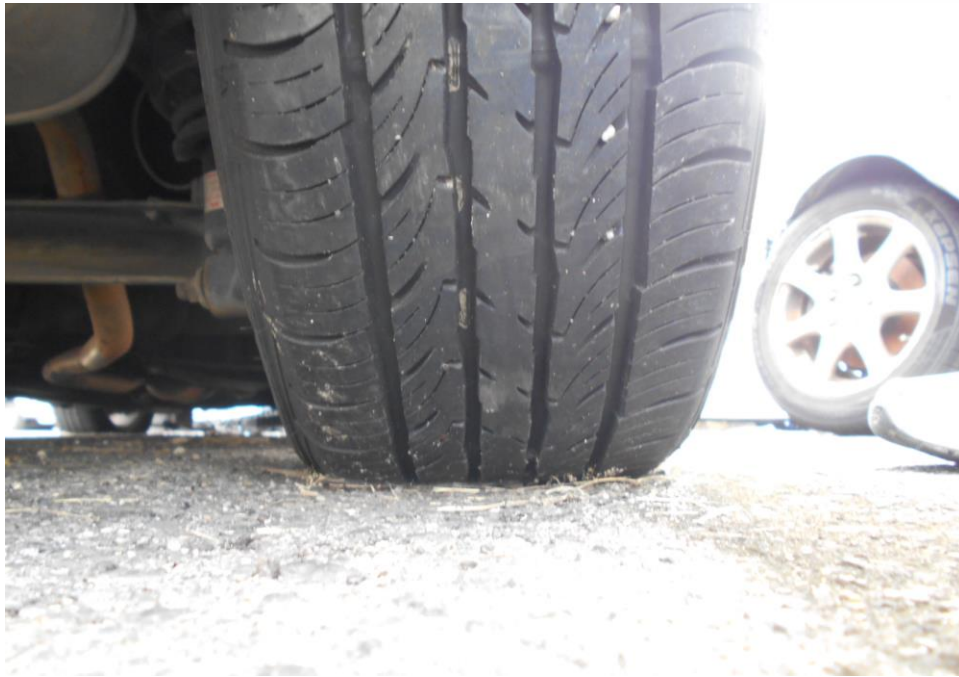
**Photo 9** shows the condition of the rear right tyre of the Motor Car, which was observed to be in serviceable condition with remaining tread depth of approximately 6.1mm. The tyre was also observed to be sufficiently inflated for vehicular operation with no tear, cut or burst mark(s).

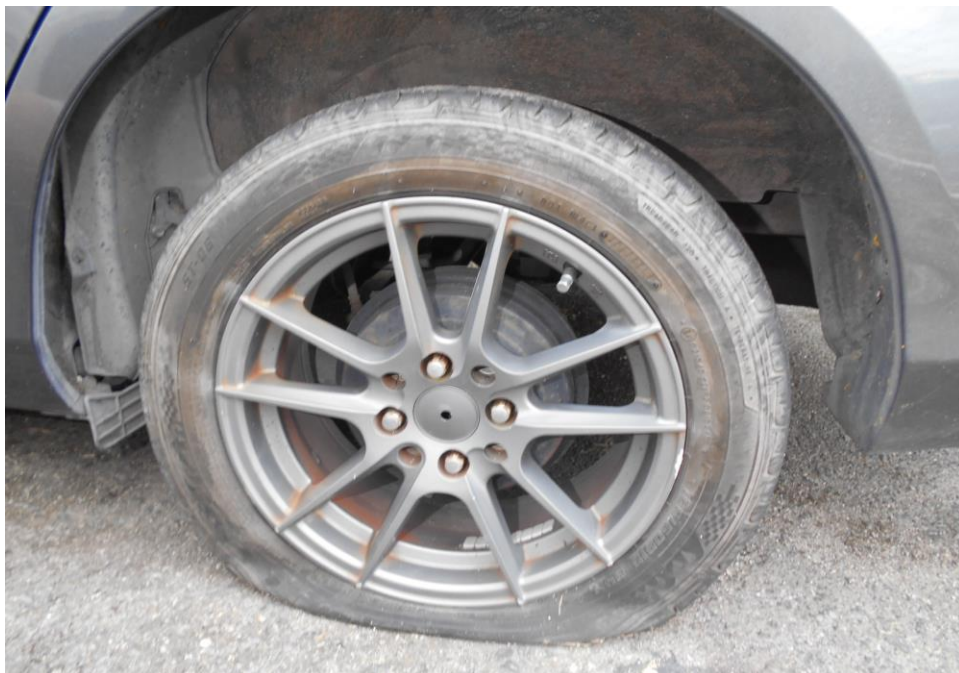
**Photo 10** shows the general condition of the rear left tyre and wheel rim of the Motor Car, which was observed to be deflated as a result of the accident with remaining tread depth of approximately 5.9mm.

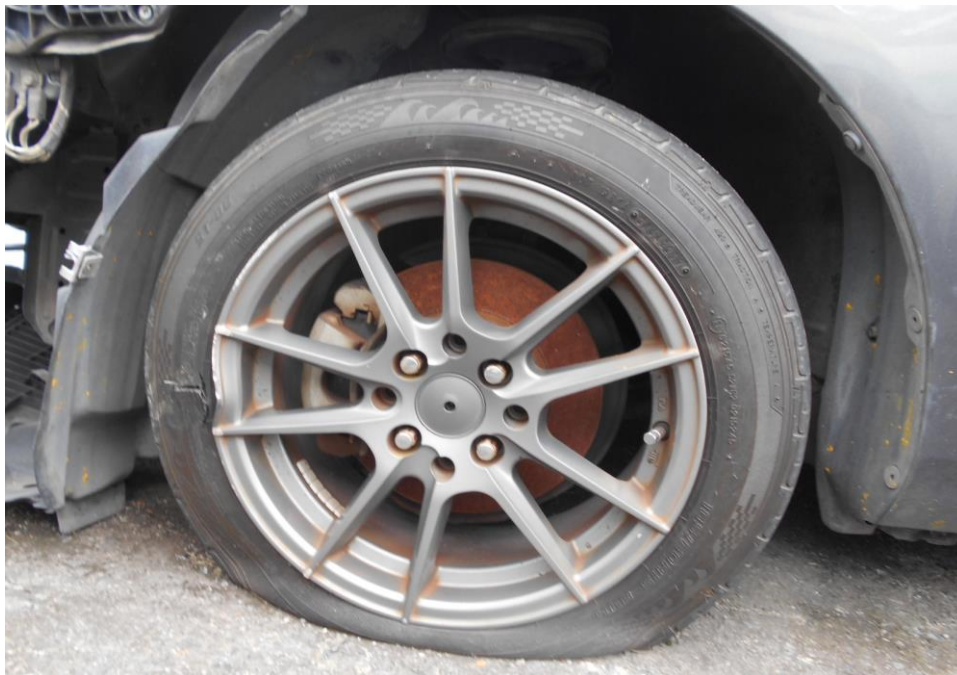
**Photo 11** shows the general condition of the front left tyre and wheel rim of the Motor Car, which was observed to be cut and deflated and the wheel rim was damaged as a result of the accident with remaining tread depth of approximately 4.6mm.

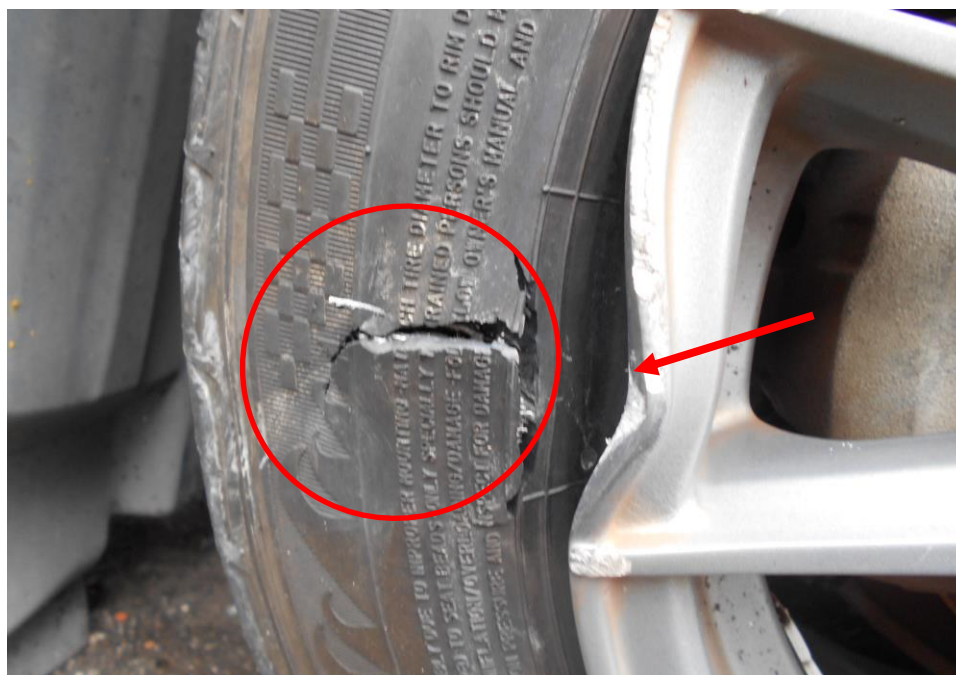
**Photo 12** shows the close up condition of the front left tyre and wheel rim of the Motor Car, which was observed to be cut and deflated (circled) and the wheel rim (arrowed) was damaged as a result of the accident with remaining tread depth of approximately 4.6mm

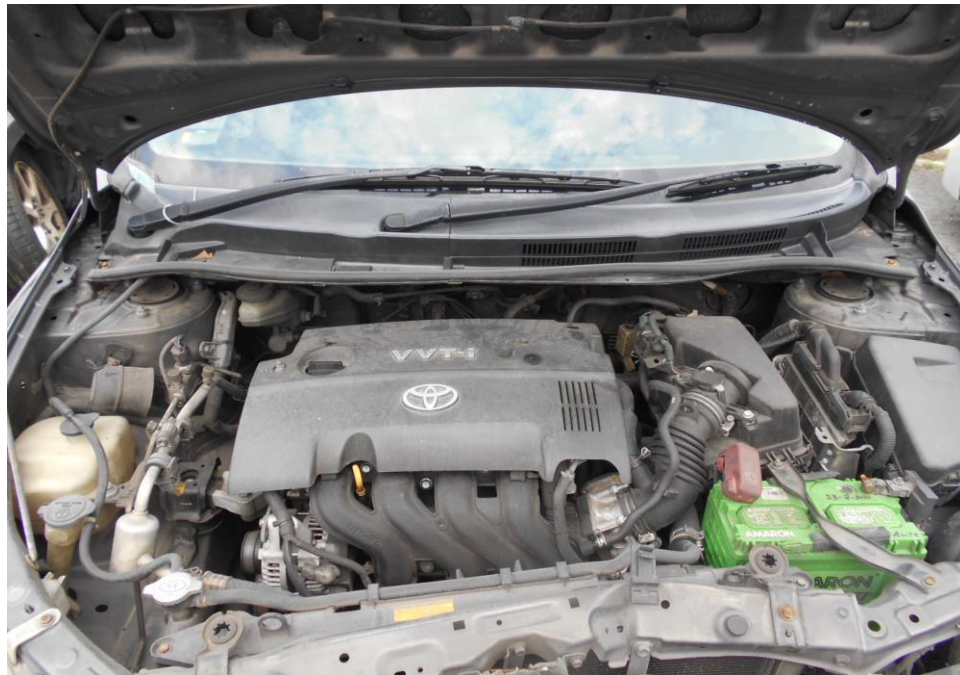
**Photo 13** shows a general view of the Motor Car's engine compartment, which was accessed by lifting the front bonnet of the Motor Car. The various parts and components inside the engine compartment were unaffected by the accident. There was also no sign(s) or indication(s) of fresh fluid leakage and/or fluid stain within the engine compartment.

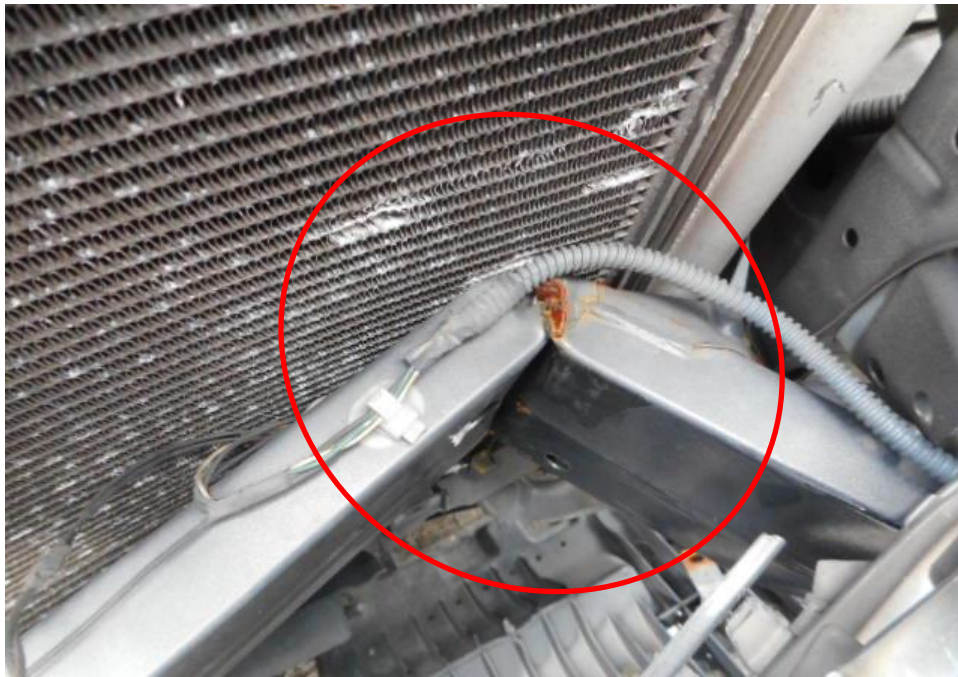
8. Upon examination of the Motor Car's engine compartment, I had observed only coolant in the radiator to be insufficient due to the damage to the front as a result of the accident. However, all the other parts and components inside the engine compartments was observed to be intact and unaffected by the accident. The engine oil and brake fluid were all found to be of sufficient level for operating purposes. Visually, there was no contamination found to these fluids.

**Photo 14** shows the close up view of the engine compartment of the Motor Car at the time of my inspection. The engine radiator (circled) was observed to be damaged and as a result of the accident.

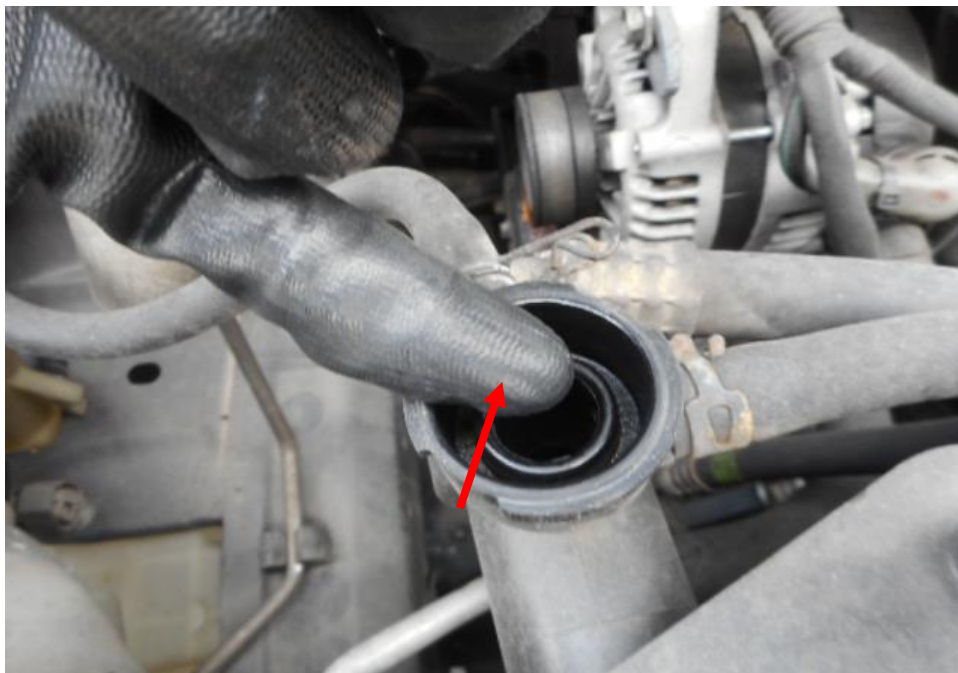
**Photo 15** shows the engine coolant radiator cap of the Motor Car at the time of my inspection. The coolant was observed to be of insufficient level (arrowed) as a result of the accident.

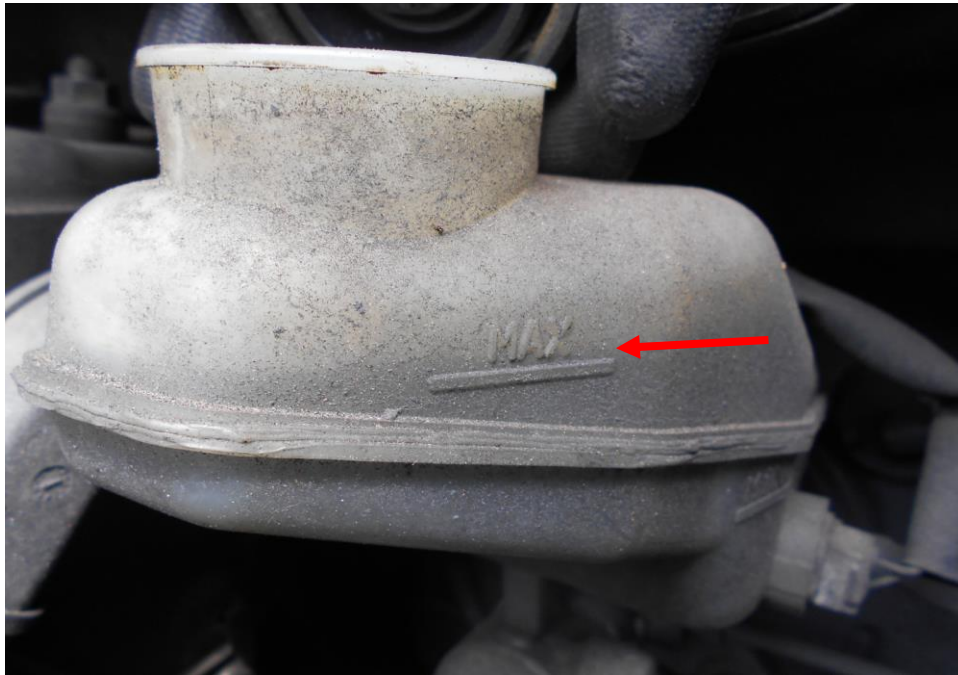
**Photo 16** shows the brake fluid reservoir of the Motor Car at the time of my inspection. The coolant was observed to be of sufficient level (arrowed) without any visible contamination.

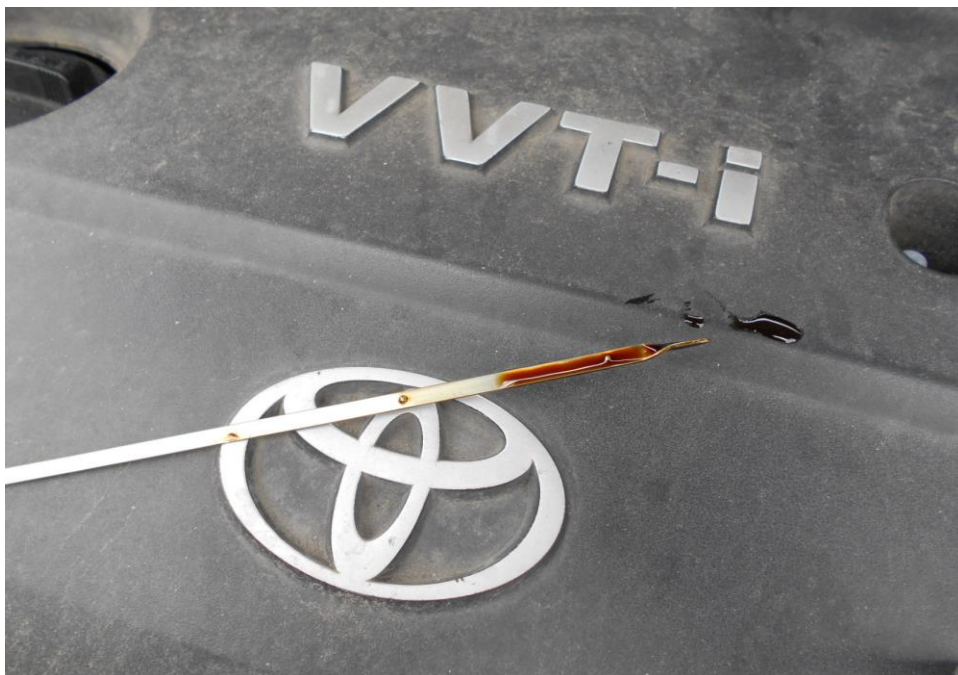
**Photo 17** shows the engine oil level dipstick of the Motor Car at the time of my inspection. The engine oil was observed to be of sufficient level and without any visible contamination.

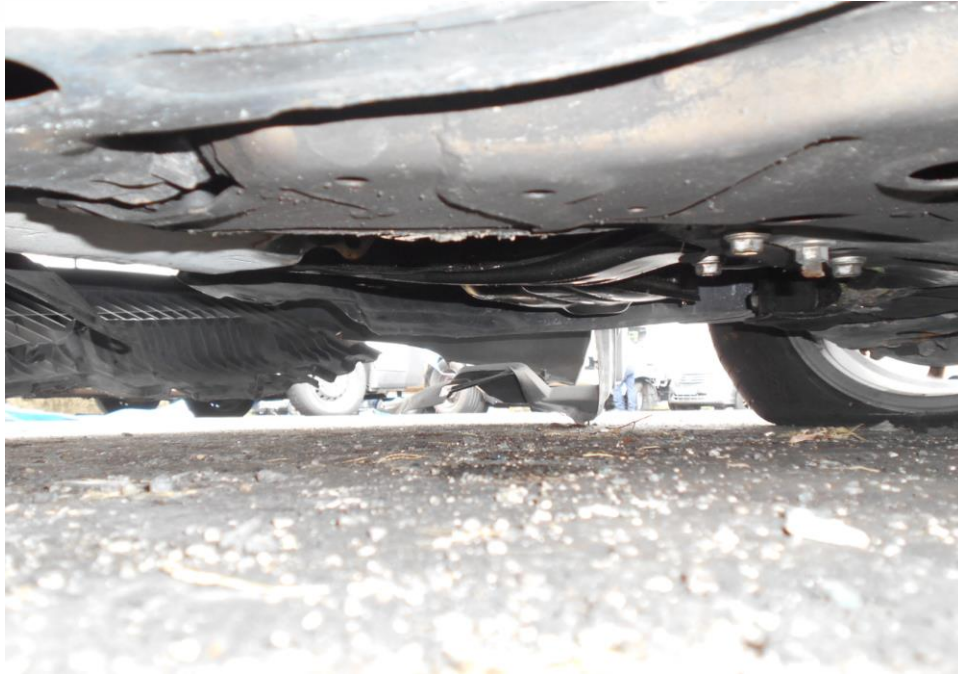
10. My subsequent checks on the underside of the Motor Car also revealed no sign(s) or indication(s) of fluid leak and/or fluid stain(s). Visually, the various undercarriage components of the Motor Car were all observed to be intact and without any visible damage. See photo 13 -18 below.

**Photo 18** shows the undercarriage of the Motor Car, at the area where the engine housing and transmission housing are located. I did not find any sign(s) or indication(s) of fluid leak and/or fluid stain(s) on the underside of the Motor Car.

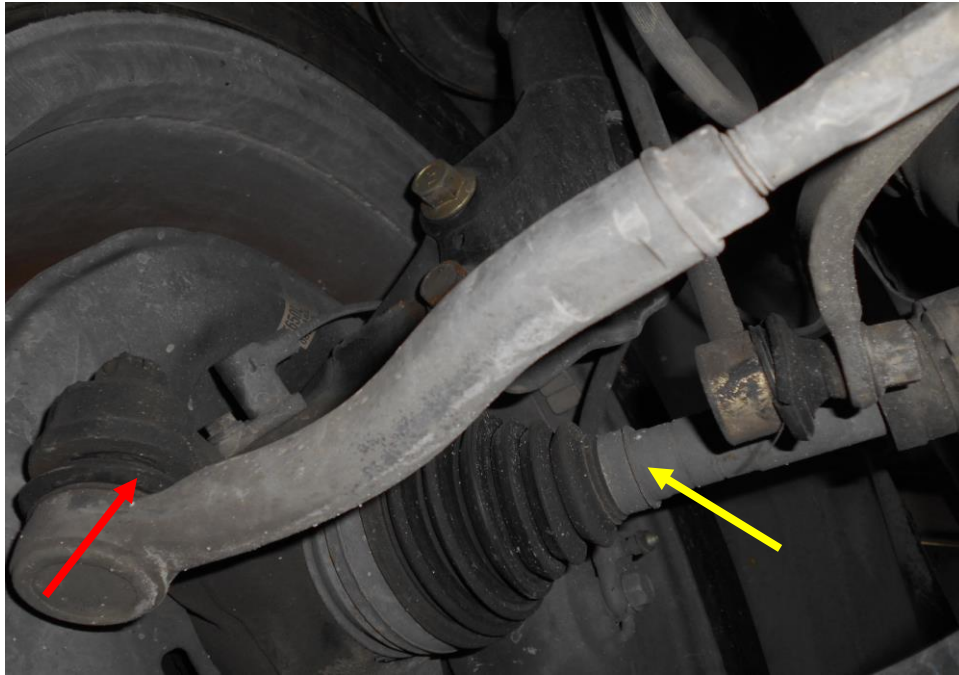
**Photo 19** shows the various undercarriage components at the left rear wheel of the Motor Car, in particular the steering tie rod (red arrow) and driveshaft (yellow arrow) and various steering components were all found to be intact. There was also no sign of fluid stain observed on the various undercarriage components at the front right wheel of the Motor Car.

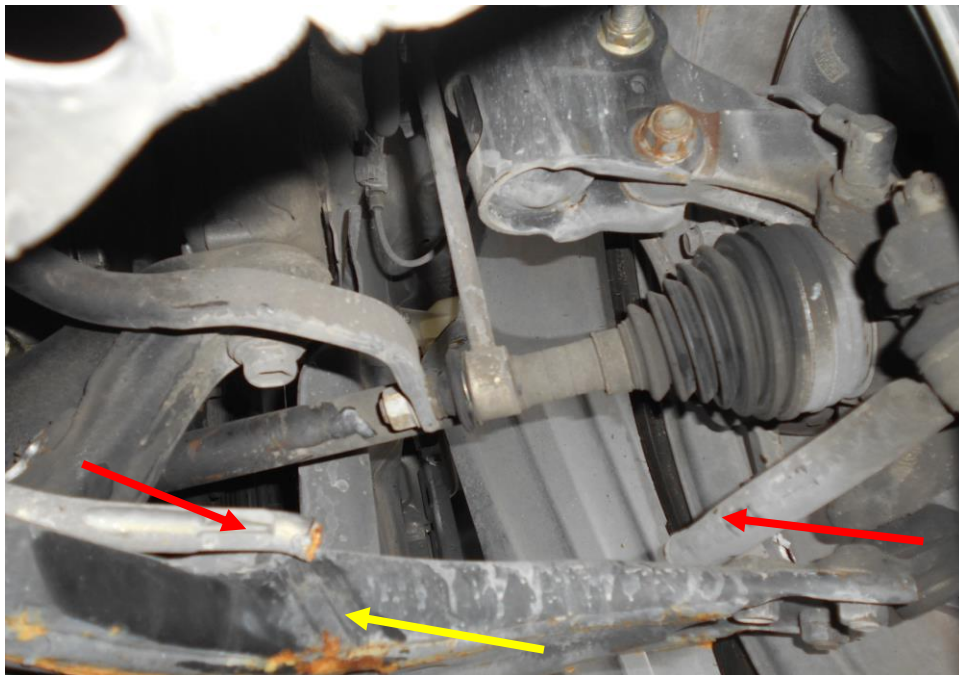
**Photo 20** shows the various undercarriage components at the front right wheel of the Motor Car, in particular the steering tie rod (red arrow) and front lower control arm (yellow arrow) was found to be damaged as a result of the accident.

14. Operational test to primarily determine whether there was any abnormality to the engine system, transmission system and braking system of the Motor Car could not be conducted given the engine of the Motor Car was unable to be started up due to the vehicle unable to be jump started despite multiple attempts and the damages sustained to the front right tie rod and lower control arm as a result of the accident.

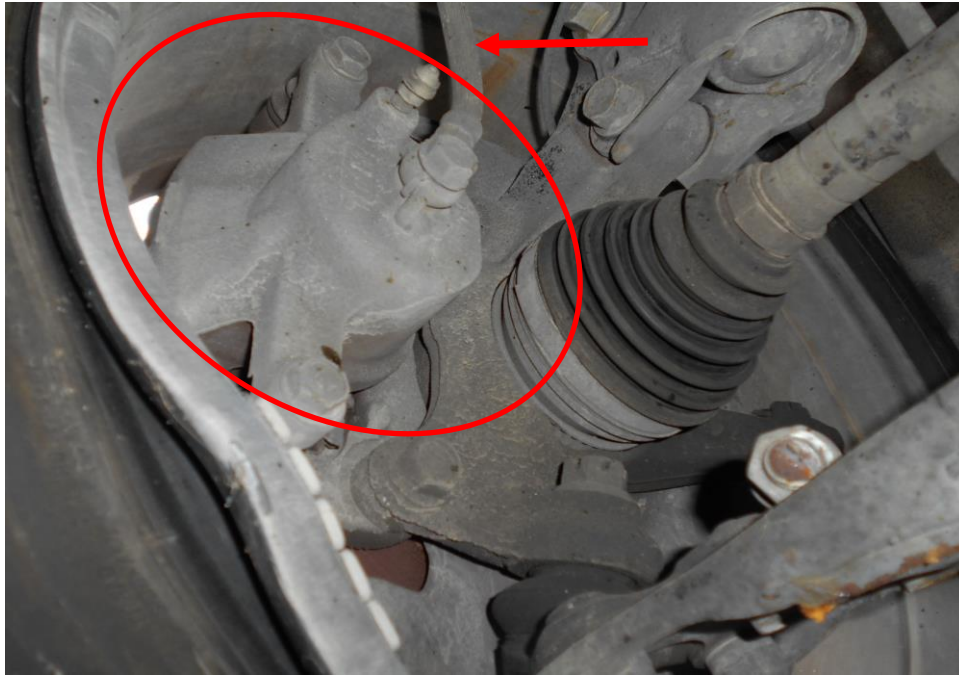
**Photo 21.** shows the brake hose/pipe (arrowed) at the front right wheel of the Motor Car. No leakage of brake fluid was observed. Visual examination of the various components of the braking system like the brake caliper (circled), brake booster, brake pedal etc had revealed all to be intact and without visible damage.

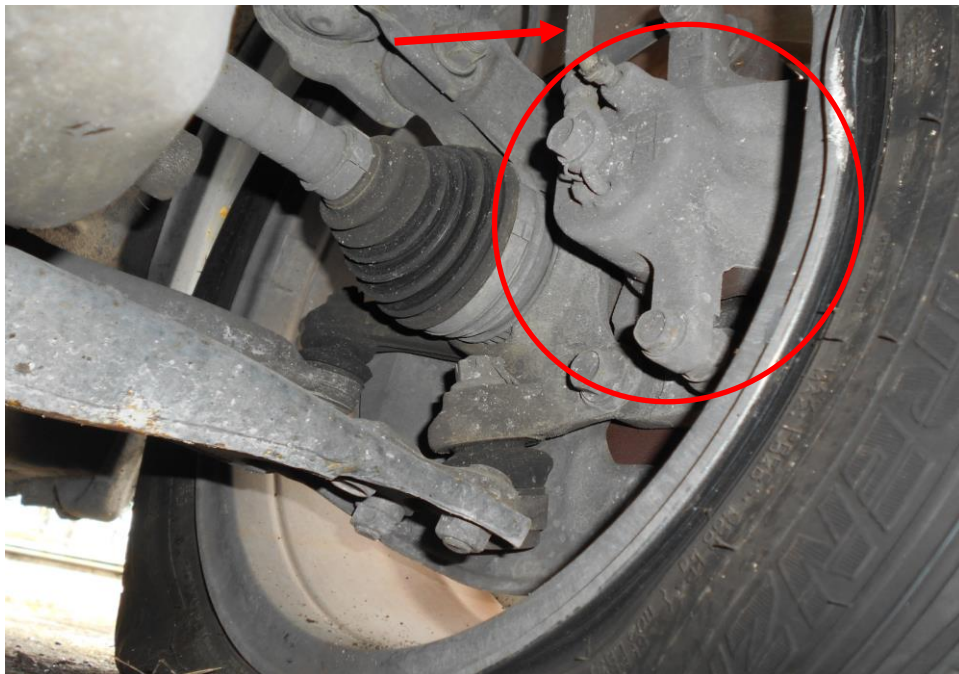
**Photo 22** shows the brake hose/pipe (arrowed) at the front left wheel of the Motor Car. No leakage of brake fluid was observed. Visual examination of the various components of the braking system like the brake caliper (circled), brake booster, brake pedal etc had revealed all to be intact and without visible damage.

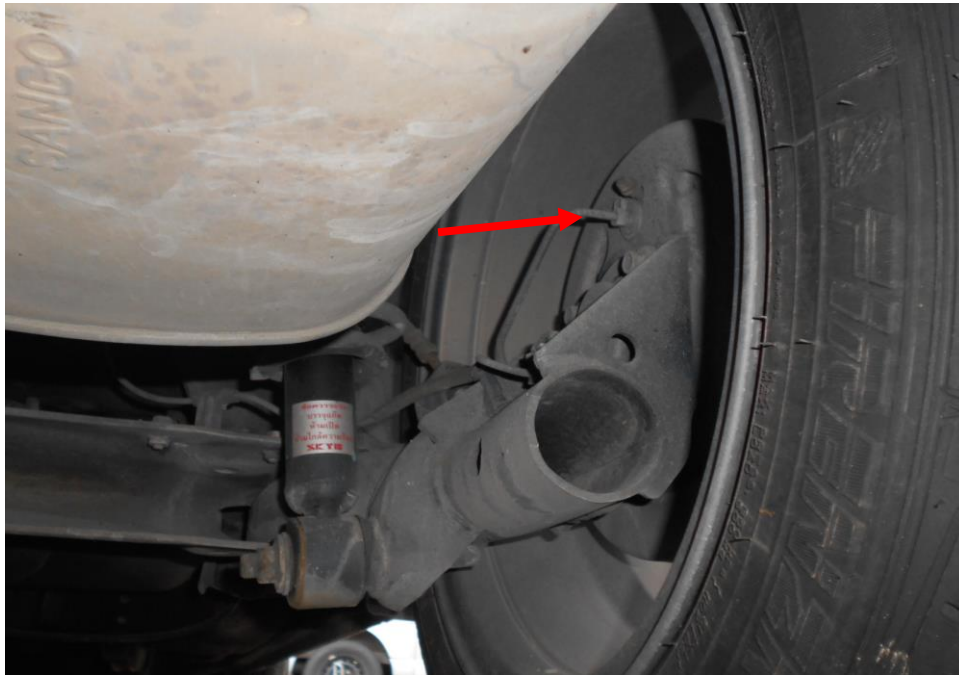
**Photo 23** shows the brake hose/pipe (arrowed) at the rear right wheel of the Motor Car. No leakage of brake fluid was observed. Visual examination of the various components of the braking system like the drum brake, brake booster, brake pedal etc. had revealed all to be intact and without visible damage.

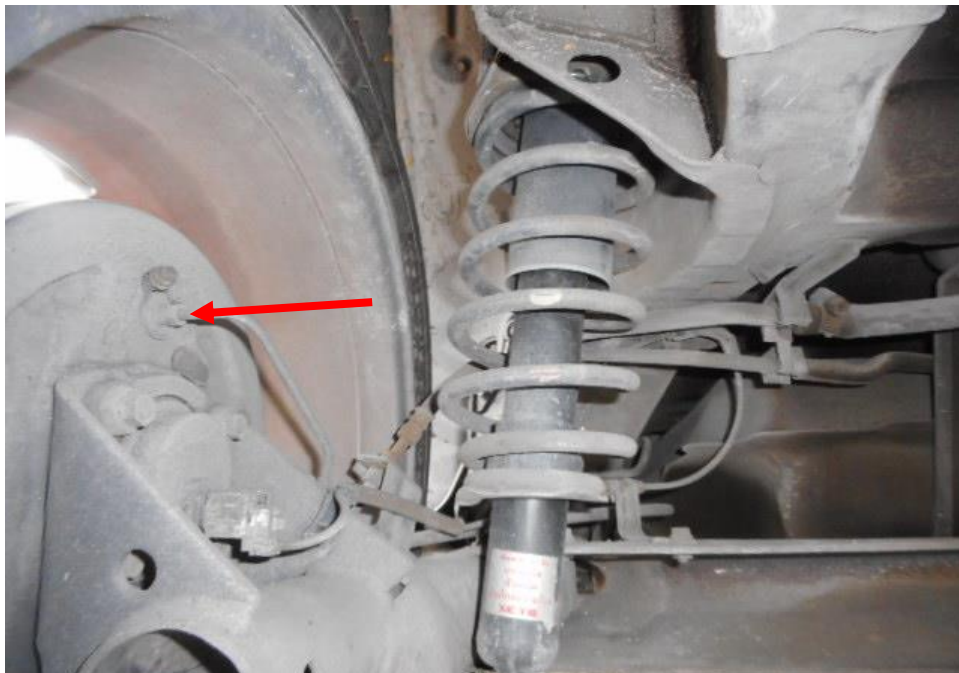
**Photo 24** shows the brake hose/pipe (arrowed) at the rear left wheel of the Motor Car. No leakage of brake fluid was observed. Visual examination of the various components of the braking system like the drum brake, brake booster, brake pedal etc. had revealed all to be intact and without visible damage.

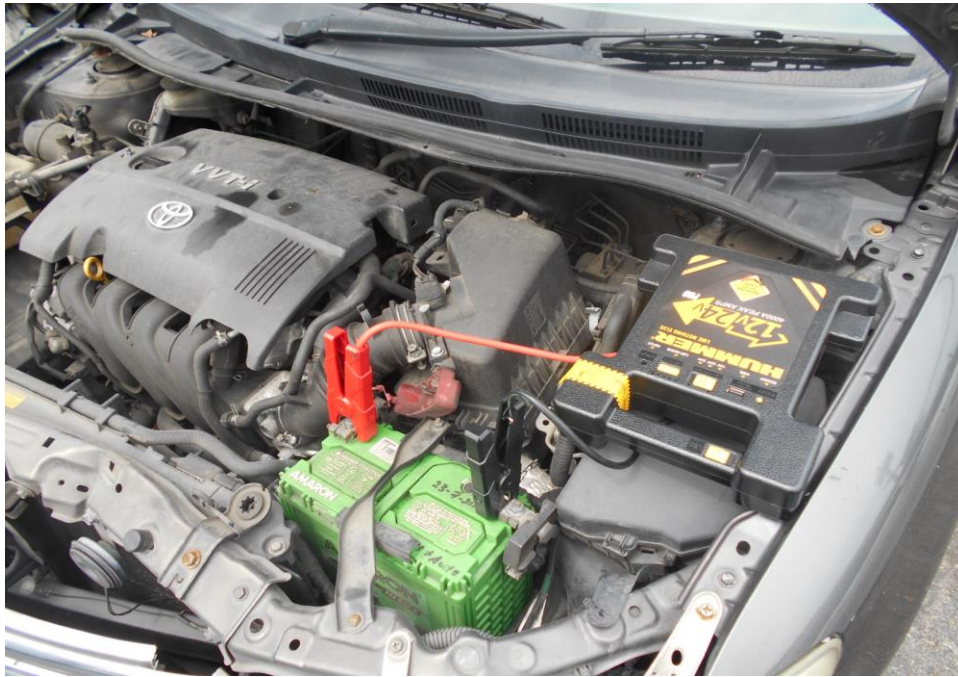
**Photo 25** shows the jumpstarting of the Motor Car using a jump starter. The engine of the Motor Car was unable to be started up despite multiple attempts in jumpstarting it.
