Your Ref: TP IP/07285/2023
Our Ref : CI/TPD23005778/P

18th July 2023

MECHANICAL INSPECTION REPORT OF MOTOR CAR SBH 3808B

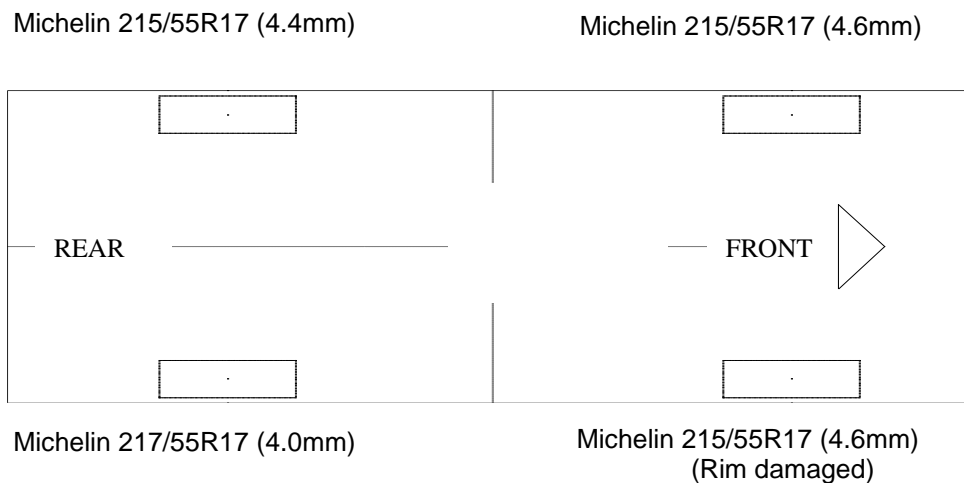
6. The front right wheel rim was observed to be damage as a result of the accident, however the condition of the Motor Car's 4 tyres was observed to be in serviceable condition. I did not find any tear, cut or burst mark(s) on the outer and the inner sidewalls as well as across the tread of the 4 tyres. The 4 tyres were observed to be sufficiently inflated for vehicular operation. The tyre brand, tyre size and remaining tread depth of the 4 tyres were recorded as follows:-

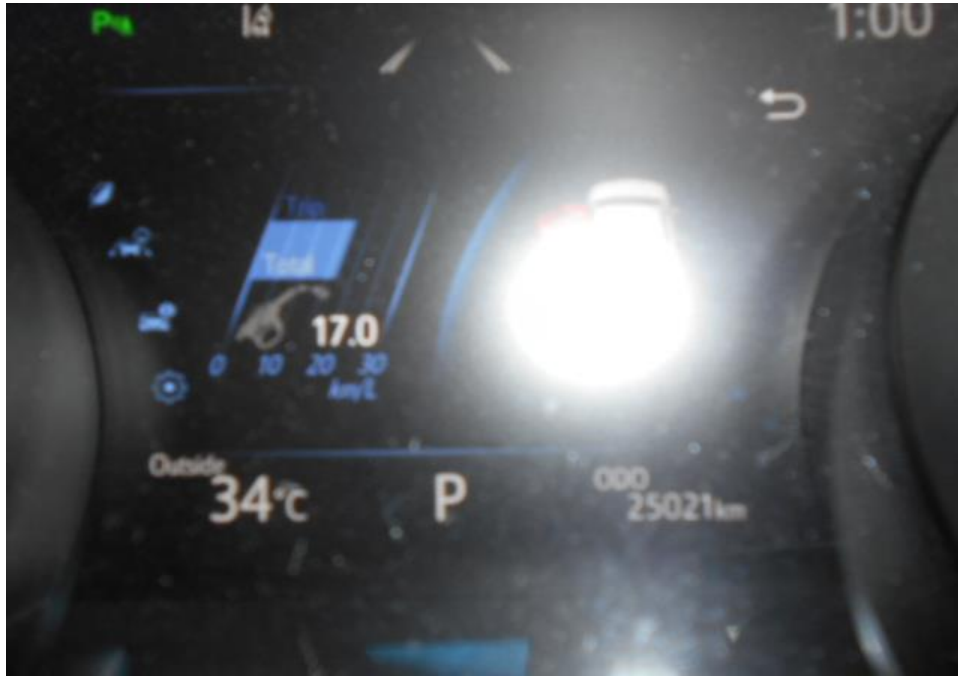
Photo 1 shows the mileage of the Motor Car at the time of my inspection. The mileage observed was 25,021km.

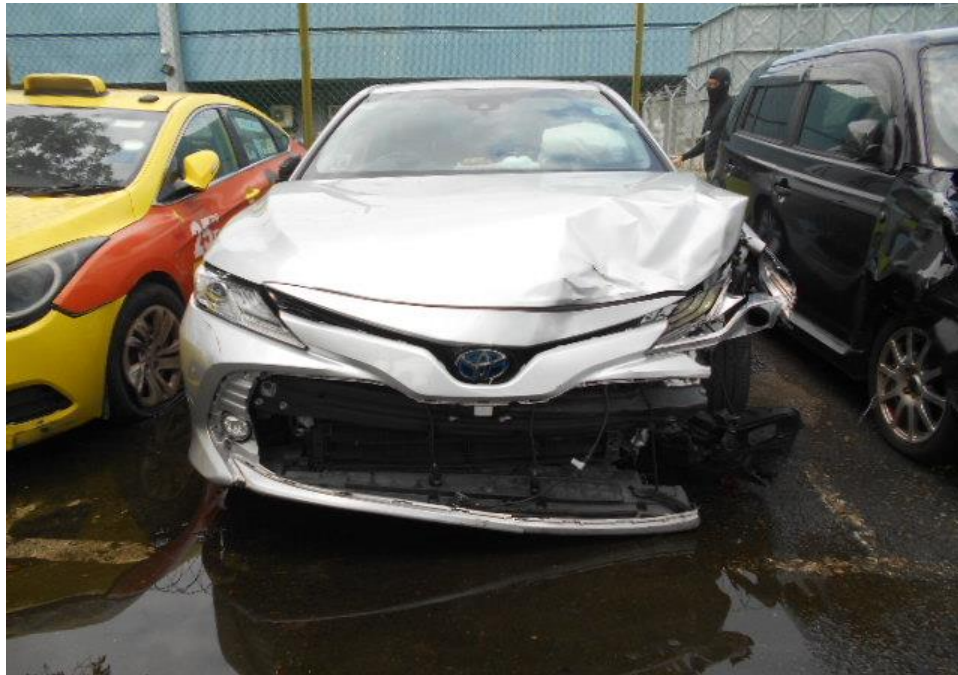
Photo 2 shows a general view of the Motor Car's front body at the time of my inspection. The front portion of the Motor Car was observed to have sustained damage. Its front windscreen, front bumper, front left and right headlamp was amongst the body parts that were damaged as a result of the accident.

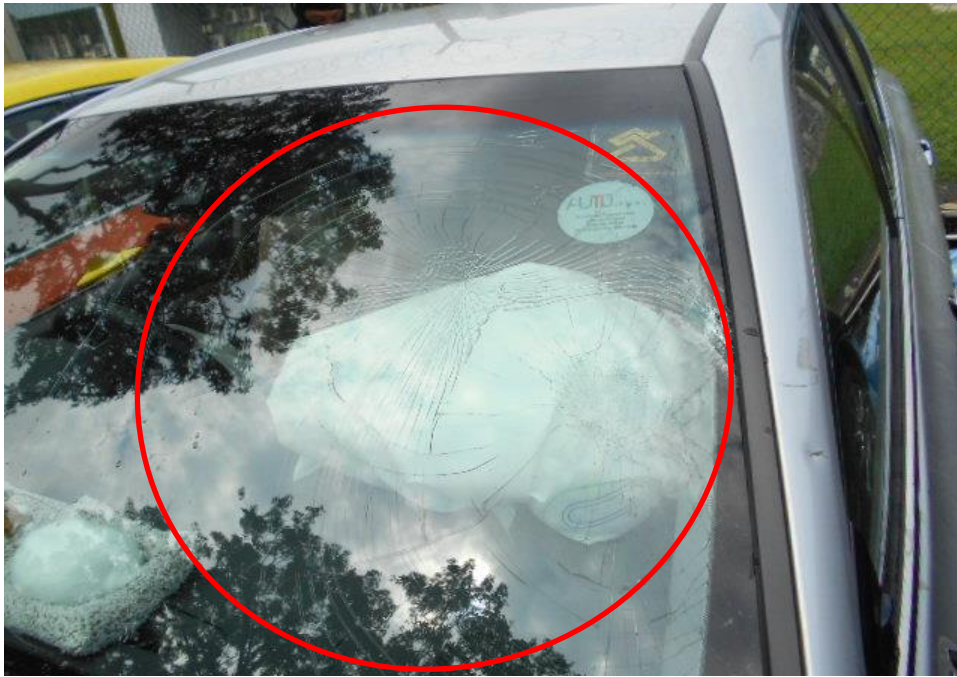
Photo 3 shows a close up view of the Motor Car's front body at the time of my inspection. The Motor Car was observed to have sustained damage at its front portion. Its front windscreen (circled) was damaged as a result of the accident.

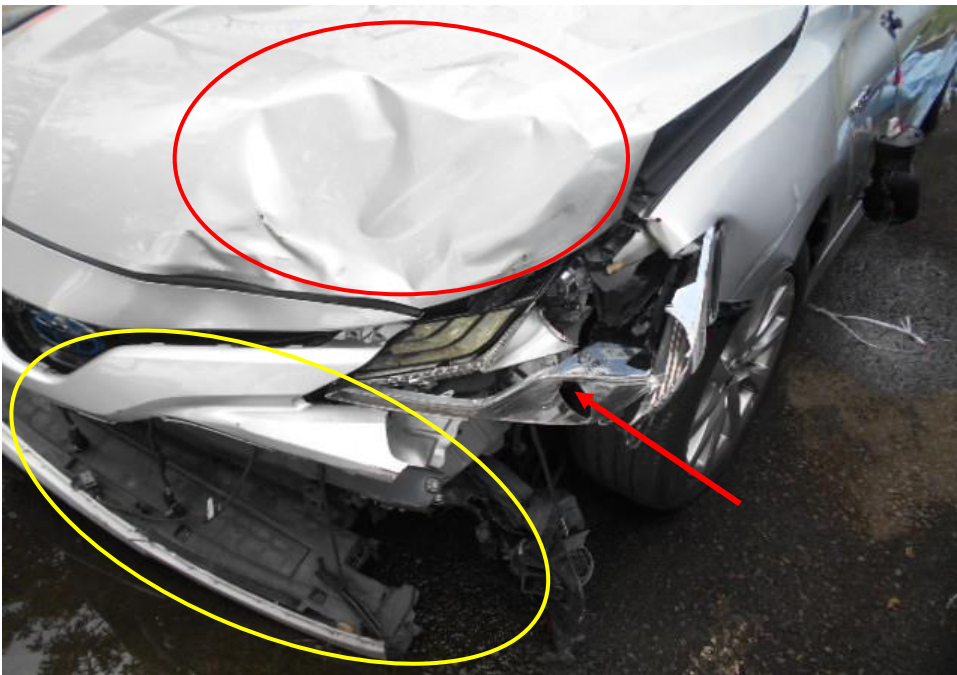
Photo 4 shows the close up view of the Motor Car's front body at the time of my inspection. The Motor Car was observed to have sustained damage at its front portion. Its front bumper (yellow circle), front bonnet (red circle) and front left headlamp (arrowed) was damaged as a result of the accident.

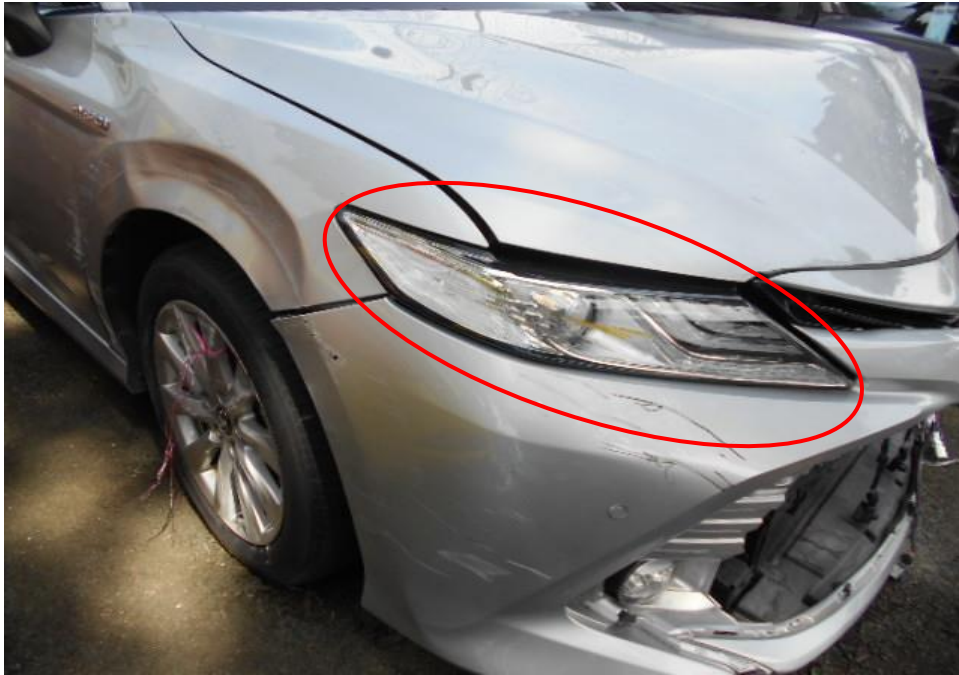
Photo 5 shows the close up view of the Motor Car's front body at the time of my inspection. The Motor Car was observed to have sustained damage at its front portion. Its front right headlamp (circled) was damaged as a result of the accident.

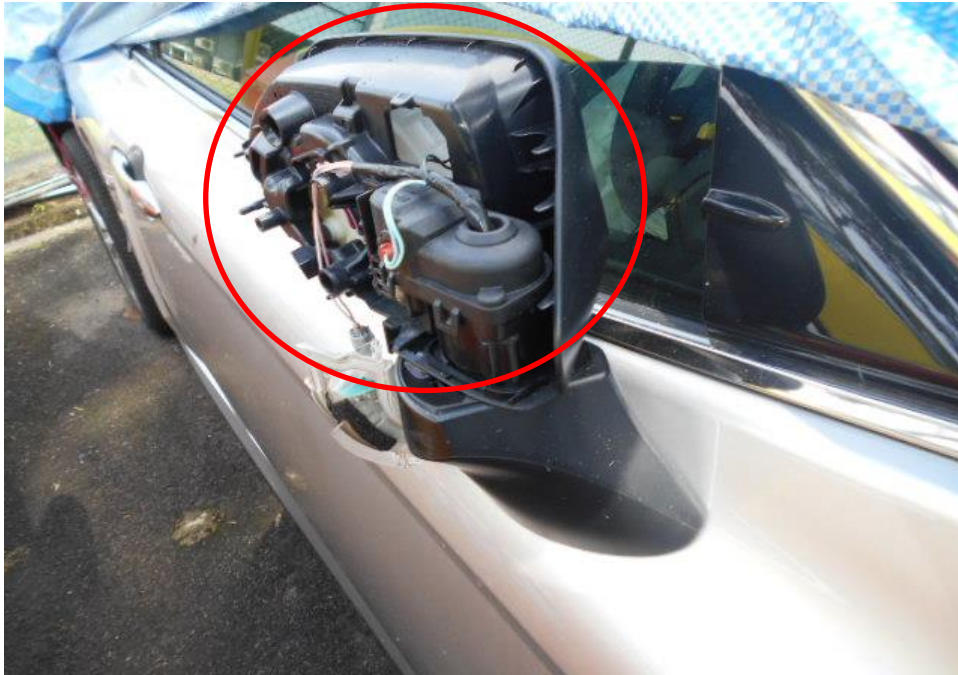
Photo 7 shows a close up view of the Motor Car's right body at the time of my inspection. The Motor Car was observed to have sustained damage at its right, portion. Its right rear view mirror (circled) was amongst the body parts that were damaged as a result of the accident.

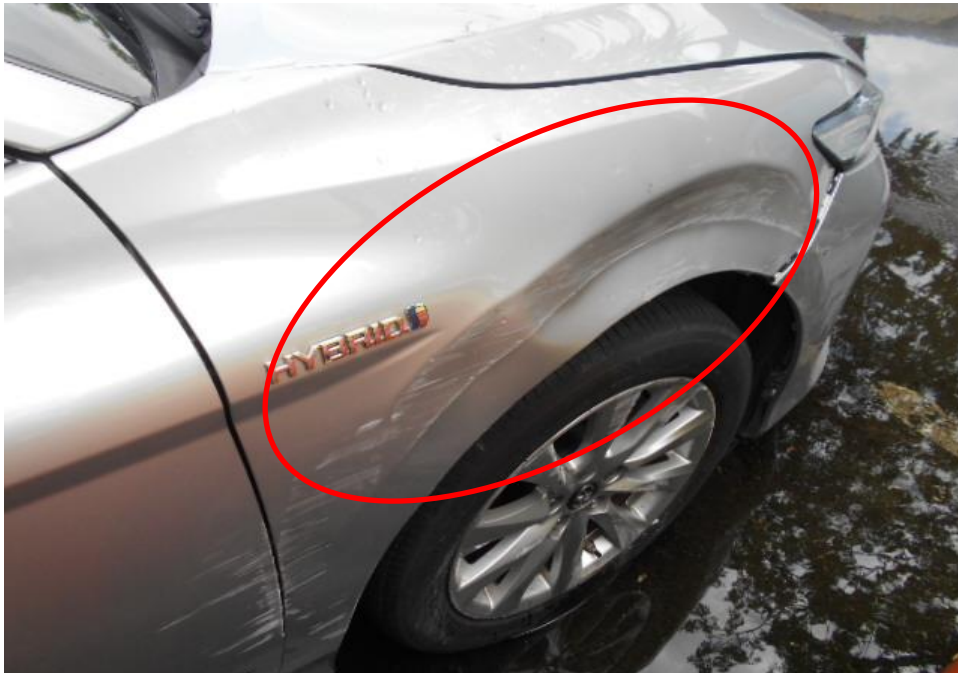
Photo 8 shows a close up view of the Motor Car's right body at the time of my inspection. The Motor Car was observed to have sustained damage at its right, portion. Its right front fender (circled) was amongst the body parts that were damaged as a result of the accident.

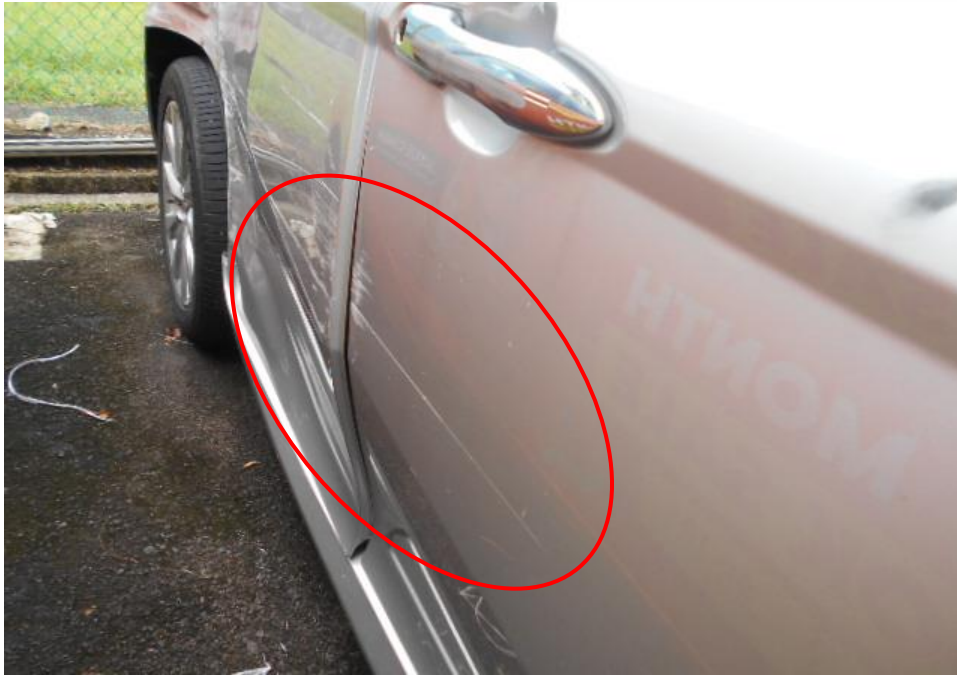
Photo 9 shows the close up view of the Motor Car's right portion at the time of my inspection. The right rear door (circled) of the Motor Car was observed to have been damaged as a result of the accident.

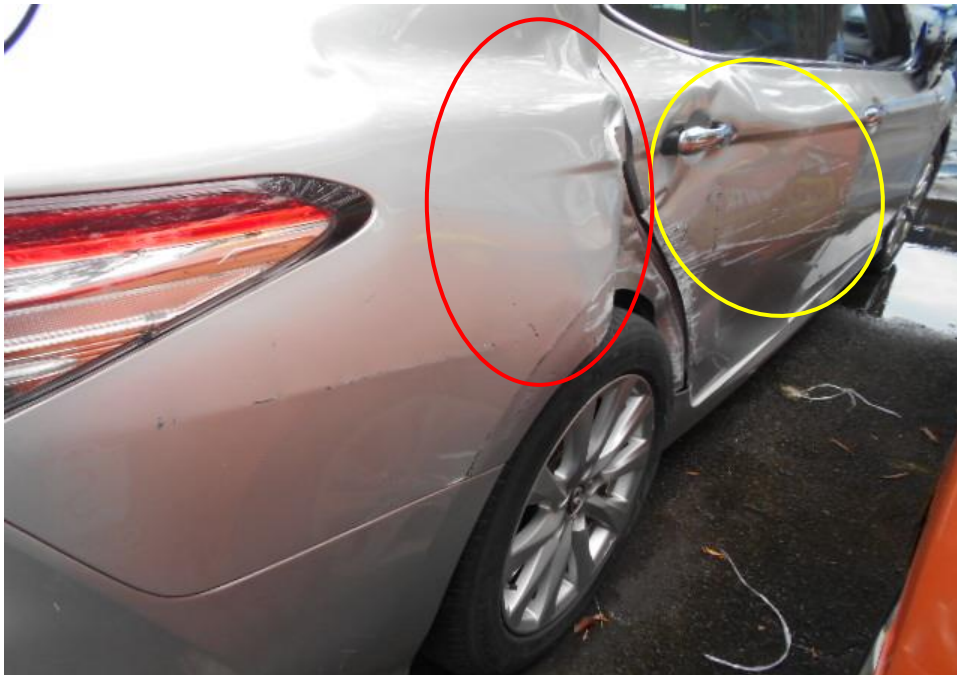
Photo 10 shows a close up view of the Motor Car's right body at the time of my inspection. The Motor Car was observed to have sustained damage at its right, portion. Its right rear quarter panel (red circle) and right door (yellow circle) was amongst the body parts that were damaged as a result of the accident.

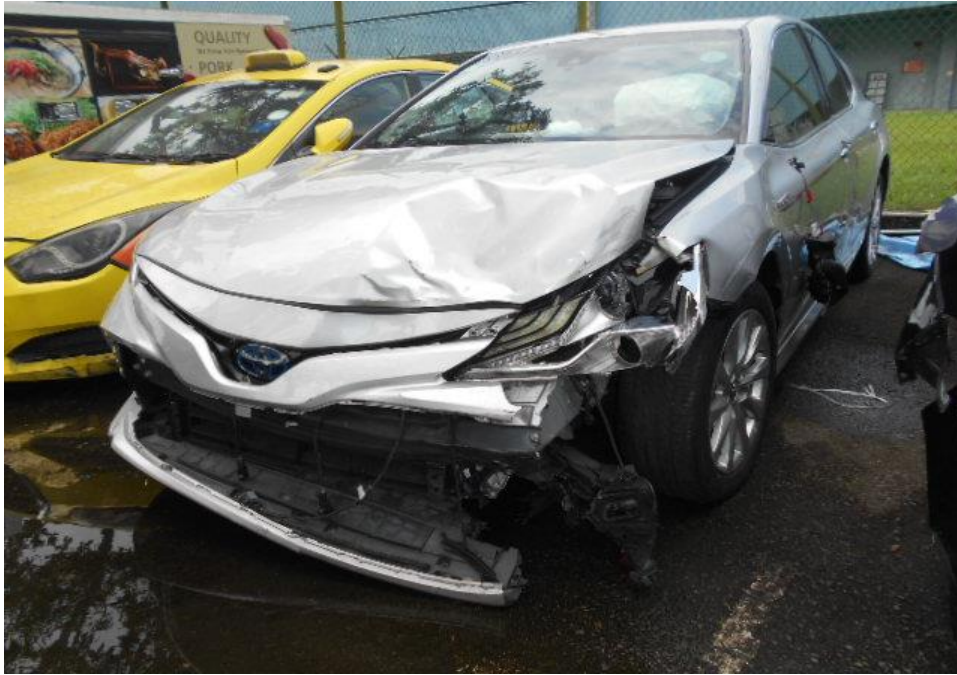
Photo 11 shows the general view of the Motor Car's left body at the time of my inspection. The Motor Car was observed to have sustained damage at its right, portion. Its left rear-view mirror left front fender and front left doors was amongst the body parts that were damaged as a result of the accident.

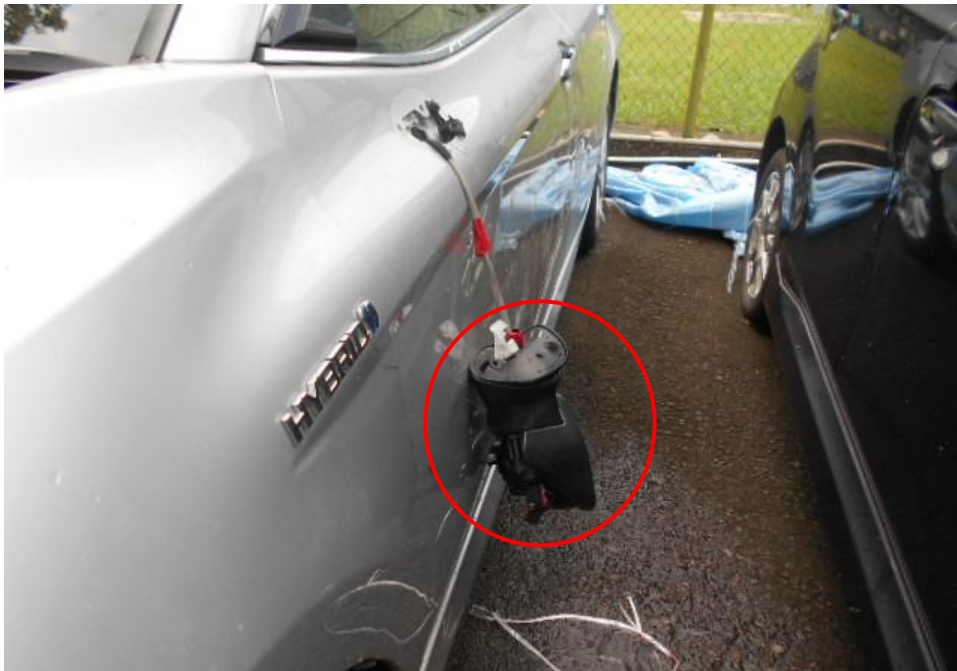
Photo 12 shows a close up view of the Motor Car's left body at the time of my inspection. The Motor Car was observed to have sustained damage at its right, portion. Its left rear view mirror (circled) was amongst the body parts that were damaged as a result of the accident.

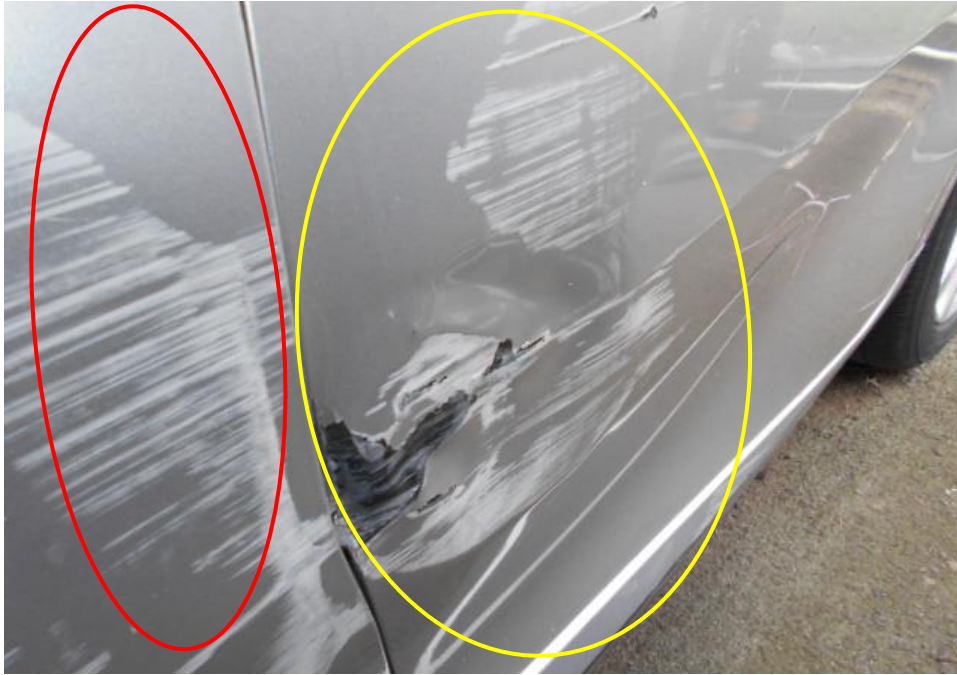
Photo 13 shows a close up view of the Motor Car's left body at the time of my inspection. The Motor Car was observed to have sustained damage at its left, portion. Its left fender (red circle) and left door (yellow circle) was amongst the body parts that were damaged as a result of the accident.

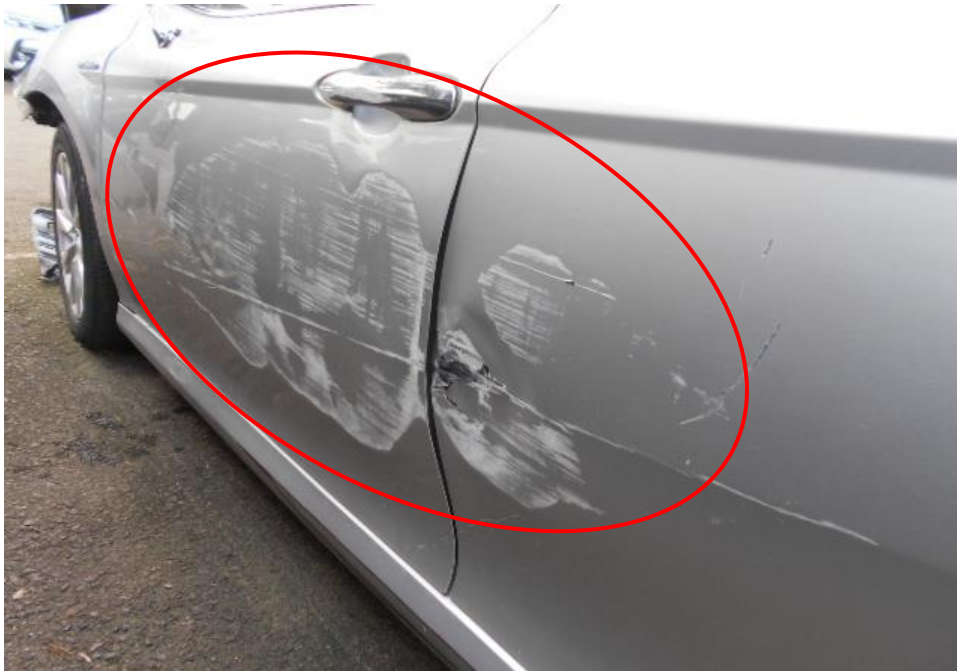
Photo 14 shows a close up view of the Motor Car's left body at the time of my inspection. The Motor Car was observed to have sustained damage at its left, portion. Its left doors (circled) was amongst the body parts that were damaged as a result of the accident.

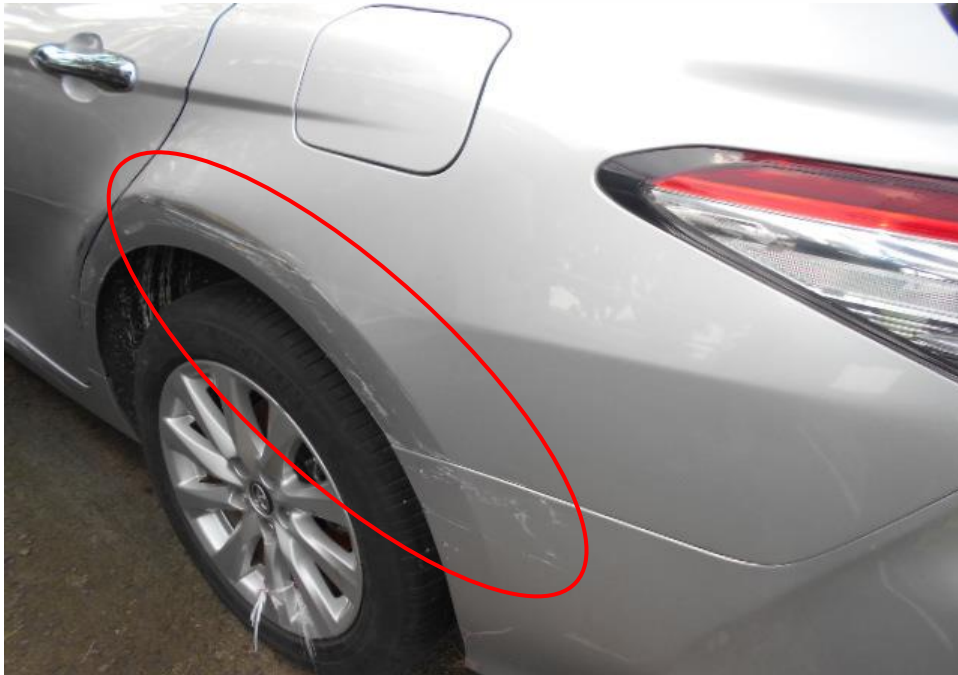
Photo 15 shows a close up view of the Motor Car's rear body at the time of my inspection. The Motor Car was observed to have sustained damage at its rear, portion. Its rear left quarter panel (circled) was amongst the body parts that were damaged as a result of the accident.

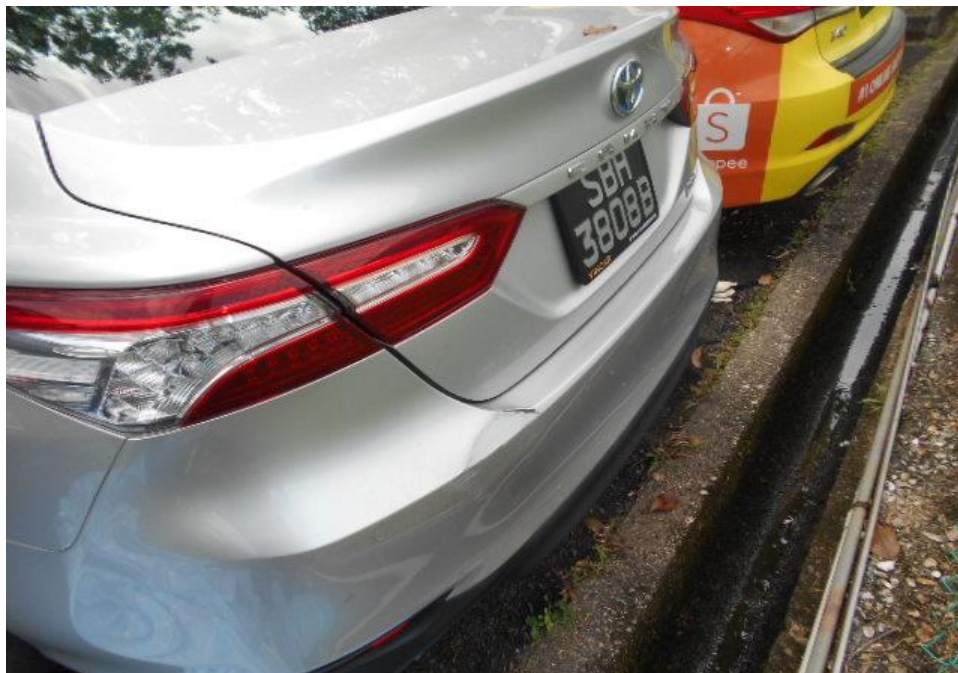
Photo 16 shows the general view of the Motor Car's rear body at the time of my inspection. The Motor Car was observed to have sustained damage at its rear, portion. Its rear bumper was amongst the body parts that were damaged as a result of the accident.

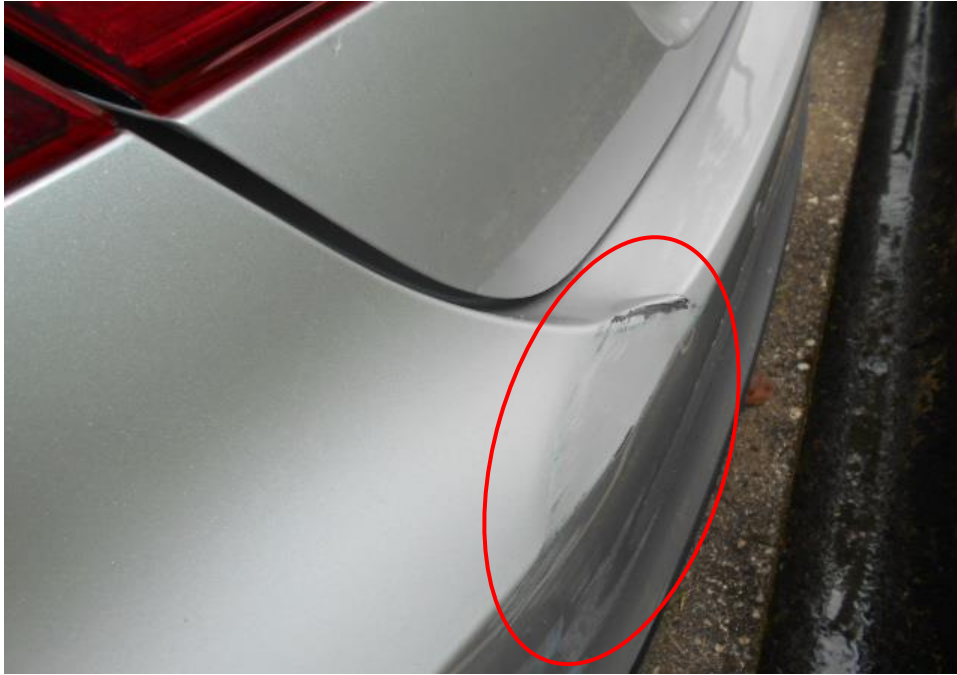
Photo 17 shows a close up view of the Motor Car's rear body at the time of my inspection. The Motor Car was observed to have sustained damage at its rear, portion. Its rear bumper (circled) was amongst the body parts that were damaged as a result of the accident.

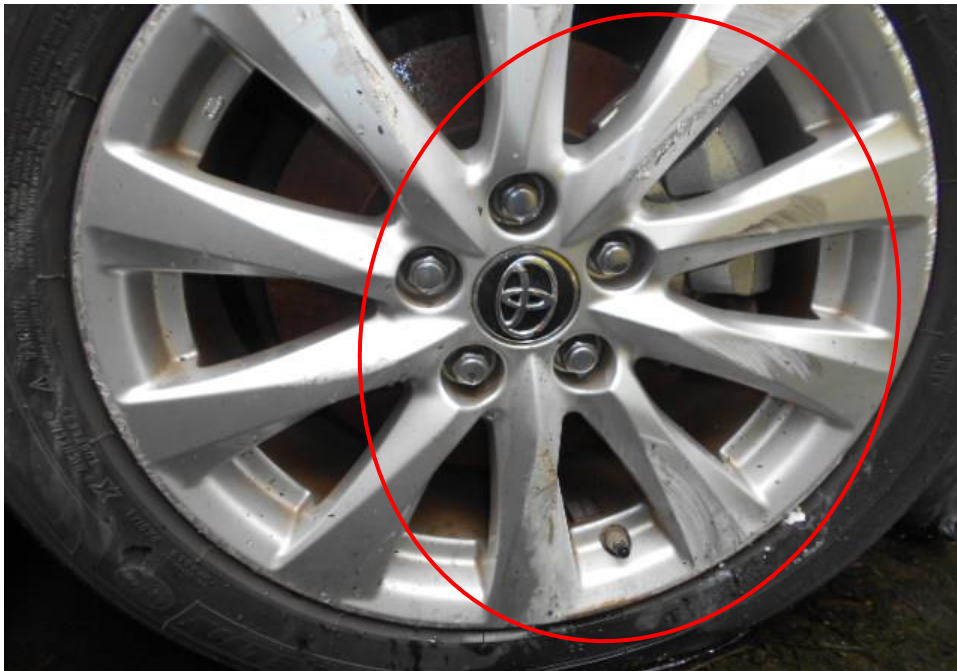
Photo 18 shows the general view of the front right wheel rim (circled) of the Motor Car, which was observed to be damaged as a result of the accident.

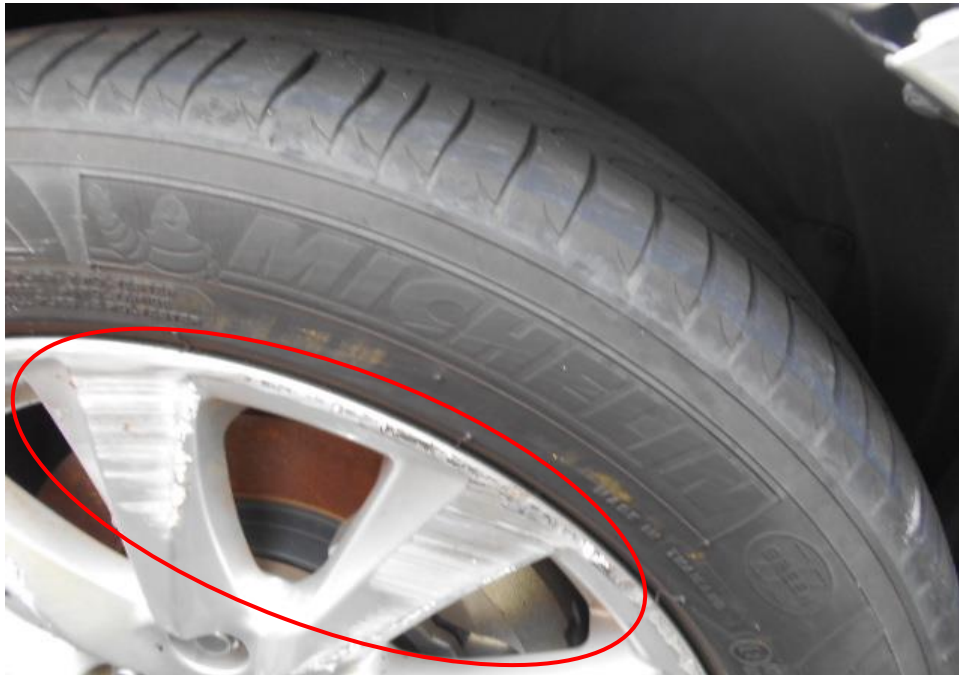
Photo 19 shows the close up condition of the front right wheel rim (circled) of the Motor Car, which was observed to be damaged as a result of the accident.

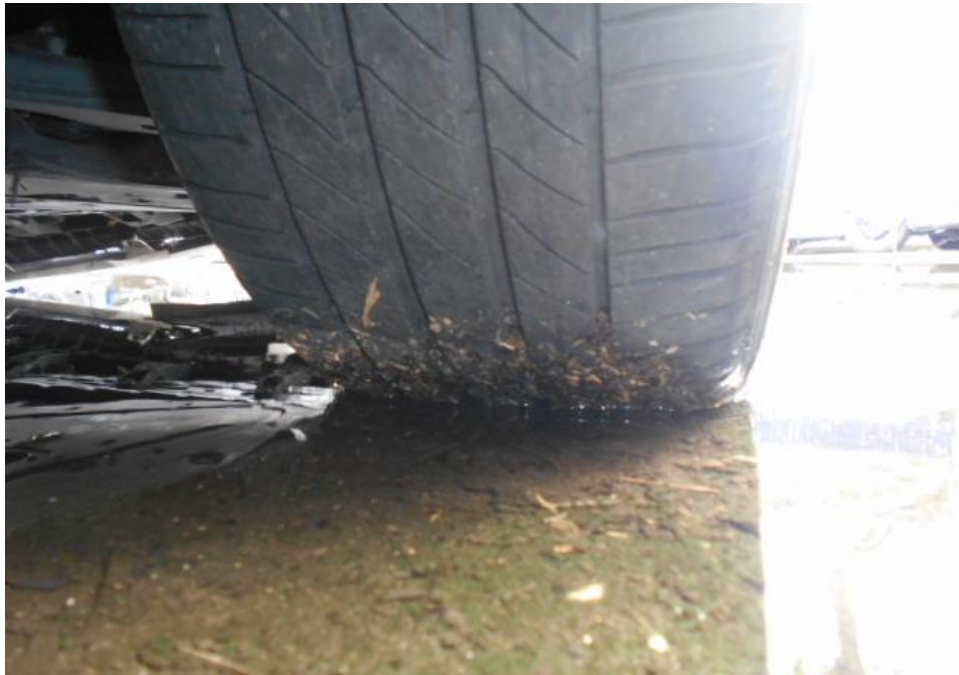
Photo 20 shows the condition of the front right tyre of the Motor Car, which was observed to be in serviceable condition with remaining tread depth of approximately 4.6mm. The tyre was also observed to be sufficiently inflated for vehicular operation with no tear, cut or burst mark(s).

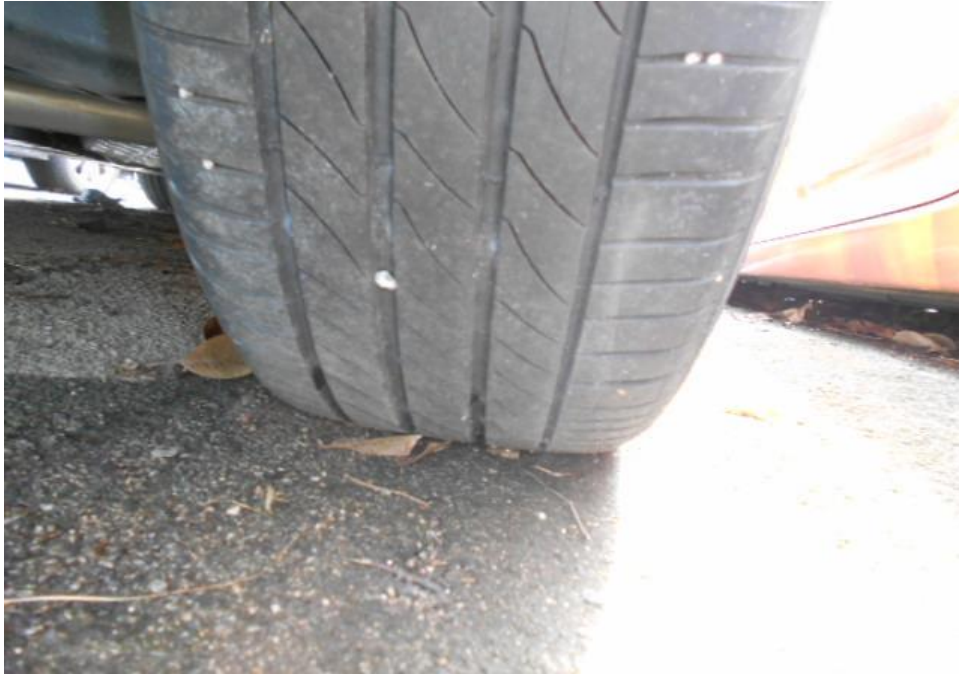
Photo 21 shows the condition of the rear left tyre of the Motor Car, which was observed to be in serviceable condition with remaining tread depth of approximately 4mm. The tyre was also observed to be sufficiently inflated for vehicular operation with no tear, cut or burst mark(s).

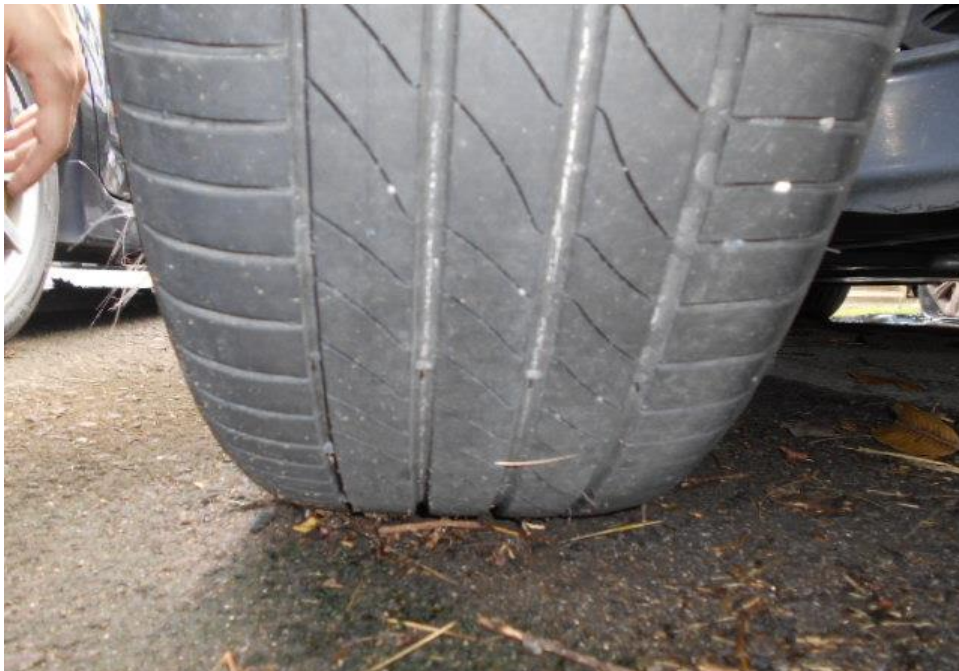
Photo 22 shows the condition of the rear left tyre of the Motor Car, which was observed to be in serviceable condition with remaining tread depth of approximately 4.4mm. The tyre was also observed to be sufficiently inflated for vehicular operation with no tear, cut or burst mark(s).

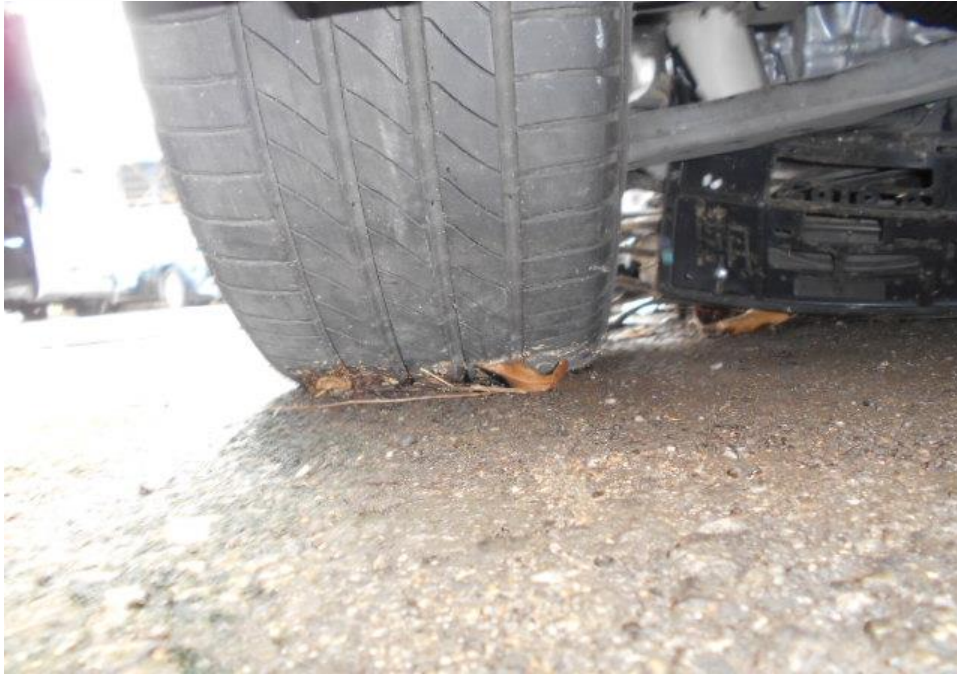
Photo 23 shows the condition of the front left tyre of the Motor Car, which was observed to be in serviceable condition with remaining tread depth of approximately 4.6mm. The tyre was also observed to be sufficiently inflated for vehicular operation with no tear, cut or burst mark(s).

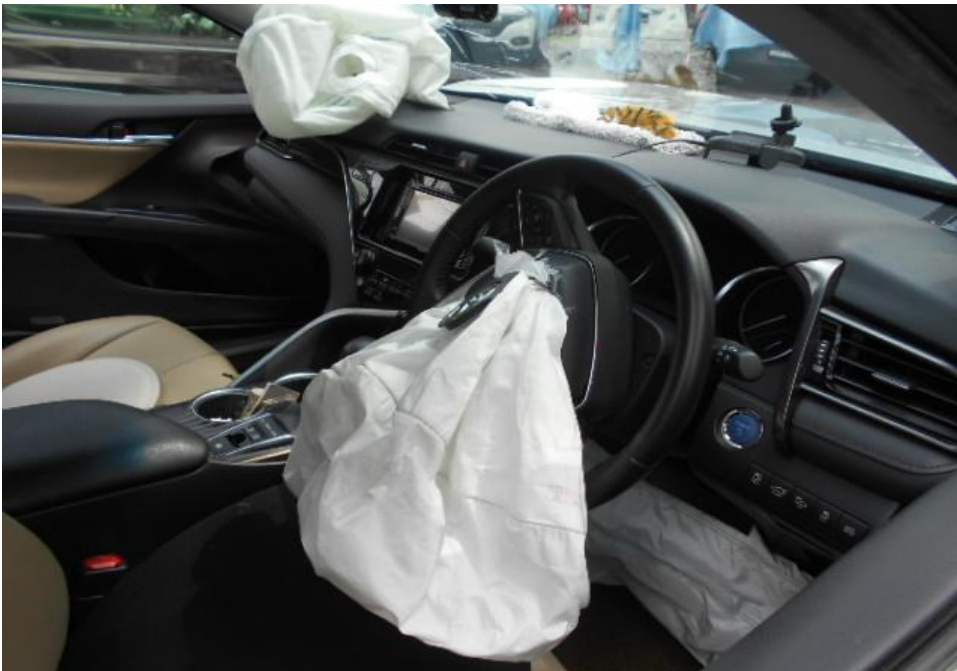
Photo 24 shows the deployment of the Supplemental Restraint System (SRS) airbag in the Motor Car as a result of the accident.

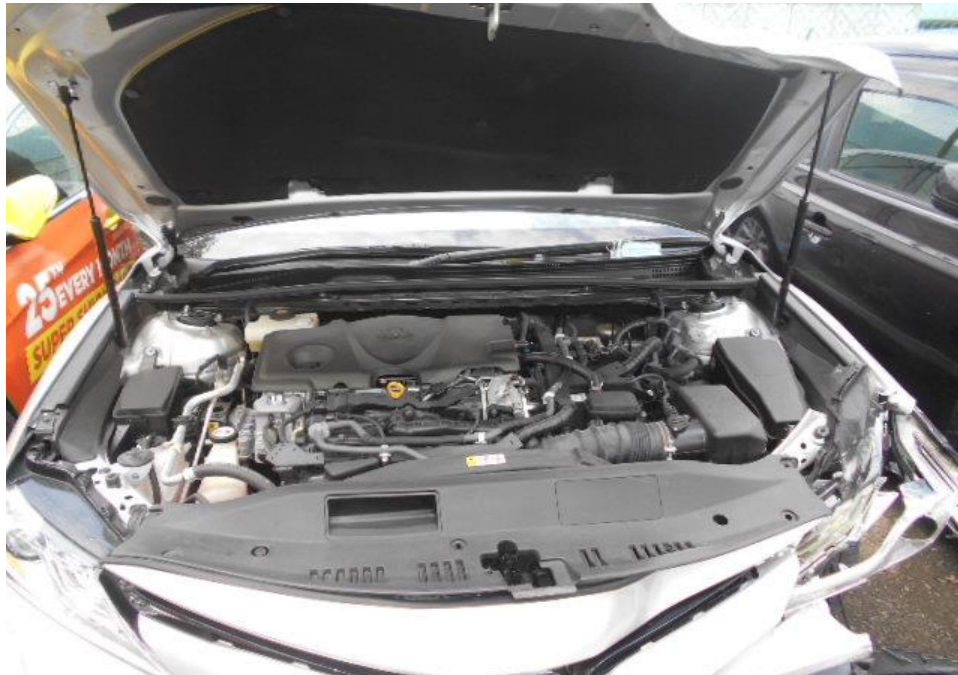
Photo 25 shows a general view of the Motor Car's engine compartment, which was accessed by lifting the front bonnet of the Motor Car. The various parts and components inside the engine compartment were unaffected by the accident. There was also no sign(s) or indication(s) of fresh fluid leakage and/or fluid stain within the engine compartment.

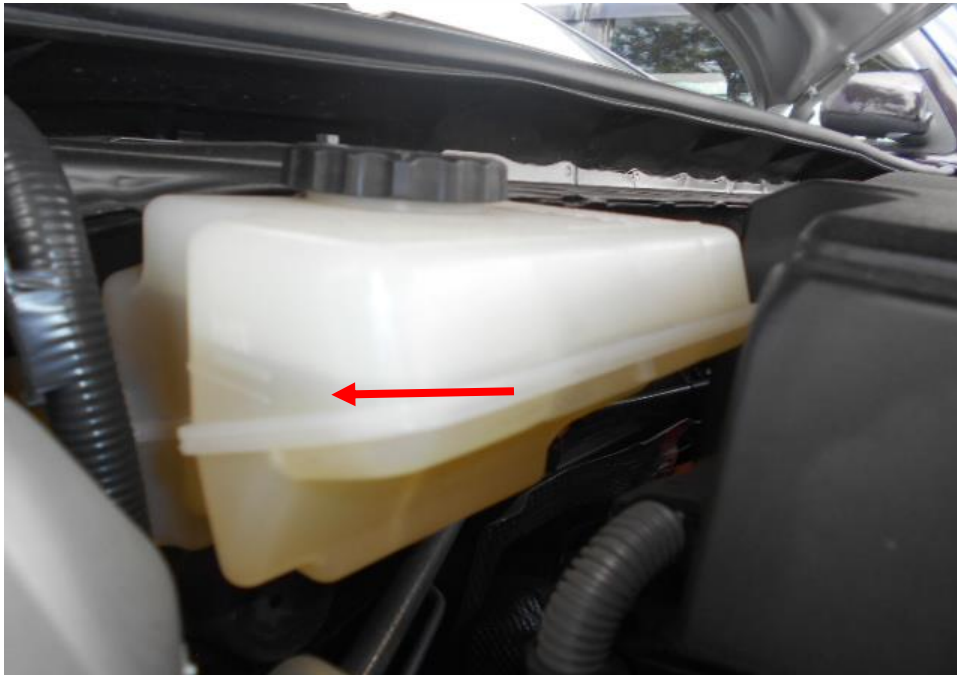
Photo 26 shows the brake fluid reservoir of the Motor Car at the time of my inspection. The brake fluid was observed to be of sufficient level (arrowed) and without any visible contamination.

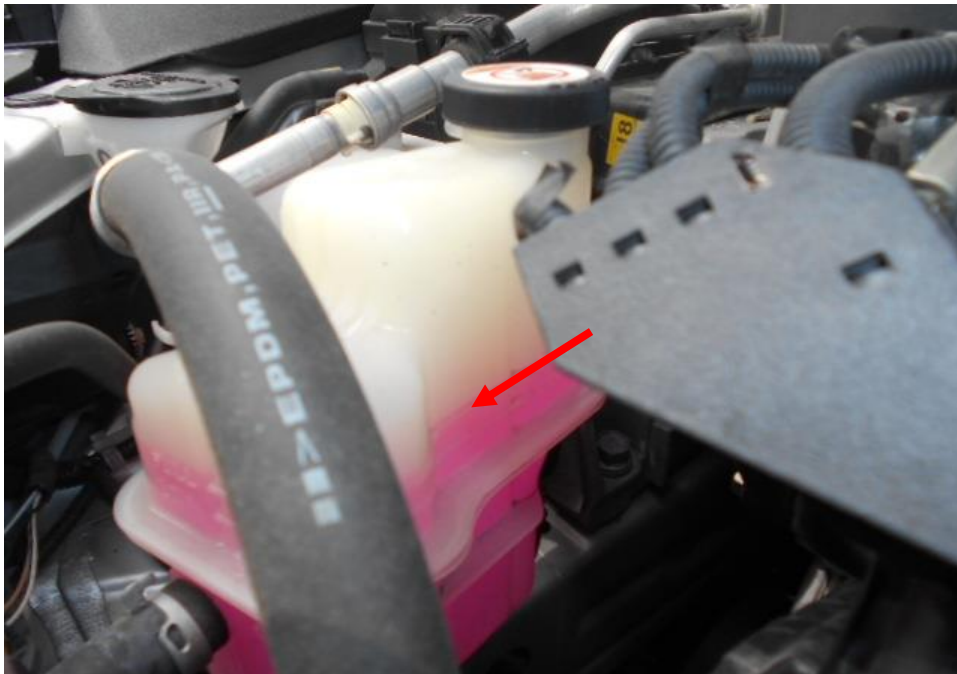
Photo 27 shows the coolant reservoir of the Motor Car at the time of my inspection. The coolant was observed to be sufficient (arrowed) and without any visible contamination.

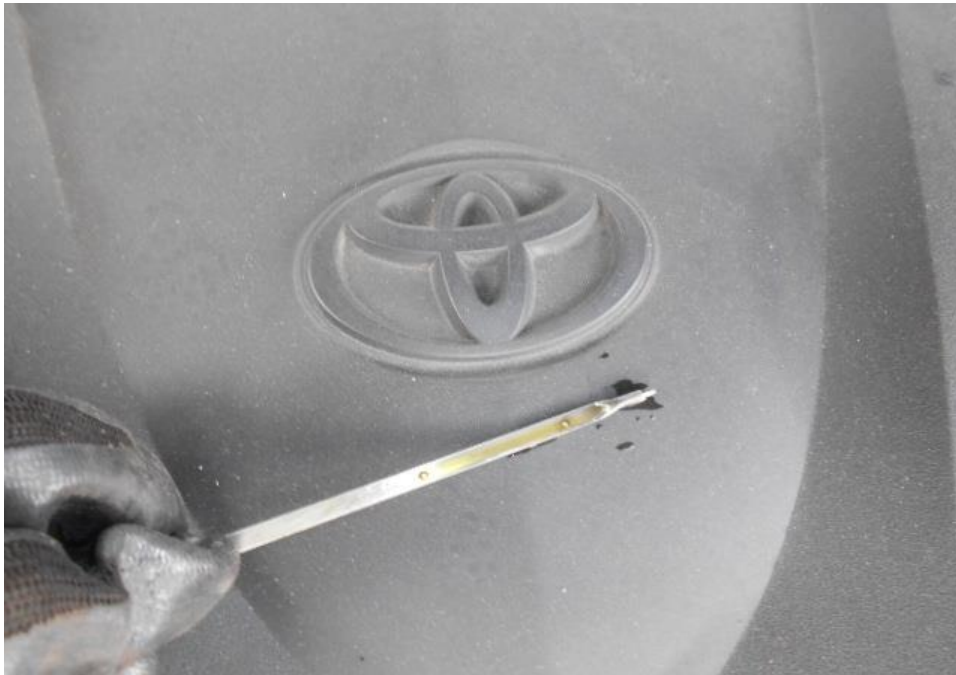
Photo 28 shows the engine oil dipstick of the Motor Car at the time of my inspection. The engine oil was observed to be sufficient (arrowed) and without any visible contamination.

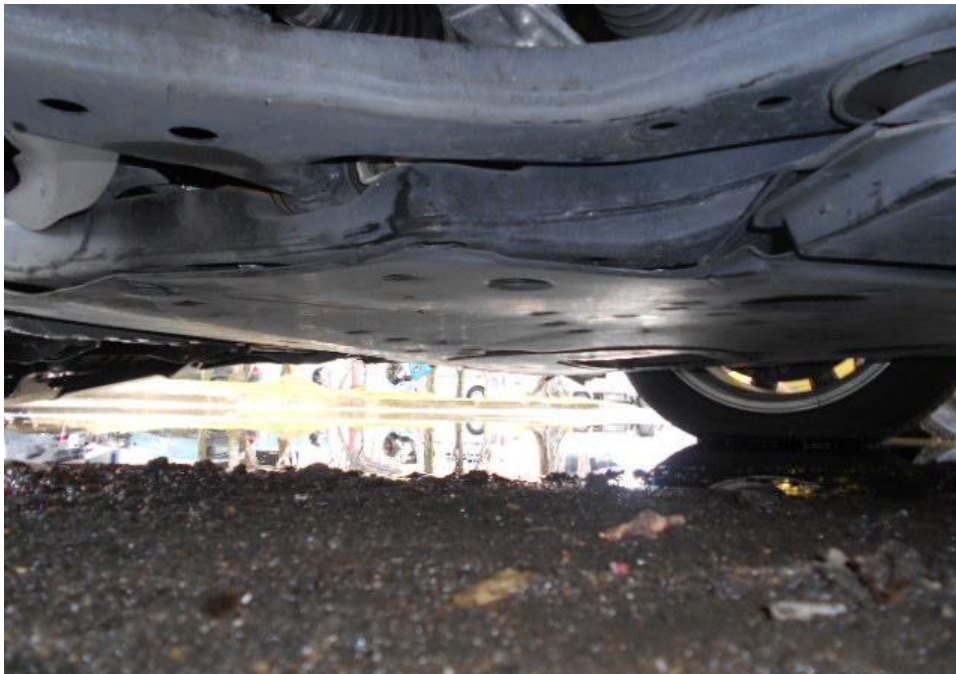
Photo 29 shows the undercarriage of the Motor Car, at the area where the engine housing and transmission housing are located. I did not find any sign(s) or indication(s) of fluid leak and/or fluid stain(s) on the underside of the Motor Car.

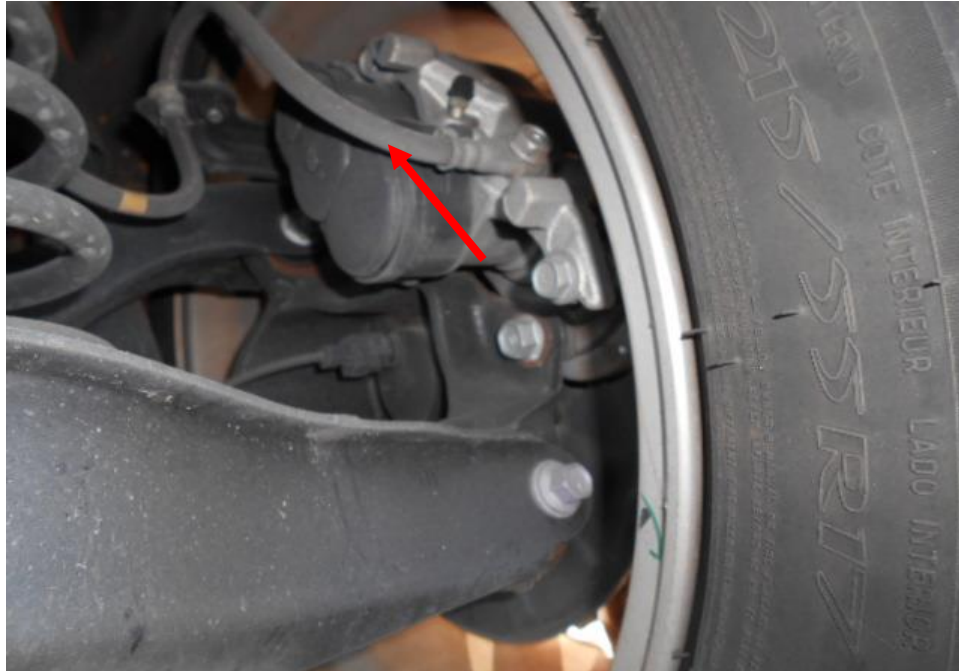
Photo 30 shows the brake hose/pipe (arrowed) at the rear right wheel of the Motor Car. No leakage of brake fluid was observed. Visual examination of the various components of the braking system like the brake caliper to be intact and without visible damage.

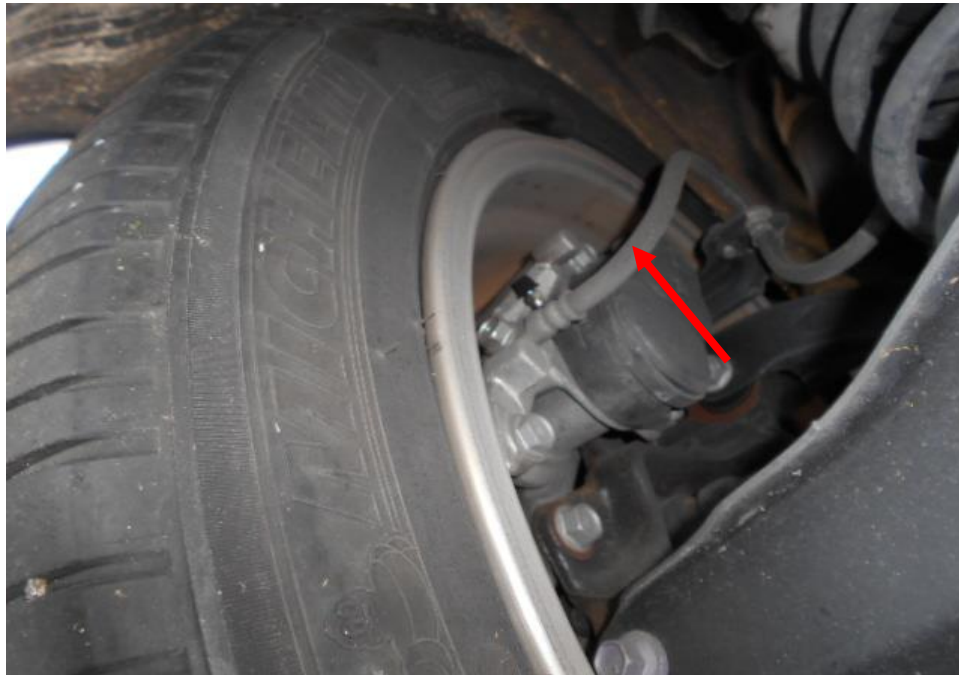
Photo 31 shows the brake hose/pipe (arrowed) at the rear left wheel of the Motor Car. No leakage of brake fluid was observed. Visual examination of the various components of the braking system like the brake caliper to be intact and without visible damage.

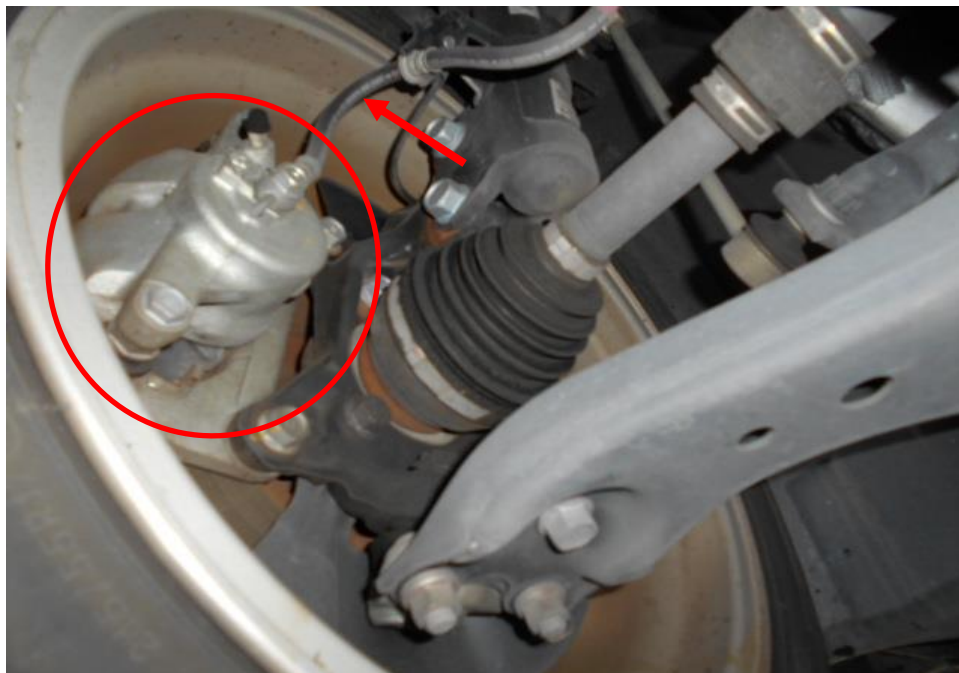
Photo 32 shows the brake hose/pipe (arrowed) at the front right wheel of the Motor Car. I did not observe any leakage of brake fluid at the time of my inspection of the Motor Car. Visual examination of the various components of the braking system the brake caliper (circled) to be intact and without visible damage.
