Your Ref: TP IP/07285/2023
Our Ref : CI/TPD23005778/P

18th July 2023

MECHANICAL INSPECTION REPORT OF MOTOR CAR SBH 3808B

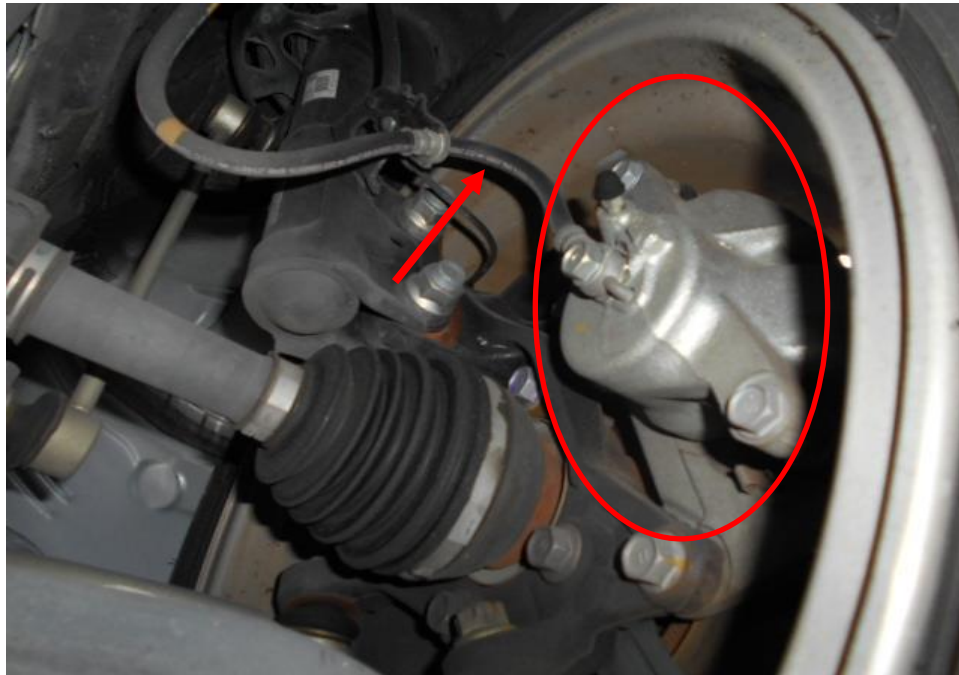
Photo 33 shows the brake hose/pipe (arrowed) at the front left wheel of the Motor Car. No leakage of brake fluid was observed. Visual examination of the various components of the braking system the brake caliper (circled) to be intact and without visible damage.

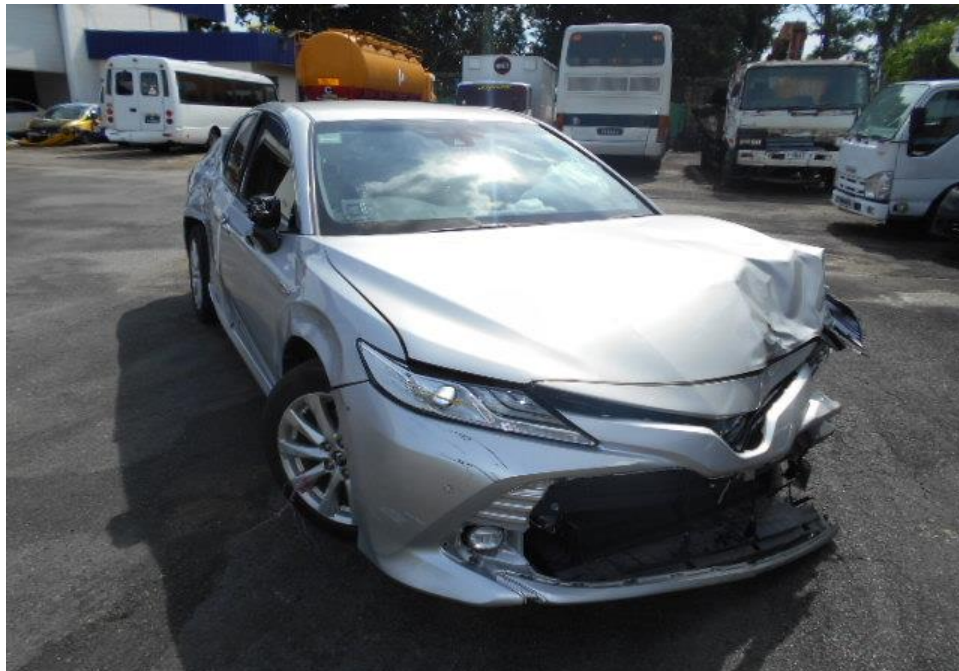
Photo 34 shows the front right wheel of the Motor Car turned to its full left. During my steering system test, I did not experience any abnormal free play and/or resistance when I had turned the steering wheel towards the left and right. This would suggest that the steering system of the Motor Car was likely to be in serviceable condition at the material time of accident.

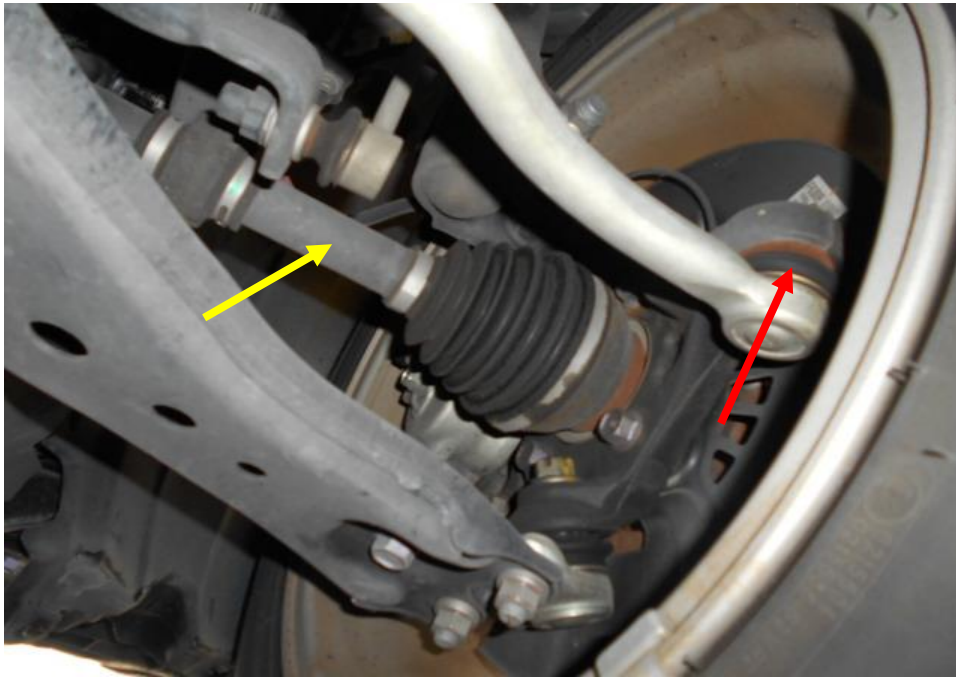
Photo 35 shows the various undercarriage components at the front right wheel of the Motor Car, in particular the steering tie rod (red arrow) and drive shaft (yellow arrow) was found to be intact. There was also no sign of fluid stain observed on the various undercarriage components at the front right wheel of the Motor Car.

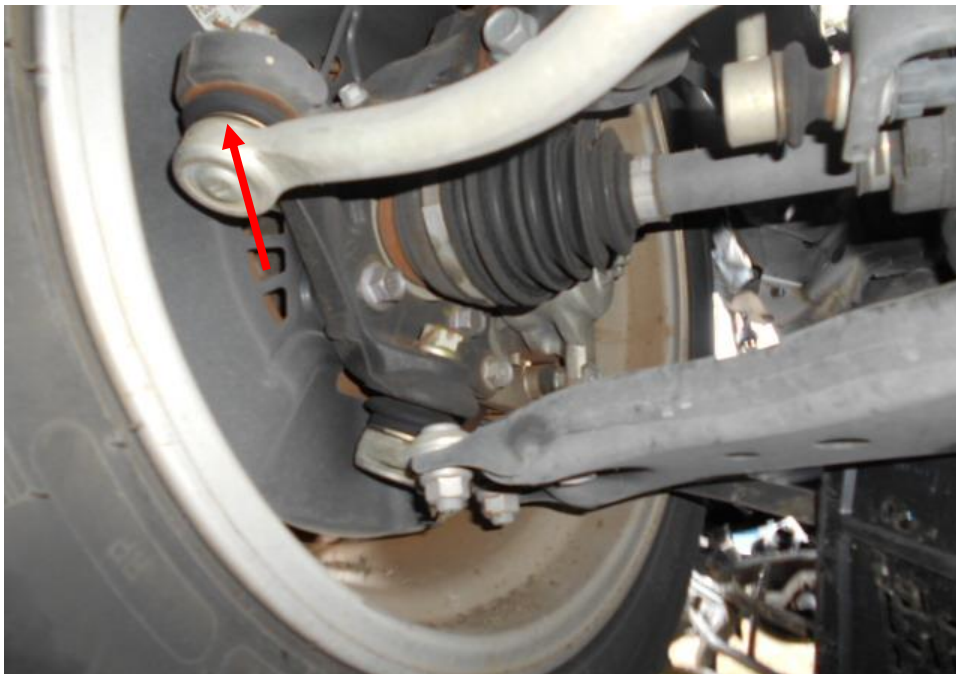
Photo 36 shows the various undercarriage components at the front left wheel of the Motor Car, in particular the steering tie rod (red arrow) was found to be intact. There was also no sign of fluid stain observed on the various undercarriage components at the front left wheel of the Motor Car.

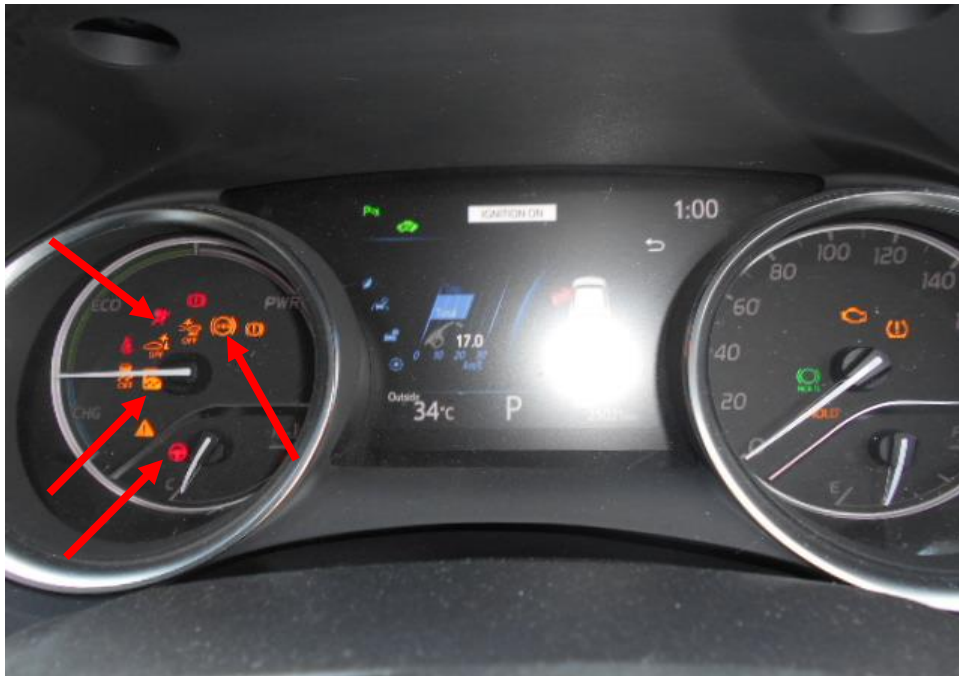
Photo 37 shows the warning light for Anti-Lock Brake System (ABS), Traction Control System (TCS), Electric Power Steering (EPS), and Supplemental Restraint System (SRS) (arrowed) appearing on the instrument panel of the Motor Car during the self-test of its various electronic operating systems when its engine was cranked.

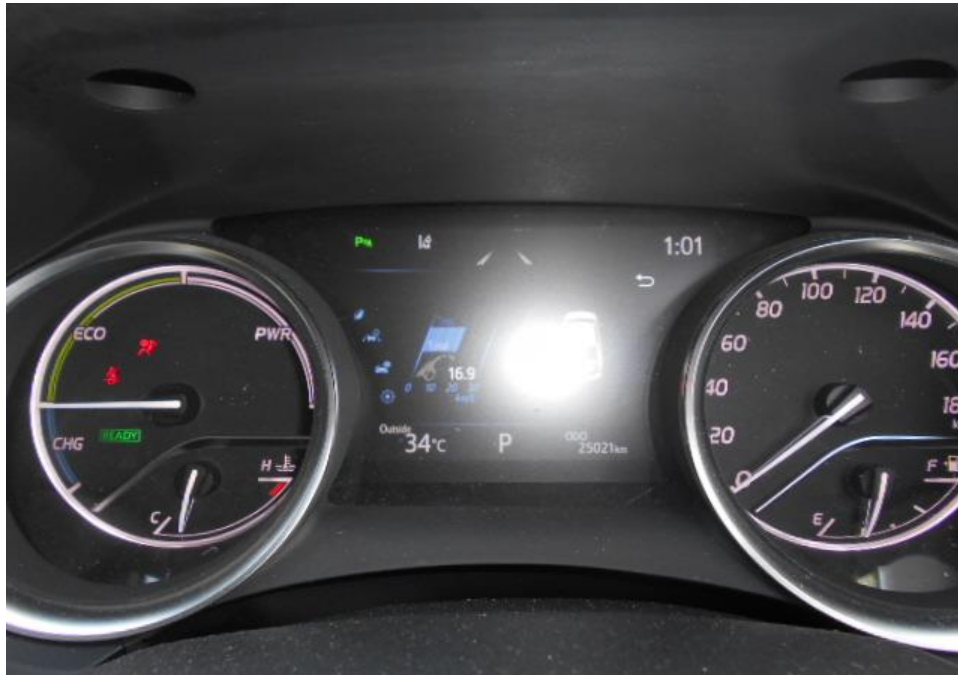
Photo 38 shows only the Supplemental Restraint System (SRS) warning lights remained illuminated on the instrument panel of the Motor Car after the engine was cranked as a result of the deployment of the airbag. However, there was no other warning lights remained illuminated on the instrument panel of the Motor Car after the engine was cranked. This would suggest that there was no abnormality to the electronic operating system of the Motor Car, like the ABS, EPS, TCS and SRS etc.

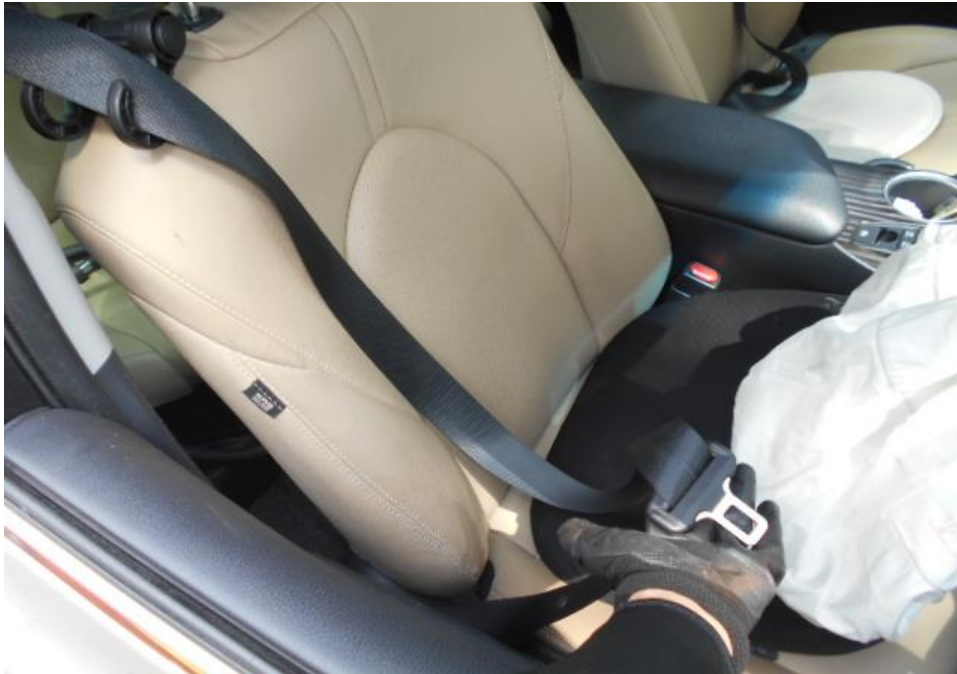
Photo 39 shows that the seat belt on the right seat was worn at the material time of accident as the safety pre-tensioners was activated at the moment of impact and caused the seat belt to be locked into the last position.

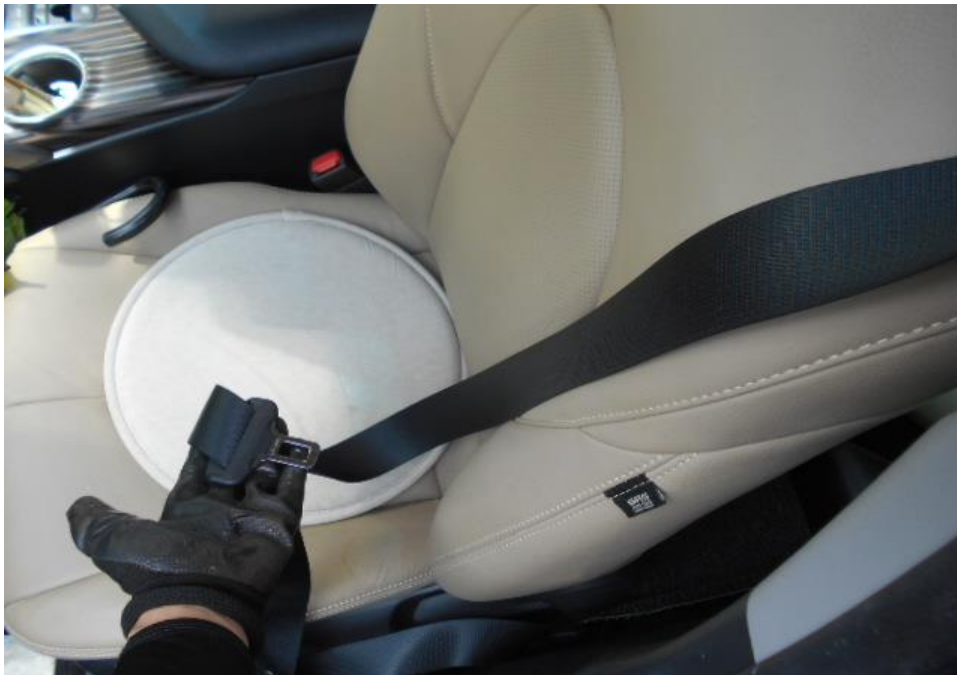
Photo 40 shows that the seat belt on the left seat was worn at the material time of accident as the safety pre-tensioners was activated at the moment of impact and caused the seat belt to be locked into the last position.
