You're Ref: TP IP/07053/2023  
Our Ref: CI/TPD23005779/P

26<sup>th</sup> July 2023

**Fatal Accident Investigation Team**

**MECHANICAL INSPECTION REPORT OF MOTOR CAR SFW 1502U**

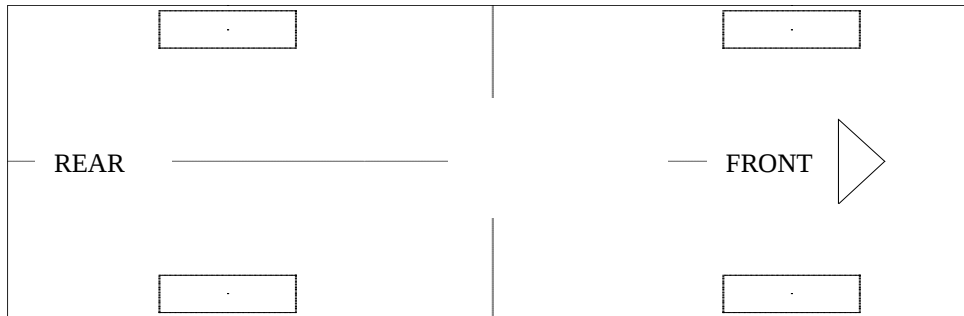
6. The condition of the Motor Car's 4 tyres was observed to be in serviceable condition. I did not find any tear, cut or burst mark(s) on the outer and the inner sidewalls as well as across the tread of the 4 tyres. The 4 tyres were also observed to be sufficiently inflated for vehicular operation. The tyre brand, tyre size and remaining tread depth of the 4 tyres were recorded as follows:-

Falken 175/70R14 (4.4mm)

Falken 175/70R14 (4.7mm)

Falken 175/70R14 (4.5mm)

Falken 175/70R14 (3.7mm)

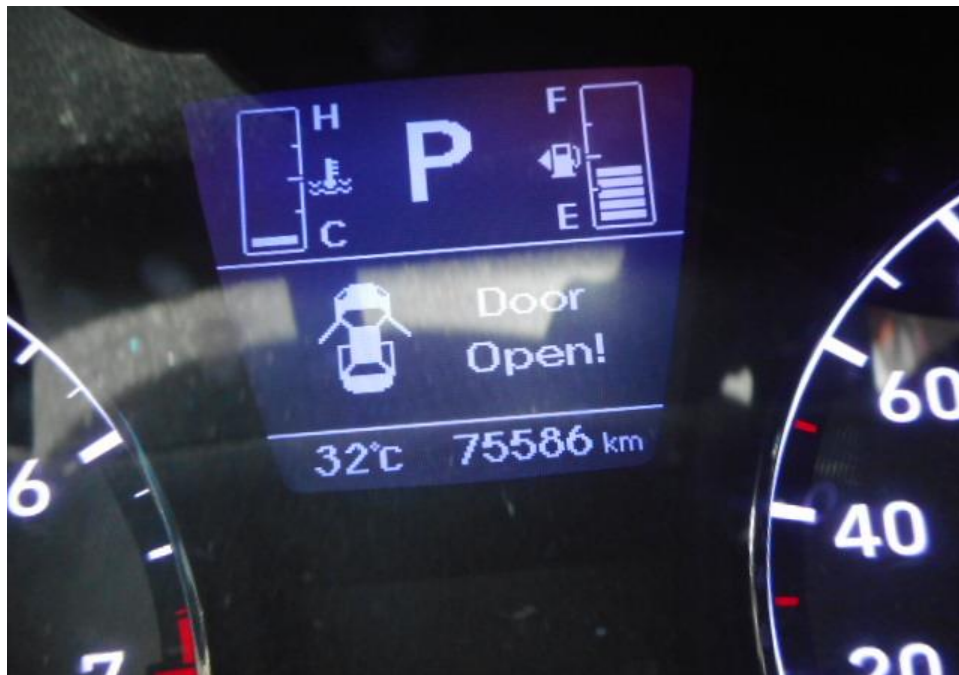
**Photo 1** shows the mileage of the Motor Car at the time of my inspection. The mileage observed was 75,586km.

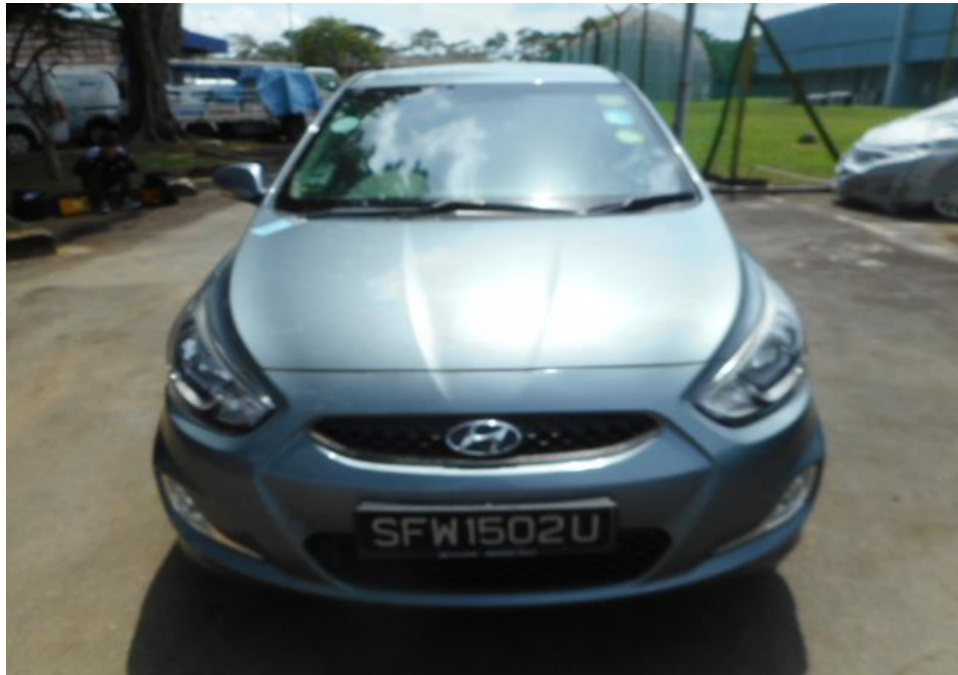
**Photo 2** shows the general view of the Motor Car's front body at the time of my inspection. The Motor Car front was observed to be unaffected by the accident.

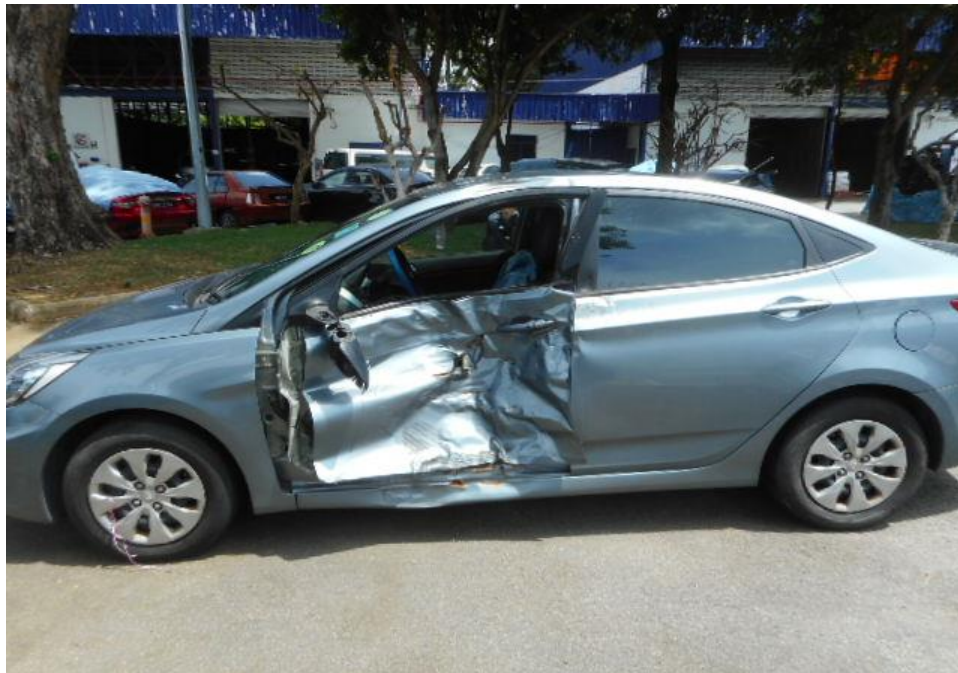
4. The mileage of the Motor Car at the time of my inspection was 75,586km.
5. The Motor Car was observed to have sustained damage at its left portion. Its left rear view mirror, left doors and left side windscreen was amongst the body parts that were damaged as a result of the accident.

**Photo 3** shows a general view of the Motor Car's left body at the time of my inspection. The left portion of the Motor Car was observed to have sustained damage. Its left rear view mirror, left doors, left side windscreen was amongst the body parts that were damaged as a result of the accident.

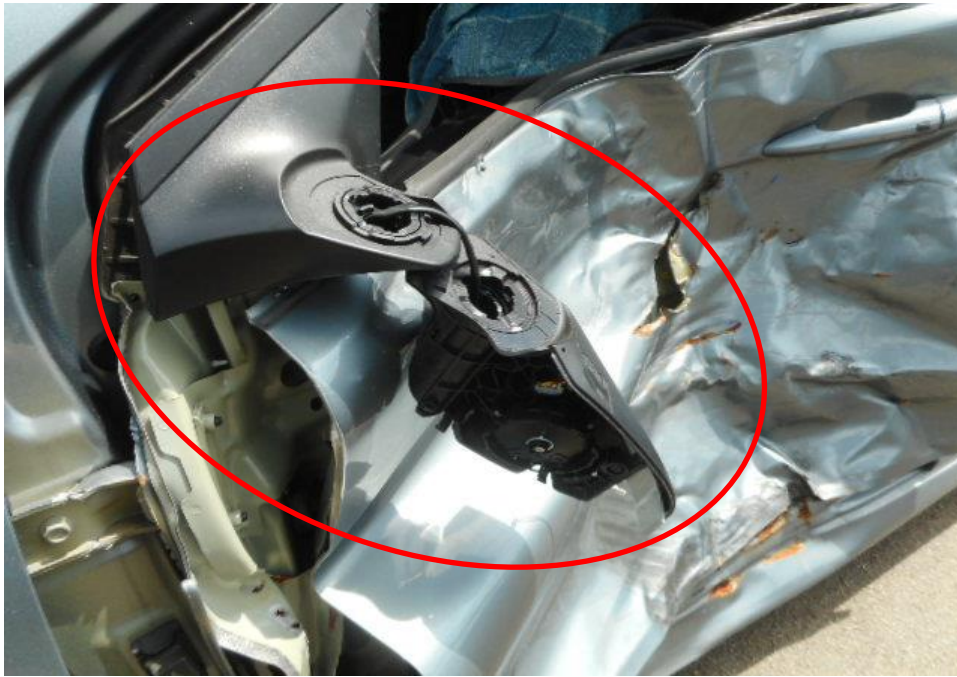
**Photo 4** shows a close up view of the Motor Car's left body at the time of my inspection. The left portion of the Motor Car was observed to have sustained damage. Its left rear view mirror (circled) was the body parts that were damaged as a result of the accident.

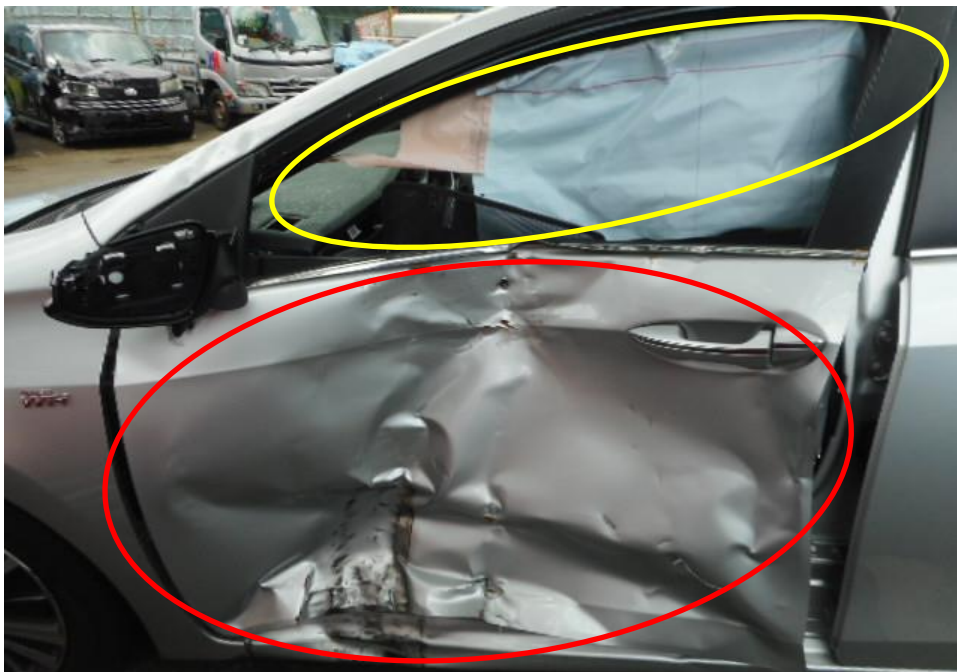
**Photo 5** shows a close up view of the Motor Car's left body at the time of my inspection. The left portion of the Motor Car was observed to have sustained damage. Its left windscreen (yellow circle) and its left door (red circle) was the body parts that were damaged as a result of the accident.

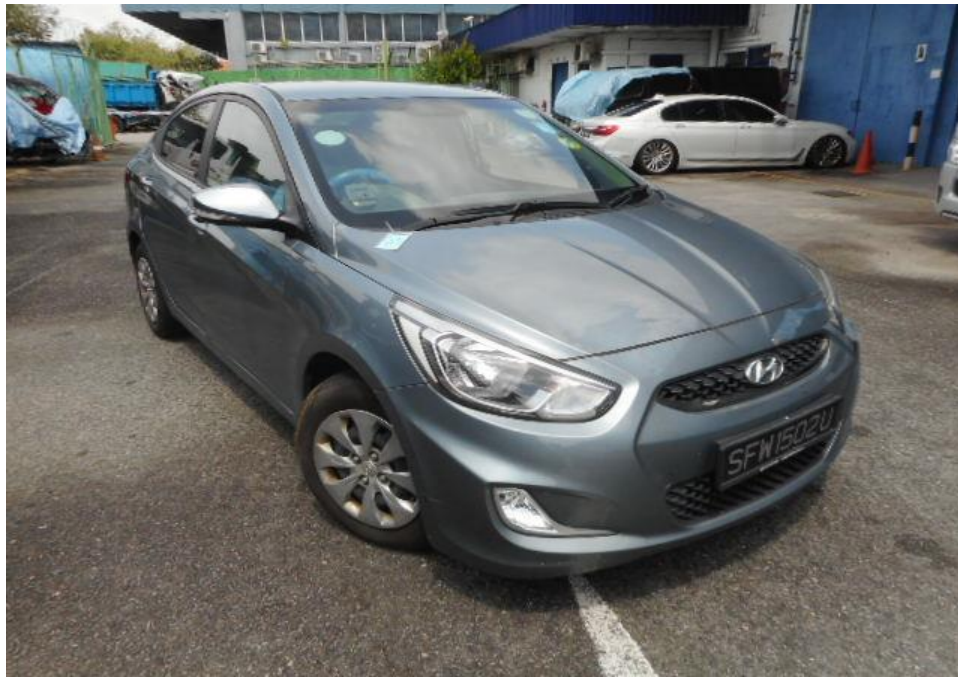
**Photo 6** shows a general view of the Motor Car's right body at the time of my inspection. The right portion of the Motor Car was observed to have been unaffected by the accident.

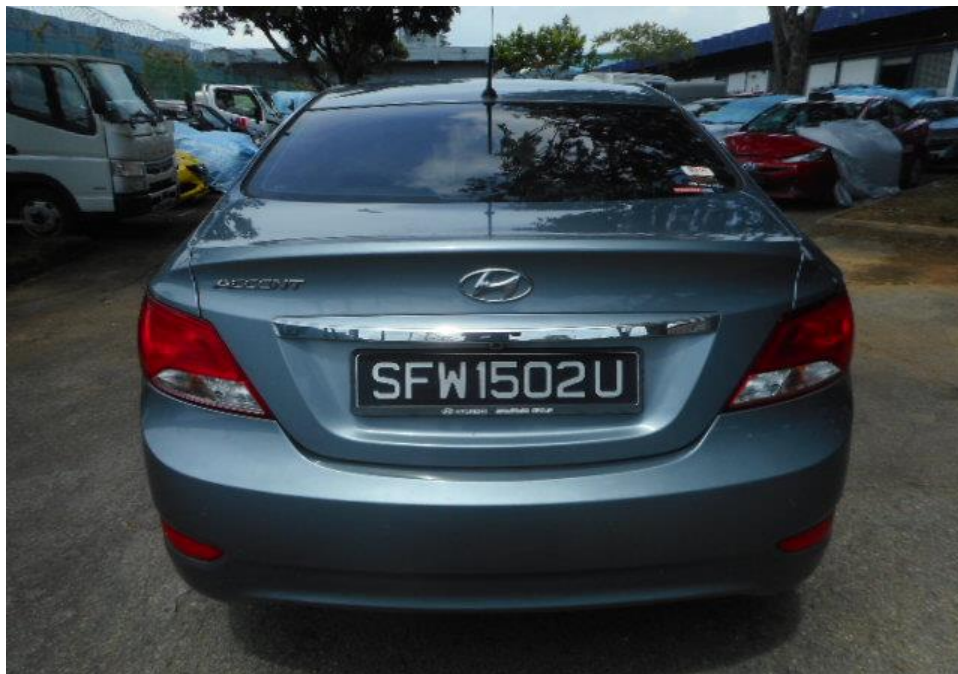
**Photo 7** shows the general view of the Motor Car's rear body at the time of my inspection. The Motor Car rear was observed to be unaffected by the accident.

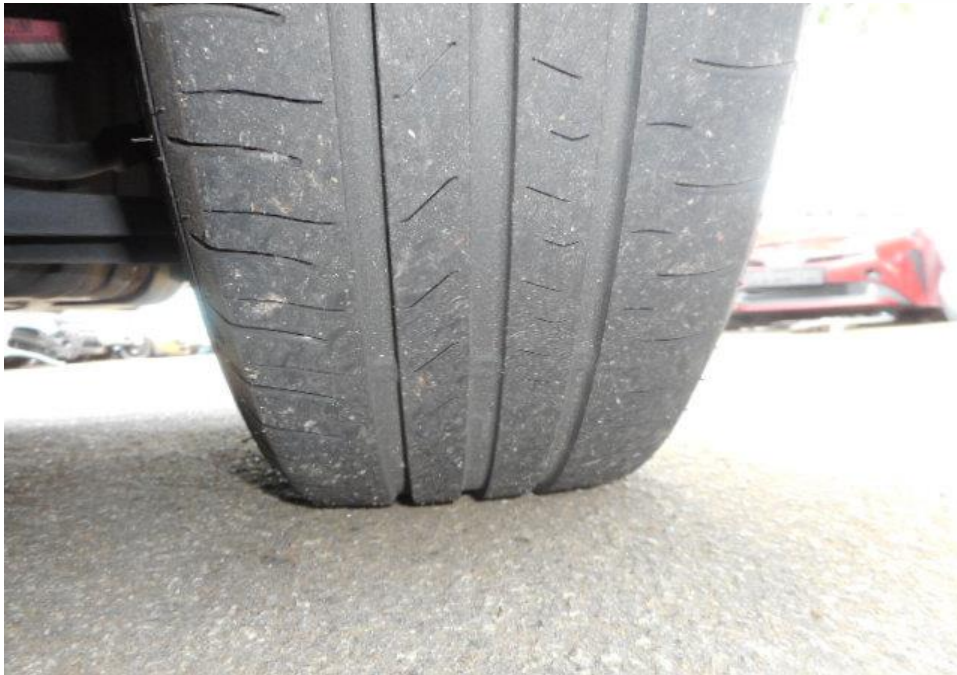
**Photo 8** shows the condition of the front right tyre of the Motor Car, which was observed to be in serviceable condition with remaining tread depth of approximately 3.7mm. The tyre was sufficiently inflated for vehicular operation with no tear, cut or burst mark(s) on the outer and the inner sidewalls as well as across the tread. The 4 tyres of the Motor Car were wrapped around standard alloy wheel rims without any damage.

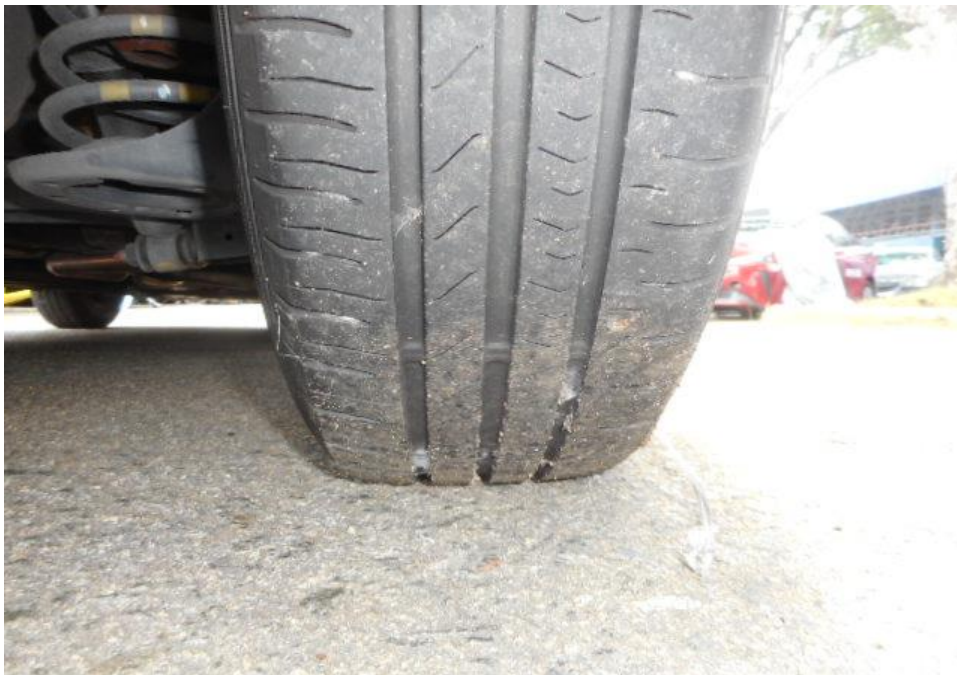
**Photo 9** shows the condition of the rear right tyre of the Motor Car, which was observed to be in serviceable condition with remaining tread depth of approximately 4.5mm. The tyre was also observed to be sufficiently inflated for vehicular operation with no tear, cut or burst mark(s).

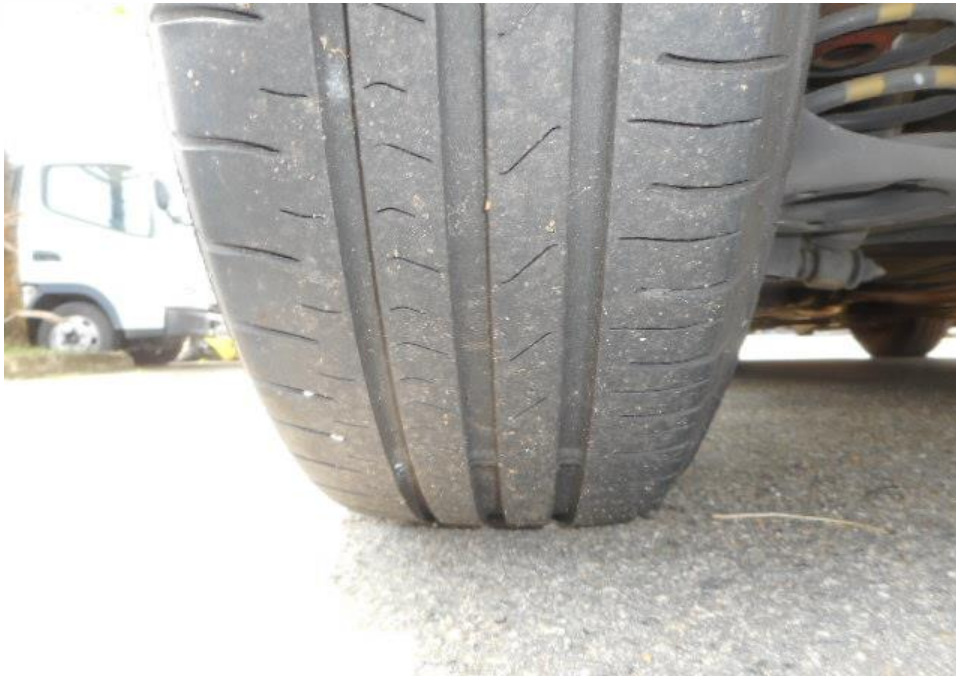
**Photo 10** shows the condition of the rear left tyre of the Motor Car, which was observed to be in serviceable condition with remaining tread depth of approximately 4.4mm. The tyre, which was wrapped around alloy wheel rim, was also observed to be sufficiently inflated for vehicular operation. The 4 tyres of the Motor Car were wrapped around standard alloy wheel rims.

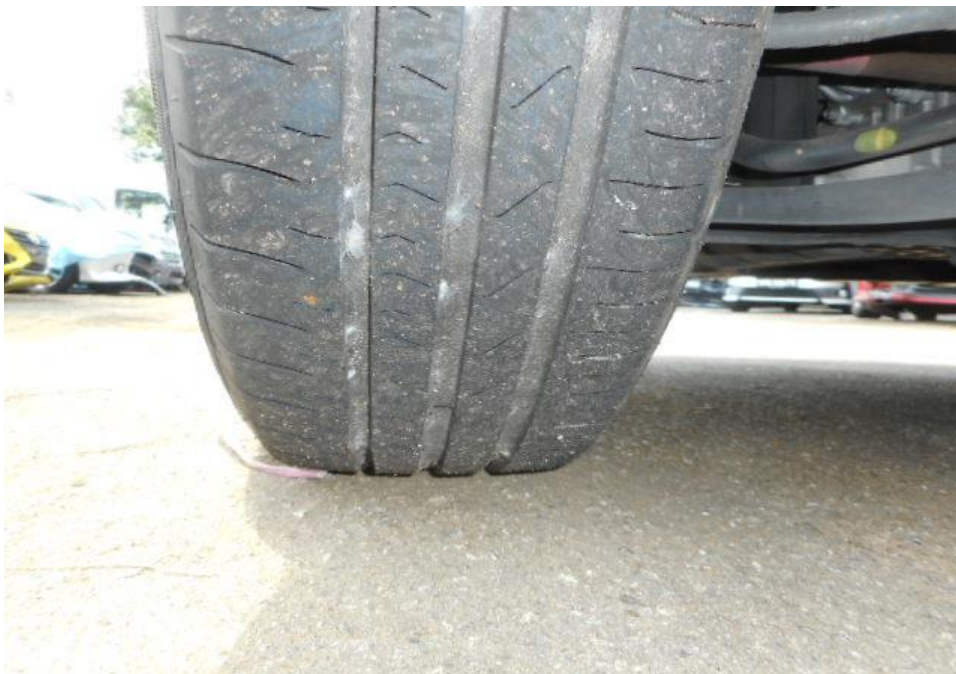
**Photo 11** shows the condition of the front left tyre of the Motor Car, which was observed to be in serviceable condition with remaining tread depth of approximately 4.7mm. There was also no tear, cut or burst mark(s) on the outer and the inner sidewalls as well as across the tread of the Motor Car's 4 tyres.

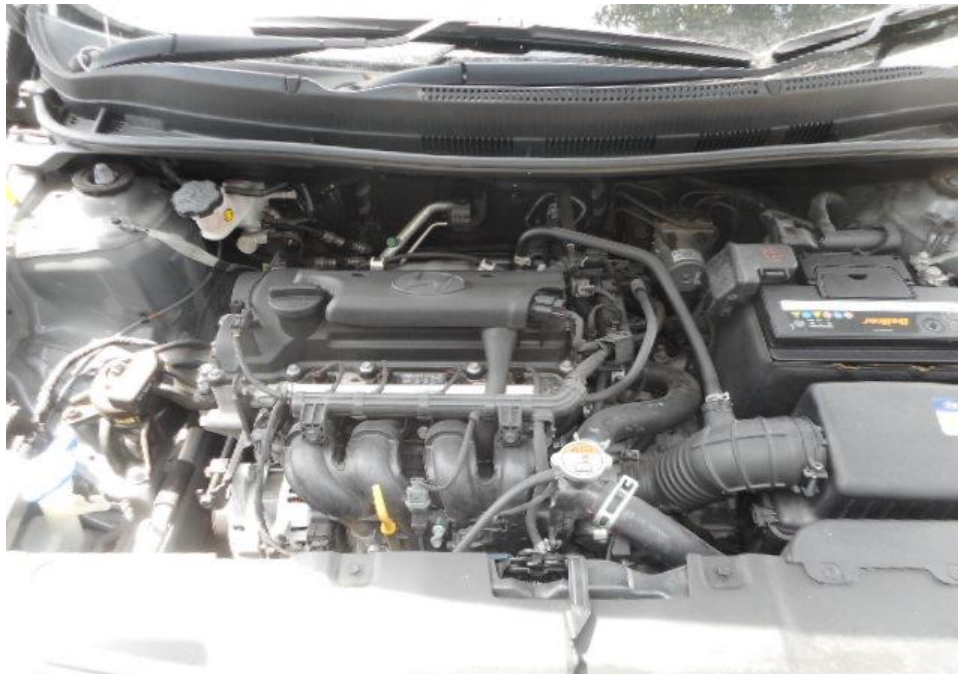
**Photo 12** shows a general view of the Motor Car's engine compartment. The various parts and components inside the engine compartment were unaffected by the accident. There was also no sign(s) or indication(s) of fluid leakage and/or fluid stain within the engine compartment.

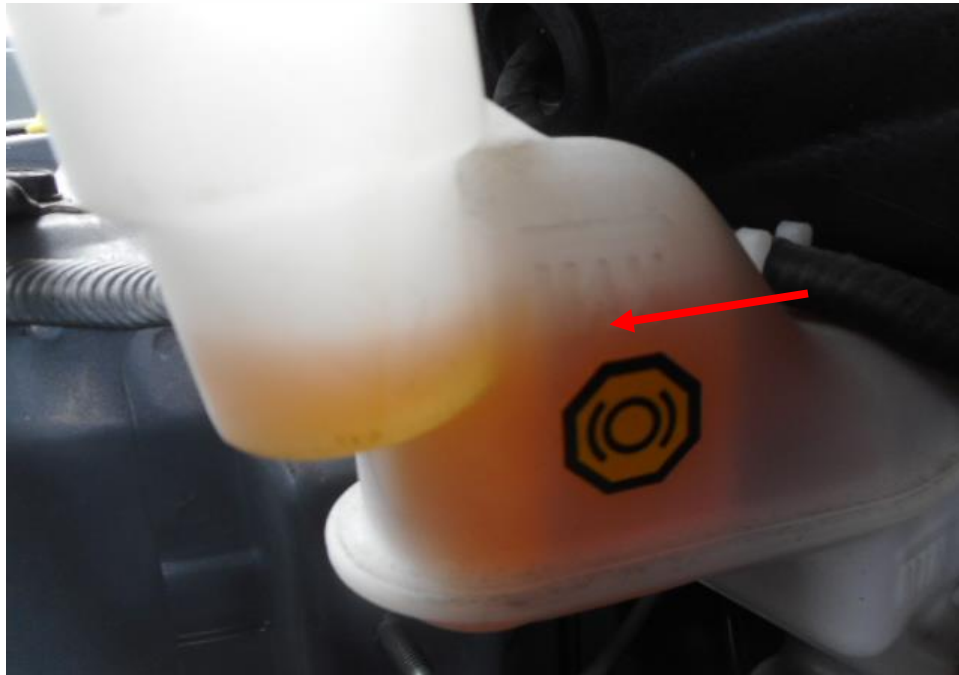
**Photo 13** shows the brake fluid reservoir of the Motor Car at the time of my inspection. The brake fluid was observed to be of sufficient level (arrowed) and without any visible contamination.

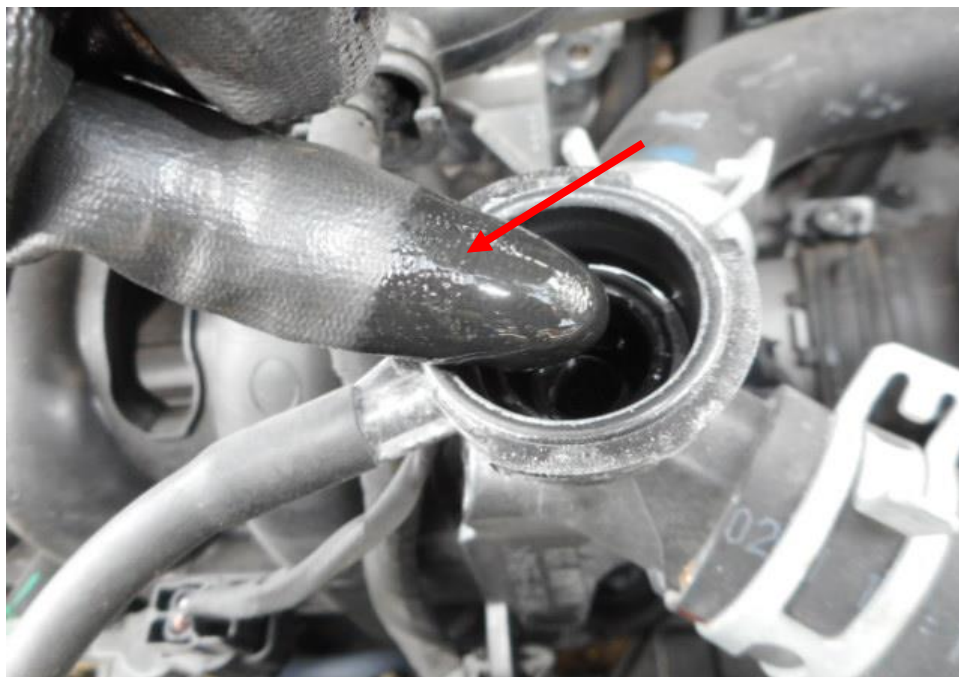
**Photo 14** shows checks being carried out to the engine coolant of the Motor Car at the time of my inspection. The engine coolant was observed to be of sufficient level (arrowed) and without any visible contamination.

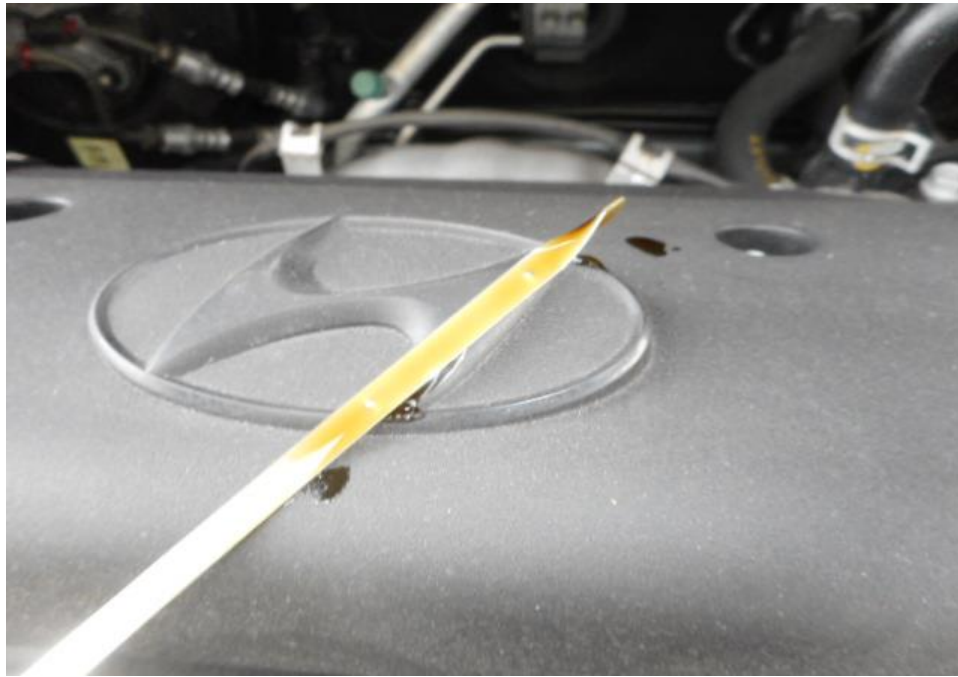
**Photo 15** shows the engine oil dipstick of the Motor Car at the time of my inspection. The engine oil was observed to be of sufficient level and without any visible contamination.

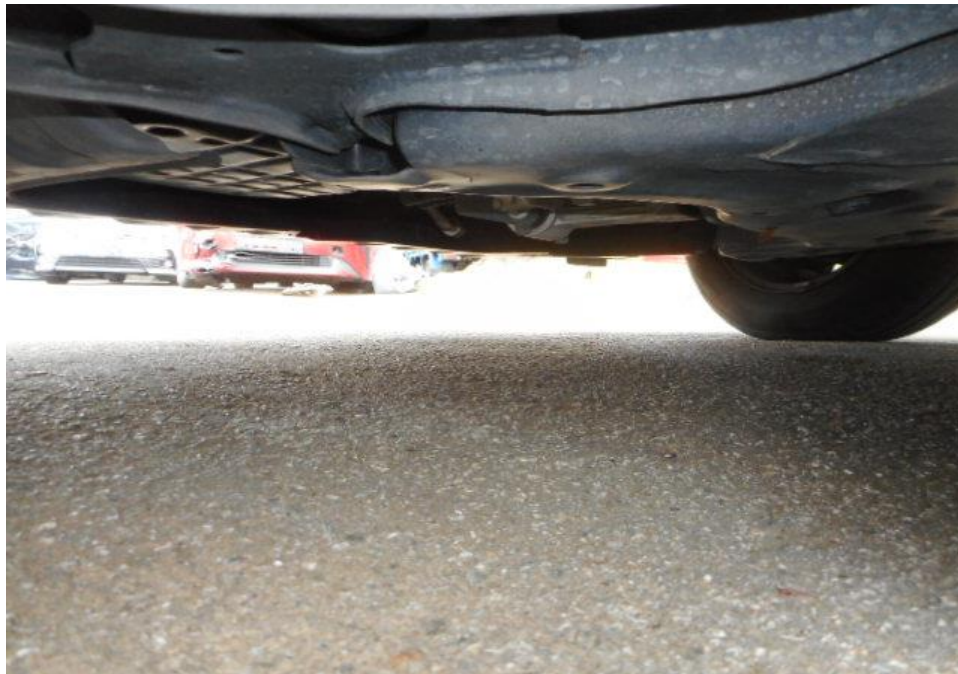
**Photo 16** shows the undercarriage of the Motor Car, at the area where the engine housing and transmission housing are located. I did not find any sign(s) or indication(s) of fluid leak and/or fluid stain(s) on the underside of the Motor Car.

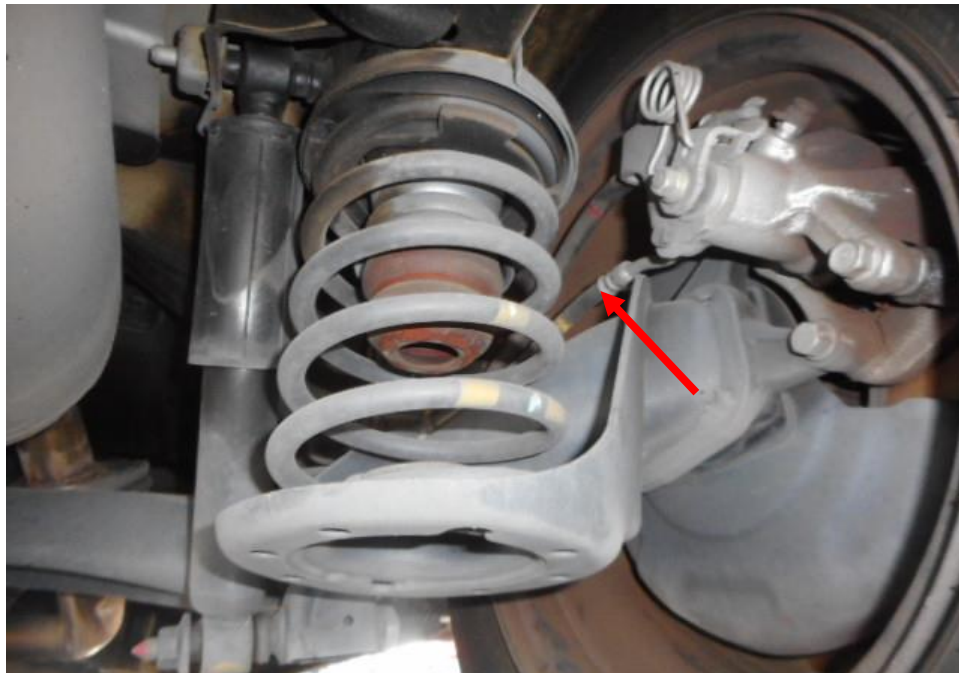
**Photo 17** shows the brake hose/pipe (arrowed) at the rear right wheel of the Motor Car. No leakage of brake fluid was observed. Visual examination of the various components of the braking system like the drum brake, brake booster, brake pedal etc. had revealed all to be intact and without visible damage.

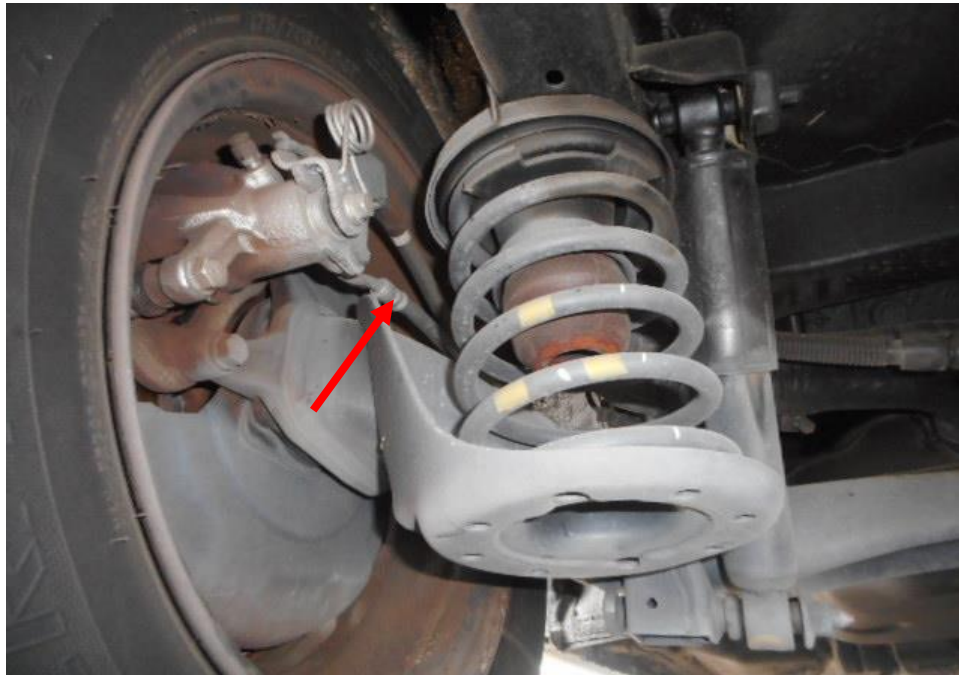
**Photo 18** shows the brake hose/pipe (arrowed) at the rear left wheel of the Motor Car. I did not observe any leakage of brake fluid at the time of my inspection of the Motor Car. Static tests of the Motor Car's braking system had indicated that there was no internal leakage of pressure/vacuum. The undercarriage components of the Motor Car were also all found to be intact and without any visible damage.

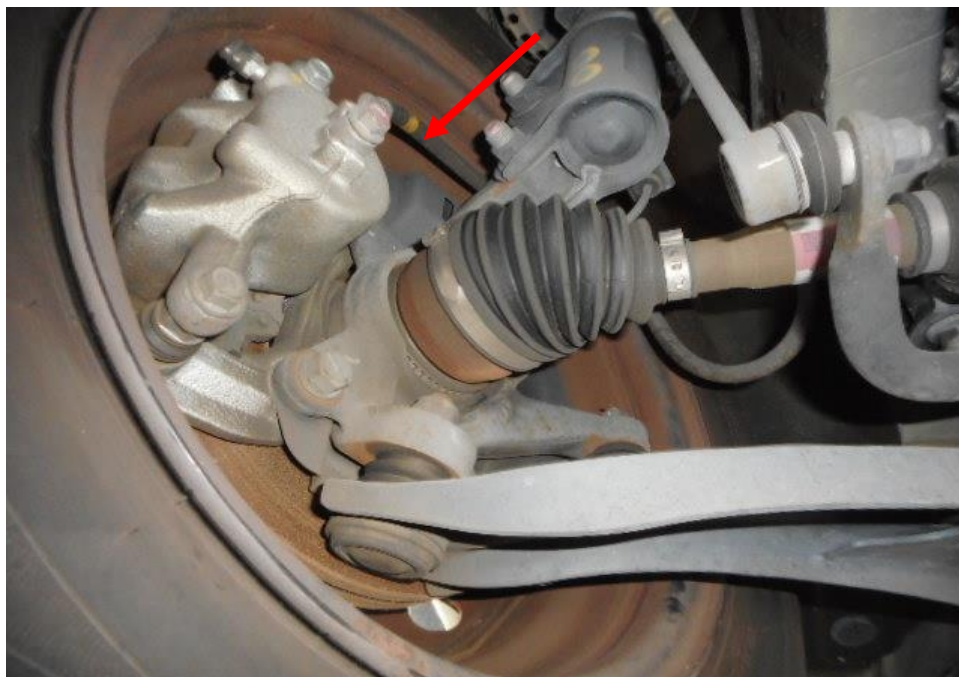
**Photo 19** shows the brake hose/pipe (arrowed) at the front right wheel of the Motor Car. I did not observe any leakage of brake fluid at the time of my inspection of the Motor Car. Static tests of the Motor Car's braking system had indicated that there was no internal leakage of pressure/vacuum. The undercarriage components of the Motor Car were also all found to be intact and without any visible damage.

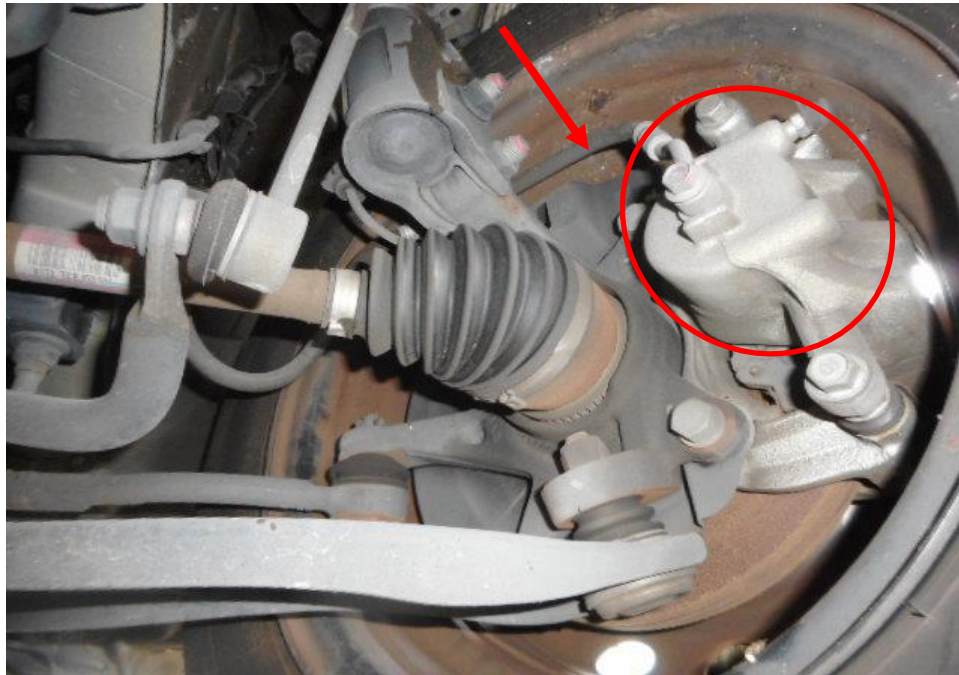
**Photo 20** shows the brake hose/pipe (arrowed) at the front left wheel of the Motor Car. No leakage of brake fluid was observed. Visual examination of the various components of the braking system like the brake caliper (circled), brake booster, brake pedal etc had revealed all to be intact and without visible damage.

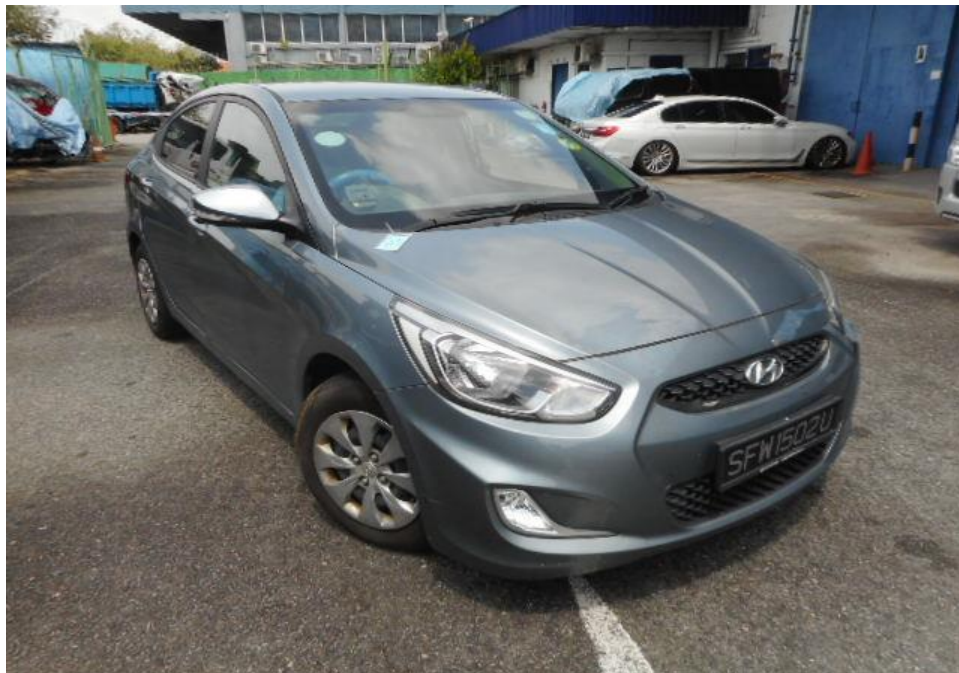
**Photo 21** shows the front right wheel of the Motor Car turned to its full left. During my steering system test, I did not experience any abnormal free play and/or resistance when I had turned the steering wheel towards the left and right. This would suggest that the steering system of the Motor Car was likely to be in serviceable condition at the material time of accident.

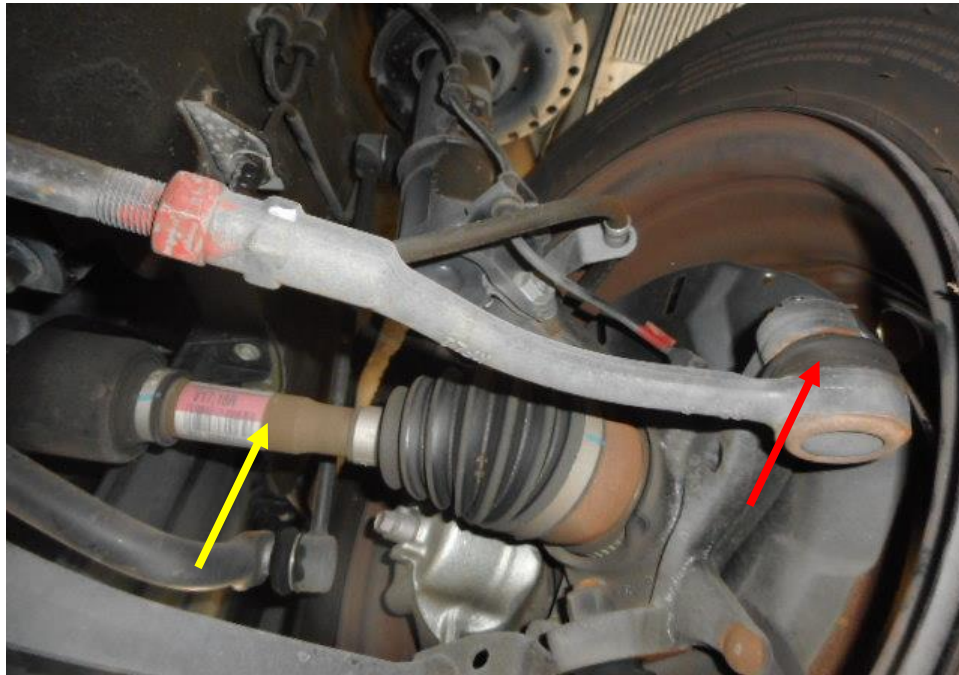
**Photo 22** shows the various undercarriage components at the front right wheel of the Motor Car, in particular the steering tie rod (red arrow) and particular the drive shaft (yellow arrow). The various steering components were all found to be intact, suggesting that the steering system of the Motor Car was likely to be in serviceable condition at the material time of accident. There was also no sign of fluid stain observed on the various undercarriage components at the front right wheel of the Motor Car.

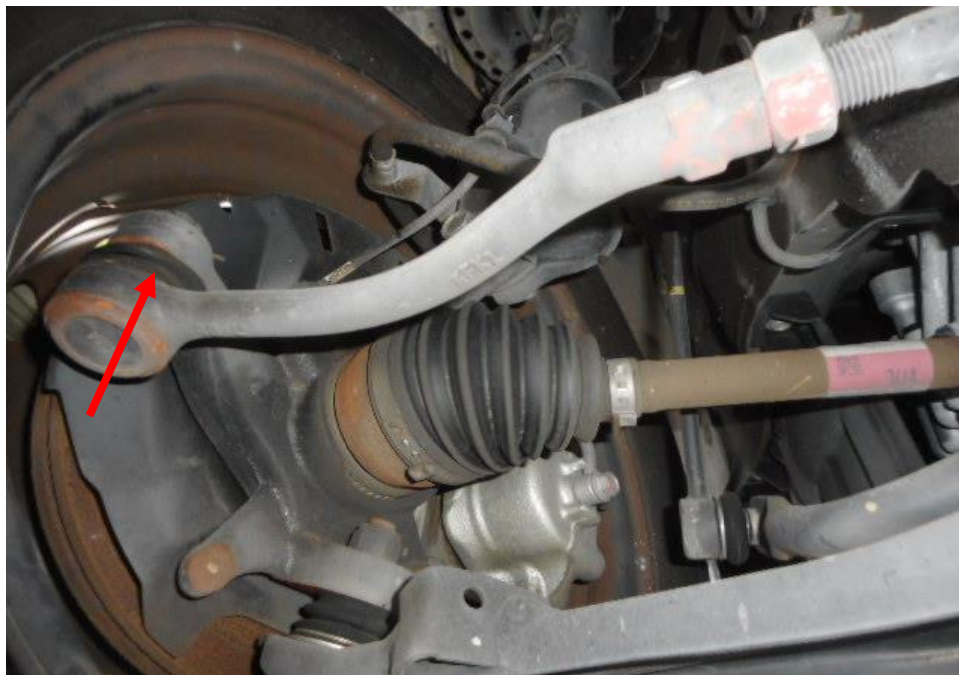
**Photo 23** shows the various undercarriage components at the front left wheel of the Motor Car, which had included the steering tie rod (arrowed). The various undercarriage components of the Motor Car were all found to be intact without any visible damage.

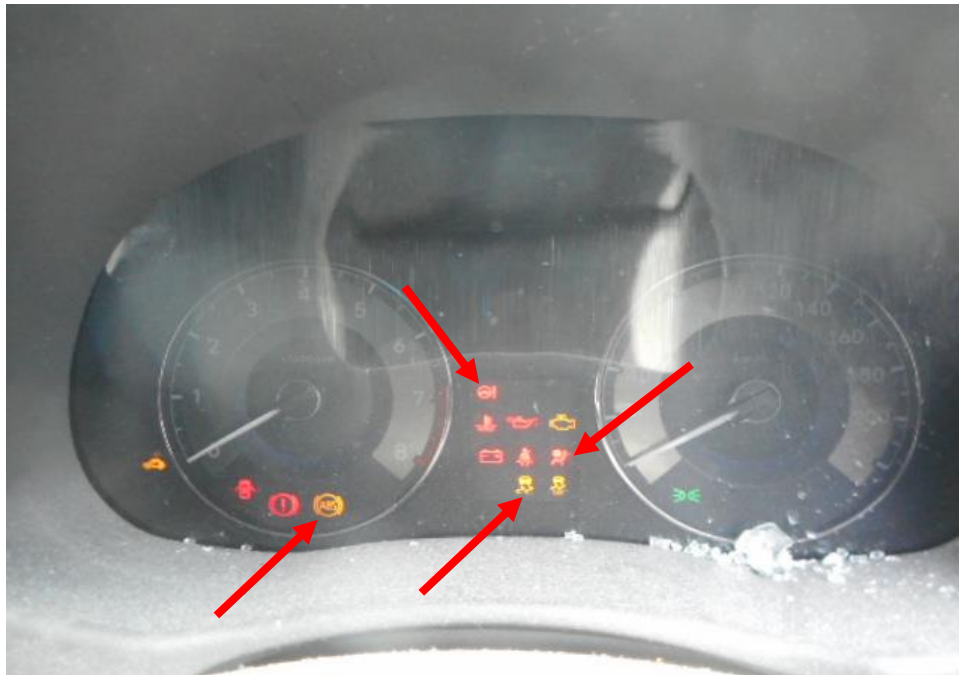
**Photo 24** shows the warning light for Anti-Lock Brake System (ABS), Traction Control System (TCS), Electric Power Steering System (EPS), and Supplemental Restraint System (SRS) (arrowed) appearing on the instrument panel of the Motor Car during the self-test of its various electronic operating systems when its engine was cranked.

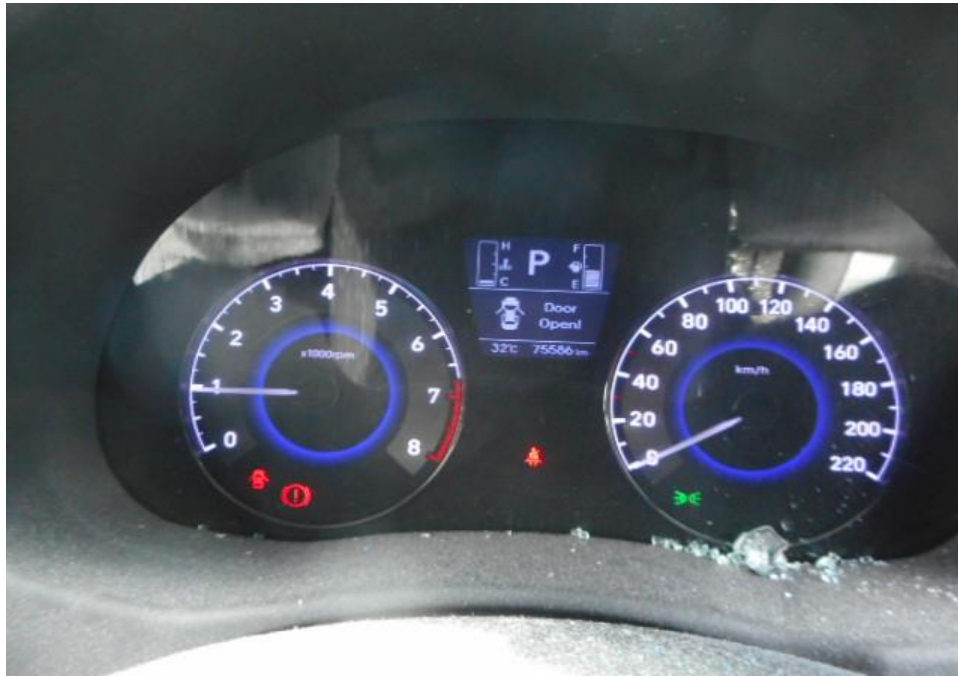
**Photo 25** shows no warning lights illuminated on the instrument panel of the Motor Car after the engine was cranked. This would suggest that there was no abnormality to the electronic operating system of the Motor Car, like the ABS, TCS, EPS, SRS and etc.
