Your Ref: TP IP/08541/2023  
Our Ref : CI/TPD23005780/P

**General Investigation Team**

**MECHANICAL INSPECTION REPORT OF MOTOR CAR SMW 2883E**

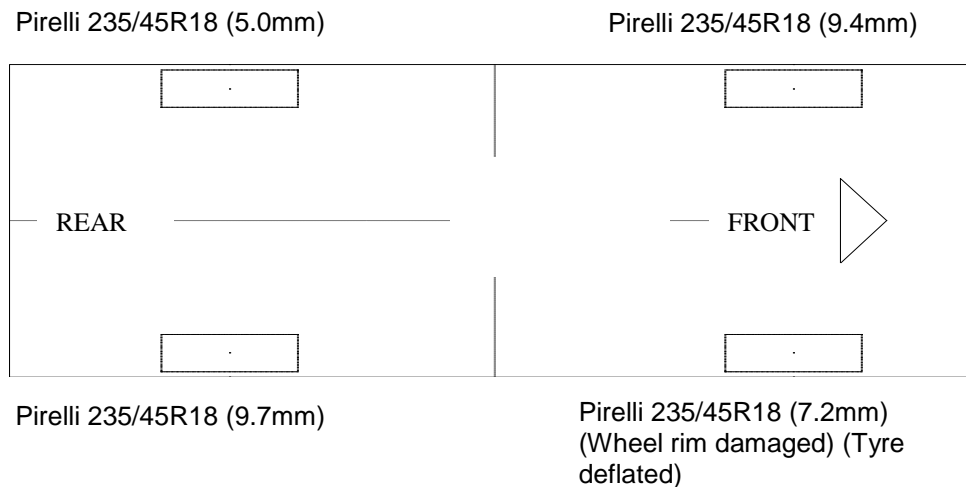
6. The front right wheel rims was observed to be damaged and causing the front right tyre to be deflated as a result of the accident. The condition of the Motor Car's 4 tyres was observed to be in serviceable condition. I did not find any tear, cut or burst mark(s) on the outer and the inner sidewalls as well as across the tread of the 4 tyres. The front right and both rear tyres were observed to be sufficiently inflated for vehicular operation. The tyre brand, tyre size and remaining tread depth of the 4 tyres were recorded as follows:-

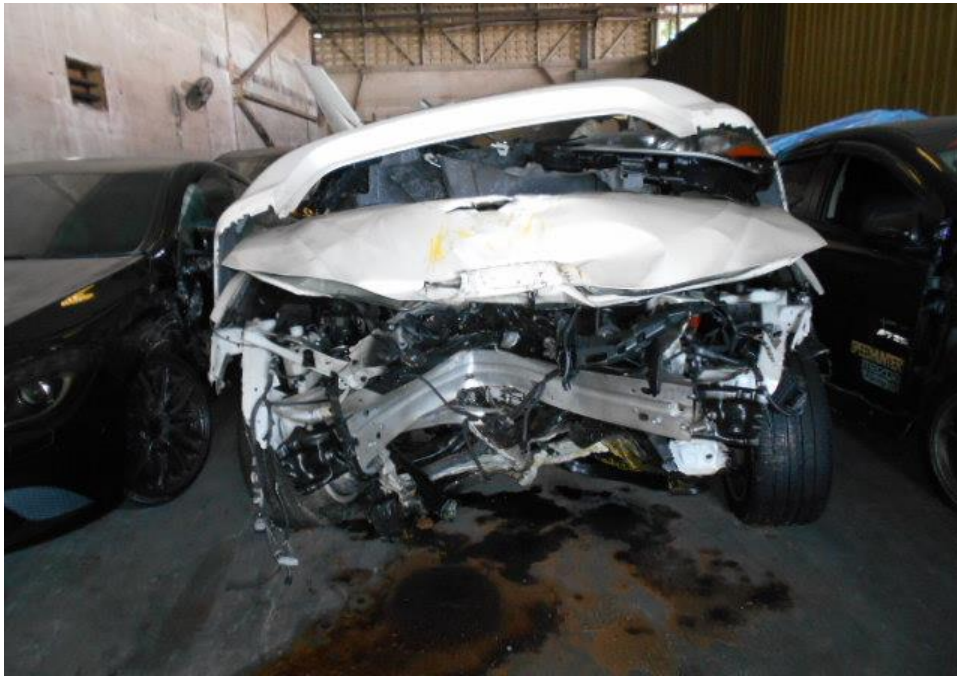
**Photo 1** shows a general view of the Motor Car's front body at the time of my inspection. The front windscreen, front bonnet, front bumper, front left fender, front right and left headlamp, Its left and right door panels, roof panel, rear windscreen was amongst the body parts that were damaged as a result of the accident. The Supplemental Restraint System (SRS) was activated as a result of the accident.

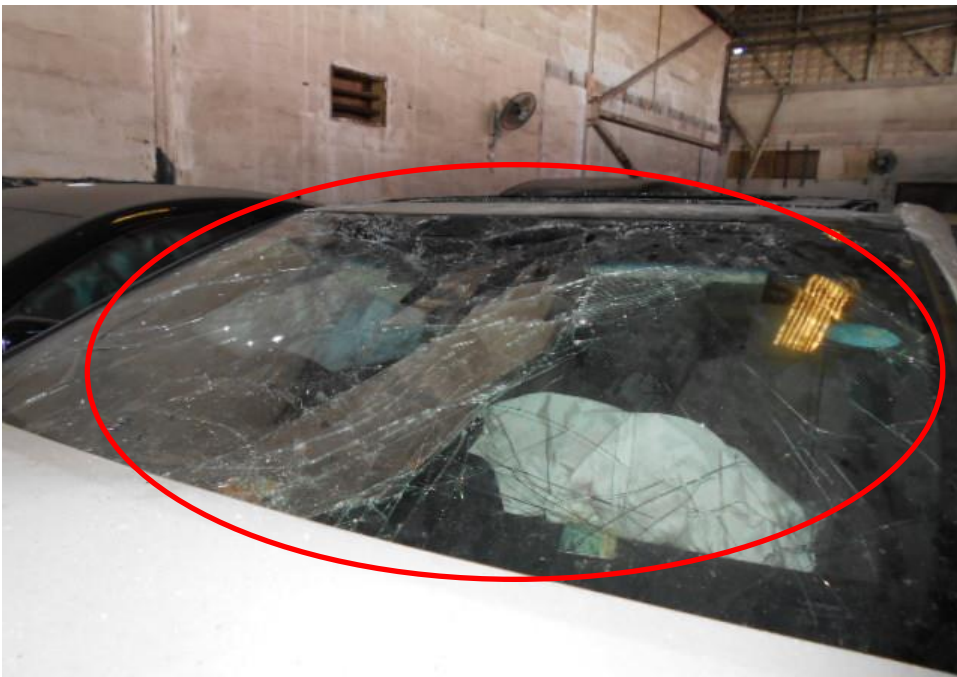
**Photo 2** shows the close up view of the Motor Car's front body and roof panel at the time of my inspection. The Motor car was observed to have sustained damage at its front portion. Its front windscreen (circled) was damaged as a result of the accident.

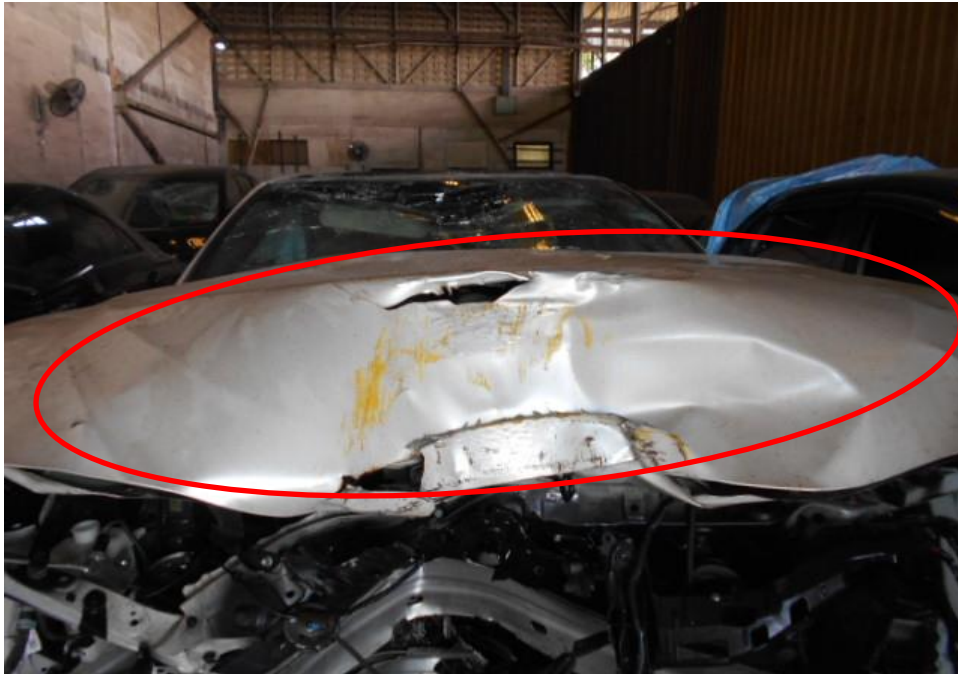
**Photo 3** shows the close up view of the Motor Car's front body at the time of my inspection. The Motor car was observed to have sustained damage at its front portion. Its front bonnet (circled) was damaged as a result of the accident.

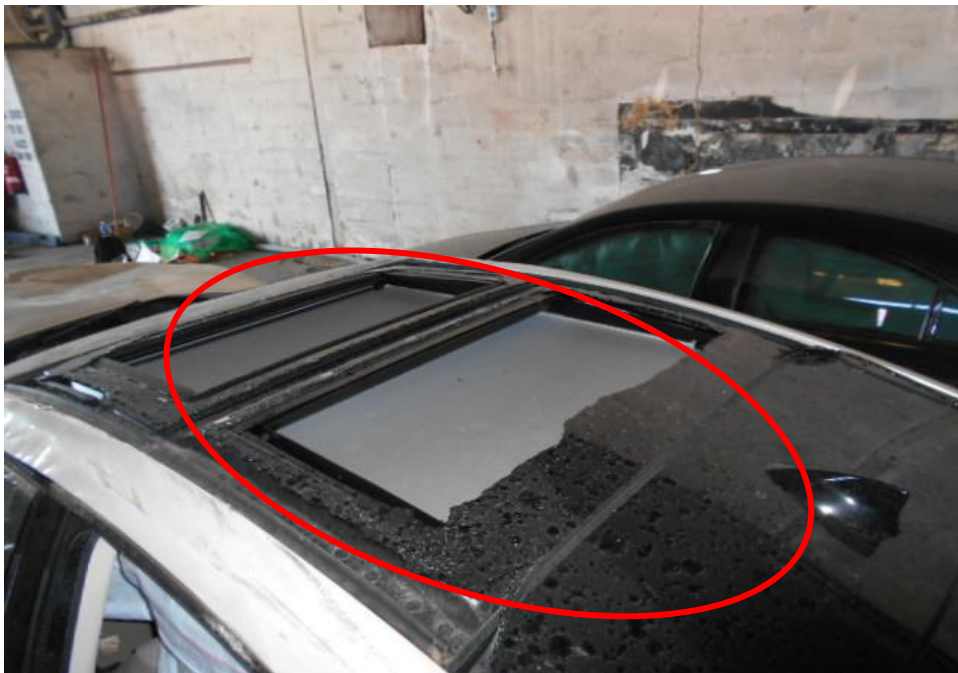
**Photo 4** shows the close up view of the Motor Car's top body and roof panel at the time of my inspection. The Motor car was observed to have sustained damage at its top portion. Its roof and sunroof panel (circled) was damaged as a result of the accident.

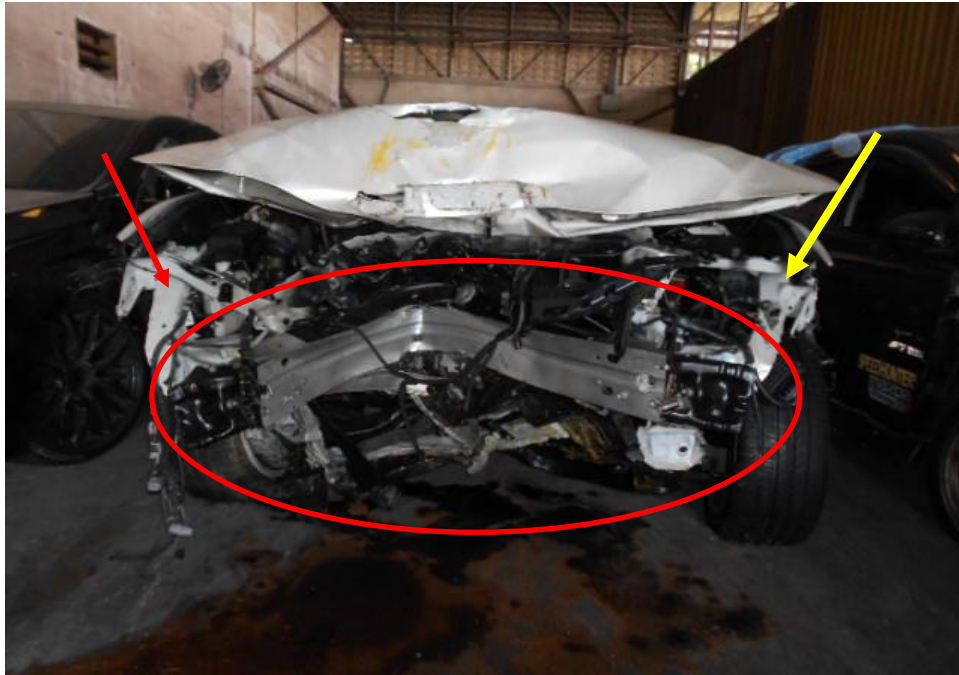
**Photo 5** shows the close up view of the Motor Car's front body at the time of my inspection. The Motor car was observed to have sustained damage at its front portion. Its front bumper (circled), its front right headlamp (red arrow) and its front left headlamp (yellow arrow) was damaged as a result of the accident.

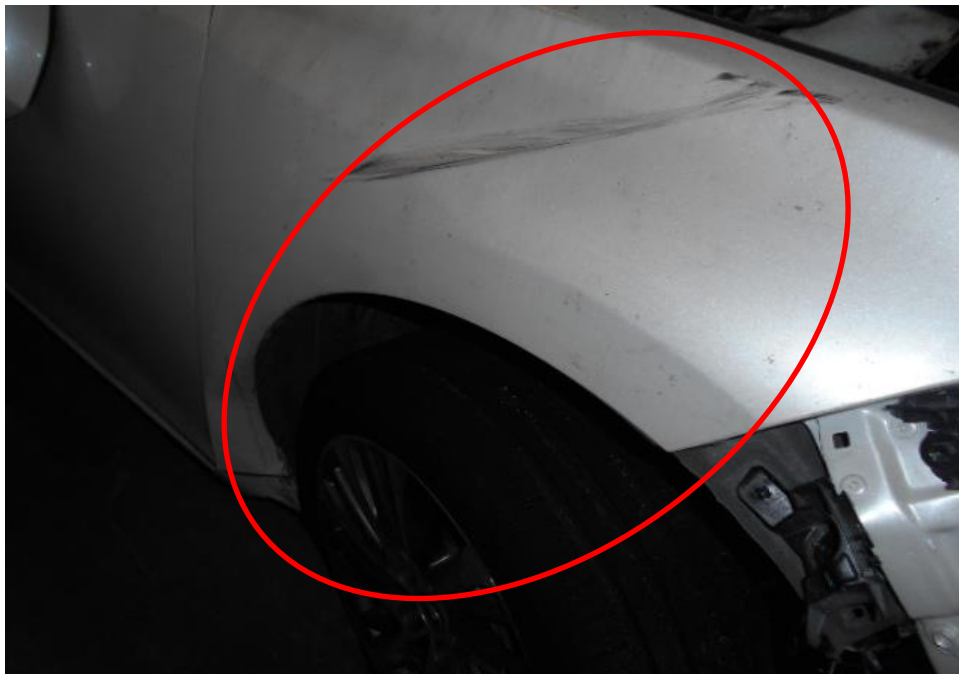
**Photo 6** shows the close up view of the Motor Car's front body at the time of my inspection. The Motor car was observed to have sustained damage at its front portion. Its front right fender (circled) was amongst the body part damaged as a result of the accident.

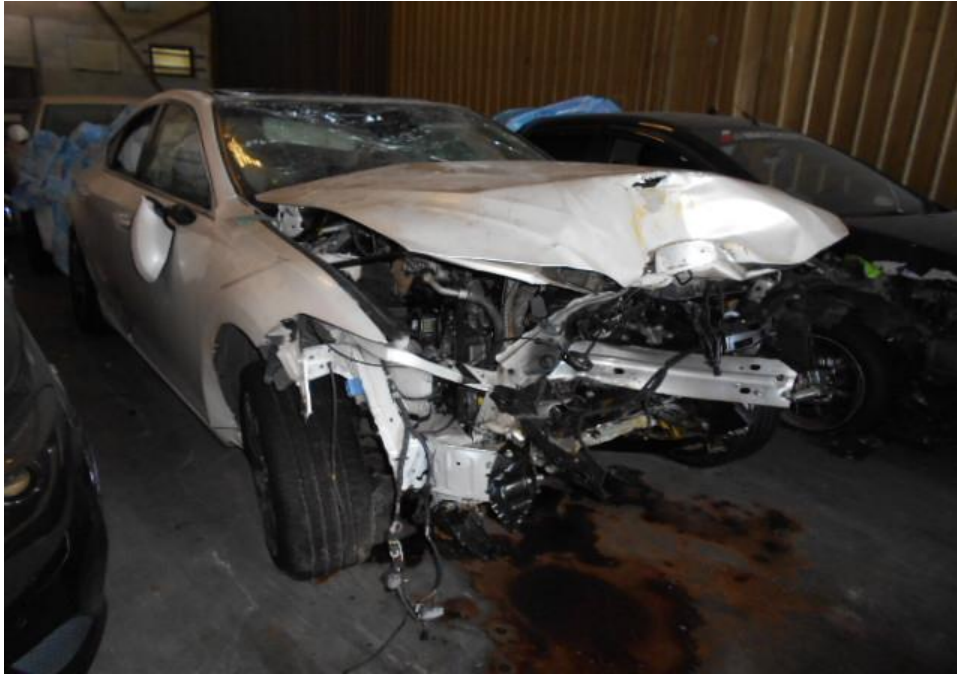
**Photo 7** shows a general view of the Motor Car's right body at the time of my inspection. The Motor car was observed to have sustained damage at its right portion. Its rear right rear view mirror, rear right door and rear right quarter panel was amongst the body parts damaged as a result of the accident.

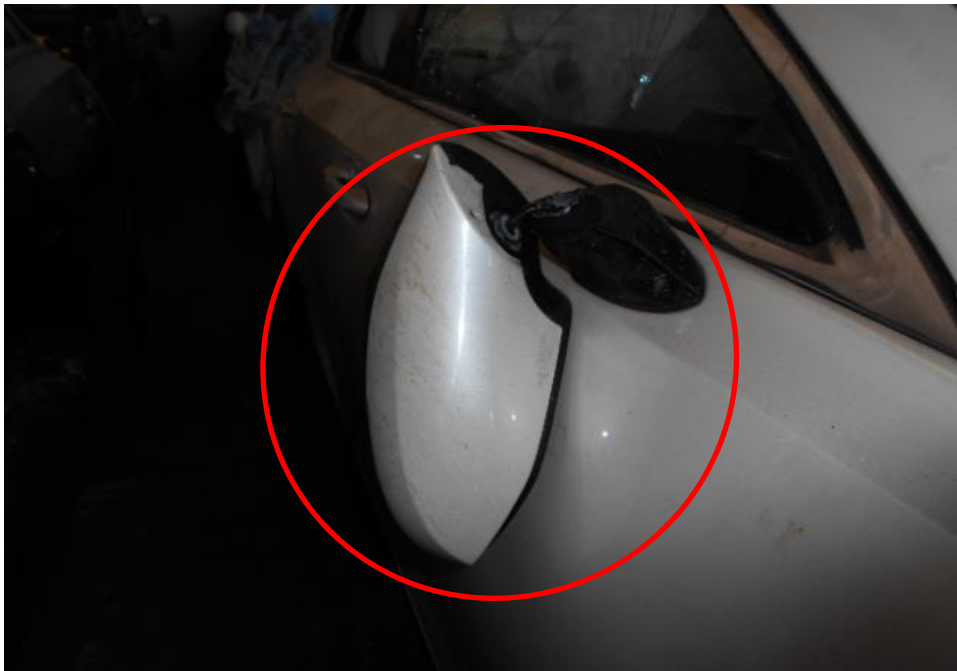
**Photo 8** shows a close up view of the Motor Car's right body at the time of my inspection. The Motor car was observed to have sustained damage at its right portion. Its rear right rear view mirror (circled) was amongst the body parts damaged as a result of the accident.

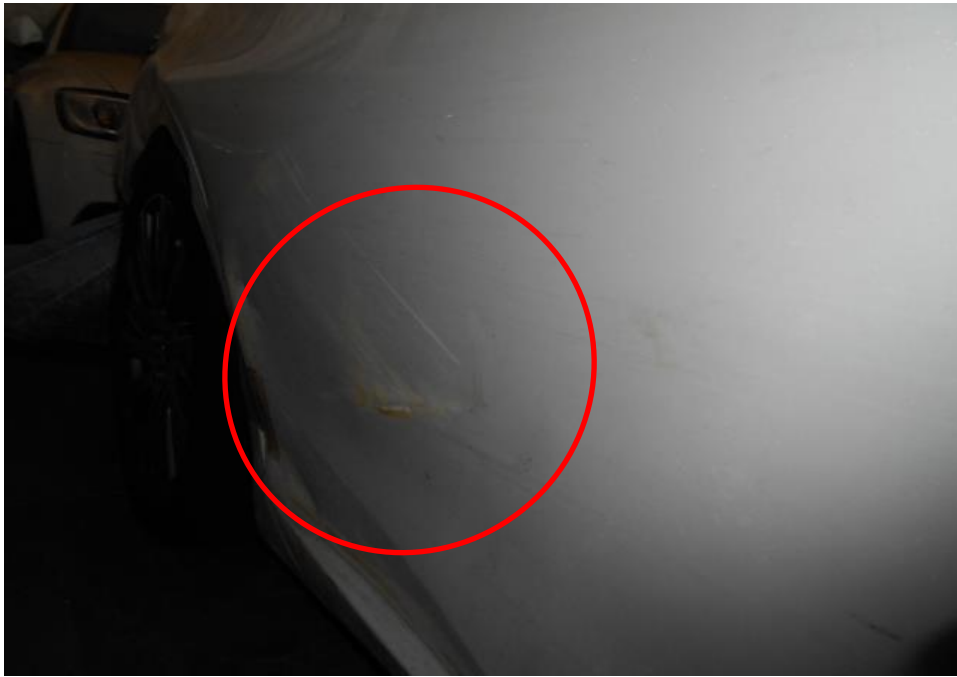
**Photo 9** shows a close up view of the Motor Car's right body at the time of my inspection. The Motor car was observed to have sustained damage at its right portion. Its rear right door was amongst the body parts damaged as a result of the accident.

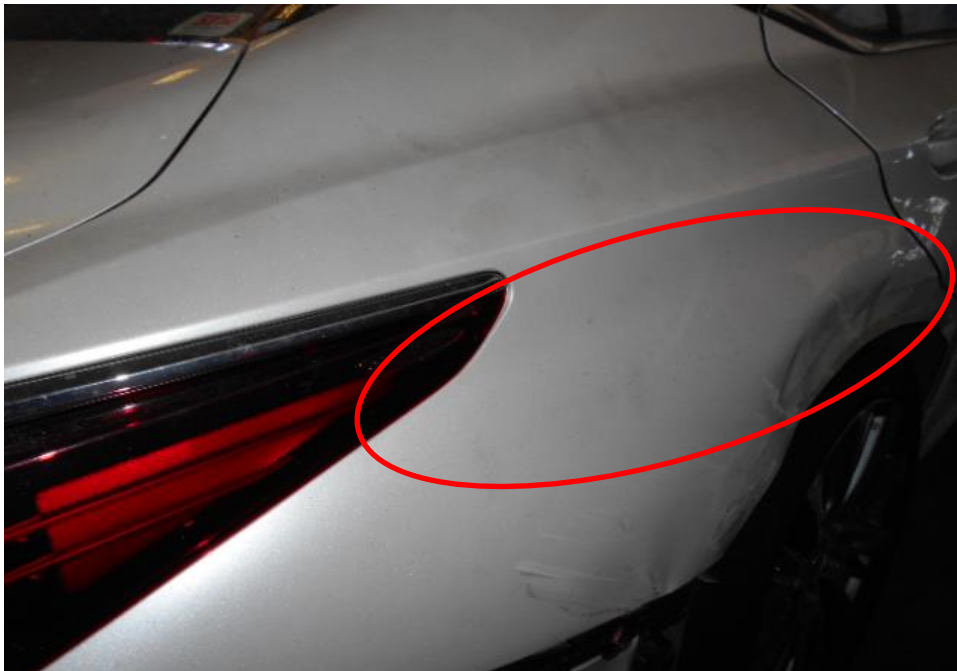
**Photo 10** shows a close up view of the Motor Car's right body at the time of my inspection. The Motor car was observed to have sustained damage at its right portion. Its right rear quarter panel was amongst the body parts damaged as a result of the accident.

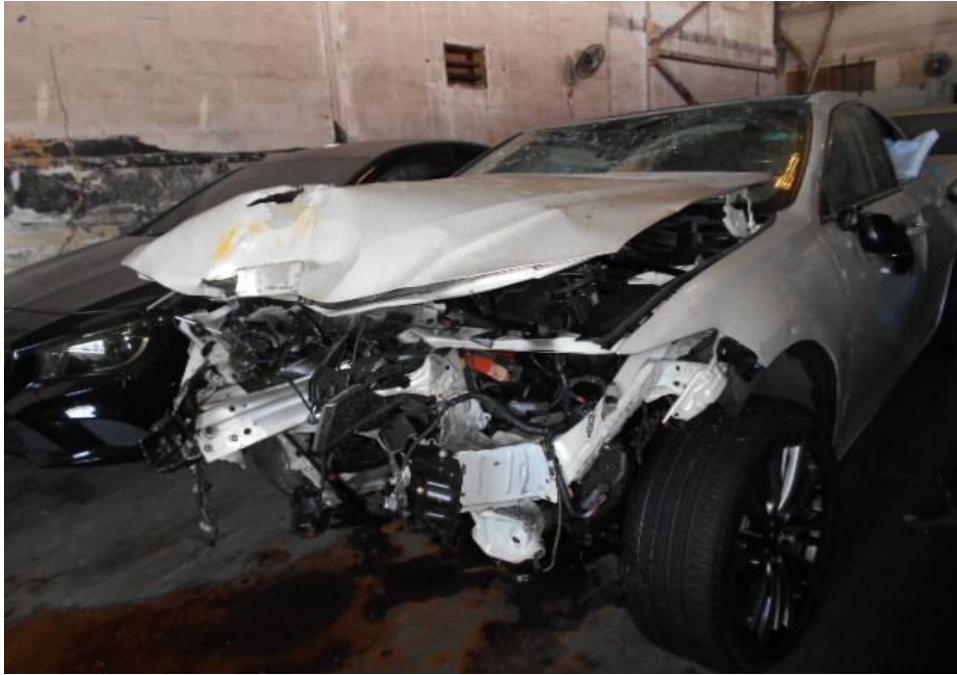
**Photo 11** shows a general view of the Motor Car's left body at the time of my inspection. The rear portion of the Motor Car was observed to sustain damages as a result of the accident. Its front left rear view mirror, front left door, rear left door and rear left quarter panel were damaged as a result of the accident.

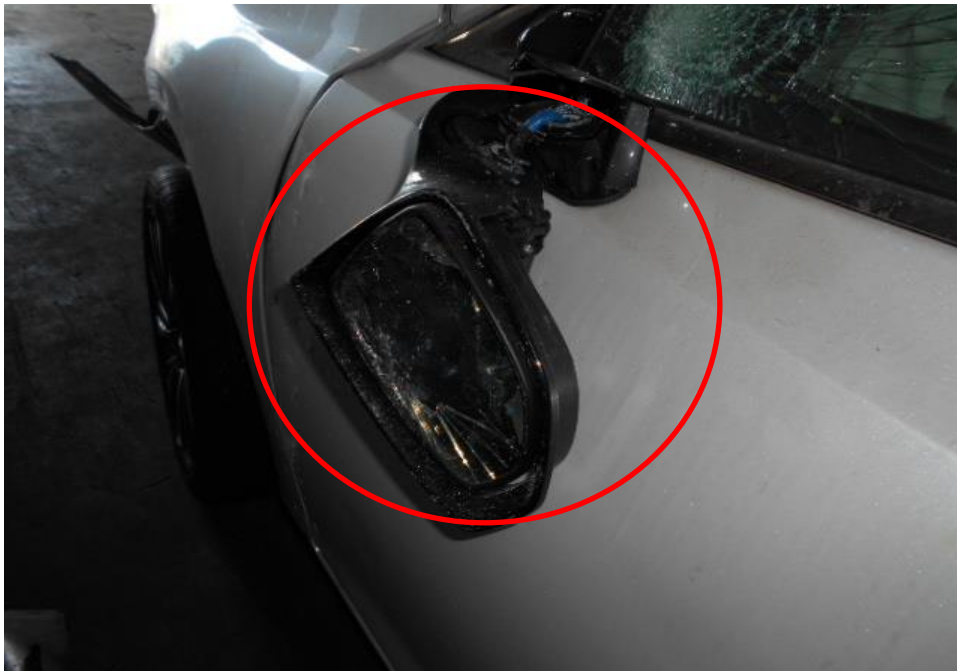
**Photo 12** shows a close up view of the Motor Car's left body at the time of my inspection. The Motor car was observed to have sustained damage at its left portion. Its left rear view mirror (circled) was amongst the body parts damaged as a result of the accident.

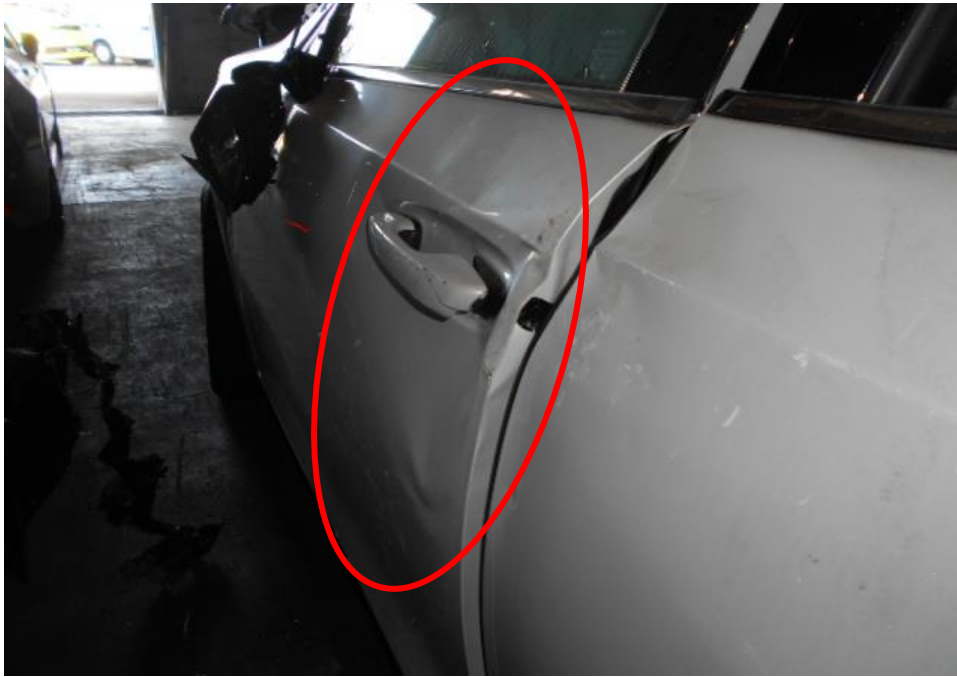
**Photo 13** shows a close up view of the Motor Car's left body at the time of my inspection. The Motor car was observed to have sustained damage at its left portion. Its front left door was amongst the body parts damaged as a result of the accident.

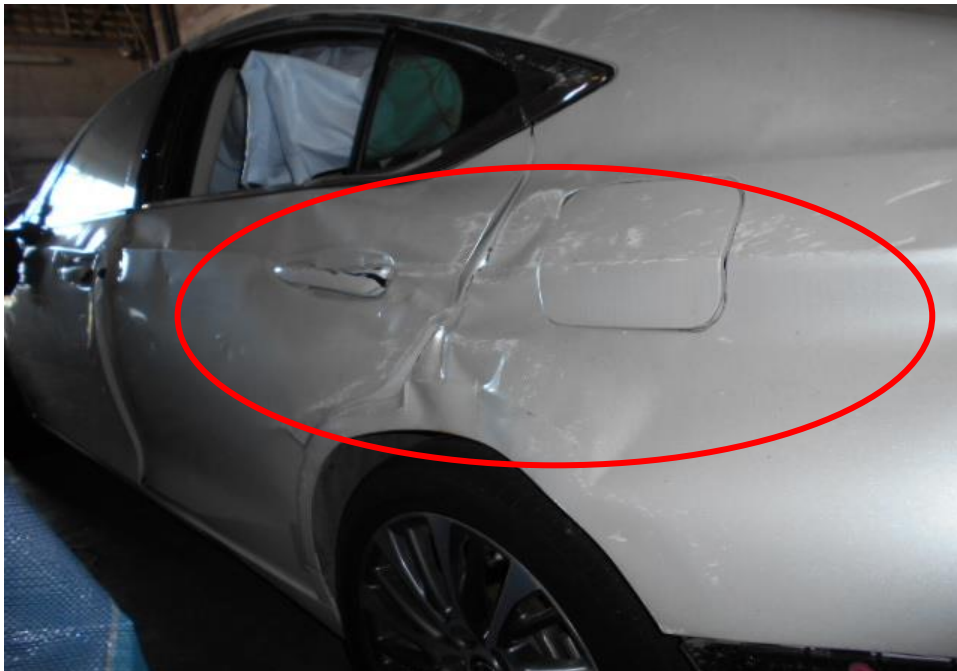
**Photo 14** shows a close up view of the Motor Car's left body at the time of my inspection. The Motor car was observed to have sustained damage at its left portion. Its rear left door and rear left quarter panel (circled) was amongst the body parts damaged as a result of the accident.

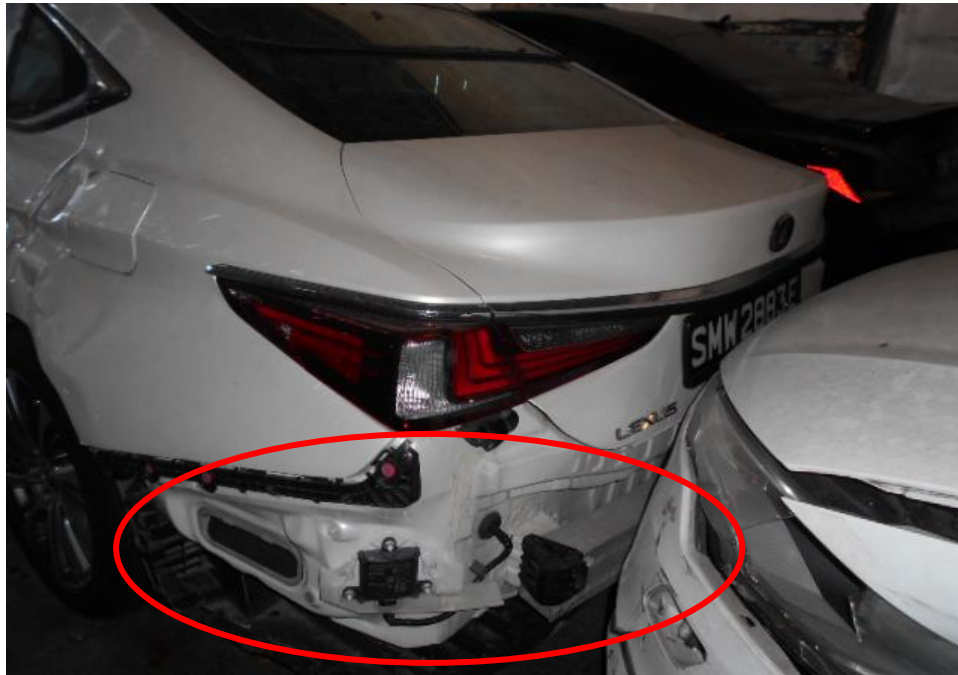
**Photo 15** shows a close up view of the Motor Car's rear body at the time of my inspection. The rear portion of the Motor Car was observed to sustain damages as a result of the accident. Its rear bumper (circled) was damaged as a result of the accident.

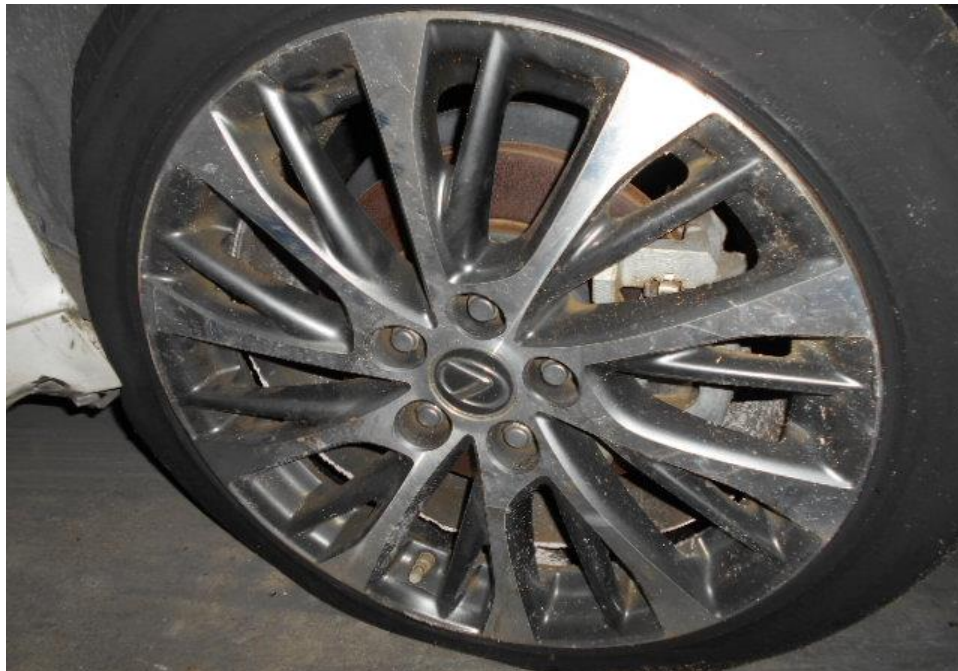
**Photo 16** shows the condition of the front right tyre of the Motor Car, which was observed to be in unserviceable condition with remaining tread depth of approximately 7.2mm. The tyre was also observed to be deflated as a result of the damaged wheel rim as a result of the accident, however there was no tear, cut or burst mark(s) on the tyre.

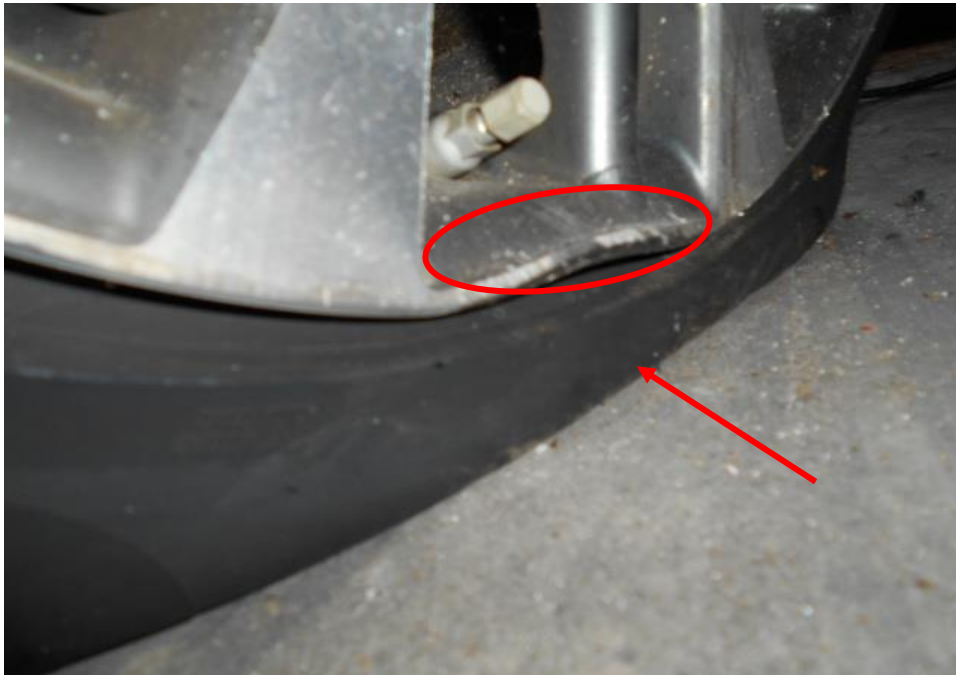
**Photo 17** shows the condition of the front right tyre and wheel rim of the Motor Car, the tyre was also observed to be deflated (arrowed) as a result of the damaged wheel rim (arrowed) as a result of the accident, however there was no tear, cut or burst mark(s) observed on the tyre.

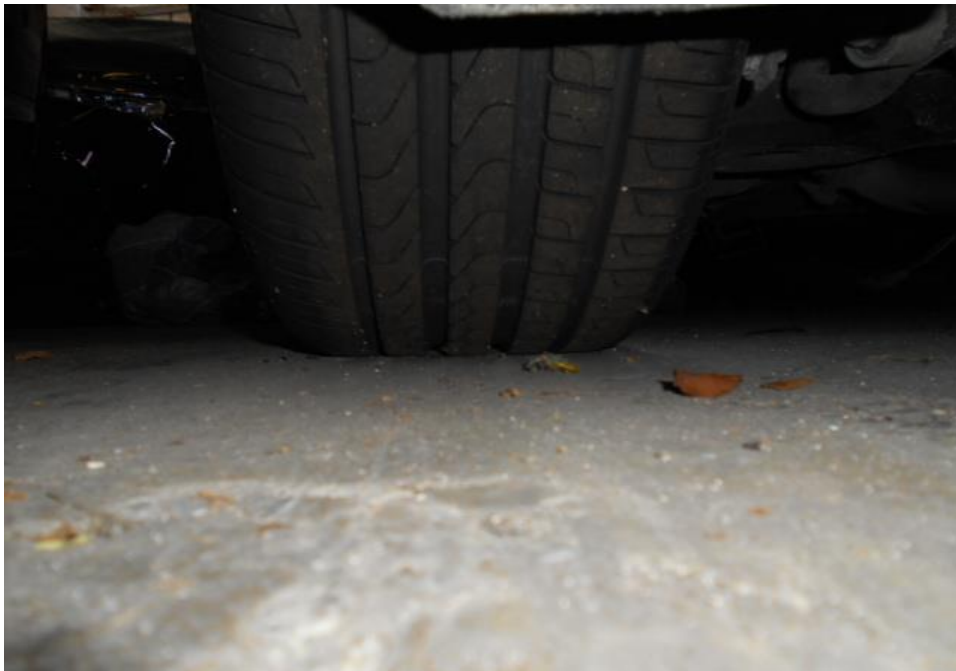
**Photo 18** shows the condition of the rear right tyre of the Motor Car, which was observed to be in serviceable condition with remaining tread depth of approximately 9.7mm. The tyre was also observed to be sufficiently inflated for vehicular operation with no tear, cut or burst mark(s).

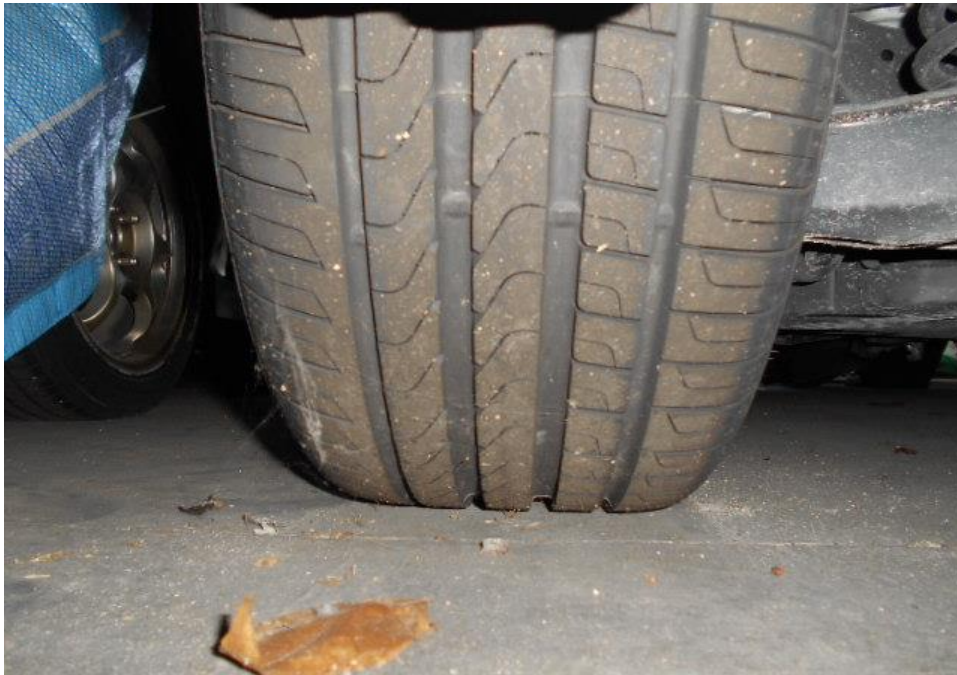
**Photo 19** shows the condition of the rear left tyre of the Motor Car, which was observed to be in serviceable condition with remaining tread depth of approximately 5.0mm. The tyre was also observed to be sufficiently inflated for vehicular operation with no tear, cut or burst mark(s).

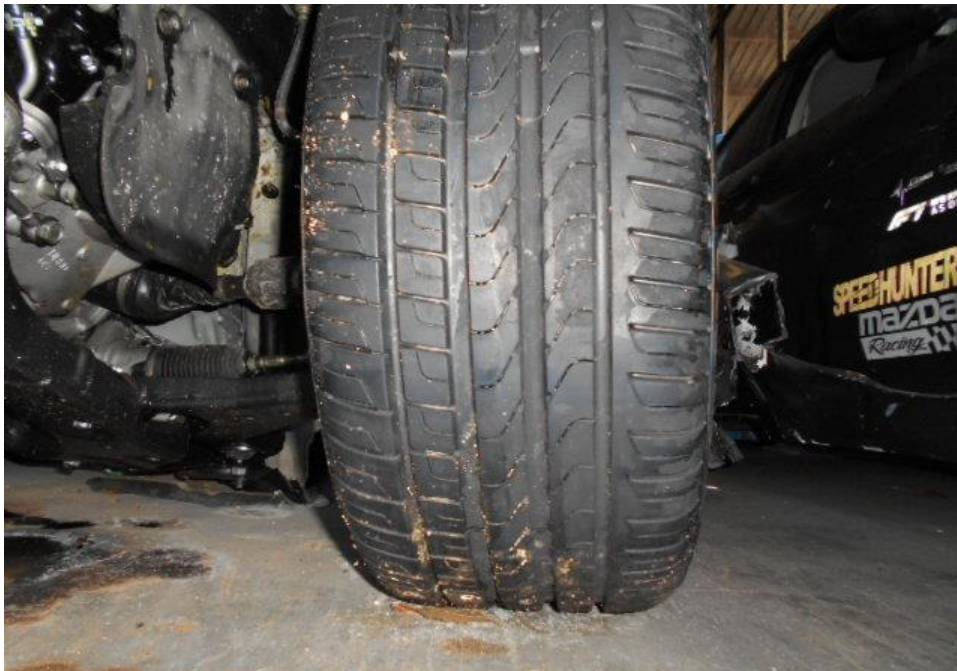
**Photo 20** shows the condition of the front left tyre of the Motor Car, which was observed to be in unserviceable condition with remaining tread depth of approximately 5.9mm. The tyre was also observed to be deflated as a result of the damaged wheel rim as a result of the accident, however there was no tear, cut or burst mark(s) on the tyre.

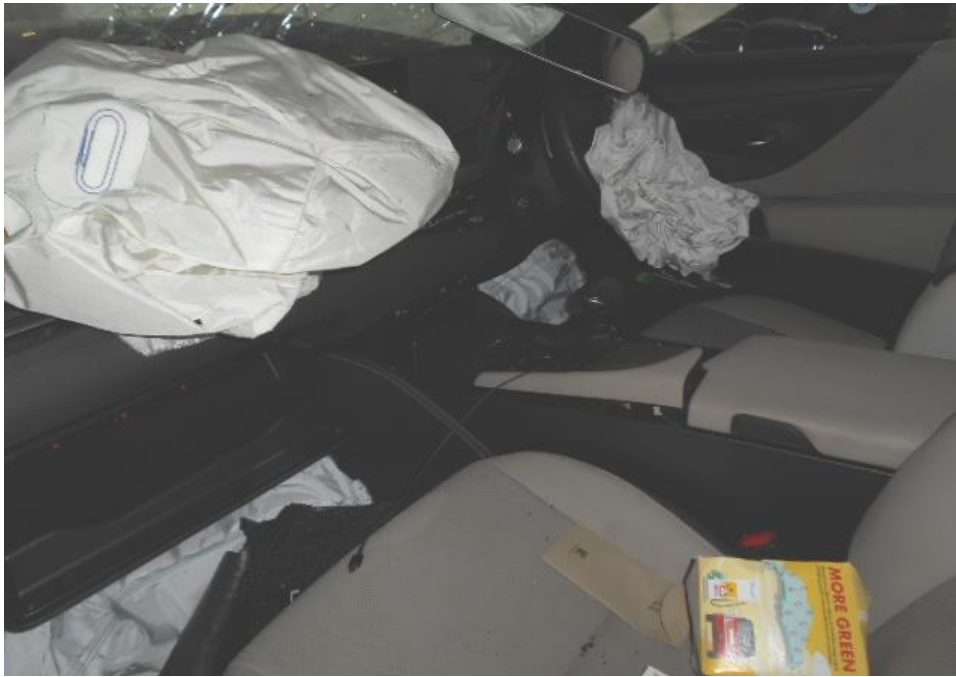
**Photo 21** shows the deployment of the Supplemental Restraint System (SRS) airbag in the Motor Car as a result of the accident.

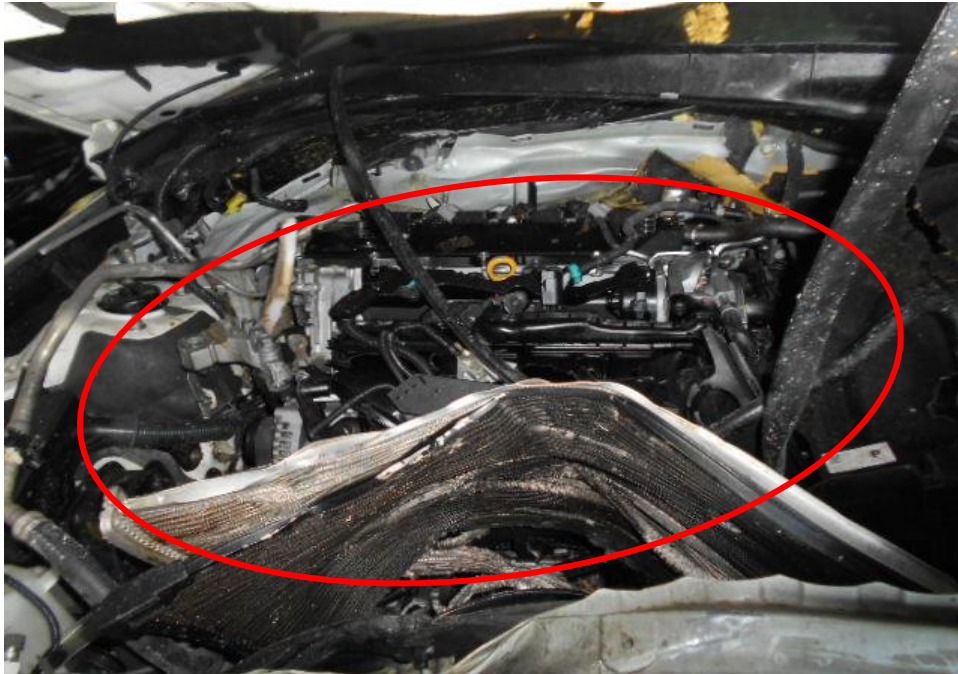
8. Upon examination of the engine compartment of the Motor Car, I had observed that the Motor Car's engine was badly damaged and crushed as a result of the accident.
9. My subsequent checks on the underside of the Motor Car revealed sign(s) or indication(s) of fluid leak and/or fluid stain(s) from the damaged engine as a result of the accident. See photo 22 and 23 below.

**Photo 22** shows a general view of the Motor Car's engine compartment. I had observed that the Motor Car's engine (circled) was badly damaged and crushed as a result of the accident.

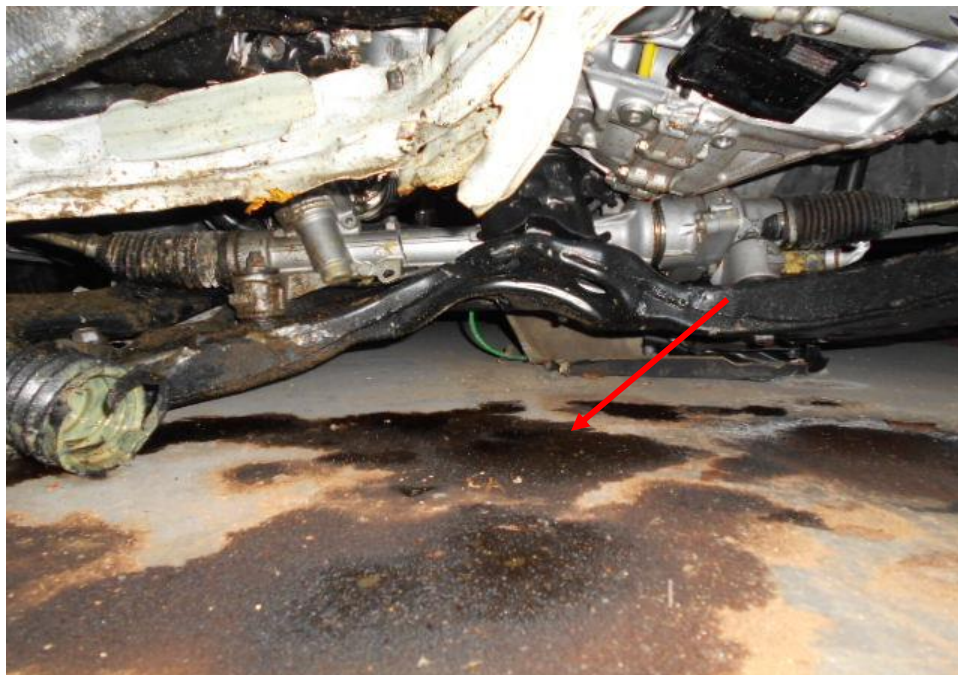
**Photo 23** shows the undercarriage of the Motor Car, at the area where the engine housing and transmission housing are located. I observed signs of engine oil (arrowed) on the underside of the Motor Car.

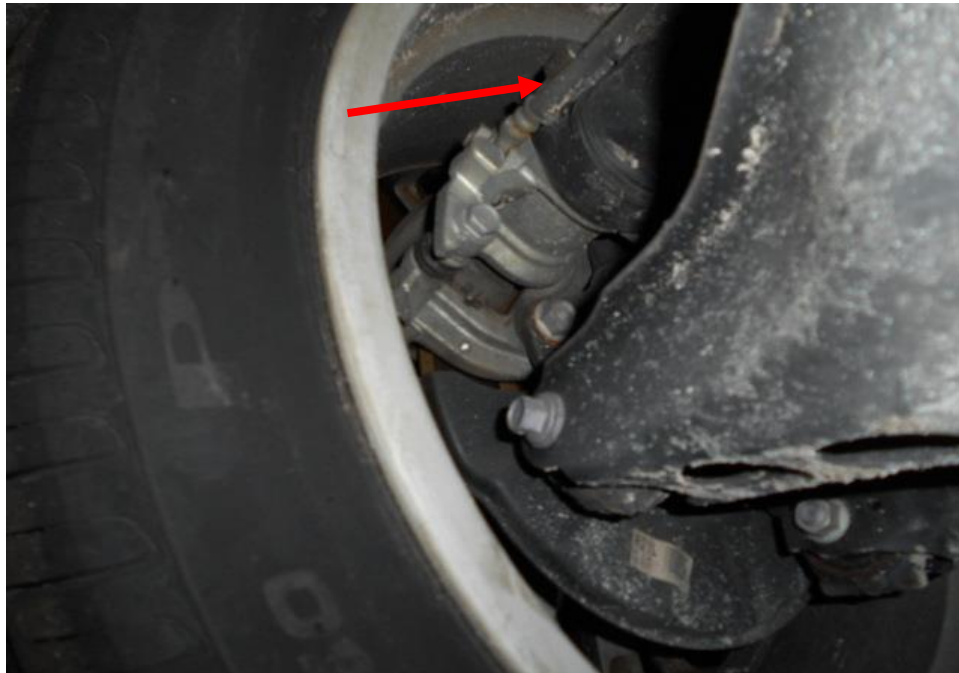
**Photo 24** shows the brake hose/pipe (arrowed) at the rear left wheel of the Motor Car. No leakage of brake fluid was observed. Visual examination of the various components of the braking system like the brake caliper to be intact without visible damage.

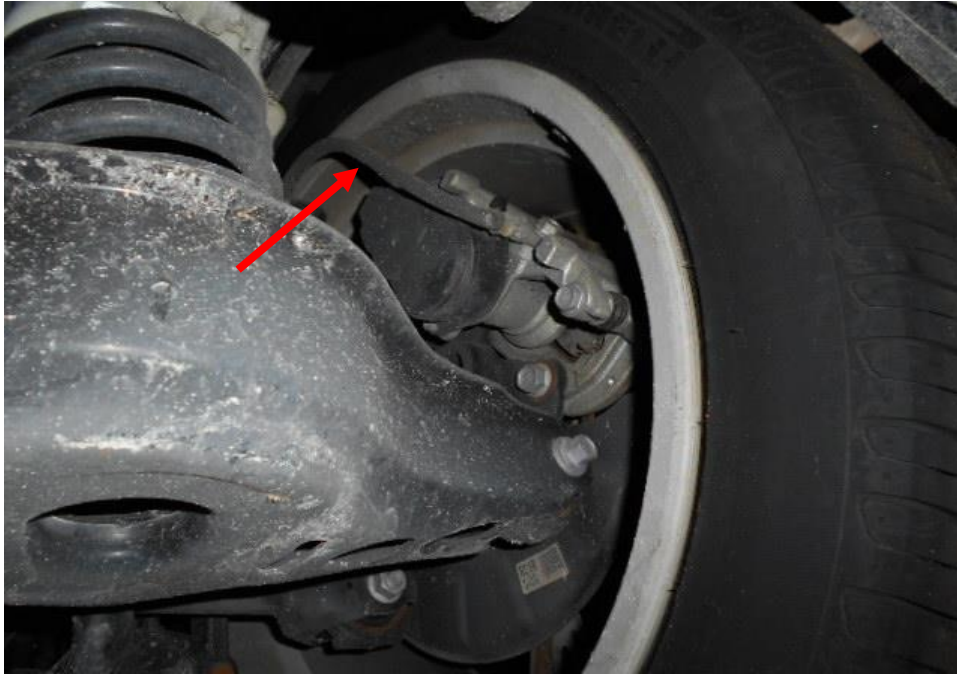
**Photo 25** shows the brake hose/pipe (arrowed) at the rear right wheel of the Motor Car. No leakage of brake fluid was observed. Visual examination of the various components of the braking system like the brake caliper to be intact without visible damage.

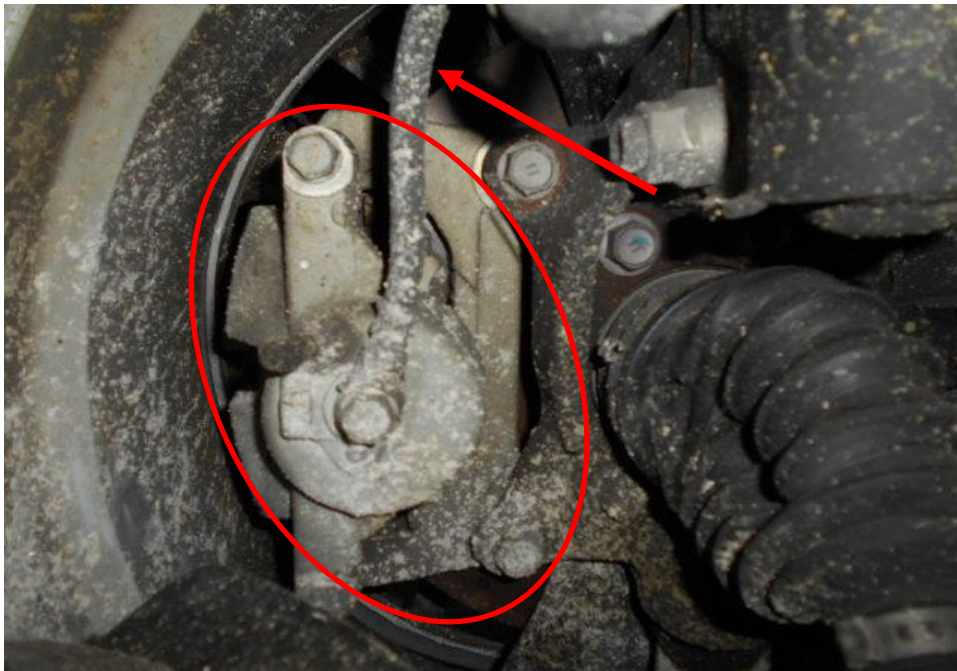
**Photo 26** shows the brake hose/pipe (arrowed) at the front right wheel of the Motor Car. I did not observe any leakage of brake fluid at the time of my inspection of the Motor Car. Visual examination of the various components of the braking system the brake caliper (circled) to be intact without visible damage.

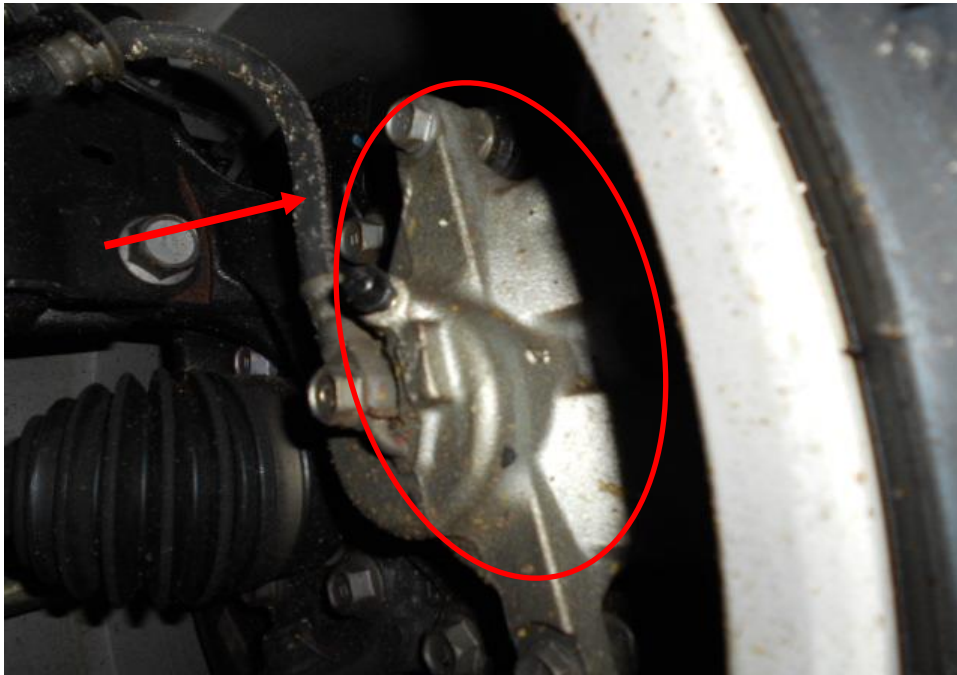
**Photo 27** shows the brake hose/pipe (arrowed) at the front left wheel of the Motor Car. No leakage of brake fluid was observed. Visual examination of the various components of the braking system like the brake caliper (circled) had revealed to be intact and without visible damage.

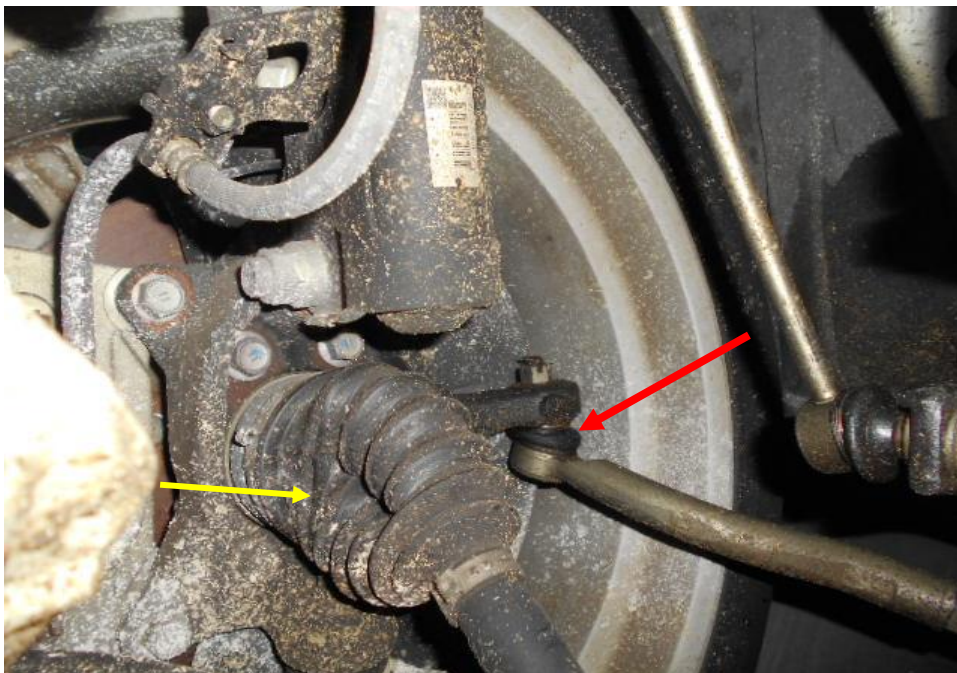
**Photo 28** shows the various undercarriage components at the front right wheel of the Motor Car, in particular the steering tie rod (red arrow) and the driveshaft (yellow arrow). The front right driveshaft was appeared to be damaged as a result of the accident. However, the steering tie rod appears to be intact without visible damage.

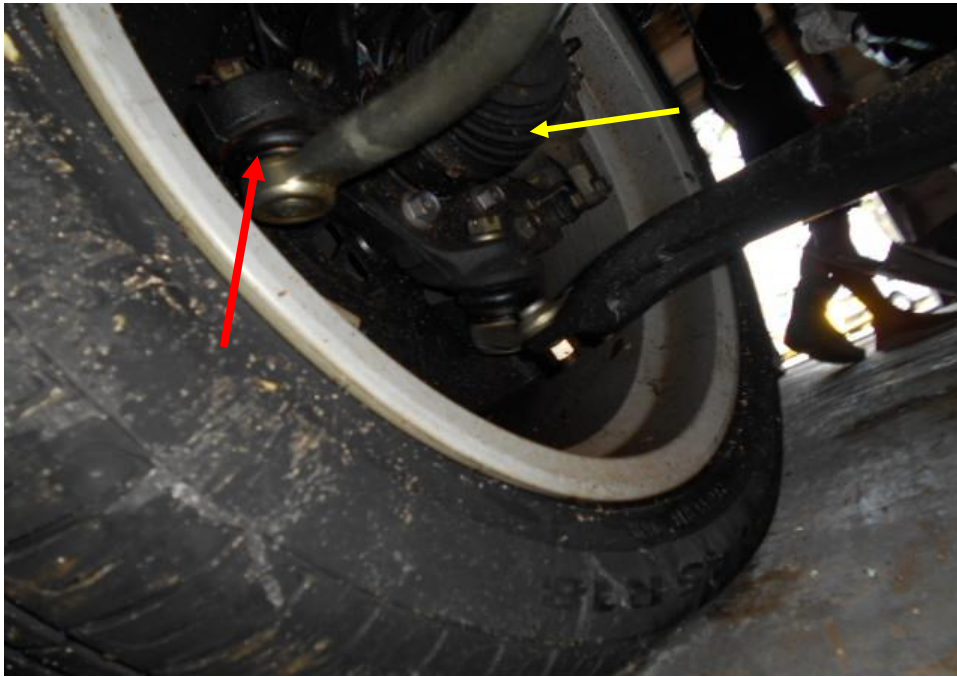
**Photo 29** shows the various undercarriage components at the front right wheel of the Motor Car, in particular the steering tie rod (red arrow) and the driveshaft (yellow arrow). The various steering components were all found to be intact.

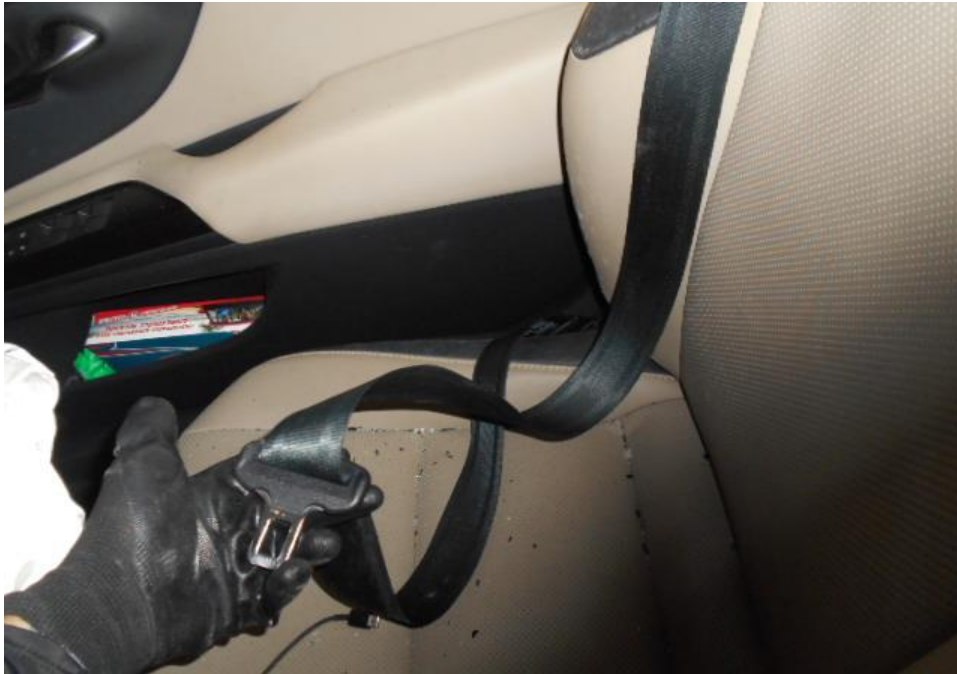
**Photo 30** shows that the front right seat belt was worn at the material time of accident as the safety pre-tensioners was activated at the moment of impact and caused the seat belt to be locked into the last position.

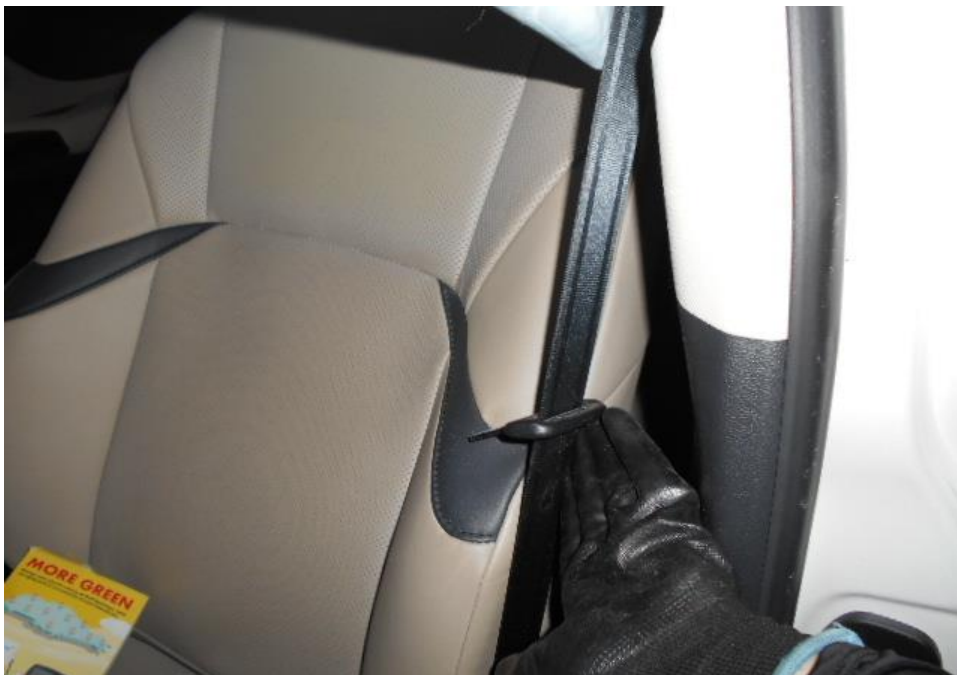
**Photo 31** shows that the front left seat belt was not worn at the material time of accident as the safety pre-tensioners was activated at the moment of impact and caused the seat belt to be locked into the last position.
