Your Ref: TP IP/09386/2023
Our Ref : CI/TPD23005782/P

Fatal Accident Investigation Team

MECHANICAL INSPECTION REPORT OF MOTOR CAR SNH 7151T

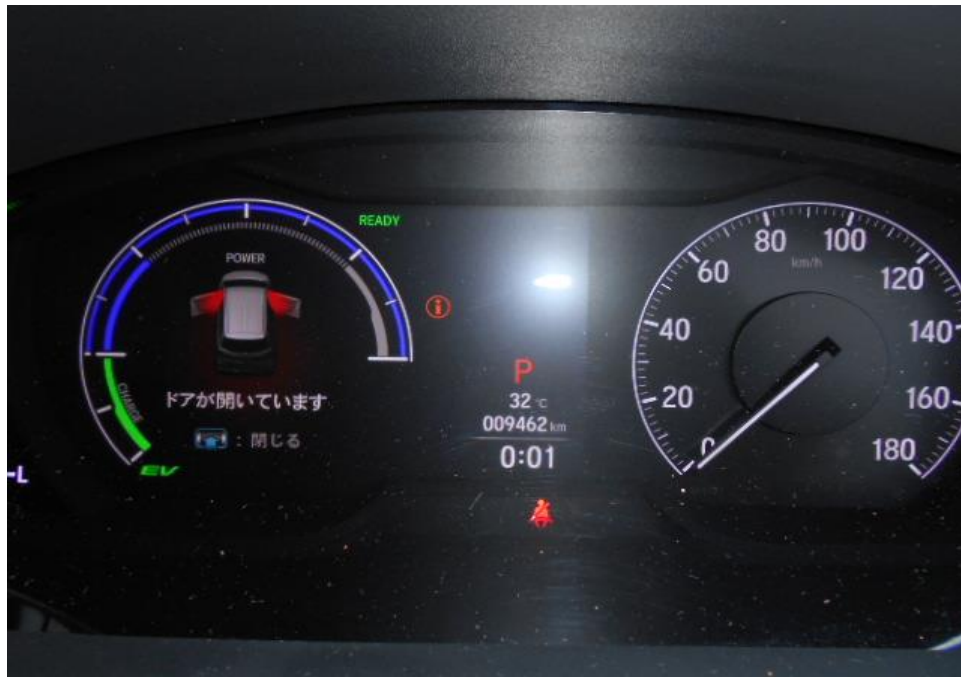
Photo 1 shows the mileage of the Motor Car at the time of my inspection. The mileage observed was 9,462km.

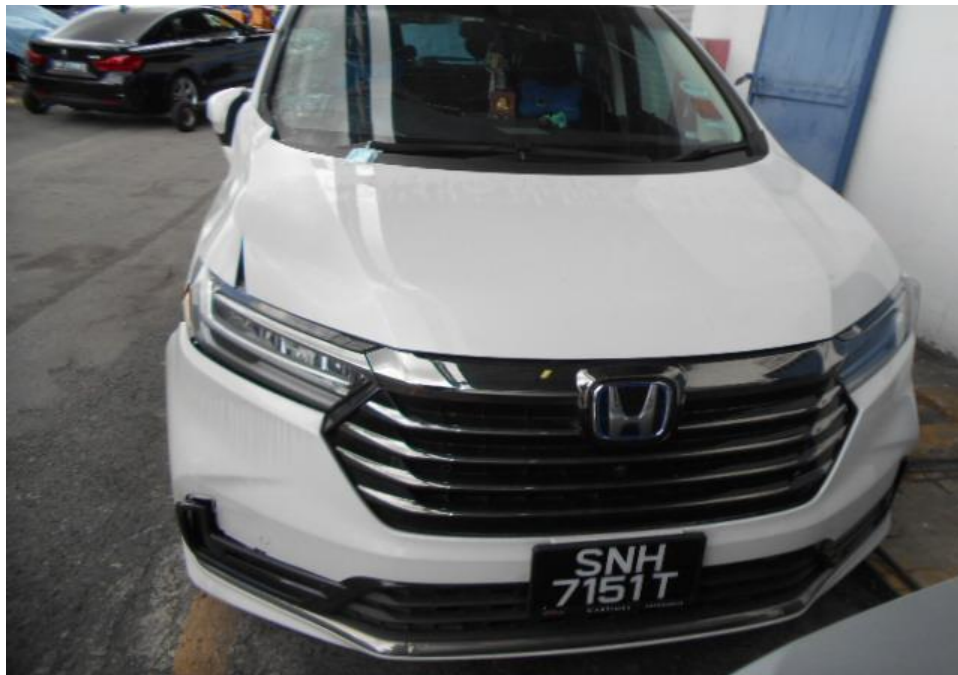
4. The mileage of the Motor Car at the time of my inspection was 9,462km.
5. The Motor car was observed to have sustained damage at its front portion. Its front bumper, front right fender, front bonnet and front windscreen, was amongst the body parts damaged as a result of the accident.

Photo 2 shows a general view of the Motor Car's front body at the time of my inspection. The Motor car was observed to have sustained damage at its front portion. Its front windscreen, front bonnet, front right fender and front bumper was amongst the body parts damaged as a result of the accident.

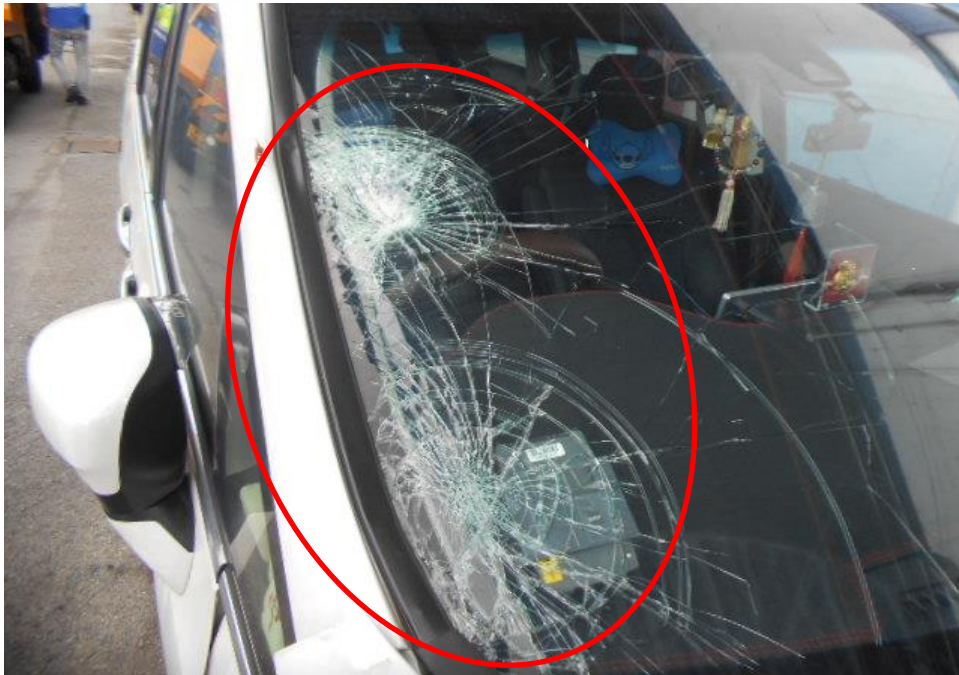
Photo 3 shows the close up view of the Motor Car's front body at the time of my inspection. The Motor Car was observed to have sustained damage at its front portion. Its front windscreen (circled) was damaged as a result of the accident

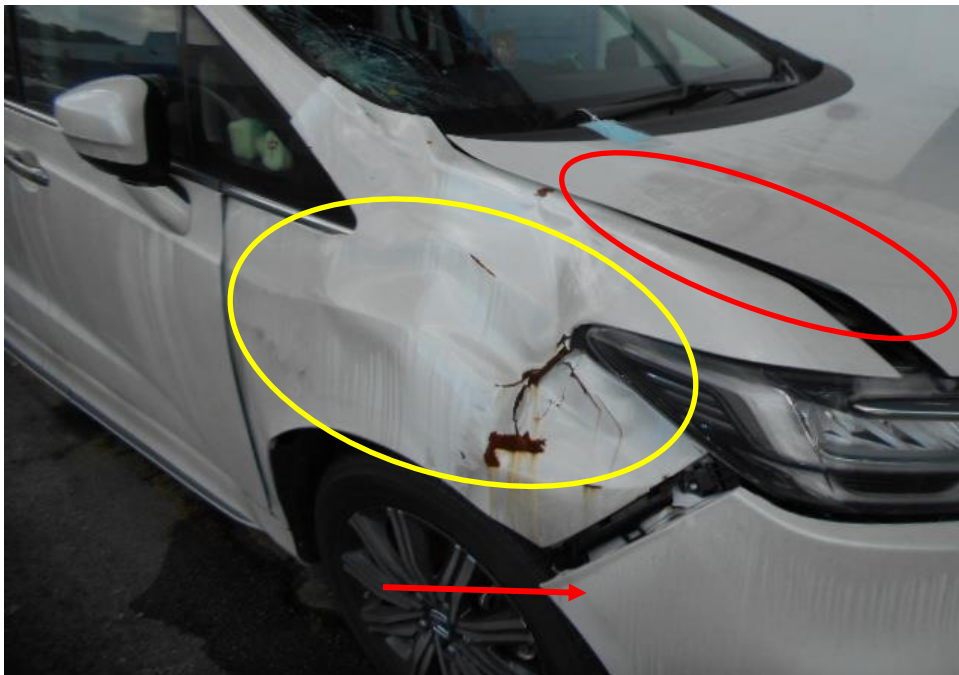
Photo 4 shows the close up view of the Motor Car's front body at the time of my inspection. The Motor car was observed to have sustained damage at its front portion. Its front right fender (yellow circle) front bonnet (red circle) and front bumper (arrowed) was damaged as a result of the accident.

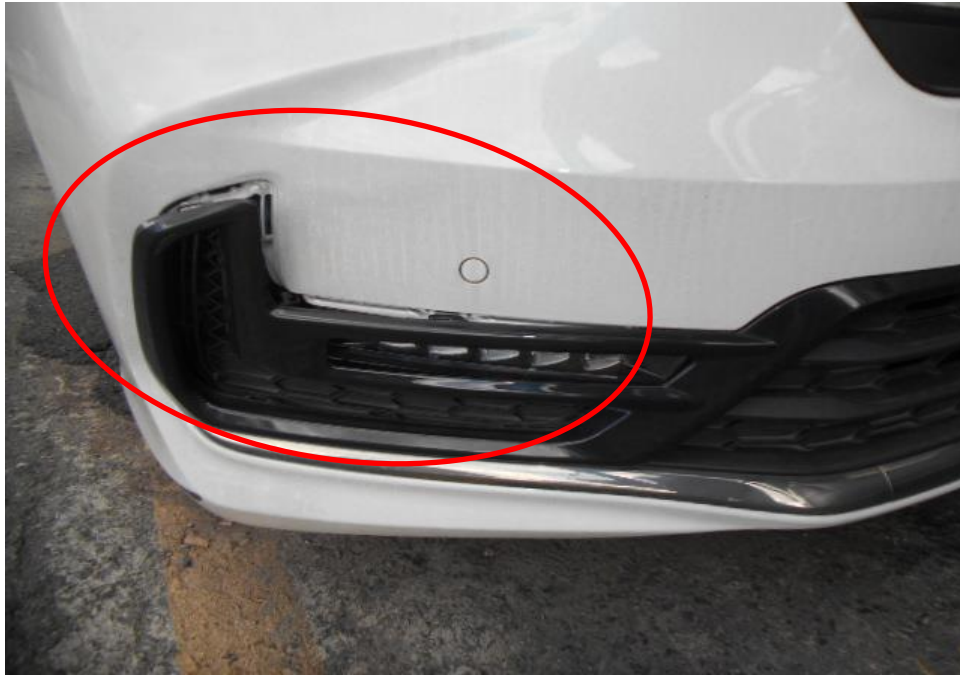
Photo 5 shows the close up view of the Motor Car's front bumper at the time of my inspection. The Motor car was observed to have sustained damage at its front portion. Its front bumper (circled) was damaged as a result of the accident.

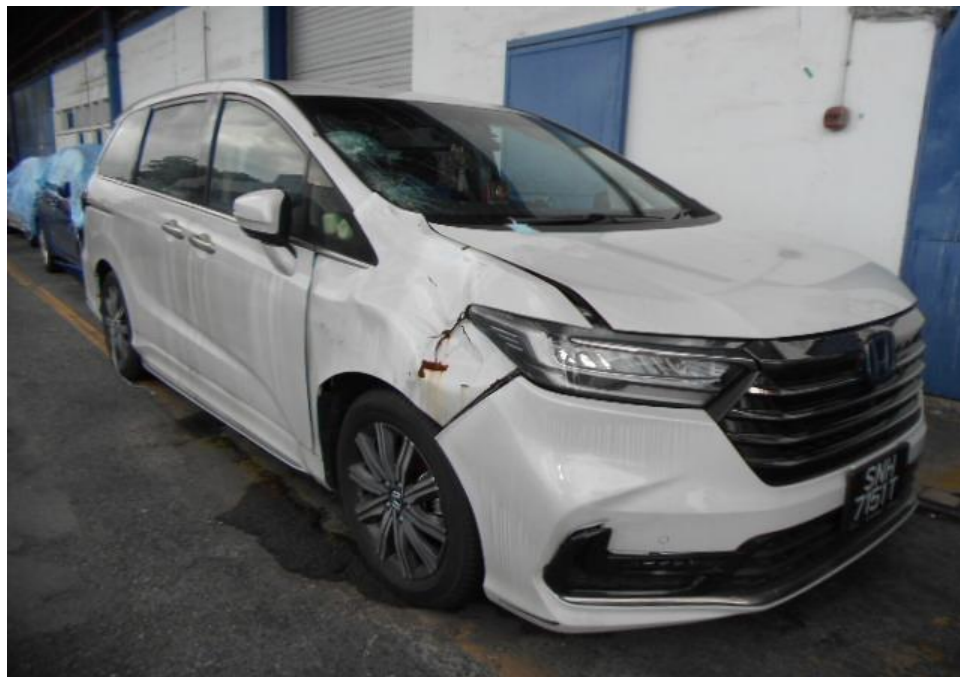
Photo 6 shows a general view of the Motor Car's right body at the time of my inspection. The right portion of the Motor Car was observed to have been undamaged by the accident.

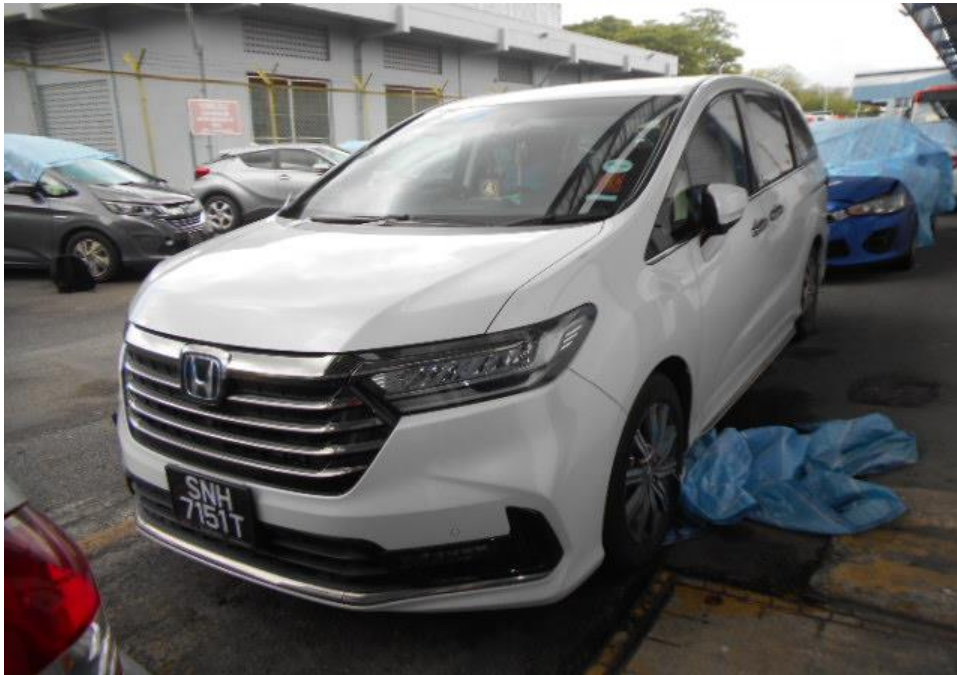
Photo 7 shows a general view of the Motor Car's left body at the time of my inspection. The left portion of the Motor Car was observed to have been undamaged by the accident.

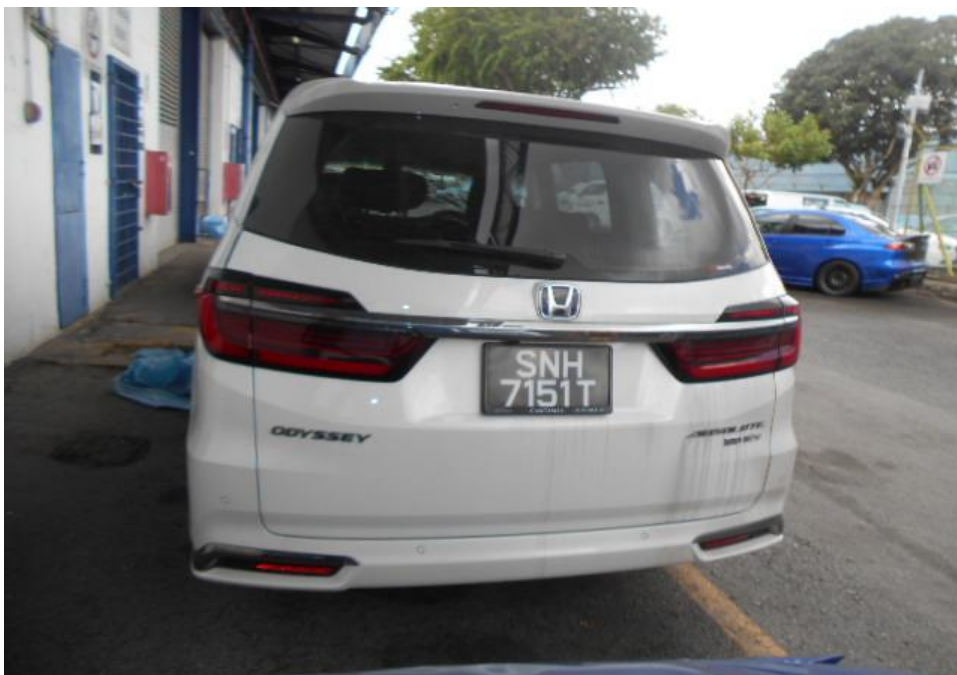
Photo 8 shows a general view of the Motor Car's rear body at the time of my inspection. The rear portion of the Motor Car was observed to have been undamaged by the accident.

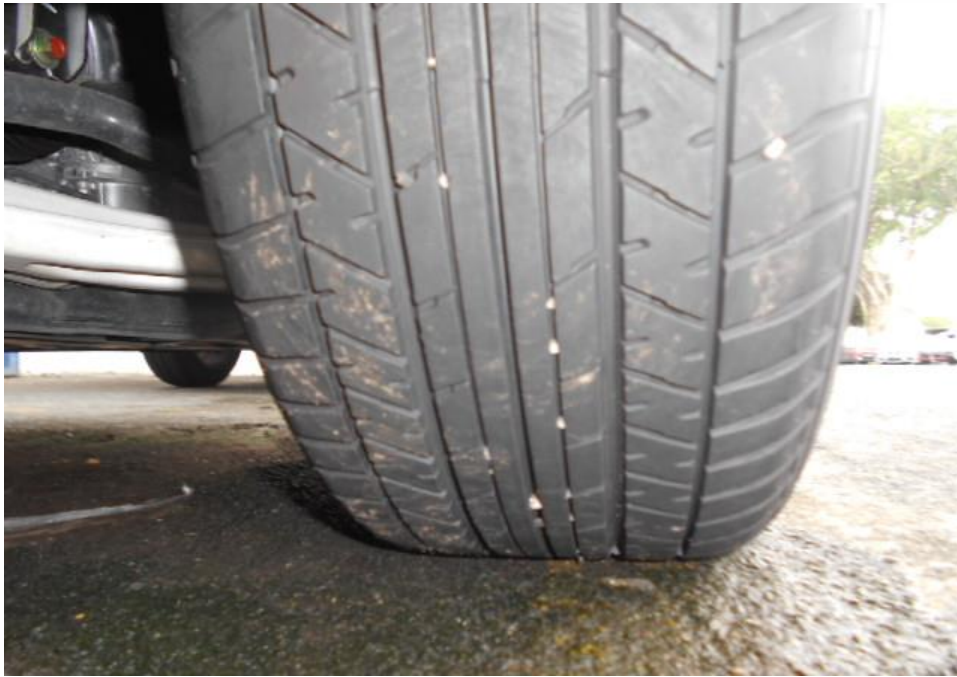
Photo 9 shows the condition of the front right tyre of the Motor Car, which was observed to be in serviceable condition with remaining tread depth of approximately 4.2mm. The tyre was also observed to be sufficiently inflated for vehicular operation with no tear, cut or burst mark(s).

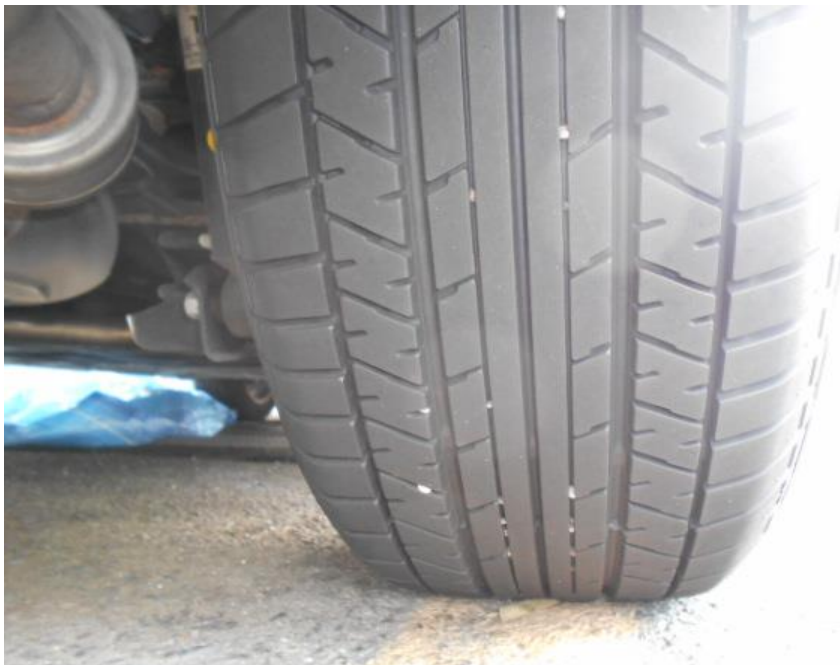
Photo 10 shows the condition of the rear right tyre of the Motor Car, which was observed to be in serviceable condition with remaining tread depth of approximately 7mm. The tyre was also observed to be sufficiently inflated for vehicular operation with no tear, cut or burst mark(s).

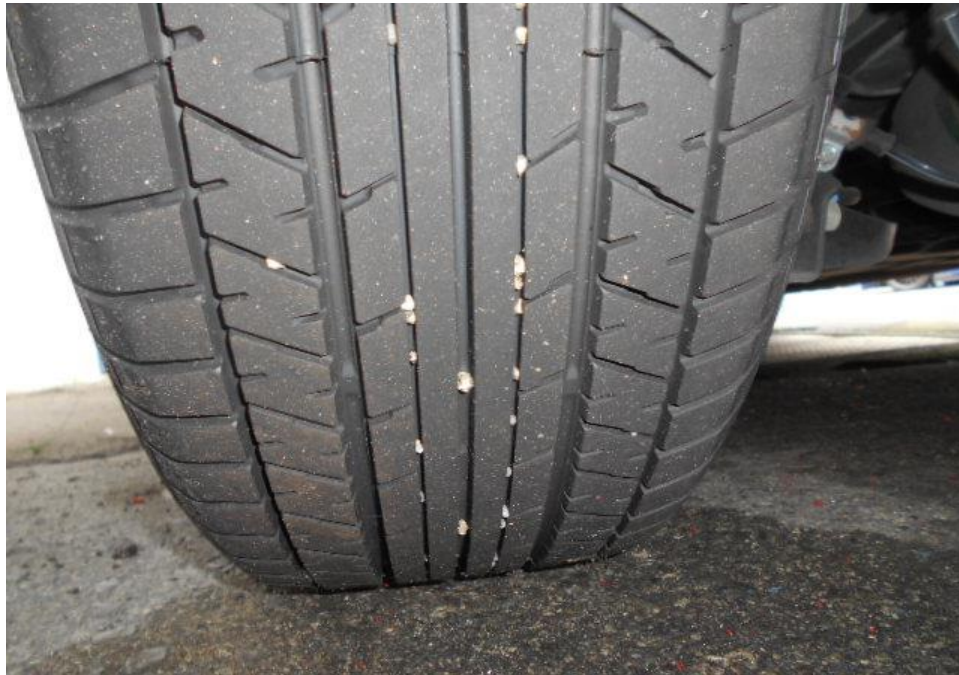
Photo 11 shows the condition of the rear left tyre of the Motor Car, which was observed to be in serviceable condition with remaining tread depth of approximately 6.9mm. The tyre was also observed to be sufficiently inflated for vehicular operation with no tear, cut or burst mark(s).

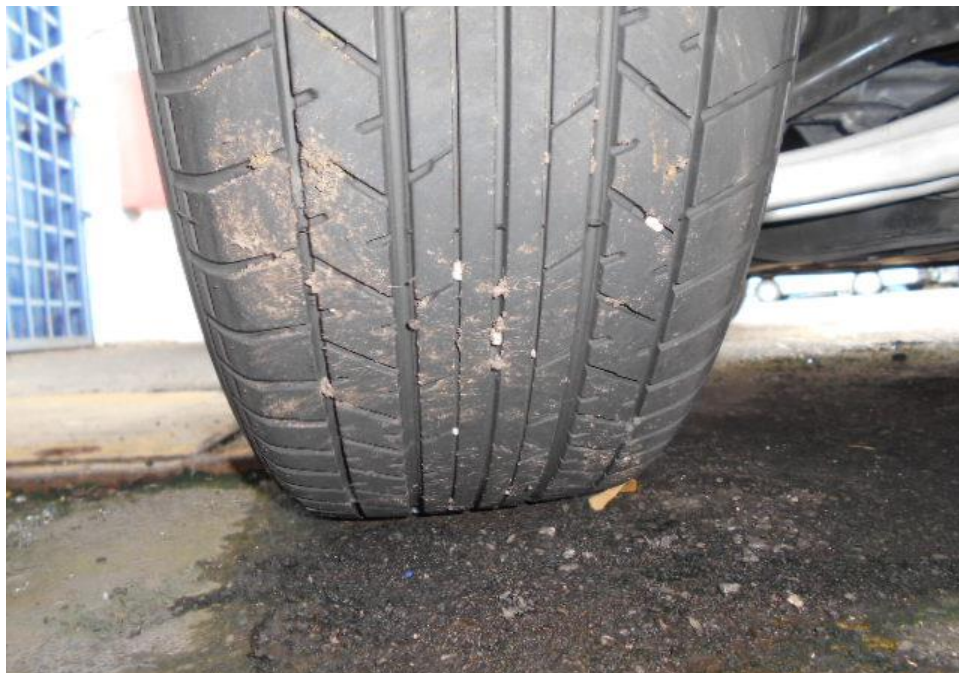
Photo 12 shows the condition of the front left tyre of the Motor Car, which was observed to be in serviceable condition with remaining tread depth of approximately 5mm. The tyre was also observed to be sufficiently inflated for vehicular operation with no tear, cut or burst mark(s).

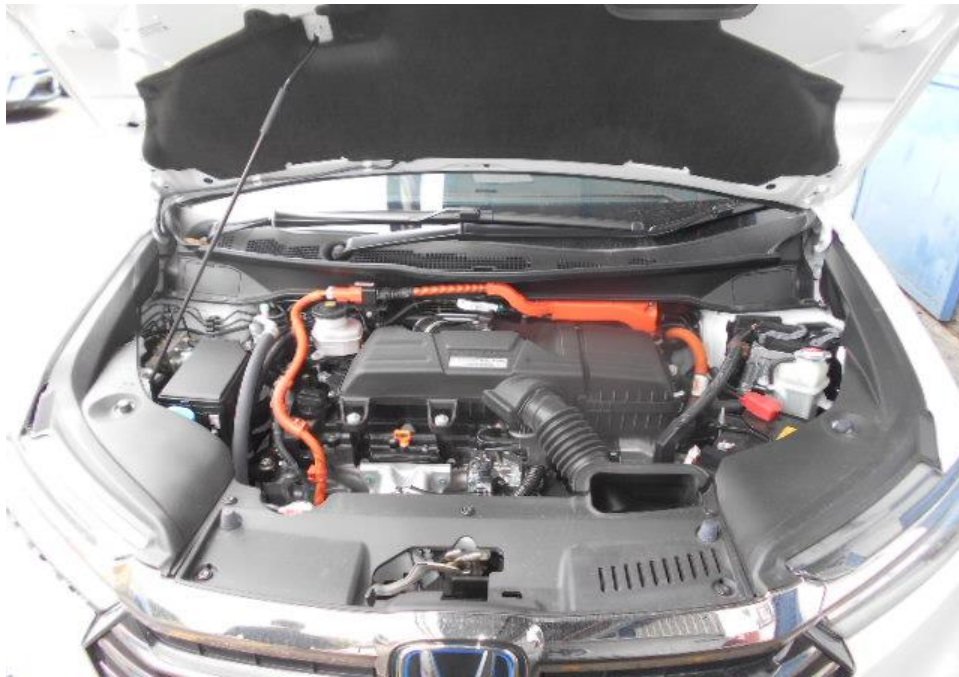
Photo 13 shows a general view of the Motor Car's engine compartment. The various parts and components inside the engine compartment were unaffected by the accident. There was also no sign(s) or indication(s) of fluid leakage and/or fluid stain within the engine bay.

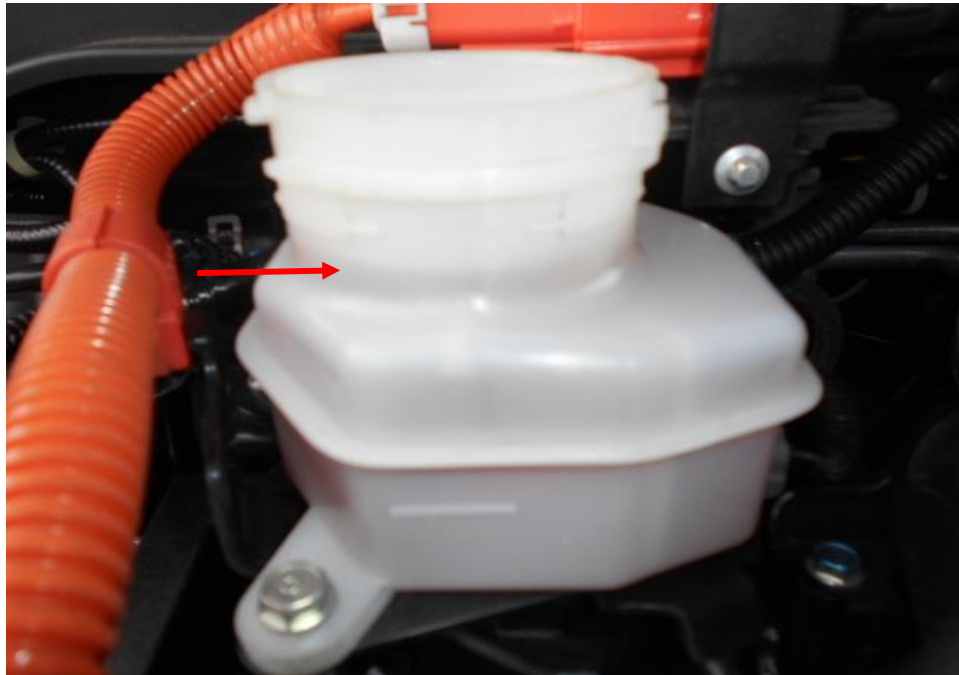
Photo 14 shows the brake fluid reservoir of the Motor Car at the time of my inspection. The brake fluid was observed to be of sufficient level (arrowed) without any visible contamination.

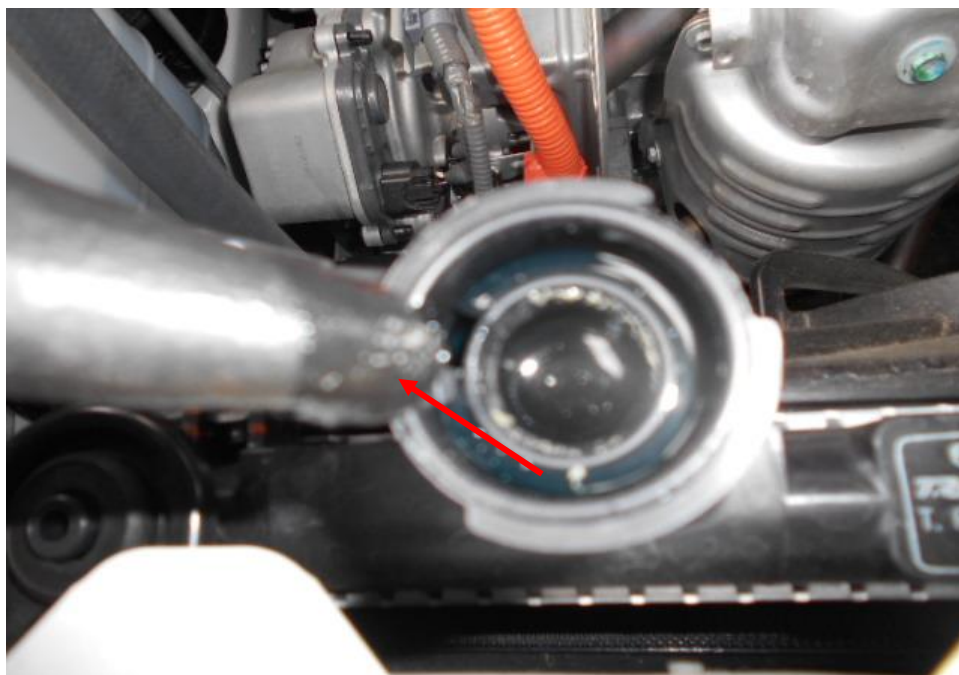
Photo 15 shows checks being carried out on the engine coolant of the Motor Car at the time of my inspection. The engine coolant was observed to be of sufficient level (arrowed) without any visible contaminations.

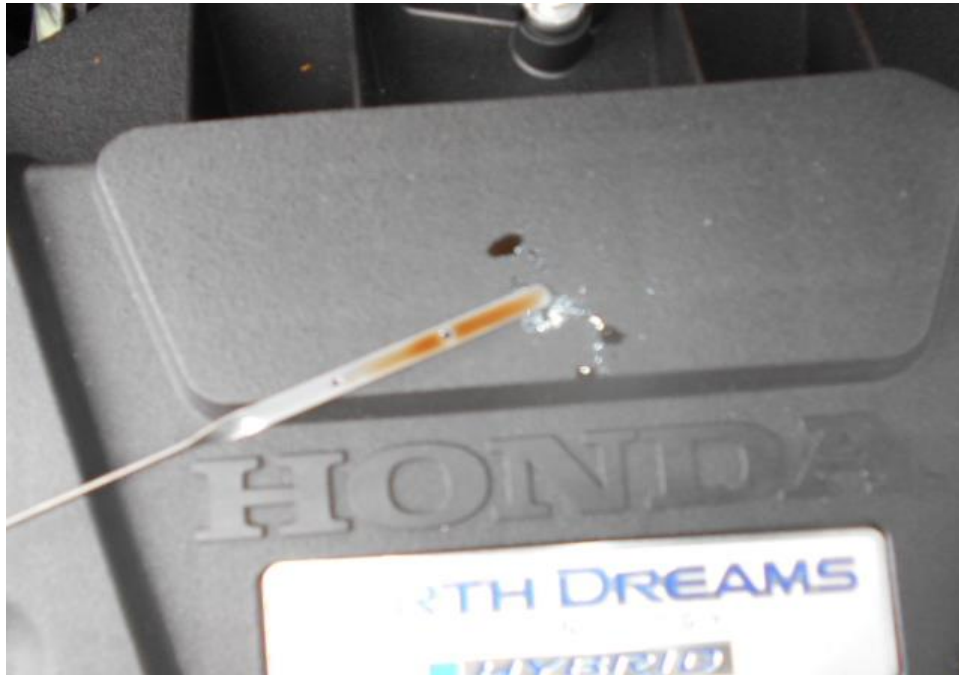
Photo 16 shows the engine oil dipstick of the Motor Car at the time of my inspection. The engine oil was observed to be of sufficient level without any visible contamination.

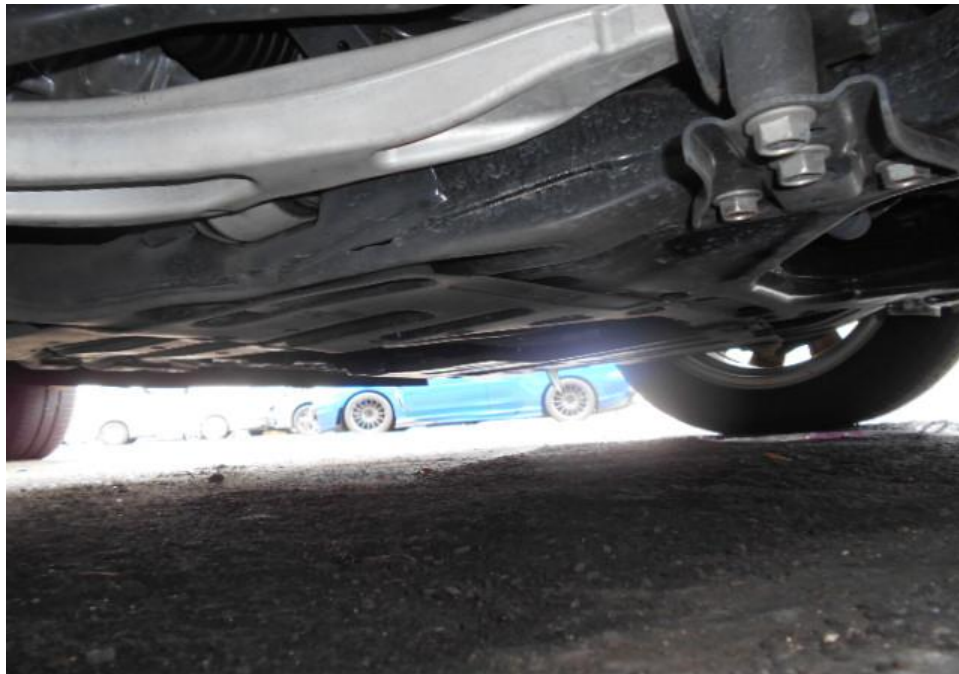
Photo 17 shows the undercarriage of the Motor Car, where the engine housing and transmission housing are located. I did not find any sign(s) or indication(s) of fluid leak and/or fluid stain(s) on the underside of the Motor Car.

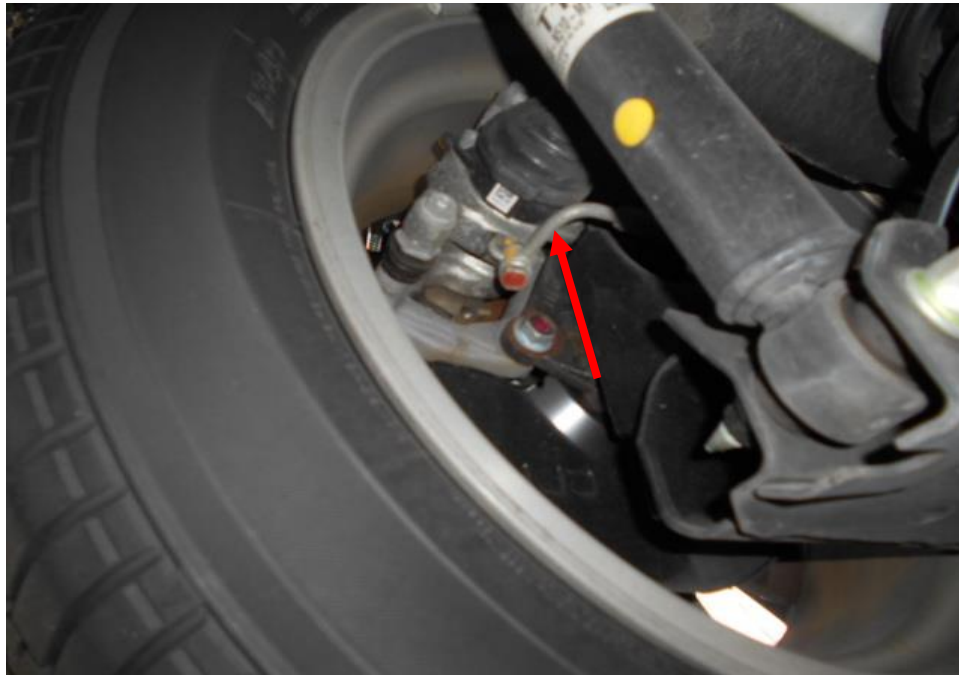
Photo 18 shows the brake hose/pipe (arrowed) at the rear left wheel of the Motor Car. No leakage of brake fluid was observed. Visual examination of the various components of the braking system like the drum brake and brake hose etc. had revealed all to be intact and without visible damage.

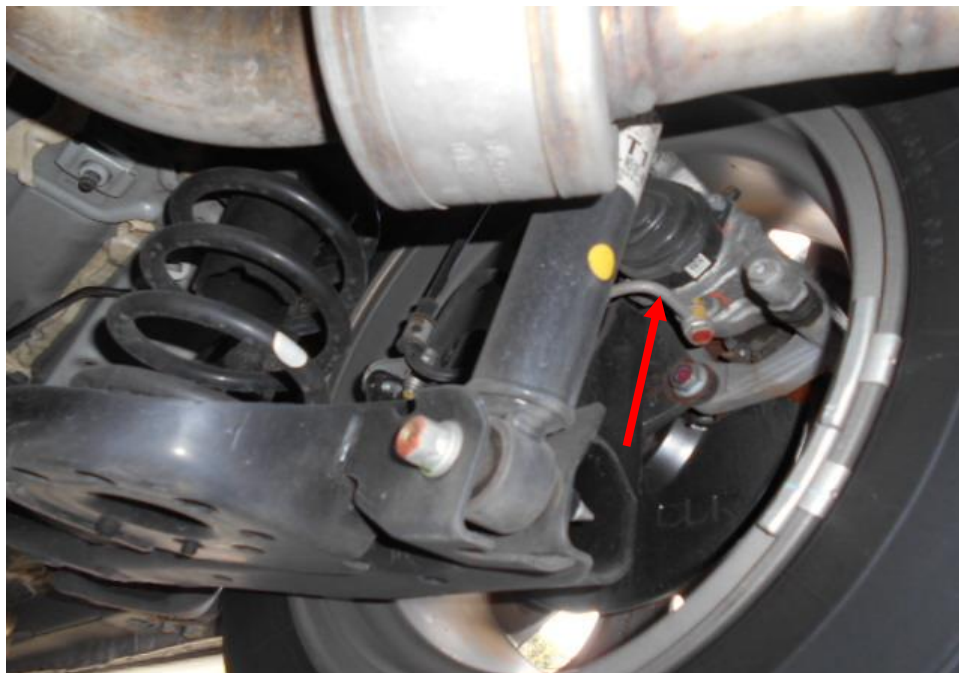
Photo 19 shows the brake hose/pipe (arrowed) at the rear right wheel of the Motor Car. No leakage of brake fluid was observed. Visual examination of the various components of the braking system like the drum brake and brake hose etc. had revealed all to be intact and without visible damage.

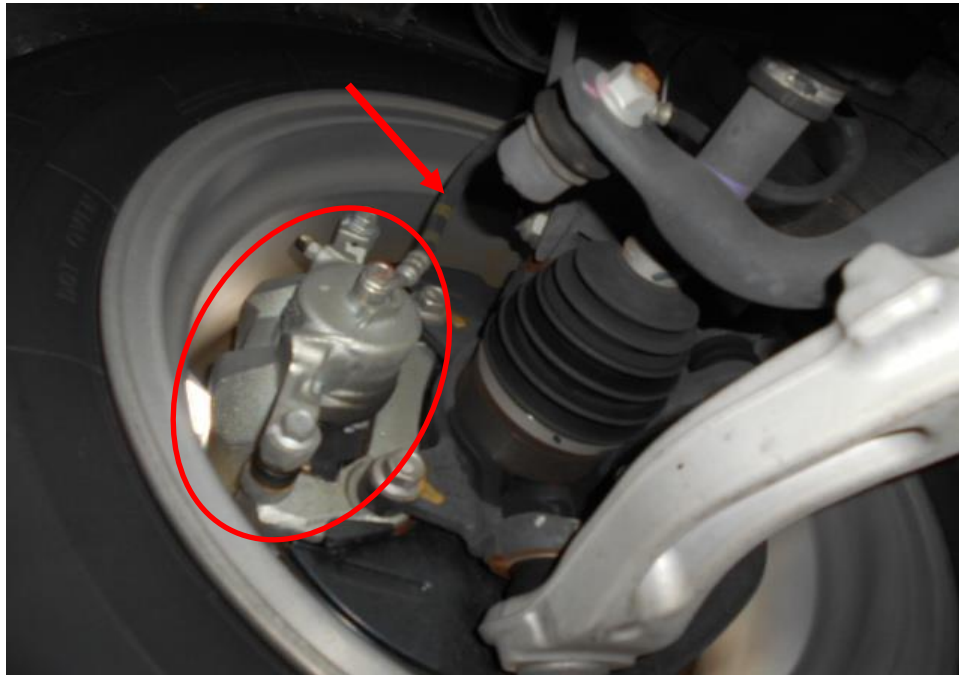
Photo 20 shows the brake hose/pipe (arrowed) at the front right wheel of the Motor Car. I did not observe any leakage of brake fluid at the time of my inspection of the Motor Car. Static tests of the Motor Car's braking system had indicated that there was no internal leakage of pressure/vacuum.

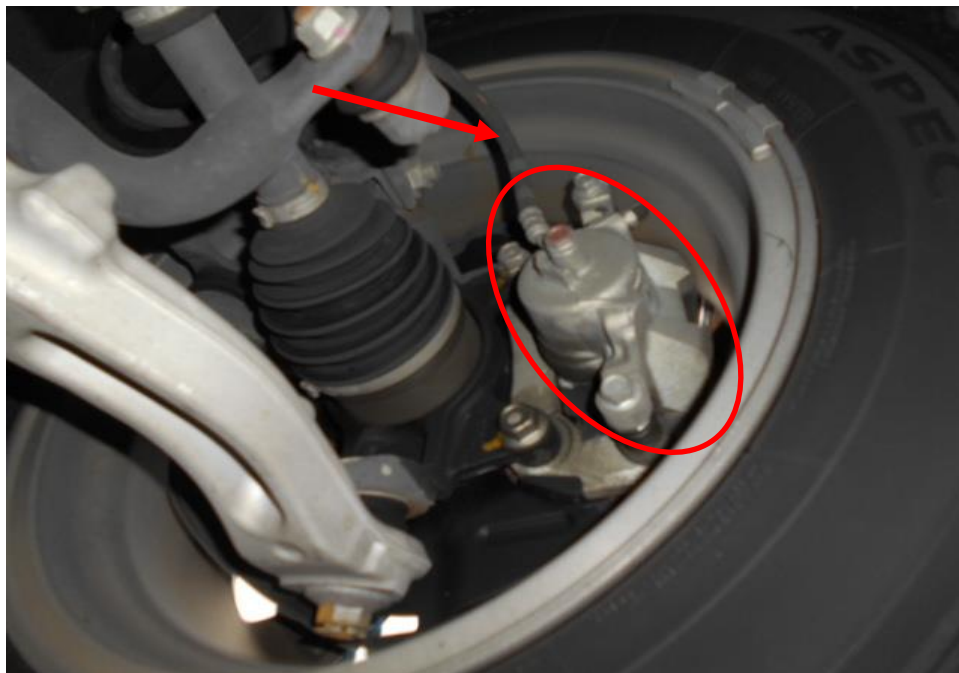
Photo 21 shows the brake hose/pipe (arrowed) at the front left wheel of the Motor Car. No leakage of brake fluid was observed. Visual examination of the various components of the braking system like the brake caliper (circled), brake hose etc had revealed all to be intact and without visible damage.

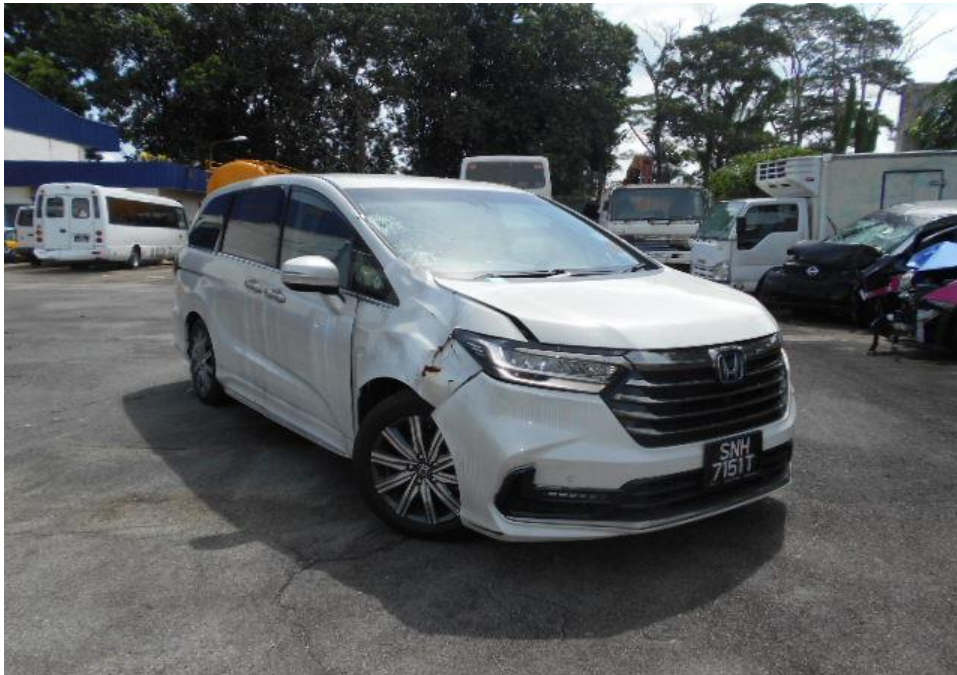
Photo 22 shows the front right wheel of the Motor Car turned to its full left. During my steering system test, I did not experience any abnormal free play and/or resistance when I had turned the steering wheel towards the left and right. This would suggest that the steering system of the Motor Car was likely to be in serviceable condition at the material time of accident.

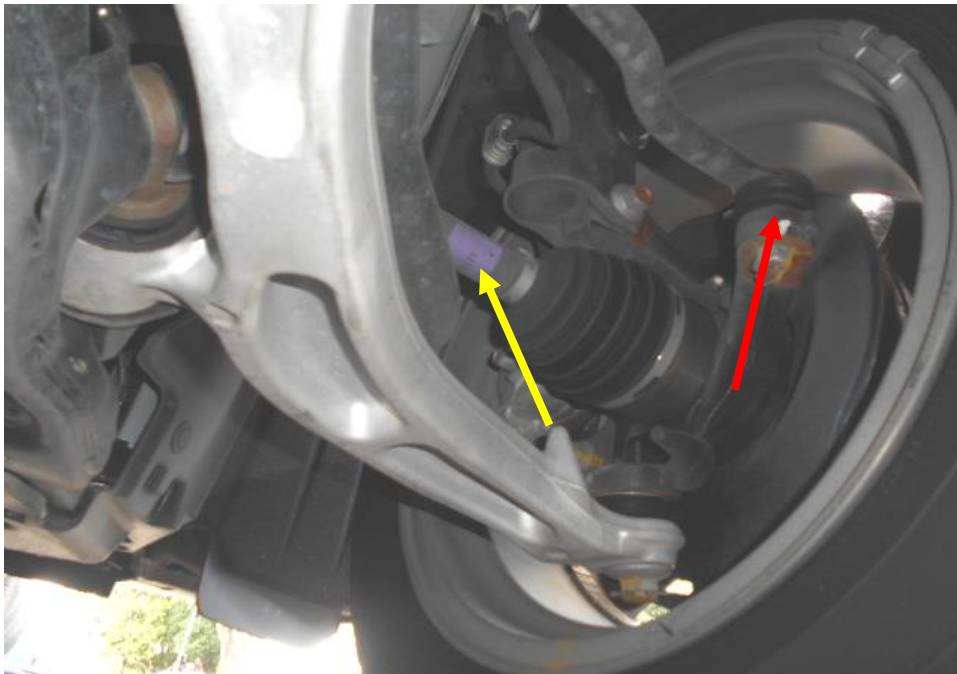
Photo 23 shows the various undercarriage components at the front right wheel of the Motor Car, in particular the steering tie rod (red arrow) and the driveshaft (yellow arrow). The various steering components were all found to be intact, suggesting that the steering system of the Motor Car was likely to be in serviceable condition at the material time of accident. There was also no sign of fluid stain observed on the various undercarriage components at the front right wheel of the Motor Car.

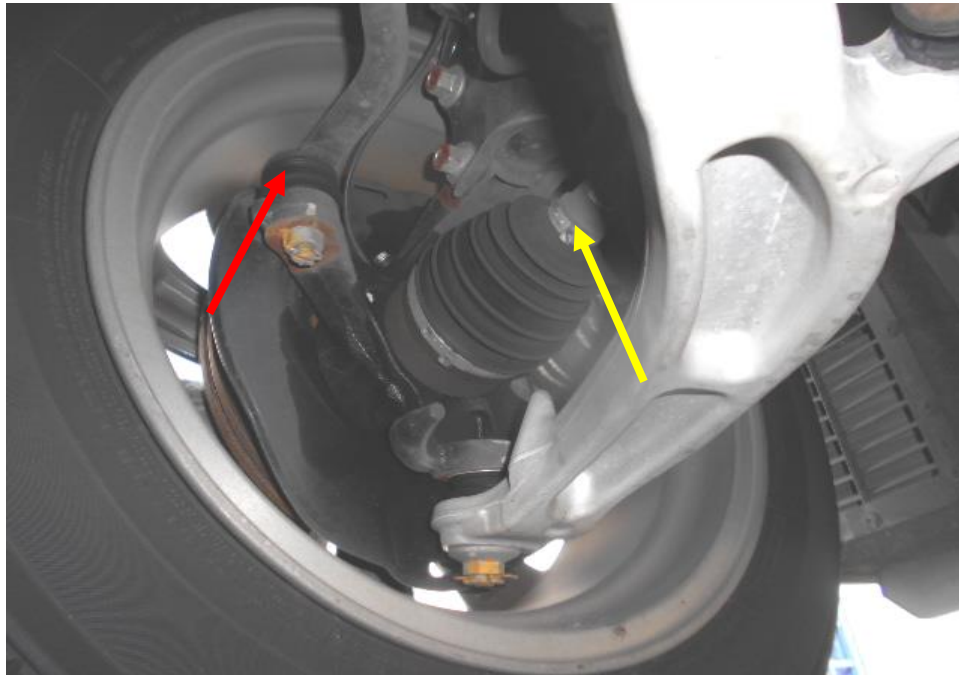
Photo 24 shows the various undercarriage components at the front left wheel of the Motor Car, in particular the steering tie rod end (arrowed). The various undercarriage components of the Motor Car were all found to be intact without any visible damage. There was also no sign of fluid stain(s) observed on the various undercarriage components.

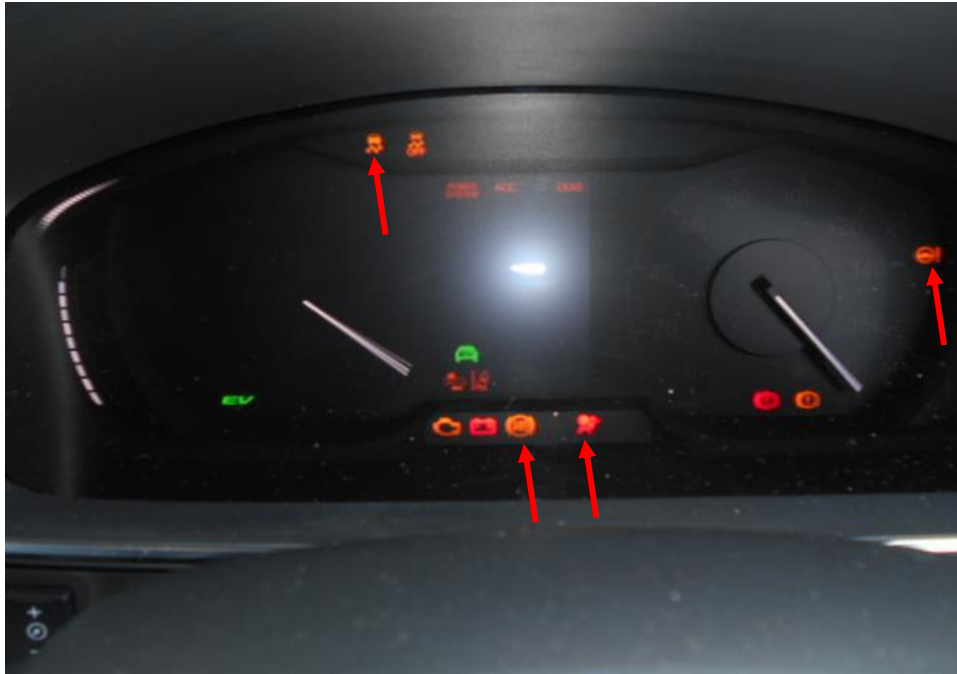
Photo 25 shows the warning light for Anti-Lock Brake System (ABS), Electric Power Steering System (EPS), Traction Control System (TCS) and Supplemental Restraint System (SRS) (arrowed) appearing on the instrument panel of the Motor Car during the self-test of its various electronic operating systems when its engine was cranked.

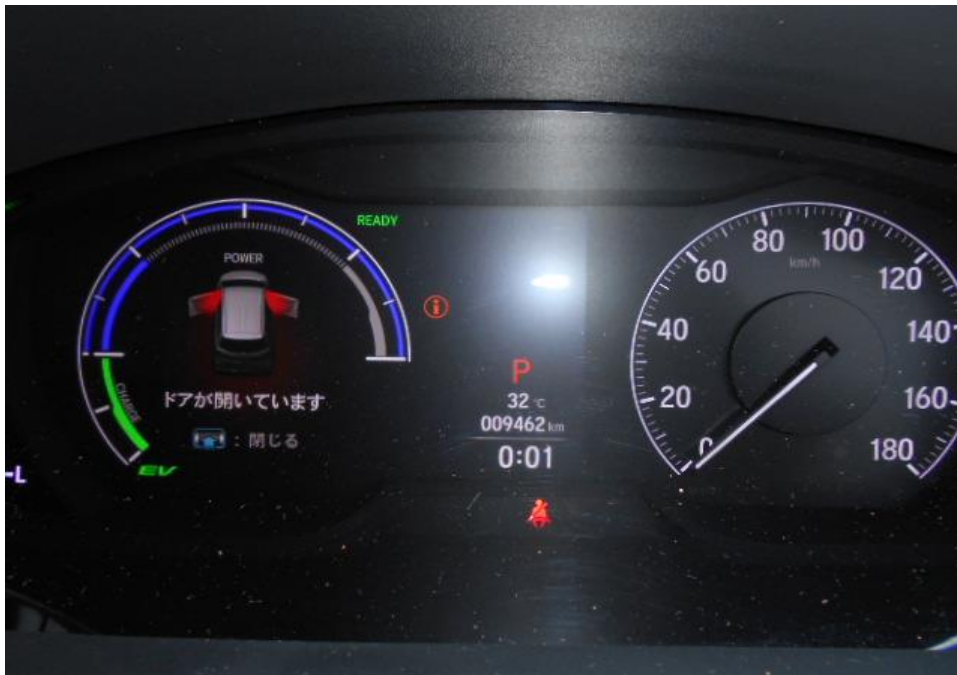
Photo 26 shows no warning lights illuminated on the instrument panel of the Motor Car after the engine was cranked. This would suggest that there was no abnormality to the electronic operating system of the Motor Car, like the ABS, EPS, TCS and SRS etc.
