Our Ref : CI/TP23006033/N

23 June 2023

**SATS Maintenance Centre**  
34 Changi North Crescent  
Singapore 499614

## **TECHNICAL INVESTIGATION REPORT OF FIRE INCIDENT INVOLVING THE MOTOR VEHICLE TR 228 ON 2 JUNE 2023**

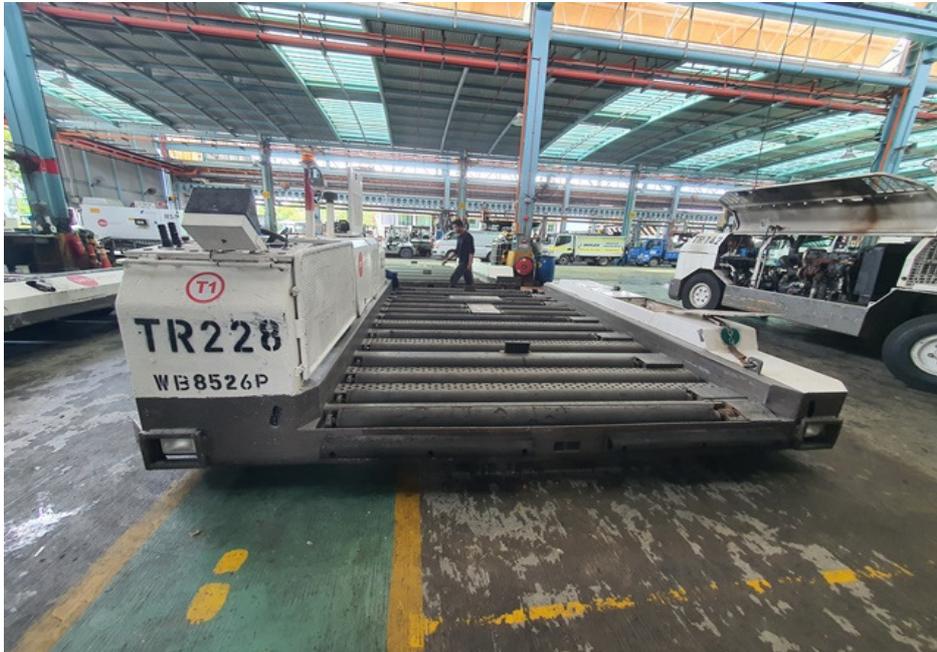
**Photo 1** shows the front view of the Transporter at the time of our inspection. The fire damage to the Transporter was confined to its instrument cluster. Most parts of the front portion were unaffected by the fire except for the instrument cluster.

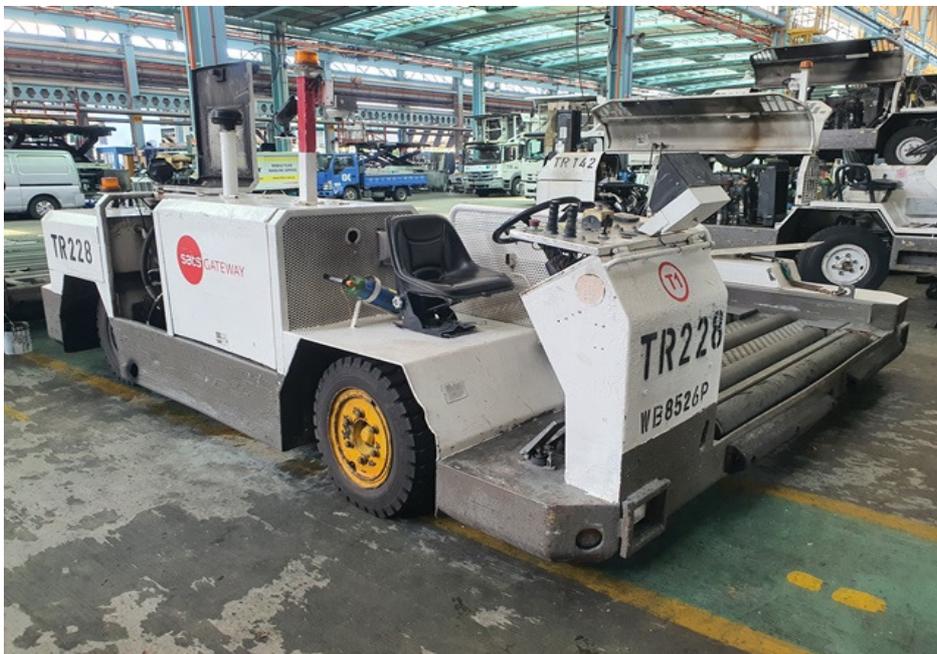
**Photo 2** shows the right body of the Transporter at the time of our inspection. The fire damage to the Transporter was confined to its instrument cluster. The right body was observed to have been unaffected by the fire.

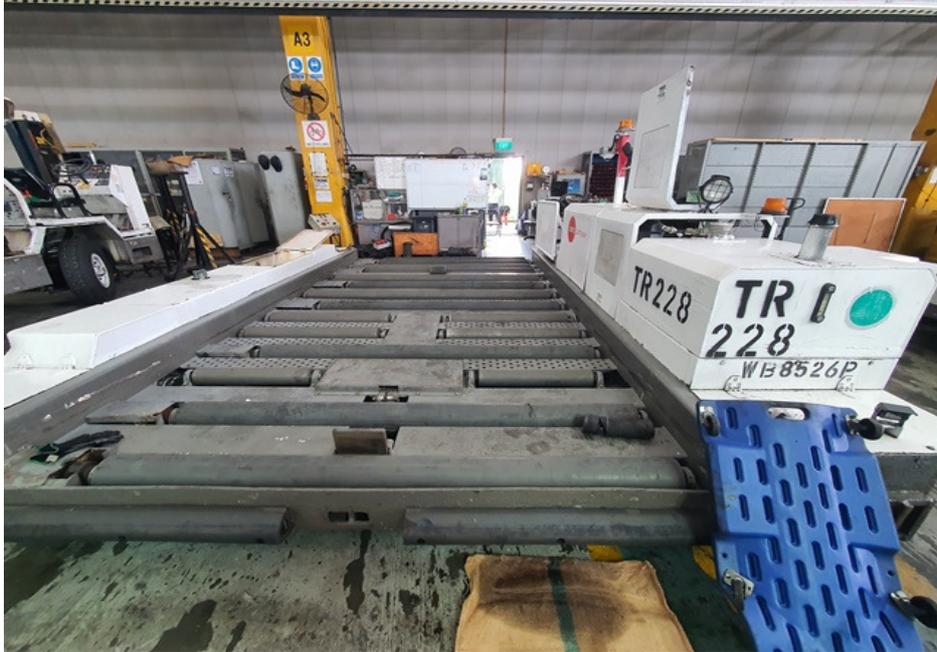
**Photo 3** shows the rear portion of the Transporter at the time of our inspection. The fire damage to the Transporter was confined to its instrument cluster. The rear portion was observed to have been unaffected by the fire.

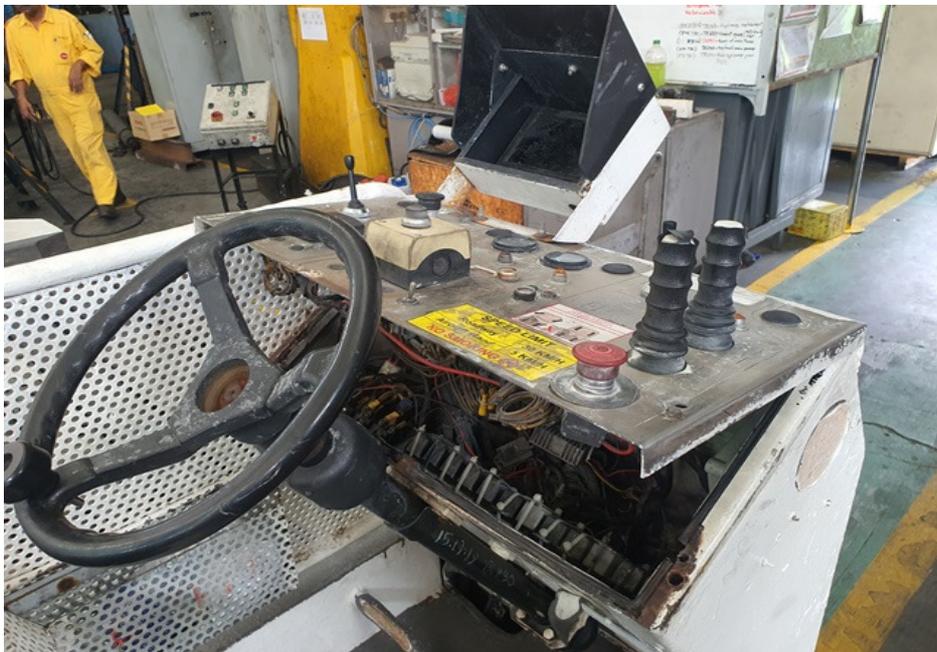
5. The Transporter was noted to have sustained fire damage that was confined to its instrument cluster. The fire damage was observed to be most severe at its operator control panel. The front exterior portion was unaffected by the fire except for the instrument cluster. The engine compartment was unaffected by the fire. See photos 1 – 4 below.

**Photo 4** shows the instrument cluster of the Transporter at the time of our inspection. The instrument cluster was significantly affected by the fire.

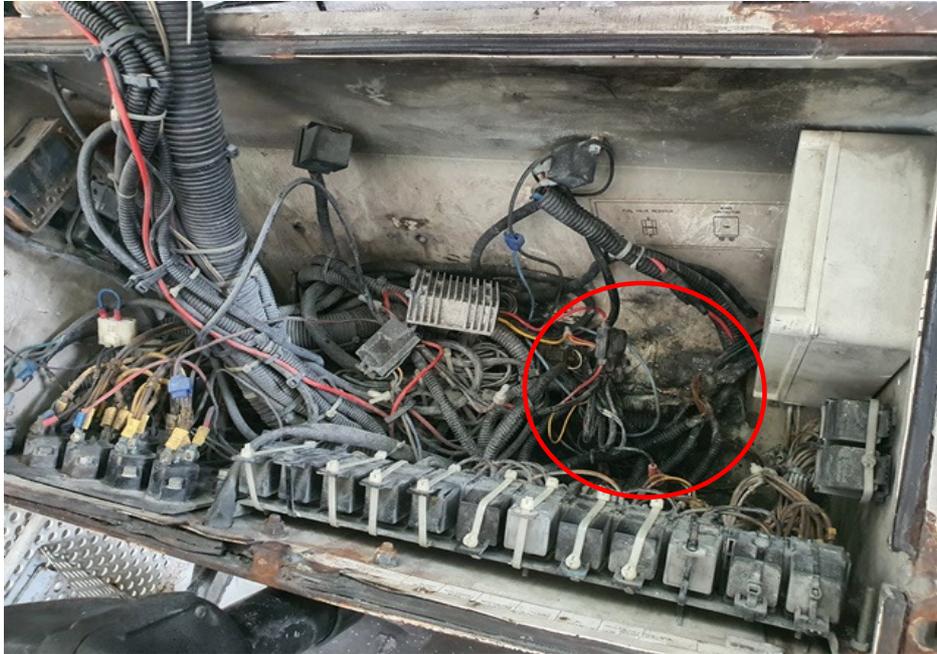
7. For this particular case, the fire appears to have originated within the operator control panel of the Transporter, somewhere around the right portion. This can be determined from the circumstances of the incident where the driver had reported seeing white smoke emitting from the right portion of the operator control panel of the Transporter.

**Photo 5** shows the burnt wirings around the right portion of the operator control panel, which was where the fire to the Transporter had likely started (circled).

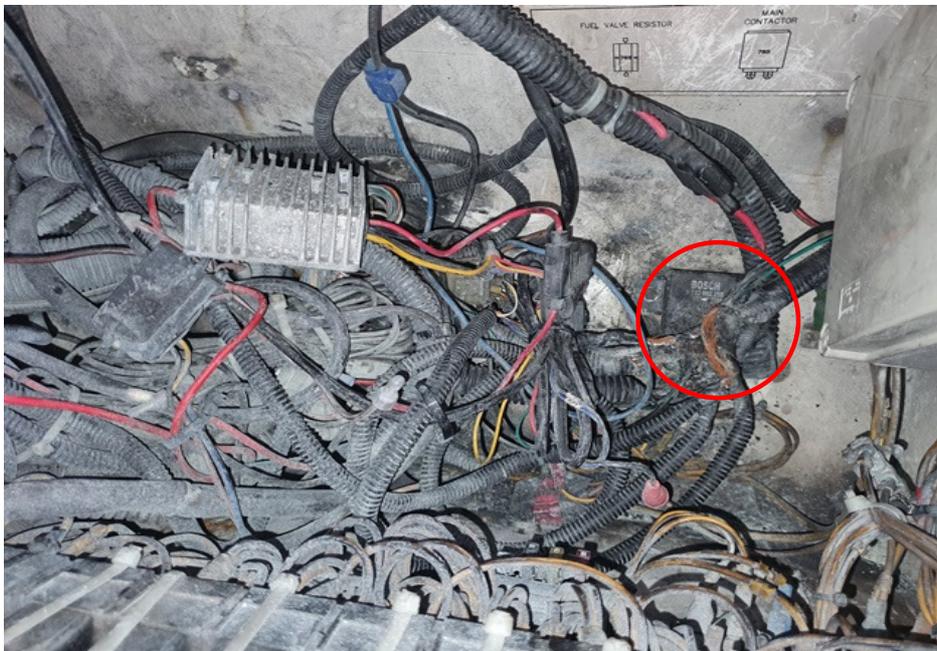
8. Upon closer examination of the right portion of the operator control panel, which was where the fire to the Transporter had likely started, we had found greenish residue on the wirings leading from an electrical relay. The wirings were original factory fitted wirings. The presence of greenish residue indicates internal heating of copper wires, a sign of an electrical short circuit occurring. The greenish residue is normally left behind from oxidation as a result of chemical reaction involving the copper wires. This physical evidence would then appear to suggest that the cause of fire to the Transporter could have possibly been due to electrical in nature. See photos 5 - 8 below.

**Photo 6** shows the right portion of the operator control panel of the Transporter. We found greenish residue on some of the burnt wirings leading from an electrical relay (circled). The presence of such greenish residue suggests occurrence of an electrical short circuit.

21. Having investigated and technically analysed the damages of burnt nature to the Transporter, we are of the view that the cause of fire to the Transporter was of electrical in nature. For this particular case, the fire had originated from the wirings within the operator control panel of the Transporter. The wirings were original factory wirings leading from one of the electrical relays of the Transporter. We are given to understand that the particular relay is part of the wiring system for the camera of the Transporter.

22. Electrical relays are exposed to both high electrical load and low electrical load, hence replacement of electric relays periodically is suggested in order to maintain integrity of the pins and inner coils. Rust or corrosion on the pins and inner coils can cause resistance, which in turn will lead to build up of heat from the electrical current passing through, potentially igniting an electrical fire. The cost of such electrical relays is not expensive.

24. We suggest that the company perform physical checks of wirings for loose connections and frayed wires should also be part of a regular maintenance checklist especially when our hot weather climate can accelerate the deterioration of wire insulations.

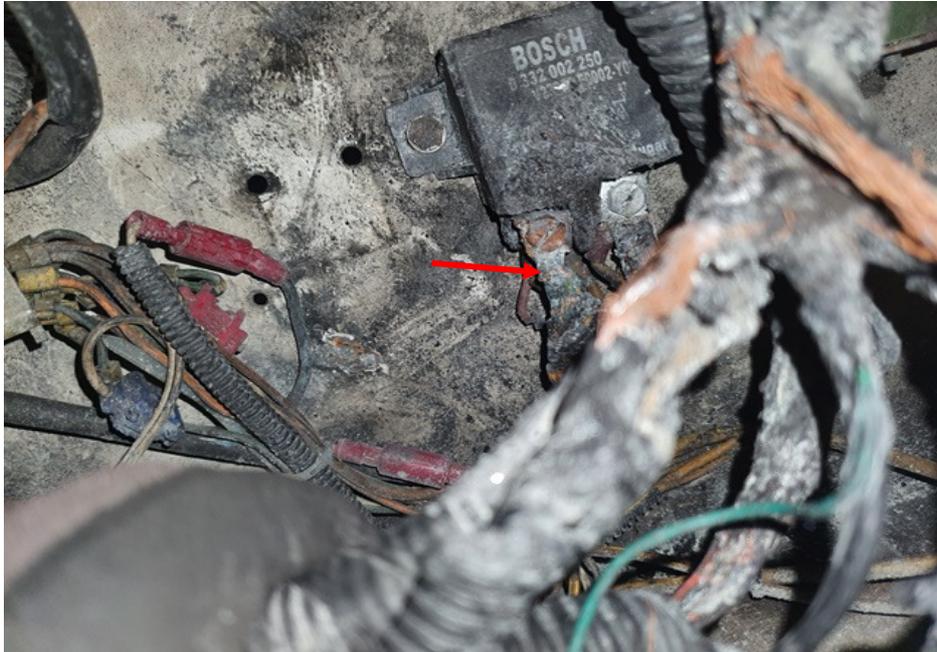
**Photo 7** shows a closer view of the greenish residue found on some of the burnt wirings leading from an electrical relay (red arrows). The presence of such greenish residue suggests occurrence of an electrical short circuit. The greenish residue is normally left behind from oxidation as a result of chemical reaction involving the copper wires.

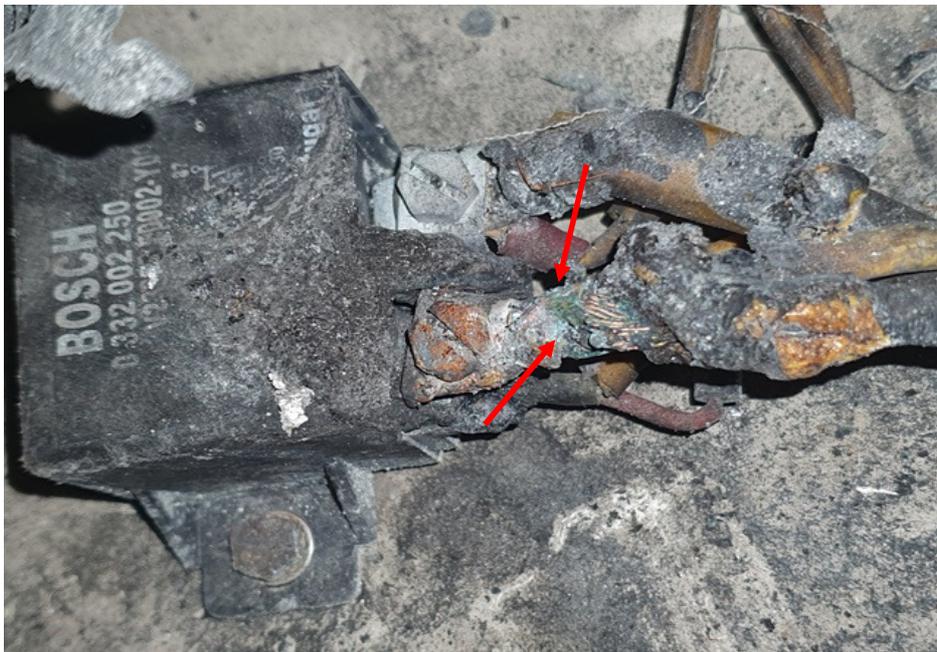
**Photo 8** shows a close up view of the greenish residue found on some of the burnt wirings leading from an electrical relay (red arrows). The presence of such greenish residue suggests occurrence of an electrical short circuit.
