Your Ref: TP IP/11422/2023
Our Ref : CI/TPD23006071/P

Fatal Accident Investigation Team

MECHANICAL INSPECTION REPORT OF MOTOR CAR SLM 1260Z

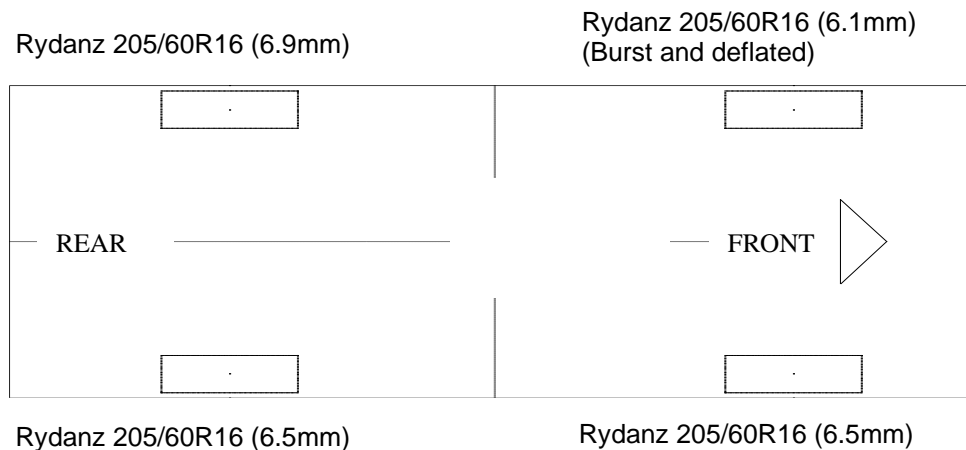
6. The front left tyre was observed to be with burst mark and deflated as a result of the accident. However, the condition of the Motor Car's front right and rear left and right tyres was observed to be in serviceable condition. I did not find any tear, cut or burst mark(s) on the outer and the inner sidewalls as well as across the tread of the 3 tyres. The 3 tyres were also observed to be sufficiently inflated for vehicular operation. The tyre brand, tyre size and remaining tread depth of the 4 tyres were recorded as follows:-

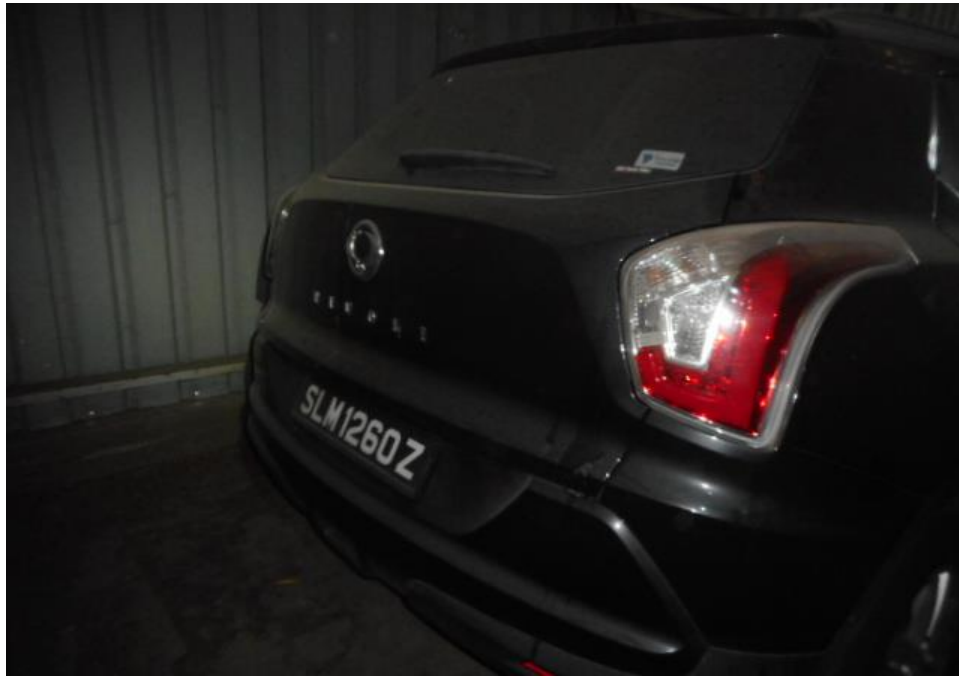
Photo 1 shows a general view of the Motor Car's rear body at the time of my inspection. The rear portion of the Motor Car was observed to be unaffected by the accident.

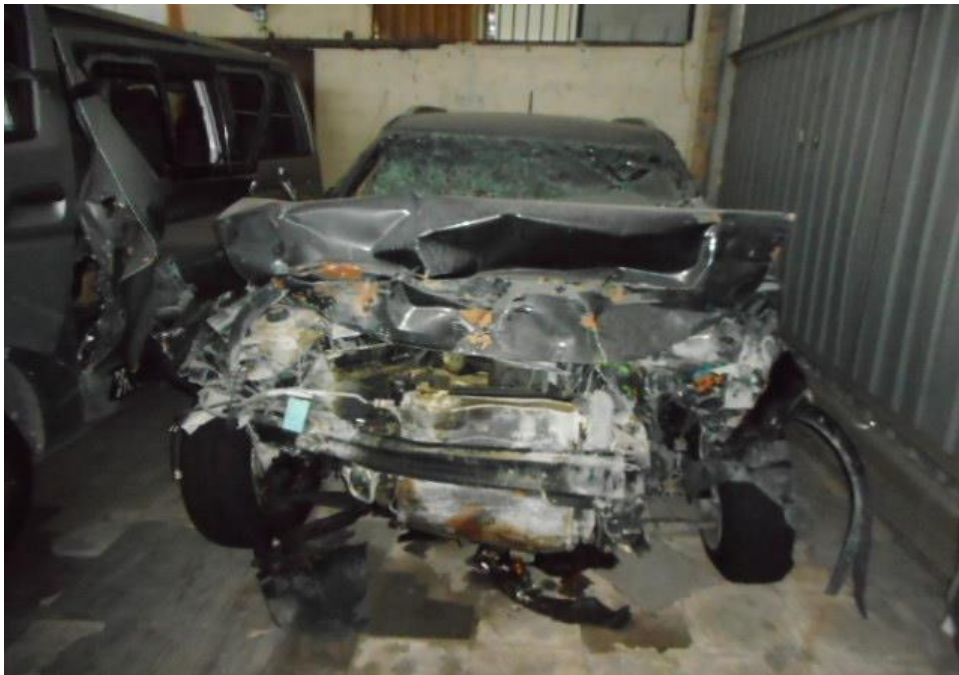
Photo 2 shows a general view of the Motor Car's front body at the time of my inspection. The Motor Car was observed to have sustained damage at its front portion. Its front windscreen, front bonnet, front bumper panel, front right and left fender was amongst the body parts and various engine components were also damaged as a result of the accident. The Supplemental Restraint System (SRS) was activated as a result of the accident.

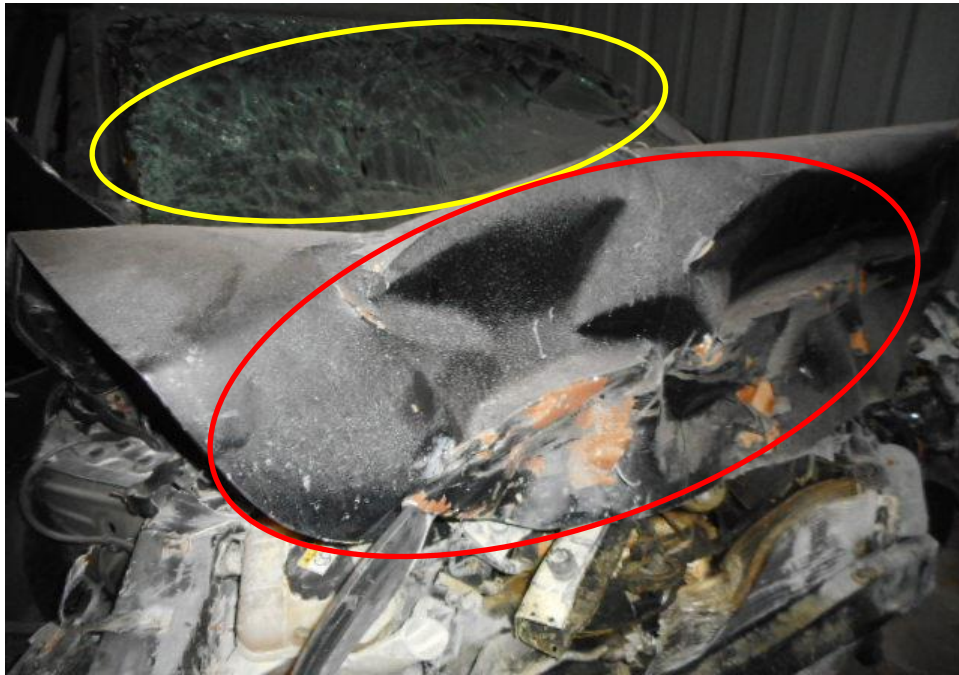
Photo 3 shows the close up view of the Motor Car's front body at the time of my inspection. The Motor Car was observed to have sustained damage at its front portion. Its front bonnet (red circle) and front windscreen (yellow circle) was damaged as a result of the accident.

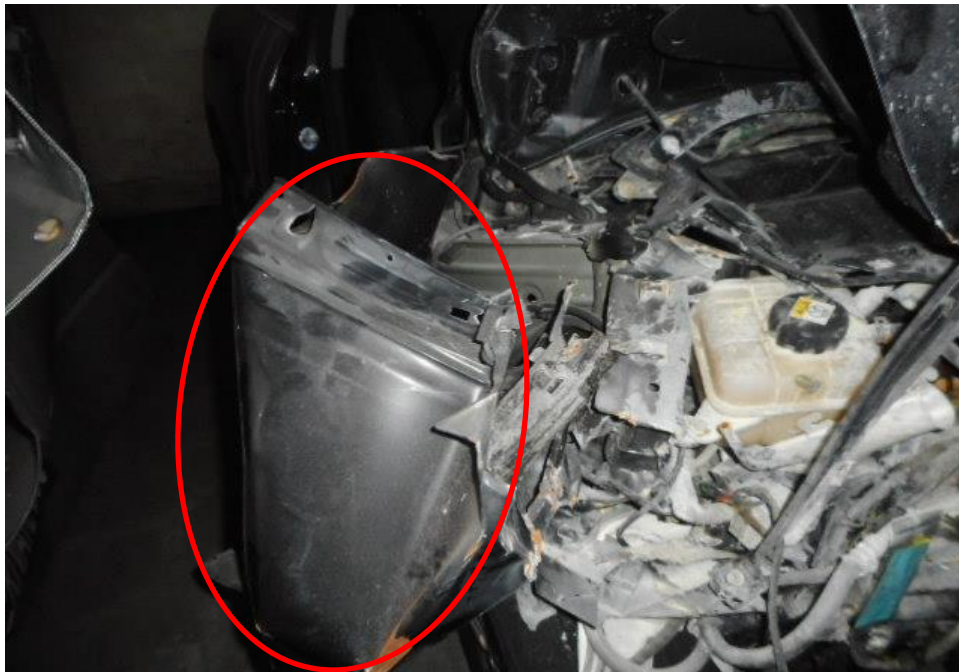
Photo 4 shows the close up view of the Motor Car's front body at the time of my inspection. The Motor Car was observed to have sustained damage at its front portion. Its front right fender (circled) was damaged as a result of the accident.

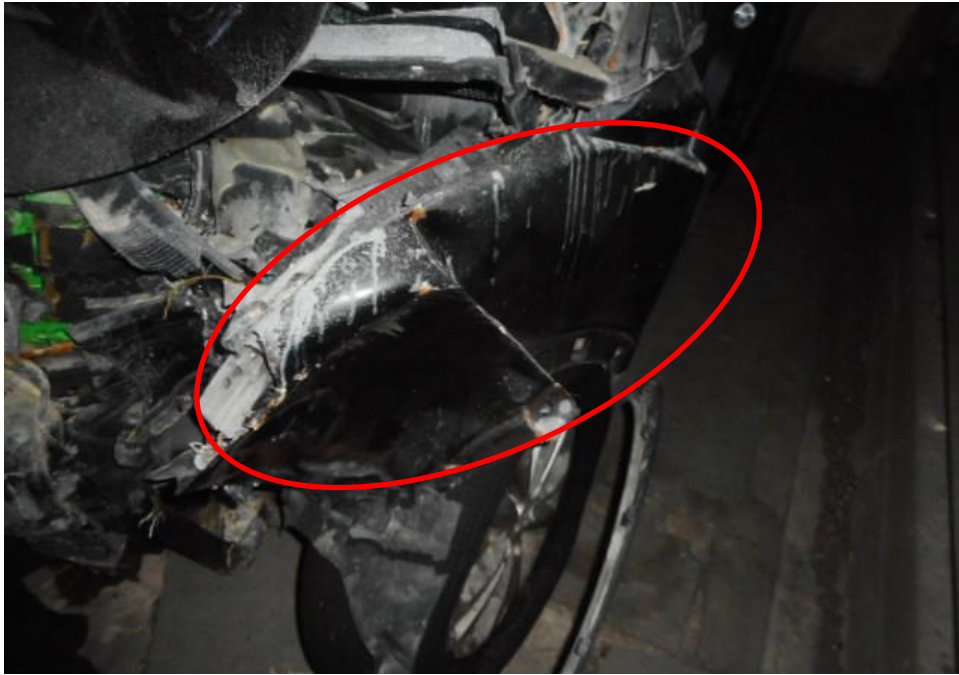
Photo 5 shows the close up view of the Motor Car's front body at the time of my inspection. The Motor Car was observed to have sustained damage at its front portion. Its front left fender (yellow circle) was damaged as a result of the accident.

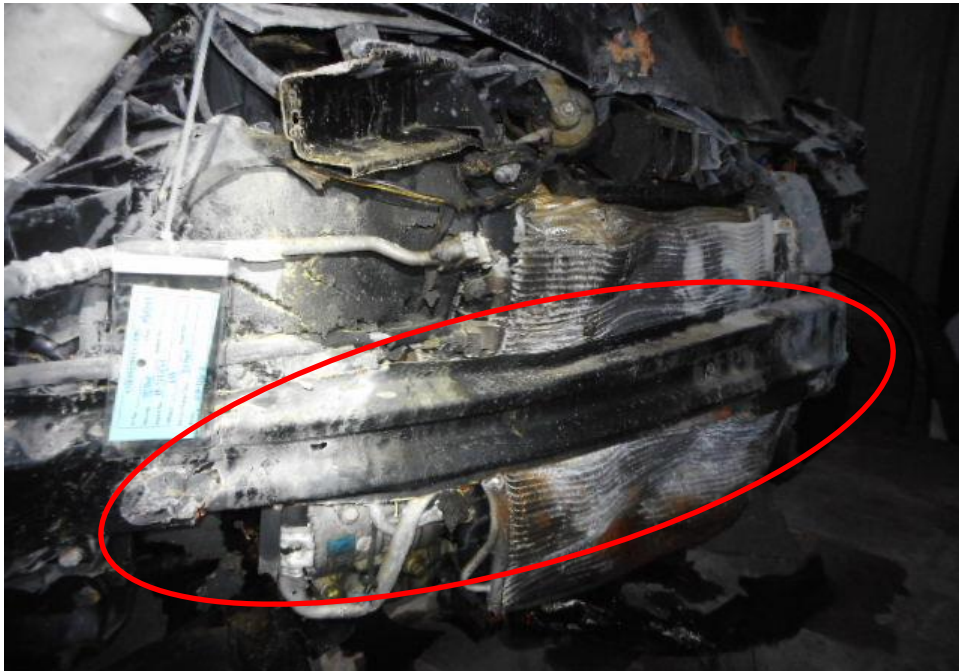
Photo 6 shows the close up view of the Motor Car's front body at the time of my inspection. The Motor Car was observed to have sustained damage at its front portion. Its front bumper reinforcement panel (circled) was damaged as a result of the accident.

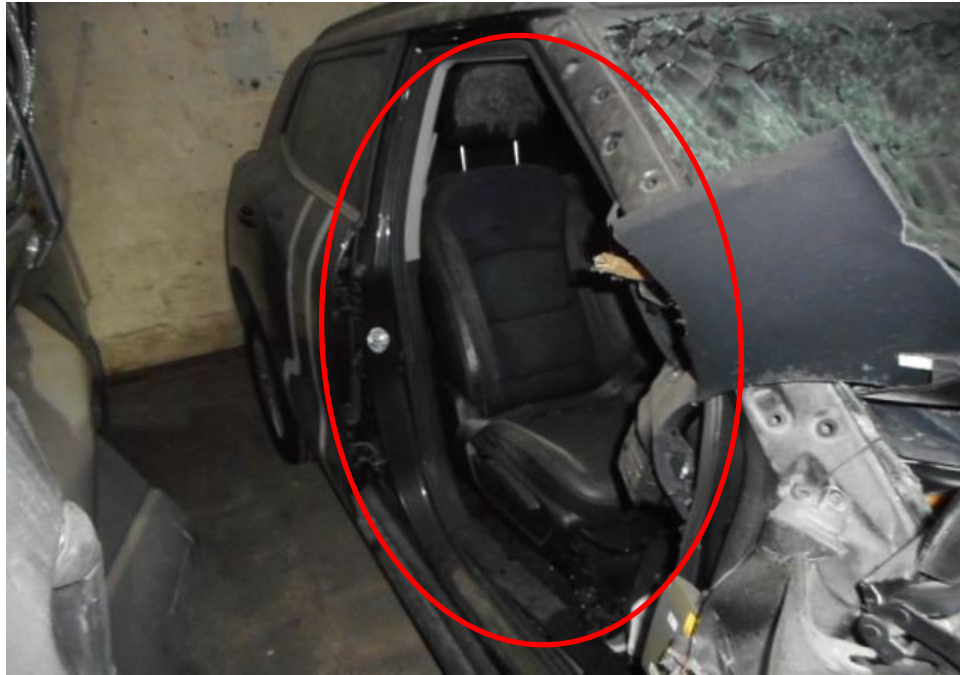
Photo 7 shows a general view of the Motor Car's right body at the time of my inspection. The right portion front right door (circled) was observed to be removed by SCDF for extraction purpose after the accident.

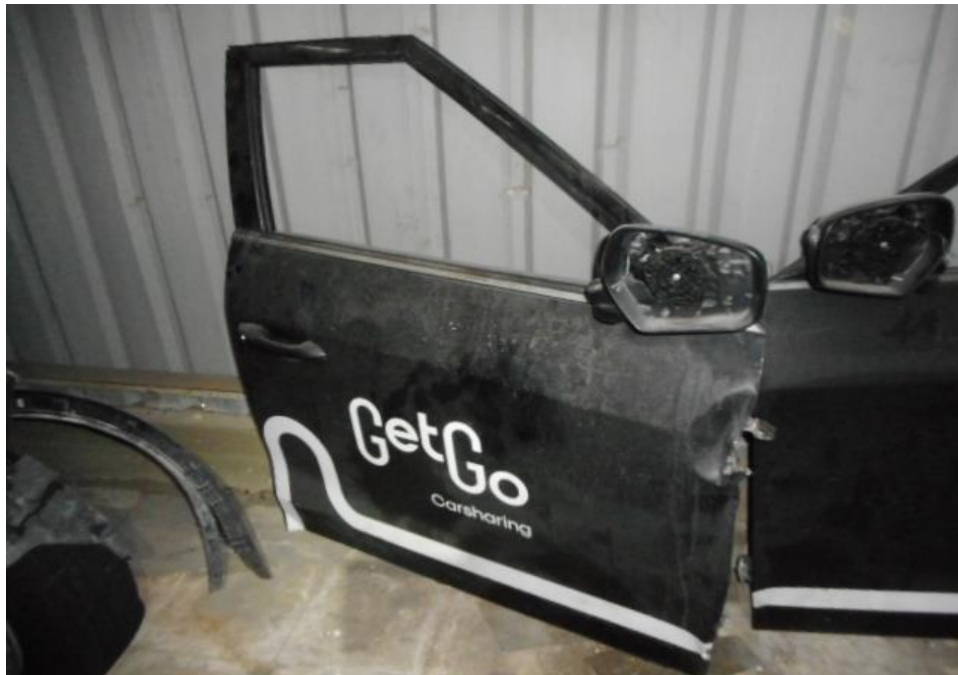
Photo 8 shows a general view of the Motor Car's right front door at the time of my inspection. The front right door was observed to be removed by SCDF for extraction purpose after the accident.

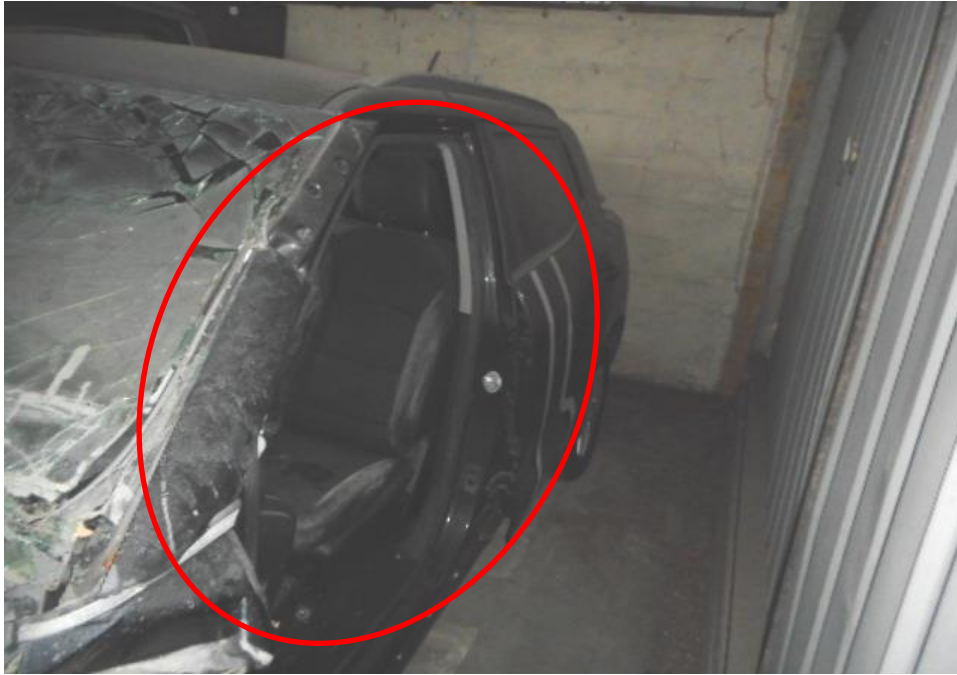
Photo 9 shows a general view of the Motor Car's left body at the time of my inspection. The left portion front left door (circled) was observed to be removed by SCDF for extraction purpose after the accident.

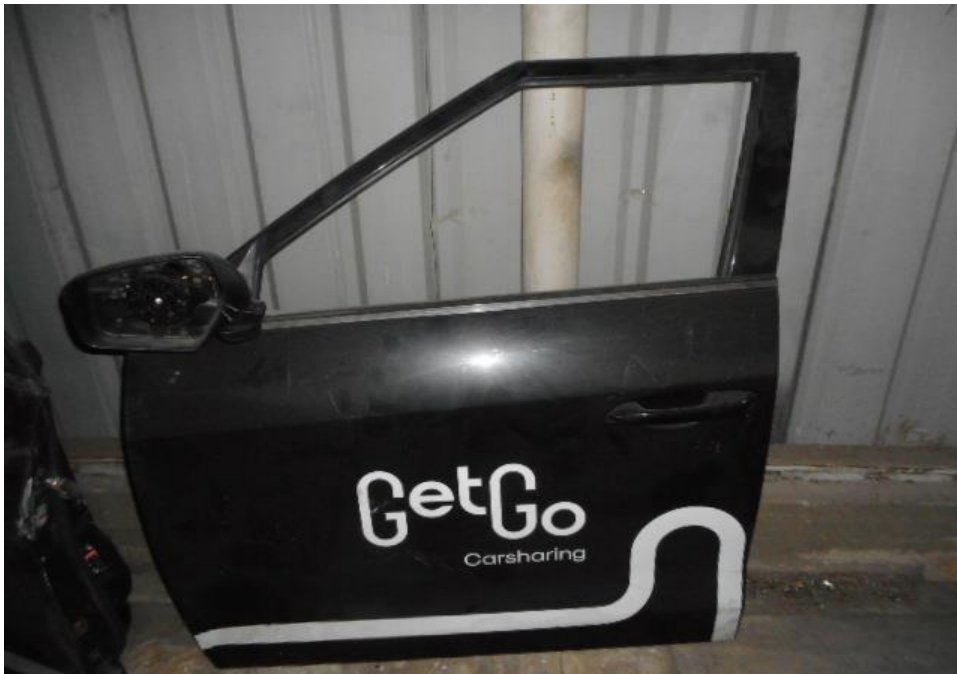
Photo 10 shows a general view of the Motor Car's left front door at the time of my inspection. The front left door was observed to be removed by SCDF for extraction purpose after the accident.

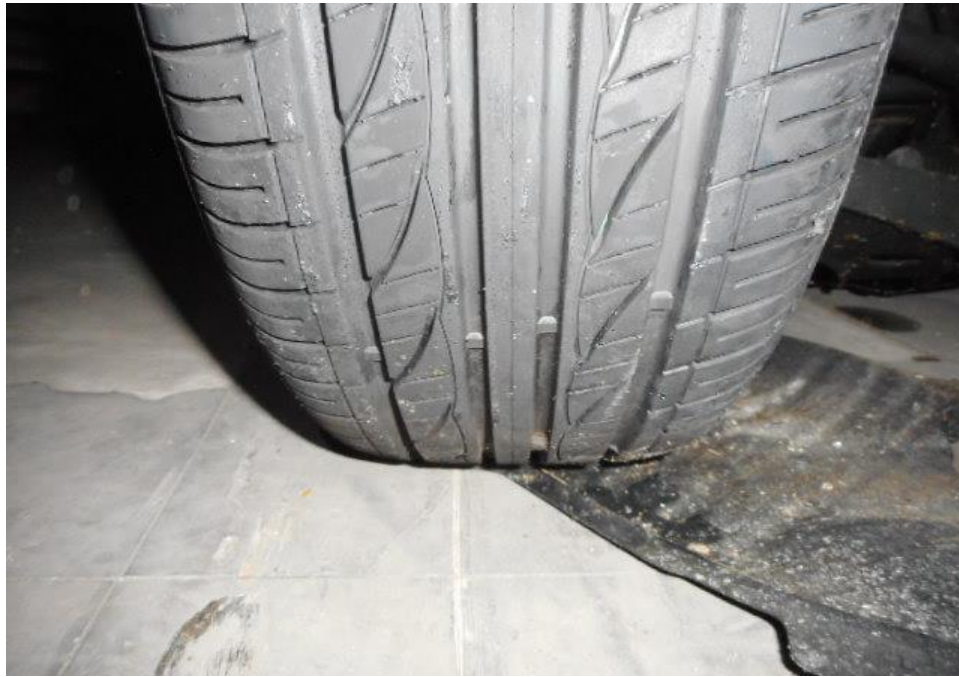
Photo 11 shows the condition of the front right tyre of the Motor Car, which was observed to be in serviceable condition with remaining tread depth of approximately 6.5mm. The tyre was also observed to be sufficiently inflated for vehicular operation with no tear, cut or burst mark(s).

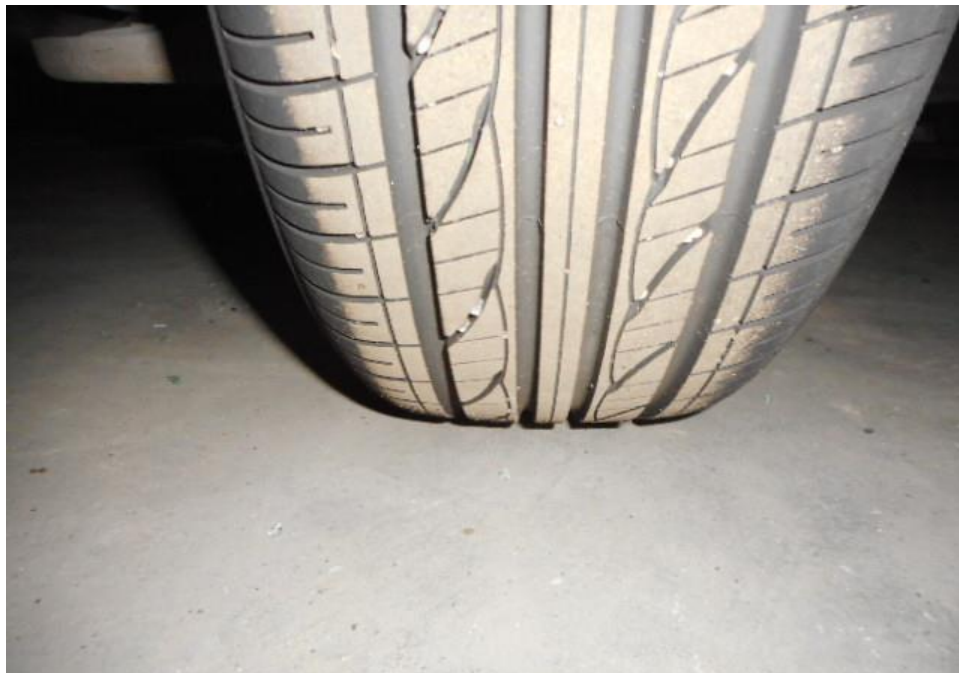
Photo 12 shows the condition of the rear right tyre of the Motor Car, which was observed to be in serviceable condition with remaining tread depth of approximately 6.5mm. The tyre was also observed to be sufficiently inflated for vehicular operation with no tear, cut or burst mark(s).

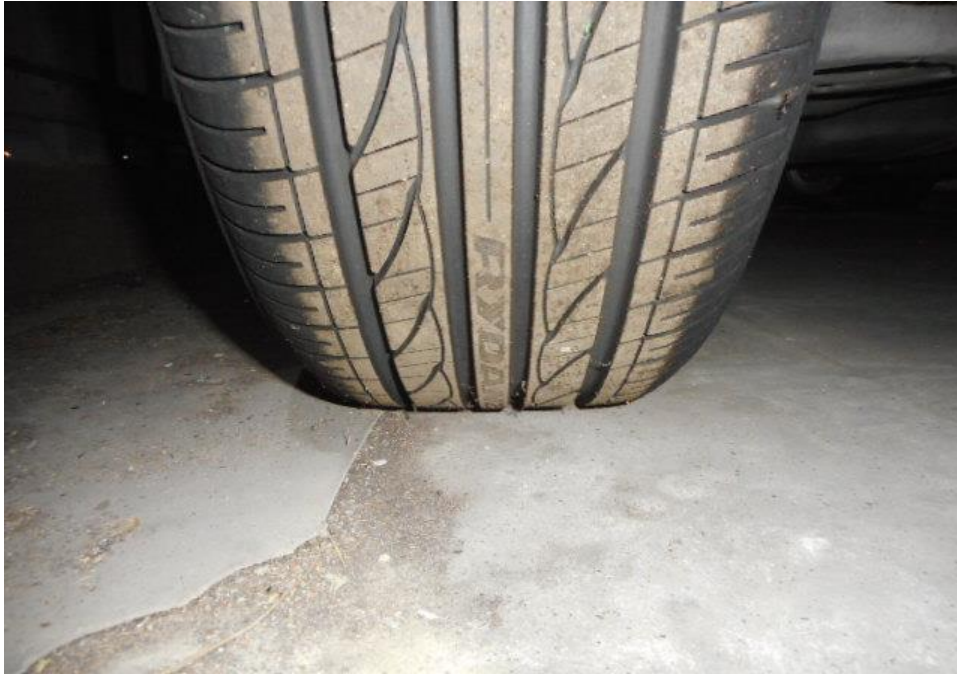
Photo 13 shows the condition of the rear left tyre of the Motor Car, which was observed to be in serviceable condition with remaining tread depth of approximately 6.9mm. The tyre was also observed to be sufficiently inflated for vehicular operation with no tear, cut or burst mark(s).

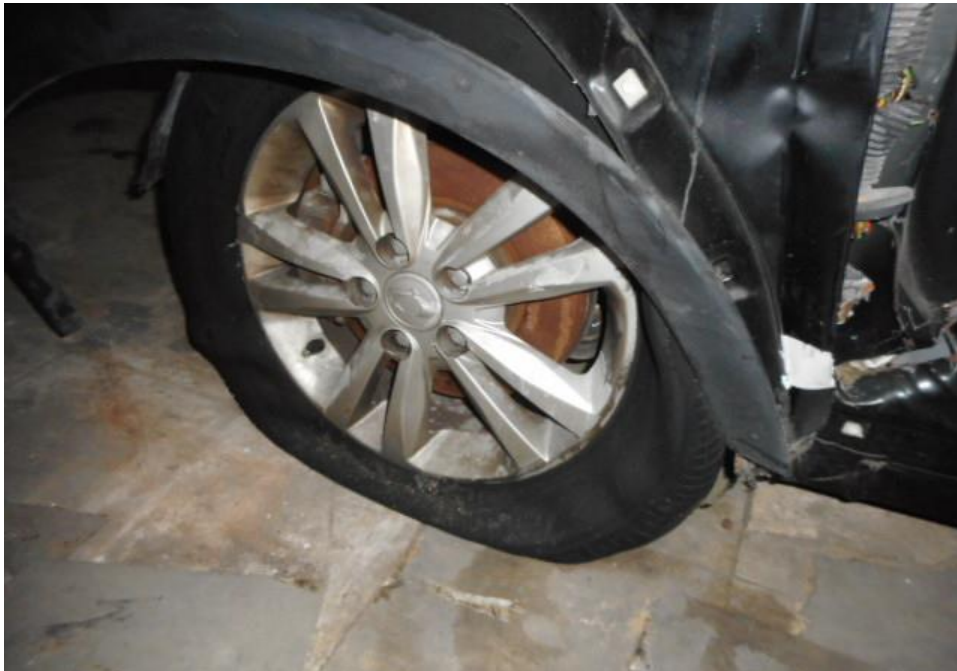
Photo 14 shows the condition of the front left tyre of the Motor Car, which was observed to be in unserviceable condition with remaining tread depth of approximately 6.1mm. The tyre, which was wrapped around alloy wheel rim, was also observed to be with burst mark and also deflated as a result of the accident.

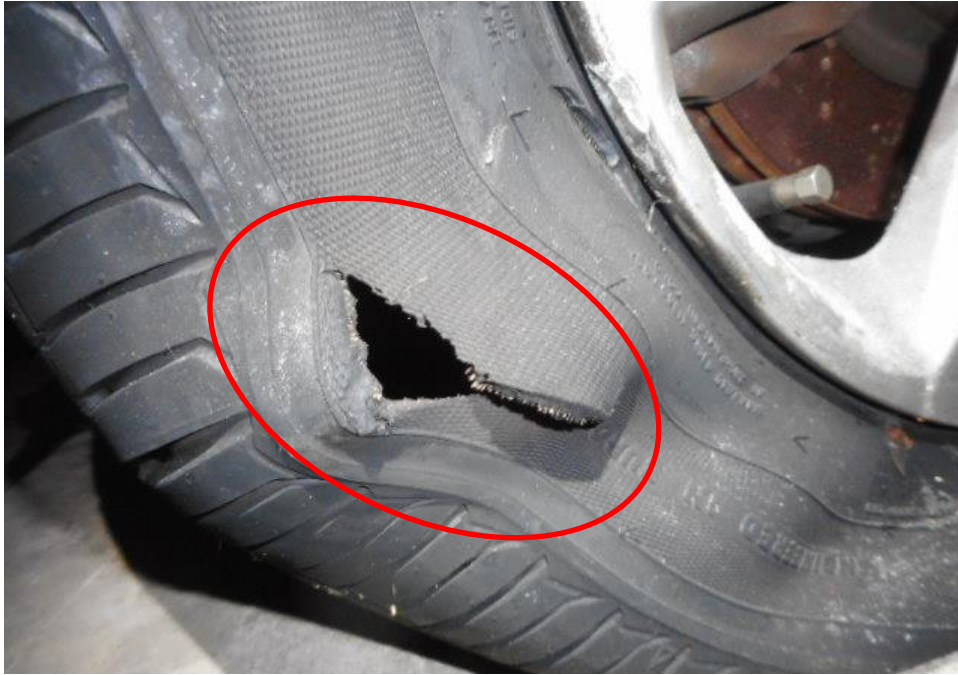
Photo 15 shows the close up view of the front right tyre of the Motor Car, which was observed to be in unserviceable condition with remaining tread depth of approximately 4mm. The tyre, which was wrapped around alloy wheel rim, was also observed to be cut and also deflated (circled) as a result of the accident.

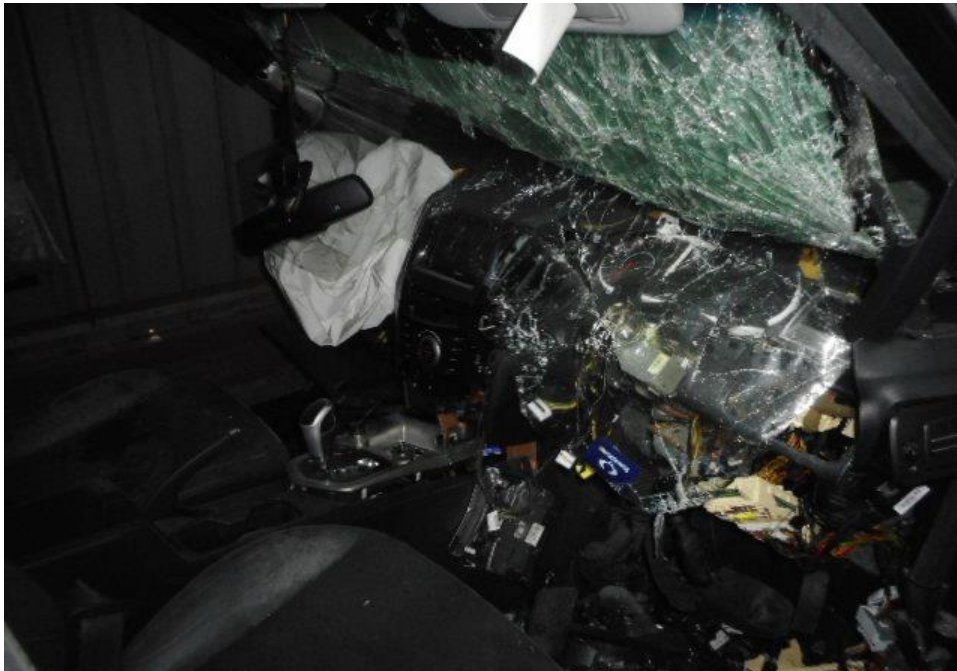
Photo 16 shows the deployment of the Supplemental Restraint System (SRS) airbag in the Motor Car as a result of the accident.

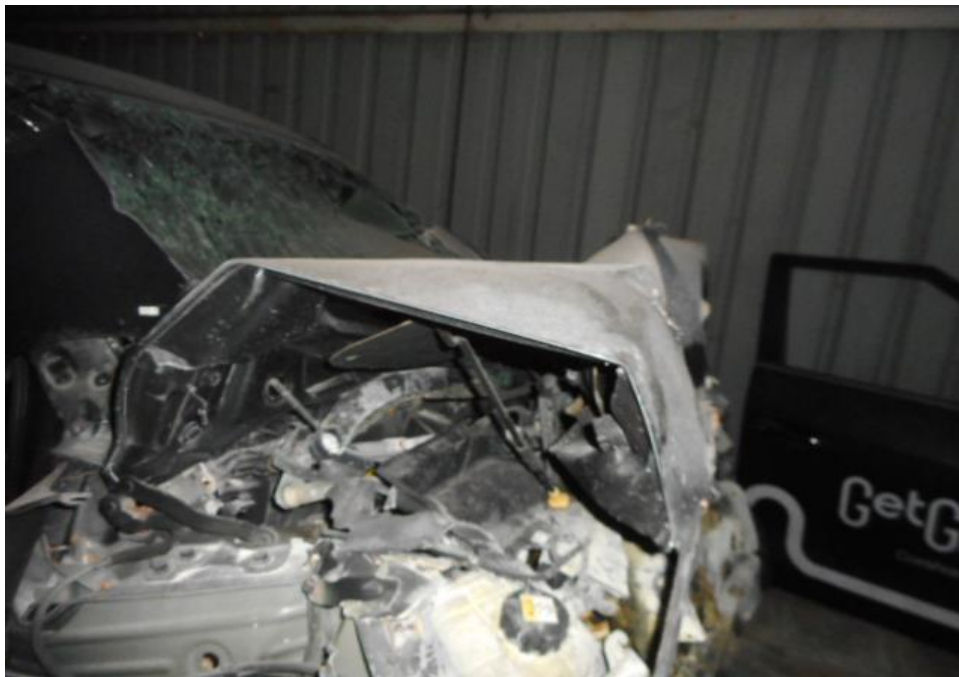
Photo 17 shows the general view of the Motor Car's front bonnet which was damage as a result of the accident causing the bonnet unable to be opened at the time of my inspection. Its engine and components were crushed and damaged as a result of the accident.

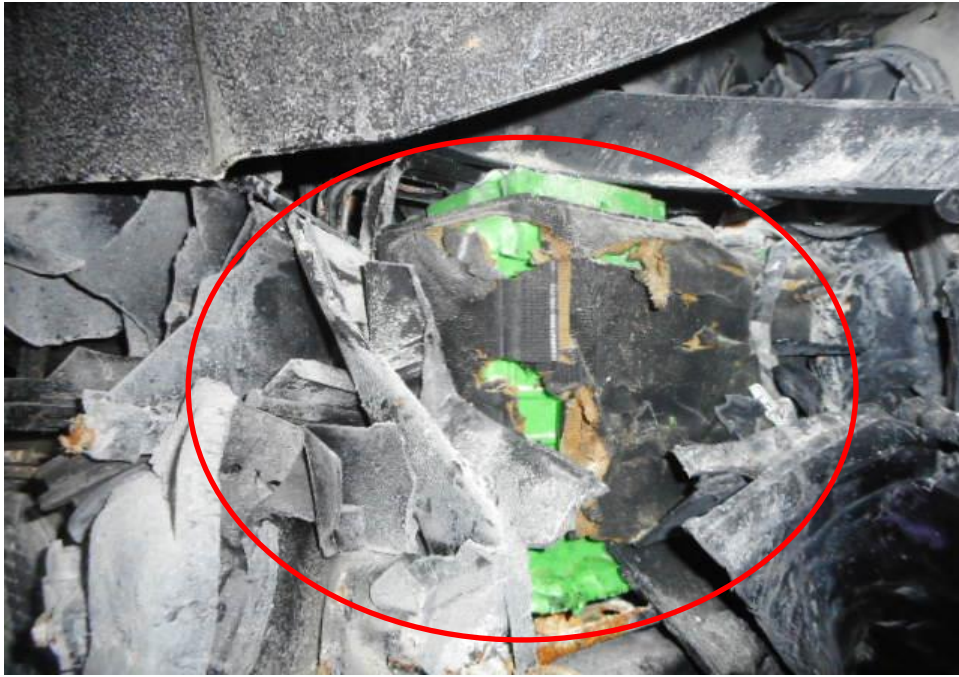
Photo 18 shows the close up view of the Motor Car's front body at the time of my inspection. The Motor Car was observed to have sustained damage at its front portion. Its ignition system battery (circled) was amongst the various components in the engine compartment were also damaged as a result of the accident.

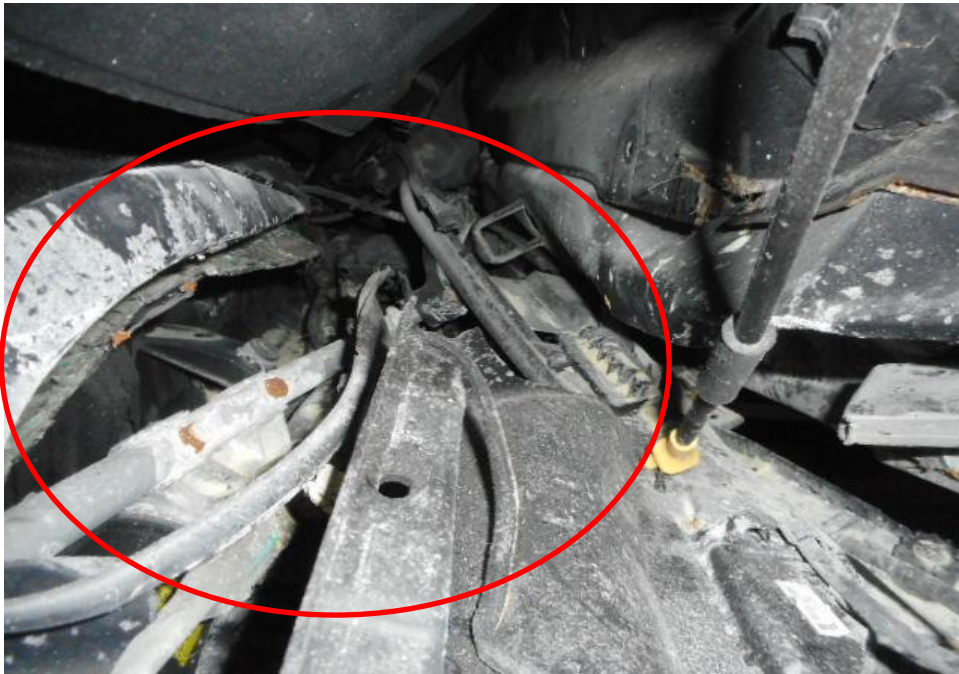
Photo 19 shows the close up view of the Motor Car's front body at the time of my inspection. The Motor Car was observed to have sustained damage at its front portion. Its engine (circled) was amongst the various components in the engine compartments were also damaged as a result of the accident.

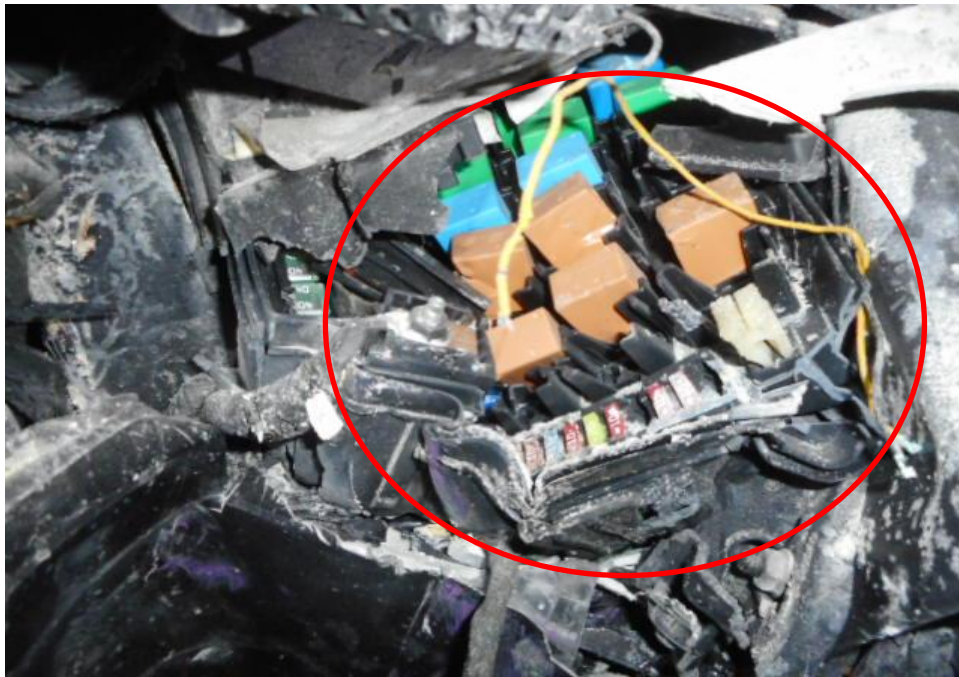
Photo 20 shows the close up view of the Motor Car's front body at the time of my inspection. The Motor Car was observed to have sustained damage at its front portion. Its electrical components (circled) was amongst the various components in the engine compartments were also damaged as a result of the accident.

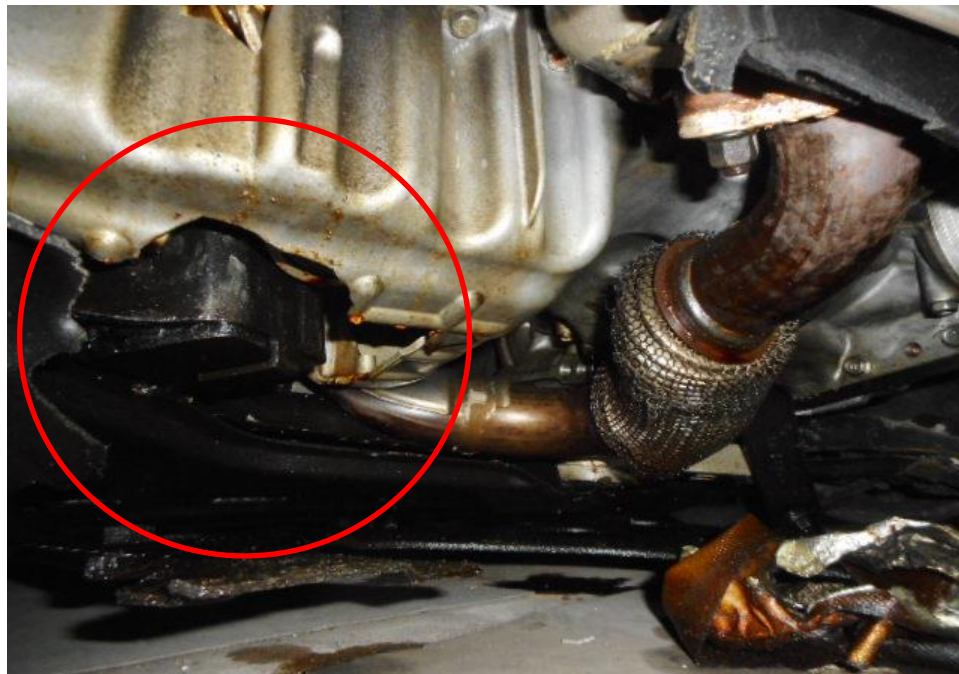
Photo 21 shows the undercarriage of the Motor Car, at the area where the engine housing and transmission housing are located. I observed signs of fluid leak and fluid stain on the underside of the Motor Car as the engine oil sump was damaged as a result of the accident.

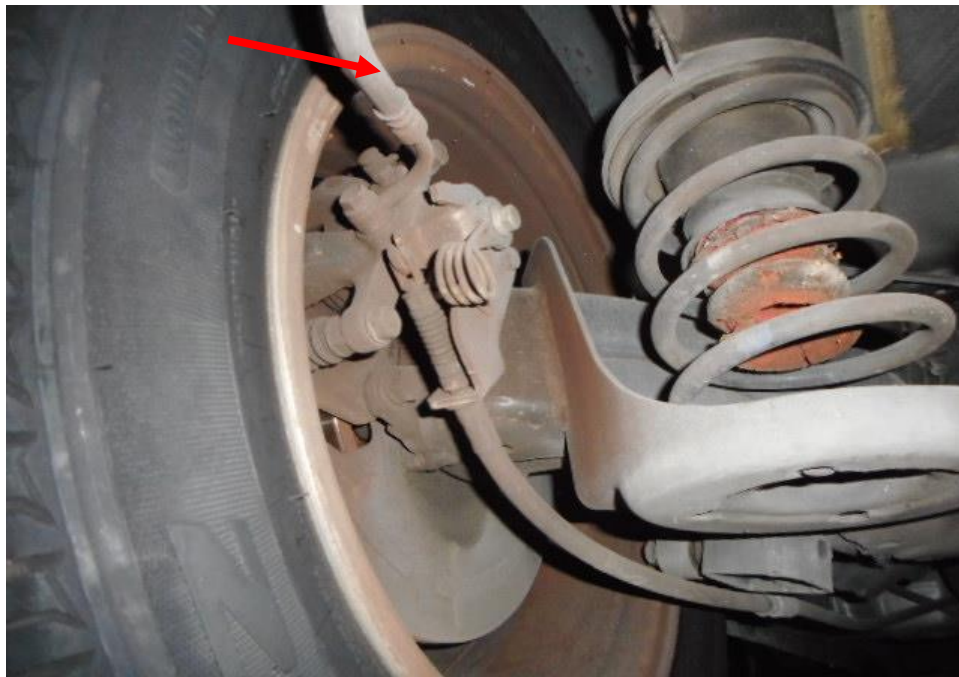
Photo 22 shows the brake hose/pipe (arrowed) at the rear left wheel of the Motor Car. No leakage of brake fluid was observed. Visual examination of the various components of the braking system like the brake caliper and etc had revealed to be intact and without visible damage.

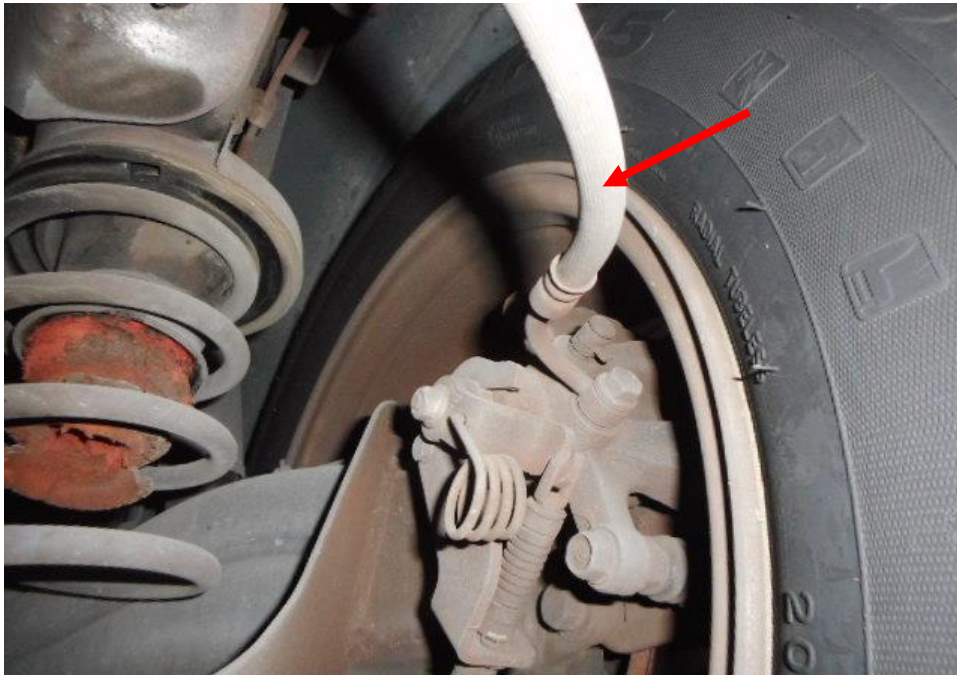
Photo 23 shows the brake hose/pipe (arrowed) at the rear right wheel of the Motor Car. No leakage of brake fluid was observed. Visual examination of the various components of the braking system like the brake caliper and etc had revealed to be intact and without visible damage.

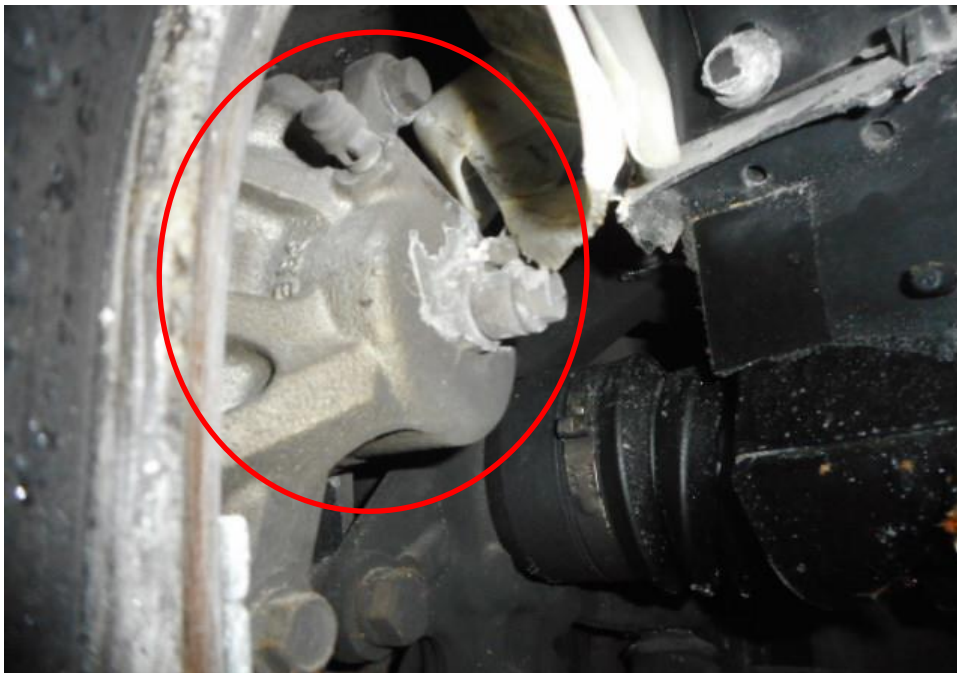
Photo 24 shows the close up view of the front right wheel rim and tyre, the viewing of the brake caliper and brake hose components at the front right wheel of the Motor Car was blocked due to the induced damages sustained to the engine and undercarriage component (circled) as a result of the accident.

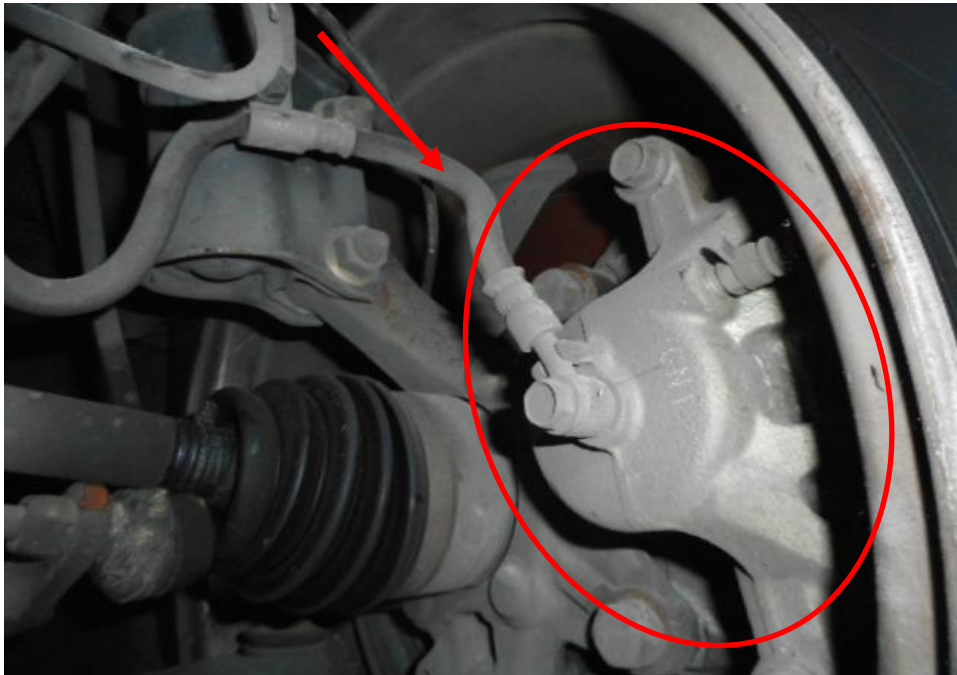
Photo 25 shows the brake hose/pipe (arrowed) at the front left wheel of the Motor Car. No leakage of brake fluid was observed. Visual examination of the various components of the braking system like the brake caliper (circled) and etc had revealed to be intact and without visible damage.

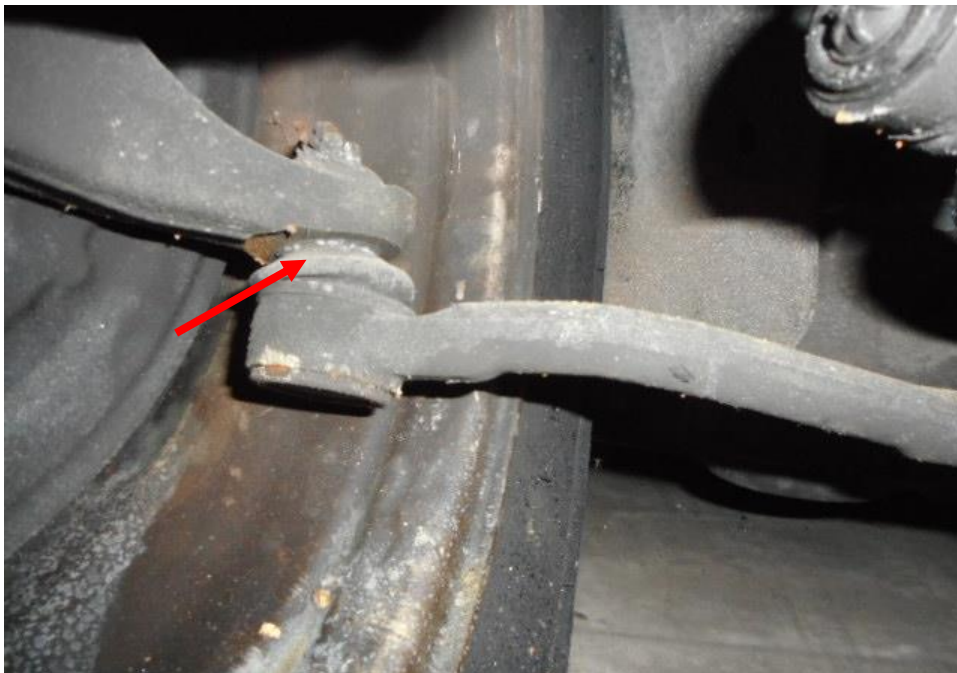
Photo 26 shows the various undercarriage components at the front left wheel of the Motor Car, in particular the steering tie rod (arrowed). The various steering components were all found to be intact.

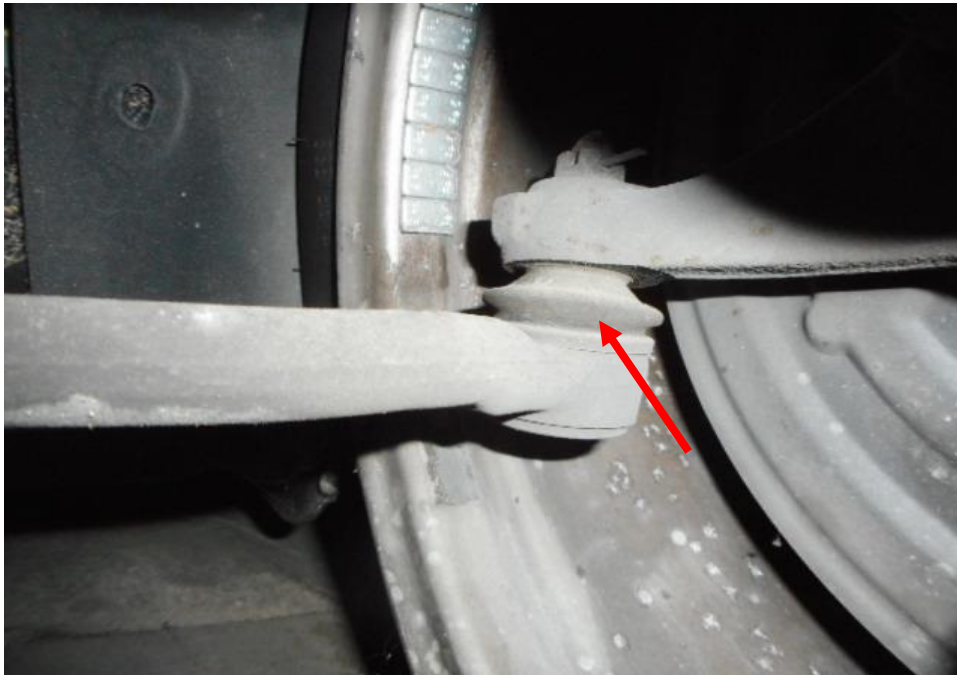
Photo 27 shows the various undercarriage components at the front left wheel of the Motor Car, in particular the steering tie rod (red arrow) and the driveshaft (yellow arrow). The various steering components were all found to be intact. There was also no sign of fluid stain observed on the various undercarriage components at the front left wheel of the Motor Car.

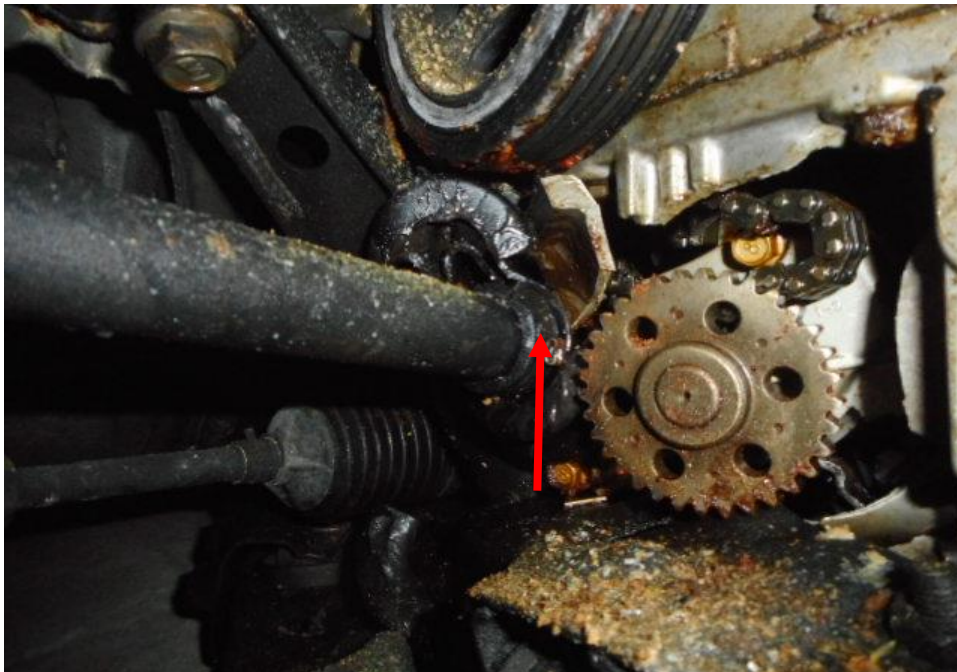
Photo 28 shows the various undercarriage components at the front right wheel of the Motor Car, in particular the driveshaft (arrowed) was observed to be damaged and broken off from the engine as a result of the accident.

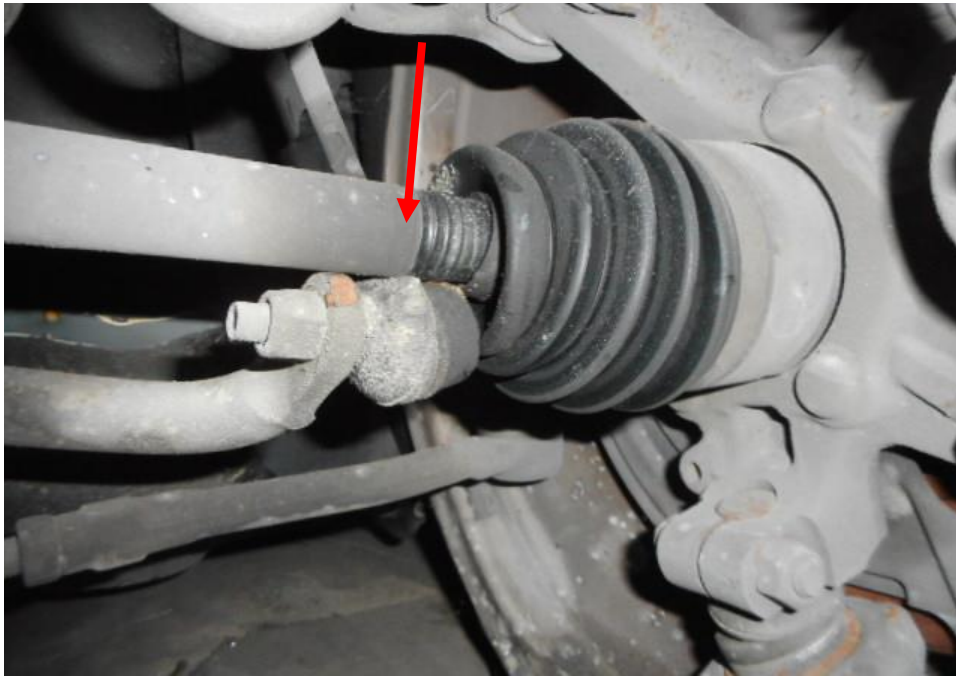
Photo 29 shows the various undercarriage components at the front left wheel of the Motor Car, in particular the driveshaft (arrowed) was observed to be damaged as a result of the accident.

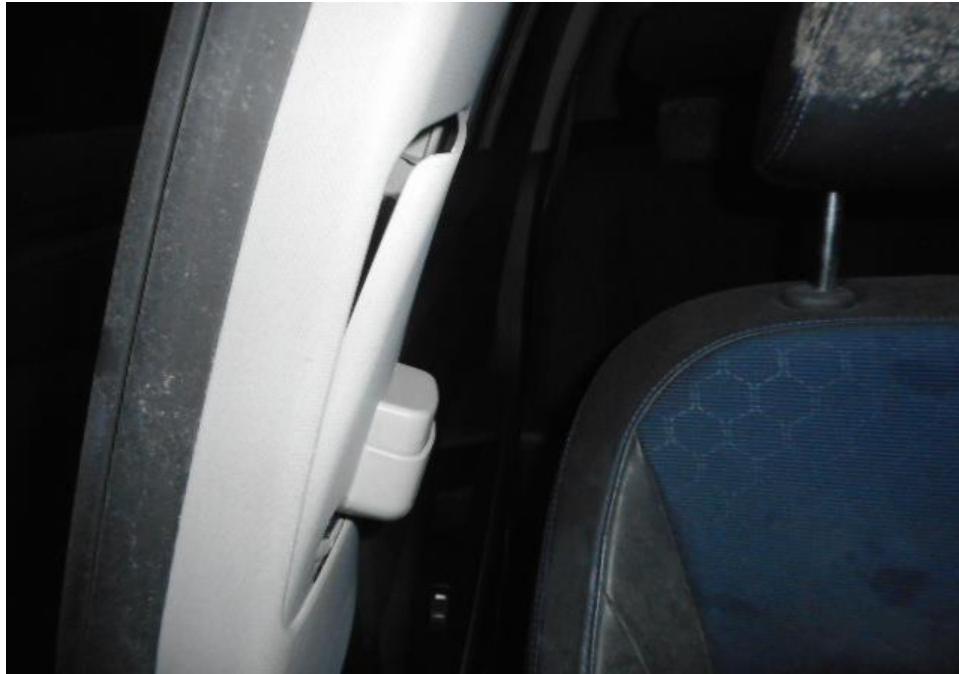
Photo 30 shows that the seat belt on the right seat was worn at the material time of accident as the safety pre-tensioners was activated at the moment of impact and caused the seat belt to be locked into the last position and the seat belt was cut for SCDF rescue extraction purposes.

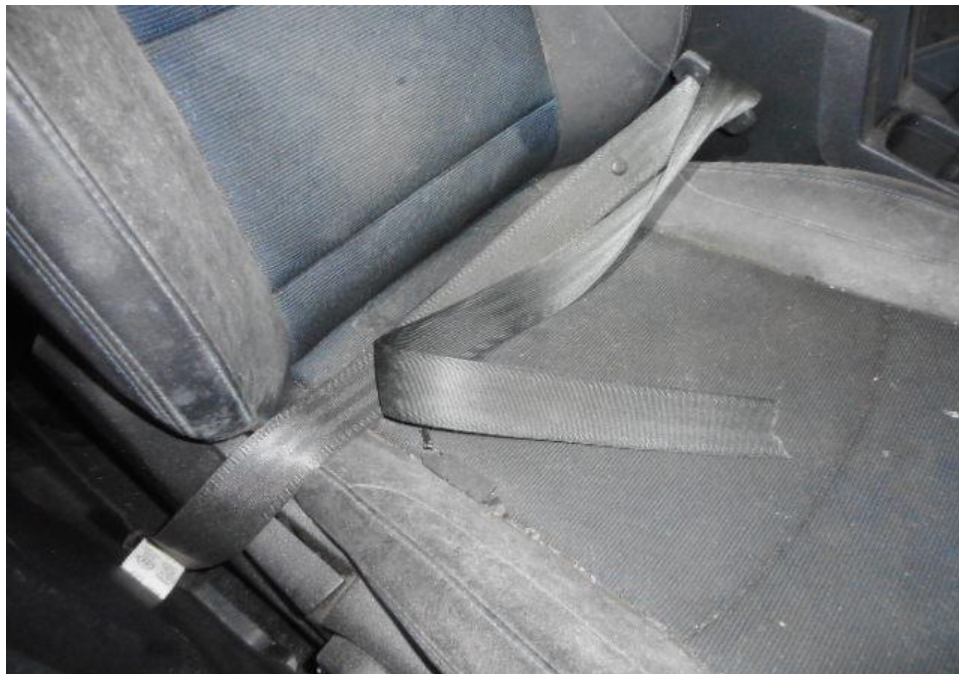
Photo 31 shows that the seat belt on the right seat was worn at the material time of accident as the safety pre-tensioners was activated at the moment of impact and caused the seat belt to be locked into the last position and the seat belt was cut for SCDF rescue extraction purposes.
