Your Ref: TP IP/11422/2023
Our Ref : CI/TPD23006071/P

Fatal Accident Investigation Team

MECHANICAL INSPECTION REPORT OF MOTOR CAR SLM 1260Z

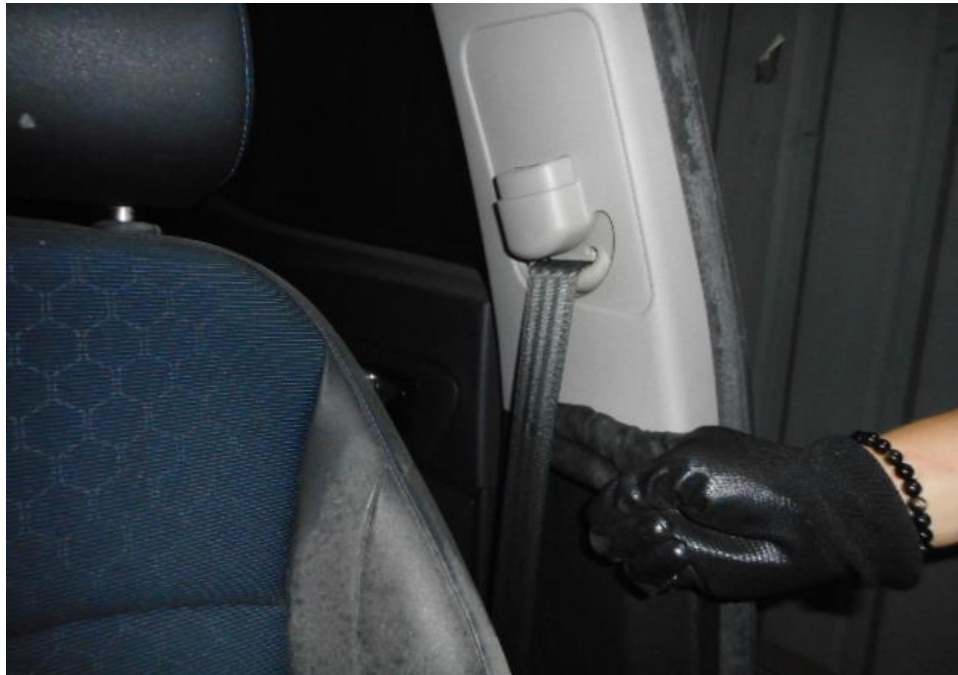
Photo 32 shows that the seat belt on the left seat was not worn at the material time of accident as the safety pre-tensioners was activated at the moment of impact and caused the seat belt to be locked into the last position.
