Your Ref: Mercedes Benz SL43 AMG Cabriolet  
(chassis number W1KVK5AB3NF008424)  
Our Ref : CI/TP23006135/D

18 June 2023

**INSPECTION REPORT OF AN UNREGISTERED MERCEDES BENZ SL43  
AMG CABRIOLET MOTOR CAR WITH CHASSIS NUMBER  
W1KVK5AB3NF008424**

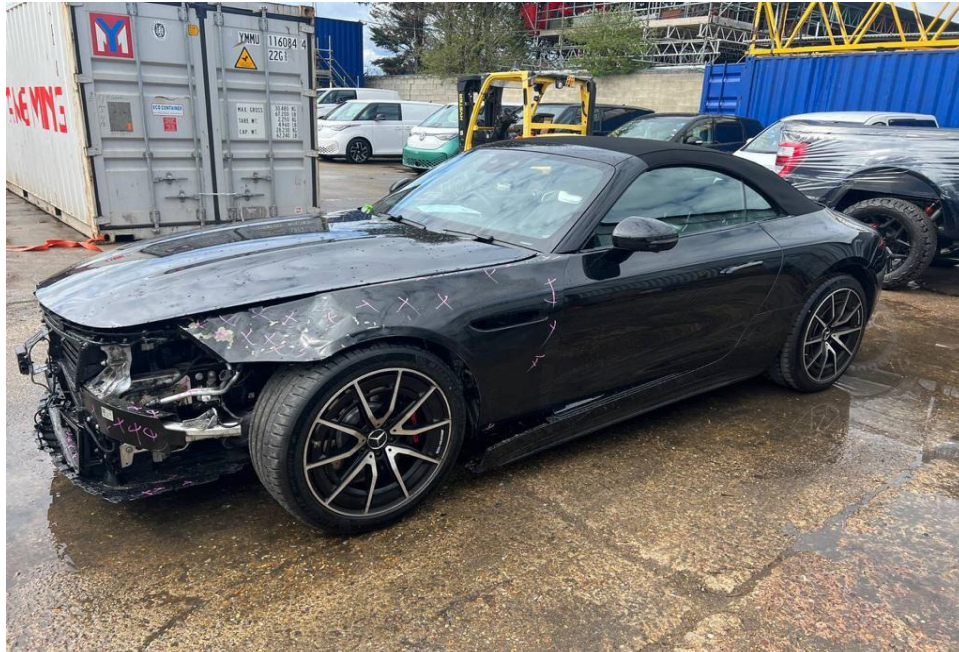
3. The photographs provided to me had showed damage to the frontal portion of the Motor Car. Body parts damaged include the front right headlamp, front left fender and left side rocker panel garnish amongst others.
4. The Motor Car's front grille, front emblem, front number plate garnish, front left headlamp, front bumper and all its related parts and attachments like the front bumper centre lower grille, front bumper left lower grille, front bumper right lower grille and front bumper sensors amongst others, were also observed to be missing/dislodged/damaged.
5. No physical damage was observed to other areas of the Motor Car. The airbag(s) of the Motor Car was not deployed as seen from the photographs that were provided to me. See photo 1 – 4 below.

**Photo 1** shows the front left body of the Motor Car (photograph provided to me). The Motor Car was observed to have sustained damage at its frontal portion. The front left fender and left side rocker panel garnish were amongst the body parts that were observed to have been damaged. The Motor Car's front bumper and all its related parts and attachments like the front bumper left lower grille and front bumper sensors amongst others, were also missing/dislodged/damaged.

24. The body parts at the frontal portion of the Motor Car were visually examined, and it was noted that the repair/restoration works carried out to the damaged area of the Motor Car (refer to photograph 1 & 2 above) were reasonably adequate and in order.

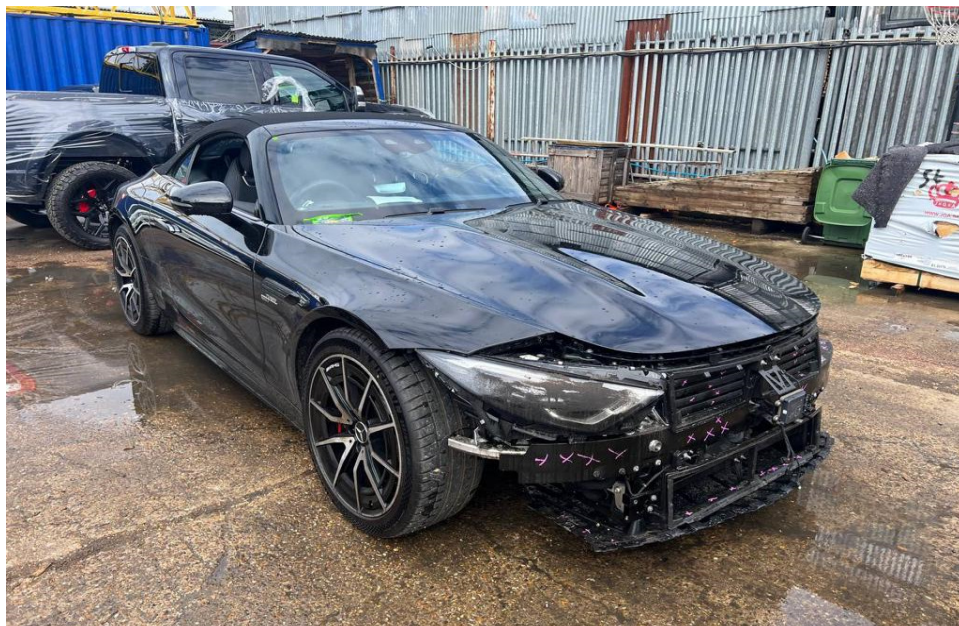
**Photo 2** shows the front right body of the Motor Car (photograph provided to me). The Motor Car was observed to have sustained damage at its frontal portion. The front right headlamp was amongst the body parts that were observed to have been damaged. The Motor Car's front grille, front emblem, front number plate garnish, front bumper and all its related parts and attachments like the front bumper centre lower grille, front bumper right lower grille and front bumper sensors amongst others, were also missing/dislodged/damaged.

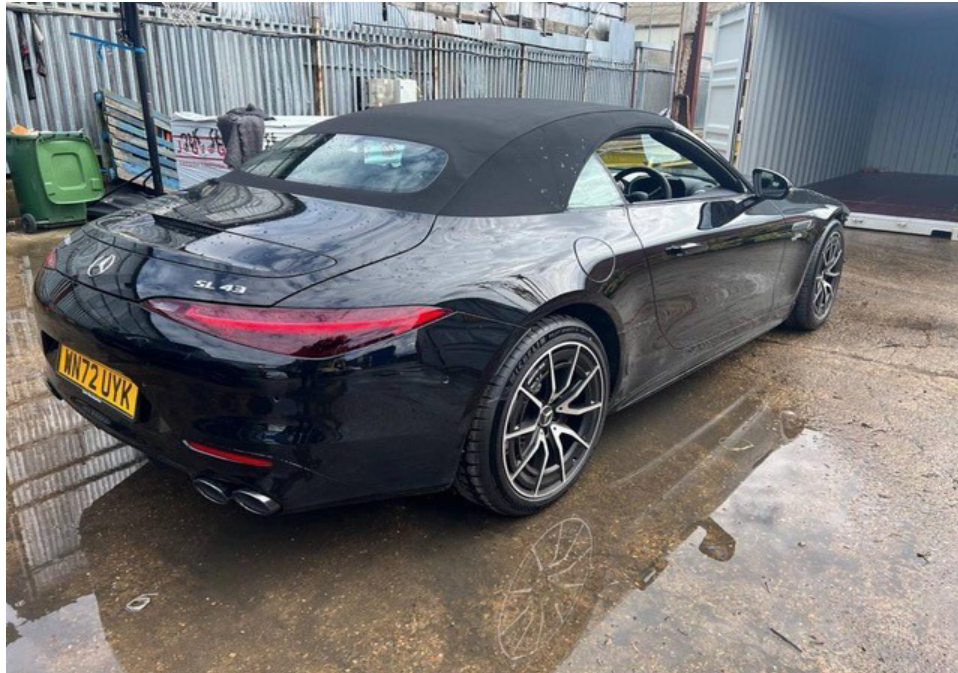
**Photo 3** shows the rear right body of the Motor Car (photograph provided to me). Apart for the frontal portion, there was no physical damage observed to other areas of the Motor Car. The airbag(s) of the Motor Car was not deployed as seen from the photographs that were provided to me.

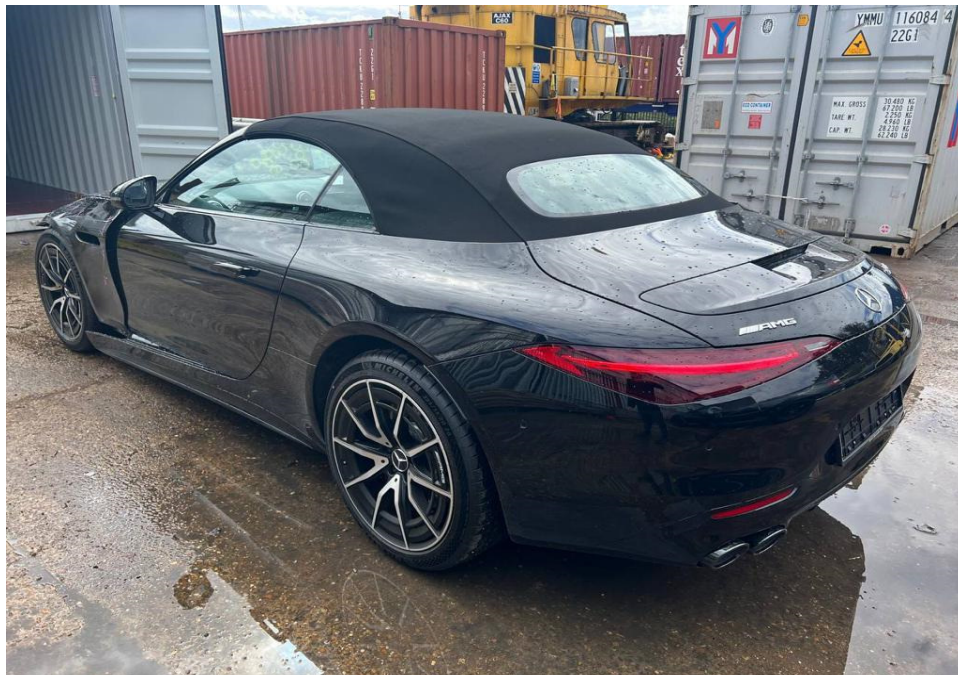
**Photo 4** shows the rear left body of the Motor Car (photograph provided to me). Apart for the frontal portion, there was no physical damage observed to other areas of the Motor Car. The airbag(s) of the Motor Car was not deployed as seen from the photographs that were provided to me.

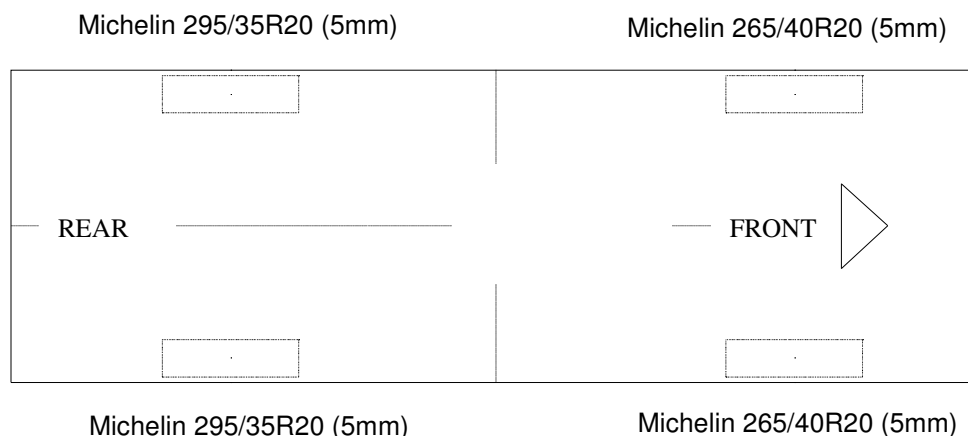
10. The Motor Car was fitted with 20inch sport wheel rims that were wrapped with tyres that were observed to be of serviceable condition. The tyres were also sufficiently inflated for vehicular operation. The tyre brand, tyre size and approximate remaining tread depth of the 4 tyres of the Motor Car were recorded as follows: -

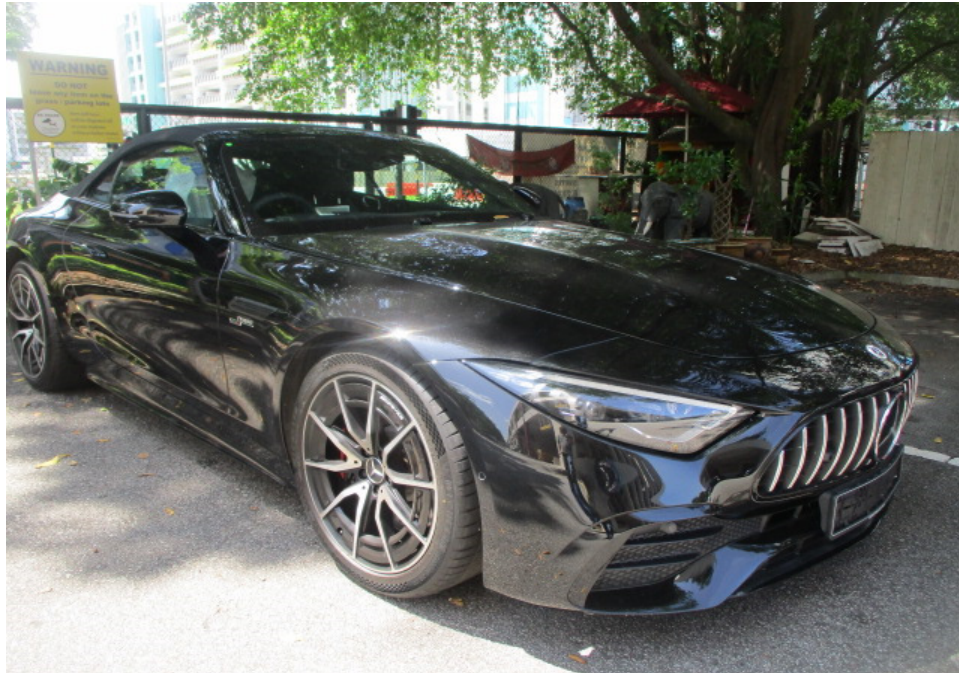
**Photo 5** shows a general view of the front right body of the Motor Car at the time of my inspection. The Motor Car was observed to be in a relatively good general condition with no loose exterior fittings observed. The body parts at the frontal portion of the Motor Car were visually examined and it was observed that the repair/restoration works carried out to the damaged area of the Motor Car (refer to photograph 1 & 2 above) were reasonably adequate and in order.

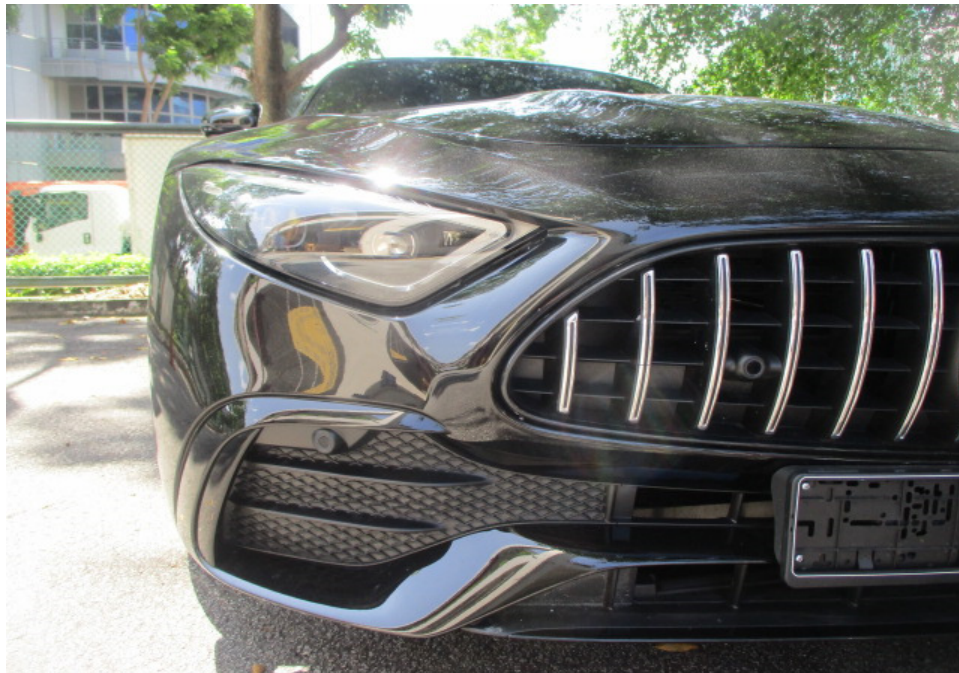
**Photo 6** shows a closer view of the Motor Car's front bumper, front bumper right lower grille, front bumper right sensor and front right headlamp. The body parts at the frontal portion of the Motor Car were visually examined and it was observed that the repair/restoration works carried out to the damaged area of the Motor Car (refer to photograph 1 & 2 above) were reasonably adequate and in order.

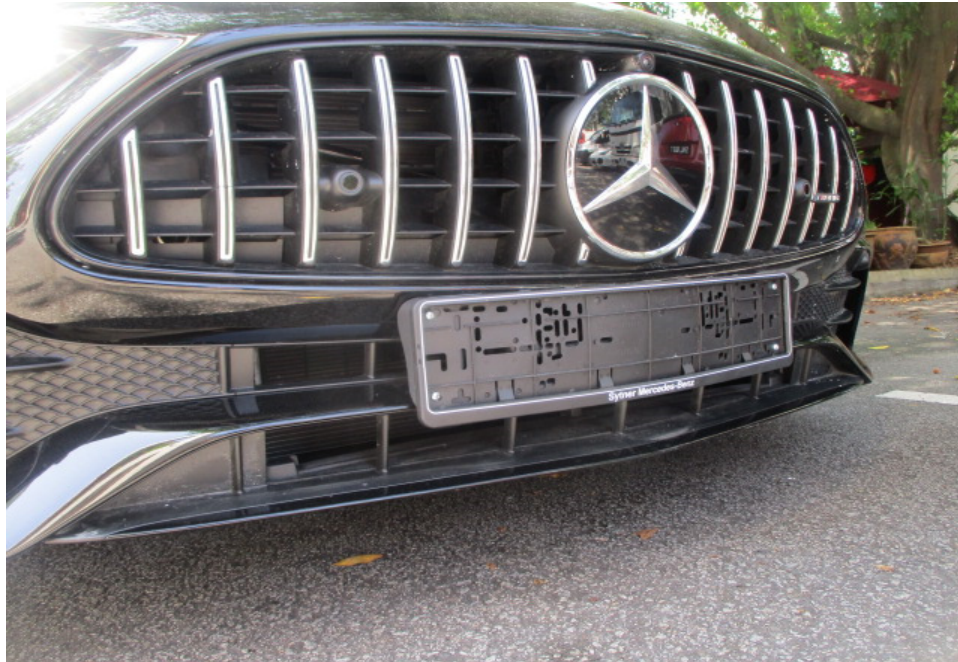
**Photo 7** shows a closer view of the Motor Car's front bumper, front bumper centre lower grille, front grille, front emblem and front number plate garnish. The body parts at the frontal portion of the Motor Car were visually examined and it was observed that the repair/restoration works carried out to the damaged area of the Motor Car (refer to photograph 1 & 2 above) were reasonably adequate and in order.

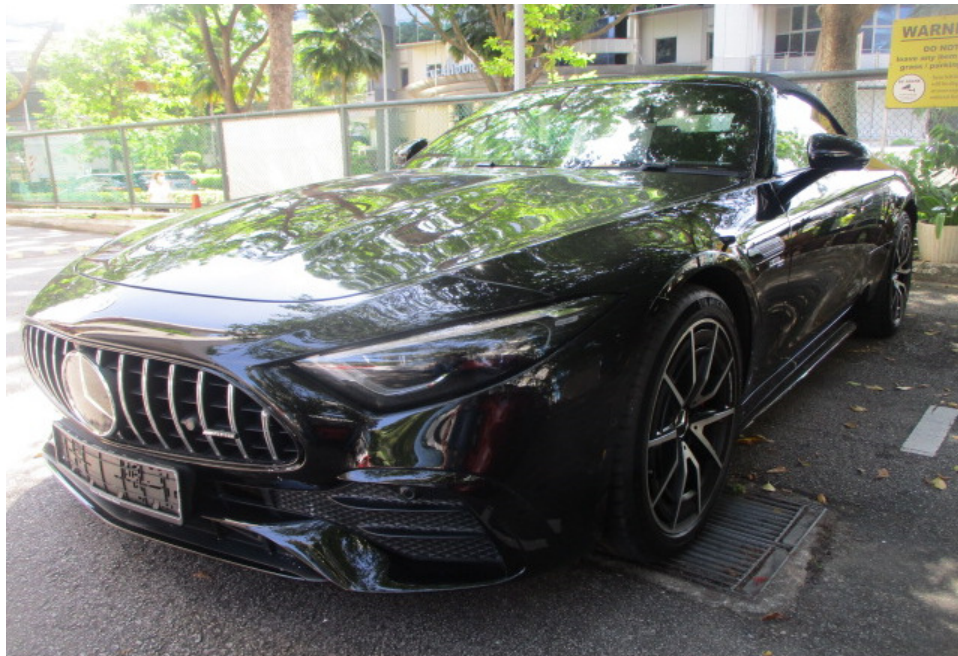
**Photo 8** shows a general view of the front left body of the Motor Car at the time of my inspection. The Motor Car was observed to be in a relatively good general condition with no loose exterior fittings observed. The body parts at the frontal portion of the Motor Car were visually examined and it was observed that the repair/restoration works carried out to the damaged area of the Motor Car (refer to photograph 1 & 2 above) were reasonably adequate and in order.

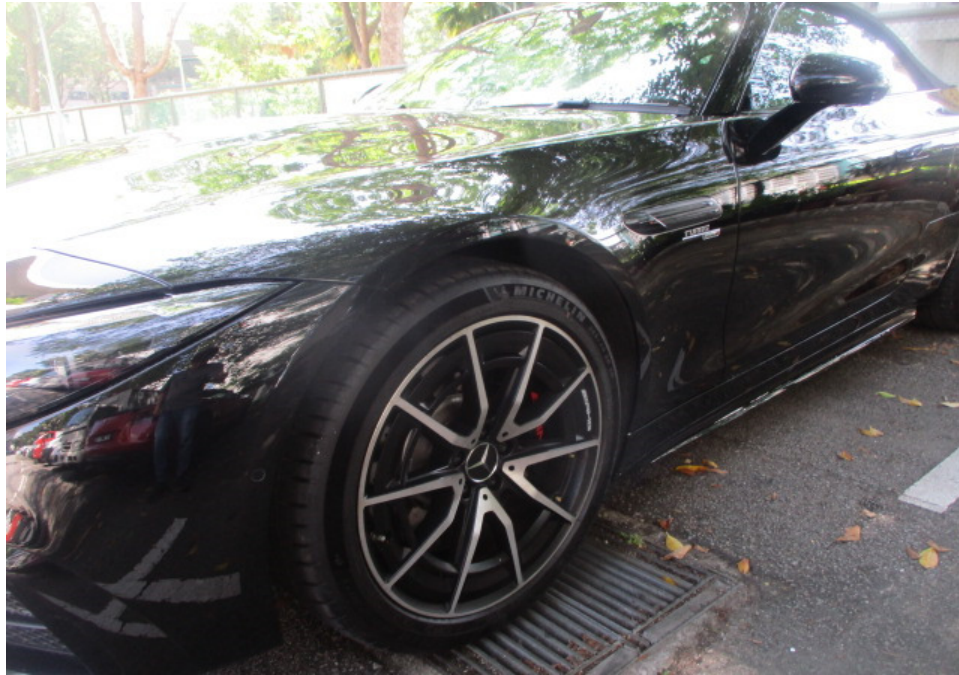
**Photo 9** shows a closer view of the Motor Car's front left fender and front left wheel rim. The body parts at the frontal portion of the Motor Car were visually examined and it was observed that the repair/restoration works carried out to the damaged area of the Motor Car (refer to photograph 1 & 2 above) were reasonably adequate and in order.

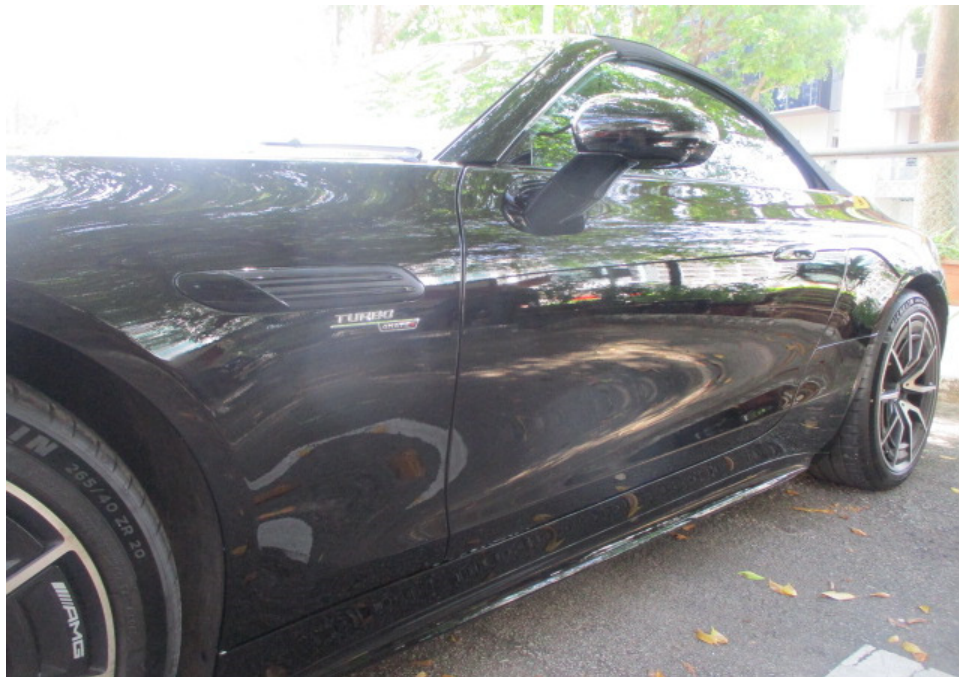
**Photo 10** shows a closer view of the Motor Car's front left fender, front left door and left side rocker panel garnish. The body parts at the frontal portion of the Motor Car were visually examined and it was observed that the repair/restoration works carried out to the damaged area of the Motor Car (refer to photograph 1 & 2 above) were reasonably adequate and in order.

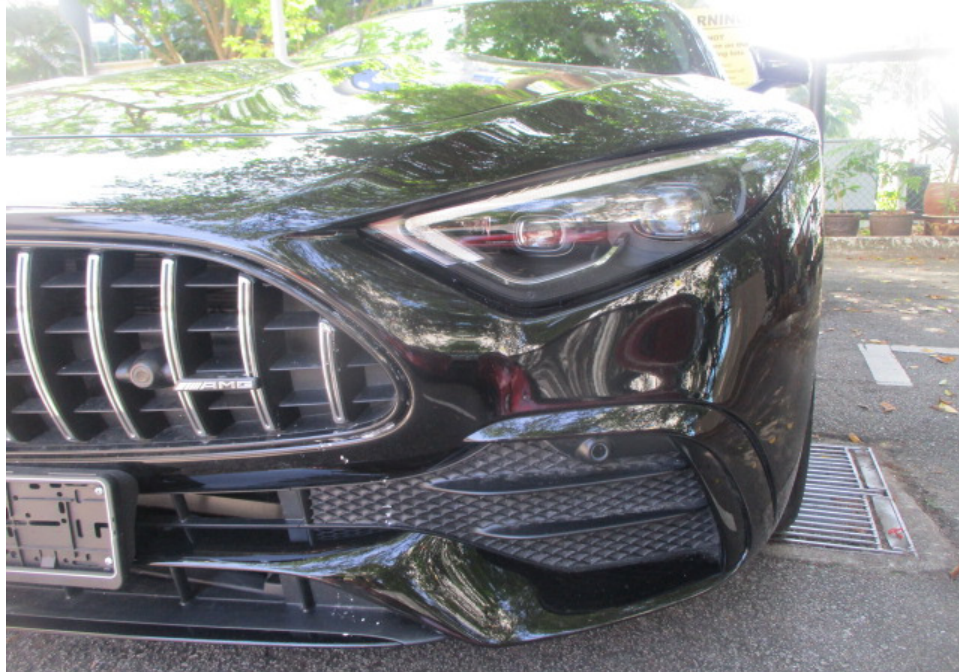
**Photo 11** shows a closer view of the Motor Car's front bumper, front bumper left lower grille, front bumper left sensor and front left headlamp. The body parts at the frontal portion of the Motor Car were visually examined and it was observed that the repair/restoration works carried out to the damaged area of the Motor Car (refer to photograph 1 & 2 above) were reasonably adequate and in order.

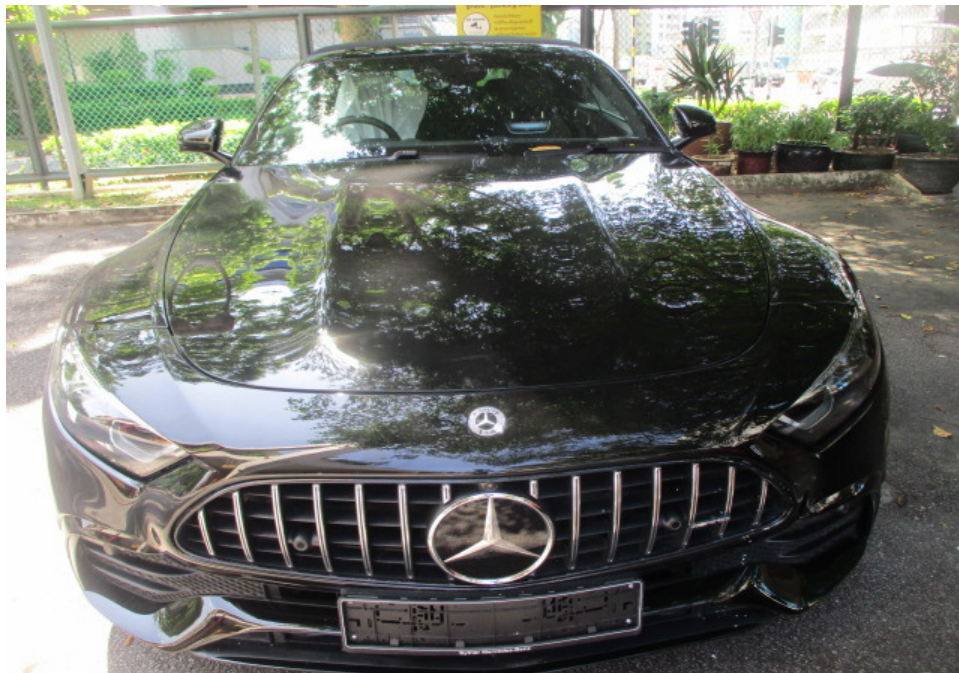
**Photo 12** shows a closer view of the Motor Car's front bonnet, front grille and front emblem. The body parts at the frontal portion of the Motor Car were visually examined and it was observed that the repair/restoration works carried out to the damaged area of the Motor Car (refer to photograph 1 & 2 above) were reasonably adequate and in order.

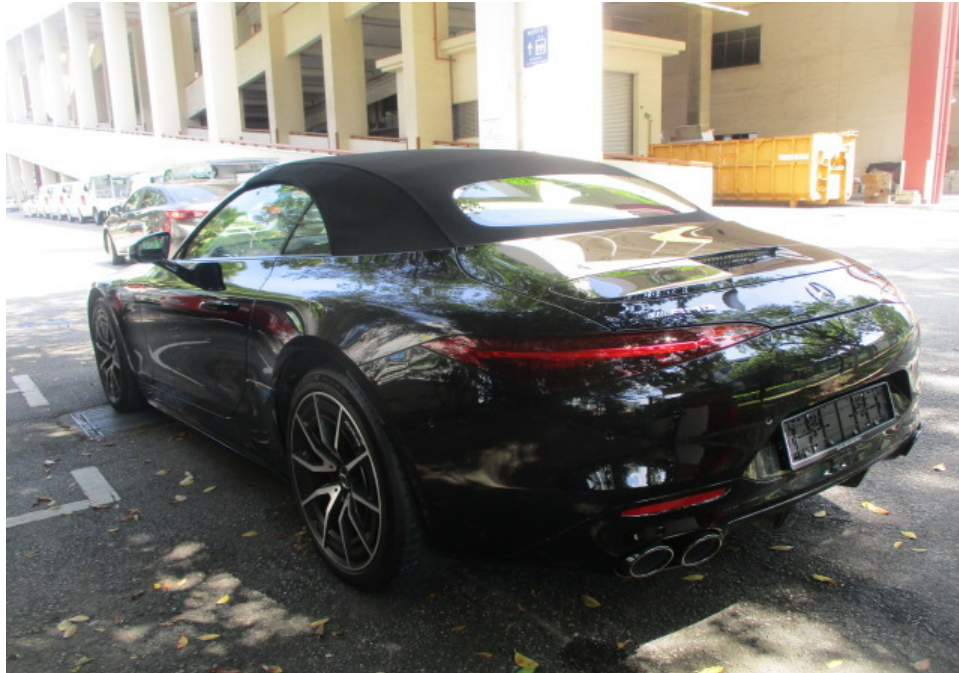
**Photo 13** shows a general view of the rear left body of the Motor Car at the time of my inspection. The Motor Car was observed to be in a relatively good general condition with no loose exterior fittings observed. The mileage of the Motor Car recorded at the time of my inspection was 1,727km.

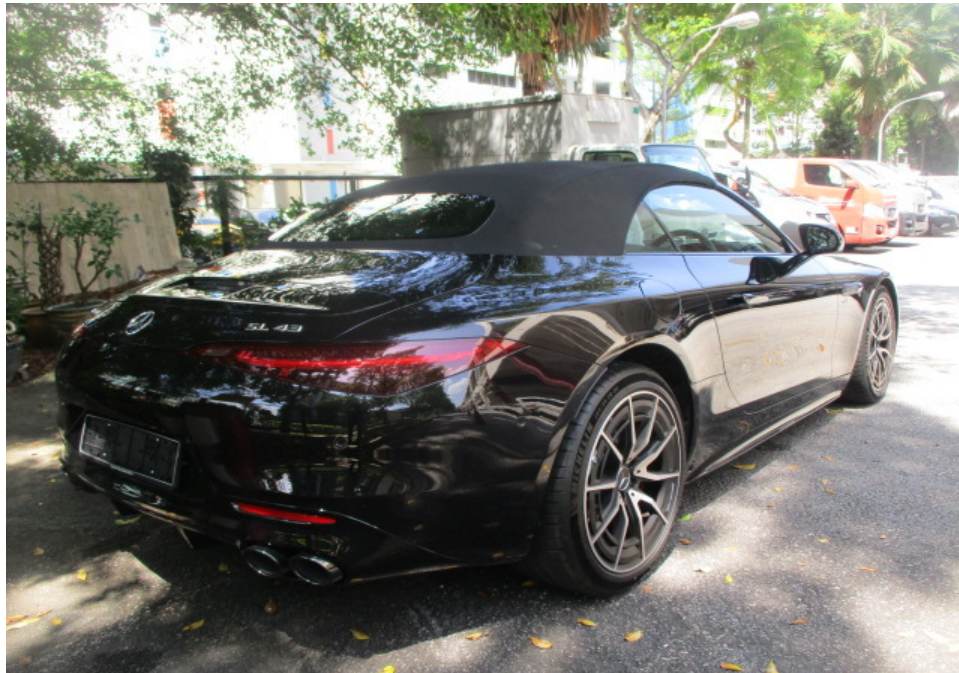
**Photo 14** shows a general view of the rear right body of the Motor Car at the time of my inspection. The Motor Car was observed to be in a relatively good general condition with no loose exterior fittings observed. The mileage of the Motor Car recorded at the time of my inspection was 1,727km.

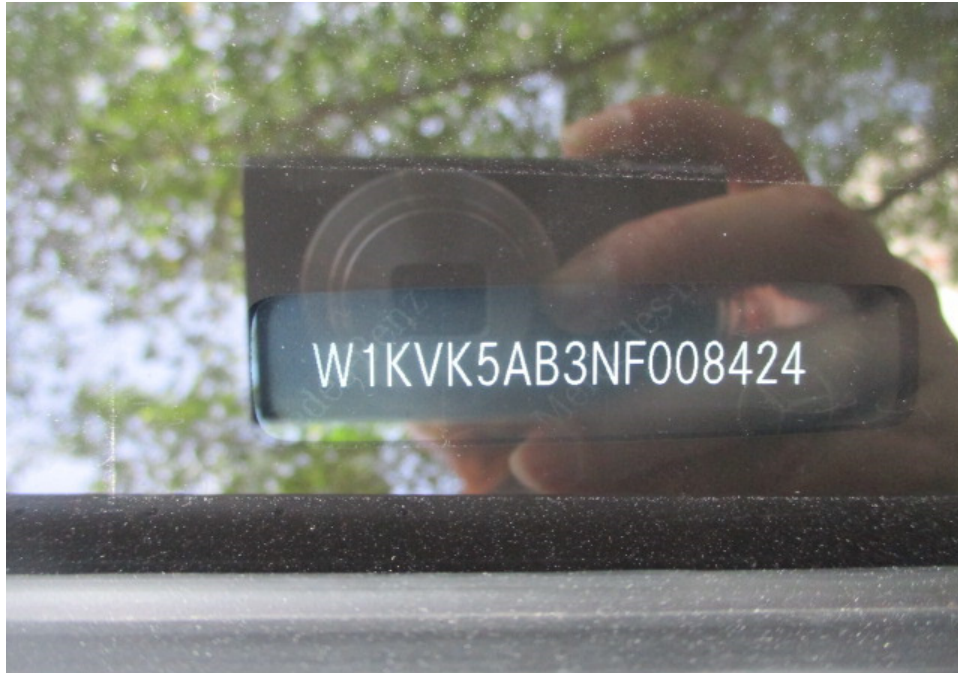
**Photo 15** shows the chassis number of the Motor Car. The chassis number recorded was W1KVK5AB3NF008424.

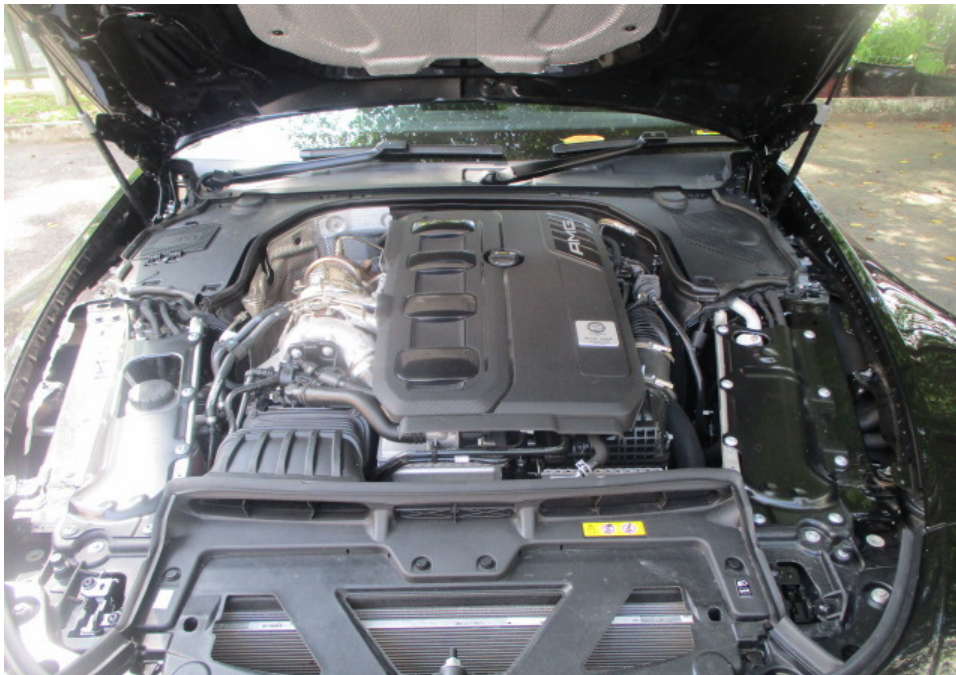
**Photo 16** shows a general view of the engine compartment of the Motor Car at the time of my inspection. The various parts and components inside the engine compartment were all observed to be intact and properly fitted. There was also no sign(s) or indication(s) of fluid leak and/or fluid stain found inside the engine compartment.

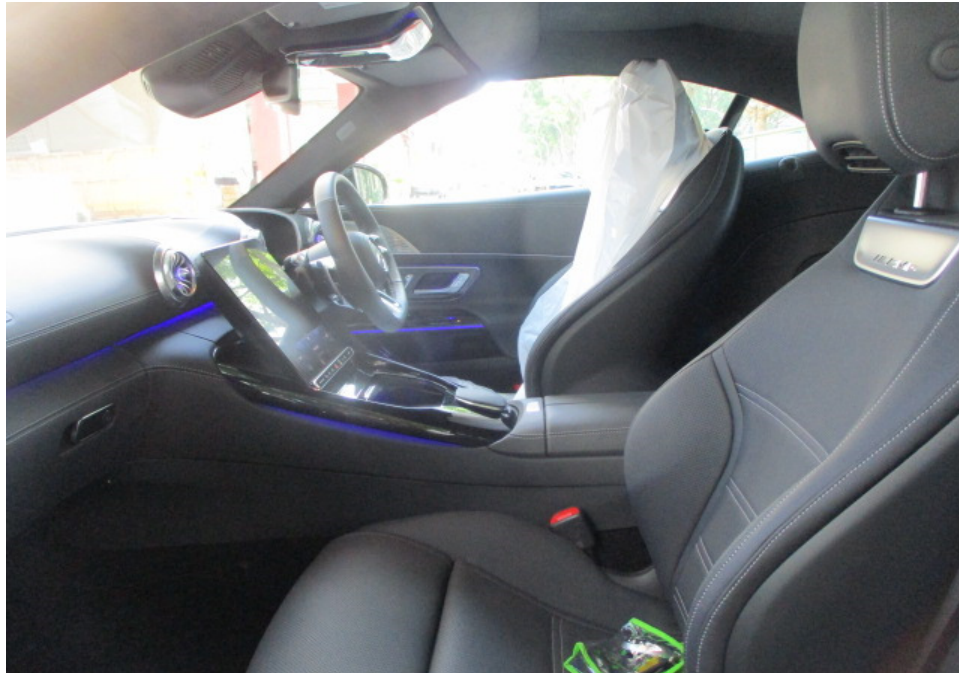
**Photo 17** shows the interior compartment of the Motor Car at the time of my inspection. The various parts and components, trims, carpet and upholstery inside the interior compartment were all observed to be intact and properly fitted.

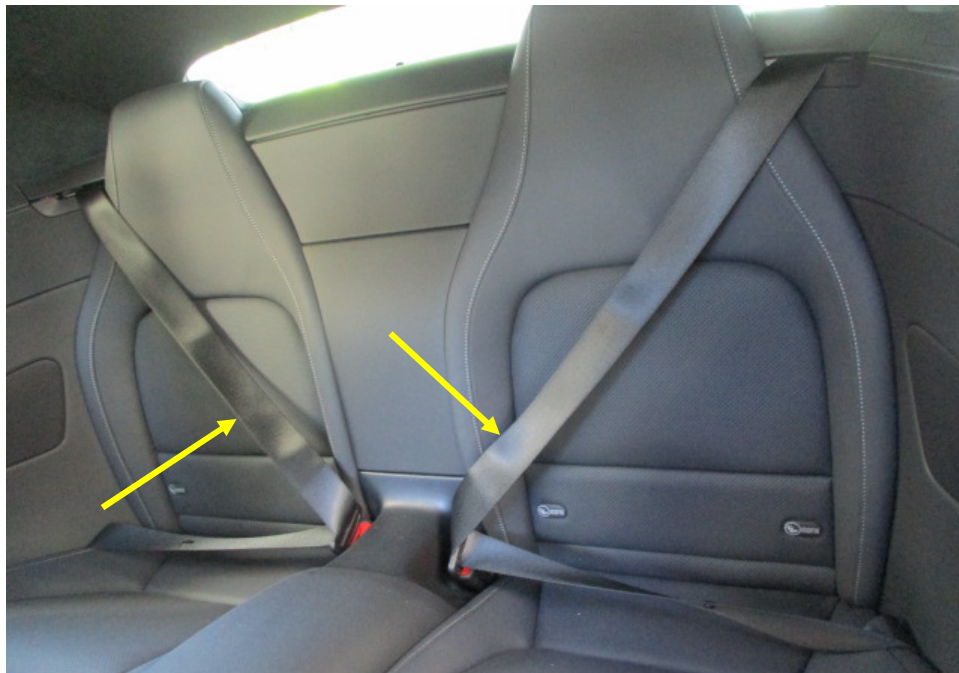
**Photo 18** shows the rear seats of the Motor Car. All the seats of the Motor Car were secured via seat rails to the floorboard. They were also fitted with a retractable seat belt reel and a pre-tensioner. The seat belts (arrowed) were tested and were able to be fastened into the respective pre-tensions that were fitted on the side of each individual seat.

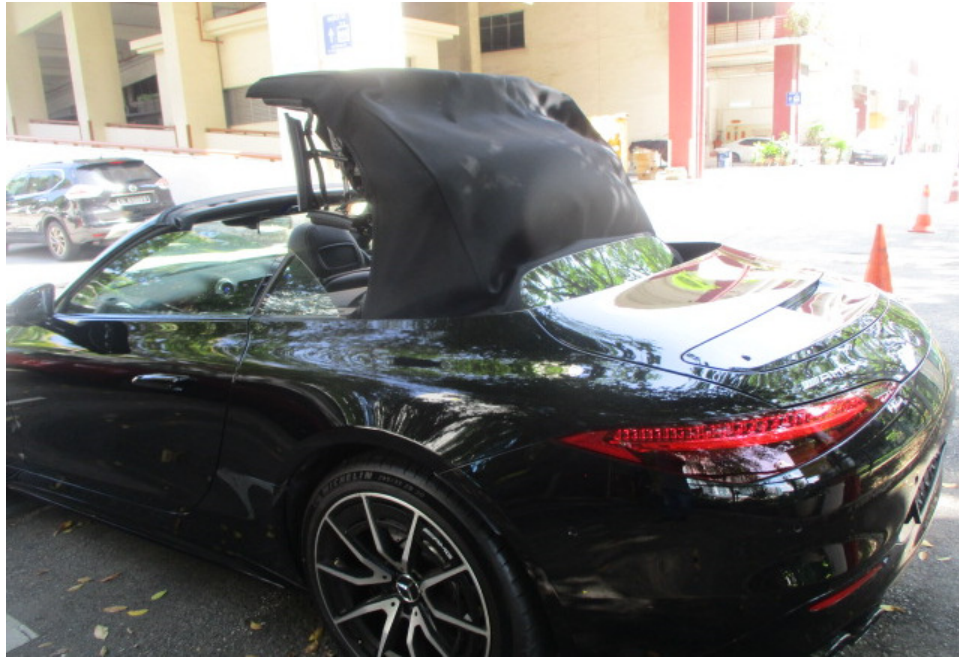
**Photo 19** shows the Motor Car's soft top roof being tested. It was observed that as a safety feature, the soft top roof could only open and close when the Motor Car was in a stationary position or at low travelling speed. When opened, the soft top roof is completely folded into the rear compartment with no parts protruding out of the Motor Car's body. The soft top roof was also found adequately secured to the "A" pillar after closing.

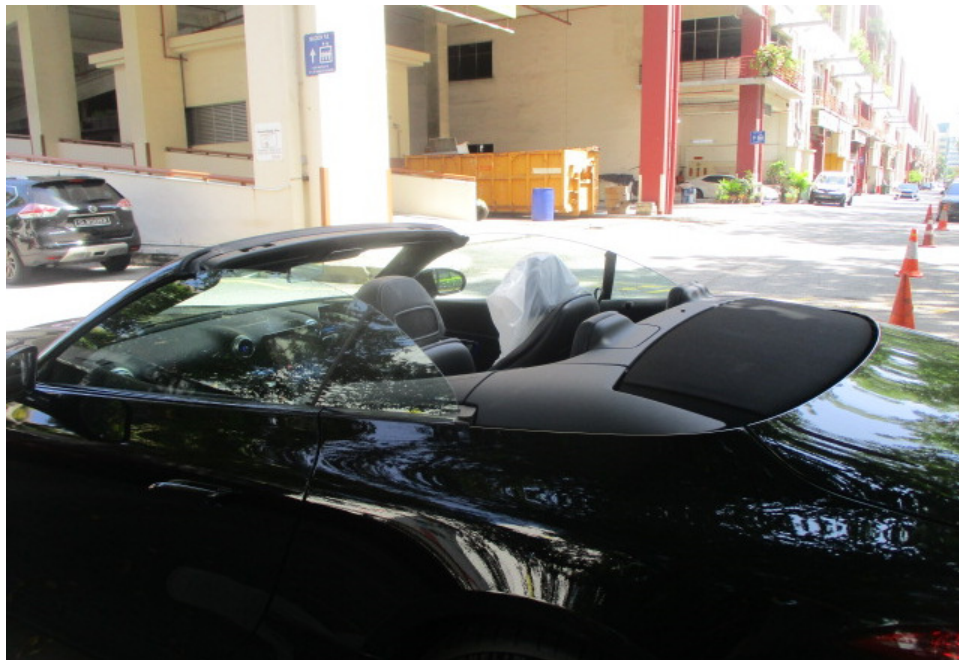
**Photo 20** shows the Motor Car with its soft top roof completely folded. It was observed that as a safety feature, the soft top roof could only open and close when the Motor Car was in a stationary position or at low travelling speed. When opened, the soft top roof is completely folded into the rear compartment with no parts protruding out of the Motor Car's body. The soft top roof was also found adequately secured to the "A" pillar after closing.

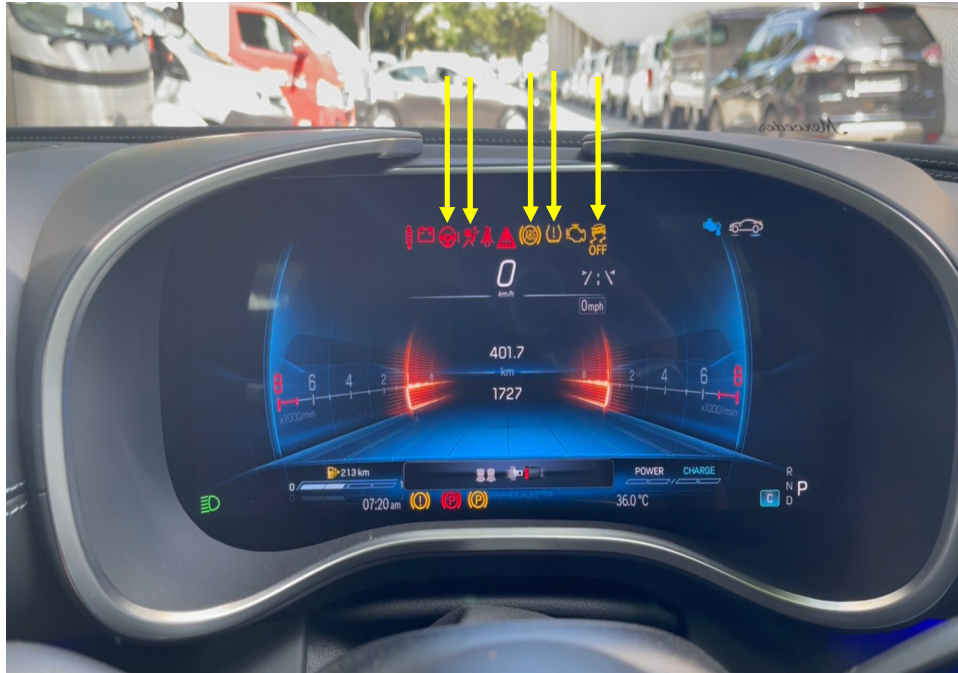
**Photo 21** shows the warning lights for the various electronic safety features appearing on the instrument panel of the Motor Car during its self-test when the engine is cranked, in particular the ABS, SRS, EPS, TPM and TCS lights (arrowed).

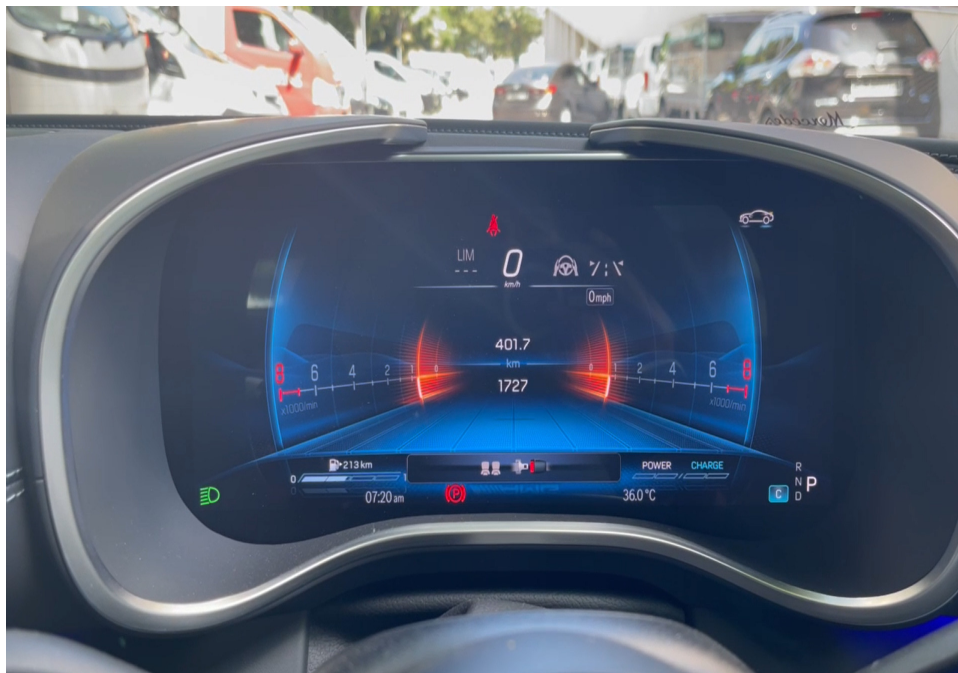
**Photo 22** shows the respective warning lights no longer illuminated, indicating that there is no fault detected to the ABS, SRS, EPS, TPM and TCS systems of the Motor Car during the self-test. These electronic systems were hence in working condition at the time of my inspection.

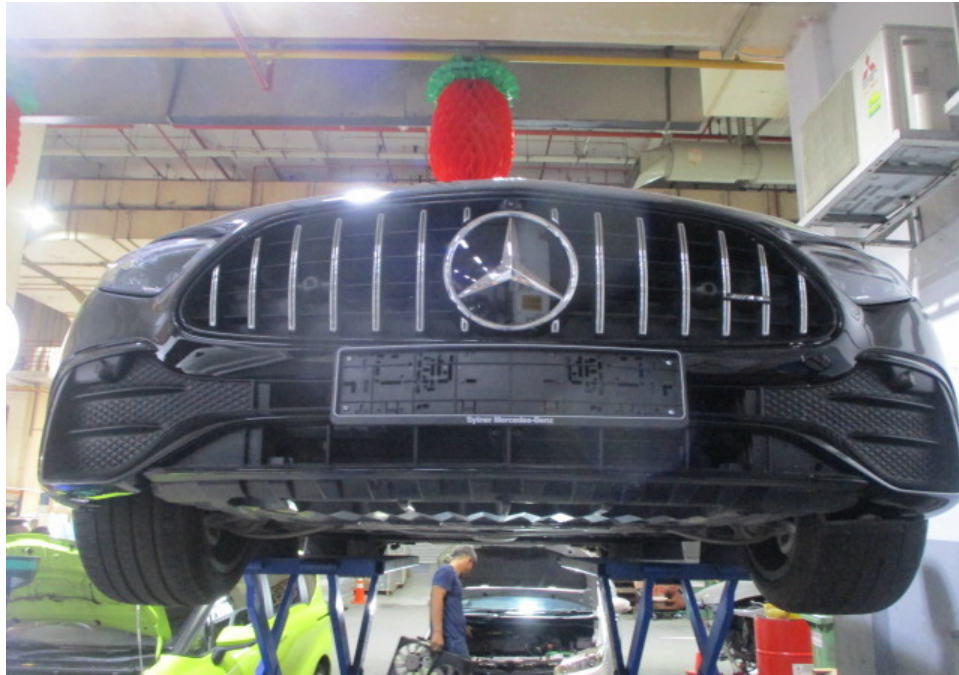
**Photo 23** shows the Motor Car hoisted up for checks on its undercarriage. There was no sign(s) or indication(s) of fluid leakage and/or fluid stain(s) on the underside of the Motor Car. The undercarriage components of the Motor Car were also all observed to be intact and secured in an appropriate manner.

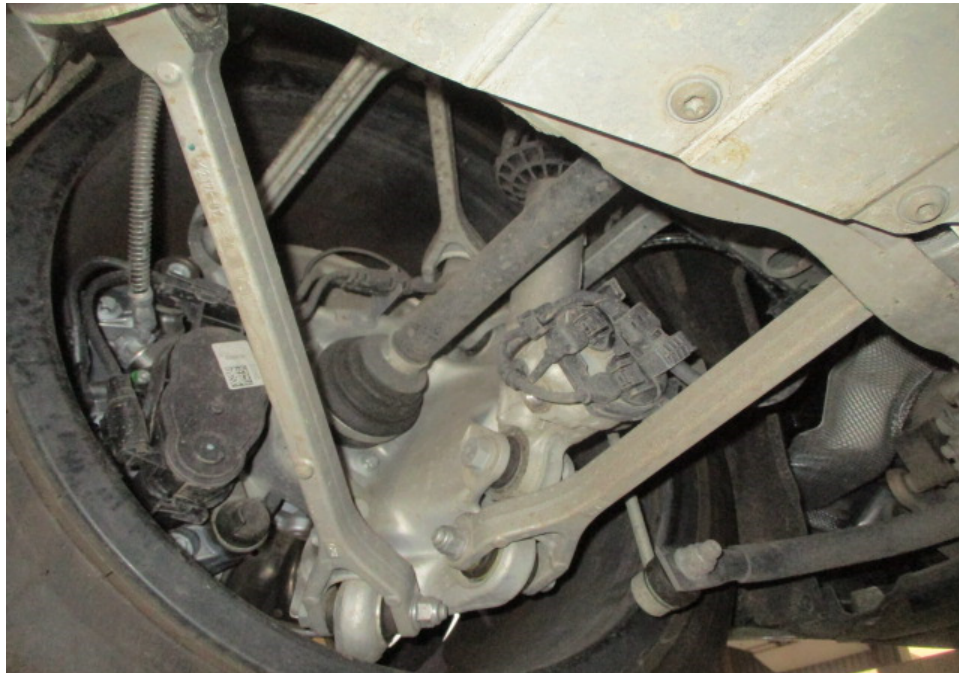
**Photo 24** shows a general view of the control arms and linkages at the rear right wheel of the Motor Car. I did not observe any fluid leak and/or fluid stain on the underside of the Motor Car. All of the Motor Car's undercarriage components were observed to be intact and secured in an appropriate manner.

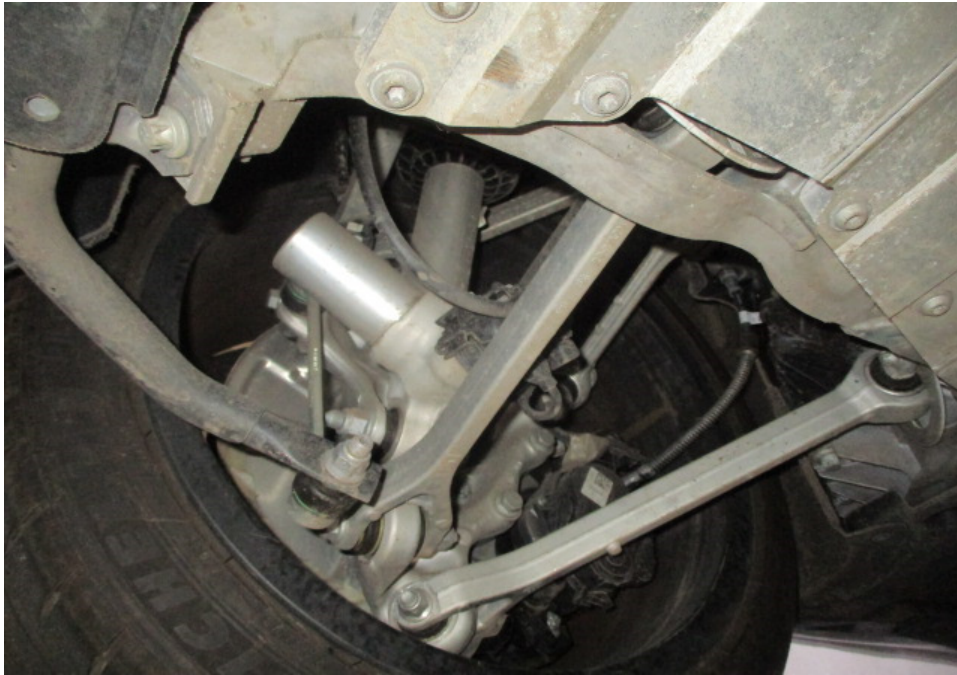
**Photo 25** shows a general view of the control arms and linkages at the rear left wheel of the Motor Car. I did not observe any fluid leak and/or fluid stain on the underside of the Motor Car. All of the Motor Car's undercarriage components were observed to be intact and secured in an appropriate manner.

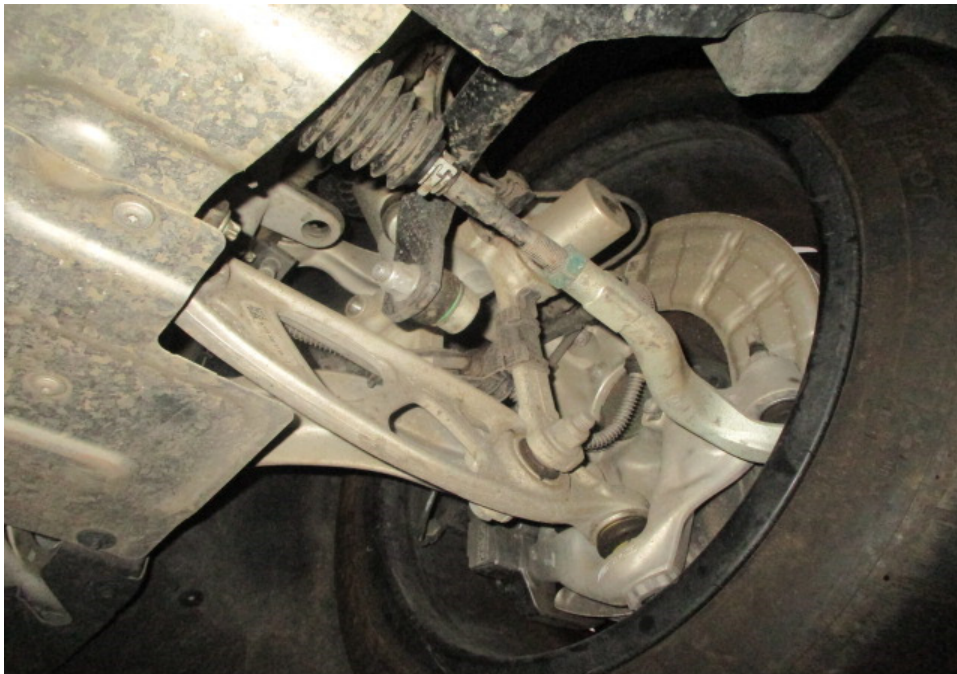
**Photo 26** shows the various undercarriage components at the front left wheel of the Motor Car. The mechanical components, control arms and linkages were all found to be intact and secured in an appropriate manner.

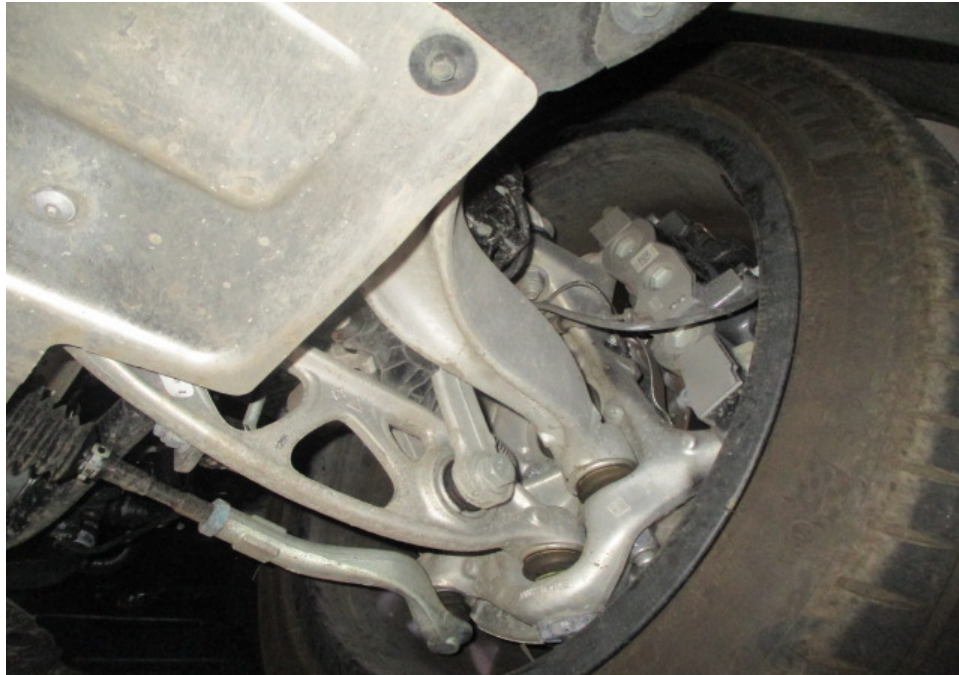
**Photo 27** shows the various undercarriage components at the front right wheel of the Motor Car. The mechanical components, control arms and linkages were all found to be intact and secured in an appropriate manner. I also did not observe any fluid leak and/or fluid stain on the underside of the Motor Car.

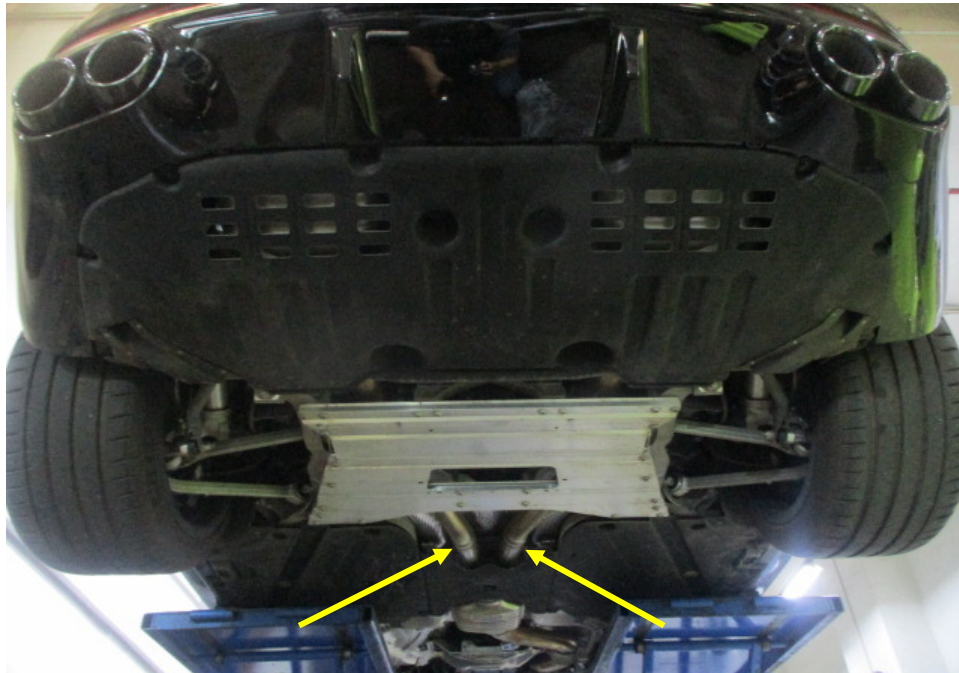
**Photo 28** shows the rear section of the Motor Car's exhaust system. My examination of the Motor Car's exhaust system revealed no sign(s) or indication(s) of any cut or weld marks along its exhaust pipes (arrowed), on its rear muffler, on its centre resonator box and on its catalytic converter.

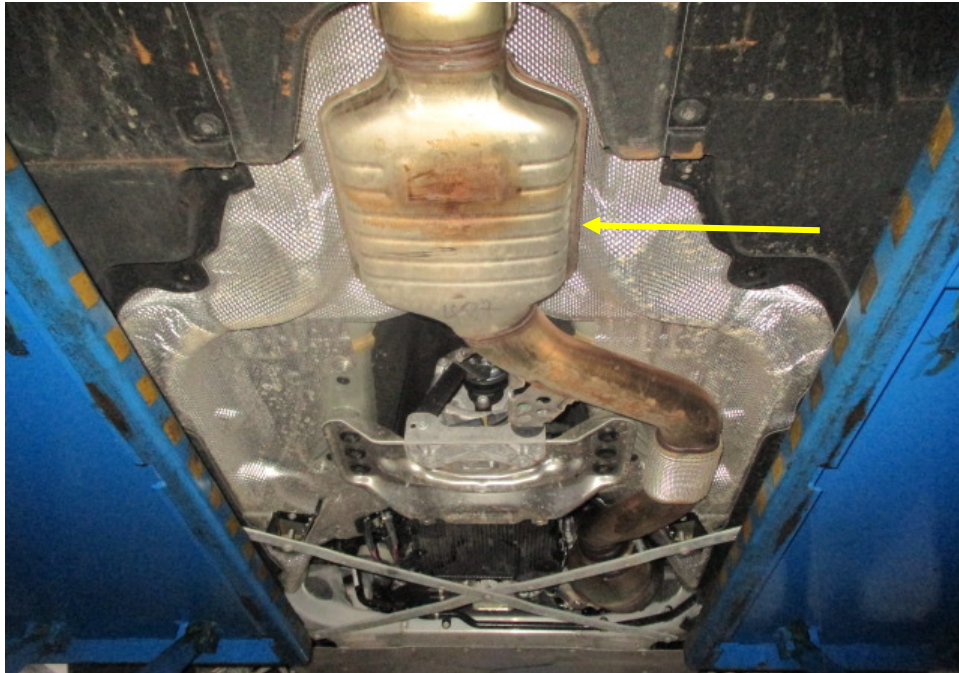
**Photo 29** shows the front section of the Motor Car's exhaust system. My examination of the Motor Car's exhaust system revealed no sign(s) or indication(s) of any cut or weld marks along its exhaust pipes, on its rear muffler, on its centre resonator box (arrowed) and on its catalytic converter.

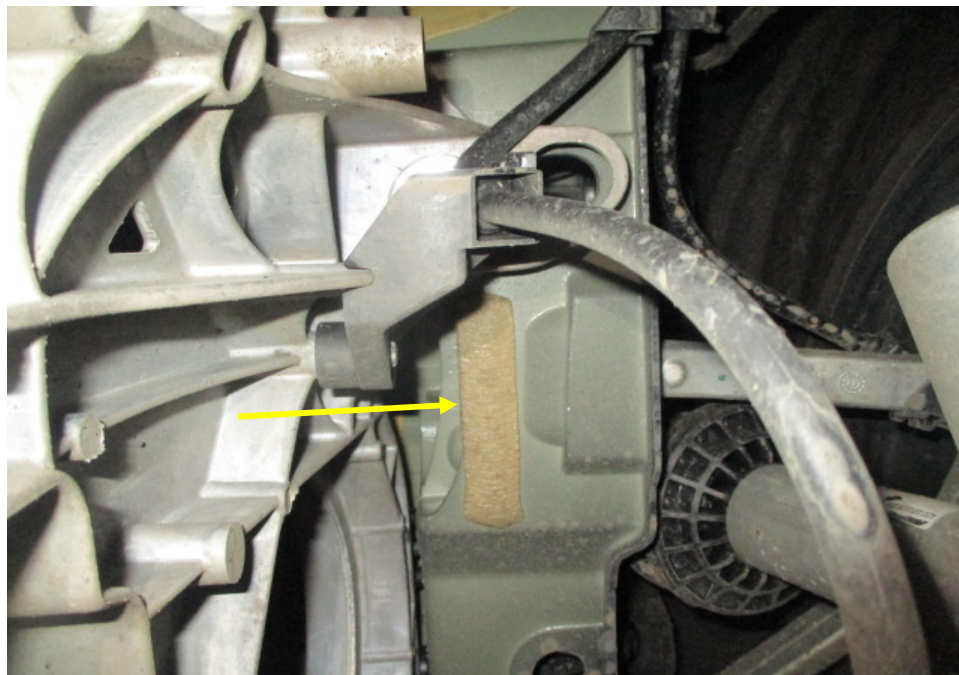
**Photo 30** shows the chassis/structural body at the underside rear right of the Motor Car. I did not find any weld marks other than original spot weld marks on the chassis/structural body of the Motor Car. The original factory sealant (arrowed) at the joints along the chassis/structural body was also untouched, indicating no work was done on the chassis/structural body of the Motor Car and that the chassis/structural body was originally fitted.
