Your Ref: Mercedes Benz SL43 AMG Cabriolet  
(chassis number W1KVK5AB3NF008424)  
Our Ref : CI/TP23006135/D

18 June 2023

**INSPECTION REPORT OF AN UNREGISTERED MERCEDES BENZ SL43  
AMG CABRIOLET MOTOR CAR WITH CHASSIS NUMBER  
W1KVK5AB3NF008424**

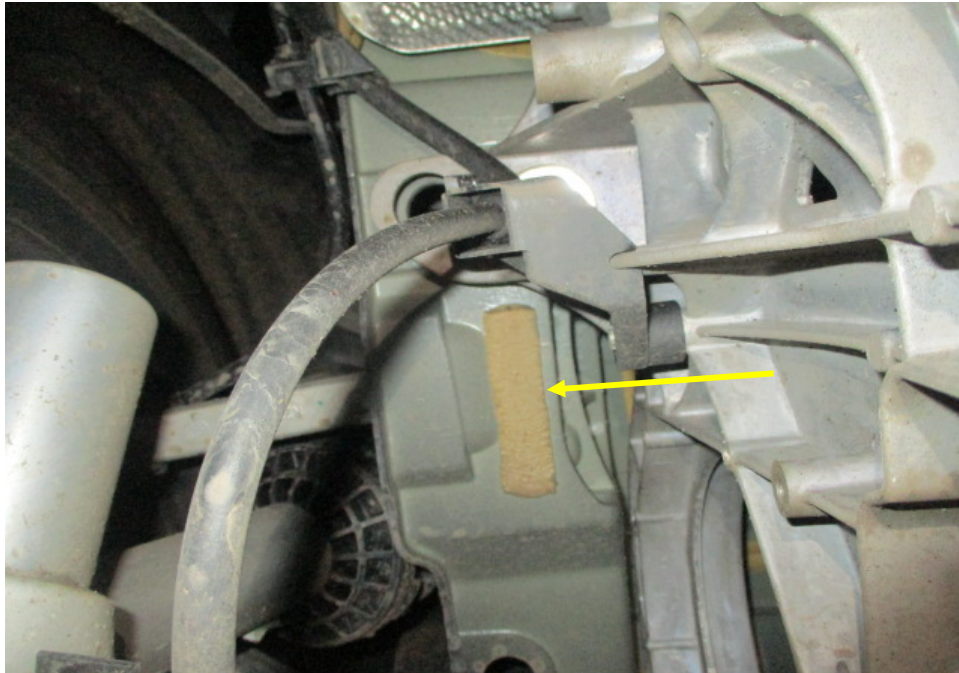
**Photo 31** shows the chassis/structural body at the underside rear left of the Motor Car. I did not find any weld marks other than original spot weld marks on the chassis/structural body of the Motor Car. The original factory sealant (arrowed) at the joints along the chassis/structural body was also untouched, indicating no work was done on the chassis/structural body of the Motor Car and that the chassis/structural body was originally fitted.

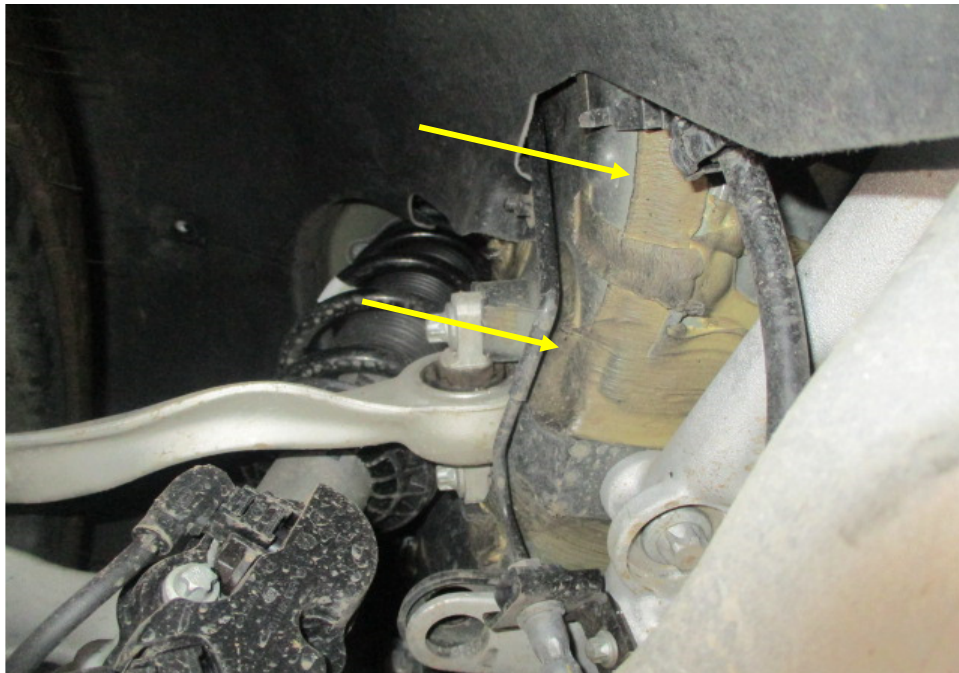
**Photo 32** shows the chassis/structural body at the underside front left of the Motor Car. The original factory sealant (arrowed) at the joints along the chassis/structural body was observed to be untouched. In general, I had found no work was carried out on the chassis/structural body of the Motor Car. The chassis/structural body of the Motor Car was originally fitted.

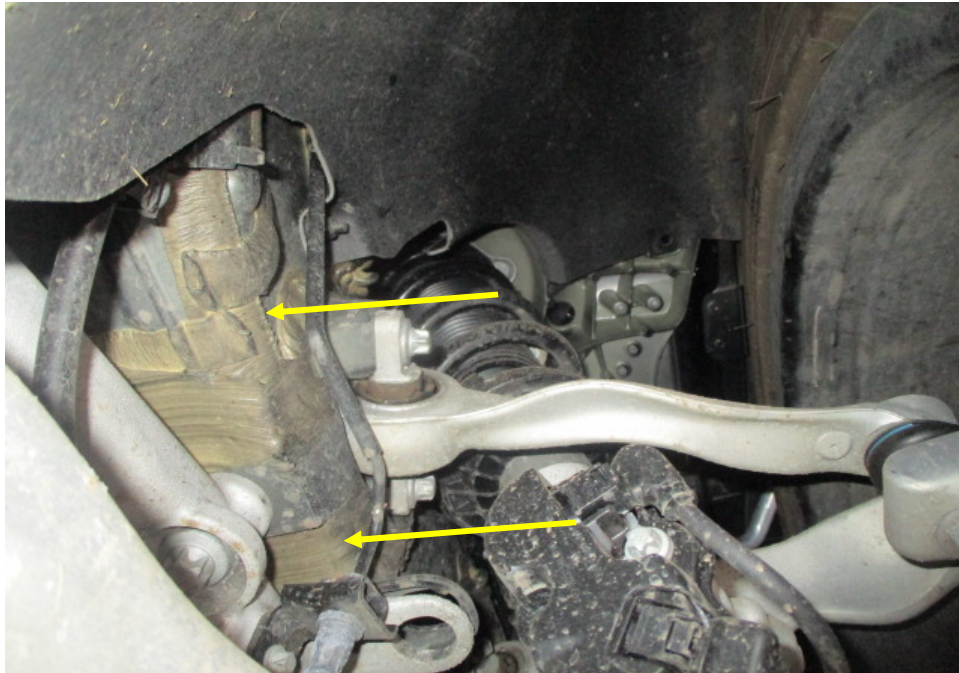
**Photo 33** shows the chassis/structural body at the underside front right of the Motor Car. I did not find any weld marks other than original spot weld marks on the chassis/structural body of the Motor Car. The original factory sealant (arrowed) at the joints along the chassis/structural body was also untouched, indicating no work was done on the chassis/structural body of the Motor Car and that the chassis/structural body was originally fitted.

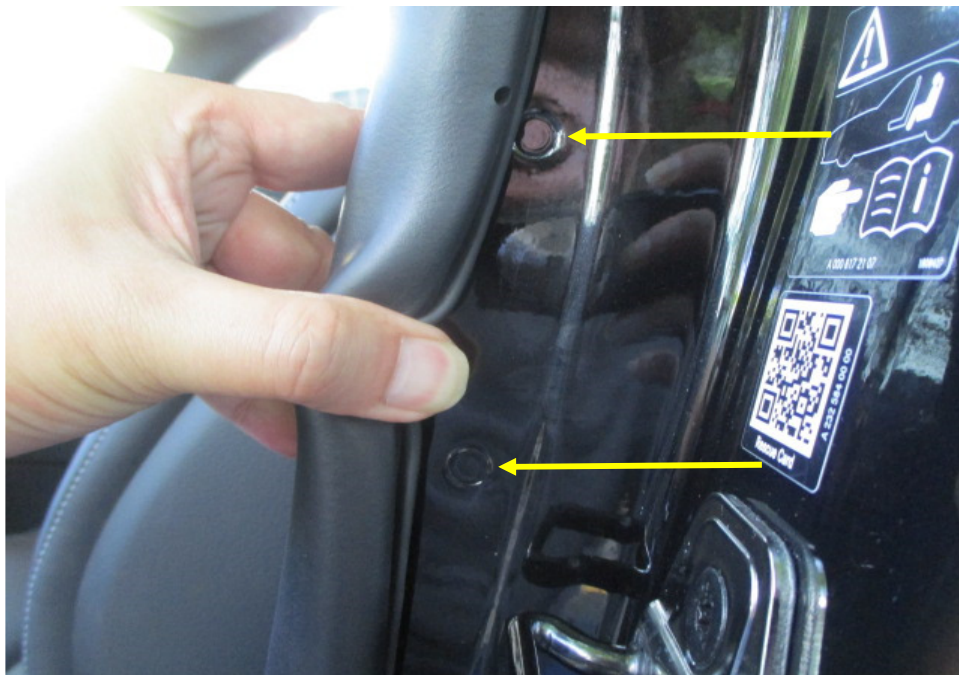
**Photo 34** shows the left side rear body panel of the Motor Car. I did not find any weld marks other than original spot weld marks (arrowed) on the left side rear body panel of the Motor Car, which indicates that there was no re-welding works carried out. In general, I had found all the non-detachable body panels of the Motor Car to be originally fitted at the time of my inspection.

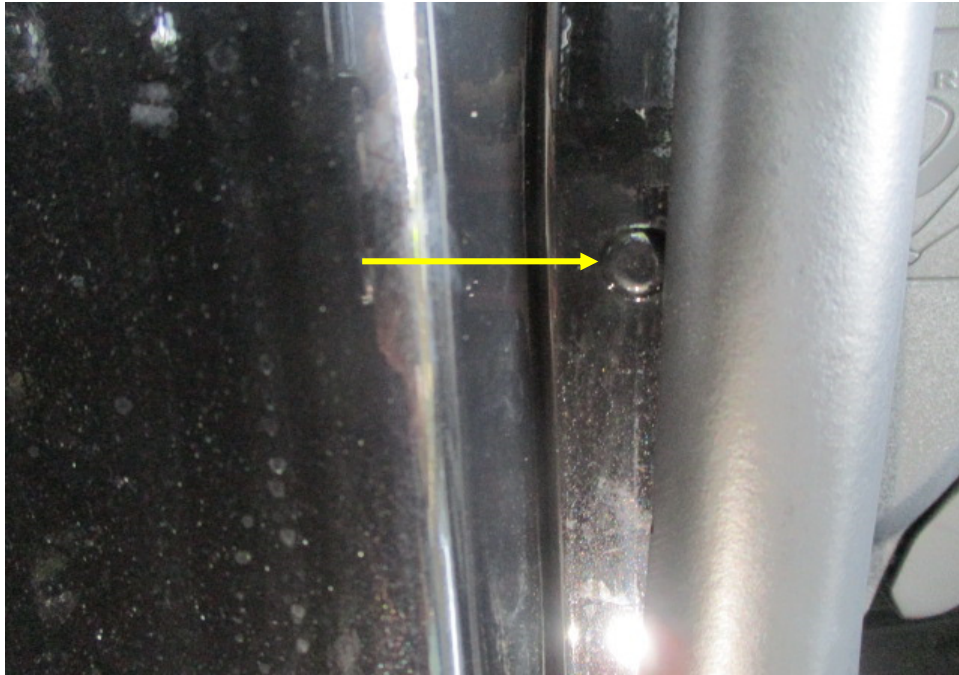
**Photo 35** shows the left side "A" pillar of the Motor Car. I did not find any weld marks other than original spot weld marks (arrowed) on the left side "A" pillar of the Motor Car, which indicates that there was no re-welding works carried out. In general, I had found all the non-detachable body panels of the Motor Car to be originally fitted at the time of my inspection.

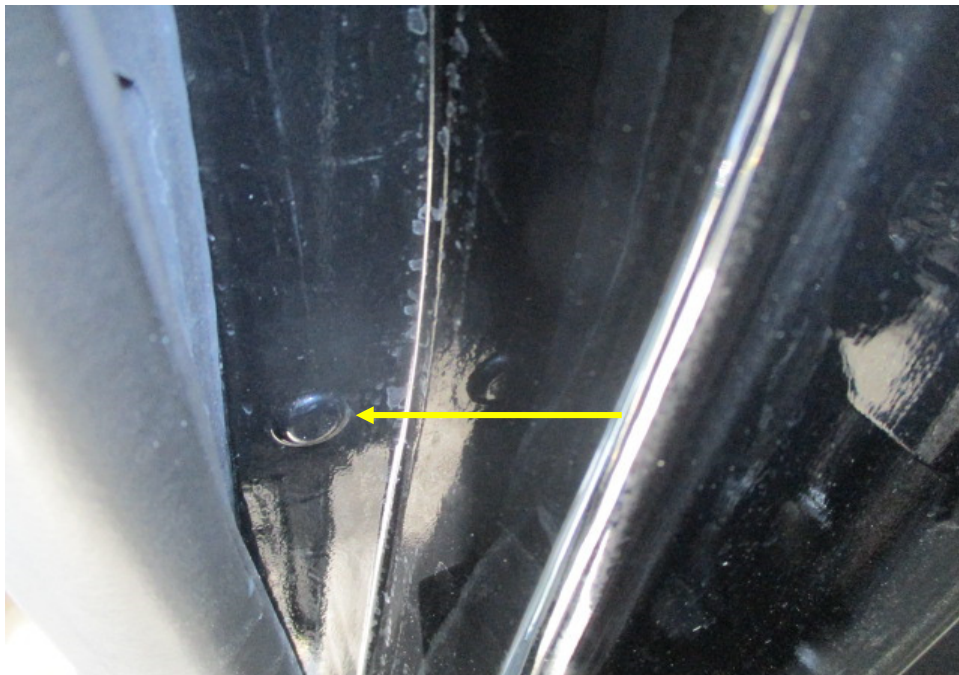
**Photo 36** shows the right side "A" pillar of the Motor Car. I did not find any weld marks other than original spot weld marks (arrowed) on the right side "A" pillar of the Motor Car, which indicates that there was no re-welding works carried out. In general, I had found all the non-detachable body panels of the Motor Car to be originally fitted at the time of my inspection.

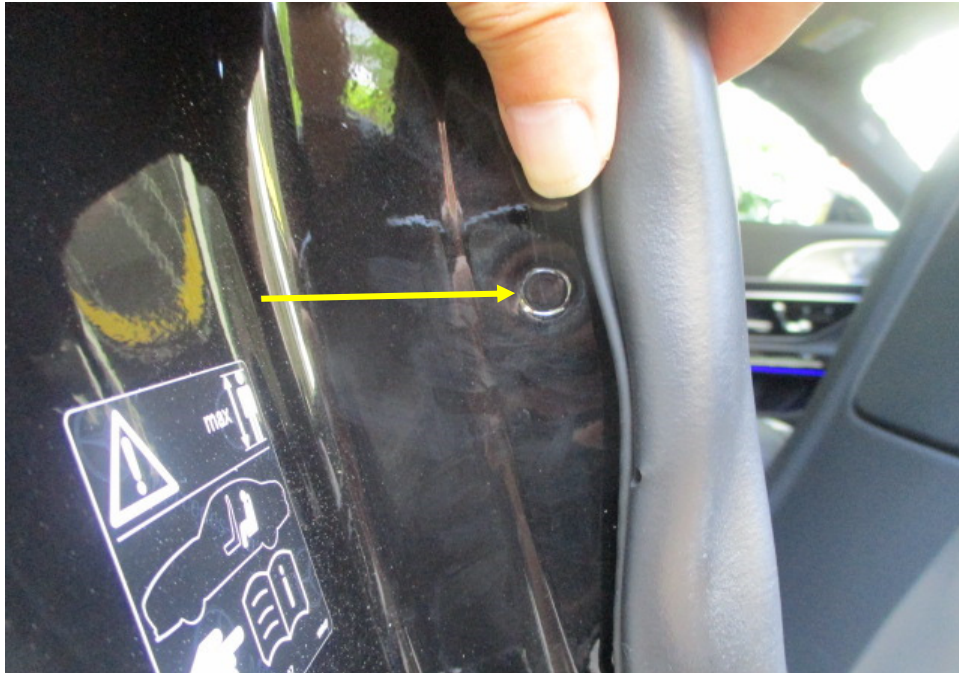
**Photo 37** shows the right side rear body panel of the Motor Car. I did not find any weld marks other than original spot weld marks (arrowed) on the right side rear body panel of the Motor Car, which indicates that there was no re-welding works carried out. In general, I had found all the non-detachable body panels of the Motor Car to be originally fitted at the time of my inspection.
