Your Ref: SJA 666E  
Our Ref : CI/TP23006161/D

19 June 2023

## **AUTOMOBILE INSPECTION REPORT OF MOTOR CAR SJA 666E**

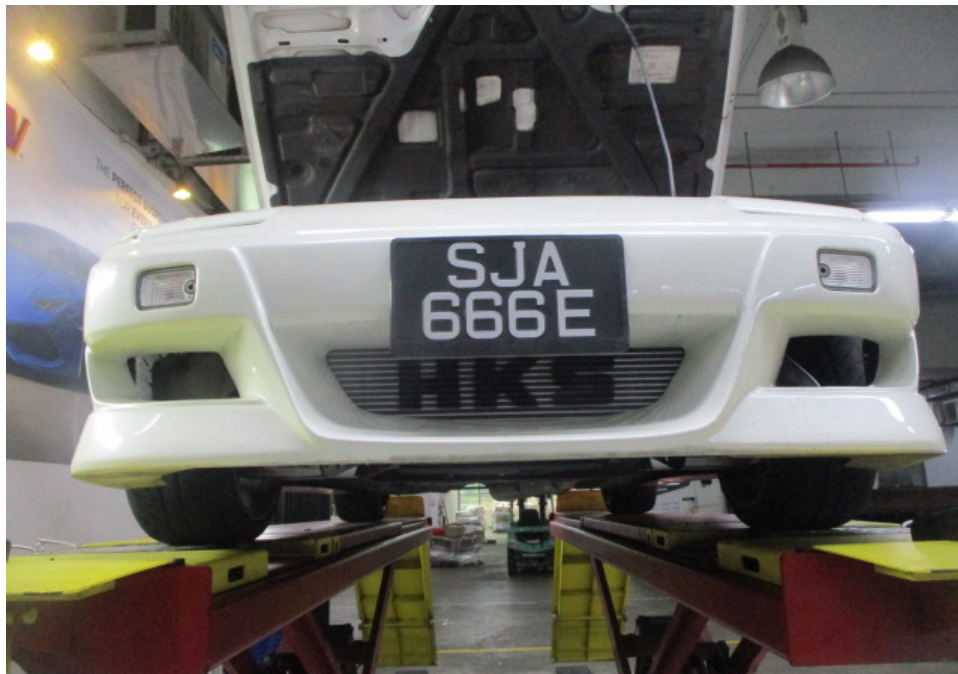
**Photo 1** shows the Motor Car hoisted up for checks on its undercarriage, in particular to its transmission assembly.

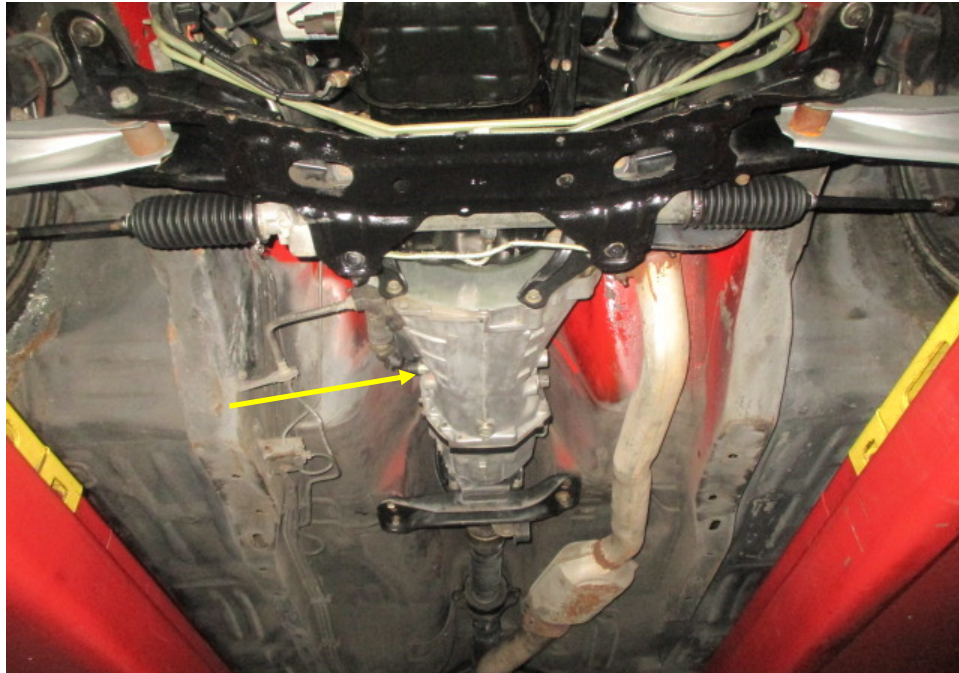
**Photo 2** shows a general view of the transmission assembly (arrowed) that was fitted on the Motor Car, as viewed from the front to rear. The front (input) side of the transmission assembly is bolted to the crankshaft side of the engine block while the rear (output) side of the transmission assembly, connects to the propeller shaft, which links to the differential at the rear axle of the Motor Car.

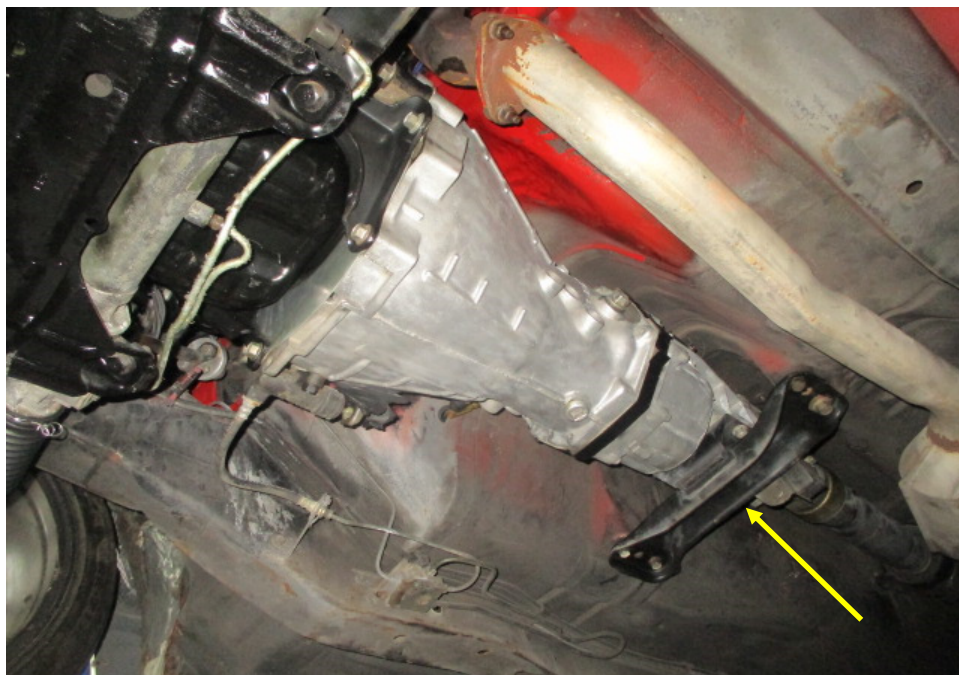
**Photo 3** shows a general view of the bracket (arrowed) that was mounted to the underside of the Motor Car's floorboard, via bolts and nuts. The bracket supports the rear (output) side of the transmission assembly.

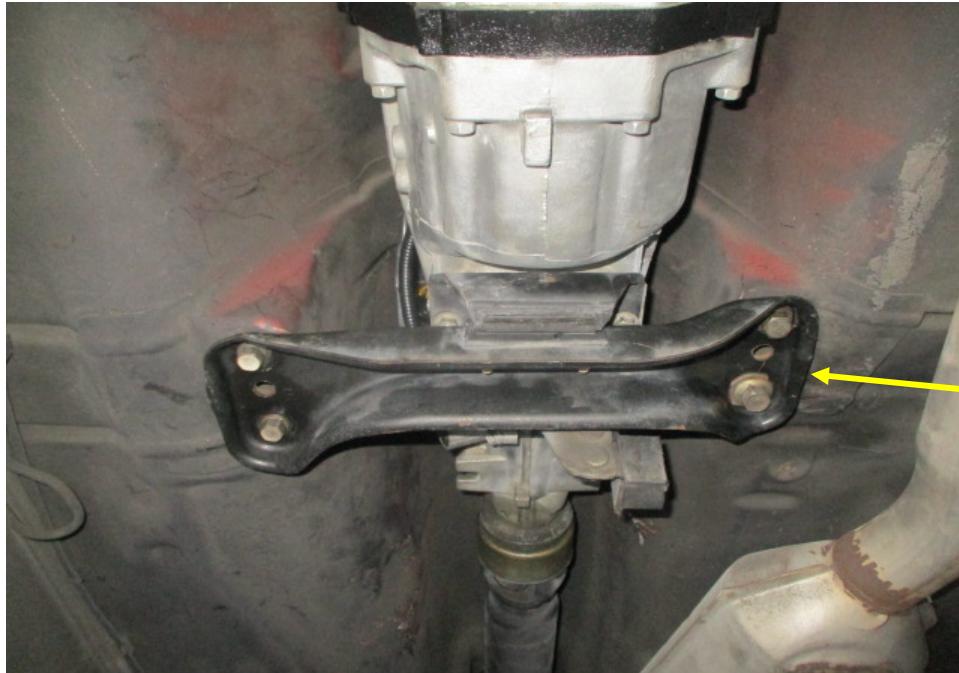
**Photo 4** shows a closer view of the bracket (arrowed) that was mounted to the underside of the Motor Car's floorboard, via bolts and nuts. The bracket supports the rear (output) side of the transmission assembly. The bracket was also with rubber bushings that absorbs any vibrations arising from the rotation of the transmission gears, minimising any stress to the bracket.

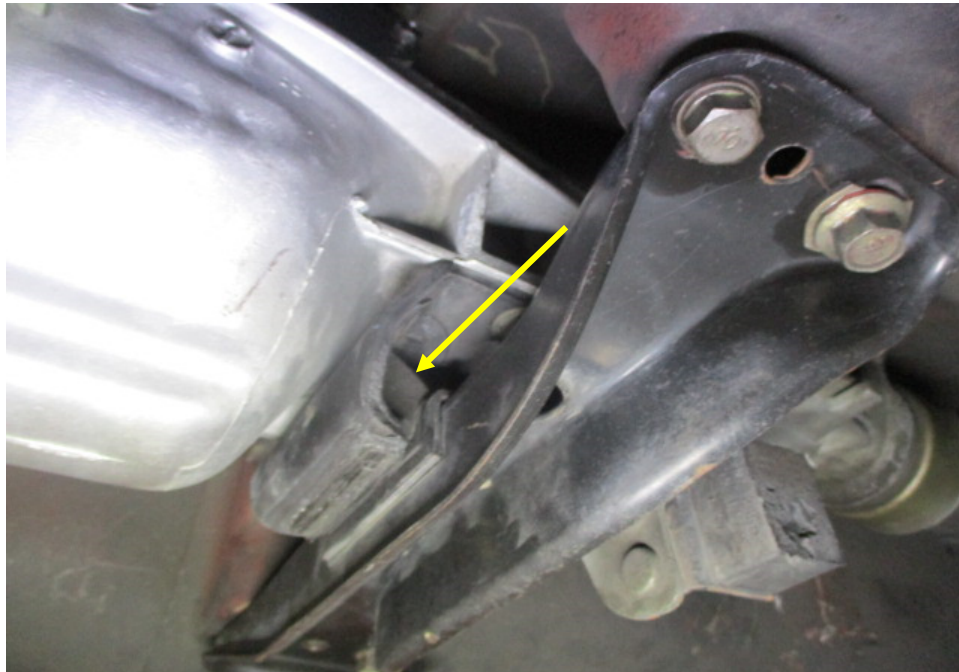
**Photo 5** shows the rubber bushing (arrowed), sitting between the transmission assembly and the bracket (front to rear view). The rubber bushing absorbs any vibrations arising from the rotation of the transmission gears, minimising any stress to the bracket.

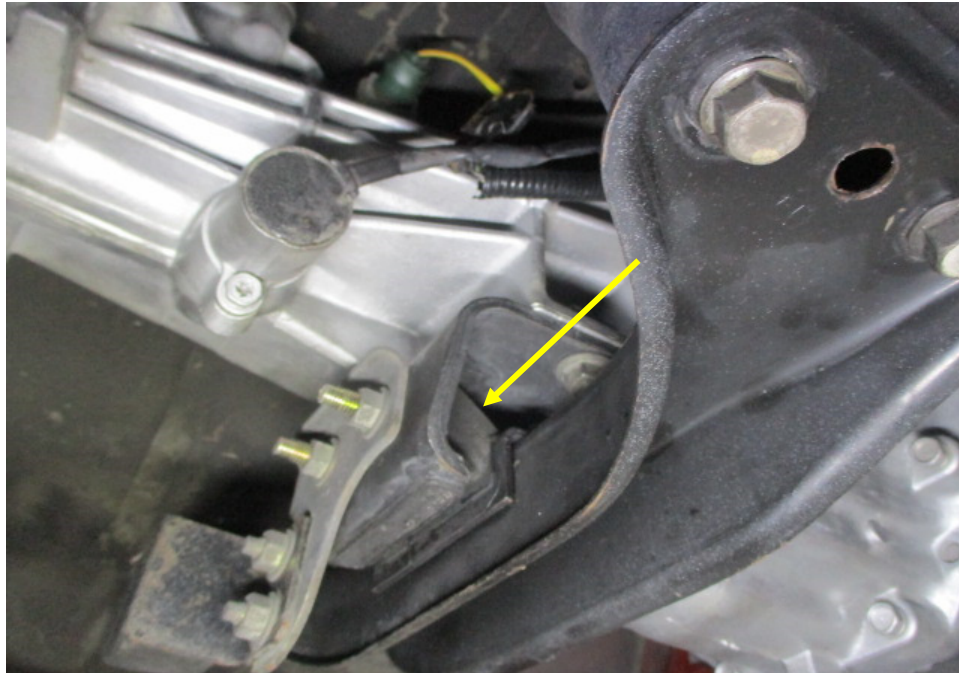
**Photo 6** shows another view of the rubber bushing (arrowed), sitting between the transmission assembly and the bracket (rear to front view). The rubber bushing absorbs any vibrations arising from the rotation of the transmission gears, minimising any stress to the bracket.

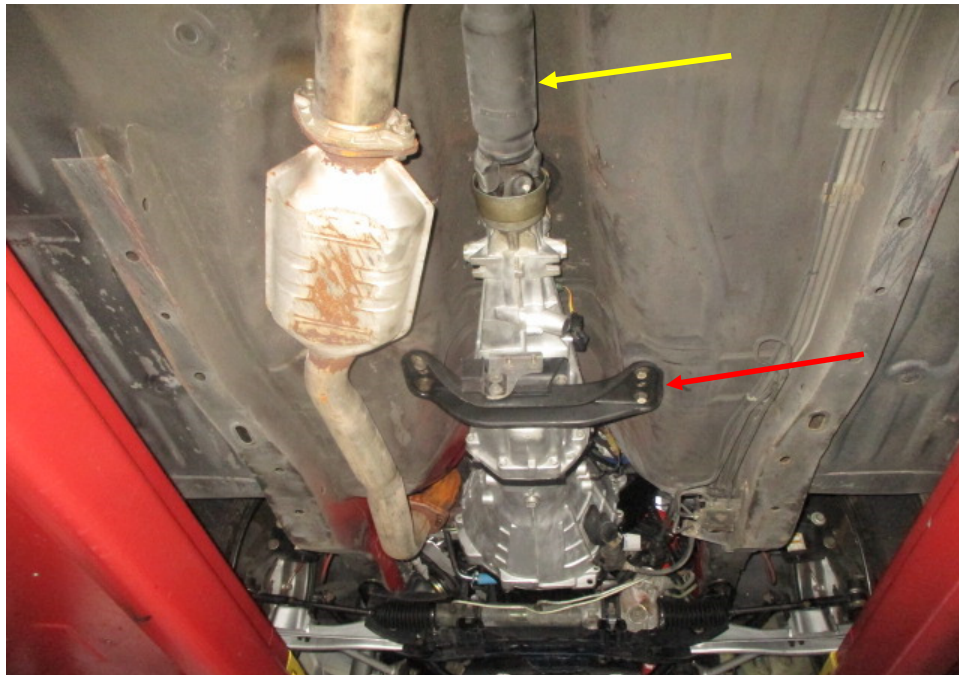
**Photo 7** shows a general view of the transmission assembly that was fitted on the Motor Car, as viewed from the rear to front. The transmission assembly is supported by a bracket (red arrow) that is mounted to the underside of the Motor Car's floorboard, via bolts and nuts. The front (input) side of the transmission assembly is bolted to the crankshaft side of the engine block while the rear (output) side of the transmission assembly, connects to the propeller shaft (yellow arrow), which links to the differential at the rear axle of the Motor Car.

10. In general, the transmission assembly of the Motor Car was found to be secured properly. It was not mounted onto the chassis body or any integral body part of the Motor Car. The structural integrity of the Motor Car is not compromised by the fitment of this particular transmission assembly. Overall, the operating condition of the Motor Car's transmission system was satisfactory throughout the Motor Car's test drive.

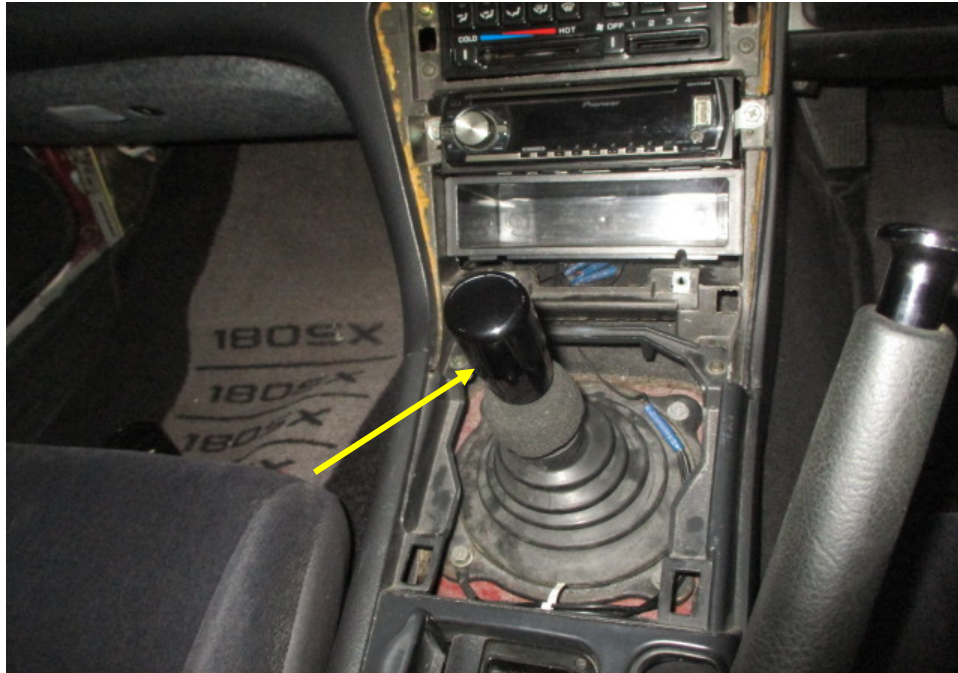
**Photo 8** shows the manual gear shifter (arrowed) for manually selecting the transmission gear to be engaged.

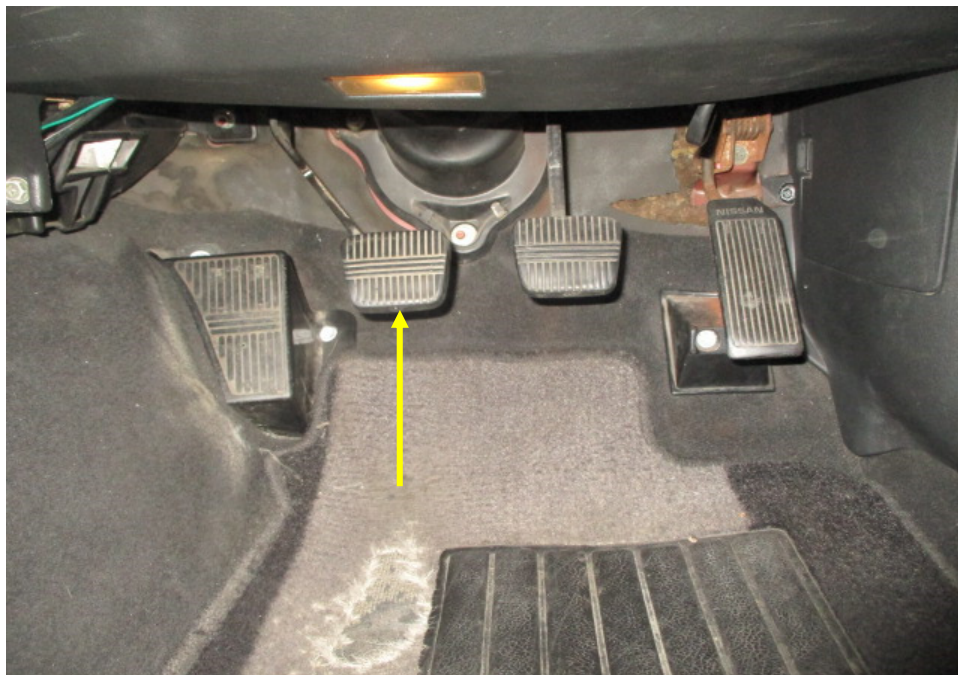
**Photo 9** shows the clutch pedal (arrowed) for engaging and disengaging the transmission gears.
