Your Ref: SFV 6969D
Our Ref : CI/TP23006162/D

AUTOMOBILE INSPECTION REPORT OF MOTOR CAR SFV 6969D

Vehicle Registration No.	: SFV 6969D
Make / Model	: Toyota ALTEZZA 2.0A
Chassis No	: SXE100052997
Year of Registration	: 2005 (May)
Mileage	: 201,448km

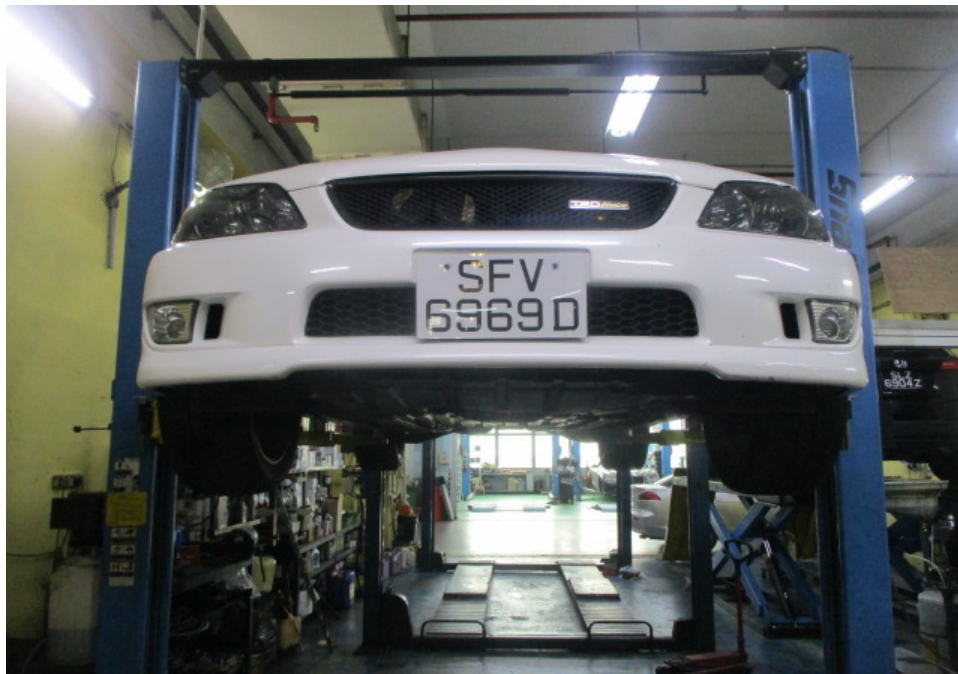
Photo 1 shows the Motor Car hoisted up for checks on its undercarriage, in particular to its transmission assembly.

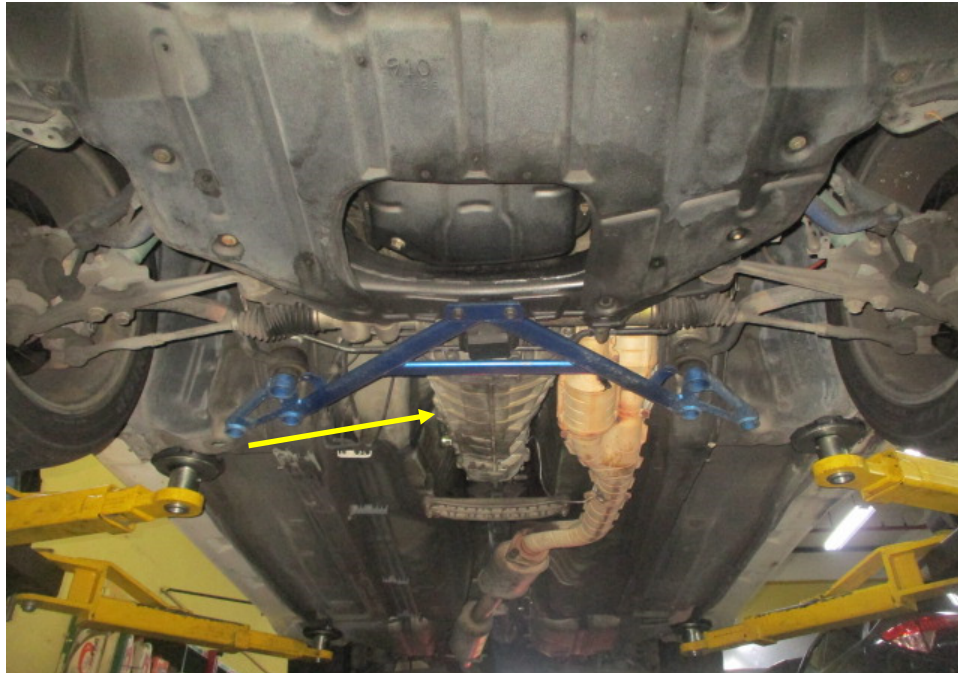
Photo 2 shows a general view of the transmission assembly (arrowed) that was fitted on the Motor Car, as viewed from the front to rear. The front (input) side of the transmission assembly is bolted to the crankshaft side of the engine block while the rear (output) side of the transmission assembly, connects to the propeller shaft, which links to the differential at the rear axle of the Motor Car.

10. In general, the transmission assembly of the Motor Car was found to be secured properly. It was not mounted onto the chassis body or any integral body part of the Motor Car. The structural integrity of the Motor Car is not compromised by the fitment of this particular transmission assembly. Overall, the operating condition of the Motor Car's transmission system was satisfactory throughout the Motor Car's test drive.

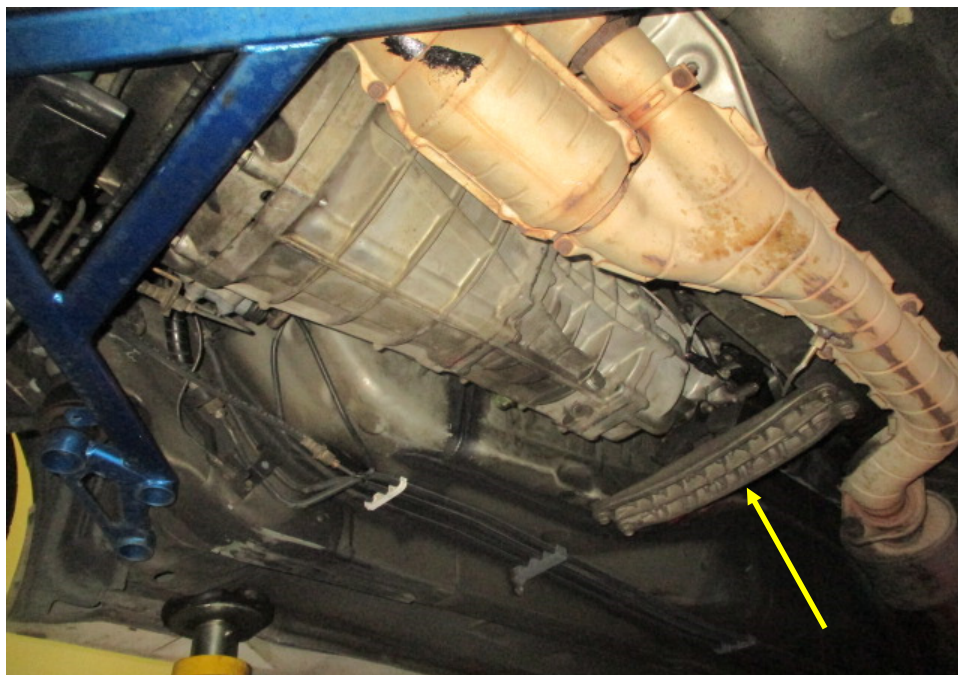
Photo 3 shows a general view of the bracket (arrowed) that was mounted to the underside of the Motor Car's floorboard, via bolts and nuts. The bracket supports the rear (output) side of the transmission assembly.

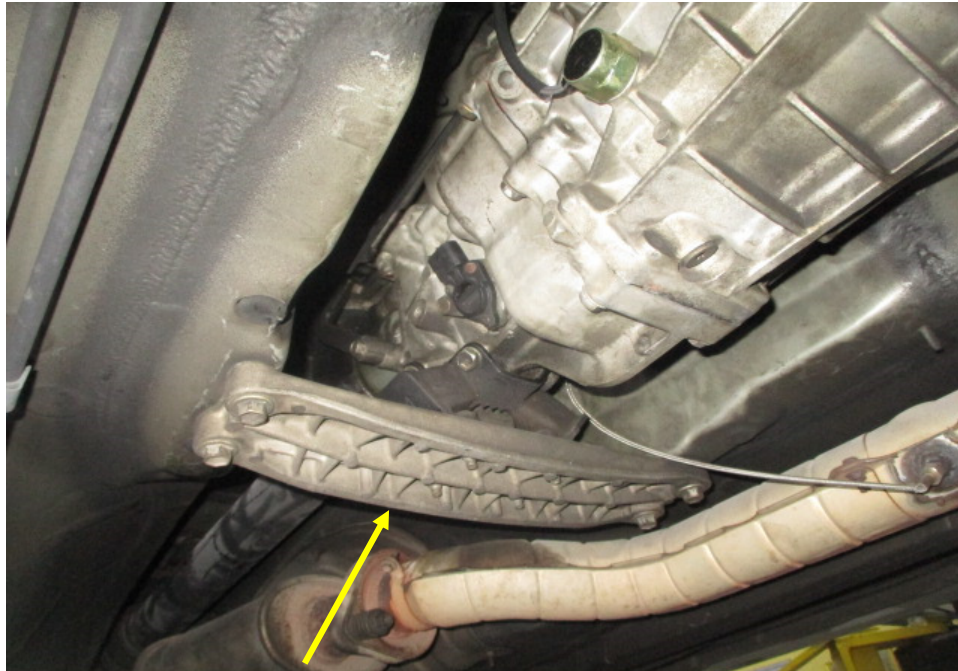
Photo 4 shows a closer view of the bracket (arrowed) that was mounted to the underside of the Motor Car's floorboard, via bolts and nuts. The bracket supports the rear (output) side of the transmission assembly. The bracket was also with rubber bushings that absorbs any vibrations arising from the rotation of the transmission gears, minimising any stress to the bracket.

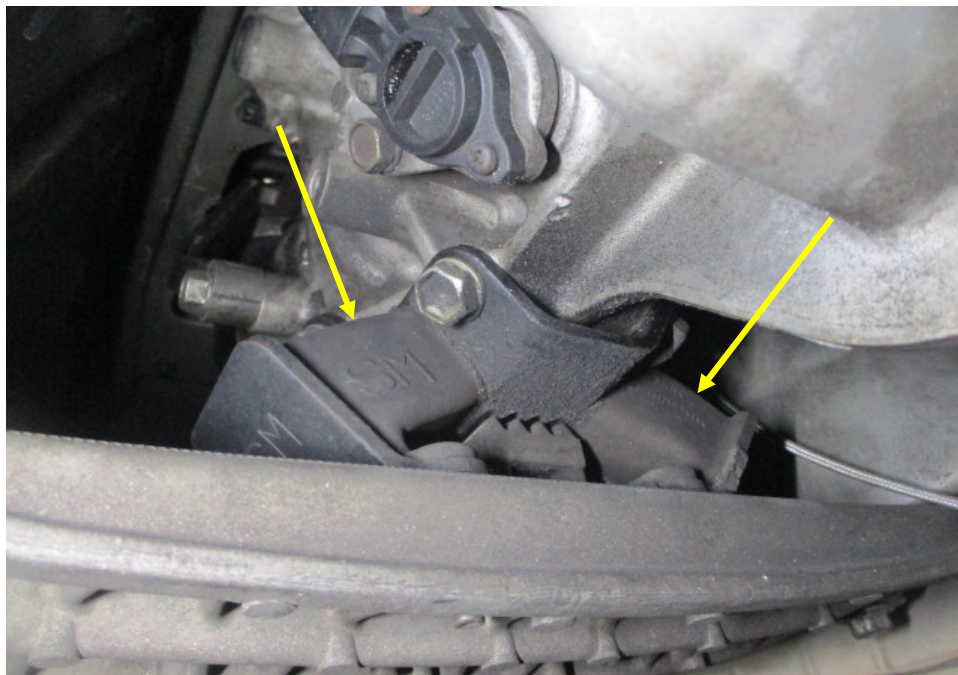
Photo 5 shows the rubber bushing (arrowed), sitting between the transmission assembly and the bracket (front to rear view). The rubber bushing absorbs any vibrations arising from the rotation of the transmission gears, minimising any stress to the bracket.

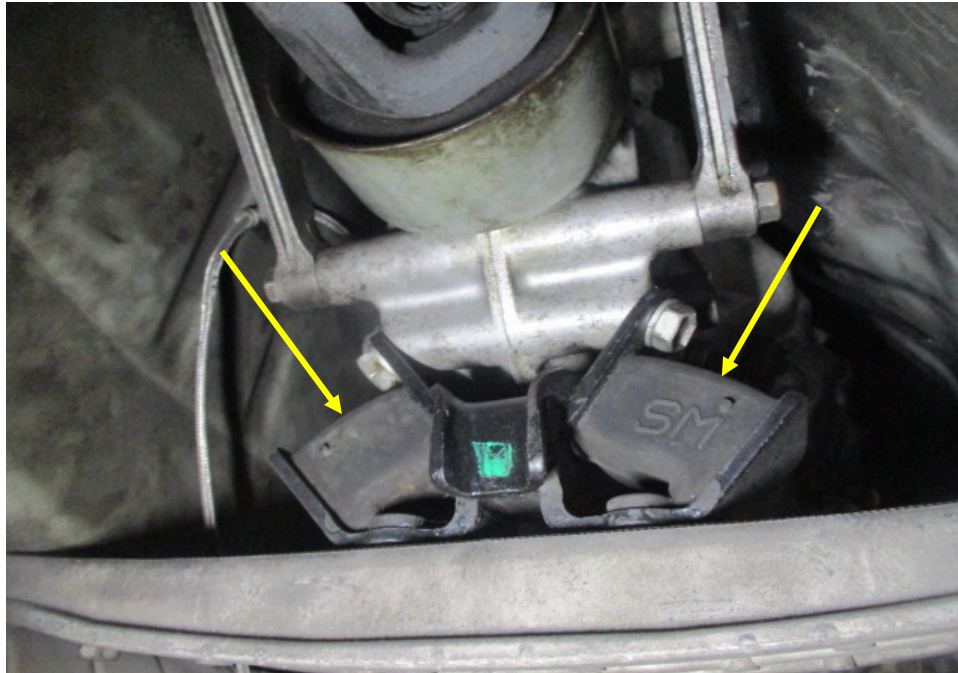
Photo 6 shows another view of the rubber bushing (arrowed), sitting between the transmission assembly and the bracket (rear to front view). The rubber bushing absorbs any vibrations arising from the rotation of the transmission gears, minimising any stress to the bracket.

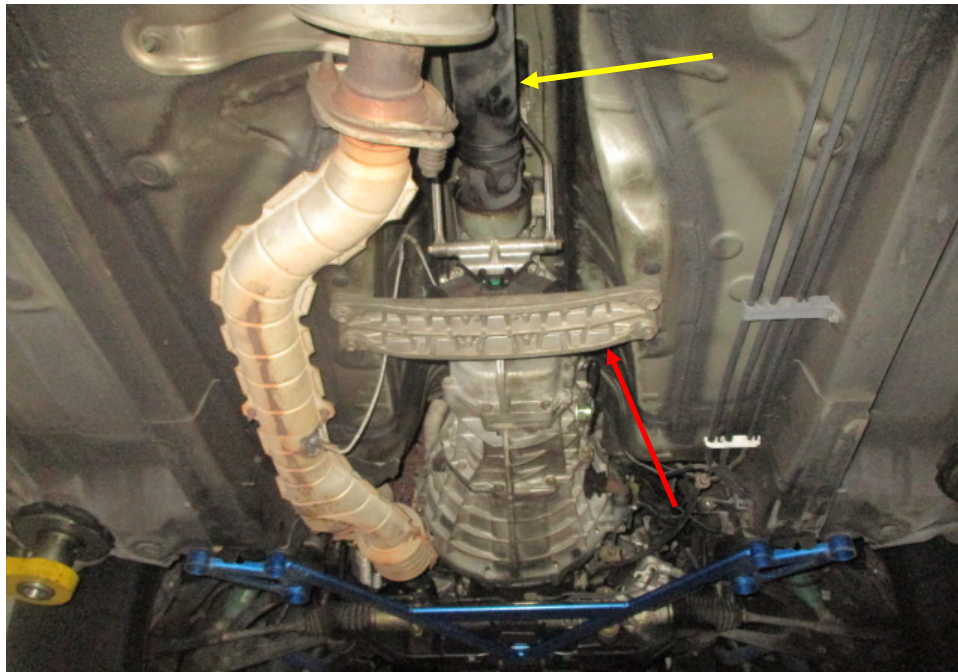
Photo 7 shows a general view of the transmission assembly that was fitted on the Motor Car, as viewed from the rear to front. The transmission assembly is supported by a bracket (red arrow) that is mounted to the underside of the Motor Car's floorboard, via bolts and nuts. The front (input) side of the transmission assembly is bolted to the crankshaft side of the engine block while the rear (output) side of the transmission assembly, connects to the propeller shaft (yellow arrow), which links to the differential at the rear axle of the Motor Car.

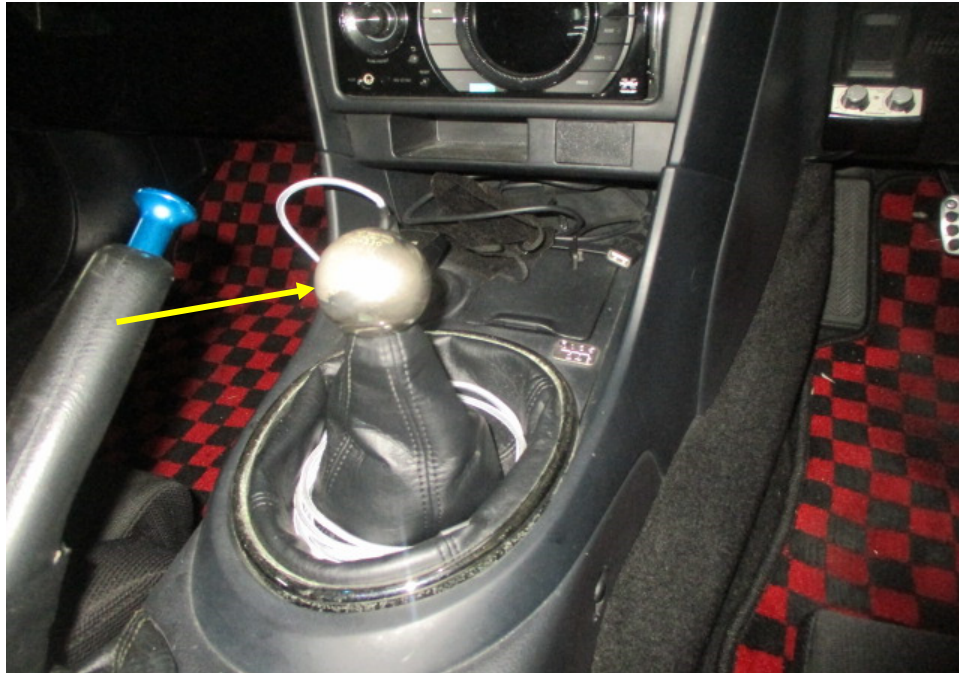
Photo 8 shows the manual gear shifter (arrowed) for manually selecting the transmission gear to be engaged.

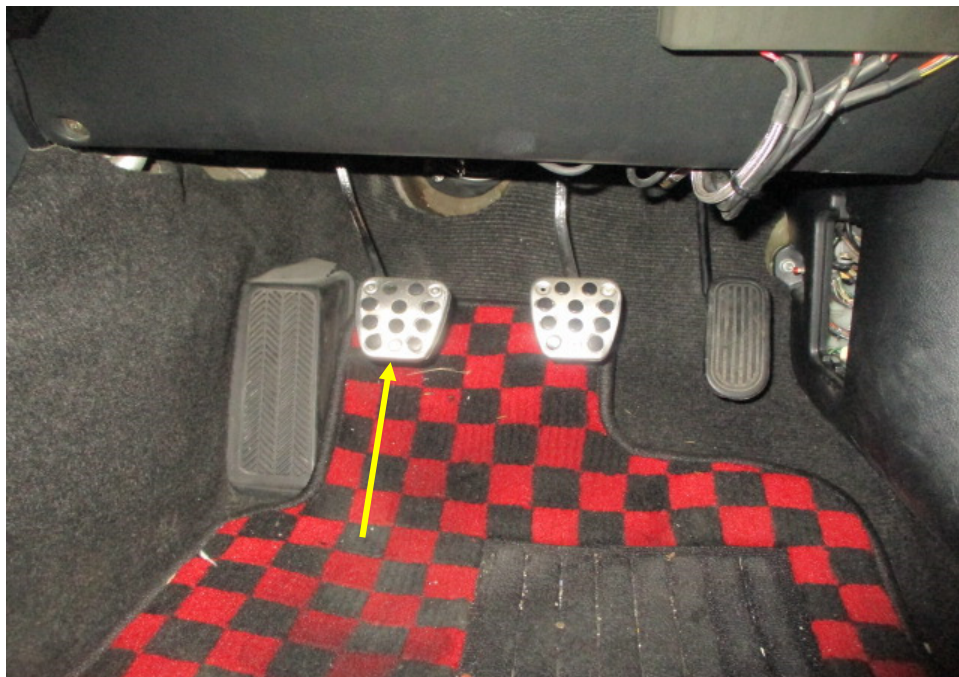
Photo 9 shows the clutch pedal (arrowed) for engaging and disengaging the transmission gears.
