Your Ref: Toyota Alphard  
(chassis number AYH300143734)  
Our Ref : CI/TP23006223/D

20 June 2023

### **INSPECTION REPORT OF AN UNREGISTERED TOYOTA ALPHARD MOTOR CAR WITH CHASSIS NUMBER AYH300143734**

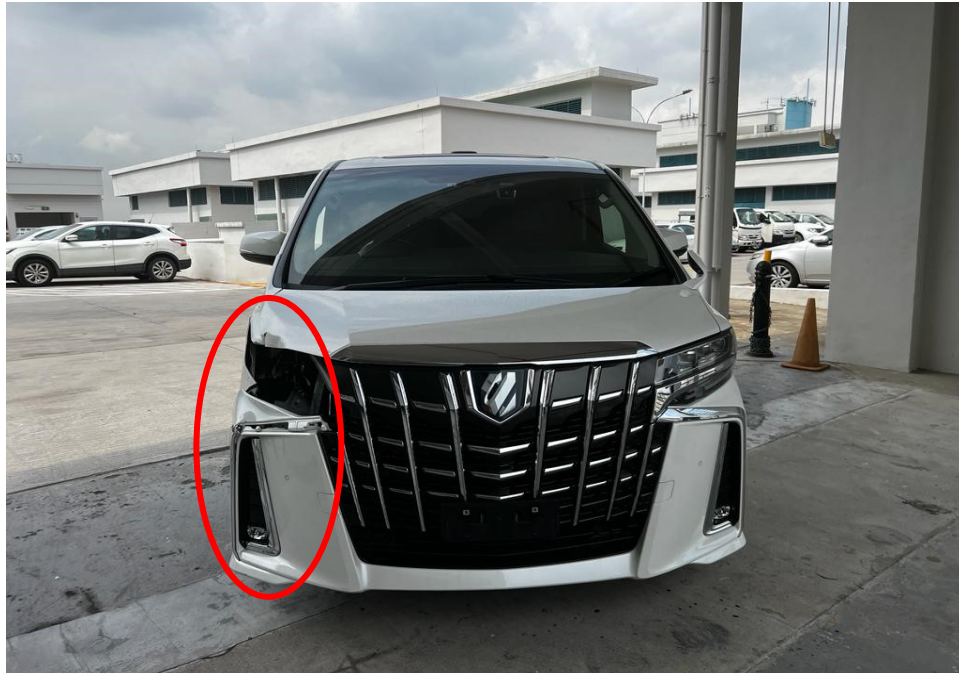
3. The photographs provided to me had showed damage to the front right portion of the Motor Car. Body parts damaged include the front bumper, front bumper right chrome moulding, front right fender and front bonnet amongst others. The front right headlamp and front right headlamp chrome moulding were also observed to be missing/dislodged/damaged.
4. No physical damage was observed to other areas of the Motor Car. The airbag(s) of the Motor Car was not deployed as seen from the photographs that were provided to me. See photo 1 – 5 below.

**Photo 1** shows the frontal body of the Motor Car (photograph provided to me). The Motor Car was observed to have sustained damage at its front right portion (circled). The front bumper, front bumper right chrome moulding and front bonnet were amongst the body parts that were observed to have been damaged. The front right headlamp and front right headlamp chrome moulding were also observed to be missing/dislodged/damaged.

22. The body parts at the front right portion of the Motor Car were visually examined and it was noted that the repair/restoration works carried out to the damaged area of the Motor Car (refer to photograph 1 & 2 above) were reasonably adequate and in order.

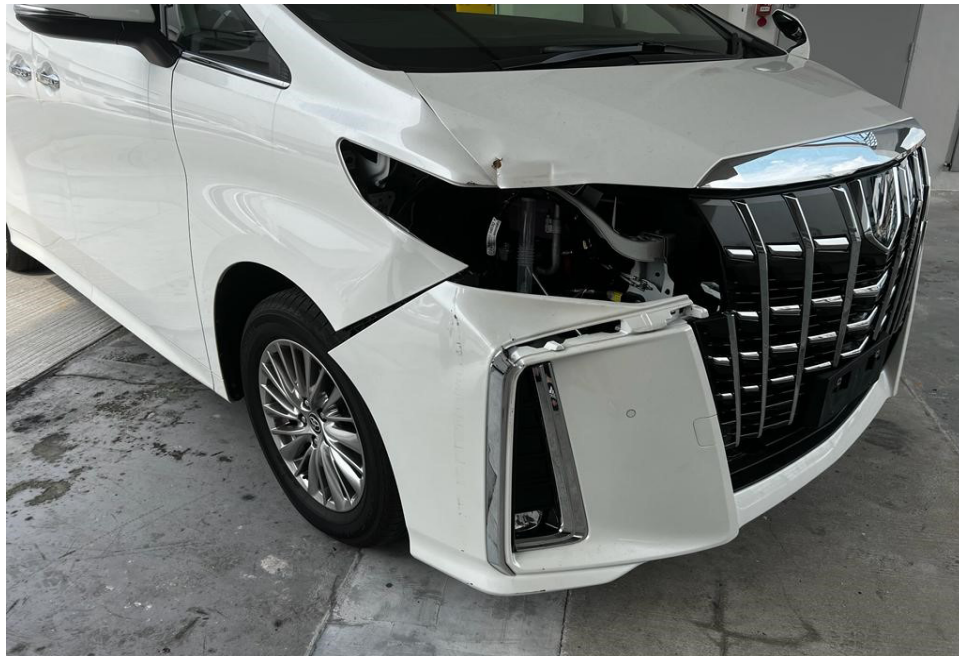
**Photo 2** shows another view of the damage at the front right portion of the Motor Car (photograph provided to me). The front bumper, front bumper right chrome moulding, front right fender and front bonnet were amongst the body parts that were observed to have been damaged. The front right headlamp and front right headlamp chrome moulding were observed to be missing/dislodged/damaged.

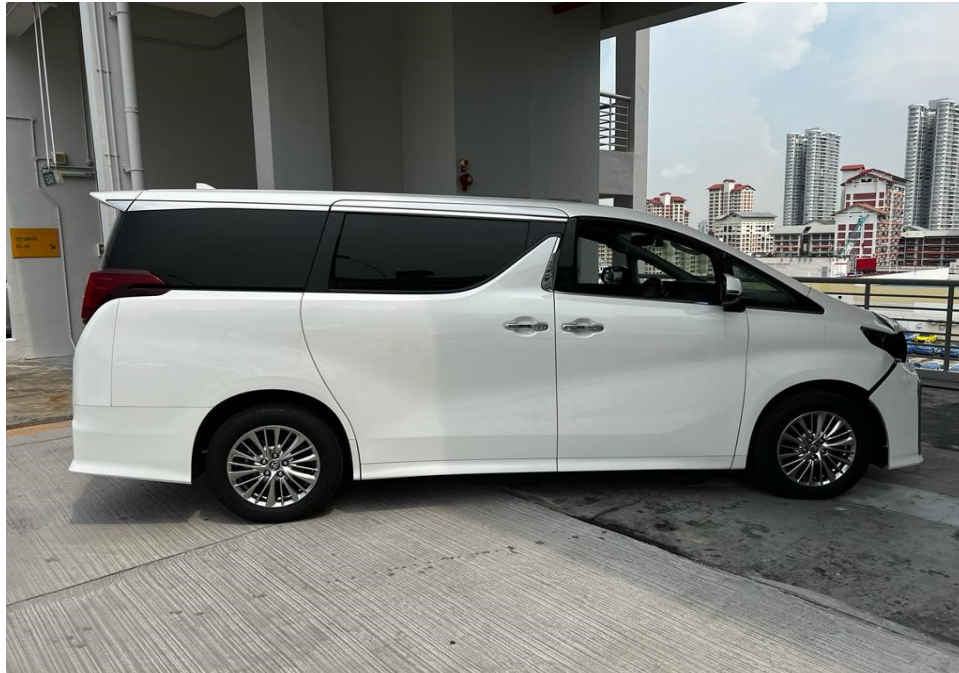
**Photo 3** shows the right side body of the Motor Car (photograph provided to me). Apart for the front right portion, the photographs provided to me did not show physical damage to other areas of the Motor Car. The Motor Car's airbag(s) was not deployed.

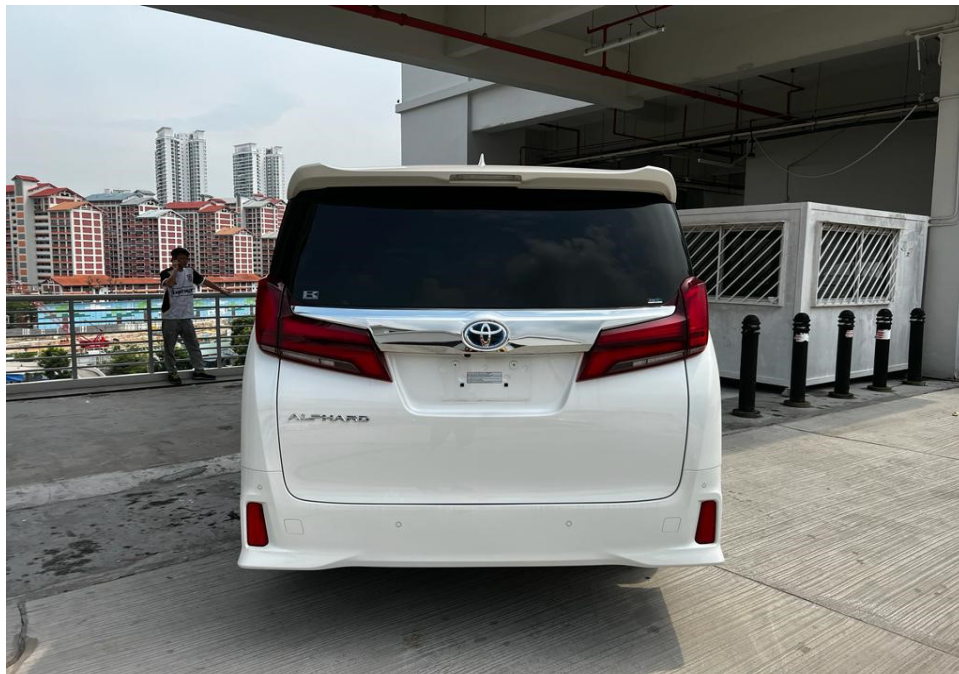
**Photo 4** shows the rear body of the Motor Car (photograph provided to me). Apart for the front right portion, the photographs provided to me did not show physical damage to other areas of the Motor Car.

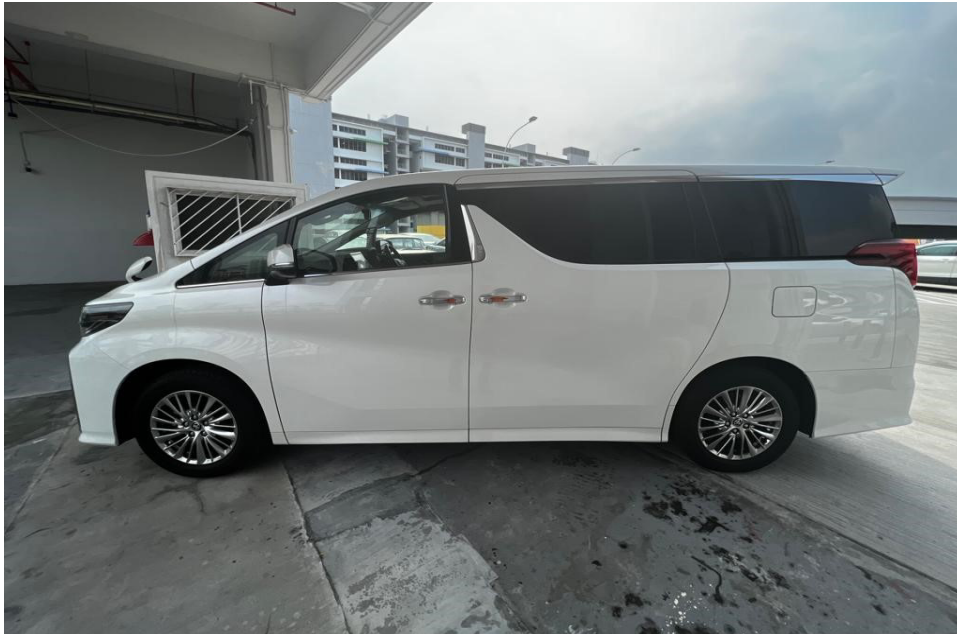
**Photo 5** shows the left side body of the Motor Car (photograph provided to me). Apart for the front right portion, the photographs provided to me did not show physical damage to other areas of the Motor Car. The Motor Car's airbag(s) was not deployed.

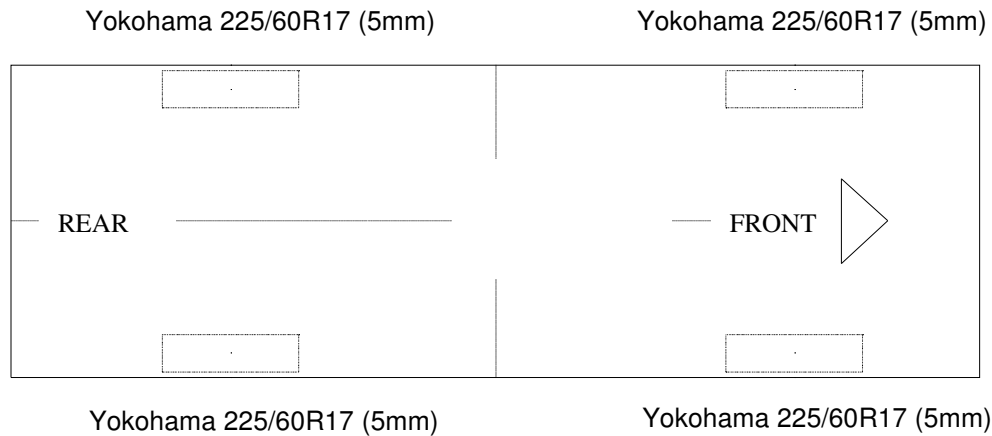
8. It was fitted with 17inch sport wheel rims that were wrapped with tyres that were observed to be of serviceable condition. The tyres were also sufficiently inflated for vehicular operation. The tyre brand, tyre size and approximate remaining tread depth of the 4 tyres of the Motor Car were recorded as follows: -

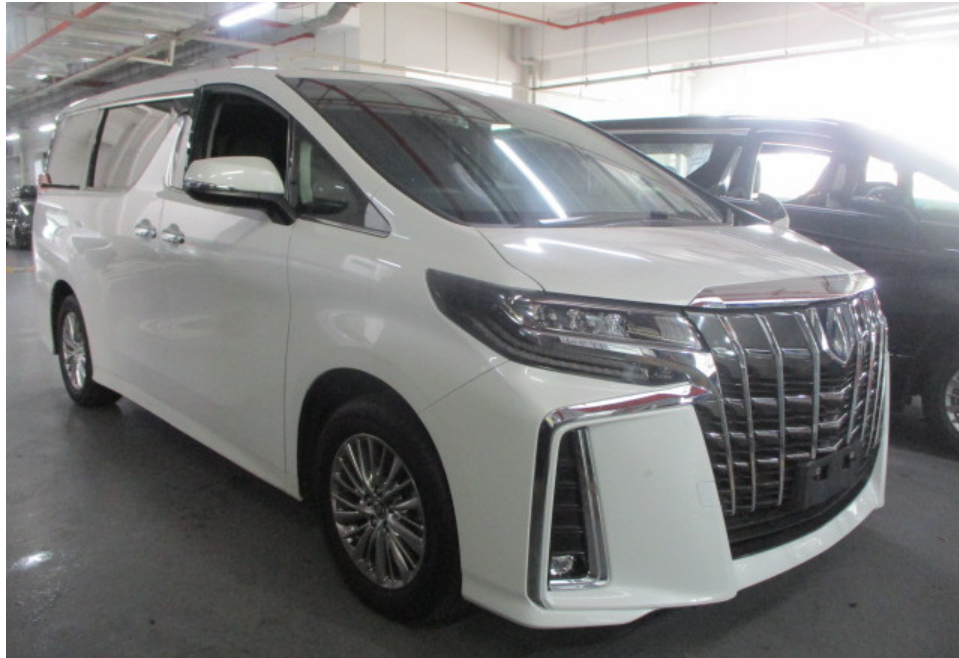
**Photo 6** shows a general view of the front right body of the Motor Car at the time of my inspection. The Motor Car was observed to be in a relatively good general condition with no loose exterior fittings observed. The body parts at the front right portion of the Motor Car were visually examined and it was observed that the repair/restoration works carried out to the damaged area of the Motor Car (refer to photograph 1 & 2 above) were reasonably adequate and in order.

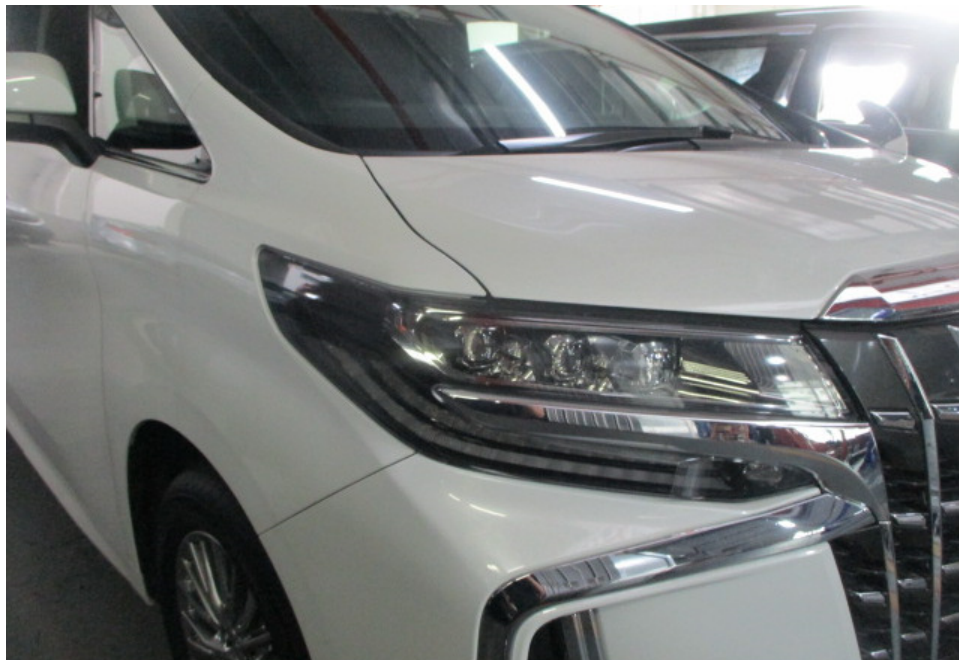
**Photo 7** shows a closer view of the Motor Car's front right fender, front right headlamp, front right headlamp chrome moulding and front bonnet. The body parts at the front right portion of the Motor Car were visually examined and it was observed that the repair/restoration works carried out to the damaged area of the Motor Car (refer to photograph 1 & 2 above) were reasonably adequate and in order.

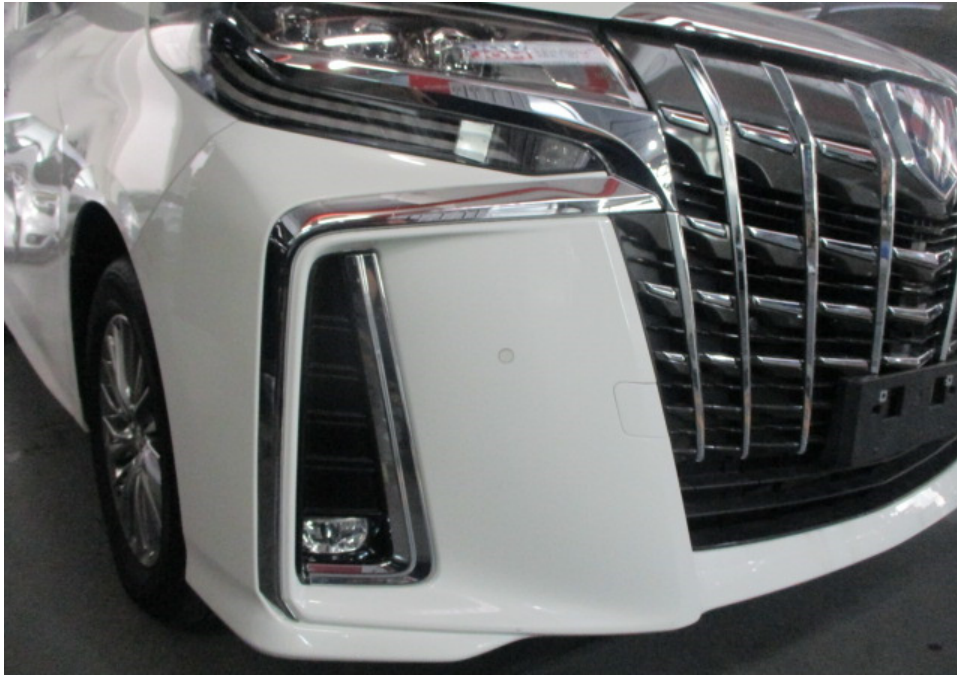
**Photo 8** shows a closer view of the Motor Car's front bumper, front bumper right chrome moulding, front right fog lamp, front right headlamp and front right headlamp chrome moulding. The body parts at the front right portion of the Motor Car were visually examined and it was observed that the repair/restoration works carried out to the damaged area of the Motor Car (refer to photograph 1 & 2 above) were reasonably adequate and in order.

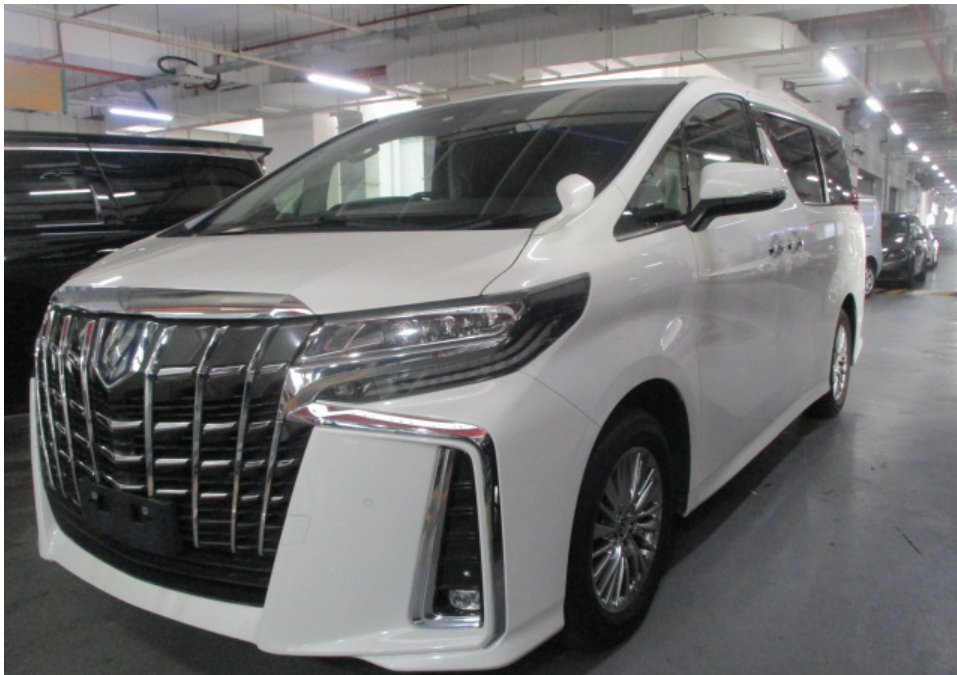
**Photo 9** shows a general view of the front left body of the Motor Car at the time of my inspection. The Motor Car was observed to be in a relatively good general condition with no loose exterior fittings observed. The mileage of the Motor Car recorded at the time of my inspection was 9,507km.

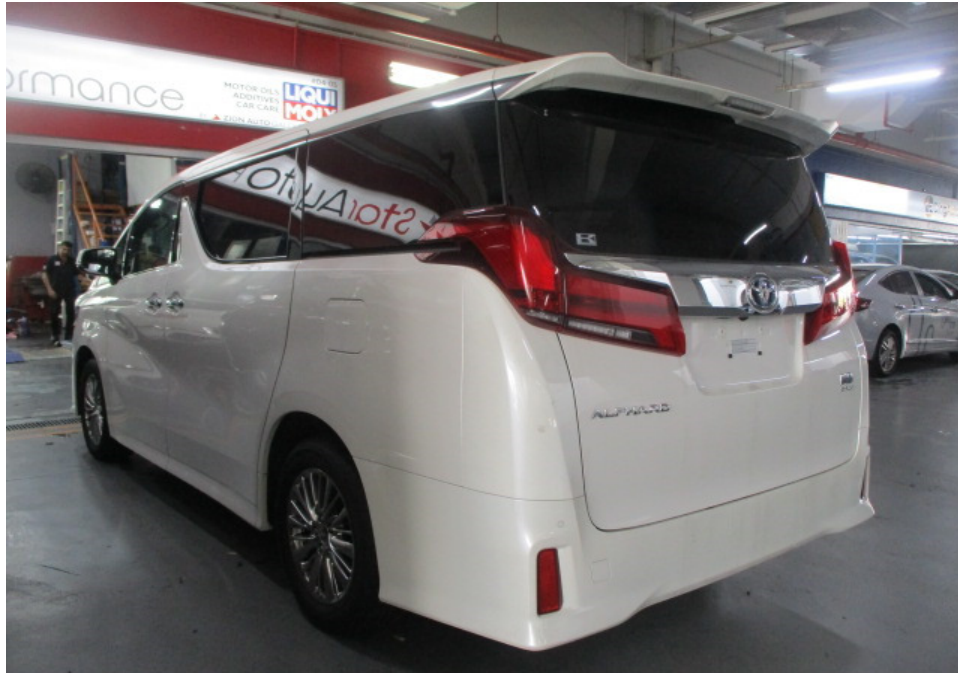
**Photo 10** shows a general view of the rear left body of the Motor Car at the time of my inspection. The Motor Car was observed to be in a relatively good general condition with no loose exterior fittings observed. The mileage of the Motor Car recorded at the time of my inspection was 9,507km.

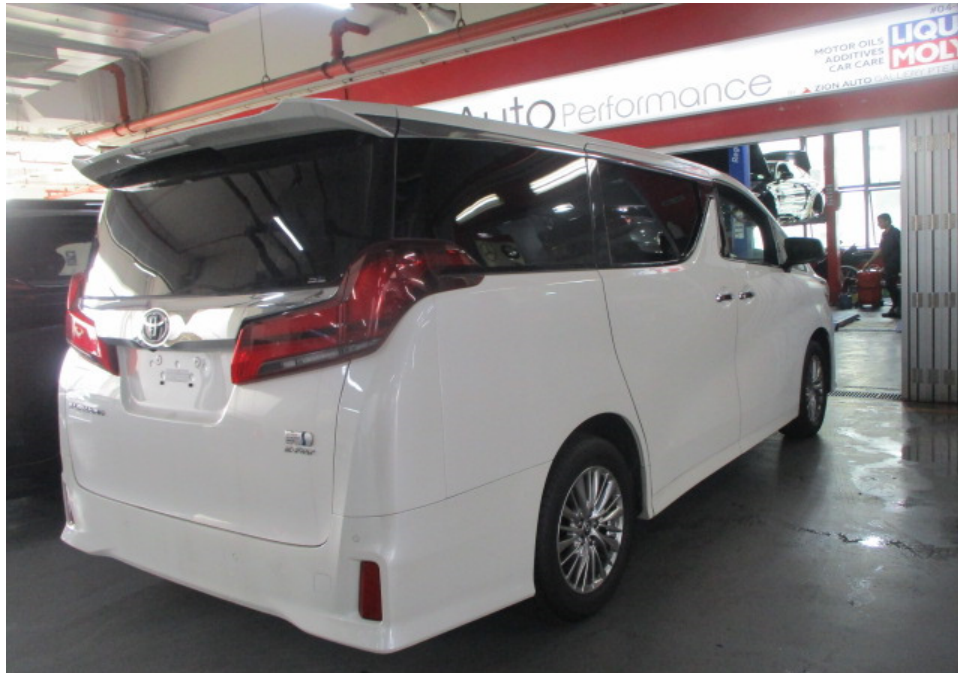
**Photo 11** shows a general view of the rear right body of the Motor Car at the time of my inspection. The Motor Car was observed to be in a relatively good general condition with no loose exterior fittings observed. The mileage of the Motor Car recorded at the time of my inspection was 9,507km.

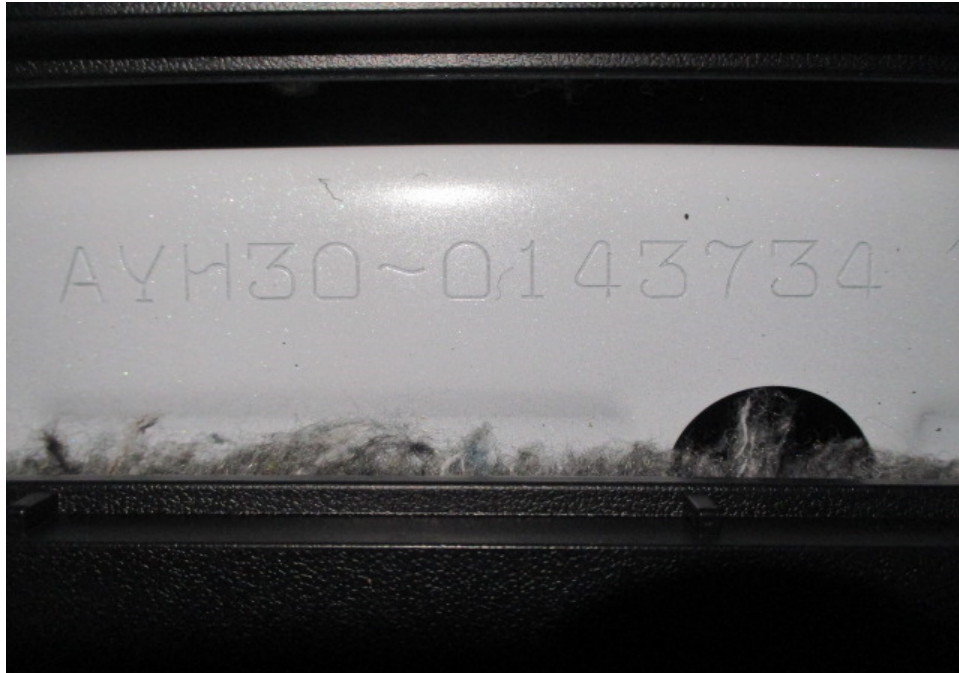
**Photo 12** shows the chassis number of the Motor Car. The chassis number recorded was AYH300143734.

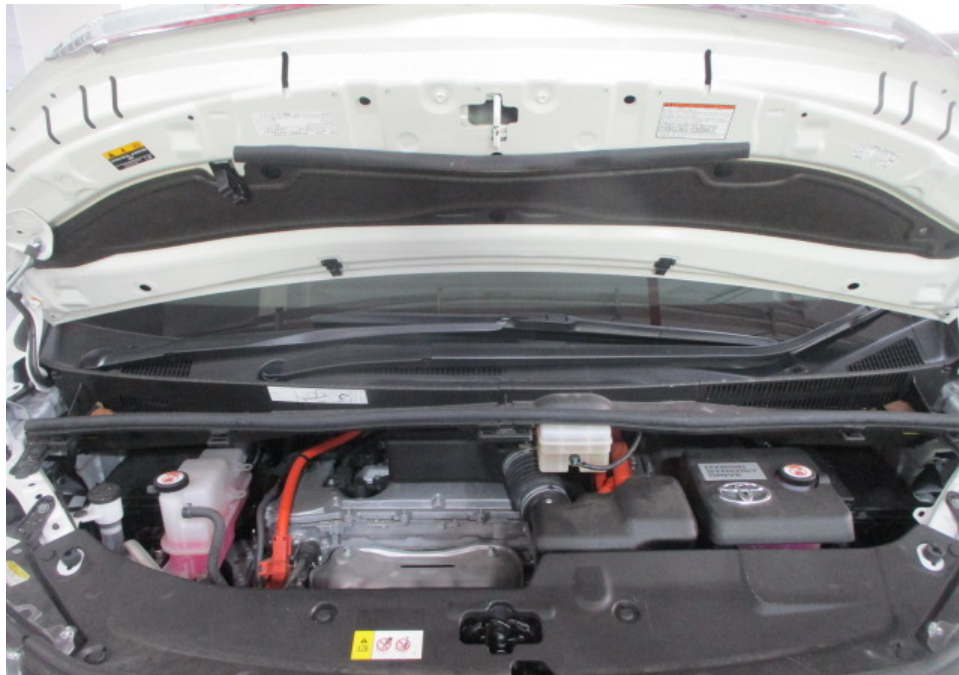
**Photo 13** shows a general view of the engine compartment of the Motor Car at the time of my inspection. The various parts and components inside the engine compartment were all observed to be intact and properly fitted. There was also no sign(s) or indication(s) of fluid leak and/or fluid stain found inside the engine compartment.

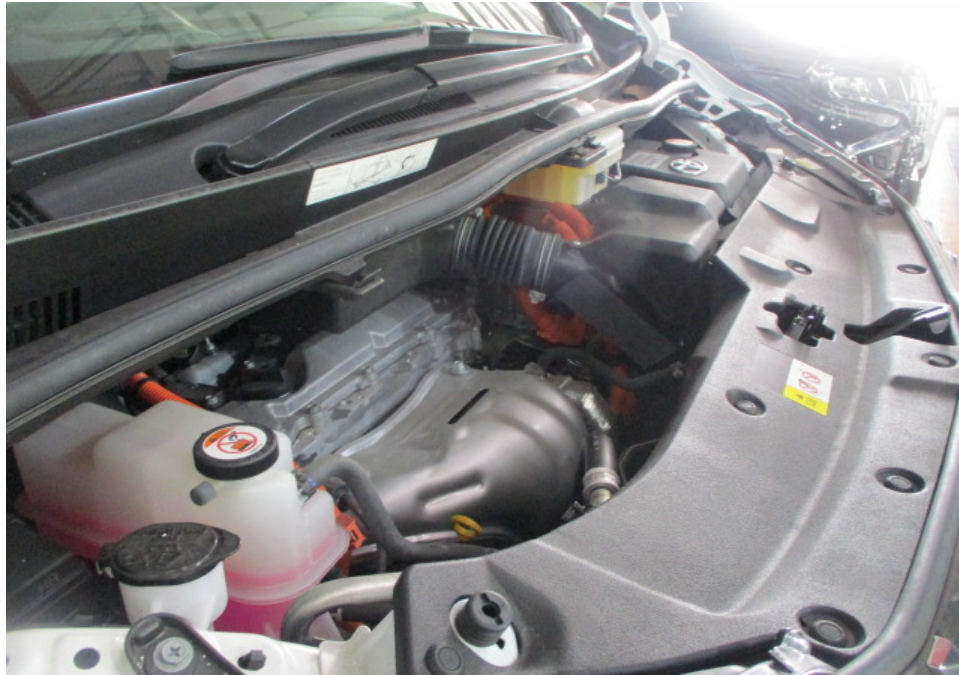
**Photo 14** shows another view of the engine compartment of the Motor Car at the time of my inspection. The various parts and components inside the engine compartment were all observed to be intact and properly fitted. There was also no sign(s) or indication(s) of fluid leak and/or fluid stain found inside the engine compartment.

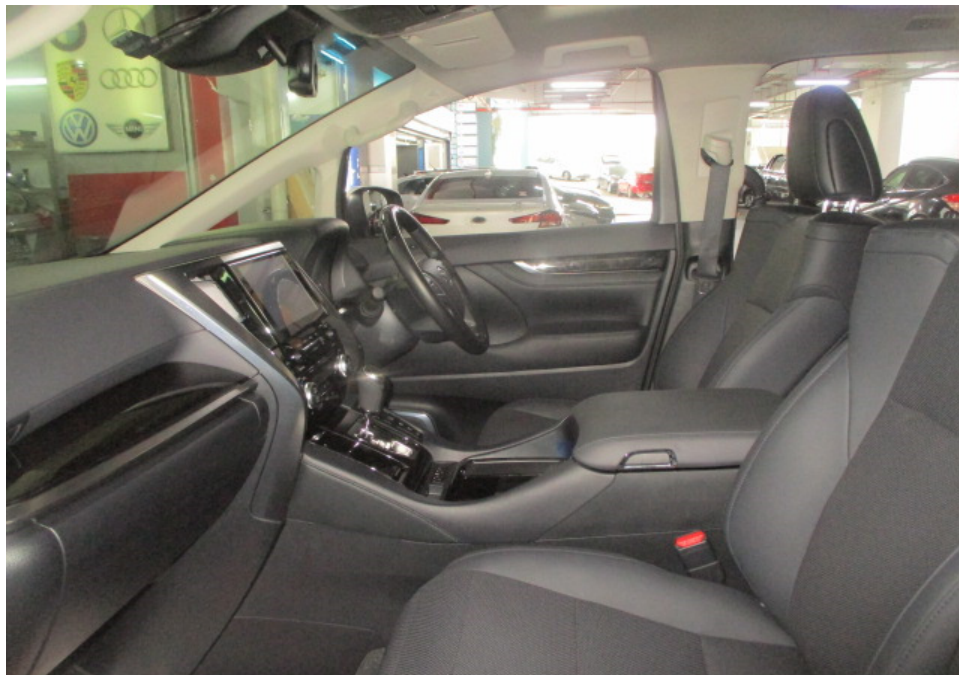
**Photo 15** shows the interior compartment of the Motor Car at the time of my inspection. The various parts and components, trims, carpet and upholstery inside the interior compartment were all observed to be intact and properly fitted.

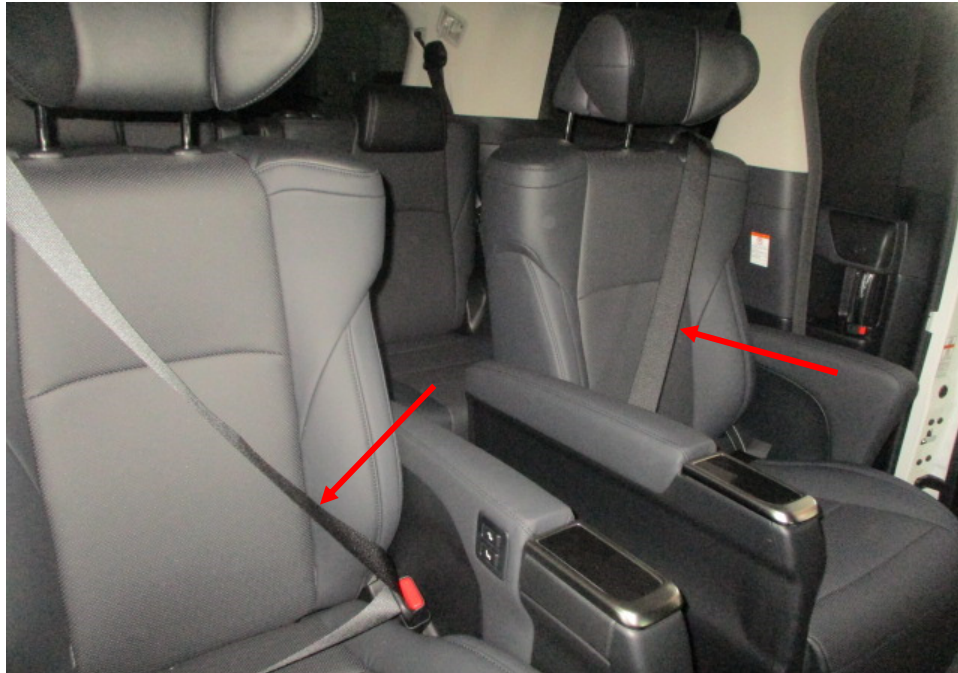
**Photo 16** shows the rear seats at the 1<sup>st</sup> row of the Motor Car. All the seats of the Motor Car were secured via seat rails to the floorboard. They were also fitted with a retractable seat belt reel and a pre-tensioner. The seat belts (arrowed) were tested and were able to be fastened into the respective pre-tensions that were fitted on the side of each individual seat.

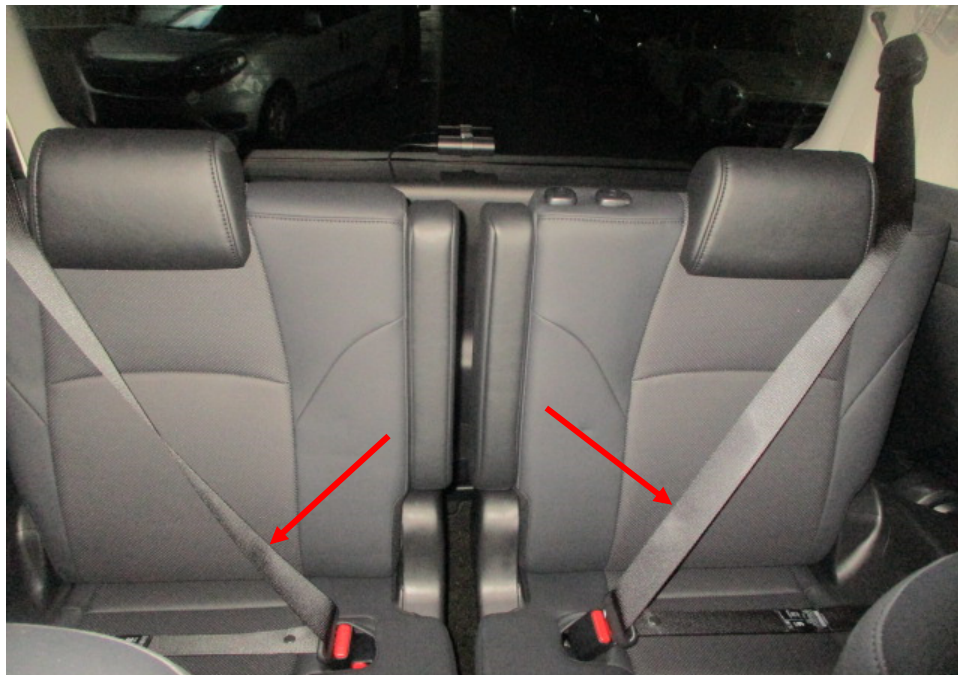
**Photo 17** shows the rear seats at the 2<sup>nd</sup> row of the Motor Car. All the seats of the Motor Car were secured via seat rails to the floorboard. They were also fitted with a retractable seat belt reel and a pre-tensioner. The seat belts (arrowed) were tested and were able to be fastened into the respective pre-tensions that were fitted on the side of each individual seat.

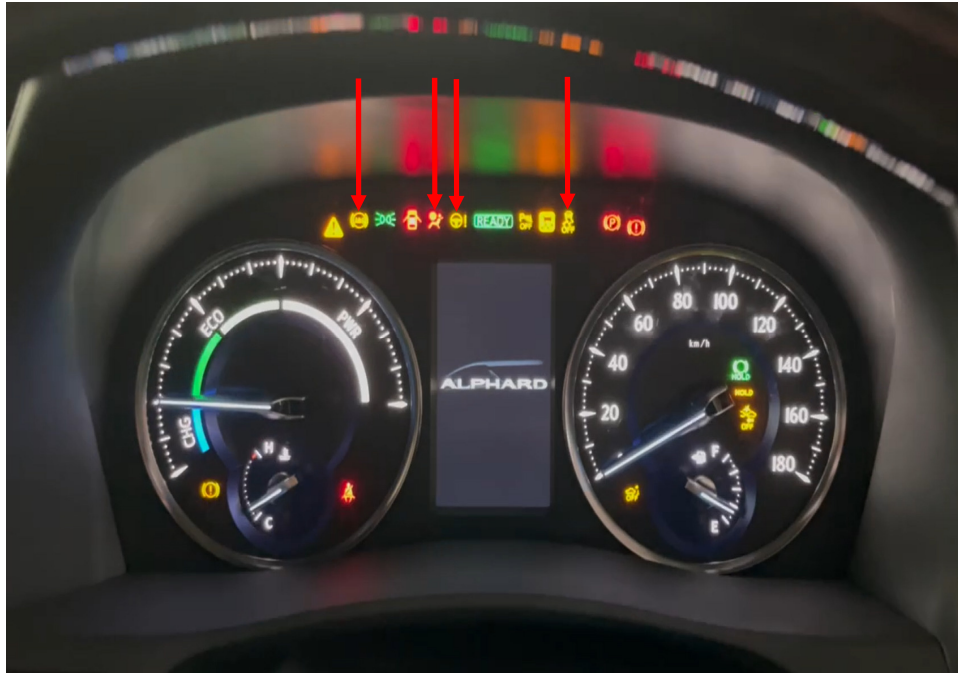
**Photo 18** shows the warning lights for the various electronic safety features appearing on the instrument panel of the Motor Car during its self-test when the engine is cranked, in particular the lights for the ABS, SRS, EPS, VSC (arrowed) and the various collision prevention systems.

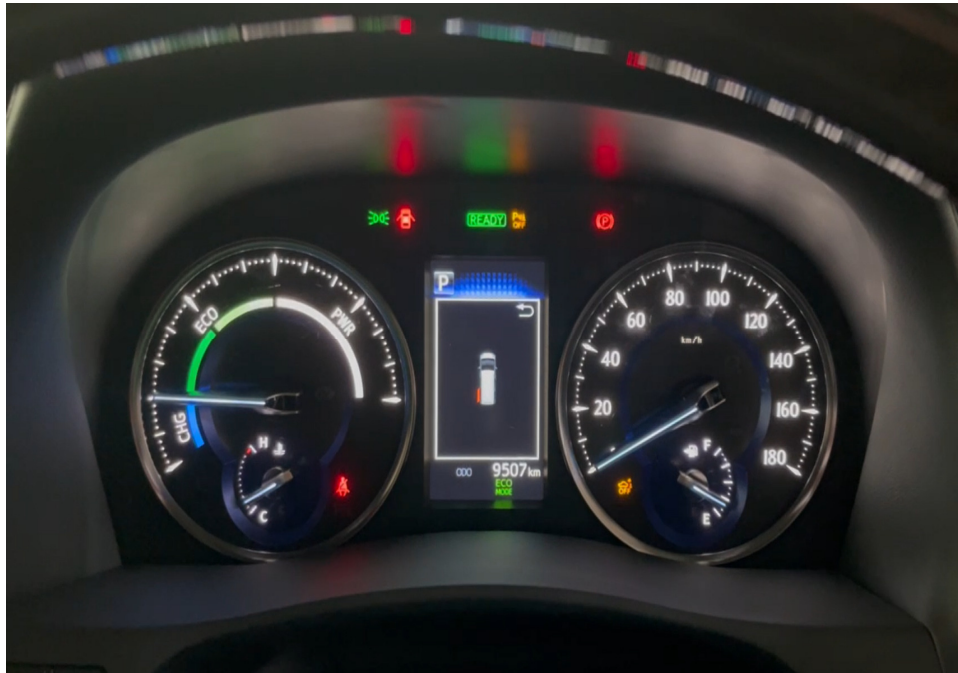
**Photo 19** shows the respective warning lights no longer illuminated, indicating that there is no fault detected to the ABS, SRS, EPS, VSC and the various collision prevention systems of the Motor Car during the self-test. These electronic systems were hence in working condition at the time of my inspection.

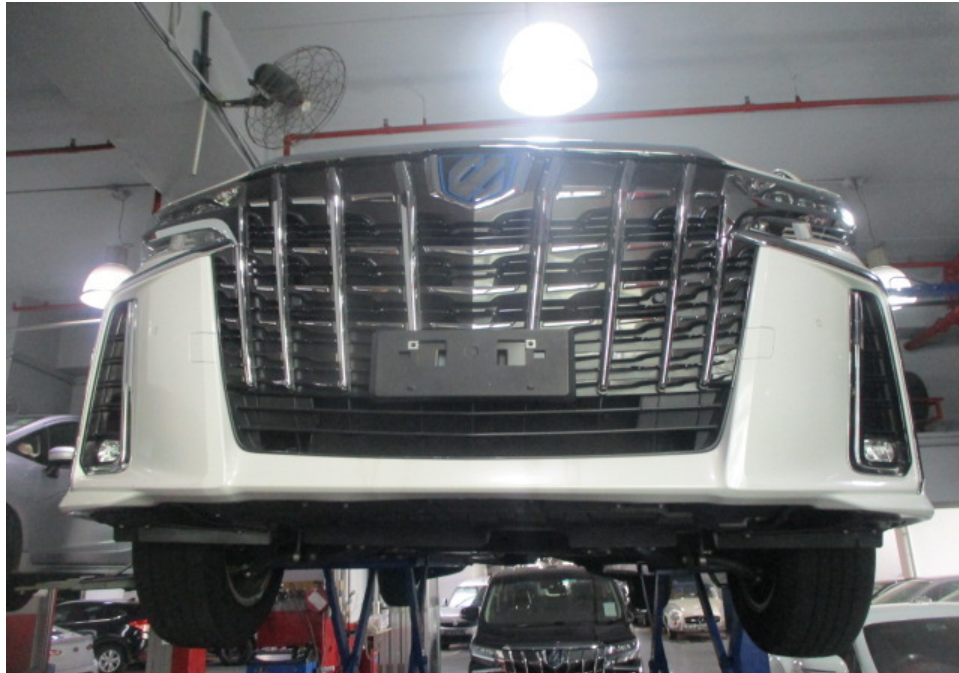
**Photo 20** shows the Motor Car hoisted up for checks on its undercarriage. There was no sign(s) or indication(s) of fluid leakage and/or fluid stain(s) on the underside of the Motor Car. The undercarriage components of the Motor Car were also all observed to be intact and secured in an appropriate manner.

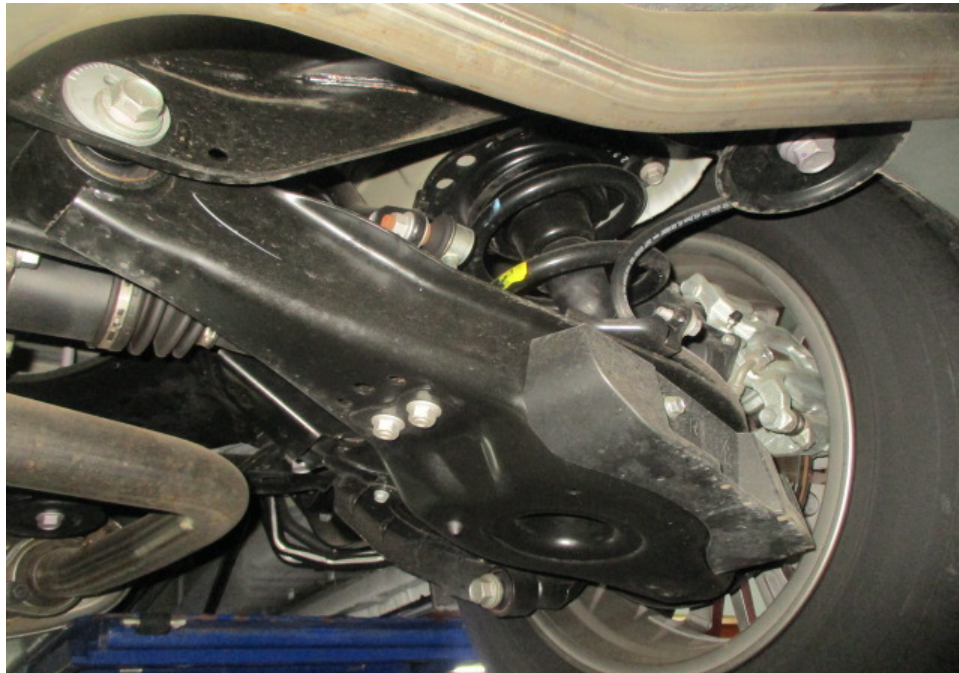
**Photo 21** shows a general view of the control arms and linkages at the rear right wheel of the Motor Car. I did not observe any fluid leak and/or fluid stain on the underside of the Motor Car. All of the Motor Car's undercarriage components were observed to be intact and secured in an appropriate manner.

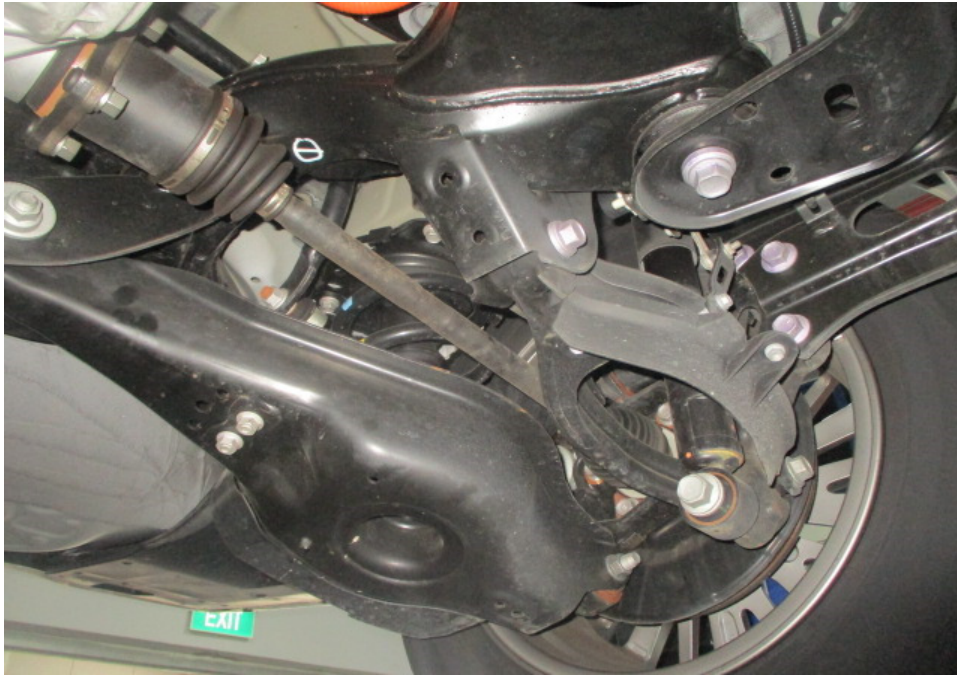
**Photo 22** shows a general view of the control arms and linkages at the rear left wheel of the Motor Car. I did not observe any fluid leak and/or fluid stain on the underside of the Motor Car. All of the Motor Car's undercarriage components were observed to be intact and secured in an appropriate manner.

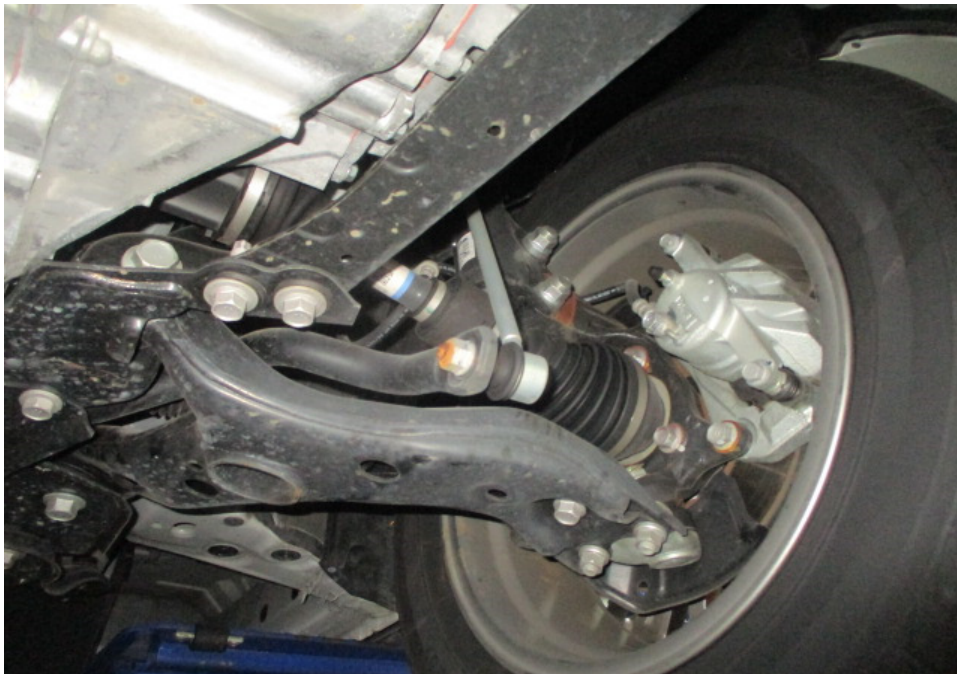
**Photo 23** shows the various undercarriage components at the front left wheel of the Motor Car. The mechanical components, control arms and linkages were all found to be intact and secured in an appropriate manner.

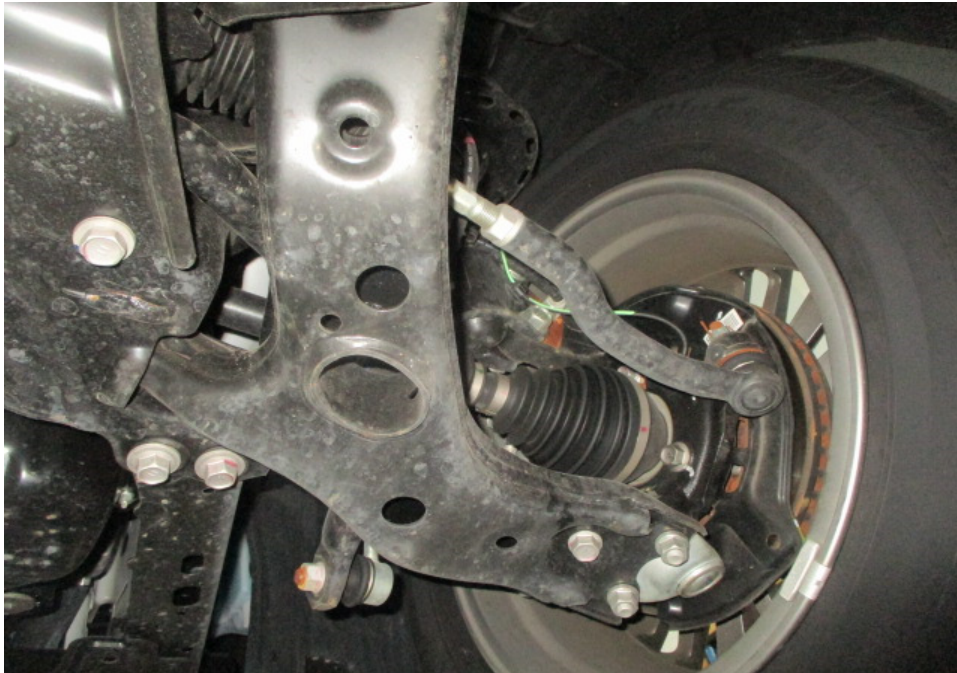
**Photo 24** shows the various undercarriage components at the front right wheel of the Motor Car. The mechanical components, control arms and linkages were all found to be intact and secured in an appropriate manner. I also did not observe any fluid leak and/or fluid stain on the underside of the Motor Car.

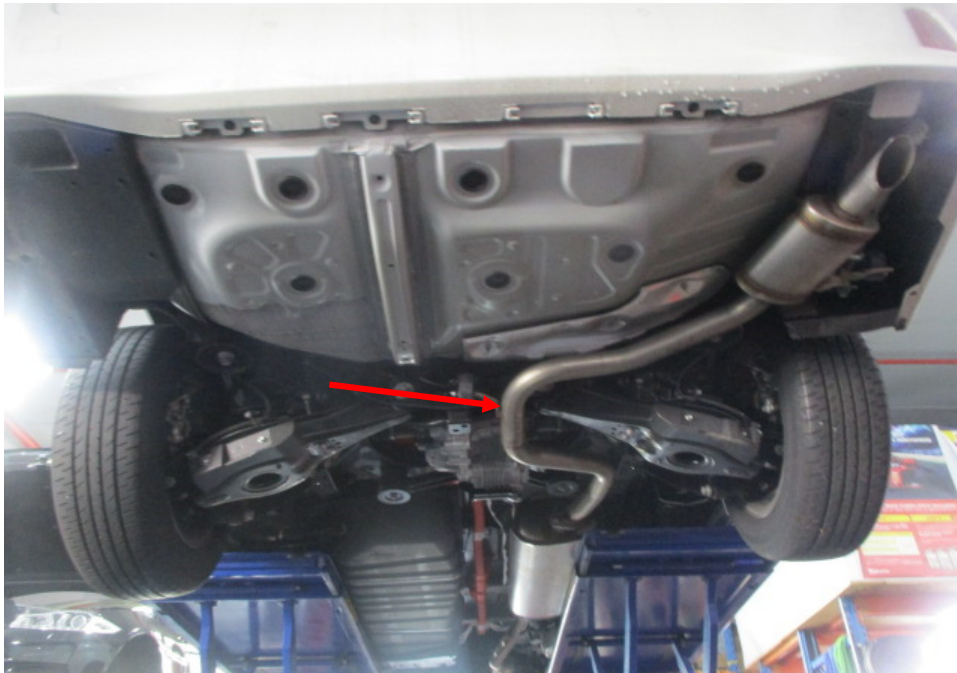
**Photo 25** shows a general view of the rear section of the Motor Car's exhaust system. My examination of the Motor Car's exhaust system revealed no sign(s) or indication(s) of any cut or weld marks along its exhaust pipe (arrowed), on its catalytic converter, on its centre resonator box and on its rear muffler.

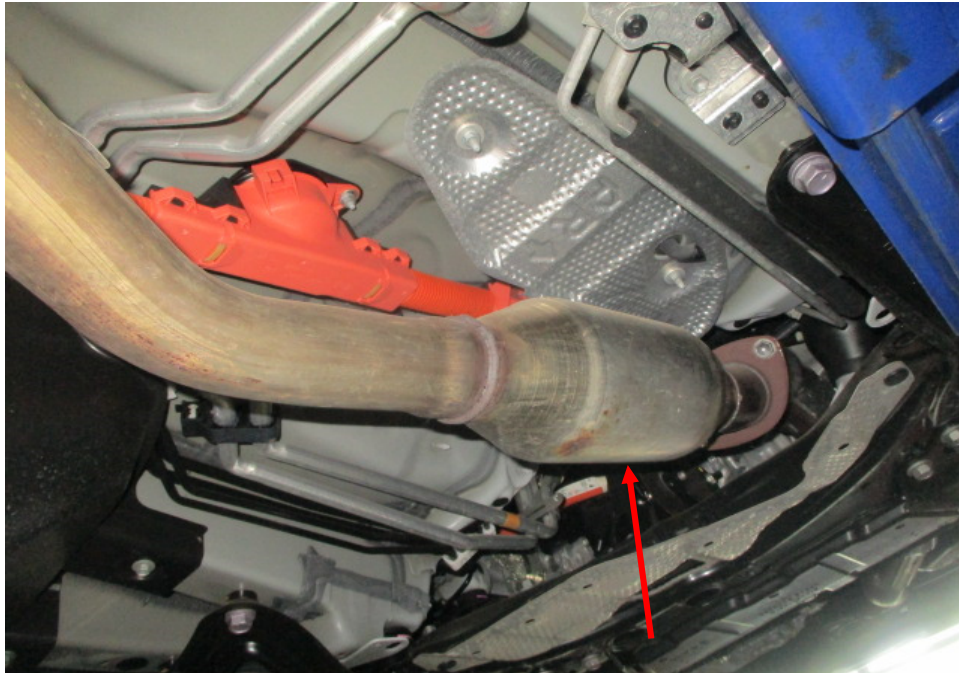
**Photo 26** shows a general view of the front section of the Motor Car's exhaust system. My examination of the Motor Car's exhaust system revealed no sign(s) or indication(s) of any cut or weld marks along its exhaust pipe, on its catalytic converter (arrowed), on its centre resonator box and on its rear muffler.

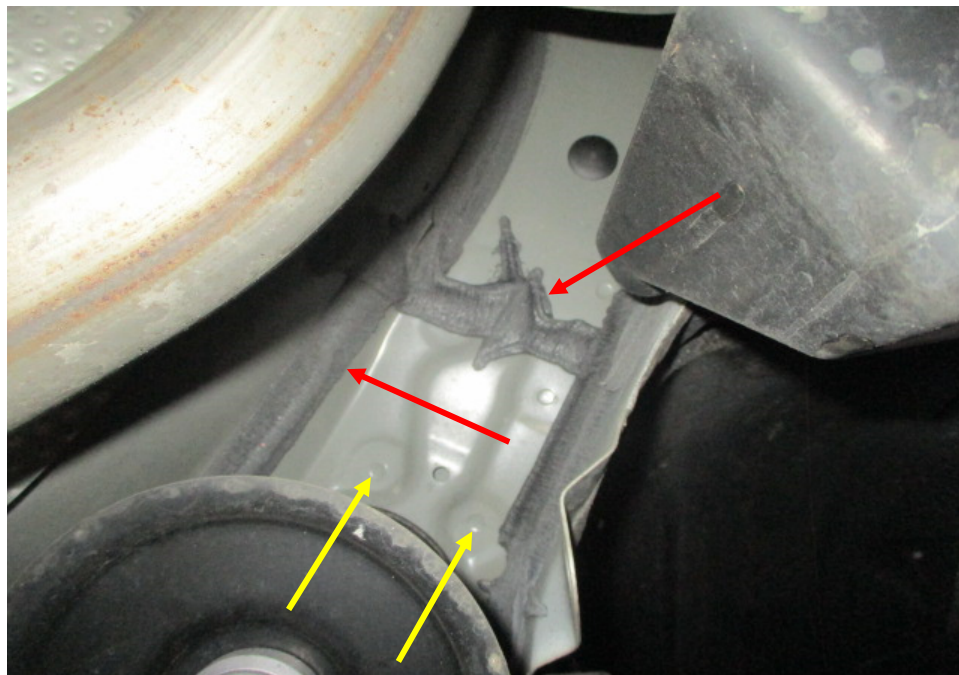
**Photo 27** shows the chassis/structural body at the underside rear right of the Motor Car. I did not find any weld marks other than original spot weld marks (yellow arrow) on the chassis/structural body of the Motor Car. The original factory sealant (red arrow) at the joints along the chassis/structural body was untouched, indicating no work was done on the chassis/structural body of the Motor Car and that the chassis/structural body was originally fitted.

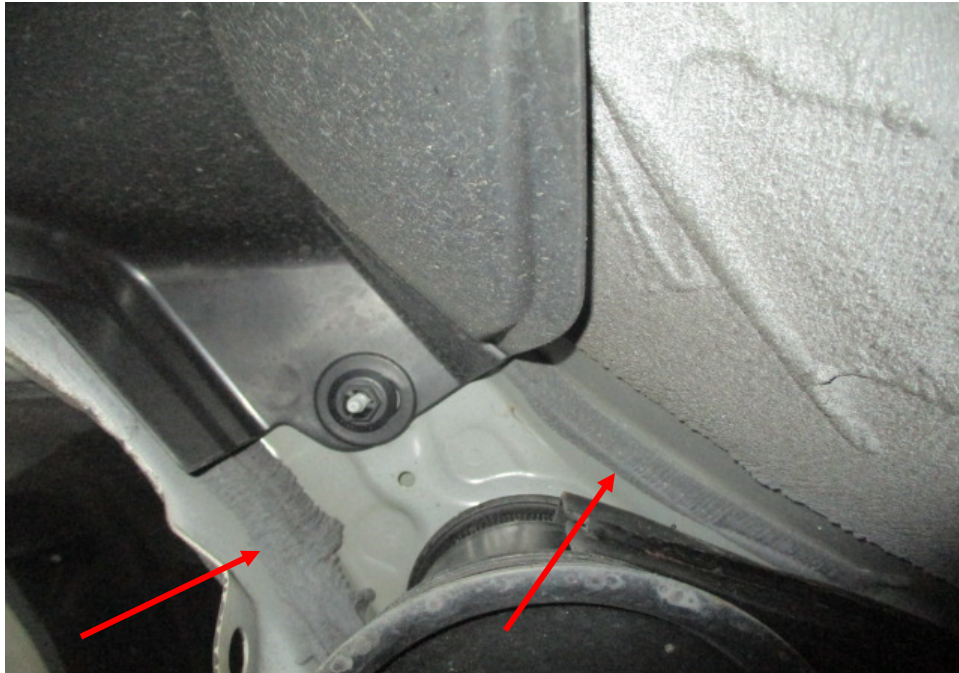
**Photo 28** shows the chassis/structural body at the underside rear left of the Motor Car. The original factory sealant (arrowed) at the joints along the chassis/structural body was observed to be untouched. In general, I had found no work was carried out on the chassis/structural body of the Motor Car. The chassis/structural body of the Motor Car was originally fitted

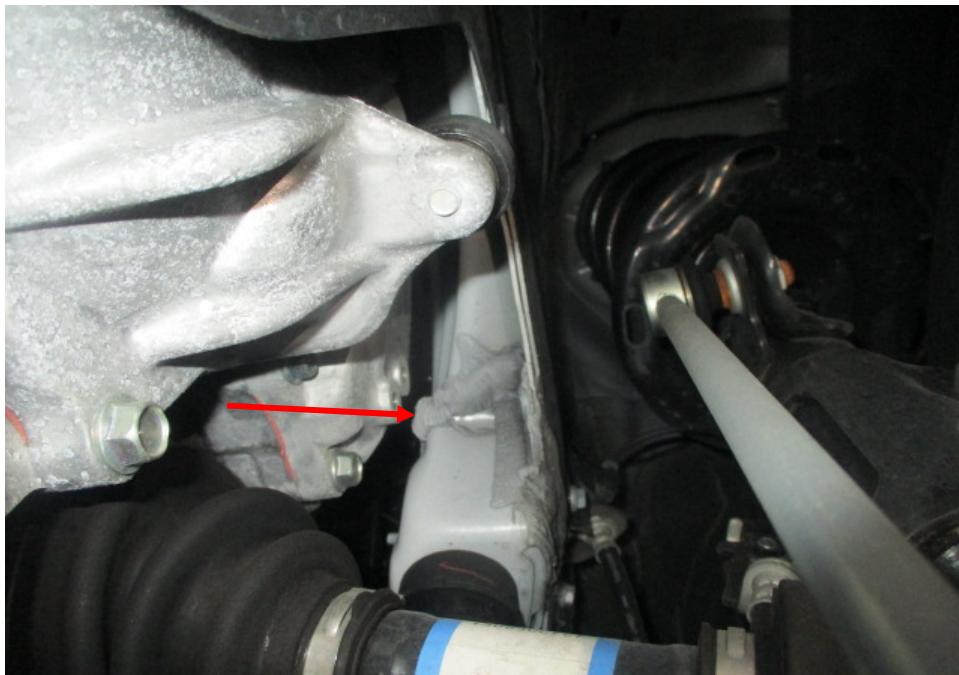
**Photo 29** shows the chassis/structural body at the underside front left of the Motor Car. The original factory sealant (arrowed) at the joints along the chassis/structural body was observed to be untouched. In general, I had found no work was carried out on the chassis/structural body of the Motor Car. The chassis/structural body of the Motor Car was originally fitted.

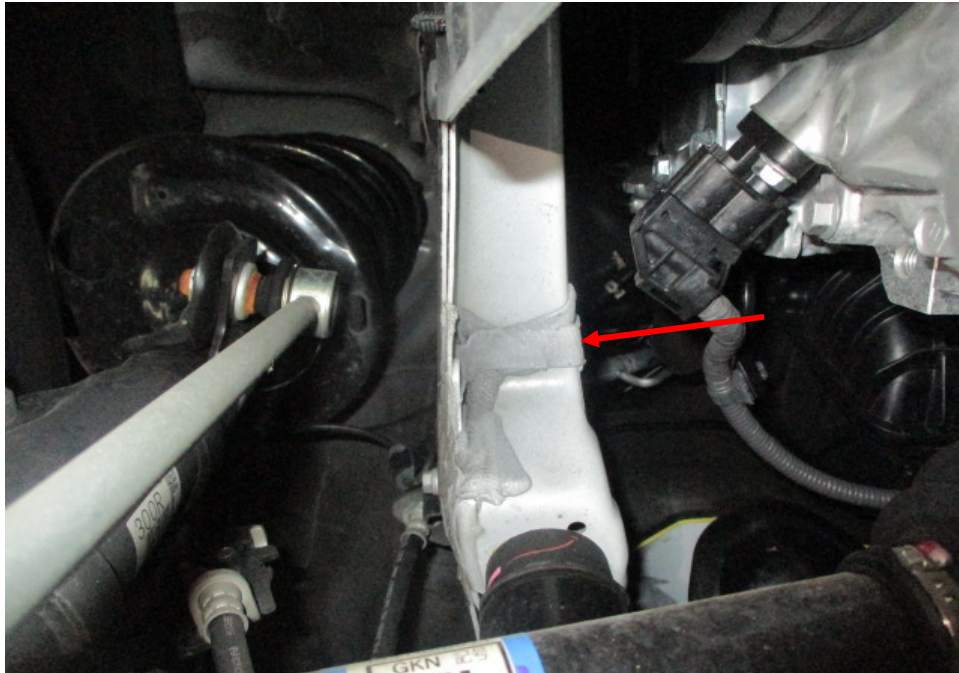
**Photo 30** shows the chassis/structural body at the underside front right of the Motor Car. The original factory sealant (arrowed) at the joints along the chassis/structural body was observed to be untouched. In general, I had found no work was carried out on the chassis/structural body of the Motor Car. The chassis/structural body of the Motor Car was originally fitted.
