Your Ref: Toyota Alphard  
(chassis number AYH300143734)  
Our Ref : CI/TP23006223/D

20 June 2023

### **INSPECTION REPORT OF AN UNREGISTERED TOYOTA ALPHARD MOTOR CAR WITH CHASSIS NUMBER AYH300143734**

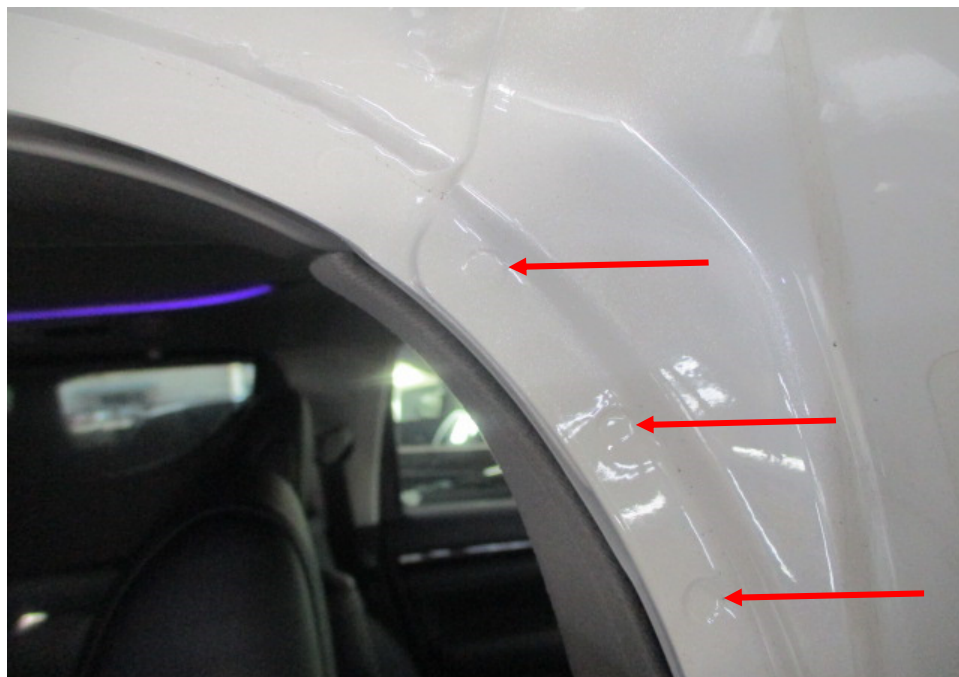
**Photo 31** shows the right side "B" pillar of the Motor Car. I did not find any weld marks other than original spot weld marks (arrowed) on the right side "B" pillar of the Motor Car, which indicates that there was no re-welding works carried out. In general, I had found all the non-detachable body panels of the Motor Car to be originally fitted at the time of my inspection.

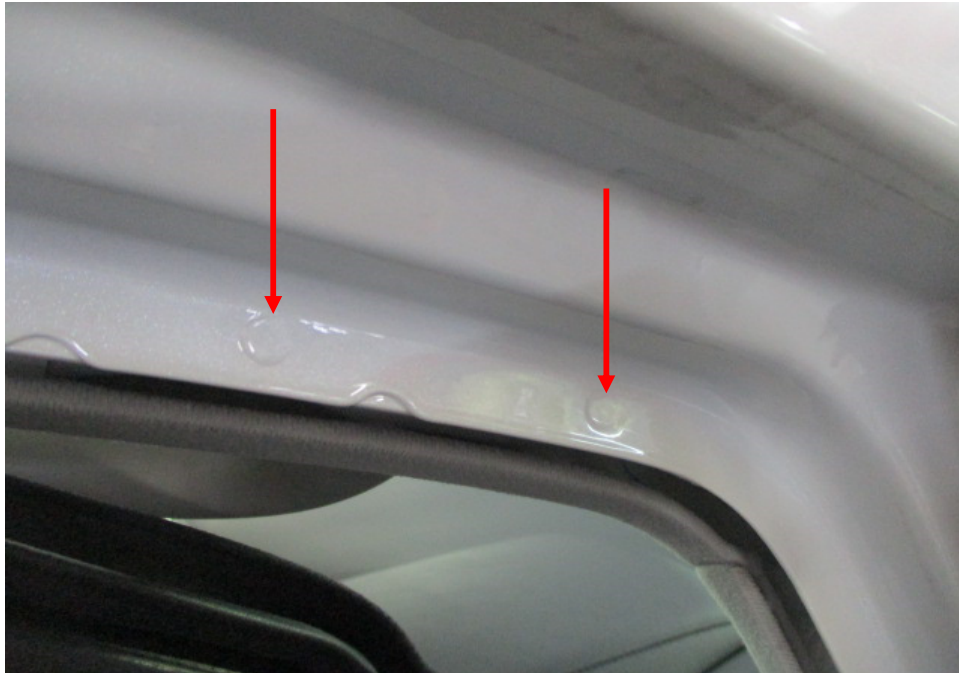
**Photo 32** shows the right side "A" pillar of the Motor Car. I did not find any weld marks other than original spot weld marks (arrowed) on the right side "A" pillar of the Motor Car, which indicates that there was no re-welding works carried out. In general, I had found all the non-detachable body panels of the Motor Car to be originally fitted at the time of my inspection.

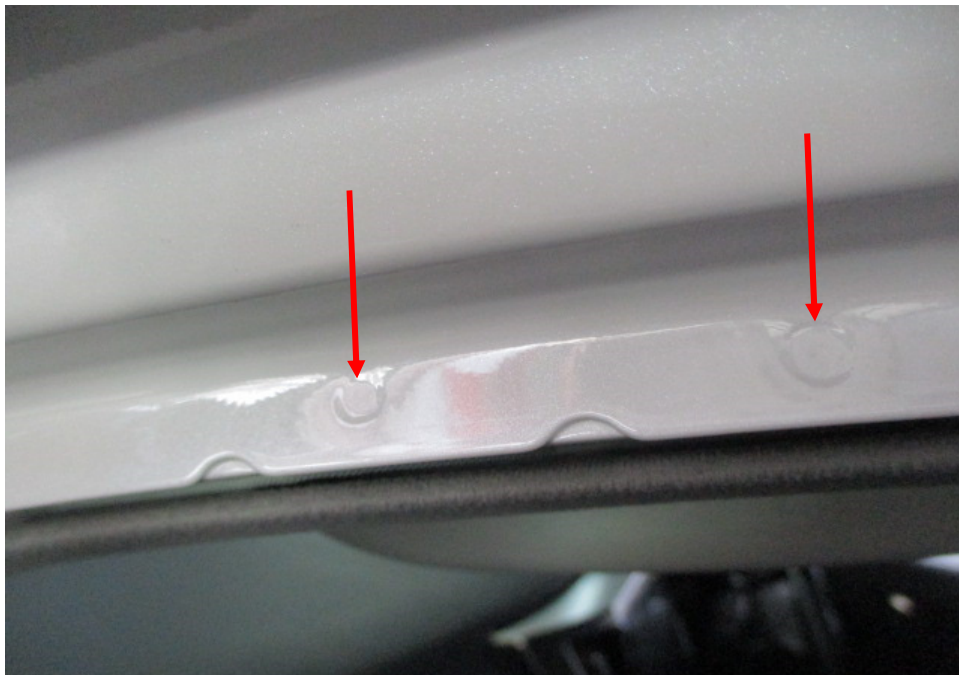
**Photo 33** shows the left side "A" pillar of the Motor Car. I did not find any weld marks other than original spot weld marks (arrowed) on the left side "A" pillar of the Motor Car, which indicates that there was no re-welding works carried out. In general, I had found all the non-detachable body panels of the Motor Car to be originally fitted at the time of my inspection.

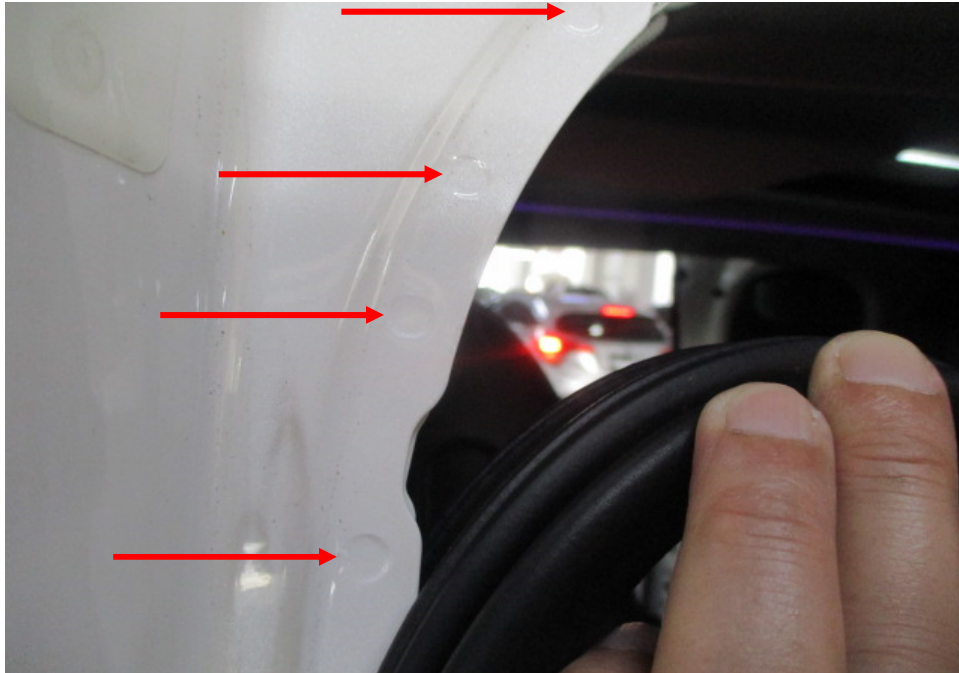
**Photo 34** shows the left side "B" pillar of the Motor Car. I did not find any weld marks other than original spot weld marks (arrowed) on the left side "B" pillar of the Motor Car, which indicates that there was no re-welding works carried out. In general, I had found all the non-detachable body panels of the Motor Car to be originally fitted at the time of my inspection.
