# NCVI INVOLVING 5-TON WITH CARGO TRAILER (MID20705 & MID92842) AT OLD CHUA CHU KANG ROAD ON 25 APR 23 AT ABOUT 1715HRS

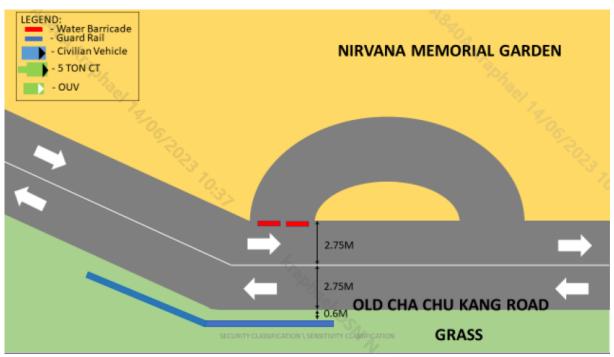
Figure A-1: Incident occurred at Old Chua Chu Kang Road. The road was narrow with a width of 2.75m per lane, with a small grass patch of 0.6m in width between the road and the guard rail.

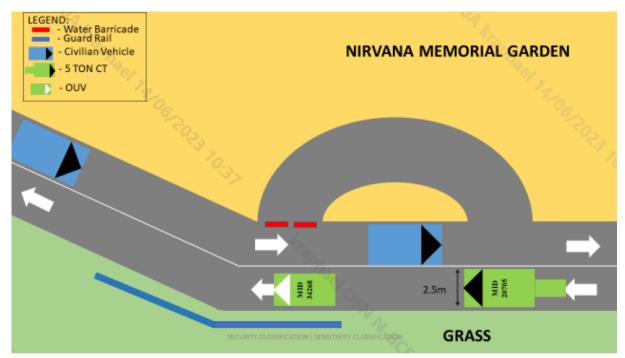
Figure A-2: MID20705 was travelling as part of a convoy movement behind OUV MID34268

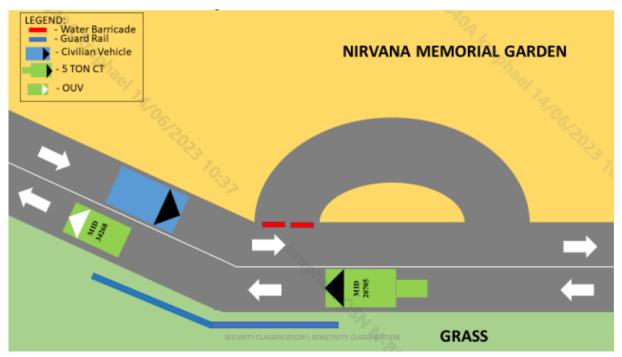
Figure A-3: A civilian truck was approaching MID 20705 in the opposite lane

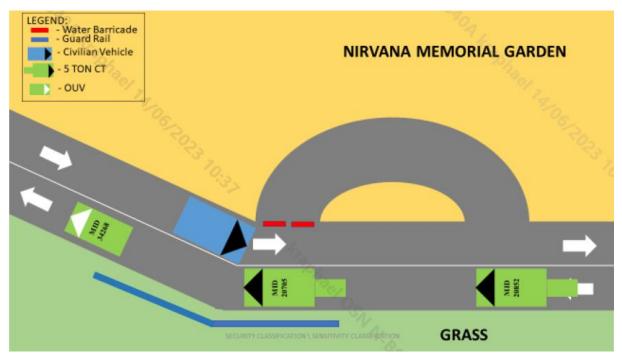
Figure A-4: Both vehicles slowed down to assess the situation, with the truck coming to a stop to give way to MID 20705

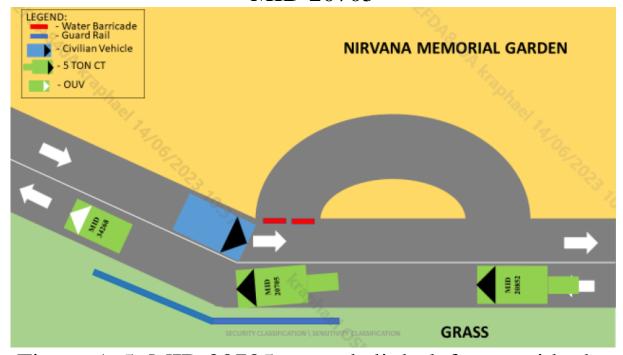
Figure A-5: MID 20705 steered slight left to avoide the oncoming truck, the front left wheel rolled on the grass patch

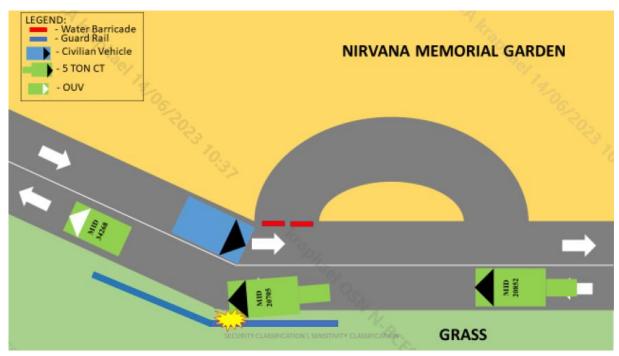
Figure A-6: Due to soft ground, MID20705 sunk in and grazed the road guard rail

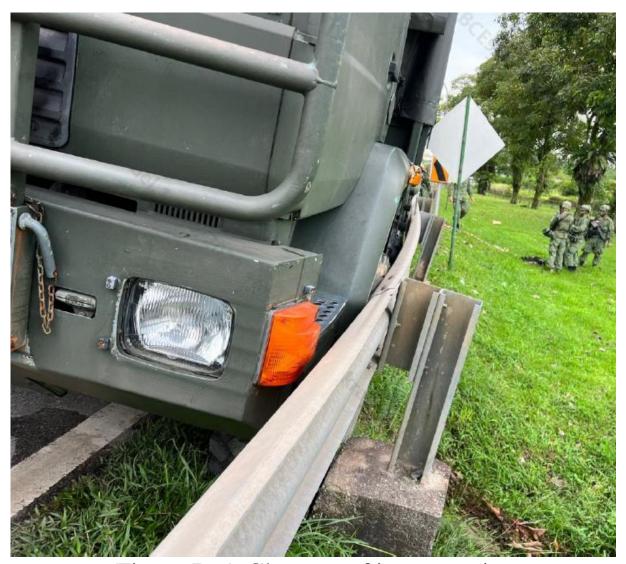
Figure B-5: Close up of impact point

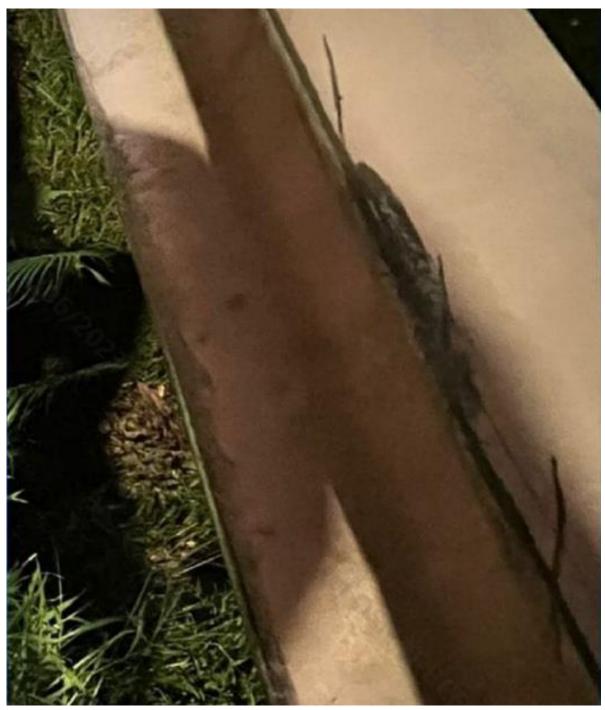
Figure B-6: Close up of damage on guard rail

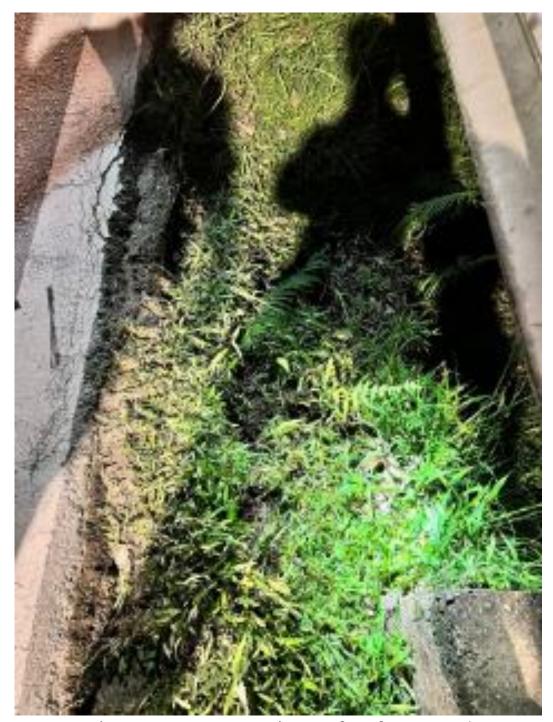
Figure B-7: Top view of soft ground

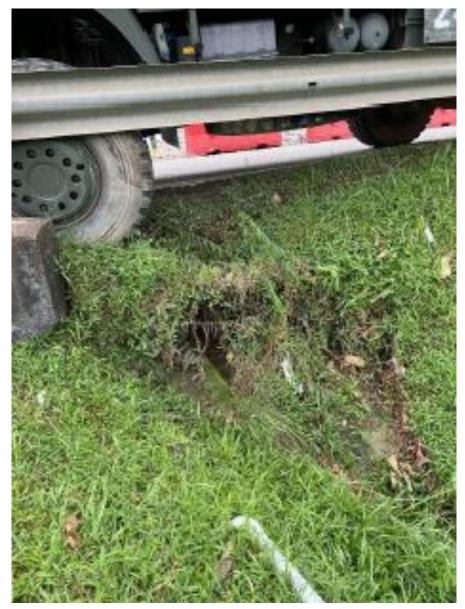
Figure B-8: Side view of soft ground
