Your Ref: Honda E Electric  
(chassis number JHMZC7840LX200927)  
Our Ref : CI/TP23006280/D

22 June 2023

**INSPECTION REPORT OF AN UNREGISTERED HONDA E ELECTRIC MOTOR CAR WITH CHASSIS NUMBER JHMZC7840LX200927**

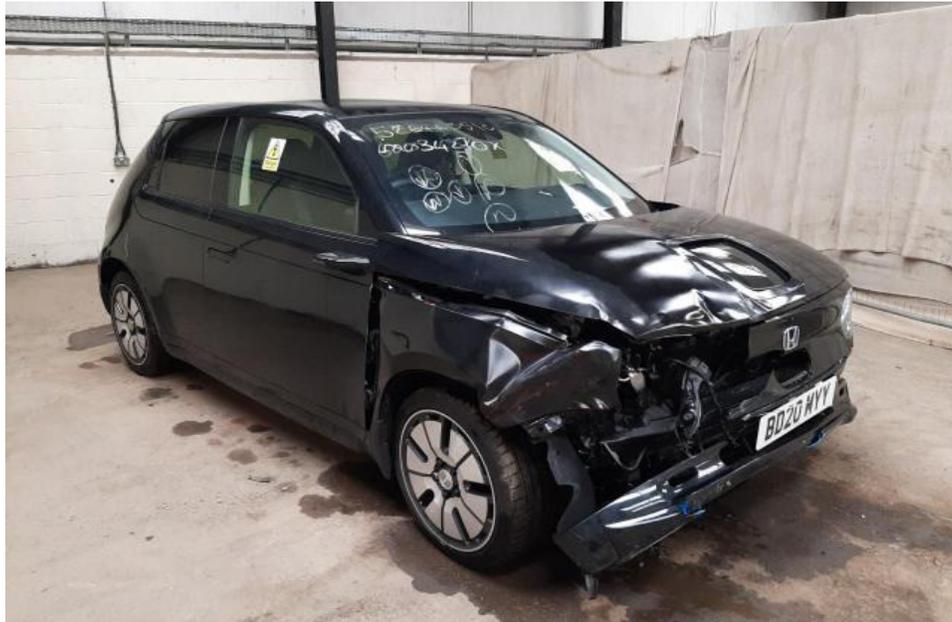
**Photo 1** shows the front right body of the Motor Car (photograph provided to me). The Motor Car was observed to have sustained damage at its front right portion. The front bumper, front bumper lower cover, front bumper centre cover, front bumper top cover, front bumper right bracket, front bonnet, front right fender, front right headlamp and front right headlamp bracket were amongst the body parts that were observed to have been damaged.

22. The body parts at the front right portion of the Motor Car were visually examined and it was noted that the repair/restoration works carried out to the damaged area of the Motor Car (refer to photograph 1 - 3 above) were reasonably adequate and in order.

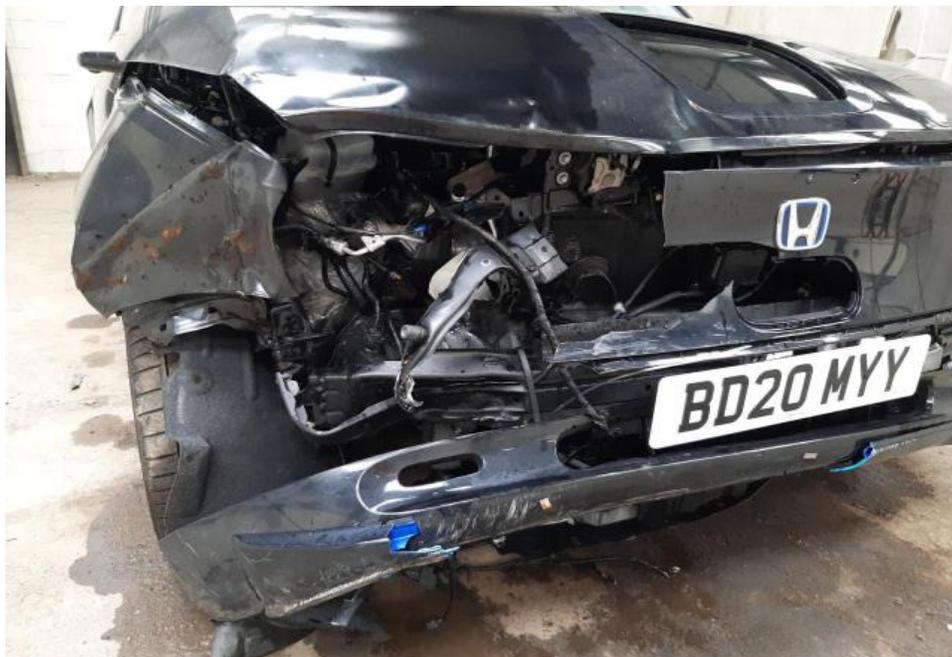
**Photo 2** shows a closer view of the damage at the front right portion of the Motor Car (photograph provided to me). The front bumper, front bumper lower cover, front bumper centre cover, front bumper top cover, front bumper sensors, front bumper reinforcement, front bumper right bracket, front bonnet, front radar cover, front radar unit, front right fender, front right fender inner shield, front right headlamp, front right headlamp bracket and front support panel were amongst the body parts that were observed to have been damaged.

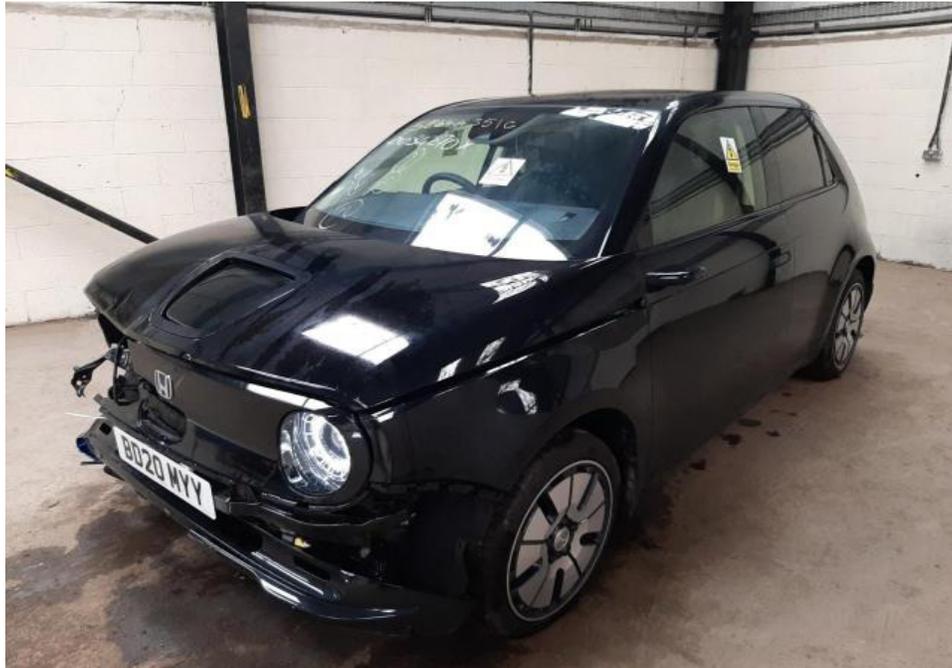
**Photo 3** shows the front left body of the Motor Car (photograph provided to me). The Motor Car was observed to have sustained damage at its front right portion. The front bumper, front bumper lower cover, front bumper centre cover, front bumper top cover, front bumper sensors, front bonnet, front radar cover and front radar unit were amongst the body parts that were observed to have been damaged.

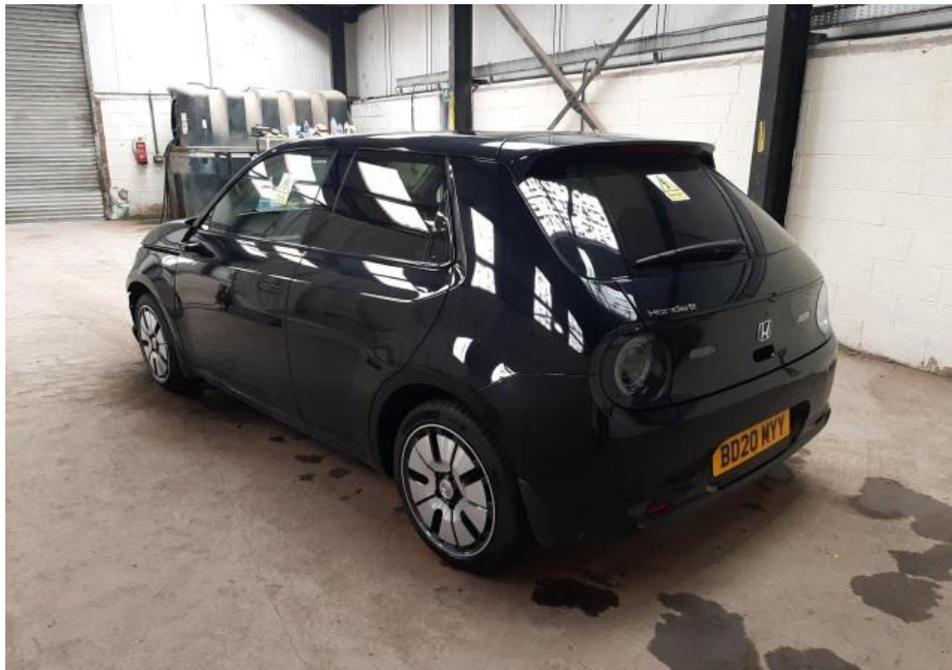
**Photo 4** shows the rear left body of the Motor Car (photograph provided to me). Apart for the front right portion, there was no physical damage observed to other areas of the Motor Car.

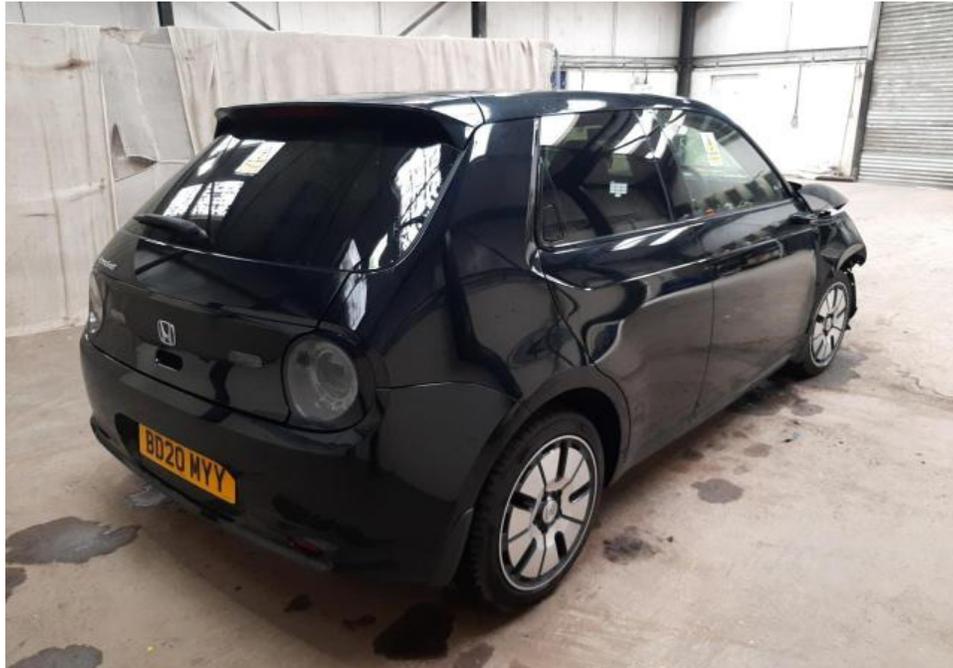
**Photo 5** shows the rear right body of the Motor Car (photograph provided to me). Apart for the front right portion, there was no physical damage observed to other areas of the Motor Car.

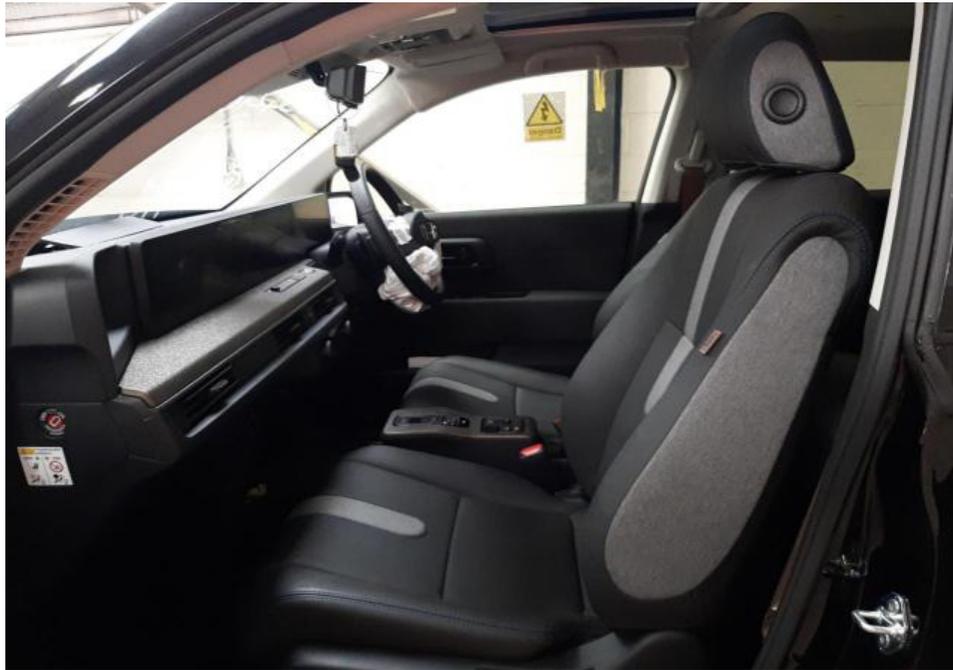
**Photo 6** shows the interior compartment of the Motor Car (photograph provided to me). The various parts and components within the interior compartment were all intact and unaffected. The Motor Car's airbag(s) was not deployed as seen from the photographs that were provided to me.

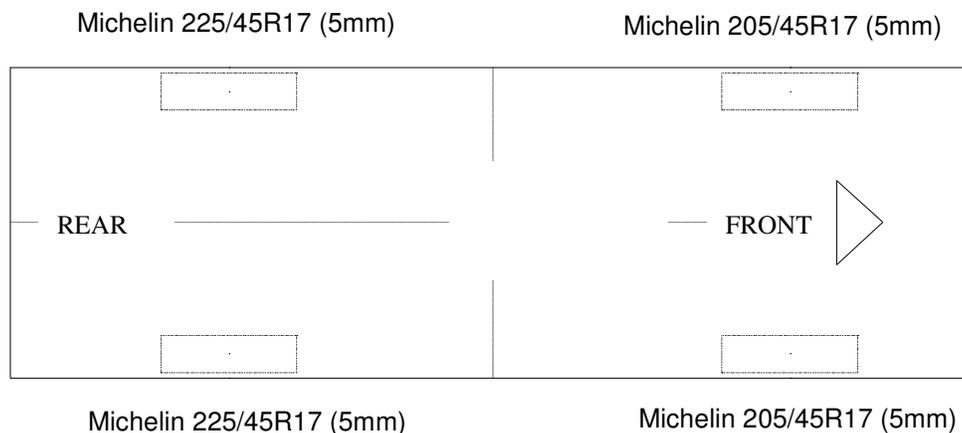
8. It was fitted with 17inch sport wheel rims that were wrapped with tyres that were observed to be of serviceable condition. The tyres were also sufficiently inflated for vehicular operation. The tyre brand, tyre size and approximate remaining tread depth of the 4 tyres of the Motor Car were recorded as follows: -

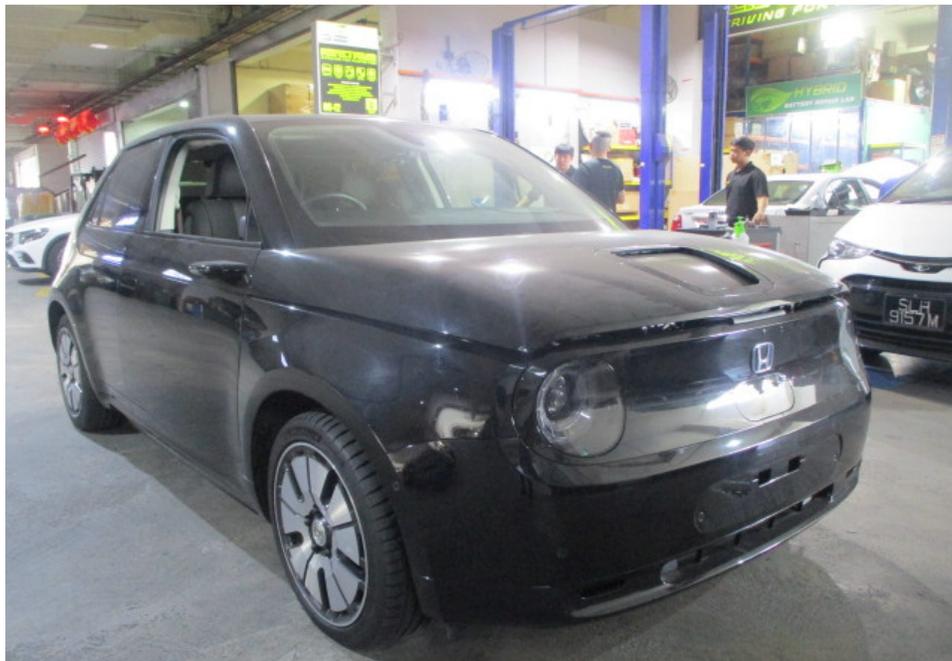
**Photo 7** shows a general view of the front right body of the Motor Car at the time of my inspection. The Motor Car was observed to be in a relatively good general condition with no loose exterior fittings observed. The body parts at the front right portion of the Motor Car were visually examined and it was observed that the repair/restoration works carried out to the damaged area of the Motor Car (refer to photograph 1 - 3 above) were reasonably adequate and in order.

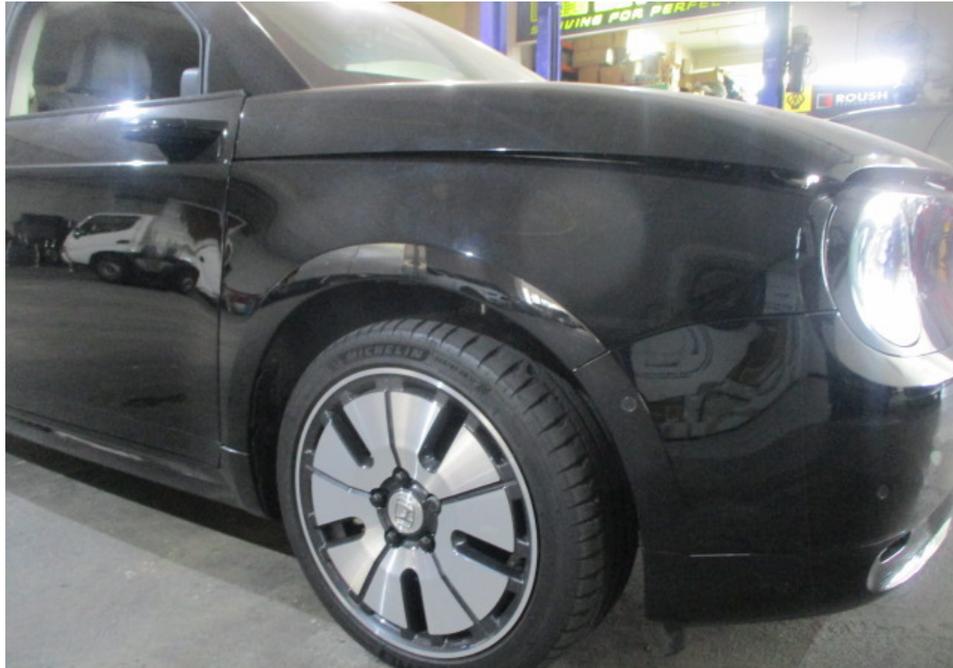
**Photo 8** shows a closer view of the Motor Car's front right wheel rim, front right fender and front bonnet at the time of my inspection. The body parts at the front right portion of the Motor Car were visually examined and it was observed that the repair/restoration works carried out to the damaged area of the Motor Car (refer to photograph 1 - 3 above) were reasonably adequate and in order.

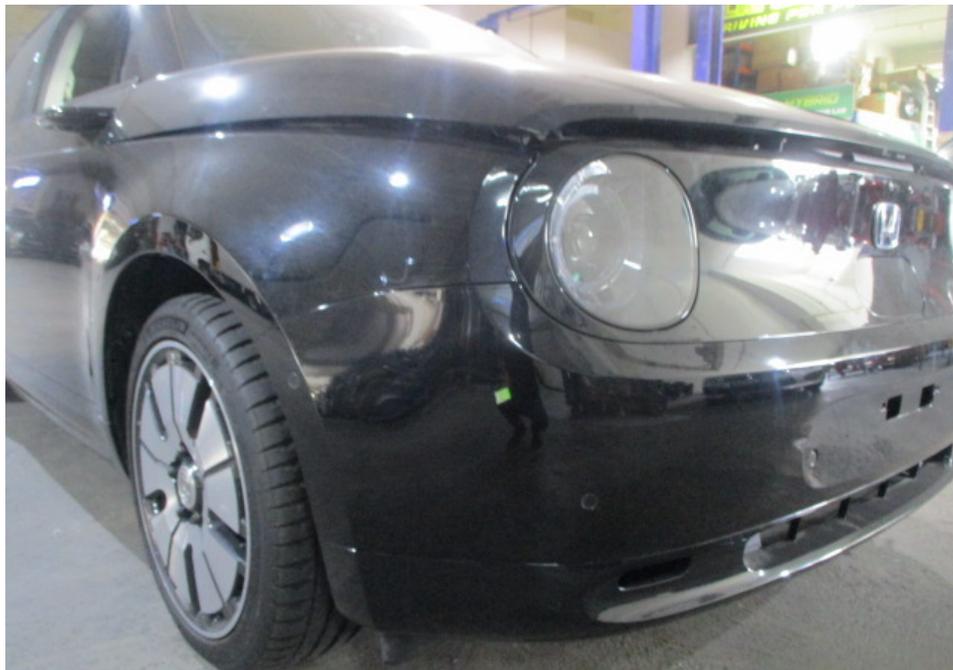
**Photo 9** shows a closer view of the Motor Car's front bumper, front bumper lower cover, front bumper centre cover, front bumper top cover and front right headlamp. The body parts at the front right portion of the Motor Car were visually examined and it was observed that the repair/restoration works carried out to the damaged area of the Motor Car (refer to photograph 1 - 3 above) were reasonably adequate and in order.

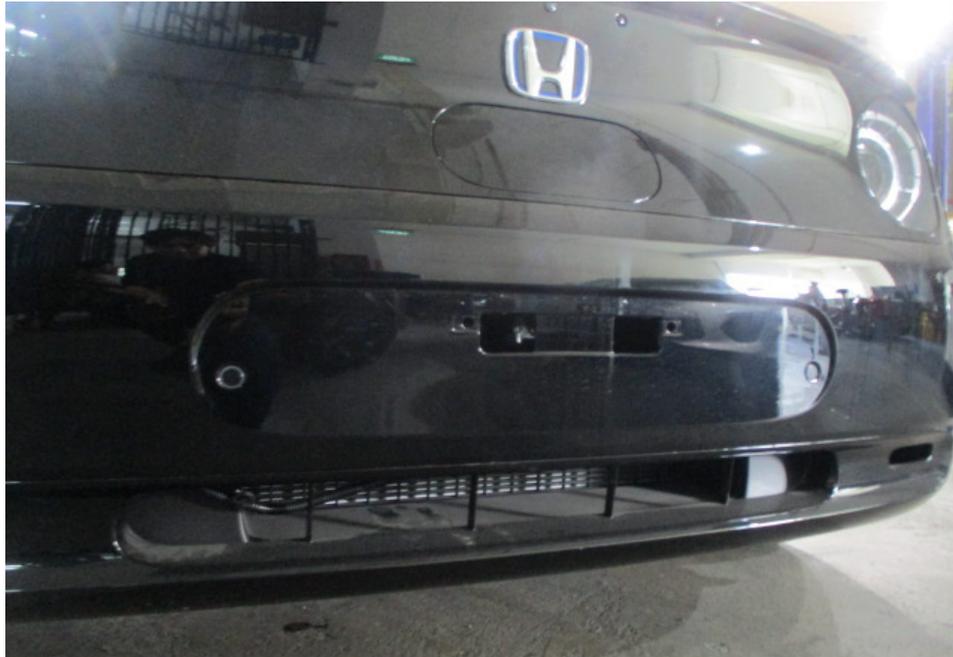
**Photo 10** shows a closer view of the Motor Car's front bumper, front bumper lower cover, front bumper centre cover, front bumper top cover, front emblem and front radar cover. The body parts at the front right portion of the Motor Car were visually examined and it was observed that the repair/restoration works carried out to the damaged area of the Motor Car (refer to photograph 1 - 3 above) were reasonably adequate and in order.

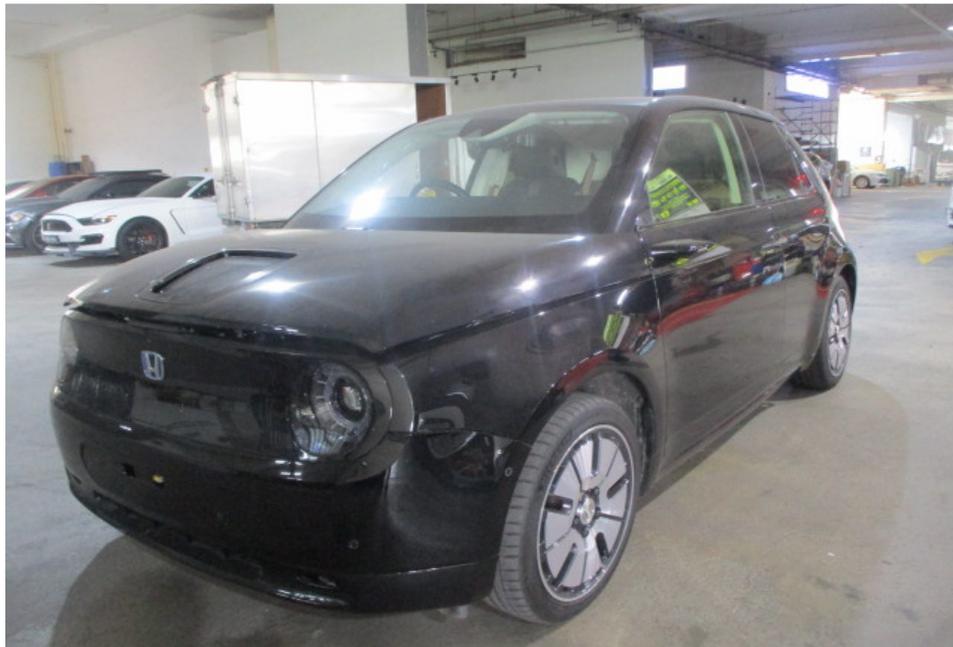
**Photo 11** shows a general view of the front left body of the Motor Car at the time of my inspection. The Motor Car was observed to be in a relatively good general condition with no loose exterior fittings observed. The body parts at the front right portion of the Motor Car were visually examined and it was observed that the repair/restoration works carried out to the damaged area of the Motor Car (refer to photograph 1 - 3 above) were reasonably adequate and in order.

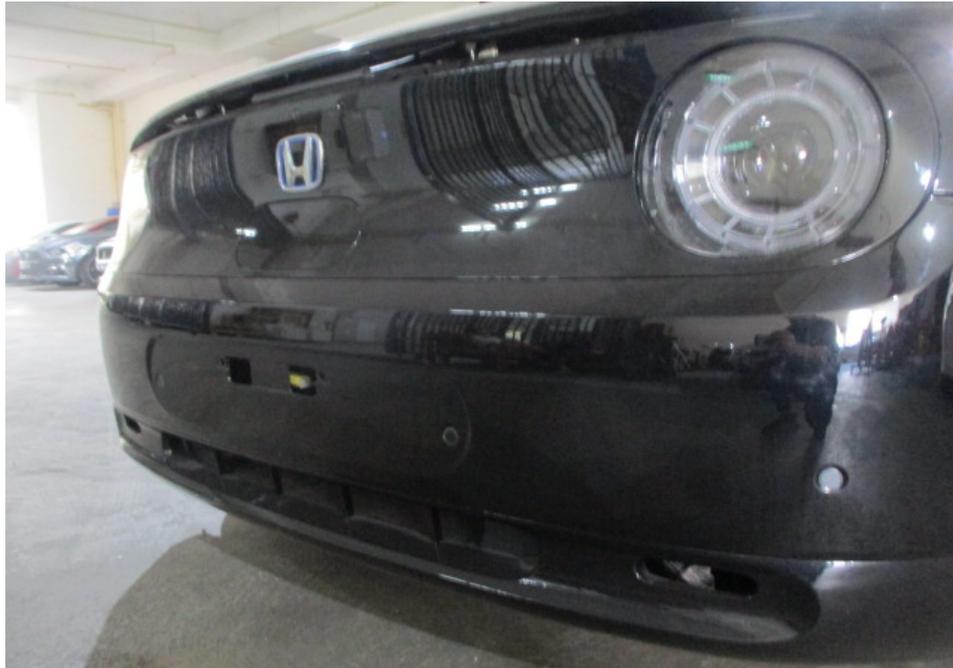
**Photo 12** shows a closer view of the Motor Car's front bumper, front bumper lower cover, front bumper centre cover, front bumper top cover, front bumper sensors and front left headlamp. The body parts at the front right portion of the Motor Car were visually examined and it was observed that the repair/restoration works carried out to the damaged area of the Motor Car (refer to photograph 1 - 3 above) were reasonably adequate and in order.

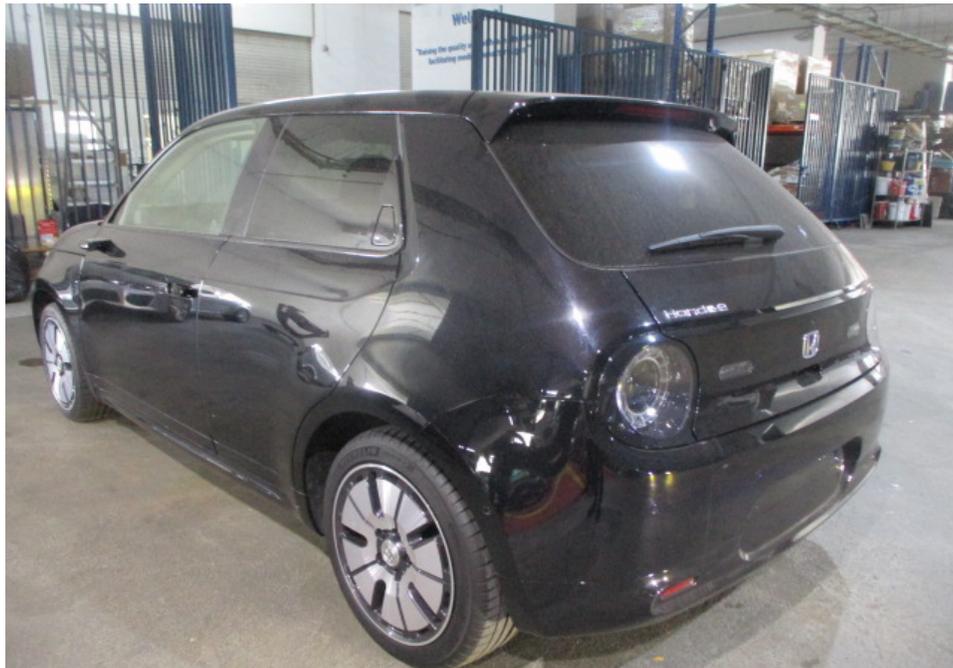
**Photo 13** shows a general view of the rear left body of the Motor Car at the time of my inspection. The Motor Car was observed to be in a relatively good general condition with no loose exterior fittings observed. The mileage of the Motor Car recorded at the time of my inspection was 33km.

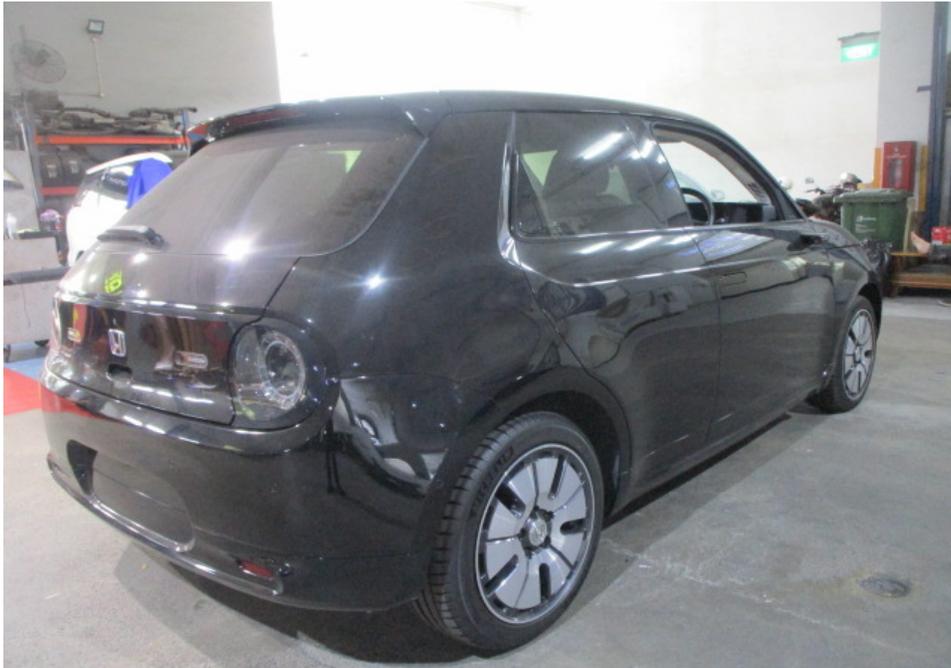
**Photo 14** shows a general view of the rear right body of the Motor Car at the time of my inspection. The Motor Car was observed to be in a relatively good general condition with no loose exterior fittings observed. The mileage of the Motor Car recorded at the time of my inspection was 33km.

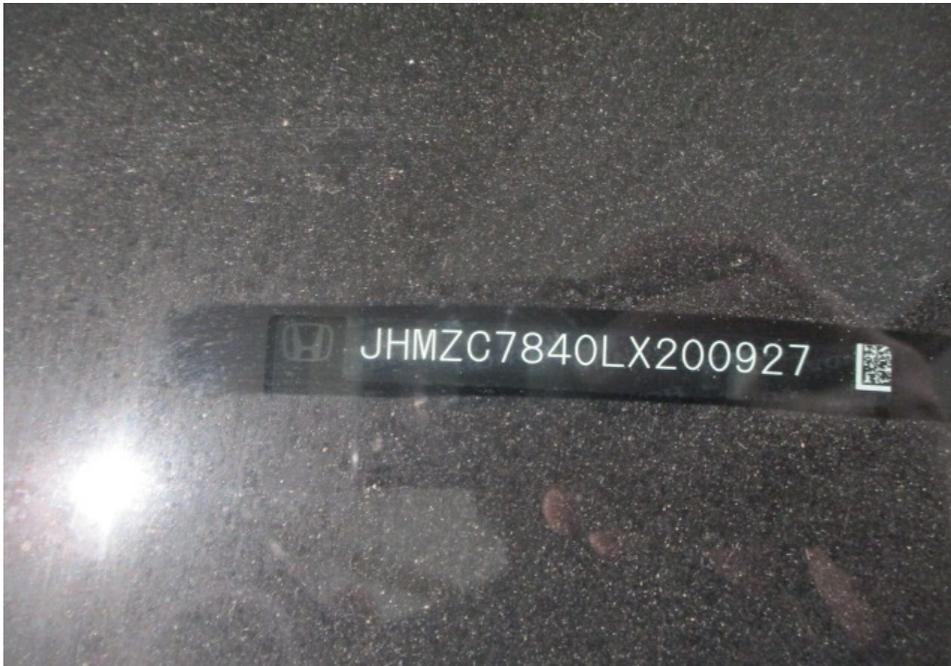
**Photo 15** shows the chassis number of the Motor Car. The chassis number recorded was JHMZC7840LX200927.

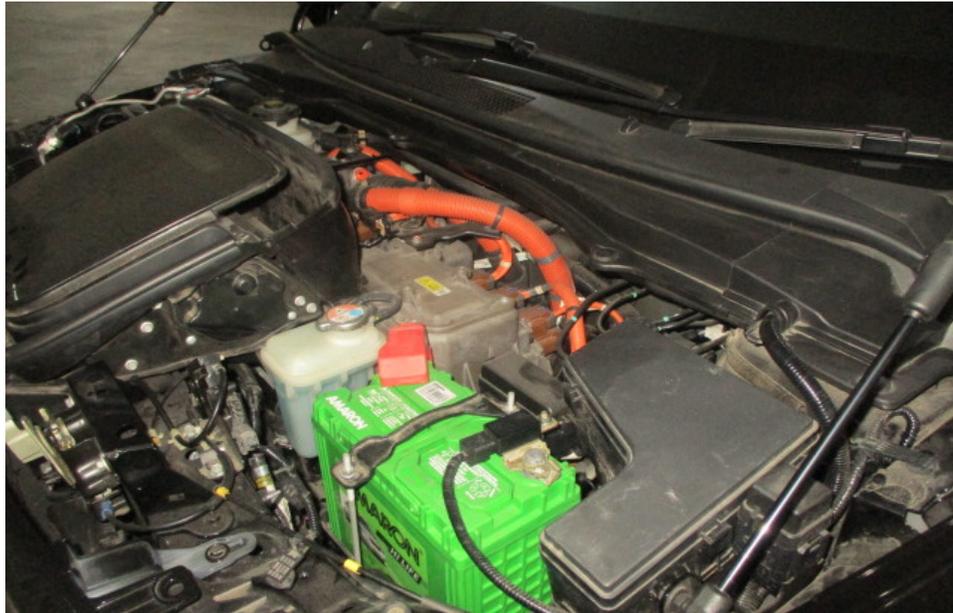
**Photo 16** shows the high voltage compartment of the Motor Car, at the location where the front electric motor is fitted. The high voltage system of the Motor Car was visually checked, and it was observed that the various high voltage parts and components like the high voltage battery, inverter unit, converter unit, high voltage cables, electric motors and electric aircon compressor amongst others, were properly secured and without any physical damage.

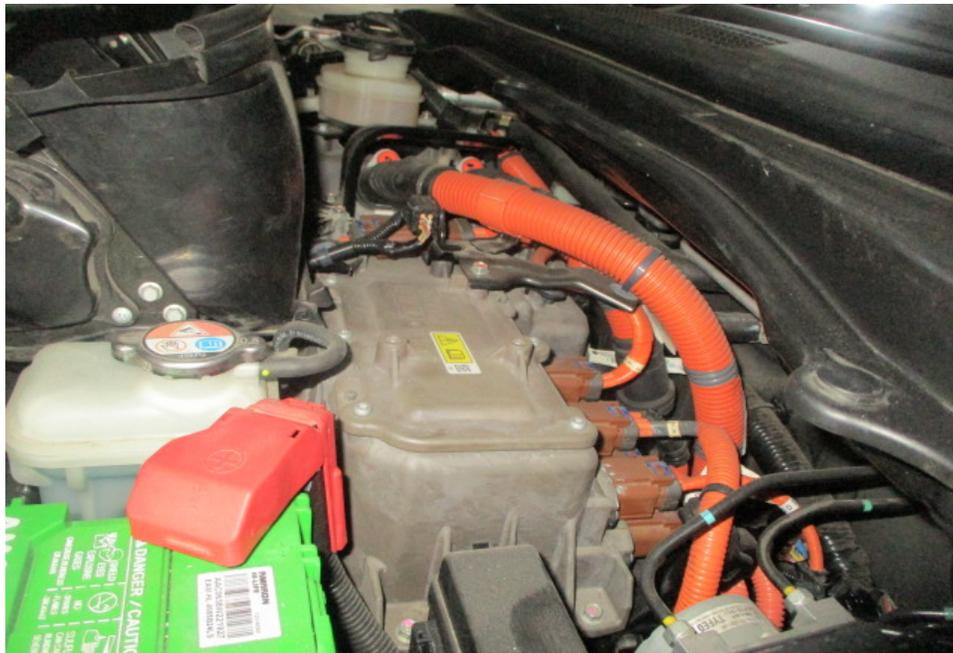
**Photo 17** shows another view of the Motor Car's high voltage compartment, at the location where the front electric motor is fitted. The high voltage system of the Motor Car was visually checked, and it was observed that the various high voltage parts and components like the high voltage battery, inverter unit, converter unit, high voltage cables, electric motors and electric aircon compressor amongst others, were properly secured and without any physical damage.

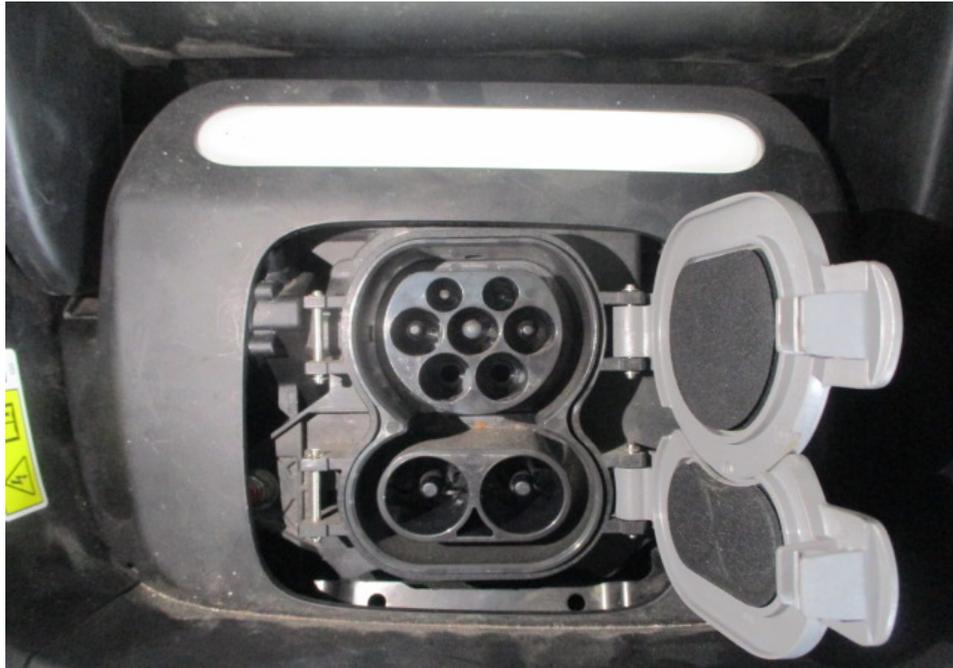
**Photo 18** shows the high voltage charging port of the Motor Car. A Combined Charging Standard 2 (CCS 2) for direct current (DC) charging was fitted within the high voltage compartment of the Motor Car. No physical damage was observed to the charging head.

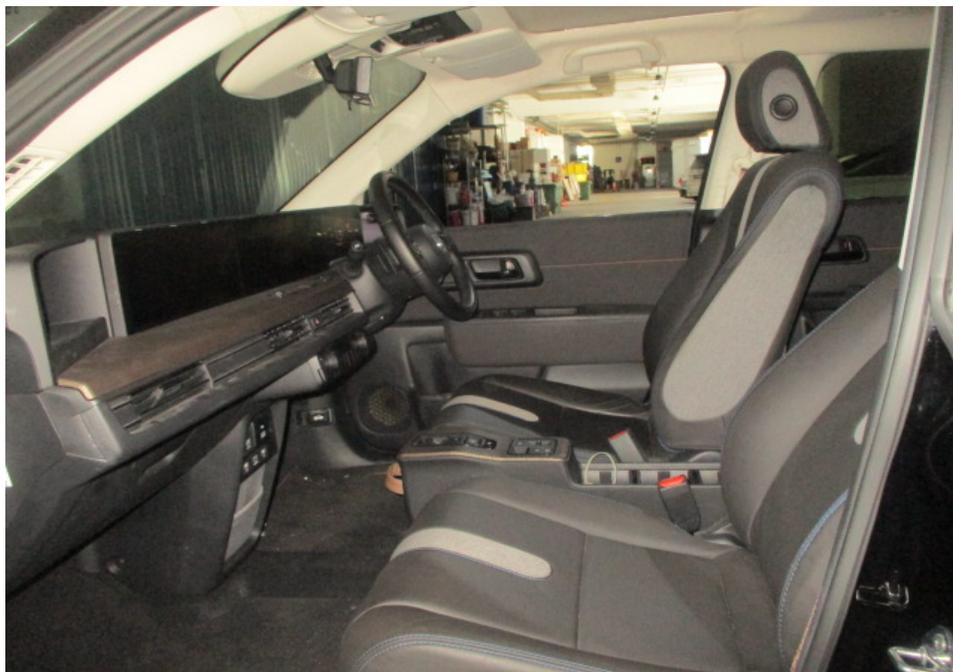
**Photo 19** shows the interior compartment of the Motor Car at the time of my inspection. The various parts and components, trims, carpet, and upholstery inside the interior compartment were all observed to be intact and properly fitted.

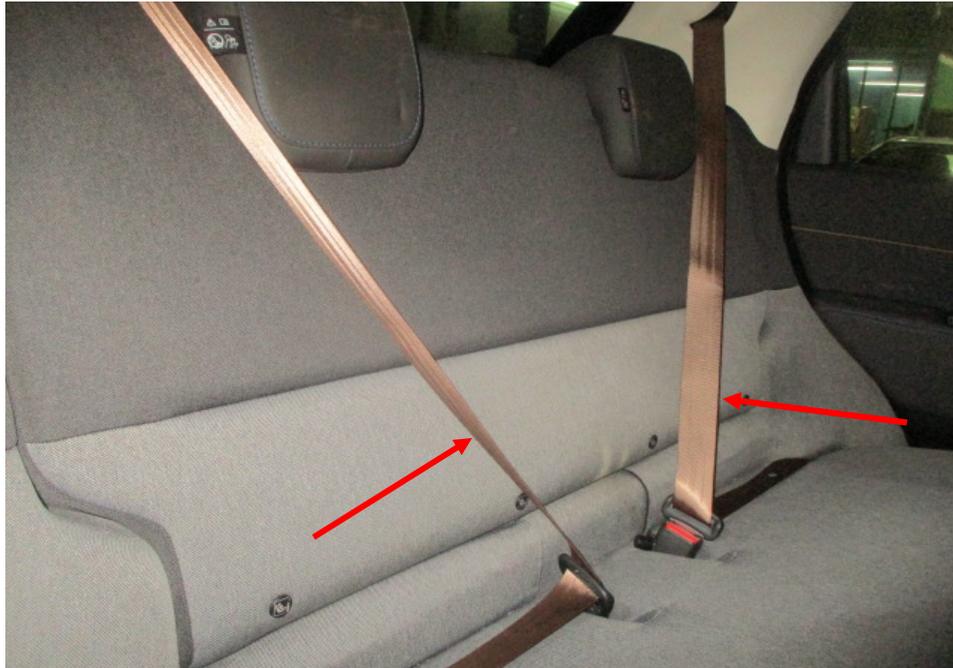
**Photo 20** shows the rear seats of the Motor Car. All the seats of the Motor Car were secured via seat rails to the floorboard. They were also fitted with a retractable seat belt reel and a pre-tensioner. The seat belts (arrowed) were tested and were able to be fastened into the respective pre-tensions that were fitted on the side of each individual seat.

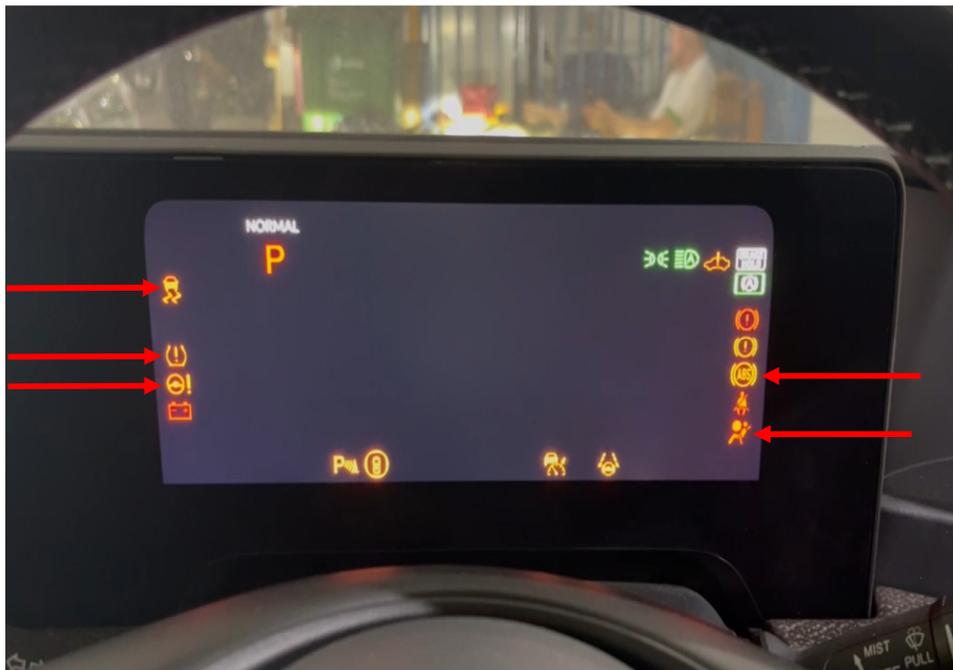
**Photo 21** shows the warning lights for the various electronic safety features appearing on the instrument panel of the Motor Car during its self-test when the engine is cranked, in particular the ABS, SRS, EPS, TPM and TCS lights (arrowed).

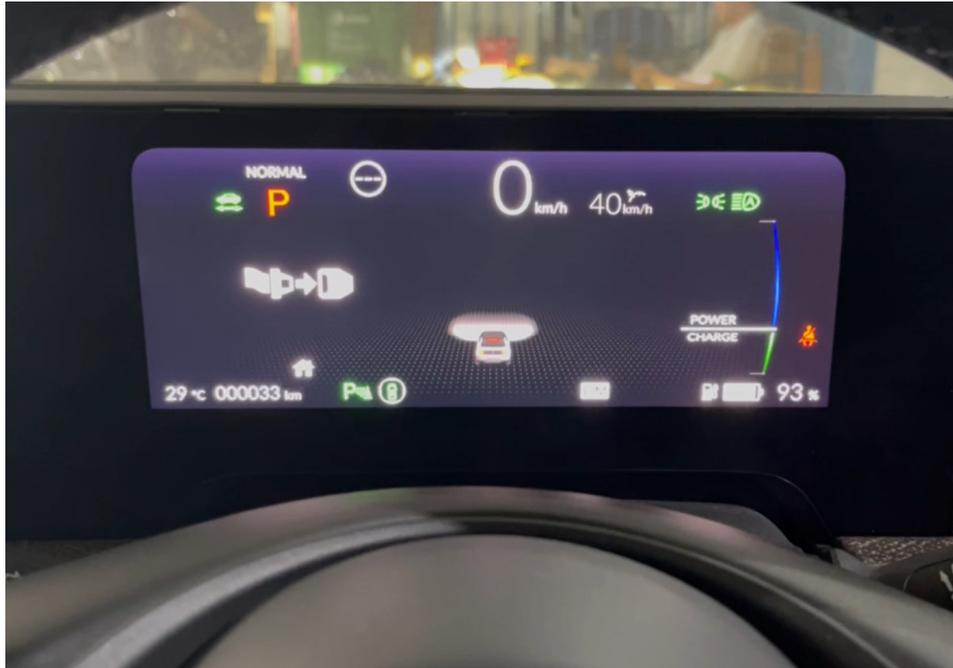
**Photo 22** shows the respective warning lights no longer illuminated, indicating that there is no fault detected to the ABS, SRS, EPS, TPM and TCS systems of the Motor Car during the self-test. These electronic systems were hence in working condition at the time of my inspection.

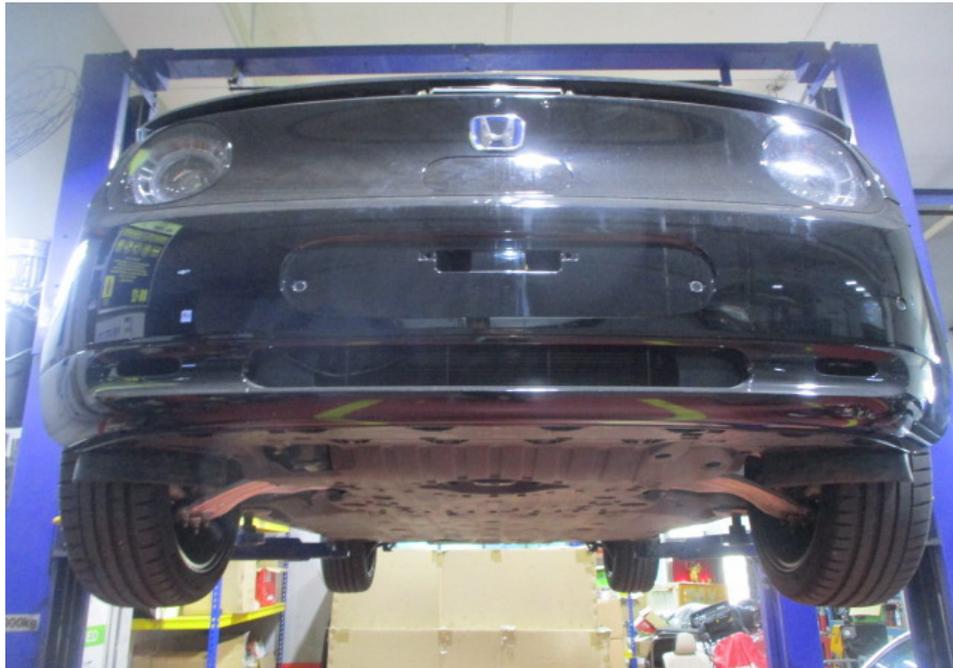
**Photo 23** shows the Motor Car hoisted up for checks on its undercarriage. There was no sign(s) or indication(s) of fluid leakage and/or fluid stain(s) on the underside of the Motor Car. The undercarriage components of the Motor Car were also all observed to be intact and secured in an appropriate manner.

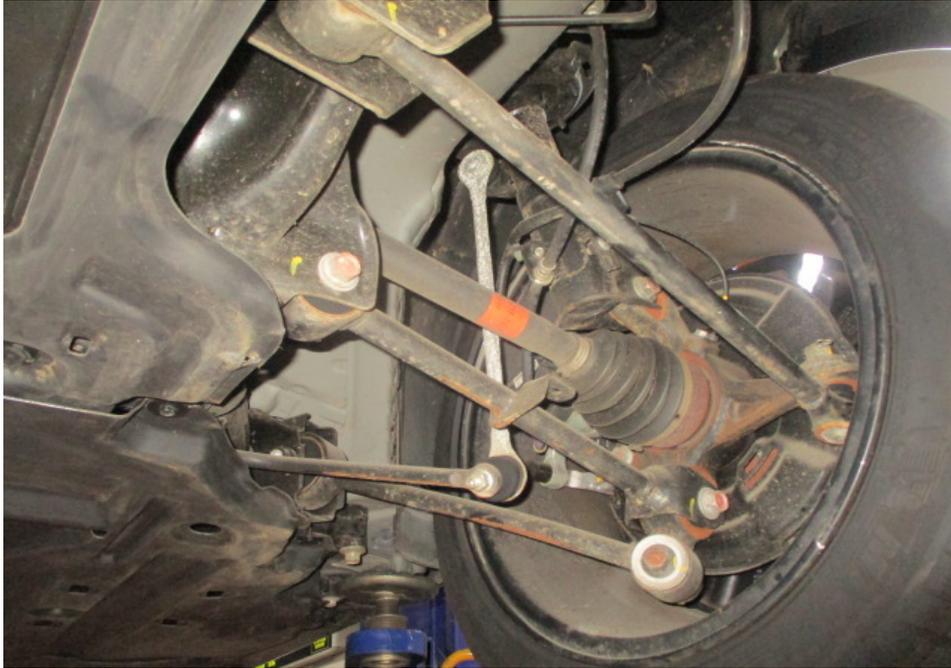
**Photo 24** shows a general view of the control arms and linkages at the rear right wheel of the Motor Car. I did not observe any fluid leak and/or fluid stain on the underside of the Motor Car. All of the Motor Car's undercarriage components were observed to be intact and secured in an appropriate manner.

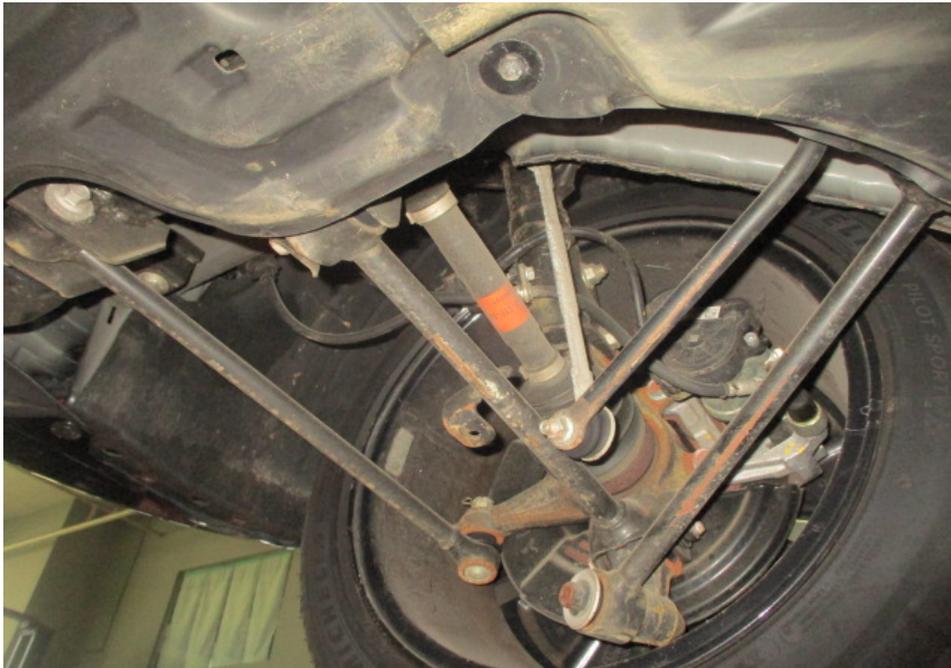
**Photo 25** shows a general view of the control arms and linkages at the rear left wheel of the Motor Car. I did not observe any fluid leak and/or fluid stain on the underside of the Motor Car. All of the Motor Car's undercarriage components were observed to be intact and secured in an appropriate manner.

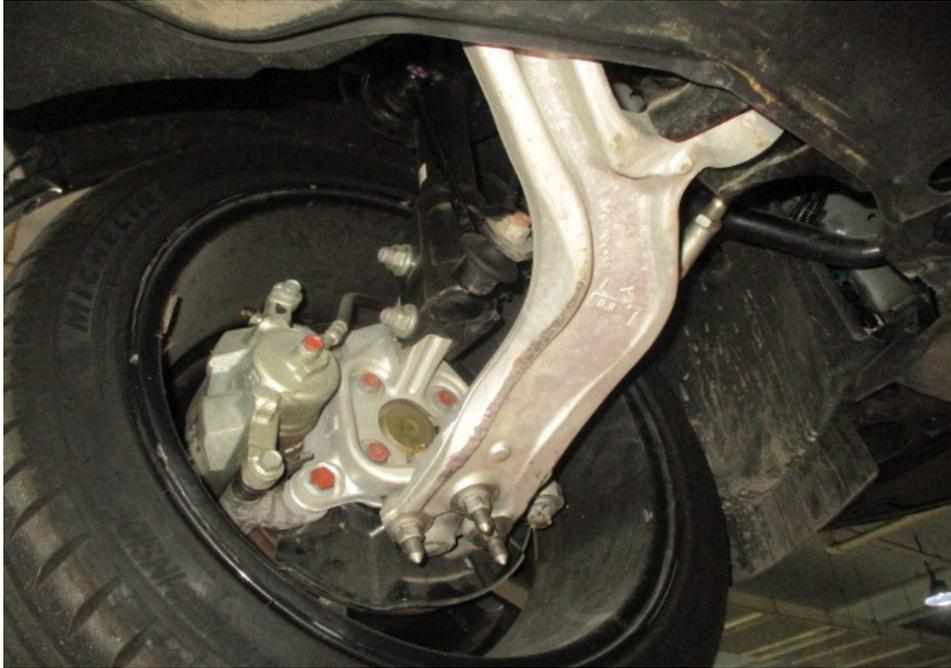
**Photo 26** shows the various undercarriage components at the front left wheel of the Motor Car. The mechanical components, control arms and linkages were all found to be intact and secured in an appropriate manner.

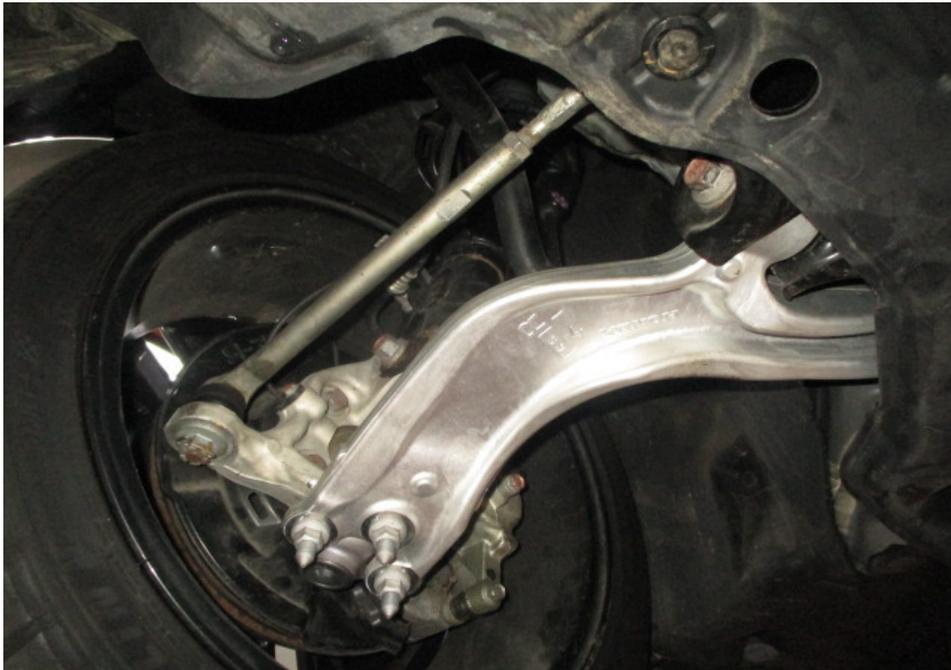
**Photo 27** shows the various undercarriage components at the front right wheel of the Motor Car. The mechanical components, control arms and linkages were all found to be intact and secured in an appropriate manner. I also did not observe any fluid leak and/or fluid stain on the underside of the Motor Car.

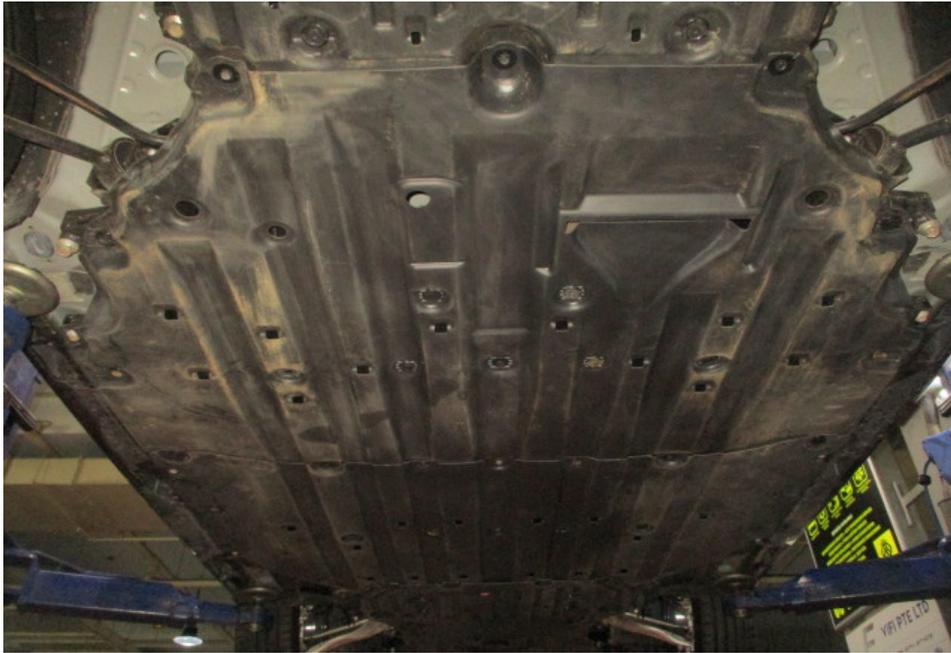
**Photo 28** shows the underside centre of the Motor Car, at the location where the high voltage battery is fitted. The high voltage system of the Motor Car was visually checked, and it was observed that the various high voltage parts and components like the high voltage battery, inverter unit, converter unit, high voltage cables, electric motors and electric aircon compressor amongst others, were properly secured and without any physical damage.

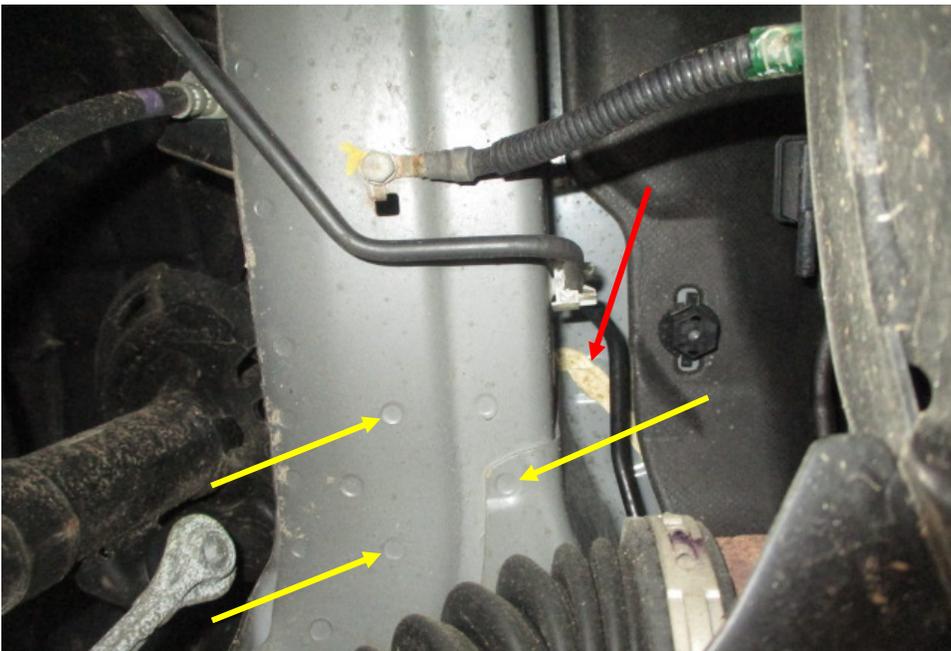
**Photo 29** shows the chassis/structural body at the underside rear right of the Motor Car. I did not find any weld marks other than original spot weld marks (yellow arrow) on the chassis/structural body of the Motor Car. The original factory sealant (red arrow) at the joints along the chassis/structural body was untouched, indicating no work was done on the chassis/structural body of the Motor Car and that the chassis/structural body was originally fitted.

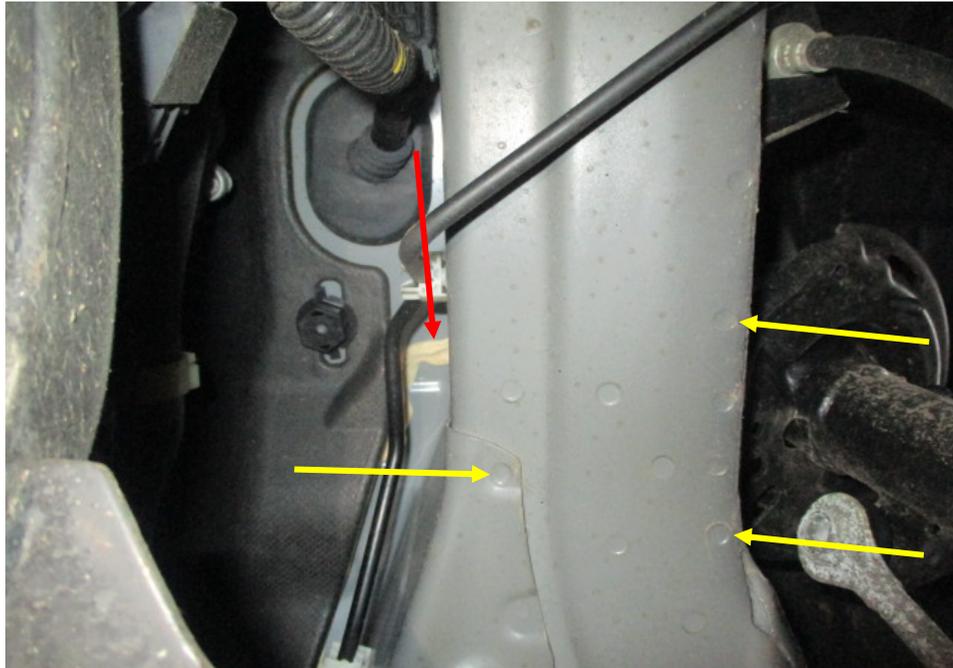
**Photo 30** shows the chassis/structural body at the underside rear left of the Motor Car. I did not find any weld marks other than original spot weld marks (yellow arrow) on the chassis/structural body of the Motor Car. The original factory sealant (red arrow) at the joints along the chassis/structural body was untouched, indicating no work was done on the chassis/structural body of the Motor Car and that the chassis/structural body was originally fitted.
