Your Ref: Honda E Electric  
(chassis number JHMZC7840LX200927)  
Our Ref : CI/TP23006280/D

22 June 2023

**INSPECTION REPORT OF AN UNREGISTERED HONDA E ELECTRIC MOTOR CAR WITH CHASSIS NUMBER JHMZC7840LX200927**

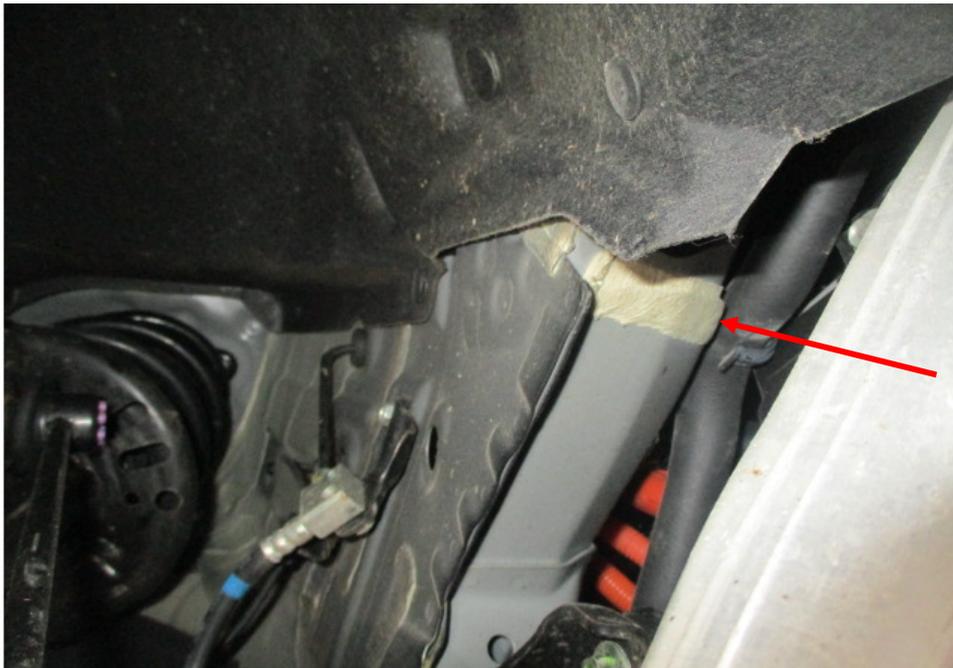
**Photo 31** shows the chassis/structural body at the underside front left of the Motor Car. The original factory sealant (arrowed) at the joints along the chassis/structural body was observed to be untouched. In general, I had found no work was carried out on the chassis/structural body of the Motor Car. The chassis/structural body of the Motor Car was originally fitted.

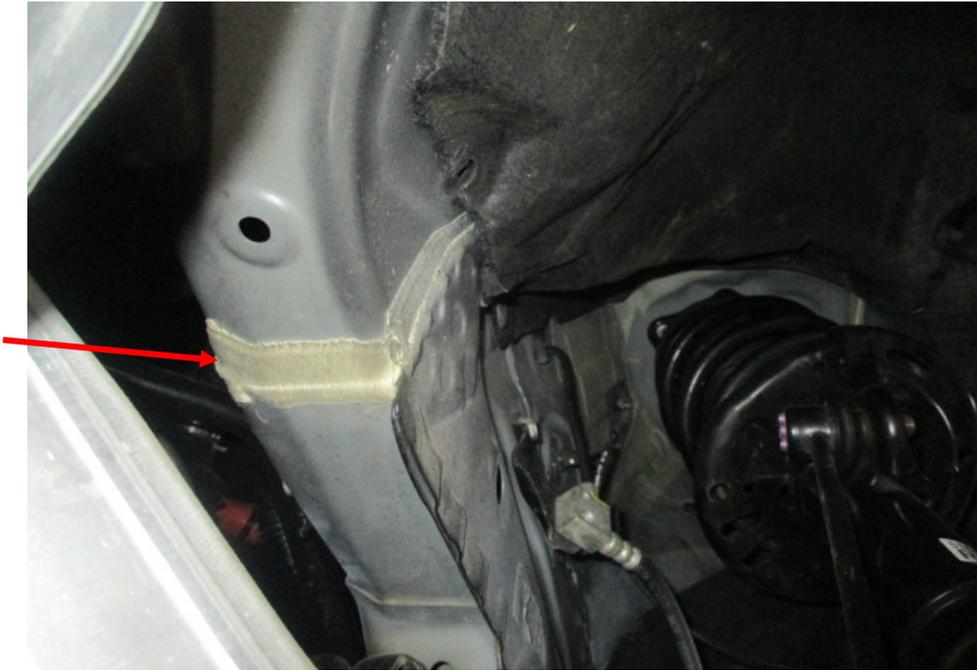
**Photo 32** shows the chassis/structural body at the underside front right of the Motor Car. The original factory sealant (arrowed) at the joints along the chassis/structural body was observed to be untouched. In general, I had found no work was carried out on the chassis/structural body of the Motor Car. The chassis/structural body of the Motor Car was originally fitted.

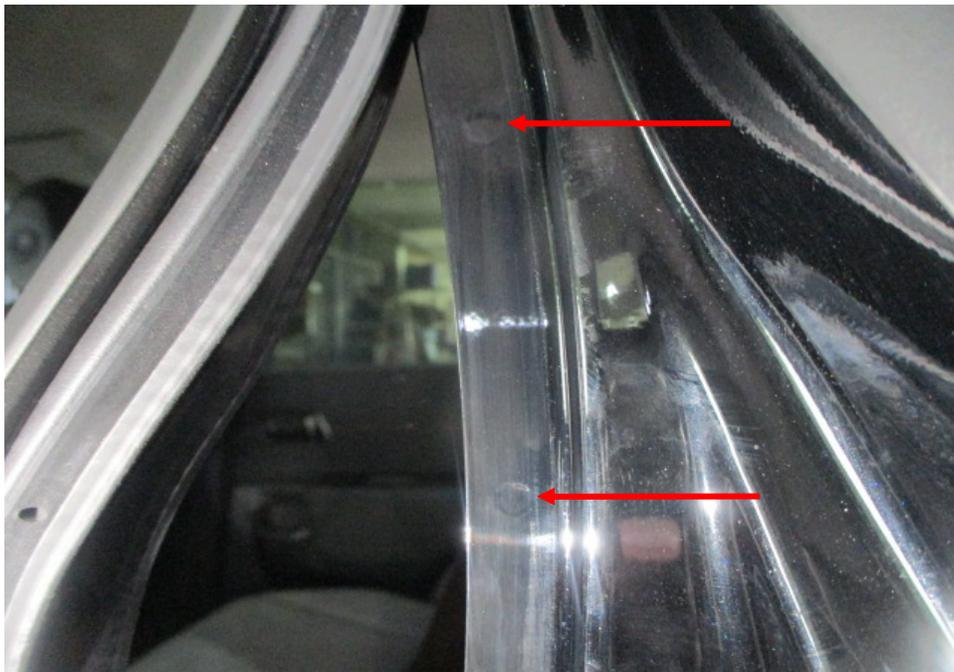
**Photo 33** shows the left side "C" pillar of the Motor Car. I did not find any weld marks other than original spot weld marks (arrowed) on the left side "C" pillar of the Motor Car, which indicates that there was no re-welding works carried out. In general, I had found all the non-detachable body panels of the Motor Car to be originally fitted at the time of my inspection.

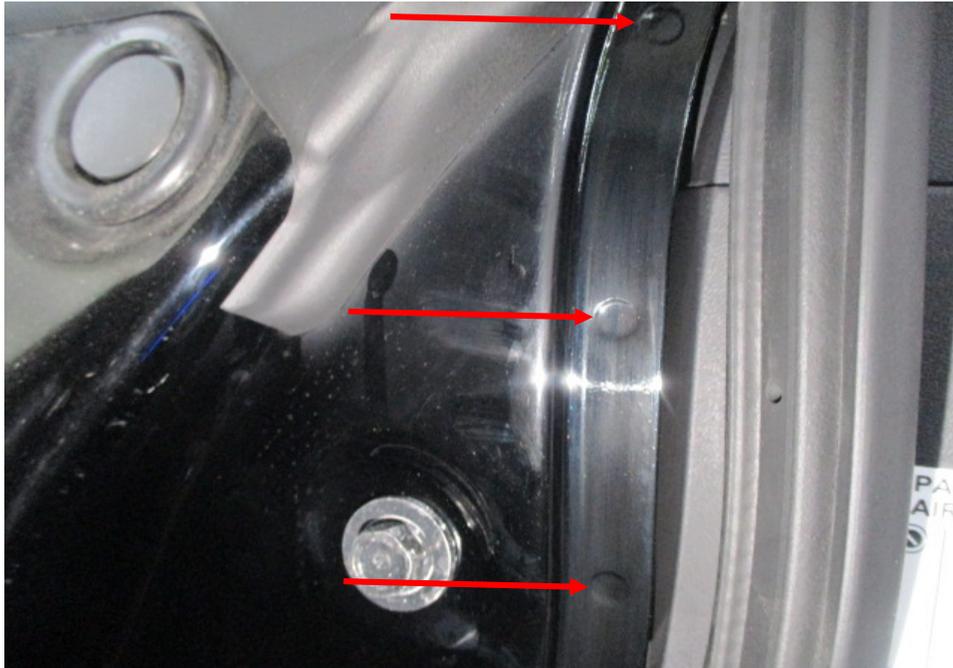
**Photo 34** shows the left side "A" pillar of the Motor Car. I did not find any weld marks other than original spot weld marks (arrowed) on the left side "A" pillar of the Motor Car, which indicates that there was no re-welding works carried out. In general, I had found all the non-detachable body panels of the Motor Car to be originally fitted at the time of my inspection.

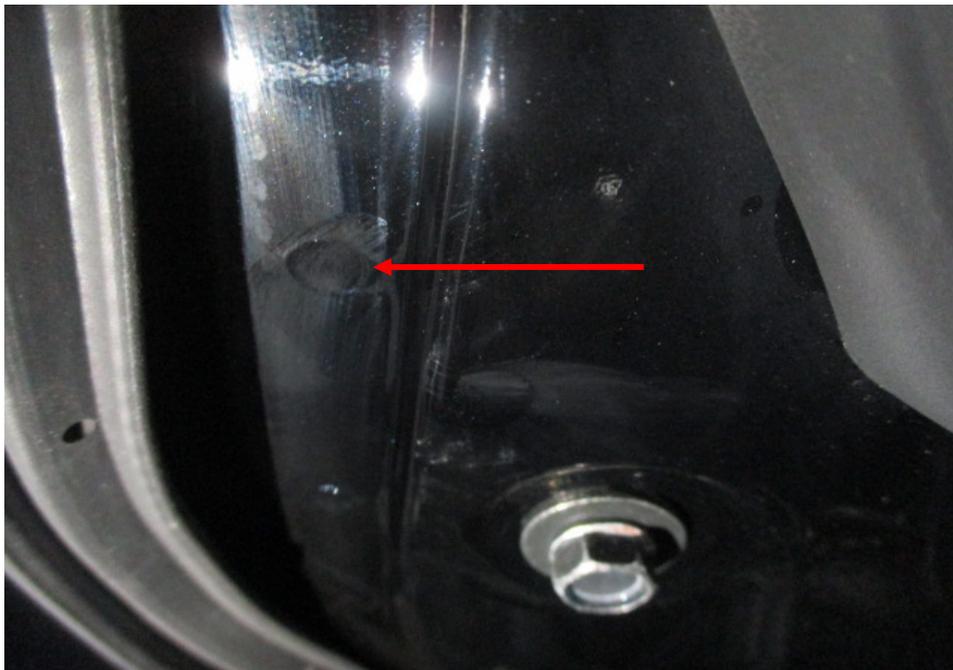
**Photo 35** shows the right side "A" pillar of the Motor Car. I did not find any weld marks other than original spot weld marks (arrowed) on the right side "A" pillar of the Motor Car, which indicates that there was no re-welding works carried out. In general, I had found all the non-detachable body panels of the Motor Car to be originally fitted at the time of my inspection.

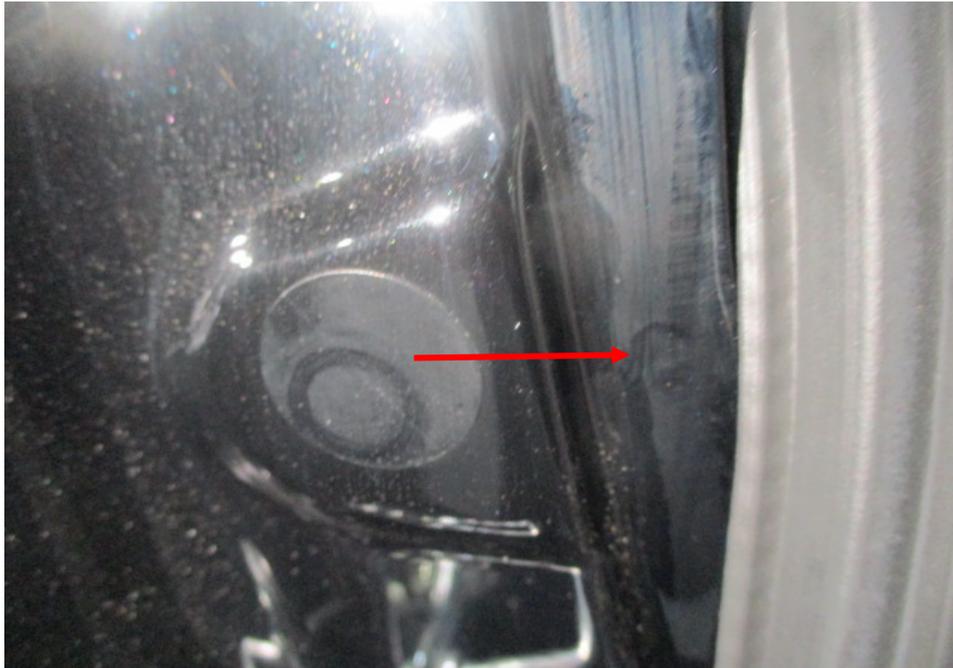
**Photo 36** shows the right side "C" pillar of the Motor Car. I did not find any weld marks other than original spot weld marks (arrowed) on the right side "C" pillar of the Motor Car, which indicates that there was no re-welding works carried out. In general, I had found all the non-detachable body panels of the Motor Car to be originally fitted at the time of my inspection.
