ALLIED AUTO APPRAISAL

Our Ref: Allied/TP/23-02005

Veh No : SMK 1458 U

Make & Model : **Toyota Wish 1.8 Auto**
Engine No : **1ZZ3240064**
Chassis No : **JTDER12WX03003120**

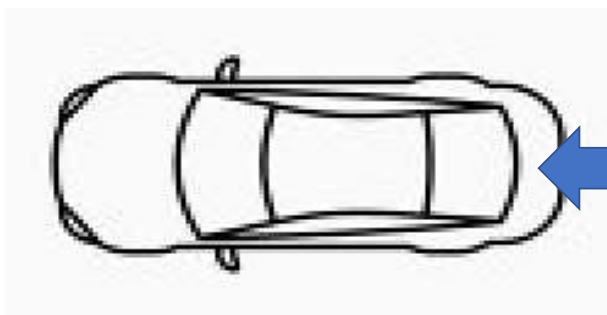
The inspected vehicle sustained damage at the **REAR** portion.

During visual inspection, our surveyor noted that the tailgate, rear end panel, rear fender panel, rear bumper and among other parts were affected.
