NCVI INVOLVING HIACE GBL1561D & CARPARK PILLAR ON 130623 AT AROUND 2145HRS AT HIGH STREET CENTRE MULTI-STOREY CARPARK

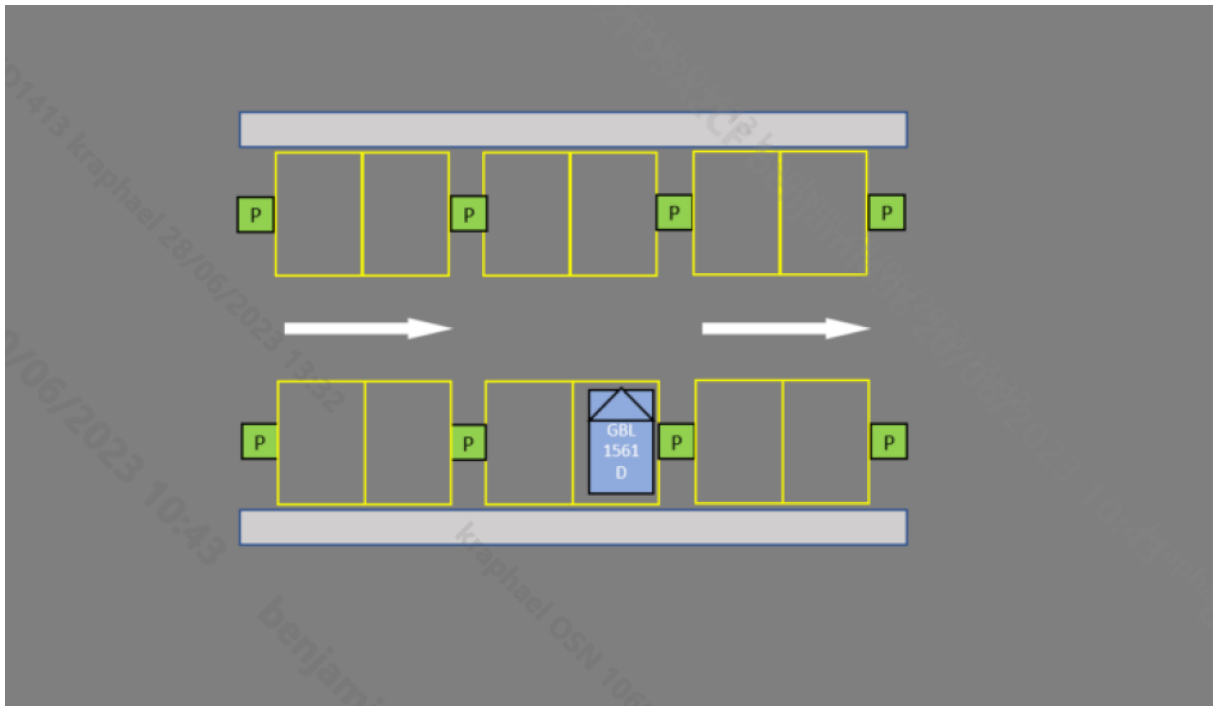
Figure A-1: Schematic of Incident

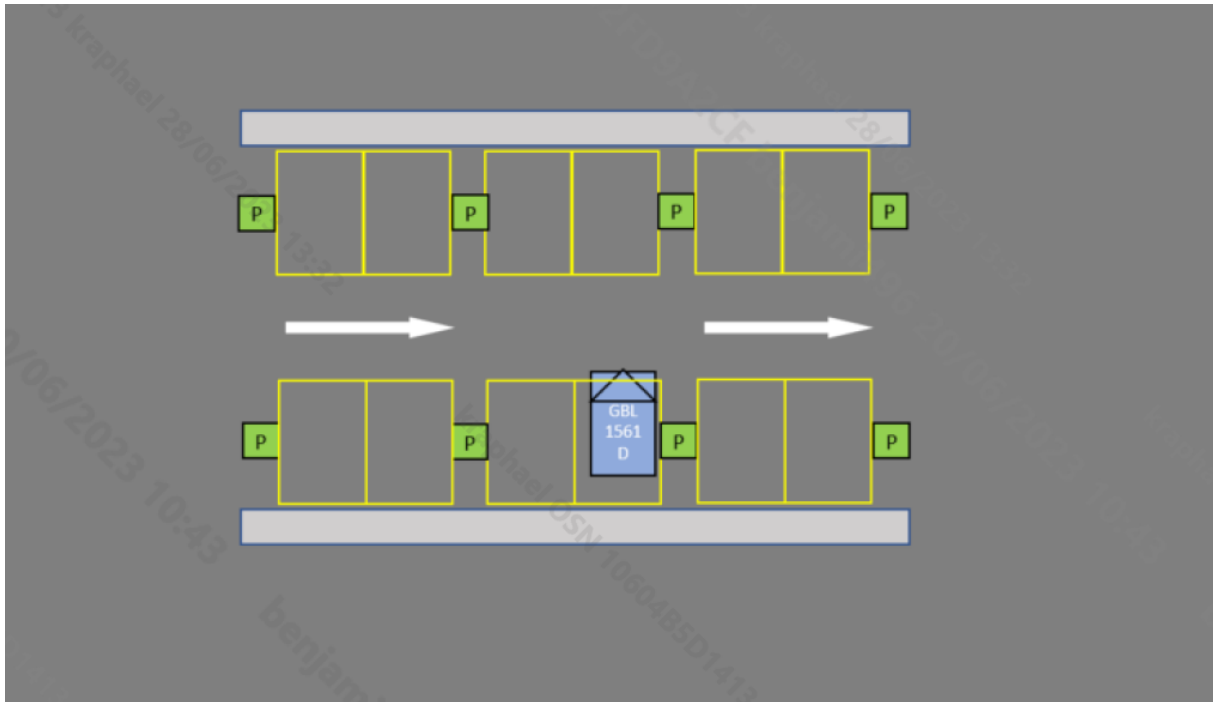
Figure A-2: Schematic of Incident

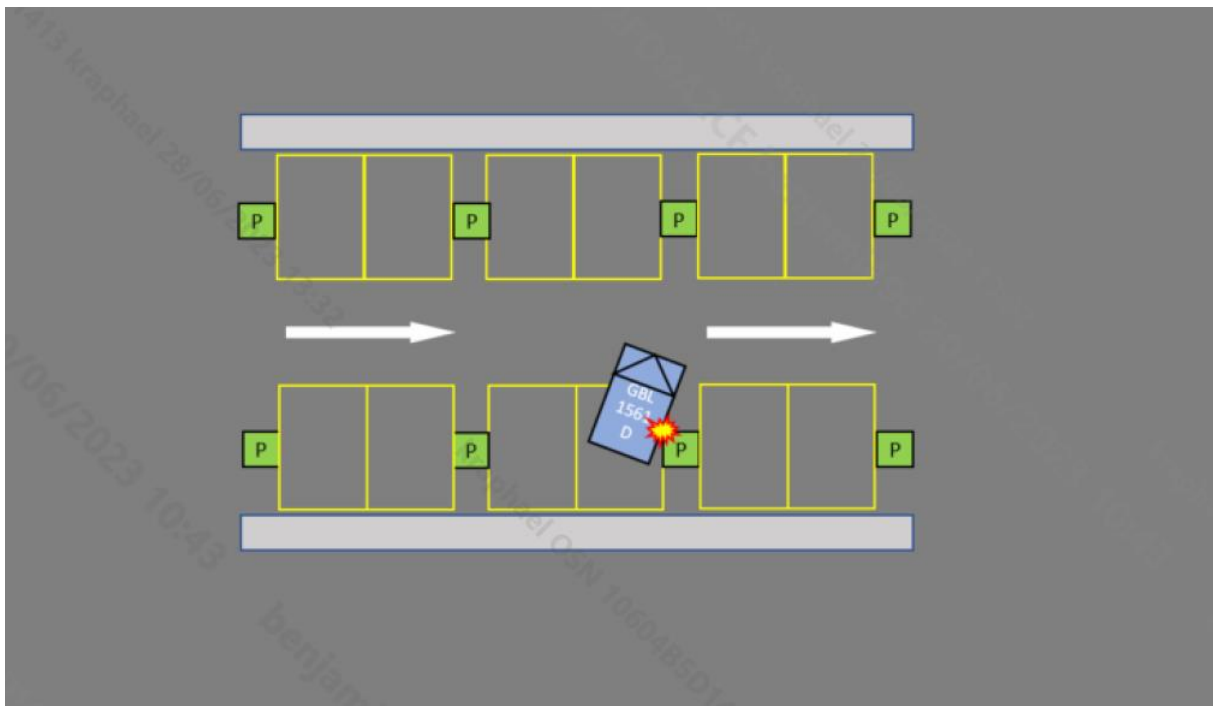
Figure A-3: Schematic of Incident

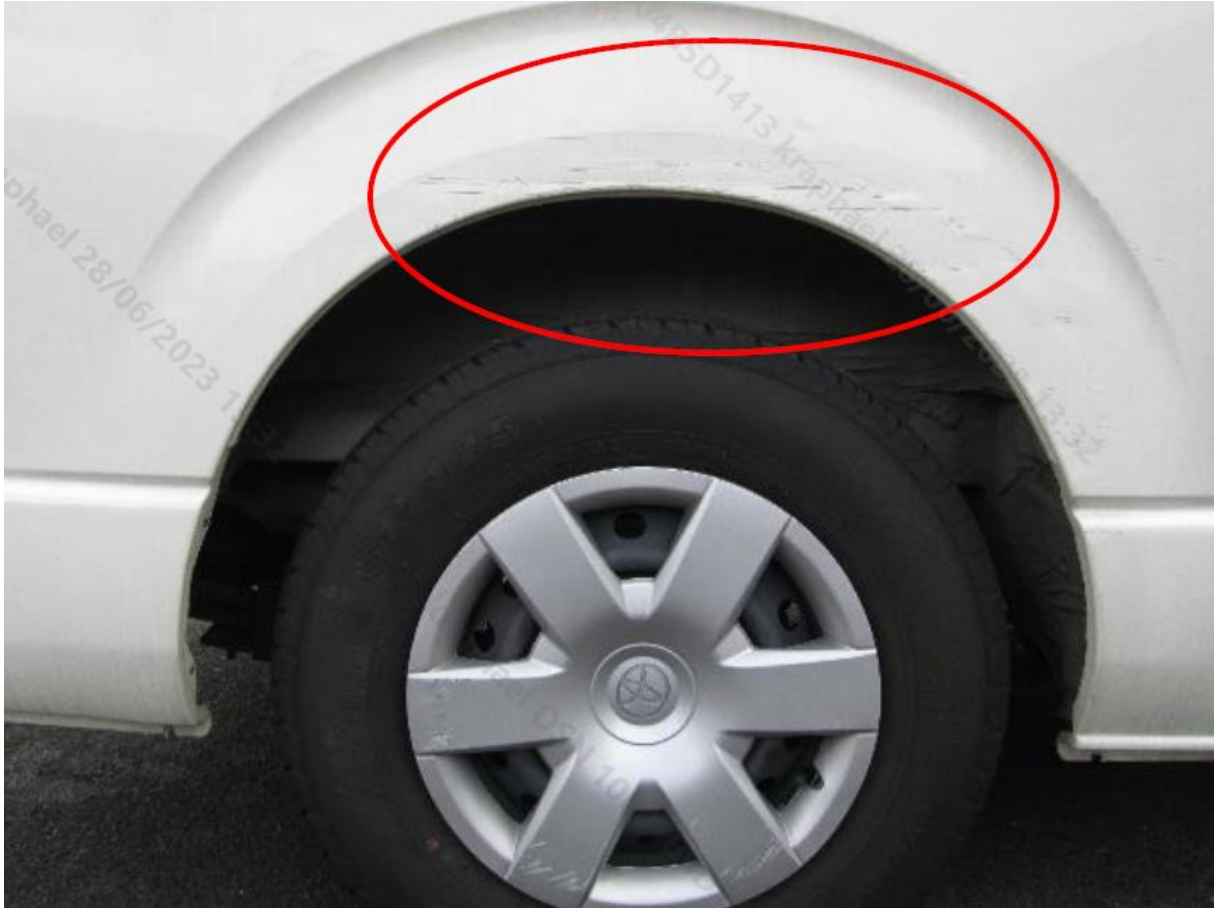
Figure B-5: Damaged Rear RHS Tyre Rim

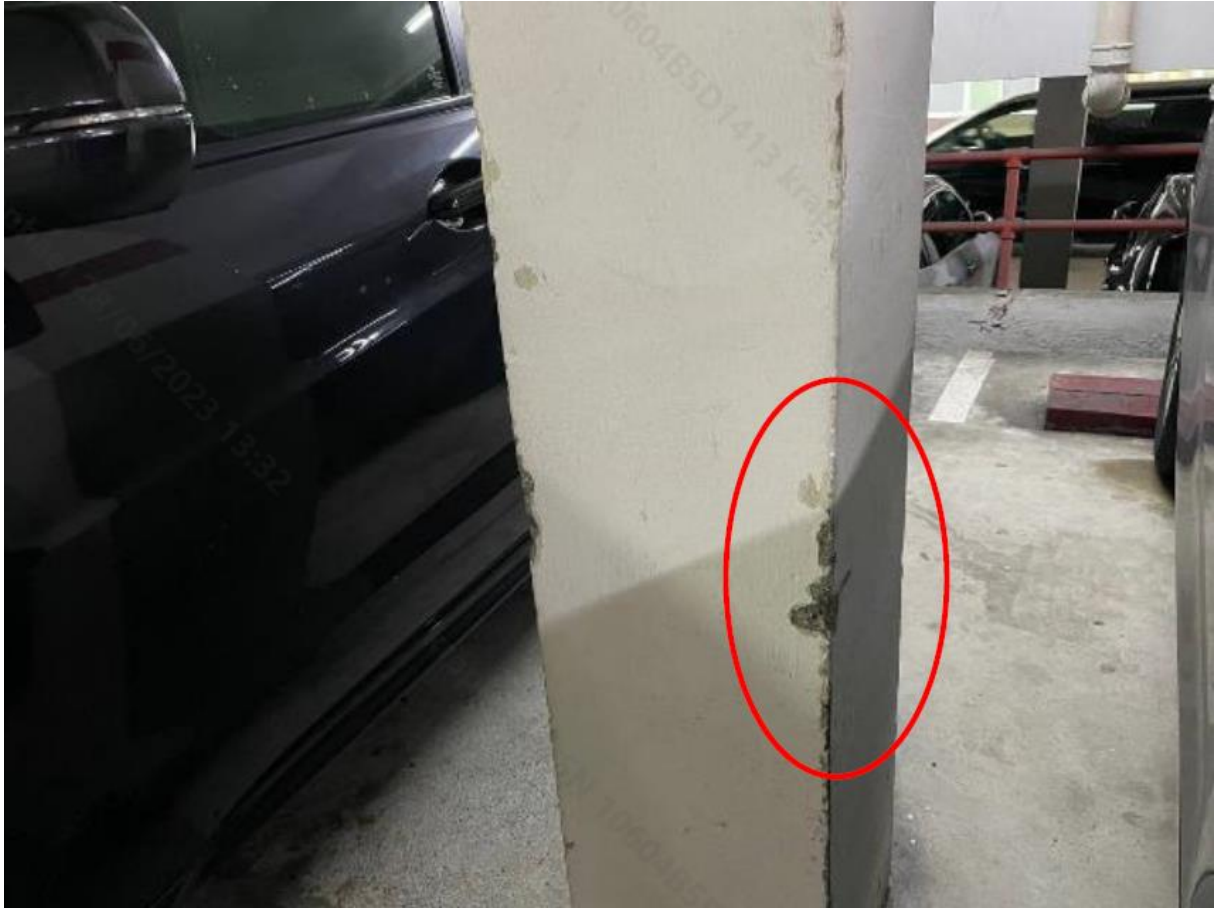
Figure B-6: Damage to Carpark Pillar
