To: TCRP PTE. LTD.
1 Bukit Batok Crescent #04-40
WCEGA Plaza
Singapore 658064

| Ref No | : 2023/06087 | Date of Report | : 10/7/2023 |
| Insured Vehicle | : SMQ5938T | Date of Inspection | : 28/6/2023 |

| Model / Make | : Mercedes C180 CGI | Pre-accident damage | : NIL |

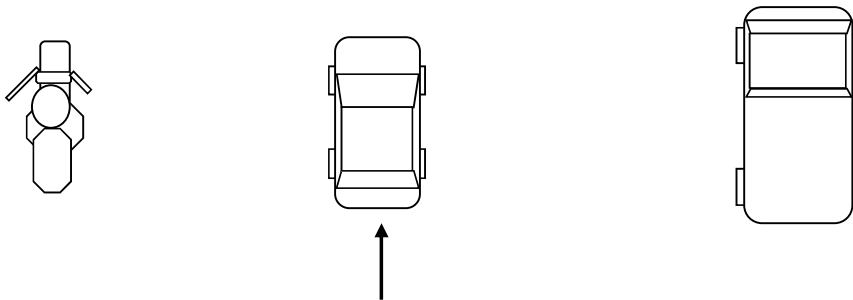
At the time of inspection, this vehicle sustained damages to the **Rear portion**.

Rear bumper dented, rear end panel push in etc.

We have not authorised repair. Under normal circumstances, estimated 4 working days are required to repair the vehicle.
