Your Ref: Porsche Cayenne  
(chassis number WP1ZZZ9YZLDA30922)  
Our Ref : CI/TP23006612/D

03 July 2023

**INSPECTION REPORT OF AN UNREGISTERED PORSCHE CAYENNE  
MOTOR CAR WITH CHASSIS NUMBER WP1ZZZ9YZLDA30922**

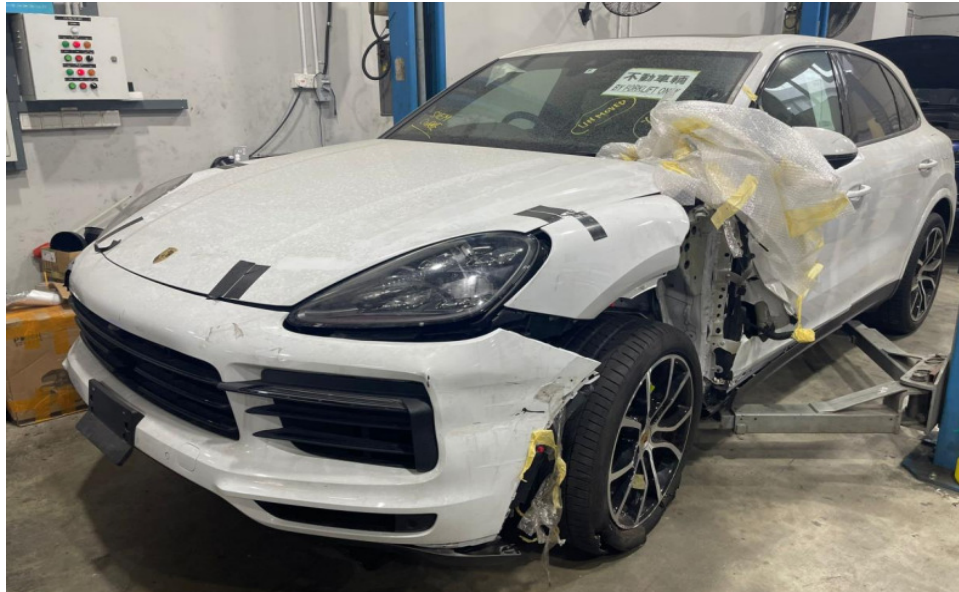
**Photo 1** shows the front left body of the Motor Car (photograph provided to me). The photographs provided to me had showed damage to the left front portion of the Motor Car. The front bumper, front bumper lower cover, front bumper left bracket, front left fender, front left fender wheel arc garnish, front left fender inner shield, front left wheel rim, front left tyre, front left "A" pillar, front left door, front left door hinges and left side rocker panel garnish were amongst the body parts that were observed to have been damaged. The airbag(s) of the Motor Car was not deployed.

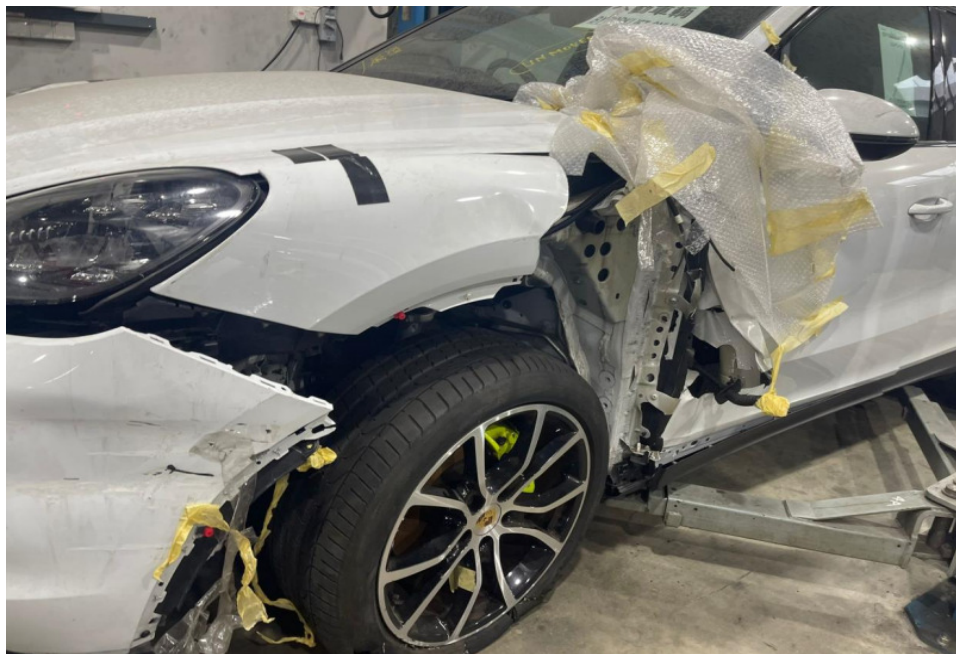
**Photo 2** shows a closer view of the damage at the left front portion of the Motor Car (photograph provided to me). The front bumper, front bumper left bracket, front left fender, front left fender wheel arc garnish, front left fender inner shield, front left wheel rim, front left tyre, front left "A" pillar, front left door, front left door hinges and left side rocker panel garnish were amongst the body parts that were observed to have been damaged.

22. The body parts at the left front portion of the Motor Car were visually examined and it was noted that the repair/restoration works carried out to the damaged area of the Motor Car (refer to photograph 1 & 2 above) were reasonably adequate and in order.

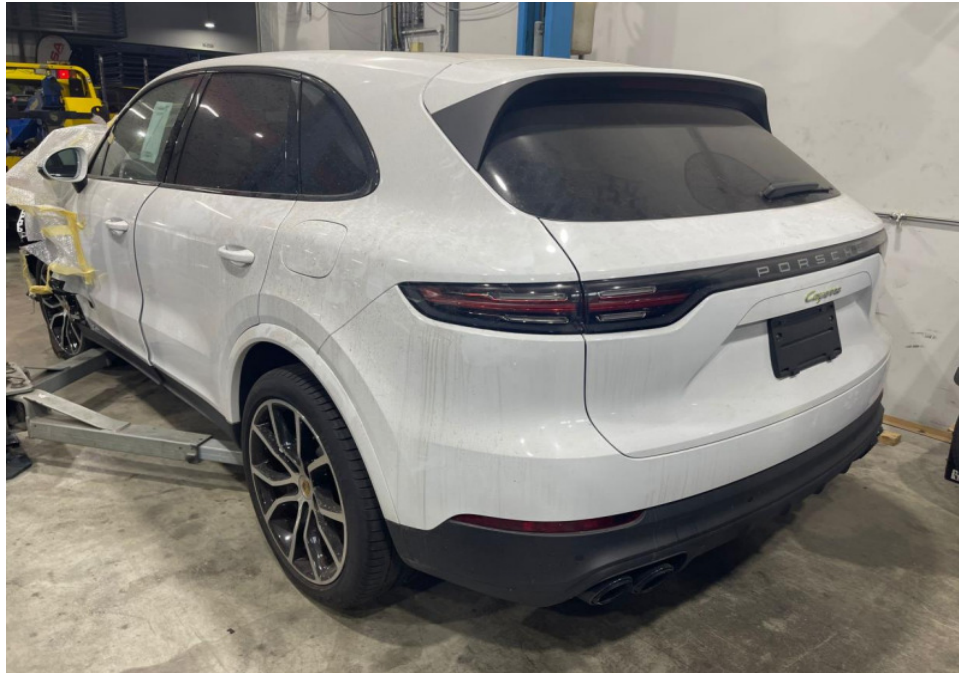
**Photo 3** shows the rear left body of the Motor Car (photograph provided to me). Apart for the left front portion, there was no physical damage observed to other areas of the Motor Car.

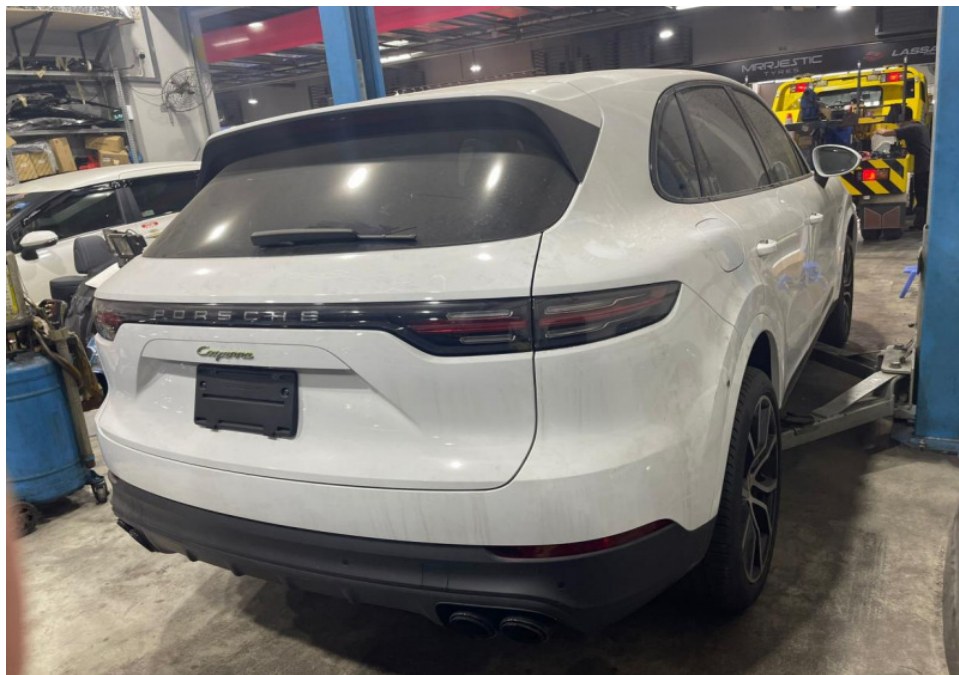
**Photo 4** shows the rear right body of the Motor Car (photograph provided to me). Apart for the left front portion, there was no physical damage observed to other areas of the Motor Car.

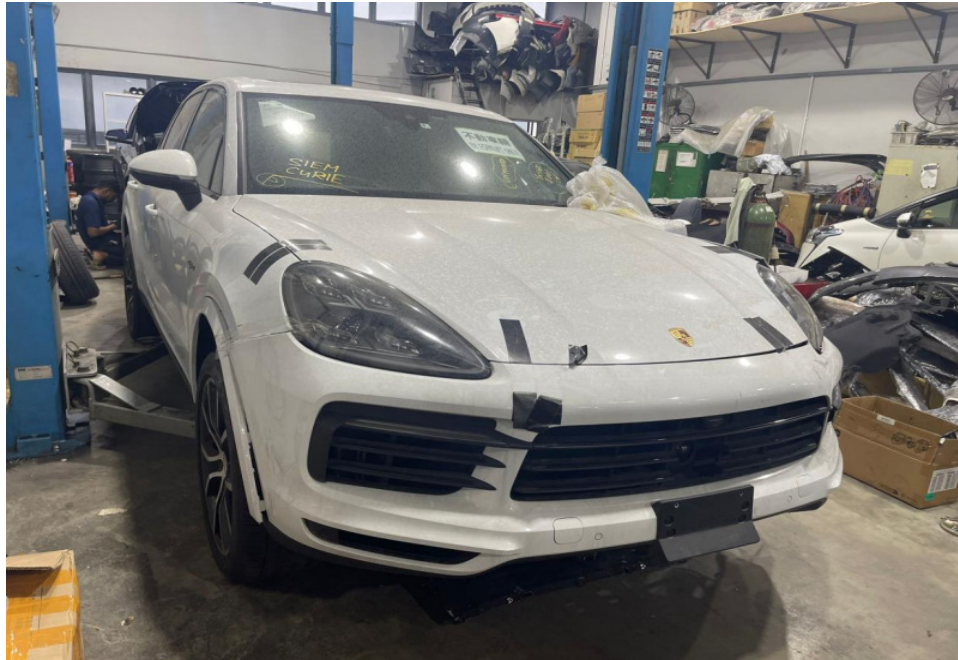
**Photo 5** shows the front right body of the Motor Car (photograph provided to me). Apart for the left front portion, there was no physical damage observed to other areas of the Motor Car. The airbag(s) of the Motor Car was not deployed.

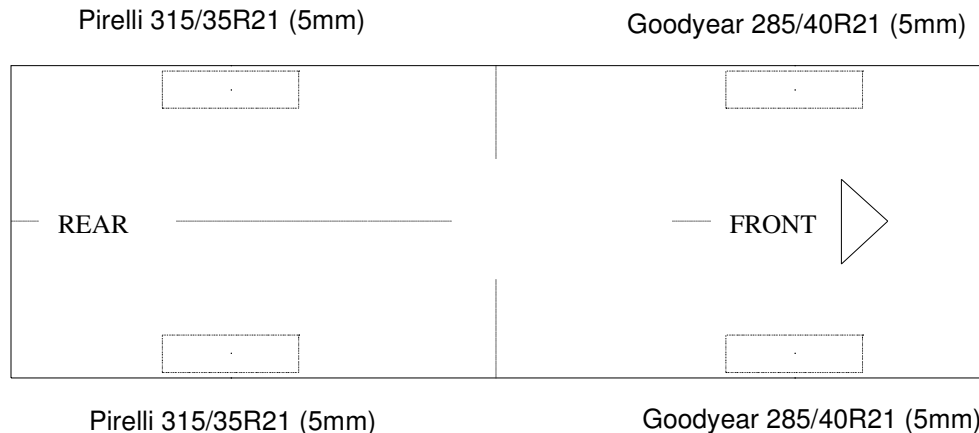
8. It was fitted with 21inch sport wheel rims that were wrapped with tyres that were observed to be of serviceable condition. The tyres were also sufficiently inflated for vehicular operation. The tyre brand, tyre size and approximate remaining tread depth of the 4 tyres of the Motor Car were recorded as follows: -

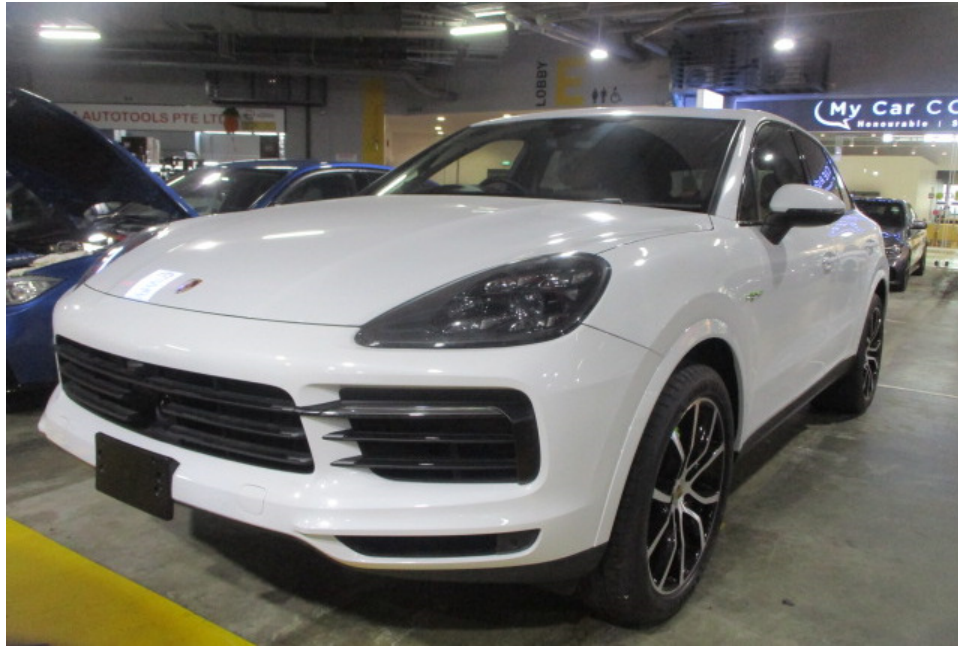
**Photo 6** shows a general view of the front left body of the Motor Car at the time of my inspection. The Motor Car was observed to be in a relatively good general condition with no loose exterior fittings observed. The body parts at the left front portion of the Motor Car were visually examined and it was observed that the repair/restoration works carried out to the damaged area of the Motor Car (refer to photograph 1 & 2 above) were reasonably adequate and in order.

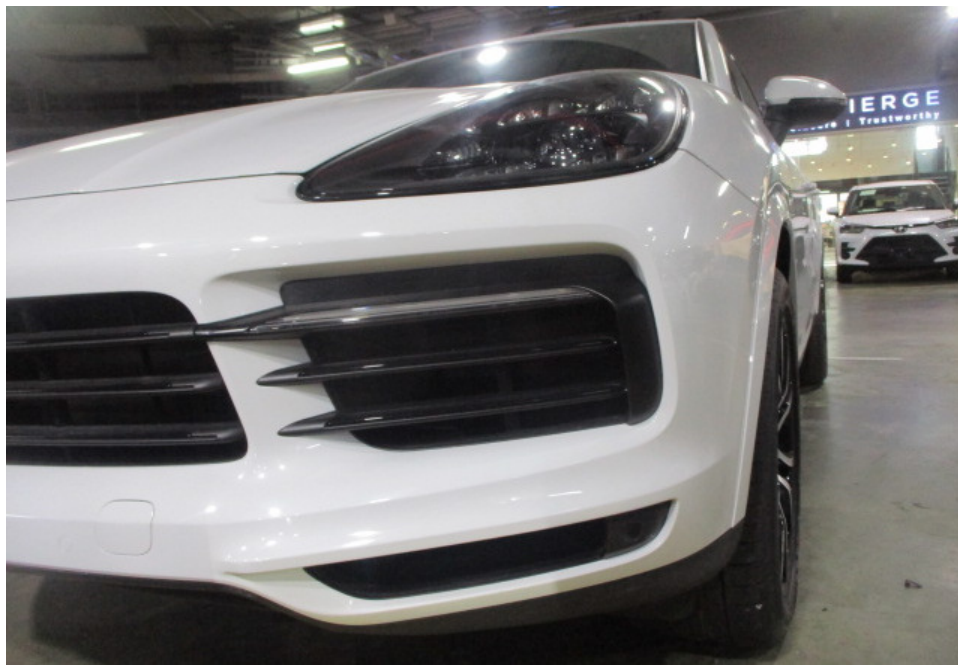
**Photo 7** shows a closer view of the Motor Car's front bumper, front bumper lower cover, front bumper left upper grille, front bumper left lower grille, front left day light and front left headlamp. The body parts at the left front portion of the Motor Car were visually examined and it was observed that the repair/restoration works carried out to the damaged area of the Motor Car (refer to photograph 1 & 2 above) were reasonably adequate and in order.

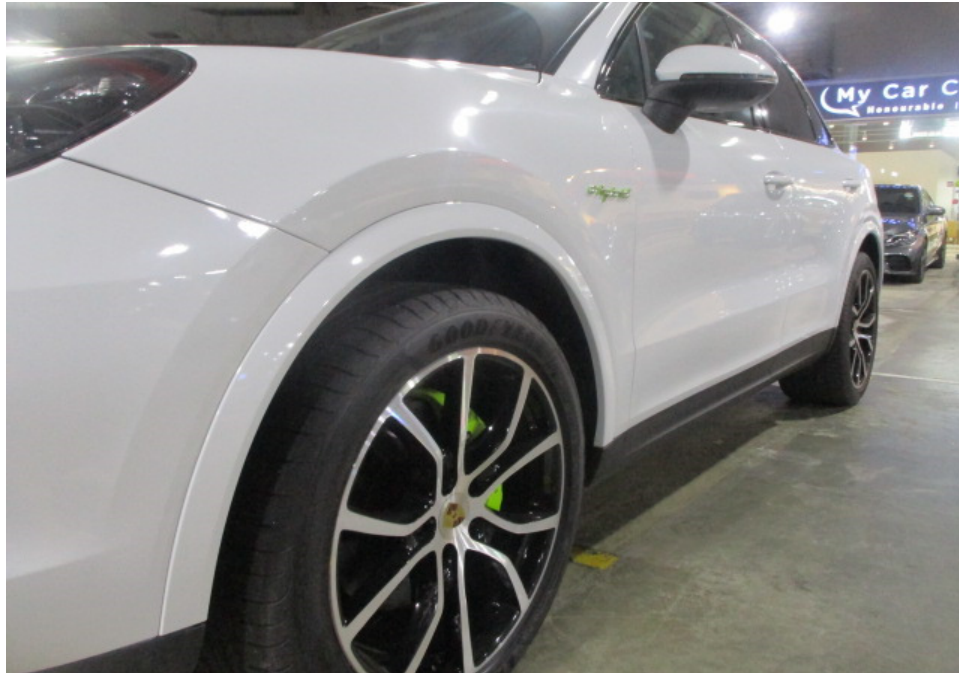
**Photo 8** shows a closer view of the Motor Car's front left fender, front left fender wheel arc garnish, front left wheel rim and front left tyre. The body parts at the left front portion of the Motor Car were visually examined and it was observed that the repair/restoration works carried out to the damaged area of the Motor Car (refer to photograph 1 & 2 above) were reasonably adequate and in order.

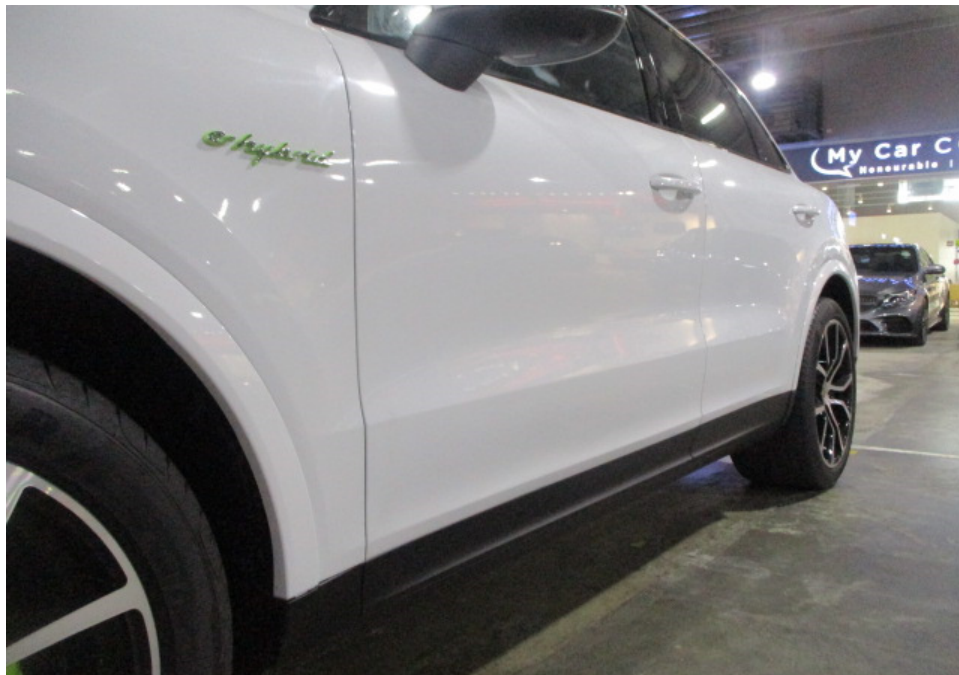
**Photo 9** shows a closer view of the Motor Car's front left fender, front left door and left side rocker panel garnish. The body parts at the left front portion of the Motor Car were visually examined and it was observed that the repair/restoration works carried out to the damaged area of the Motor Car (refer to photograph 1 & 2 above) were reasonably adequate and in order.

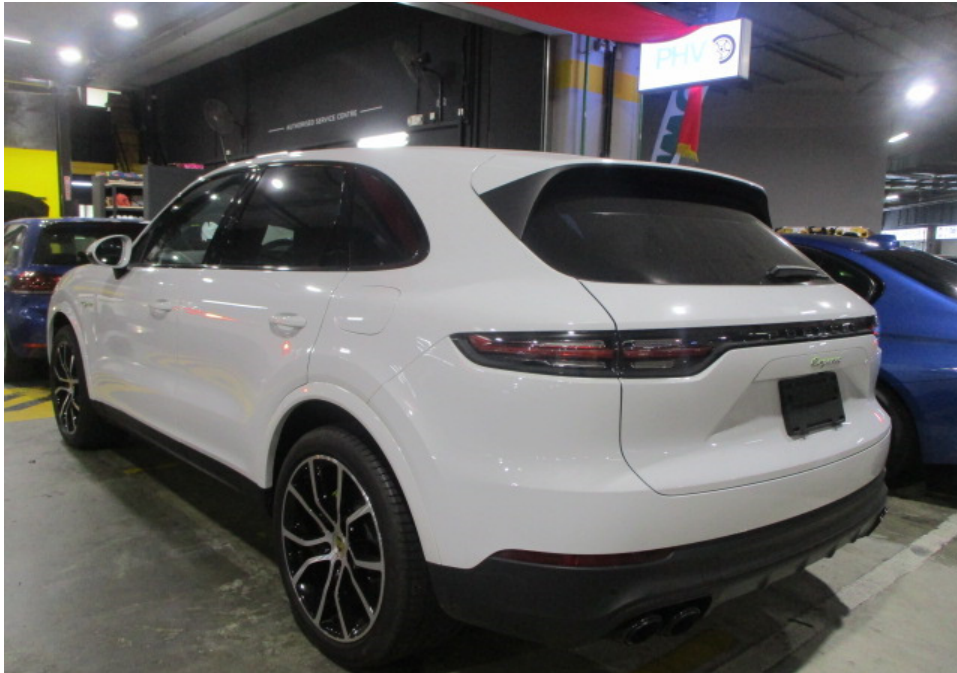
**Photo 10** shows a general view of the rear left body of the Motor Car at the time of my inspection. The Motor Car was observed to be in a relatively good general condition with no loose exterior fittings observed. The mileage of the Motor Car recorded at the time of my inspection was 9,669km.

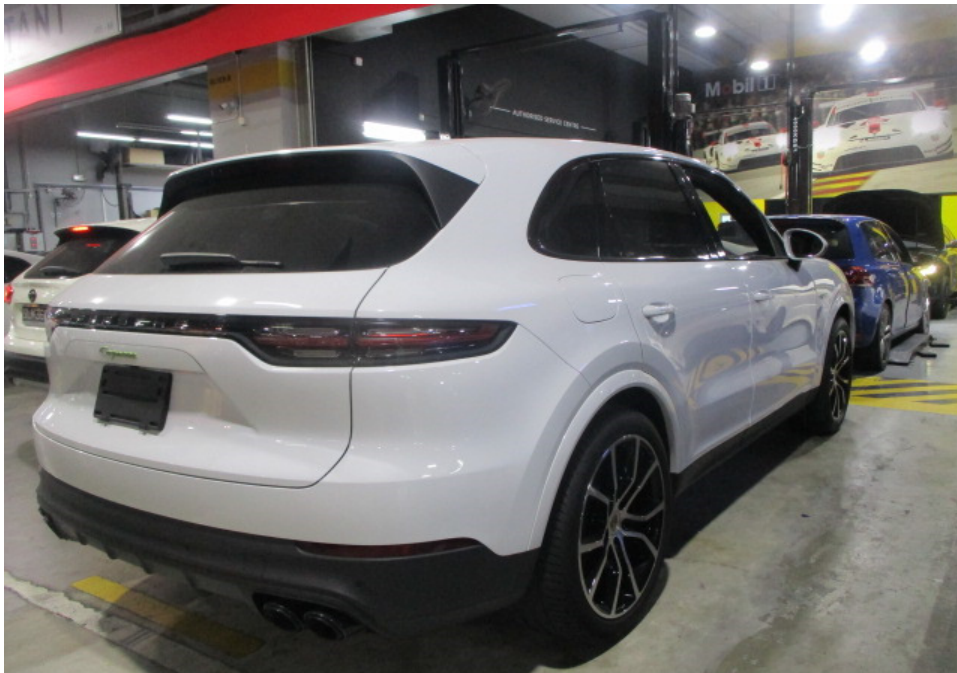
**Photo 11** shows a general view of the rear right body of the Motor Car at the time of my inspection. The Motor Car was observed to be in a relatively good general condition with no loose exterior fittings observed. The mileage of the Motor Car recorded at the time of my inspection was 9,669km.

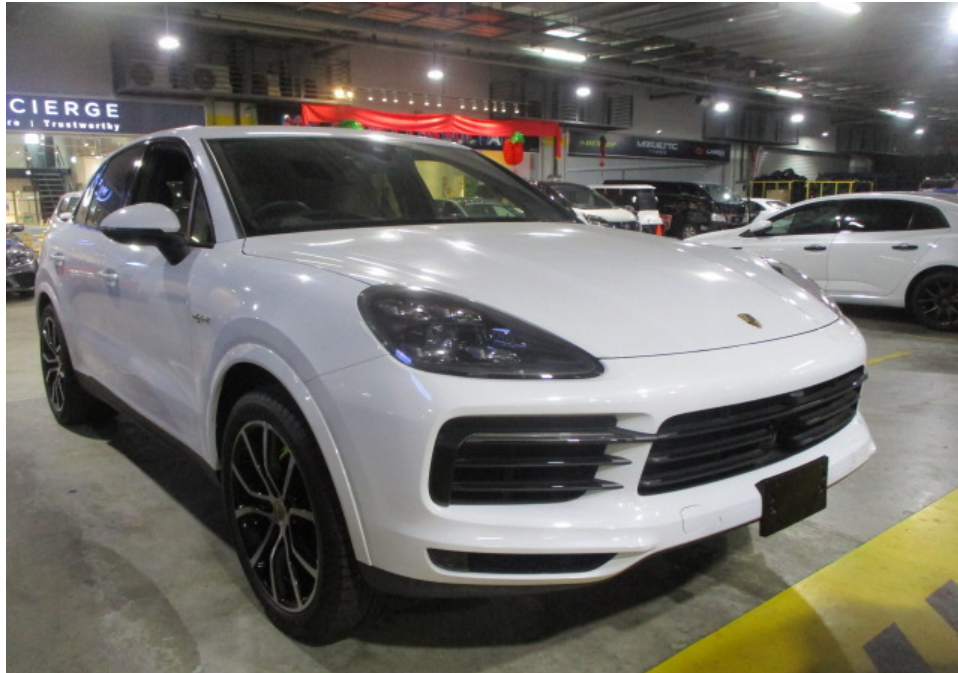
**Photo 12** shows a general view of the front right body of the Motor Car at the time of my inspection. The Motor Car was observed to be in a relatively good general condition with no loose exterior fittings observed. The mileage of the Motor Car recorded at the time of my inspection was 9,669km.

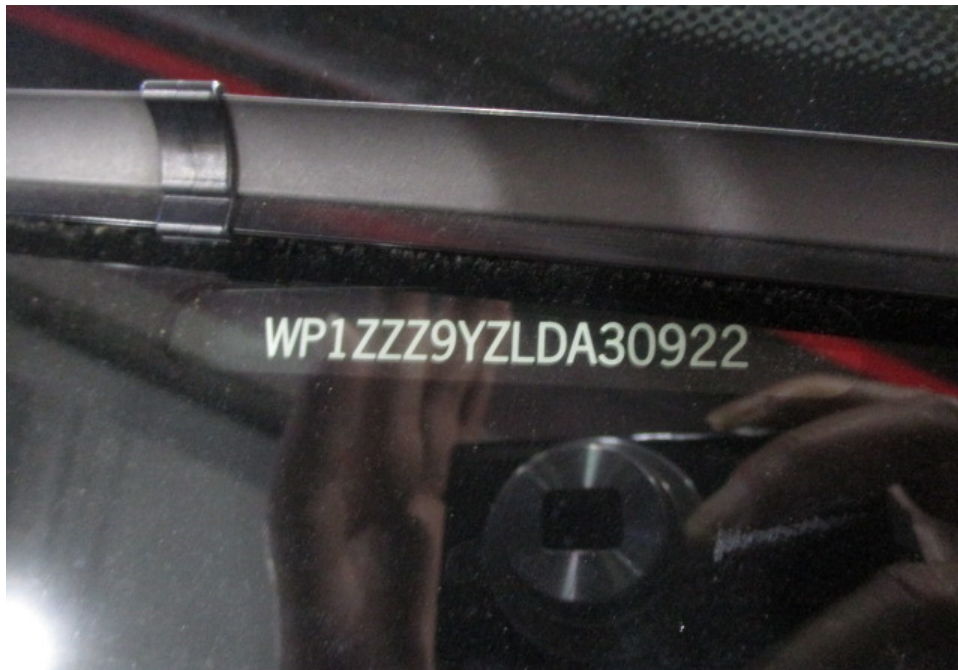
**Photo 13** shows the chassis number of the Motor Car. The chassis number recorded was WP1ZZZ9YZLDA30922.

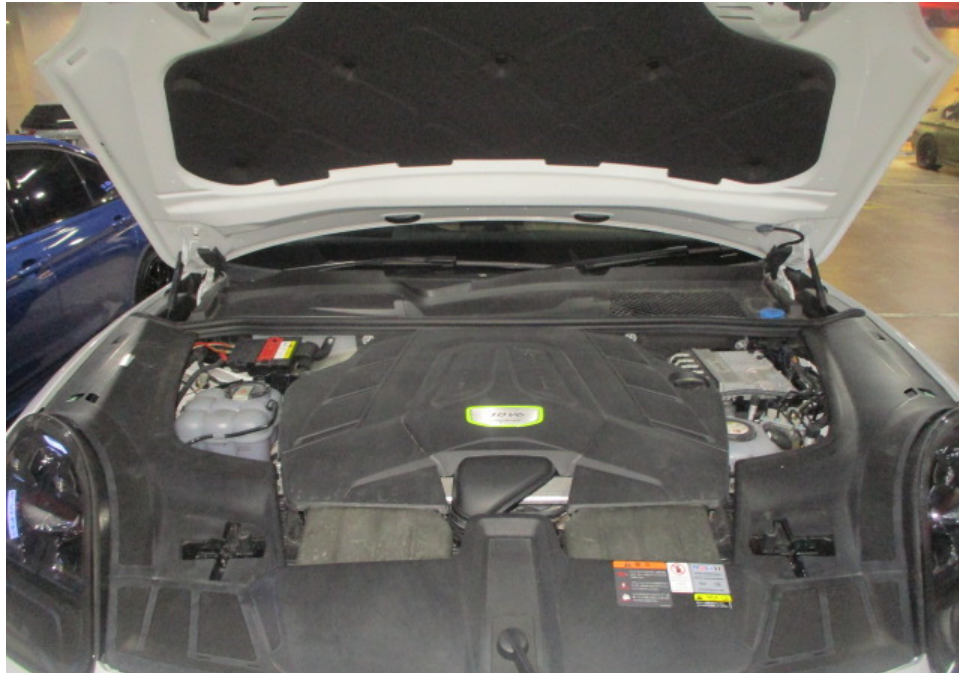
**Photo 14** shows a general view of the engine compartment of the Motor Car at the time of my inspection. The various parts and components inside the engine compartment were all observed to be intact and properly fitted. There was also no sign(s) or indication(s) of fluid leak and/or fluid stain found inside the engine compartment.

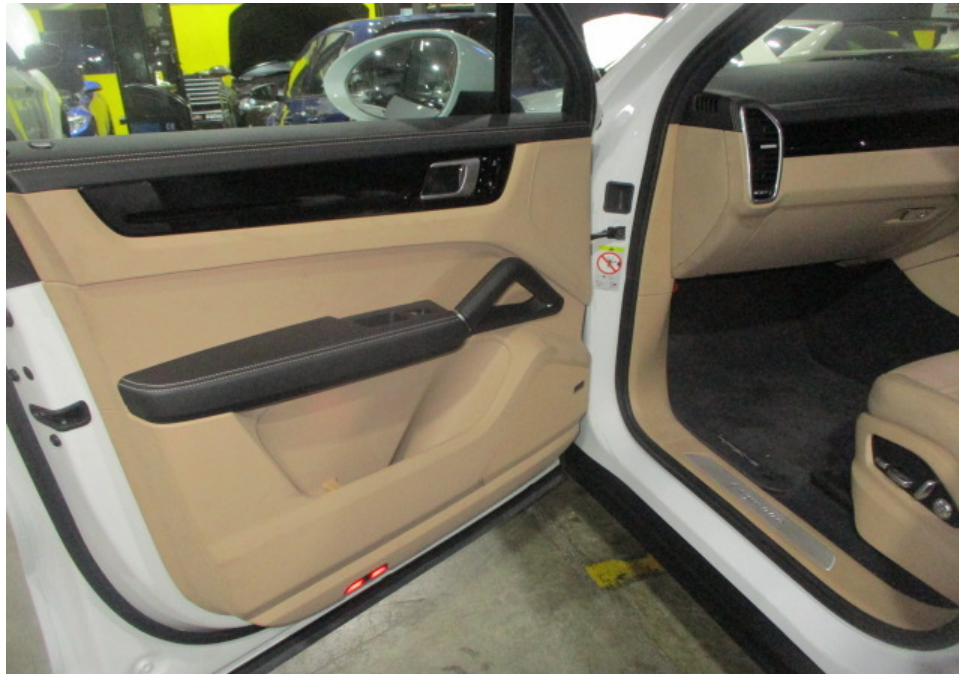
**Photo 15** shows a closer view of the Motor Car's front left door inner trimboard, front left door inner handle and front left door window. The various parts and components, trims, carpet, and upholstery inside the interior compartment were all observed to be intact and properly fitted.

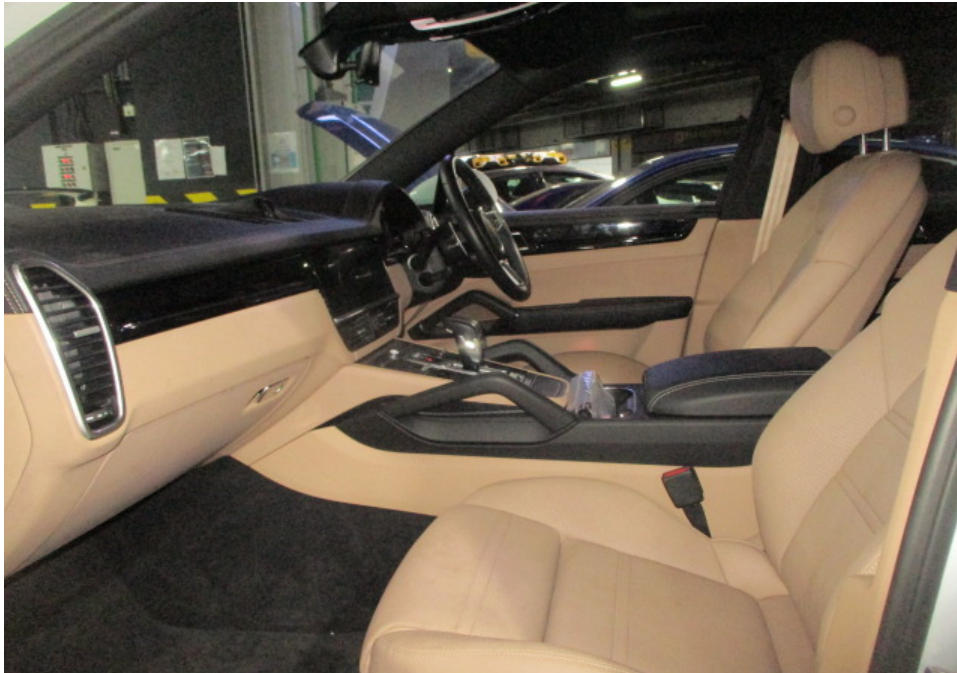
**Photo 16** shows the interior compartment of the Motor Car at the time of my inspection. The various parts and components, trims, carpet, and upholstery inside the interior compartment were all observed to be intact and properly fitted.

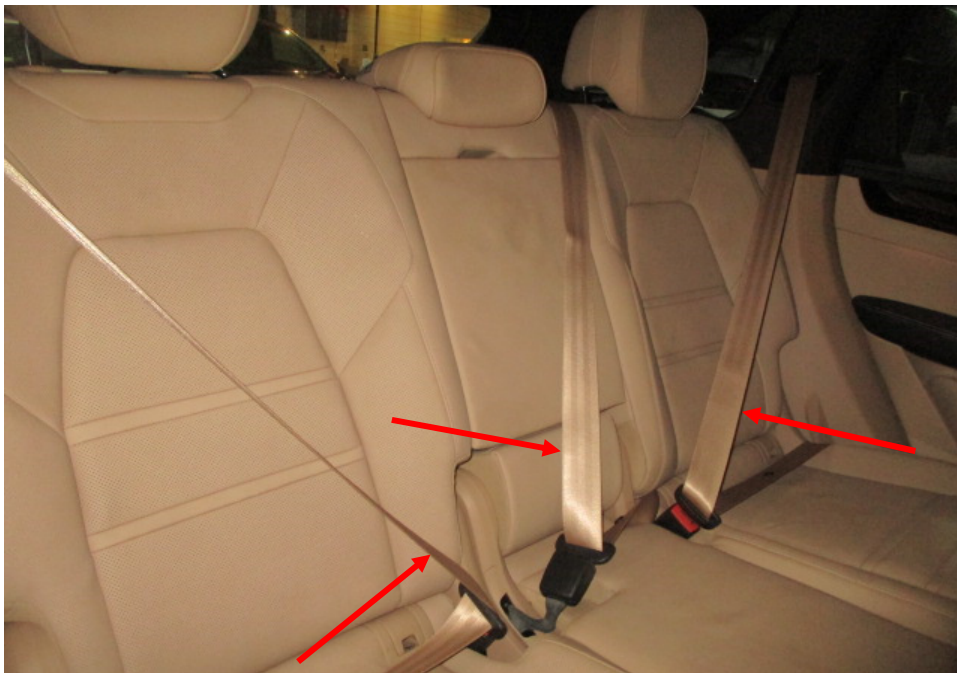
**Photo 17** shows the rear seats of the Motor Car. All the seats of the Motor Car were secured via seat rails to the floorboard. They were also fitted with a retractable seat belt reel and a pre-tensioner. The seat belts (arrowed) were tested and were able to be fastened into the respective pre-tensions that were fitted on the side of each individual seat.

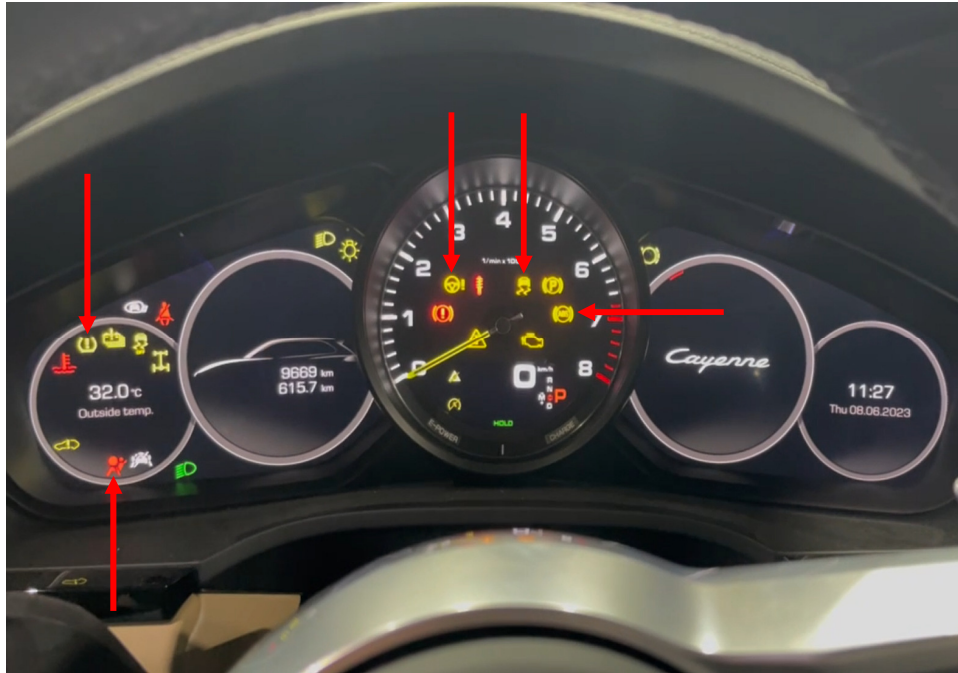
**Photo 18** shows the warning lights for the various electronic safety features appearing on the instrument panel of the Motor Car during its self-test when the engine is cranked, in particular the ABS, SRS, EPS, TPM and TCS lights (arrowed).

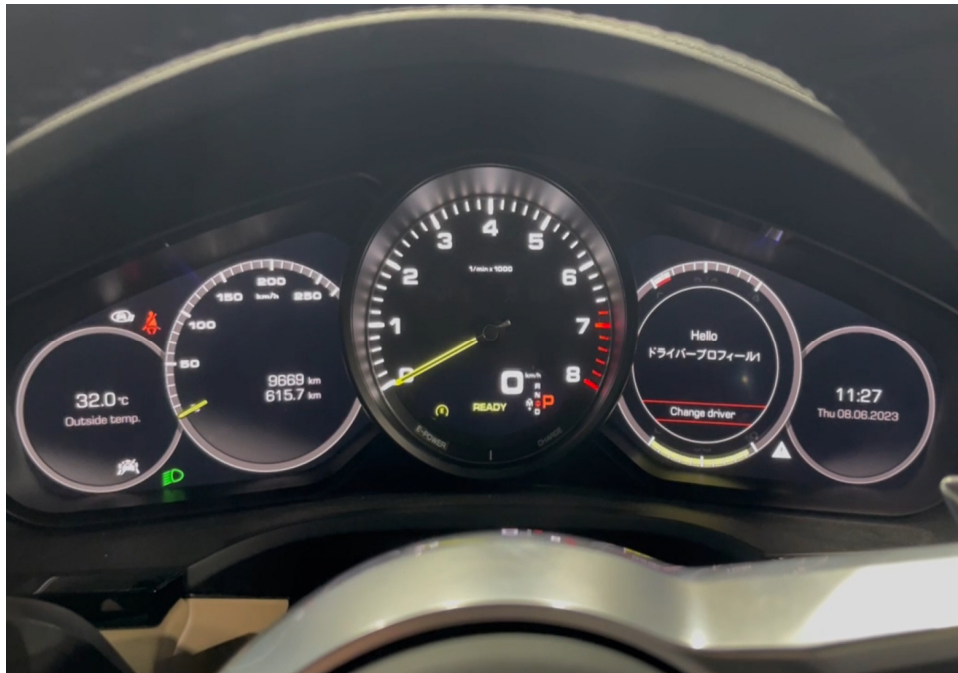
**Photo 19** shows the respective warning lights no longer illuminated, indicating that there is no fault detected to the ABS, SRS, EPS, TPM and TCS systems of the Motor Car during the self-test. These electronic systems were hence in working condition at the time of my inspection.

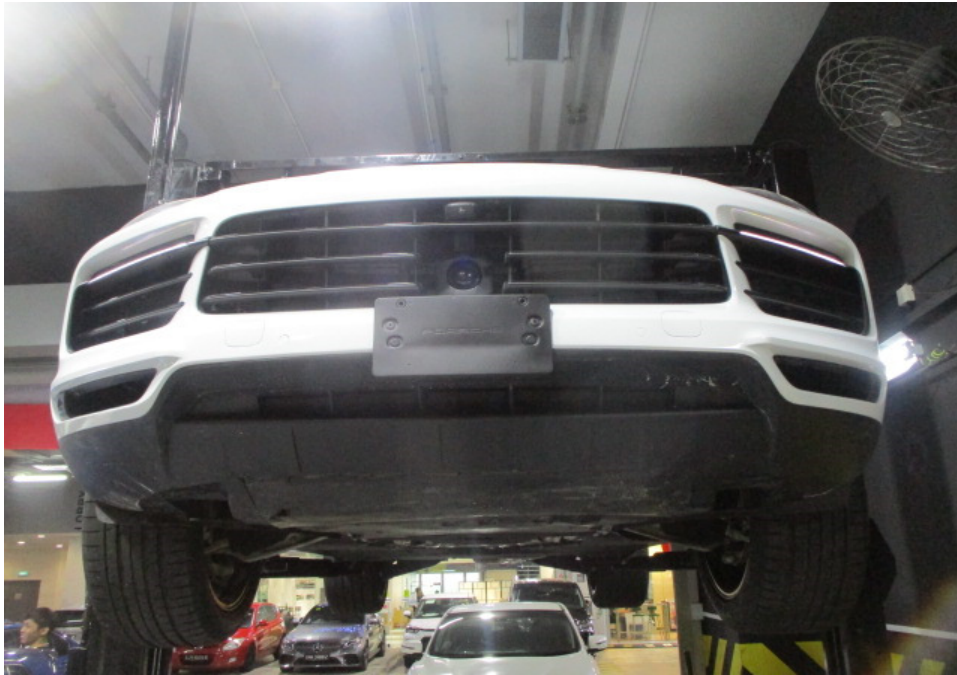
**Photo 20** shows the Motor Car hoisted up for checks on its undercarriage. There was no sign(s) or indication(s) of fluid leakage and/or fluid stain(s) on the underside of the Motor Car. The undercarriage components of the Motor Car were also all observed to be intact and secured in an appropriate manner.

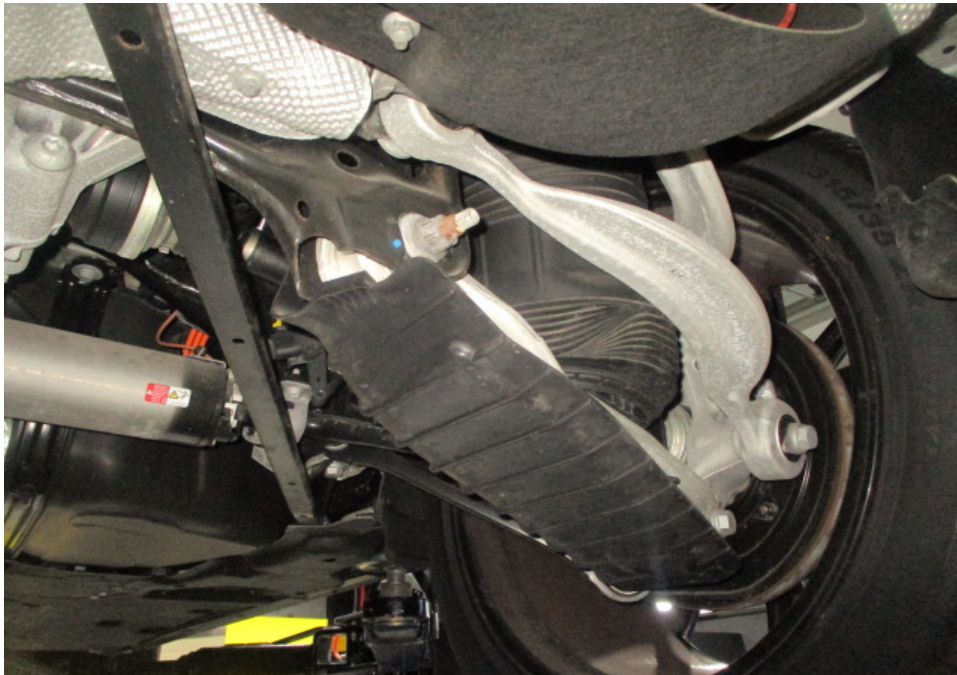
**Photo 21** shows a general view of the control arms and linkages at the rear right wheel of the Motor Car. I did not observe any fluid leak and/or fluid stain on the underside of the Motor Car. All of the Motor Car's undercarriage components were observed to be intact and secured in an appropriate manner.

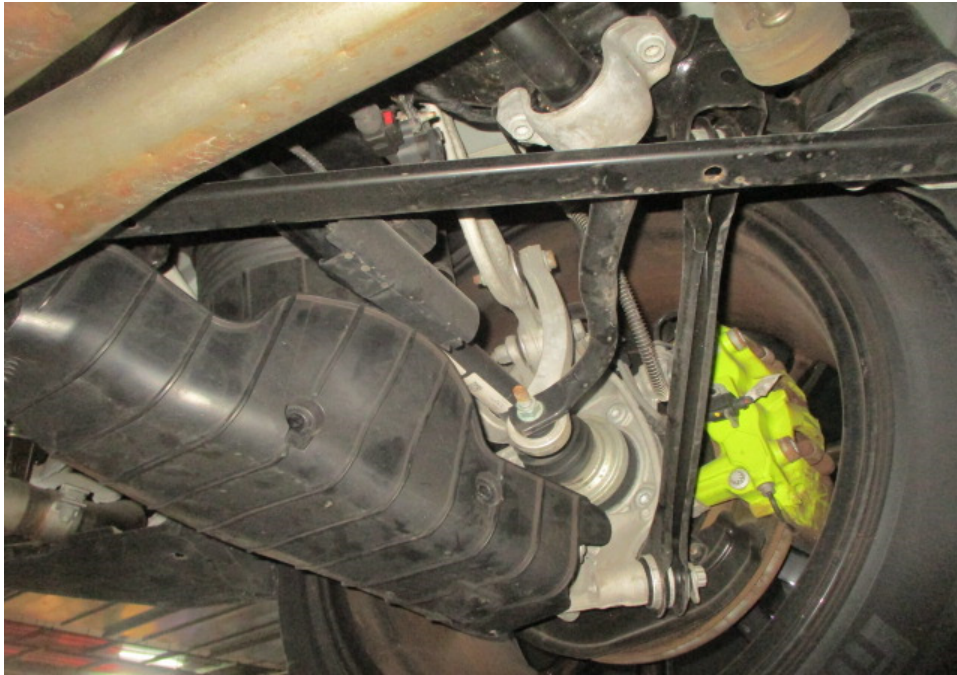
**Photo 22** shows a general view of the control arms and linkages at the rear left wheel of the Motor Car. I did not observe any fluid leak and/or fluid stain on the underside of the Motor Car. All of the Motor Car's undercarriage components were observed to be intact and secured in an appropriate manner.

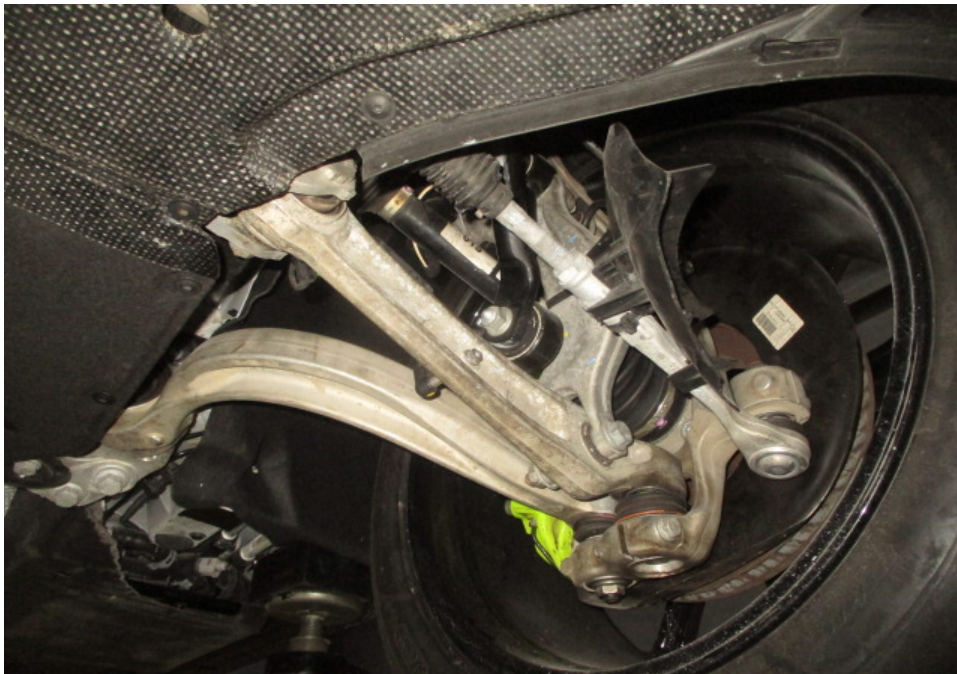
**Photo 23** shows the various undercarriage components at the front left wheel of the Motor Car. The mechanical components, control arms and linkages were all found to be intact and secured in an appropriate manner.

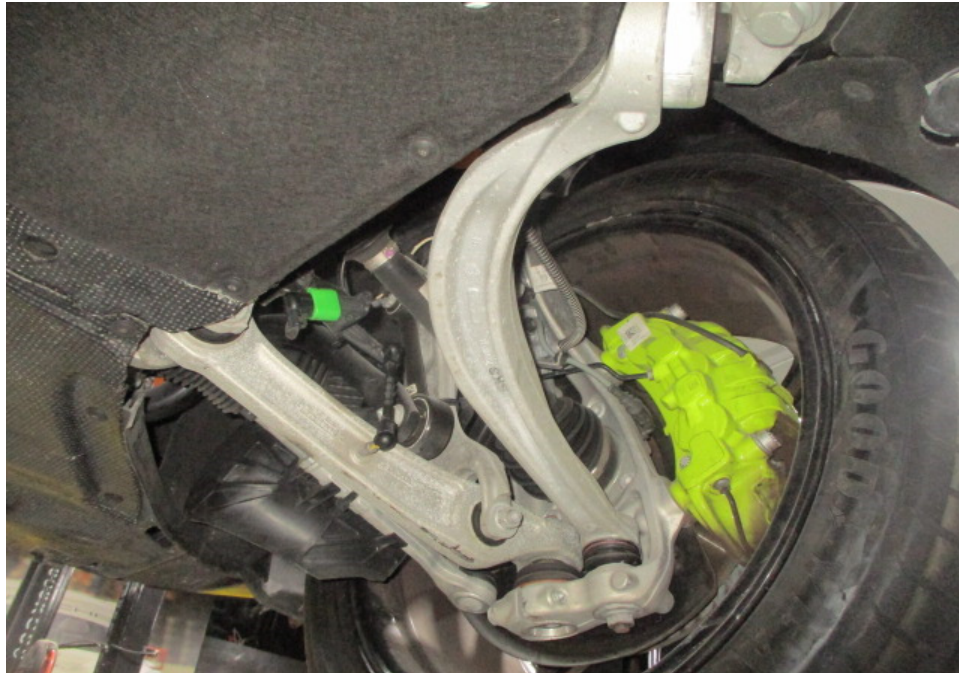
**Photo 24** shows the various undercarriage components at the front right wheel of the Motor Car. The mechanical components, control arms and linkages were all found to be intact and secured in an appropriate manner. I also did not observe any fluid leak and/or fluid stain on the underside of the Motor Car.

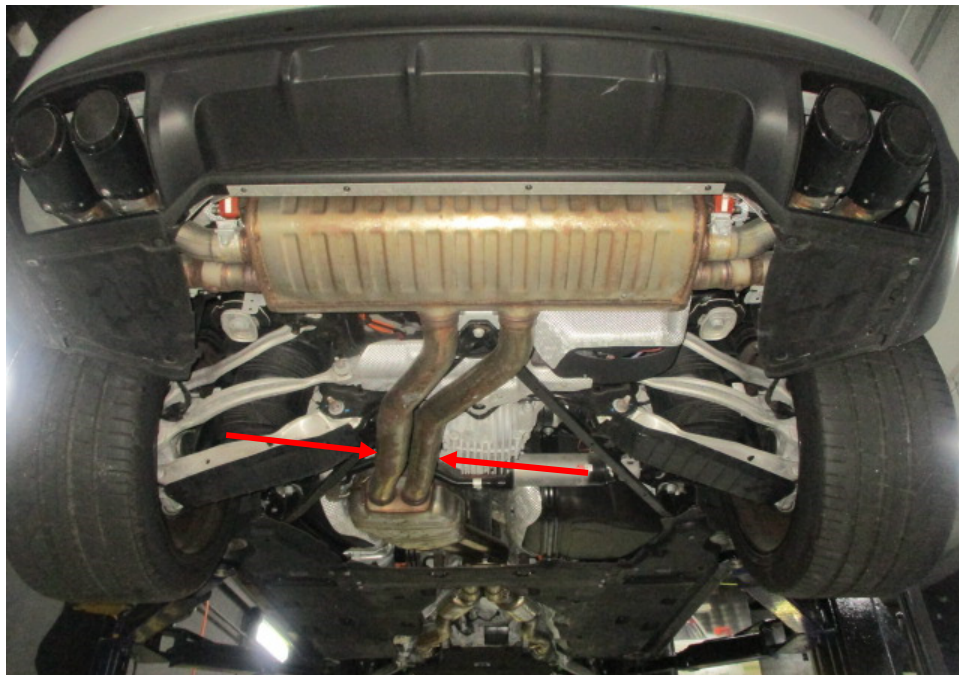
**Photo 25** shows the rear section of the Motor Car's exhaust system. My examination of the Motor Car's exhaust system revealed no sign(s) or indication(s) of any cut or weld marks along its exhaust pipes (arrowed), on its rear muffler, on its centre resonator boxes and on its catalytic converters.

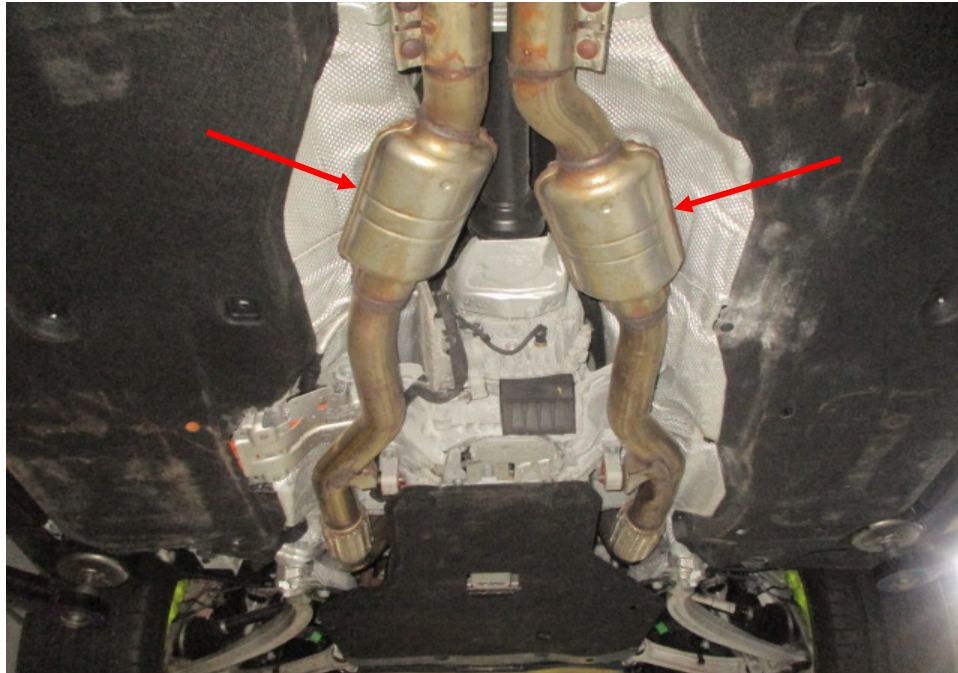
**Photo 26** shows the front section of the Motor Car's exhaust system. My examination of the Motor Car's exhaust system revealed no sign(s) or indication(s) of any cut or weld marks along its exhaust pipes, on its rear muffler, on its centre resonator boxes (arrowed) and on its catalytic converters.

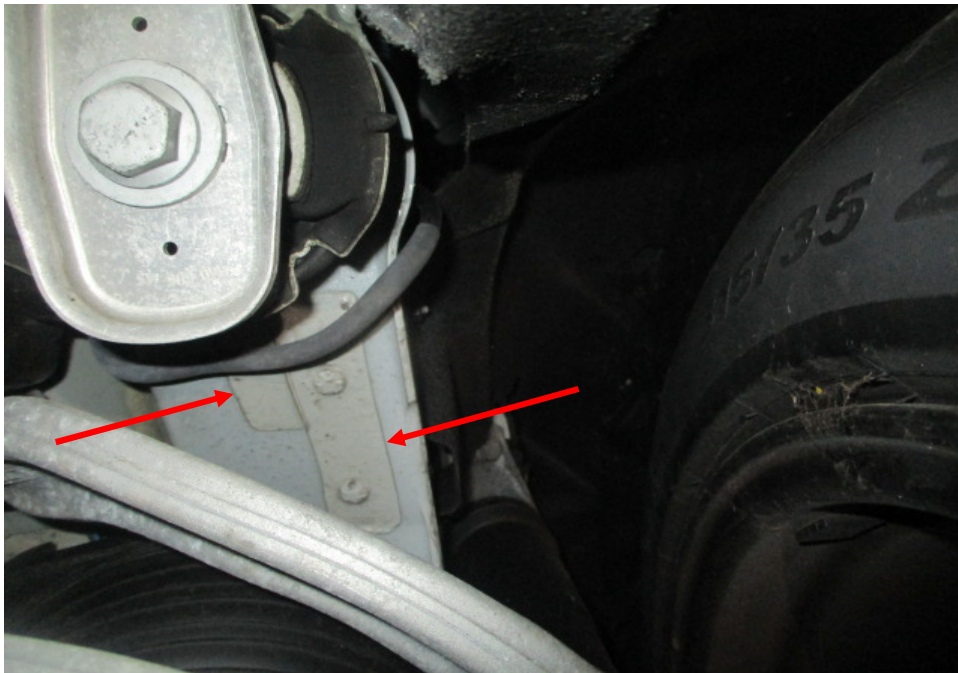
**Photo 27** shows the chassis/structural body at the underside rear right of the Motor Car. I did not find any weld marks other than original spot weld marks on the chassis/structural body of the Motor Car. The original factory sealant (arrowed) at the joints along the chassis/structural body was untouched, indicating no work was done on the chassis/structural body of the Motor Car and that the chassis/structural body was originally fitted.

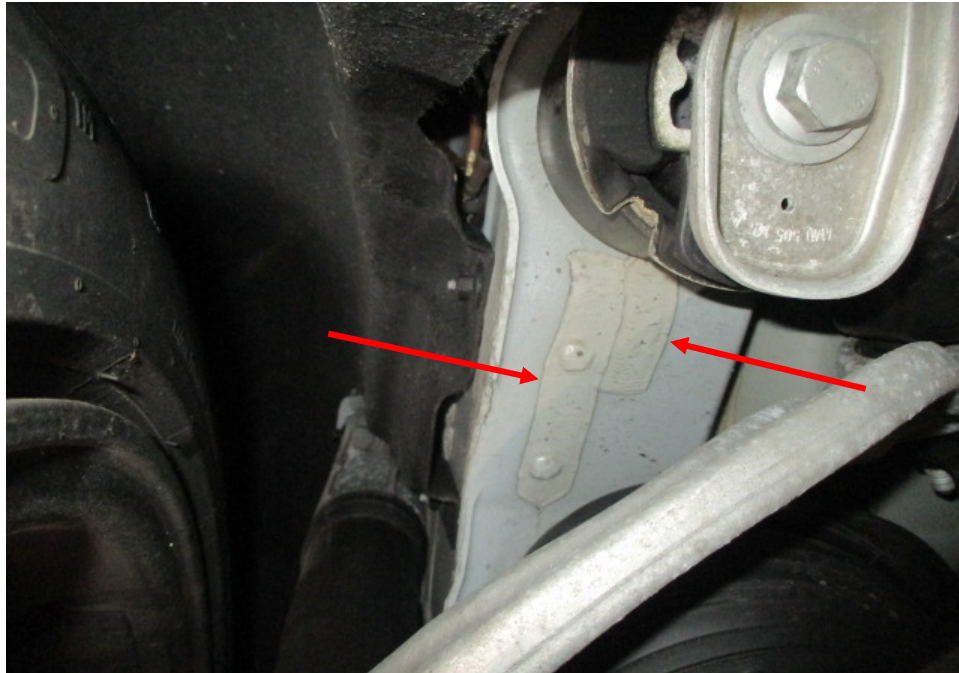
**Photo 28** shows the chassis/structural body at the underside rear left of the Motor Car. I did not find any weld marks other than original spot weld marks on the chassis/structural body of the Motor Car. The original factory sealant (arrowed) at the joints along the chassis/structural body was untouched, indicating no work was done on the chassis/structural body of the Motor Car and that the chassis/structural body was originally fitted.

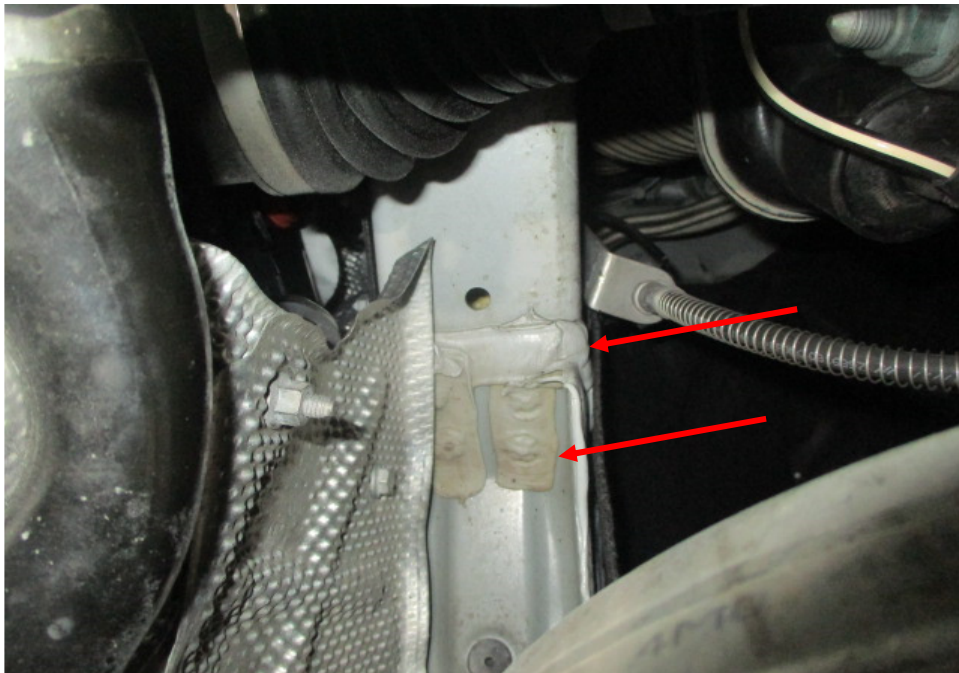
**Photo 29** shows the chassis/structural body at the underside front left of the Motor Car. The original factory sealant (arrowed) at the joints along the chassis/structural body was observed to be untouched. In general, I had found no work was carried out on the chassis/structural body of the Motor Car. The chassis/structural body of the Motor Car was originally fitted.

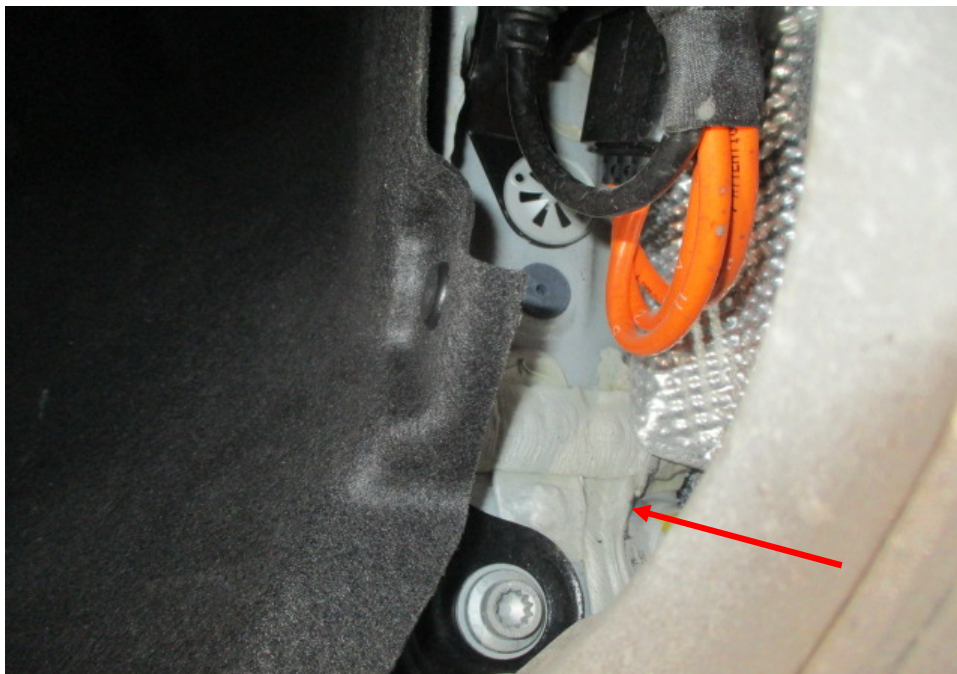
**Photo 30** shows the chassis/structural body at the underside front right of the Motor Car. The original factory sealant (arrowed) at the joints along the chassis/structural body was observed to be untouched. In general, I had found no work was carried out on the chassis/structural body of the Motor Car. The chassis/structural body of the Motor Car was originally fitted.
