Your Ref: Porsche Taycan Cross Turismo  
(chassis number WP0ZZZY1ZNSA75234)  
Our Ref : CI/TP23006613/D

03 July 2023

**INSPECTION REPORT OF AN UNREGISTERED PORSCHE TAYCAN CROSS TURISMO MOTOR CAR WITH CHASSIS NUMBER WP0ZZZY1ZNSA75234**

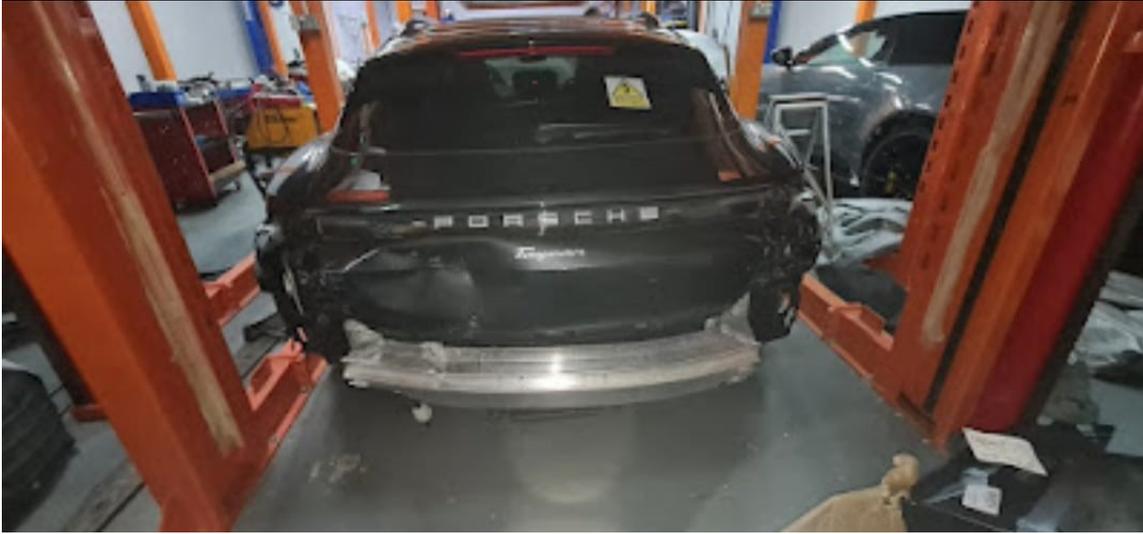
3. The photographs provided to me had showed damage to the rear portion of the Motor Car. Body parts damaged include the rear bumper reinforcement and rear tailgate amongst others.
4. The Motor Car's rear left taillamp, rear right taillamp, rear bumper and all its related parts and attachments like the rear bumper lower cover, rear bumper lower skirt, rear bumper left reflector, rear bumper right reflector and rear bumper sensors amongst others, were also missing/dislodged/damaged.
5. No physical damage was observed to other areas of the Motor Car. The airbag(s) of the Motor Car was not deployed as seen from the photographs that were provided to me. See photo 1 – 5 below.

**Photo 1** shows a general view of the rear body of the Motor Car (photograph provided to me). The Motor Car was observed to have sustained damage at its rear portion. The rear bumper reinforcement and rear tailgate were amongst the body parts that were observed to have been damaged. The Motor Car's rear left taillamp, rear right taillamp, rear bumper and all its related parts and attachments like the rear bumper lower cover, rear bumper lower skirt, rear bumper left reflector, rear bumper right reflector and rear bumper sensors amongst others, were also missing/dislodged/damaged.

23. The body parts at the rear portion of the Motor Car were visually examined, and it was noted that the repair/restoration works carried out to the damaged area of the Motor Car (refer to photograph 1 above) were reasonably adequate and in order.

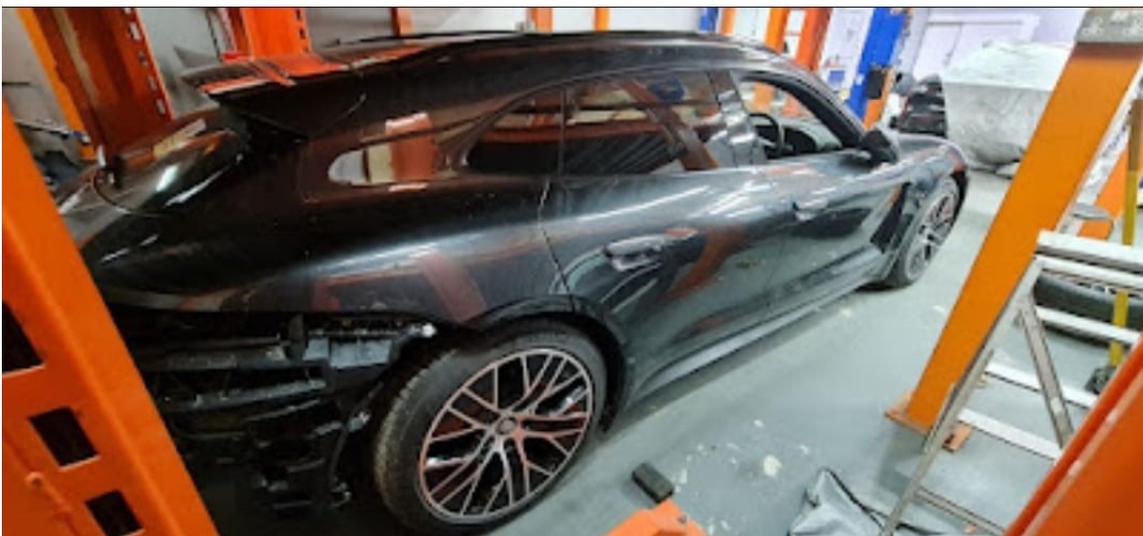
**Photo 2** shows a general view of the rear right body of the Motor Car (photograph provided to me). Apart for the rear portion, there was no physical damage observed to other areas of the Motor Car. The airbag(s) of the Motor Car was not deployed as seen from the photographs that were provided to me.

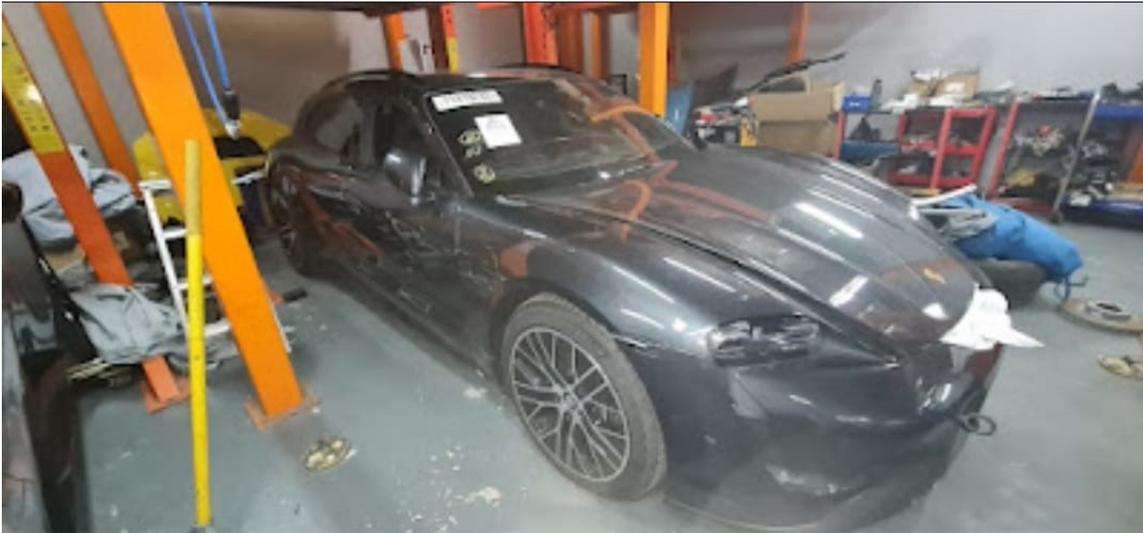
**Photo 3** shows a general view of the front right body of the Motor Car (photograph provided to me). Apart for the rear portion, there was no physical damage observed to other areas of the Motor Car. The airbag(s) of the Motor Car was not deployed as seen from the photographs that were provided to me.

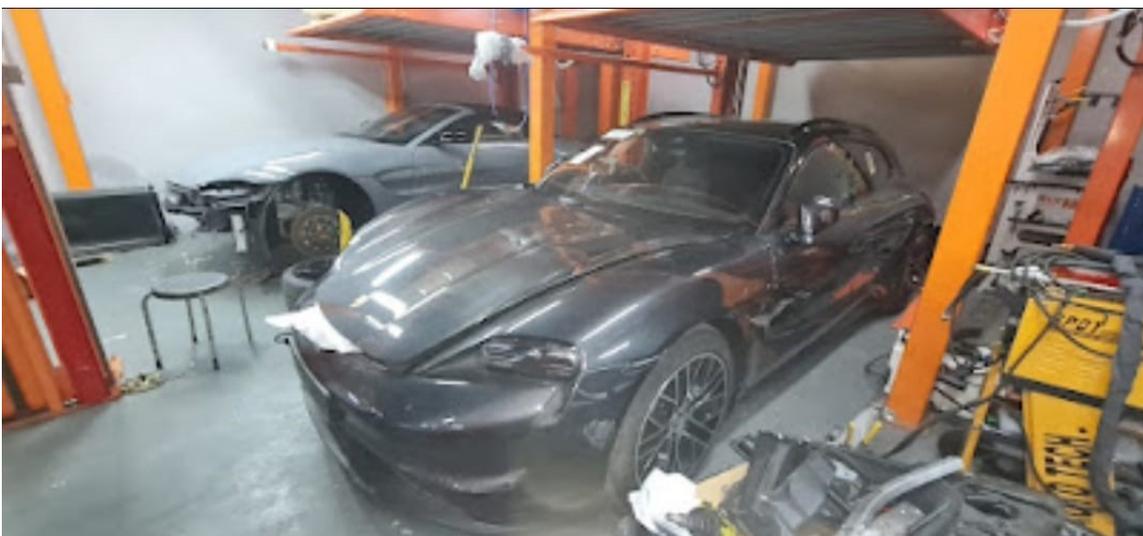
**Photo 4** shows a general view of the front left body of the Motor Car (photograph provided to me). Apart for the rear portion, there was no physical damage observed to other areas of the Motor Car. The airbag(s) of the Motor Car was not deployed as seen from the photographs that were provided to me.

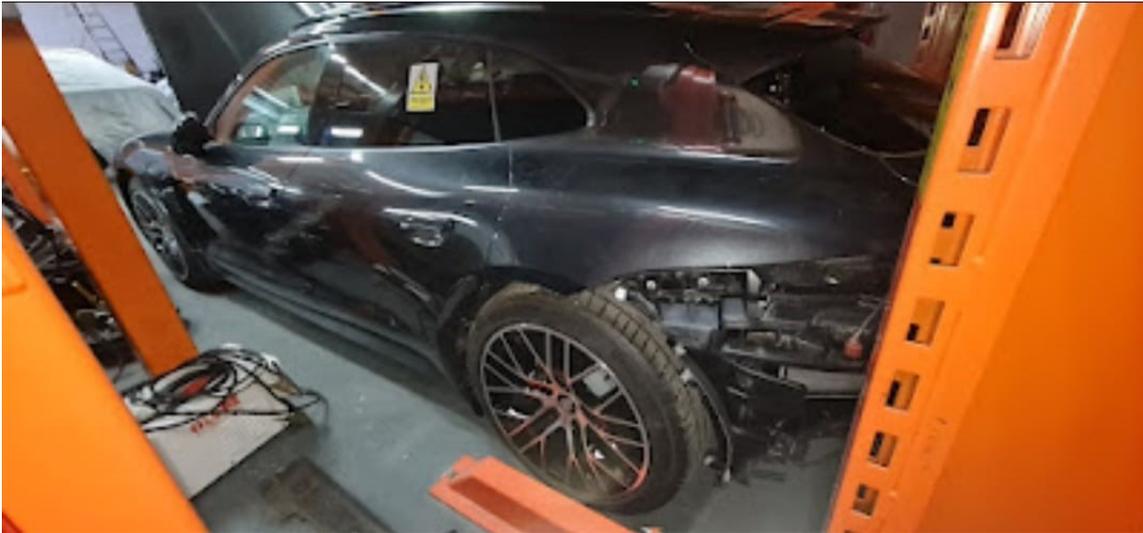
**Photo 5** shows a general view of the rear left body of the Motor Car (photograph provided to me). Apart for the rear portion, there was no physical damage observed to other areas of the Motor Car. The airbag(s) of the Motor Car was not deployed as seen from the photographs that were provided to me.

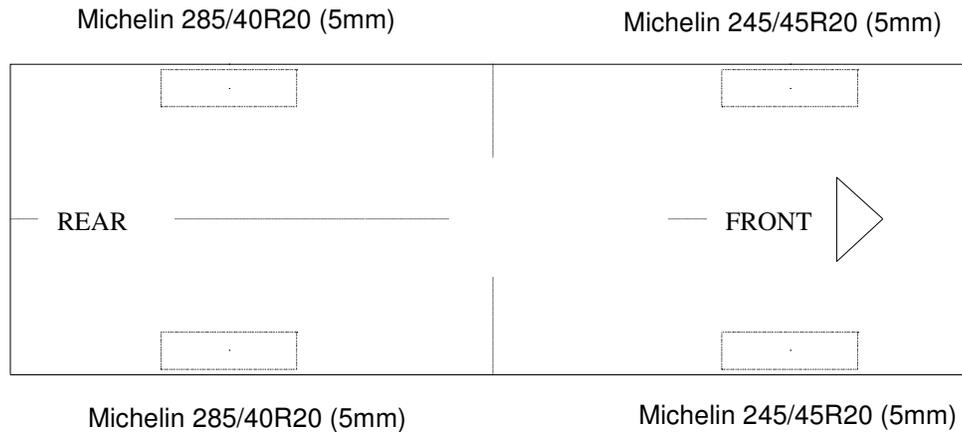
9. The Motor Car was fitted with 20inch sport wheel rims that were wrapped with tyres that were observed to be of serviceable condition. The tyres were also sufficiently inflated for vehicular operation. The tyre brand, tyre size and approximate remaining tread depth of the 4 tyres of the Motor Car were recorded as follows: -

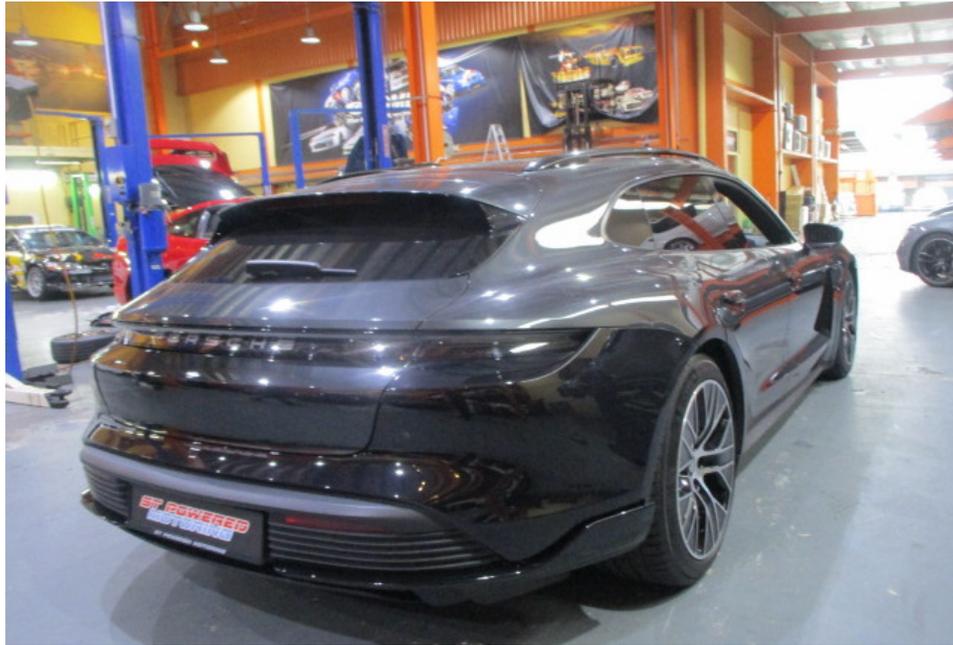
**Photo 6** shows a general view of the rear right body of the Motor Car at the time of my inspection. The Motor Car was observed to be in a relatively good general condition with no loose exterior fittings observed. The body parts at the rear portion of the Motor Car were visually examined and it was observed that the repair/restoration works carried out to the damaged area of the Motor Car (refer to photograph 1 above) were reasonably adequate and in order.

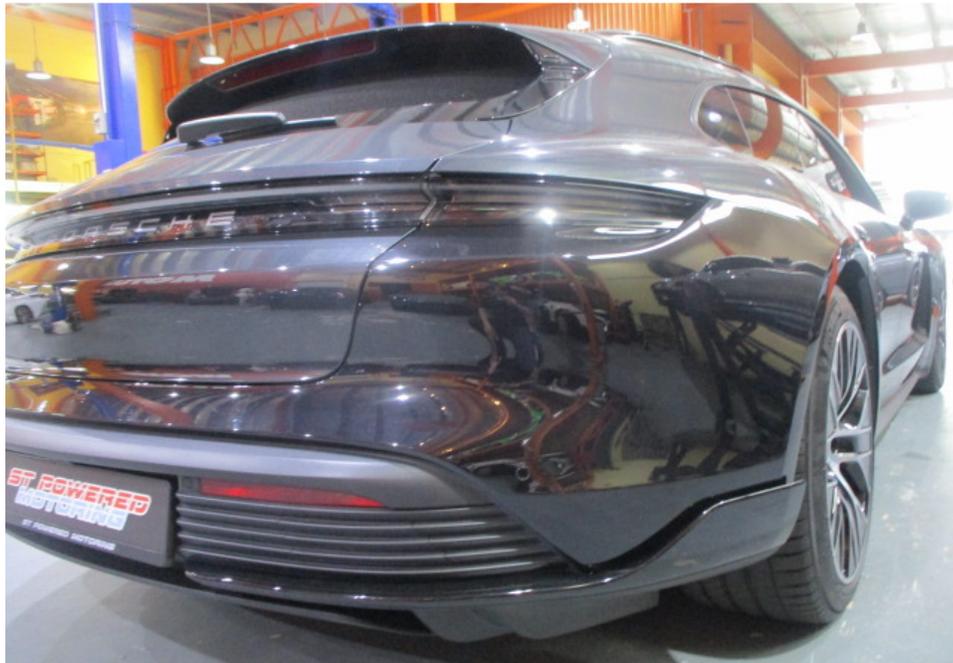
**Photo 7** shows a closer view of the Motor Car's rear bumper, rear bumper lower cover, rear bumper lower skirt, rear bumper right reflector and rear right taillamp. The body parts at the rear portion of the Motor Car were visually examined and it was observed that the repair/restoration works carried out to the damaged area of the Motor Car (refer to photograph 1 above) were reasonably adequate and in order.

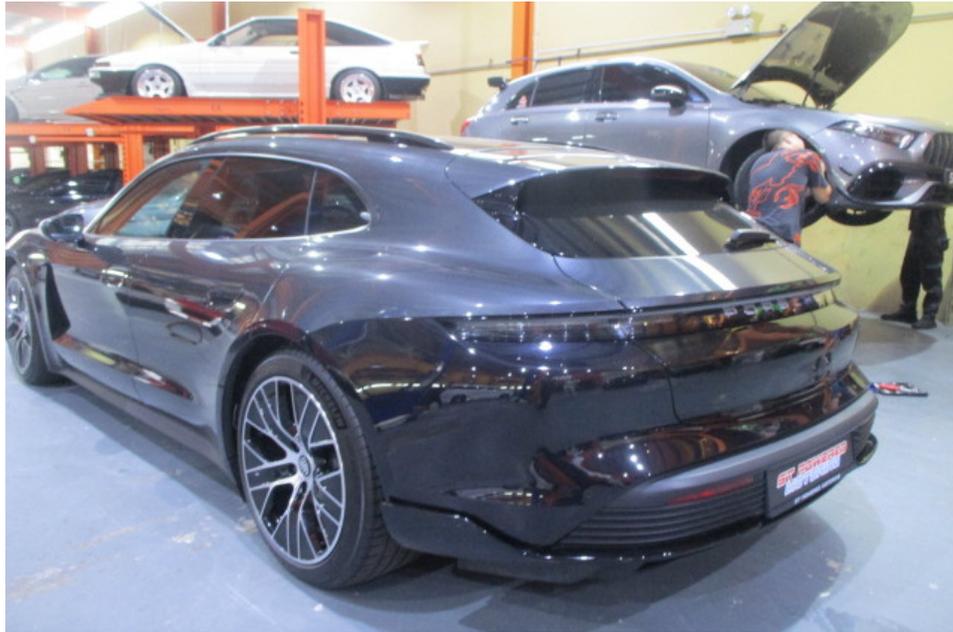
**Photo 8** shows a general view of the rear left body of the Motor Car at the time of my inspection. The Motor Car was observed to be in a relatively good general condition with no loose exterior fittings observed. The body parts at the rear portion of the Motor Car were visually examined and it was observed that the repair/restoration works carried out to the damaged area of the Motor Car (refer to photograph 1 above) were reasonably adequate and in order.

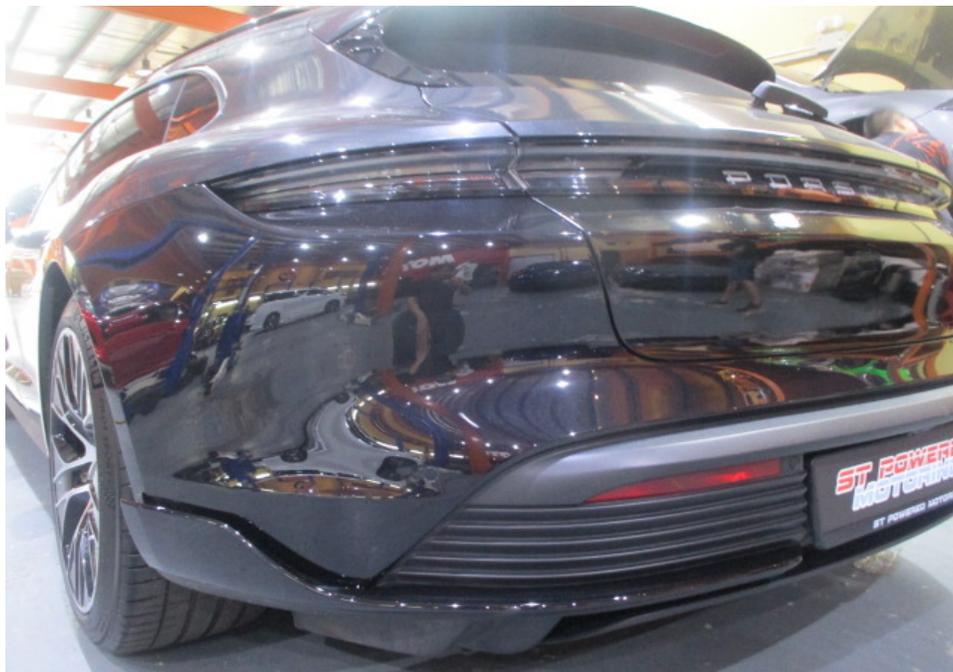
**Photo 9** shows a closer view of the Motor Car's rear bumper, rear bumper lower cover, rear bumper lower skirt, rear bumper left reflector and rear left taillamp. The body parts at the rear portion of the Motor Car were visually examined and it was observed that the repair/restoration works carried out to the damaged area of the Motor Car (refer to photograph 1 above) were reasonably adequate and in order.

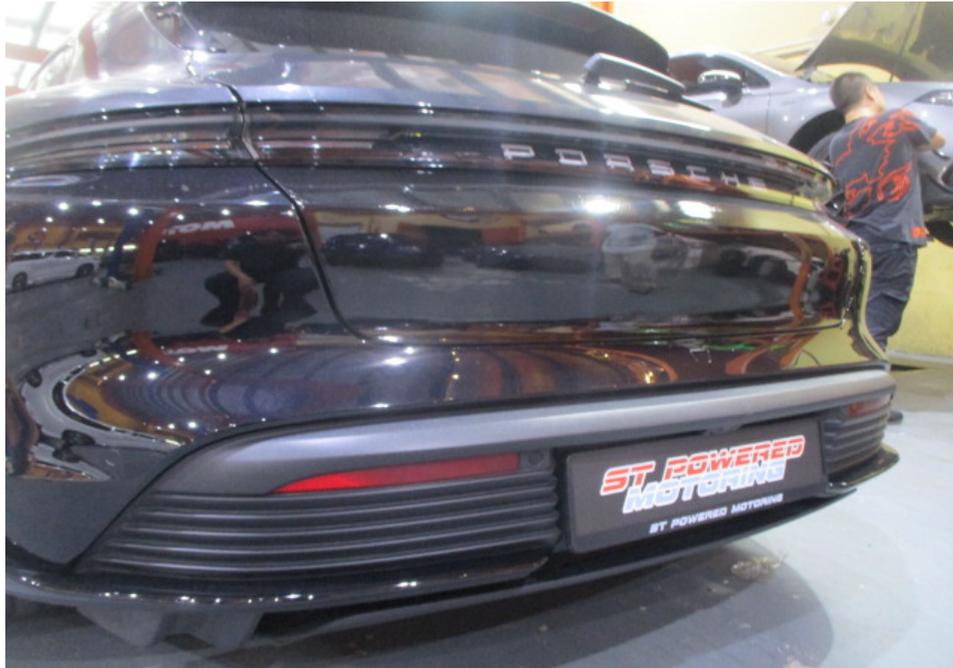
**Photo 10** shows a closer view of the Motor Car's rear bumper, rear bumper lower cover, rear bumper lower skirt, rear bumper left reflector and rear tailgate. The body parts at the rear portion of the Motor Car were visually examined and it was observed that the repair/restoration works carried out to the damaged area of the Motor Car (refer to photograph 1 above) were reasonably adequate and in order.

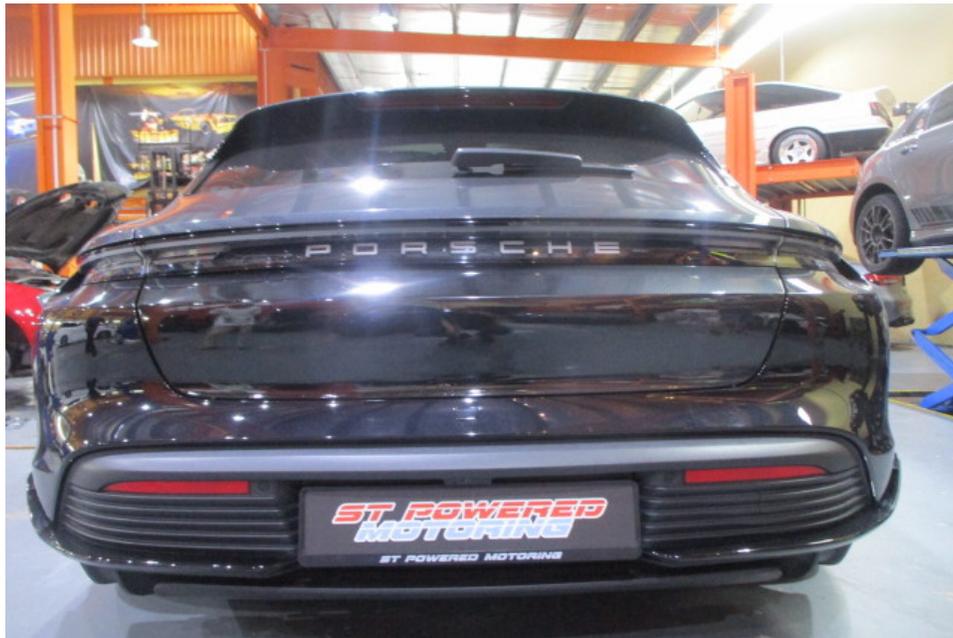
**Photo 11** shows a closer view of the Motor Car's rear portion. The Motor Car was observed to be in a relatively good general condition with no loose exterior fittings observed. The body parts at the rear portion of the Motor Car were visually examined and it was observed that the repair/restoration works carried out to the damaged area of the Motor Car (refer to photograph 1 above) were reasonably adequate and in order.

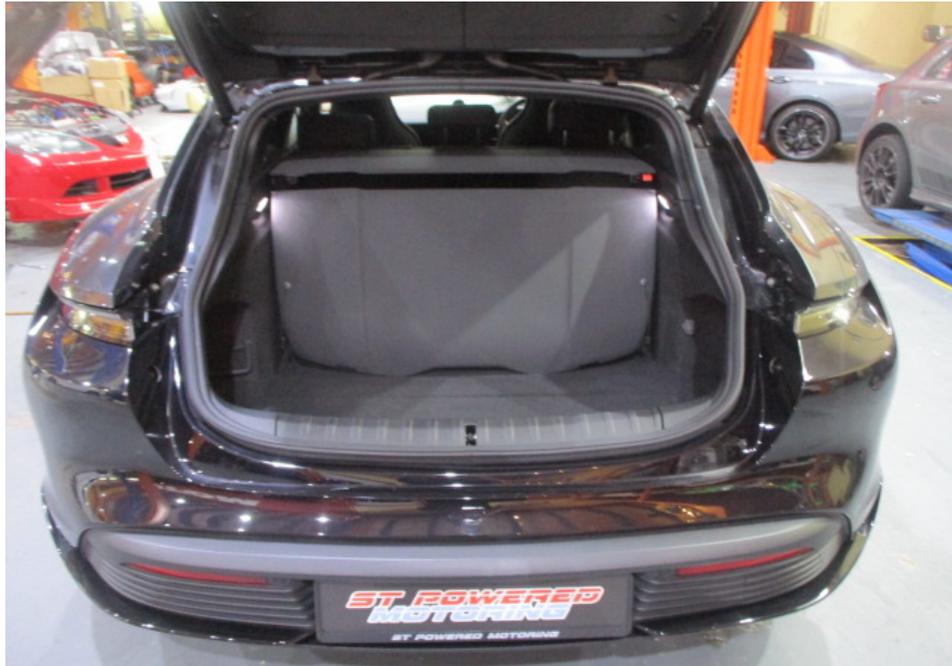
**Photo 12** shows a general view of the Motor Car's rear compartment at the time of my inspection. The various parts and components, trims, carpet, and upholstery inside the rear compartment were all observed to be intact and properly fitted.

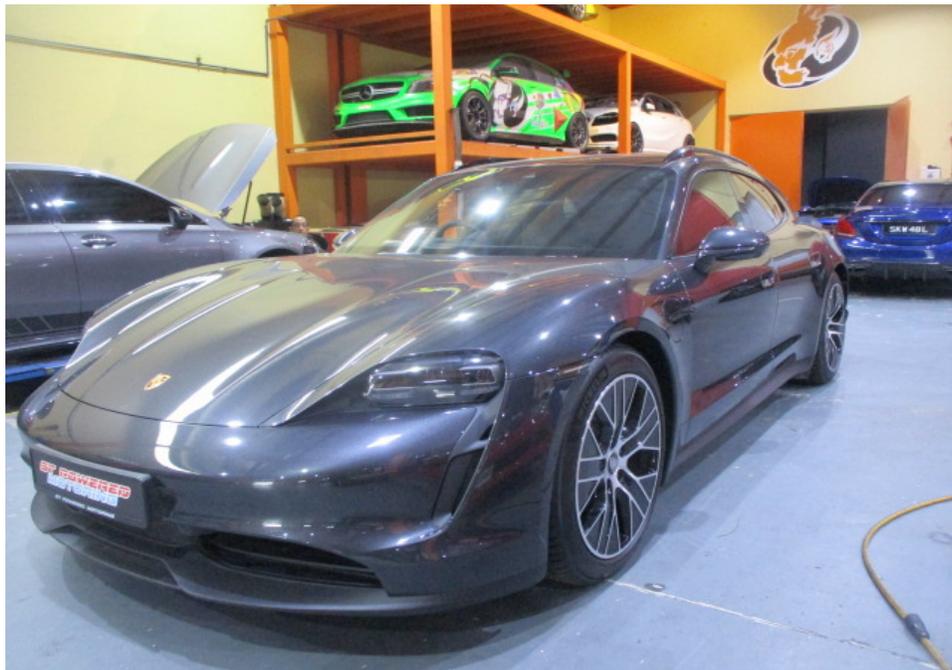
**Photo 13** shows a general view of the front left body of the Motor Car at the time of my inspection. The Motor Car was observed to be in a relatively good general condition with no loose exterior fittings observed. The mileage of the Motor Car recorded at the time of my inspection was 505km.

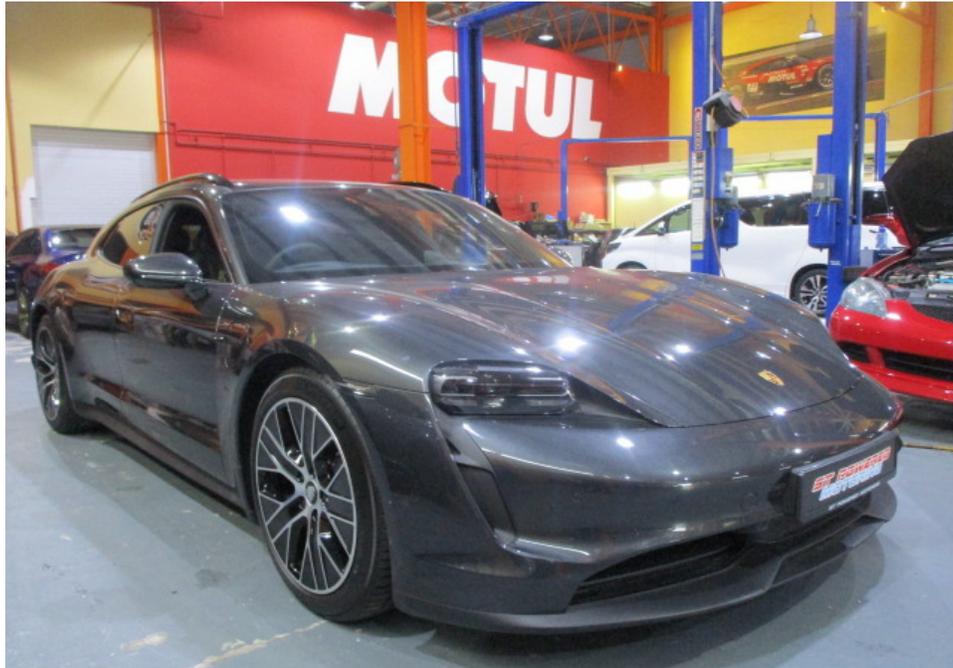
**Photo 14** shows a general view of the front right body of the Motor Car at the time of my inspection. The Motor Car was observed to be in a relatively good general condition with no loose exterior fittings observed. The mileage of the Motor Car recorded at the time of my inspection was 505km.

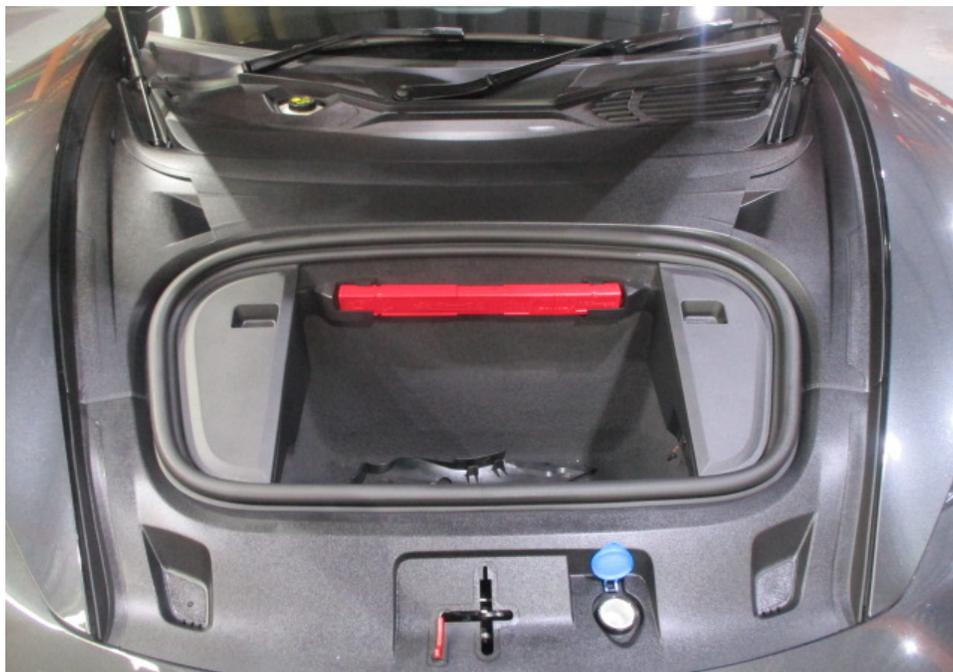
**Photo 15** shows a general view of the Motor Car's front bonnet compartment at the time of my inspection. All inner trims, garnishes and upholstery etc were observed to be properly fitted.

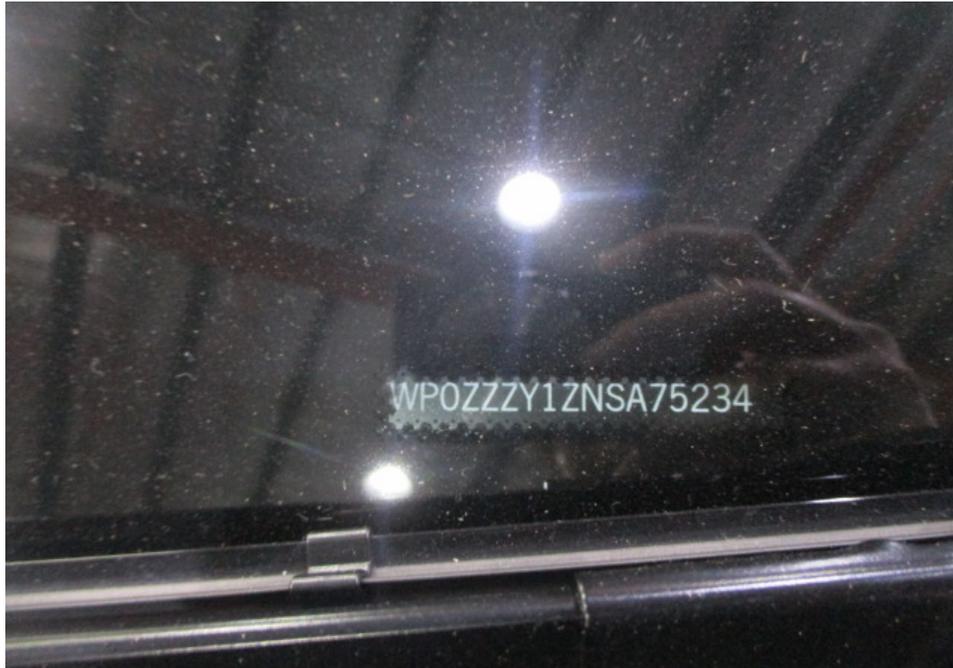
**Photo 16** shows the chassis number of the Motor Car. The chassis number recorded was WP0ZZZY1ZNSA75234.

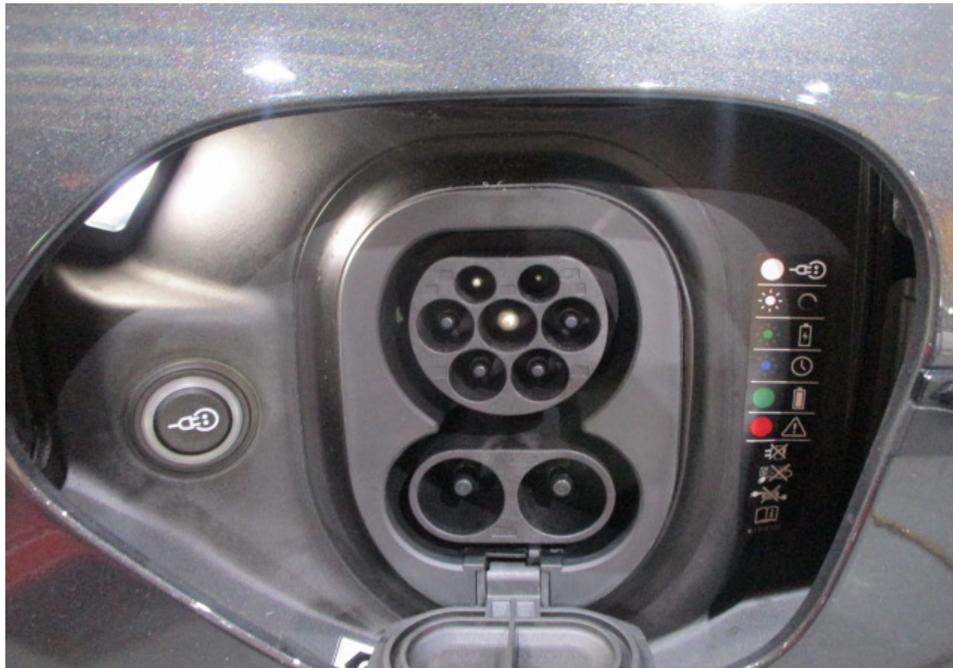
**Photo 17** shows the high voltage charging port located at the front left fender of the Motor Car at the time of my inspection. A Combined Charging Standard 2 (CCS 2) for direct current (DC) charging was fitted on the front left fender of the Motor Car. No physical damage was observed to the charging head.

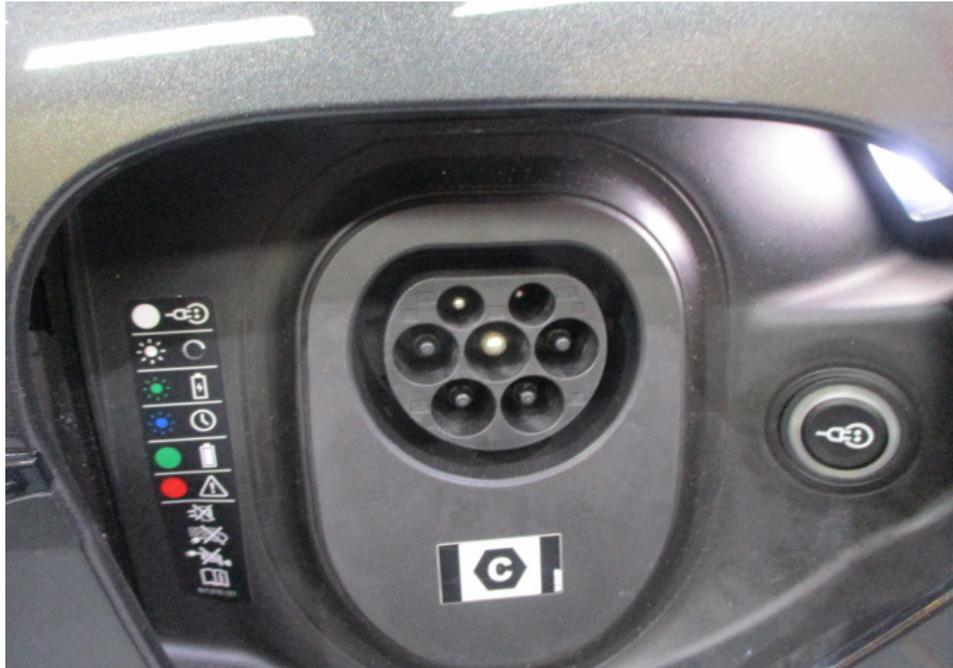
**Photo 18** shows the high voltage charging port located at the front right fender of the Motor Car at the time of my inspection. A JS 1772 (Type 2) for alternating current (AC) charging was fitted on the front right fender of the Motor Car. No physical damage was observed to the charging head.

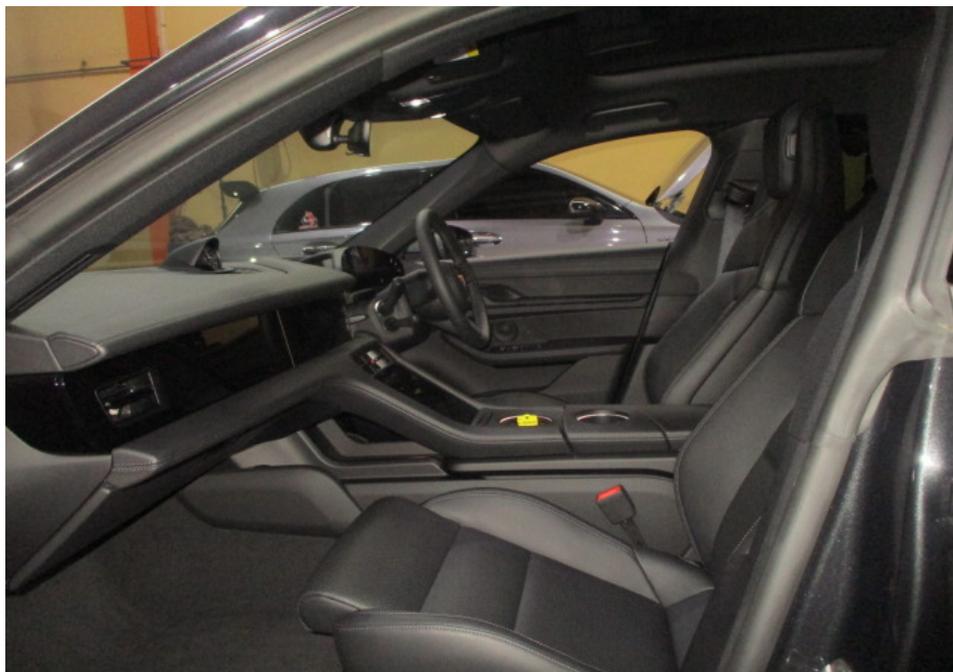
**Photo 19** shows the interior compartment of the Motor Car at the time of my inspection. The various parts and components, trims, carpet, and upholstery inside the interior compartment were all observed to be intact and properly fitted.

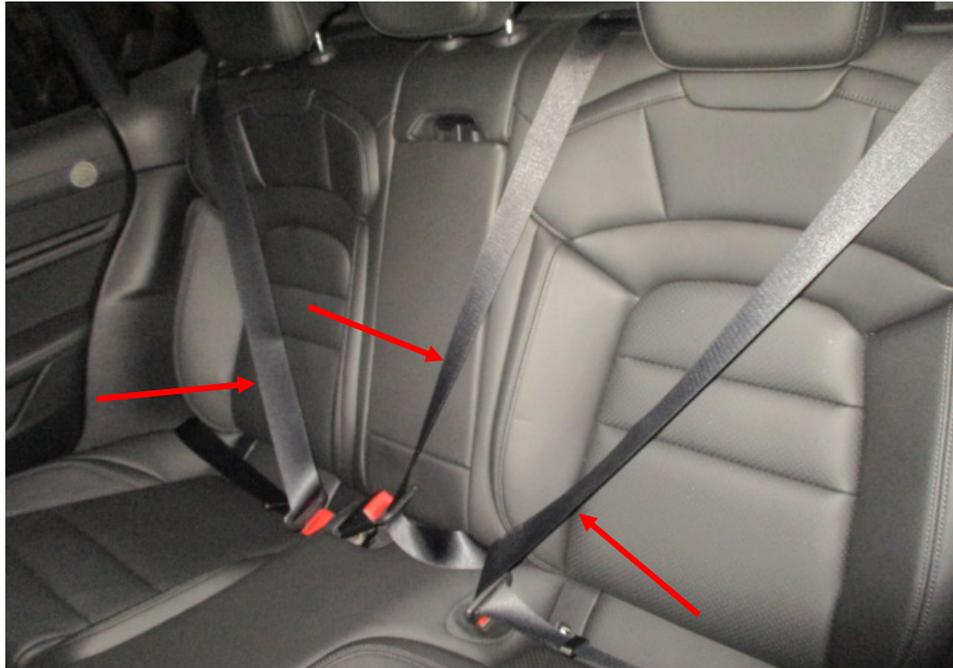
**Photo 20** shows the rear seats of the Motor Car. All the seats of the Motor Car were secured via seat rails to the floorboard. They were also fitted with a retractable seat belt reel and a pre-tensioner. The seat belts (arrowed) were tested and were able to be fastened into the respective pre-tensions that were fitted on the side of each individual seat.

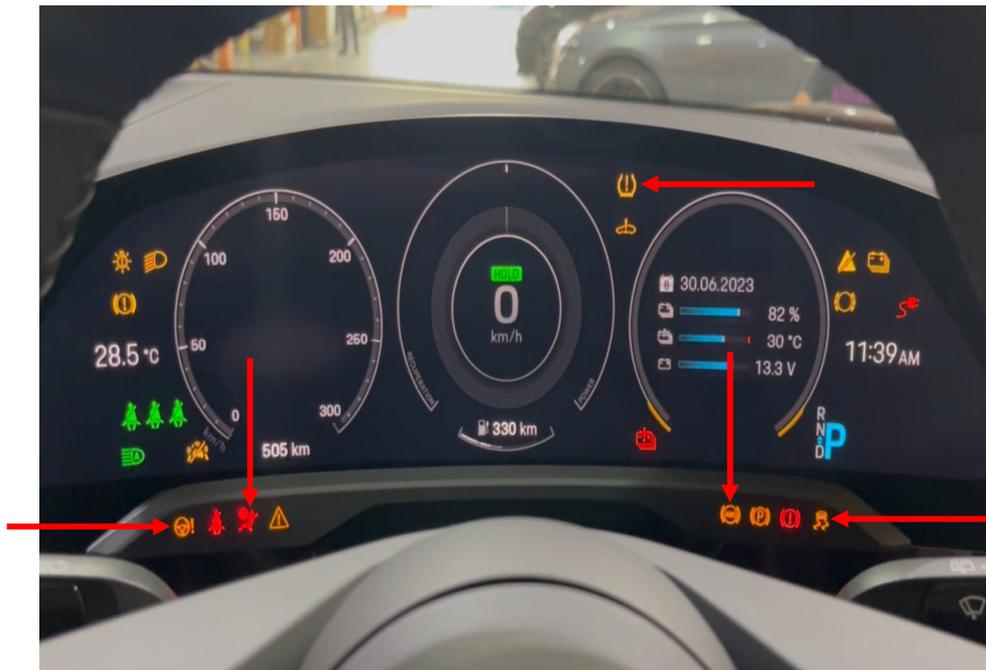
**Photo 21** shows the warning lights for the various electronic safety features appearing on the instrument panel of the Motor Car during its self-test when the engine is cranked, in particular the ABS, SRS, EPS, TPM and SCS lights (arrowed).

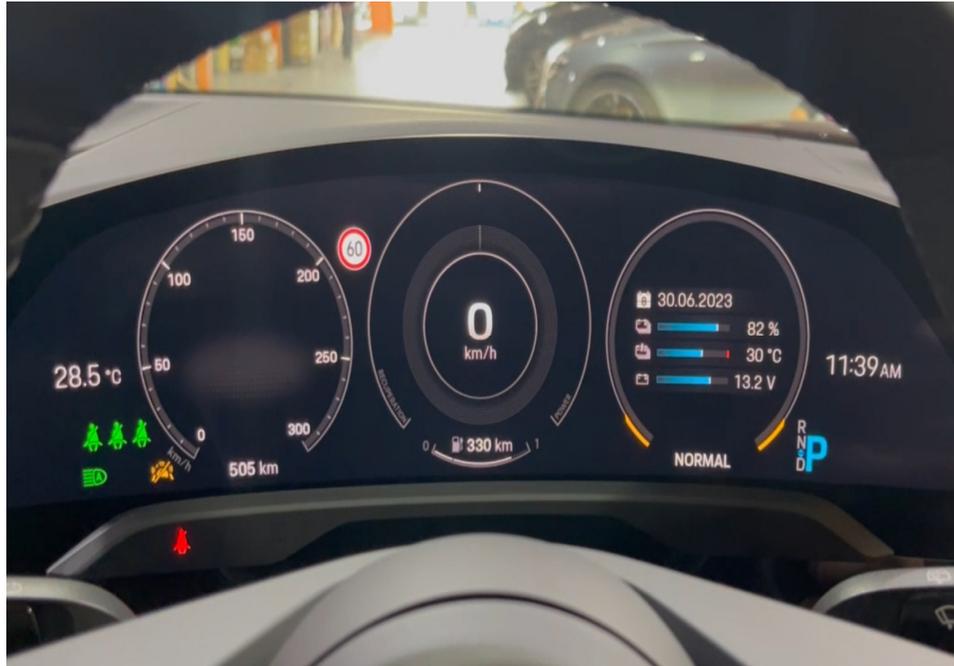
**Photo 22** shows the respective warning lights no longer illuminated, indicating that there is no fault detected to the ABS, SRS, EPS, TPM and SCS systems of the Motor Car during the self-test. These electronic systems were hence in working condition at the time of my inspection.

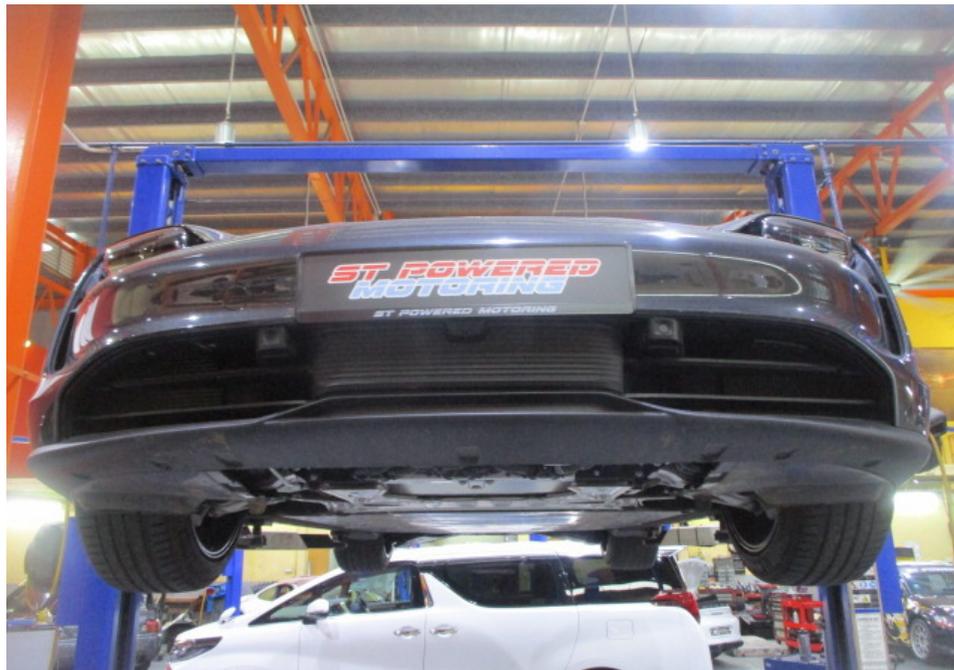
**Photo 23** shows the Motor Car hoisted up for checks on its undercarriage. There was no sign(s) or indication(s) of fluid leakage and/or fluid stain(s) on the underside of the Motor Car. The undercarriage components of the Motor Car were also all observed to be intact and secured in an appropriate manner.

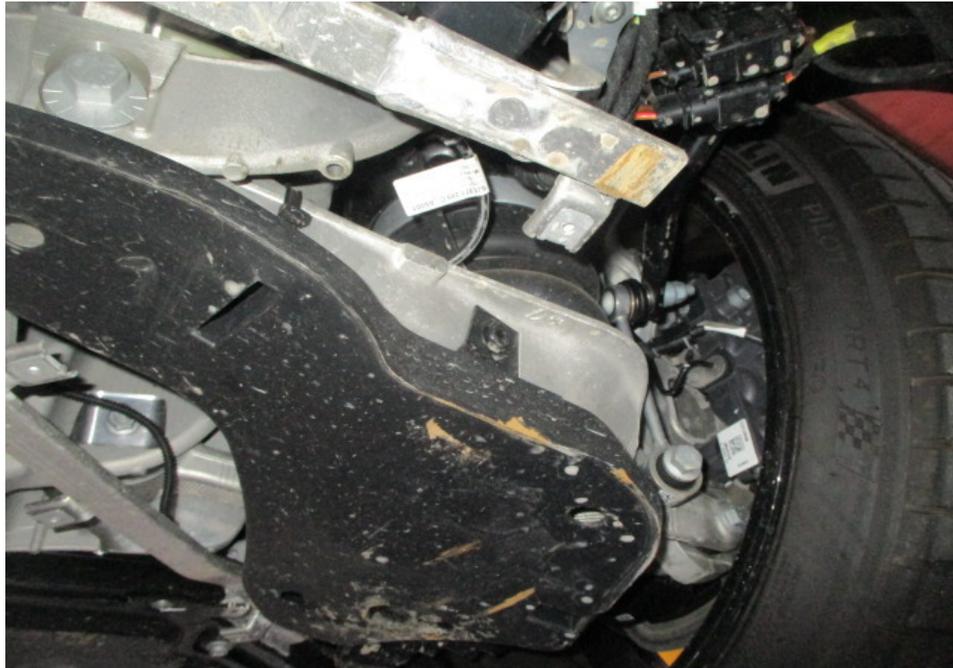
**Photo 24** shows a general view of the control arms and linkages at the rear right wheel of the Motor Car. I did not observe any fluid leak and/or fluid stain on the underside of the Motor Car. All of the Motor Car's undercarriage components were observed to be intact and secured in an appropriate manner.

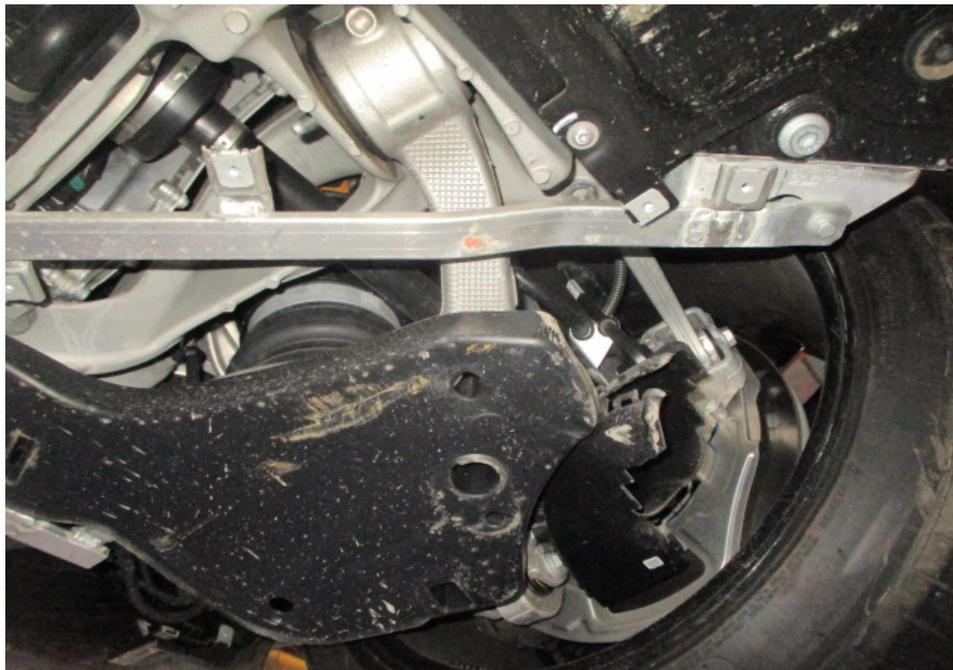
**Photo 25** shows a general view of the control arms and linkages at the rear left wheel of the Motor Car. I did not observe any fluid leak and/or fluid stain on the underside of the Motor Car. All of the Motor Car's undercarriage components were observed to be intact and secured in an appropriate manner.

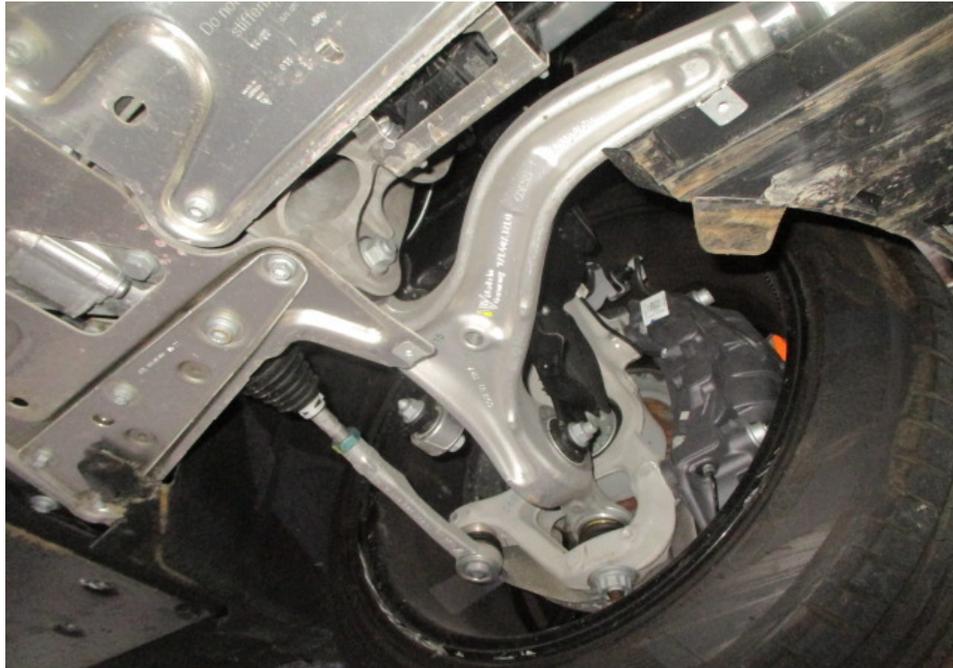
**Photo 26** shows the various undercarriage components at the front left wheel of the Motor Car. The mechanical components, control arms and linkages were all found to be intact and secured in an appropriate manner.

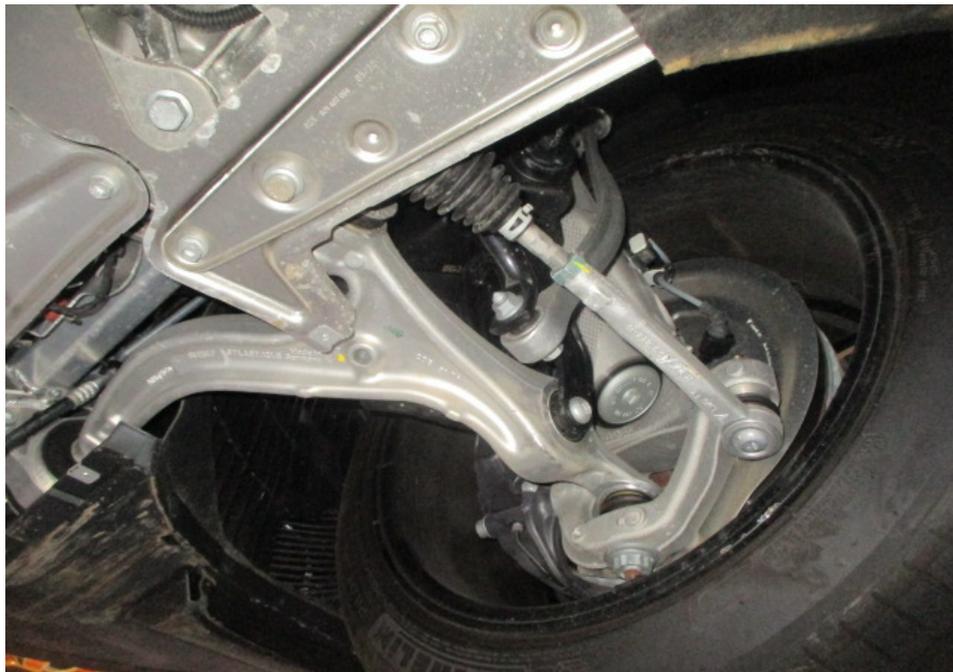
**Photo 27** shows the various undercarriage components at the front right wheel of the Motor Car. The mechanical components, control arms and linkages were all found to be intact and secured in an appropriate manner. I also did not observe any fluid leak and/or fluid stain on the underside of the Motor Car.

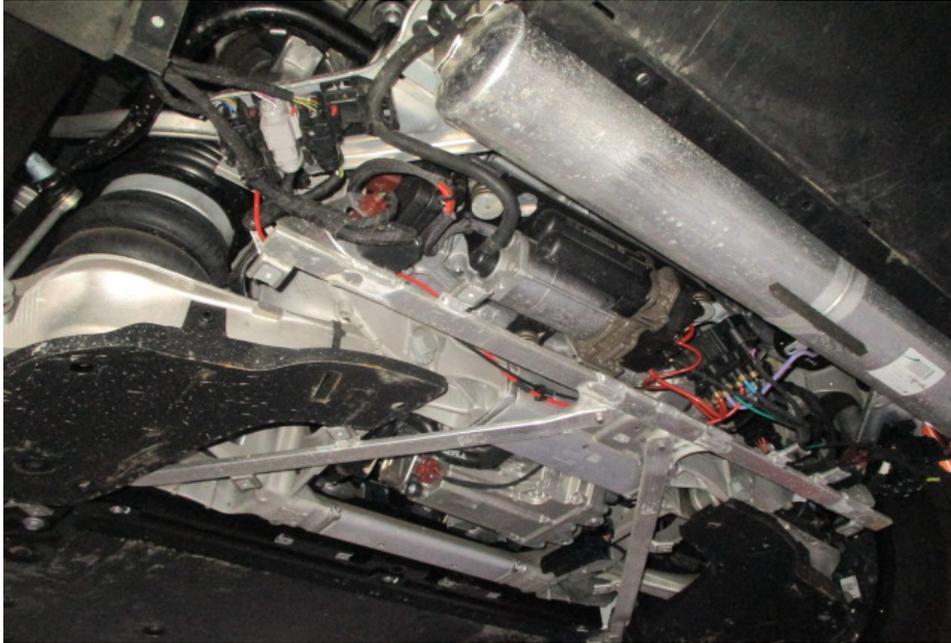
**Photo 28** shows the underside rear of the Motor Car, at the location where the rear electric motor is fitted. The high voltage system of the Motor Car was visually checked, and it was observed that the various high voltage parts and components like the high voltage battery, inverter unit, converter unit, high voltage cables, electric motors and electric aircon compressor amongst others, were properly secured and without any physical damage.

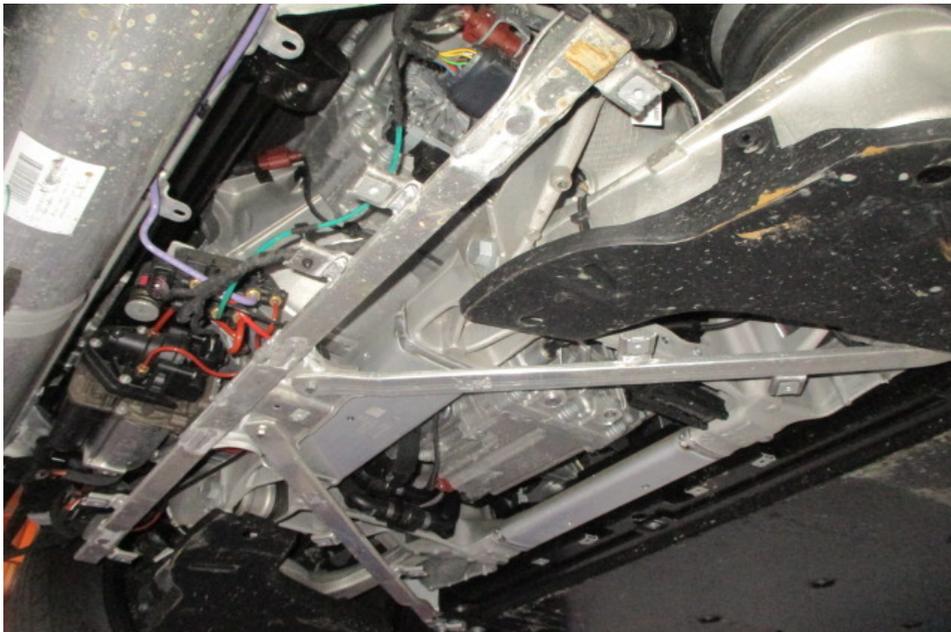
**Photo 29** shows another view of the underside rear of the Motor Car, at the location where the rear electric motor is fitted. The high voltage system of the Motor Car was visually checked, and it was observed that the various high voltage parts and components like the high voltage battery, inverter unit, converter unit, high voltage cables, electric motors and electric aircon compressor amongst others, were properly secured and without any physical damage.

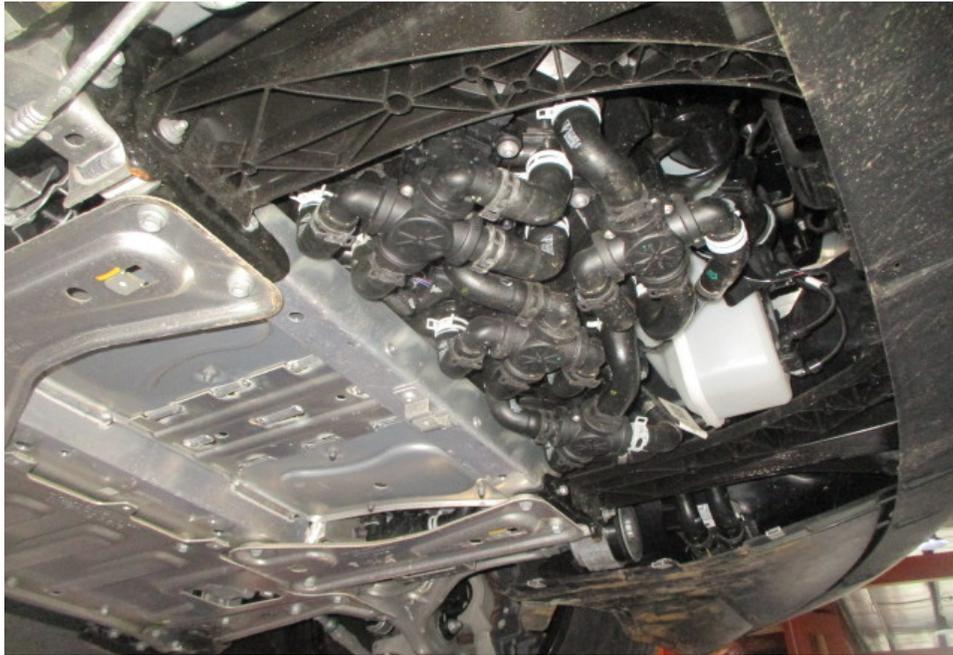
**Photo 30** shows the underside front of the Motor Car, at the location where the front electric motor, is fitted. The high voltage system of the Motor Car was visually checked, and it was observed that the various high voltage parts and components like the high voltage battery, inverter unit, converter unit, high voltage cables, electric motors and electric aircon compressor amongst others, were properly secured and without any physical damage.
