Your Ref: Porsche Taycan Cross Turismo  
(chassis number WP0ZZZY1ZNSA75234)  
Our Ref : CI/TP23006613/D

03 July 2023

**INSPECTION REPORT OF AN UNREGISTERED PORSCHE TAYCAN CROSS TURISMO MOTOR CAR WITH CHASSIS NUMBER WP0ZZZY1ZNSA75234**

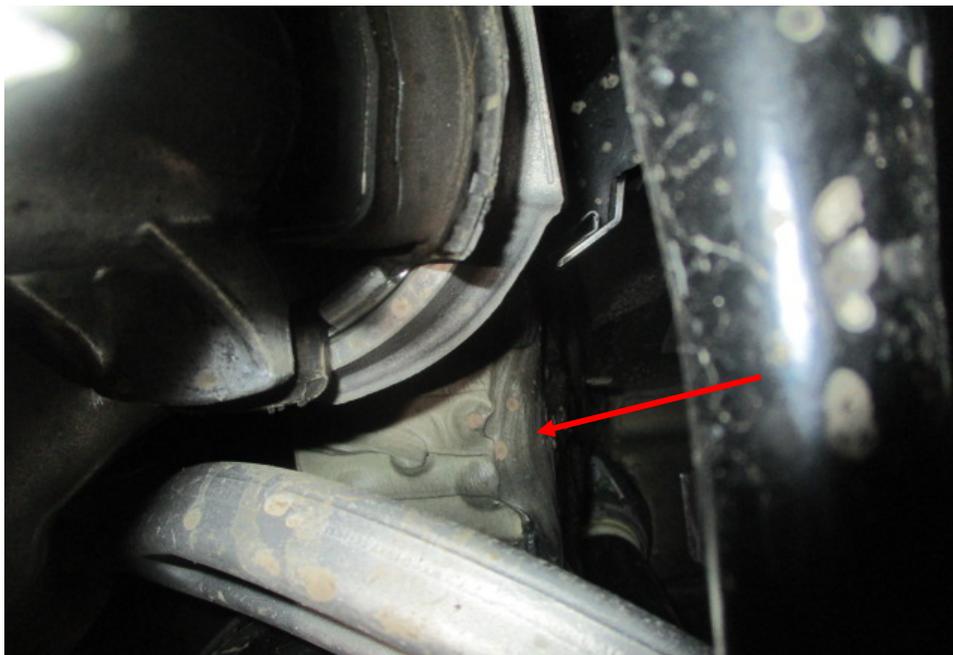
**Photo 31** shows the chassis/structural body at the underside rear right of the Motor Car. I did not find any weld marks other than original spot weld marks on the chassis/structural body of the Motor Car. The original factory sealant (arrowed) at the joints along the chassis/structural body was untouched, indicating no work was done on the chassis/structural body of the Motor Car and that the chassis/structural body was originally fitted.

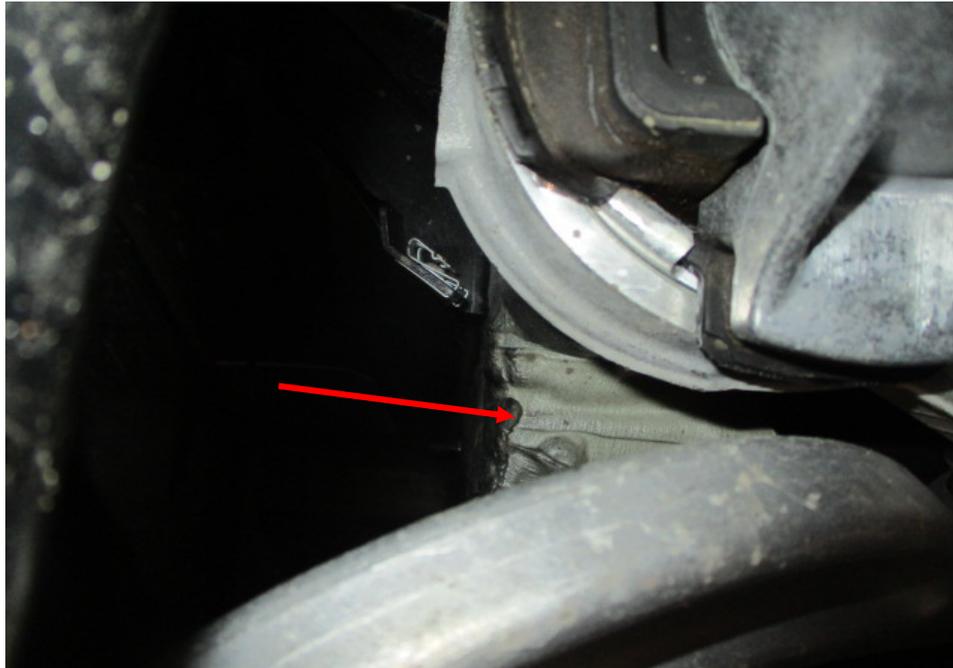
**Photo 32** shows the chassis/structural body at the underside rear left of the Motor Car. The original factory sealant (arrowed) at the joints along the chassis/structural body was observed to be untouched. In general, I had found no work was carried out on the chassis/structural body of the Motor Car. The chassis/structural body of the Motor Car was originally fitted.

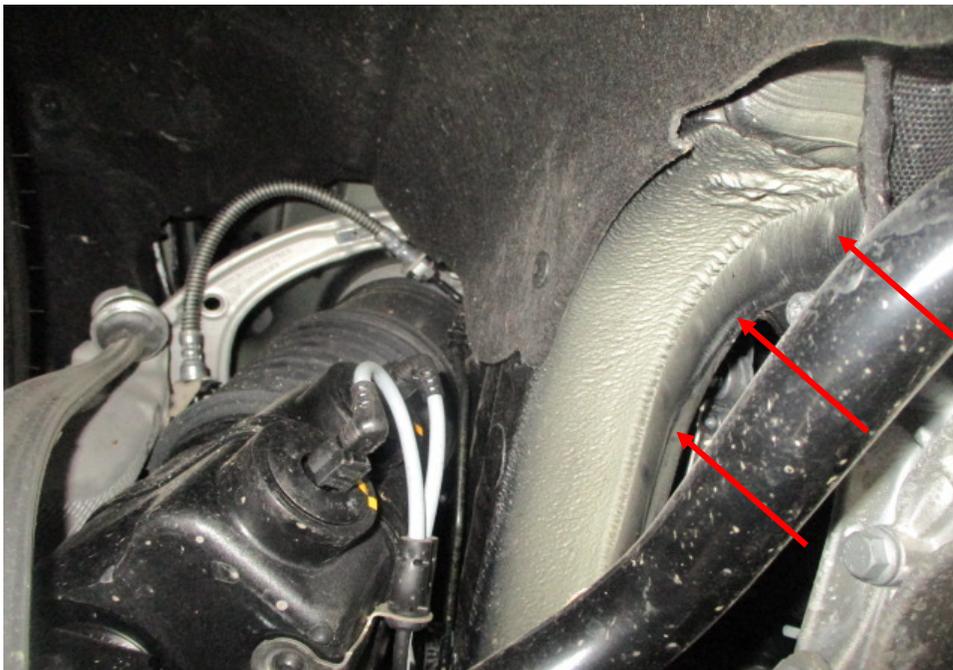
**Photo 33** shows the chassis/structural body at the underside front left of the Motor Car. I did not find any weld marks other than original spot weld marks on the chassis/structural body of the Motor Car. The original factory sealant (arrowed) at the joints along the chassis/structural body was untouched, indicating no work was done on the chassis/structural body of the Motor Car and that the chassis/structural body was originally fitted.

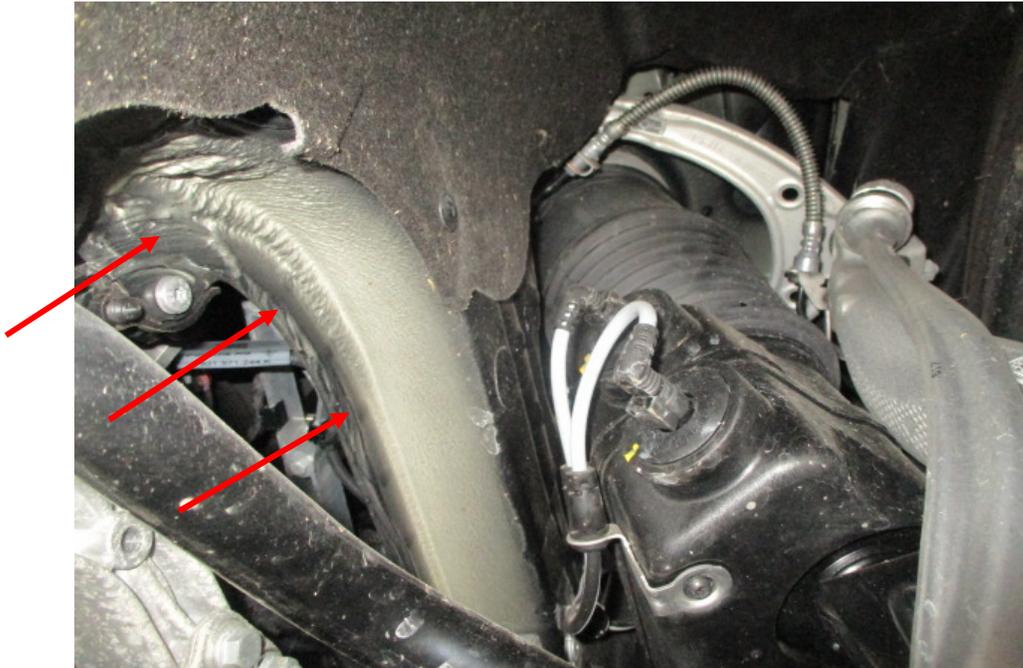
**Photo 34** shows the chassis/structural body at the underside front right of the Motor Car. The original factory sealant (arrowed) at the joints along the chassis/structural body was observed to be untouched. In general, I had found no work was carried out on the chassis/structural body of the Motor Car. The chassis/structural body of the Motor Car was originally fitted.
