Your Ref: Toyota Land Cruiser
(chassis number URJ2024212803)
Our Ref : CI/TP23006671/D

03 July 2023

**INSPECTION REPORT OF AN UNREGISTERED TOYOTA LAND CRUISER
MOTOR CAR WITH CHASSIS NUMBER URJ2024212803**

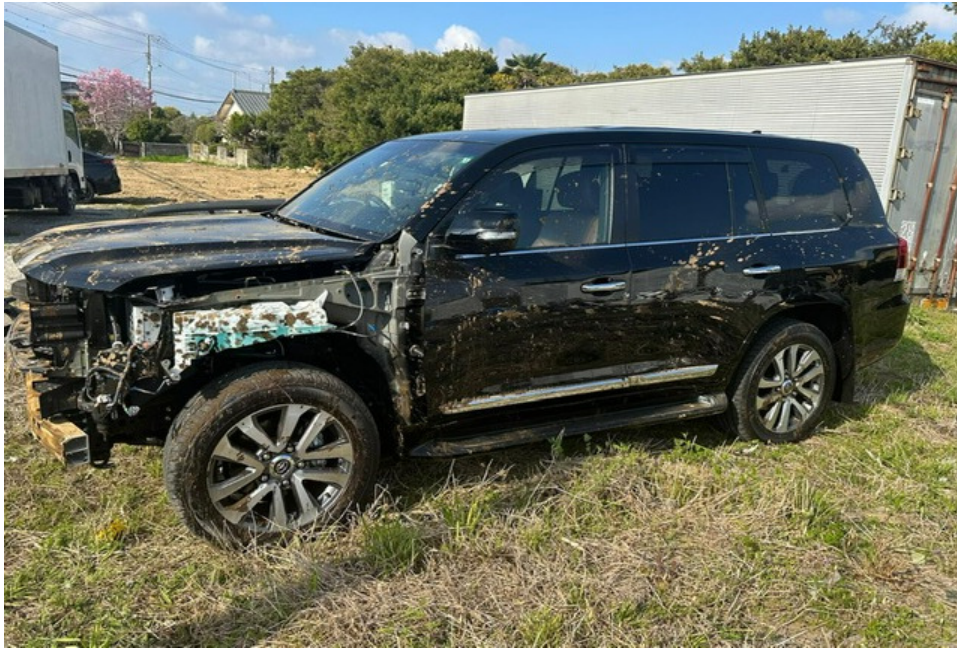
Photo 1 shows the front left body of the Motor Car (photograph provided to me). The photographs provided to me had showed the Motor Car's front left fender, front left blind spot mirror, front left headlamp, front bumper and all its related parts and attachments like the front bumper centre lower grille, front bumper sensors, front bumper left fog lamp cover and front bumper left fog lamp amongst others, missing/dislodged/damaged.

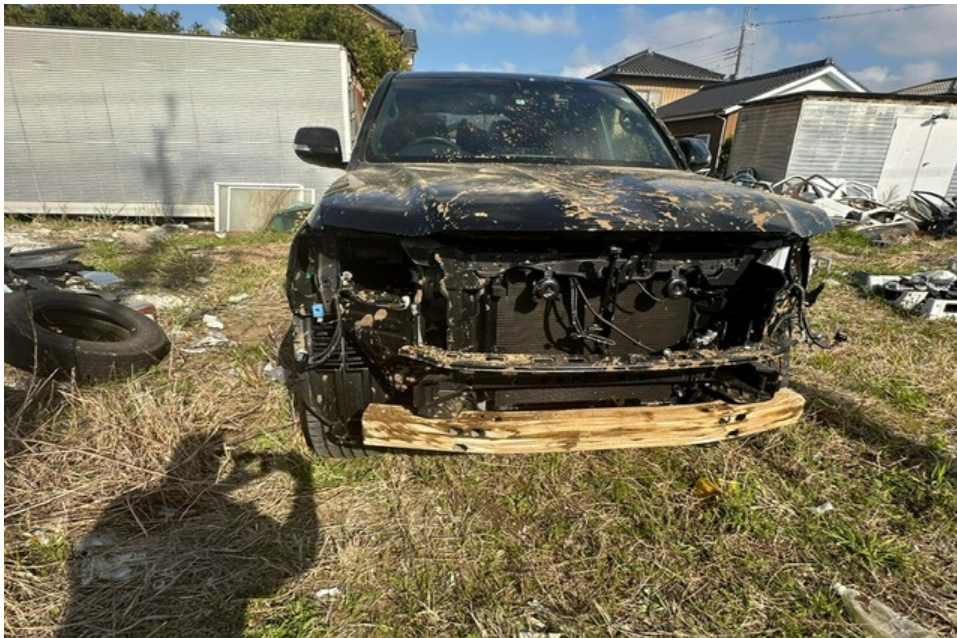
Photo 2 shows the frontal body of the Motor Car (photograph provided to me). The photographs provided to me had showed the Motor Car's front left headlamp, front right headlamp, front lower grille, front upper grille, front emblem, front bumper and all its related parts and attachments like the front bumper centre lower grille, front bumper sensors, front bumper left fog lamp cover, front bumper left fog lamp, front bumper right fog lamp cover and front bumper right fog lamp amongst others, missing/dislodged/damaged.

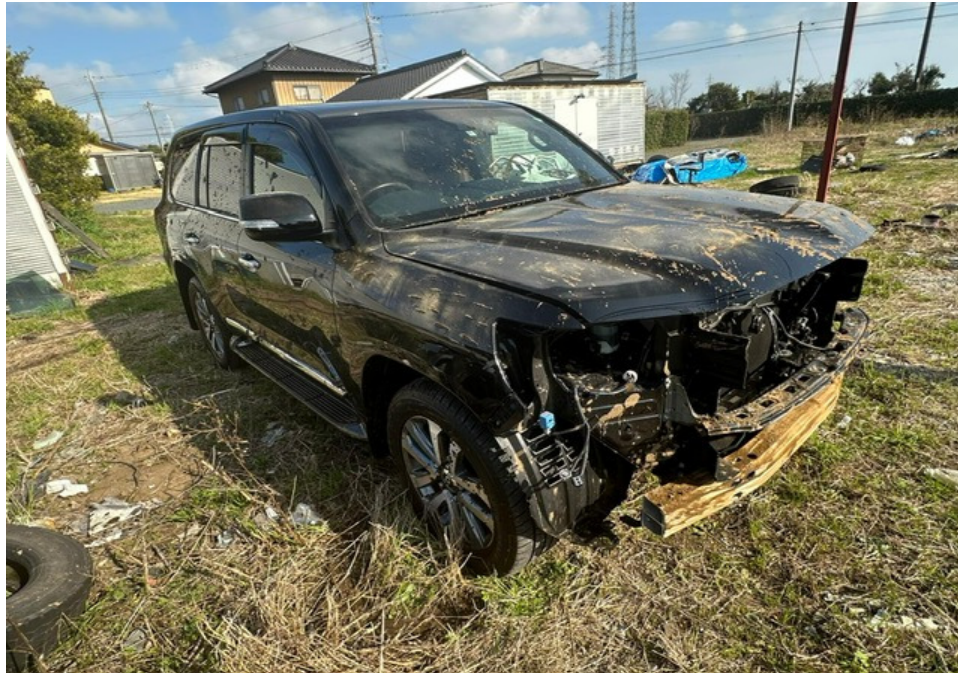
Photo 3 shows the front right body of the Motor Car (photograph provided to me). The photographs provided to me had showed the Motor Car's front right headlamp, front lower grille, front upper grille, front emblem, front bumper and all its related parts and attachments like the front bumper centre lower grille, front bumper sensors, front bumper right fog lamp cover and front bumper right fog lamp amongst others, missing/dislodged/damaged. The airbag(s) of the Motor Car was not deployed.

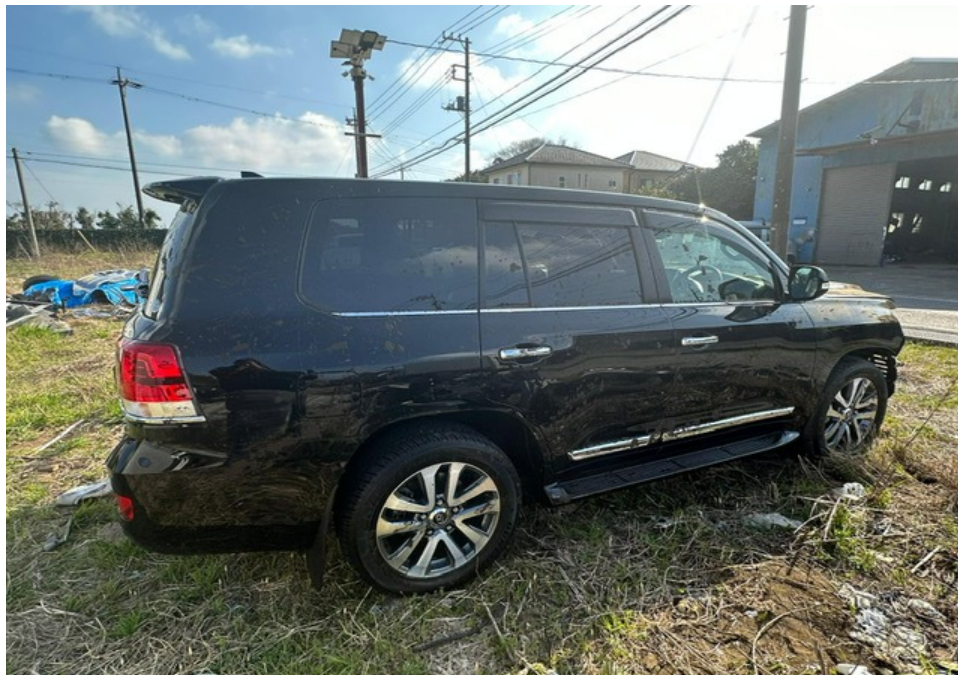
Photo 4 shows the rear right body of the Motor Car (photograph provided to me). Apart for the frontal portion, there was no physical damage observed to other areas of the Motor Car.

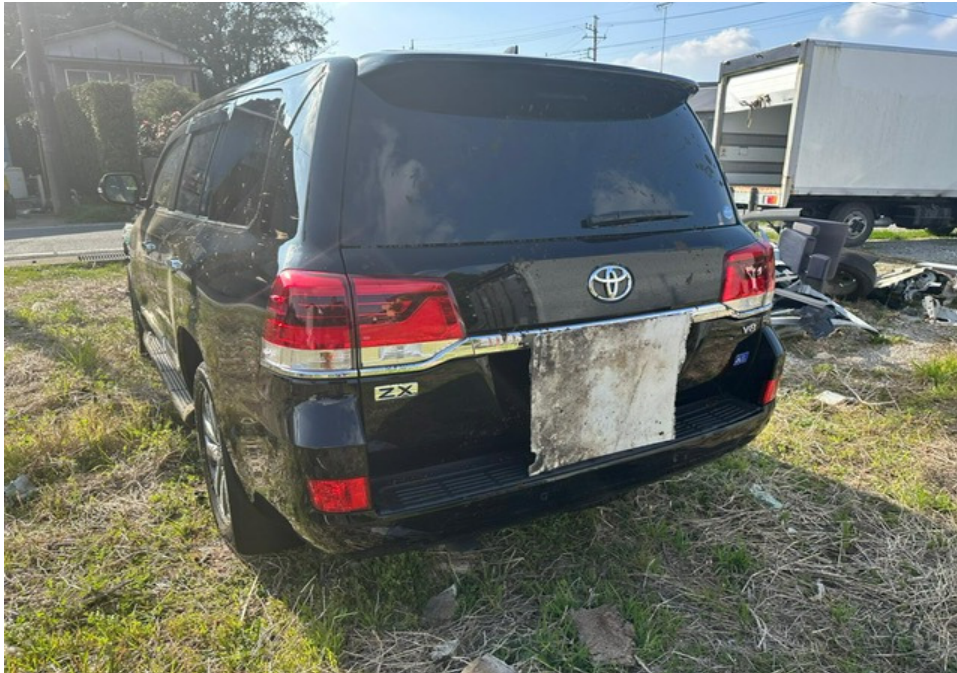
Photo 5 shows the rear right body of the Motor Car (photograph provided to me). Apart for the frontal portion, there was no physical damage observed to other areas of the Motor Car.

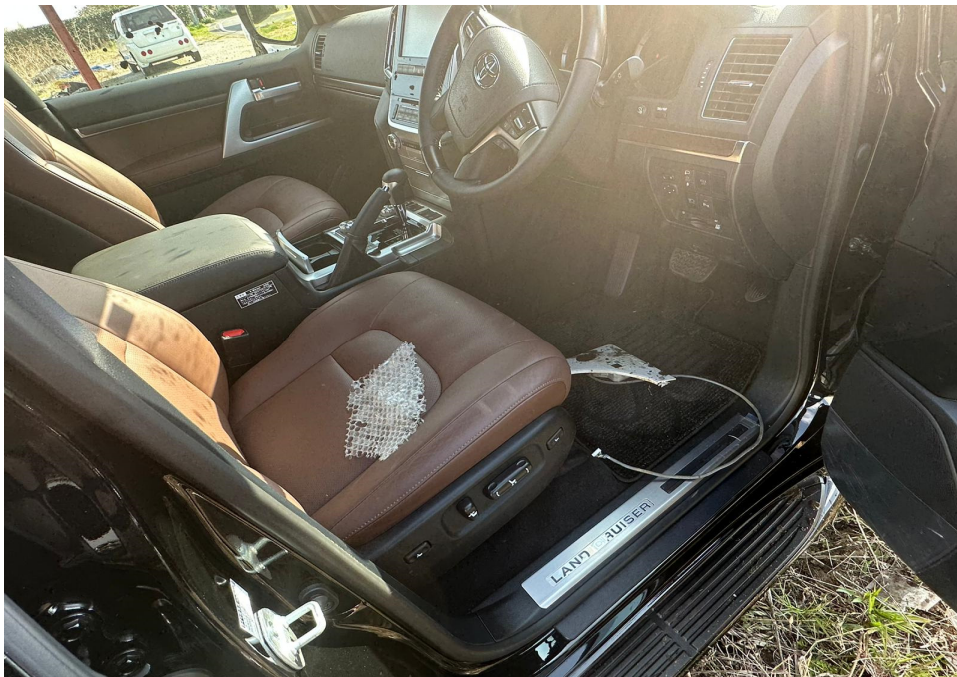
Photo 6 shows the interior compartment of the Motor Car (photograph provided to me). The various parts and components within the interior compartment were all intact and unaffected. The Motor Car's airbag(s) was not deployed as seen from the photographs that were provided to me.

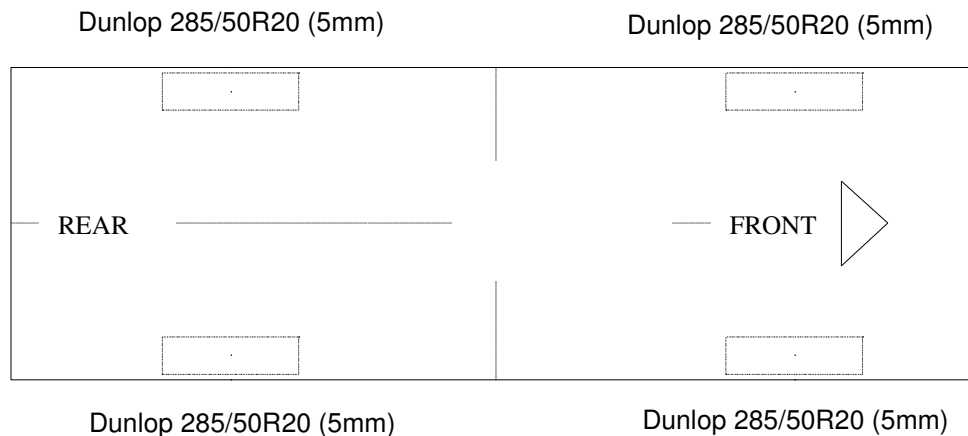
8. The Motor Car was fitted with 20inch sport wheel rims that were wrapped with tyres that were observed to be of serviceable condition. The tyres were also sufficiently inflated for vehicular operation. The tyre brand, tyre size and approximate remaining tread depth of the 4 tyres of the Motor Car were recorded as follows: -

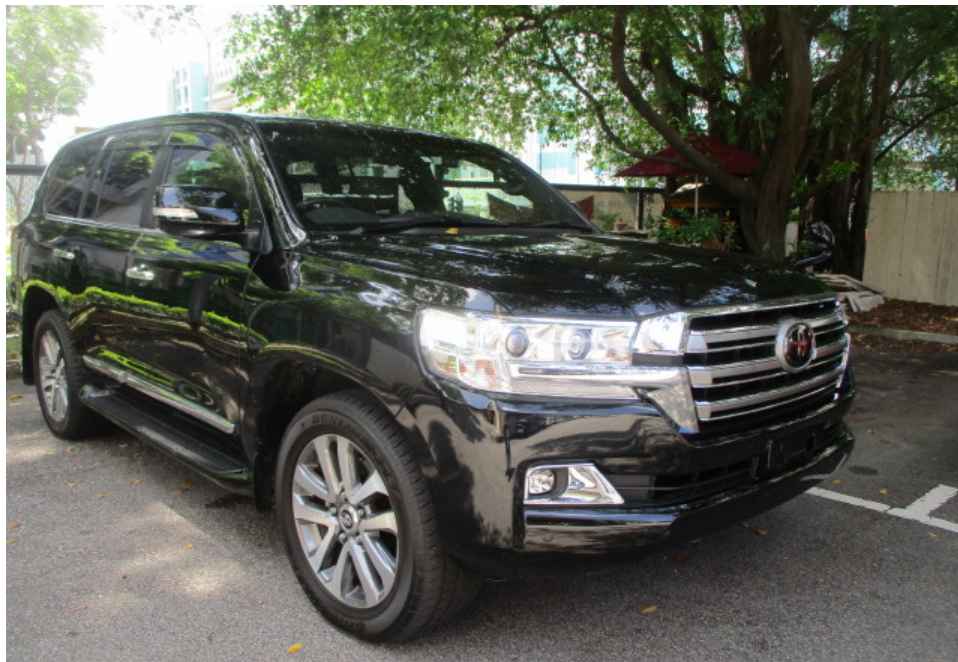
Photo 7 shows a general view of the front right body of the Motor Car at the time of my inspection. The Motor Car was observed to be in a relatively good general condition with no loose exterior fittings observed. The body parts at the frontal portion of the Motor Car were visually examined and it was observed that the repair/restoration works carried out to the damaged area of the Motor Car (refer to photograph 1 - 3 above) were reasonably adequate and in order.

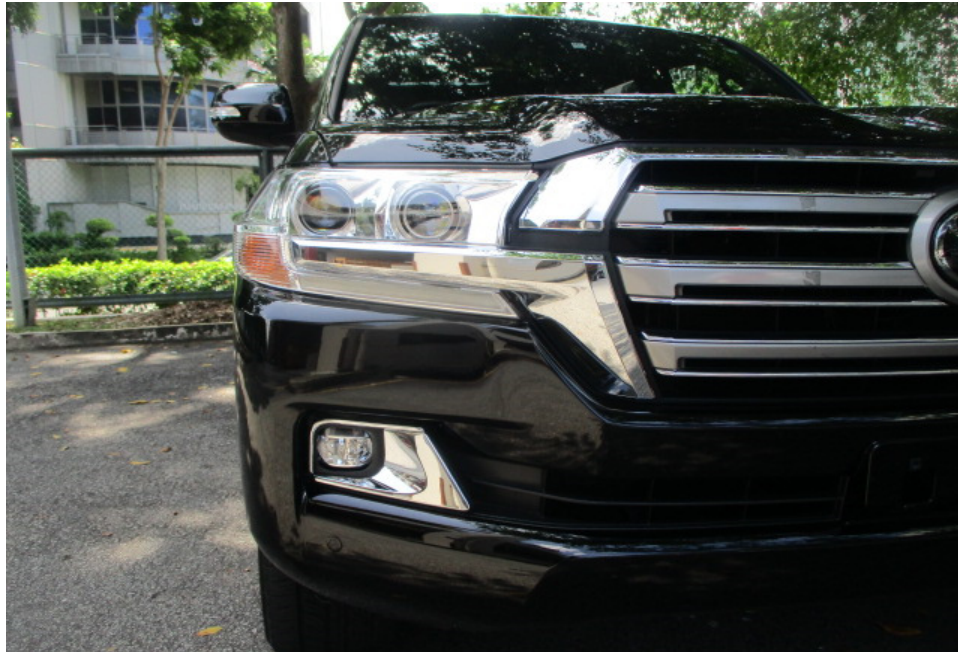
Photo 8 shows a closer view of the Motor Car's front bumper, front bumper right fog lamp cover, front bumper right fog lamp and front right headlamp. The body parts at the frontal portion of the Motor Car were visually examined and it was observed that the repair/restoration works carried out to the damaged area of the Motor Car (refer to photograph 1 - 3 above) were reasonably adequate and in order.

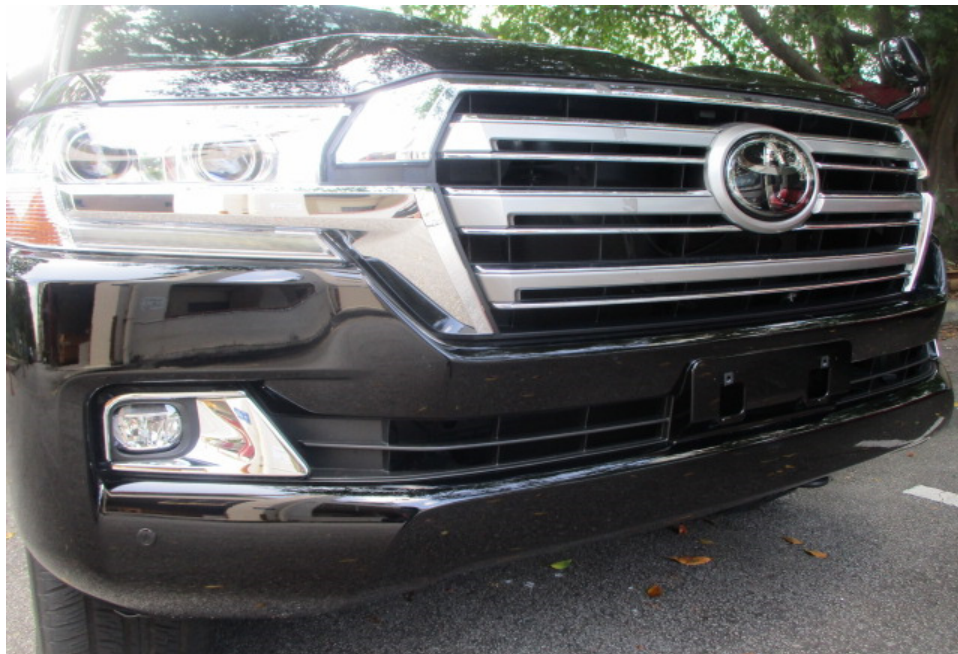
Photo 9 shows a closer view of the Motor Car's front bumper, front bumper left sensor, front bumper centre lower grille, front bumper right fog lamp cover, front bumper right fog lamp, front lower grille and front upper grille. The body parts at the frontal portion of the Motor Car were visually examined and it was observed that the repair/restoration works carried out to the damaged area of the Motor Car (refer to photograph 1 - 3 above) were reasonably adequate and in order.

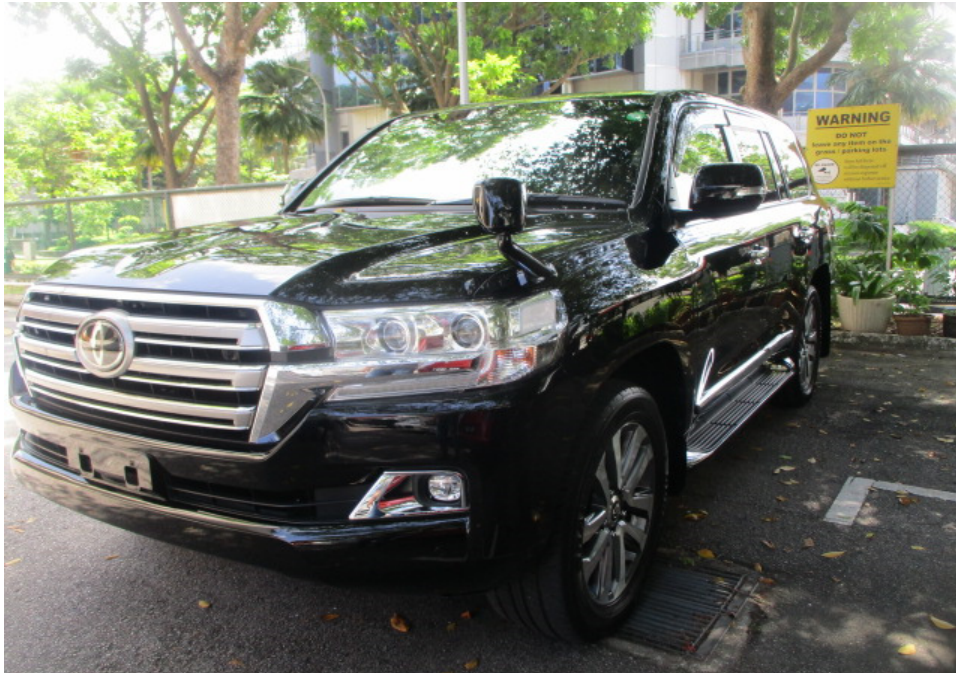
Photo 10 shows a general view of the front left body of the Motor Car at the time of my inspection. The Motor Car was observed to be in a relatively good general condition with no loose exterior fittings observed. The body parts at the frontal portion of the Motor Car were visually examined and it was observed that the repair/restoration works carried out to the damaged area of the Motor Car (refer to photograph 1 - 3 above) were reasonably adequate and in order.

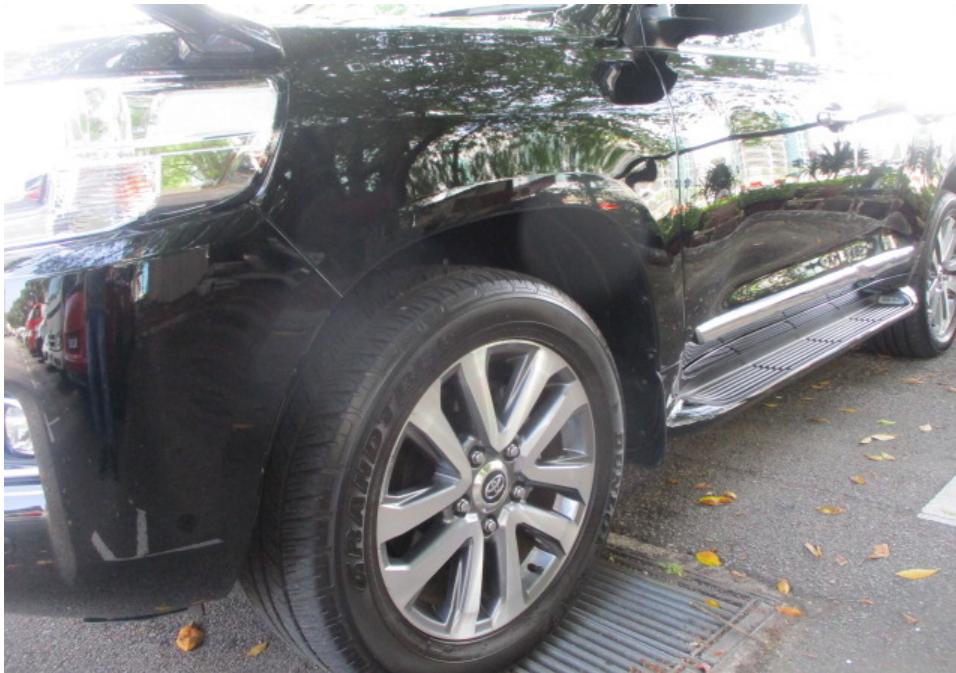
Photo 11 shows a closer view of the Motor Car's front left fender, front left wheel rim and front left tyre. The body parts at the frontal portion of the Motor Car were visually examined and it was observed that the repair/restoration works carried out to the damaged area of the Motor Car (refer to photograph 1 - 3 above) were reasonably adequate and in order.

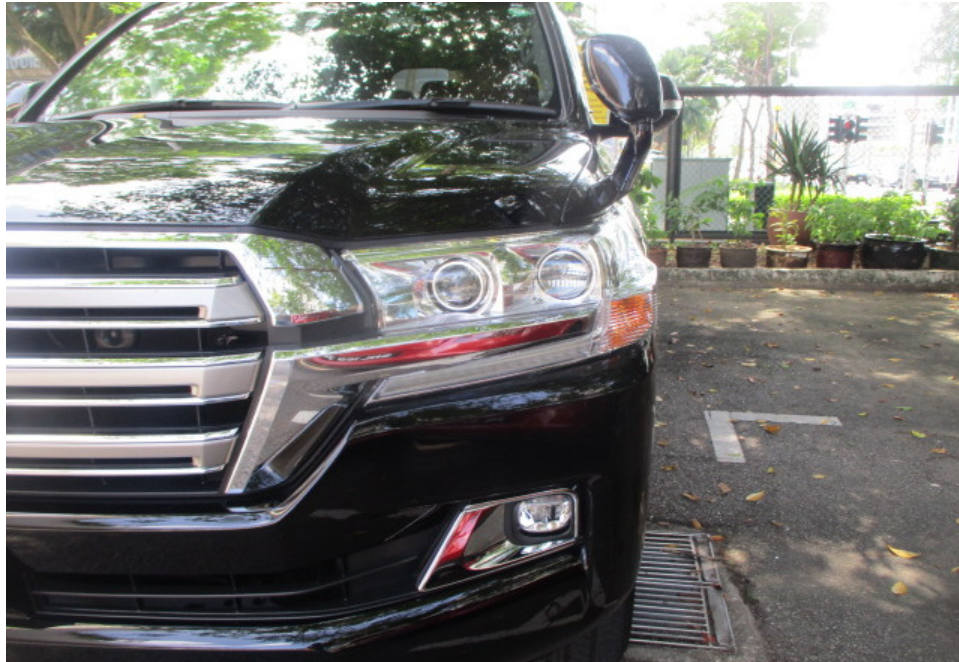
Photo 12 shows a closer view of the Motor Car's front bumper, front bumper left fog lamp cover, front bumper left fog lamp, front left headlamp and front left blind spot mirror. The body parts at the frontal portion of the Motor Car were visually examined and it was observed that the repair/restoration works carried out to the damaged area of the Motor Car (refer to photograph 1 - 3 above) were reasonably adequate and in order.

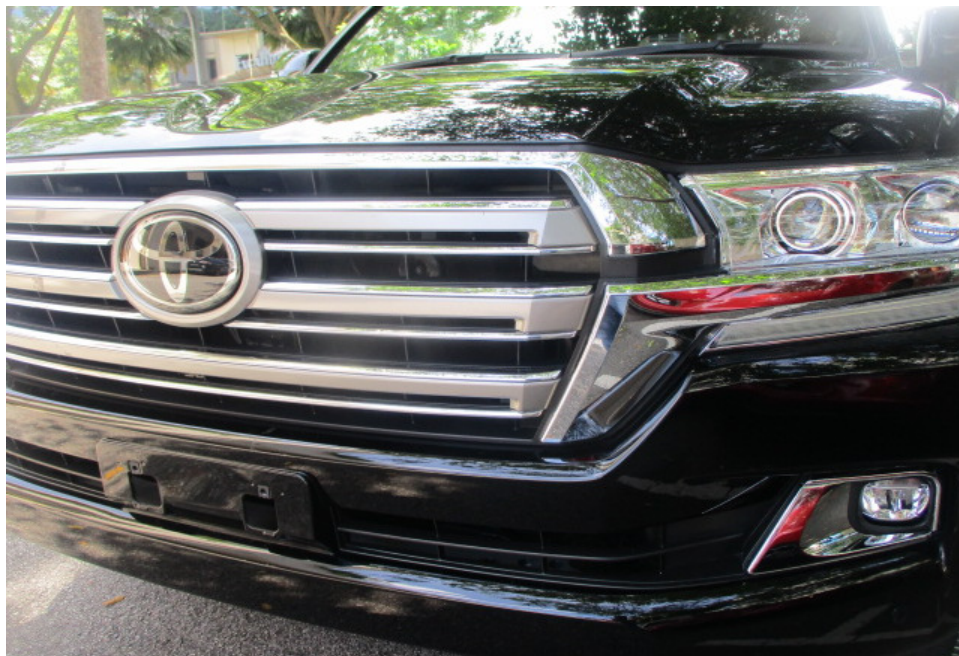
Photo 13 shows a closer view of the Motor Car's front bumper, front bumper centre lower grille, front bumper left fog lamp cover, front bumper left fog lamp, front lower grille, front upper grille and front emblem. The body parts at the frontal portion of the Motor Car were visually examined and it was observed that the repair/restoration works carried out to the damaged area of the Motor Car (refer to photograph 1 - 3 above) were reasonably adequate and in order.

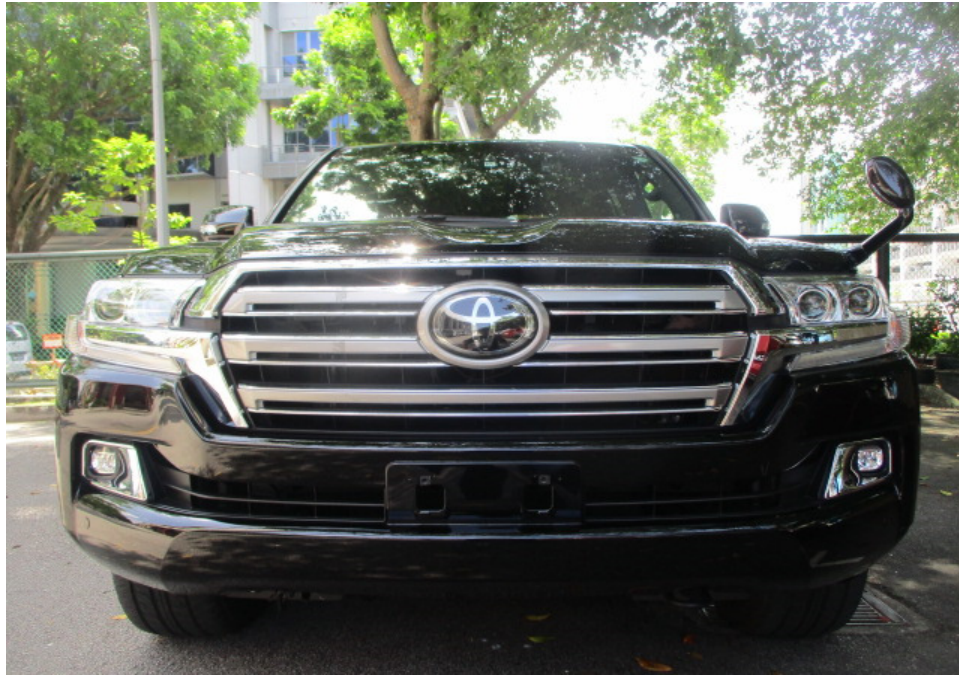
Photo 14 shows a closer view of the Motor Car's frontal body. The Motor Car was observed to be in a relatively good general condition with no loose exterior fittings observed. The body parts at the frontal portion of the Motor Car were visually examined and it was observed that the repair/restoration works carried out to the damaged area of the Motor Car (refer to photograph 1 - 3 above) were reasonably adequate and in order.

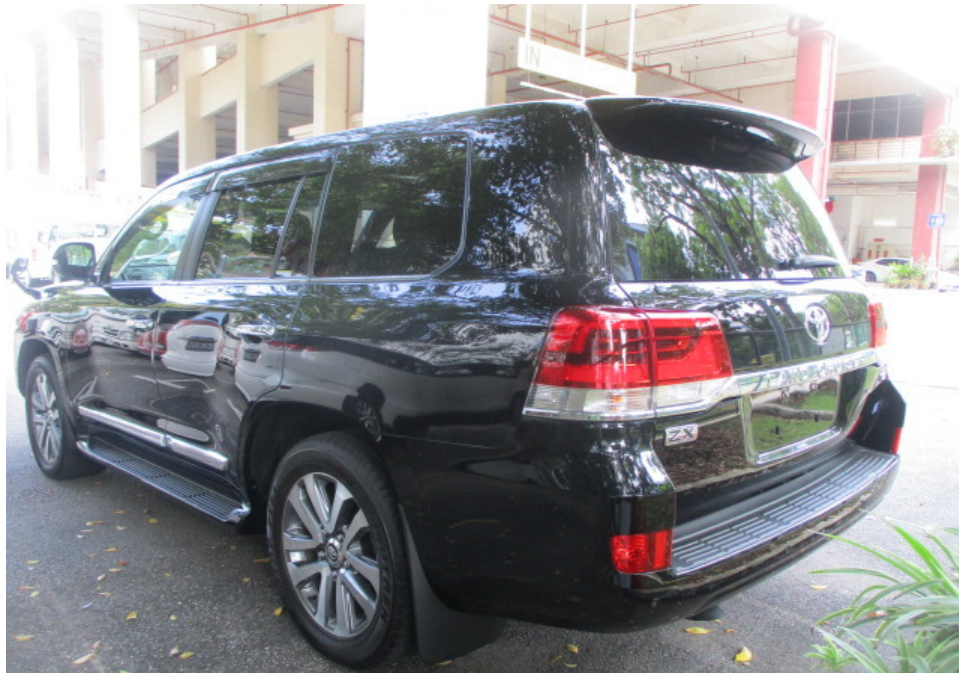
Photo 15 shows a general view of the rear left body of the Motor Car at the time of my inspection. The Motor Car was observed to be in a relatively good general condition with no loose exterior fittings observed. The mileage of the Motor Car recorded at the time of my inspection was 8,943km.

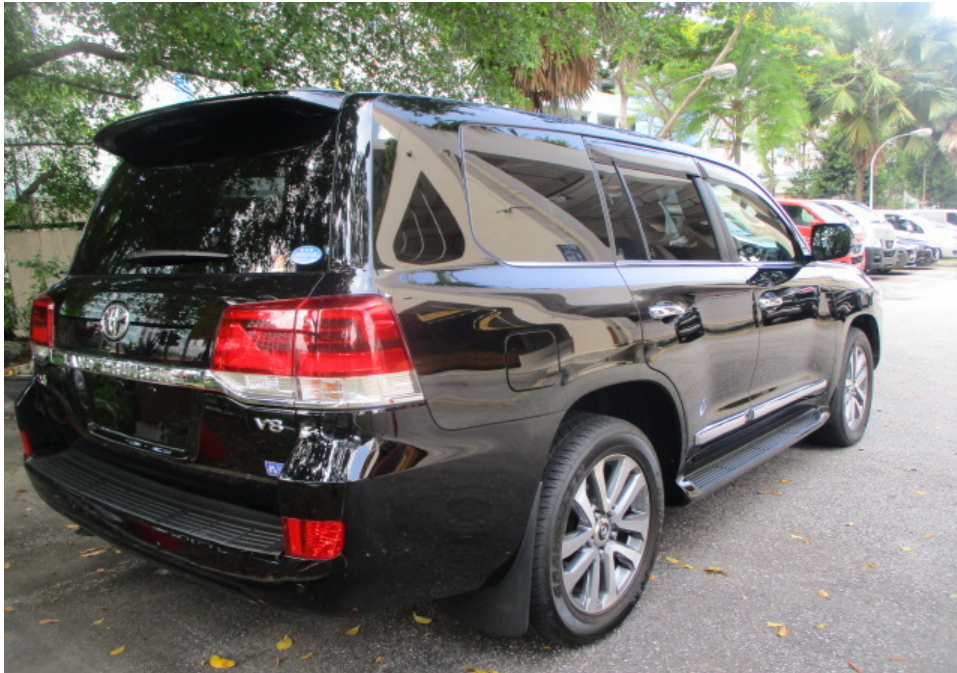
Photo 16 shows a general view of the rear right body of the Motor Car at the time of my inspection. The Motor Car was observed to be in a relatively good general condition with no loose exterior fittings observed. The mileage of the Motor Car recorded at the time of my inspection was 8,943km.

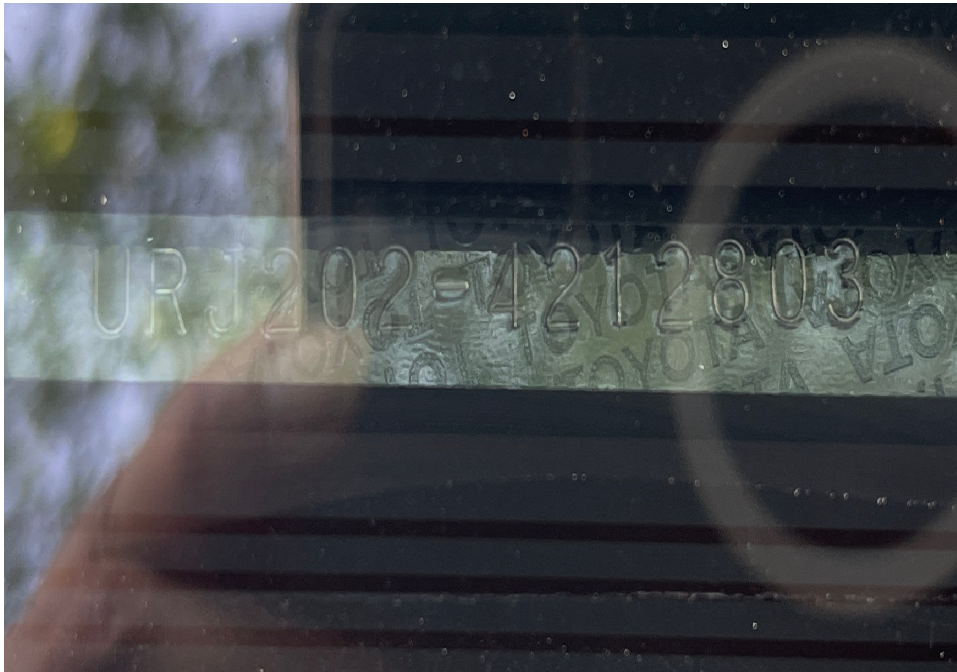
Photo 17 shows the chassis number of the Motor Car. The chassis number recorded was URJ2024212803.

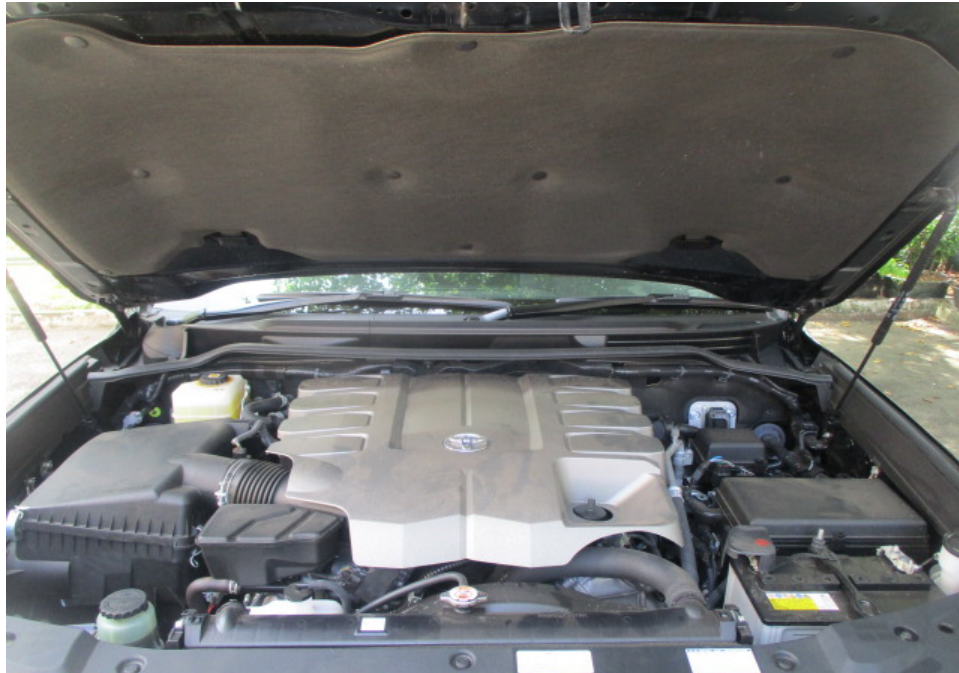
Photo 18 shows a general view of the Motor Car's engine compartment at the time of my inspection. The various parts and components inside the engine compartment were all observed to be intact and properly fitted. There was also no sign(s) or indication(s) of fluid leak and/or fluid stain found inside the engine compartment.

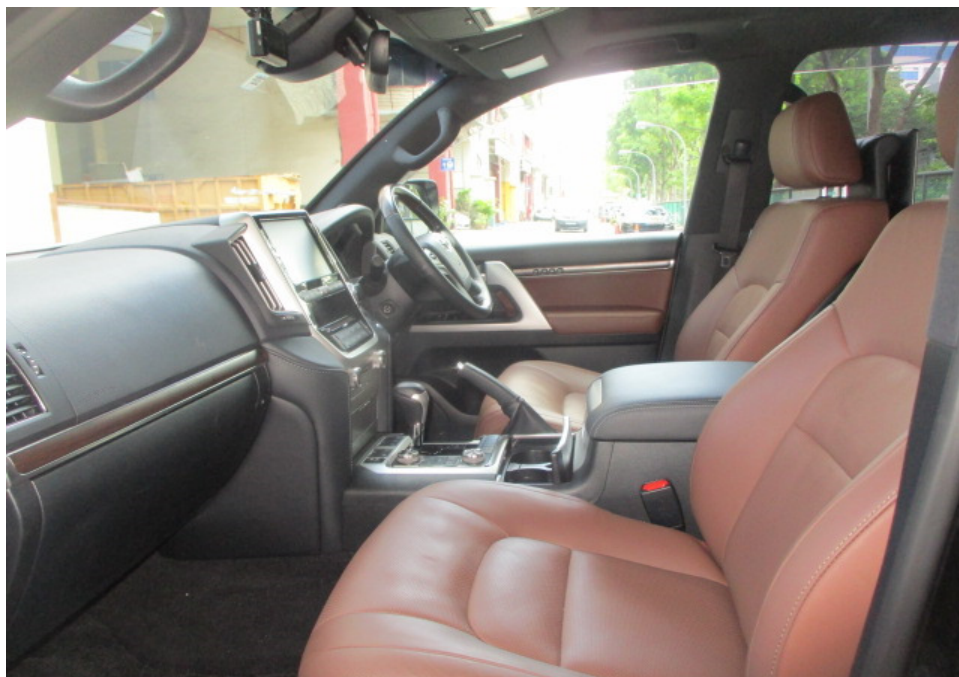
Photo 19 shows the interior compartment of the Motor Car at the time of my inspection. The various parts and components, trims, carpet, and upholstery inside the interior compartment were all observed to be intact and properly fitted.

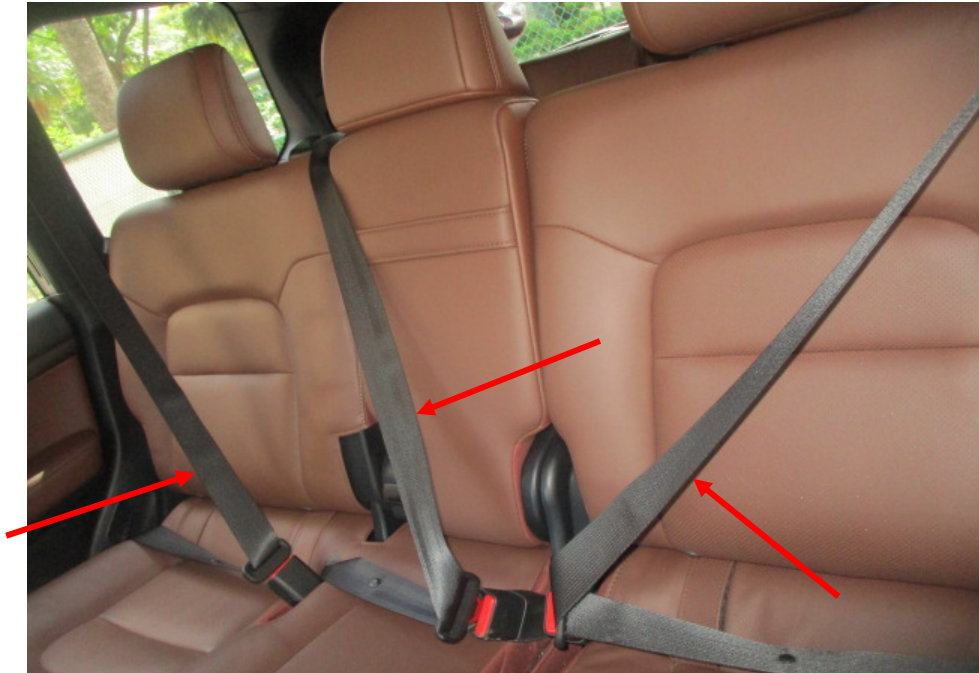
Photo 20 shows the rear seats at the 1st row of the Motor Car. All the seats of the Motor Car were secured via seat rails to the floorboard. They were also fitted with a retractable seat belt reel and a pre-tensioner. The seat belts (arrowed) were tested and were able to be fastened into the respective pre-tensions that were fitted on the side of each individual seat.

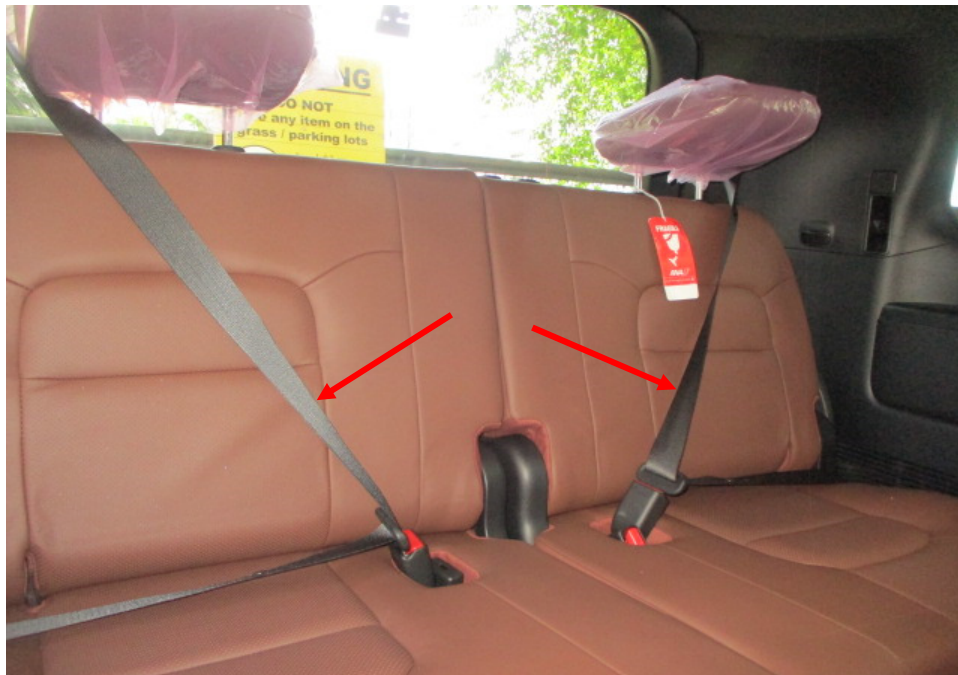
Photo 21 shows the rear seats at the 2nd row of the Motor Car. All the seats of the Motor Car were secured via seat rails to the floorboard. They were also fitted with a retractable seat belt reel and a pre-tensioner. The seat belts (arrowed) were tested and were able to be fastened into the respective pre-tensions that were fitted on the side of each individual seat.

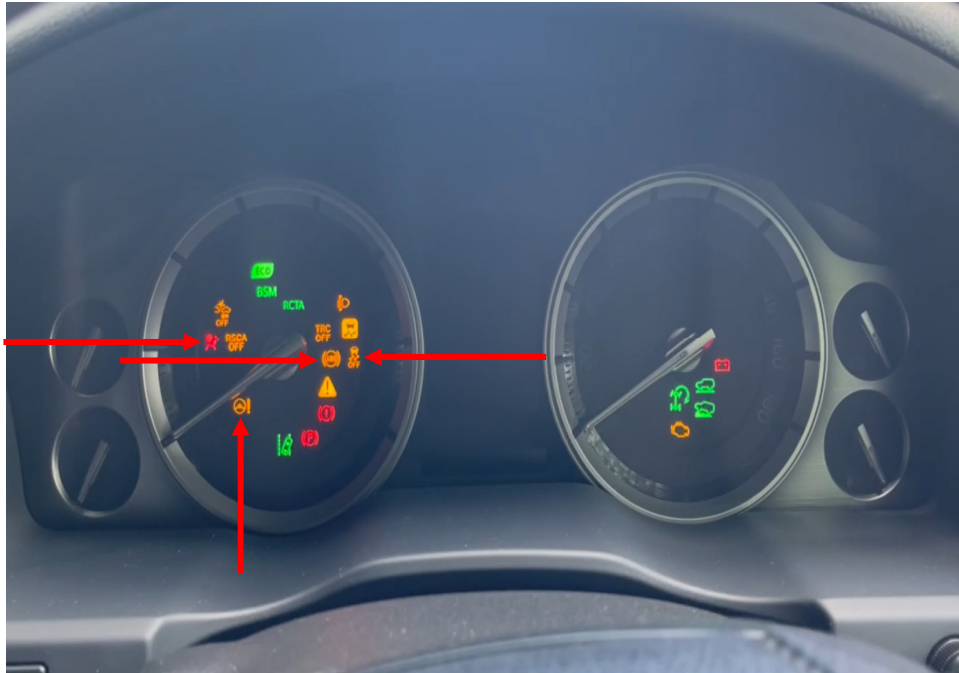
Photo 22 shows the warning lights for the various electronic safety features appearing on the instrument panel of the Motor Car during its self-test when the engine is cranked, in particular the ABS, SRS, EPS and TCS lights (arrowed).

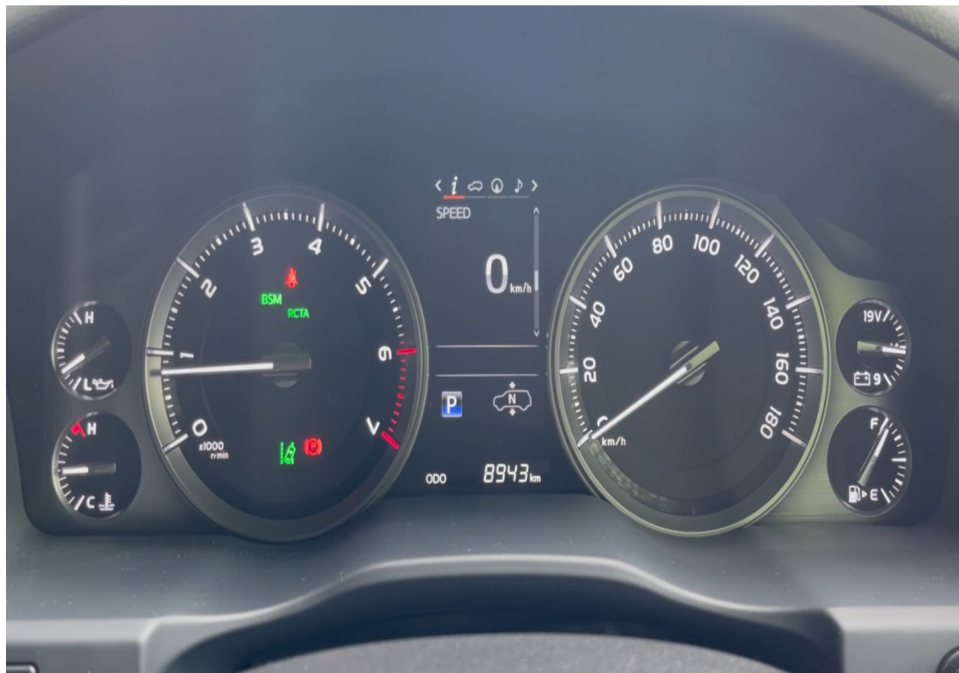
Photo 23 shows the respective warning lights no longer illuminated, indicating that there is no fault detected to the ABS, SRS, EPS and TCS systems of the Motor Car during the self-test. These electronic systems were hence in working condition at the time of my inspection.

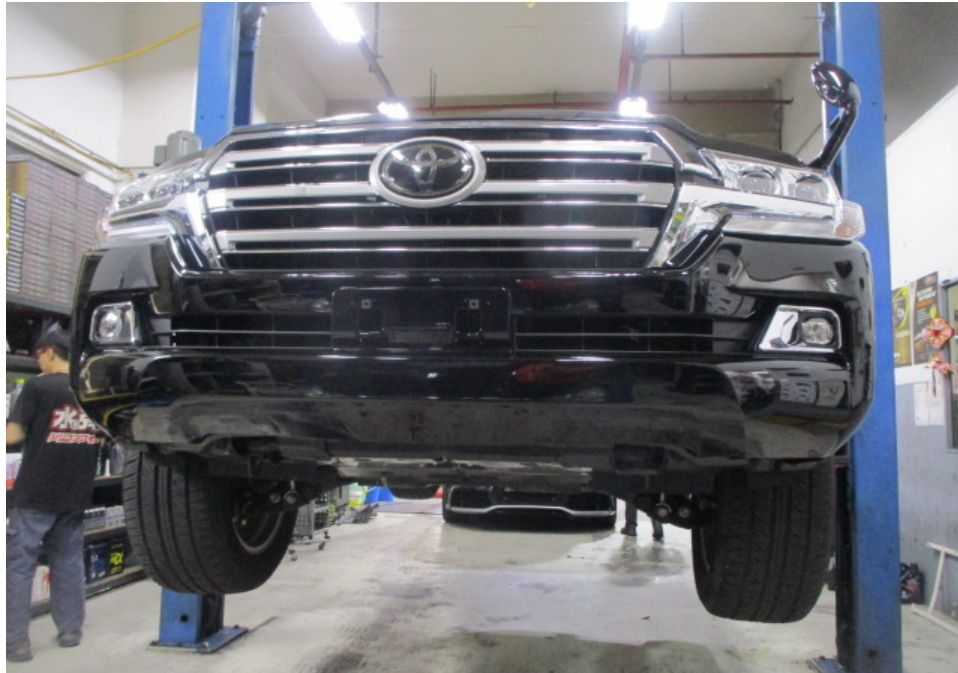
Photo 24 shows the Motor Car hoisted up for checks on its undercarriage. There was no sign(s) or indication(s) of fluid leakage and/or fluid stain(s) on the underside of the Motor Car. The undercarriage components of the Motor Car were also all observed to be intact and secured in an appropriate manner.

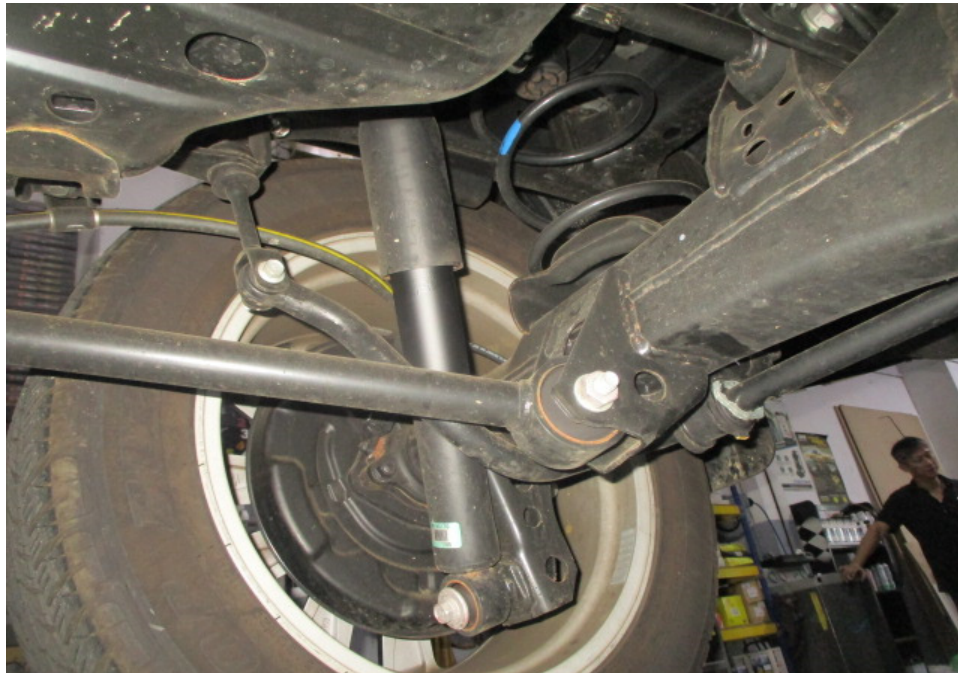
Photo 25 shows a general view of the control arms and linkages at the rear right wheel of the Motor Car. I did not observe any fluid leak and/or fluid stain on the underside of the Motor Car. All of the Motor Car's undercarriage components were observed to be intact and secured in an appropriate manner.

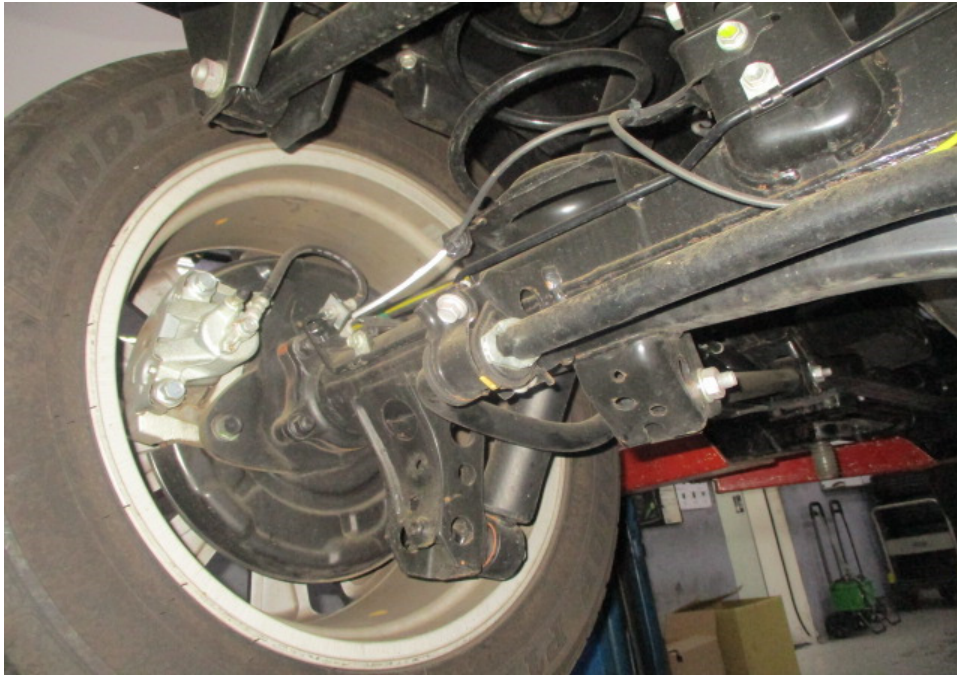
Photo 26 shows a general view of the control arms and linkages at the rear left wheel of the Motor Car. I did not observe any fluid leak and/or fluid stain on the underside of the Motor Car. All of the Motor Car's undercarriage components were observed to be intact and secured in an appropriate manner.

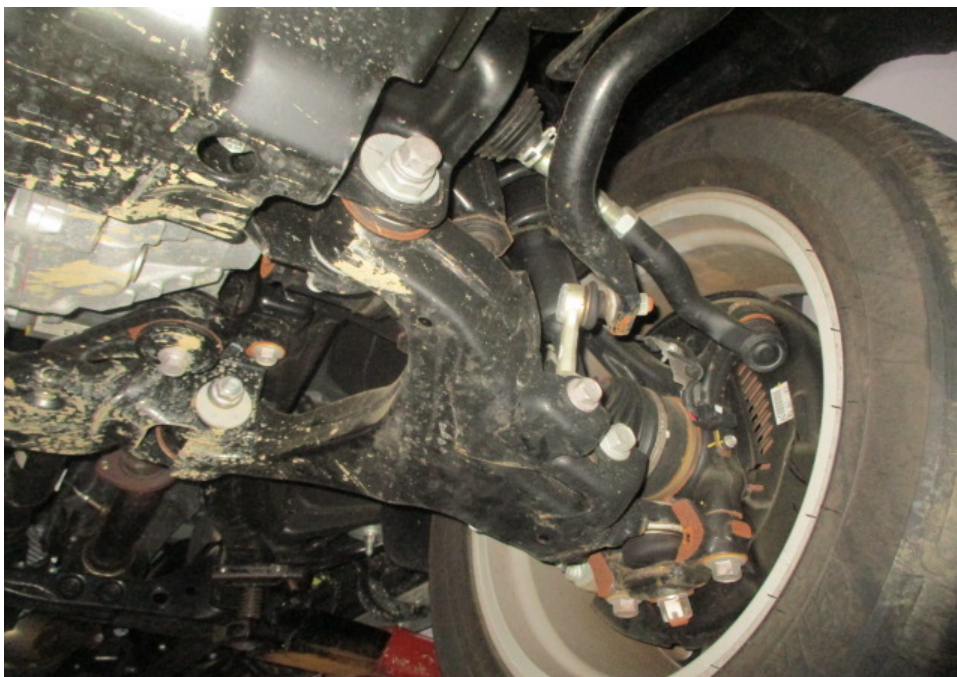
Photo 27 shows the various undercarriage components at the front left wheel of the Motor Car. The mechanical components, control arms and linkages were all found to be intact and secured in an appropriate manner.

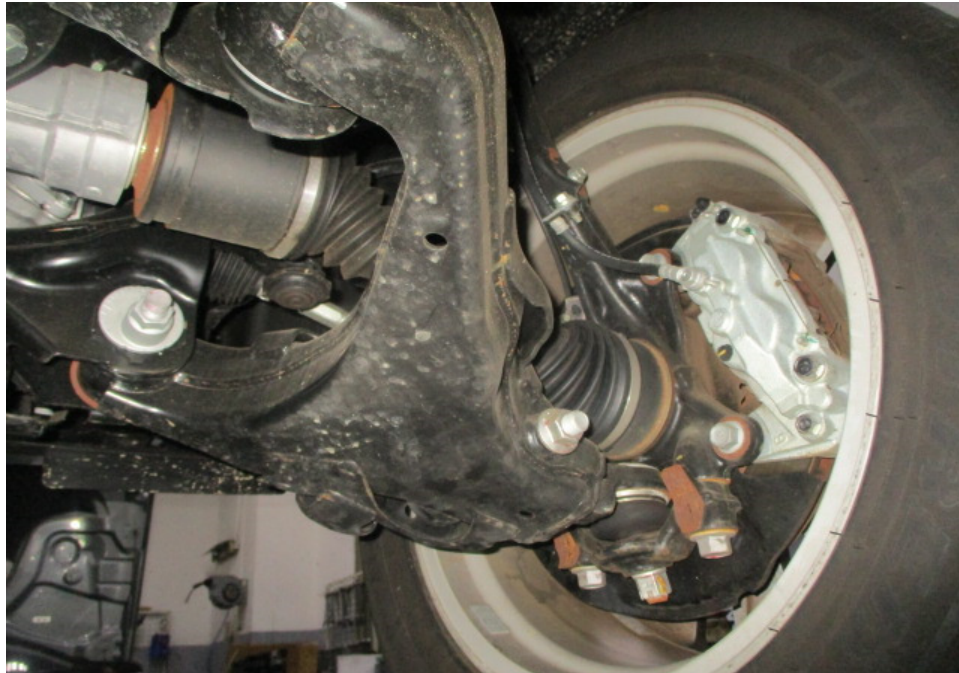
Photo 28 shows the various undercarriage components at the front right wheel of the Motor Car. The mechanical components, control arms and linkages were all found to be intact and secured in an appropriate manner. I also did not observe any fluid leak and/or fluid stain on the underside of the Motor Car.

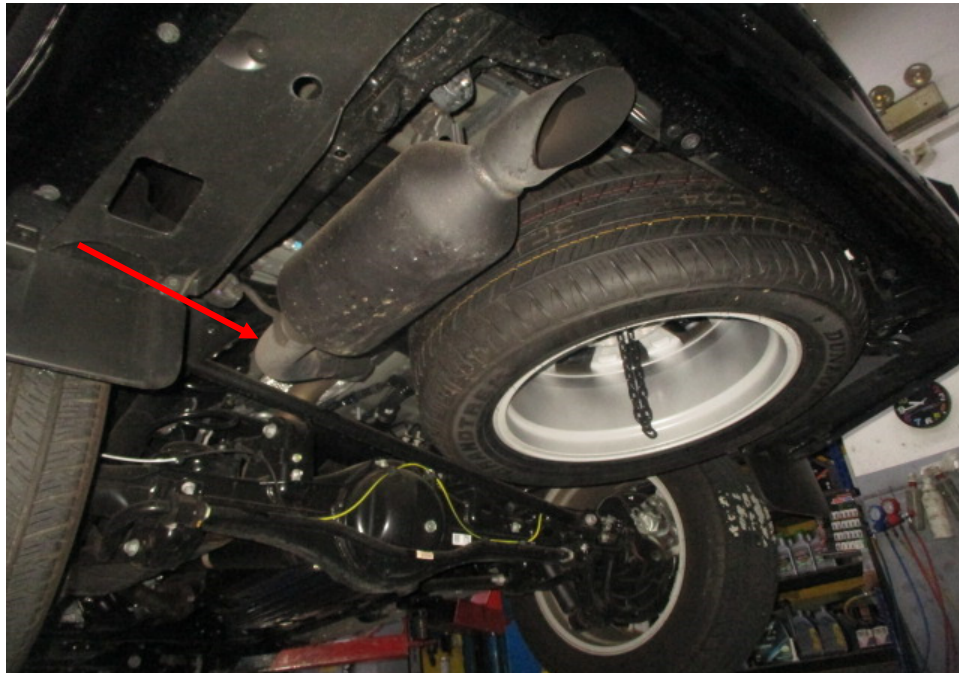
Photo 29 shows the rear section of the Motor Car's exhaust system. My examination of the Motor Car's exhaust system revealed no sign(s) or indication(s) of any cut or weld marks along its exhaust pipes (arrowed), on its rear muffler, on its centre resonator box and on its catalytic converters.

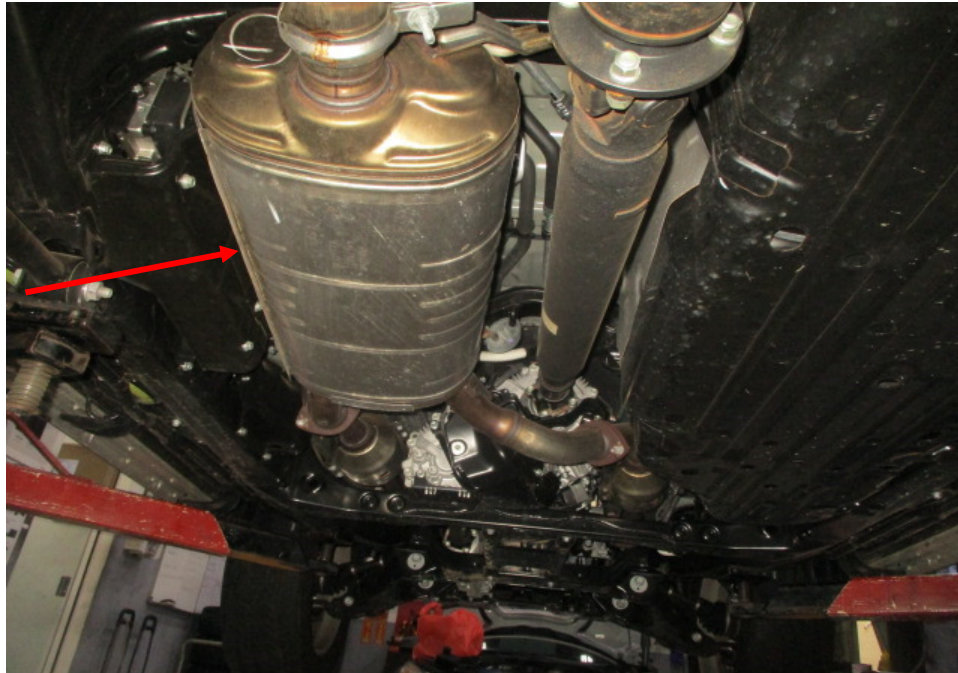
Photo 30 shows the front section of the Motor Car's exhaust system. My examination of the Motor Car's exhaust system revealed no sign(s) or indication(s) of any cut or weld marks along its exhaust pipes, on its rear muffler, on its centre resonator box (arrowed) and on its catalytic converters.
