Your Ref: Toyota Land Cruiser
(chassis number URJ2024212803)
Our Ref : CI/TP23006671/D

03 July 2023

**INSPECTION REPORT OF AN UNREGISTERED TOYOTA LAND CRUISER
MOTOR CAR WITH CHASSIS NUMBER URJ2024212803**

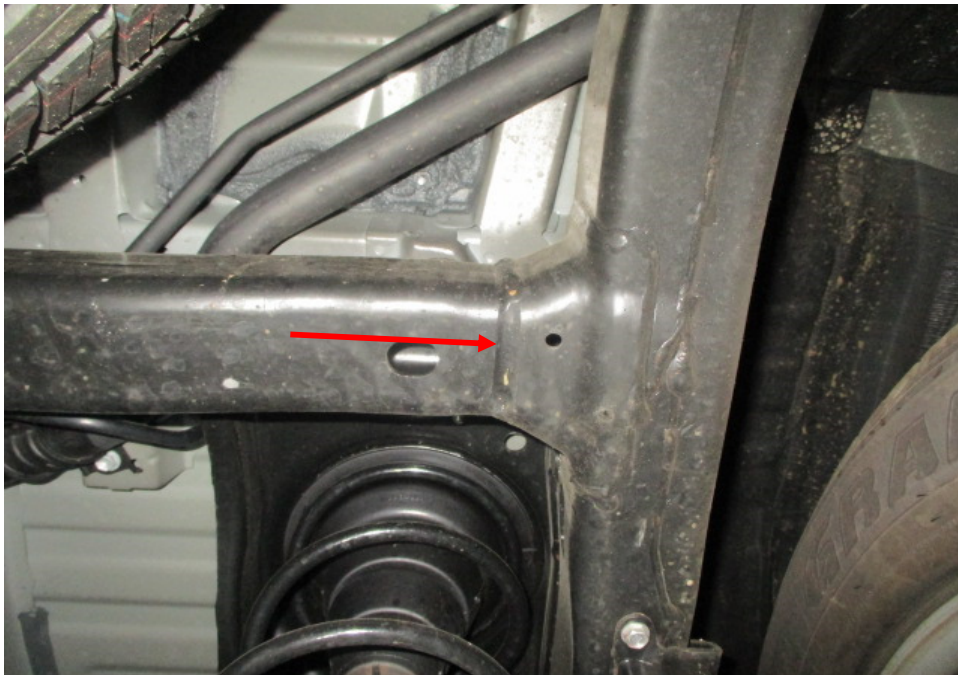
Photo 31 shows the chassis/structural body at the underside rear right of the Motor Car. I did not find any weld marks other than original spot weld marks on the chassis/structural body of the Motor Car. The original factory sealant (arrowed) at the joints along the chassis/structural body was untouched, indicating no work was done on the chassis/structural body of the Motor Car and that the chassis/structural body was originally fitted.

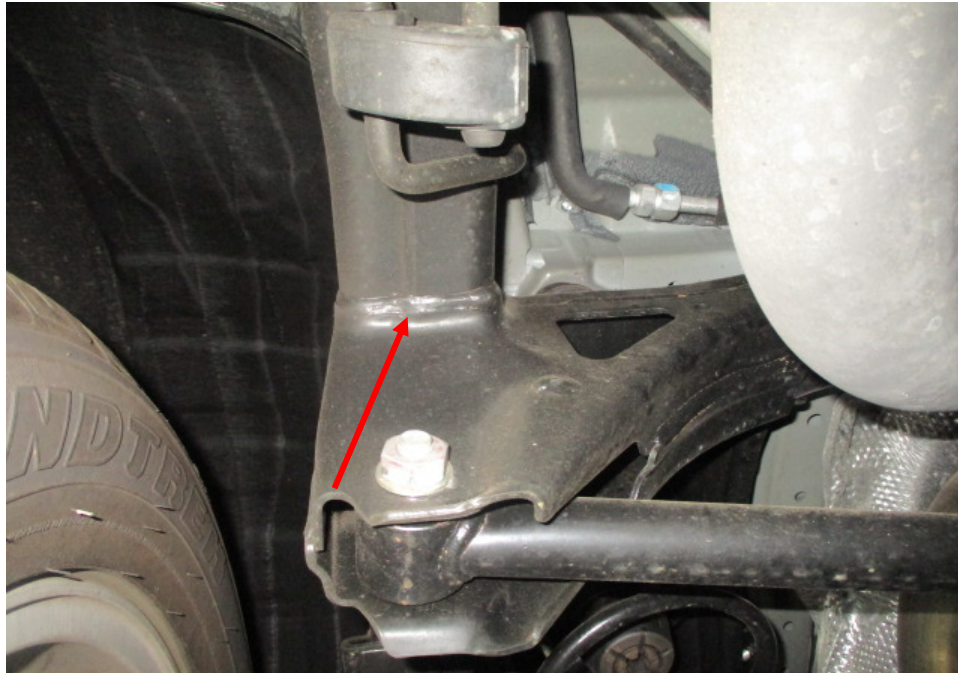
Photo 32 shows the chassis/structural body at the underside rear left of the Motor Car. I did not find any weld marks other than original spot weld marks on the chassis/structural body of the Motor Car. The original factory sealant (arrowed) at the joints along the chassis/structural body was untouched, indicating no work was done on the chassis/structural body of the Motor Car and that the chassis/structural body was originally fitted.

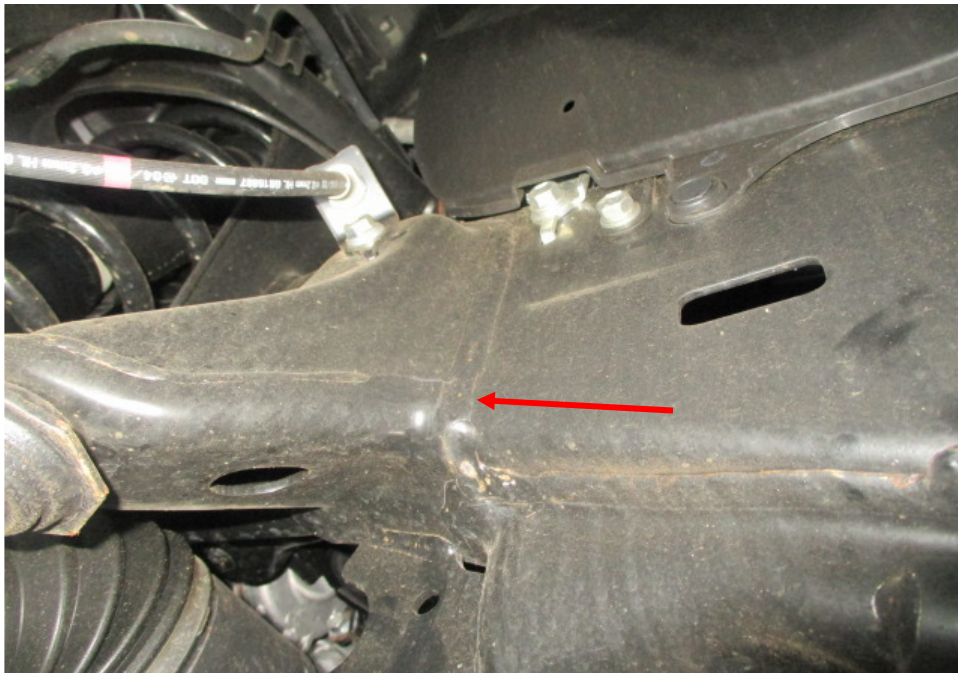
Photo 33 shows the chassis/structural body at the underside front left of the Motor Car. The original factory sealant (arrowed) at the joints along the chassis/structural body was observed to be untouched. In general, I had found no work was carried out on the chassis/structural body of the Motor Car. The chassis/structural body of the Motor Car was originally fitted.

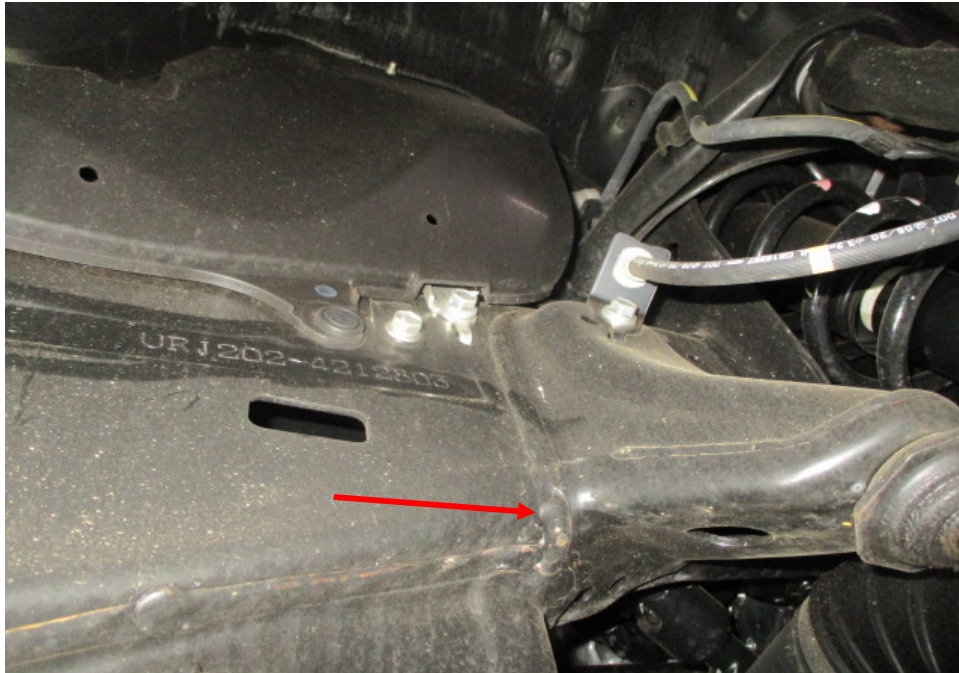
Photo 34 shows the chassis/structural body at the underside front right of the Motor Car. I did not find any weld marks other than original spot weld marks on the chassis/structural body of the Motor Car. The original factory sealant (arrowed) at the joints along the chassis/structural body was untouched, indicating no work was done on the chassis/structural body of the Motor Car and that the chassis/structural body was originally fitted.

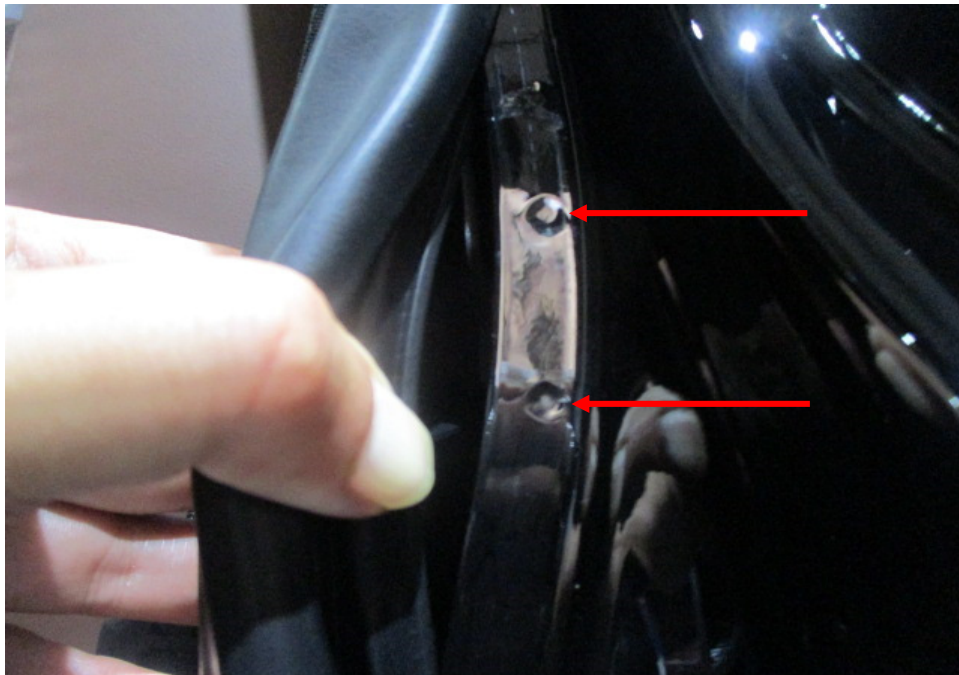
Photo 35 shows the left side "C" pillar of the Motor Car. I did not find any weld marks other than original spot weld marks (arrowed) on the left side "C" pillar of the Motor Car, which indicates that there was no re-welding works carried out. In general, I had found all the non-detachable body panels of the Motor Car to be originally fitted at the time of my inspection.

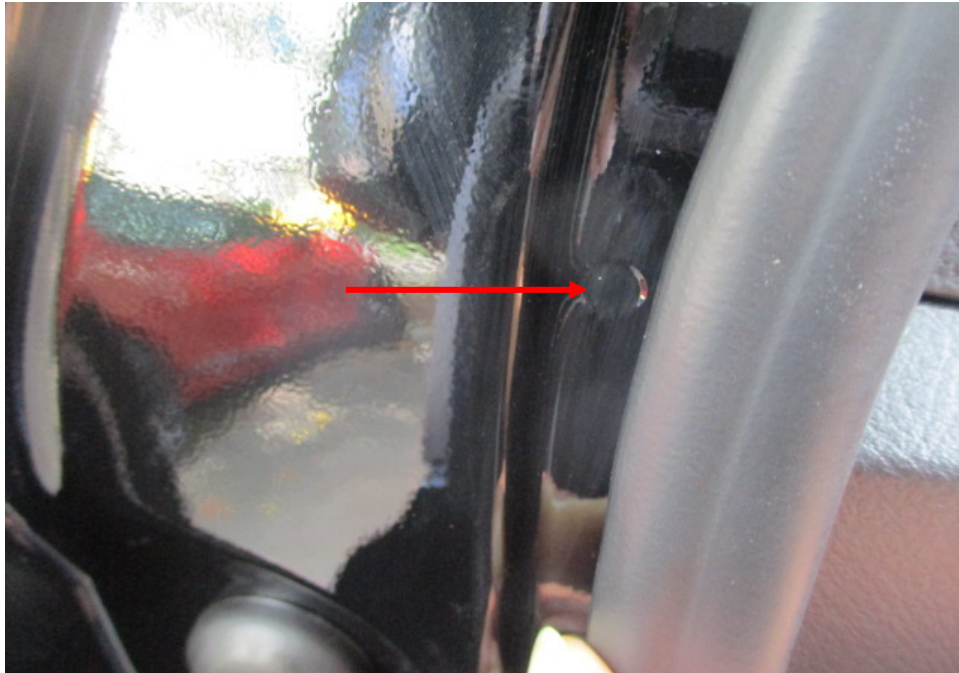
Photo 36 shows the left side "A" pillar of the Motor Car. I did not find any weld marks other than original spot weld marks (arrowed) on the left side "A" pillar of the Motor Car, which indicates that there was no re-welding works carried out. In general, I had found all the non-detachable body panels of the Motor Car to be originally fitted at the time of my inspection.

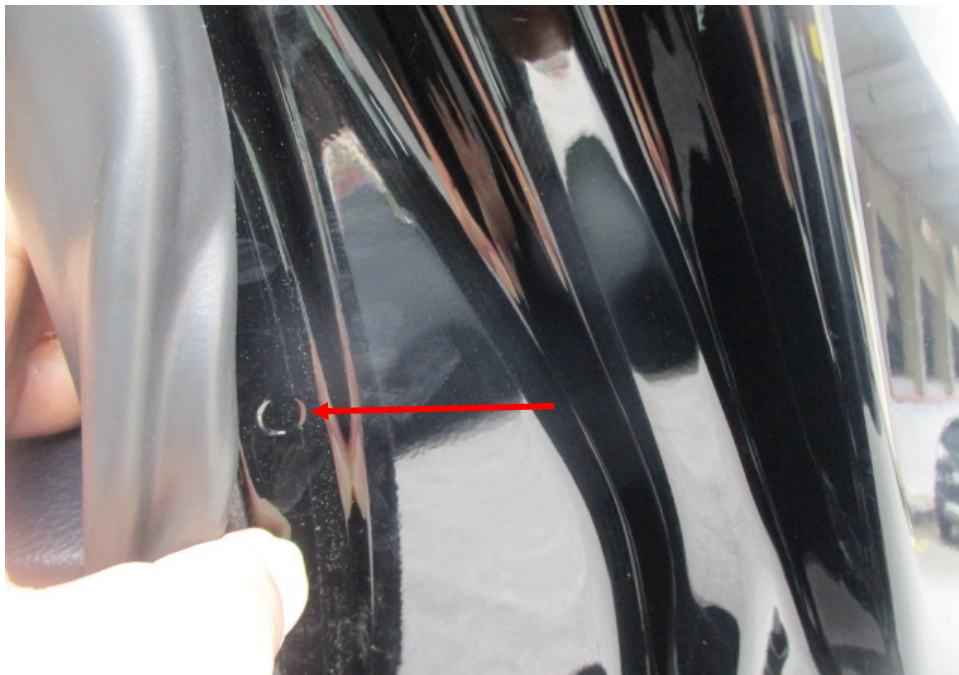
Photo 37 shows the right side "A" pillar of the Motor Car. I did not find any weld marks other than original spot weld marks (arrowed) on the right side "A" pillar of the Motor Car, which indicates that there was no re-welding works carried out. In general, I had found all the non-detachable body panels of the Motor Car to be originally fitted at the time of my inspection.

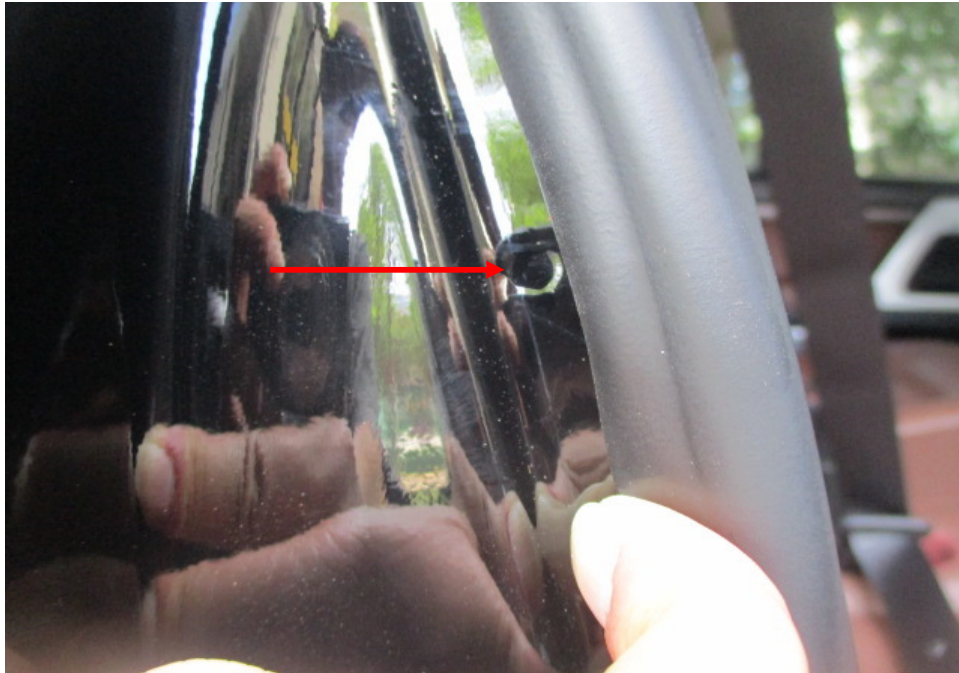
Photo 38 shows the right side "C" pillar of the Motor Car. I did not find any weld marks other than original spot weld marks (arrowed) on the right side "C" pillar of the Motor Car, which indicates that there was no re-welding works carried out. In general, I had found all the non-detachable body panels of the Motor Car to be originally fitted at the time of my inspection.
