**MECHANICAL INSPECTION REPORT OF MOTOR LORRY GBD 7002D**

1. I refer to your request on 23<sup>rd</sup> June 2023 to conduct a physical inspection of a Motor Lorry bearing registration number GBD 7002D (herein referred to as "**Motor Lorry**"), which was involved in a road traffic accident on 16<sup>th</sup> January 2023.
2. The objective of this inspection is to determine if there was any possible mechanical failure to the Motor Lorry that may have contributed to the accident.
3. Following the request, I had carried out a physical inspection of the Motor Lorry on 12<sup>th</sup> July 2023 at the premises of Traffic Police vehicle pound, 517 Airport Road Singapore 539942. I now set out below my observations and comments with respect to this inspection.

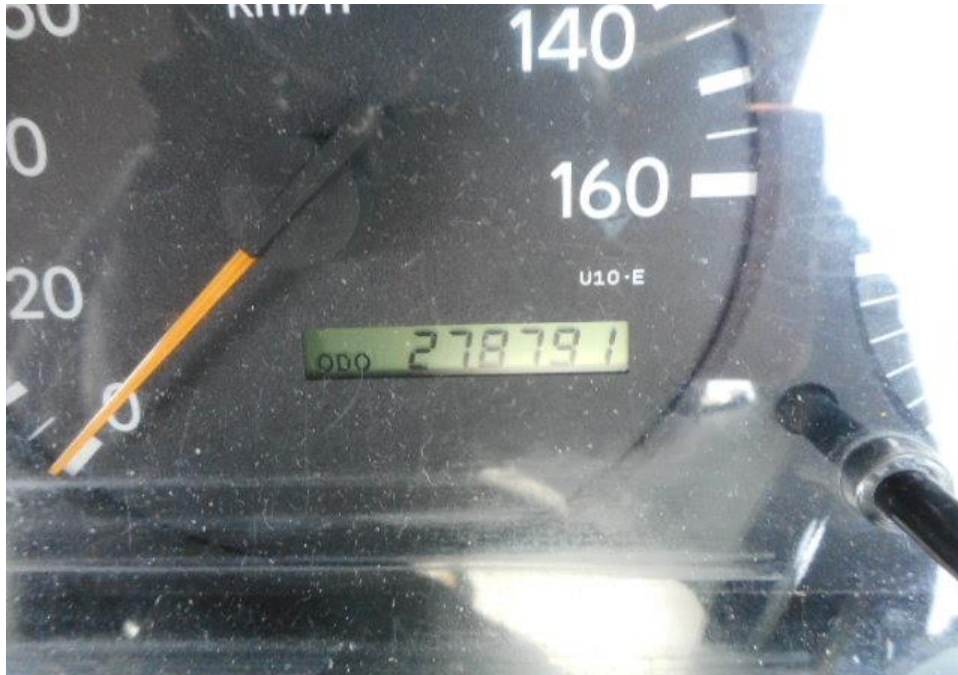
**Photo 1** shows a general view of the instrument cluster of the Motor Lorry at the time of my inspection. The mileage of the Motor Lorry was 278,791km

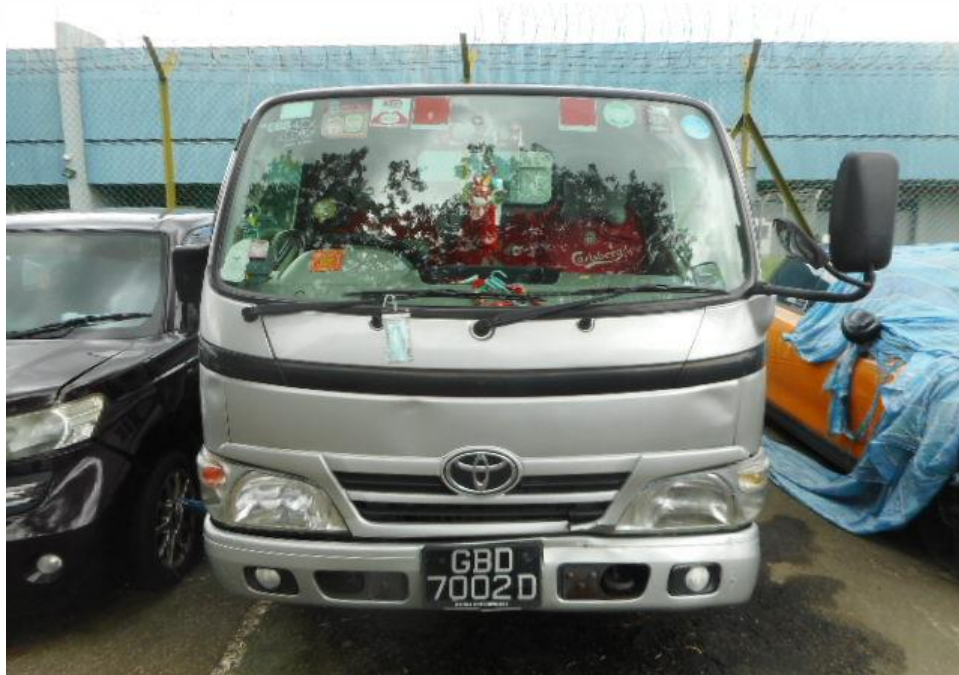
4. The mileage of the Motor Lorry at the time of my inspection was 278,791km.
5. The Motor Lorry appeared to have sustained damage at its frontal portion. Its front body panel, front grille, front number plate and front bumper was damaged at the time of my inspection as a result of the accident.

**Photo 2** shows a general view of the Motor Lorry's frontal portion at the time of my inspection. It appeared to have sustained damage at its frontal portion. Its front body panel, front grille, front number plate and front bumper was damaged at the time of my inspection as a result of the accident.

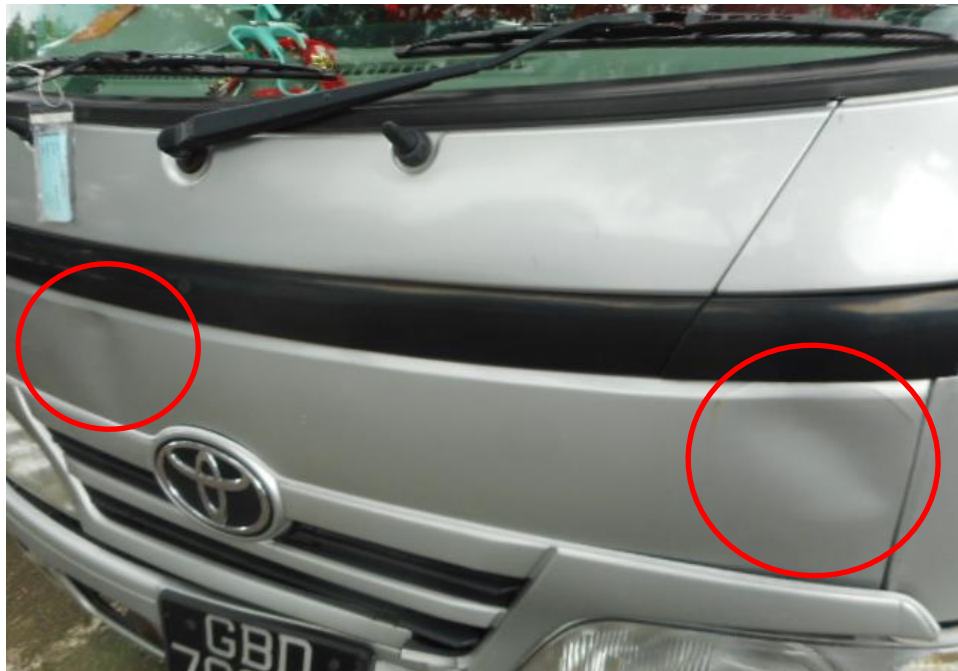
**Photo 3** shows a close up view of the Motor Lorry's frontal portion at the time of my inspection. It appeared to have sustained damage at its frontal portion. Its front body panel (circled) was damage at the time of my inspection as a result of the accident.

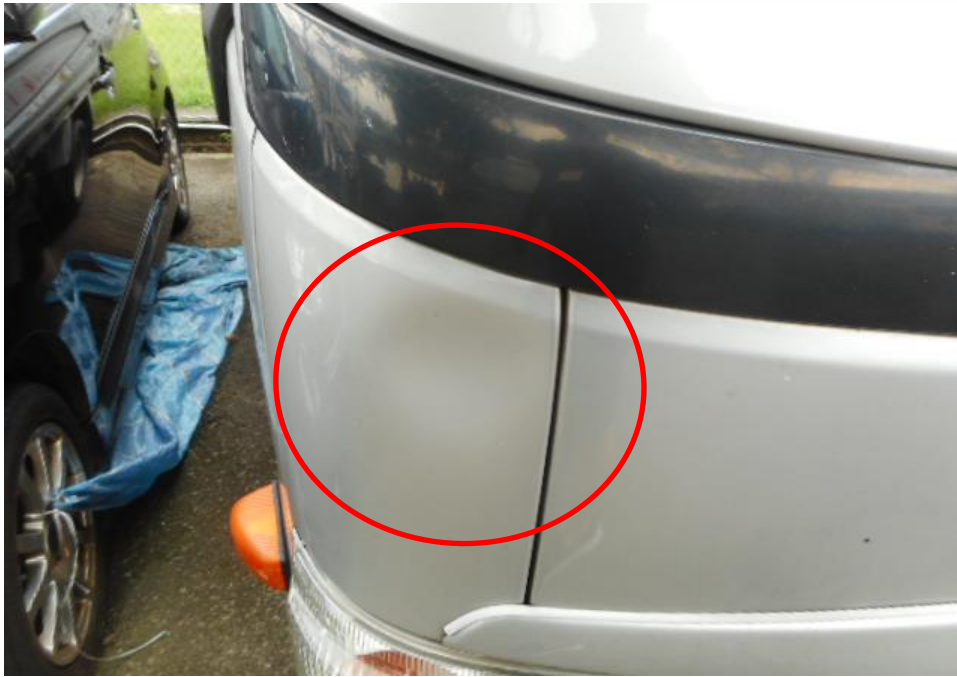
**Photo 4** shows a close up view of the Motor Lorry's frontal portion at the time of my inspection. It appeared to have sustained damage at its frontal portion. Its front body panel (circled) was damage at the time of my inspection as a result of the accident.

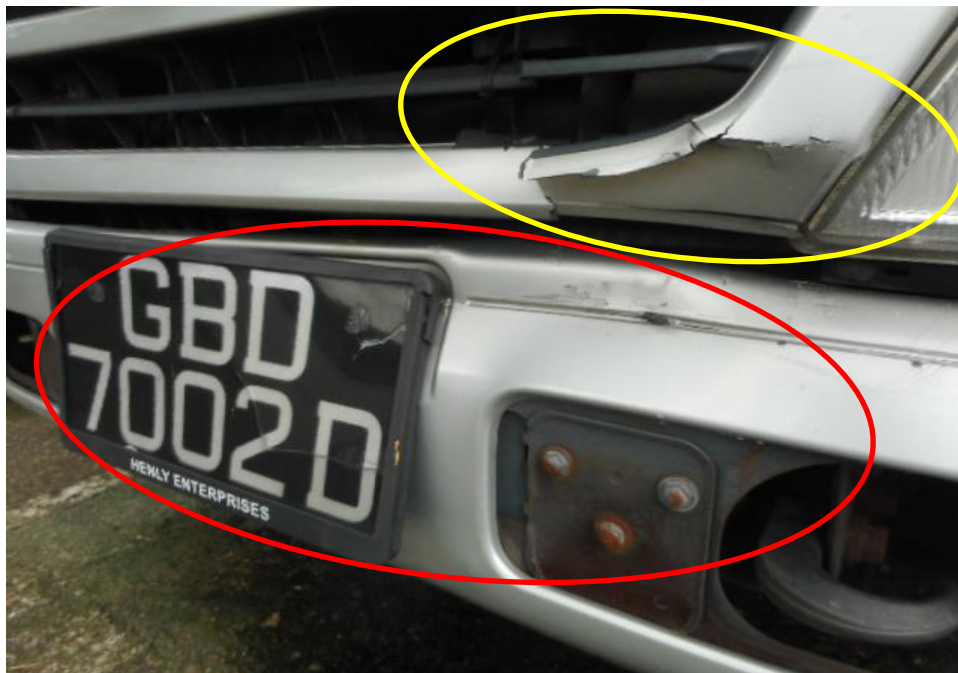
**Photo 5** shows a close up view of the Motor Lorry's frontal portion at the time of my inspection. It appeared to have sustained damage at its frontal portion. Its front grille (yellow circle), front bumper and front number plate (red circle) was damage at the time of my inspection as a result of the accident.

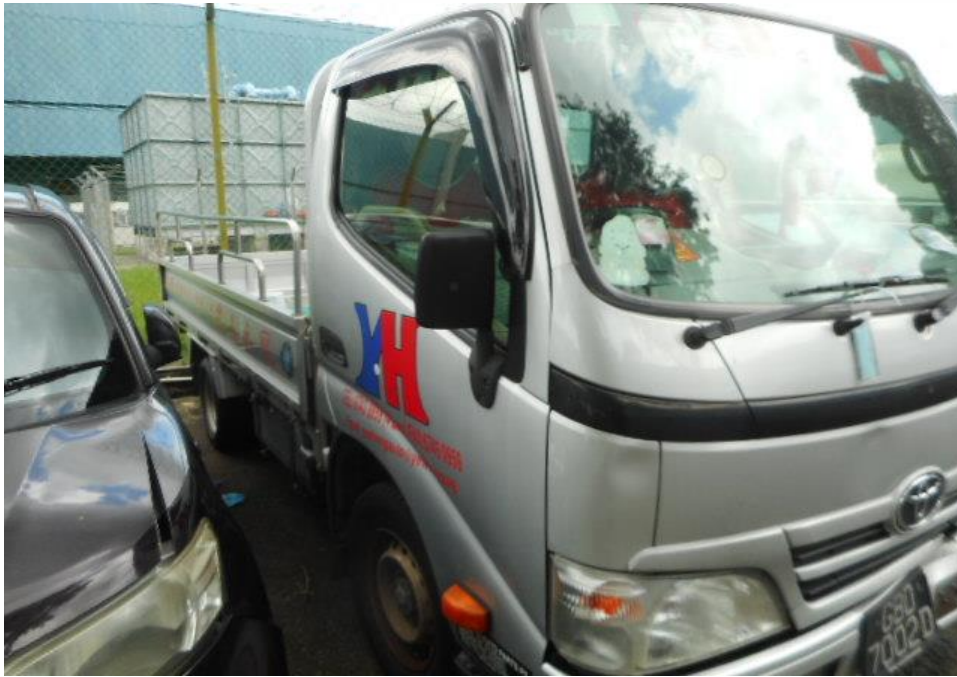
**Photo 6** shows a general view of the right body of the Motor Lorry at the time of my inspection. The Motor Lorry was observed to be intact and unaffected by the accident.

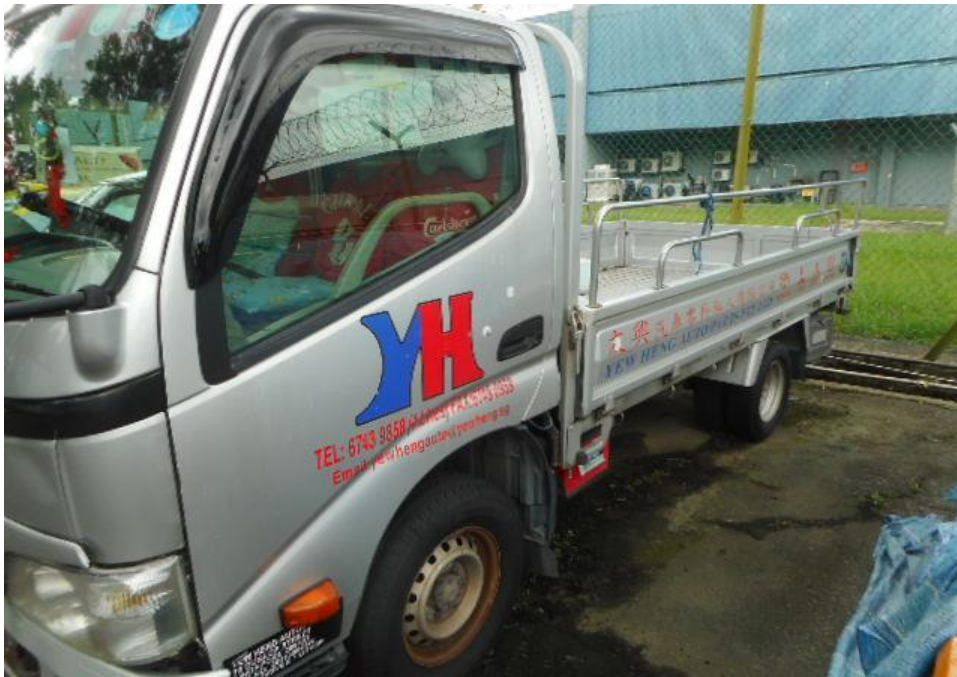
**Photo 7** shows a general view of the left body of the Motor Lorry at the time of my inspection. The Motor Lorry was observed to be intact and unaffected by the accident.

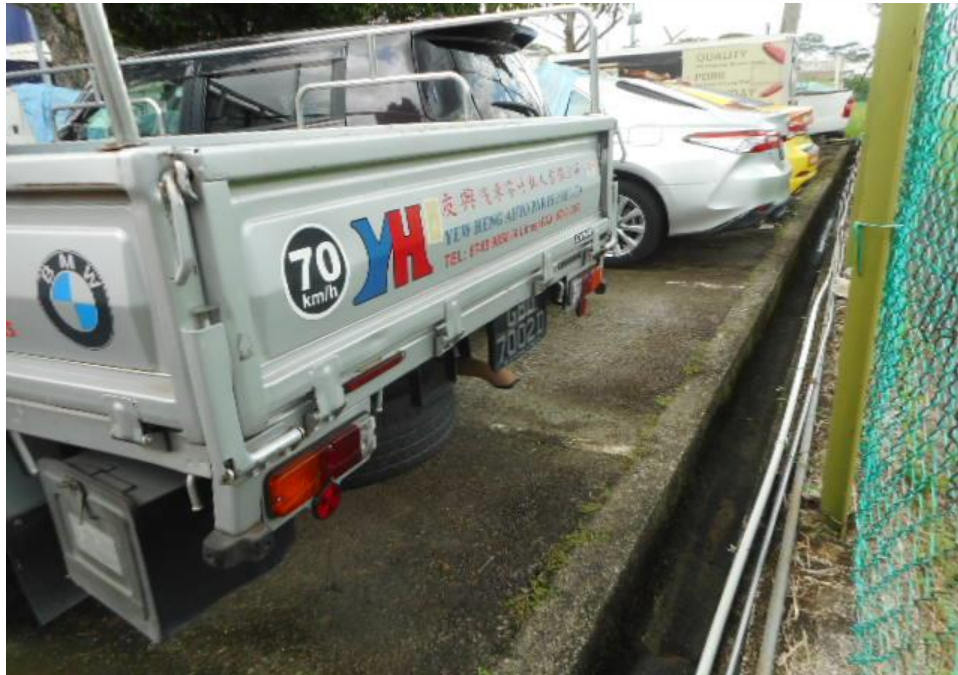
**Photo 8** shows a general view of the rear body of the Motor Lorry at the time of my inspection. The Motor Lorry was observed to be intact and unaffected by the accident.

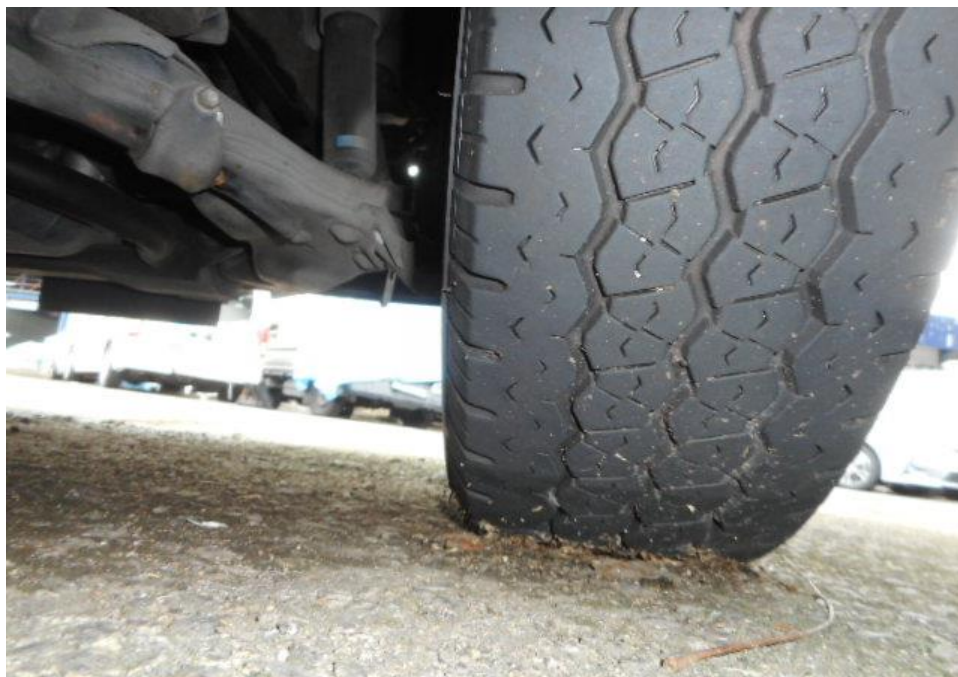
**Photo 9** shows the condition of the front right tyre of the Motor Lorry, which was observed to be in serviceable condition with remaining tread depth of approximately 5.6mm. The tyre, which was wrapped around standard steel wheel rim, was also observed to be sufficiently inflated for vehicular operation. There was no tear, cut or burst mark(s) on the outer and the inner sidewalls as well as across the tread of the 6 tyres that were fitted on the Motor Lorry.

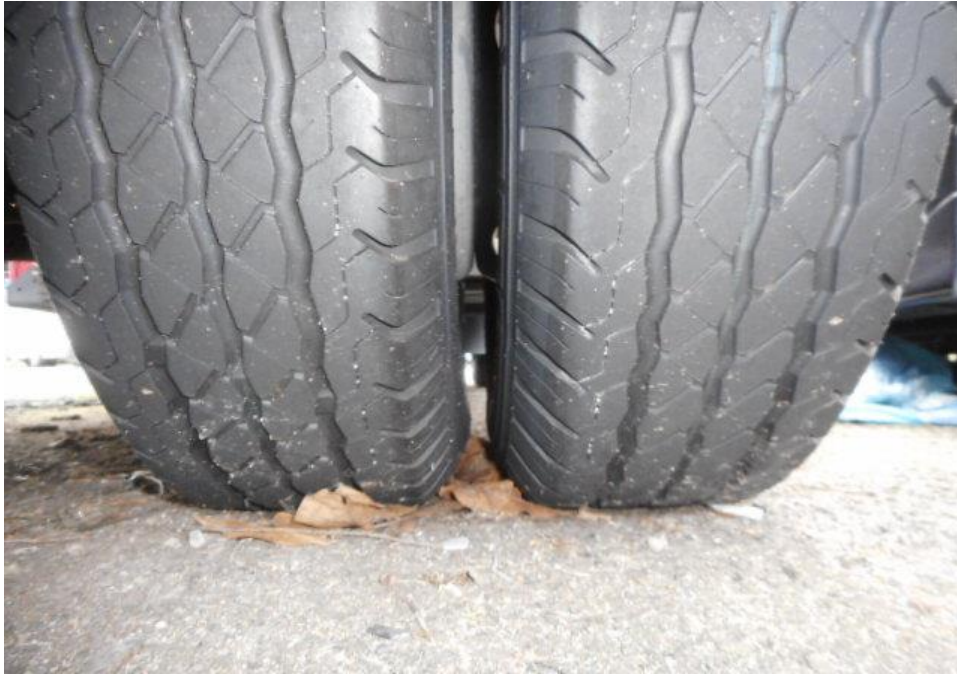
**Photo 10** shows the condition of the rear right tyre of the Motor Lorry, which was observed to be in serviceable condition with remaining tread depth of approximately 3.3mm. The tyre, which was wrapped around standard steel wheel rim, it was observed to be sufficiently inflated for vehicular operation.

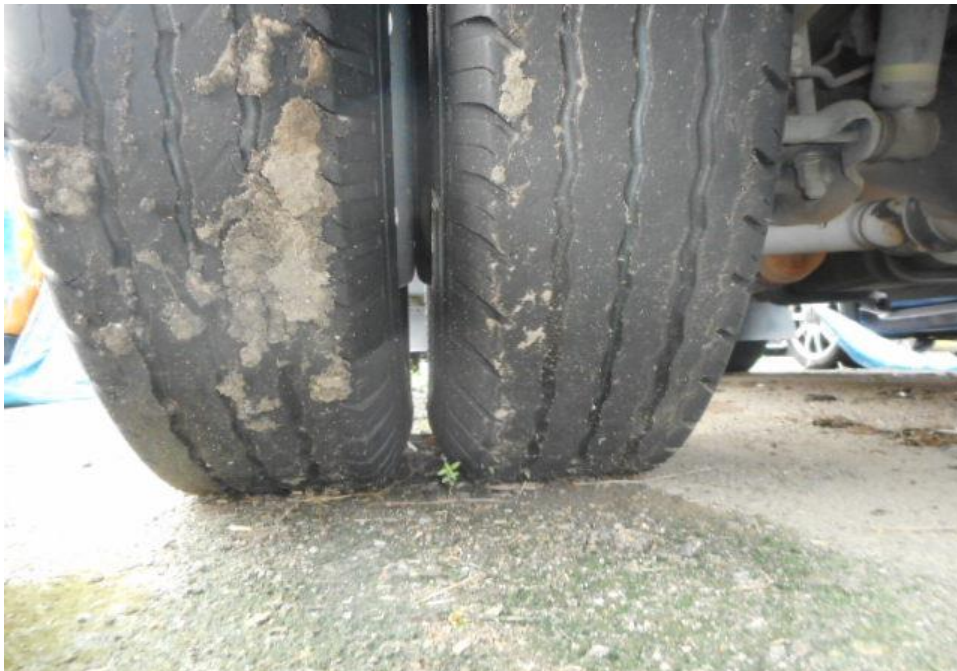
**Photo 11** shows the condition of the rear left tyres of the Motor Lorry, which was observed to be in serviceable condition with remaining tread depth of approximately 1.7mm. The tyres, which were wrapped around standard steel wheel rim, were also observed to be sufficiently inflated for vehicular operation. There was also no damage found on all 6 steel wheel rims of the Motor Lorry.

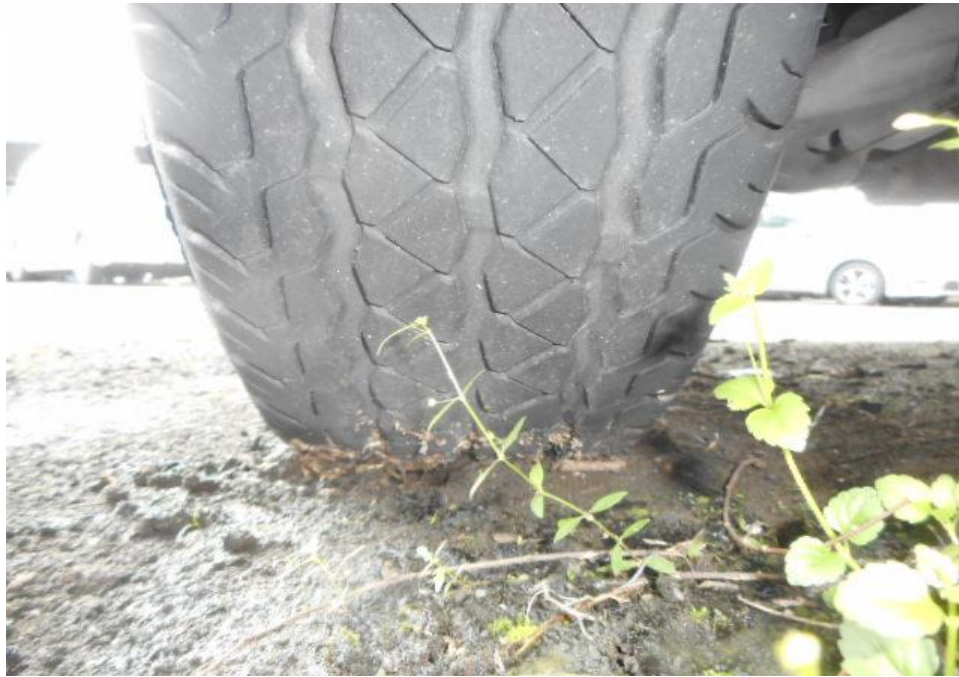
**Photo 12** shows the condition of the rear right tyres of the Motor Lorry, which were observed to be in serviceable condition with remaining, tread depth of approximately 5.3mm. There was also no tear, cut or burst mark(s) on the outer and the inner sidewalls as well as across the tread of the 6 tyres that were fitted on the Motor Lorry.

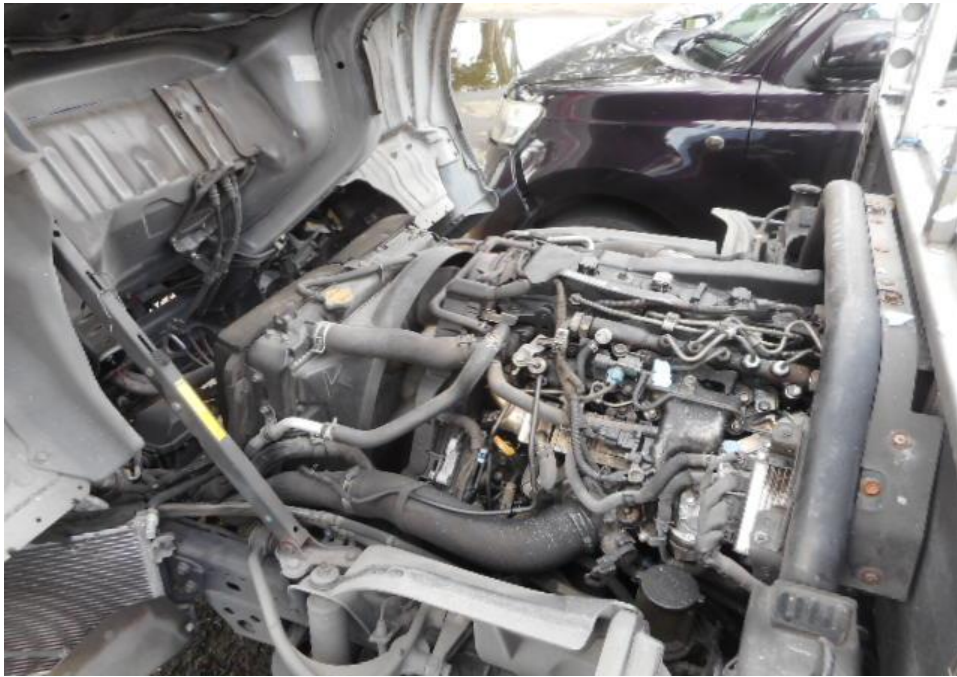
**Photo 13** shows a general view of the Motor Lorry's engine compartment, which was accessed by lifting the front cabin of the Motor Lorry. The various parts and components inside the engine compartment were unaffected by the accident. There was also no sign(s) or indication(s) of fresh fluid leakage and/or fluid stain within the engine compartment

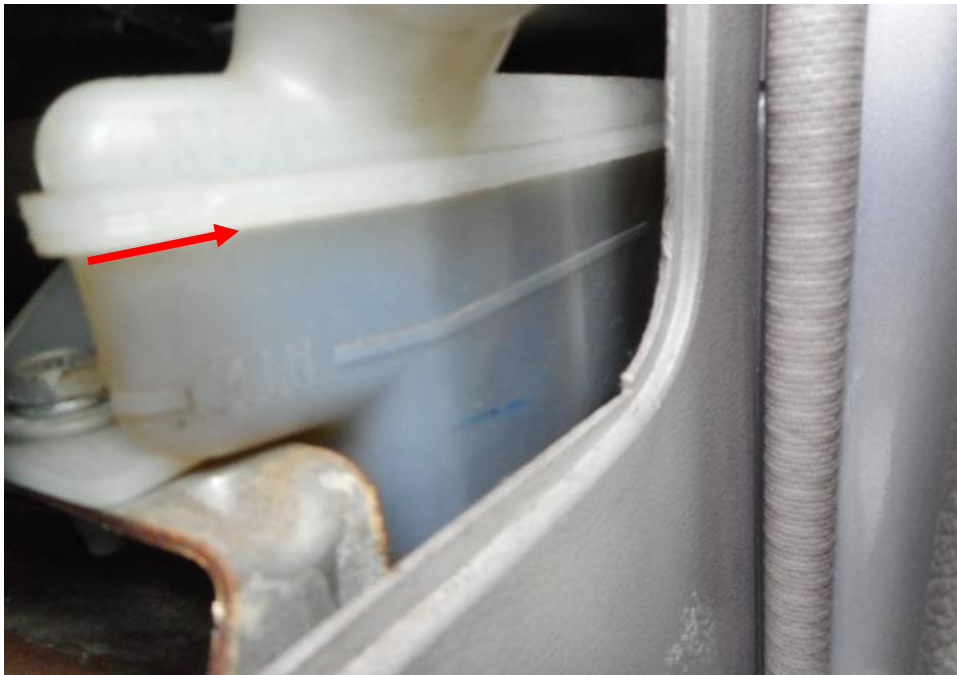
**Photo 14** shows the brake fluid reservoir of the Motor Lorry at the time of my inspection. The brake fluid was observed to be of sufficient level (arrowed) and without any visible contamination.

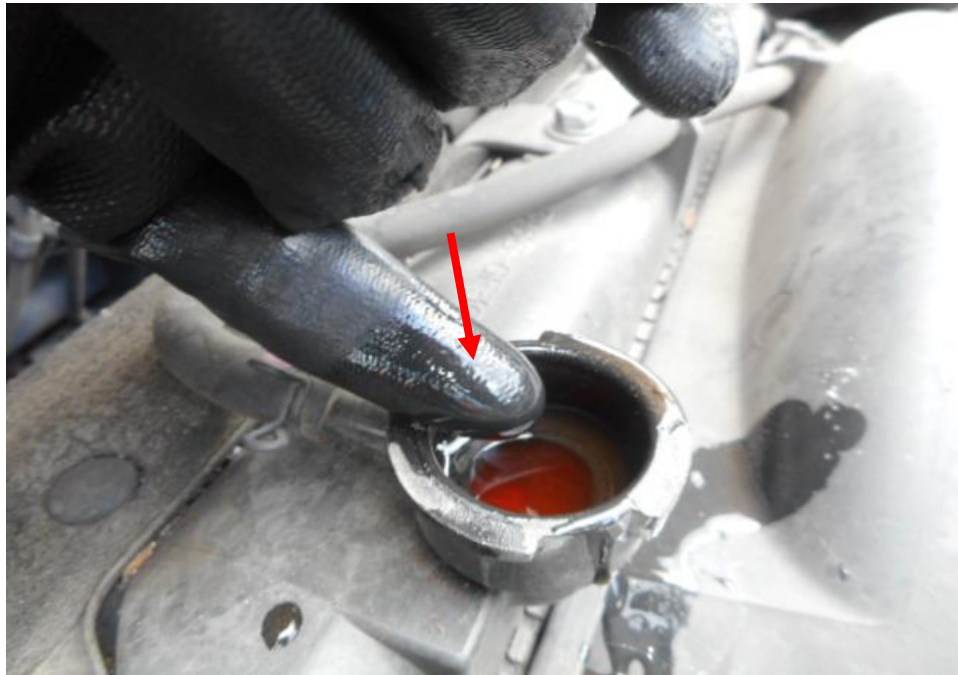
**Photo 15** shows the engine coolant of the Motor Lorry at the time of my inspection. The engine coolant was observed to be of sufficient level (arrowed) and without any visible contamination.

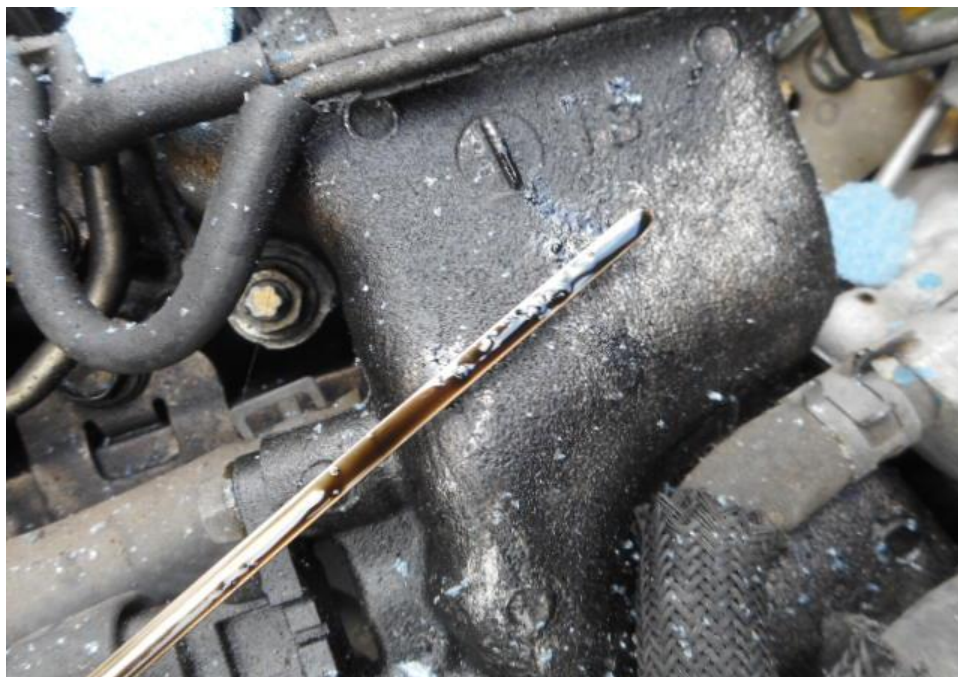
**Photo 16** shows the engine oil dip stick of the Motor Lorry at the time of my inspection. The engine oil was observed to be of sufficient level and without any visible contamination.

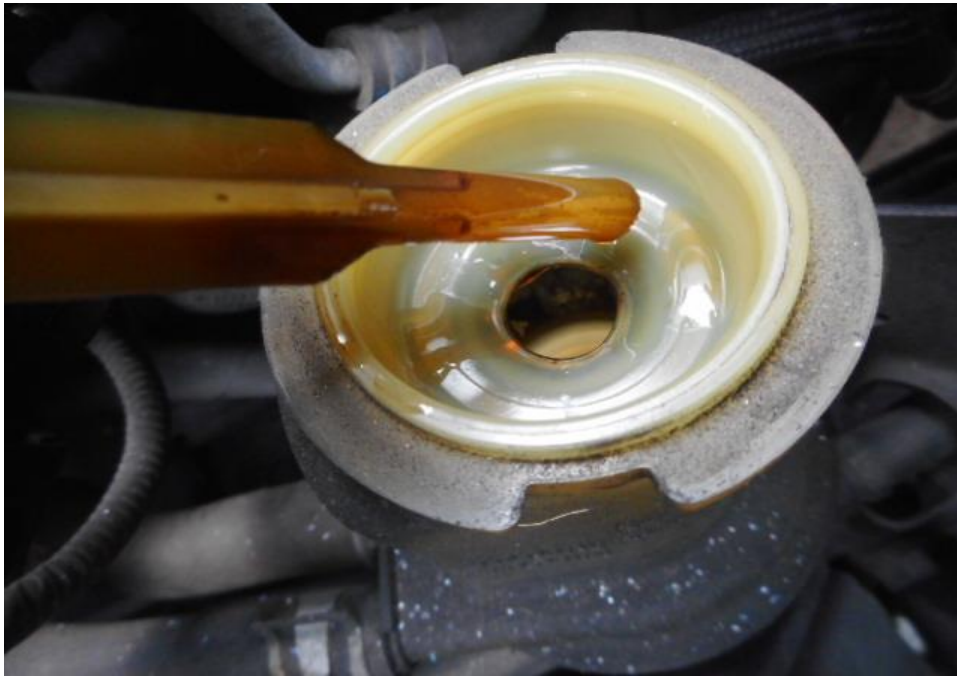
**Photo 17** shows the power steering fluid dip stick of the Motor Lorry at the time of my inspection. The power steering fluid was observed to be of sufficient level and without any visible contamination.

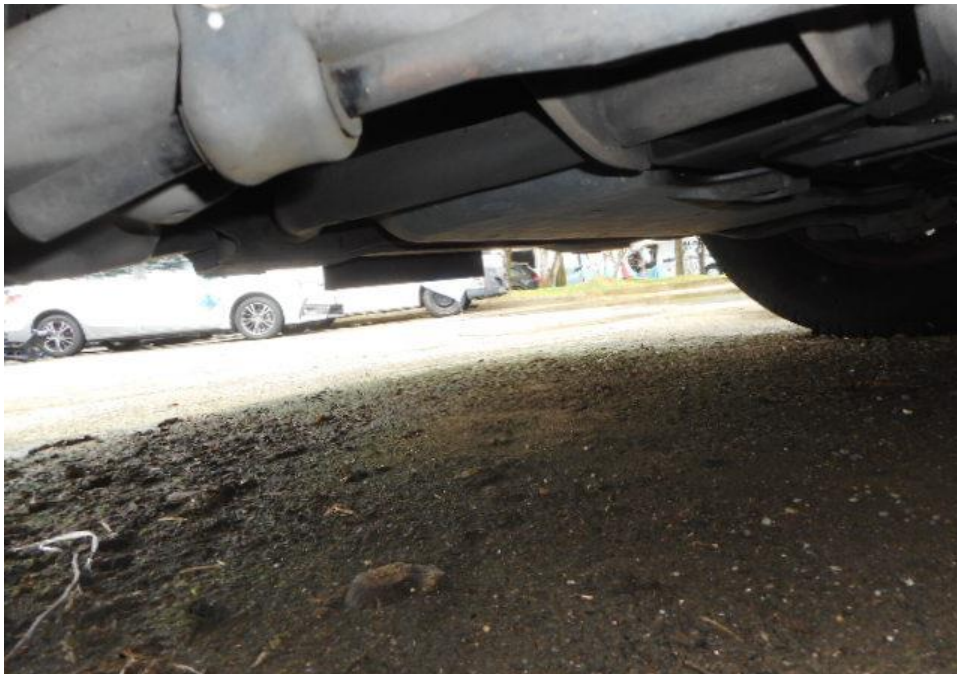
**Photo 18** shows the undercarriage of the Motor Lorry, at the area where the engine housing and transmission housing are located at. We did not observe any leak and/or fluid stain(s) on the underside of the Motor Lorry.

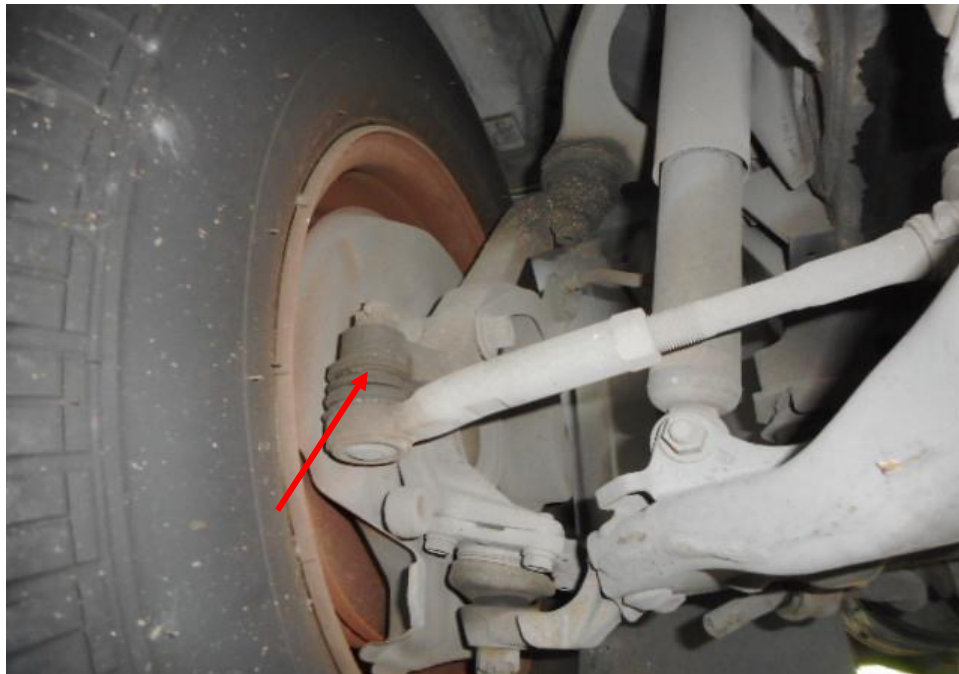
**Photo 19** shows the various undercarriage components at the front right wheel of the Motor Lorry, in particular the steering tie rod end (arrowed). The various steering components were all found to be intact, suggesting that the steering system of the Motor Lorry was likely to be in serviceable condition at the material time of accident. There was also no sign of fluid stain(s) observed on the various undercarriage components.

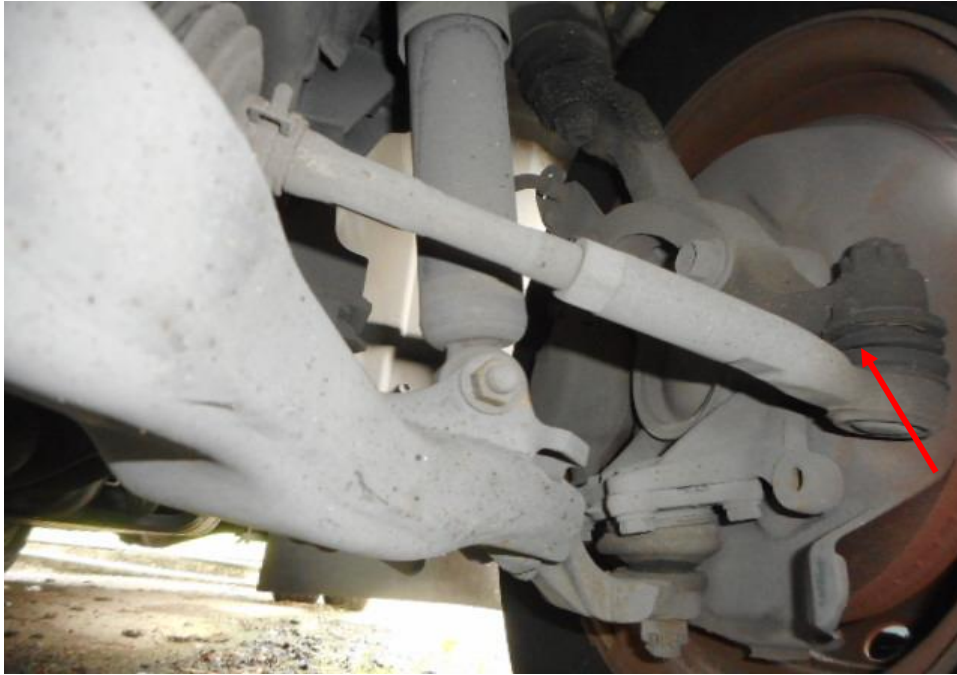
**Photo 20** shows the various undercarriage components at the front left wheel of the Motor Lorry, in particular the steering tie rod end (arrowed). The various undercarriage components of the Motor Lorry were all found to be intact without any visible damage. There was also no sign of fluid stain(s) observed on the various undercarriage components.

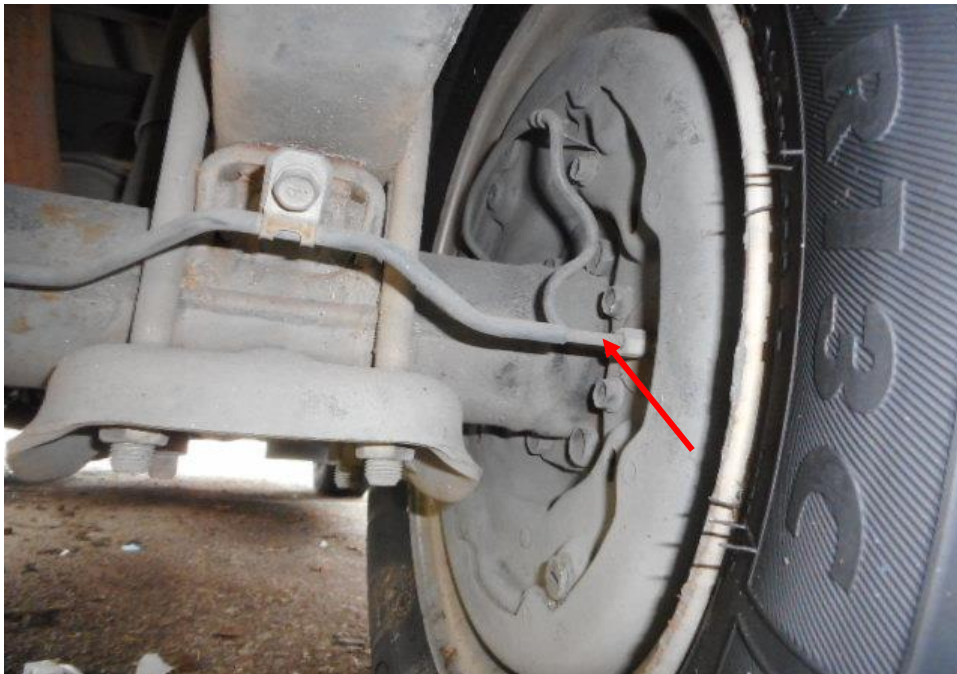
**Photo 21** shows the brake pipe (arrowed) at the rear right wheel of the Motor Lorry. I did not observe any leakage of brake fluid at the time of my inspection of the Motor Lorry. My static tests of the Motor Lorry's braking system, along with my visual examination of the various mechanical components in the braking system, had indicated that there was no internal leakage of pressure/vacuum. Hence the braking system of the Motor Lorry was likely to be in serviceable condition at the material time of accident.

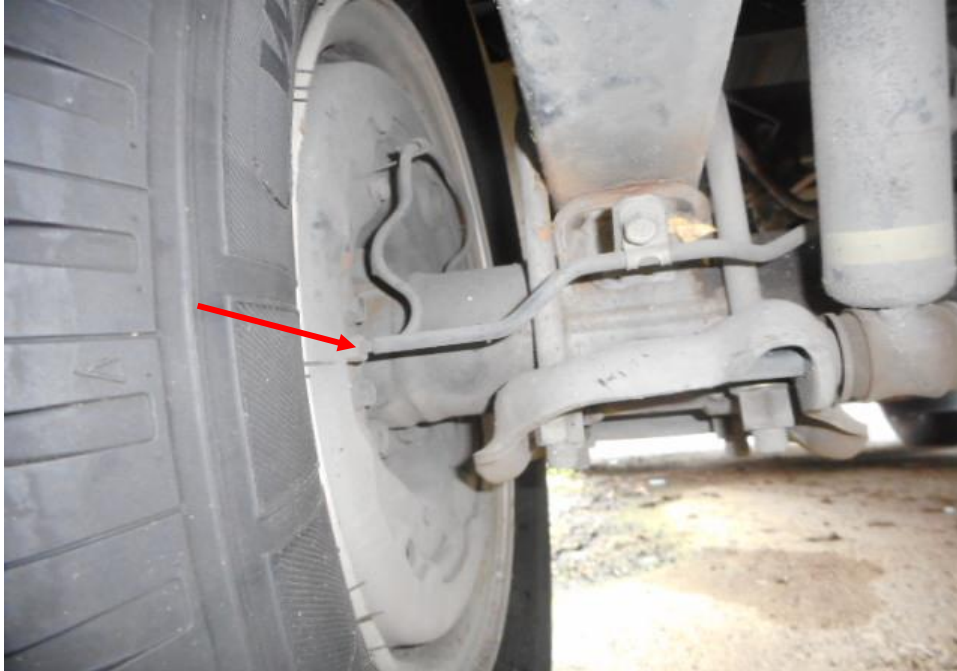
**Photo 22** shows the brake pipe (arrowed) at the rear left wheel of the Motor Lorry. I did not observe any leakage of brake fluid at the time of my inspection of the Motor Lorry. My static tests of the Motor Lorry's braking system, along with my visual examination of the various mechanical components in the braking system had indicated that there was no internal leakage of pressure/vacuum. Hence the braking system of the Motor Lorry was likely to be in serviceable condition at the material time of accident.

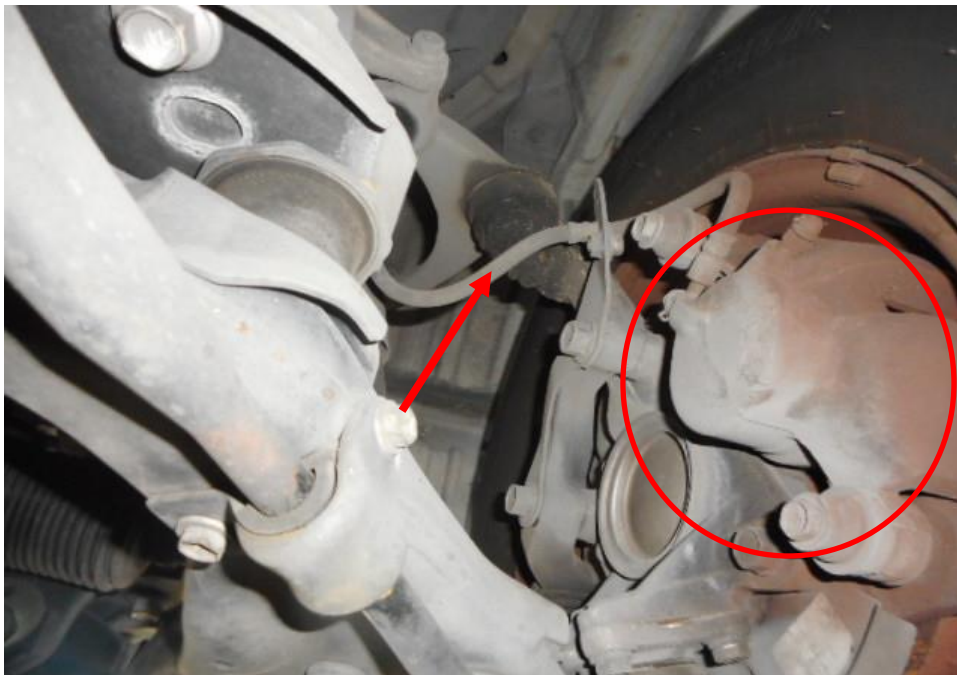
**Photo 23** shows the brake hose/pipe (arrowed) at the front right wheel of the Motor Lorry. No leakage of brake fluid was observed. Visual examination of the various components of the braking system like the brake caliper (circled), brake booster, brake pedal etc had revealed all to be intact and without visible damage at the time of accident. There was also no sign of fluid stain(s) observed on the various undercarriage components.

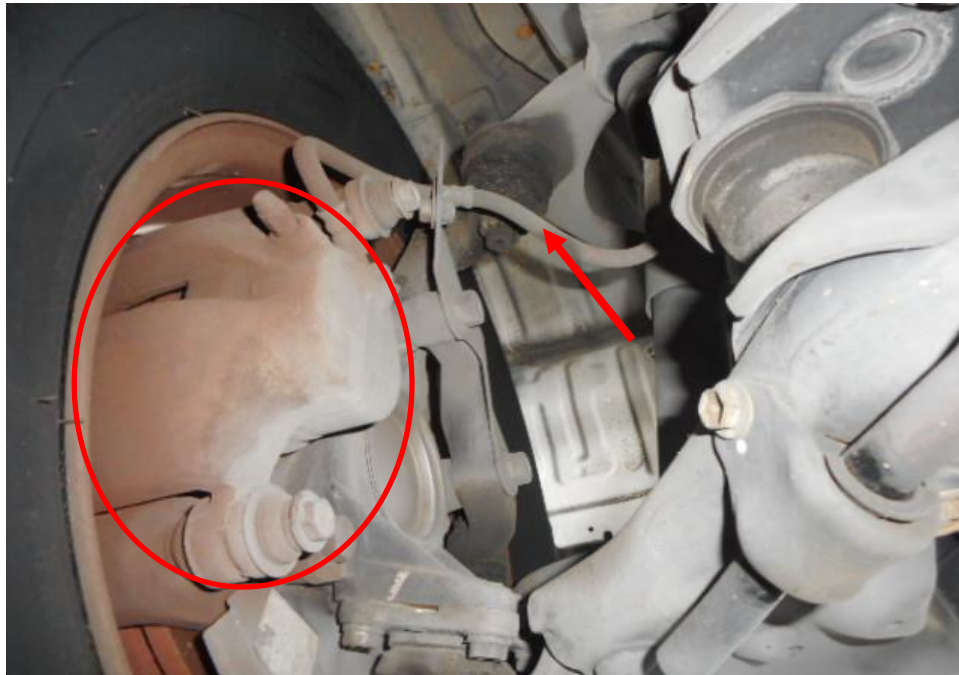
**Photo 24** shows the brake hose/pipe (arrowed) at the front left wheel of the Motor Lorry. No leakage of brake fluid was observed. Visual examination of the various components of the braking system like the brake caliper (circled), brake booster, brake pedal etc had revealed all to be intact and without visible damage at the time of accident. There was also no sign of fluid stain(s) observed on the various undercarriage components.

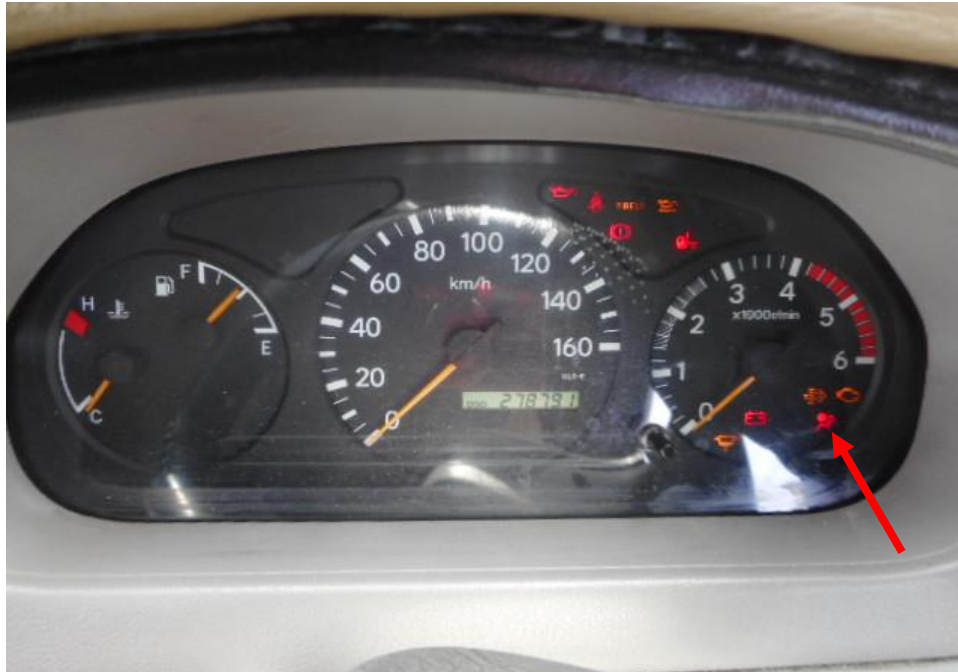
**Photo 26** shows the warning light for Supplemental Restraint System (SRS) (arrowed) appearing on the instrument panel of the Motor Van during the self-test of its various electronic operating systems when its engine was cranked.

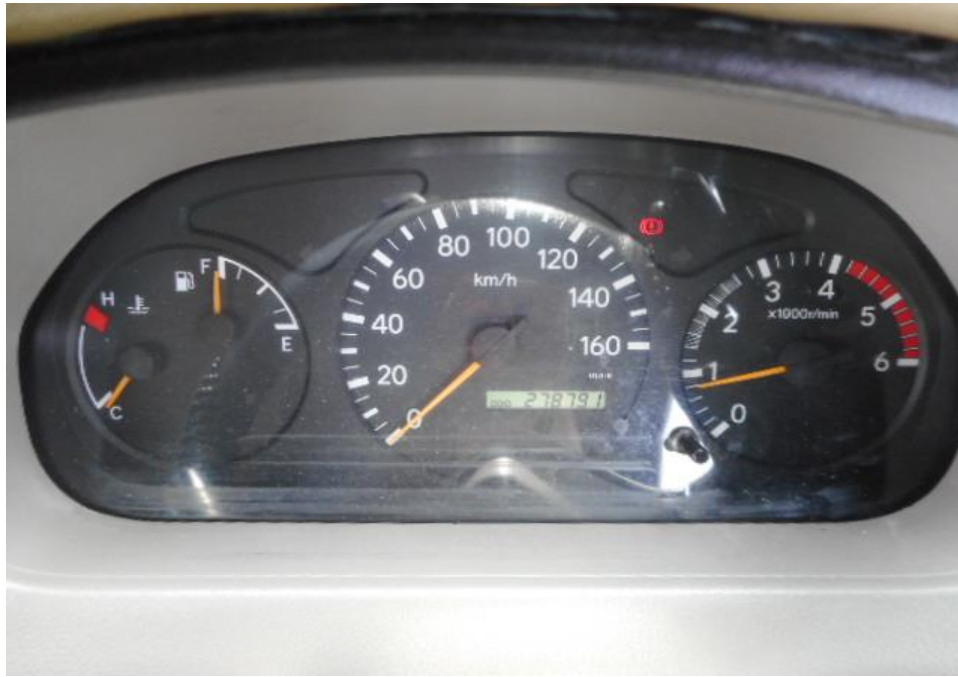
**Photo 27** shows no warning lights illuminated on the instrument panel of the Motor Van after the engine was cranked. This would suggest that there was no abnormality to the electronic operating system of the Motor Van, like the SRS and etc.
