Your Ref: TP IP/17077/2023  
Our Ref : CI/TPD23006779/P

**Fatal Accident Investigation Team**

**MECHANICAL INSPECTION REPORT OF MOTOR VAN PC 6510A**

1. I refer to your request on 23<sup>rd</sup> June 2023 to conduct a physical inspection of a Motor Van bearing registration number PC 6510A (herein referred to as "**Motor Van**"), which was involved in a road traffic accident on 20<sup>th</sup> June 2023.
2. The objective of this inspection is to determine if there was any possible mechanical failure to the Motor Van that may have contributed to the accident.
3. Following the request, I had carried out a physical inspection of the Motor Van on 17<sup>th</sup> July 2023 at the premises of Traffic Police vehicle pound, 517 Airport Road Singapore 539942. I now set out below my observations and comments with respect to this inspection.

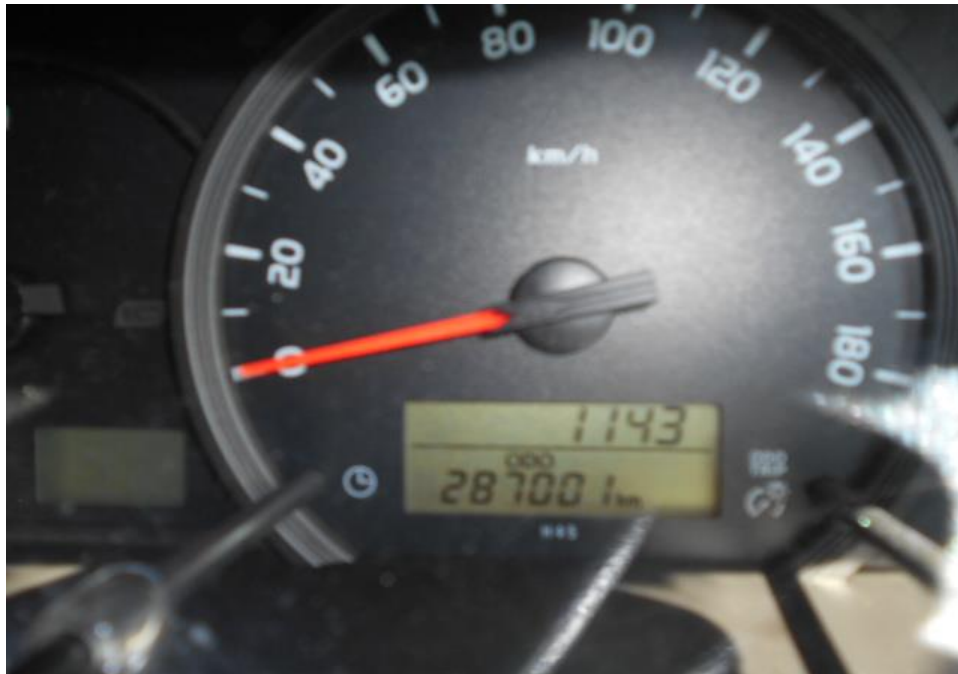
**Photo 1** shows a general view of the instrument cluster of the Motor Van at the time of my inspection. The mileage of the Motor Van was 287,001km

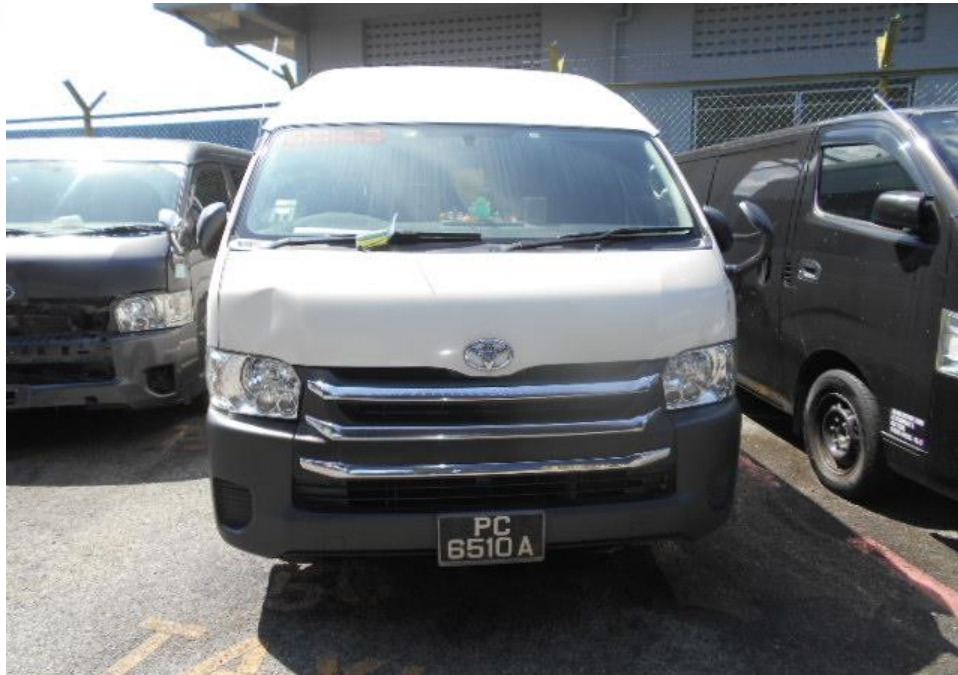
4. The mileage of the Motor Van at the time of my inspection was 287,001km.
5. The Motor Van observed to have sustained damage at its frontal portion. Its front body, was damage at the time of my inspection.

**Photo 2** shows a general view of the Motor Van's frontal portion at the time of my inspection. It appeared to have sustained damage at its front portion. Its front body panel was damage at the time of my inspection as a result of the accident.

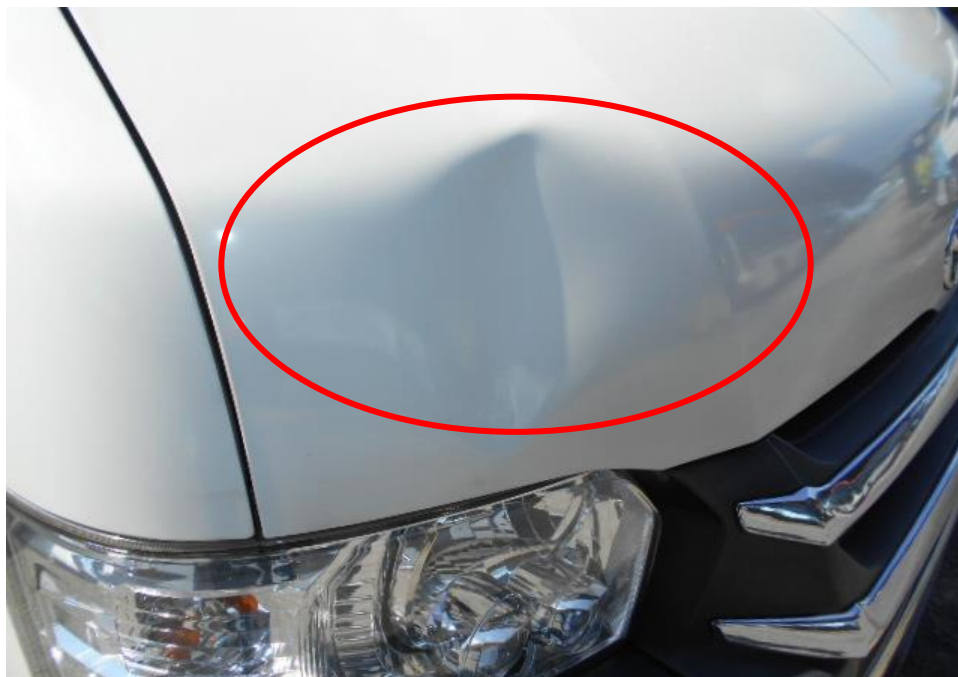
**Photo 3** shows a close up view of the Motor Van's frontal portion at the time of my inspection. It appeared to have sustained damage at its frontal. Its front body panel (circled) was damage at the time of my inspection as a result of the accident.

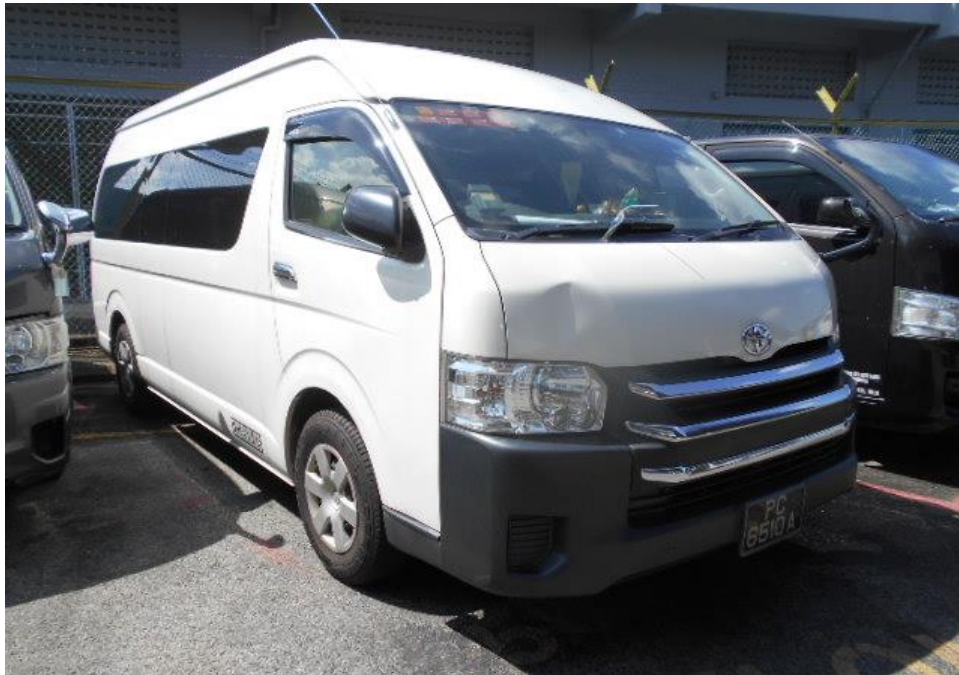
**Photo 4** shows a general view of the Motor Van's right body at the time of my inspection. It was observed to be intact and unaffected by the accident.

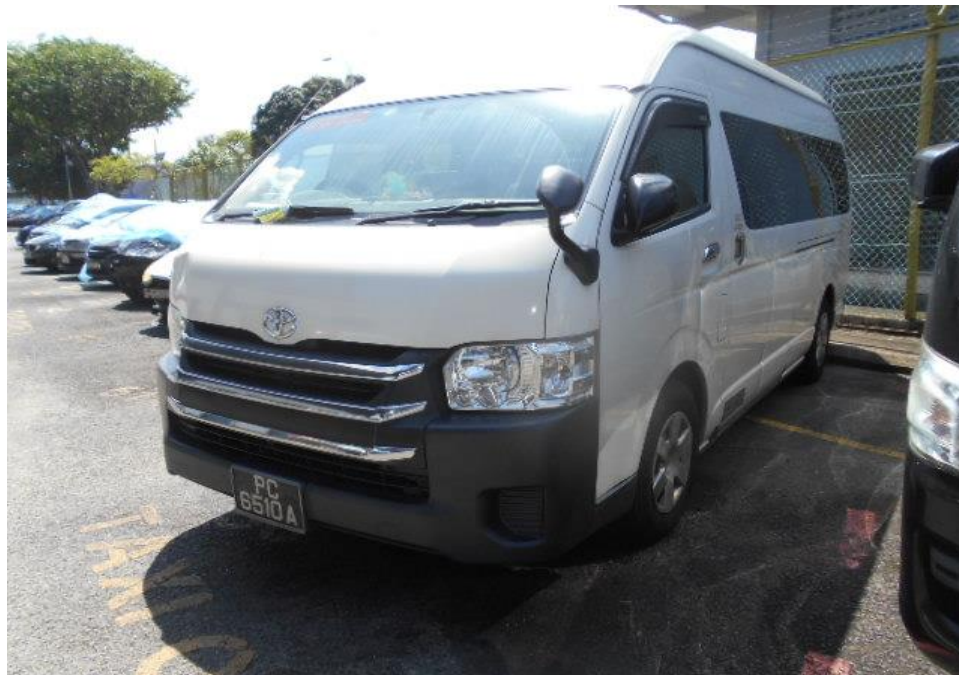
**Photo 5** shows a general view of the Motor Van's left body at the time of my inspection. It was observed to be intact and unaffected by the accident.

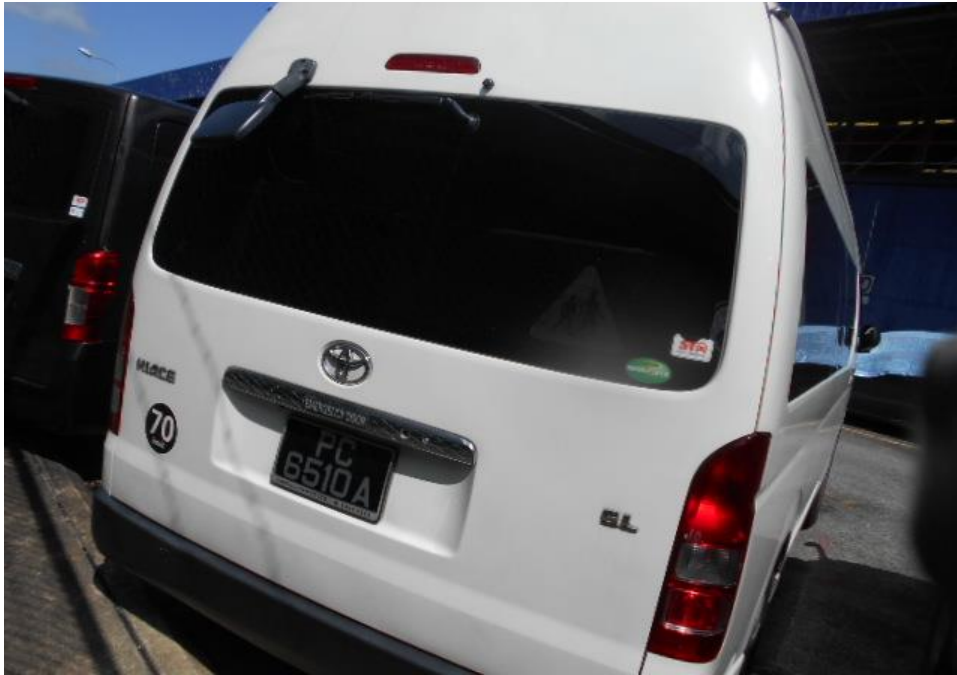
**Photo 6** shows a general view of the rear body of the Motor Van at the time of my inspection. The Motor Van was observed to be intact and unaffected by the accident.

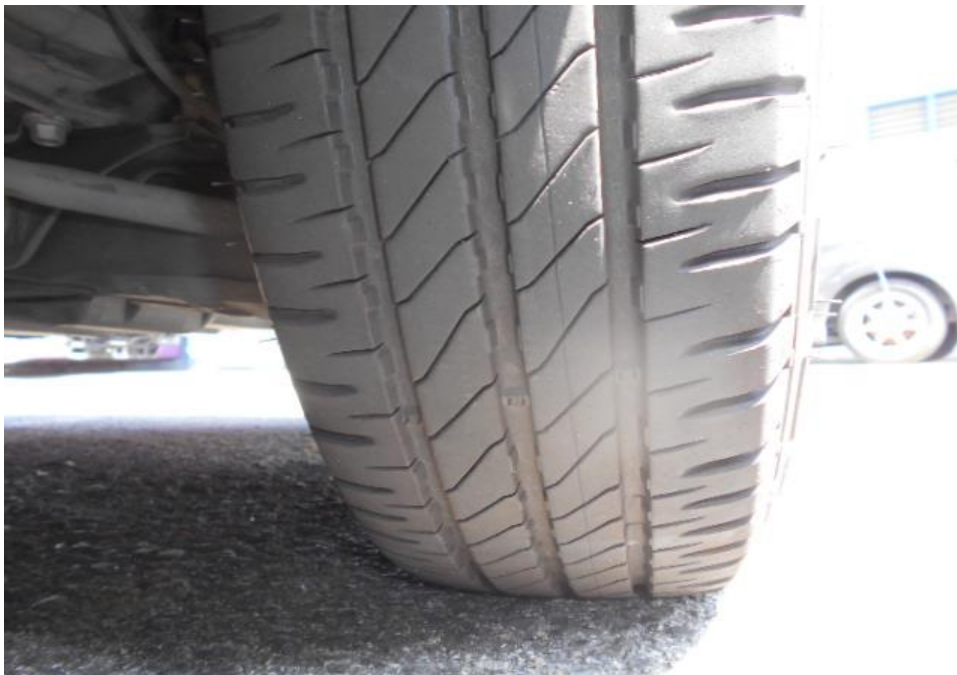
**Photo 7** shows the condition of the front right tyre of the Motor Van, which was observed to be in serviceable condition with remaining tread depth of approximately 6.9mm. The tyre, which was wrapped around standard steel wheel rim, was also observed to be sufficiently inflated for vehicular operation. There was no tear, cut or burst mark(s) on the outer and the inner sidewalls as well as across the tread of the 4 tyres that were fitted on the Motor Van.

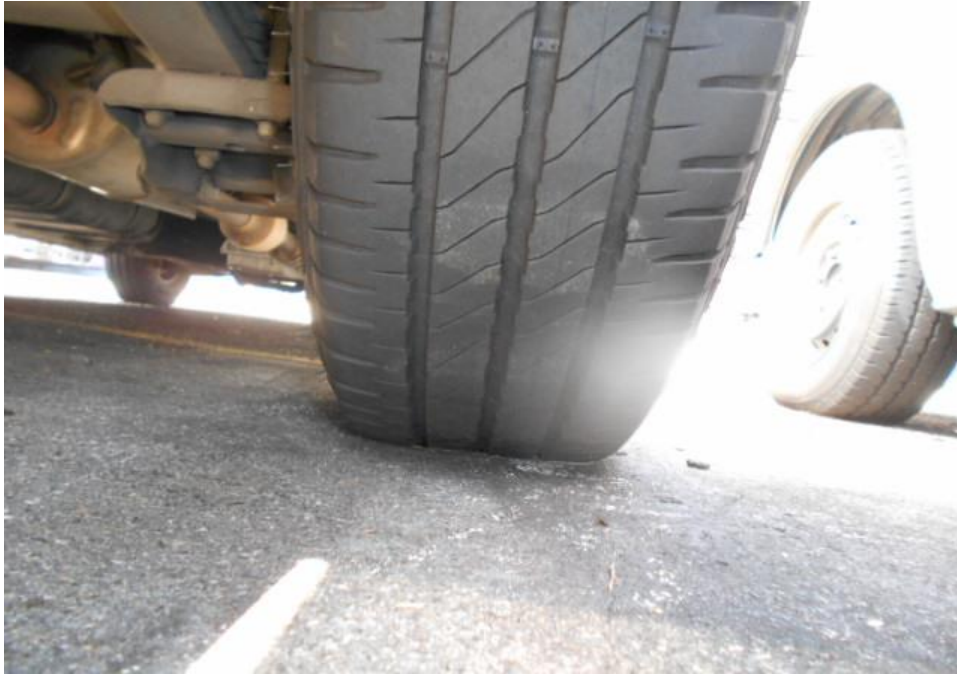
**Photo 8** shows the condition of the rear right tyre of the Motor Van, which was observed to be in serviceable condition with remaining tread depth of approximately 4.5mm. The tyre, which was wrapped around standard steel wheel rim, it was observed to be sufficiently inflated for vehicular operation.

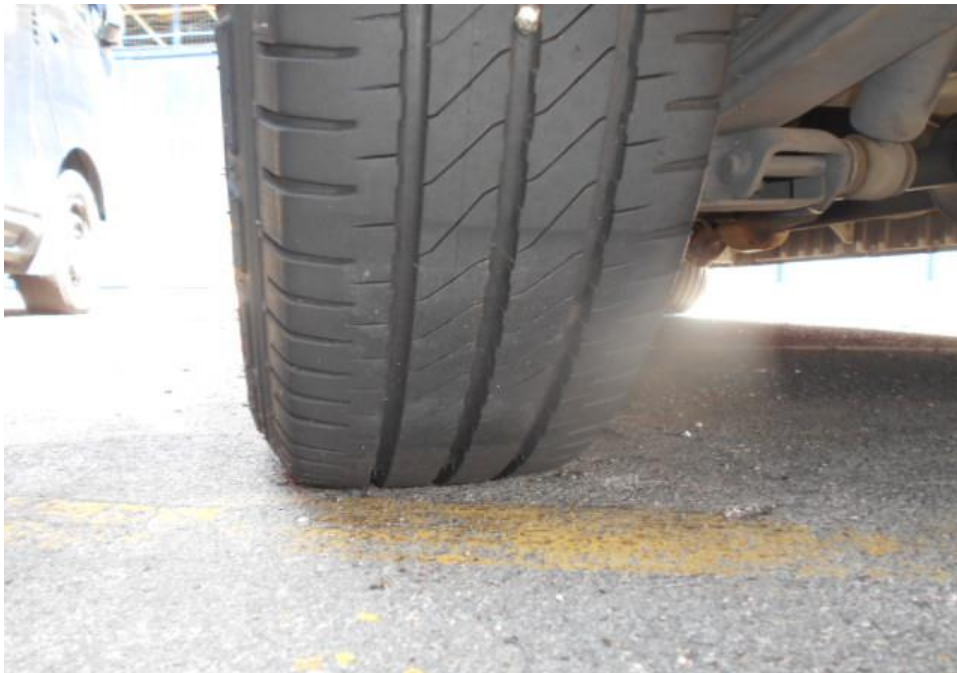
**Photo 9** shows the condition of the rear left tyres of the Motor Van, which was observed to be in serviceable condition with remaining tread depth of approximately 4.18mm. The tyres, which were wrapped around standard steel wheel rim, were also observed to be sufficiently inflated for vehicular operation. There was also no damage found on all 4 steel wheel rims of the Motor Van.

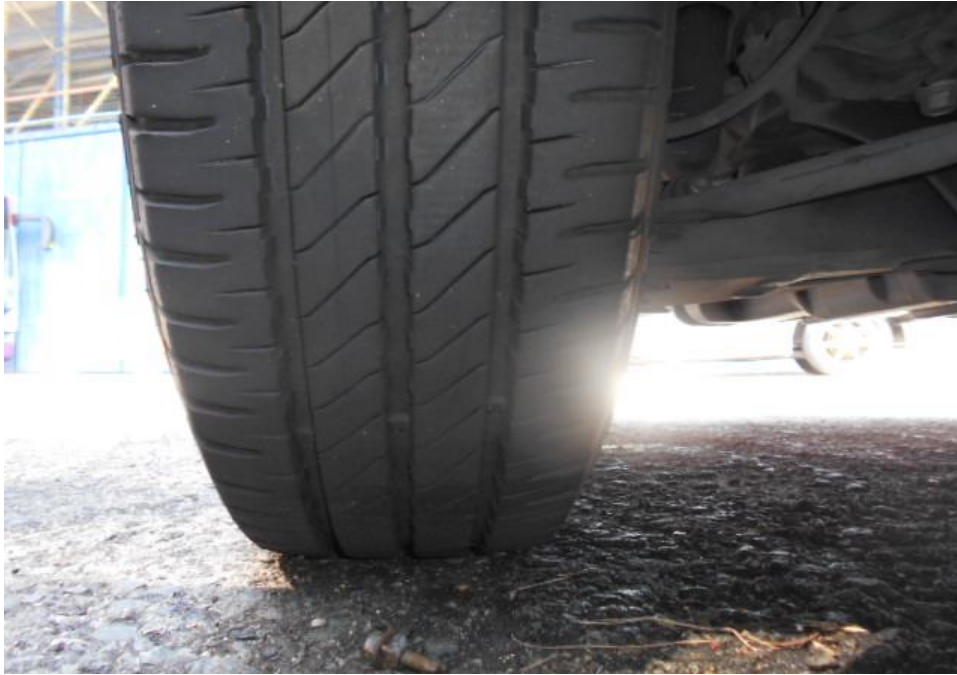
**Photo 10** shows the condition of the front left tyres of the Motor Van, which were observed to be in serviceable condition with remaining, tread depth of approximately 7.4mm. There was also no tear, cut or burst mark(s) on the outer and the inner sidewalls as well as across the tread of the 4 tyres that were fitted on the Motor Van.

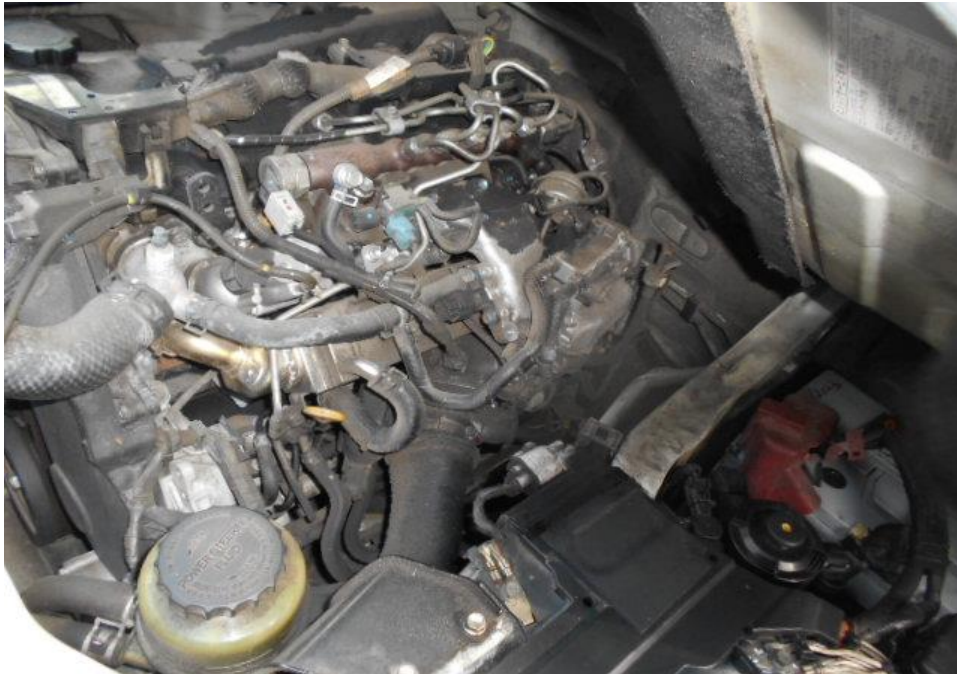
**Photo 11** shows a general view of the Motor Van's engine compartment, which was accessed by lifting the front cabin of the Motor Van. The various parts and components inside the engine compartment were unaffected by the accident. There was also no sign(s) or indication(s) of fresh fluid leakage and/or fluid stain within the engine compartment

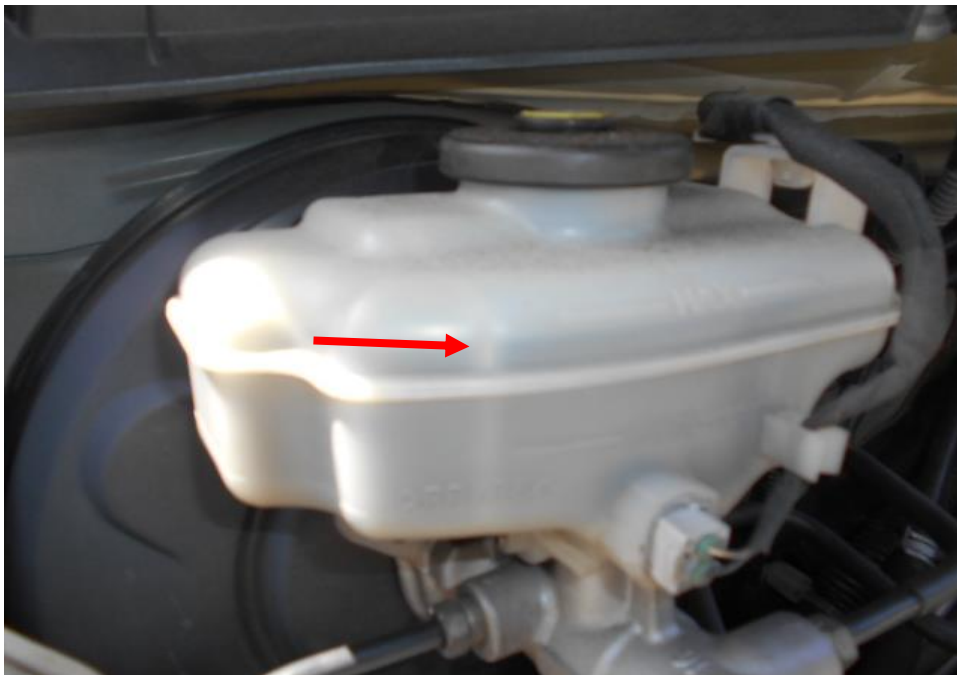
**Photo 12** shows the brake fluid reservoir of the Motor Van at the time of my inspection. The brake fluid was observed to be of sufficient level (arrowed) and without any visible contamination.

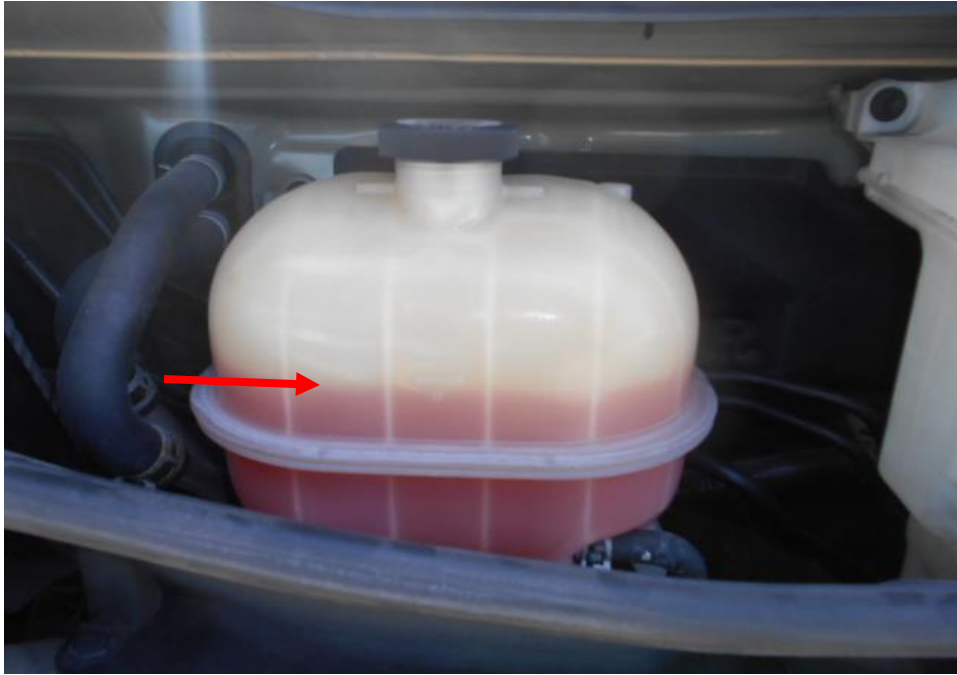
**Photo 13** shows the engine coolant of the Motor Van at the time of my inspection. The engine coolant was observed to be of sufficient level (arrowed) and without any visible contamination

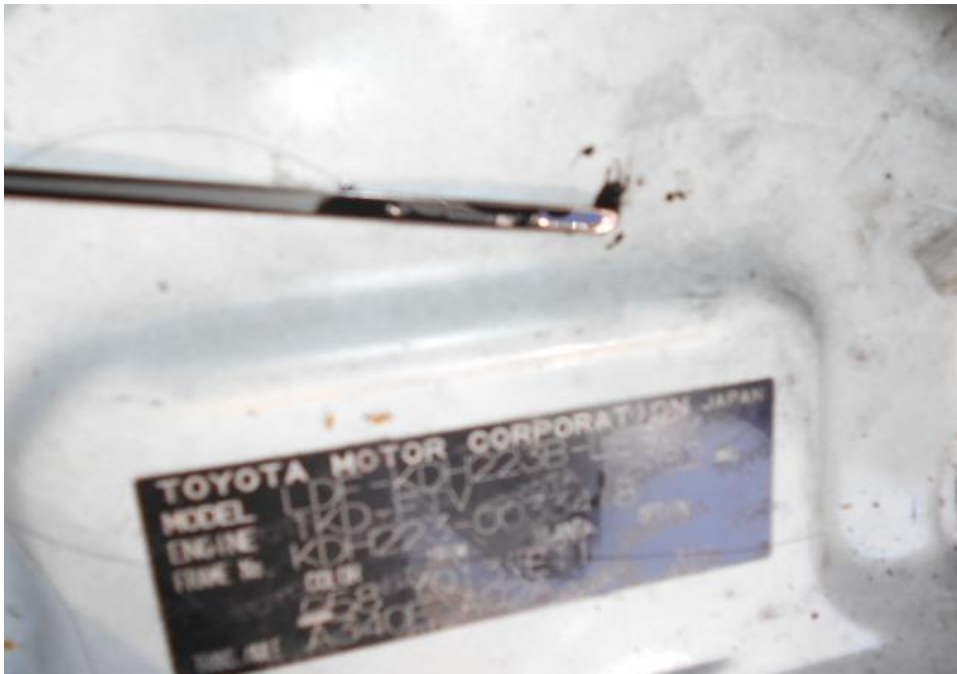
**Photo 14** shows the engine oil dip stick of the Motor Van at the time of my inspection. The engine oil was observed to be of sufficient level and without any visible contamination.

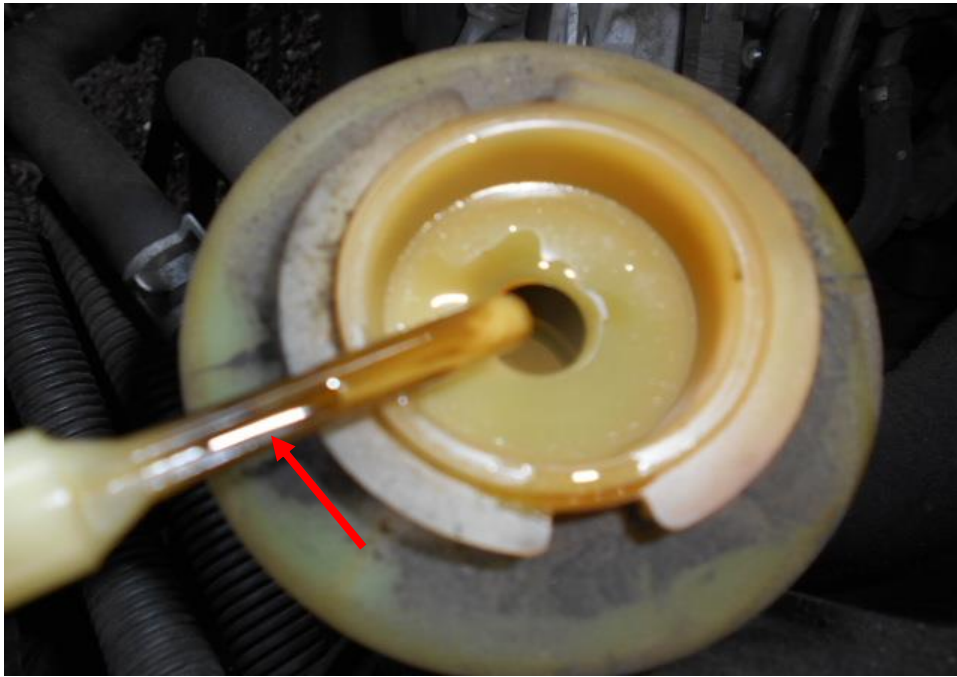
**Photo 15** shows the power steering fluid dip stick of the Motor Van at the time of my inspection. The steering fluid was observed to be of sufficient level (arrowed) and without any visible contamination.

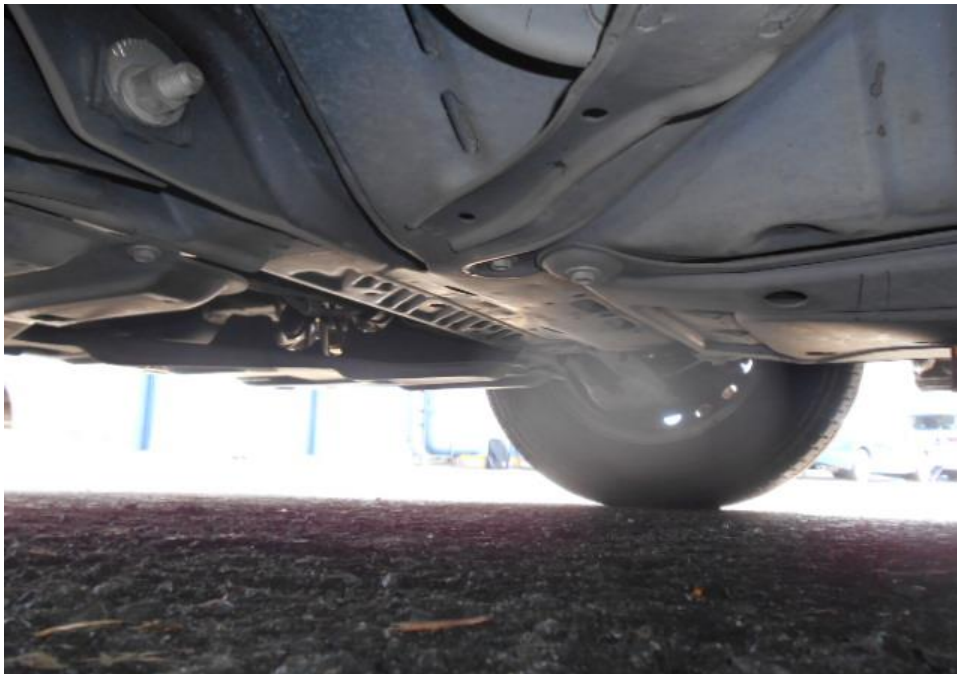
**Photo 16** shows the undercarriage of the Motor Van, at the area where the engine housing and transmission housing are located. I did not find any sign(s) or indication(s) of fluid leak and/or fluid stain(s) on the underside of the Motor Van.

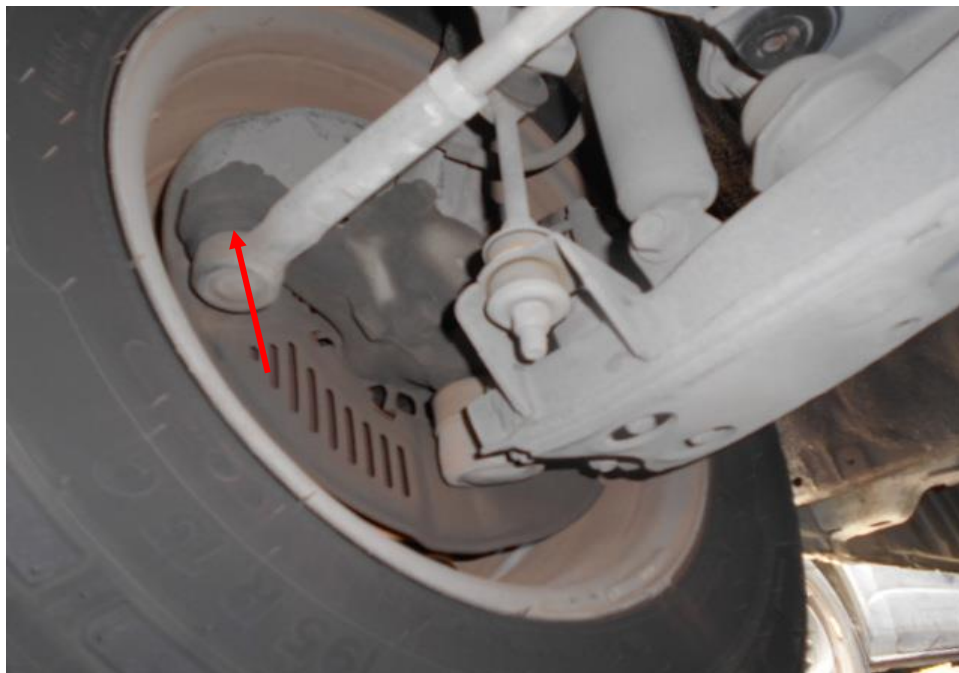
**Photo 17** shows the various undercarriage components at the front right wheel of the Motor Van, in particular the steering tie rod end (arrowed). The various steering components were all found to be intact, suggesting that the steering system of the Motor Van was likely to be in serviceable condition at the material time of accident. There was also no sign of fluid stain(s) observed on the various undercarriage components.

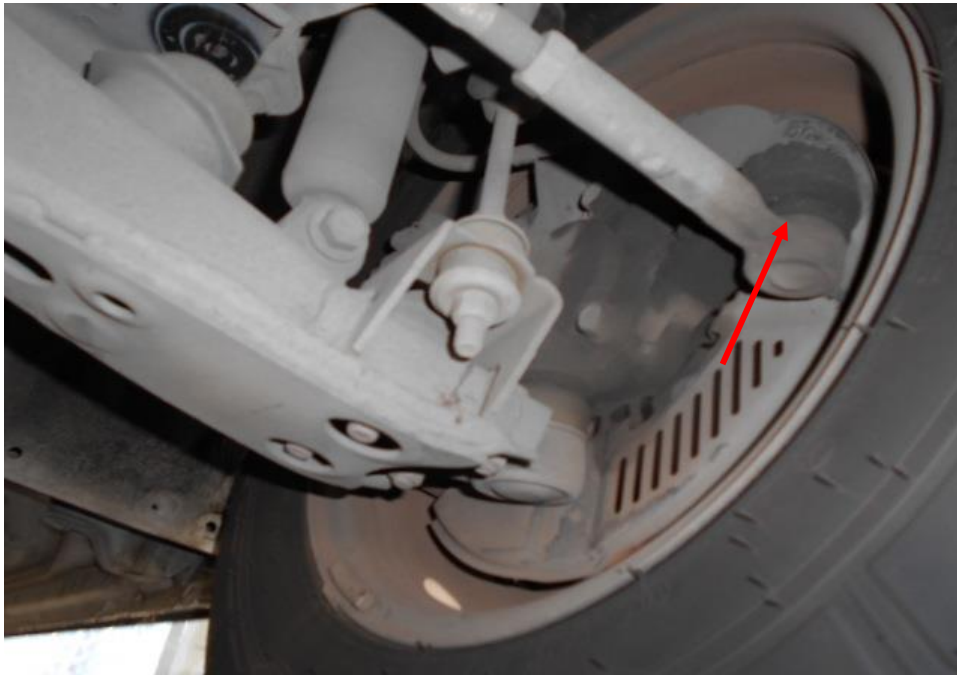
**Photo 18** shows the various undercarriage components at the front left wheel of the Motor Van, in particular the steering tie rod end (arrowed). The various undercarriage components of the Motor Van were all found to be intact without any visible damage. There was also no sign of fluid stain(s) observed on the various undercarriage components.

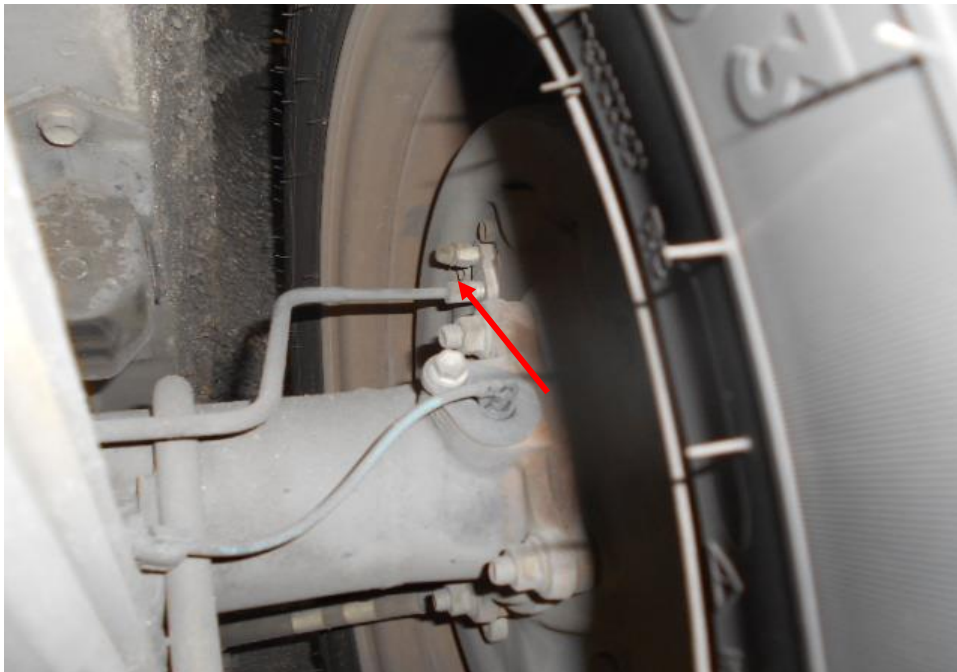
**Photo 19** shows the brake pipe (arrowed) at the rear right wheel of the Motor Van. I did not observe any leakage of brake fluid at the time of my inspection of the Motor Van. My static tests of the Motor Van's braking system, along with my visual examination of the various mechanical components in the braking system, had indicated that there was no internal leakage of pressure/vacuum. Hence the braking system of the Motor Van was likely to be in serviceable condition at the material time of accident.

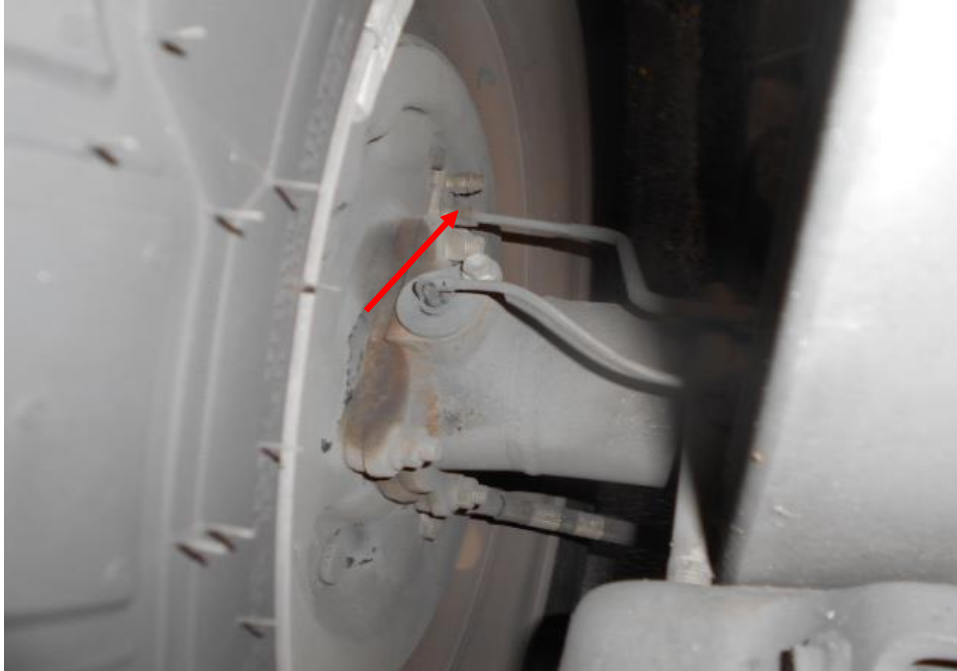
**Photo 20** shows the brake pipe (arrowed) at the rear left wheel of the Motor Van. I did not observe any leakage of brake fluid at the time of my inspection of the Motor Van. My static tests of the Motor Van's braking system, along with my visual examination of the various mechanical components in the braking system had indicated that there was no internal leakage of pressure/vacuum. Hence the braking system of the Motor Van was likely to be in serviceable condition at the material time of accident.

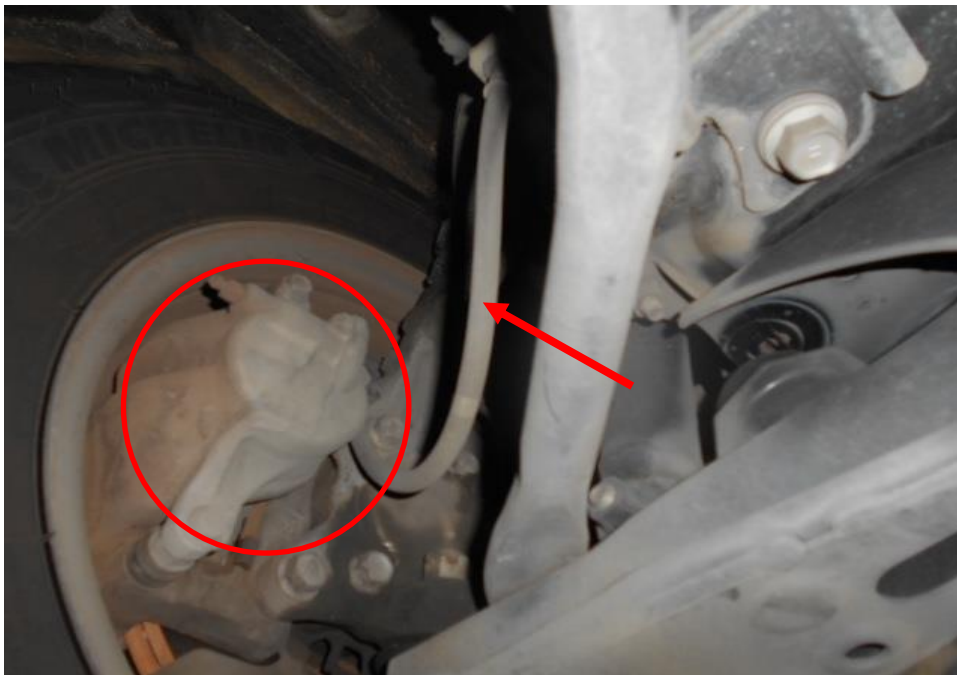
**Photo 21** shows the brake hose/pipe (arrowed) at the front right wheel of the Motor Van. No leakage of brake fluid was observed. Visual examination of the various components of the braking system like the brake caliper (circled), brake booster, brake pedal etc had revealed all to be intact and without visible damage at the time of accident. There was also no sign of fluid stain(s) observed on the various undercarriage components.

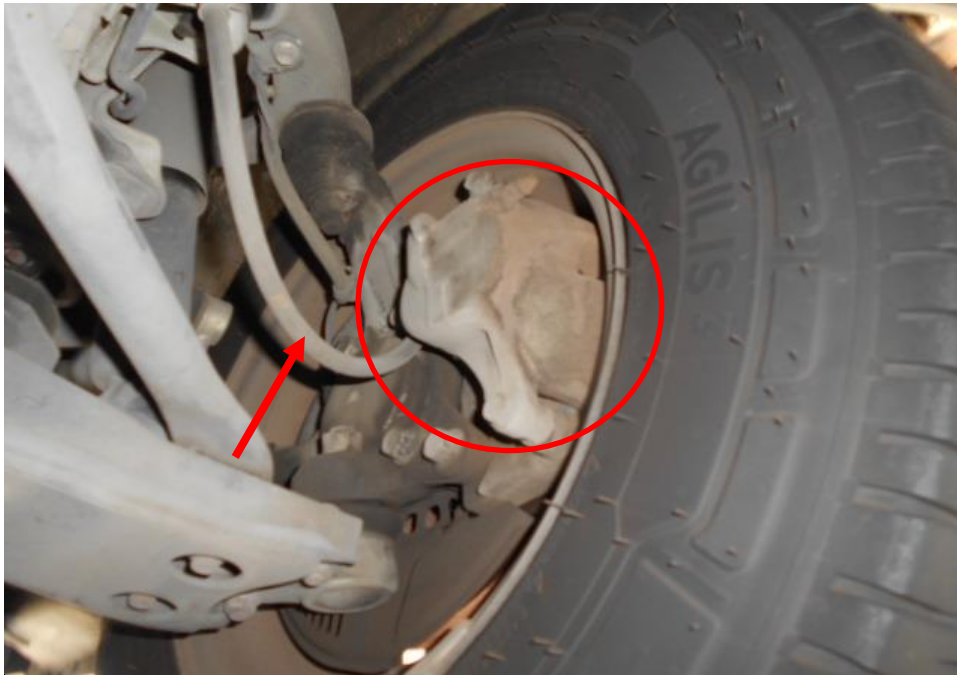
**Photo 22** shows the brake hose/pipe (arrowed) at the front left wheel of the Motor Van. No leakage of brake fluid was observed. Visual examination of the various components of the braking system like the brake caliper (circled), brake booster, brake pedal etc had revealed all to be intact and without visible damage at the time of accident. There was also no sign of fluid stain(s) observed on the various undercarriage components.

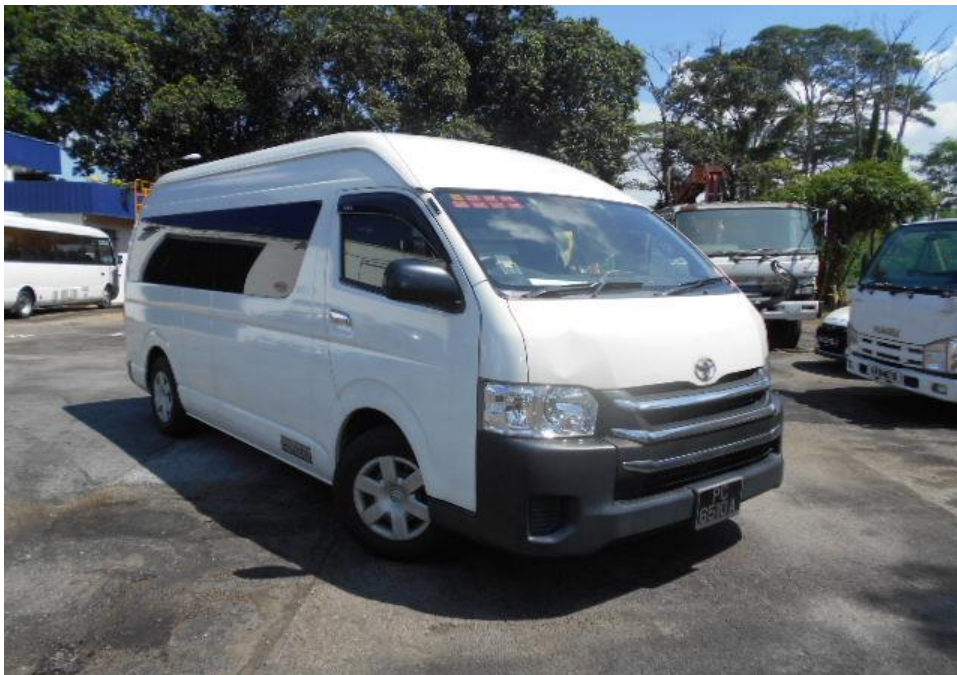
**Photo 23** shows the front right wheel of the Motor Van turned to its full left. During my steering system test, I did not experience any abnormal free play and/or resistance when I had turned the steering wheel towards full left and full right. This would suggest that the steering system of the Motor Van was likely to be in serviceable condition at the material time of accident.

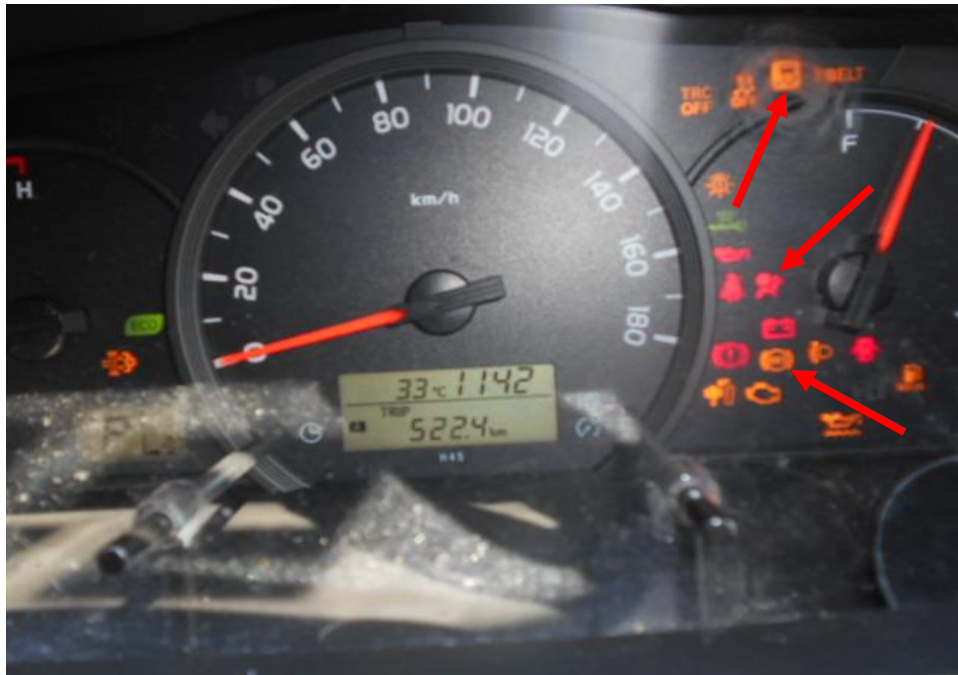
**Photo 24** shows the warning light for Anti-Lock Brake System (ABS), Traction Control System (TCS) and Supplemental Restraint System (SRS) (arrowed) appearing on the instrument panel of the Motor Van during the self-test of its various electronic operating systems when its engine was cranked.

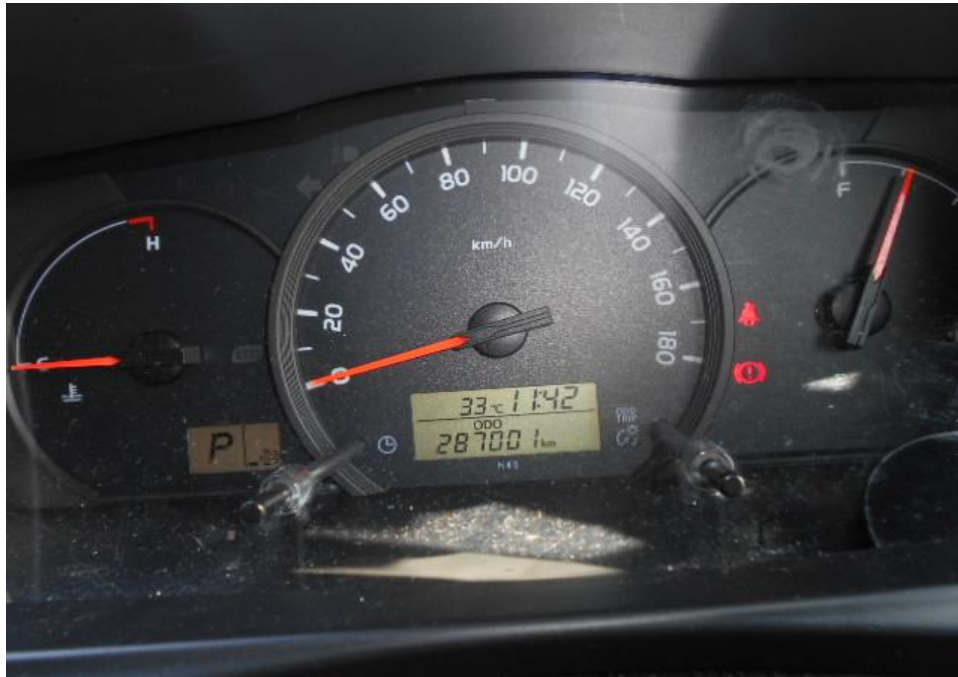
**Photo 25** shows no warning lights illuminated on the instrument panel of the Motor Van after the engine was cranked. This would suggest that there was no abnormality to the electronic operating system of the Motor Van, like the ABS, TCS, SRS and etc.
