Your Ref: TP TP/11422/2023  
Our Ref : CI/TPD23006782/P

**Fatal Accident Investigation Team**

**MECHANICAL INSPECTION REPORT OF MOTOR BUS SBS 6171B**

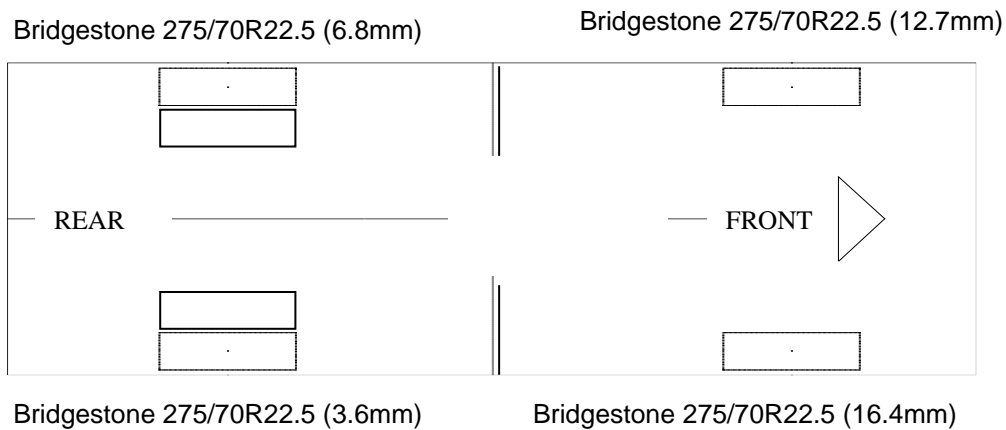
6. The 2 front tyres and 4 rear tyres of the Motor Bus were observed to be in serviceable condition and sufficiently inflated for vehicular operation. I did not find any tear or burst mark(s) on the outer and inner sidewalls as well as across the tread of the 6 tyres. The tyre brand, tyre size and remaining tread depth of the 6 tyres of the Motor Bus were recorded as follows:-

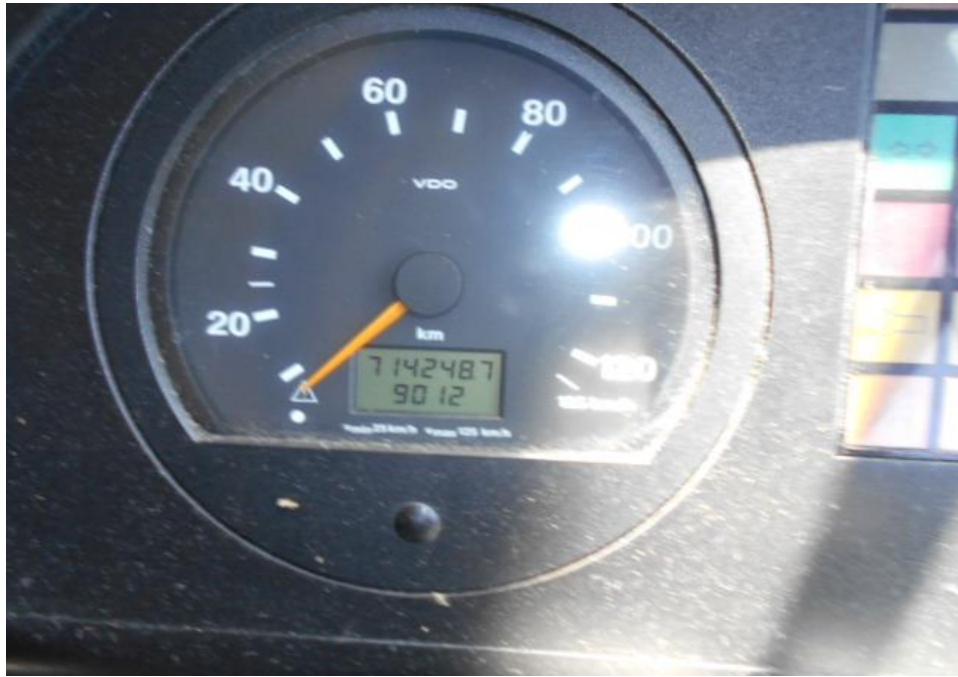
**Photo 1** shows a general view of the instrument cluster of the Motor Bus at the time of my inspection. The mileage of the Motor Bus was 714,248km

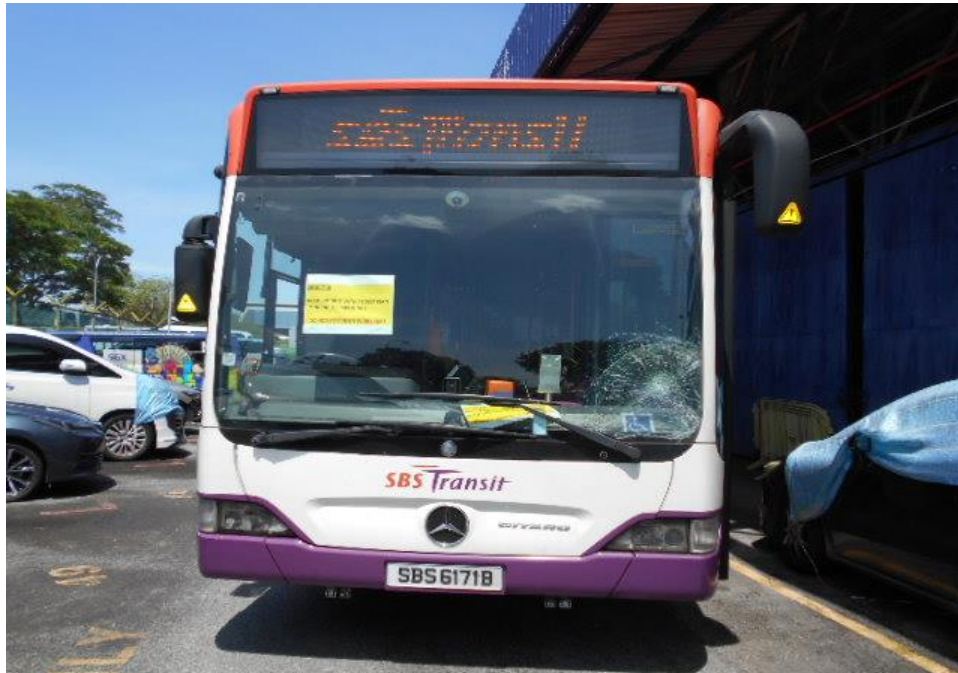
**Photo 2** shows a general view of the front body of the Motor Bus at the time of my inspection. The Motor Bus was observed to have sustained damages at its front windscreen was observed to be damage at the time of my inspection.

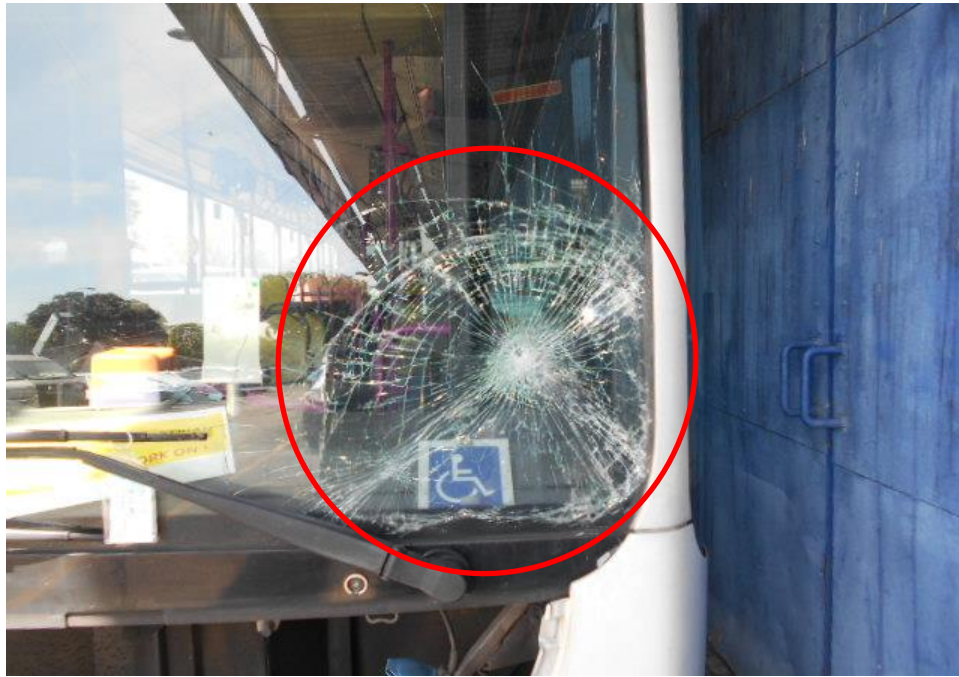
**Photo 3** shows a close up view of the front body of the Motor Bus at the time of my inspection. The Motor Bus was observed to have sustained damages at its front portion. Its front windscreen (circled) was damaged as a result of the accident.

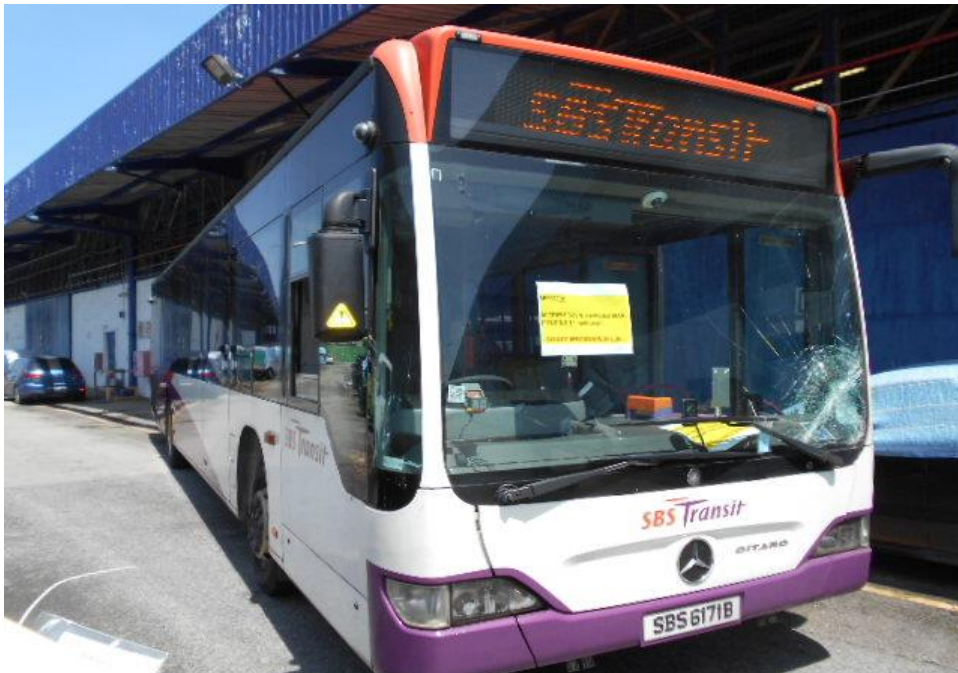
**Photo 4** shows the general view of the right body of the Motor Bus at the time of my inspection. The Motor Bus was observed to be intact and unaffected by the accident.

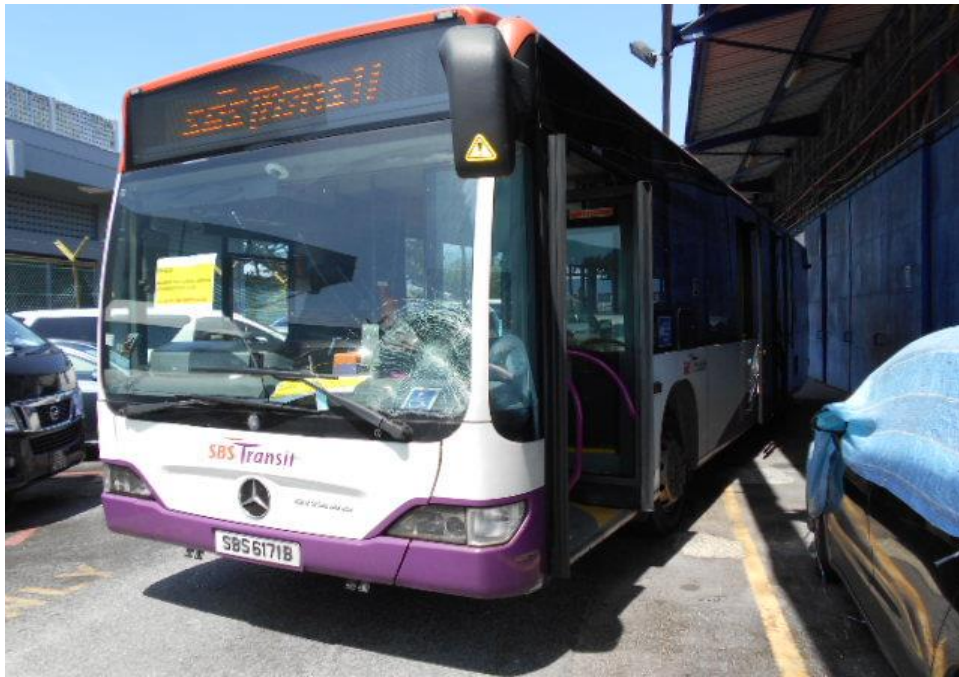
**Photo 5** shows the general view of the left body of the Motor Bus at the time of my inspection. The Motor bus was observed to be intact and unaffected by the accident.

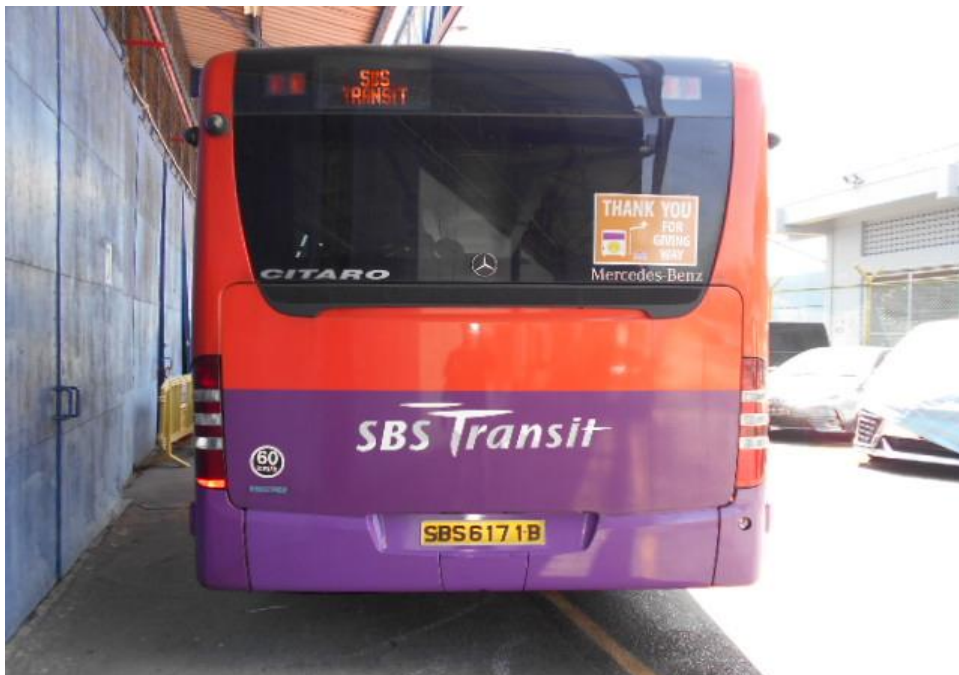
**Photo 6** shows the general view of the rear body of the Motor Bus at the time of my inspection. The Motor Bus was observed to be intact and unaffected by the accident.

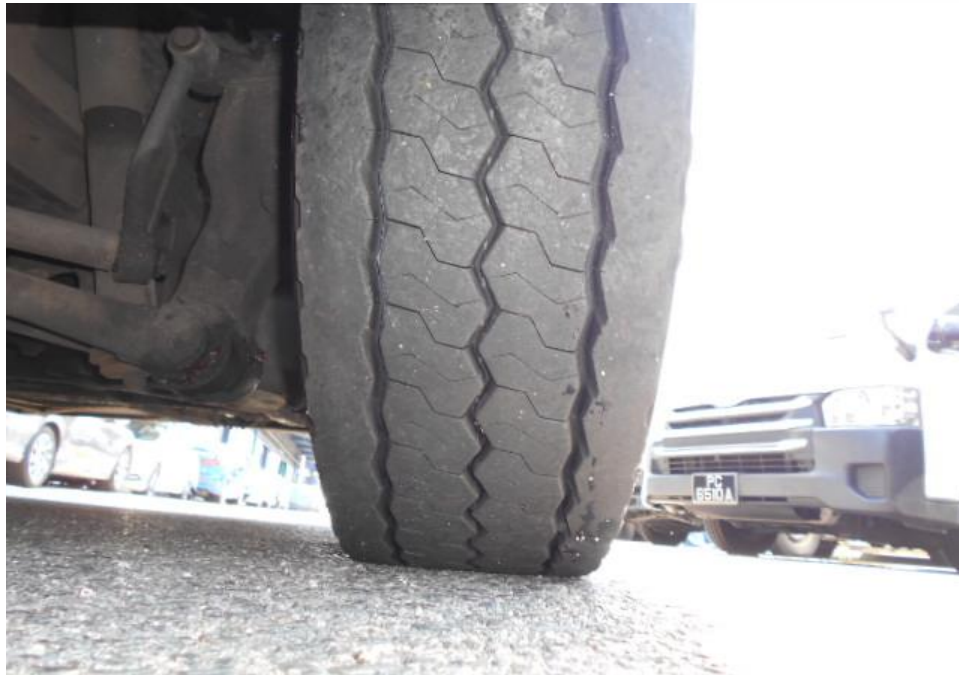
**Photo 7** shows the condition of the front right tyre of the Motor Bus, which was observed to be in serviceable condition with remaining tread depth of approximately 16.4mm. The tyre, which was wrapped around standard steel wheel rim, was also observed to be sufficiently inflated for vehicular operation. There was no tear, cut or burst mark(s) on the outer and the inner sidewalls as well as across the tread of the 6 tyres that were fitted on the Motor Bus.

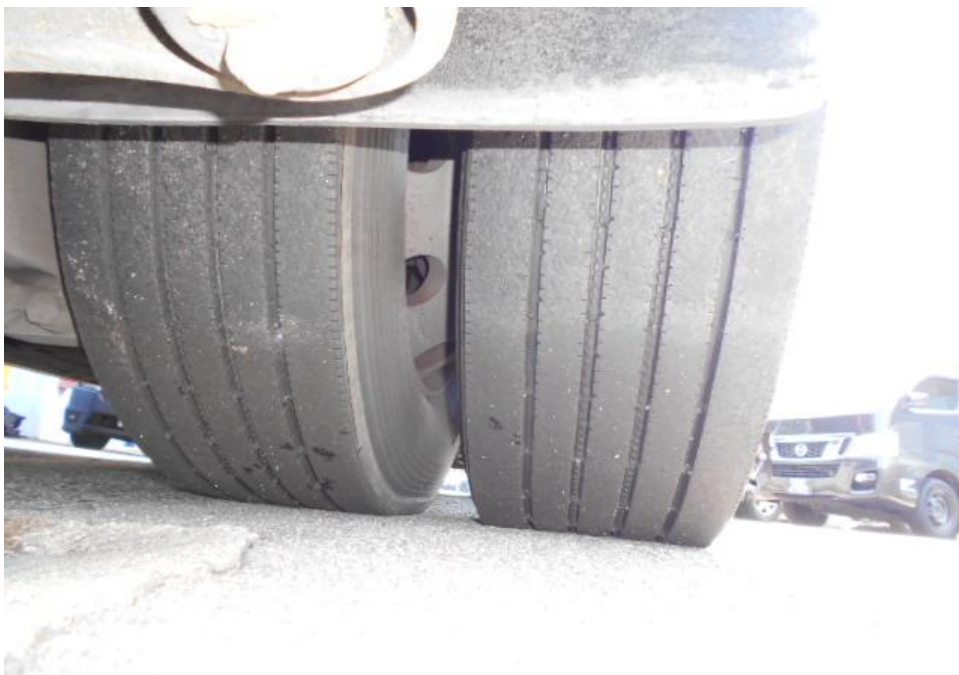
**Photo 8** shows the condition of the rear right tyre of the Motor Bus, which was observed to be in serviceable condition with remaining tread depth of approximately 3.6mm. The tyre, which was wrapped around standard steel wheel rim, was also observed to be sufficiently inflated for vehicular operation

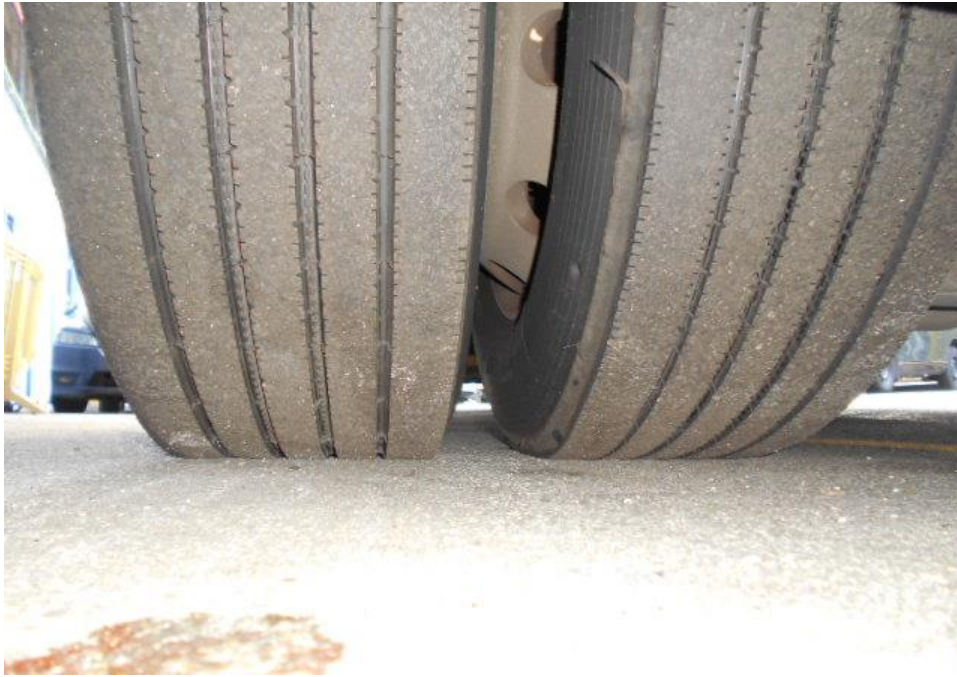
**Photo 9** shows the condition of the rear left tyre of the Motor Bus, which was observed to be in serviceable condition with remaining tread depth of approximately 6.8mm. The tyre, which was wrapped around standard steel wheel rim, was also observed to be sufficiently inflated for vehicular operation.

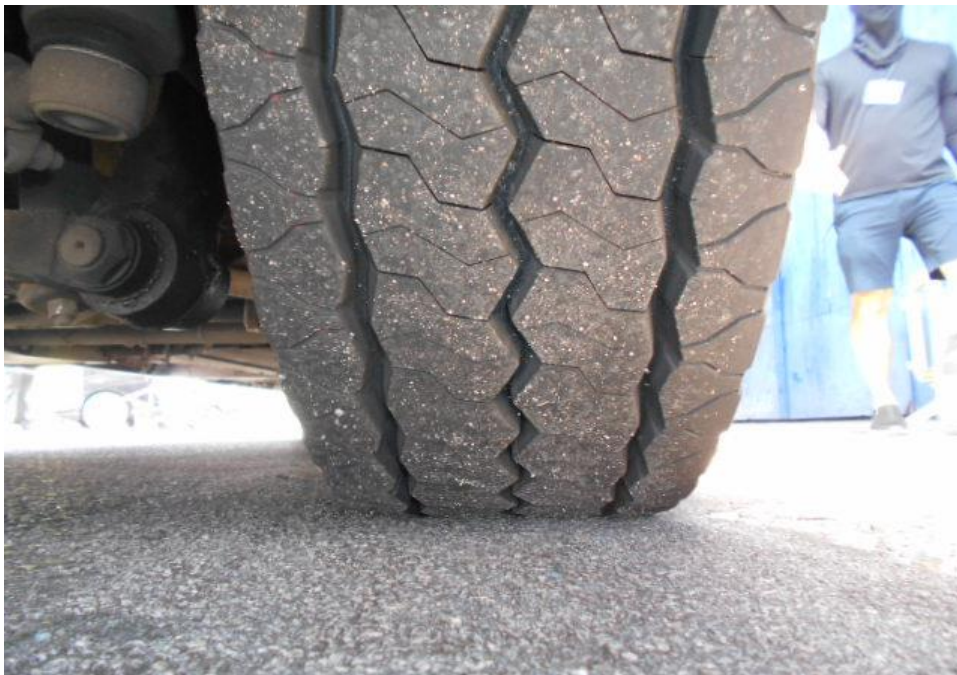
**Photo 10** shows the condition of the front left tyre of the Motor Bus, which was observed to be in serviceable condition with remaining tread depth of approximately 12.7mm. The tyre, which was wrapped around standard steel wheel rim, was also observed to be sufficiently inflated for vehicular operation.

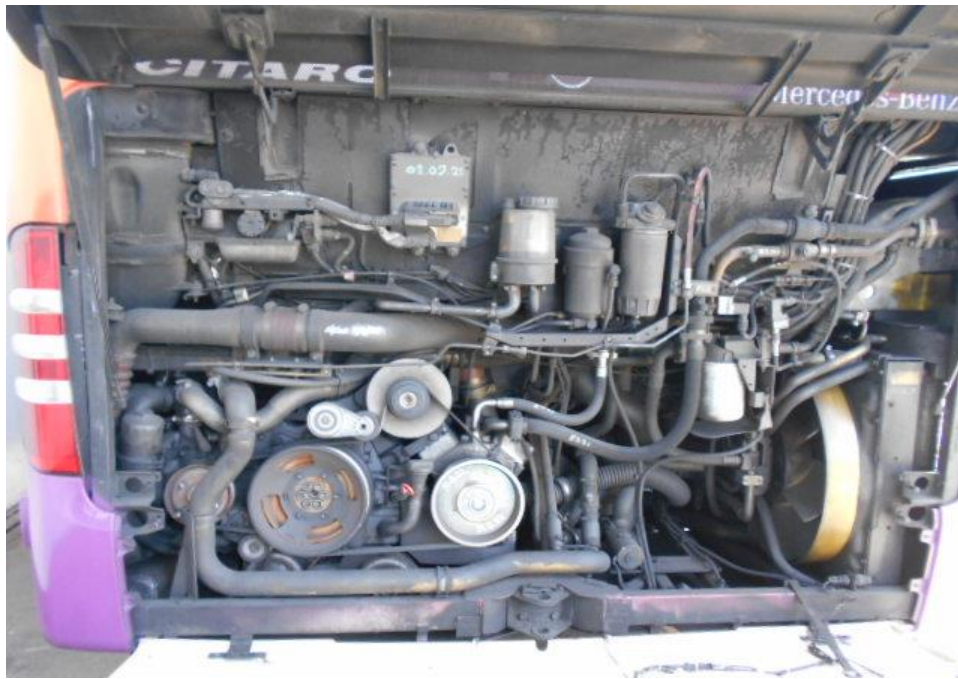
**Photo 11** shows a general view of the Motor Bus's engine compartment, which was accessed by lifting the rear of the Motor Bus. The various parts and components inside the engine compartment were unaffected by the accident. There was also no sign(s) or indication(s) of fresh fluid leakage and/or fluid stain within the engine compartment.

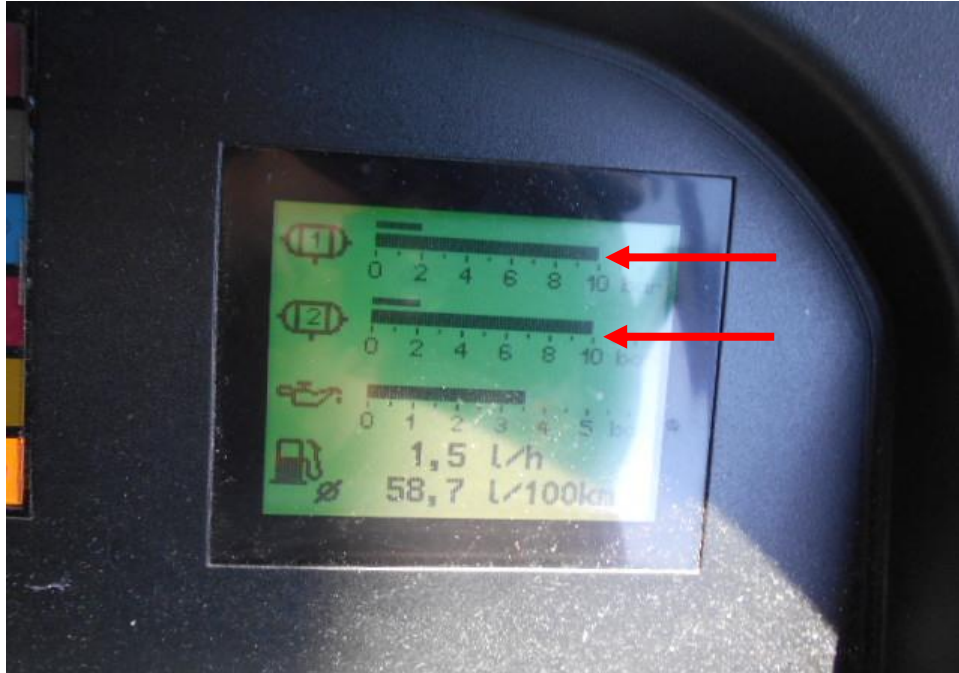
**Photo 12** shows the air in the air brake cylinder of the Motor Bus at the time of my inspection. The air in the cylinder was observed to be of sufficient level & serviceable at the time of my inspection.

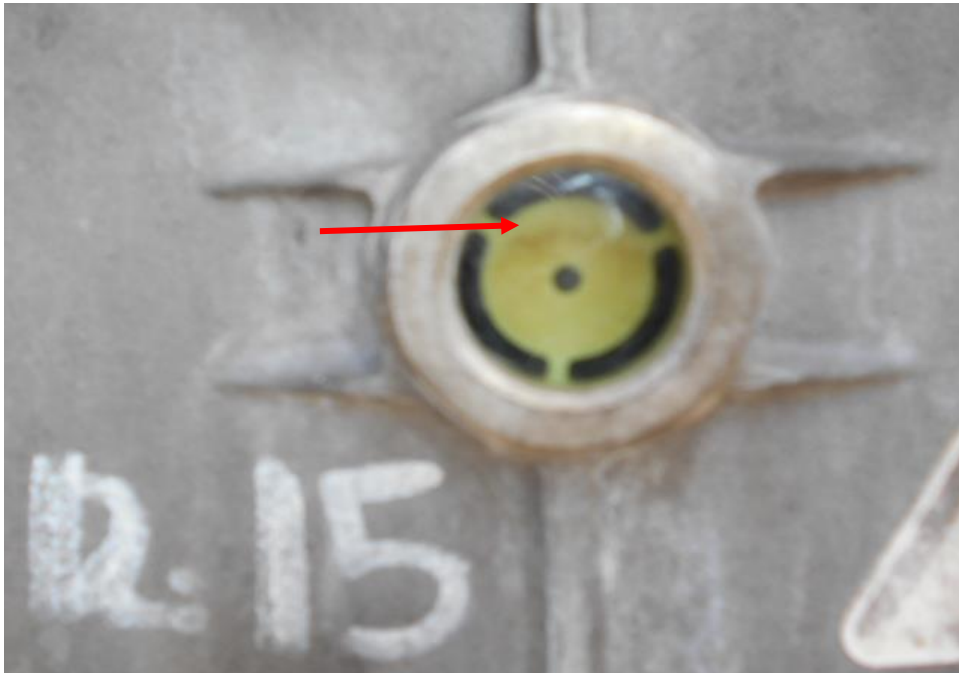
**Photo 13** shows the engine coolant reservoir of the Motor Bus at the time of my inspection. The engine coolant was observed to be of sufficient level (arrowed) and without any visible contamination.

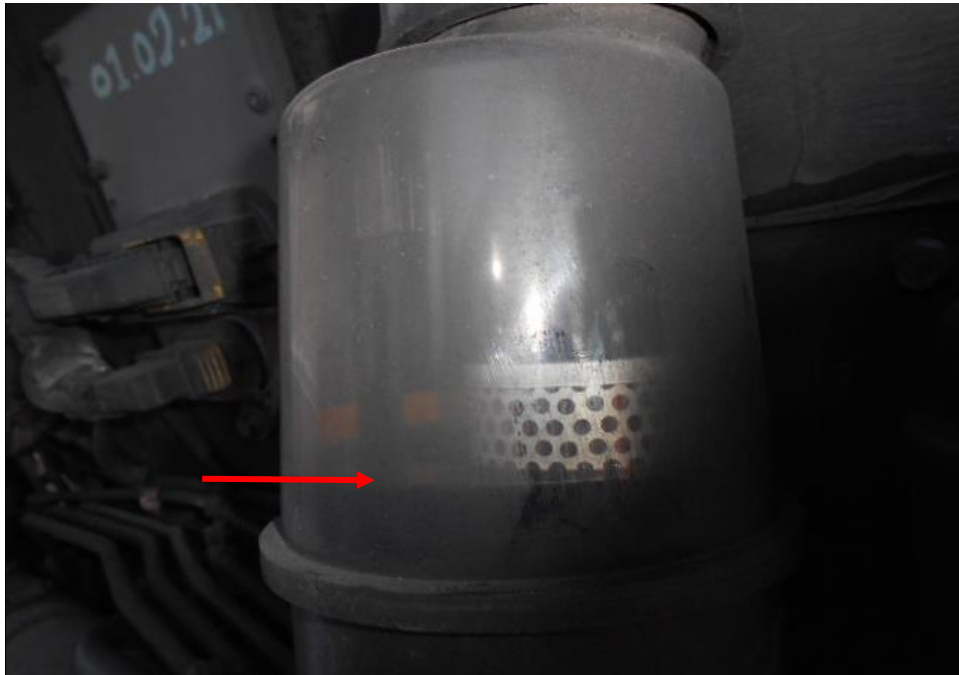
**Photo 14** shows the power steering reservoir of the Motor Bus at the time of my inspection. The power steering was observed to be of sufficient level (arrowed) and without any visible contamination.

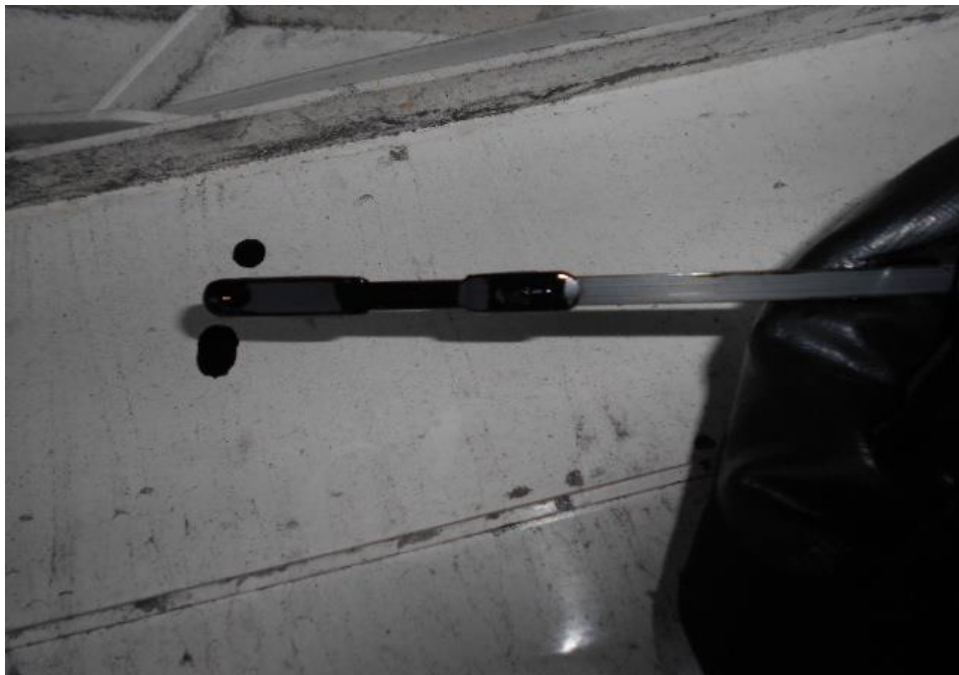
**Photo 15** shows the engine oil dip stick of the Motor Bus at the time of my inspection. The engine oil was observed to be sufficient for operation and without any visible contamination.

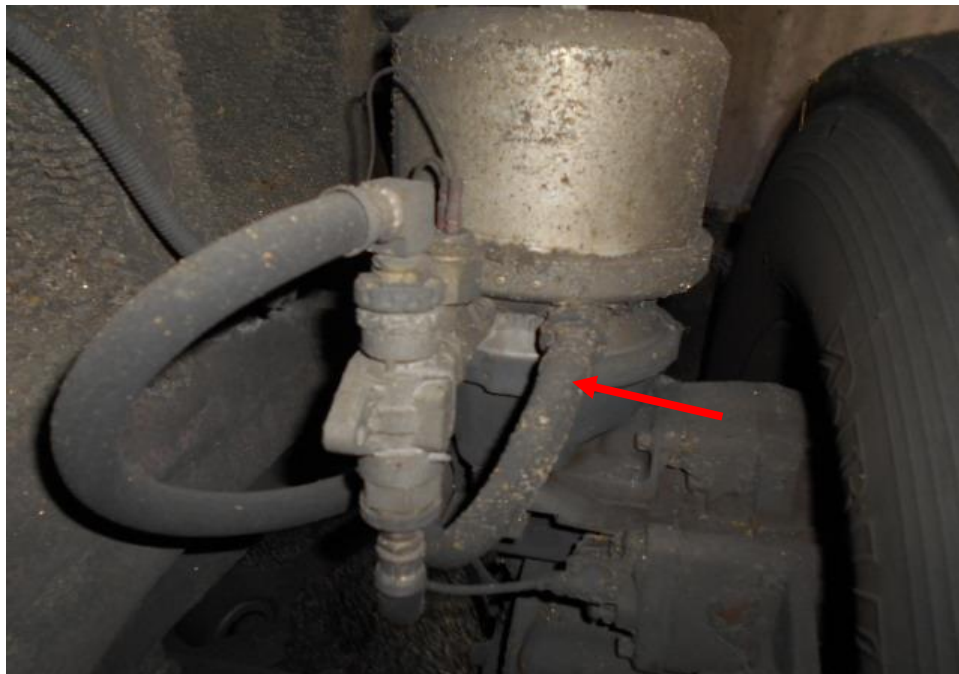
**Photo 16** shows the brake pipe (arrowed) at the rear right wheel of the Motor Bus. I did not observe any leakage of brake fluid at the time of my inspection of the Motor Bus. My visual examination of the various mechanical components of the braking system were generally intact and unaffected by the accident.

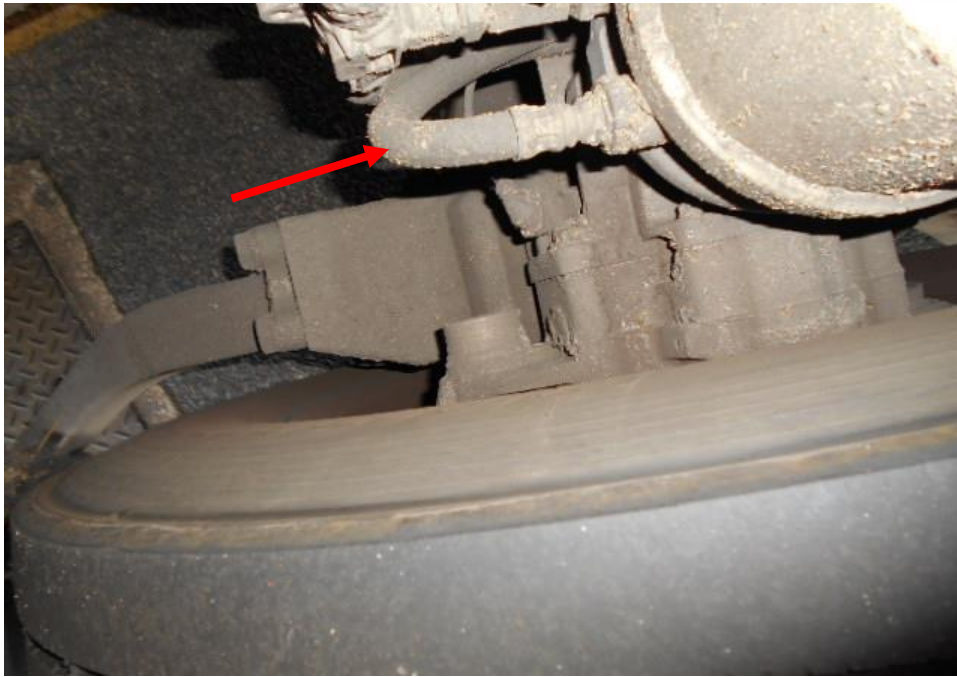
**Photo 17** shows the brake pipe (arrowed) at the rear left wheel of the Motor Bus. I did not observe any leakage of brake fluid at the time of my inspection of the Motor Bus. My visual examination of the various mechanical components of the braking system were generally intact and unaffected by the accident.

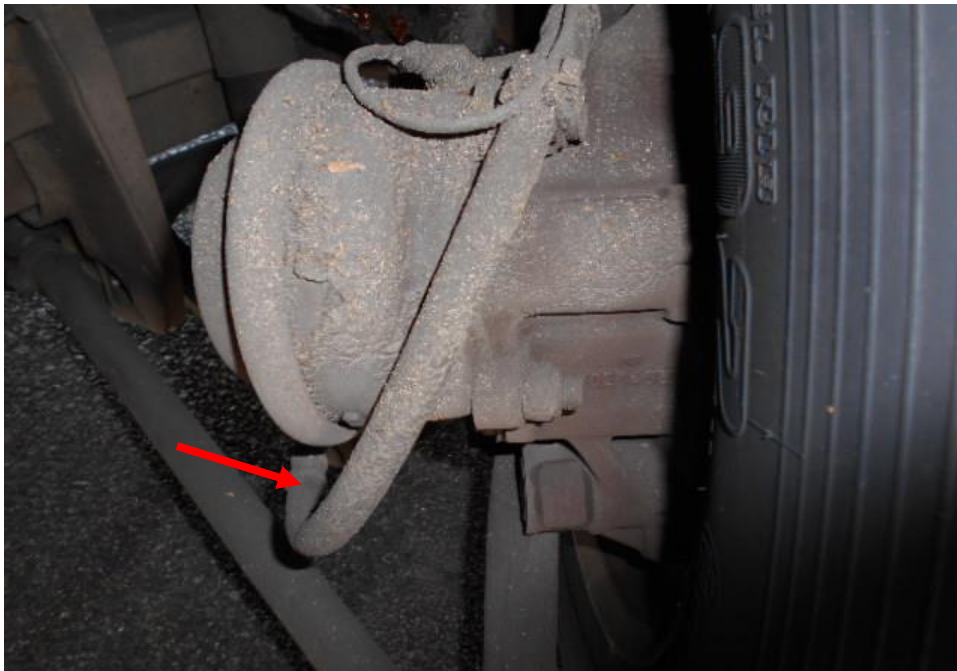
**Photo 18** shows the brake pipe (arrowed) at the front left wheel of the Motor Bus. I did not observe any leakage of brake fluid at the time of my inspection of the Motor Bus. My visual examination of the various mechanical components of the braking system were generally intact and unaffected by the accident.

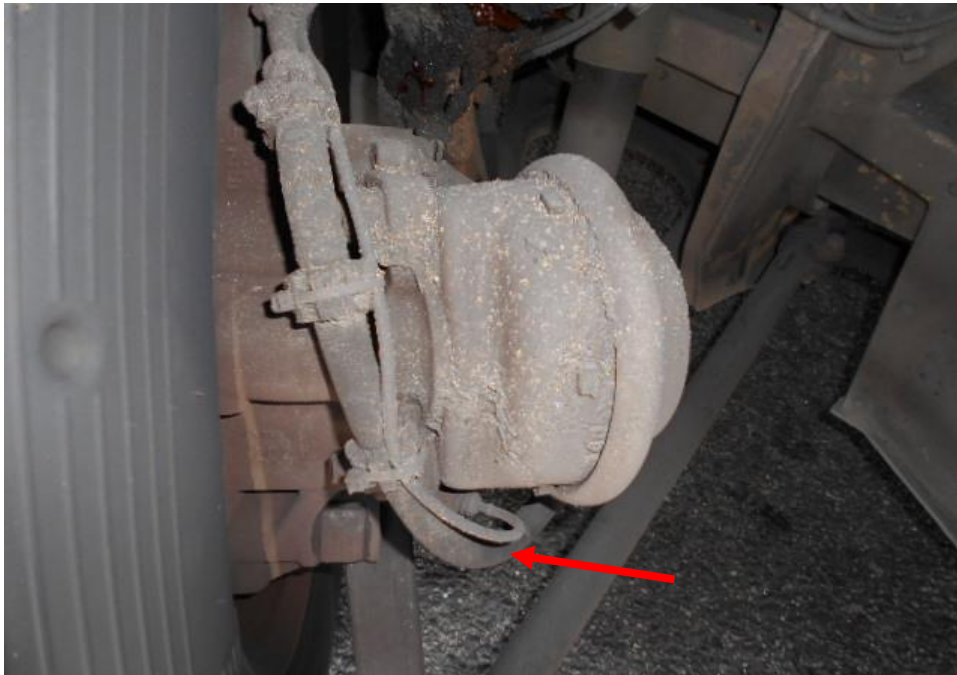
**Photo 19** shows the brake hose/pipe (arrowed) at the front right wheel of the Motor Bus. I did not observe any leakage of brake fluid at the time of my inspection of the Motor Bus. My visual examination of the various mechanical components of the braking system were generally intact and unaffected by the accident.

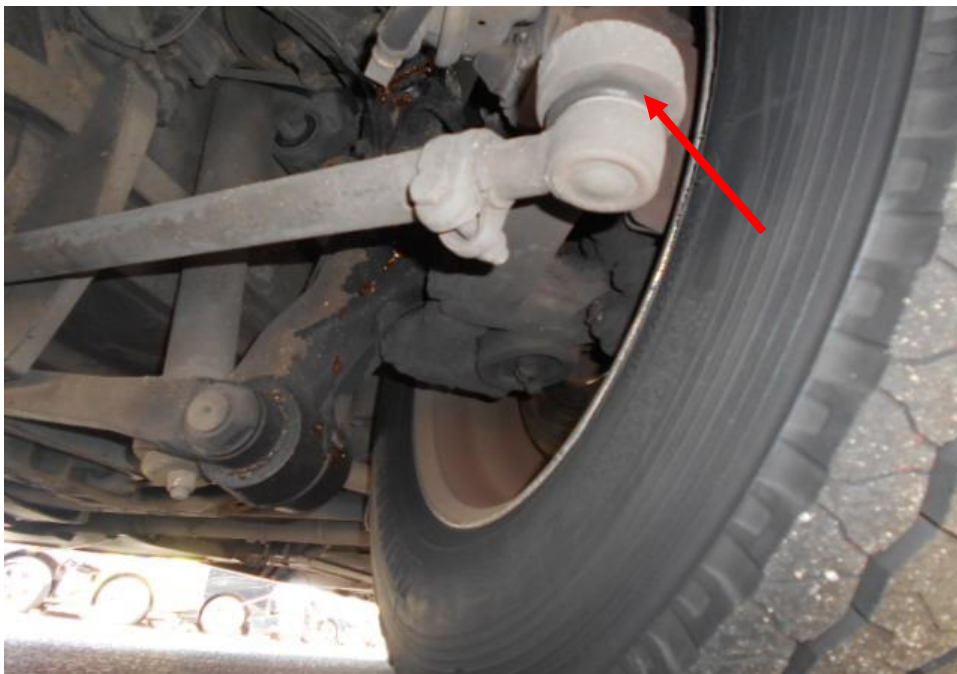
**Photo 20** shows the various undercarriage components at the front right wheel of the Motor Car, in particular the steering tie rod end (arrowed). The various steering components were all found to be intact. There was also no sign of fluid stain(s) observed on the various undercarriage components.

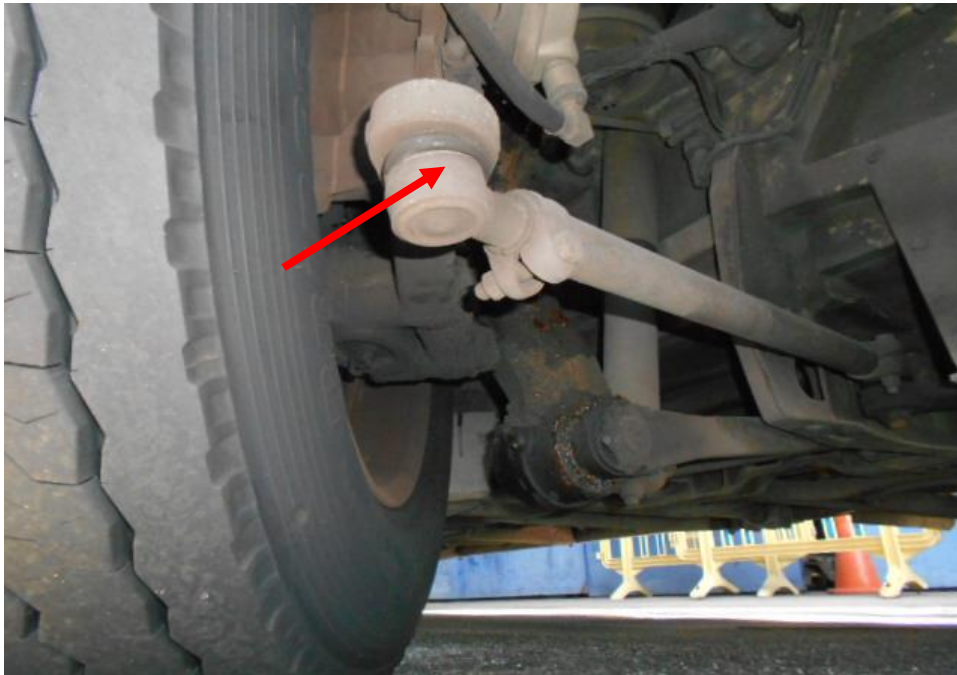
**Photo 21** shows the various undercarriage components at the front left wheel of the Motor Car, in particular the steering tie rod end (arrowed). The various steering components were all found to be intact. There was also no sign of fluid stain(s) observed on the various undercarriage components.

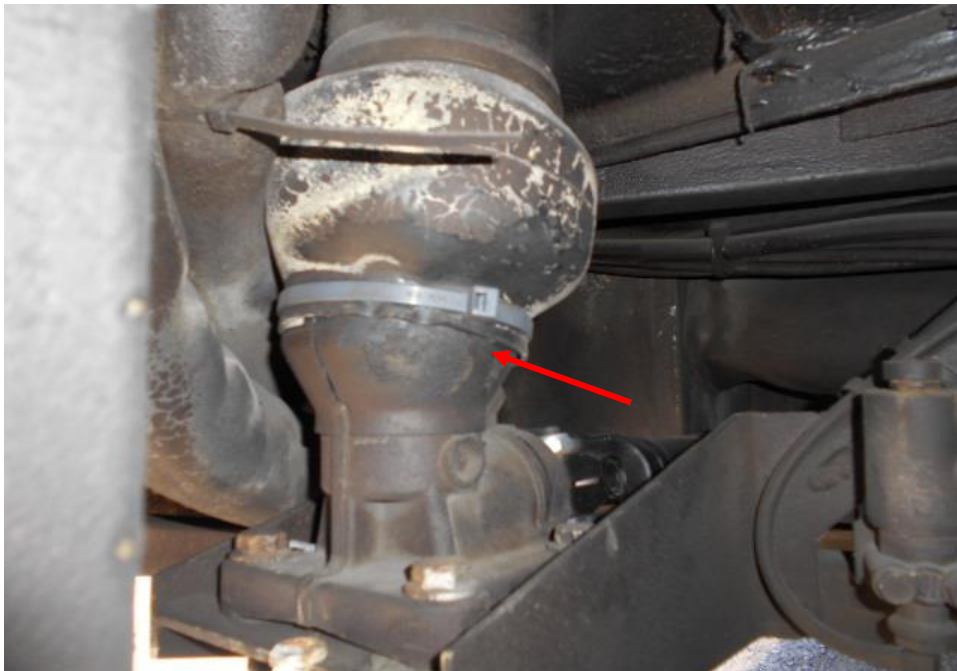
**Photo 22** shows the steering box component (arrowed) at the undercarriage of the Motor Bus was found to be intact and without any visible damage. There was also no signs of fluid stain(s) observed on the various undercarriage components.

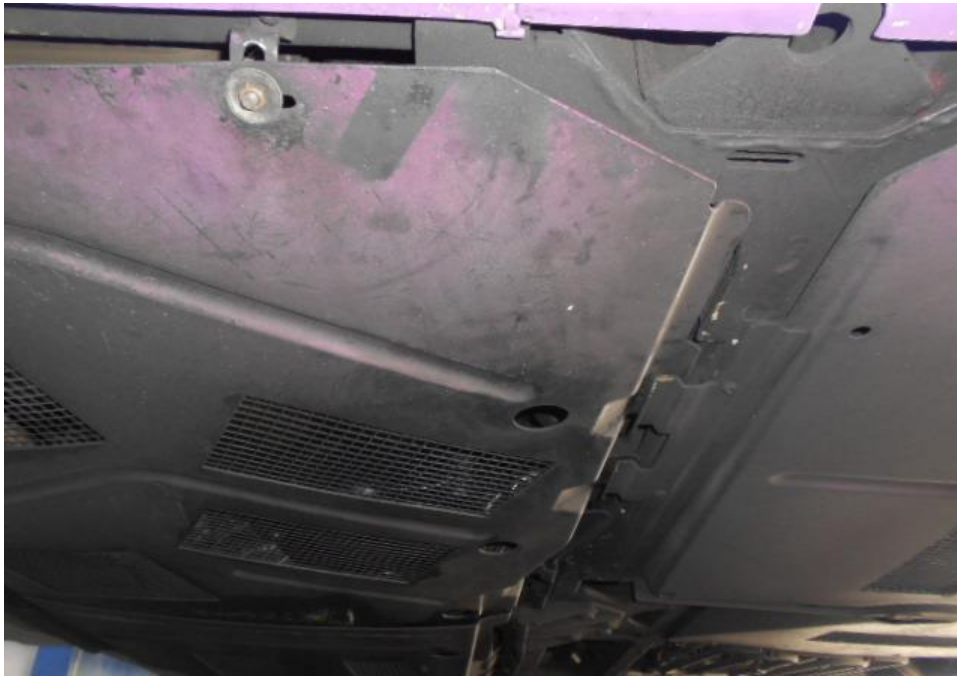
**Photo 23** shows the undercarriage of the Motor Bus, at the area where the engine housing and transmission housing are located. I did not find any sign(s) or indication(s) of fluid leak and/or fluid stain(s) on the underside of the Motor Bus.
