You're Ref: TP TP/09540/2023  
Our Ref: CI/TPD23006785/P

14<sup>th</sup> July 2023

**MECHANICAL INSPECTION REPORT OF MOTOR CAR SNF 2520E**

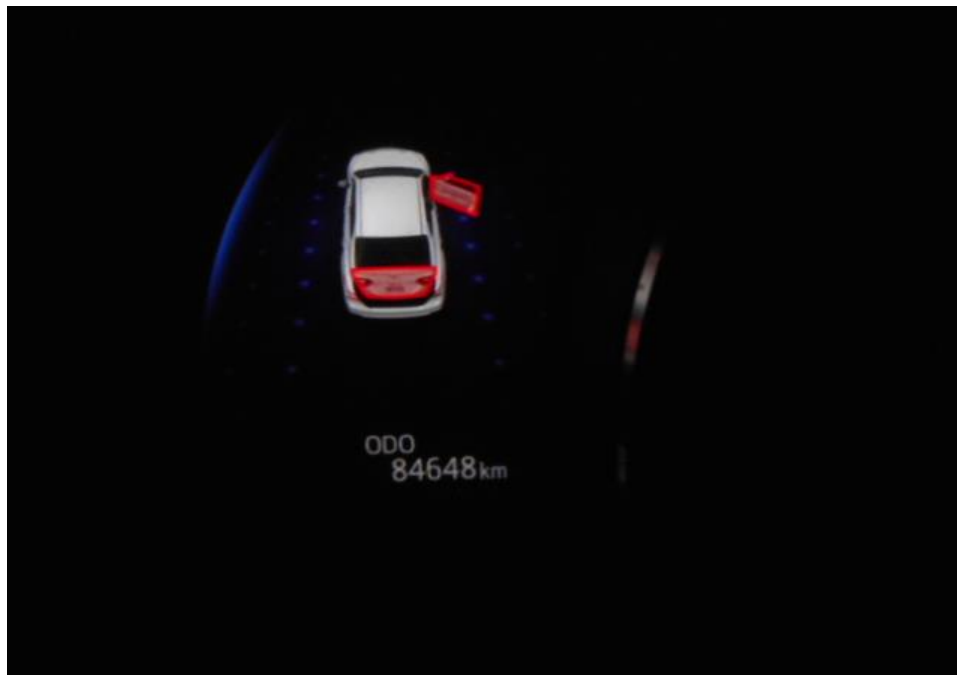
**Photo 1** shows the mileage of the Motor Car at the time of my inspection. The mileage observed was 84,648km.

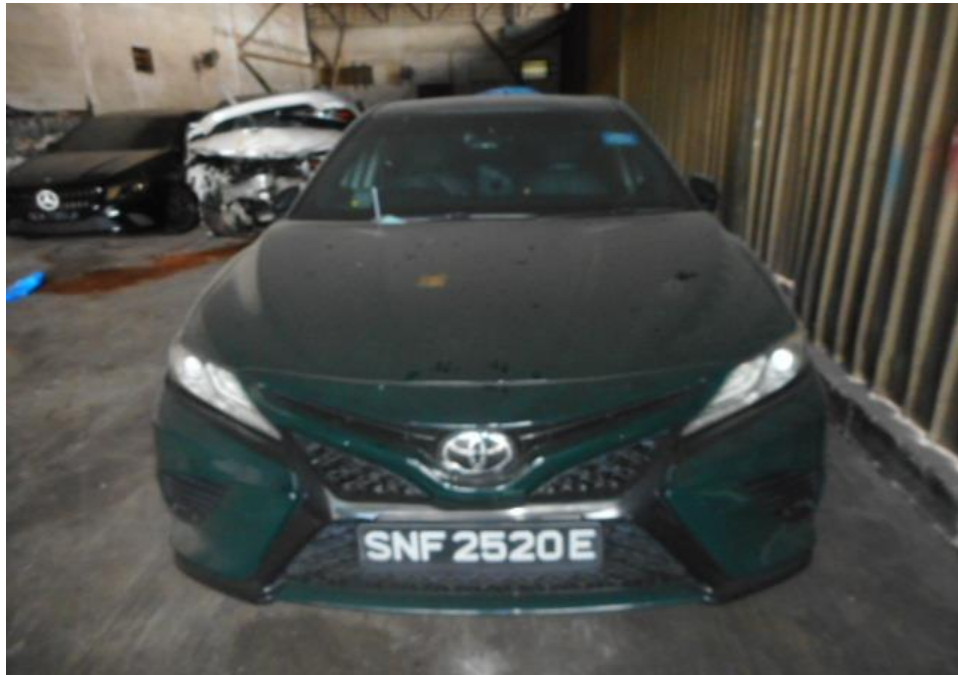
**Photo 2** shows a general view of the Motor Car's front body at the time of my inspection. The Motor Car front was observed to be unaffected by the accident.

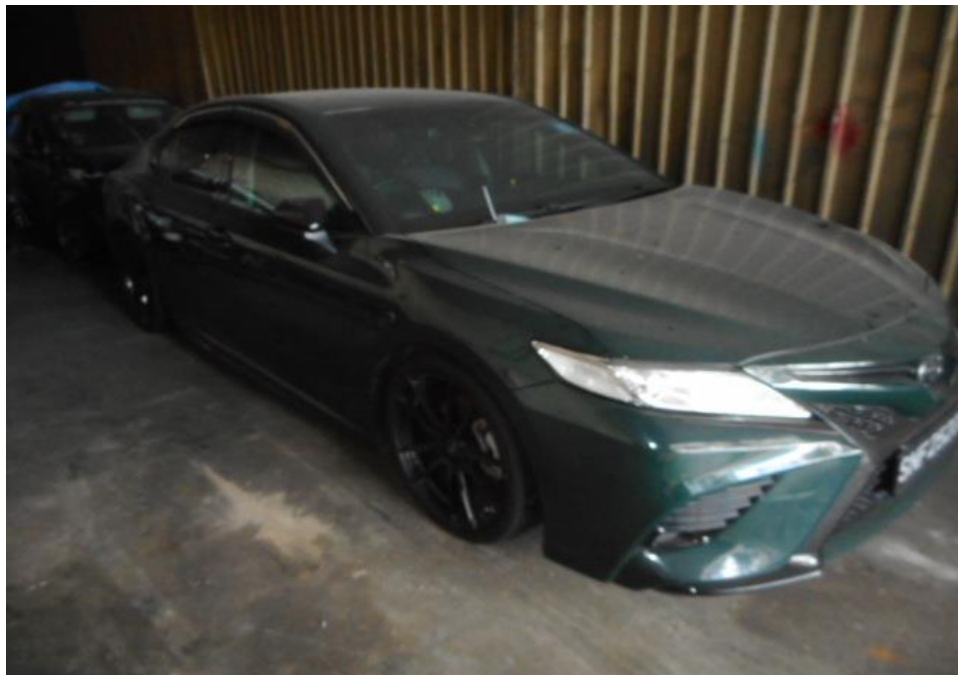
**Photo 3** shows a general view of the Motor Car's right body at the time of my inspection. The right portion of the Motor Car was observed to have been unaffected by the accident.

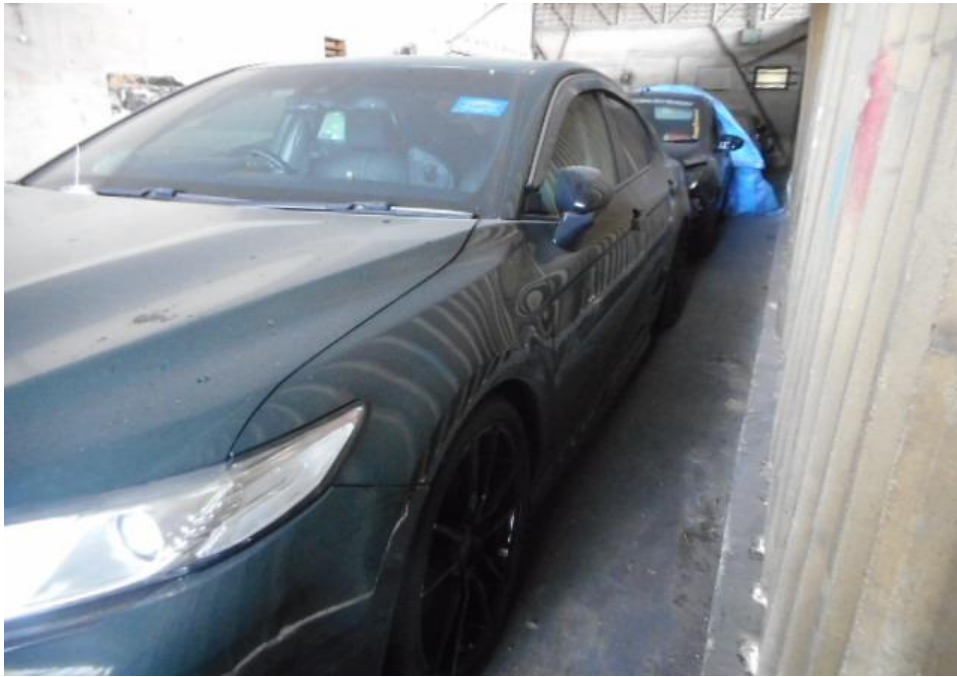
**Photo 4** shows a general view of the Motor Car's left body at the time of my inspection. The Motor Car left was observed to be unaffected by the accident.

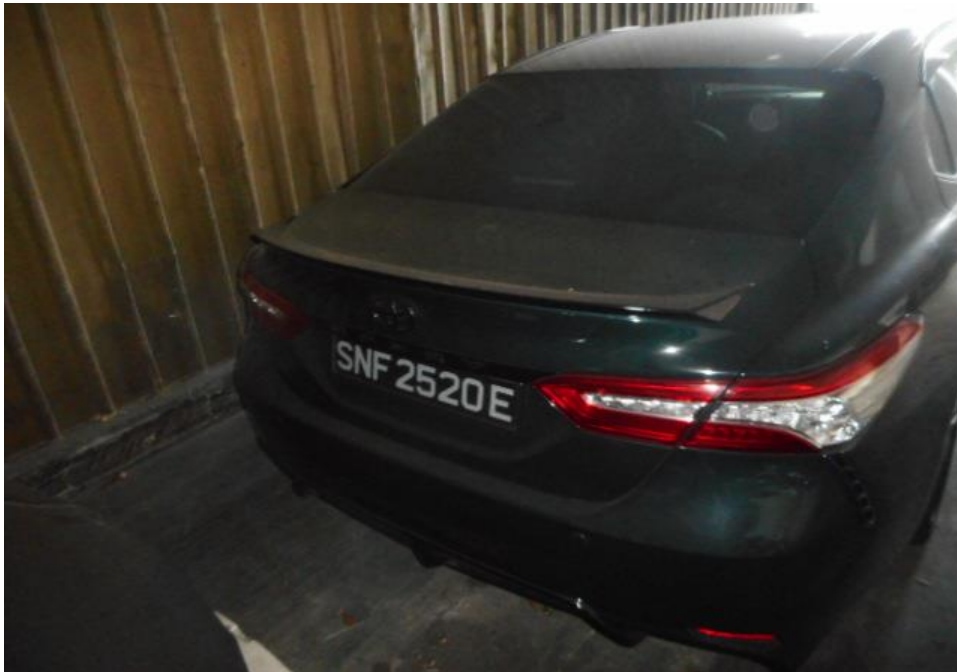
**Photo 5** shows the general view of the Motor Car's rear body at the time of my inspection. The Motor Car rear was observed to be unaffected by the accident.

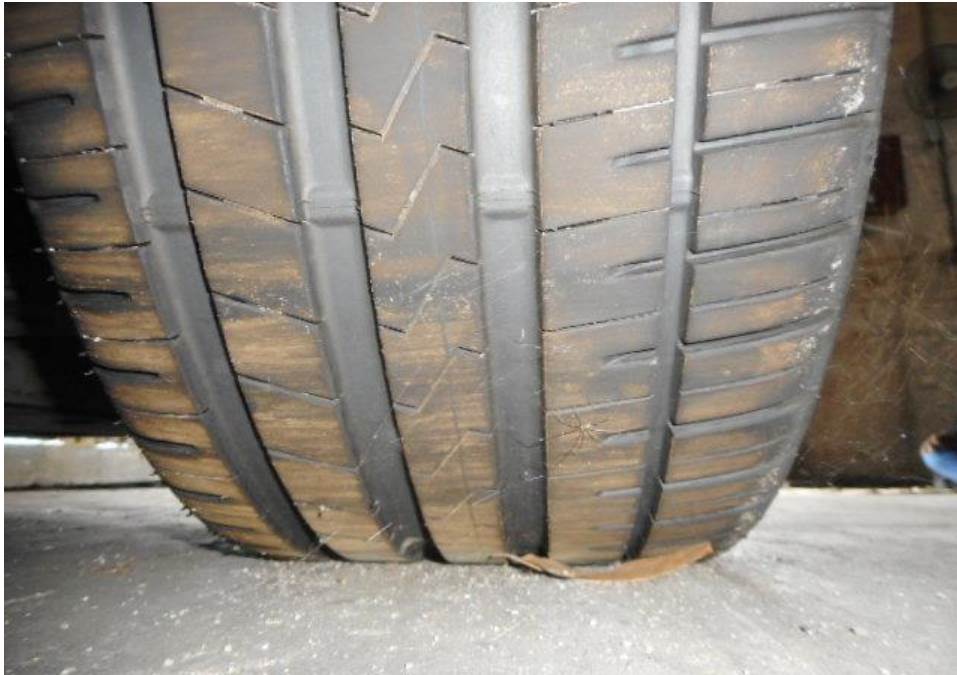
**Photo 6** shows the condition of the front right tyre of the Motor Car, which was observed to be in serviceable condition with remaining tread depth of approximately 6.3mm. The tyre was sufficiently inflated for vehicular operation with no tear, cut or burst mark(s) on the outer and the inner sidewalls as well as across the tread. The 4 tyres of the Motor Car were wrapped around standard alloy wheel rims without any damage.

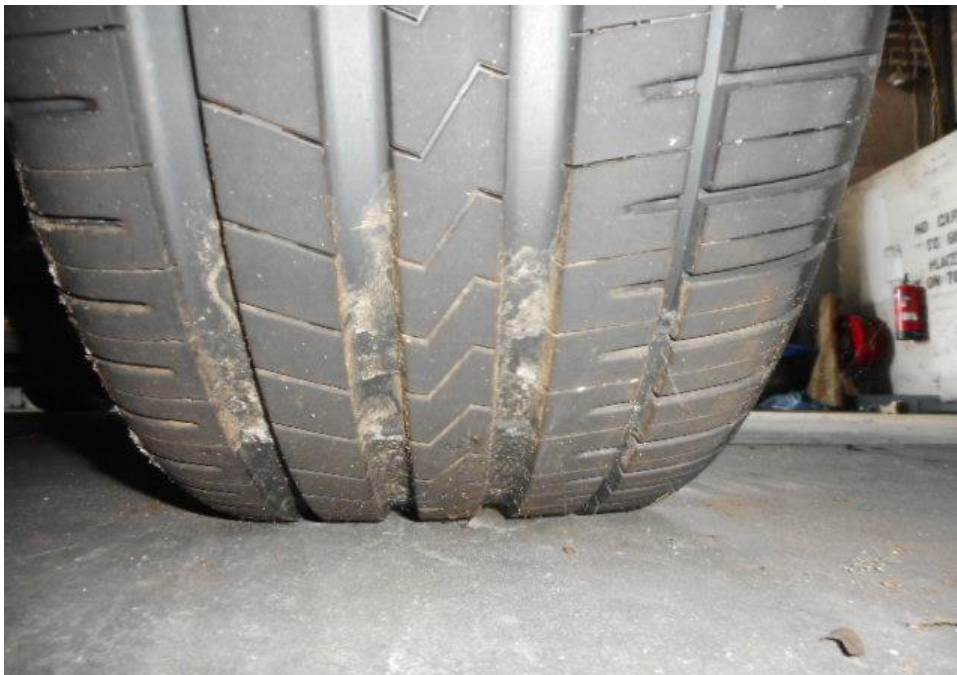
**Photo 7** shows the condition of the rear right tyre of the Motor Car, which was observed to be in serviceable condition with remaining tread depth of approximately 6.9mm. The tyre was also observed to be sufficiently inflated for vehicular operation with no tear, cut or burst mark(s).

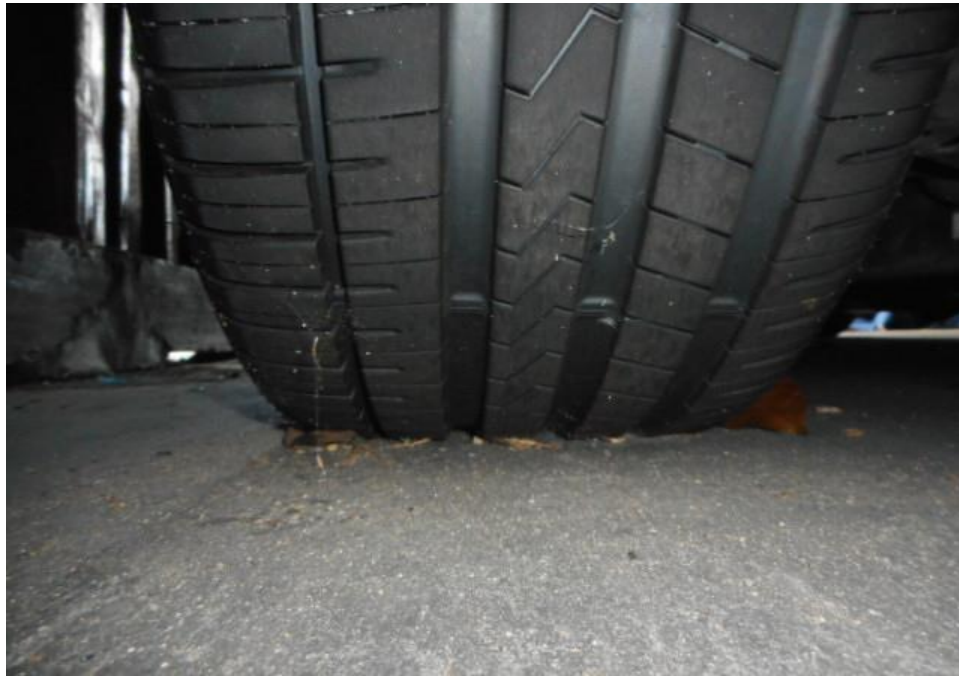
**Photo 8** shows the condition of the rear left tyre of the Motor Car, which was observed to be in serviceable condition with remaining tread depth of approximately 7.5mm. The tyre, which was wrapped around alloy wheel rim, was also observed to be sufficiently inflated for vehicular operation. The 4 tyres of the Motor Car were wrapped around standard alloy wheel rims.

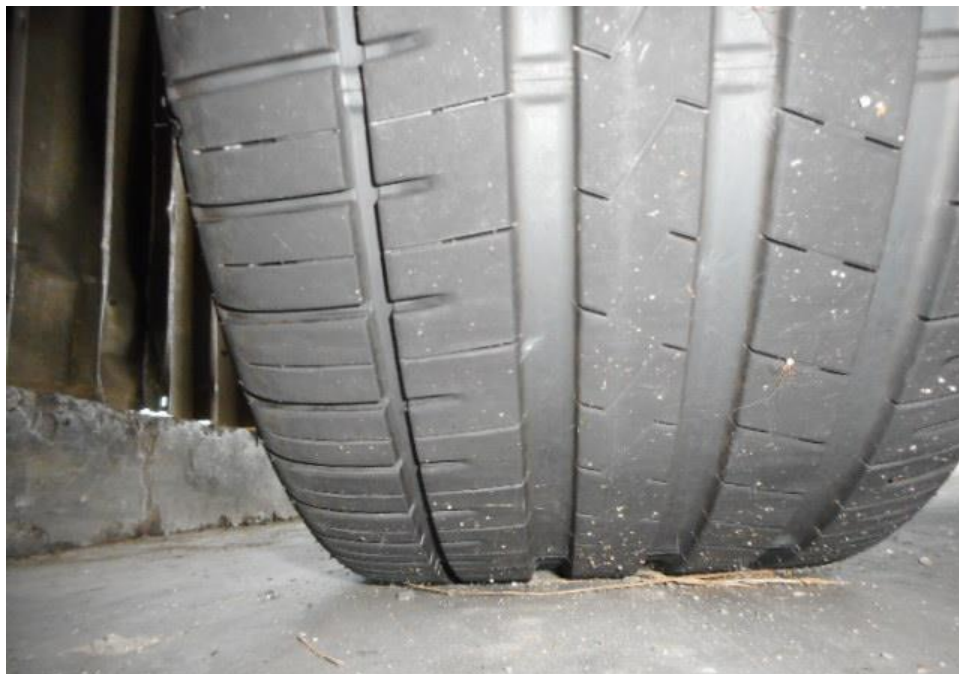
**Photo 9** shows the condition of the front left tyre of the Motor Car, which was observed to be in serviceable condition with remaining tread depth of approximately 6.3mm. There was also no tear, cut or burst mark(s) on the outer and the inner sidewalls as well as across the tread of the Motor Car's 4 tyres.

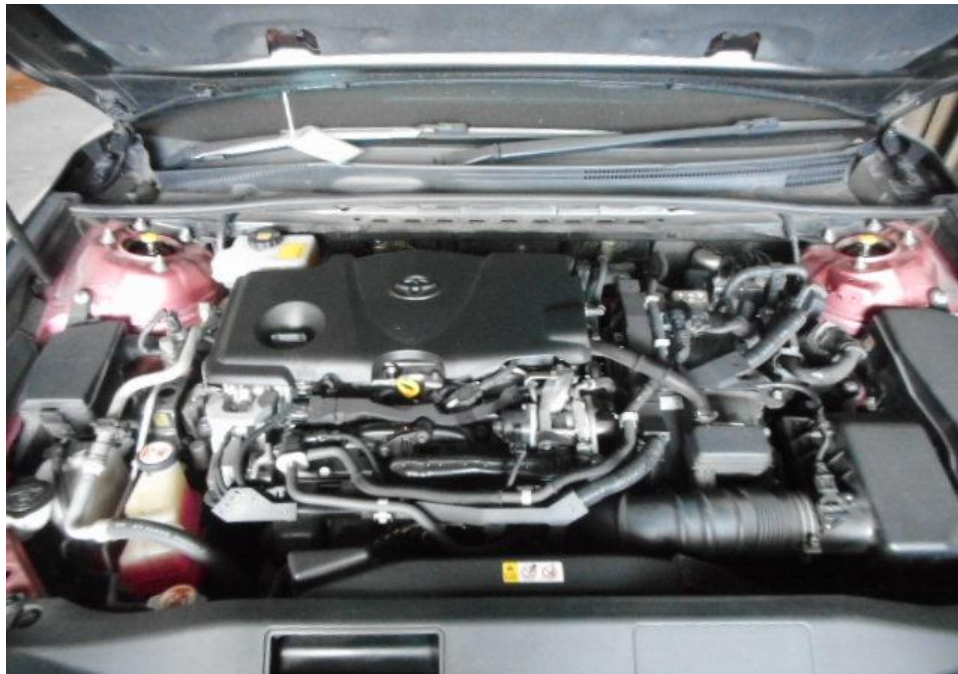
**Photo 10** shows a general view of the Motor Car's engine compartment. The various parts and components inside the engine compartment were unaffected by the accident. There was also no sign(s) or indication(s) of fluid leakage and/or fluid stain within the engine compartment.

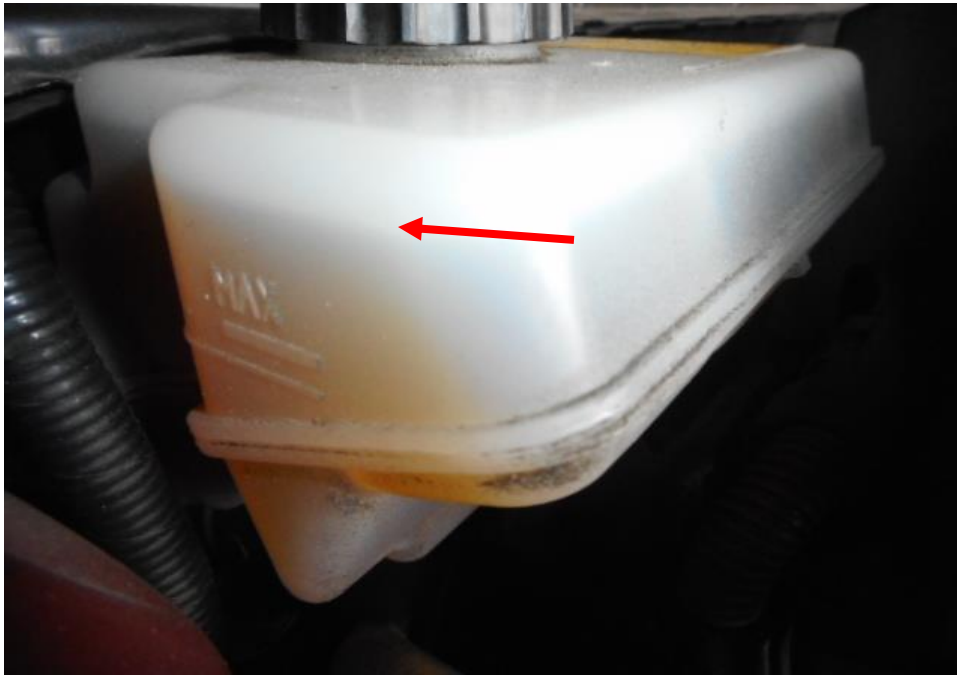
**Photo 11** shows the brake fluid reservoir of the Motor Car at the time of my inspection. The brake fluid was observed to be of sufficient level (arrowed) and without any visible contamination.

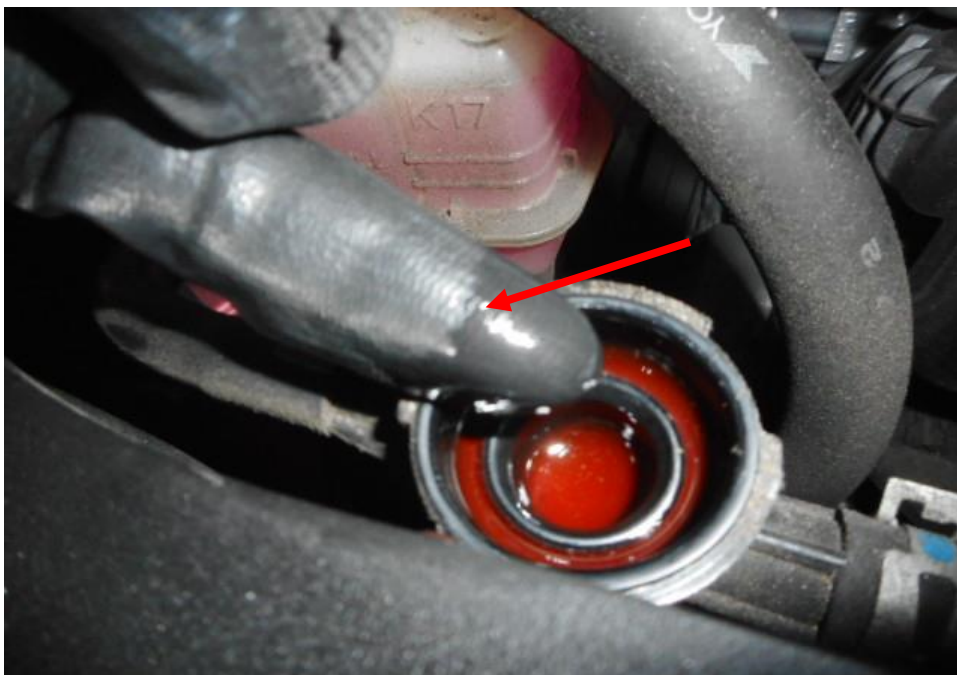
**Photo 12** shows checks being carried out to the engine coolant of the Motor Car at the time of my inspection. The engine coolant was observed to be of sufficient level (arrowed) and without any visible contamination.

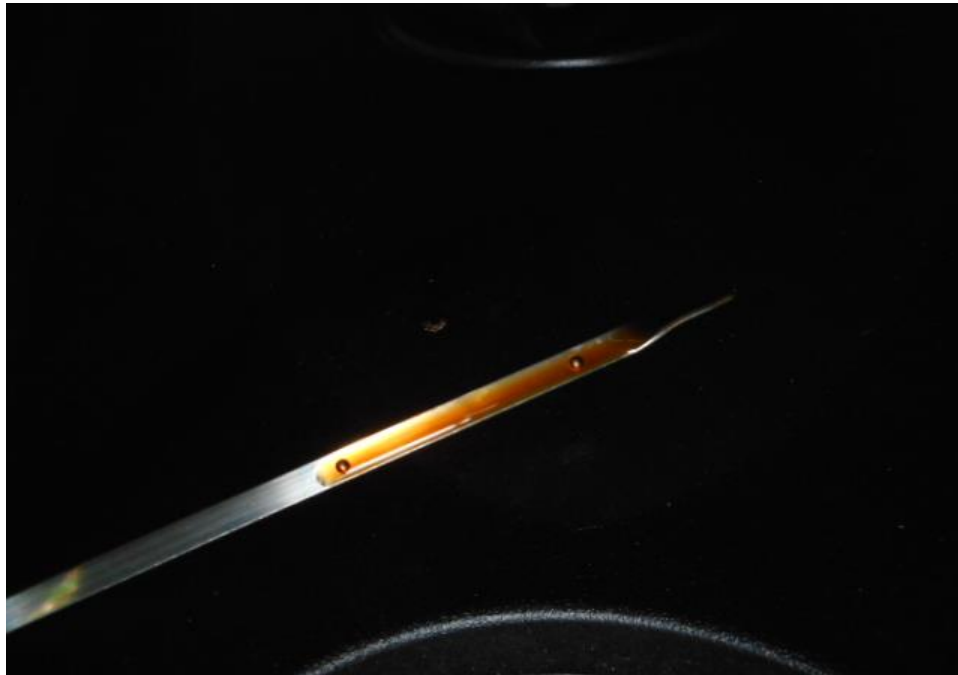
**Photo 13** shows the engine oil dipstick of the Motor Car at the time of my inspection. The engine oil was observed to be of sufficient level and without any visible contamination.

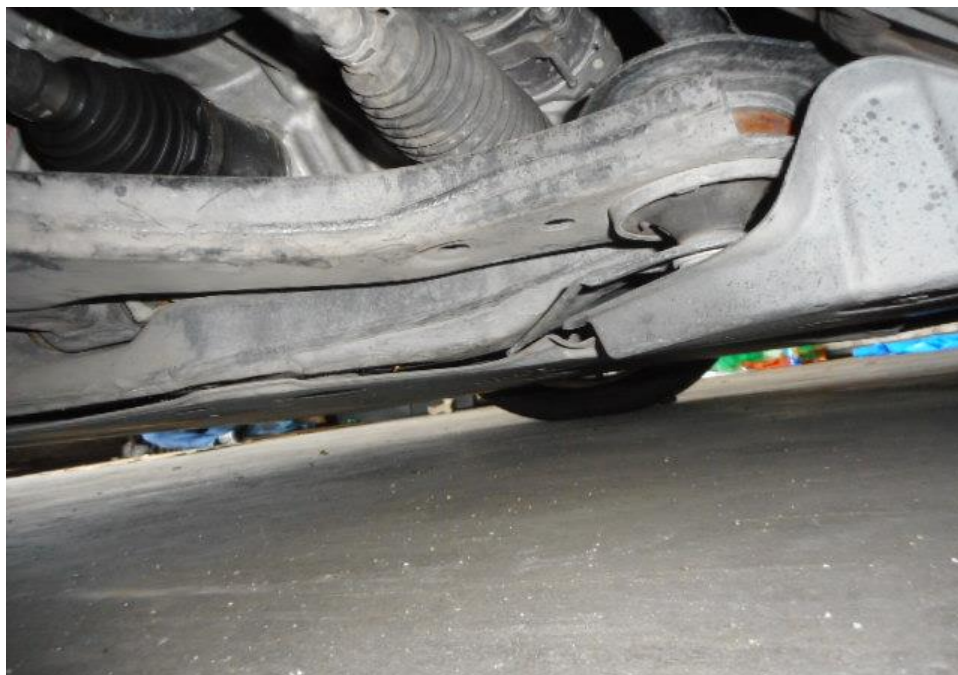
**Photo 14** shows the undercarriage of the Motor Car, at the area where the engine housing and transmission housing are located. I did not find any sign(s) or indication(s) of fluid leak and/or fluid stain(s) on the underside of the Motor Car.

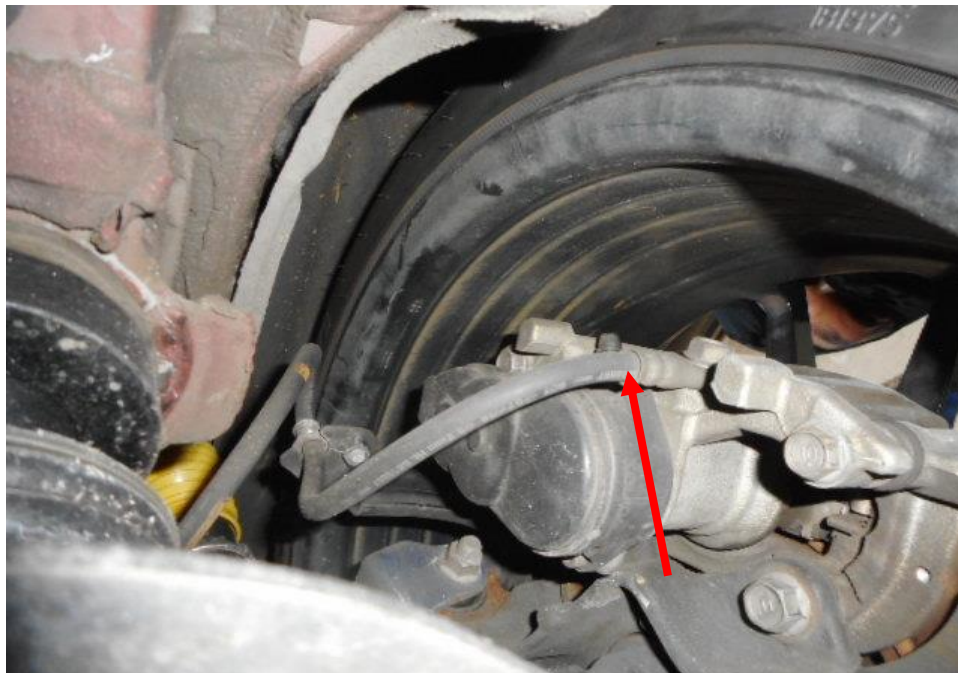
**Photo 15** shows the brake hose/pipe (arrowed) at the rear right wheel of the Motor Car. No leakage of brake fluid was observed. Visual examination of the various components of the braking system like the drum brake, brake booster, brake pedal etc. had revealed all to be intact and without visible damage.

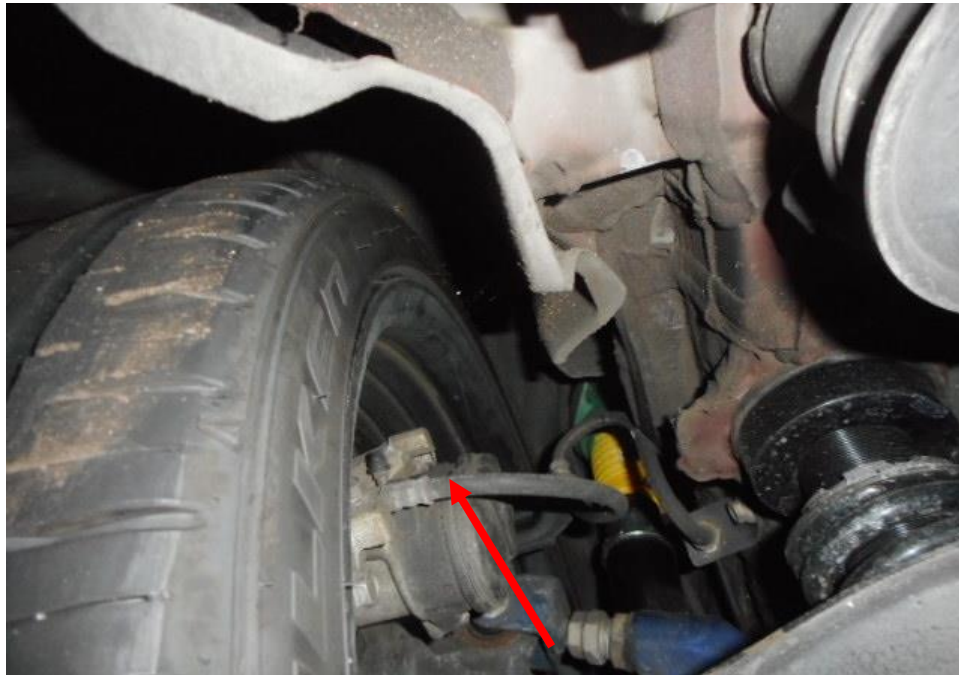
**Photo 16** shows the brake hose/pipe (arrowed) at the rear left wheel of the Motor Car. I did not observe any leakage of brake fluid at the time of my inspection of the Motor Car. Static tests of the Motor Car's braking system had indicated that there was no internal leakage of pressure/vacuum. The undercarriage components of the Motor Car were also all found to be intact and without any visible damage.

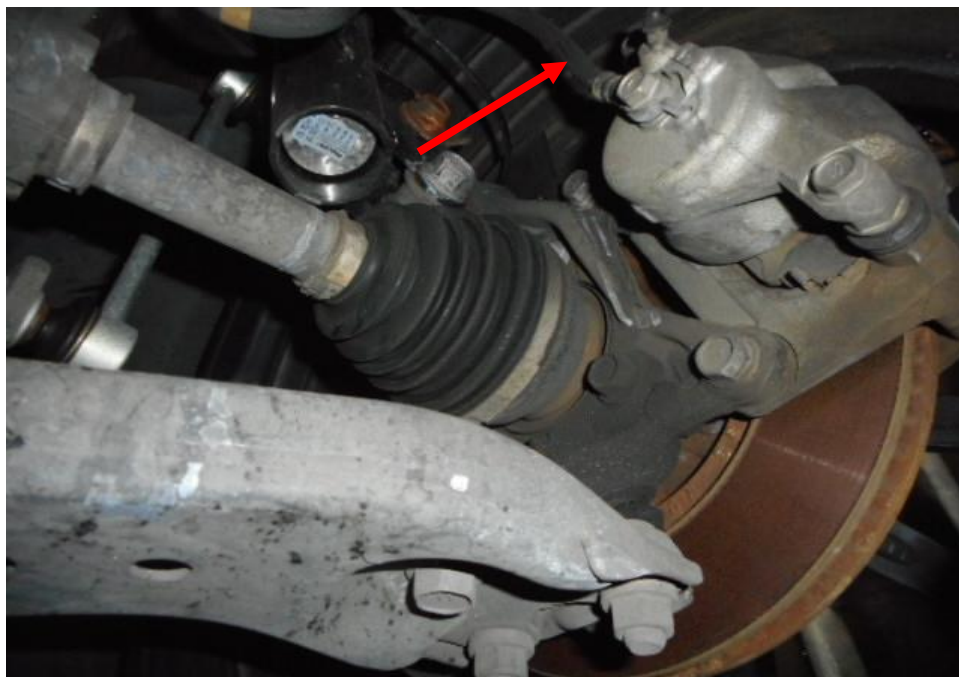
**Photo 17** shows the brake hose/pipe (arrowed) at the front right wheel of the Motor Car. I did not observe any leakage of brake fluid at the time of my inspection of the Motor Car. Static tests of the Motor Car's braking system had indicated that there was no internal leakage of pressure/vacuum. The undercarriage components of the Motor Car were also all found to be intact and without any visible damage.

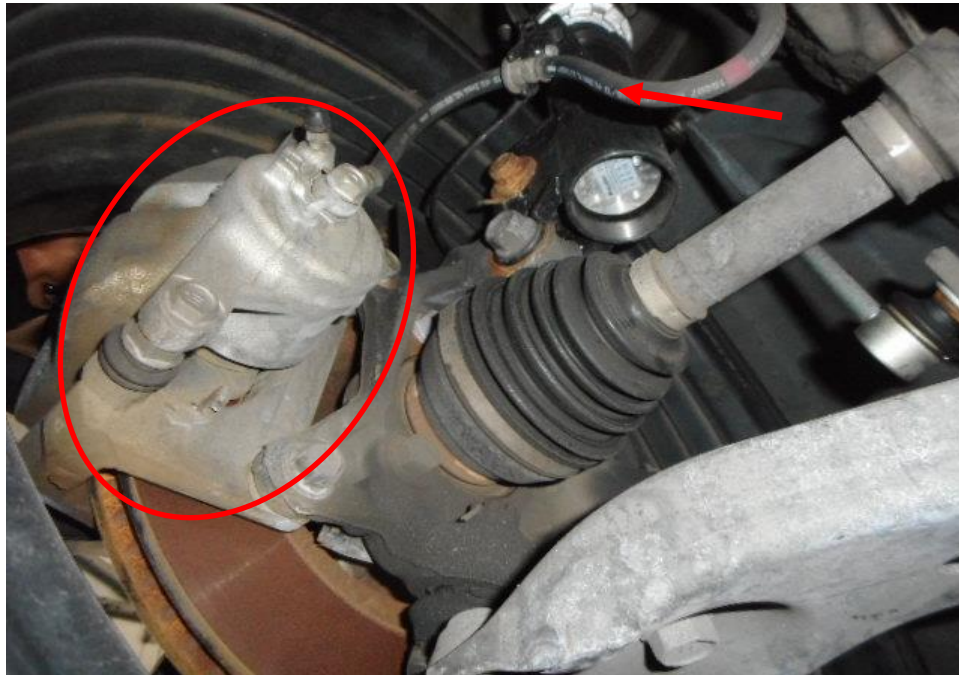
**Photo 18** shows the brake hose/pipe (arrowed) at the front left wheel of the Motor Car. No leakage of brake fluid was observed. Visual examination of the various components of the braking system like the brake caliper (circled), brake booster, brake pedal etc had revealed all to be intact and without visible damage.

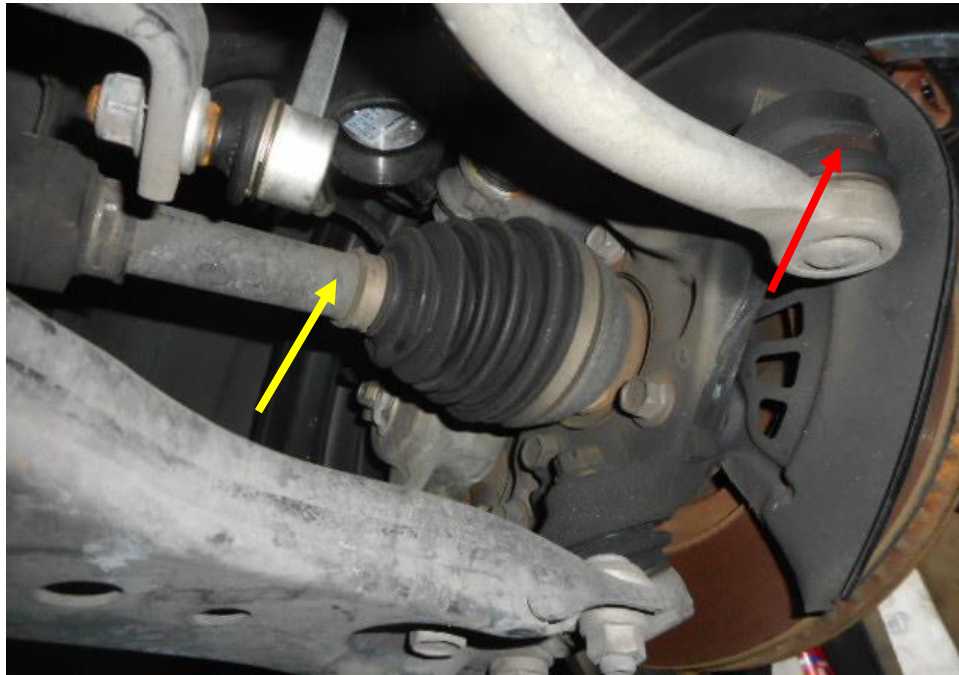
**Photo 20** shows the various undercarriage components at the front right wheel of the Motor Car, in particular the steering tie rod (red arrow) and the drive shaft (yellow arrow). The various steering components were all found to be intact, suggesting that the steering system of the Motor Car was likely to be in serviceable condition at the material time of accident. There was also no sign of fluid stain observed on the various undercarriage components at the front right wheel of the Motor Car.

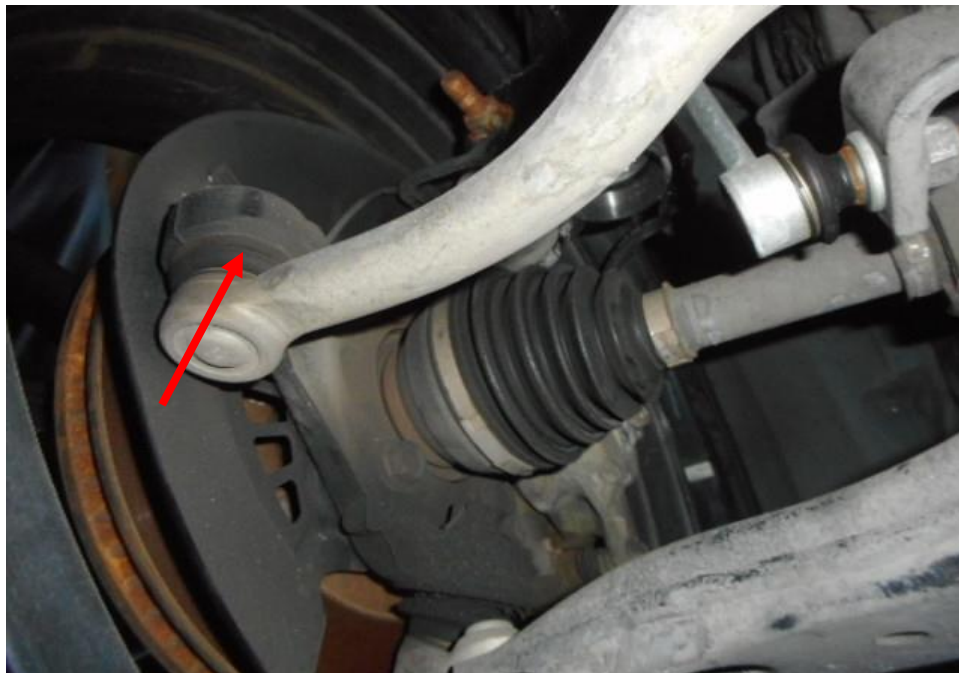
**Photo 21** shows the various undercarriage components at the front left wheel of the Motor Car, which had included the steering tie rod (arrowed). The various undercarriage components of the Motor Car were all found to be intact without any visible damage.

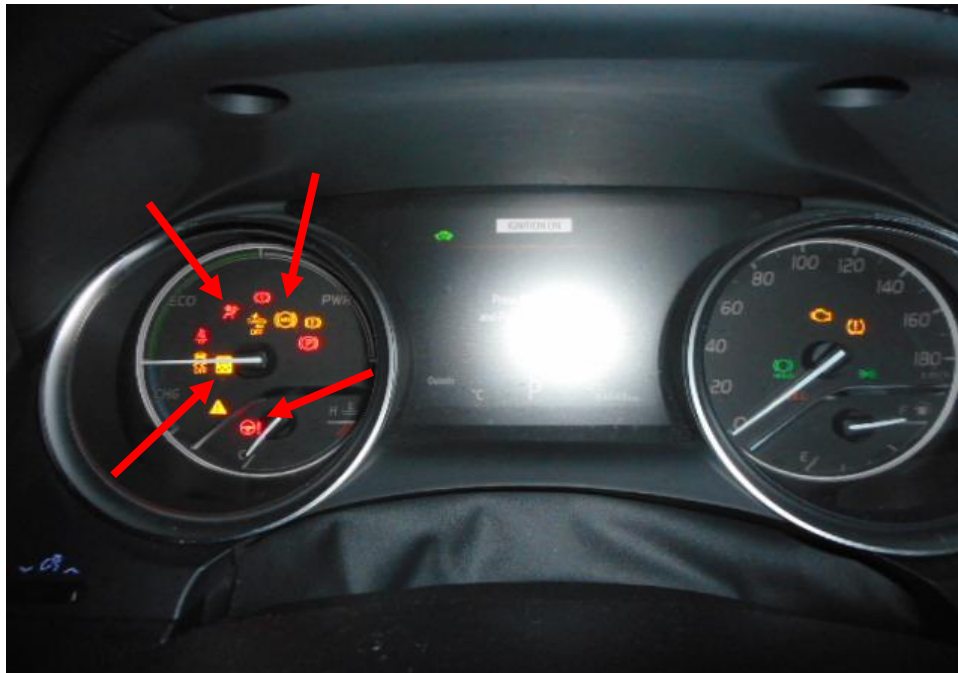
**Photo 22** shows the warning light for Anti-Lock Brake System (ABS), Electric Power Steering System (EPS), Traction Control System (TCS) and Supplemental Restraint System (SRS) (arrowed) appearing on the instrument panel of the Motor Car during the self-test of its various electronic operating systems when its engine was cranked.

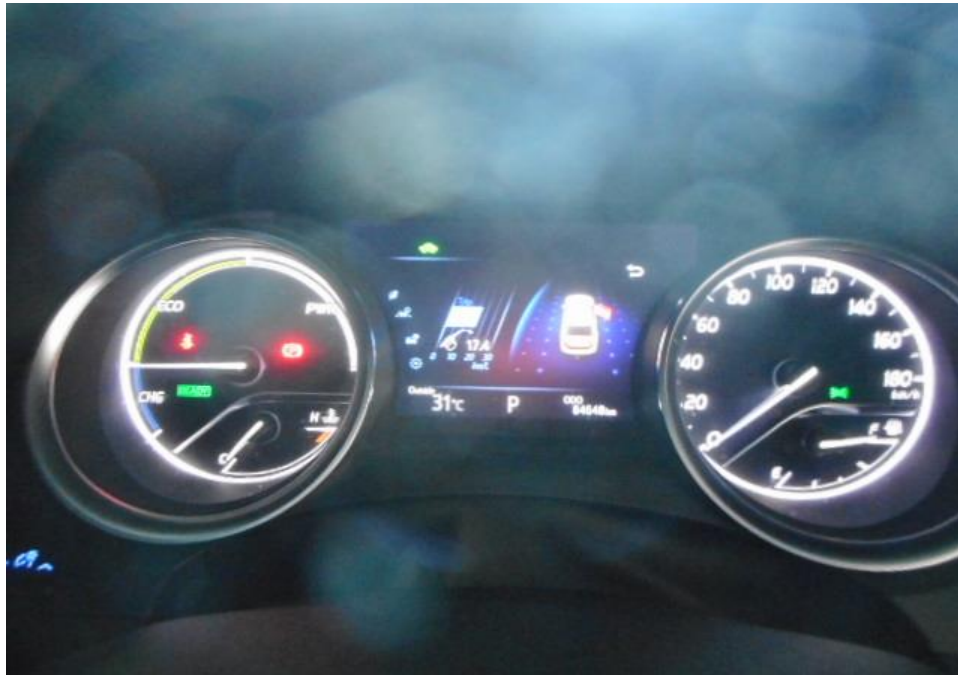
**Photo 23** shows no warning lights illuminated on the instrument panel of the Motor Car after the engine was cranked. This would suggest that there was no abnormality to the electronic operating system of the Motor Car, like the ABS, EPS, TCS and SRS etc.
