Your Ref: TP TP/13898/2023
Our Ref : CI/TPD23006793/P

18th July 2023

MECHANICAL INSPECTION REPORT OF MOTOR CAR SLV 1860U

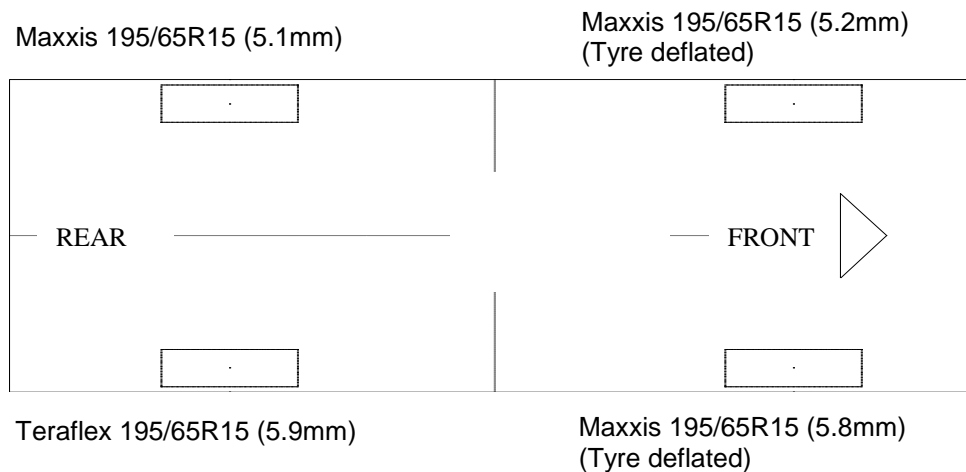
6. The front left and right tyre was observed to be deflated as a result of the accident, however the condition of the Motor Car's 2 rear tyres was observed to be in serviceable condition. I did not find any tear, cut or burst mark(s) on the outer and the inner sidewalls as well as across the tread of the 2 rear tyres. The rear right and rear left both rear tyres were observed to be sufficiently inflated for vehicular operation. The tyre brand, tyre size and remaining tread depth of the 4 tyres were recorded as follows:-

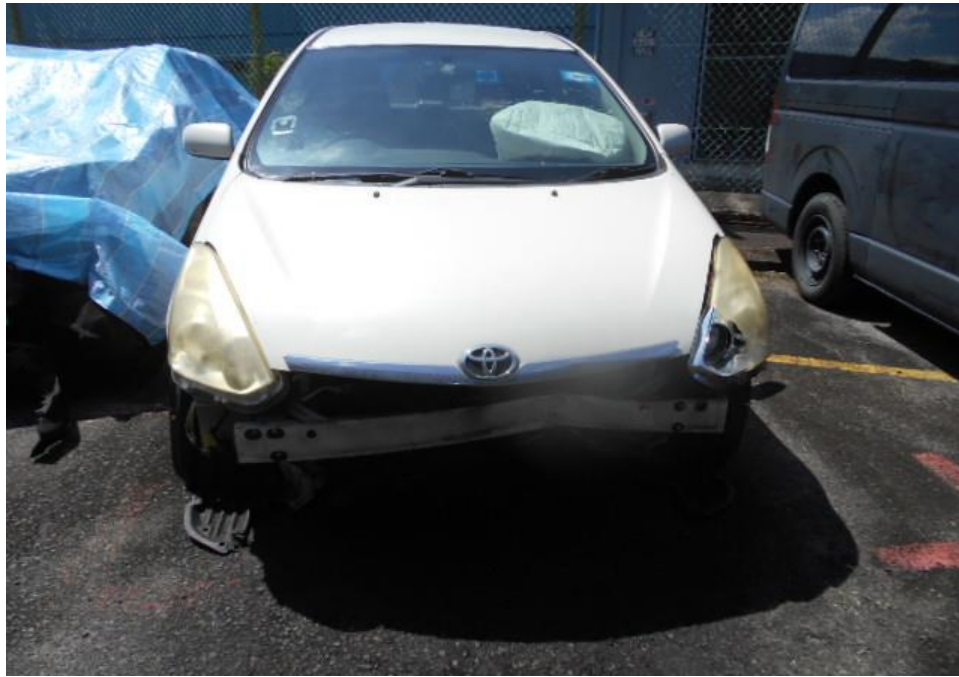
Photo 1 shows a general view of the Motor Car's front body at the time of my inspection. The front bumper which was observed to be missing, front windscreen, and front left headlamp was amongst the body parts that were damaged as a result of the accident. The Supplemental Restraint System (SRS) was activated as a result of the accident.

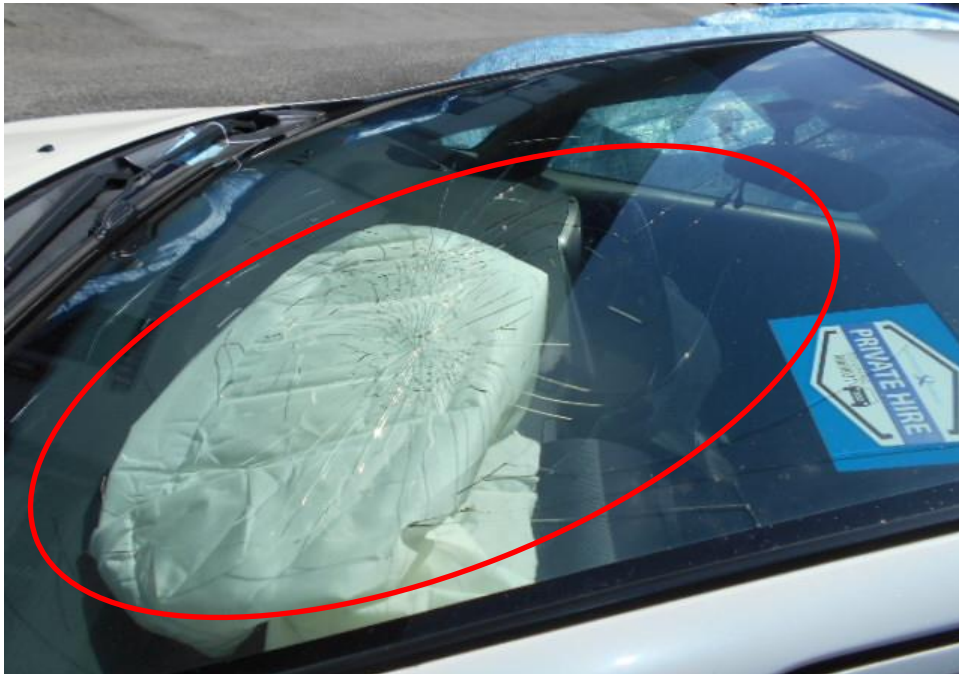
Photo 2 shows the close up view of the Motor Car's front body and roof panel at the time of my inspection. The Motor car was observed to have sustained damage at its front portion. Its front windscreen (circled) was damaged as a result of the accident.

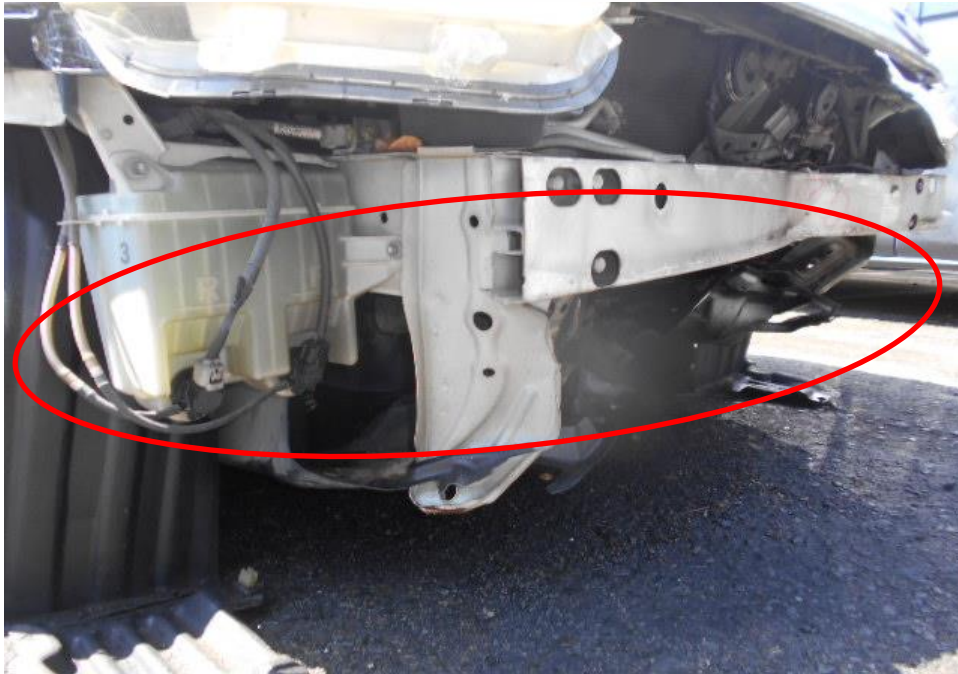
Photo 3 shows the close up view of the Motor Car's front body at the time of my inspection. The Motor car was observed to have sustained damage at its front portion. Its front bonnet (circled) was missing as a result of the accident.

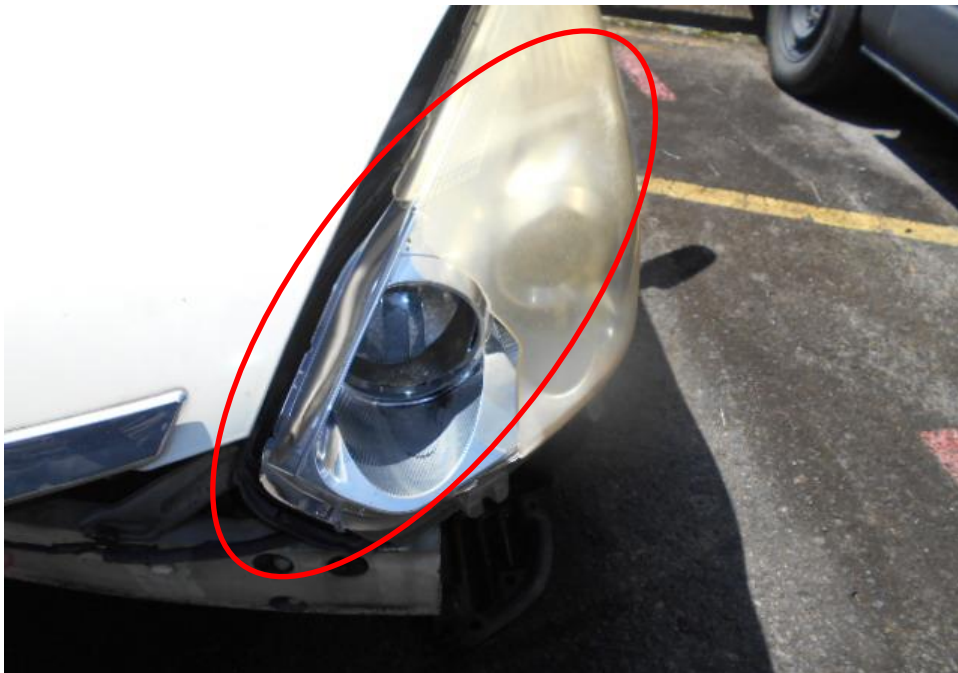
Photo 4 shows the close up view of the Motor Car's front body at the time of my inspection. The Motor car was observed to have sustained damage at its front portion. Its front left headlamp (circled) was damaged as a result of the accident.

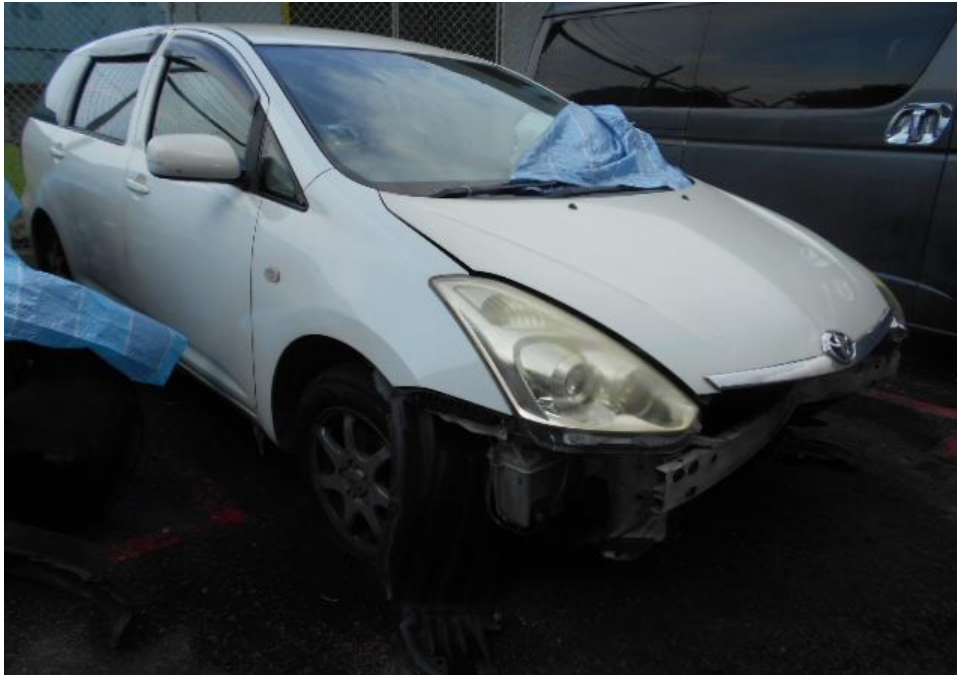
Photo 5 shows a general view of the Motor Car's right body at the time of my inspection. The Motor Car was observed to be intact and unaffected by the accident.

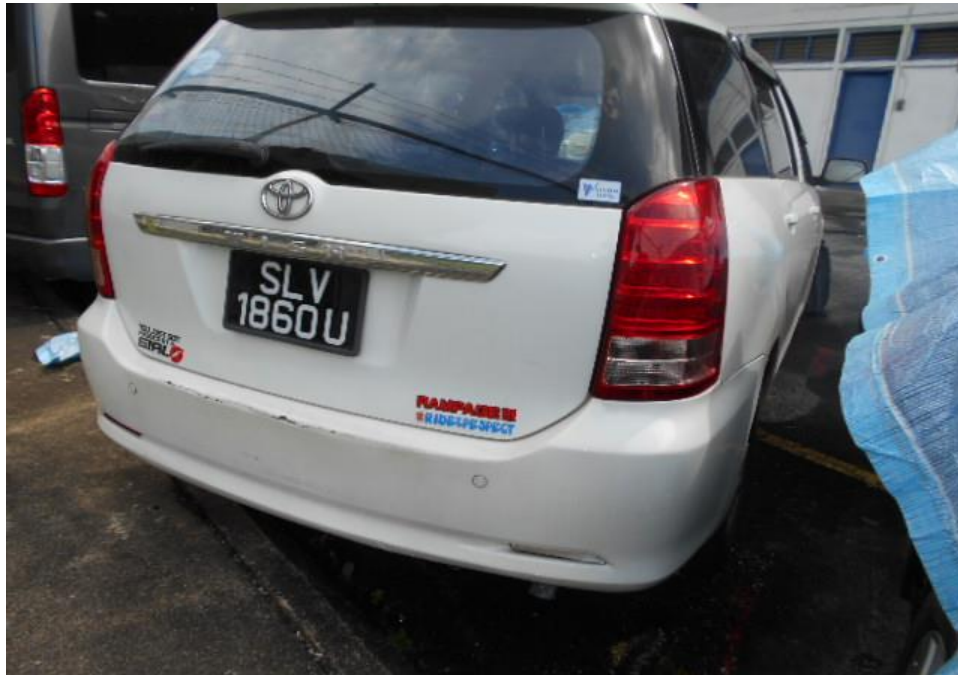
Photo 7 shows a close up view of the Motor Car's rear body at the time of my inspection. The rear portion of the Motor Car was observed to be intact and unaffected by the accident.

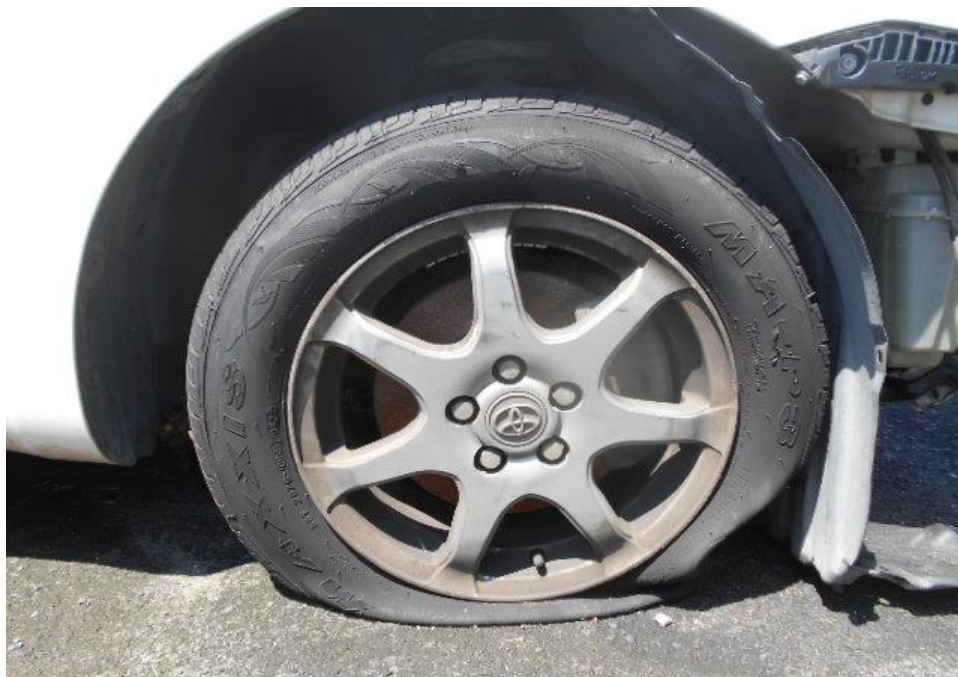
Photo 8 shows the condition of the front right tyre of the Motor Car, which was observed to be in unserviceable condition with remaining tread depth of approximately 5.8mm. The tyre was also observed to be deflated as a result of the damaged wheel rim as a result of the accident, however there was no tear, cut or burst mark(s) on the tyre.

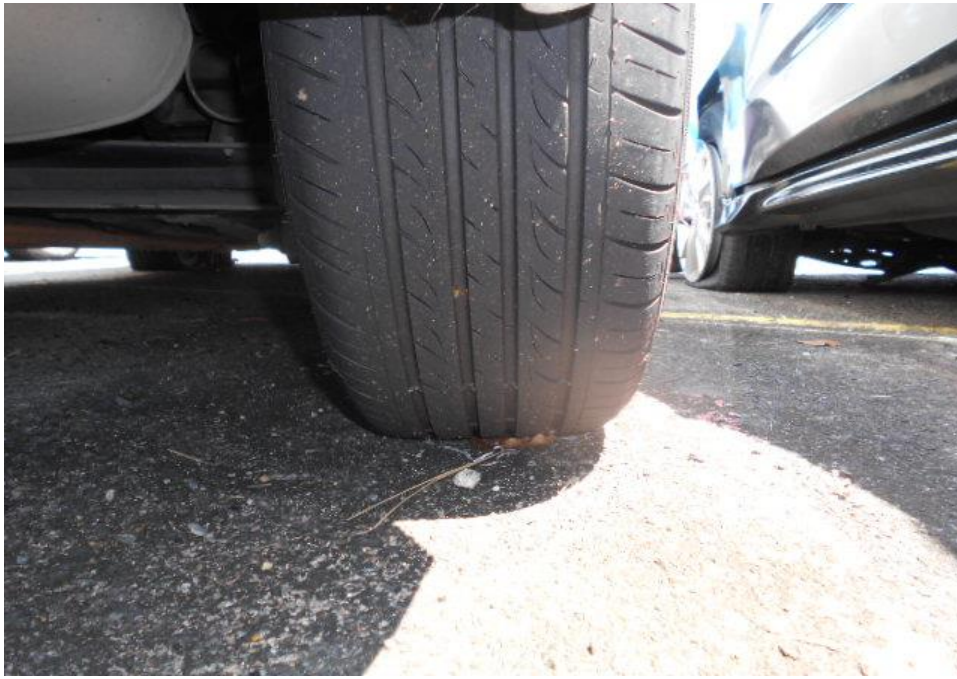
Photo 9 shows the condition of the rear right tyre of the Motor Car, which was observed to be in serviceable condition with remaining tread depth of approximately 5.9mm. The tyre was also observed to be sufficiently inflated for vehicular operation with no tear, cut or burst mark(s).

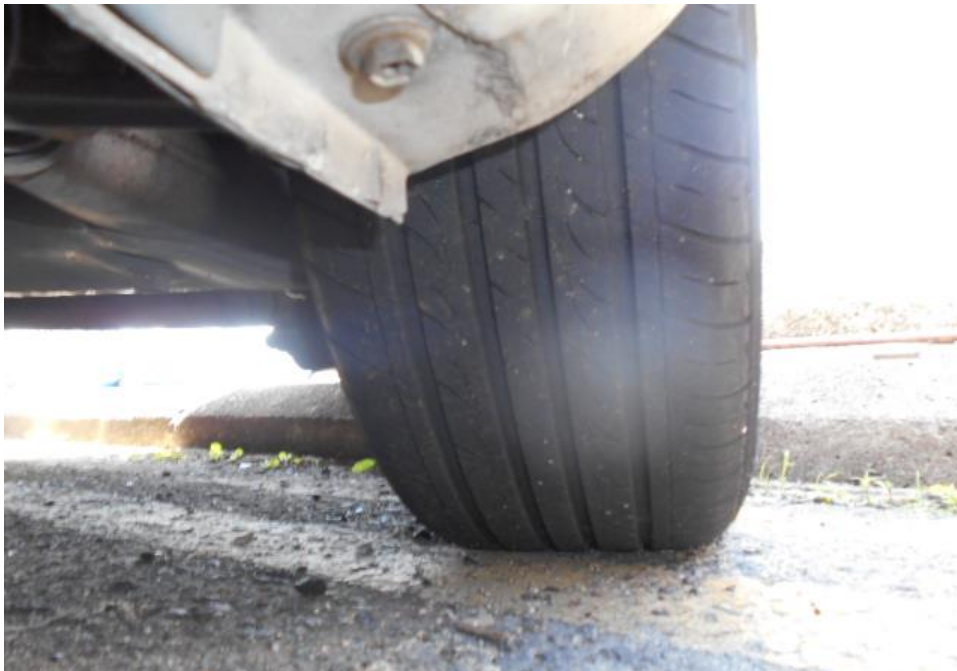
Photo 10 shows the condition of the rear left tyre of the Motor Car, which was observed to be in serviceable condition with remaining tread depth of approximately 5.1mm. The tyre was also observed to be sufficiently inflated for vehicular operation with no tear, cut or burst mark(s).

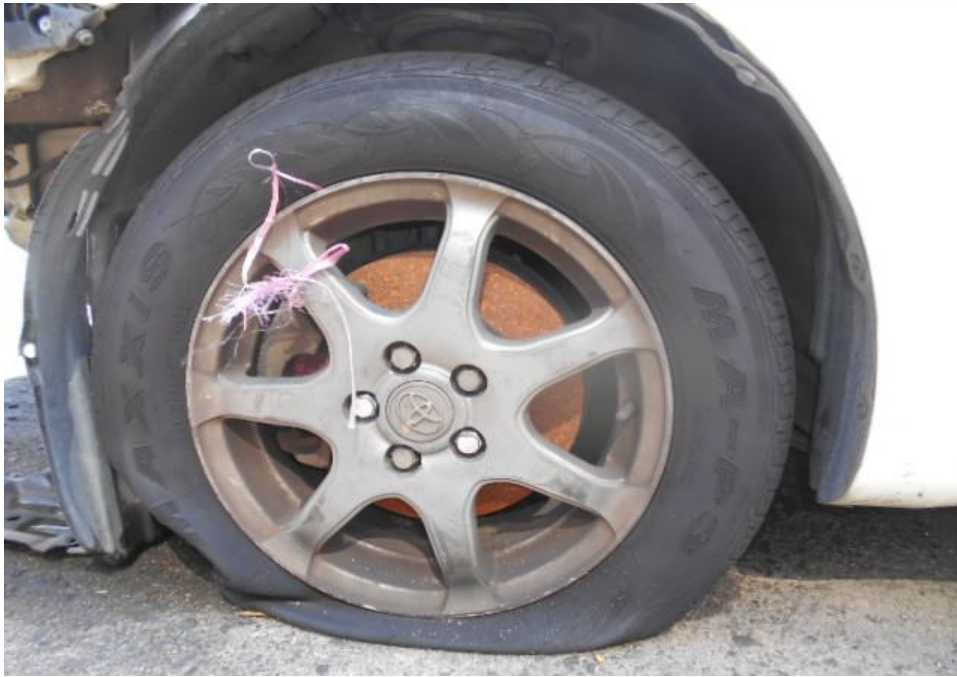
Photo 11 shows the condition of the front left tyre of the Motor Car, which was observed to be in unserviceable condition with remaining tread depth of approximately 5.9mm. The tyre was also observed to be deflated as a result of the damaged wheel rim as a result of the accident, however there was no tear, cut or burst mark(s) on the tyre.

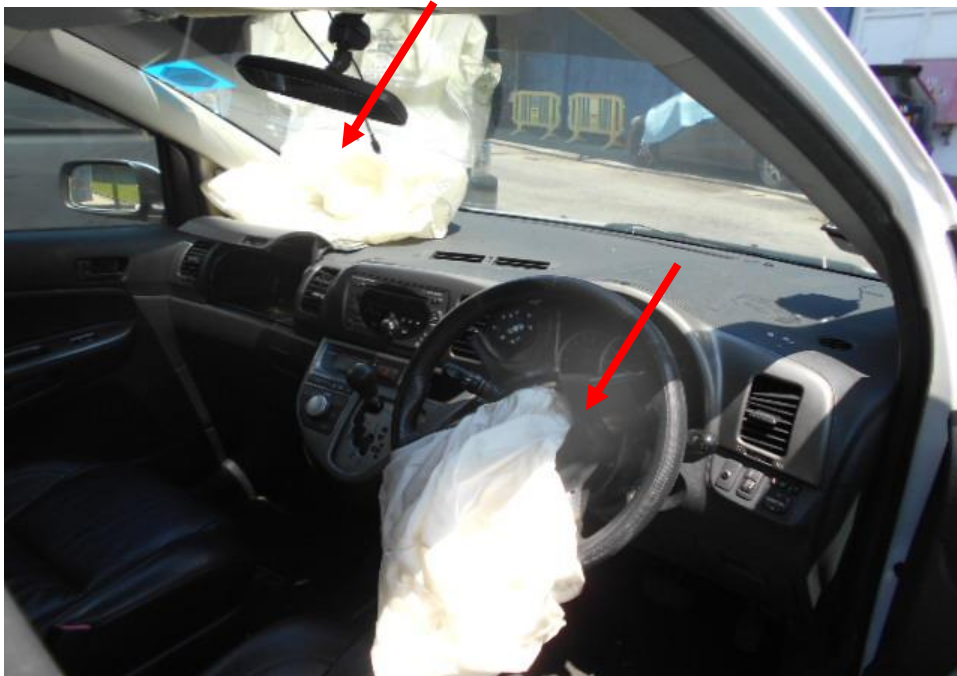
Photo 12 shows the deployment of the Supplemental Restraint System (SRS) airbag in the Motor Car as a result of the accident.

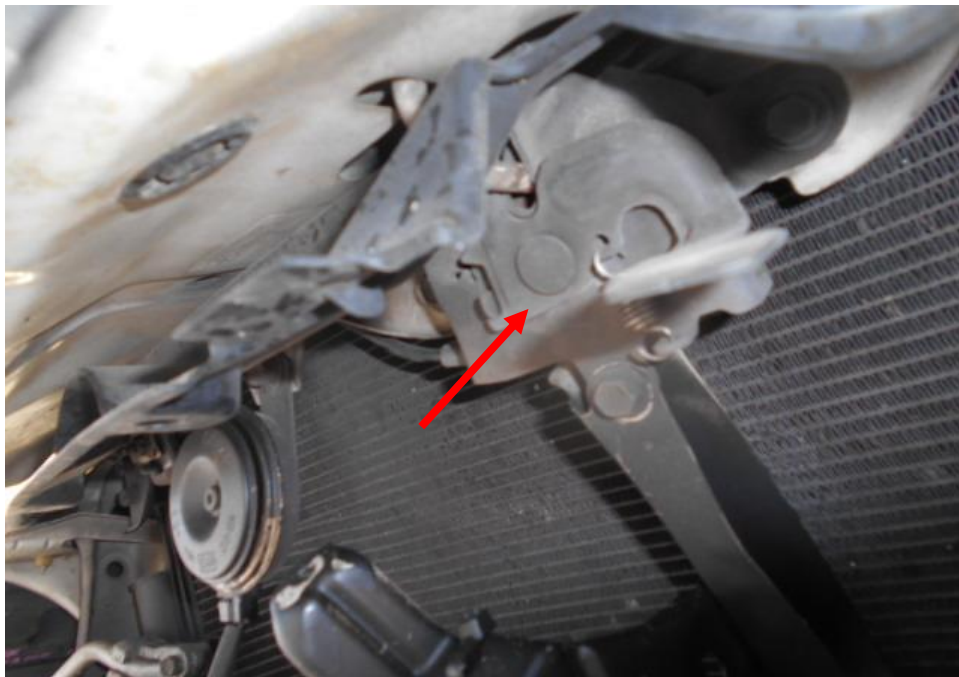
8. We were unable to raise the front bonnet of the Motor car to conduct the examination of the Motor Car's engine compartment because the damage caused by the accident had resulted in the damages to the lock mechanism of the bonnet and the structure of the engine compartment. (Unable to open).
9. My subsequent checks on the underside of the Motor Car revealed sign(s) or indication(s) of fluid leak and/or fluid stain(s) from the damaged engine as a result of the accident. See photo 13- 15 below.

Photo 13 shows the close up view of the damaged front bonnet lock mechanism (arrowed) and the structure of the engine compartment of the Motor Car at the time of my inspection resulting it unable to open a result of the accident. (Unable to open)

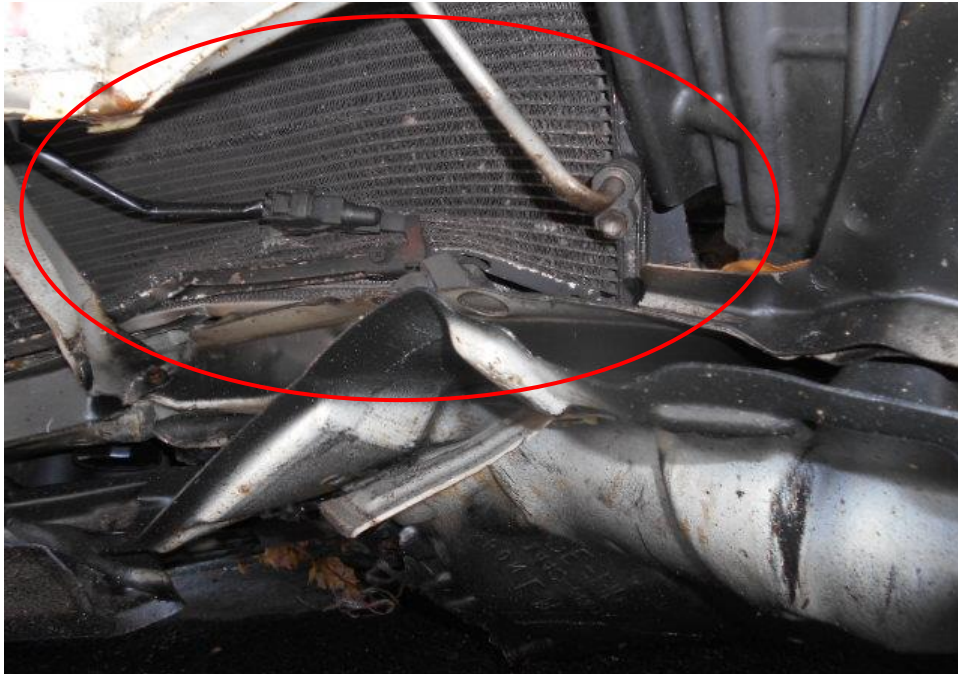
Photo 14 shows checks being carried out to the engine coolant of the Motor Car at the time of my inspection. The engine coolant radiator (circled) was damaged as a result of the accident.

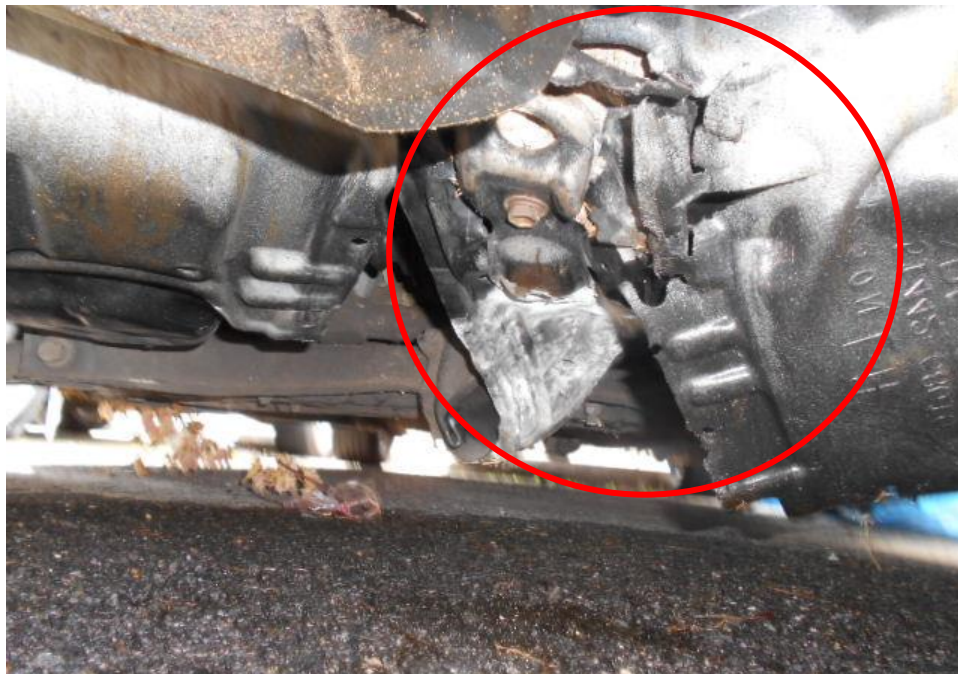
Photo 15 shows the undercarriage of the Motor Car, at the area where the engine housing and transmission housing are located. The transmission housing (circled) was observed to be damaged as a result of the accident, however I did not find any sign(s) or indication(s) of fluid leak and/or fluid stain(s) on the underside of the Motor Car.

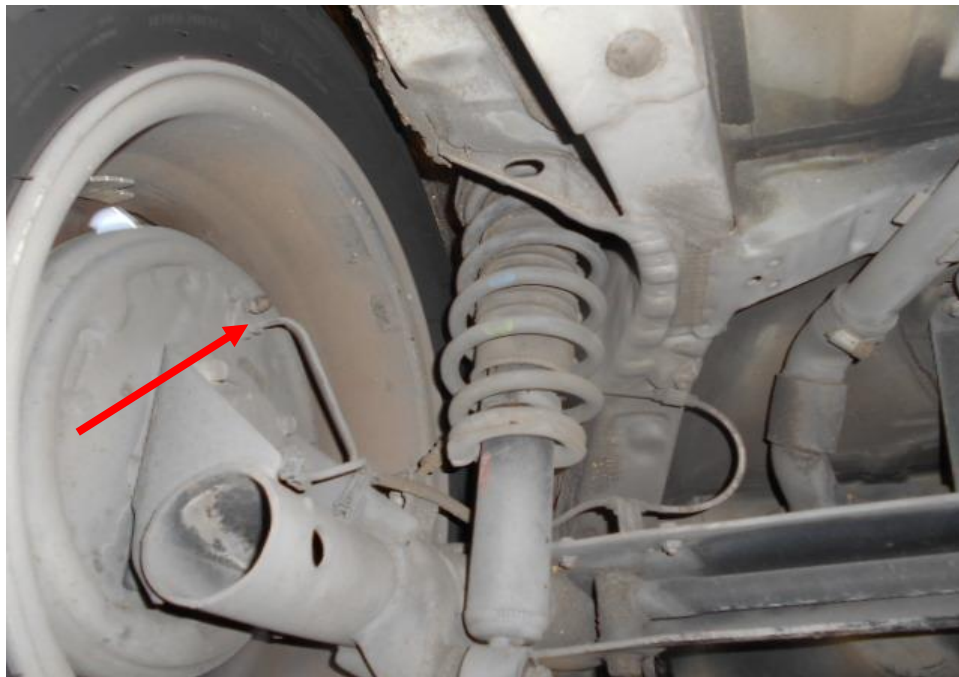
Photo 16 shows the brake hose/pipe (arrowed) at the rear left wheel of the Motor Car. No leakage of brake fluid was observed. Visual examination of the various components of the braking system like the brake drum to be intact and without visible damage.

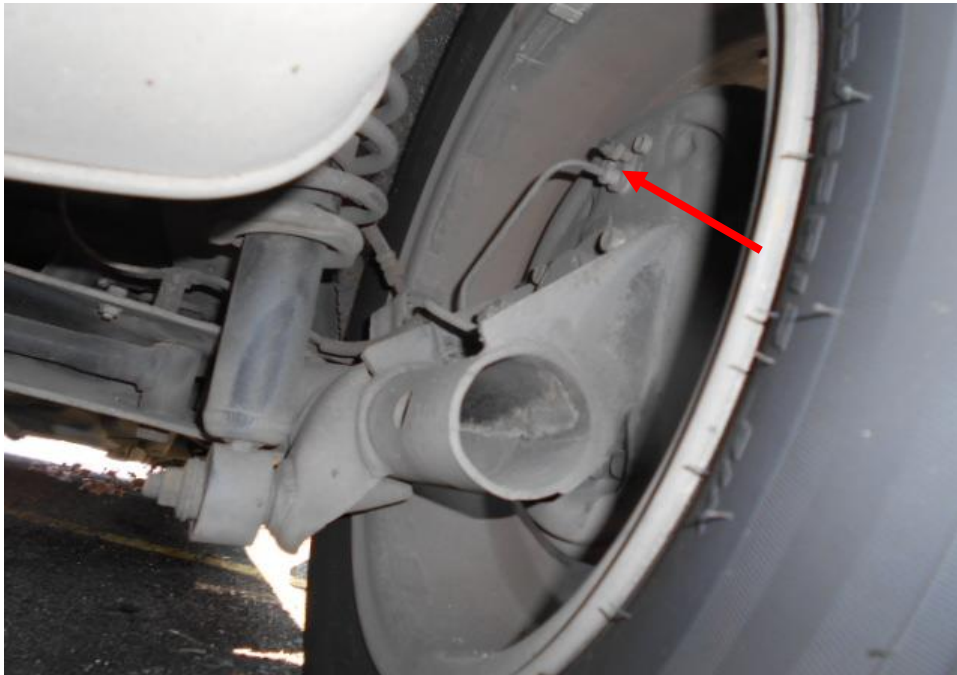
Photo 17 shows the brake hose/pipe (arrowed) at the rear right wheel of the Motor Car. No leakage of brake fluid was observed. Visual examination of the various components of the braking system like the brake drum to be intact and without visible damage.

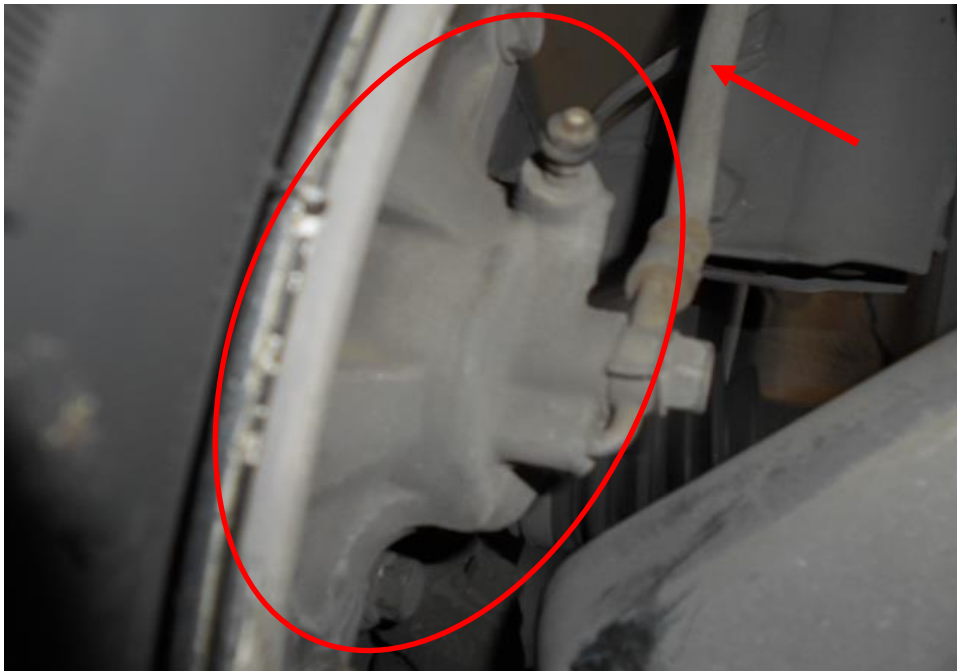
Photo 18 shows the brake hose/pipe (arrowed) at the front right wheel of the Motor Car. I did not observe any leakage of brake fluid at the time of my inspection of the Motor Car. Visual examination of the various components of the braking system the brake caliper (circled) to be intact and without visible damage.

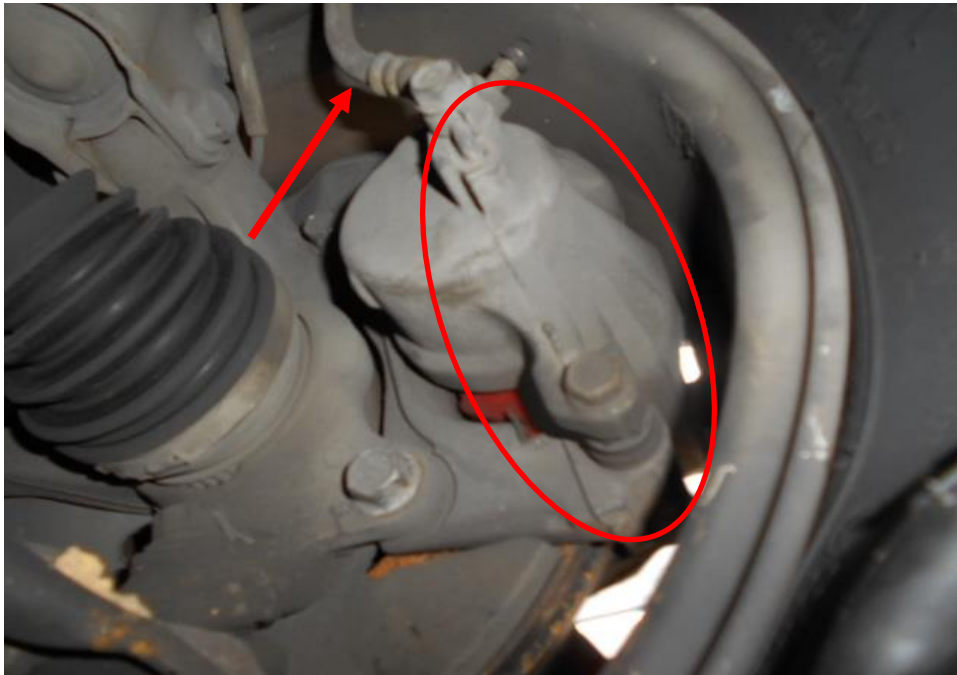
Photo 19 shows the brake hose/pipe (arrowed) at the front left wheel of the Motor Car. No leakage of brake fluid was observed. Visual examination of the various components of the braking system like the brake caliper (circled) had revealed to be intact and without visible damage.

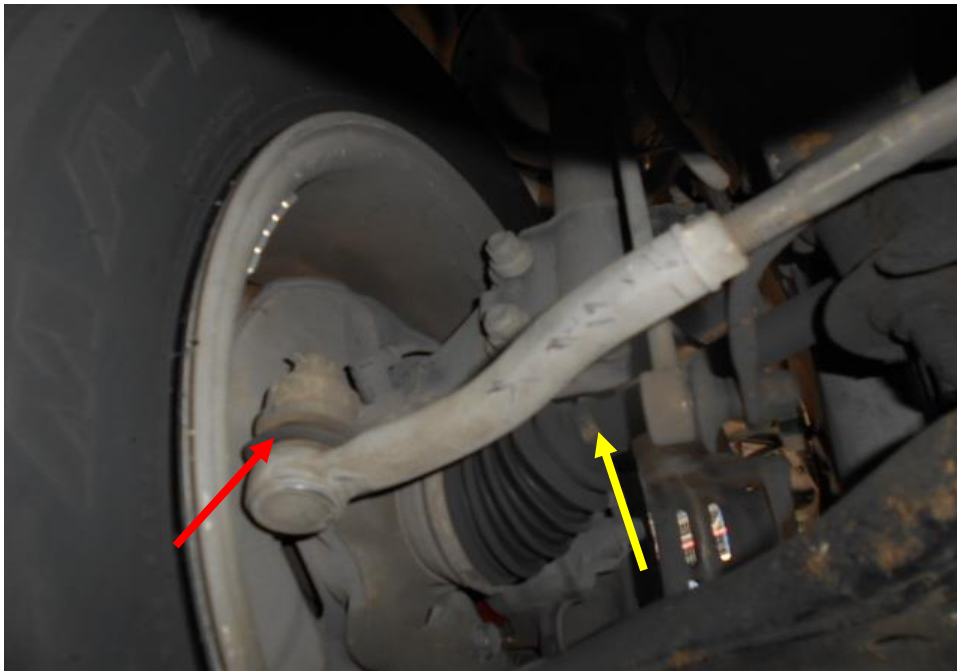
Photo 20 shows the various undercarriage components at the front right wheel of the Motor Car, in particular the steering tie rod (red arrow) and the driveshaft (yellow arrow). The various steering components were all found to be intact. There was also no sign of fluid stain observed on the various undercarriage components at the front right wheel of the Motor Car.

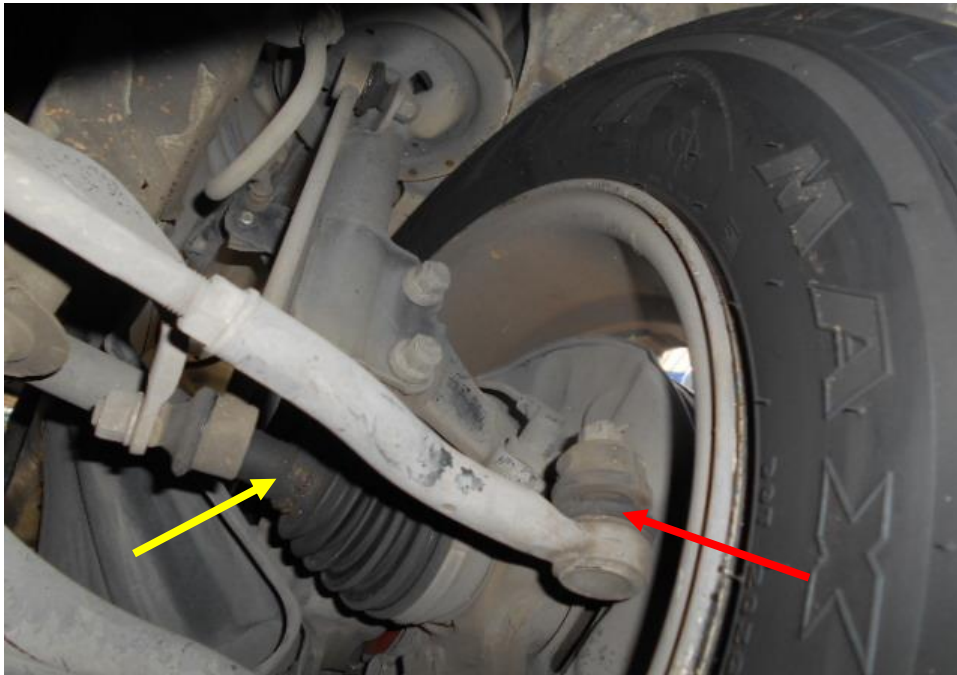
Photo 21 shows the various undercarriage components at the front left wheel of the Motor Car, in particular the steering tie rod end (arrowed) was observed to be damaged as a result of the accident.

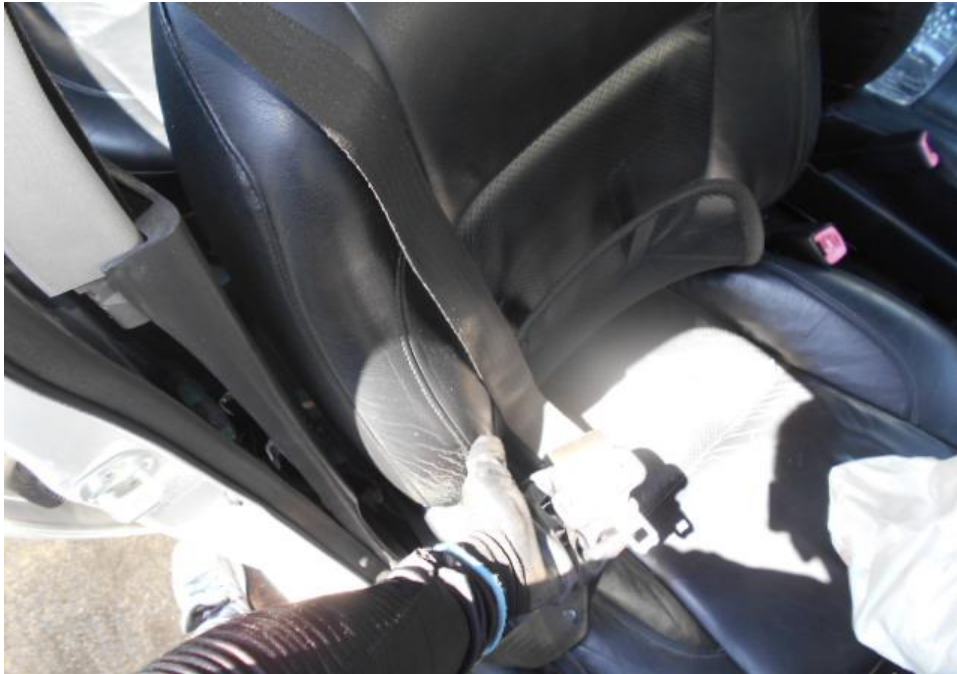
Photo 22 shows that the seat belt on the right seat was worn at the material time of accident as the safety pre-tensioners was activated at the moment of impact and caused the seat belt to be locked into the last position.

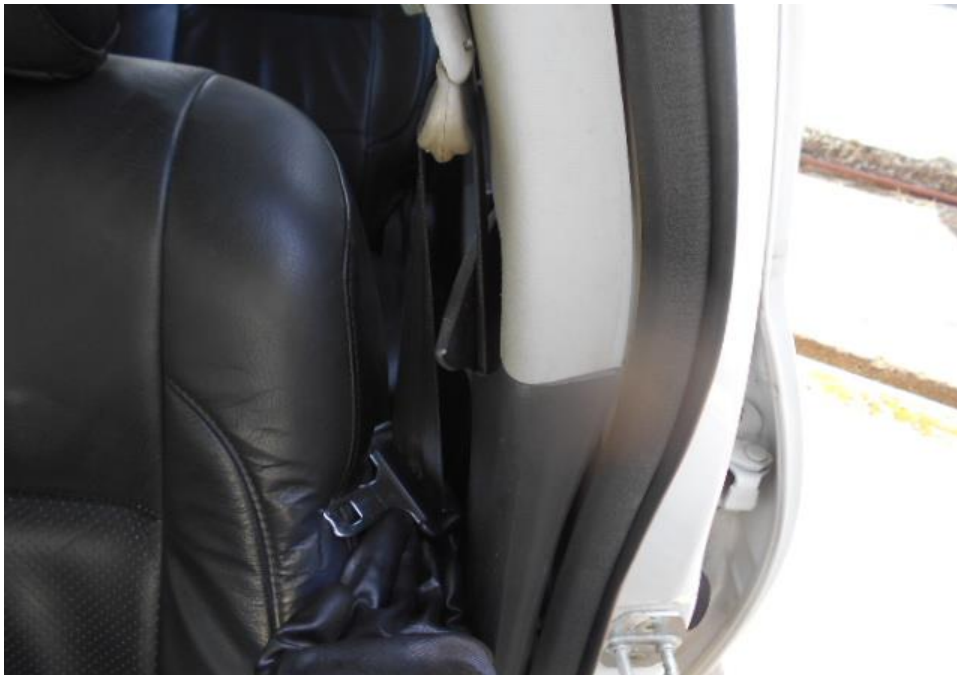
Photo 23 shows that the seat belt on the left seat as the safety pre-tensioners was activated at the moment of impact and caused the seat belt to be locked into the last position.
