MECHANICAL INSPECTION REPORT OF MOTOR CAR SJJ 1297H

1. I refer to your request on 10th June 2023 to conduct a physical inspection of a Motor car bearing registration number SJJ 1297H (herein referred to as "**Motor Car**"), which was involved in a road traffic accident on 4th January 2023.
2. The objective of the inspection is to determine if there was any possible mechanical failure to the Motor car that may have contributed to the accident.
3. Following the request, I had carried out a physical inspection of the Motor Car on 24th July 2023 at the premises of Traffic Police vehicle pound, 517 Airport Road Singapore 539942. I now set out below my observations and comments with respect to this inspection.

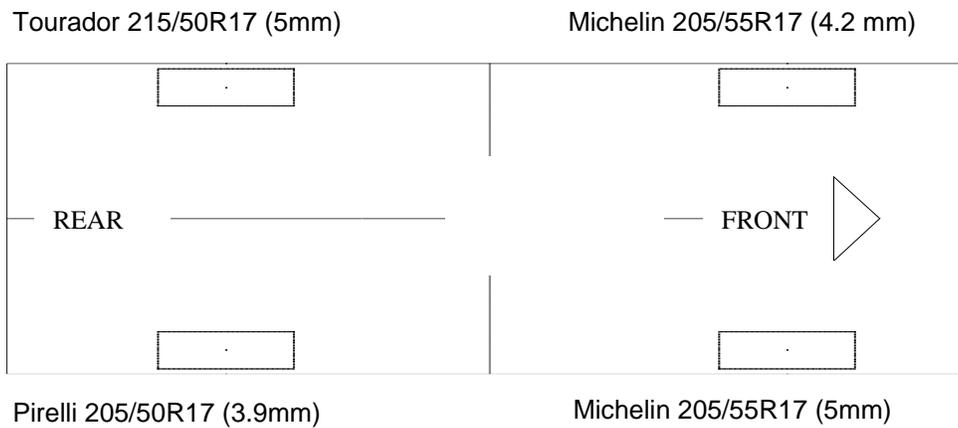
6. The 4 tyres of the Motor Car were observed to be in serviceable condition and sufficiently inflated for vehicular operation. I did not find any tear, cut or burst mark(s) on the outer and the inner sidewalls as well as across the tread of the 4 tyres. The tyre brand, tyre size and remaining tread depth of the 4 tyres of the Motor Car were recorded as follows:-

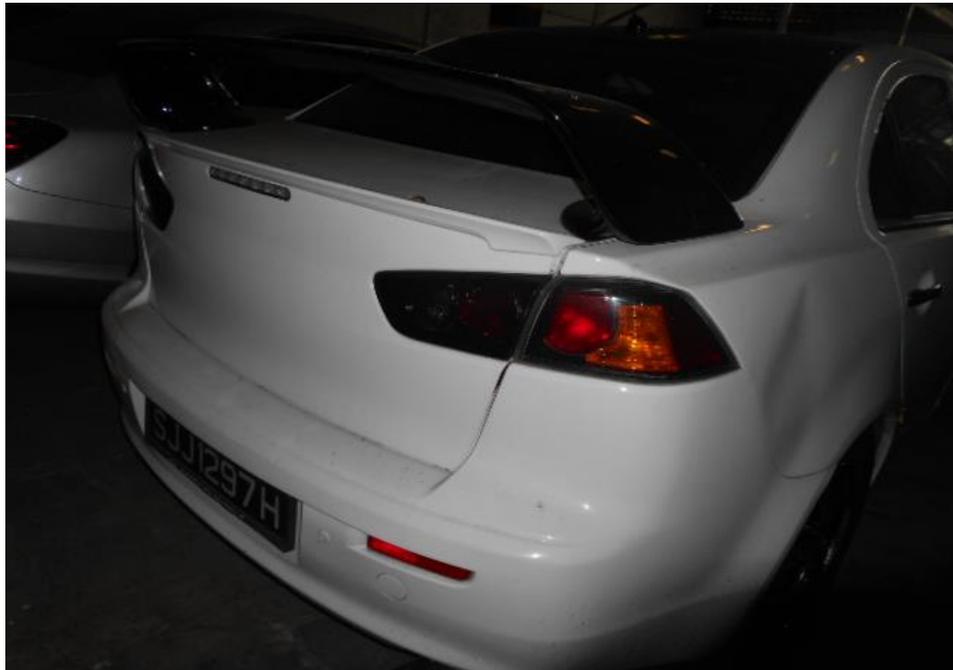
Photo 1 shows a general view of the Motor Car's rear body at the time of my inspection. The rear portion of the Motor Car was observed to have been undamaged by the accident.

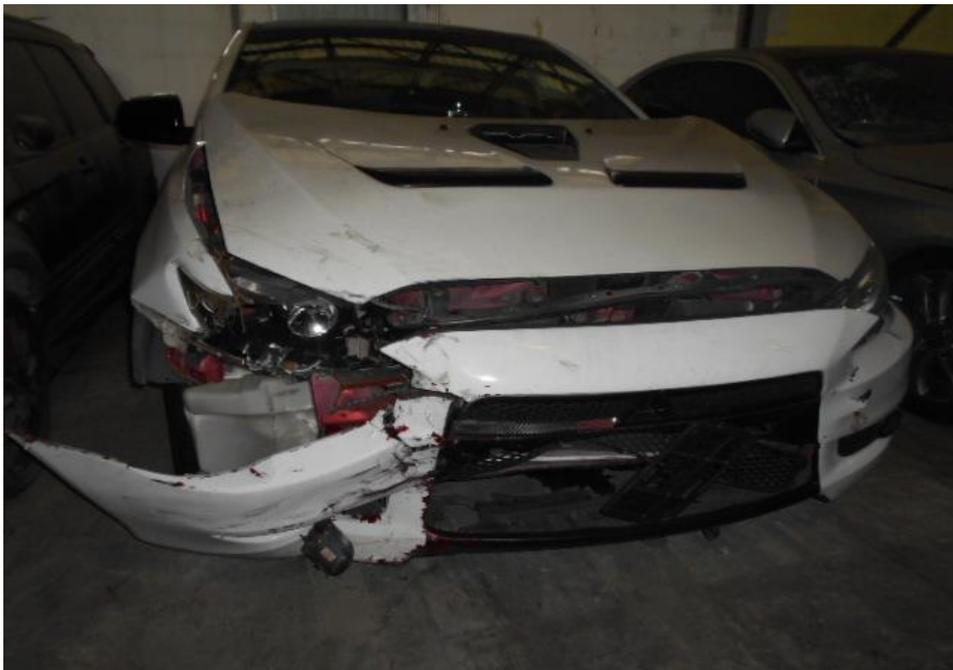
Photo 2 shows the close up view of the Motor Car's front body at the time of my inspection. The Motor car was observed to have sustained damage at its front portion. Its front bonnet, front bumper, front grille, front right fender and front right head lamp was damaged as a result of the accident.

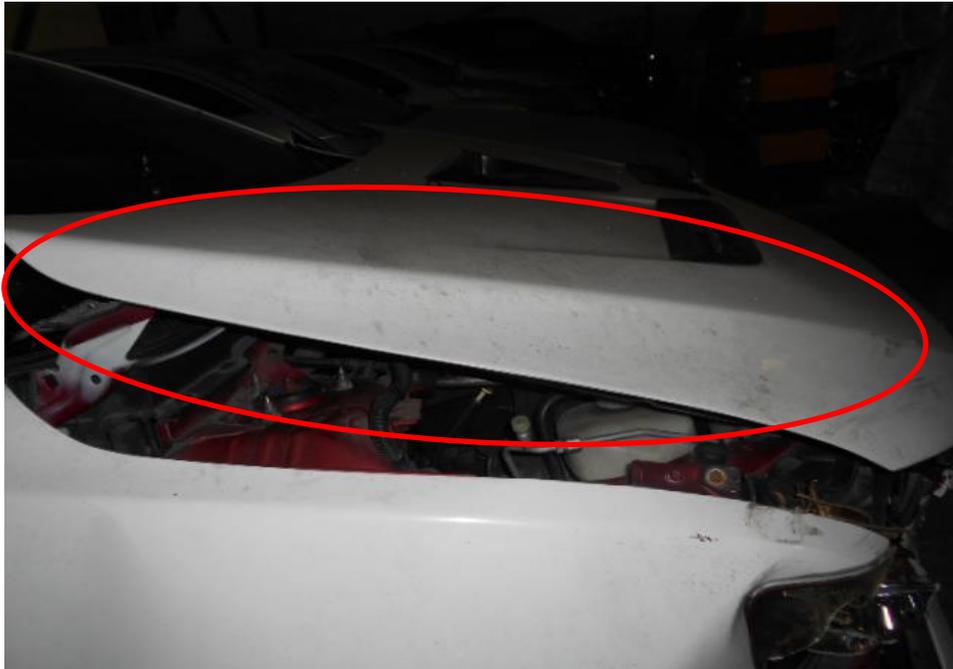
Photo 3 shows the close up view of the Motor Car's front body at the time of my inspection. The Motor car was observed to have sustained damage at its front portion. Its front bonnet (circled) was damaged as a result of the accident.

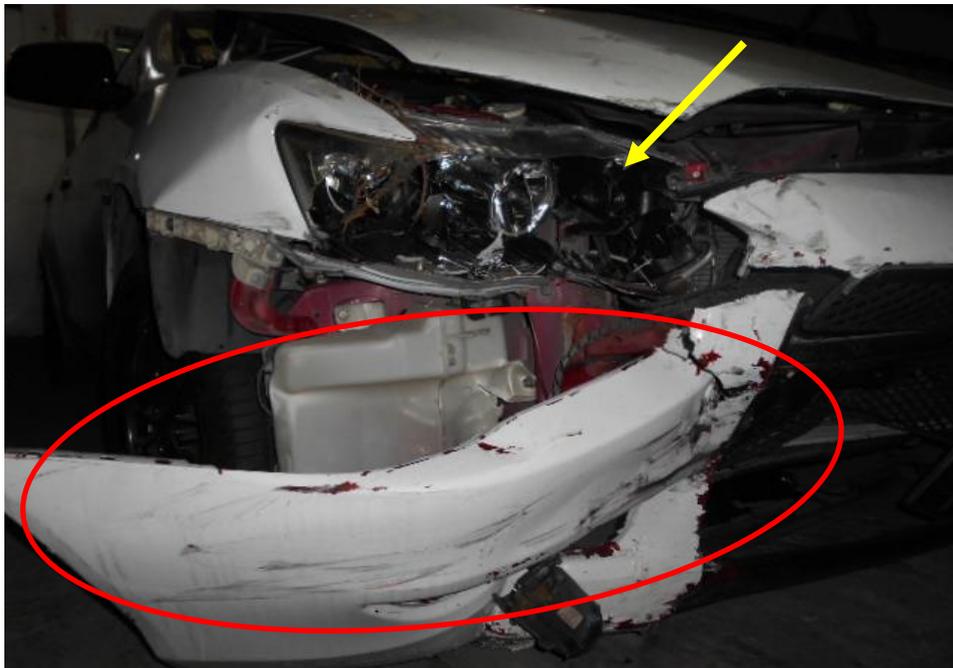
Photo 4 shows the close up view of the Motor Car's front body at the time of my inspection. The Motor car was observed to have sustained damage at its front portion. Its front bumper (circled) and its front right headlamp (arrowed) was damaged as a result of the accident.

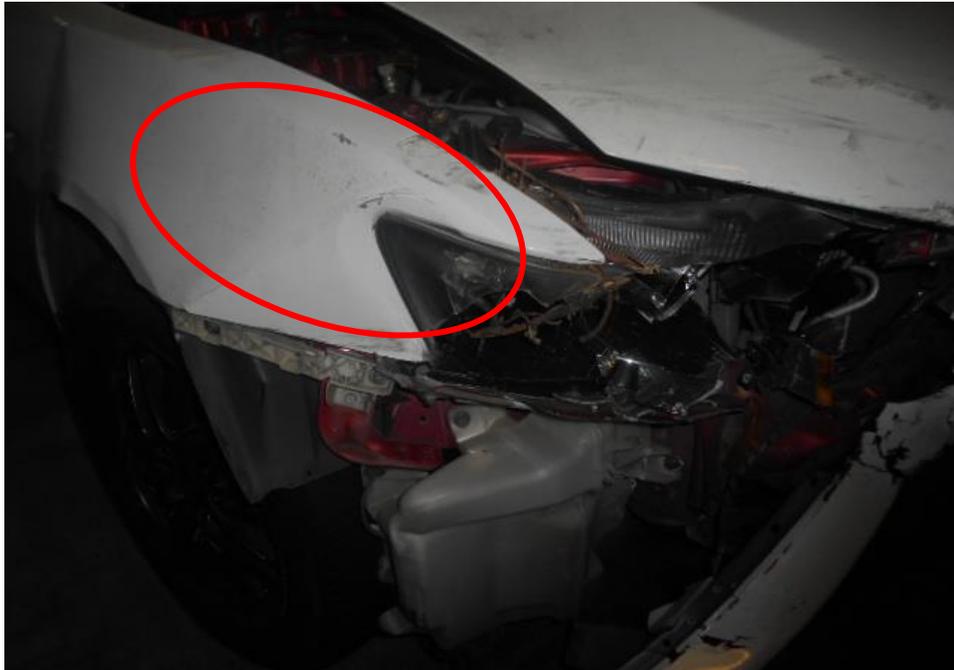
Photo 5 shows the close up view of the Motor Car's front body at the time of my inspection. The Motor Car was observed to have sustained damage at its front portion. Its front right fender (circled) was amongst the body part damaged as a result of the accident.

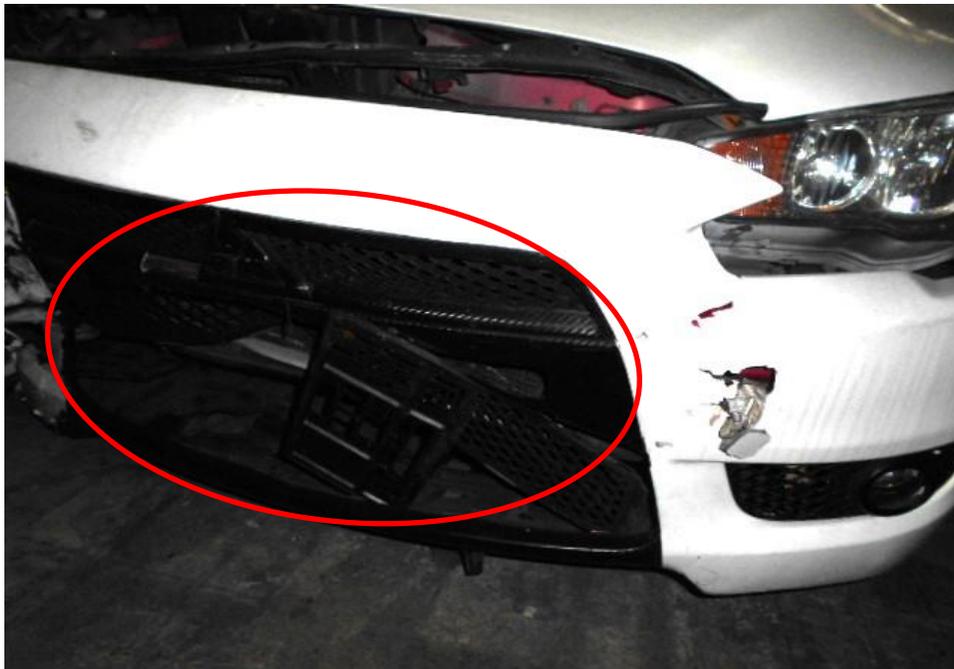
Photo 6 shows the close up view of the Motor Car's front body at the time of my inspection. The Motor car was observed to have sustained damage at its front portion. Its front grille (circled) was amongst the body part damaged as a result of the accident.

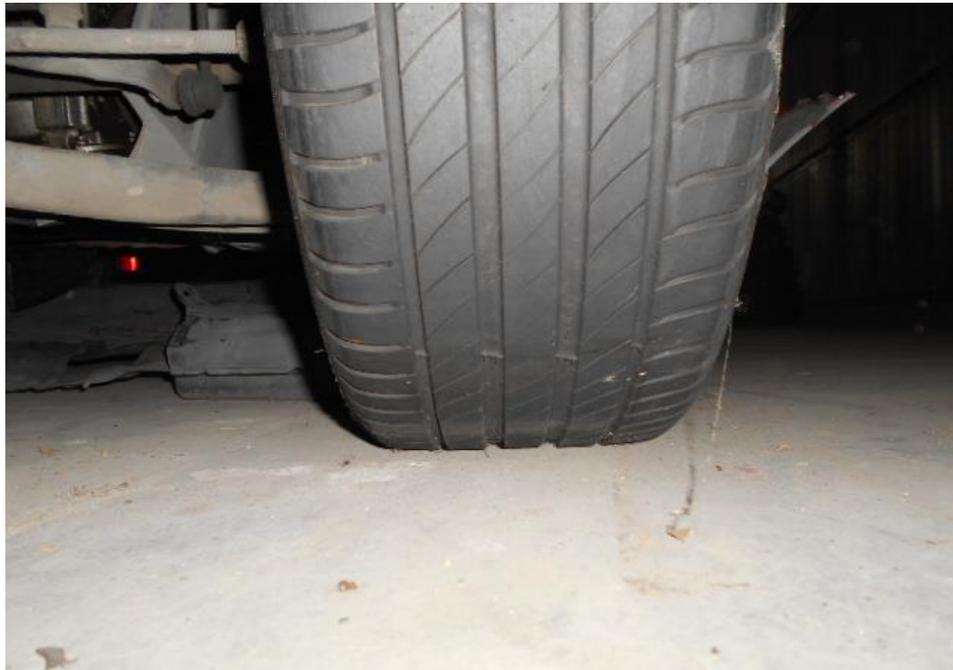
Photo 9 shows the condition of the front right tyre of the Motor Car, which was observed to be in serviceable condition with remaining tread depth of approximately 6mm. The tyre, which was wrapped around alloy wheel rim, was also observed to be sufficiently inflated for vehicular operation.

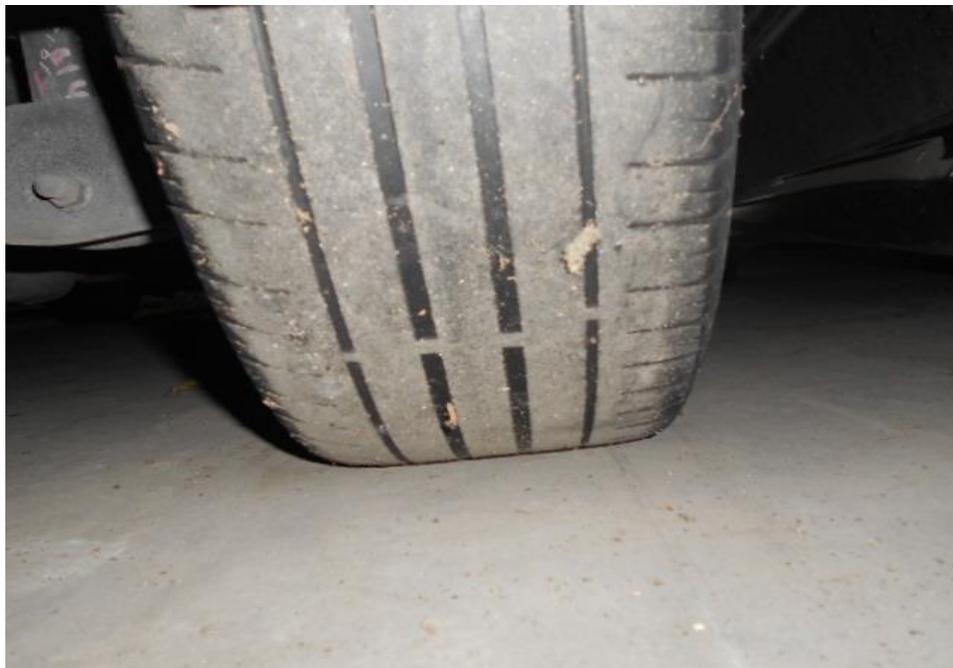
Photo 10 shows the condition of the rear right tyre of the Motor Car, which was observed to be in serviceable condition with remaining tread depth of approximately 3.9mm. The tyre was also observed to be sufficiently inflated for vehicular operation with no tear, cut or burst mark(s).

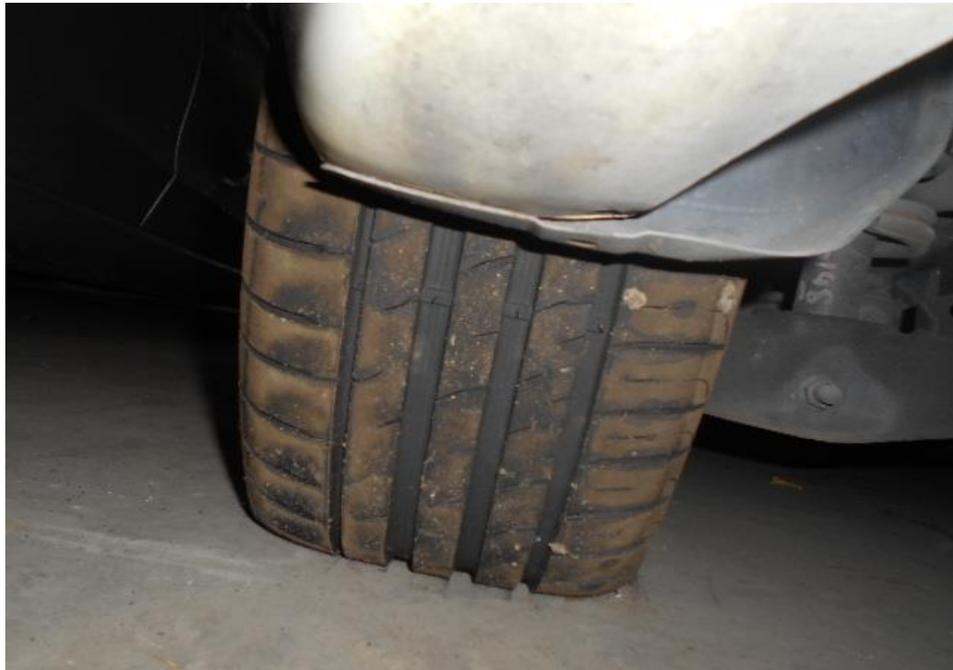
Photo 11 shows the condition of the rear left tyre of the Motor Car, which was observed to be in serviceable condition with remaining tread depth of approximately 5mm. The tyre was also observed to be sufficiently inflated for vehicular operation with no tear, cut or burst mark(s).

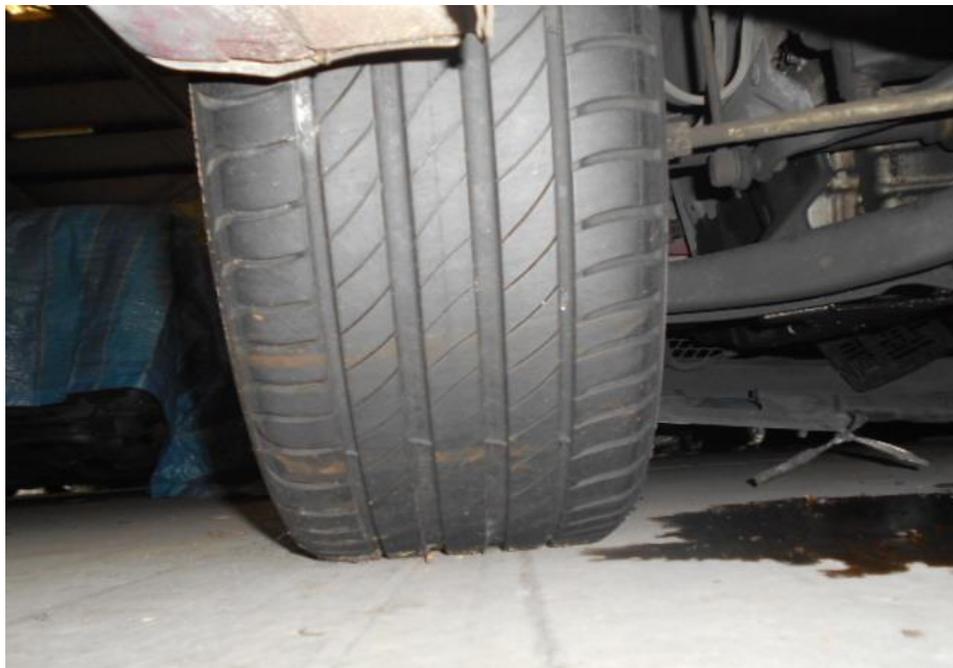
Photo 12 shows the condition of the front left tyre of the Motor Car, which was observed to be in serviceable condition with remaining tread depth of approximately 4.2mm. The tyre was also observed to be sufficiently inflated for vehicular operation with no tear, cut or burst mark(s).

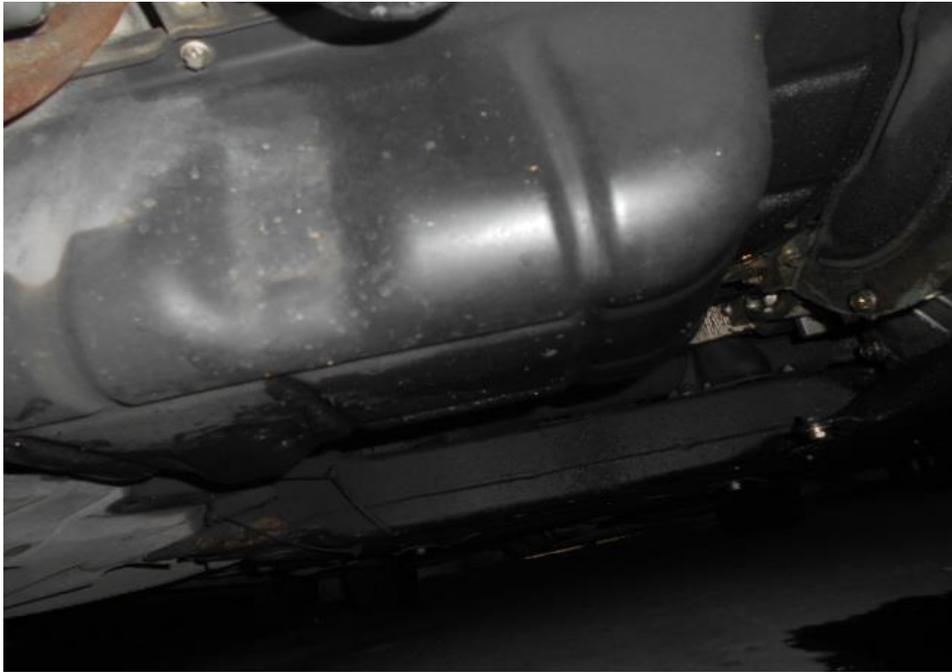
Photo 14 shows the undercarriage of the Motor Car, at the area where the engine housing and transmission housing is located. I did not find any sign(s) or indication(s) of fluid leak, however old fluid stain(s) was observed on the underside of the Motor Car.

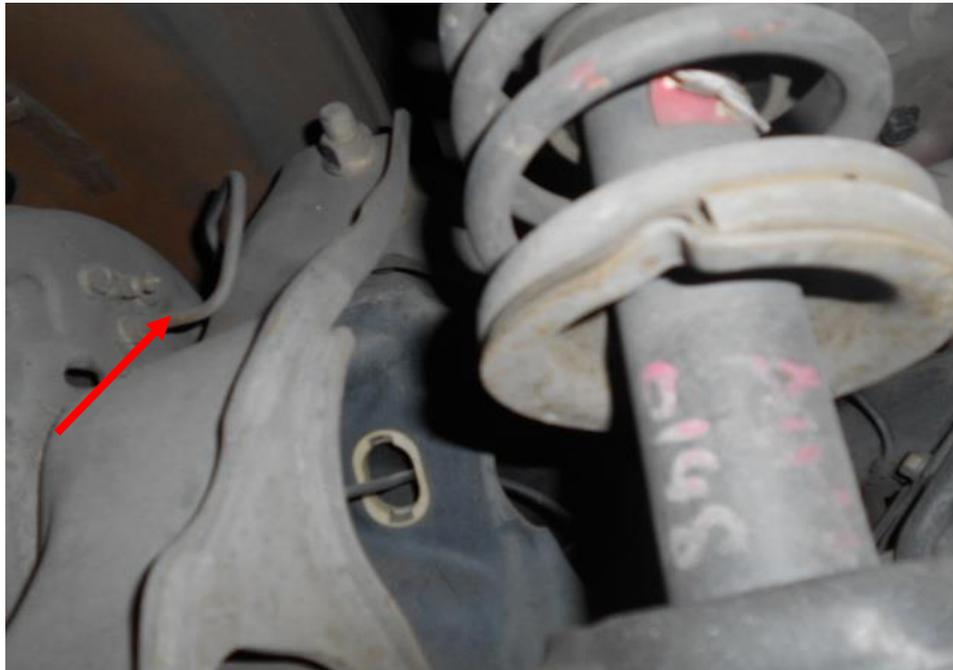
Photo 15 shows the brake hose/pipe (arrowed) at the rear left wheel of the Motor Car. No leakage of brake fluid was observed. Visual examination of the various components of the braking system like the brake drum to be intact and without visible damage.

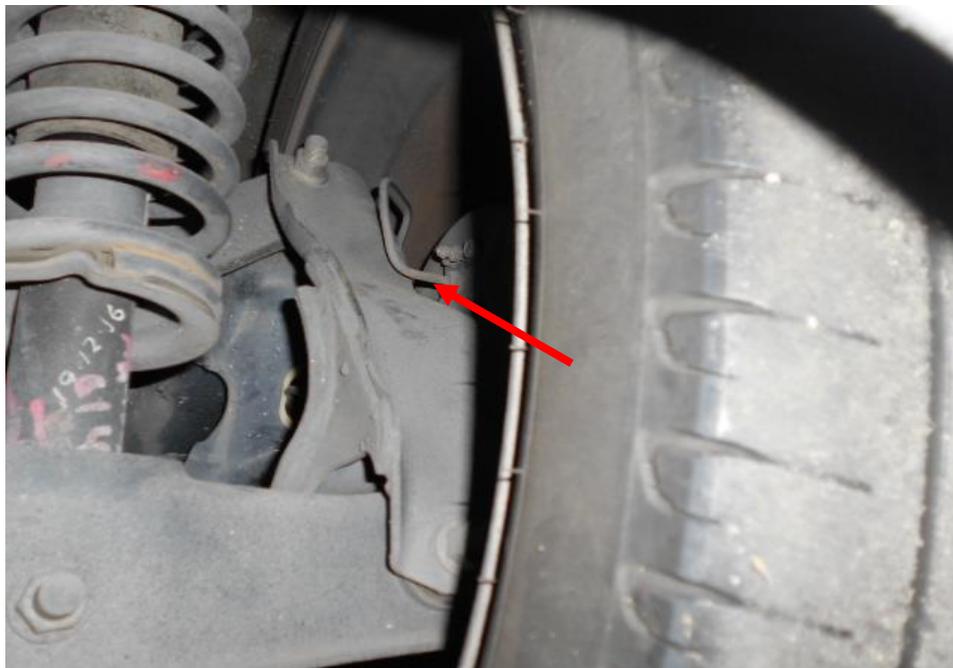
Photo 16 shows the brake hose/pipe (arrowed) at the rear right wheel of the Motor Car. No leakage of brake fluid was observed. Visual examination of the various components of the braking system like the brake drum to be intact and without visible damage.

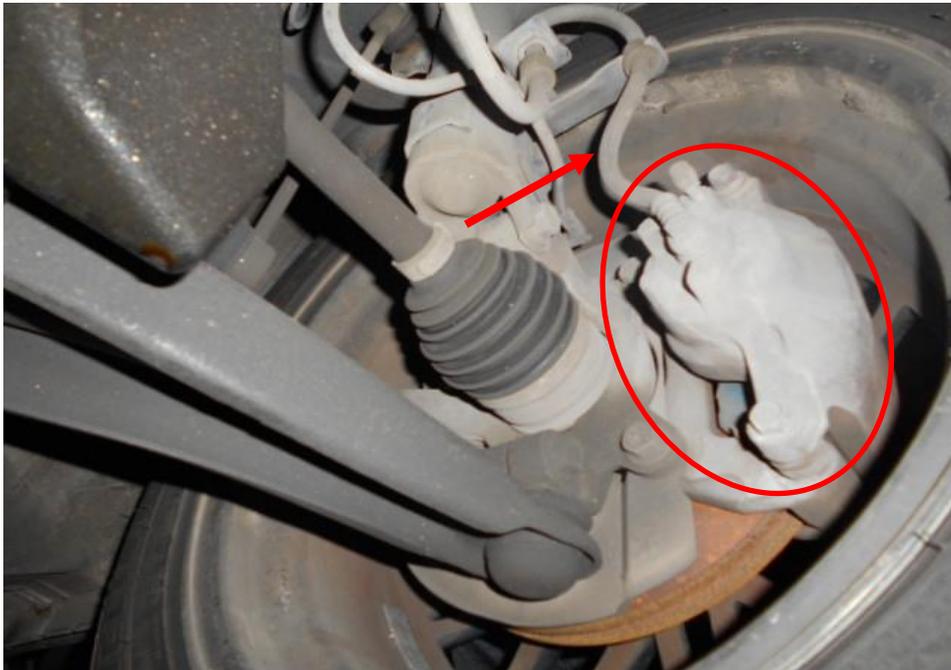
Photo 17 shows the brake hose/pipe (arrowed) at the front right wheel of the Motor Car. I did not observe any leakage of brake fluid at the time of my inspection of the Motor Car. Visual examination of the various components of the braking system the brake caliper (circled) to be intact and without visible damage.

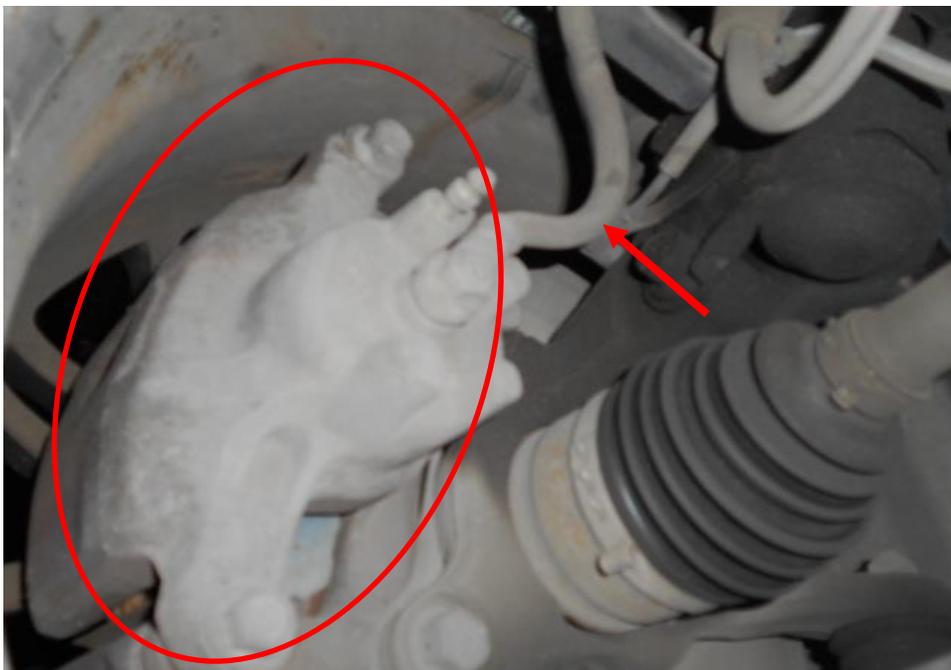
Photo 18 shows the brake hose/pipe (arrowed) at the front left wheel of the Motor Car. No leakage of brake fluid was observed. Visual examination of the various components of the braking system like the brake caliper (circled) had revealed to be intact and without visible damage.

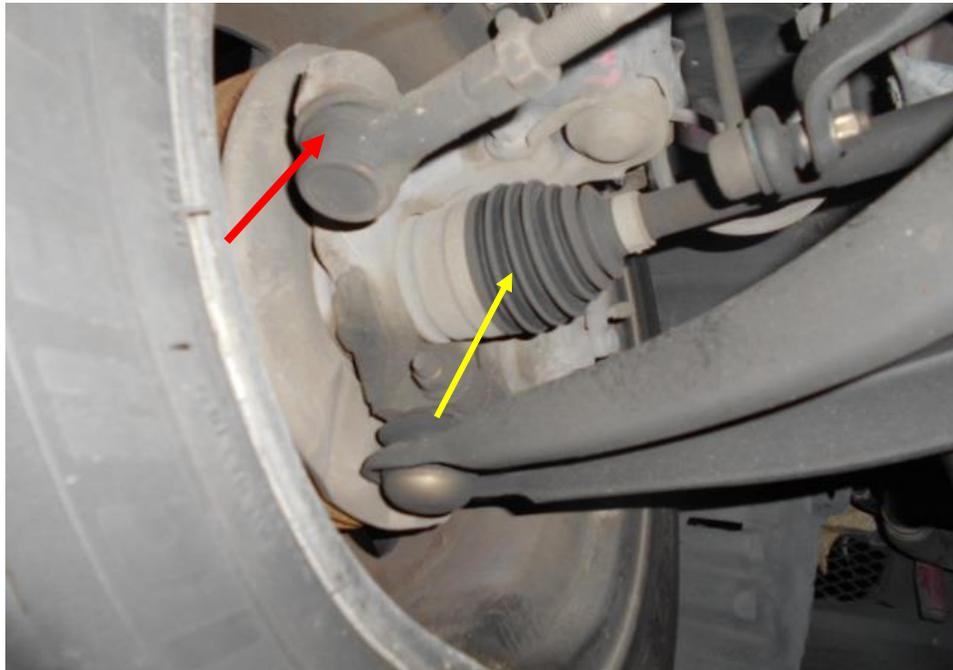
Photo 19 shows the various undercarriage components at the front right wheel of the Motor Car, in particular the steering tie rod (red arrow) and the driveshaft (yellow arrow). The various steering components were all found to be intact. There was also no sign of fluid stain observed on the various undercarriage components at the front right wheel of the Motor Car.

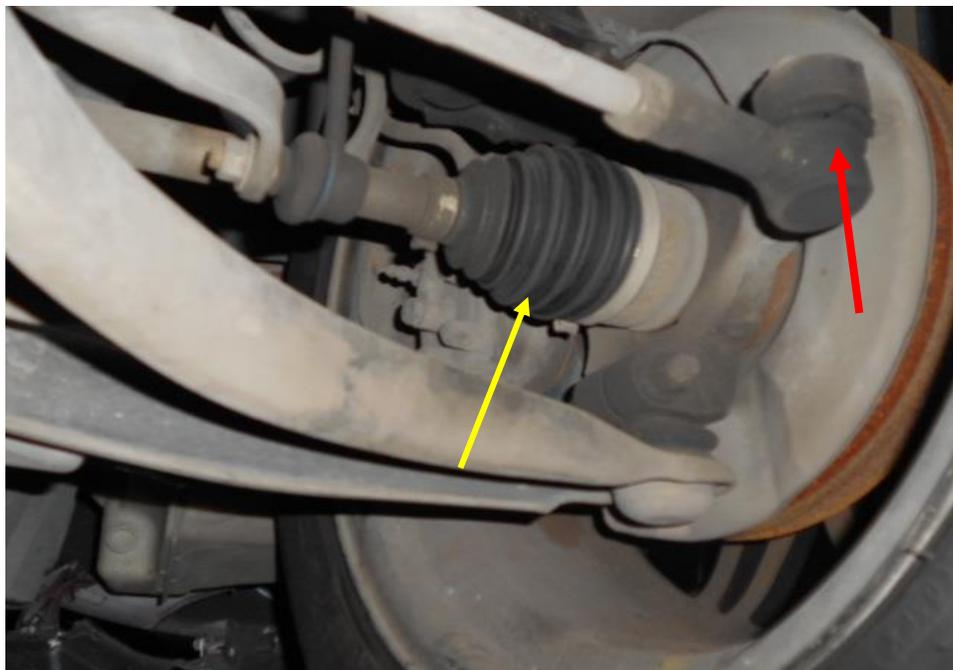
Photo 20 shows the various undercarriage components at the front left wheel of the Motor Car, in particular the steering tie rod end (arrowed) and the driveshaft (yellow arrow). The various steering components were all found to be intact. There was also no signs of fluid stain observed on the various undercarriage components at the front left wheel of the Motor Car.
