Your Ref: TP TP/14608/2023
Our Ref : CI/TPD23006798/P

MECHANICAL INSPECTION REPORT OF MOTOR BUS SMB 3139A

1. I refer to your request on 10th June 2023 to conduct a physical inspection of a Motor Bus bearing registration number SMB 3139A (herein referred to as "**Motor Bus**"), which was involved in a fatal road traffic accident on 25th May 2023.
2. The objective of this inspection is to determine if there was any possible mechanical failure to the Motor Bus that may have contributed to the accident.
3. Following the request, I had carried out a physical inspection of the Motor Bus on 27th July 2023 at the premises of Traffic Police vehicle pound, 517 Airport Road Singapore 539942. I now set out below my observations and comments with respect to this inspection.

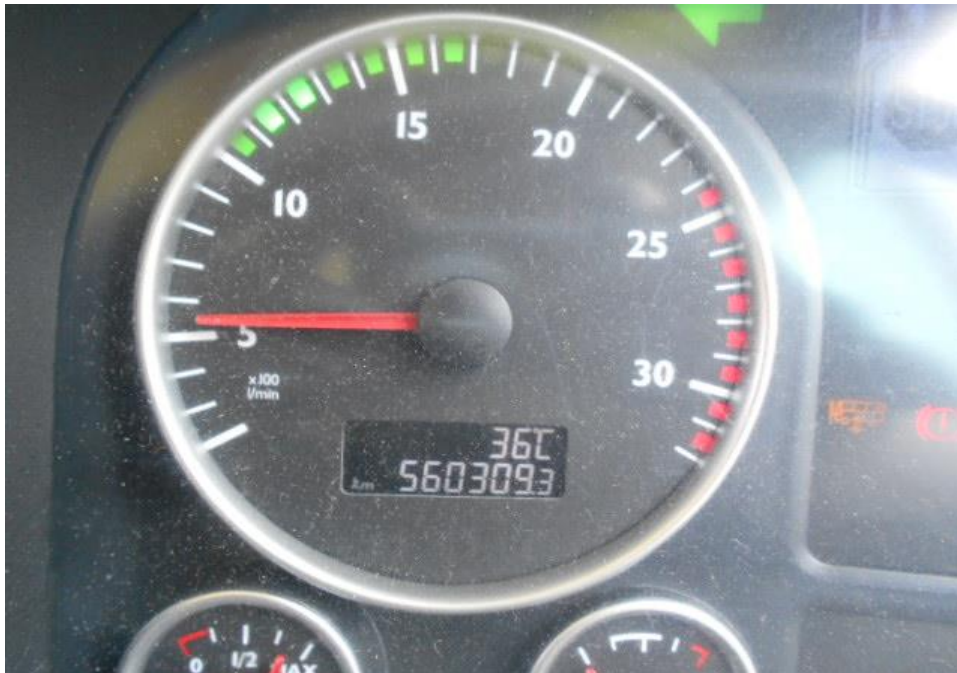
Photo 1 shows a general view of the instrument cluster of the Motor Bus at the time of my inspection. The mileage of the Motor Bus was 560,309km

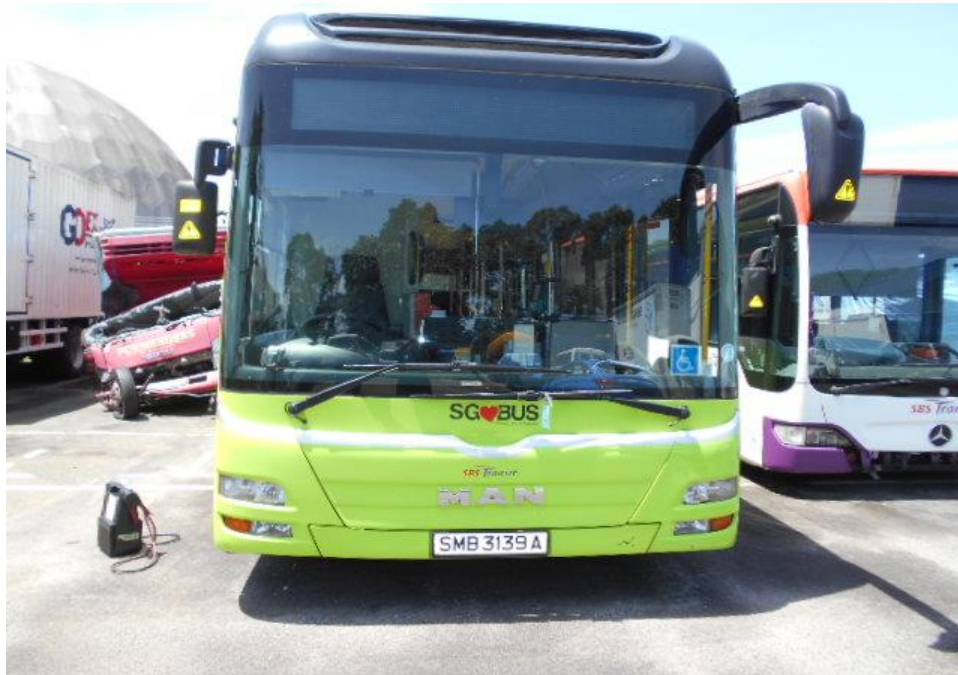
Photo 2 shows a general view of the front body of the Motor Bus at the time of my inspection. It was observed to be intact and unaffected by the accident.

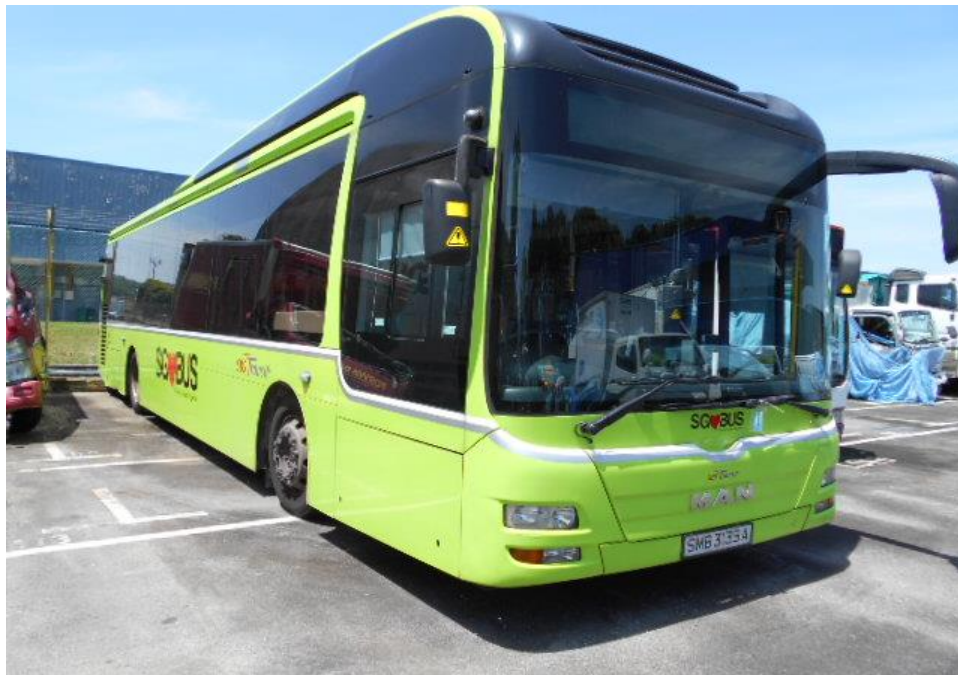
Photo 3 shows a general view of the right portion of the Motor Bus at the time of my inspection. It was observed to be intact and unaffected by the accident.

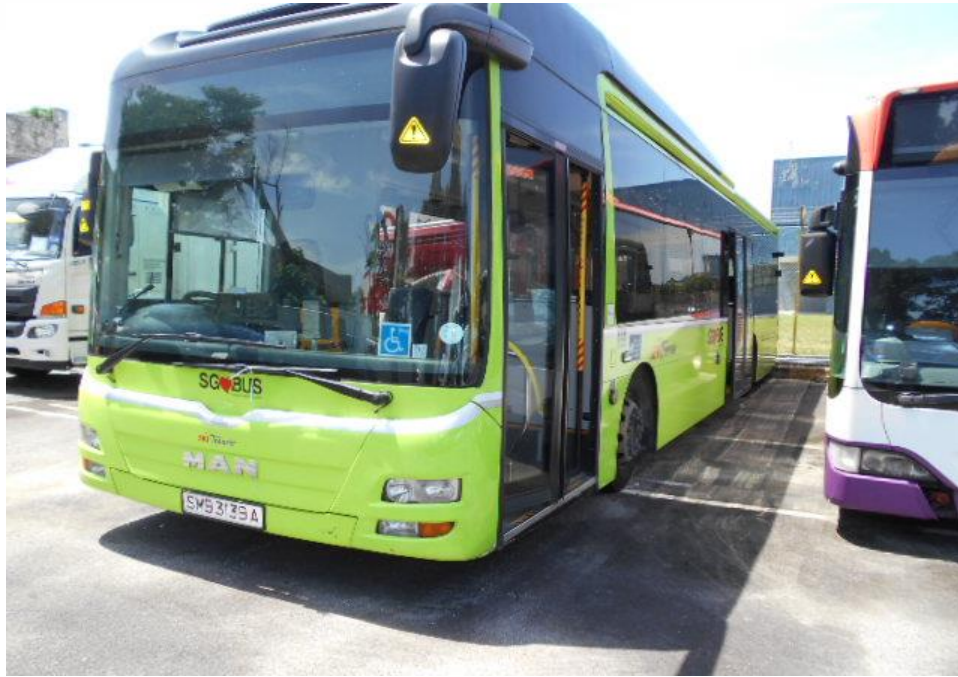
Photo 4 shows a general view of the left body of the Motor Bus at the time of my inspection. The Motor Bus was observed to be intact and unaffected by the accident.

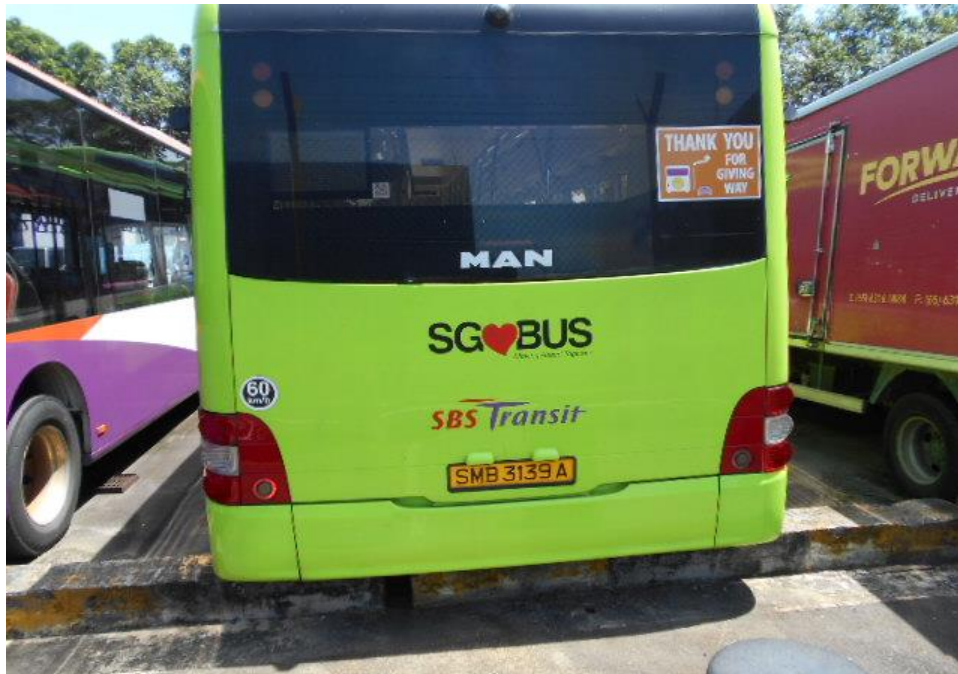
Photo 5 shows a general view of the rear body of the Motor Bus at the time of my inspection. The Motor Bus was observed to be intact and unaffected by the accident.

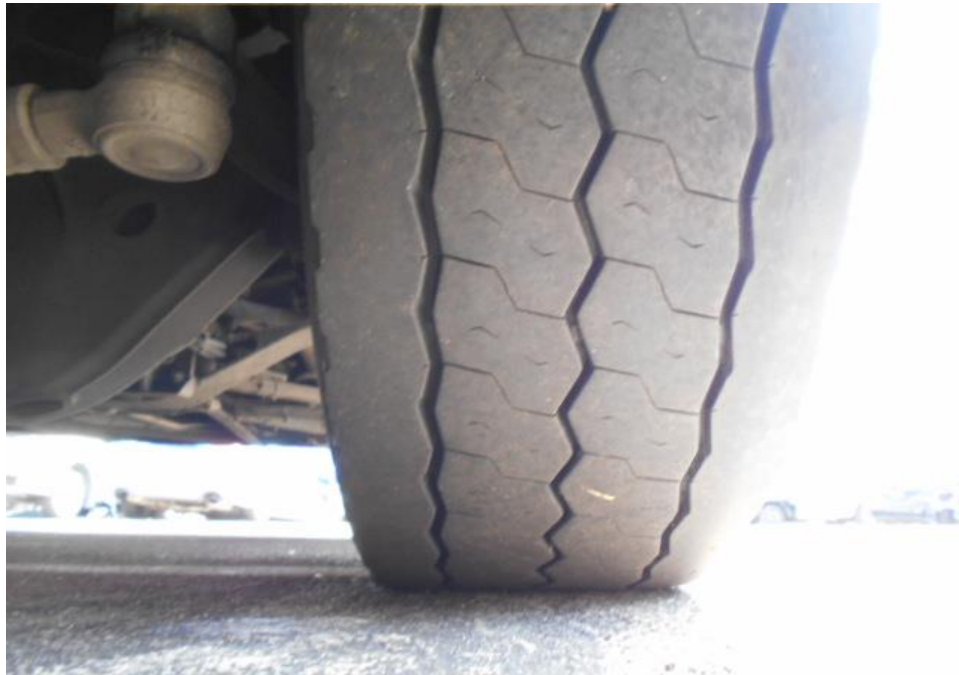
Photo 6 shows the condition of the front right tyre of the Motor Bus, which was observed to be in serviceable condition with remaining tread depth of approximately 13.2mm. The tyre, which was wrapped around standard steel wheel rim, was also observed to be sufficiently inflated for vehicular operation. There was no tear, cut or burst mark(s) on the outer and the inner sidewalls as well as across the tread of the 6 tyres that were fitted on the Motor Bus.

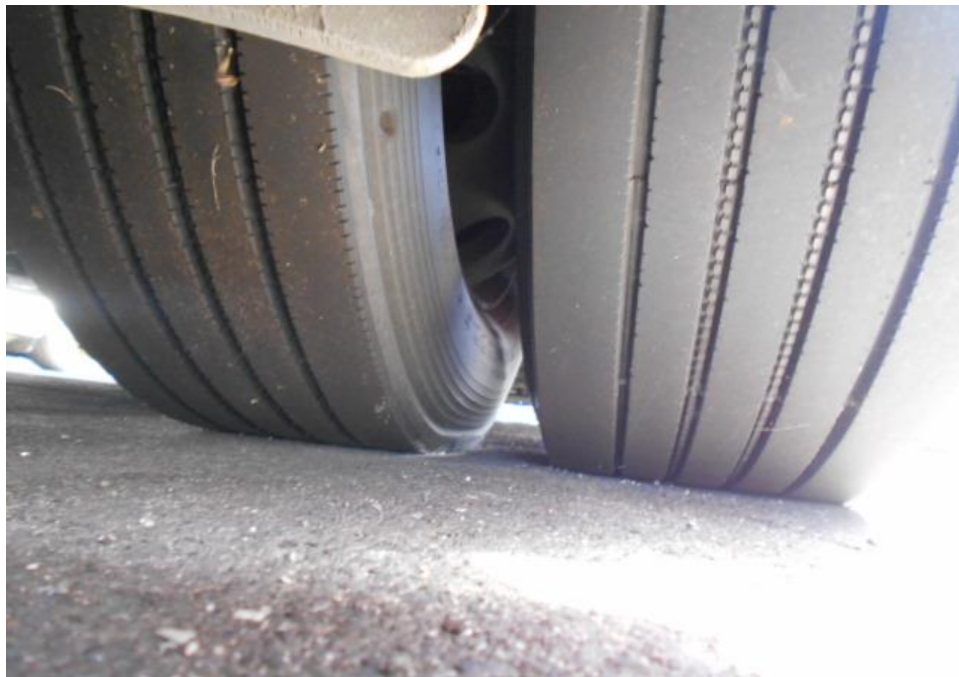
Photo 7 shows the condition of the rear right tyre of the Motor Bus, which was observed to be in serviceable condition with remaining tread depth of approximately 9.6mm. The tyre, which was wrapped around standard steel wheel rim, was also observed to be sufficiently inflated for vehicular operation.

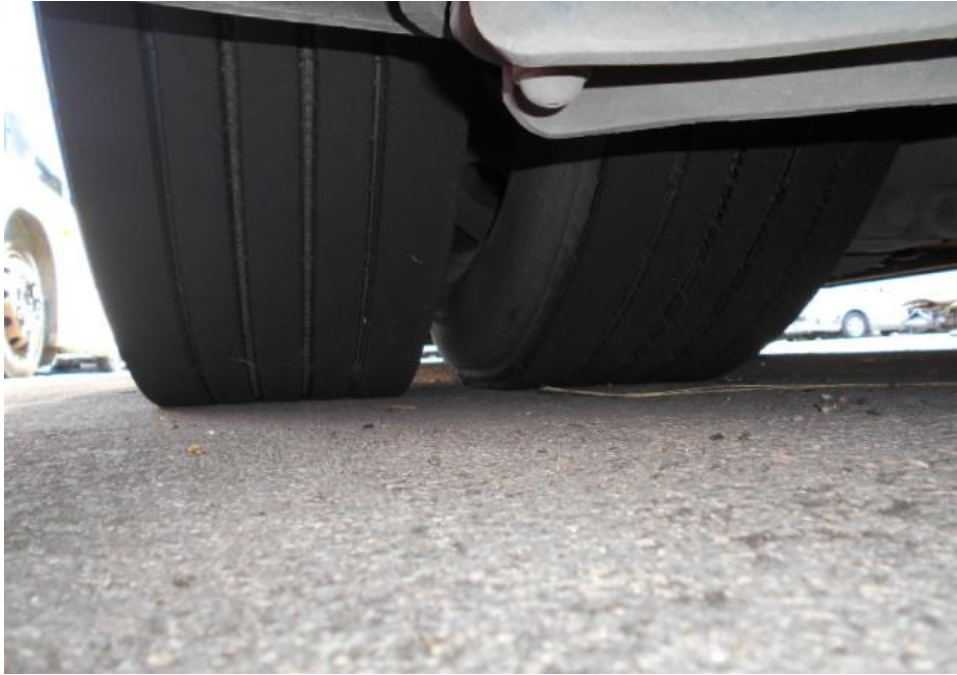
Photo 8 shows the condition of the rear left tyres of the Motor Bus, which was observed to be in serviceable condition with remaining tread depth of approximately 9.4mm. The tyres, which were wrapped around standard steel wheel rim, were also observed to be sufficiently inflated for vehicular operation. There was also no damage found on all 6 steel wheel rims of the Motor Bus.

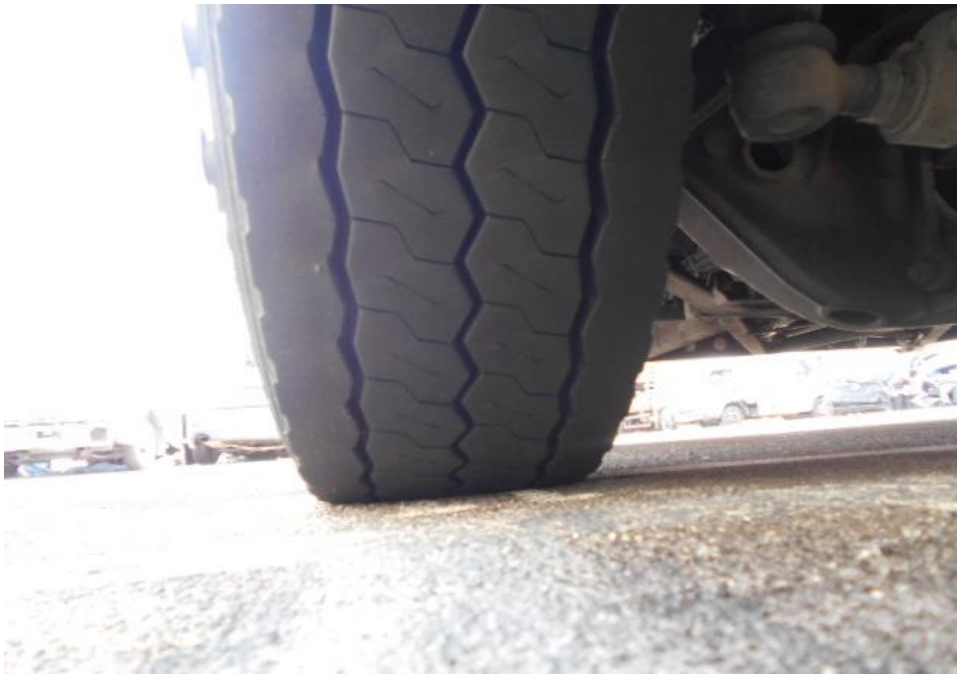
Photo 9 shows the condition of the front left tyres of the Motor Bus, which were observed to be in serviceable condition with remaining tread depth of approximately 12.6mm. There was also no tear, cut or burst mark(s) on the outer and the inner sidewalls as well as across the tread of the 6 tyres that were fitted on the Motor Bus.

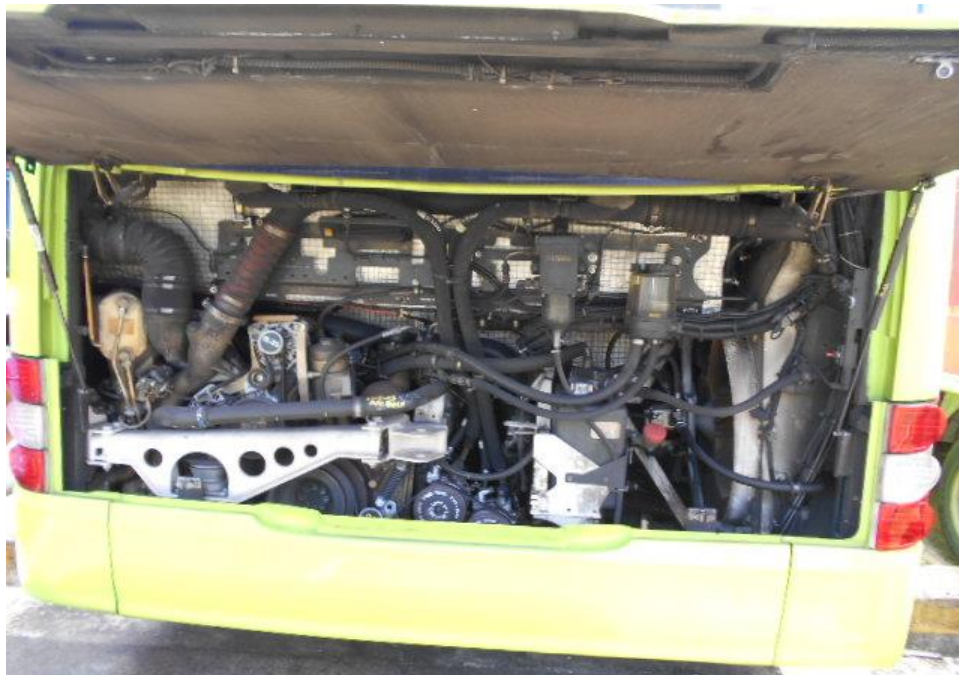
Photo 10 shows a general view of the Motor Bus's engine compartment, which was accessed by lifting the rear of the Motor Bus. The various parts and components inside the engine compartment were unaffected by the accident. There was also no sign(s) or indication(s) of fresh fluid leakage and/or fluid stain within the engine compartment

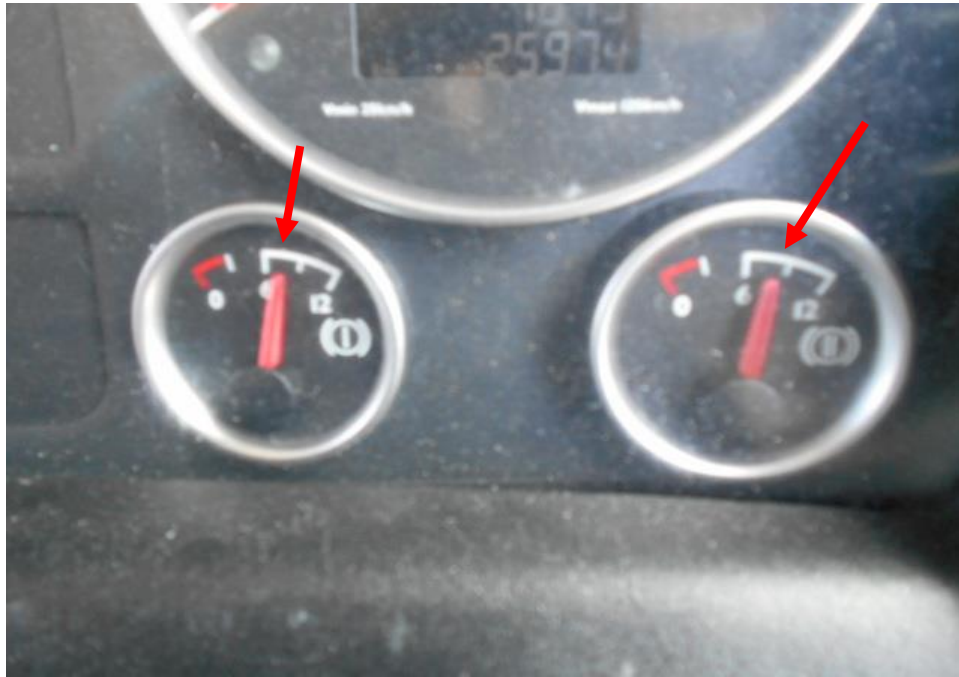
Photo 11 shows the air in the air brake cylinder of the Motor Bus at the time of my inspection. The air in the cylinder was observed to be of sufficient level & serviceable at the time of the accident.

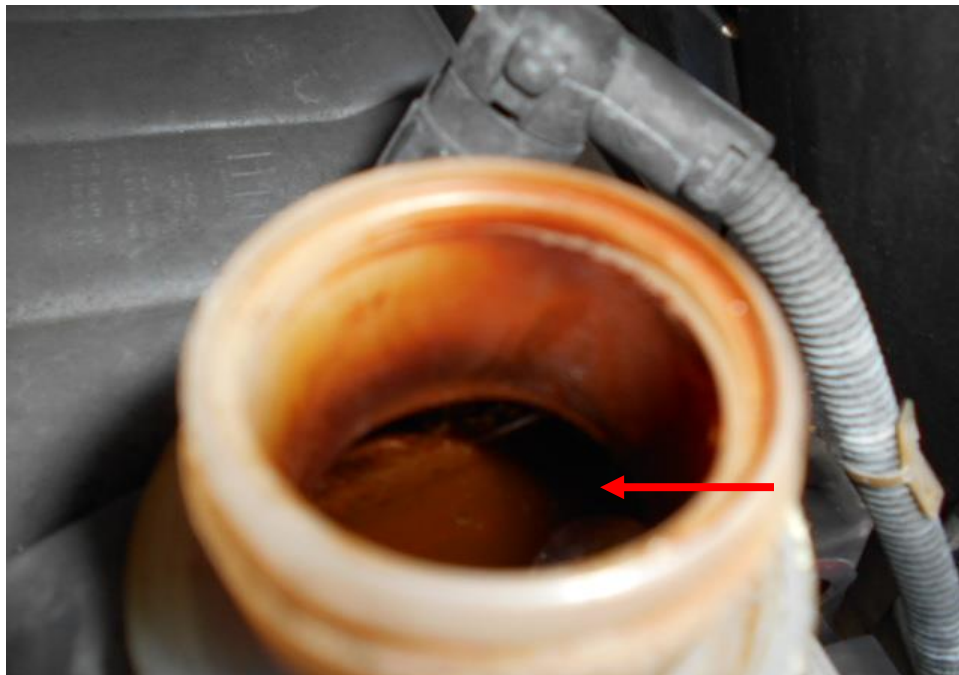
Photo 12 shows the engine coolant reservoir of the Motor Bus at the time of my inspection. The engine coolant was observed to be of sufficient level (arrowed) and without any visible contamination.

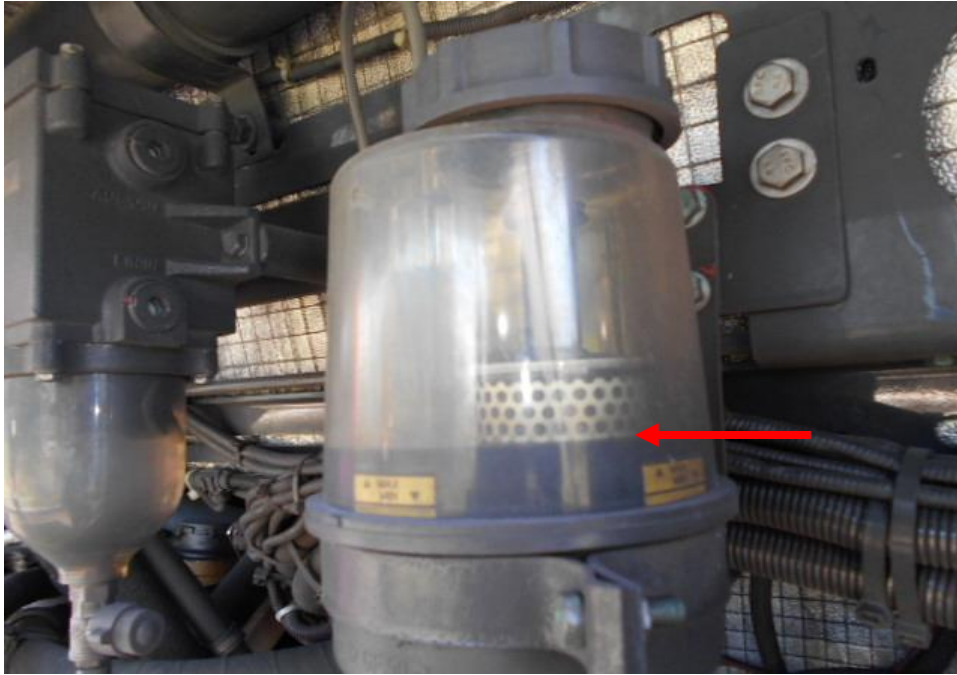
Photo 13 shows the power steering fluid reservoir of the Motor Bus at the time of my inspection. The power steering fluid was observed to be of sufficient level and without any visible contamination.

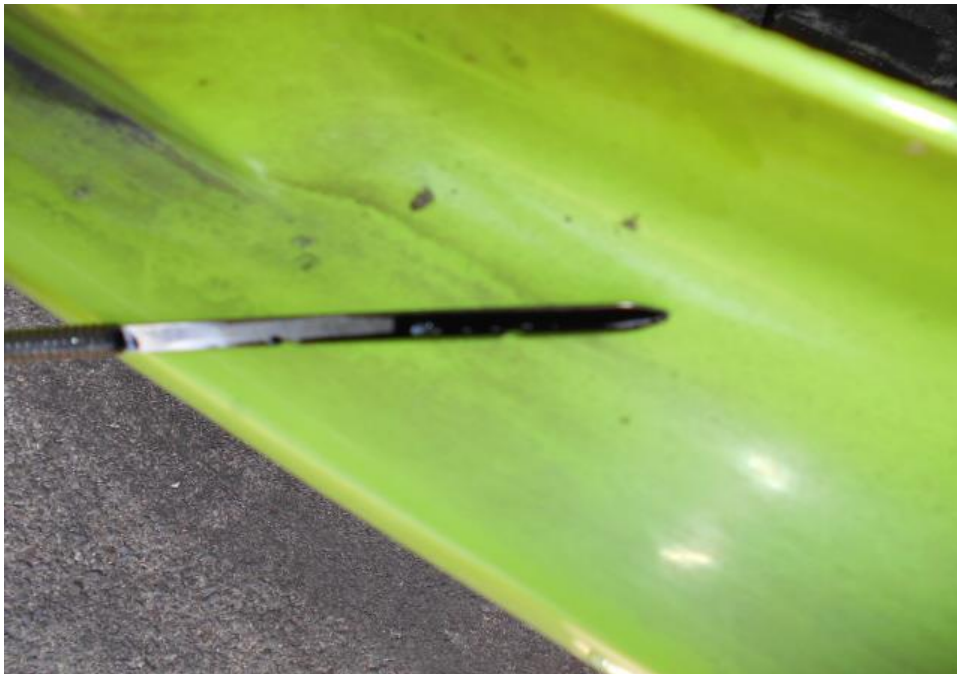
Photo 14 shows the engine oil dip stick system of the Motor Bus at the time of my inspection. The engine oil was observed to be sufficient for operation and without any visible contamination.

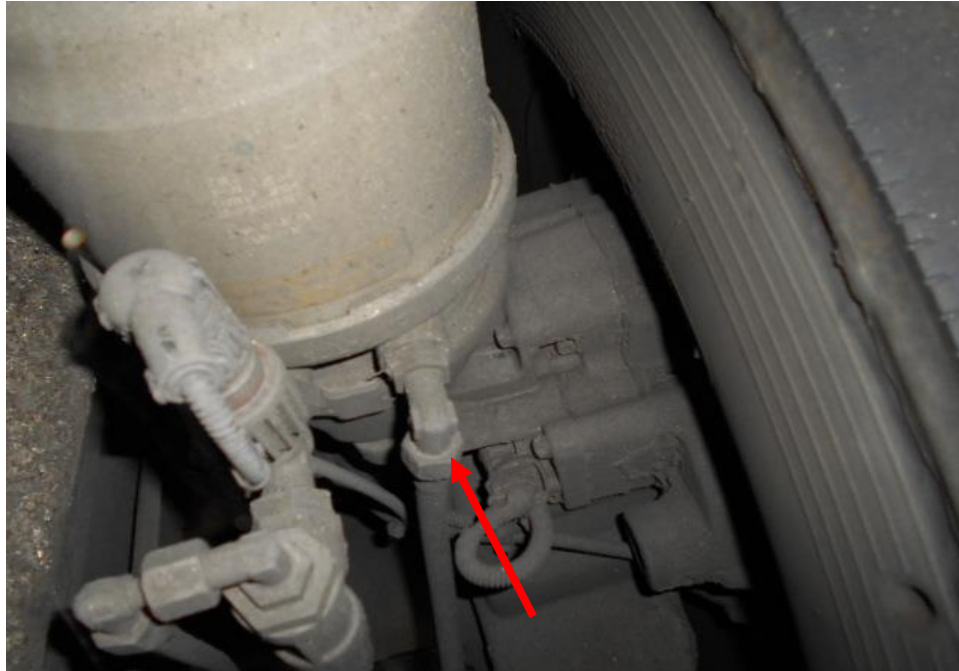
Photo 15 shows the brake pipe (arrowed) at the rear right wheel of the Motor Bus. I did not observe any leakage of brake fluid at the time of my inspection of the Motor Bus. My static tests of the Motor Bus's braking system, along with my visual examination of the various mechanical components in the braking system, had indicated that there was no internal leakage of pressure/vacuum. Hence the braking system of the Motor Bus was likely to be in serviceable condition at the material time of accident.

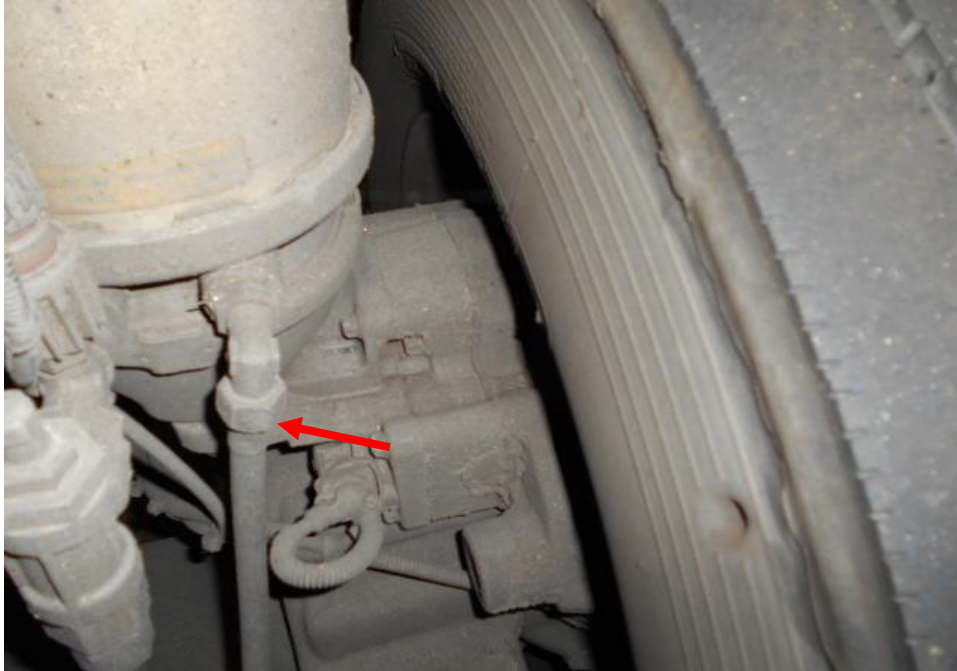
Photo 16 shows the brake pipe (arrowed) at the rear left wheel of the Motor Bus. I did not observe any leakage of brake fluid at the time of my inspection of the Motor Bus. My static tests of the Motor Bus's braking system, along with my visual examination of the various mechanical components in the braking system, had indicated that there was no internal leakage of pressure/vacuum. Hence the braking system of the Motor Bus was likely to be in serviceable condition at the material time of accident.

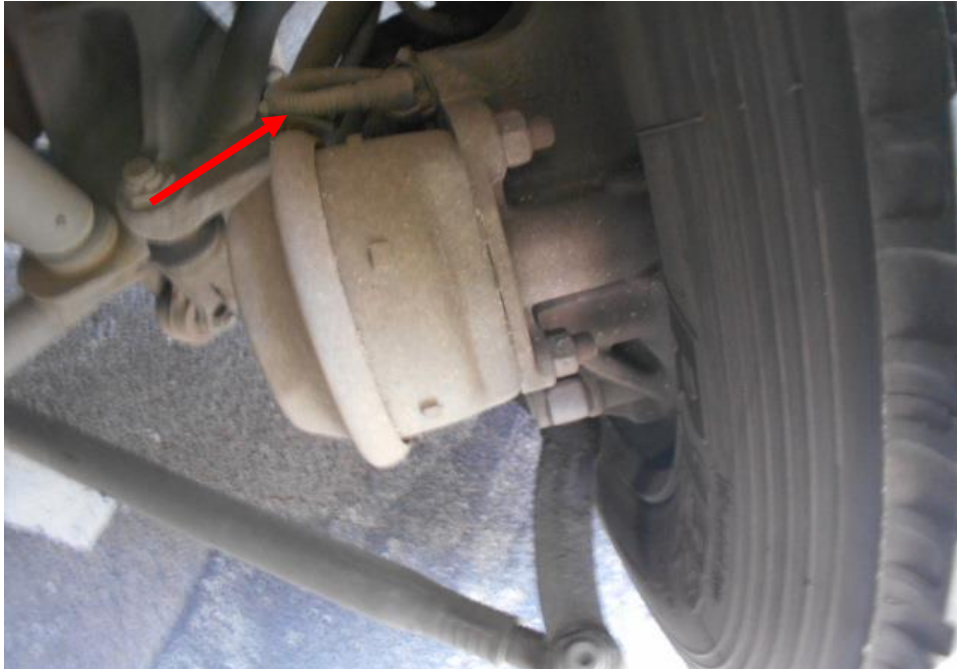
Photo 17 shows the brake pipe (arrowed) at the front right wheel of the Motor Bus. I did not observe any leakage of brake fluid at the time of my inspection of the Motor Bus. My static tests of the Motor Bus's braking system, along with my visual examination of the various mechanical components in the braking system, had indicated that there was no internal leakage of pressure/vacuum. Hence the braking system of the Motor Bus was likely to be in serviceable condition at the material time of accident.

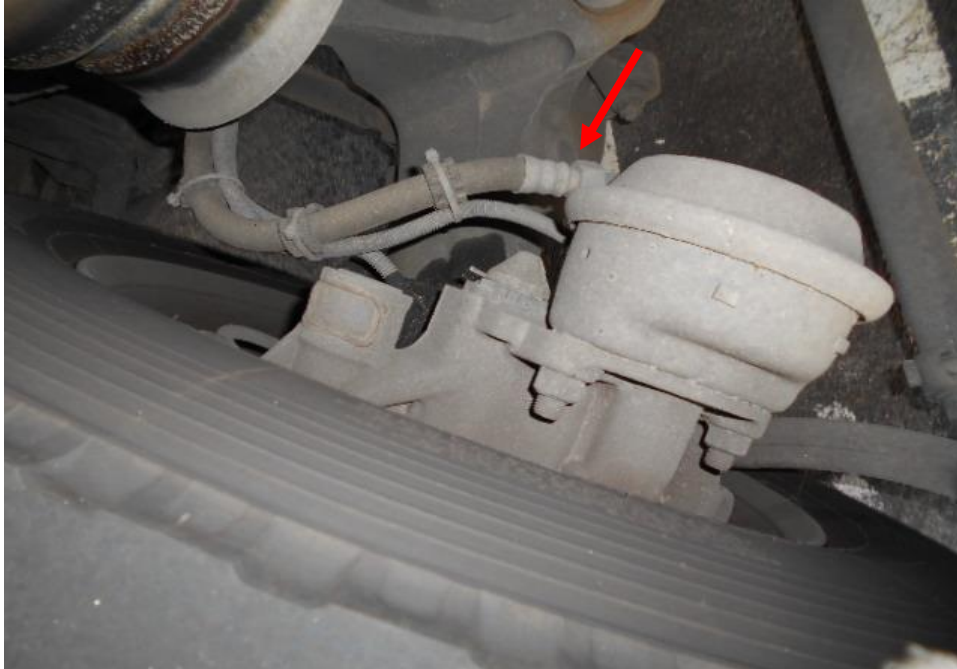
Photo 18 shows the brake pipe (arrowed) at the front left wheel of the Motor Bus. I did not observe any leakage of brake fluid at the time of my inspection of the Motor Bus. My static tests of the Motor Bus's braking system, along with my visual examination of the various mechanical components in the braking system had indicated that there was no internal leakage of pressure/vacuum. Hence the braking system of the Motor Bus was likely to be in serviceable condition at the material time of accident.

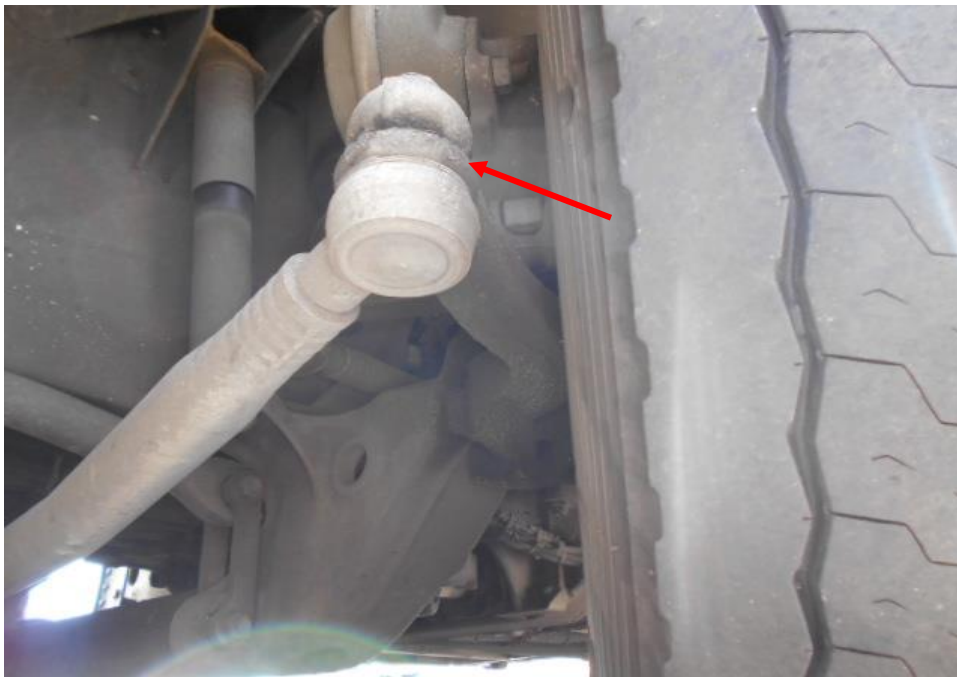
Photo 19 shows the various undercarriage components at the front right wheel of the Motor Bus, in particular the steering tie rod end (arrowed). The various steering components were all found to be intact, suggesting that the steering system of the Motor Bus was likely to be in serviceable condition at the material time of accident. There was also no sign of fluid stain(s) observed on the various undercarriage components.

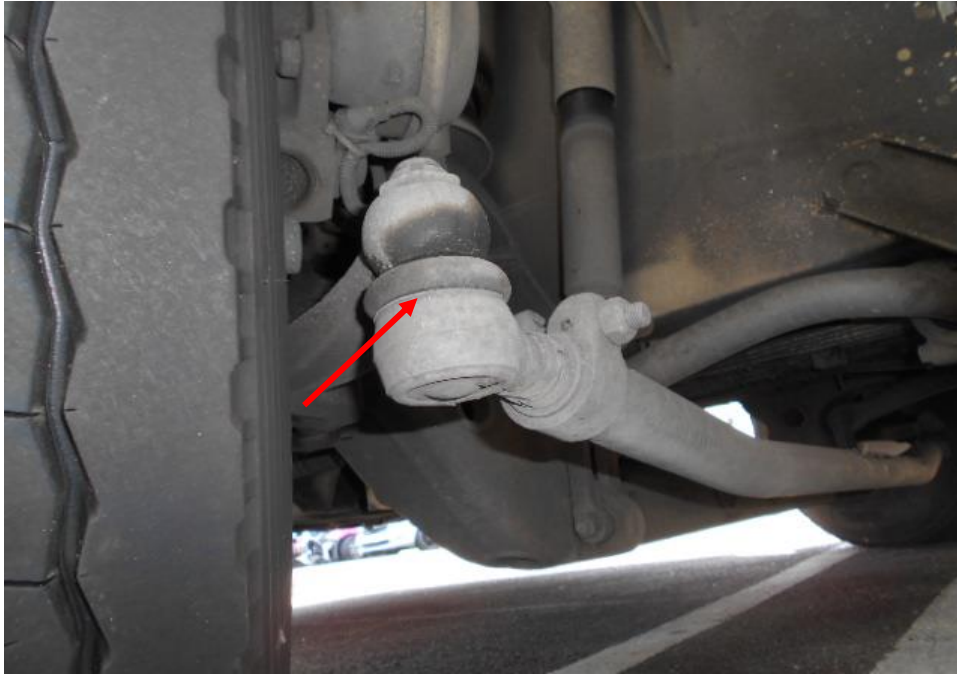
Photo 20 shows the various undercarriage components at the front left wheel of the Motor Bus, in particular the steering tie rod end (arrowed). The various undercarriage components of the Motor Bus were all found to be intact without any visible damage. There was also no sign of fluid stain(s) observed on the various undercarriage components.

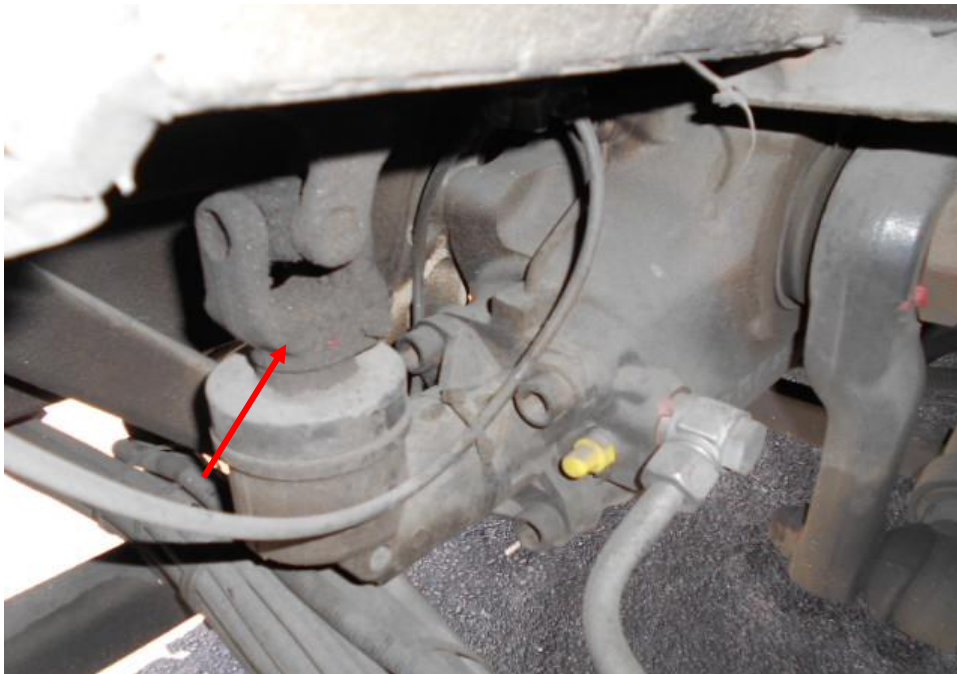
Photo 21 shows the steering box component (arrowed) at the undercarriage of the Motor Bus was found to be intact without any visible damage. There was also no sign of fluid stain(s) observed on the various undercarriage components.

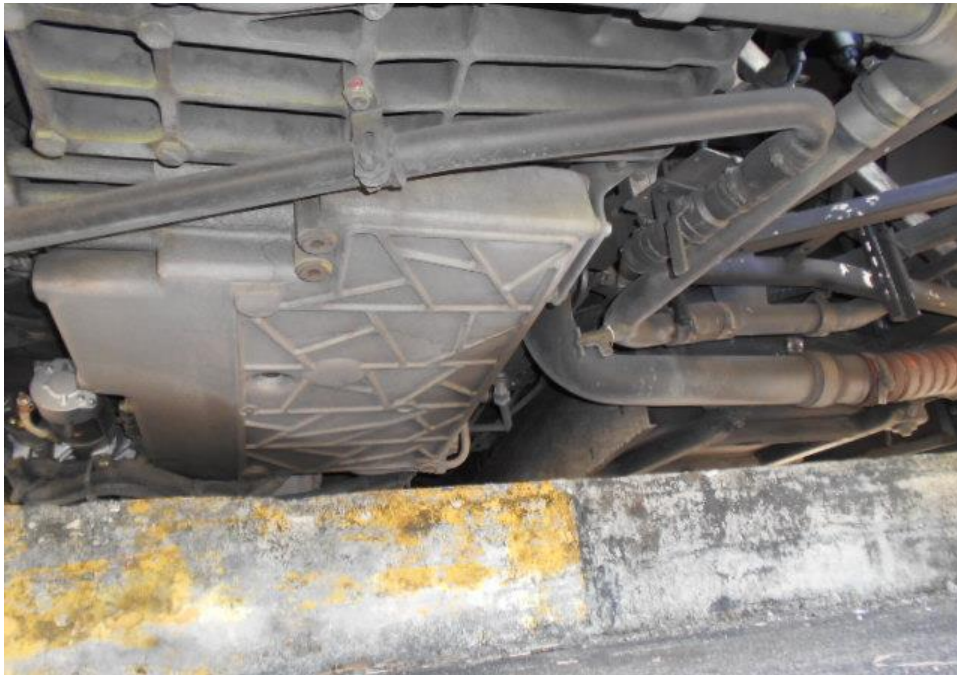
Photo 22 shows the undercarriage of the Motor Bus, at the area where the engine housing and transmission housing are located. I did not find any sign(s) or indication(s) of fluid leak and/or fluid stain(s) on the underside of the Motor Bus.

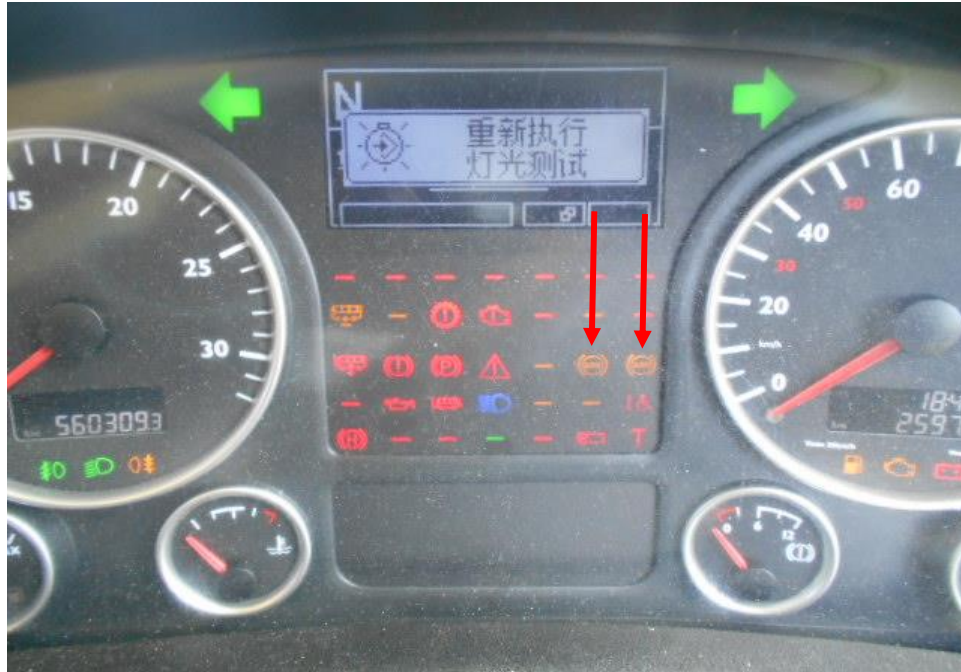
Photo 24 shows the warning light for Traction Control System (TCS) and Anti-Lock Braking System (ABS) appearing on the instrument panel of the Motor Bus during the self-test of its various electronic operating systems when its engine was cranked.

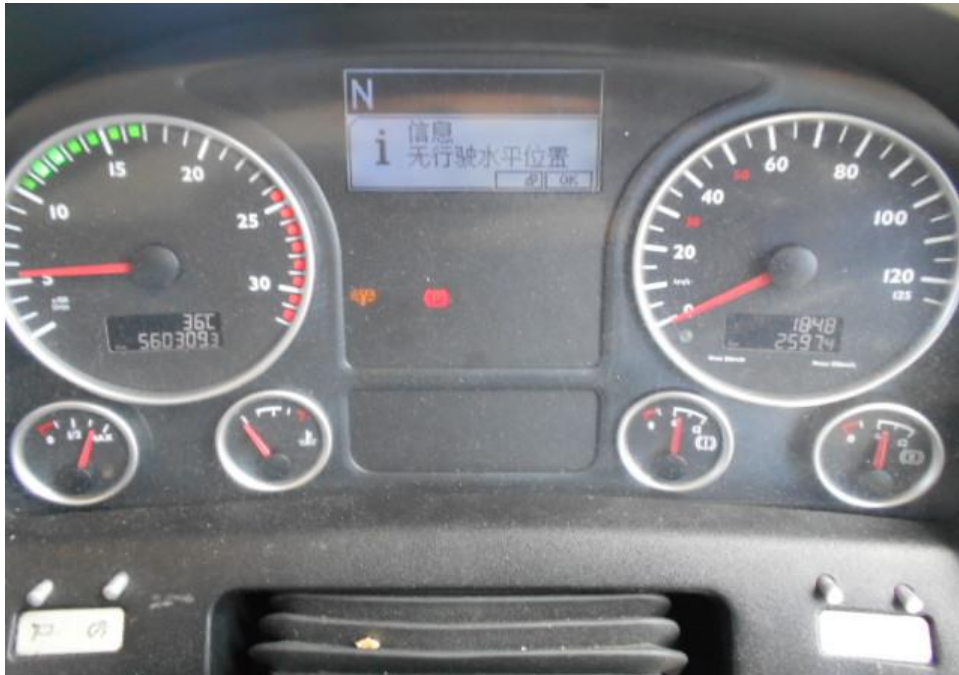
Photo 25 shows no warning lights illuminated on the instrument panel of the Motor Bus after the engine was cranked. This would suggest that there was no abnormality to the various electronic operating systems of the Motor Bus, like the TCS, ABS and etc.
