You're Ref: TP TP/12972/2023
Our Ref: CI/TPD23006801/P

17th July 2023

MECHANICAL INSPECTION REPORT OF MOTOR TAXI SHC 669K

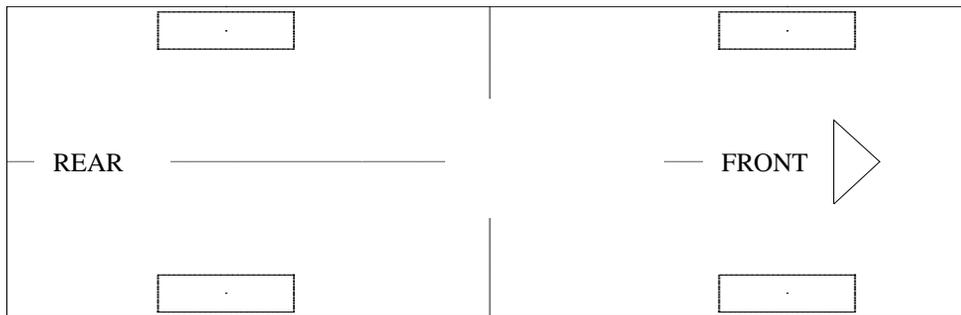
6. The condition of the Motor Car's 4 tyres was observed to be in serviceable condition. I did not find any tear, cut or burst mark(s) on the outer and the inner sidewalls as well as across the tread of the 4 tyres. The 4 tyres were also observed to be sufficiently inflated for vehicular operation. The tyre brand, tyre size and remaining tread depth of the 4 tyres were recorded as follows:-

Westlake 195/65R15 (4.4mm)

Westlake 195/65R15 (3.4mm)

Westlake 195/65R15 (4.7mm)

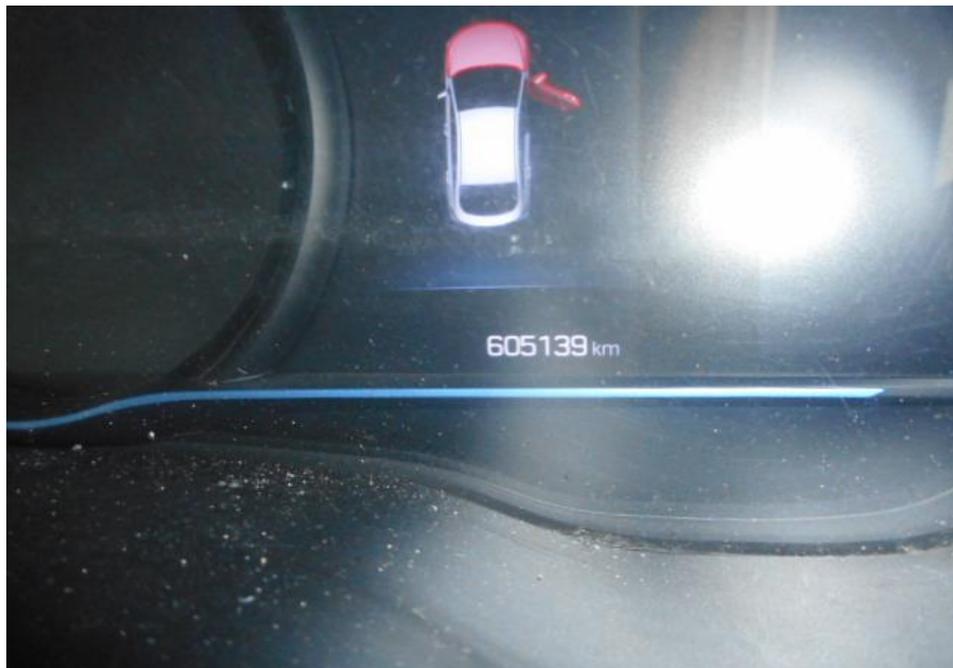
Photo 1 shows the mileage of the Motor Taxi at the time of my inspection. The mileage observed was 605,139km.

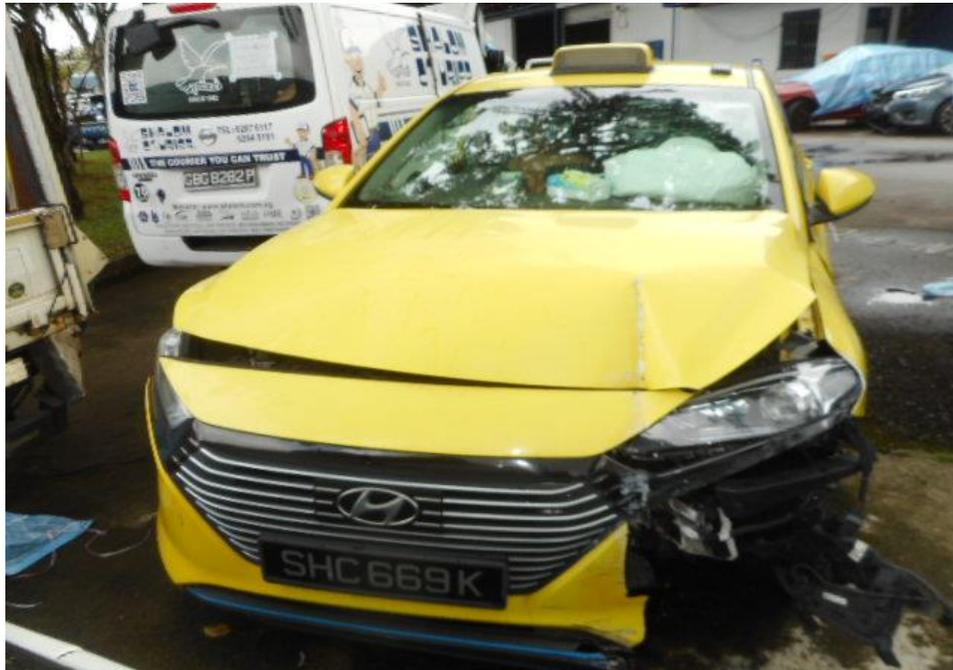
4. The mileage of the Motor Taxi at the time of my inspection was 605,139km.
5. The Motor Taxi was observed to have sustained damage at its front portion. Its front bonnet, front bumper, front left fender and front reinforcement was amongst the body parts and various engine components were also damaged as a result of the accident.

Photo 2 shows a general view of the Motor Taxi's front body at the time of my inspection. The front portion of the Motor Taxi was observed to have sustained damage. Its front windscreen, front bonnet, front bumper, front right fender and front reinforcement was amongst the body parts and various engine components were also damaged as a result of the accident.

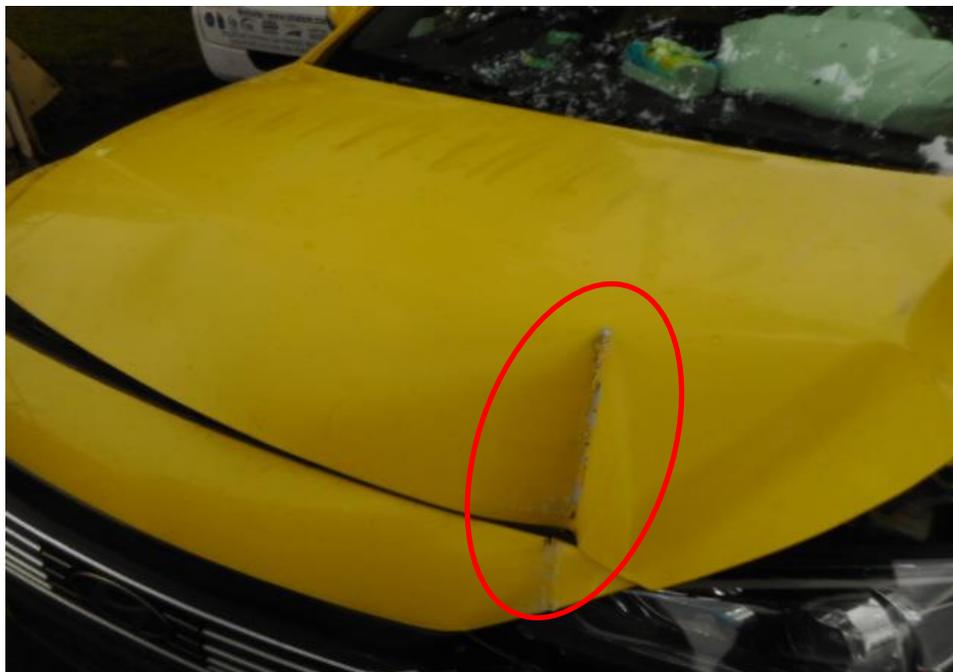
Photo 3 shows the close up view of the Motor Taxi's front body at the time of my inspection. The Motor Taxi was observed to have sustained damage at its front bonnet (circled) as a result of the accident.

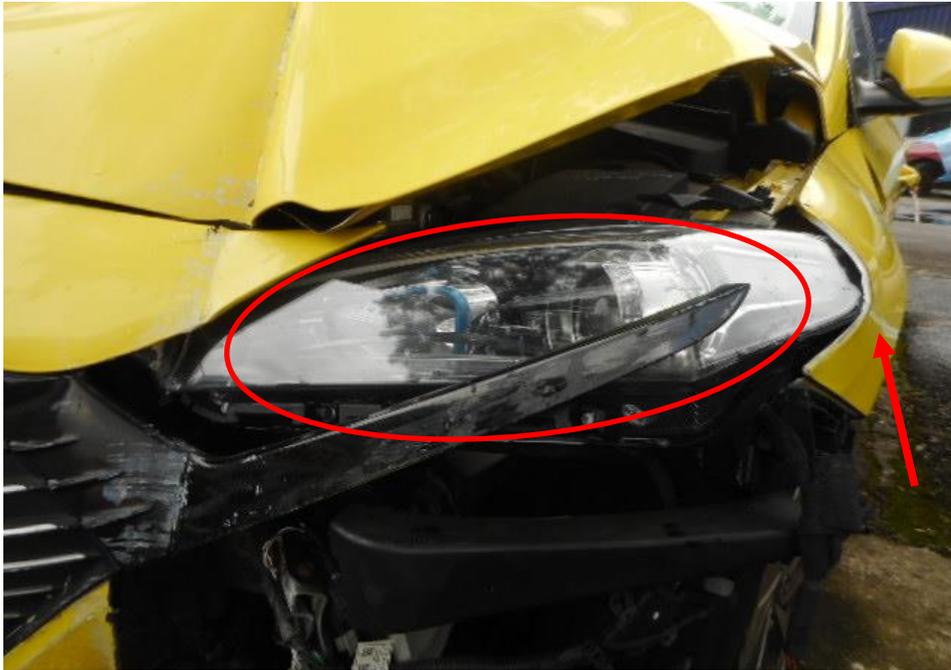
Photo 4 shows the close up view of the Motor Taxi's front body at the time of my inspection. The Motor Taxi was observed to have sustained damage at its front left headlamp (circled) and front left fender as a result of the accident.

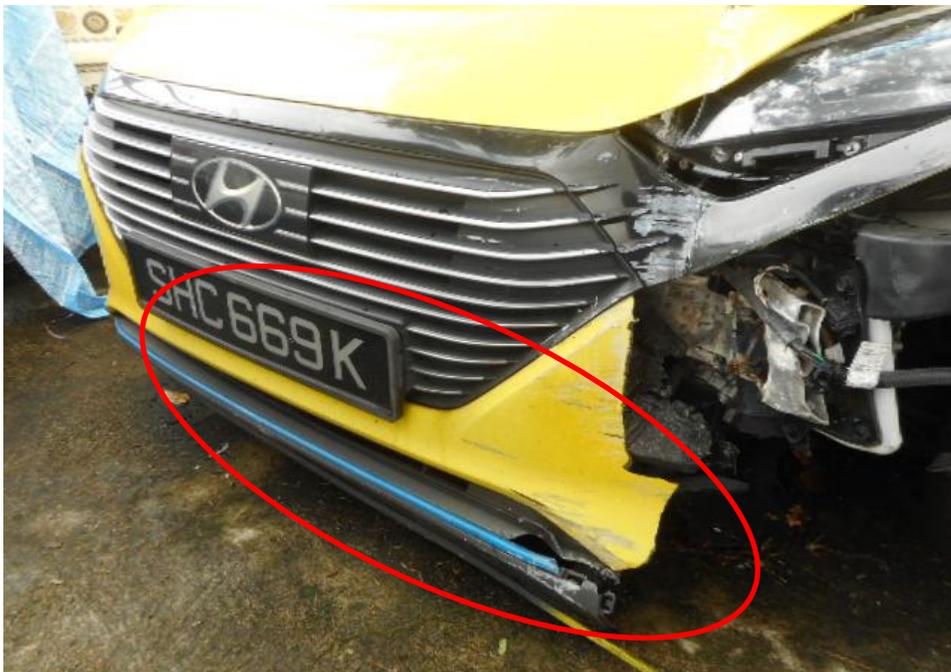
Photo 5 shows the close up view of the Motor Taxi's front body at the time of my inspection. The Motor Taxi was observed to have sustained damage at its front bumper (circled) and front left fender (arrowed) as a result of the accident.

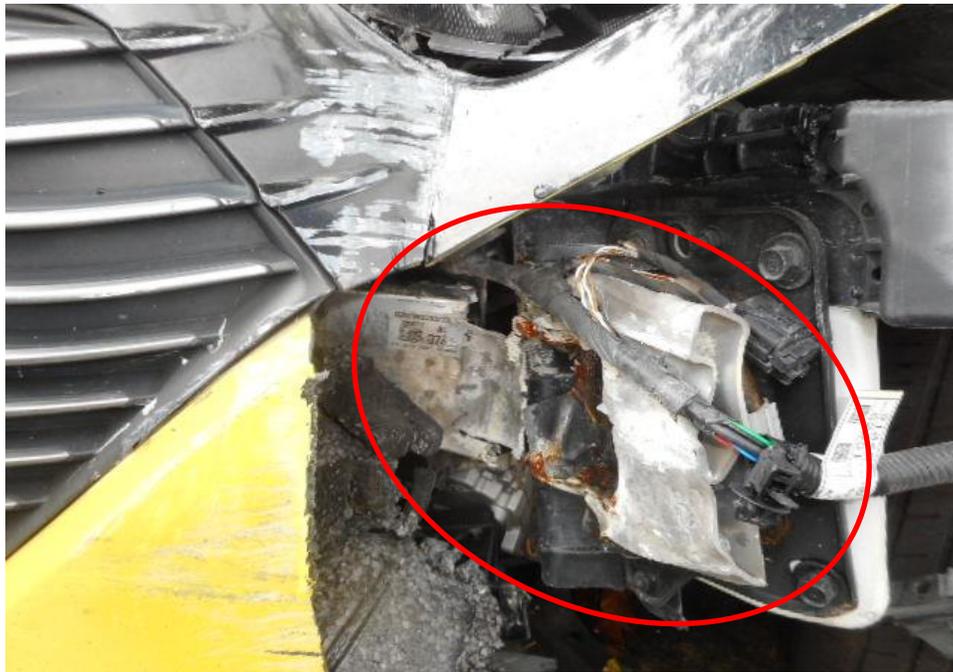
Photo 6 shows the close up view of the Motor Taxi's front body at the time of my inspection. The Motor Taxi was observed to have sustained damage at its front reinforcement (circled) as a result of the accident.

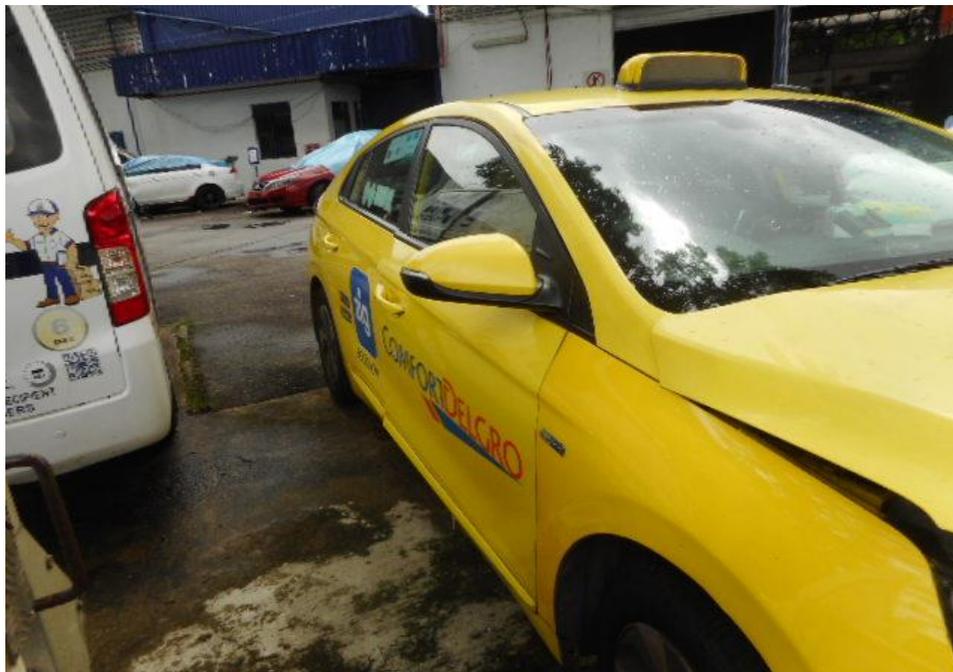
Photo 7 shows a general view of the Motor Taxi's right body at the time of my inspection. The right portion of the Motor Taxi was observed to have been unaffected by the accident.

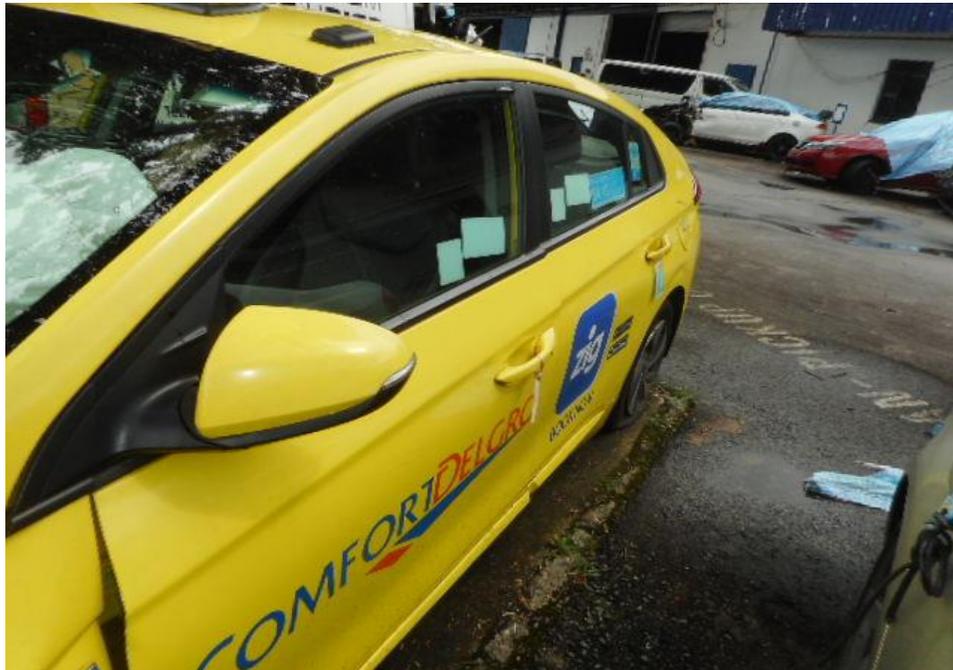
Photo 8 shows a general view of the Motor Taxi's left body at the time of my inspection. The left portion of the Motor Taxi was observed to have been unaffected by the accident.

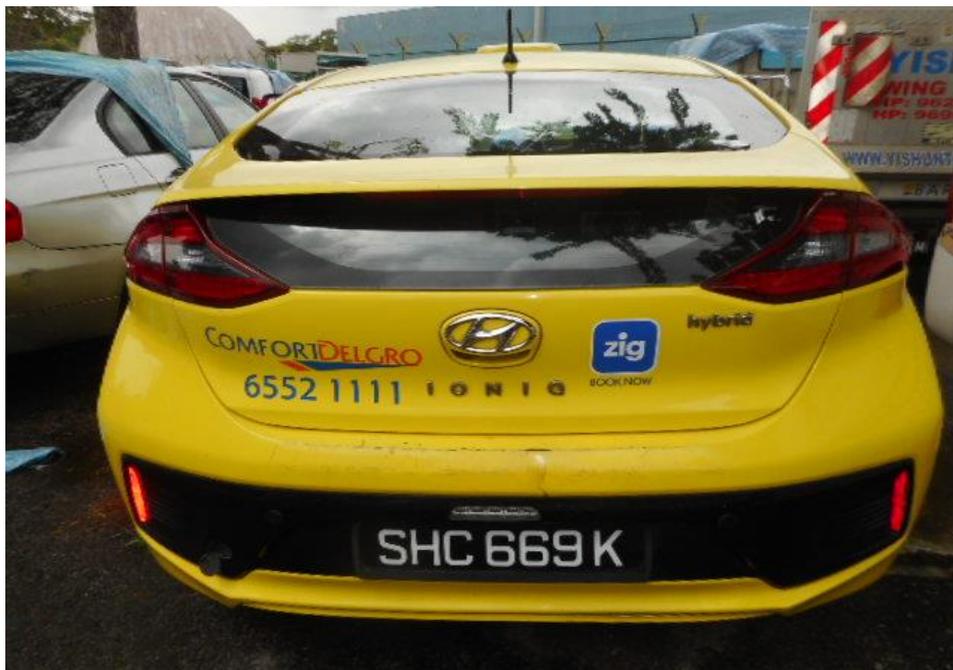
Photo 9 shows the general view of the Motor Taxi's rear body at the time of my inspection. The Motor Taxi rear was observed to be unaffected by the accident.

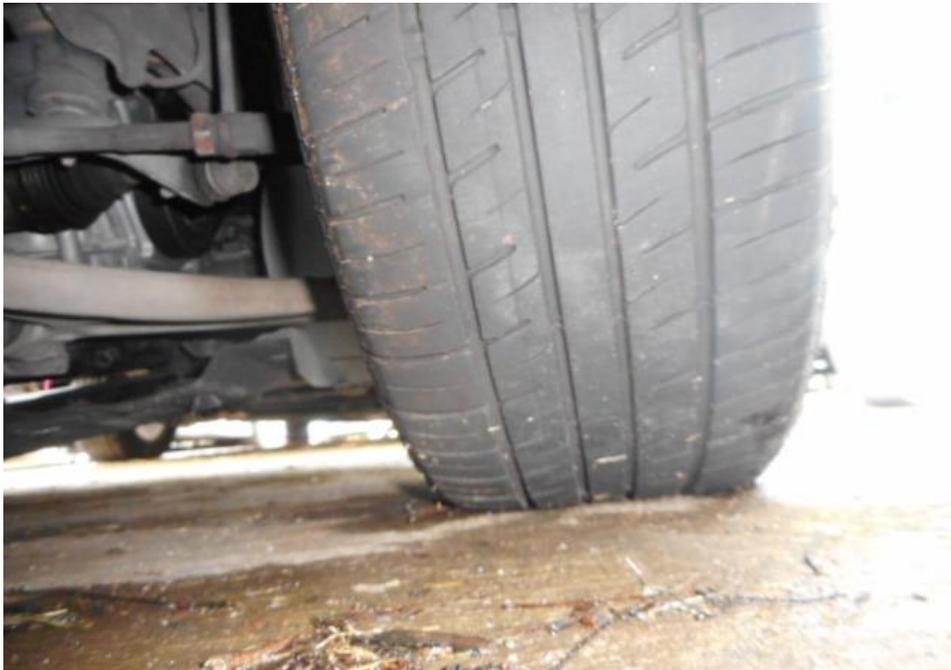
Photo 10 shows the condition of the front right tyre of the Motor Taxi, which was observed to be in serviceable condition with remaining tread depth of approximately 4.7mm. The tyre was also observed to be sufficiently inflated for vehicular operation with no tear, cut or burst mark(s).

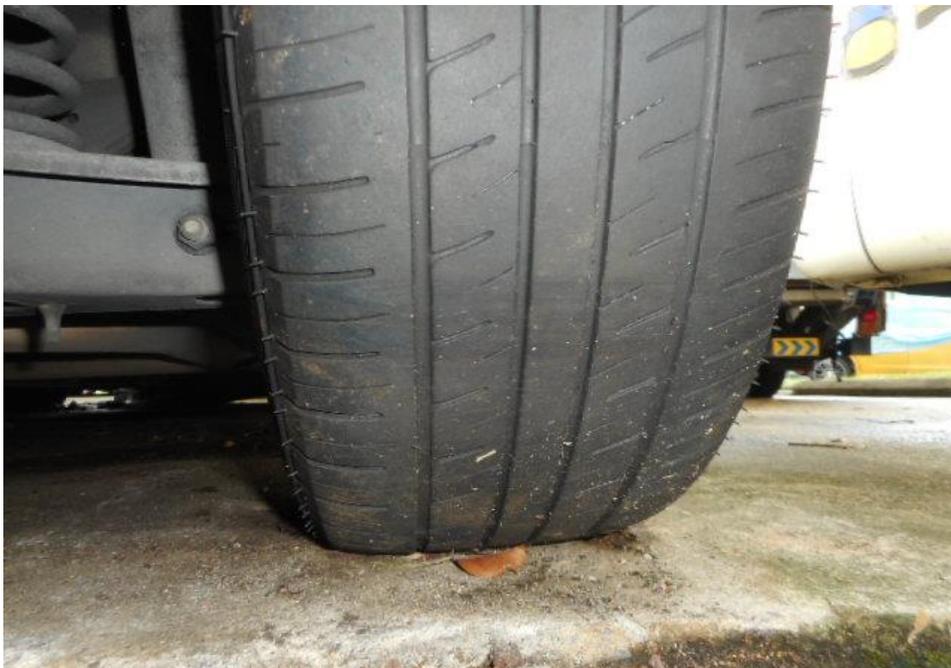
Photo 11 shows the condition of the rear right tyre of the Motor Taxi, which was observed to be in serviceable condition with remaining tread depth of approximately 3.4mm. The tyre was also observed to be sufficiently inflated for vehicular operation with no tear, cut or burst mark(s).

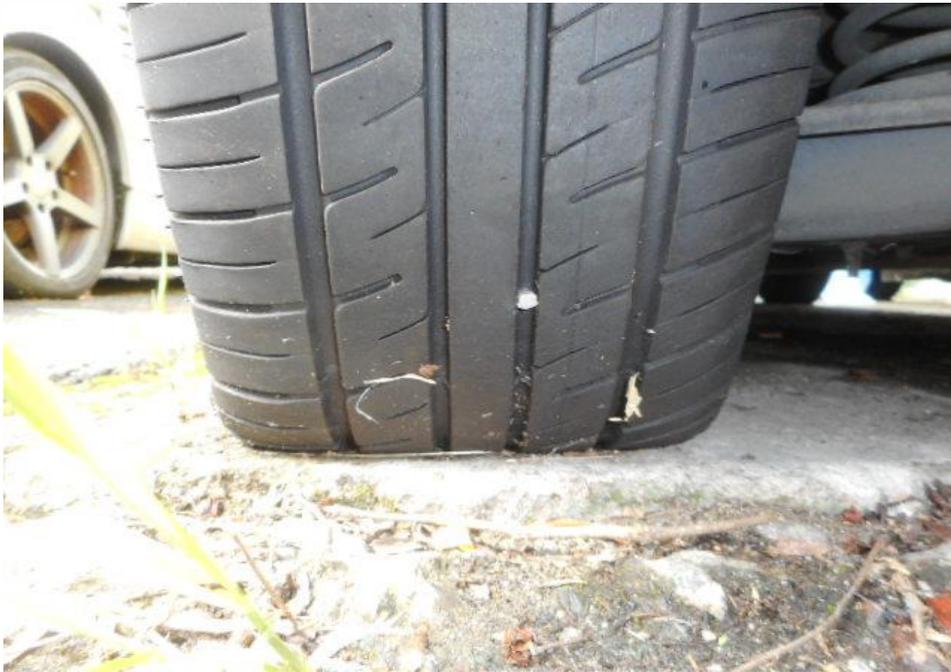
Photo 12 shows the condition of the rear left tyre of the Motor Taxi, which was observed to be in serviceable condition with remaining tread depth of approximately 4.4mm. The tyre, which was wrapped around steel wheel rim, was also observed to be sufficiently inflated for vehicular operation. The 4 tyres of the Motor Taxi were wrapped around standard steel wheel rims.

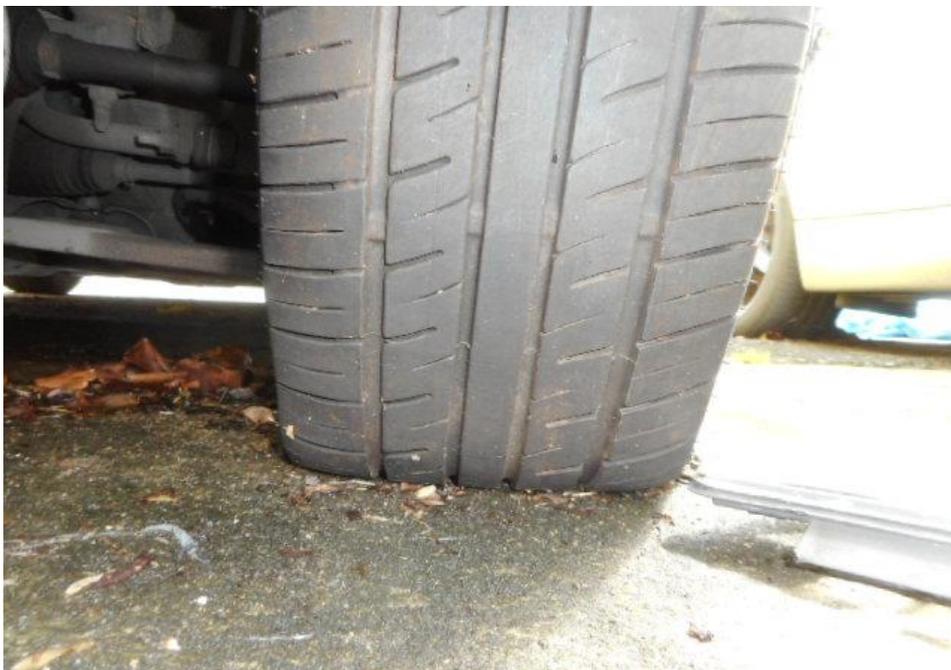
Photo 13 shows the condition of the front left tyre of the Motor Taxi, which was observed to be in serviceable condition with remaining tread depth of approximately 4.4mm. The tyre was also observed to be sufficiently inflated for vehicular operation with no tear, cut or burst mark(s).

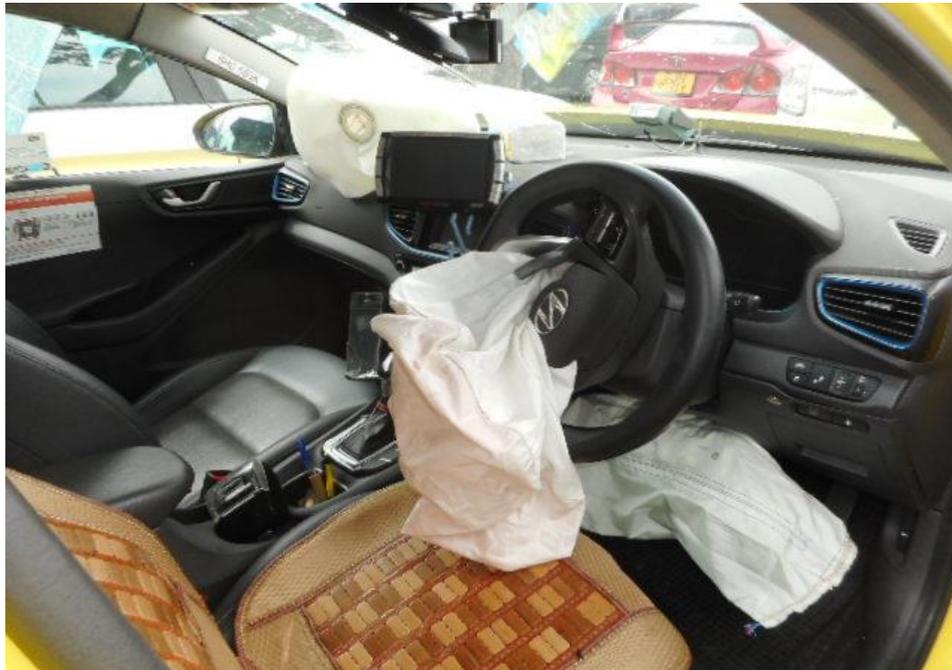
Photo 14 shows the deployment of the Supplemental Restraint System (SRS) airbag in the Motor Taxi as a result of the accident.

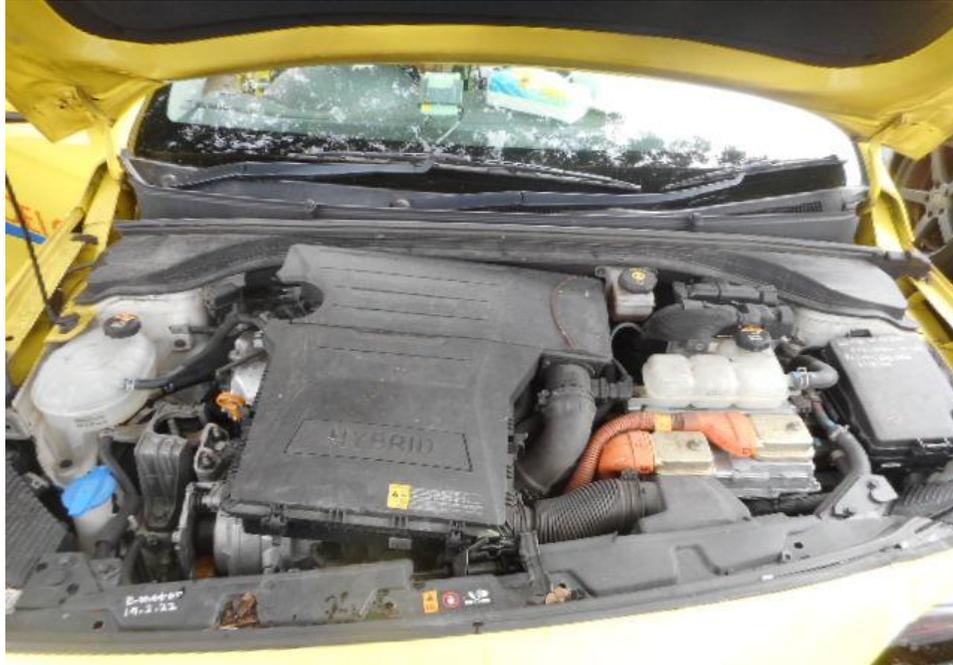
9. Further examination of the engine compartment revealed no sign(s) or indication(s) of fluid leakage and/or fluid stain within the engine compartment of the Motor Taxi. The engine air filter box, throttle body, engine cooling fan and electrical wirings was observed to be damaged as a result of the induce impact as a result of the accident.

Photo 15 shows a general view of the Motor Taxi's engine compartment, I had observed that the engine air filter box, throttle body, engine cooling fan and electrical wirings was observed to be damaged as a result of the induce impact as a result of the accident.

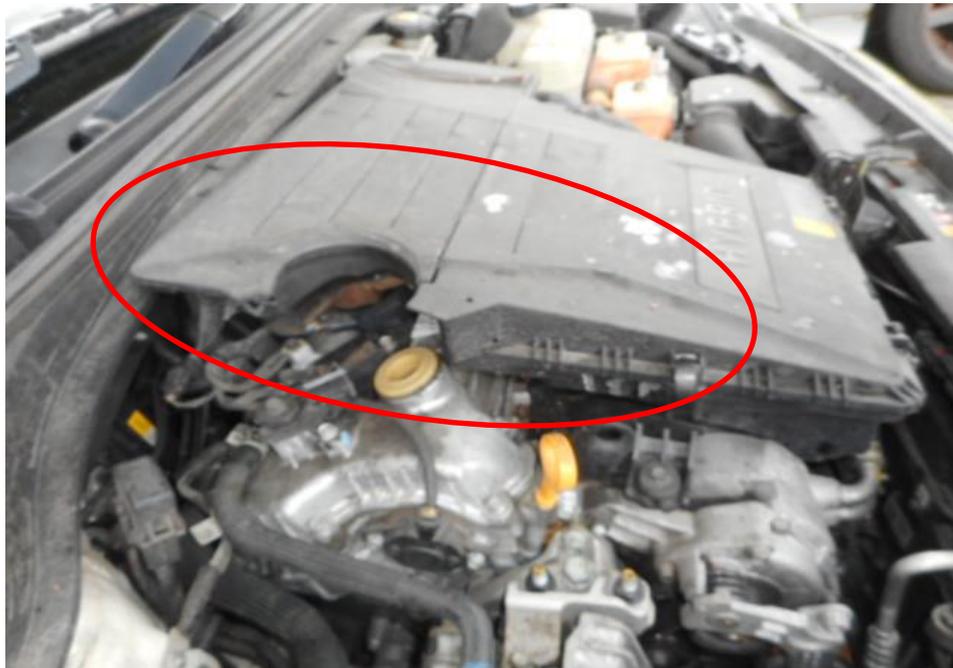
Photo 16 shows the close up view of the engine compartment of the Motor Taxi at the time of my inspection. The engine air filter box (circled) of the Motor Taxi was damaged as a result of the accident.

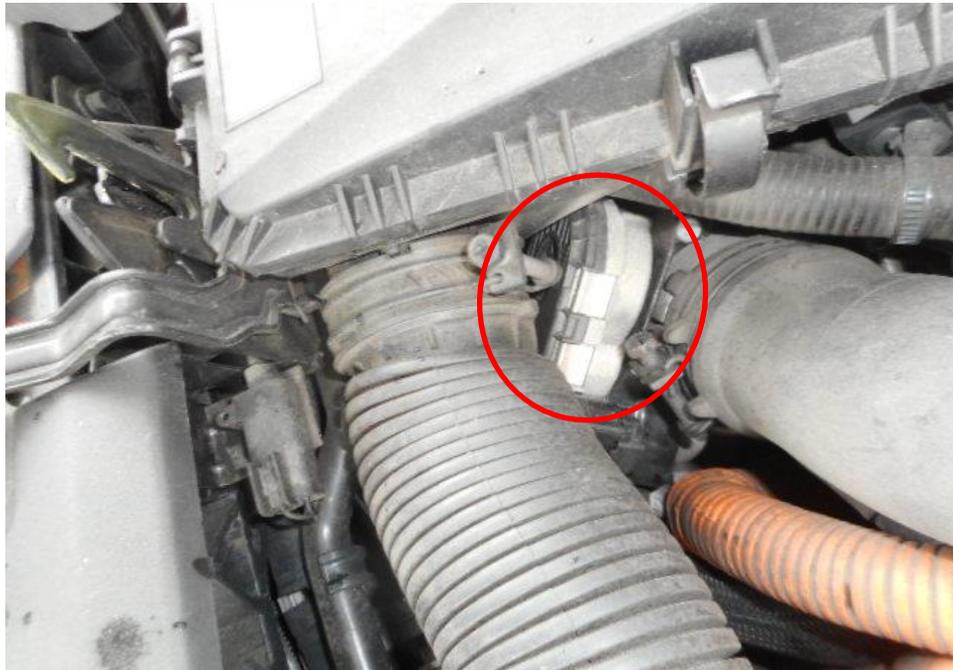
Photo 17 shows the close up view of the engine compartment of the Motor Taxi at the time of my inspection. The engine throttle body (circled) of the Motor Taxi was damaged as a result of the accident.

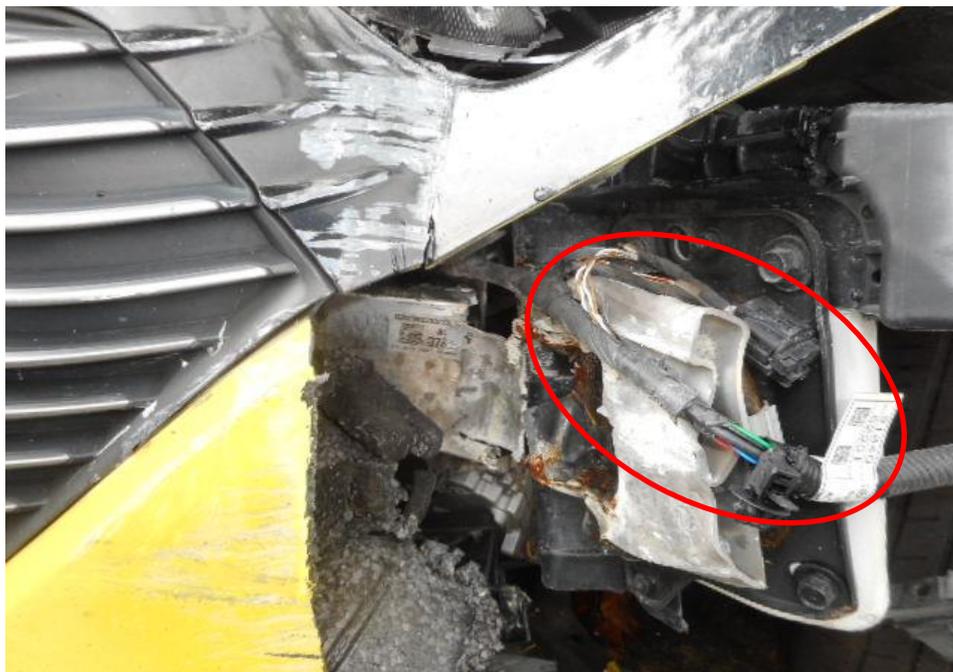
Photo 18 shows the close up view of the engine compartment of the Motor Taxi at the time of my inspection. The electrical wirings (circled) of the Motor Taxi was damaged as a result of the accident.

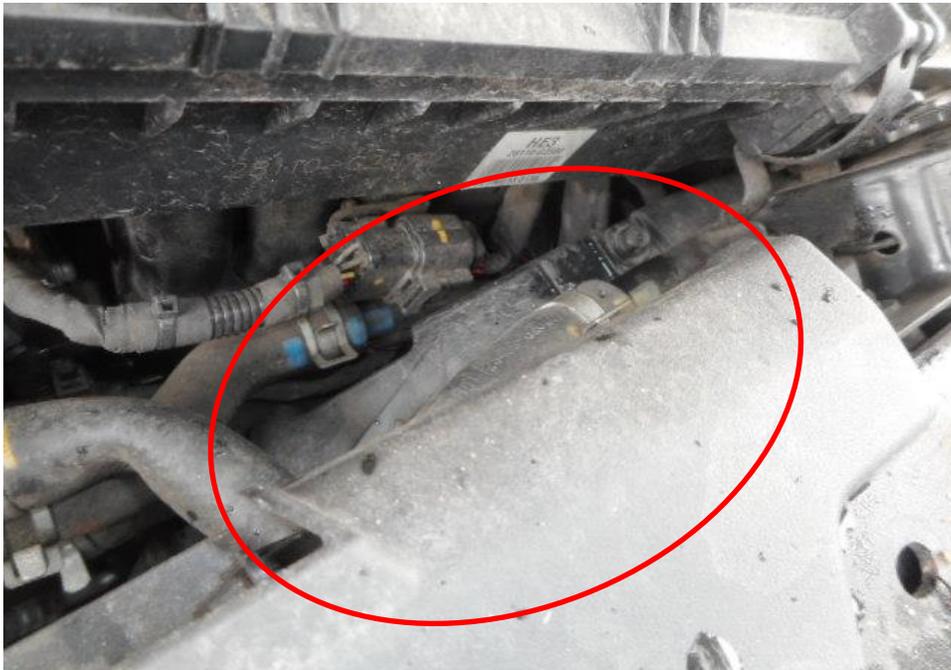
Photo 19 shows the close up view of the engine compartment of the Motor Taxi at the time of my inspection. The electrical wirings (circled) of the Motor Taxi was damaged as a result of the accident.

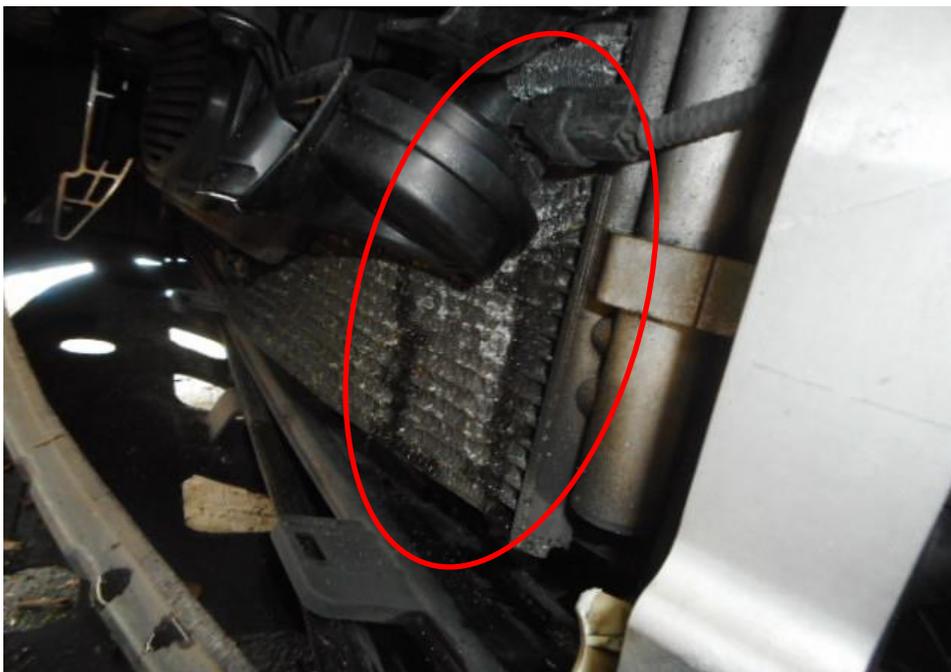
Photo 20 shows the close up view of the engine coolant radiator of the Motor Taxi at the time of my inspection. The engine coolant radiator (circled) of the Motor Taxi was damaged as a result of the accident.

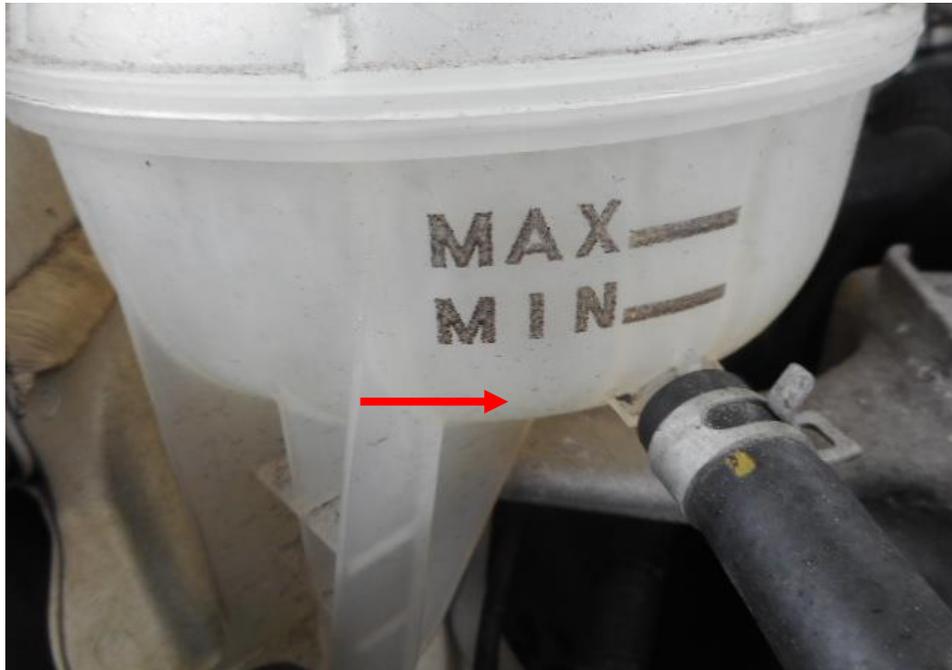
8. Upon examination of the engine compartment of the Motor Taxi, the brake fluid and engine oil were all found to be of sufficient level for operating purposes. Visually, there was also no contamination found to these fluids. However, the engine coolant was observed to be insufficient as the engine coolant radiator was damaged by the accident.

Photo 21 shows checks being carried out to the engine coolant of the Motor Taxi at the time of my inspection. The engine coolant was observed to be of insufficient level (arrowed) as the damage to the engine coolant hose has caused a leakage.

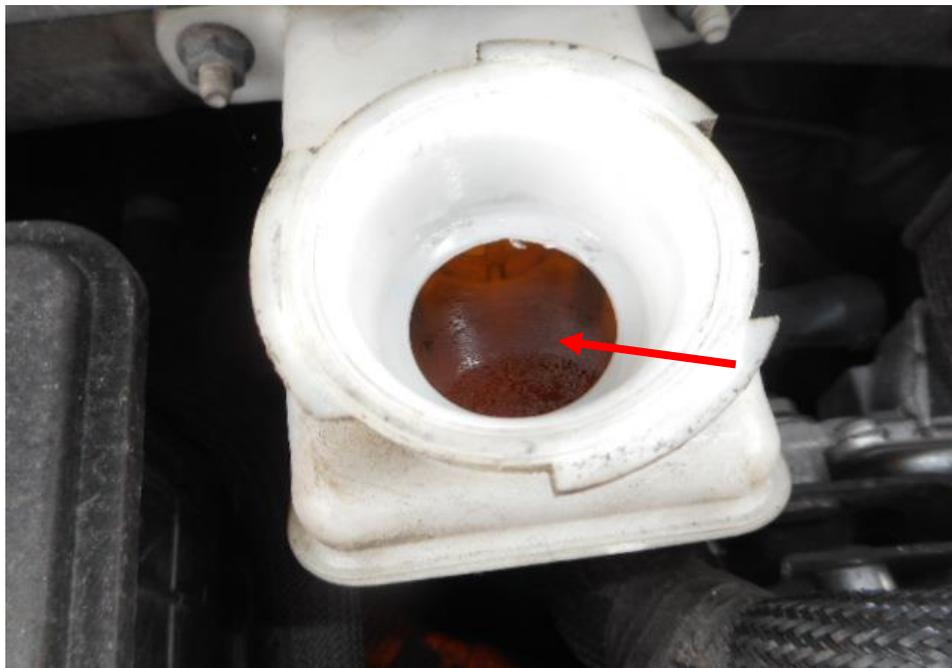
Photo 22 shows the brake fluid reservoir of the Motor Taxi at the time of my inspection. The brake fluid was observed to be of sufficient level (arrowed) and without any visible contamination.

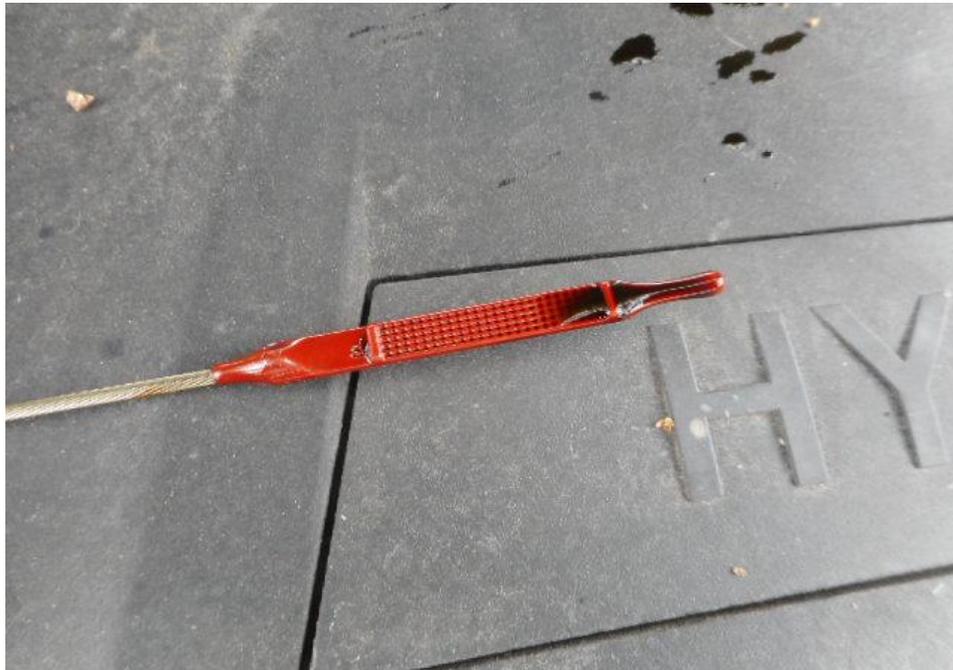
Photo 23 shows the engine oil dip stick of the Motor Taxi at the time of my inspection. The engine oil was observed to be of sufficient level and without any visible contamination.

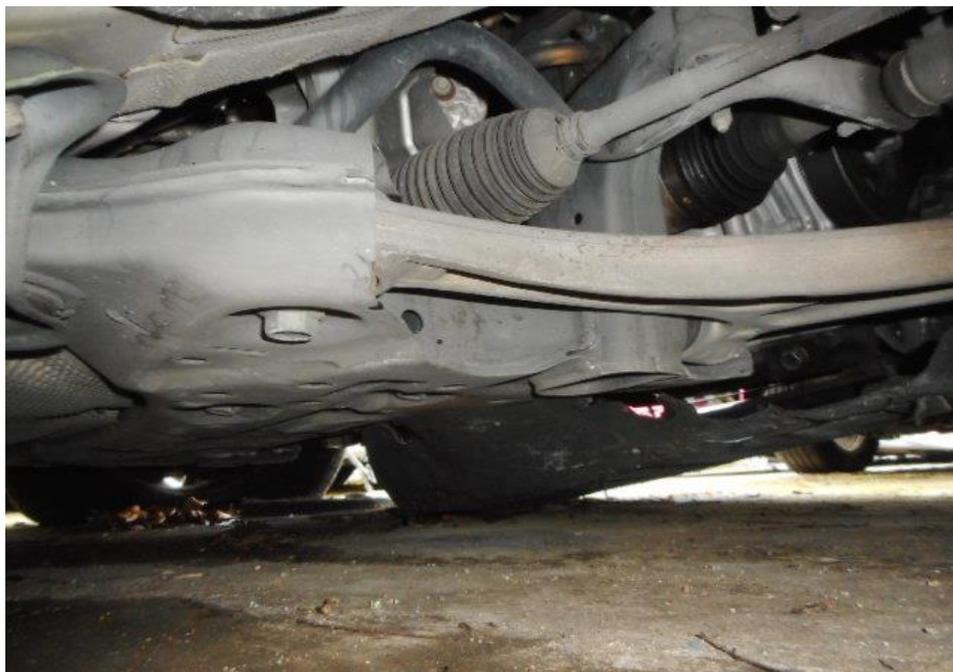
10. My subsequent checks on the underside of the Motor Taxi also revealed no sign(s) or indication(s) of fluid leak and/or fluid stain(s). Visually, the various undercarriage components of the Motor Taxi were all observed to be intact and without any visible damage. See photo 15 – 24 below.

Photo 24 shows the undercarriage of the Motor Taxi, at the area where the engine housing and transmission housing are located. I did not find any sign(s) or indication(s) of fluid leak and/or fluid stain(s) on the underside of the Motor Taxi.

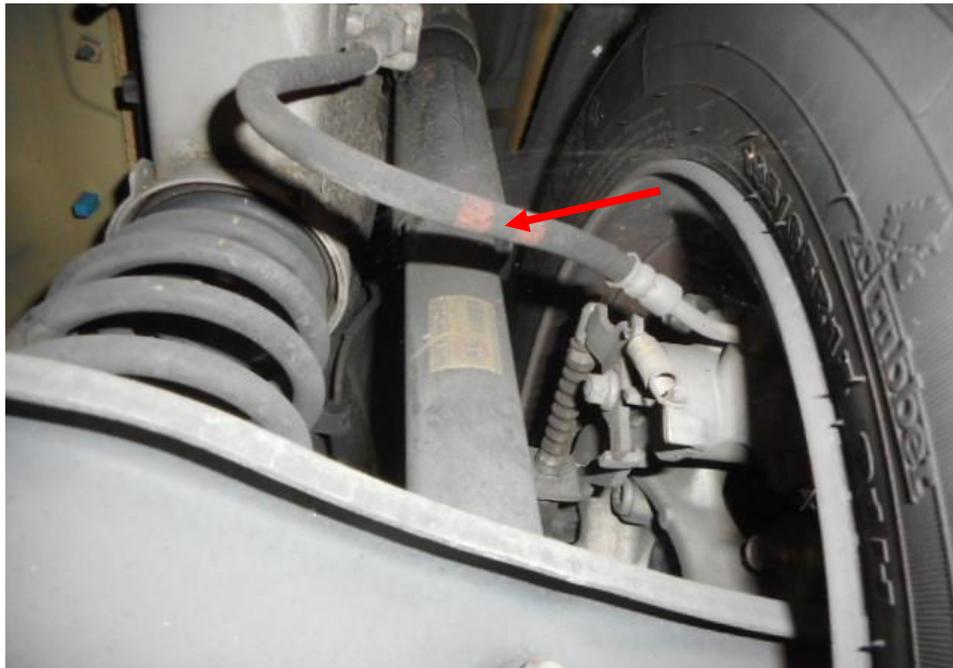
Photo 25 shows the brake hose/pipe (arrowed) at the rear right wheel of the Motor Taxi. No leakage of brake fluid was observed. Visual examination of the various components of the braking system like the drum brake, brake booster, brake pedal etc. had revealed all to be intact and without visible damage.

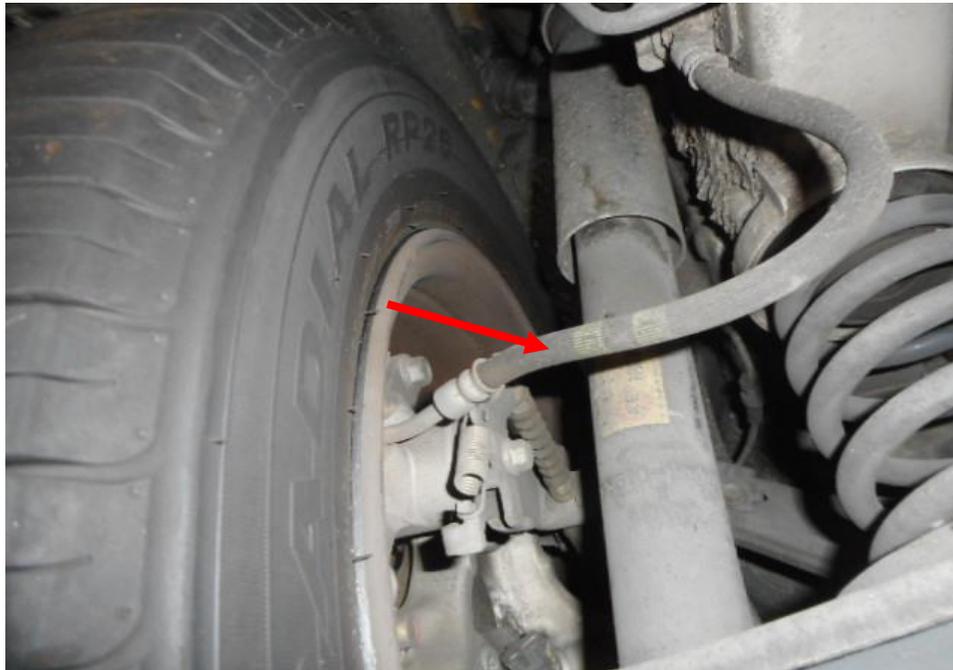
Photo 26 shows the brake hose/pipe (arrowed) at the rear left wheel of the Motor Taxi. I did not observe any leakage of brake fluid at the time of my inspection of the Motor Taxi. The undercarriage components of the Motor Taxi were also all found to be intact and without any visible damage.

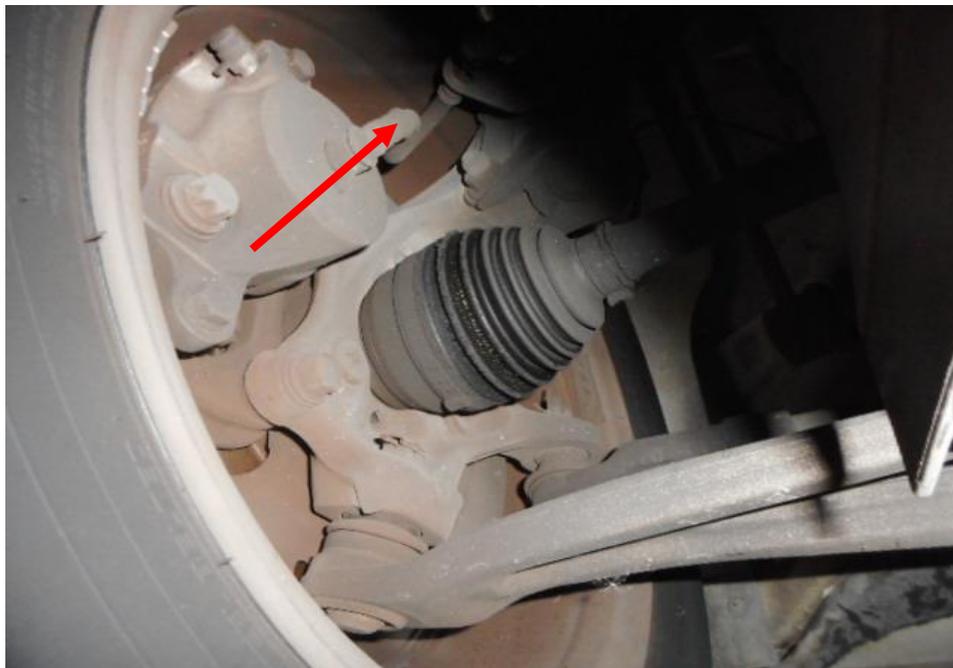
Photo 27 shows the brake hose/pipe (arrowed) at the front right wheel of the Motor Taxi. I did not observe any leakage of brake fluid at the time of my inspection of the Motor Taxi. The undercarriage components of the Motor Taxi were also all found to be intact and without any visible damage.

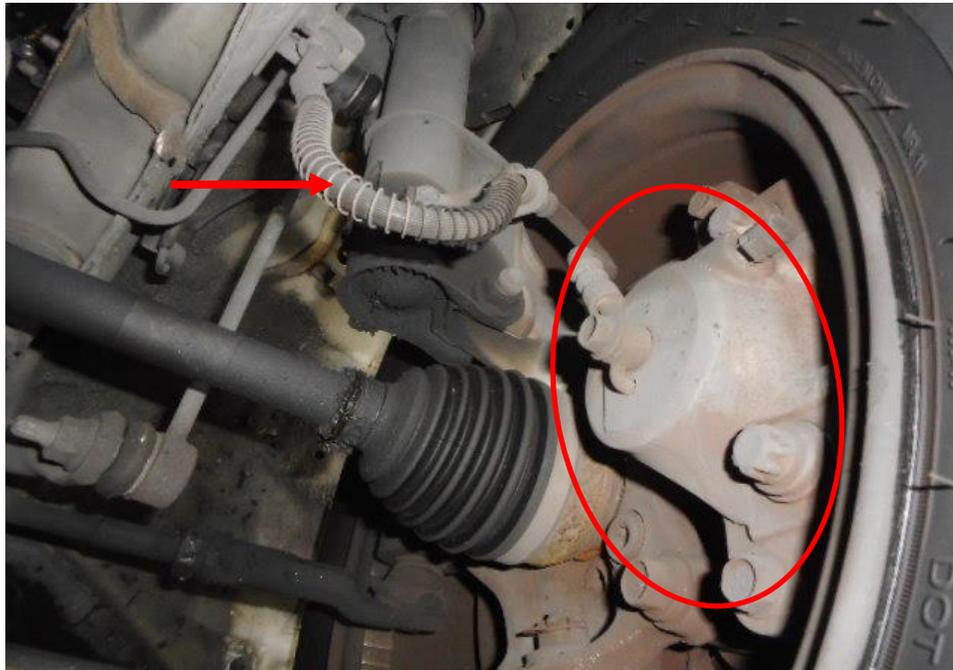
Photo 28 shows the brake hose/pipe (arrowed) at the front left wheel of the Motor Taxi. No leakage of brake fluid was observed. Visual examination of the various components of the braking system like the brake caliper (circled), brake booster, brake pedal etc had revealed all to be intact and without visible damage.

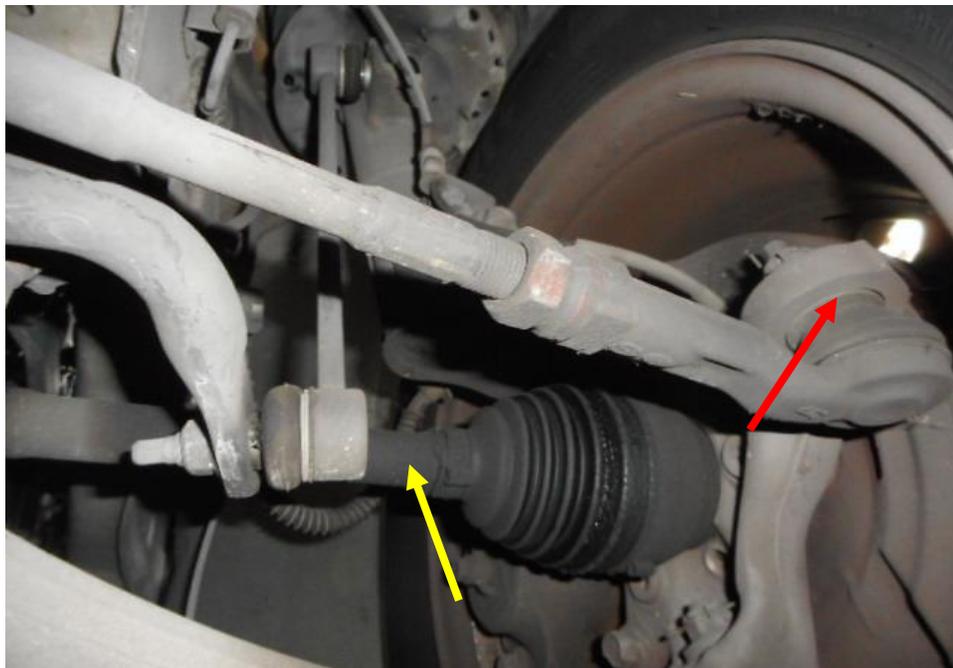
Photo 29 shows the various undercarriage components at the front right wheel of the Motor Taxi, which had included the steering tie rod (arrowed) and drive shaft (yellow arrow). The various undercarriage components of the Motor Taxi were all found to be intact without any visible damage.

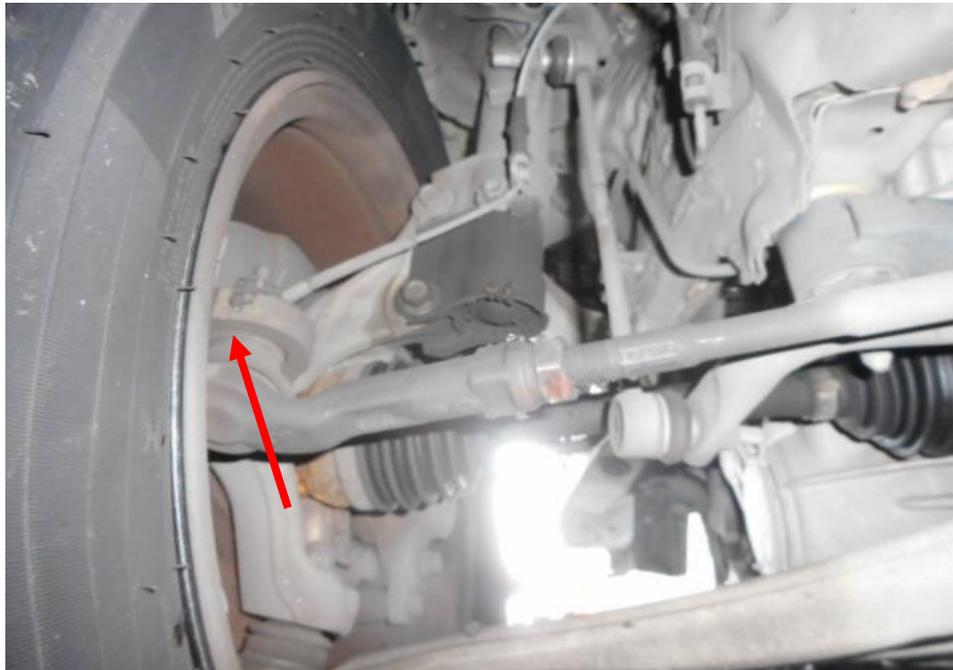
Photo 30 shows the various undercarriage components at the front left wheel of the Motor Taxi, which had included the steering tie rod (arrowed). The various undercarriage components of the Motor Taxi were all found to be intact without any visible damage.

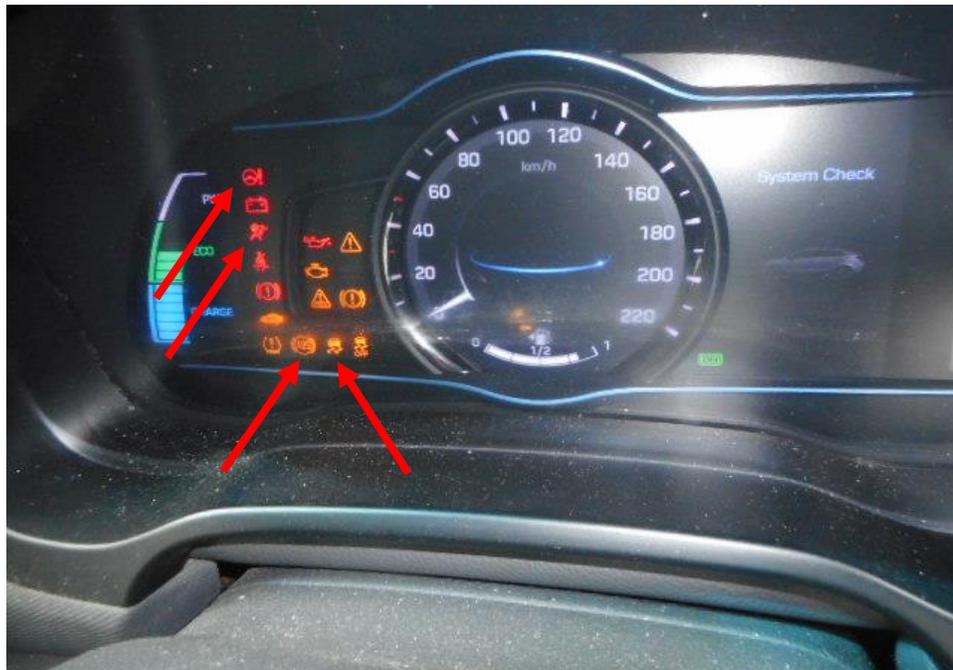
13. The Motor Taxi 's automatic self-test of the functionality of its electronic operating systems like the Anti-Lock Brake System (ABS) and Electric Power Steering System (EPS) and Traction Control System (TCS) during cranking of the engine had indicated that the system were in working condition and without abnormality. This can be established from the warning lights disappearing from the instrument panel after the self-test. However, the Supplemental Restraint System (SRS), engine light and coolant light remained illuminated as a result of the deployment of the airbag, damages to the electrical throttle body and electrical wirings as well as insufficient coolant in the engine due to the damaged coolant radiator as a result of the accident. See photo 31 & 32 below.

Photo 31 shows the warning light for Anti-Lock Brake System (ABS) and Power Steering System (EPS), Supplemental Restraint System (SRS) and Traction Control (TC) (arrowed) appearing on the instrument panel of the Motor Taxi during the self-test of its various electronic operating systems when its engine was cranked.
