You're Ref: TP TP/12972/2023
Our Ref: CI/TPD23006801/P

17th July 2023

MECHANICAL INSPECTION REPORT OF MOTOR TAXI SHC 669K

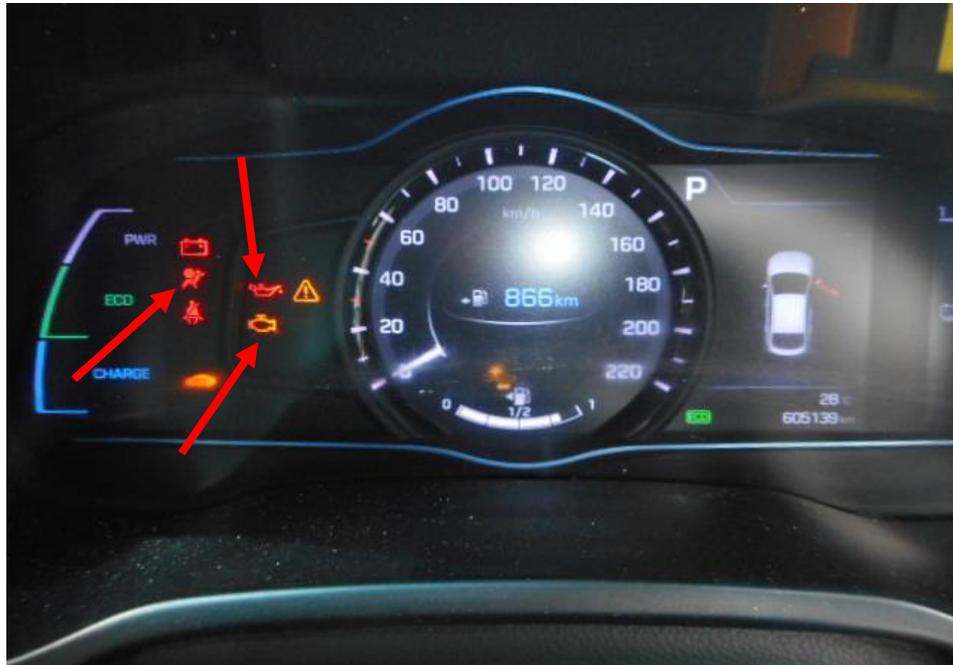
Photo 32 shows only the warning lights of the Supplemental Restraint System (SRS), engine light and coolant light remained illuminated on the instrument panel of the Motor Taxi after the engine was cranked and these was a result of the deployment of the airbag, damages to the electrical throttle body and electrical wirings as well as insufficient coolant in the engine due to the damaged coolant radiator as a result of the accident. However, the ABS, EPS and TCS did not light up and this would suggest that there was no abnormality to the electronic operating system of the Motor Taxi, like the ABS, EPS, SRS, and TCs etc.

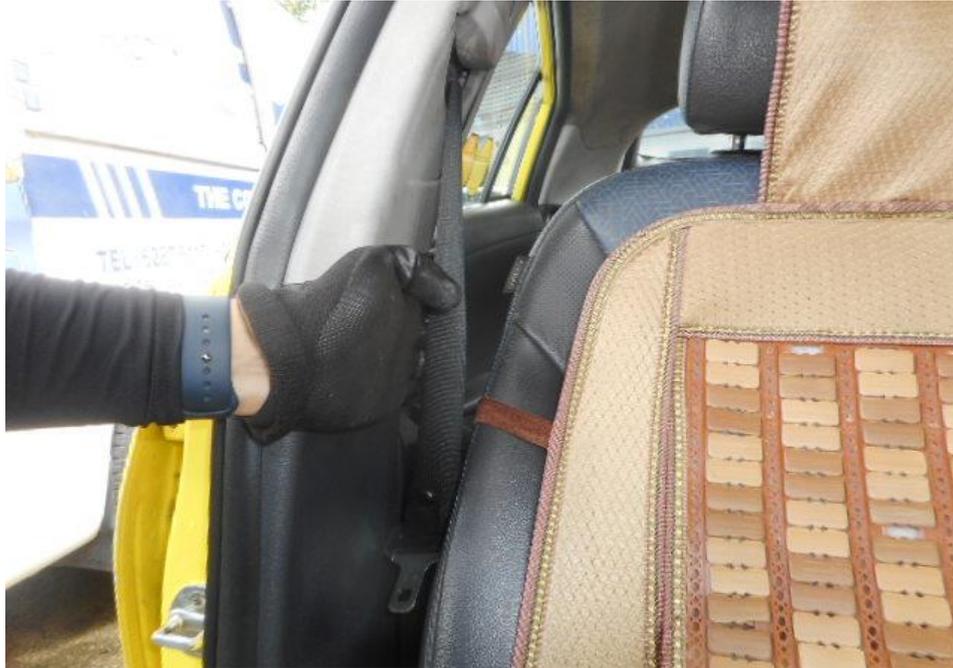
14. The right and left seat belt of the “Motor Taxi” was not worn at the material time of accident as the respective pre-tensioners that were fitted at the side of each seat was activated upon the material time. See photo 33 and 34 below.

Photo 33 shows that the seat belt on the right seat was not worn at the material time of accident as the safety pre-tensioners was activated at the moment of impact and caused the seat belt to be locked into the last position.

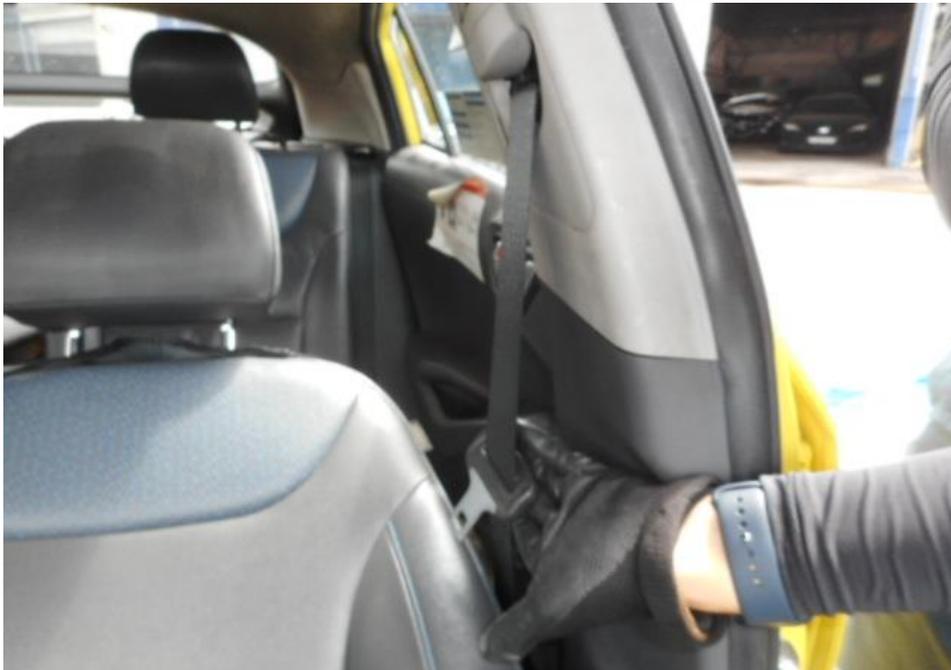
Photo 34 shows that the seat belt on the left seat was not worn at the material time of accident as the safety pre-tensioners was activated at the moment of impact and caused the seat belt to be locked into the last position.
