You're Ref: TP TP/13497/2023
Our Ref: CI/TPD23006805/P

28th July 2023

MECHANICAL INSPECTION REPORT OF MOTOR CAR SME 1267K

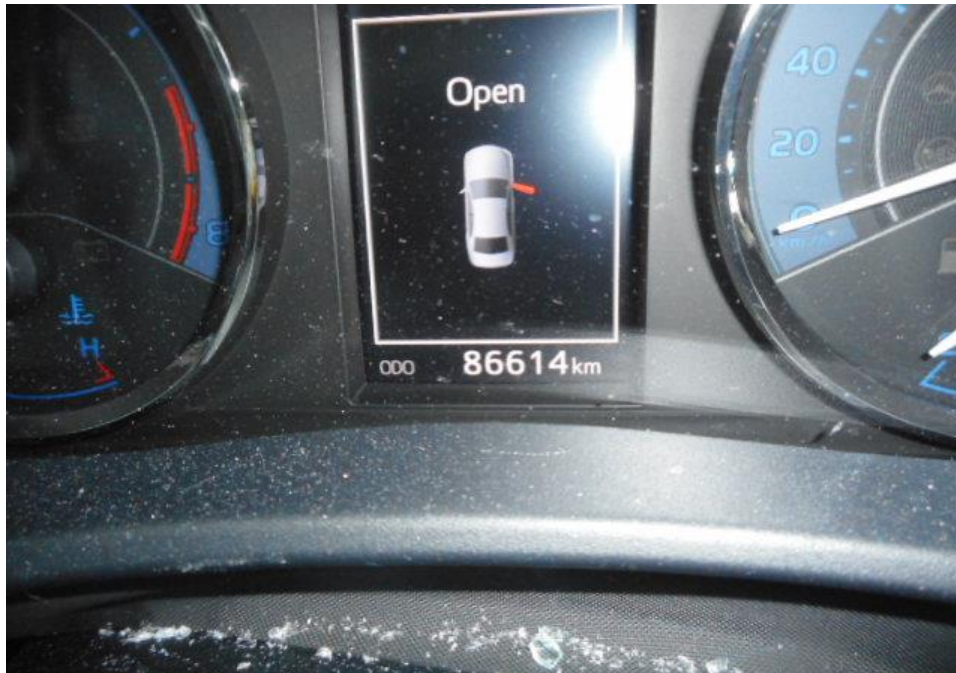
Photo 1 shows the mileage of the Motor Car at the time of my inspection. The mileage observed was 86,614km.

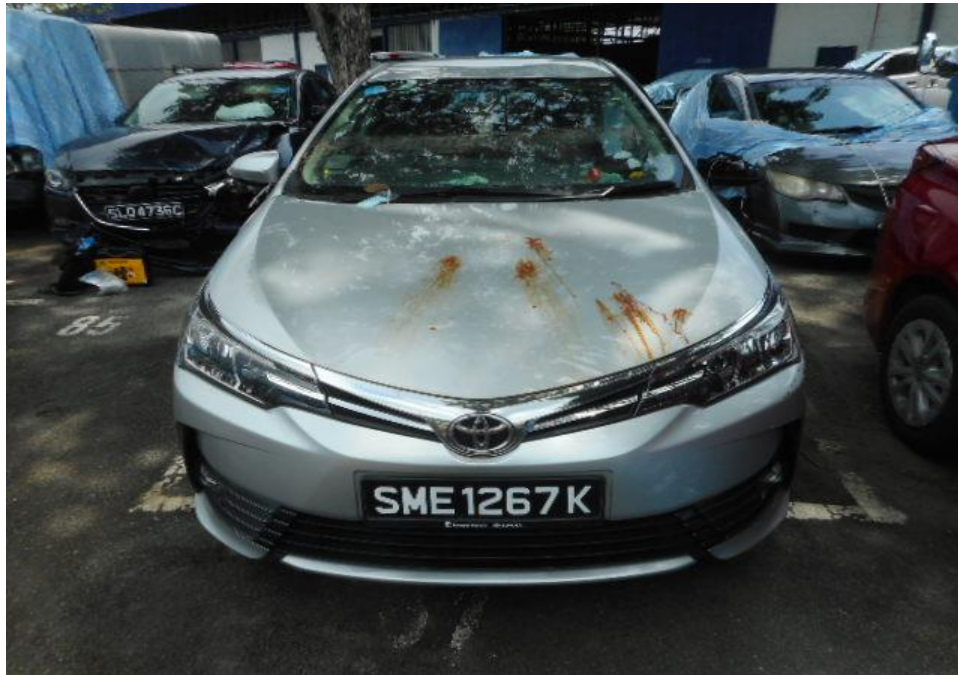
Photo 2 shows the general view of the Motor Car's front body at the time of my inspection. The Motor Car front was observed to be unaffected by the accident.

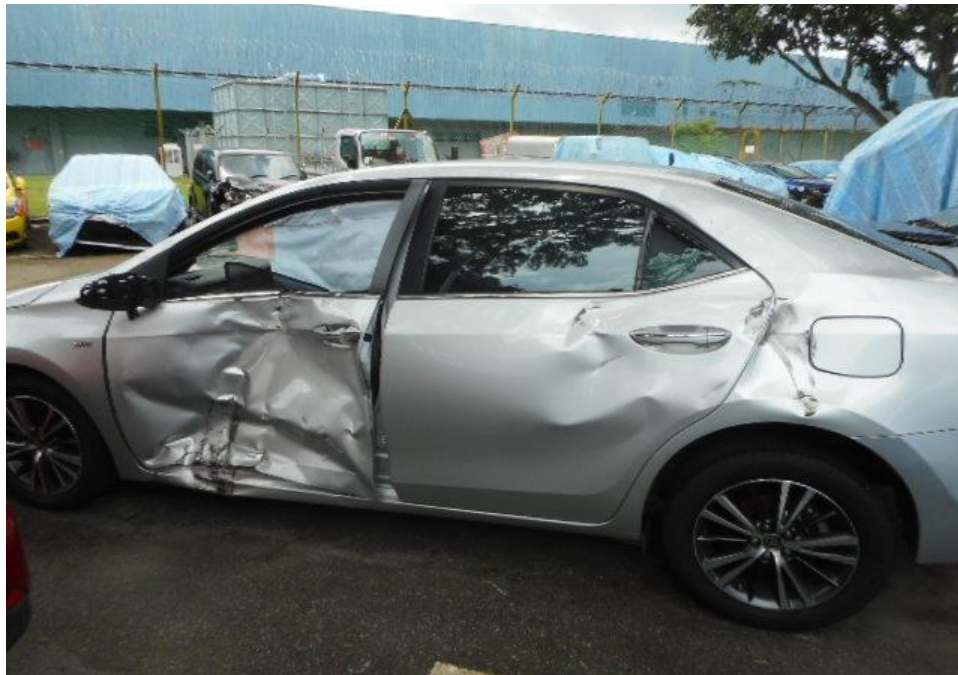
Photo 3 shows a general view of the Motor Car's left body at the time of my inspection. The left portion of the Motor Car was observed to have sustained damage. Its left rear view mirror, left doors, left side windscreen, left quarter body panel and its roof was amongst the body parts that were damaged as a result of the accident. The Supplemental Restraint System (SRS) was activated as a result of the accident.

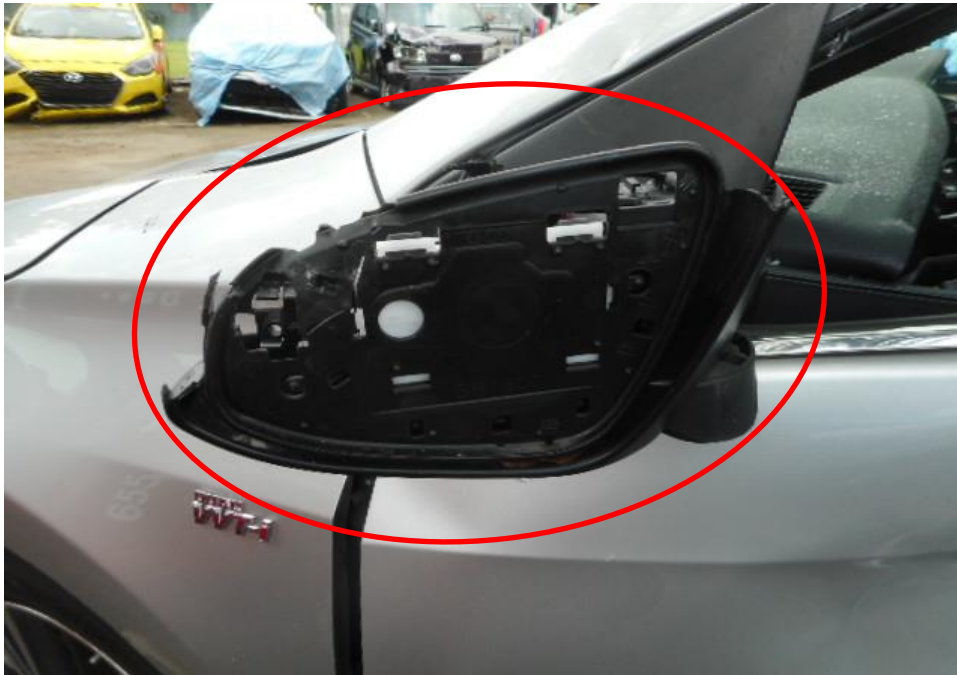
Photo 4 shows a close up view of the Motor Car's left body at the time of my inspection. The left portion of the Motor Car was observed to have sustained damage. Its left rear view mirror (circled) was the body parts that were damaged as a result of the accident.

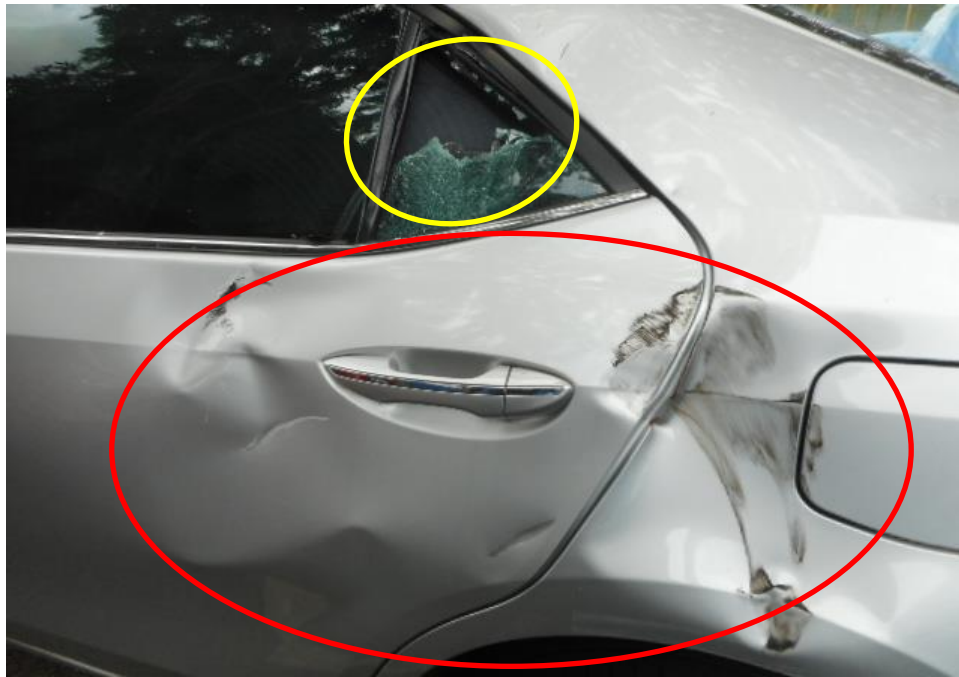
Photo 6 shows a close up view of the Motor Car's left body at the time of my inspection. The left portion of the Motor Car was observed to have sustained damage. Its left door, its left quarter body panel (red circle) and its left windscreen (yellow circle) and was the body parts that were damaged as a result of the accident.

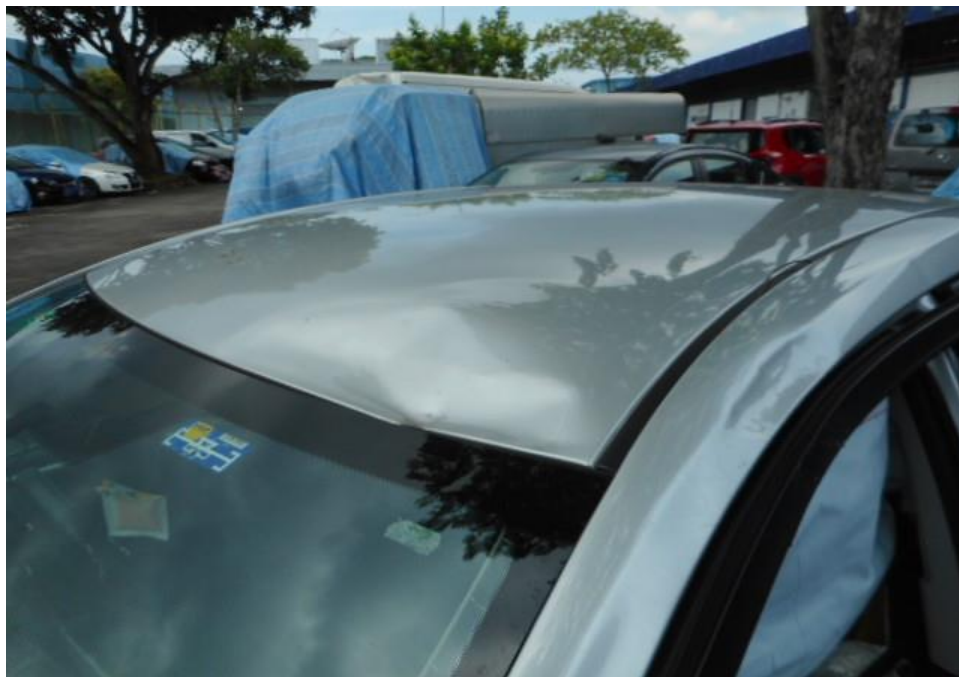
Photo 7 shows a general view of the Motor Car's roof at the time of my inspection. The roof portion of the Motor Car was observed to have sustained damage. Its roof was amongst the body parts that were damaged as a result of the accident.

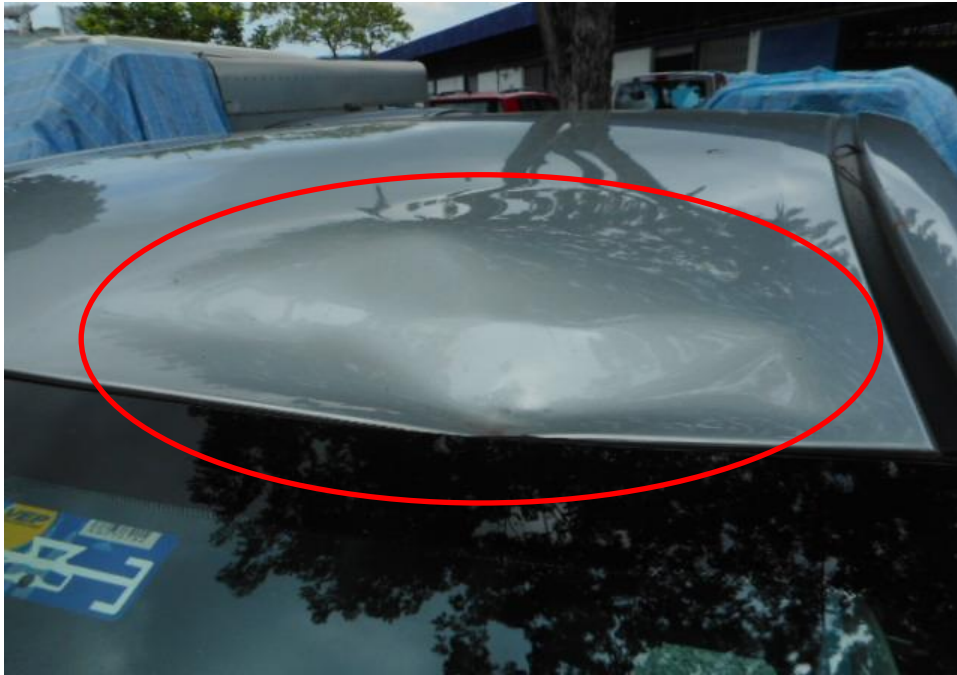
Photo 8 shows a close up view of the Motor Car's roof at the time of my inspection. The roof portion of the Motor Car was observed to have sustained damage. Its roof (circled) was amongst the body parts that were damaged as a result of the accident.

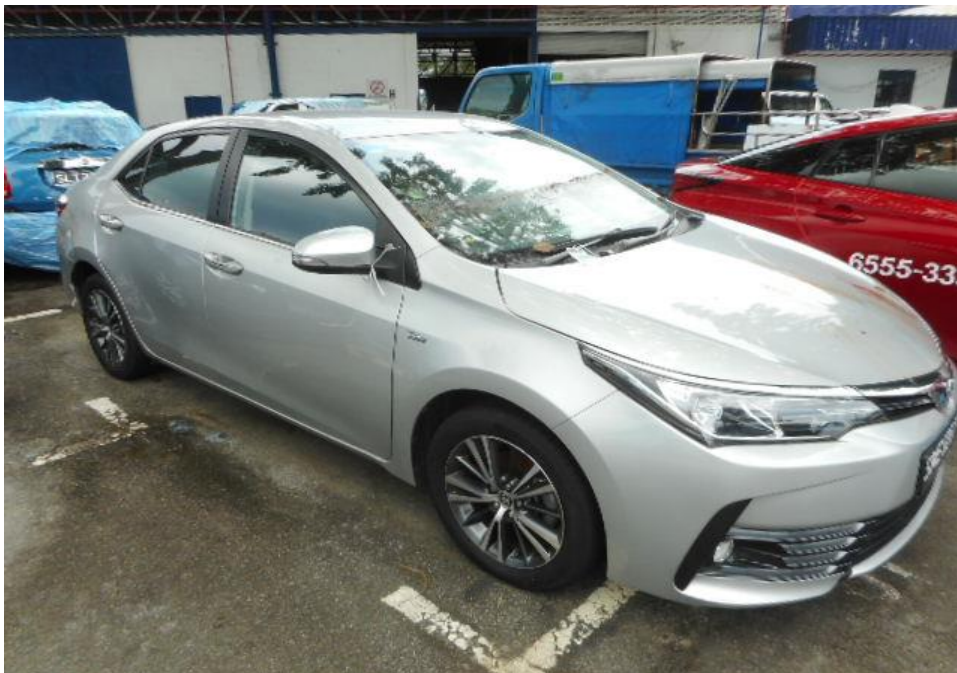
Photo 9 shows a general view of the Motor Car's right body at the time of my inspection. The right portion of the Motor Car was observed to have been unaffected by the accident.

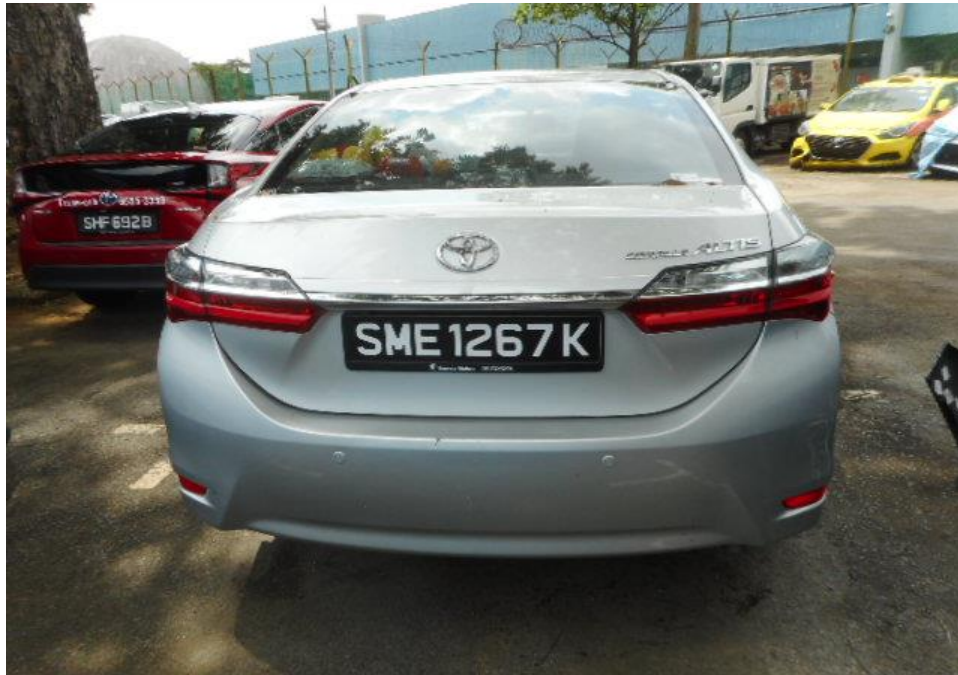
Photo 10 shows the general view of the Motor Car's rear body at the time of my inspection. The Motor Car rear was observed to be unaffected by the accident.

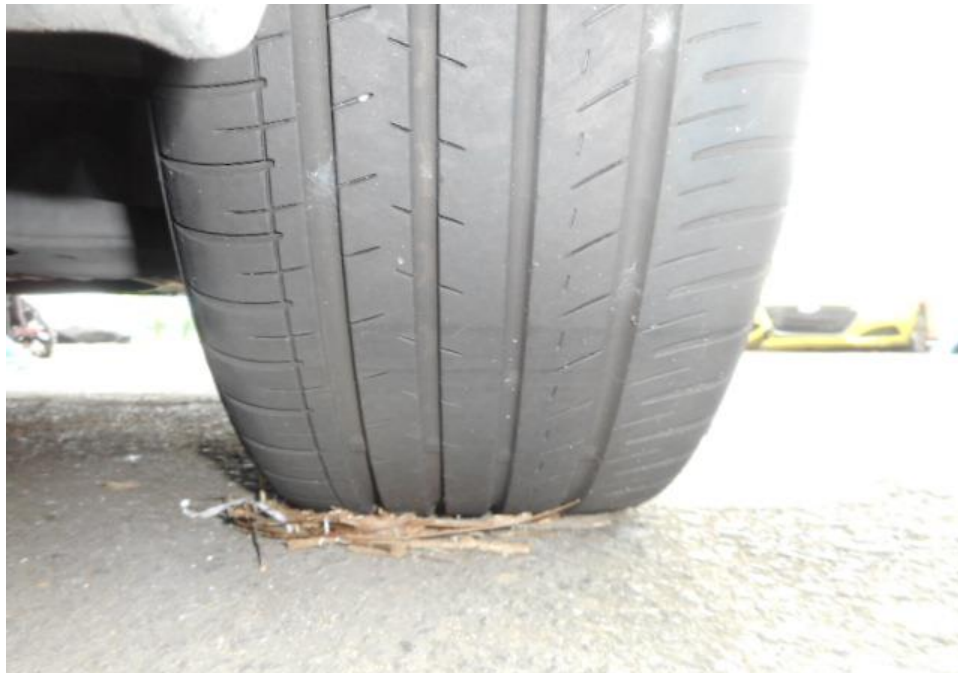
Photo 11 shows the condition of the front right tyre of the Motor Car, which was observed to be in serviceable condition with remaining tread depth of approximately 4.7mm. The tyre was sufficiently inflated for vehicular operation with no tear, cut or burst mark(s) on the outer and the inner sidewalls as well as across the tread. The 4 tyres of the Motor Car were wrapped around standard alloy wheel rims without any damage.

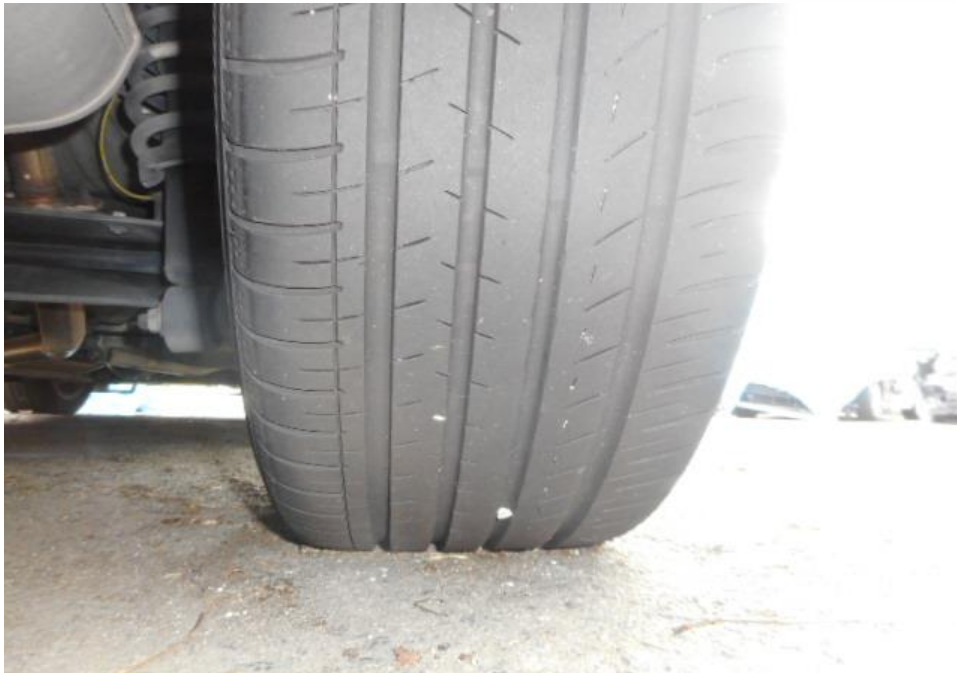
Photo 12 shows the condition of the rear right tyre of the Motor Car, which was observed to be in serviceable condition with remaining tread depth of approximately 5.2mm. The tyre was also observed to be sufficiently inflated for vehicular operation with no tear, cut or burst mark(s).

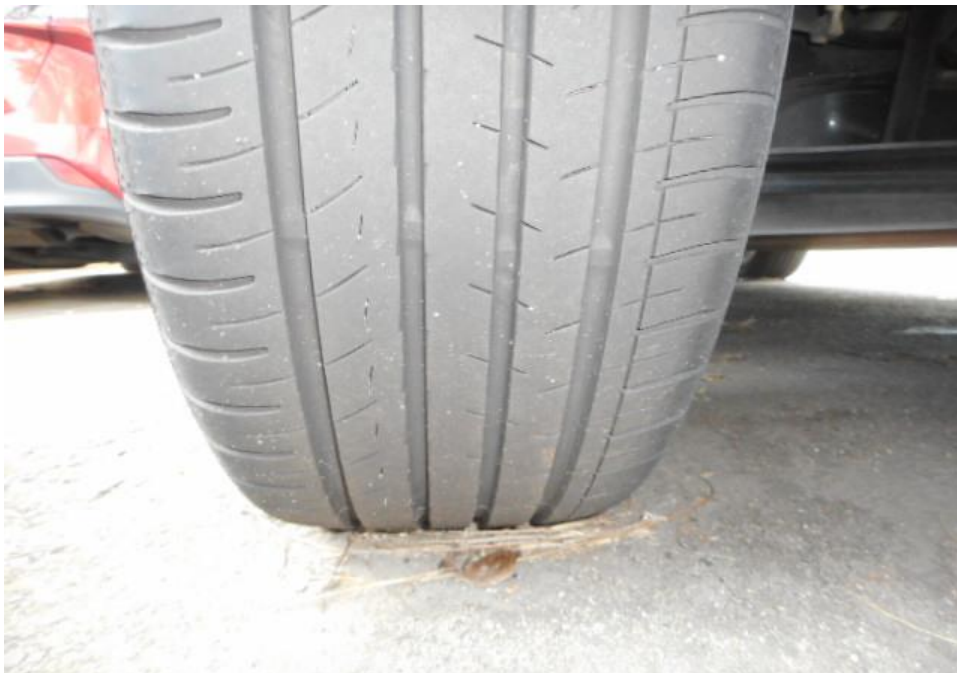
Photo 13 shows the condition of the rear left tyre of the Motor Car, which was observed to be in serviceable condition with remaining tread depth of approximately 4.6mm. The tyre, which was wrapped around alloy wheel rim, was also observed to be sufficiently inflated for vehicular operation. The 4 tyres of the Motor Car were wrapped around standard alloy wheel rims.

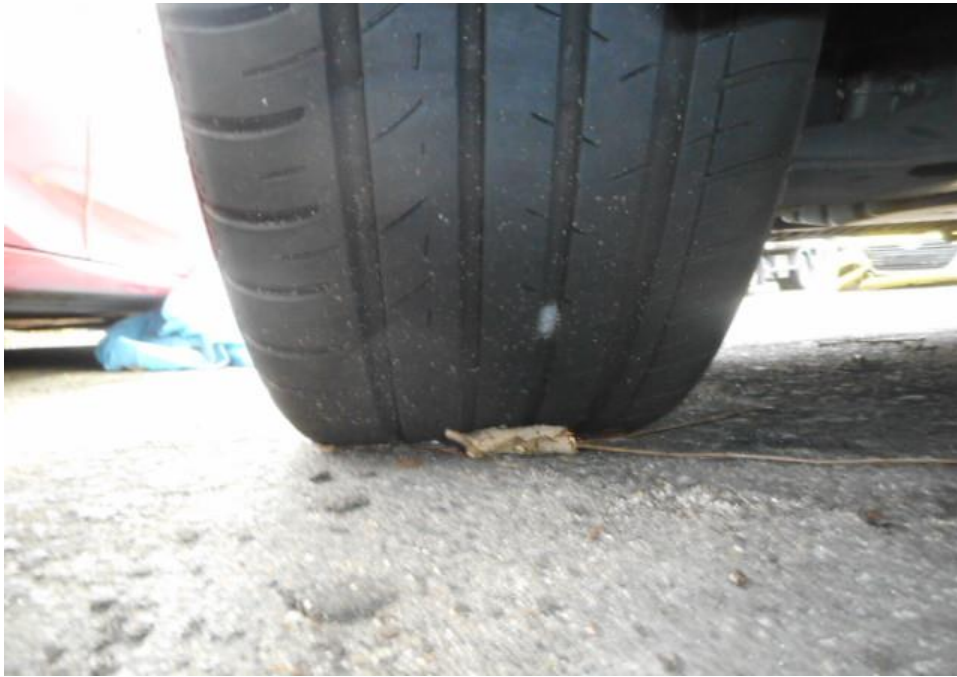
Photo 14 shows the condition of the front left tyre of the Motor Car, which was observed to be in serviceable condition with remaining tread depth of approximately 4.6mm. There was also no tear, cut or burst mark(s) on the outer and the inner sidewalls as well as across the tread of the Motor Car's 4 tyres.

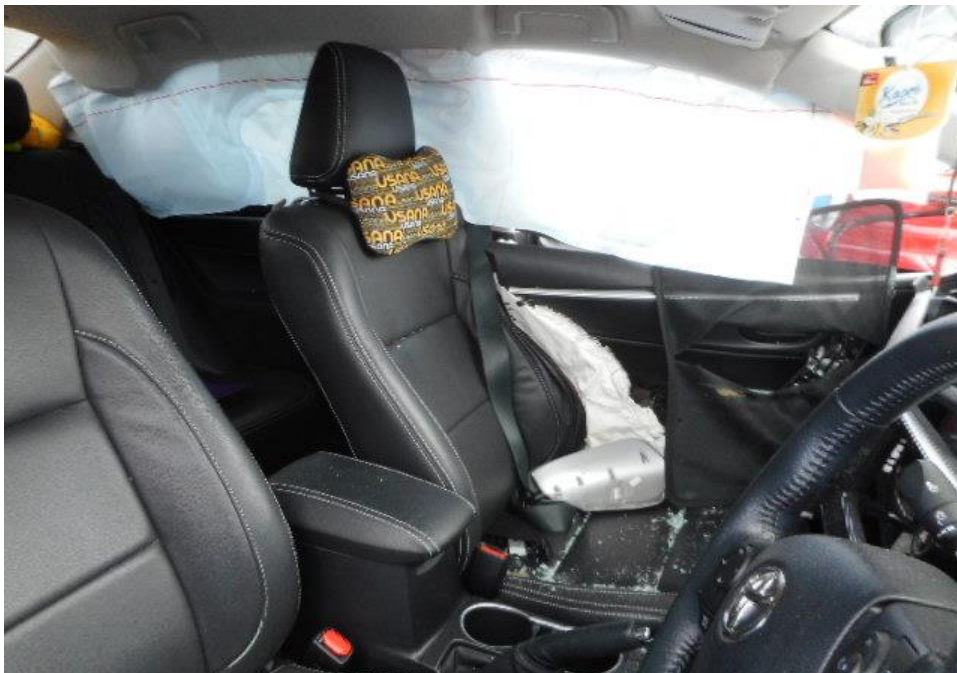
Photo 15 shows the deployment of the Supplemental Restraint System (SRS) airbag in the Motor Car as a result of the accident.

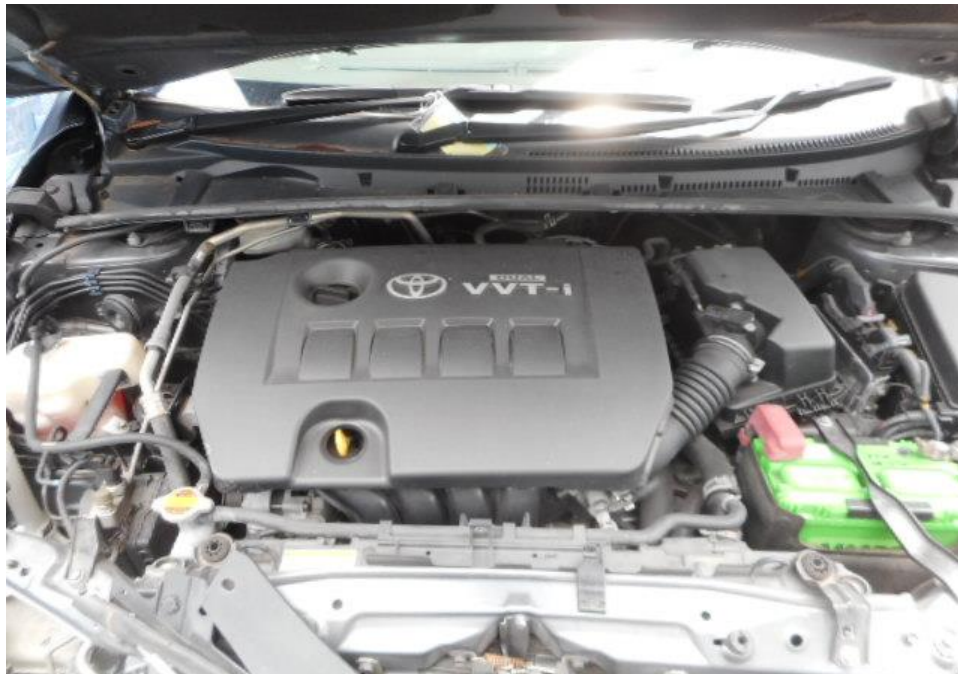
Photo 16 shows a general view of the Motor Car's engine compartment. The various parts and components inside the engine compartment were unaffected by the accident. There was also no sign(s) or indication(s) of fluid leakage and/or fluid stain within the engine compartment.

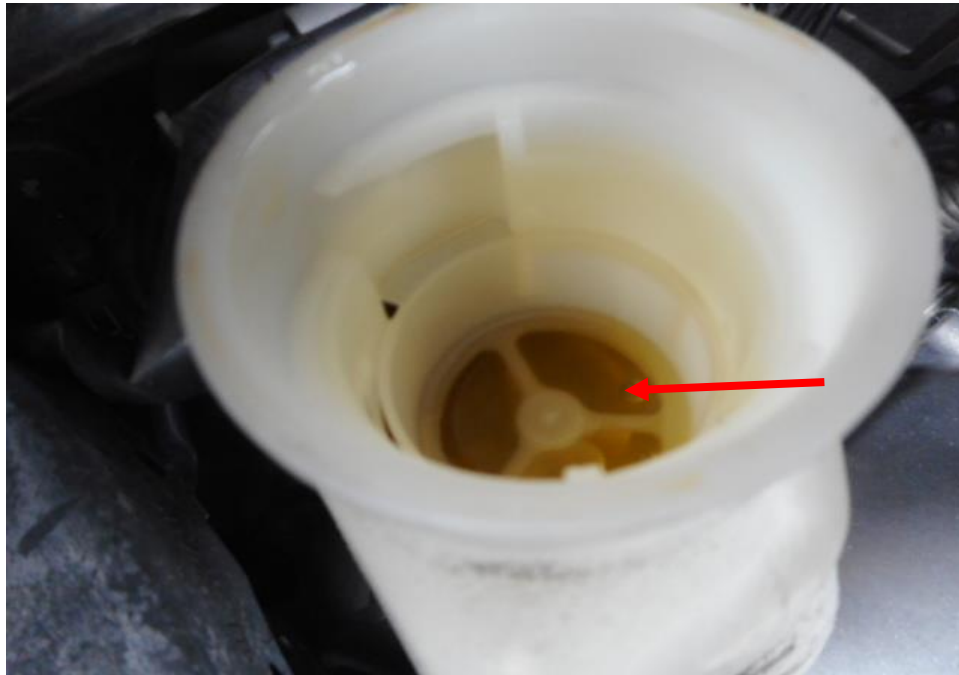
Photo 17 shows the brake fluid reservoir of the Motor Car at the time of my inspection. The brake fluid was observed to be of sufficient level (arrowed) and without any visible contamination.

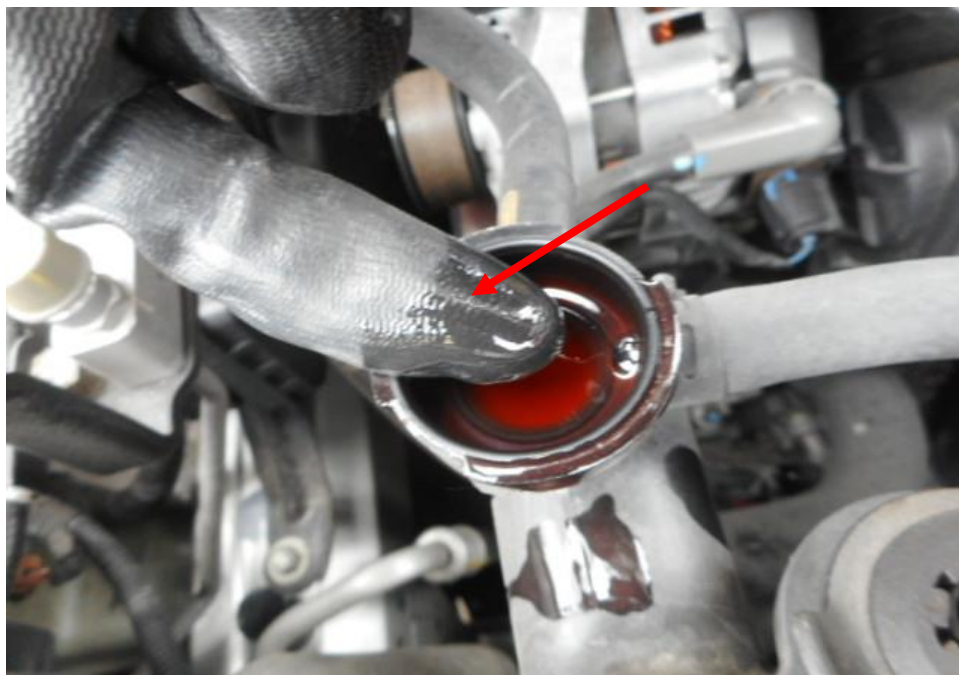
Photo 18 shows checks being carried out to the engine coolant of the Motor Car at the time of my inspection. The engine coolant was observed to be of sufficient level (arrowed) and without any visible contamination.

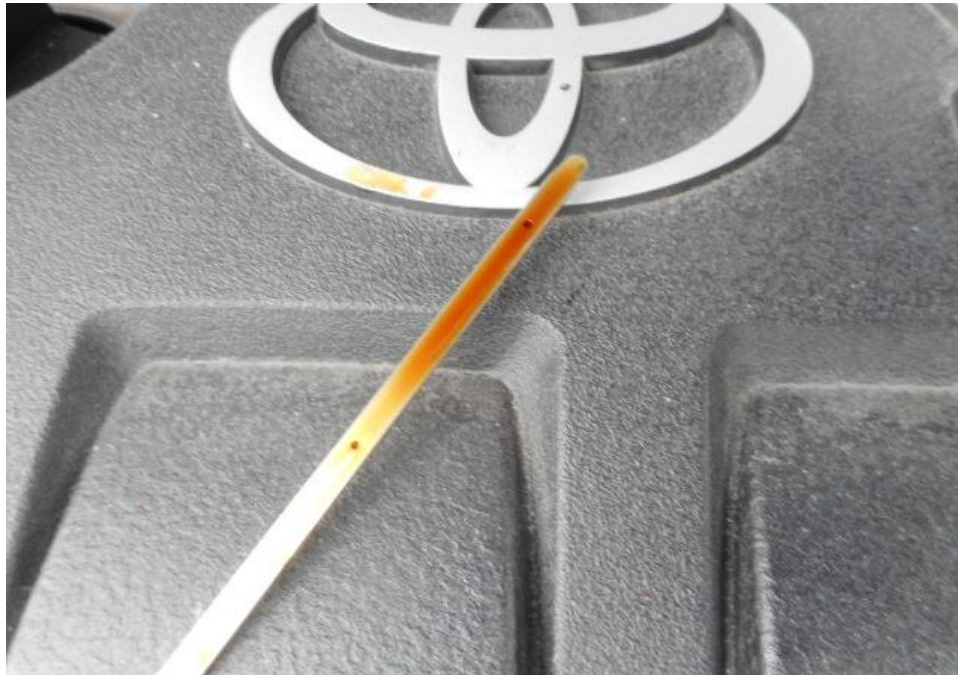
Photo 19 shows the engine oil dipstick of the Motor Car at the time of my inspection. The engine oil was observed to be of sufficient level and without any visible contamination.

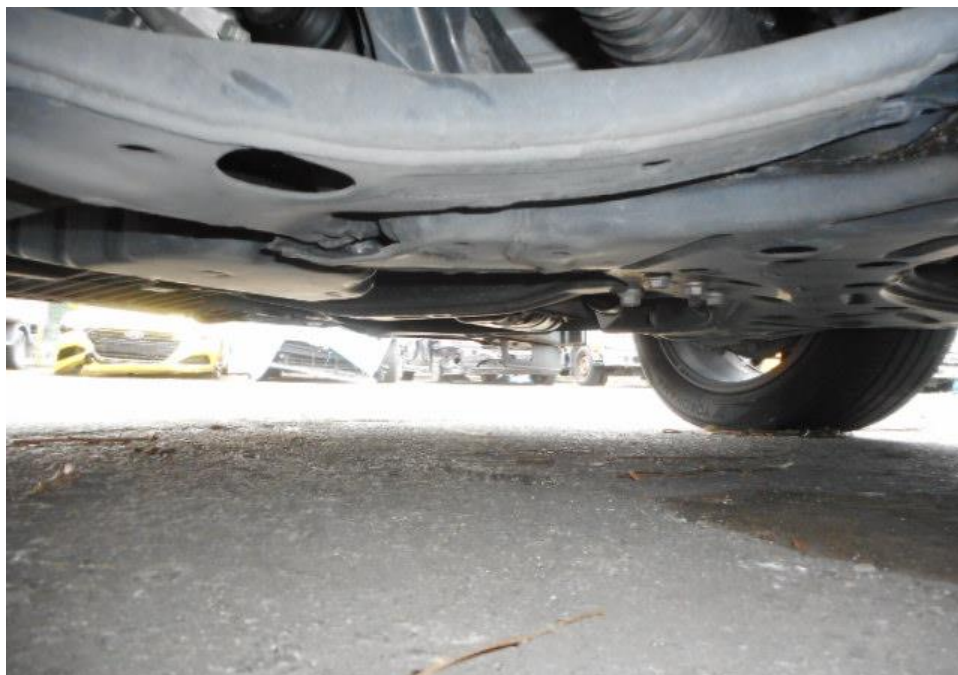
Photo 20 shows the undercarriage of the Motor Car, at the area where the engine housing and transmission housing are located. I did not find any sign(s) or indication(s) of fluid leak and/or fluid stain(s) on the underside of the Motor Car.

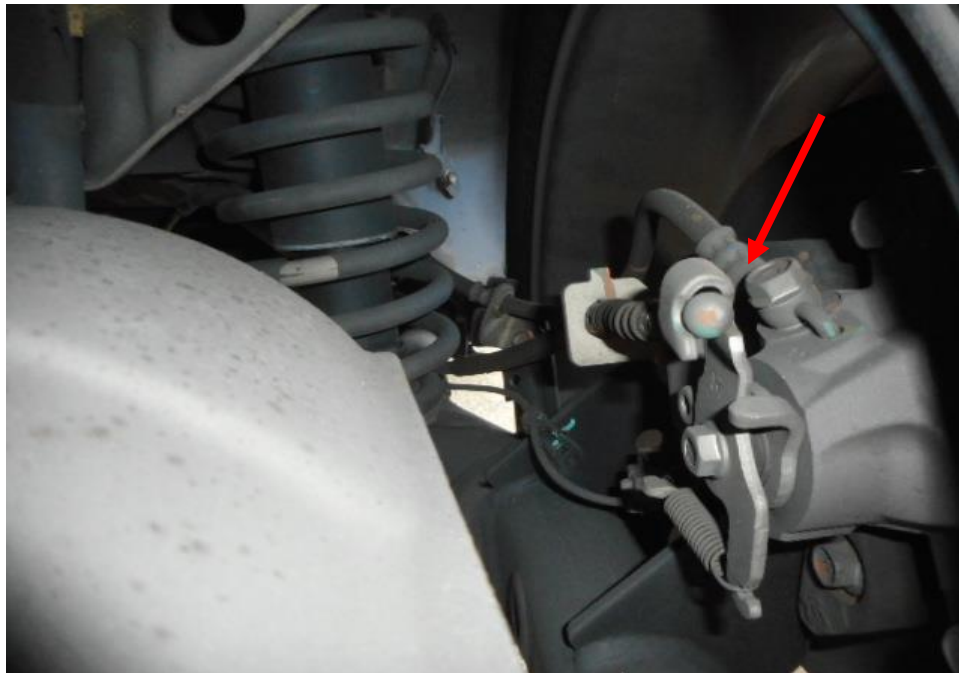
Photo 21 shows the brake hose/pipe (arrowed) at the rear right wheel of the Motor Car. No leakage of brake fluid was observed. Visual examination of the various components of the braking system like the drum brake, brake booster, brake pedal etc. had revealed all to be intact and without visible damage.

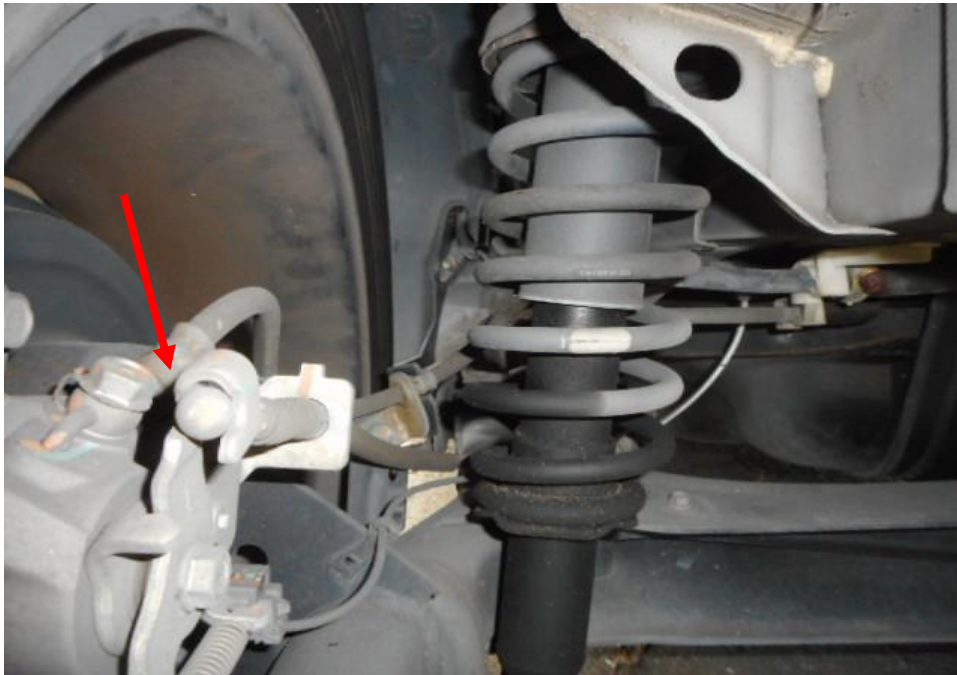
Photo 22 shows the brake hose/pipe (arrowed) at the rear left wheel of the Motor Car. I did not observe any leakage of brake fluid at the time of my inspection of the Motor Car. Static tests of the Motor Car's braking system had indicated that there was no internal leakage of pressure/vacuum. The undercarriage components of the Motor Car were also all found to be intact and without any visible damage.

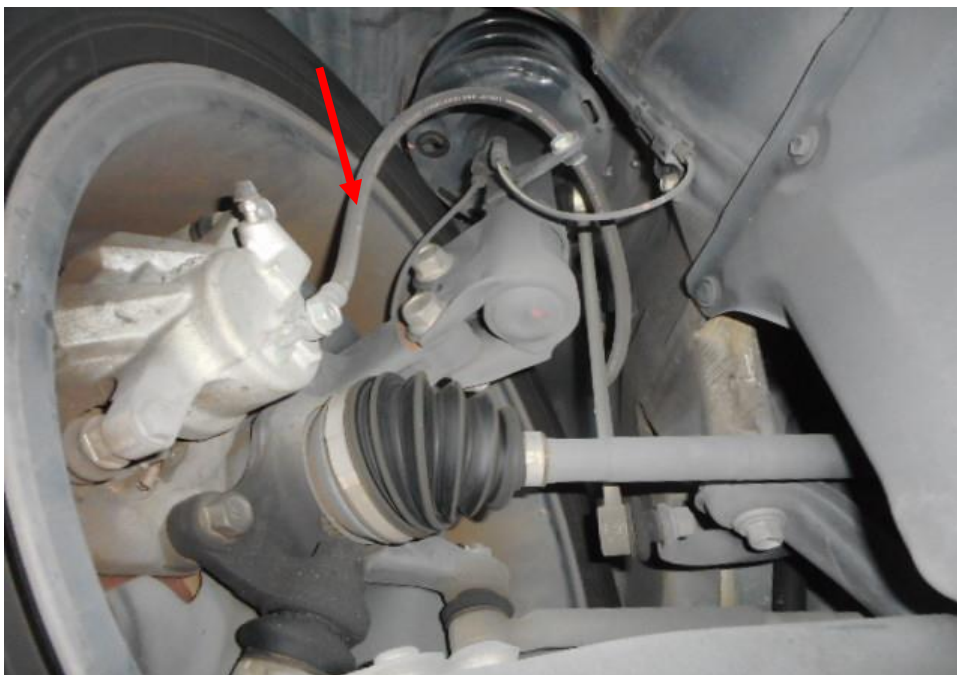
Photo 23 shows the brake hose/pipe (arrowed) at the front right wheel of the Motor Car. I did not observe any leakage of brake fluid at the time of my inspection of the Motor Car. Static tests of the Motor Car's braking system had indicated that there was no internal leakage of pressure/vacuum. The undercarriage components of the Motor Car were also all found to be intact and without any visible damage.

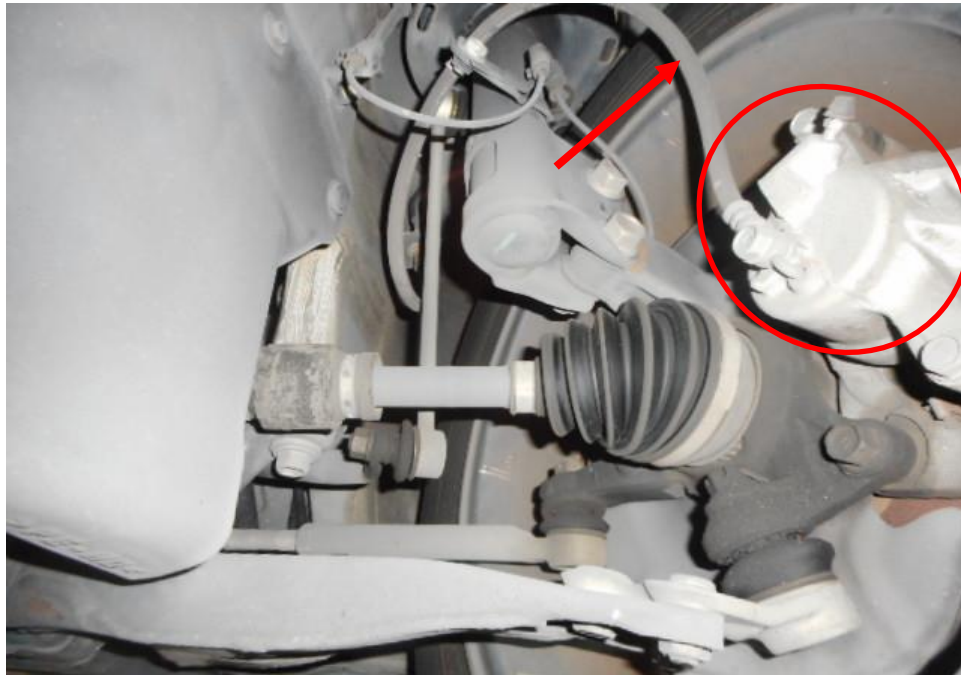
Photo 24 shows the brake hose/pipe (arrowed) at the front left wheel of the Motor Car. No leakage of brake fluid was observed. Visual examination of the various components of the braking system like the brake caliper (circled), brake booster, brake pedal etc had revealed all to be intact and without visible damage.

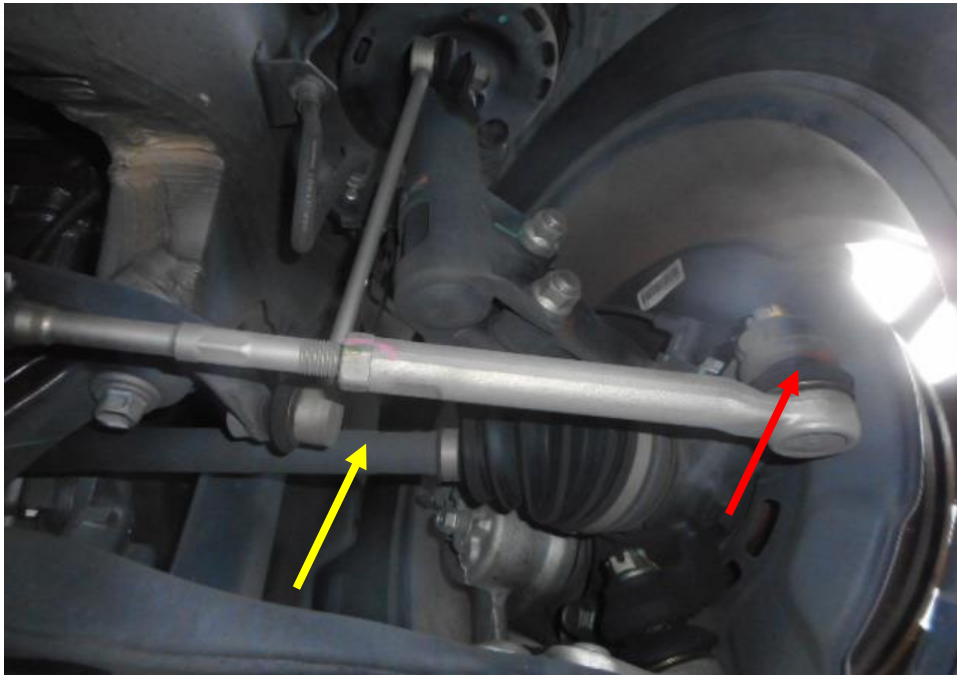
Photo 26 shows the various undercarriage components at the front right wheel of the Motor Car, in particular the steering tie rod (red arrow) and particular the drive shaft (yellow arrow). The various steering components were all found to be intact, suggesting that the steering system of the Motor Car was likely to be in serviceable condition at the material time of accident. There was also no sign of fluid stain observed on the various undercarriage components at the front right wheel of the Motor Car.

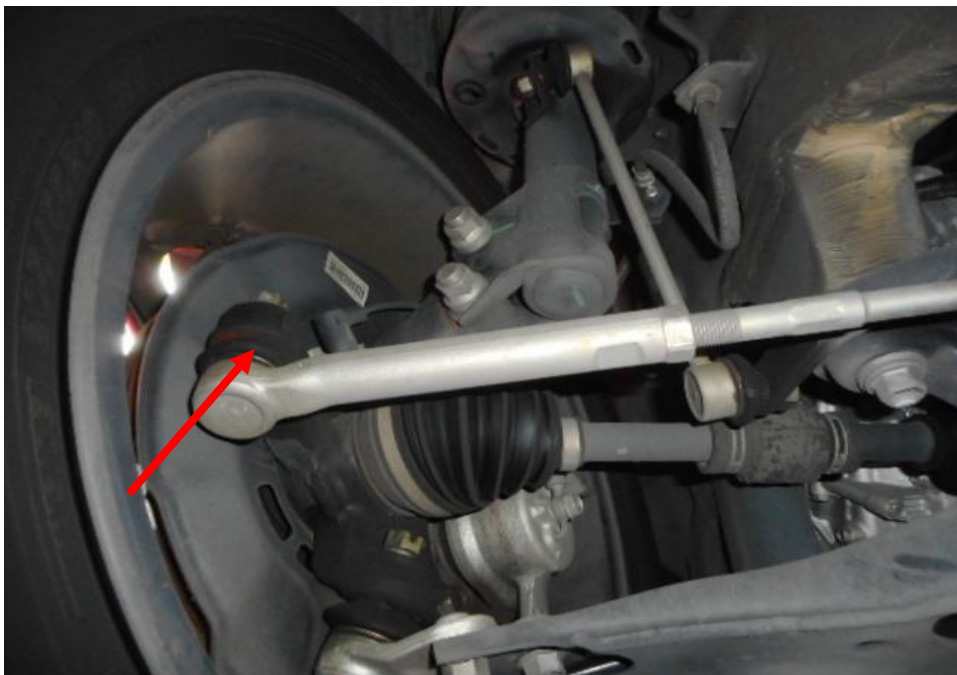
Photo 27 shows the various undercarriage components at the front left wheel of the Motor Car, which had included the steering tie rod (arrowed). The various undercarriage components of the Motor Car were all found to be intact without any visible damage.

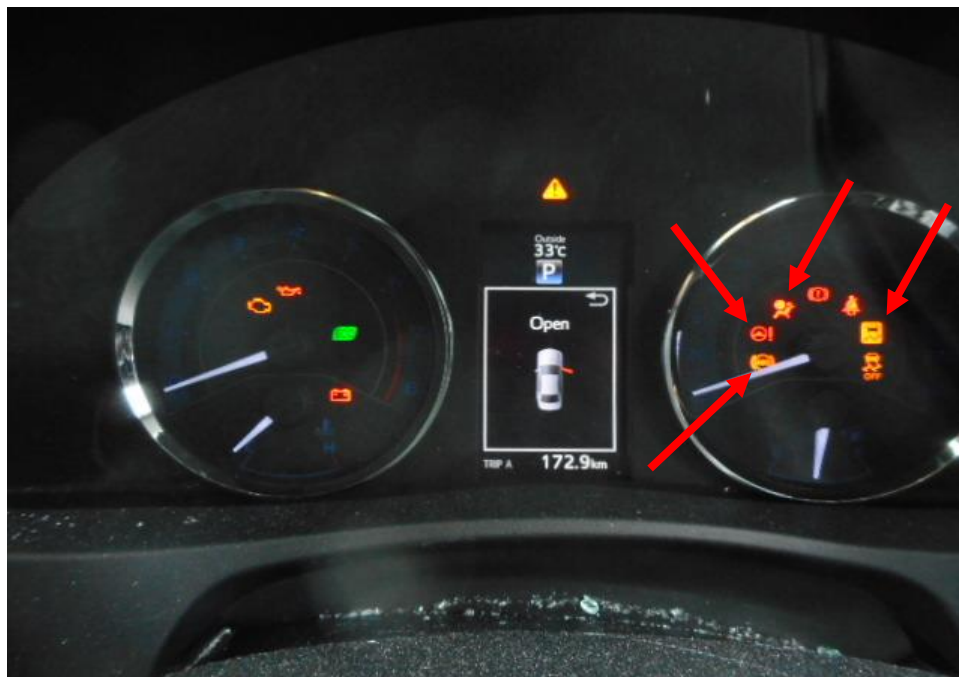
Photo 28 shows the warning light for Anti-Lock Brake System (ABS), Traction Control System (TCS), Electric Power Steering System (EPS), and Supplemental Restraint System (SRS) (arrowed) appearing on the instrument panel of the Motor Car during the self-test of its various electronic operating systems when its engine was cranked.

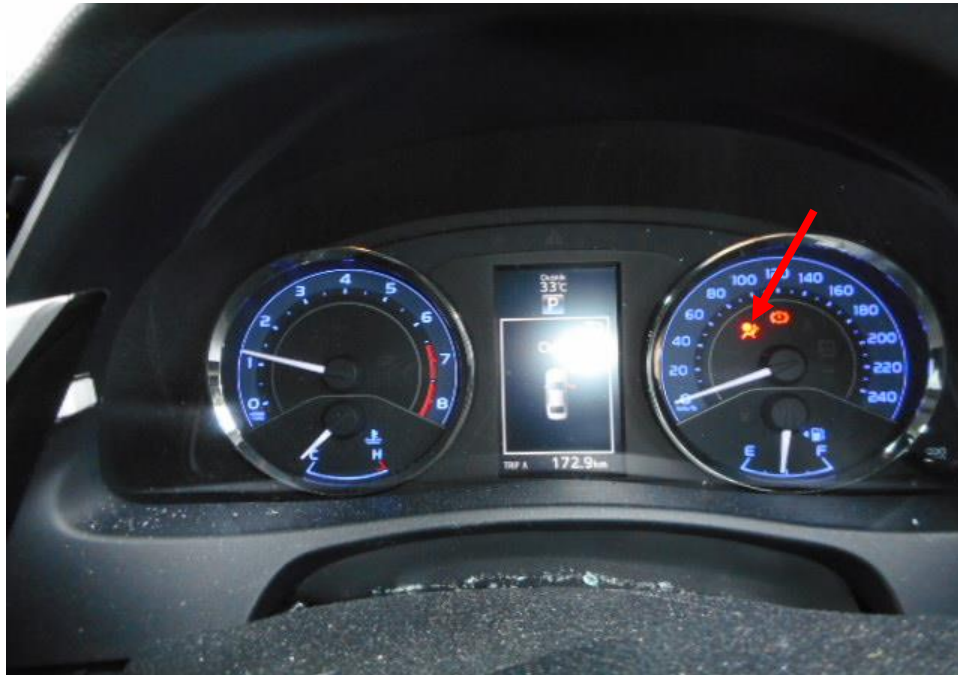
Photo 29 shows only the Supplemental Restraint System (SRS) remained illuminated on as due to the deployment of the Airbag as a result of the accident. No other warning lights illuminated on the instrument panel of the Motor Car after the engine was cranked. This would suggest that there was no abnormality to the electronic operating system of the Motor Car, like the ABS, TCS, EPS and etc.

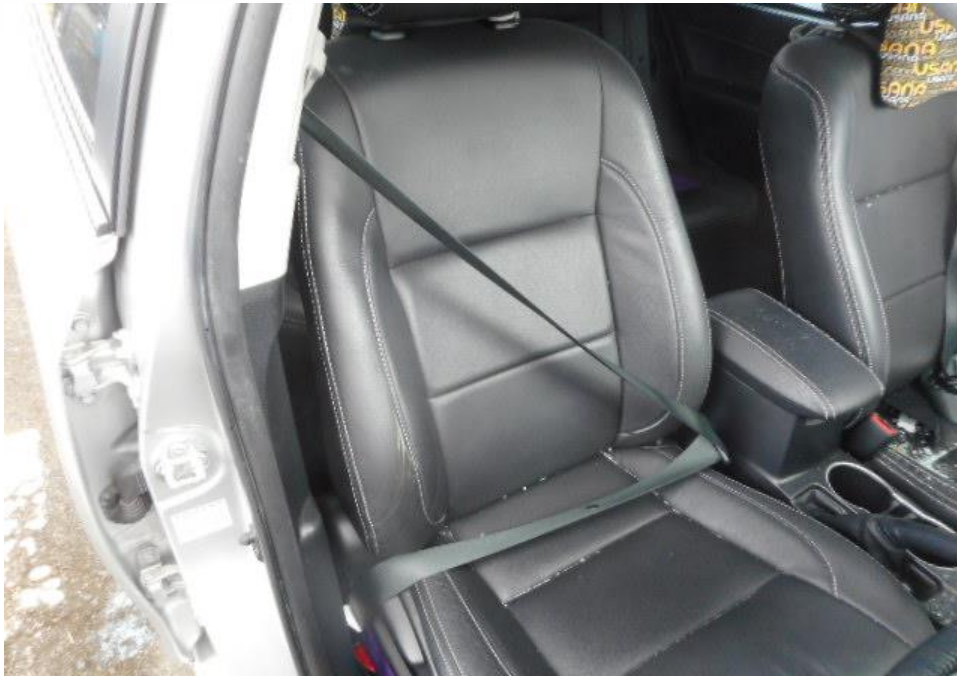
Photo 30 shows that the seat belt on the right seat was able to be fastened securely into the respective pre-tensioners that were fitted at the sides of each seat.

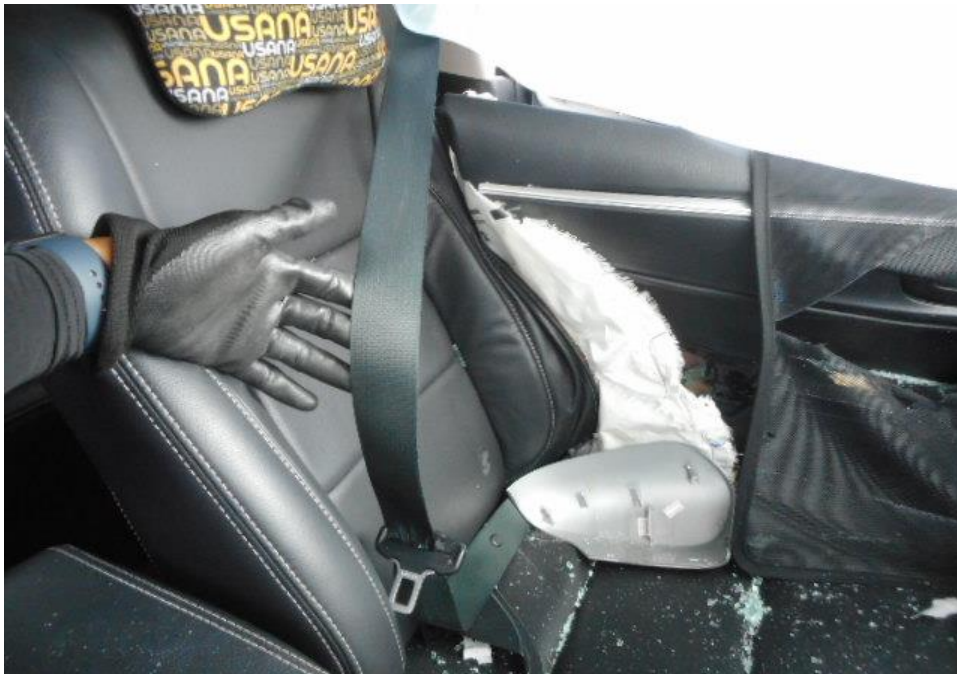
Photo 31 shows that the seat belt on the left seat was worn at the material time of accident as the safety pre-tensioners was activated at the moment of impact and caused the seat belt to be locked into the last position.
