Your Ref: TP TP/10622/2023
Our Ref : CI/TPD23006809/P

31st July 2023

Fatal Accident Investigation Team

MECHANICAL INSPECTION REPORT OF MOTOR CAR SMQ 539U

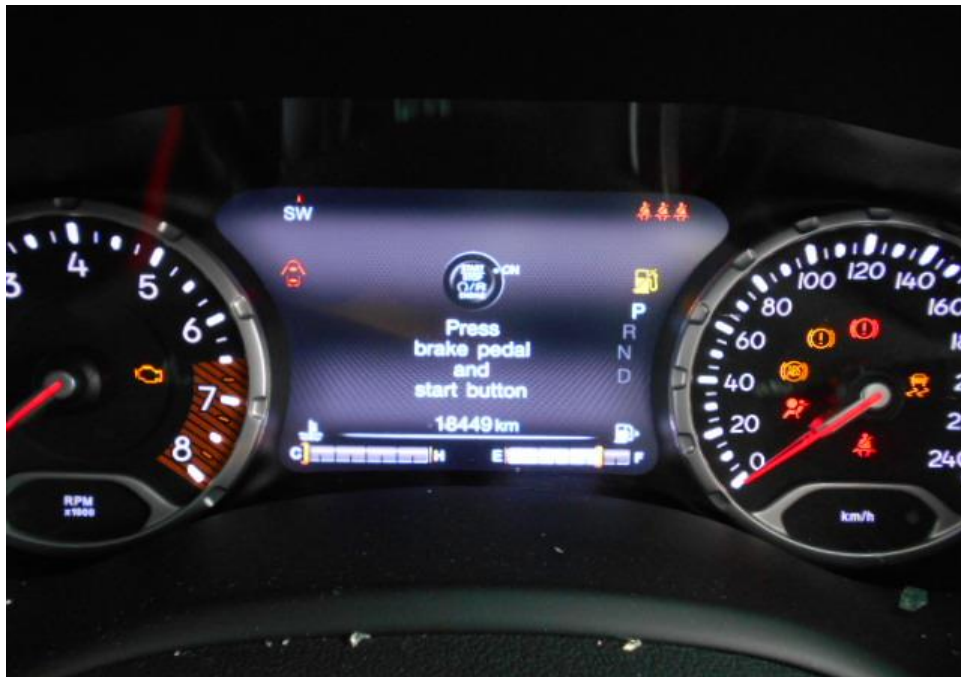
Photo 1 shows a general view of the instrument cluster of the Motor Van at the time of my inspection. The mileage of the Motor Car was 18,449km.

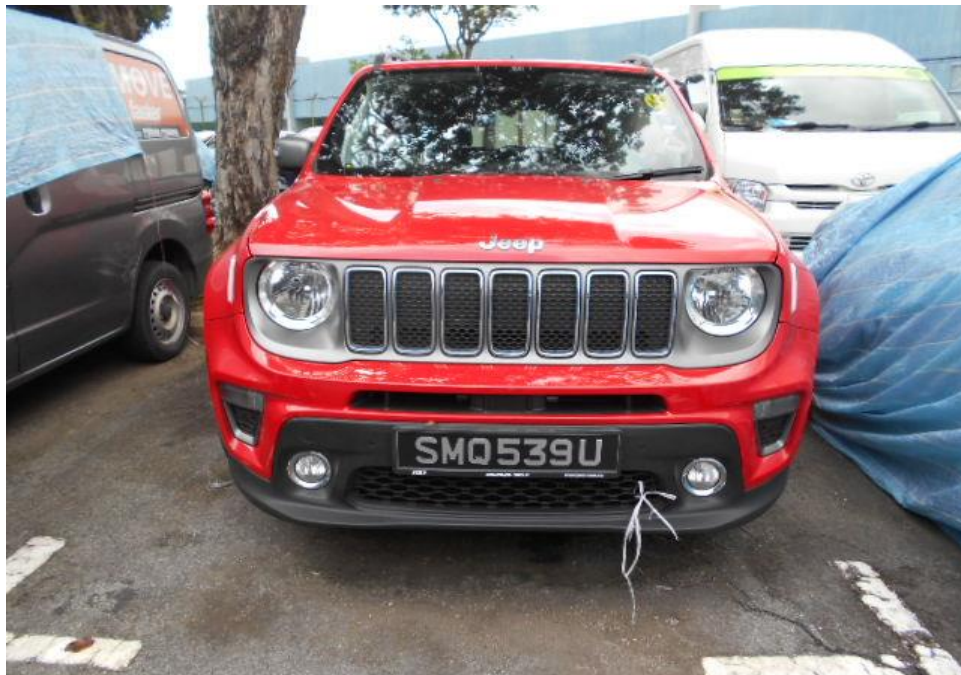
Photo 2 shows a general view of the Motor Car's front body at the time of my inspection. The front portion of the Motor Car was observed to have been undamaged by the accident.

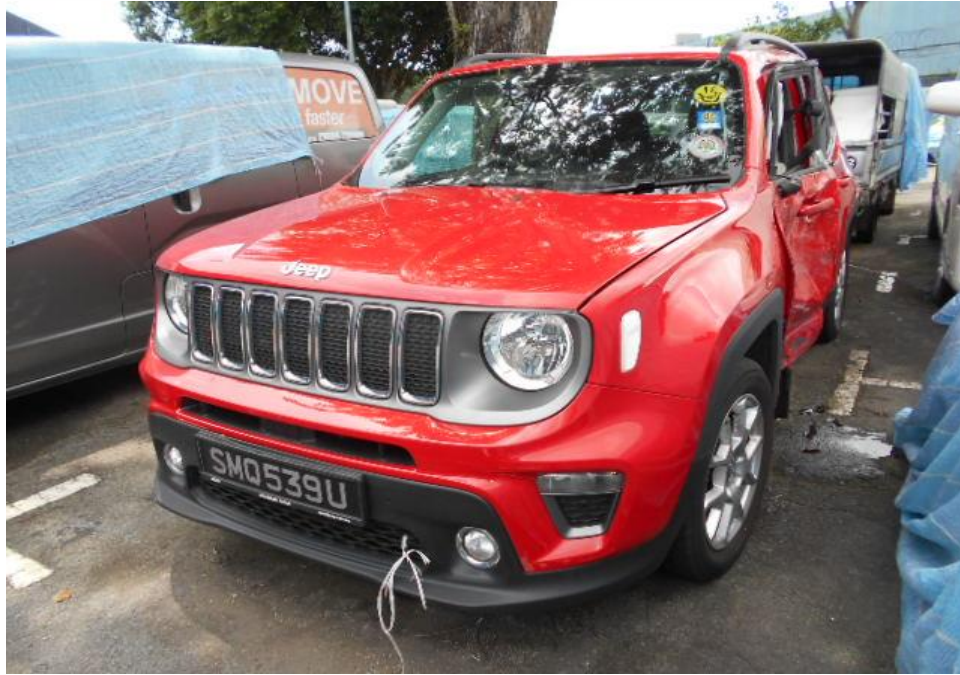
Photo 3 shows the general view of the Motor Car's left body at the time of my inspection. The Motor Car was observed to sustained damage at its left front door and left rear view mirror were amongst the body parts that were damaged as a result of the accident. The Supplemental Restraint System (SRS) was activated as a result of the accident.

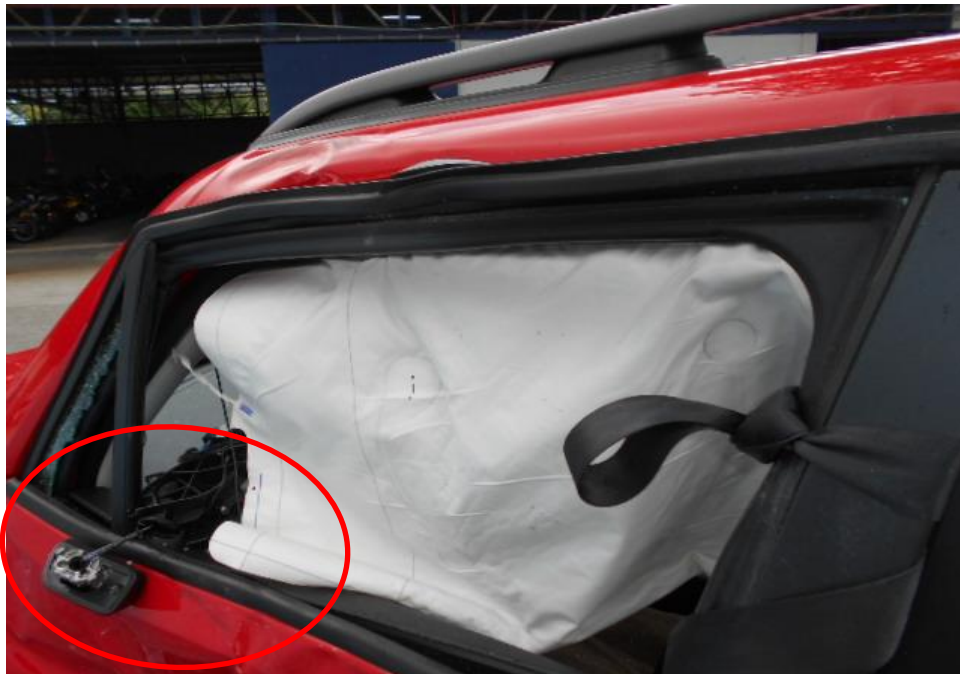
Photo 4 shows the close up view of the Motor Car's left body at the time of my inspection. The motor car was observed to have sustained damage at its left portion. Its left rear view mirror (circled) was damaged as a result of the accident.

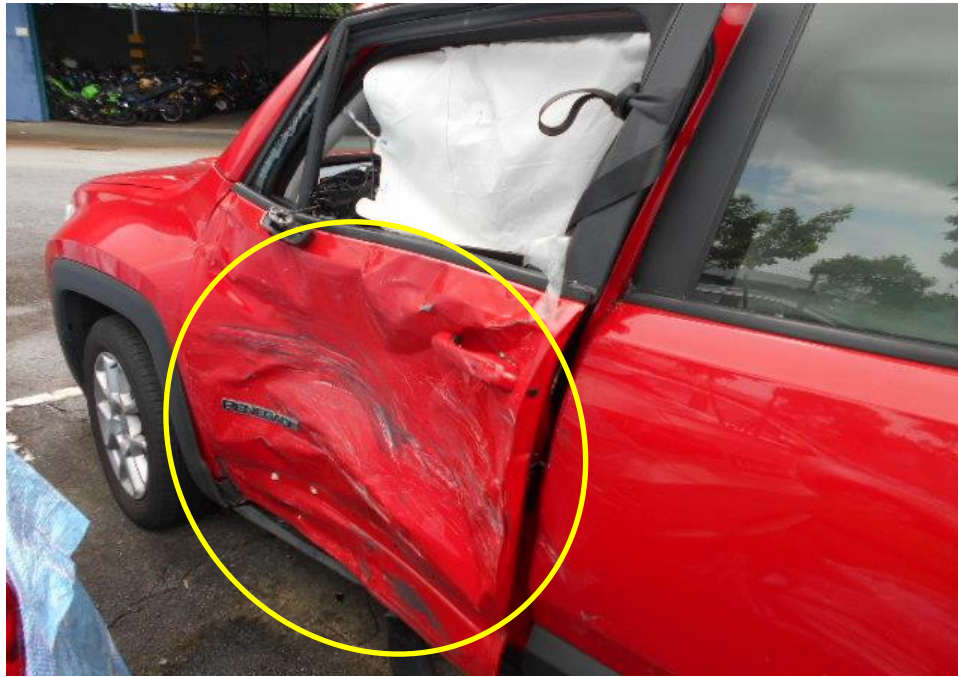
Photo 5 shows the close up view of the Motor Car's left body at the time of my inspection. The Motor Car was observed to have sustained damage at its left portion. Its left front door (circled) was damaged as a result of the accident.

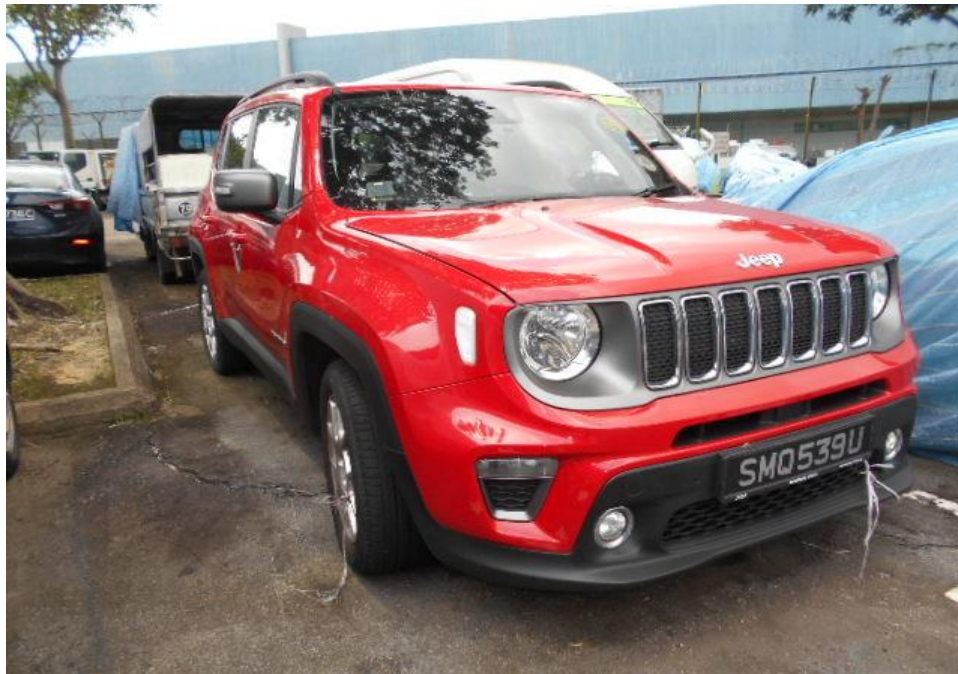
Photo 6 shows a general view of the Motor Car's right body at the time of my inspection. The right portion of the Motor Car was observed to have been undamaged by the accident.

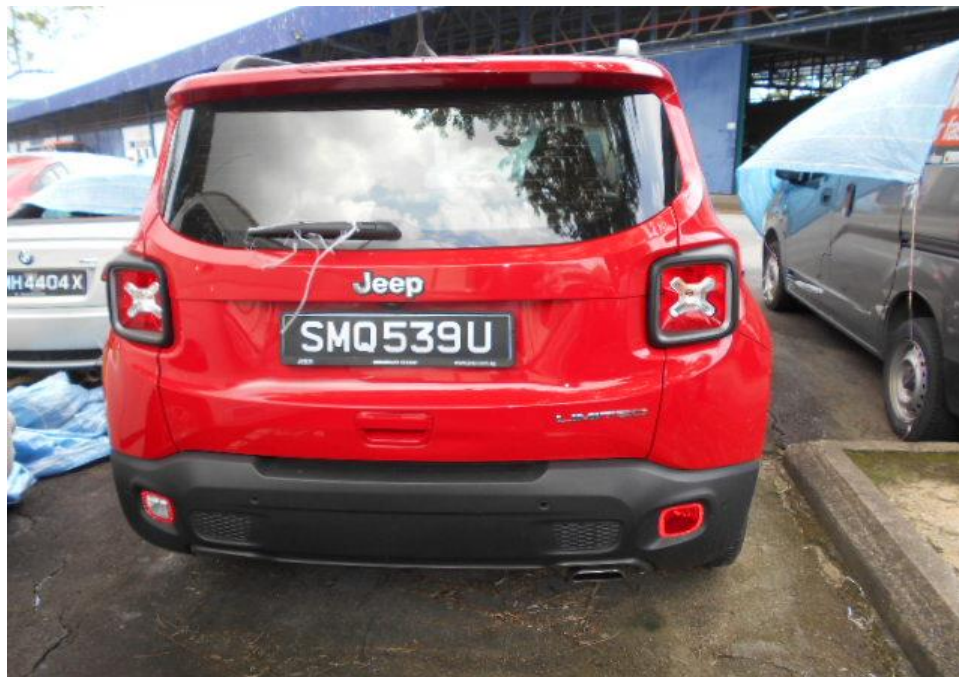
Photo 7 shows a general view of the Motor Car's rear body at the time of my inspection. The rear portion of the Motor Car was observed to have been undamaged by the accident.

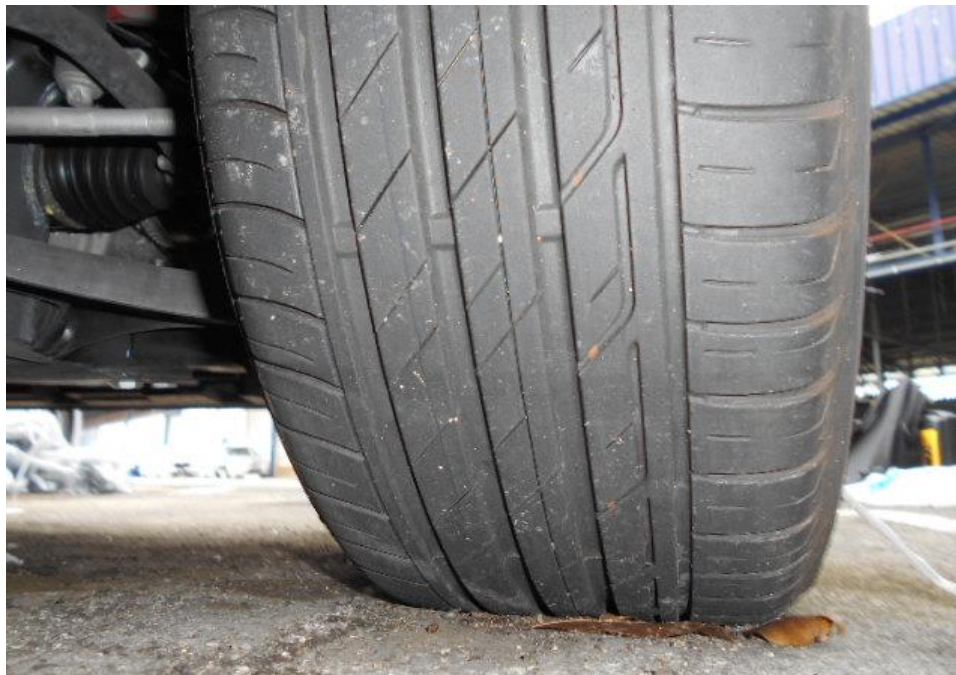
Photo 8 shows the condition of the front right tyre of the Motor Car, which was observed to be in serviceable condition with remaining tread depth of approximately 6.6mm. The tyre was also observed to be sufficiently inflated for vehicular operation with no tear, cut or burst mark(s).

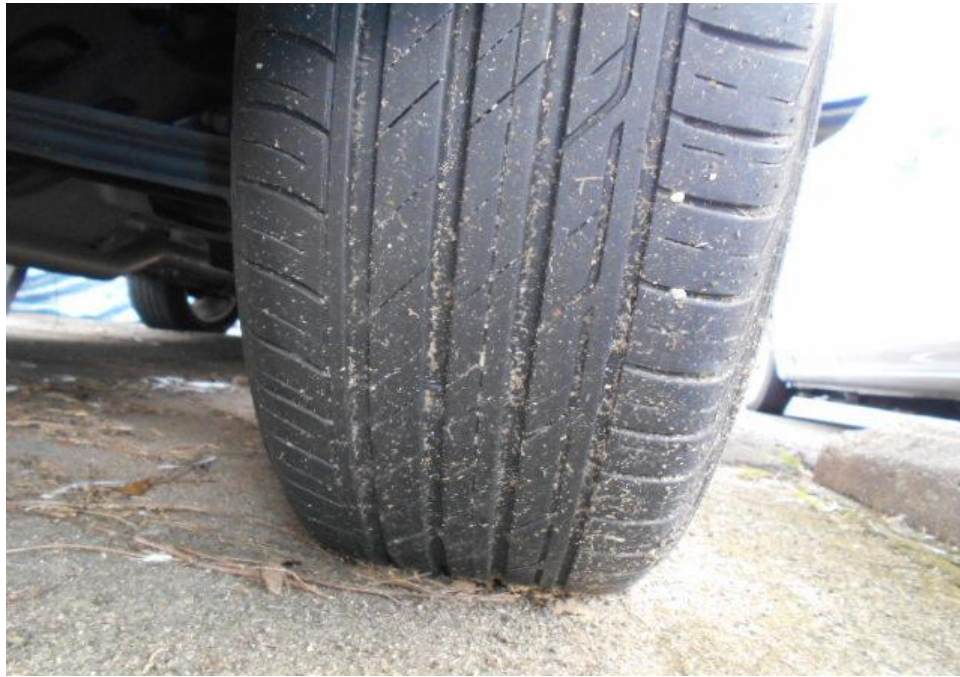
Photo 9 shows the condition of the rear right tyre of the Motor Car, which was observed to be in serviceable condition with remaining tread depth of approximately 6.8mm. The tyre was also observed to be sufficiently inflated for vehicular operation with no tear, cut or burst mark(s).

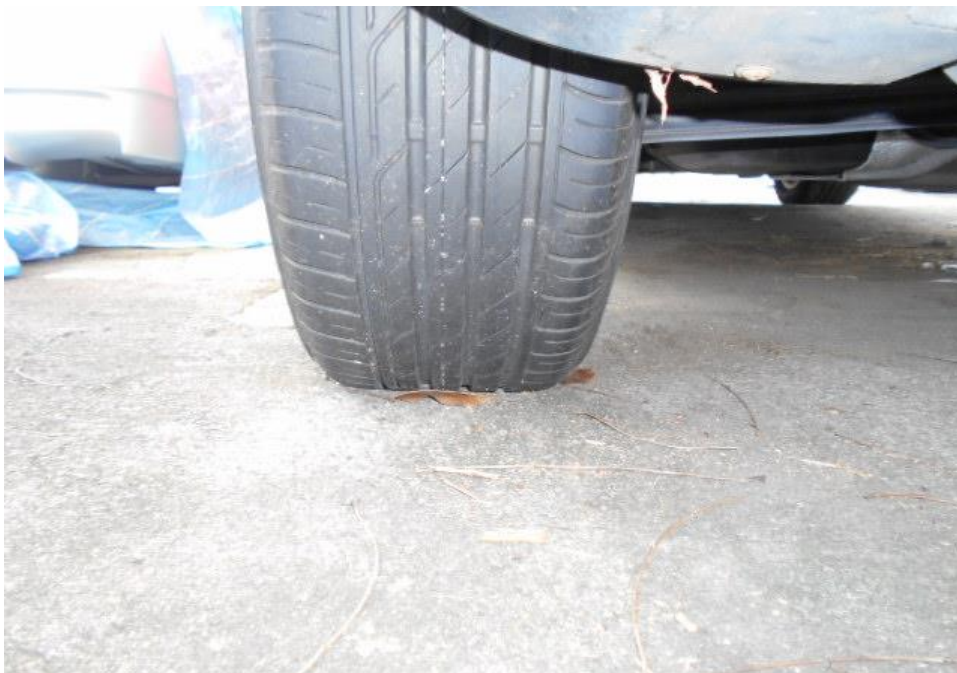
Photo 10 shows the condition of the rear left tyre of the Motor Car, which was observed to be in serviceable condition with remaining tread depth of approximately 6.2mm. The tyre was also observed to be sufficiently inflated for vehicular operation with no tear, cut or burst mark(s).

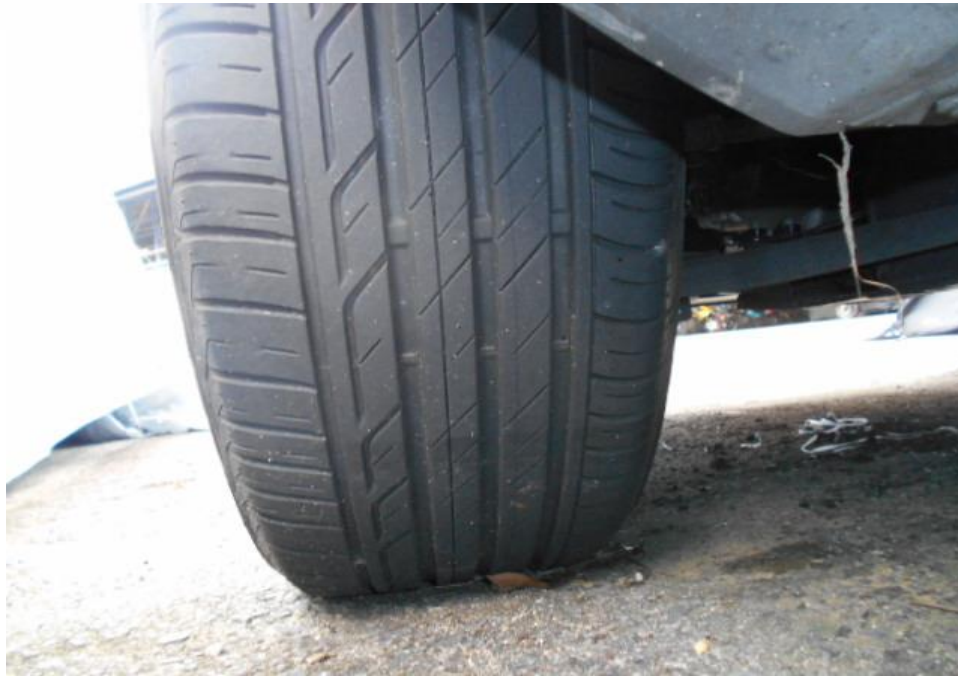
Photo 11 shows the condition of the front left tyre of the Motor Car, which was observed to be in serviceable condition with remaining tread depth of approximately 6.5mm. The tyre was also observed to be sufficiently inflated for vehicular operation with no tear, cut or burst mark(s).

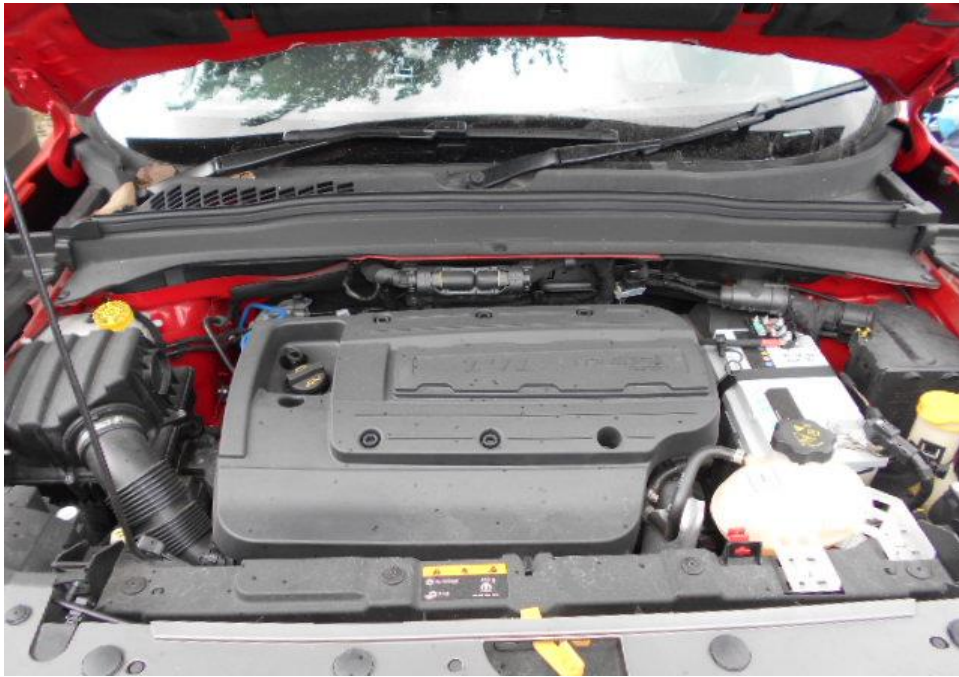
Photo 12 shows a general view of the Motor Car's engine compartment, which was accessed by lifting the front bonnet of the Motor Car. The various parts and components inside the engine compartment were unaffected by the accident. There was also no sign(s) or indication(s) of fresh fluid leakage and/or fluid stain within the engine compartment.

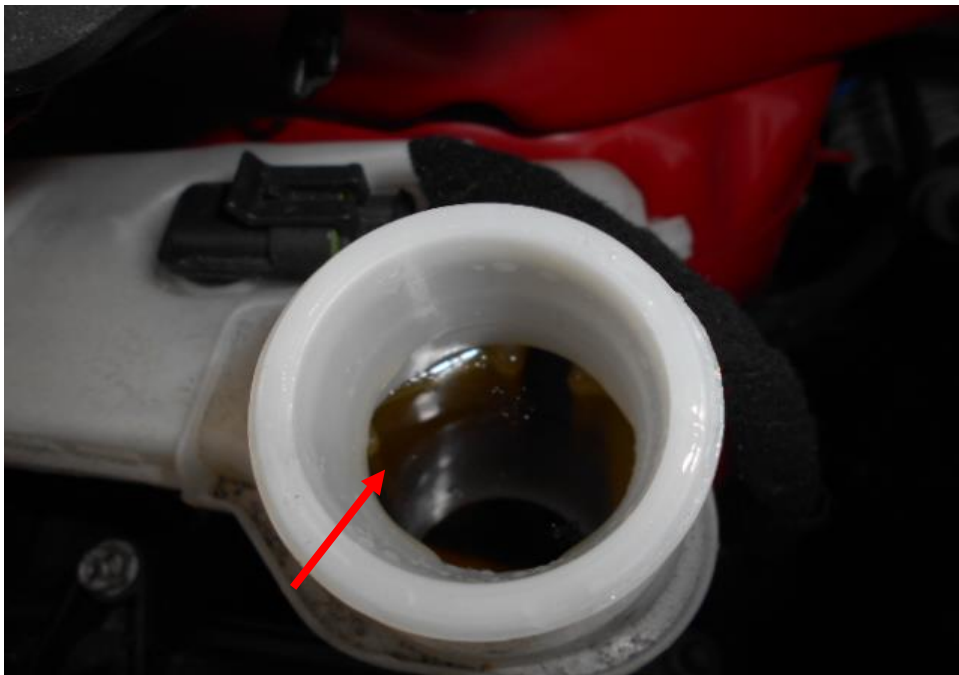
Photo 13 shows the brake fluid reservoir of the Motor Car at the time of my inspection. The brake fluid was observed to be of sufficient level (arrowed) and without any visible contamination.

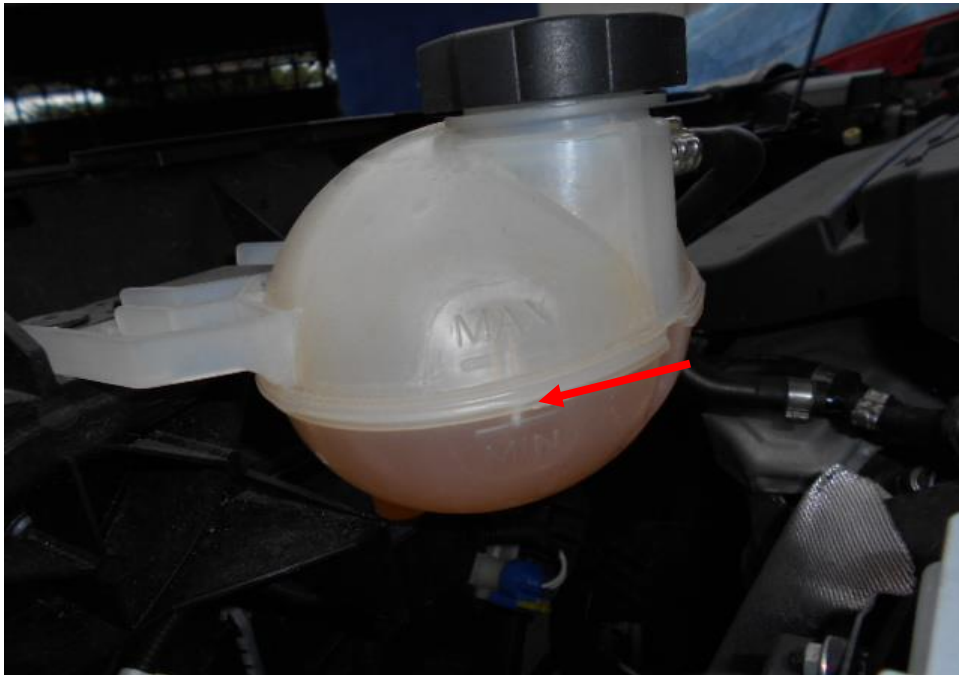
Photo 14 shows the engine coolant of the Motor Car at the time of my inspection. The engine coolant was observed to be of sufficient level.

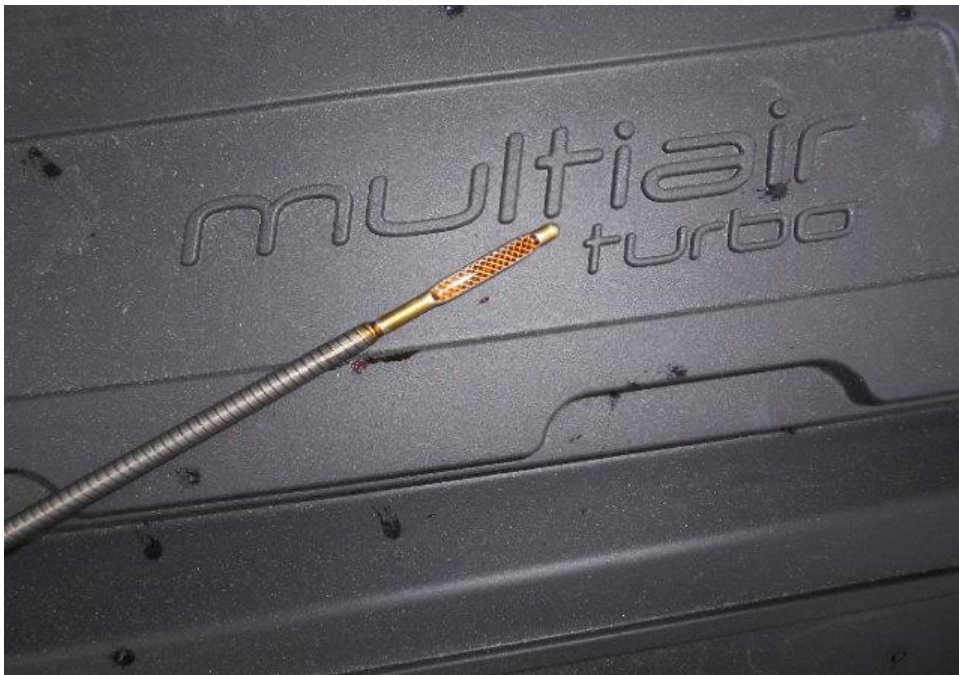
Photo 15 shows the engine oil dip stick of the Motor Car at the time of my inspection. The engine oil was observed to be of sufficient level and without any visible contamination.

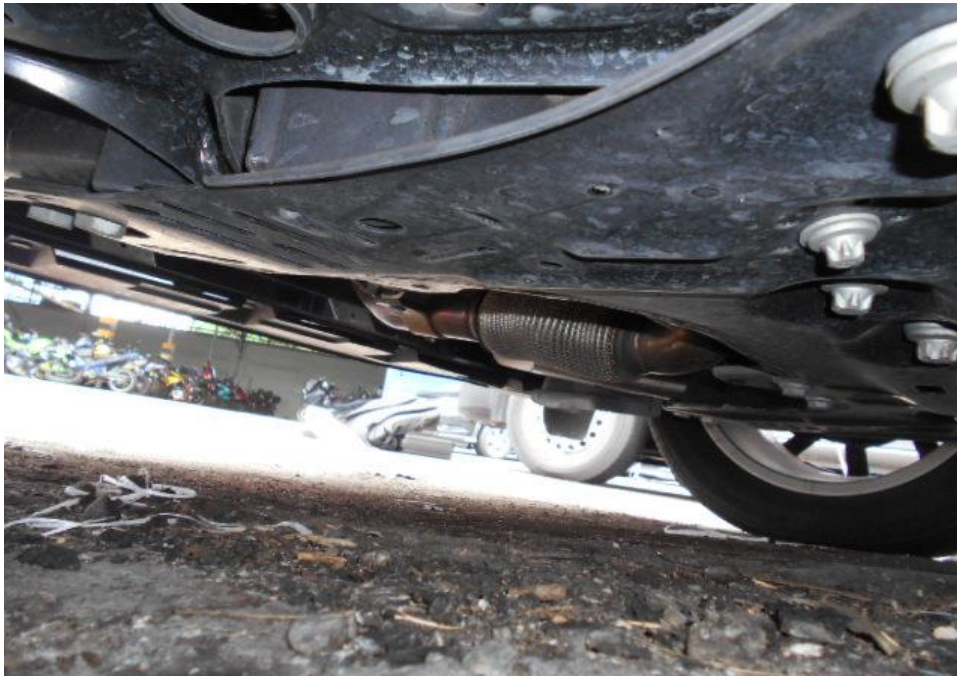
Photo 16 shows the undercarriage of the Motor Car, at the area where the engine housing and transmission housing are located. I did not find any sign(s) or indication(s) of fluid leak and/or fluid stain(s) on the underside of the Motor Car.

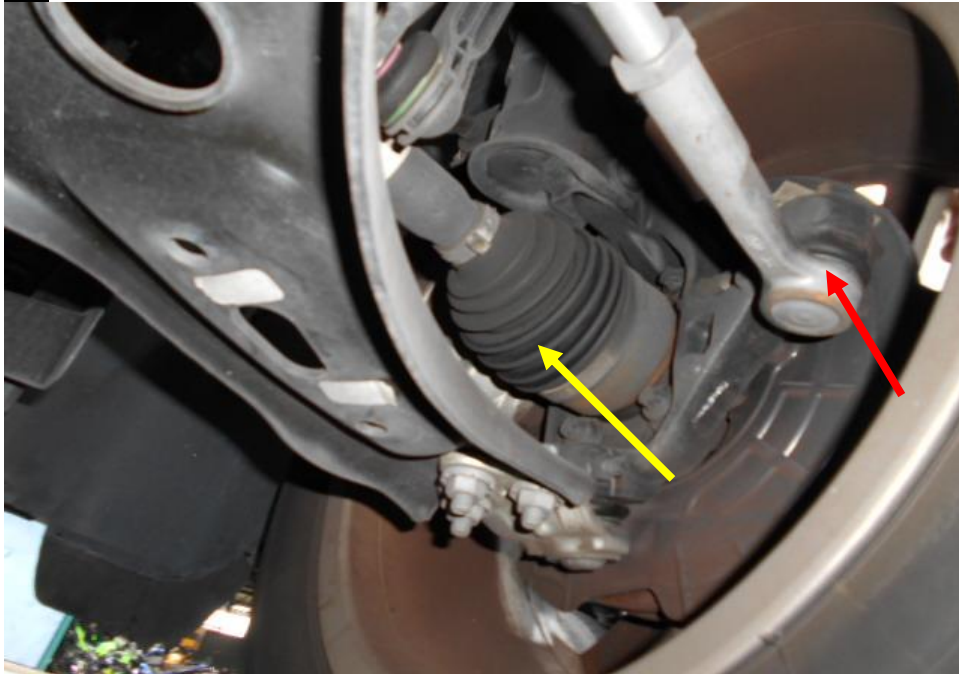
Photo 17 shows the various undercarriage components at the front right wheel of the Motor Car, in particular the steering tie rod (red arrow) and the driveshaft (yellow arrow). The various steering components were all found to be intact, suggesting that the steering system of the Motor Car was likely to be in serviceable condition at the material time of accident. There was also no sign of fluid stain observed on the various undercarriage components at the front right wheel of the Motor Car.

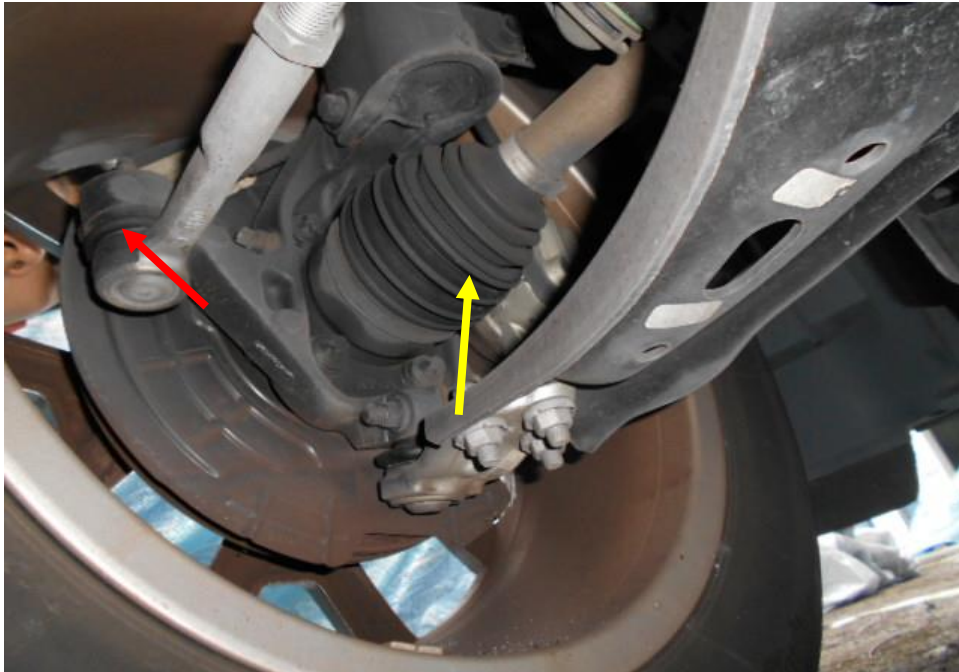
Photo 18 shows the various undercarriage components at the front left wheel of the Motor Car, in particular the steering tie rod (red arrow) and the driveshaft (yellow arrow). The various steering components were all found to be intact, suggesting that the steering system of the Motor Car was likely to be in serviceable condition at the material time of accident. There was also no sign of fluid stain observed on the various undercarriage components at the front right wheel of the Motor Car.

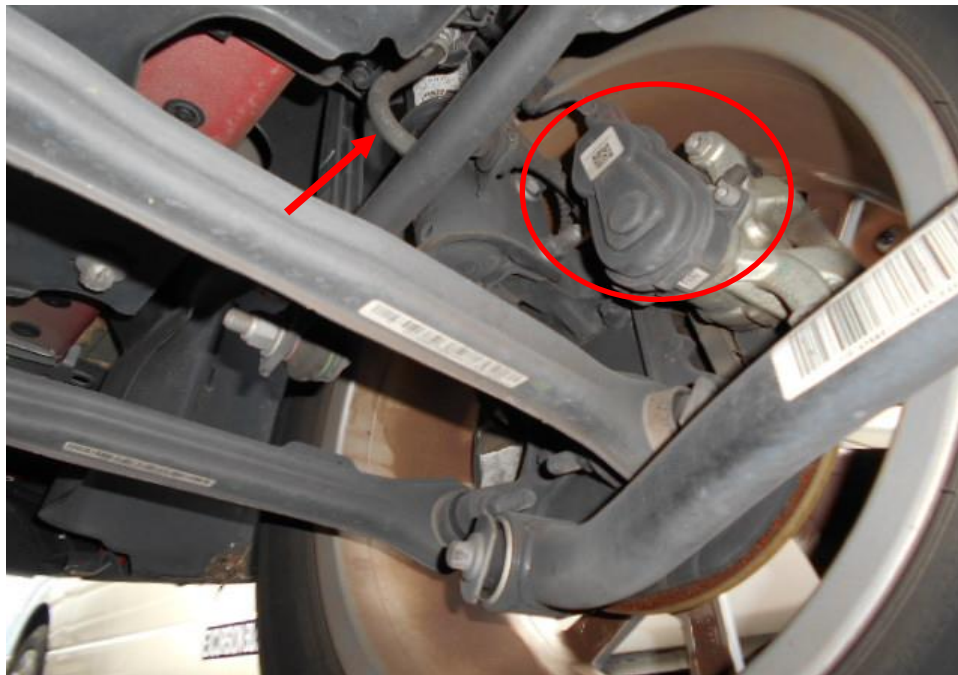
Photo 19 shows the brake hose/pipe (arrowed) at the rear right wheel of the Motor Car. No leakage of brake fluid was observed. Visual examination of the various components of the braking system like the brake caliper (circled), brake booster, brake pedal etc had revealed all to be intact and without visible damage.

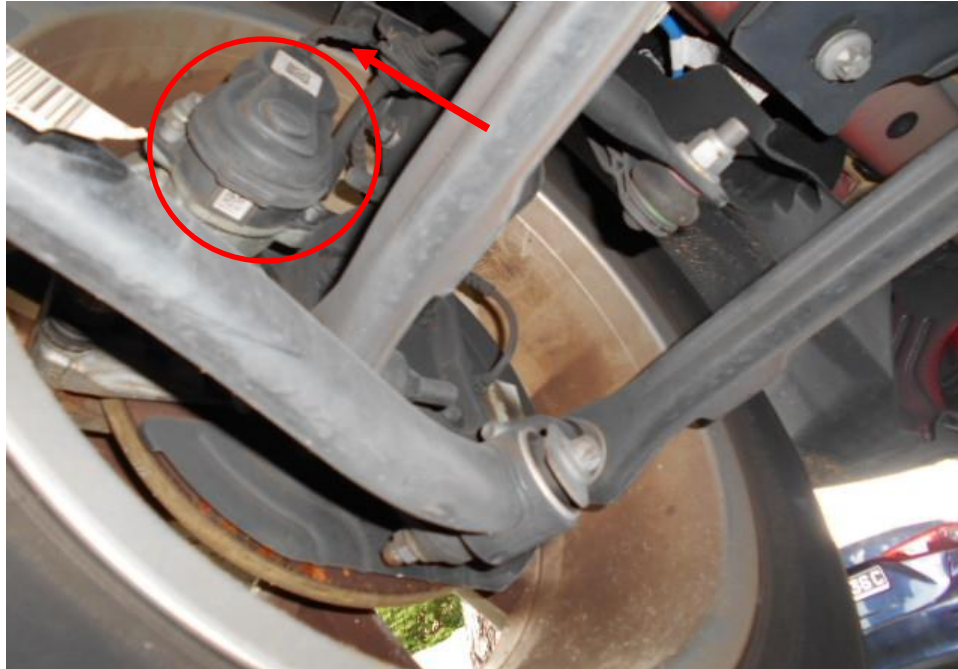
Photo 20 shows the brake hose/pipe (arrowed) at the rear left wheel of the Motor Car. No leakage of brake fluid was observed. Visual examination of the various components of the braking system like the brake caliper (circled), brake booster, brake pedal etc had revealed all to be intact and without visible damage.

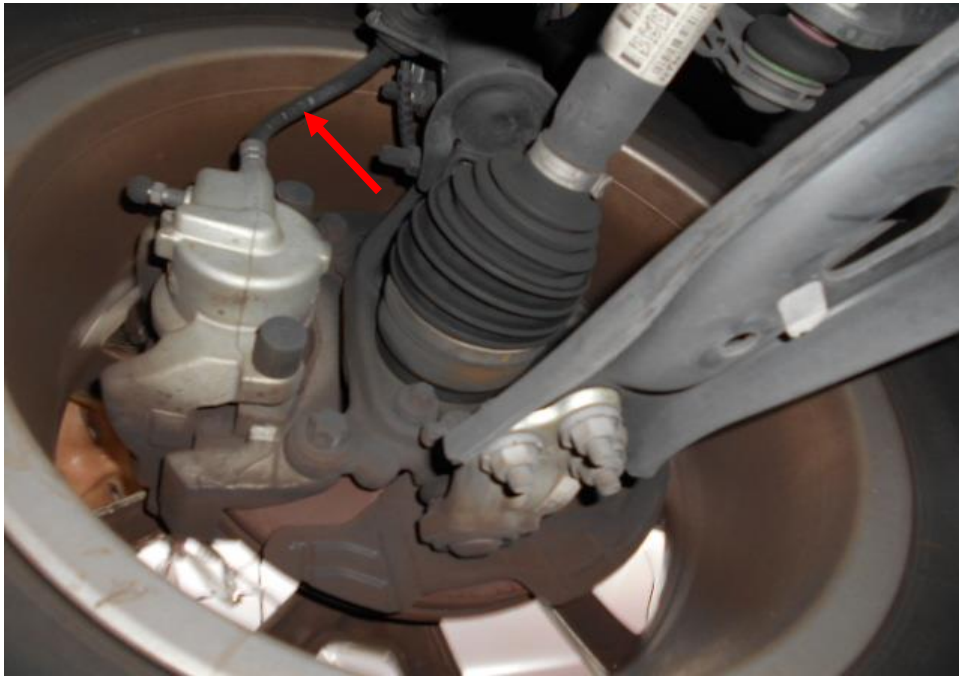
Photo 21 shows the brake hose/pipe (arrowed) at the front right wheel of the Motor Car. No leakage of brake fluid was observed. Visual examination of the various components of the braking system like the disc brake, brake booster, brake pedal etc. had revealed all to be intact and without visible damage.

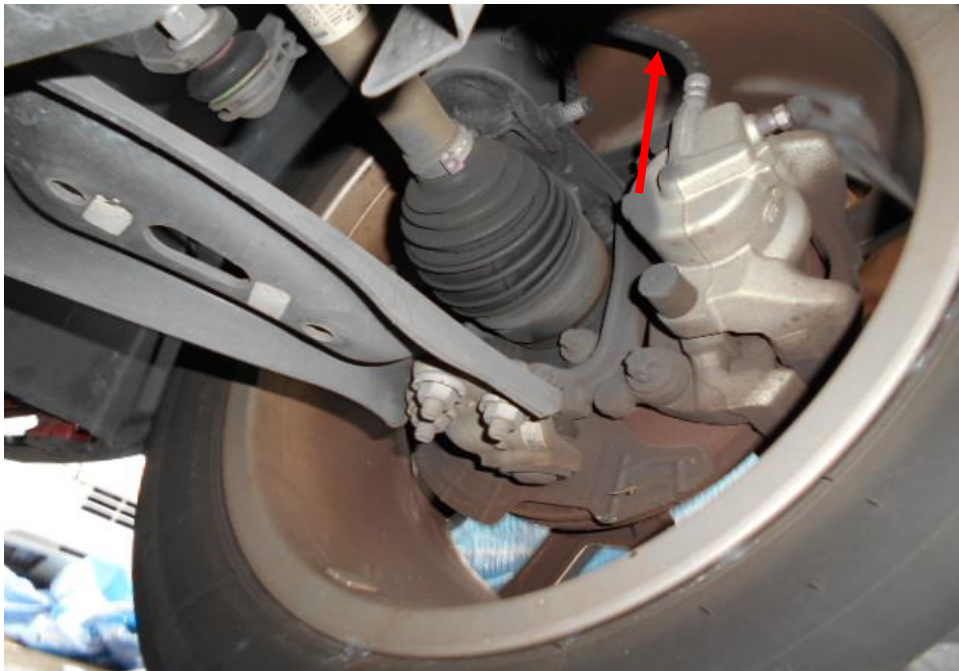
Photo 22 shows the brake hose/pipe (arrowed) at the front left wheel of the Motor Car. No leakage of brake fluid was observed. Visual examination of the various components of the braking system like the disc brake, brake booster, brake pedal etc. had revealed all to be intact and without visible damage.

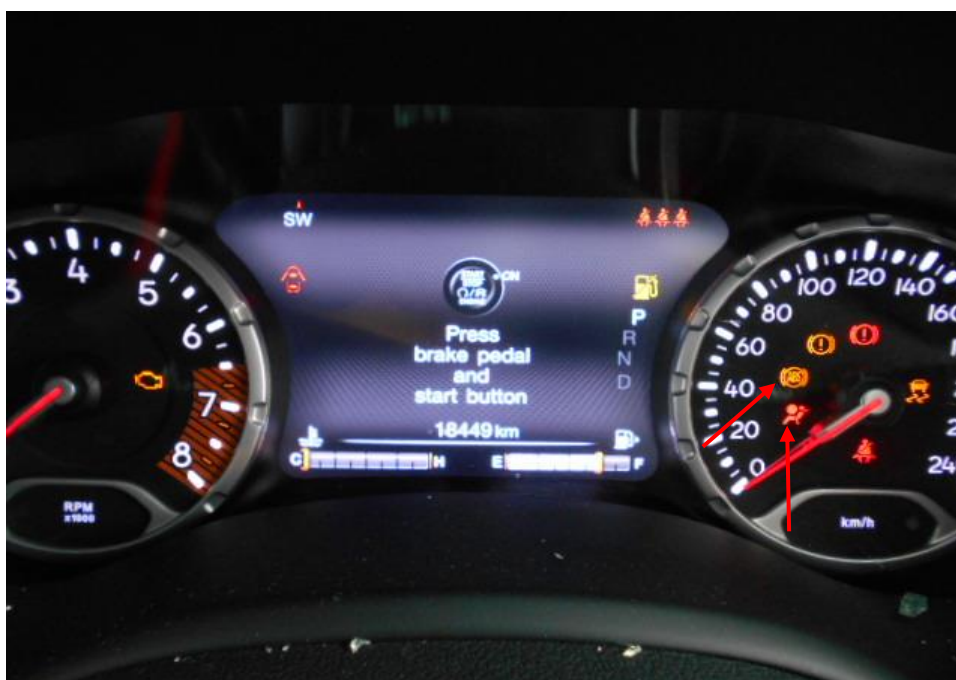
13. The Motor Car's automatic self-test of the functionality of its electronic operating systems like the Anti-lock Brake System (ABS), Traction Control System (TCS) and Supplemental Restraint System (SRS) was unable to be conducted as the engine of the Motor Car was unable to be started up as the fuel was cut off due to the result of the accident. A warning message for the fuel cut-off was triggered and shown on the instrumental panel at the material time of inspection. This prevented me from starting up the Motor Car. See photo 23 & 24 below.

Photo 23 shows the warning light for Supplemental Restraint System (SRS), Traction Control System (TCS) and Anti-Lock Brake System (ABS) (arrowed) appearing on the instrument panel of the Motor Car during the self-test of its various electronic operating systems before the engine was cranked.

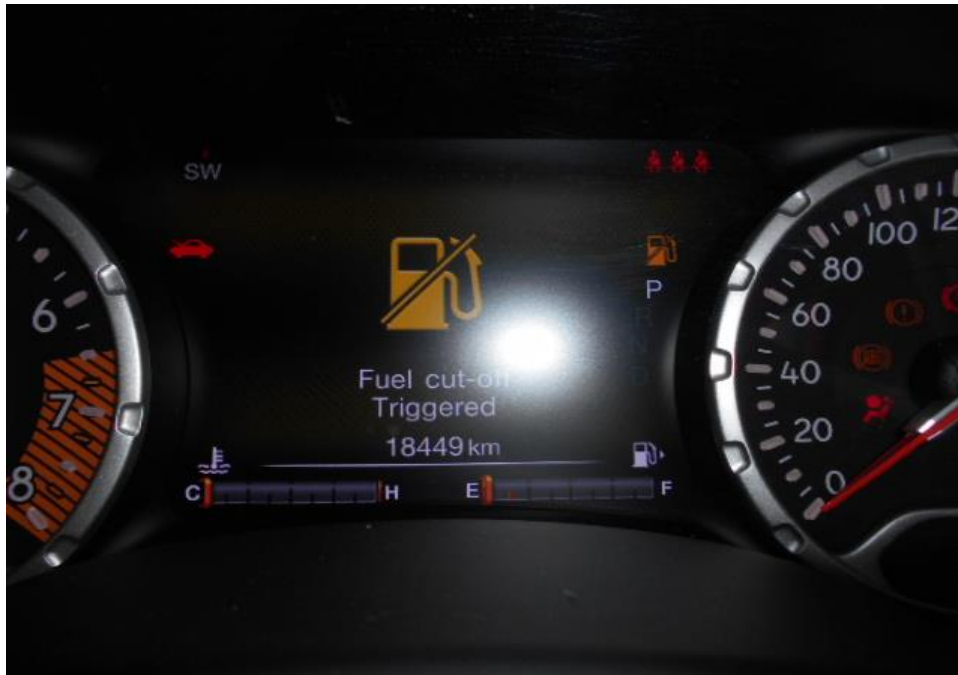
Photo 24 shows the Fuel cut-off Triggered warning lights illuminated on the instrument panel as a result of the accident, this had prevented me from starting up the Motor Car to conduct the automatic self-test of the functionality of its electronic operating systems like the ABS, TCS, SRS and etc.

14. .Operational test to primarily determine whether there was any abnormality to the engine system, transmission system and braking system of the Motor Car could not be conducted given the engine of the Motor Car was unable to be started due to the accident triggering a Fuel cut-off to the engine of the Motor Car. See photo 24 above.
