Your Ref: 318726
Our Ref : CI/MSG23006869/P

6th July 2023

MECHANICAL INSPECTION REPORT OF CEMENT MIXER, WC 5202M

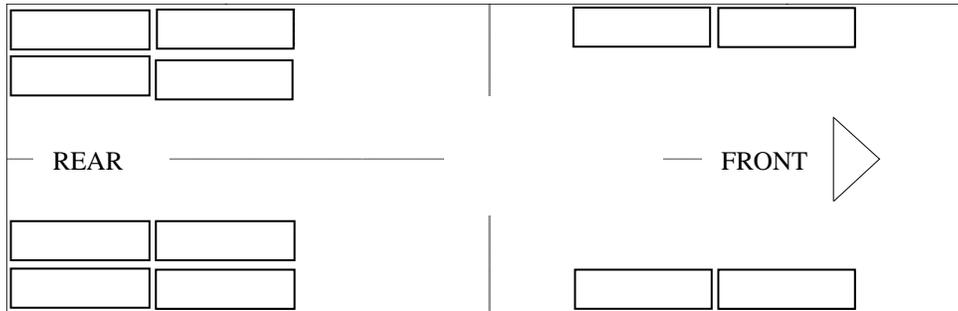
6. The 4 front tyres and 8 rear tyres of the Cement Mixer were observed to be in serviceable condition and sufficiently inflated for vehicular operation. I did not find any tear, cut or burst mark(s) on the outer and the inner sidewalls as well as across the tread of the 12 tyres of the Cement Mixer. The tyre brand, tyre size and remaining tread depth of the 12 tyres of the Cement Mixer were recorded as follows:-

Aplus 295/80 R22.5 (10.7mm)

Golden Crown 295/80 R22.5 (9.6mm)

Aplus 295/80 R22.5 (10.2mm)

Aplus 295/80 R22.5 (9.5mm)

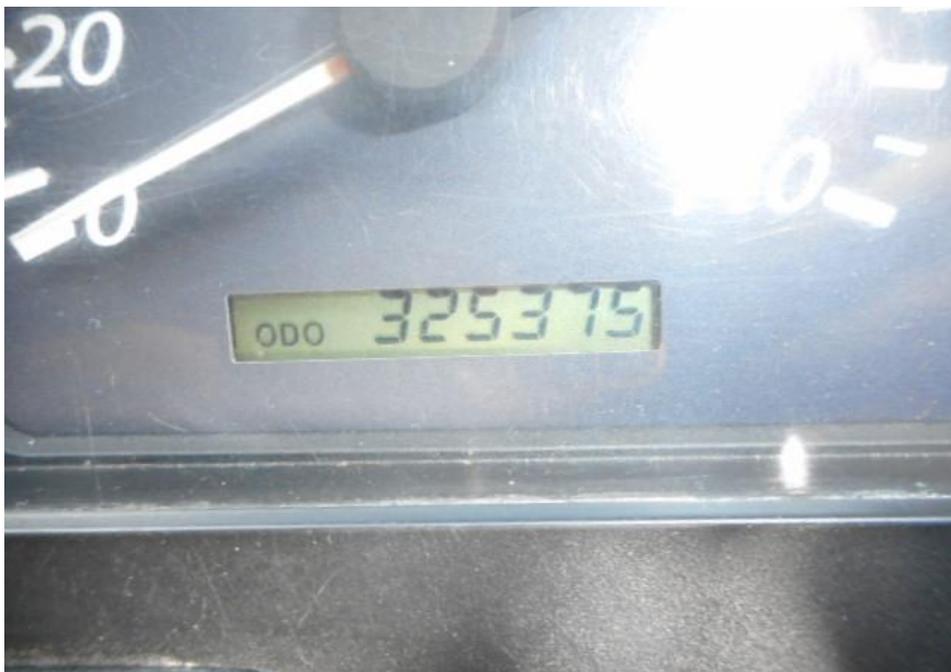
Photo 1 shows a general view of the instrument cluster of the Cement Mixer at the time of my inspection. The mileage of the Cement Mixer was 325,375km

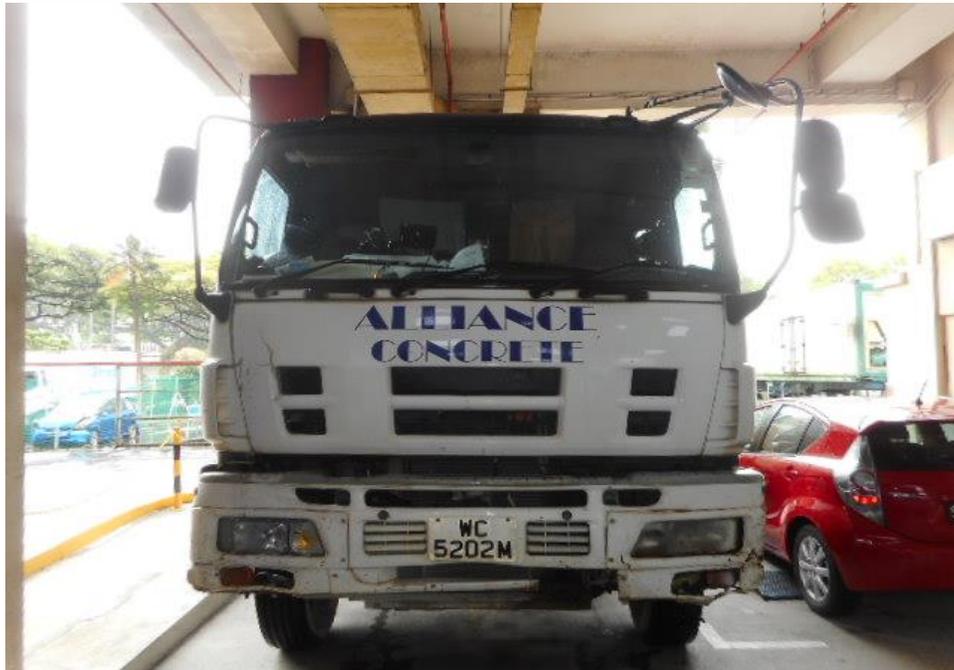
Photo 2 shows a general view of the front body of the Cement Mixer at the time of my inspection. The front portion of the Cement Mixer was observed to have sustained damage. Its front right headlamp was amongst the body part that were damaged as a result of the accident.

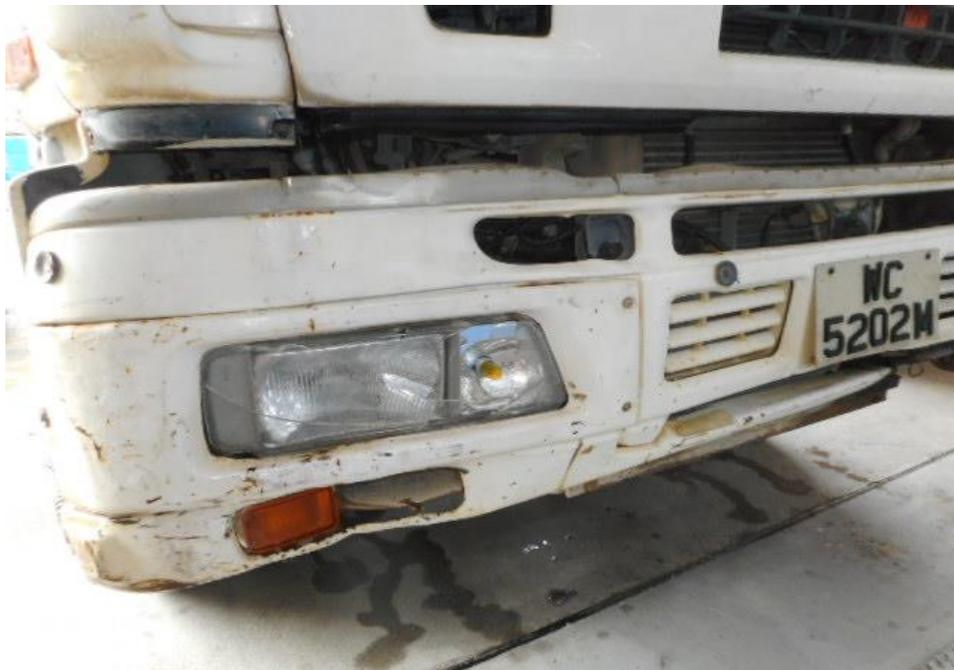
Photo 3 shows a general up view of the Motor Car's front body at the time of my inspection. The front portion of the Motor Car was observed to have sustained damage. Its front right headlamp was the body part that were damaged as a result of the accident.

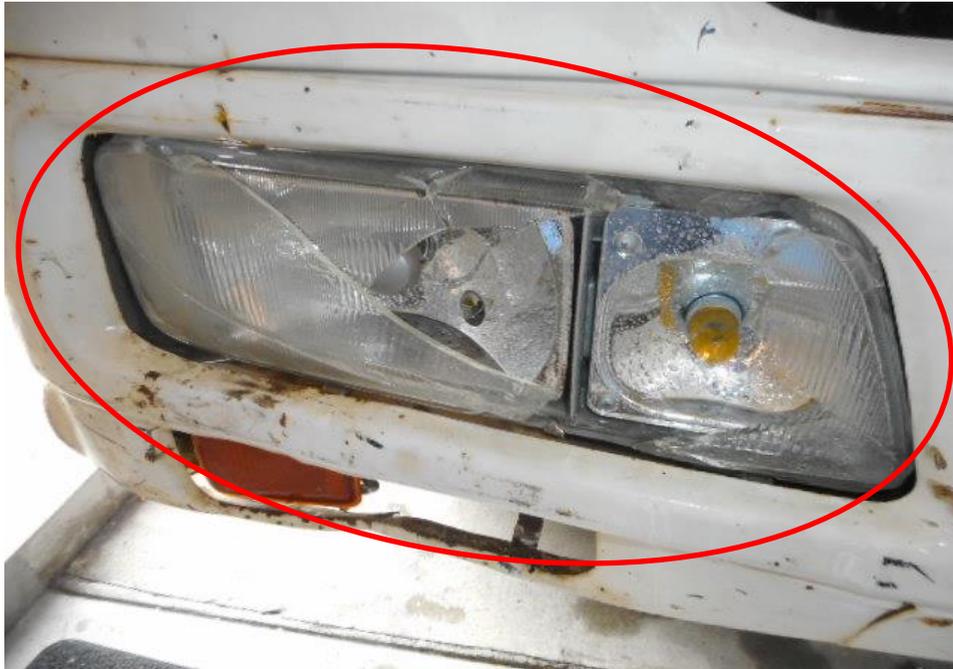
Photo 4 shows a close up view of the Motor Car's front body at the time of my inspection. The front portion of the Motor Car was observed to have sustained damage. Its front right headlamp (circled) was the body parts that were damaged as a result of the accident.

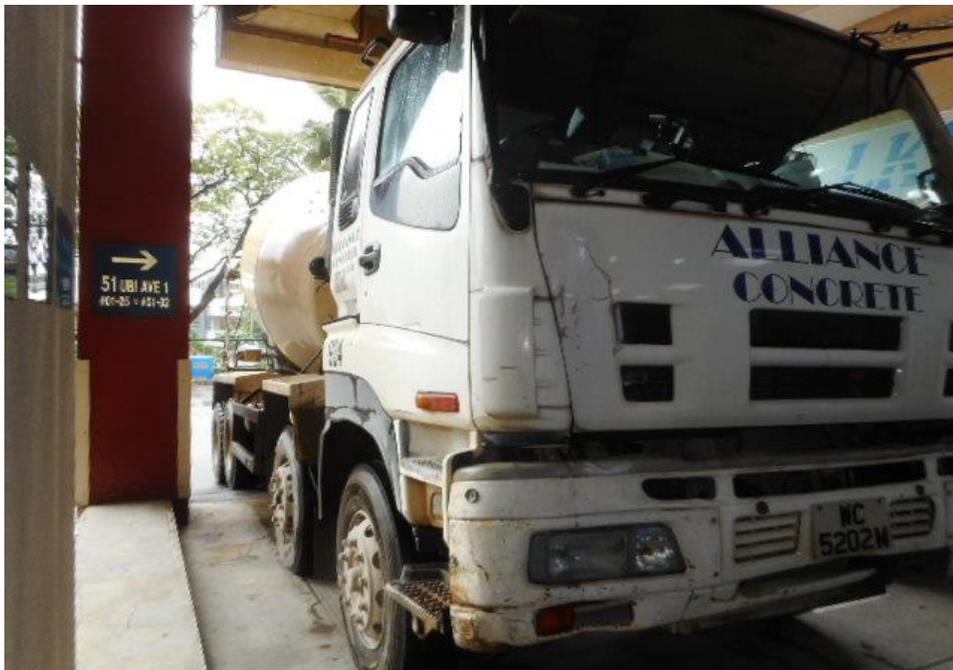
Photo 5 shows a general view of the right body of the Cement Mixer at the time of my inspection. The Cement Mixer was observed to be intact and unaffected by the accident.

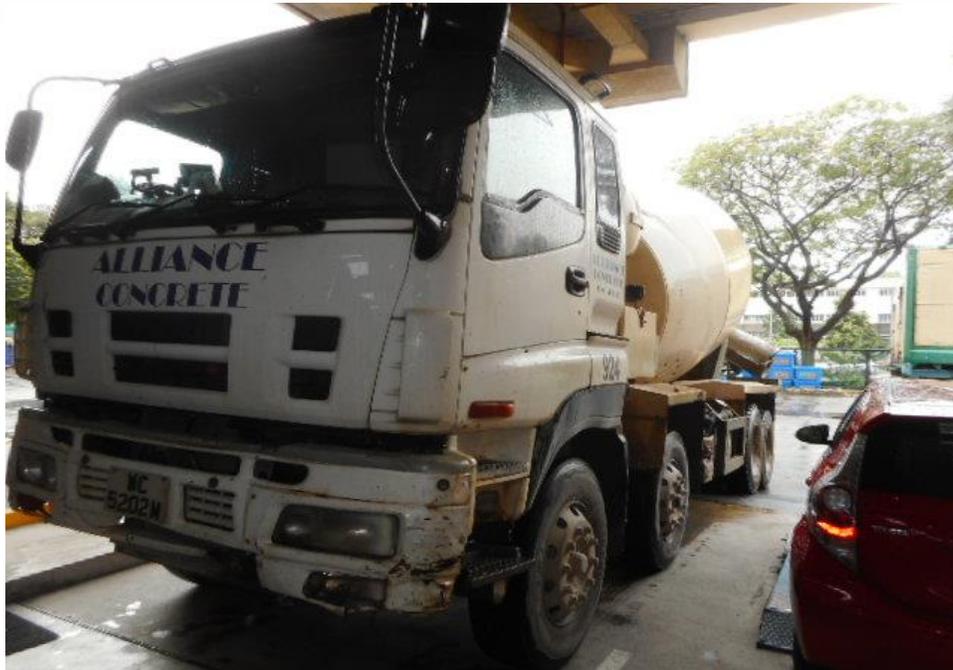
Photo 6 shows a general view of the left body of the Cement Mixer at the time of my inspection. The Cement Mixer was observed to be intact and unaffected by the accident.

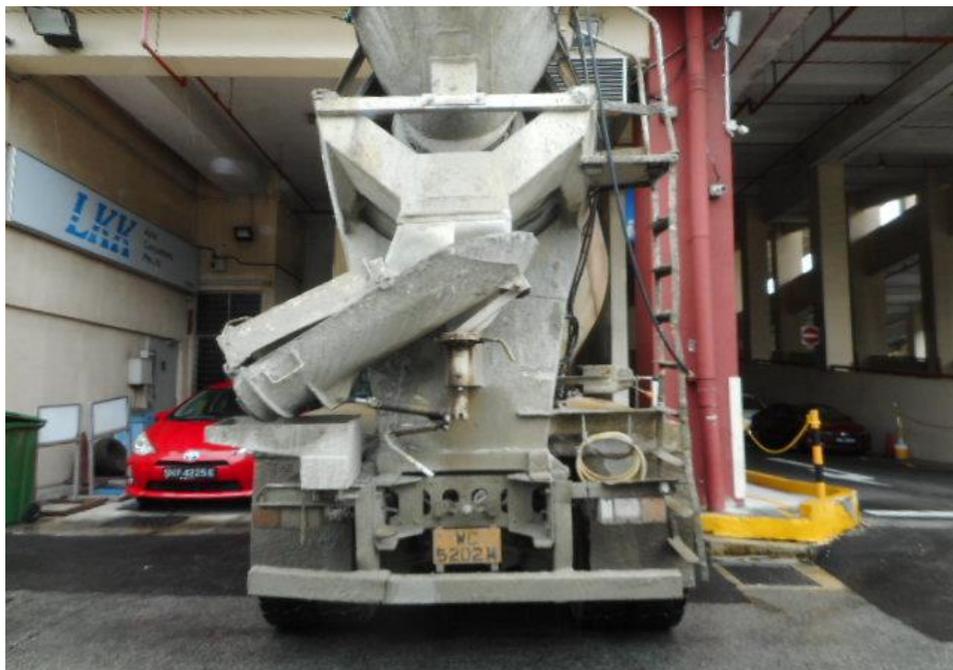
Photo 7 shows a general view of the Cement Mixer's rear body at the time of my inspection. The Cement Mixer was observed to be intact and unaffected by the accident.

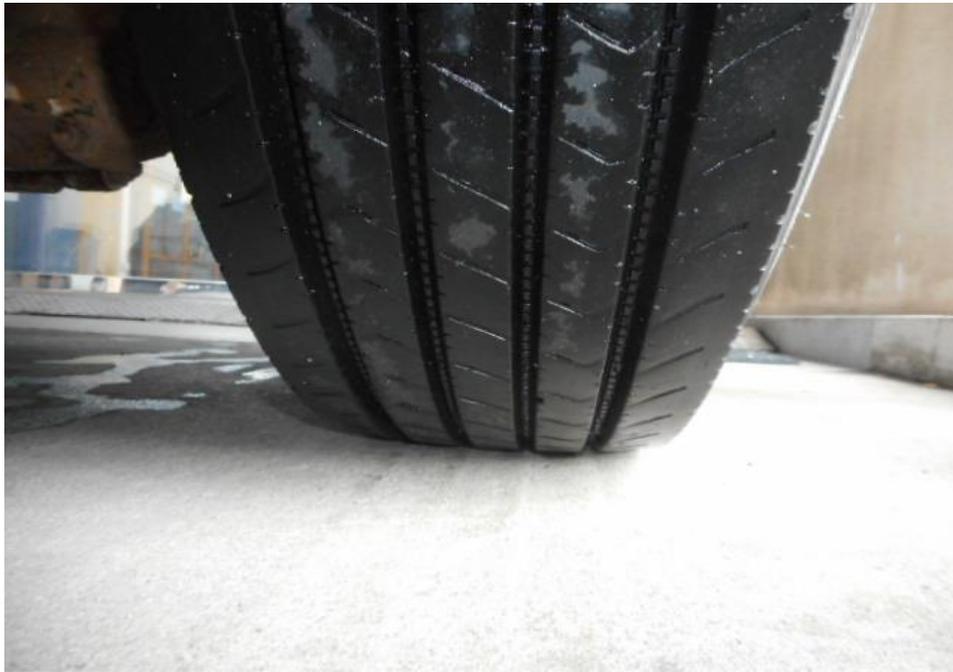
Photo 8 shows the condition of the front right tyre of the Cement Mixer, which was observed to be in serviceable condition with remaining tread depth of approximately 9.5 mm. The tyre, which was wrapped around standard steel wheel rim, was also observed to be sufficiently inflated for vehicular operation. There was no tear, cut or burst mark(s) on the outer and the inner sidewalls as well as across the tread of the 12 tyres that were fitted on the Cement Mixer.

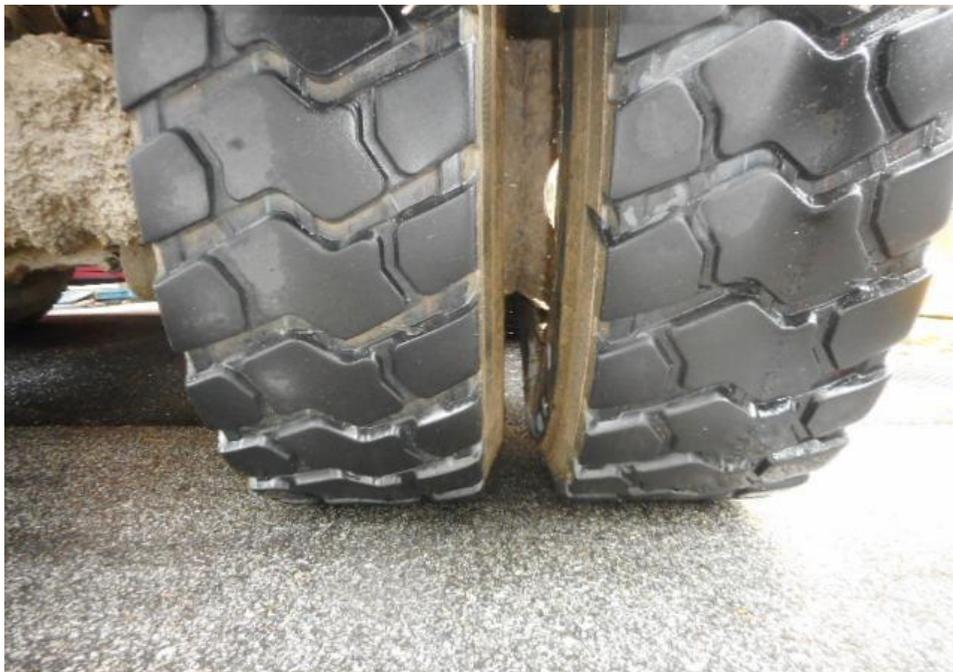
Photo 9 shows the condition of the rear right tyre of the Cement Mixer, which was observed to be in serviceable condition with remaining tread depth of approximately 10.2mm. The tyre, which was wrapped around standard steel wheel rim, was also observed to be sufficiently inflated for vehicular operation.

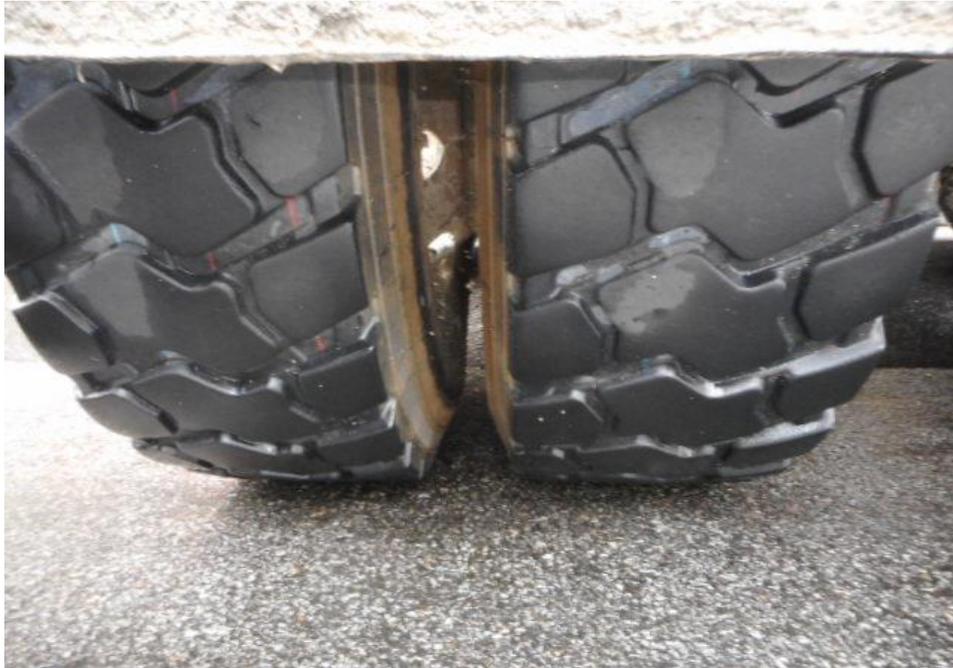
Photo 10 shows the condition of the rear left tyres of the Cement Mixer, which was observed to be in serviceable condition with remaining tread depth of approximately 10.7mm. The tyres, which were wrapped around standard steel wheel rim, were also observed to be sufficiently inflated for vehicular operation. There was also no damage found on all 12 steel wheel rims of the Cement Mixer.

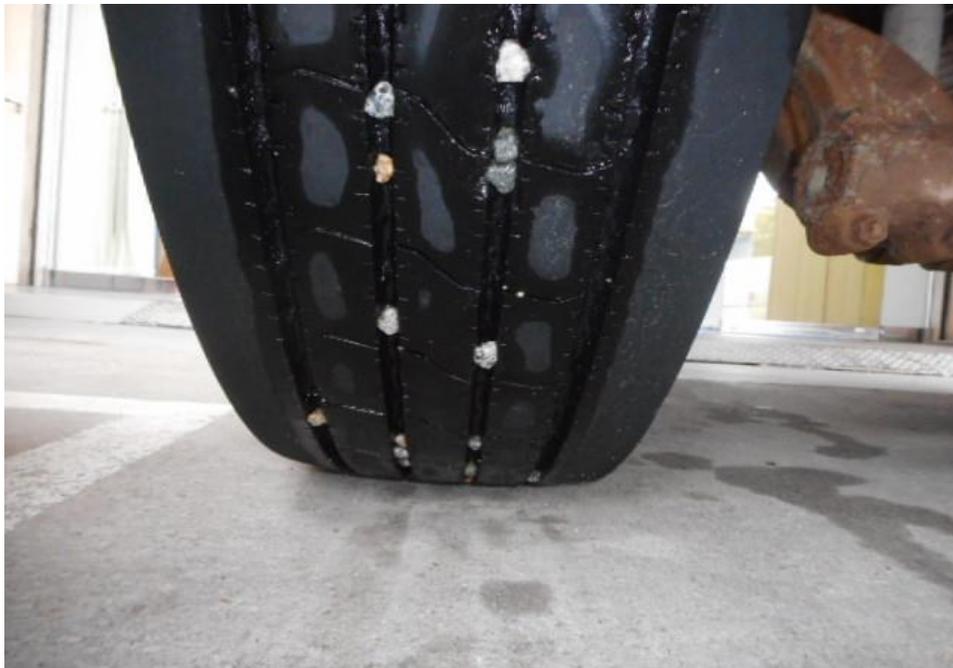
Photo 11 shows the condition of the front left tyres of the Cement Mixer, which were observed to be in serviceable condition with remaining tread depth of approximately 9.6mm. There was also no tear, cut or burst mark(s) on the outer and the inner sidewalls as well as across the tread of the 12 tyres that were fitted on the Cement Mixer.

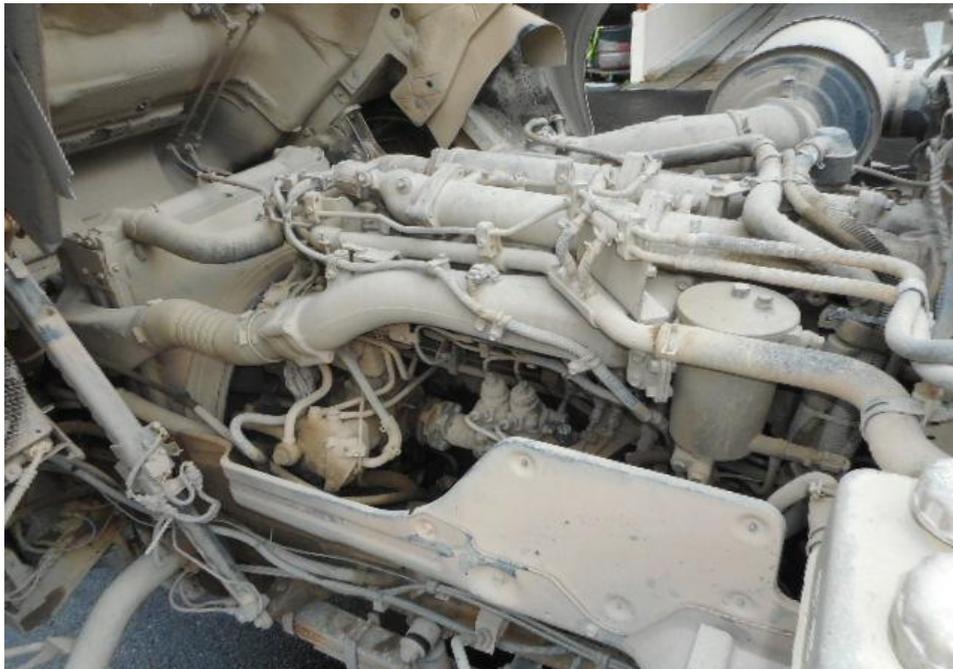
Photo 12 shows a general view of the Cement Mixer's engine compartment, which was accessed by lifting the front cabin of the Cement Mixer. The various parts and components inside the engine compartment were unaffected by the accident. There was also no sign(s) or indication(s) of fresh fluid leakage and/or fluid stain within the engine compartment

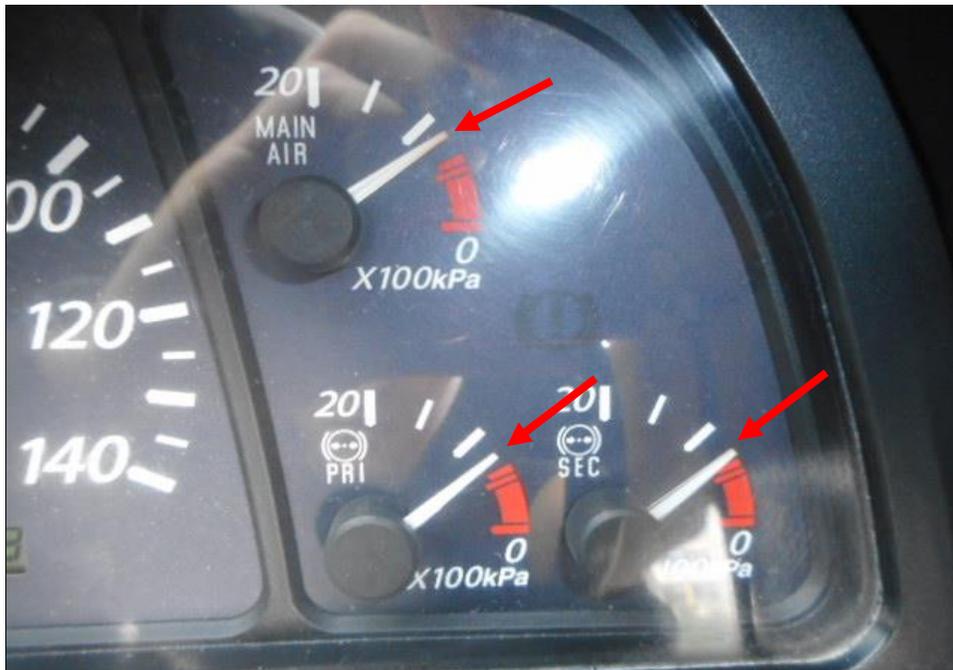
Photo 13 shows the air in the air brake cylinders of the Cement Mixer at the time of my inspection. The air in the cylinder was observed to be of sufficient level & serviceable at the time of the accident.

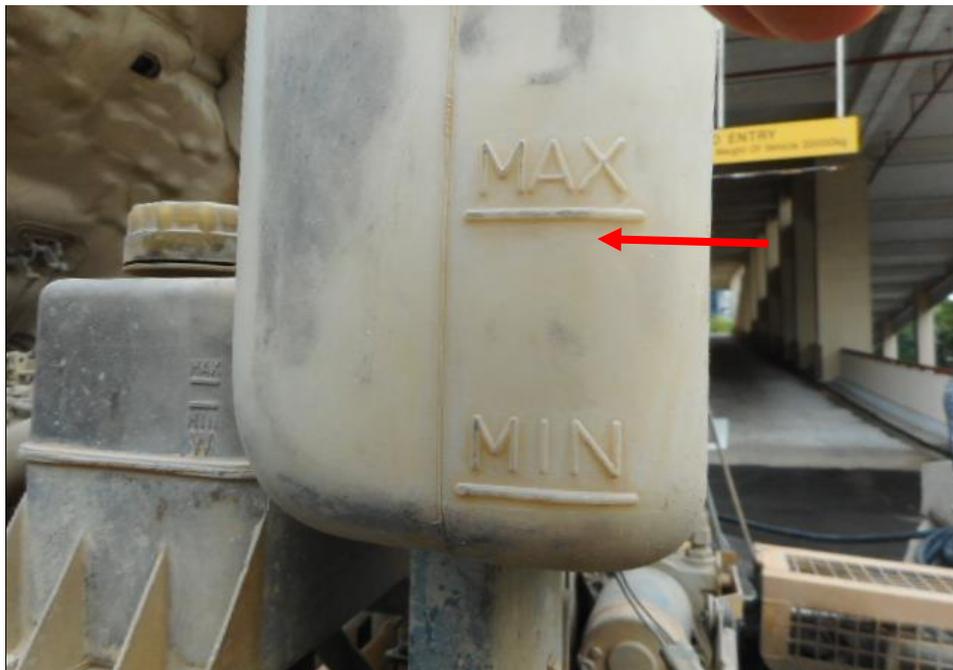
Photo 14 shows the engine coolant reservoir of the Cement Mixer at the time of my inspection. The engine coolant was observed to be of sufficient level (arrowed) and without any visible contamination.

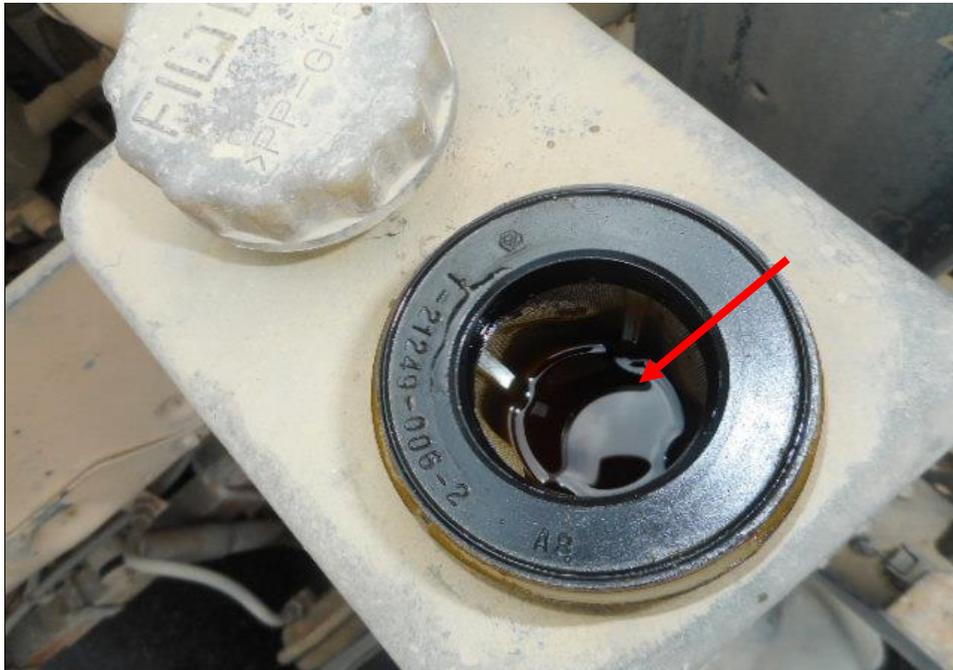
Photo 15 shows the power steering fluid reservoir of the Cement Mixer at the time of my inspection. The power steering fluid was observed to be of sufficient level (arrowed) and without any visible contamination.

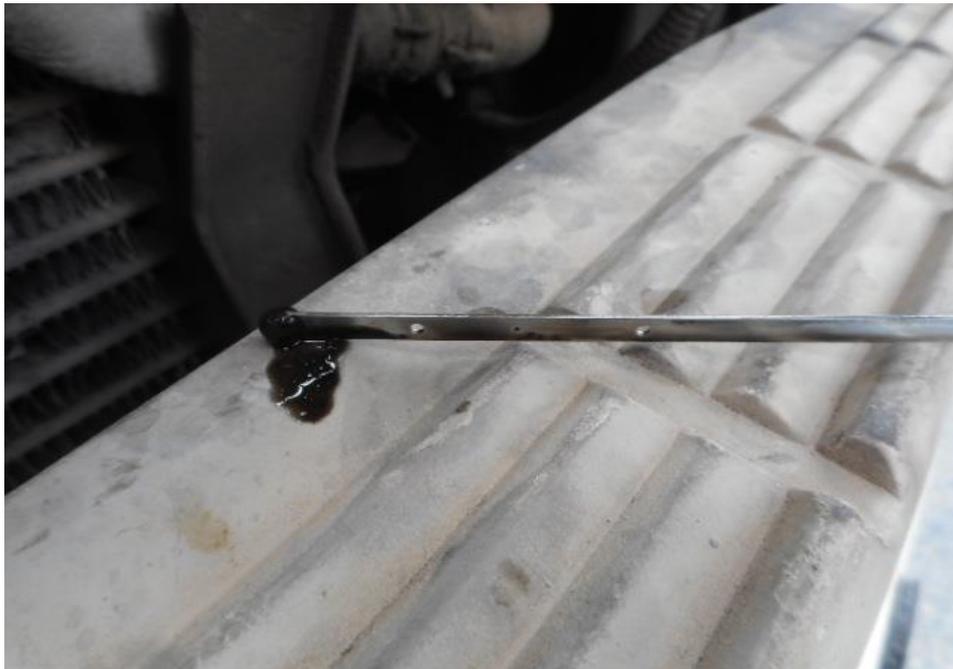
Photo 16 shows the engine oil dip stick of the Cement Mixer at the time of my inspection. The engine oil was observed to be of sufficient level at the time of our inspection.

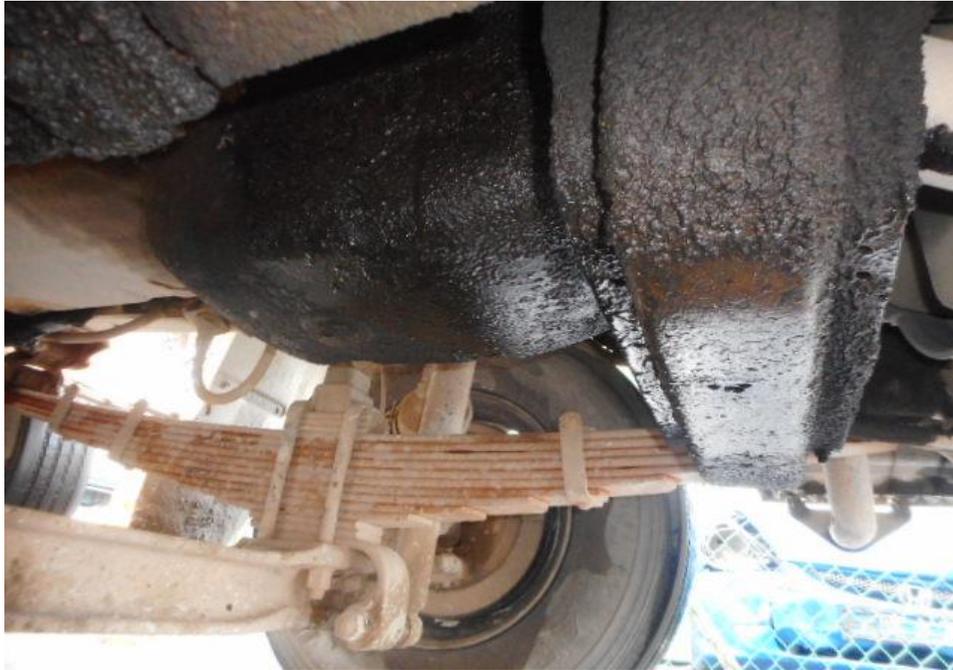
Photo 17 shows the undercarriage of the Cement Mixer, at the area where the engine housing located. I did not find any sign(s) or indication(s) of fluid leak. However, there was old fluid stain(s) was observed on the underside of the Cement Mixer.

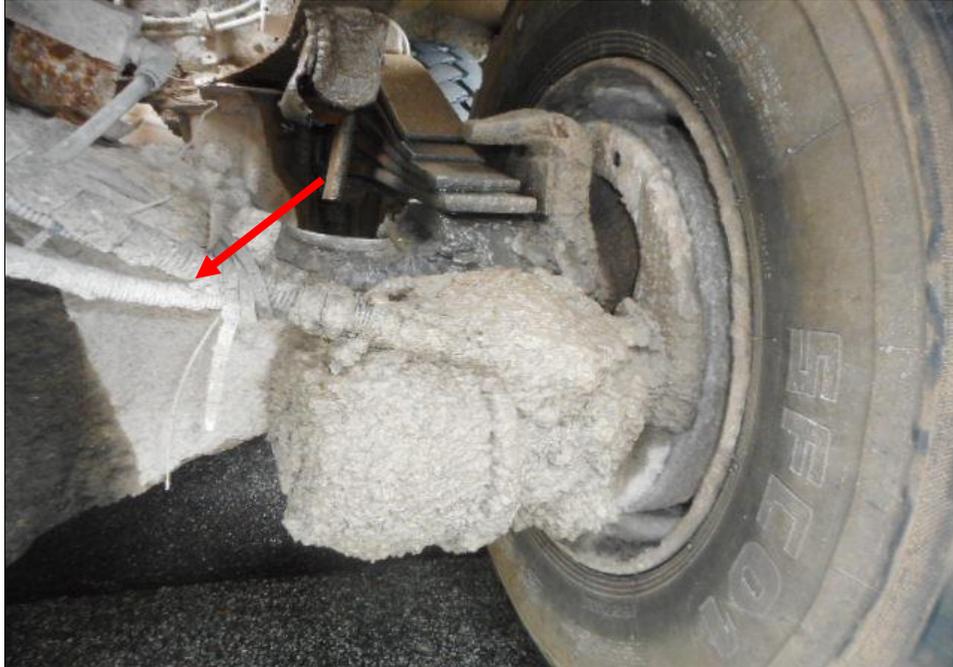
Photo 18 shows the brake pipe (arrowed) at the rear right wheel of the Cement Mixer. I did not observe any leakage of brake fluid at the time of my inspection of the Cement Mixer. My static tests of the Cement Mixer's braking system, along with my visual examination of the various mechanical components in the braking system, had indicated that there was no internal leakage of pressure/vacuum. Hence the braking system of the Cement Mixer was likely to be in serviceable condition at the material time of accident.

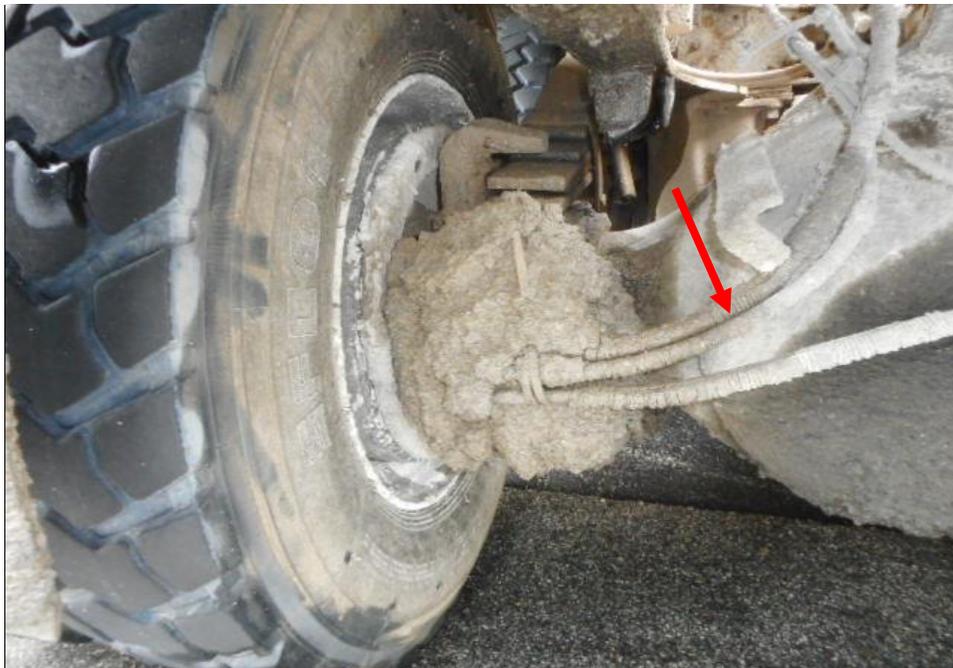
Photo 19 shows the brake pipe (arrowed) at the rear left wheel of the Cement Mixer. I did not observe any leakage of brake fluid at the time of my inspection of the Cement Mixer. My static tests of the Cement Mixer's braking system, along with my visual examination of the various mechanical components in the braking system, had indicated that there was no internal leakage of pressure/vacuum. Hence the braking system of the Cement Mixer was likely to be in serviceable condition at the material time of accident.

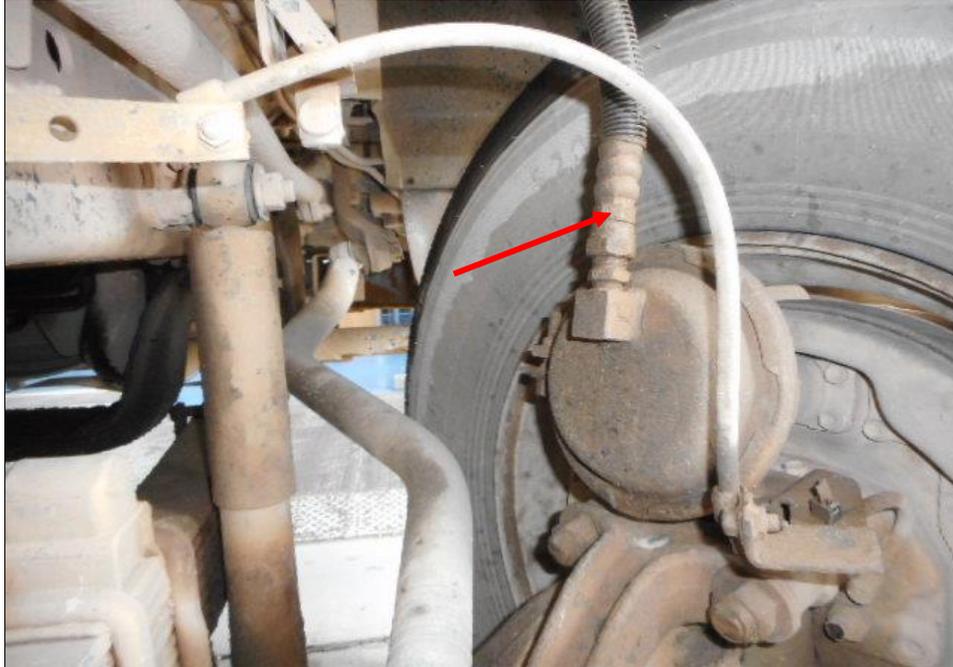
Photo 20 shows the brake pipe (arrowed) at the front right wheel of the Cement Mixer. I did not observe any leakage of brake fluid at the time of my inspection of the Cement Mixer. My static tests of the Cement Mixer's braking system, along with my visual examination of the various mechanical components in the braking system, had indicated that there was no internal leakage of pressure/vacuum. Hence the braking system of the Cement Mixer was likely to be in serviceable condition at the material time of accident.

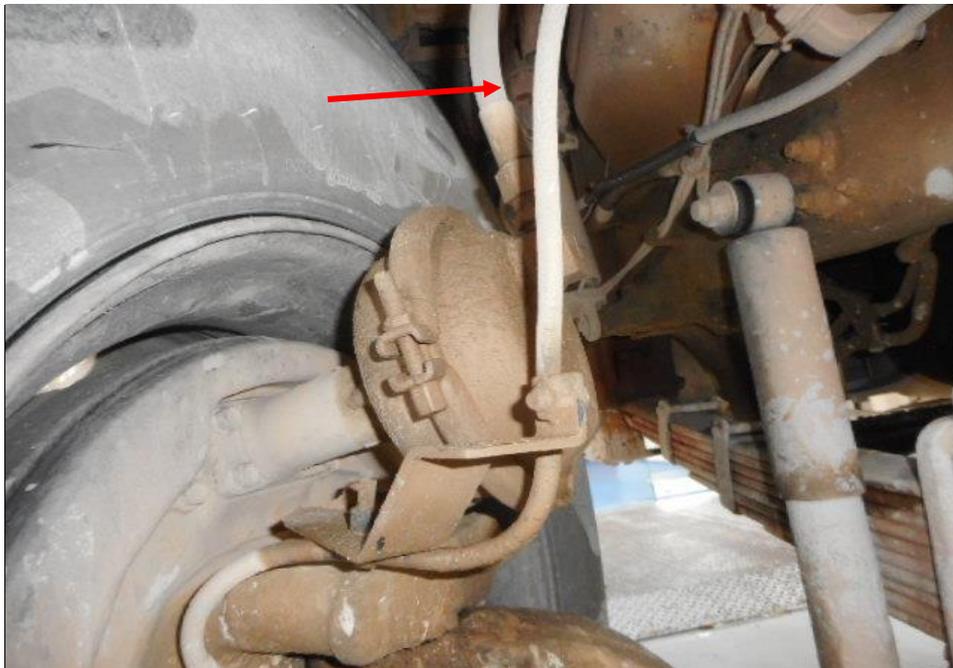
Photo 21 shows the brake pipe (arrowed) at the front left wheel of the Cement Mixer. I did not observe any leakage of brake fluid at the time of my inspection of the Cement Mixer. My static tests of the Cement Mixer's braking system, along with my visual examination of the various mechanical components in the braking system had indicated that there was no internal leakage of pressure/vacuum. Hence the braking system of the Cement Mixer was likely to be in serviceable condition at the material time of accident.

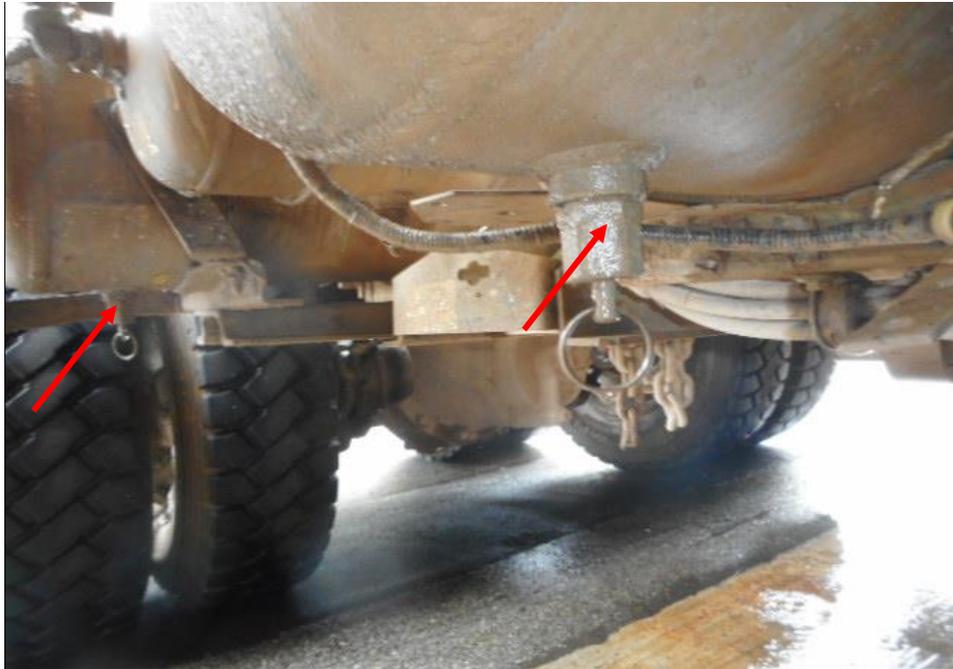
Photo 22 shows the air brake cylinders (arrowed) at the undercarriage of the Cement Mixer. I did not observe any leakage of air brake fluid at the time of my inspection of the Cement Mixer. My static tests of the Cement Mixer's braking system, along with my visual examination of the various mechanical components in the braking system had indicated that there was no internal leakage of pressure/vacuum. Hence the braking system of the Cement Mixer was likely to be in serviceable condition at the material time of accident.

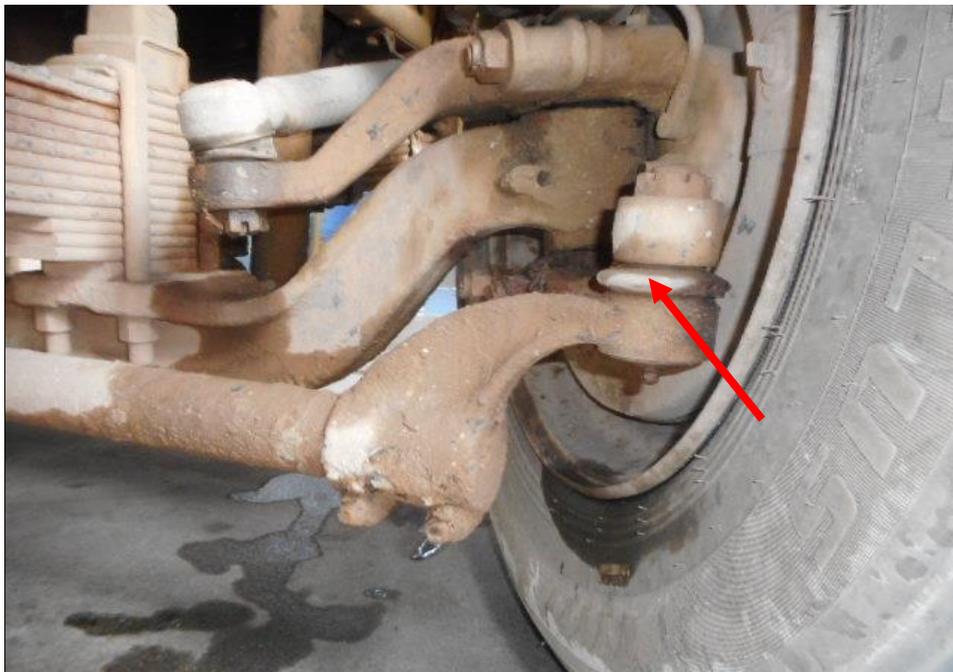
Photo 23 shows the various undercarriage components at the front right wheel of the Cement Mixer, in particular the steering tie rod end (arrowed). The various steering components were all found to be intact, suggesting that the steering system of the Cement Mixer was likely to be in serviceable condition at the material time of accident. There was also no sign of fluid stain(s) observed on the various undercarriage components.

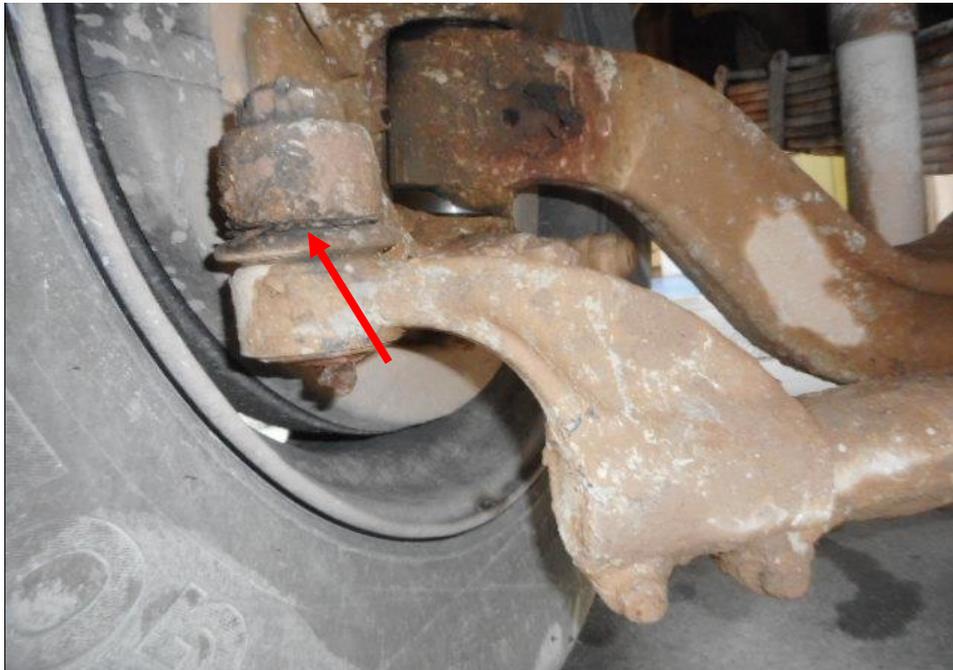
Photo 24 shows the various undercarriage components at the front left wheel of the Cement Mixer, in particular the steering tie rod end (arrowed). The various undercarriage components of the Cement Mixer were all found to be intact without any visible damage. There was also no sign of fluid stain(s) observed on the various undercarriage components.

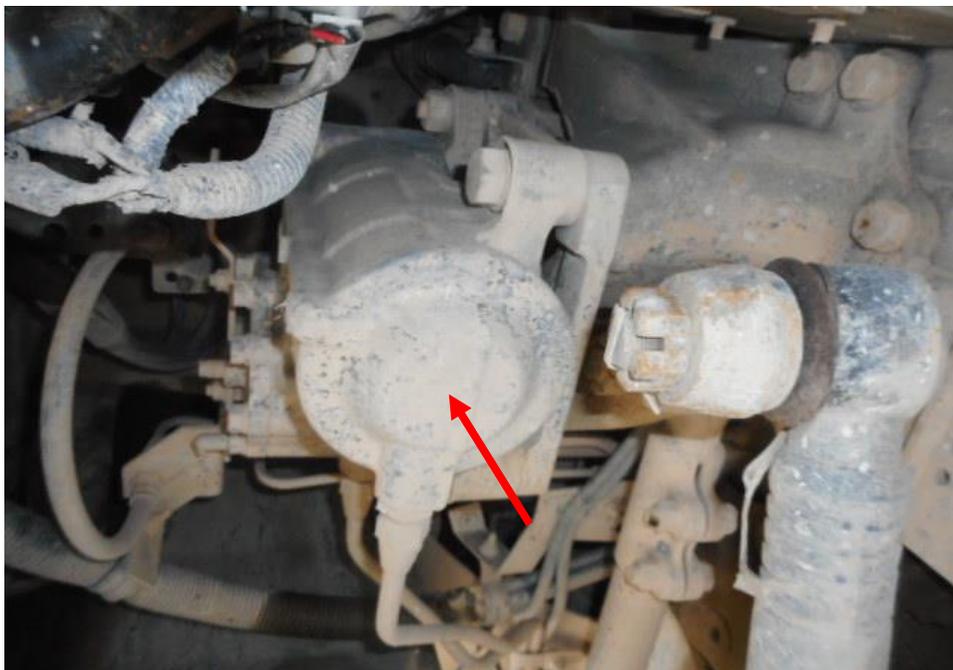
Photo 25 shows the steering box component (arrowed) at the undercarriage of the Cement Mixer was found to be intact without any visible damage. There was also no sign of fluid stain(s) observed on the various undercarriage components.

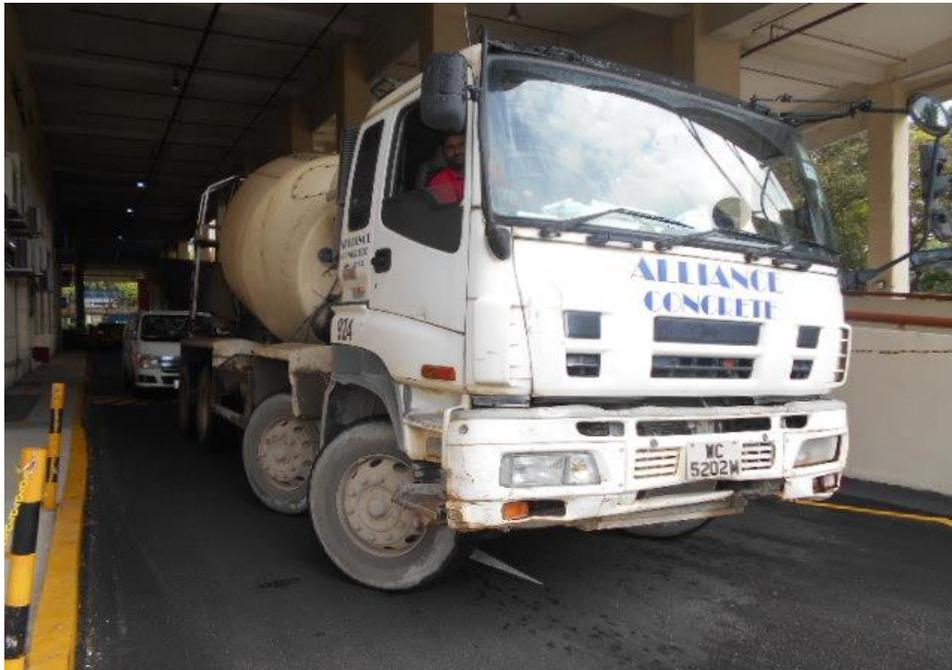
Photo 26 shows the front right wheel of the Cement Mixer turned to its full left. During my steering system test, I did not experience any abnormal free play and/or resistance when I had turned the steering wheel towards full left and full right. This would suggest that the steering system of the Cement Mixer was likely to be in serviceable condition at the material time of accident.

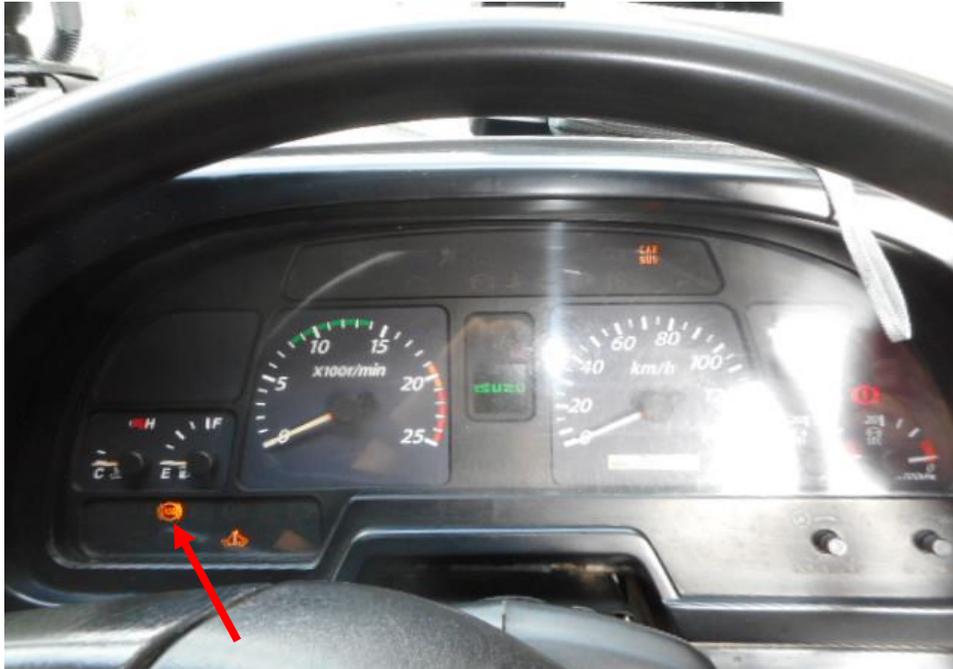
Photo 27 shows the warning light for Anti-Lock Braking System (ABS) (arrowed) appearing on the instrument panel of the Prime Mover during the self-test of its various electronic operating systems when its engine was cranked.

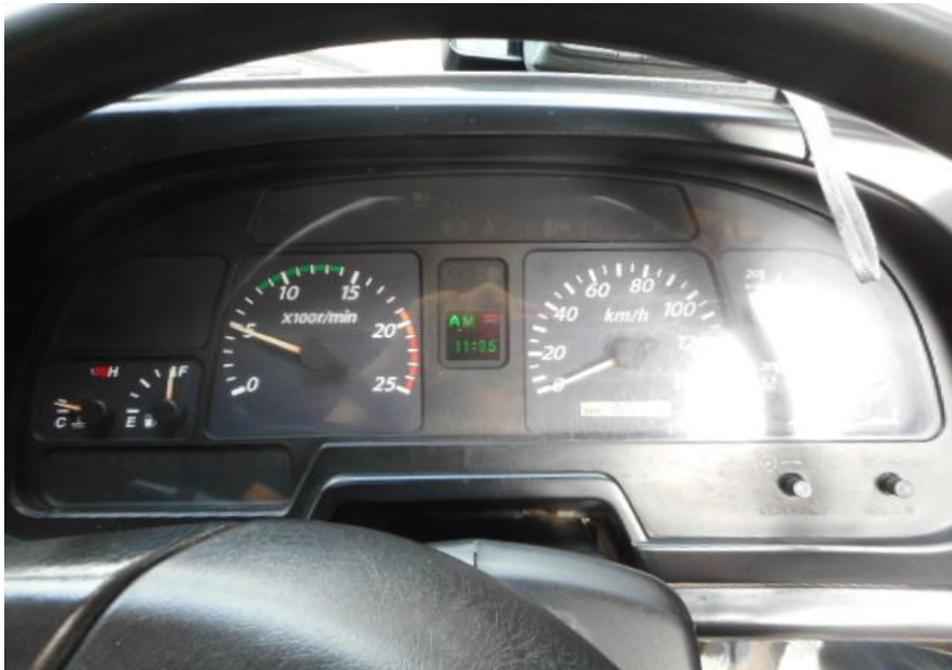
Photo 28 shows no warning lights illuminated on the instrument panel of the Motor Car after the engine was cranked. This would suggest that there was no abnormality to the electronic operating system of the Motor Car, like the ABS and etc.
