Your Ref: 321146
Our Ref : CS4/MSG23006885/N

24 July 2023

TECHNICAL INVESTIGATION REPORT OF FIRE INCIDENT INVOLVING THE INSURED VEHICLE GBJ 4281C ON 4 JULY 2023

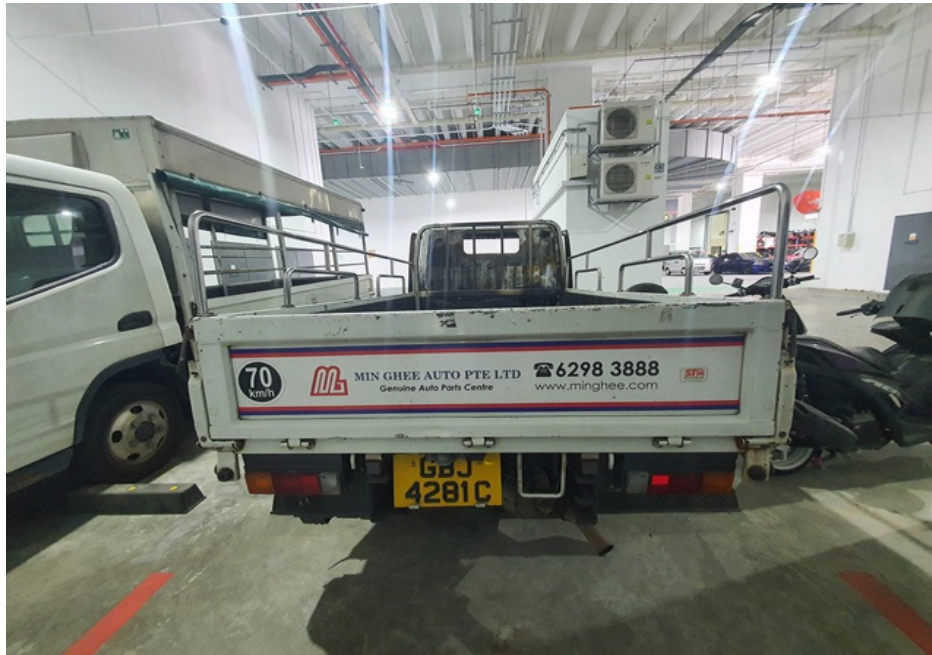
Photo 1 shows the rear portion of the Insured Vehicle at the time of our inspection. The damage to the Insured Vehicle was confined to its frontal portion. The exterior body of the Insured Vehicle was relatively unaffected by the incident except for the frontal portion.

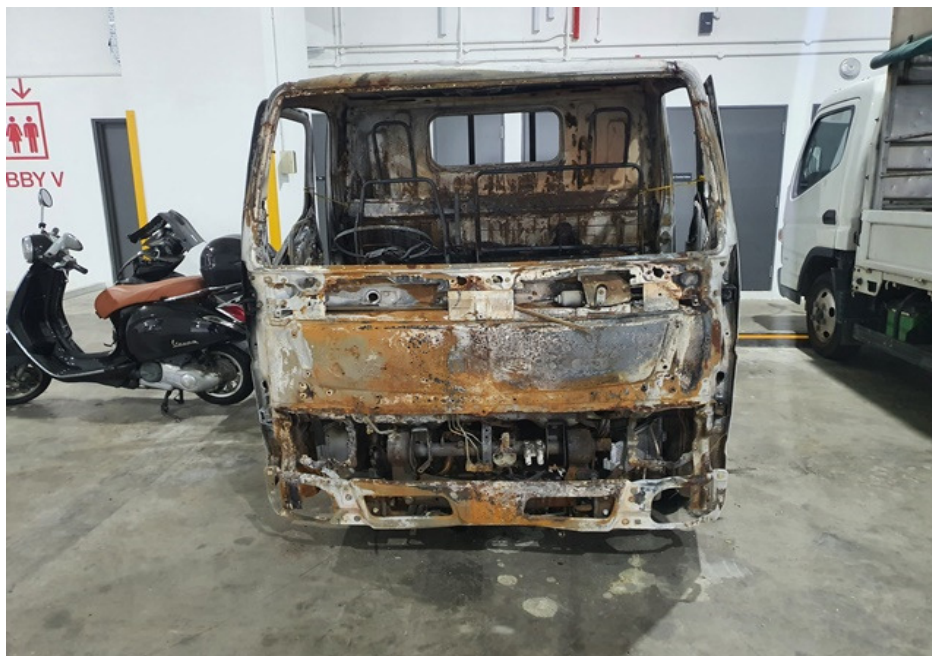
Photo 2 shows the frontal portion of the Insured Vehicle at the time of our inspection. The damage to the Insured Vehicle was confined to its frontal portion. The exterior body of the Insured Vehicle was relatively unaffected by the incident except for the frontal portion.

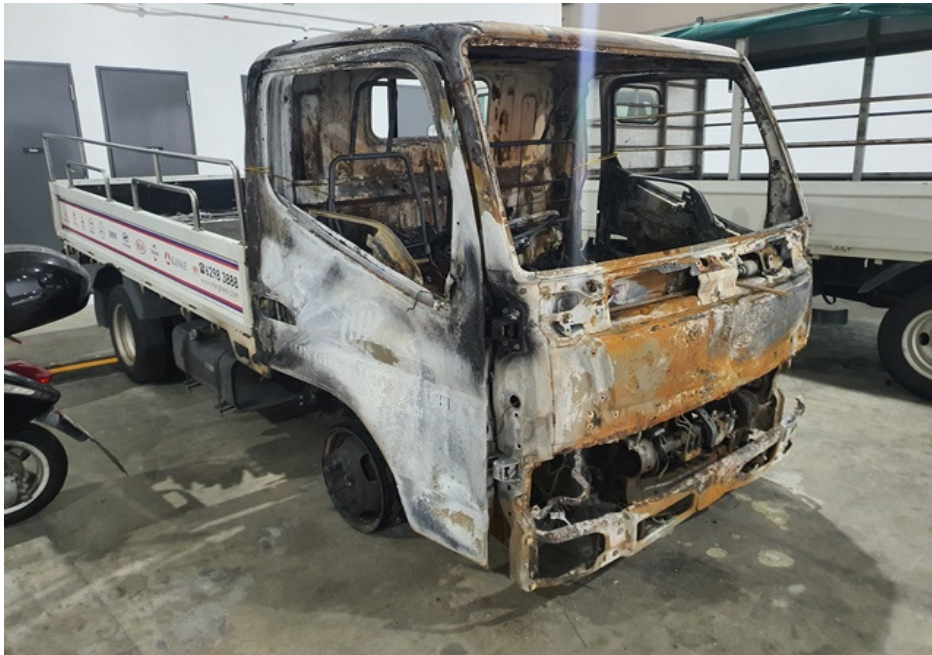
Photo 3 shows the right frontal portion of the Insured Vehicle at the time of our inspection. The exterior body of the Insured Vehicle was relatively unaffected by the incident except for the frontal portion.

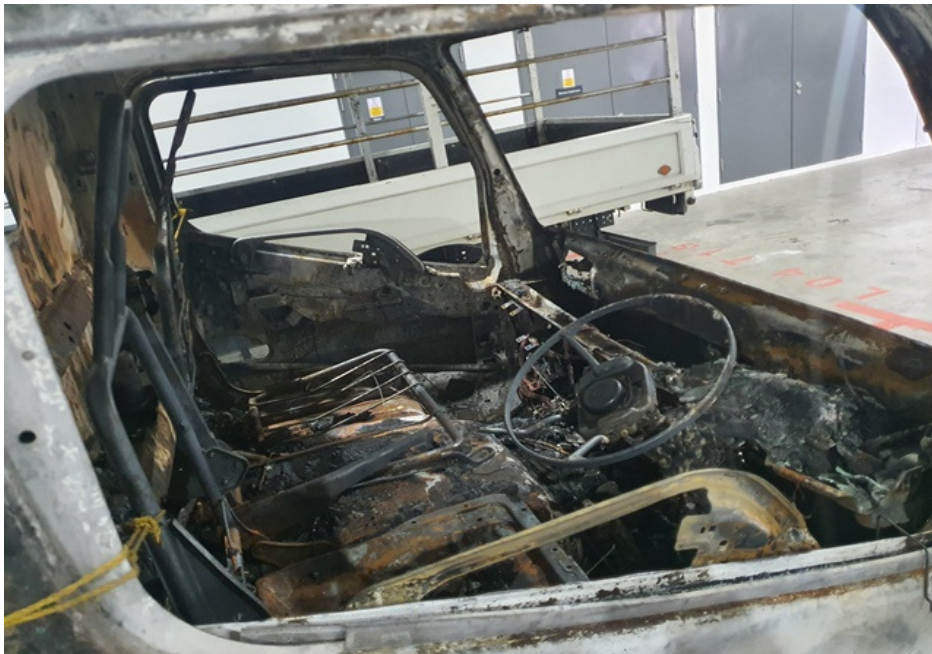
Photo 4 shows the interior compartment the Insured Vehicle at the time of our inspection. The interior compartment of the Insured Vehicle was severely affected by the fire.

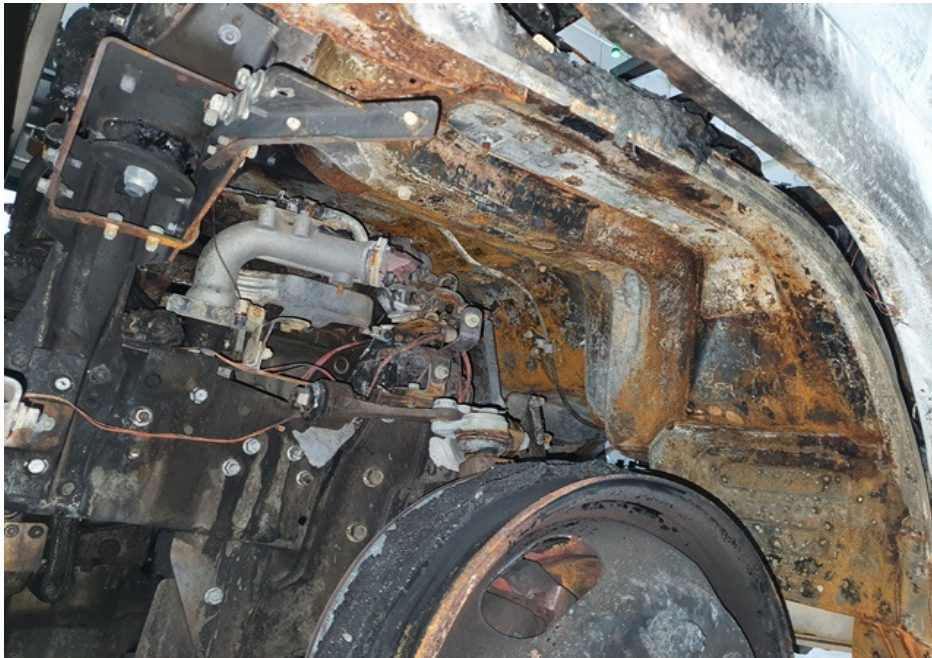
Photo 5 shows the engine compartment of the Insured Vehicle which is situated beneath the cab at the time of our inspection. The engine compartment of the Insured Vehicle was severely affected by the fire. Most of the components inside the engine compartment were found to be severely burnt and/or melted as a result of the fire.

10. For this particular case, most of the components inside the engine compartment were found to be severely burnt and/or melted as a result of the fire. The severely burnt and/or melted components had jammed the cab tilt lever. Hence we were unable to lift the cab of the Insured Vehicle to have a closer examination of the engine compartment.

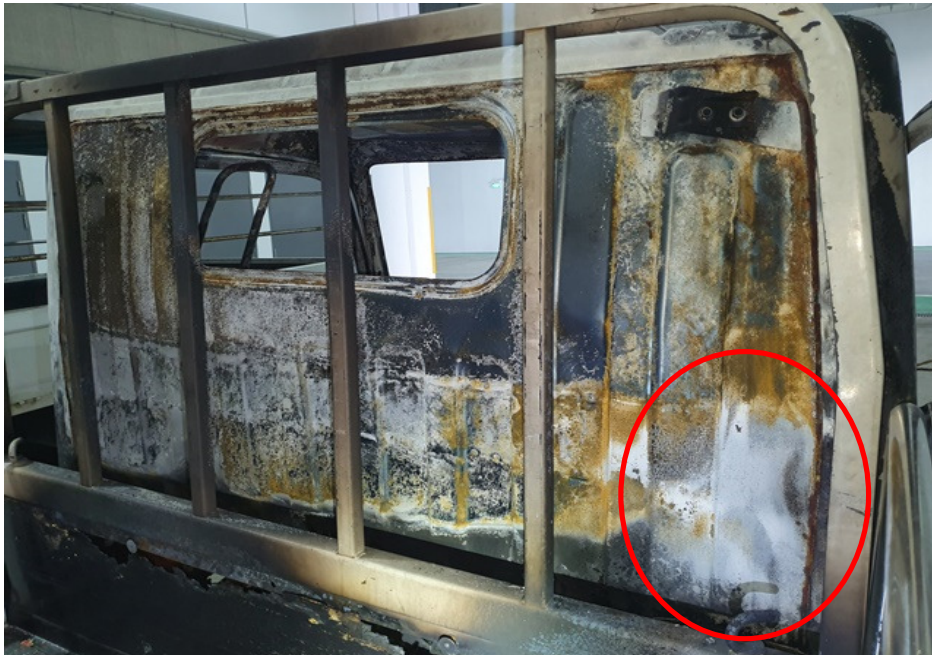
8. For this particular case, the fire appears to have originated within the engine compartment of the Insured Vehicle. This can be determined from the burn pattern and the high heat intensity burn marks (whitish burn marks) found on the rear right portion of the cab as well as the rust that had developed on the underside of the cab of the Insured Vehicle.
9. The whitish burn marks are a result of exposure to prolonged heat intensity. Rust would normally start to develop around these areas soon after a fire as prolonged exposure to high heat intensity usually causes steel/metal material body parts to be exposed to natural environmental condition. The rust that had developed on the underside of the cab of the Insured Vehicle is an indication that the engine compartment had sustained exposure to prolonged high heat intensity. See photos 6 & 7 below.

Photo 6 shows the whitish burn marks that were found on the rear right portion of the cab of the Insured Vehicle (circled). Such whitish burn marks are a result of exposure to prolonged heat intensity.

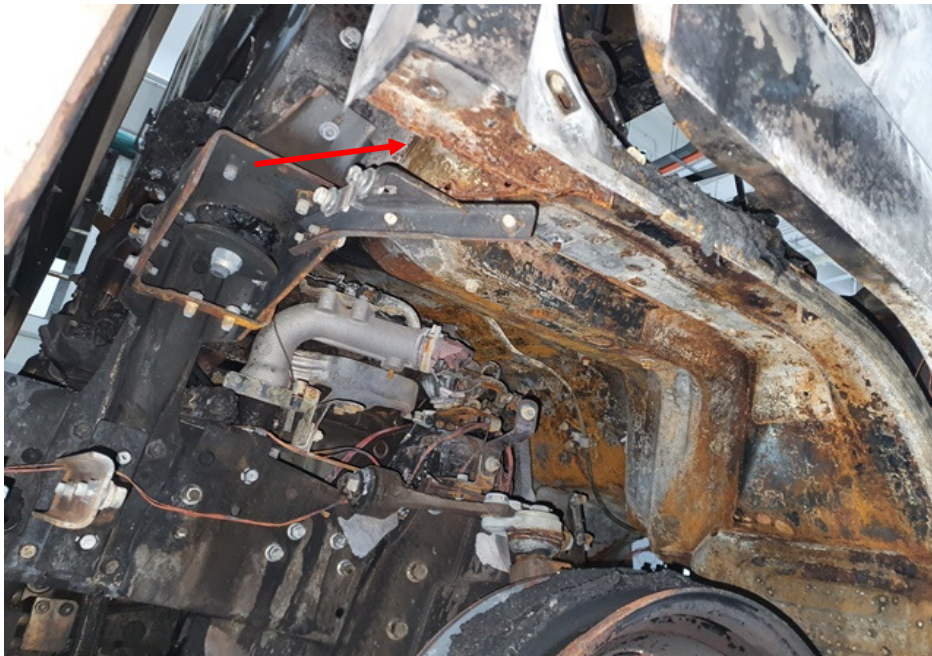
Photo 7 shows the rust that had developed on the underside of the cab of the Insured Vehicle (arrowed) which is an indication that the fire to the Insured Vehicle had originated from the engine compartment. The development of rust is an indication that the area was exposed to prolonged exposure to high heat intensity, which had caused the steel/metal material of the cab to be exposed to natural environmental condition.

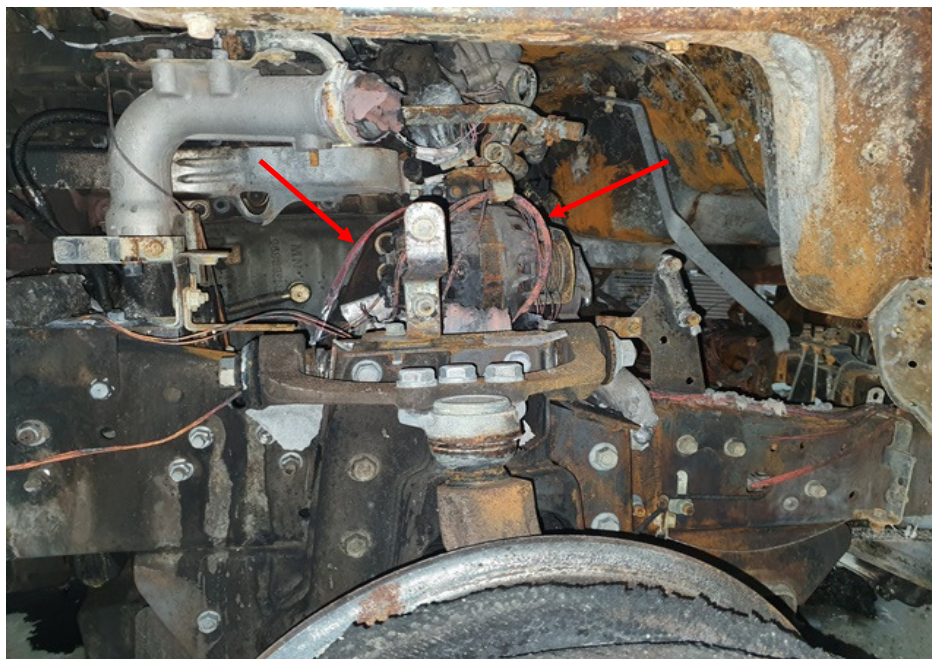
11. Therefore based on circumstances of the case where it was reported that the fire was seen from the underside of the right portion of the cab as well as upon closer examination of the right portion of the engine compartment, which was where the fire to the Insured Vehicle had likely started, we had found several stretches of wiring burnt internally to its bare copper state. Such condition normally indicates internal heating of copper wires which is a sign of an electrical short circuit occurring. This physical evidence would then appear to suggest that the cause of fire to the Insured Vehicle could have possibly been due to electrical in nature. See photos 8 & 9 below.

Photo 8 shows the wirings around the right side of the engine compartment, which is in the immediate vicinity where the fire to the Insured Vehicle had likely started. The wirings (red arrows) were found to have been burnt internally to its bare copper state, suggesting occurrence of an electrical short circuit.

25. The possibility of the fire being due to electrical in nature would then seem more likely given that engine overheating and external factors would both seem unlikely. The fire being due to electrical nature is also supported by the condition of the wirings around the right portion of the engine compartment of the Insured Vehicle, which was earlier discussed in paragraph 11 above.

27. Having investigated and technically analysed the damages of burnt nature to the Insured Vehicle, we are of the view that the cause of fire to the Insured Vehicle was of electrical in nature. For this particular case, the fire had originated along the wirings around the engine compartment. The wirings were original factory wirings inside the engine compartment of the Insured Vehicle.

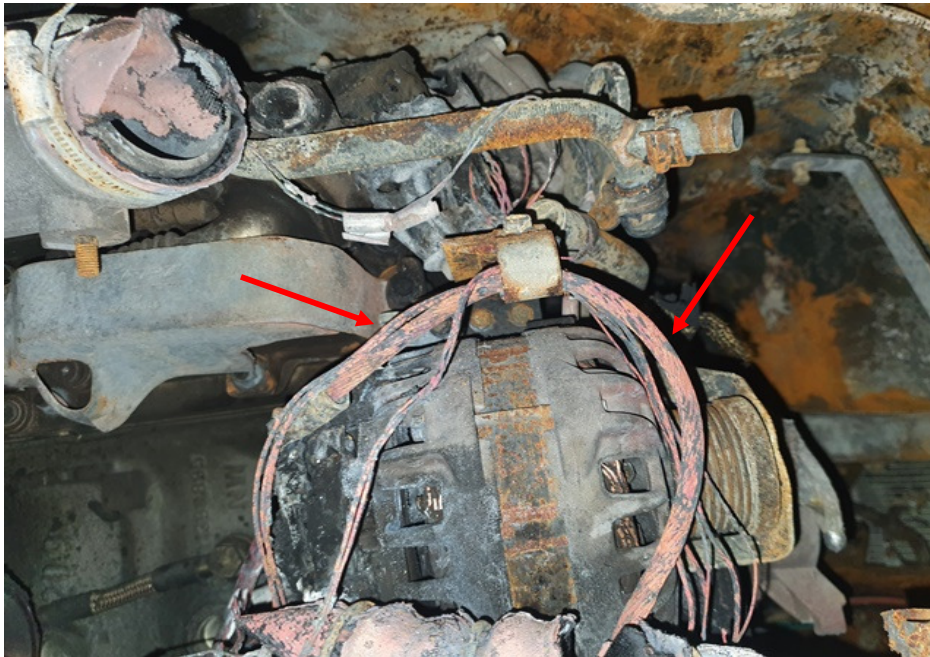
Photo 9 shows a closer view of the wirings (red arrows) which were found to have been burnt internally to its bare copper state, suggesting occurrence of an electrical short circuit.

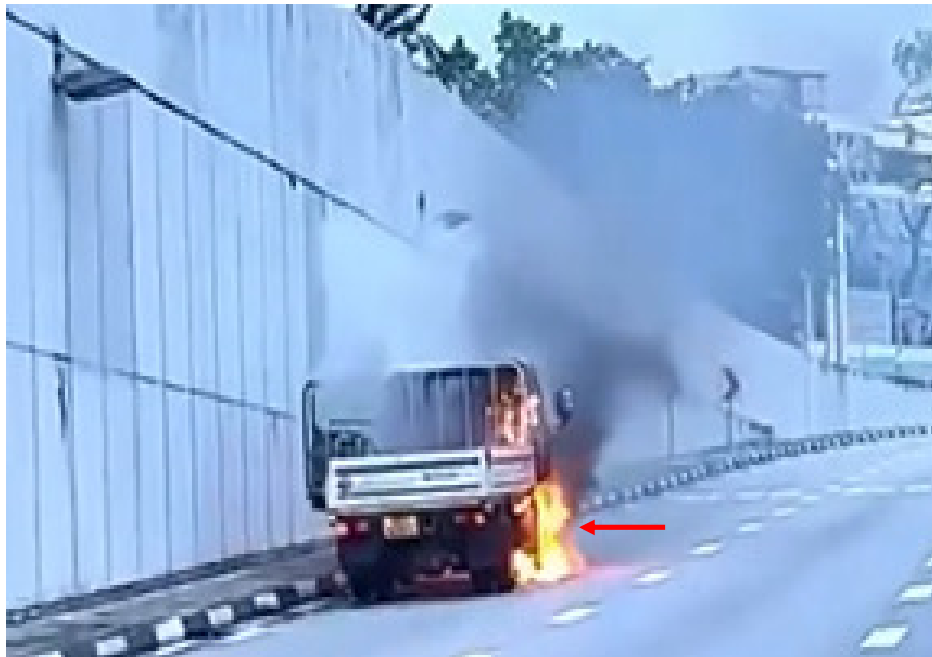
Photo 10 shows the Insured Vehicle on fire before the arrival of the SCDF. In general, the information that could be gathered from this photograph had corresponded to the events that were related to us by Mr Tay, which is the fire had started from the engine compartment (arrowed).

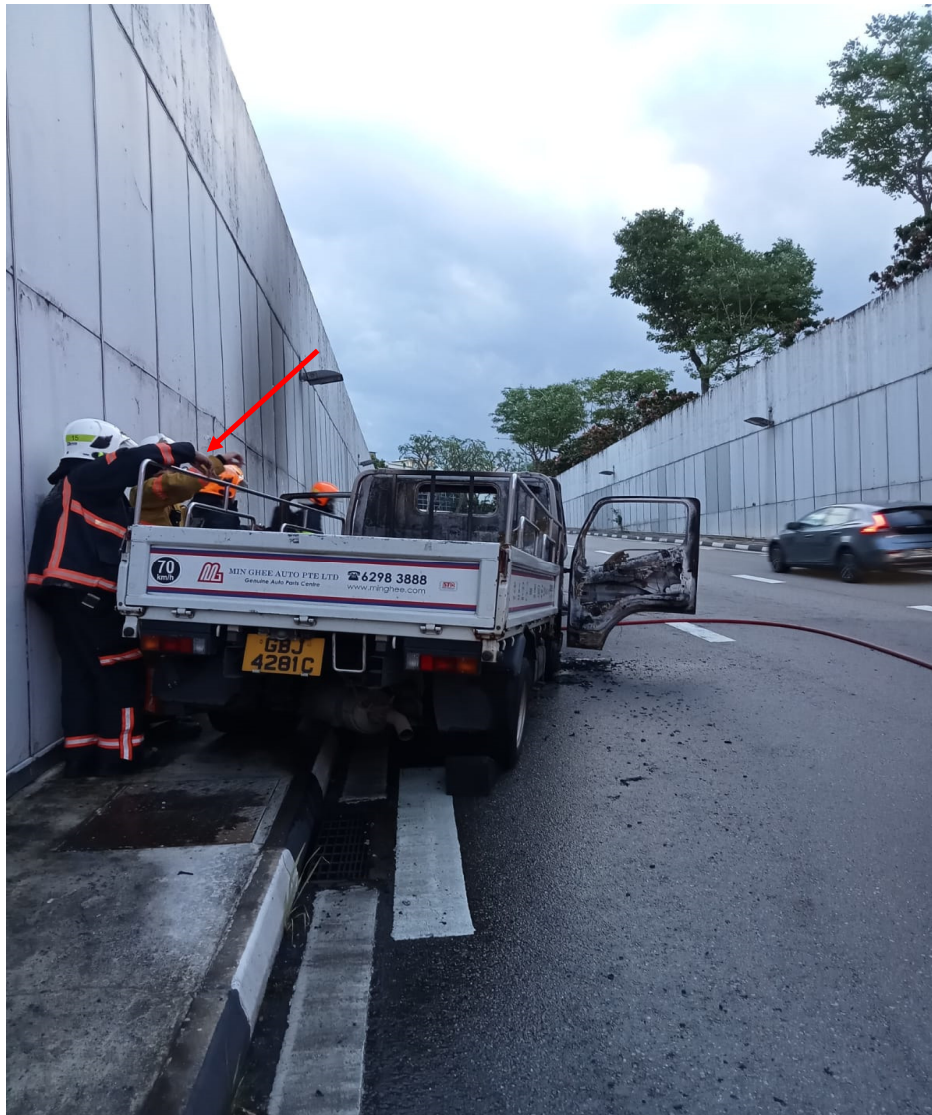
Photo 11 shows the Insured Vehicle after the fire was extinguished. In general, the information that could be gathered from this photograph had corresponded to the events that were related to us by Mr Tay, which is the SCDF had responded to the incident (arrowed).
